RESIDENTIAL HOME INSPECTION

301 W 1st Ave
La Habra, CA 90631

MAY 6, 2026

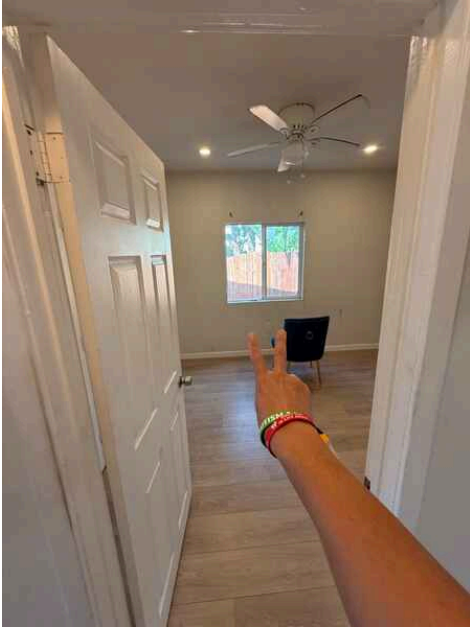
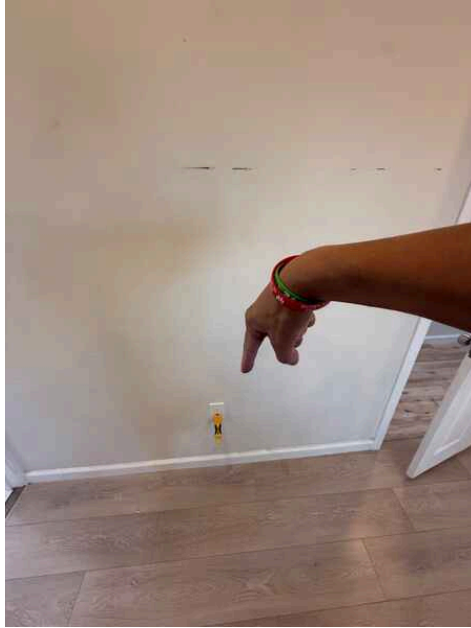
17.4.1 Switches, Fixtures & Receptacles

NO POWER AT OUTLET(S)

Recommend Electrician to evaluate and repair.

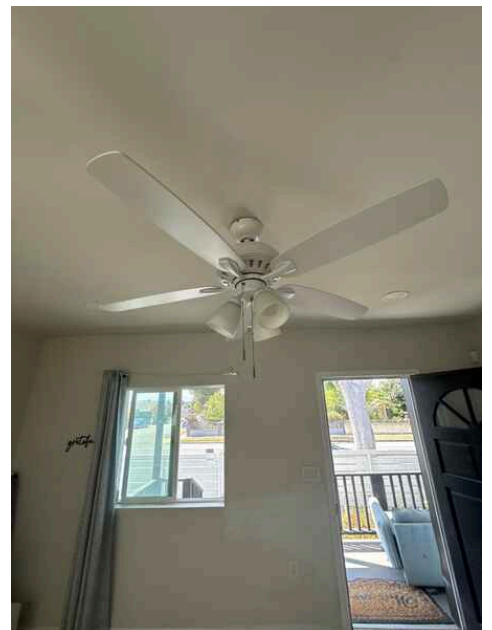
17.4.2 Switches, Fixtures & Receptacles

CEILING FAN DID NOT OPERATE

Recommend further evaluation and repair by a qualified professional.

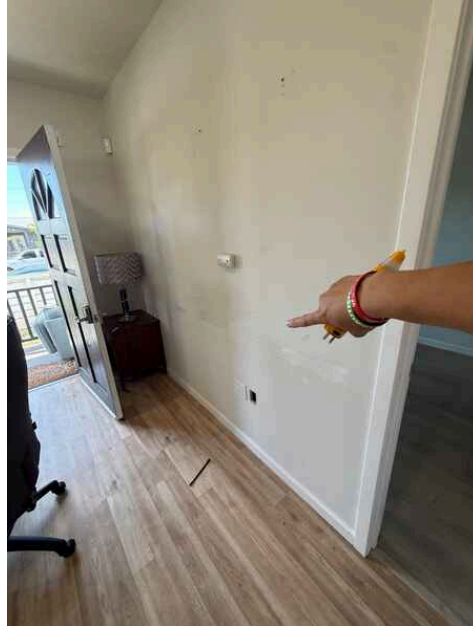
DAMAGE AT DRYWALL

Damage at drywall was observed. Servicing is recommended.

Contact a qualified professional.

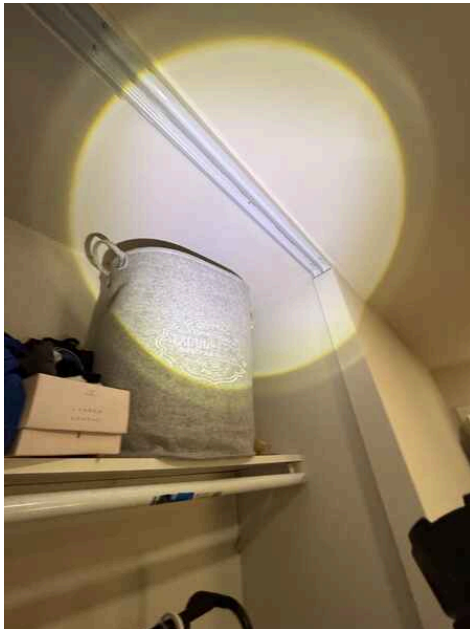
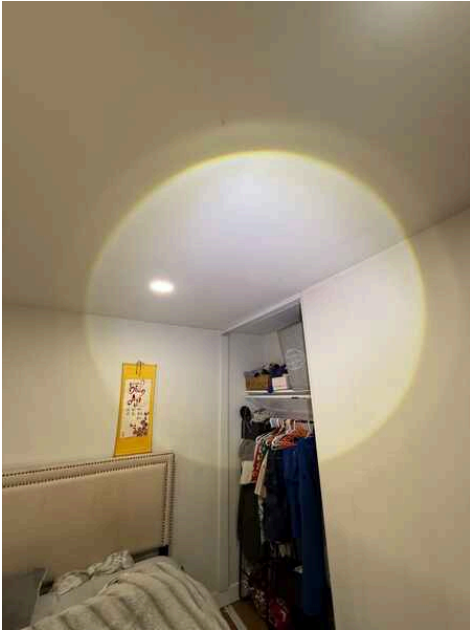
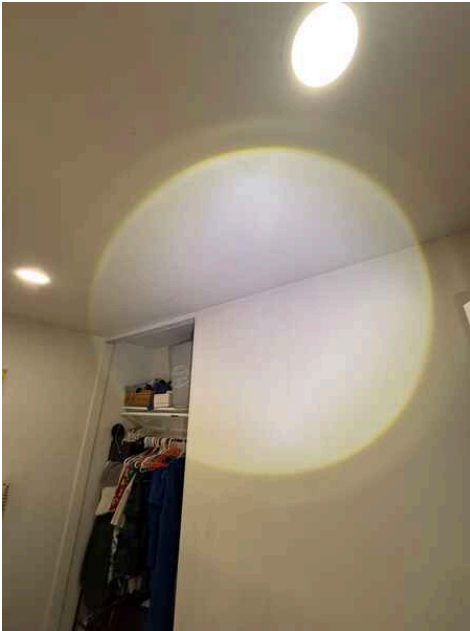
MOISTURE STAINING AT WALLS & CEILING

Moisture stains were observed at the walls and ceiling which suggest ongoing or past moisture issues. Further evaluation and servicing is recommended before the close of escrow.

Contact a qualified professional.

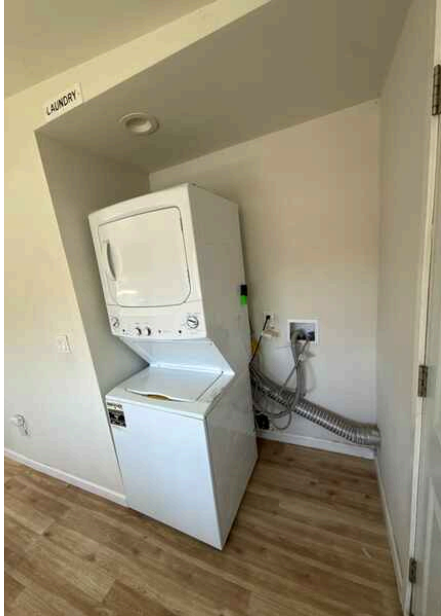
Laundry room was inspected.

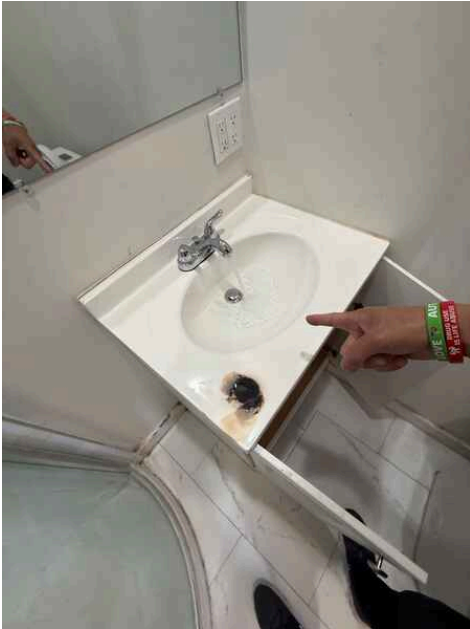
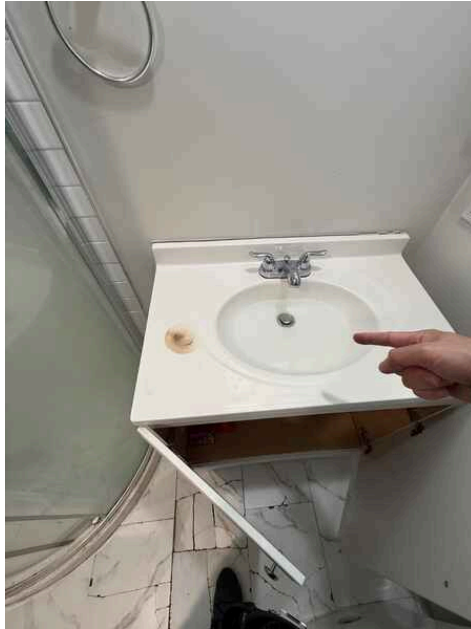
Recommend having the drain cleaned or serviced to restore proper flow.

Contact a qualified professional.

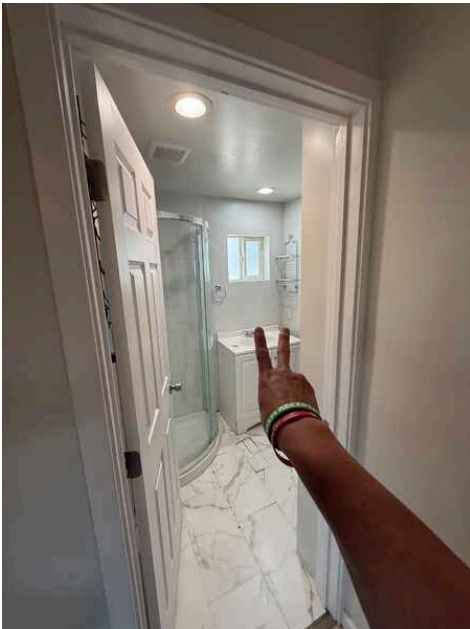
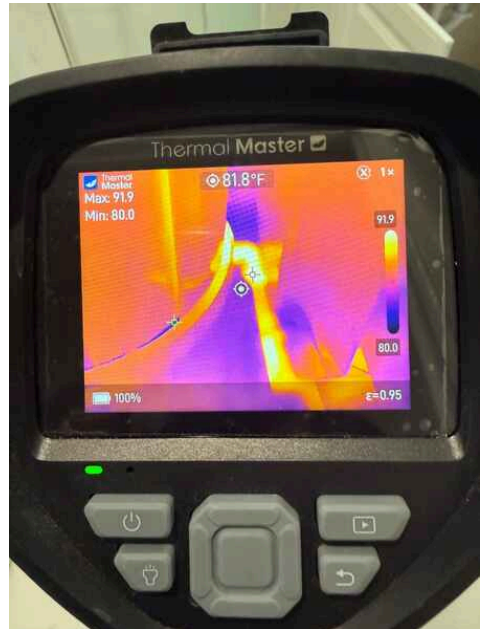
20.3.2 Sinks, Tubs & Showers

ACTIVE LEAK AT SHOWER

Active leak of observed at the shower.
 Moisture possibly penetrating through door.
 Evaluation and servicing is recommended.

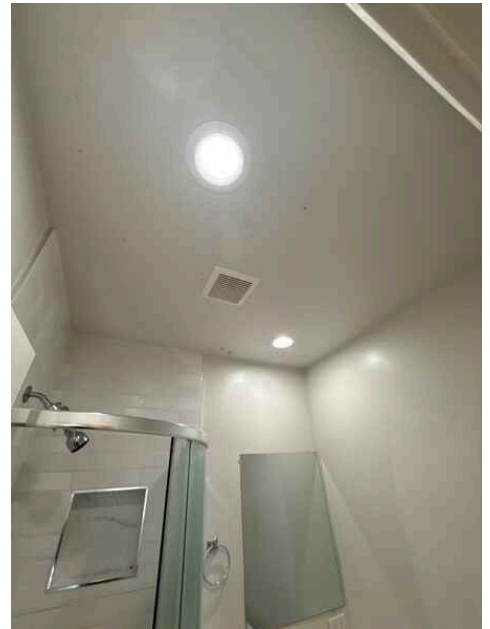
20.6.1 Heat Source in Bathroom

BATHROOM LACKS PERMANENT HEAT SOURCE

Contact a qualified heating and cooling contractor

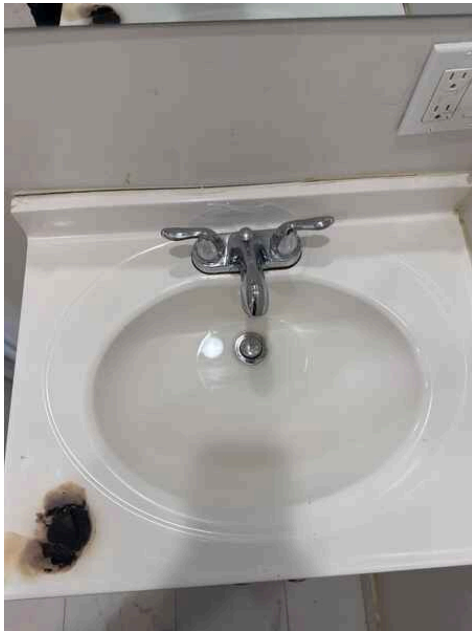
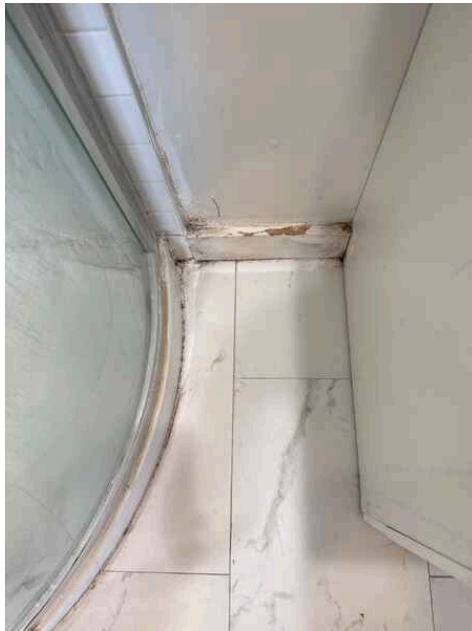
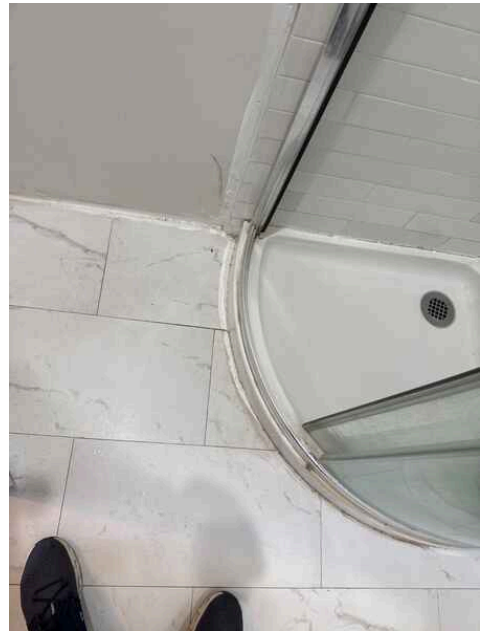
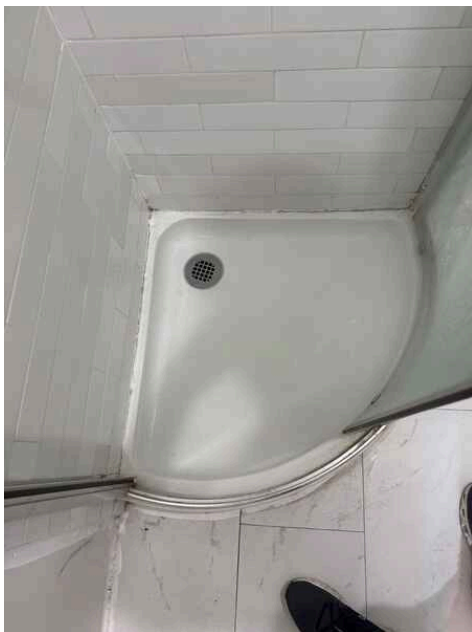
Lack of caulk and seal was observed.

Caulk and seal is recommended underneath the sink plumbing connections, shower tiles, ceiling, and baseboards to prevent moisture intrusion.

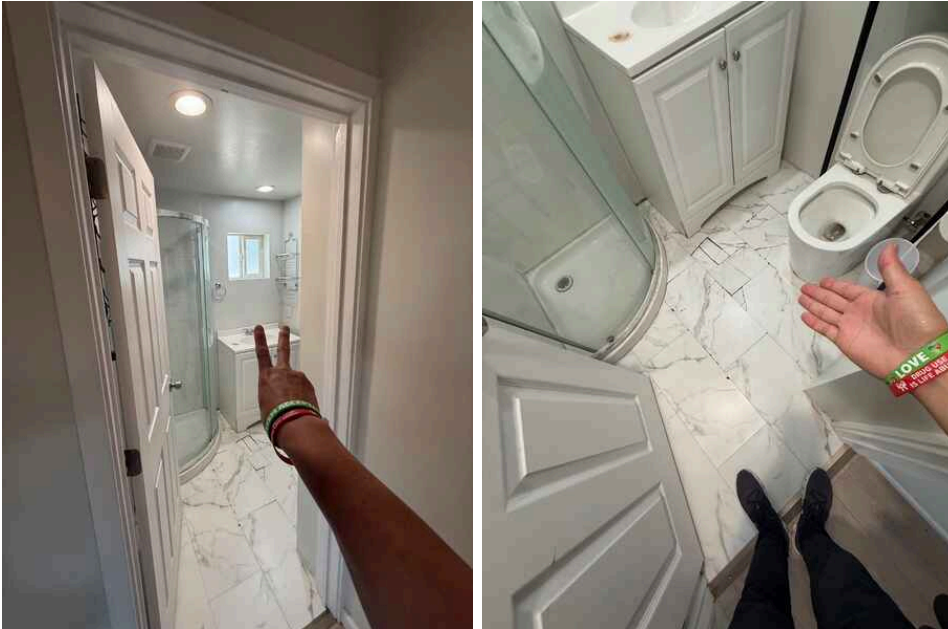
20.7.3 Cabinetry, Ceiling, Walls & Floor

FLOOR DAMAGE

Damage and cracks at the bathroom floor.

Correction is recommended to prevent further deterioration.

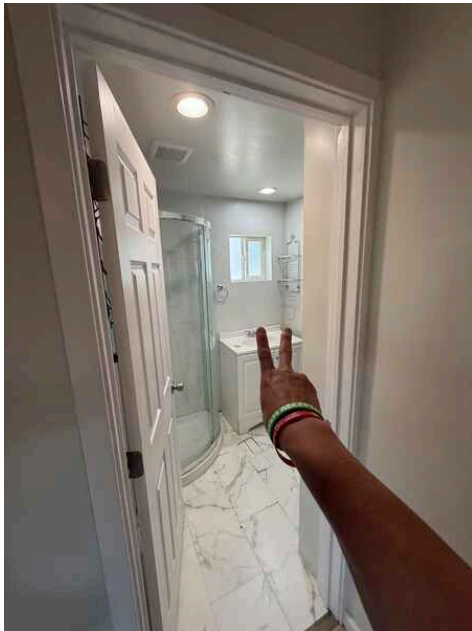
I observed that a door does not latch and close properly as intended.

Servicing is recommended.

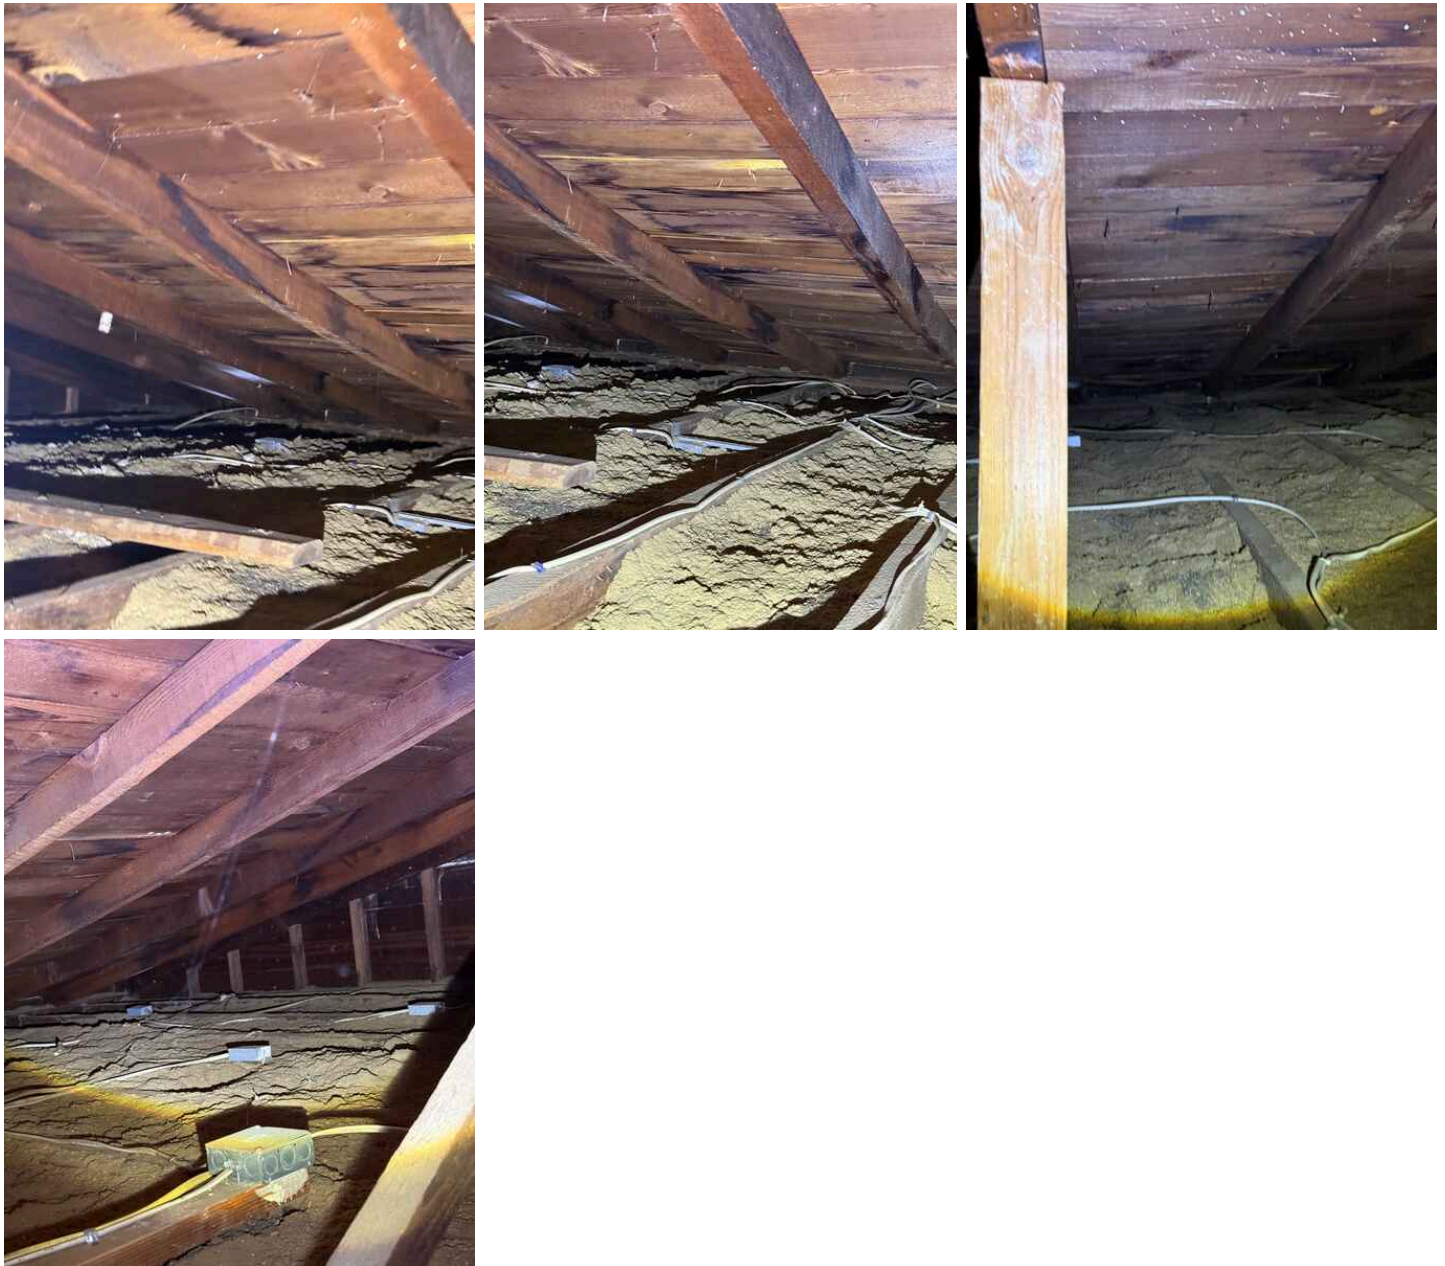
22.1.2 Structural Components & Observations in Attic

BATHROOM EXHAUST VENT DISCHARGING INTO ATTIC

Contact a qualified professional.

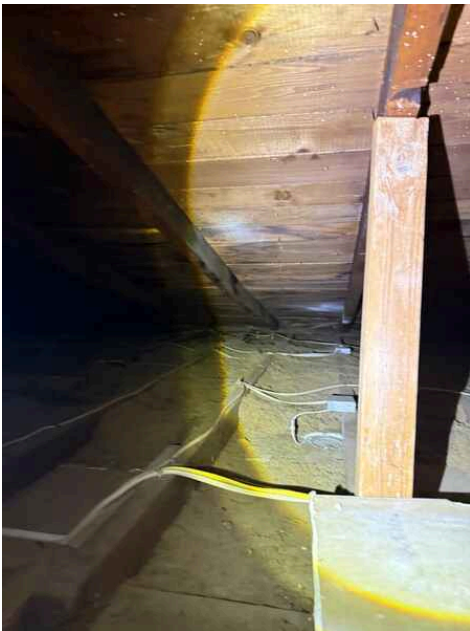
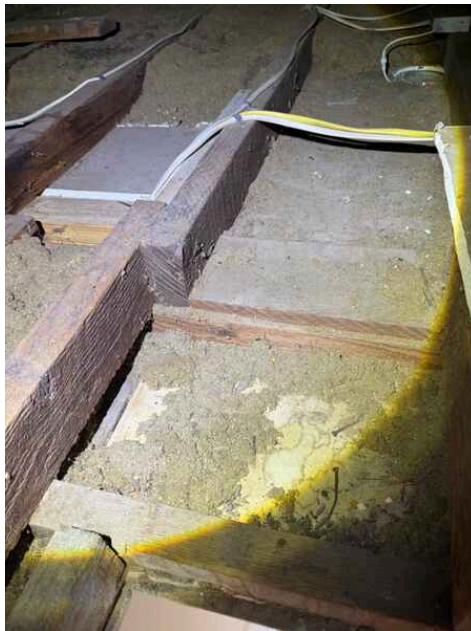
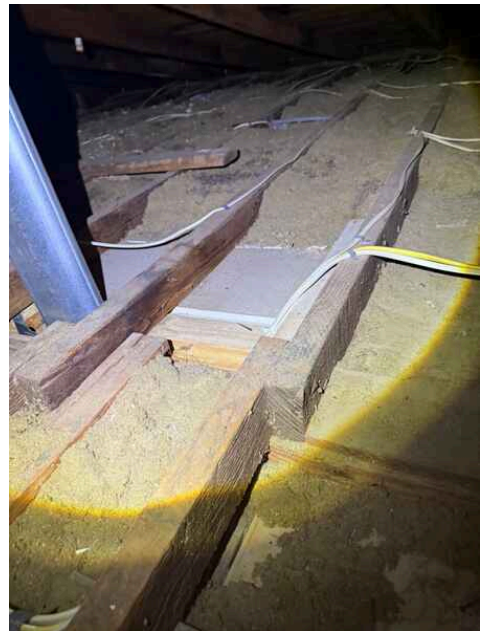
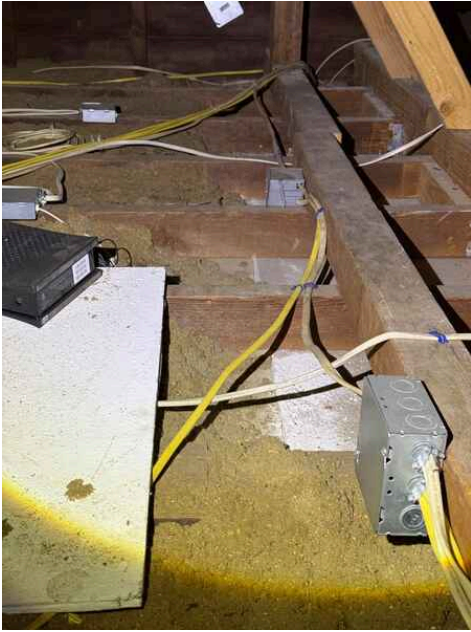
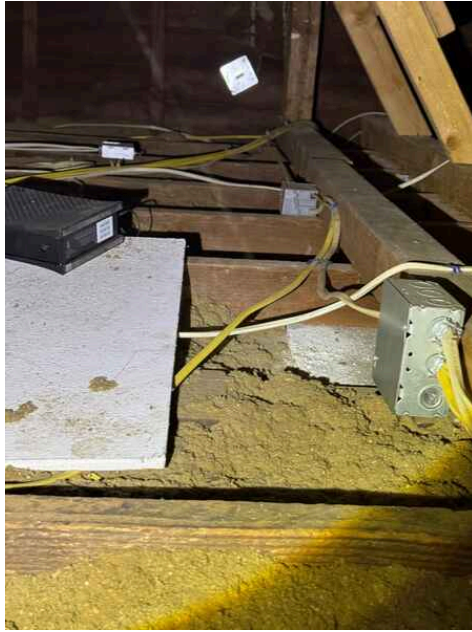
I observed indications that the home was not insulated and sealed properly. This condition will create a heat/energy loss area.

Adding additional insulation and air sealing at the attic access is recommended.

Contact a qualified professional.

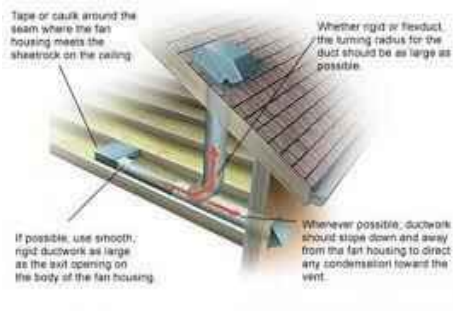
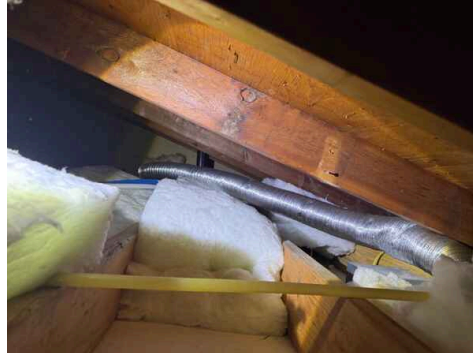
The bathroom exhaust vent is discharging moisture-laden air directly into the attic instead of being properly vented to the home's exterior. This condition can lead to elevated humidity, condensation, and potential mold or wood damage in the attic.

Recommend having the exhaust fans vent properly routed to the exterior by a qualified contractor.

Contact a qualified professional.
