HOME INSPECTION SERVICE

Property Inspection Report

Property Address: 179 Pomona Ave Long Beach, CA

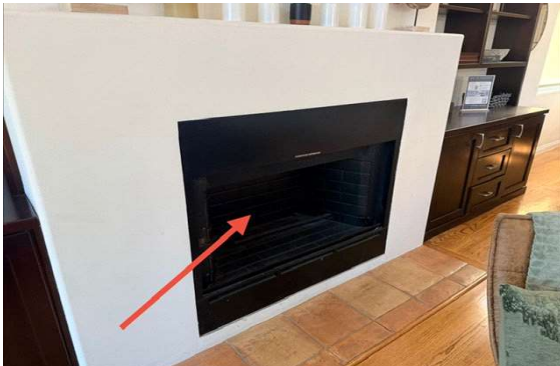
Ceiling	X			
Walls	X			
Floor Type	X			HARDWOOD TYPE MATERIAL.
Windows	X			
Entry Door	X	X		PATCH AT MID, CAUSE UNKNOWN.
Sliding Glass Doors	X			
Fireplace	X		X	(GAS OPERATION).SOOT BUILD UP, RECOMMEND TO BE CLEANED. MISSING SPARK SCREEN, SAFETY CONCERN.
Electrical	X			
Door Bell	X			
General Notes	+	+	+	FLOORING THROUGH OUT HOME UNEVEN, CAUSE UNKNOWN, REVIEW WITH SELLER. NOT RATED. AT 1ST FL. SINGLE GLASS PANE WINDOW THROUGH OUT HOME. RECOMMEND UP DATE. SOME SCRATCHES, STAINS, NICKS AT AREAS TO FLOORING THROUGH OUT HOME.

Inspection Area		Good	Fair	Poor	Comment
Living Room	Fireplace				(GAS OPERATION).SOOT BUILD UP, RECOMMEND TO BE CLEANED. MISSING SPARK SCREEN, SAFETY CONCERN.
Loft Area	Windows				DOES NOT OPERATE PROPERLY. APPEAR TO BE PAINTED SHUT.
Under House	Note				UNABLE TO VIEW /INSPECT DUE TO BLOCKED ACCESS, RECOMMEND FURTHER INSPECTION.
Water Heater	Gas Valve - Gas Li				MISSING DRIP LEG, NTBS.

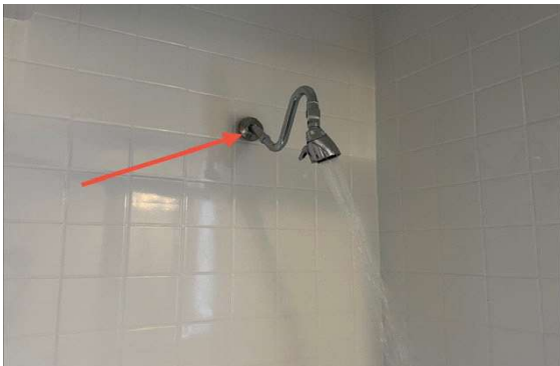
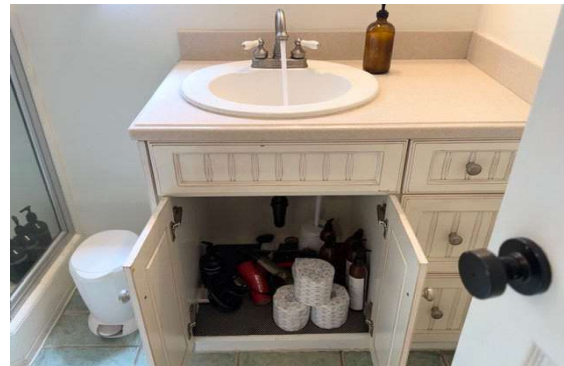
Bathroom 2 Game Room

Ceiling	X			
Walls	X			
Floor Type	X			TILE.
Windows	X		X	IMPROPER, NTBS.
Doors	X			
Counter Tops	X			
Cabinets	X			
Sinks	X	X		STOPPER DOES NOT OPERATE PROPERLY.
Mirrors	X			
Shower	X	X		SUPPLY LINE LOOSE IN WALL.
Shower Walls	X	X		SOME CRACKS IN GROUT.
Shower Enclosure	X	X		CORROSION AT CORNERS.
Toilet	X			
Plumbing	X			
Electrical	X			
GFI's	X

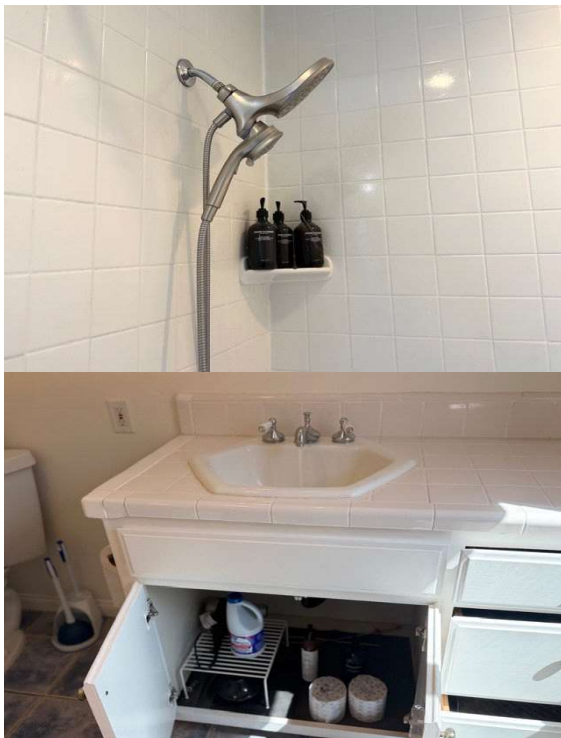
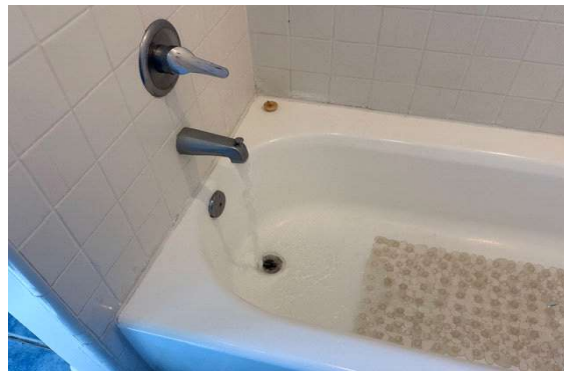
Inspection Area	Good	Fair	Poor	Comment
Bathroom 3 W				
Ceiling	X			
Walls	X			
Floor Type	X			
Windows	X			
Doors	X			
Counter Tops	X			
Cabinets	X			
Sinks	X	X		STOPPER DOES NOT OPERATE PROPERLY.
Mirrors	X			
Bath Tub	X	X		STOPPER DOES NOT OPERATE PROPERLY, NEEDS ADJUSTMENT.
Shower	X	X		SUPPLY LINE LOOSE IN WALL.
Shower Walls	X	X		BLACK STAINS, CRACKS IN GROUT/CAULKING.
Shower Enclosure	+	+	+	(CURTAIN). NOT EVALUATED. NOT RATED.
Toilet	X			
Plumbing	X			
Electrical	X			
GFI's	X

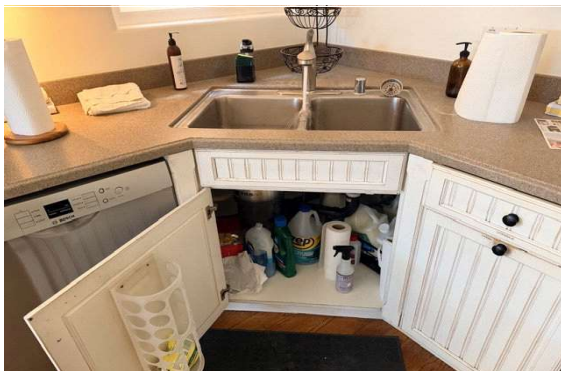
Inspection Area	Good	Fair	Poor	Comment
Kitchen				
Ceiling	X			
Walls	X			
Floor Type	X			HARDWOOD TYPE MATERIAL.
Windows	X			
Counter Tops	X			
Cabinets	X			
Sink	X			
Hand Sprayer	X			
Dishwasher	X			A FULL CYCLE IS NOT POSSIBLE DURING THE INSPECTION, THEREFORE WE CANNOT COMMENT ON THE FULL EXTENT OF ITS FUNCTIONS OR THE ABILITY TO CLEAN.
Drain Loop	X			
Disposal	X			
Sink Plumbing	X			
Range	X			(GAS). START UP TEST ONLY. REVIEW WITH SELLER.
Oven	X			(ELECTRIC). START UP TEST ONLY, REVIEW WITH SELLER.
Fan and Hood	X			
Venting	X			
Electrical	X			
GFI's	X			
Microwave	X

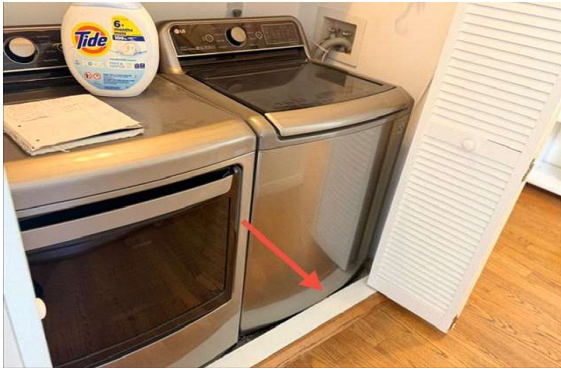
Inspection Area	Good	Fair	Poor	Comment
Laundry Room				
Laundry Location	+	+	+	2ND FL.NOT RATED.
Ceiling	X			
Walls	X			
Floor Type	X		X	MISSING DRIP PAN, NTBS.
Doors	X			
Dryer Vent	X		X	SOME DEBRIS, NEED TO BE CLEARED.
Laundry Plumbing	X			
Waste Line	X			
Gas Line	+	+	+	UNABLE TO VIEW DUE TO POSITION OF WASHER / DRYER. NOT RATED.
Electrical	X		X	OUTLET(S) NOT GFI PROTECTED, NTBS.

Hallways	Windows	DAMAGED PANE OBSERVED N/E
Hallways	Smoke - Carbon D	MISSING, NTBS. 1ST FL.
Heating Cooling	Heating Electrical	EXPOSING WIRES, NTBS. AT SEAL TIGHT, SAFETY CONCERN.
Heating Cooling	Gas Valve	MISSING DRIP LEG, NTBS
Heating Cooling	Filters	NEEDS TO BE CLEANED OR REPLACED.
Laundry Room	Floor Type	MISSING DRIP PAN, NTBS.
Laundry Room	Dryer Vent	SOME DEBRIS, NEED TO BE CLEARED.
Laundry Room	Electrical	OUTLET(S) NOT GFI PROTECTED, NTBS.

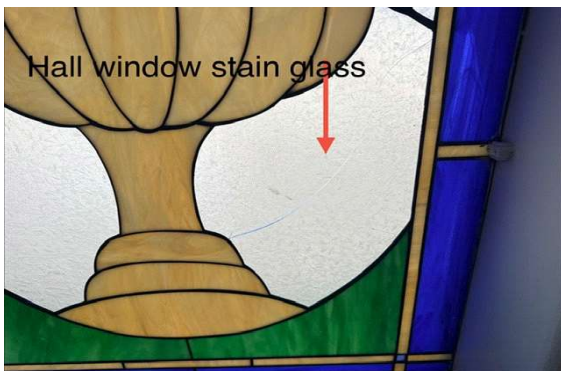
Inspection Area	Good	Fair	Poor	Comment
Hallways				
Ceiling	X			
Walls	X			
Floor Type	X	X		HARDWOOD TYPE MATERIAL. STAINS SCRATCHES.
Windows	X		X	DAMAGED PANE OBSERVED N/E
Doors	X			
Electrical	X			
Smoke - Carbon Detectors	X		X	MISSING, NTBS. 1ST FL.
Stairs	X			
Hand Rails	X

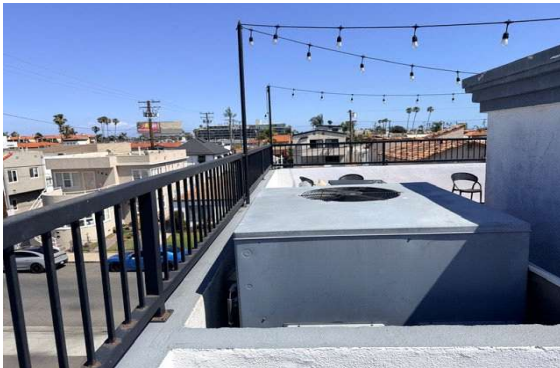
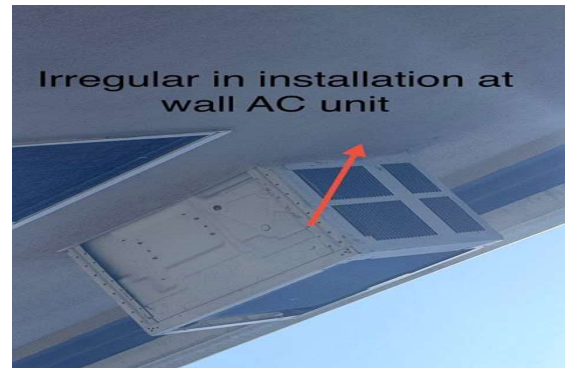
Unit Location	+	+	+	EXTERIOR ROOF DECK. NOT RATED.
Heat Type	+	+	+	PACKAGE UNIT. NOT RATED.
BTUs	+	+	+	UNKNOWN, REVIEW WITH SELLER. NOT RATED.
Heater Condition	X			NOTE: CONDUCTED PERFORMANCE TEST ONLY. RECOMMEND SERVICE. RECOMMEND FURTHER INSPECTION. (OLDER UNIT).
Temp Differentials	X			
Heating Electrical	X		X	EXPOSING WIRES, NTBS. AT SEAL TIGHT, SAFETY CONCERN.
Enclosure	X			
Gas Valve	X		X	MISSING DRIP LEG, NTBS
Vent	X			
Combustion Air	X			
Filters		X	X	NEEDS TO BE CLEANED OR REPLACED.
Thermostats	X			
Registers	X			RECOMMEND SERVICE.

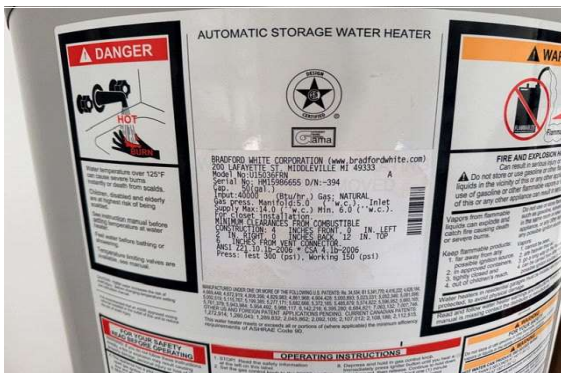
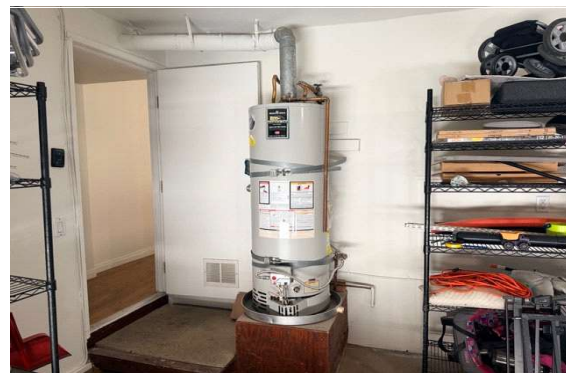
Inspection Area	Good	Fair	Poor	Comment
Unit Location	+	+	+	AT GARAGE. NOT RATED.
Type -Mfg-Year	+	+	+	GAS. (BRADFORD / WHITE). NOT RATED. RECOMMEND SERVICE.
Gallons	+	+	+	50. NOT RATED.
Unit Condition	X			
Wtr Htr Plumbing	X			
T.P.R.V.	X			
Overflow Line	X			
Wtr Htr Strapping	X			
Wtr Htr Electrical	X			
Gas Valve - Gas Line	X		X	MISSING DRIP LEG, NTBS.
Vent Pipe	X			
Combustion Air	X			
Base - Platform	X

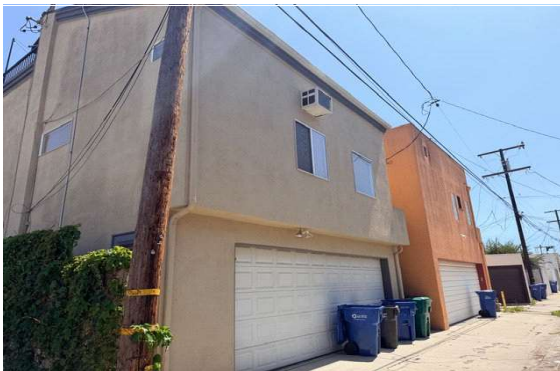
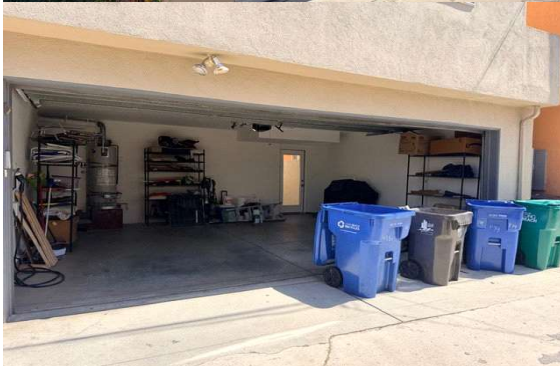
Garage / Carport

Inspection Area	Good	Fair	Poor	Comment
Garage General Info	+	+	+	LIMITED INSPECTION DUE TO PERSONAL PROPERTY. NOT RATED.
Vehicle Doors	X			
Hardware - Springs	X			
Opener	X			
Infrared Sensors	X			
Ceiling	X			
Walls	X			
Fire Wall	X		X	EXPOSED OPENINGS, NTBS.
Door to Interior	X			
Exterior Door	X		X	DAMAGED GLASS.
Slab	X	X		(CONCRETE). SLIGHT CRACKS IN AREAS.
Garage Electrical	X			
Ventilation	X			
General View	X

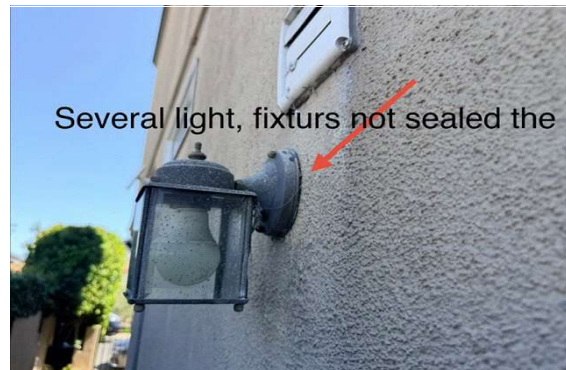
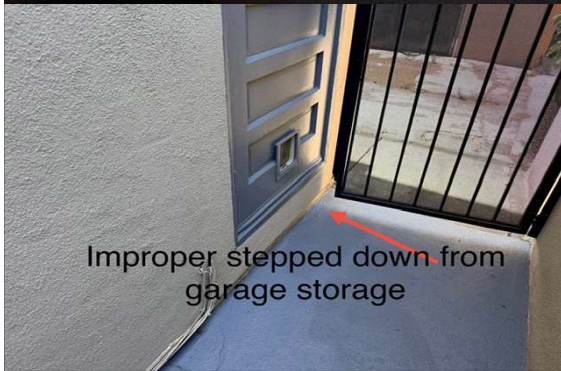
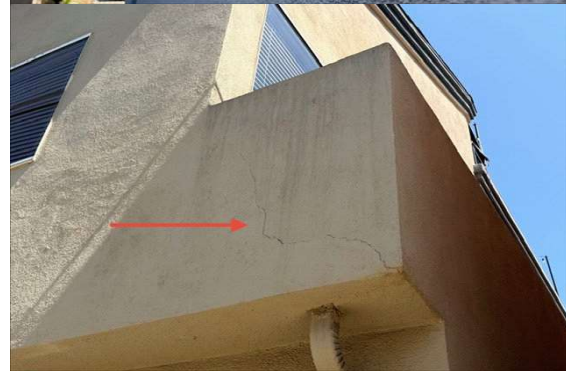
Inspection Area	Good	Fair	Poor	Comment
Exterior Items				
Exterior Walls	X	X		(WOOD FRAME) IMPROPER INSTALLATION AT WINDOW A/C UNIT, NOTE: NOT TESTED, REVIEW WITH SELLER.
Siding	X		X	(STUCCO). SOME EXPOSED OPENINGS, CRACKS, BLISTERING, STAINS IN AREAS. LARGE CRACK AT N/W ABOVE GARAGE.
Eaves and Fascia	X			
Soffits	X			
Trim	X	X		MINOR DETERIORATION, CRACKS, NEEDS CAULKING IN AREAS.
Paint	X			
Windows	X

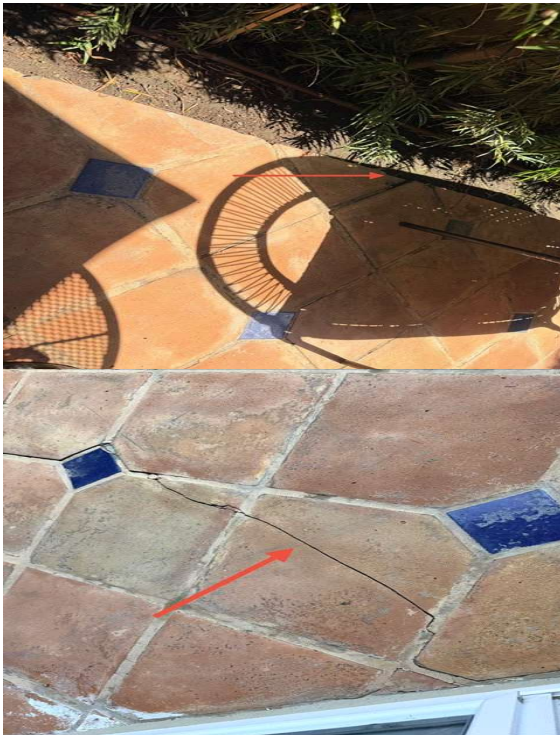
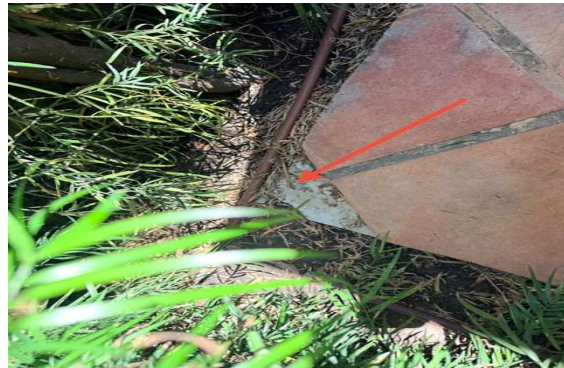
Inspection Area	Good	Fair	Poor	Comment
Grounds				
Driveway	X	X		(CONCRETE).SOME CRACKS IN AREAS.
Sidewalks	X	X		(PAVERS). (CONCRETE). (TILE PAVER). SOME CRACKS IN AREAS.
Patio Deck	X		X	DAMAGED/CRACKED TILE.
Grade	X	X		IMPROPER GRADE IN AREAS.
Balcony	X	X		EXPOSED BOLTING AT WALL AREAS.
Door	X		X	IMPROPER STEP DOWN OFF GARAGE N/. SAFETY CONCERN.
Fence - Walls	X			NOTE: LIMITED INSPECTION DUE TO VEGETATION, UNABLE TO VIEW ALL AREAS. CORROSION / RUST IN AREAS AT ROOF DECK.
Gates	X		X	FRONT GATE STRIKER DOES NOT OPERATE.
General Note	+	+	+	ADDITIONS ARE NOT CHECKED FOR PERMITS OR CODE COMPLIANCE, RECOMMEND REVIEW WITH SELLER/AGENT. NOT RATED.

Section	Line No.	Issue Description
Bathroom 2 Game Roo	Windows	IMPROPER, NTBS.
Bathroom Master	Shower Enclosure	APPEARS TO LEAK MOISTURE STAINS/CORROSION AT CORNERS.
Bathroom Master	Plumbing	TUB SHOWER WAND DOES NOT OPERATE PROPERLY..
Bedroom Master	Smoke Detector	IMPROPER LOCATION, SHOULD BE NO GREATER THEN TWO FEET FROM DOOR FRAME
Electrical	Main Panel	MINOR RUST TO BOX. INSIDE COVER IMPROPER, NTBS EXPOSED OPENING.
Electrical	Panel Wiring	SPLICED WIRING IN PANEL, NTBS, SAFETY CONCERN.
Electrical	Breakers	NOT ALL BREAKERS ARE NOT CLEARLY LABELED / IDENTIFIED, NTBS.
Exterior Items	Siding	(STUCCO). SOME EXPOSED OPENINGS, CRACKS, BLISTERING, STAINS IN AREAS. LARGE CRACK AT N/W ABOVE GARAGE.
Garage / Carport	Fire Wall	EXPOSED OPENINGS, NTBS.
Garage / Carport	Exterior Door	DAMAGED GLASS.
Grounds	Patio Deck	DAMAGED/CRACKED TILE.
Grounds	Door	IMPROPER STEP DOWN OFF GARAGE N/. SAFETY CONCERN.
Grounds	Gates	FRONT GATE STRIKER DOES NOT OPERATE.

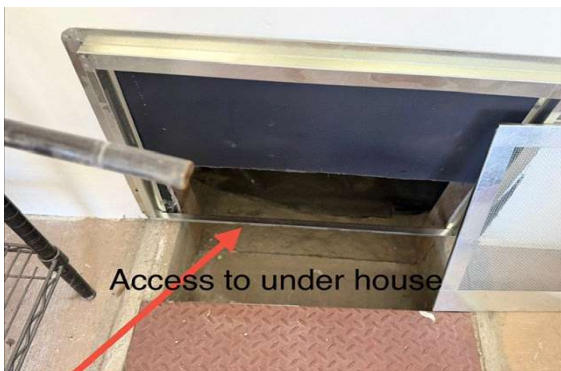
Under House

Note			X	UNABLE TO VIEW /INSPECT DUE TO BLOCKED ACCESS, RECOMMEND FURTHER INSPECTION.
Ventilation	X			
Vent Screens	X	X		SOME RUSTED.
Sub Floor	X	X		UNEVEN AT DINING ROOM AREAS, CAUSE UNKNOWN.
