## **HOME INSPECTION REPORT**

**21210 Arrow Hwy, Spc 36, Covina, CA**

Inspection Date: 1/10/2026  
Report Number: 11026covina

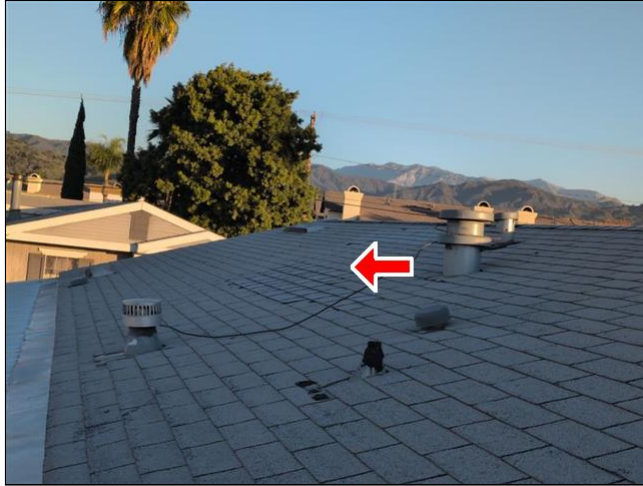
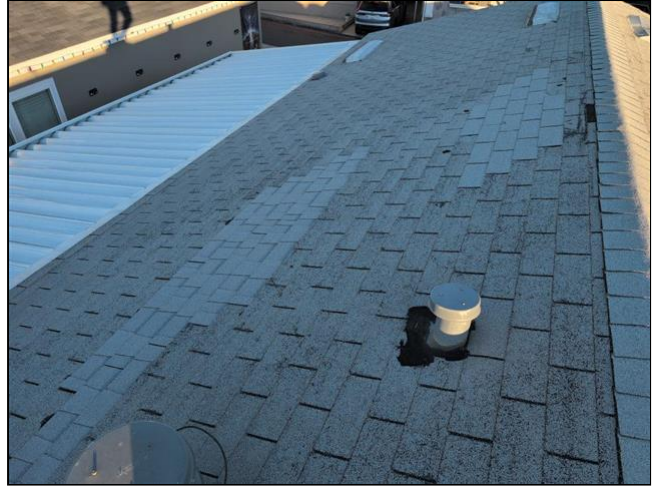
1.0 Item 1(Picture)

(2) Evidence of repairs observed. Unable to determine the cause or effectiveness of the repairs.

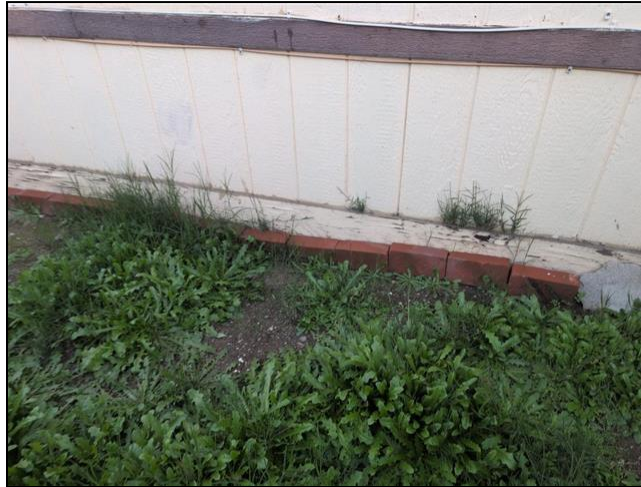
2.2 Item 1(Picture)

(1) Weathered wood at siding around the property. Suggest maintenance.

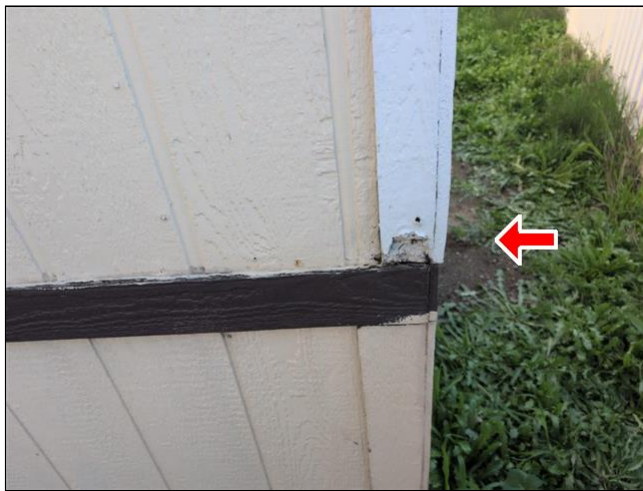
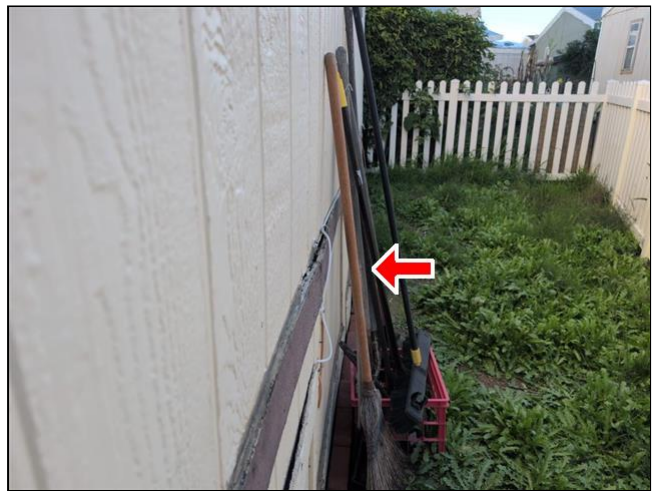
2.2 Item 2(Picture)

🏠 (2) Deterioration observed at the right side of the home. Recommend further evaluation by a licensed branch 3 pest inspector, prior to the end of the contingency period.

(2) Deterioration observed at the right side of the home. Recommend further evaluation by a licensed branch 3 pest inspector, prior to the end of the contingency period.

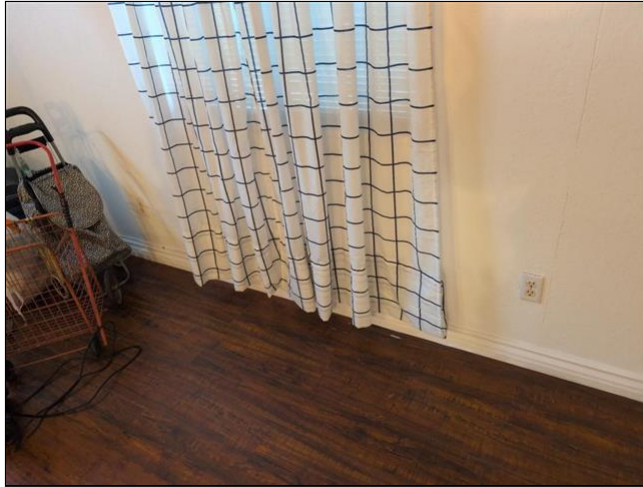
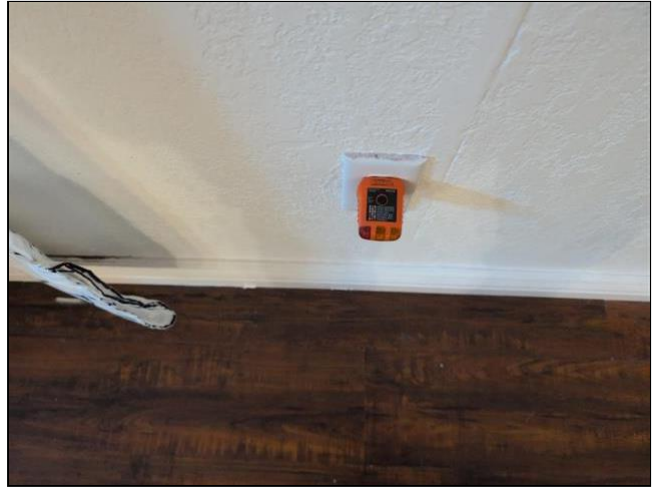
3.4 Item 1(Picture)

Inoperable outlet(s) observed at family room. Recommend correcting.

Inoperable outlet(s) observed at family room. Recommend correcting.

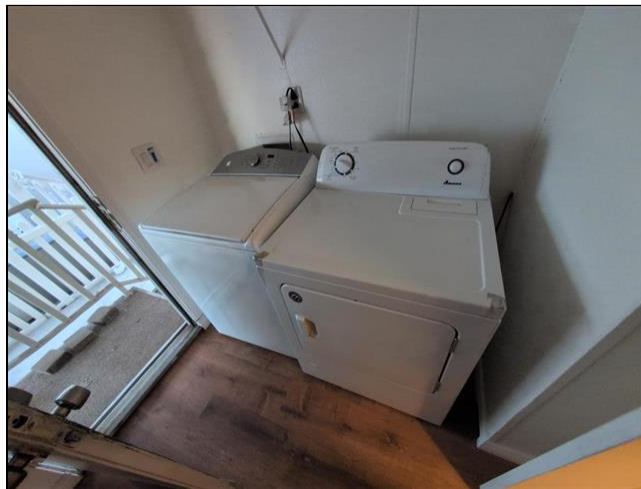
4.4 Item 1(Picture)

(1) Washer connections present. Faucet and drain not tested. Suggest verifying condition with the seller, prior to the end of the contingency period.

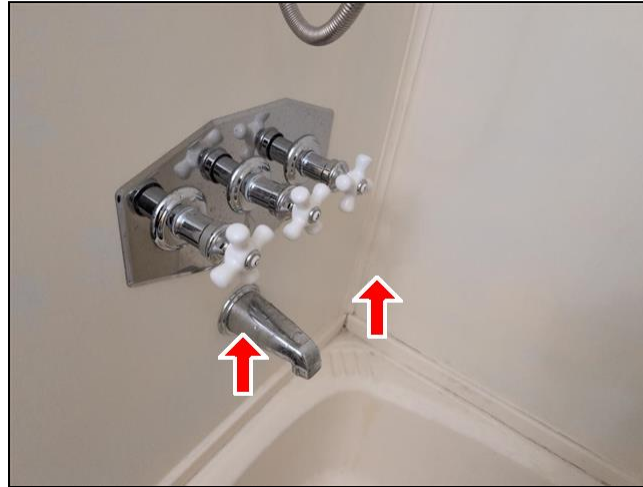
4.5 Item 1(Picture)

🏠 (2) Hot and cold are incorrectly identified at hall bathroom shower. Recommend correcting.

(2) Hot and cold are incorrectly identified at hall bathroom shower. Recommend correcting.

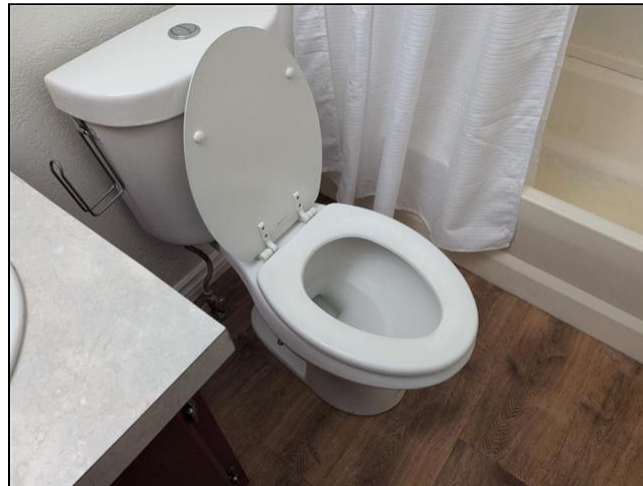
4.6 Item 1(Picture)

🏠 (1) Toilet base is not secured to the floor at bathroom. The wax ring at the base of the toilet must have a water tight seal, to prevent leakage from occurring. Recommend replacing the wax ring and securing the base to the floor.

(1) Toilet base is not secured to the floor at bathroom. The wax ring at the base of the toilet must have a water tight seal, to prevent leakage from occurring. Recommend replacing the wax ring and securing the base to the floor.

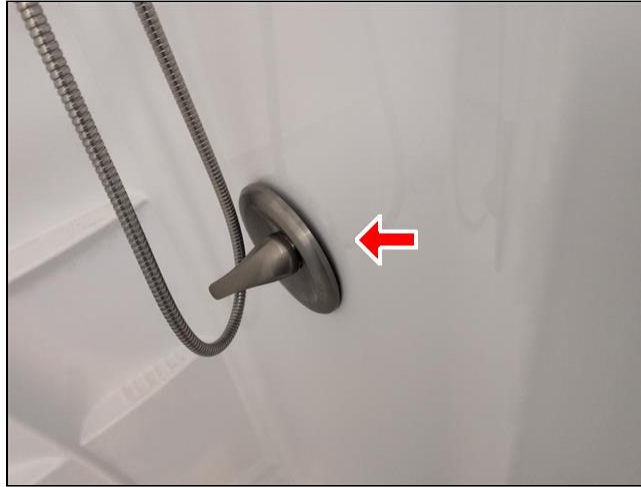
4.6 Item 2(Picture)

(2) Backing plate is not secured and caulked at master bathroom shower. Suggest maintenance

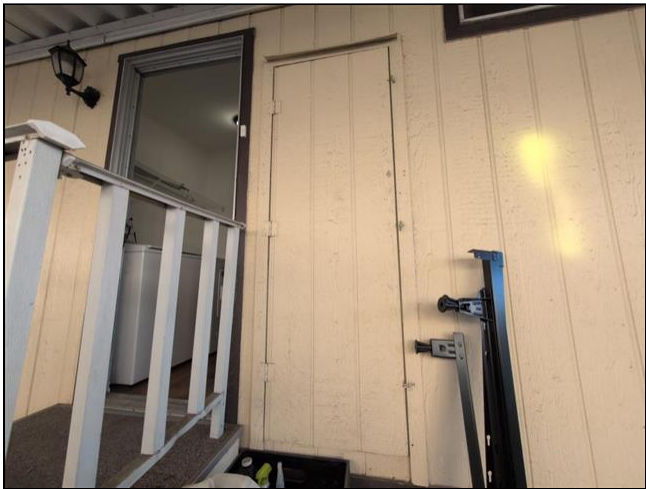
5.0 Item 1(Picture)

Inadequate ventilation observed at the heating closet. Recommend correcting.

Inadequate ventilation observed at the heating closet. Recommend correcting.

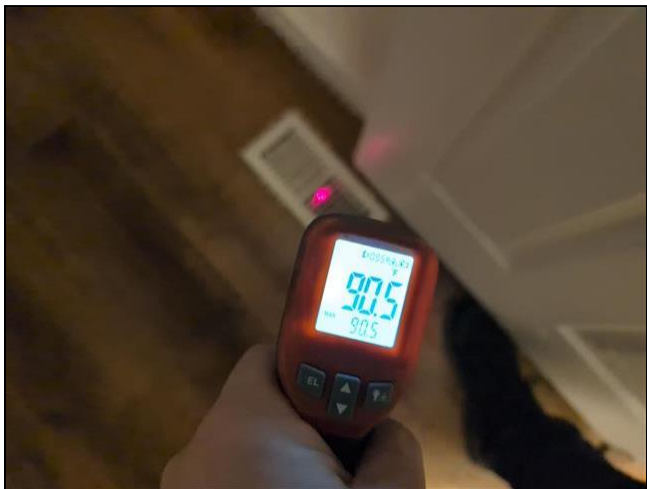
6.1 Item 1(Picture)

(1) Unit was tested using normal operating controls and provided heat at the service registers. Changing the air filters, servicing and regular maintenance of the components is necessary to prolong the service life of the system.

🏠 (2) The HVAC components and compartment are dirty/dusty. This can affect the operation of the system. Recommend contacting a qualified HVAC service technician for maintenance, prior to the end of the contingency period.

(2) The HVAC components and compartment are dirty/dusty. This can affect the operation of the system. Recommend contacting a qualified HVAC service technician for maintenance, prior to the end of the contingency period.

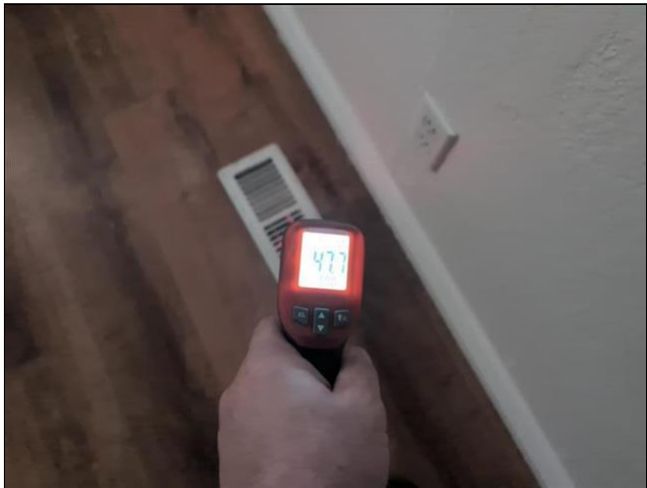
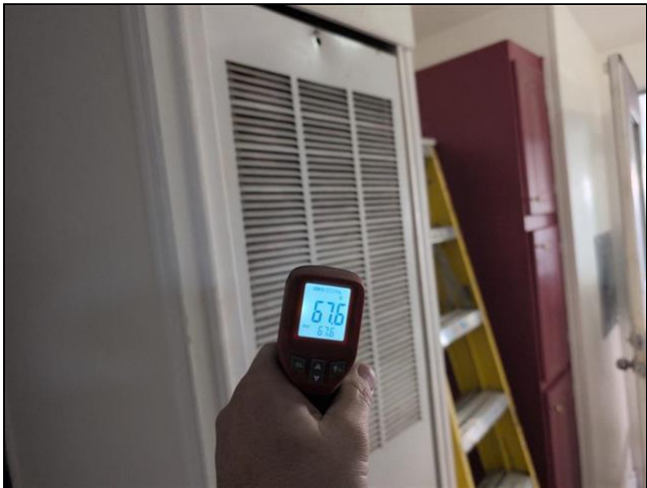
6.2 Item 1(Picture)

(1) The air conditioning system was operated using normal operation controls (thermostat). The difference between the return air vent and the service registers was between the recommended range of 15 to 20 degrees Fahrenheit. Changing the air filters, servicing and regular maintenance of the components is necessary to prolong the service life of the system.

🏠 (2) The HVAC components and compartment are dirty/dusty. This can affect the operation of the system. Recommend servicing.

(2) The HVAC components and compartment are dirty/dusty. This can affect the operation of the system. Recommend servicing.

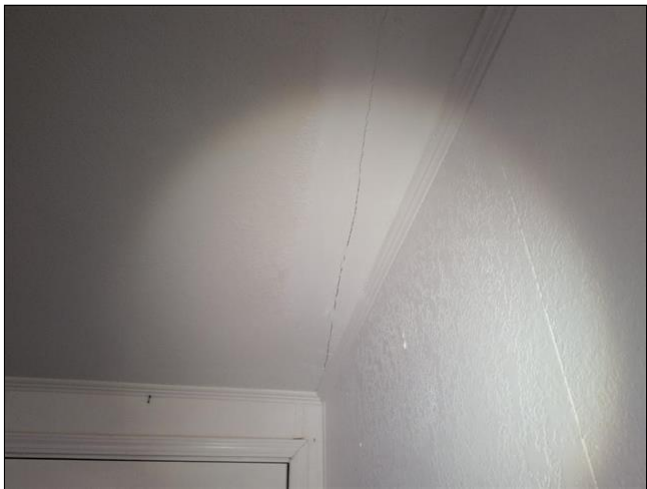
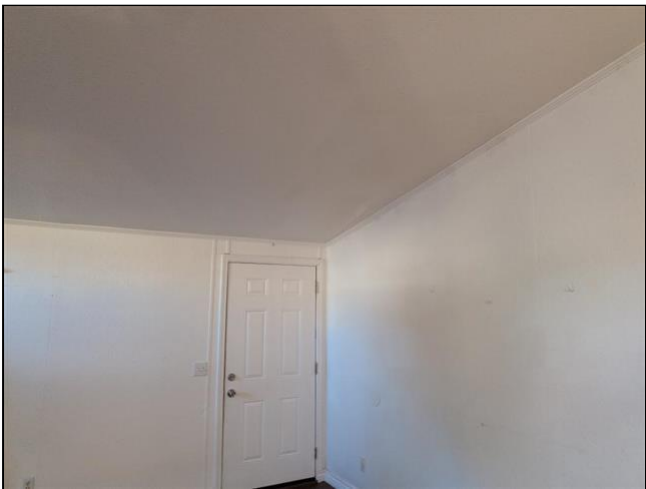
8.1 Item 1(Picture)

Crack at family room ceiling. Doors and windows in that area all closed with normal operation. No damage observed on exterior siding or roofing in that area. Unable to determine cause of crack. Suggest correcting.

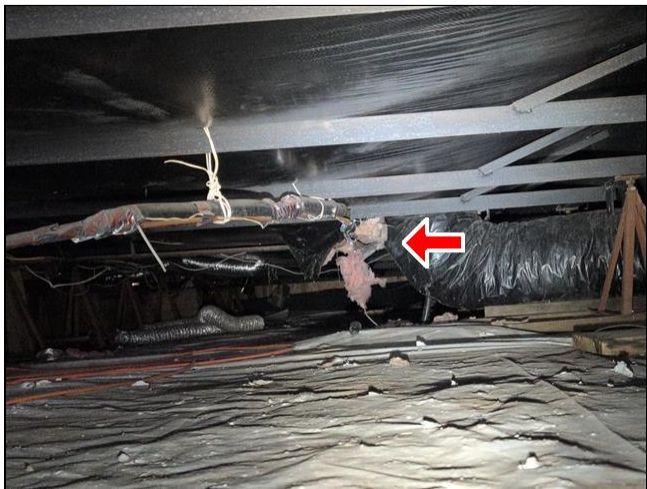
9.8 Item 1(Picture)

🏠 Insulation is loose in areas throughout the crawlspace. Recommend correcting.

Insulation is loose in areas throughout the crawlspace. Recommend correcting.

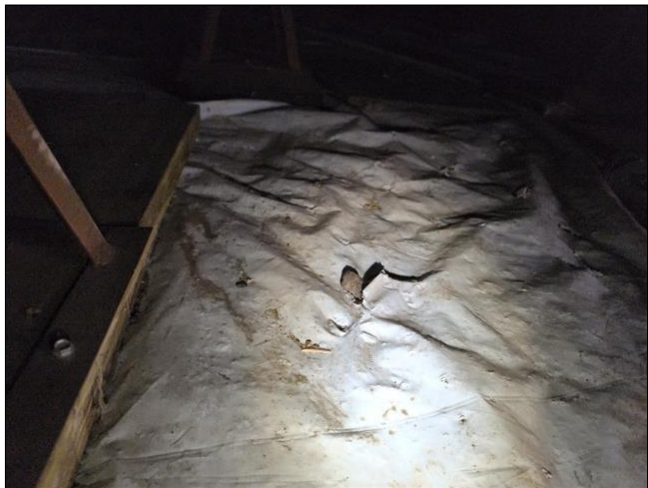
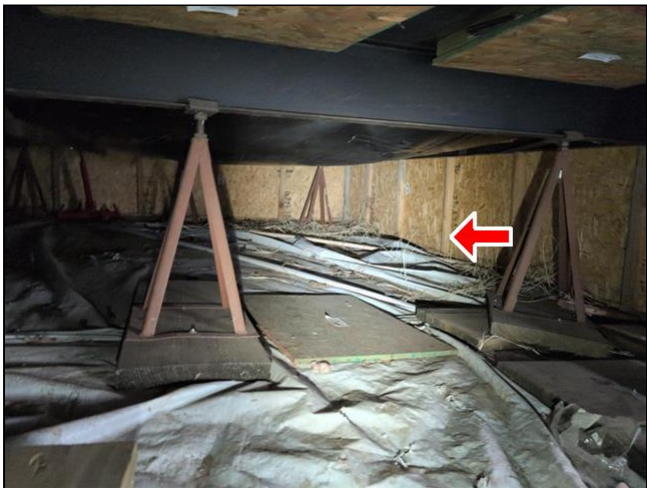
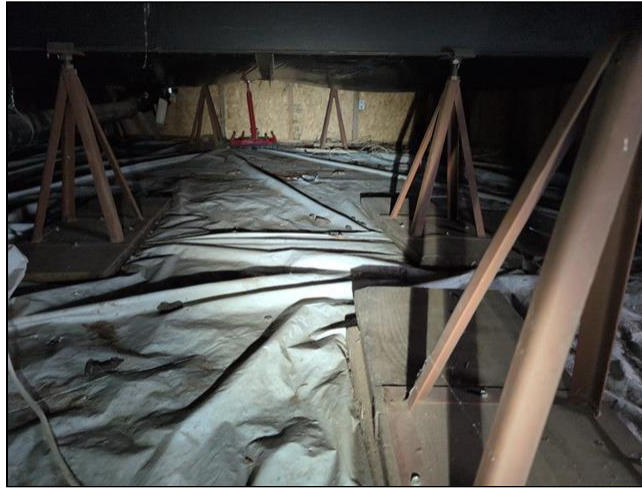
9.9 Item 1(Picture)

🏠 Animal droppings observed in the crawlspace. Recommend correcting.

Animal droppings observed in the crawlspace. Recommend correcting.
