Accurate Inspection Team LLC
Property Inspection Report

1002 E Leadora Ave, Glendora, Ca 91741
Inspection prepared for:
Date of Inspection: 4/8/2026 Time: 11:00 am
Age of Home: 1974 Size: 1861 sq ft
Weather: Sunny & Cool

Report Summary

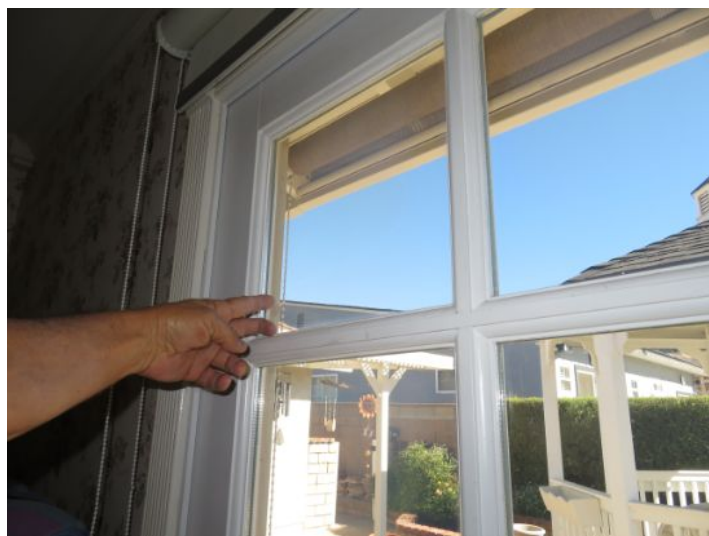
Observations: worn hardware, tempered glass, **condensation present between the glass, no switchable light source to the exterior**

condensation present between the glass

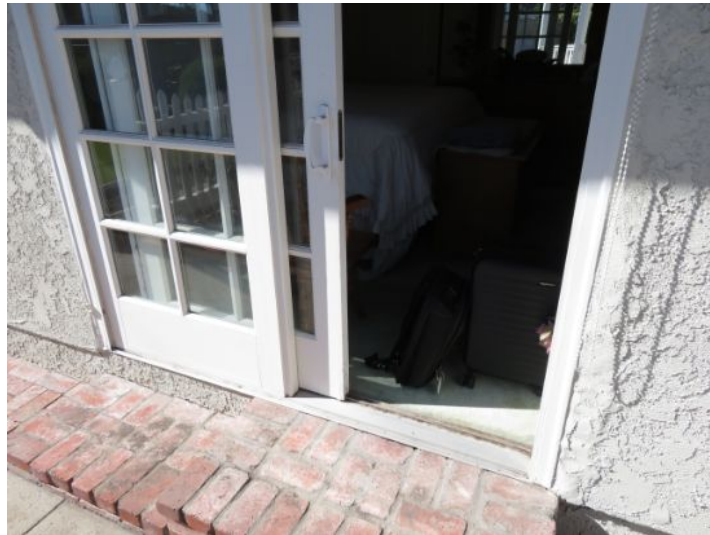
Observations: **sliding screen door is missing**

sliding screen door is missing

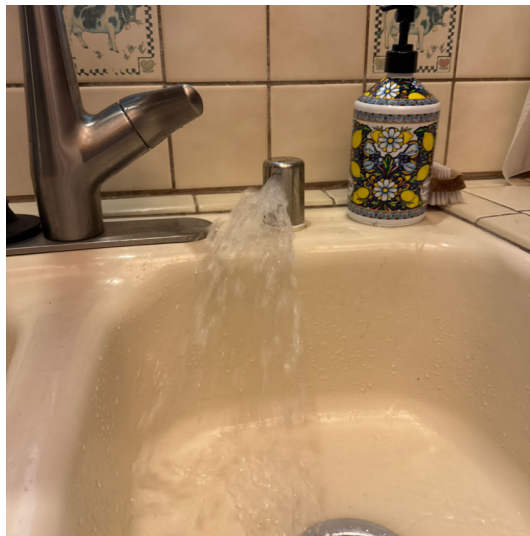
Observations: operated, worn unit, **water discharged out of the air gap while draining**

water discharged out of the air gap while draining

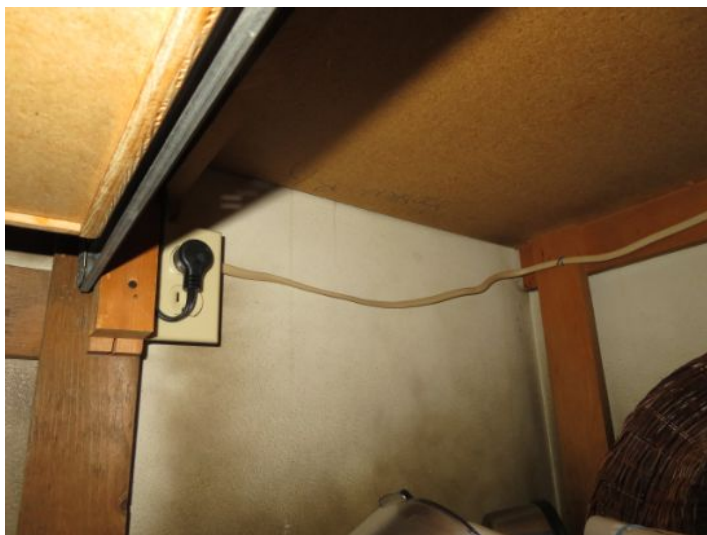
Observations: worn switches & outlets, **romex wiring in the cabinet**

romex wiring in the cabinet

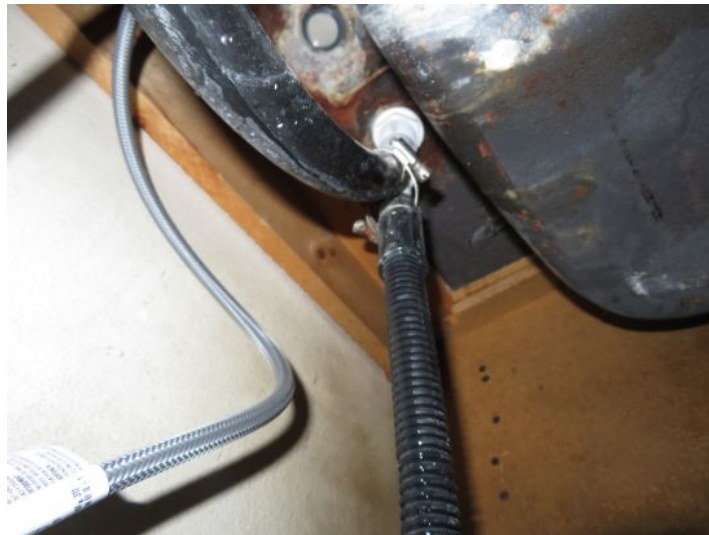
Observations: some not accessible due to personal items, worn fixtures, corrosion present, **visible leaking under the sink from the dishwasher air gap**

visible leaking under the sink from the dishwasher air gap

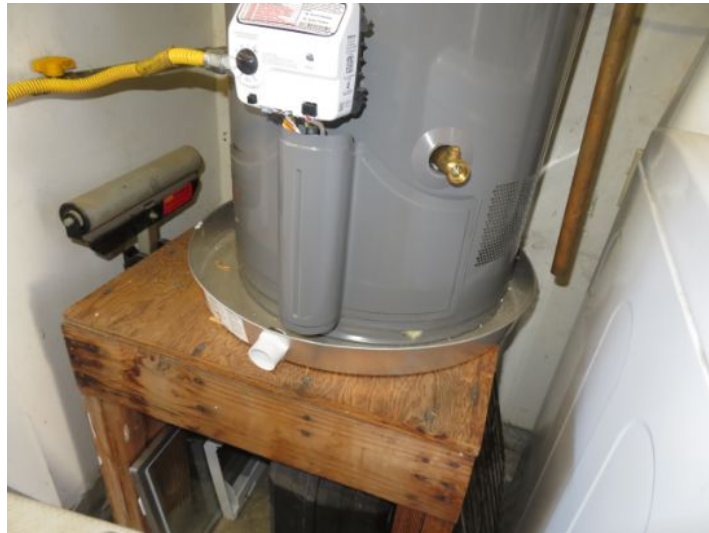
Observations: missing drain line at the drip pan, does not extent to the exterior

missing drain line at the drip pan, does not extent to the exterior

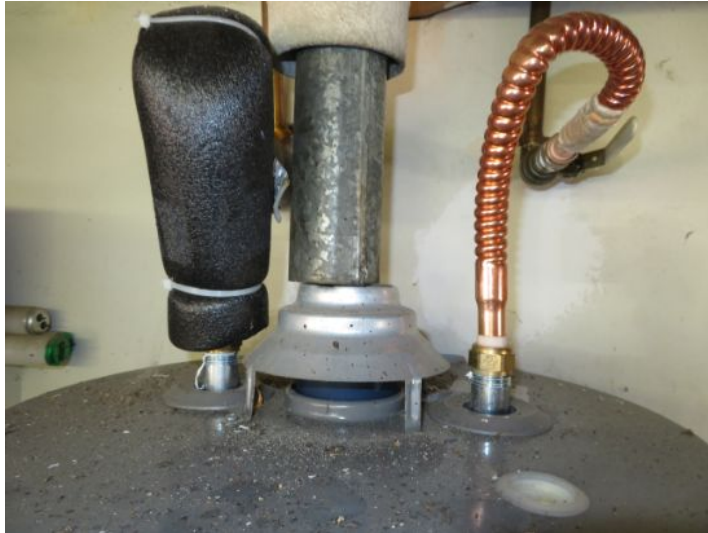
Observations: limited inspection only, metal vent pipe goes into a old transit vent pipe, recommend replace wit a double wall vent pipe, **loose connection at the draft diverter**

loose connection at the draft diverter

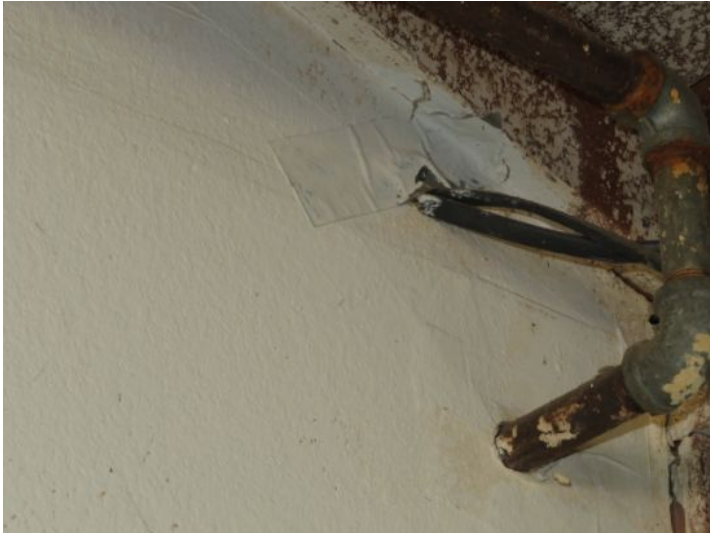
romex wire runs through a firewall

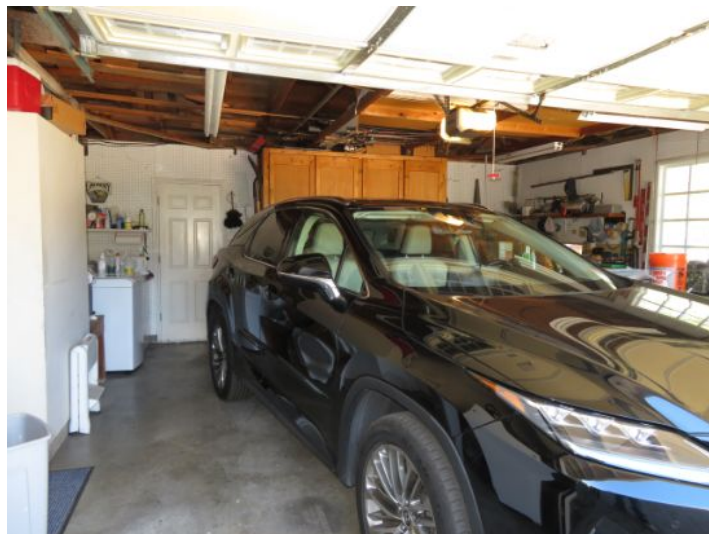
Observations: cracking small, chipped, personal items present some not accessible

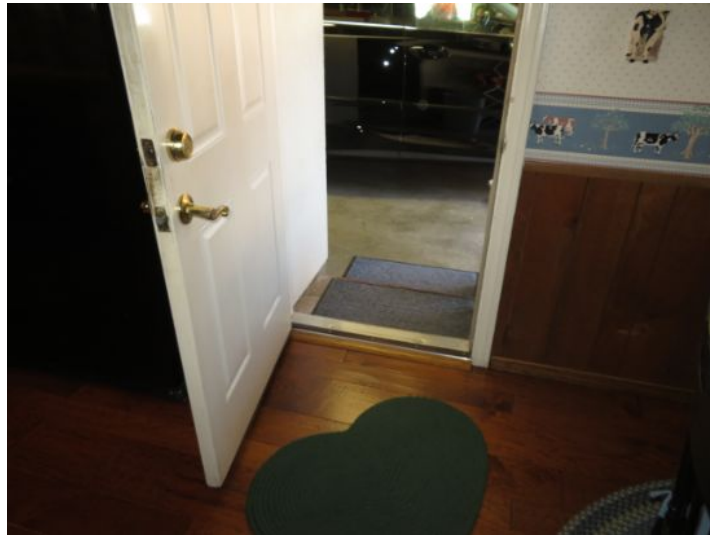
Observations: worn hardware, fire door from the garage to the interior did not self close and latch

fire door from the garage to the interior did not self close and latch

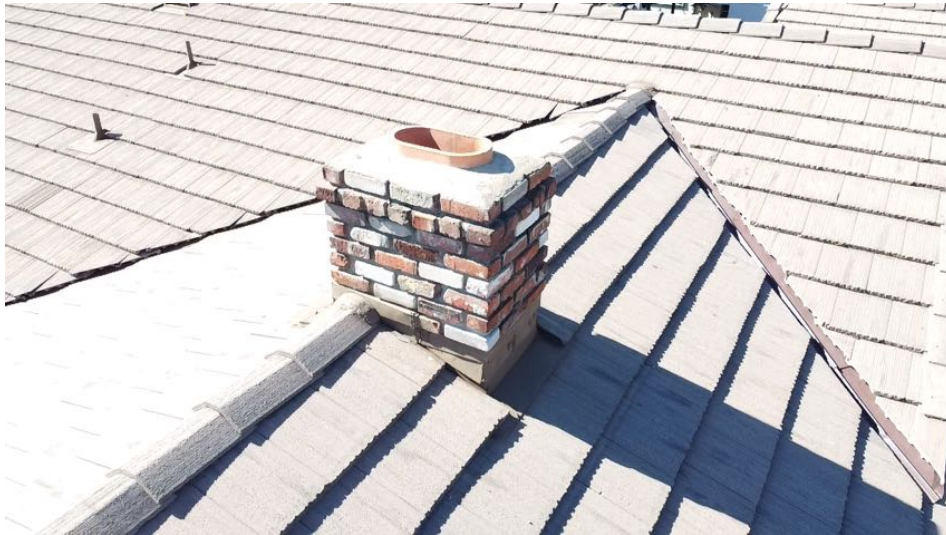
Observations: present, **recommend installing a rain cap spark arrestor for the chimney**

recommend installing a rain cap spark arrestor for the chimney

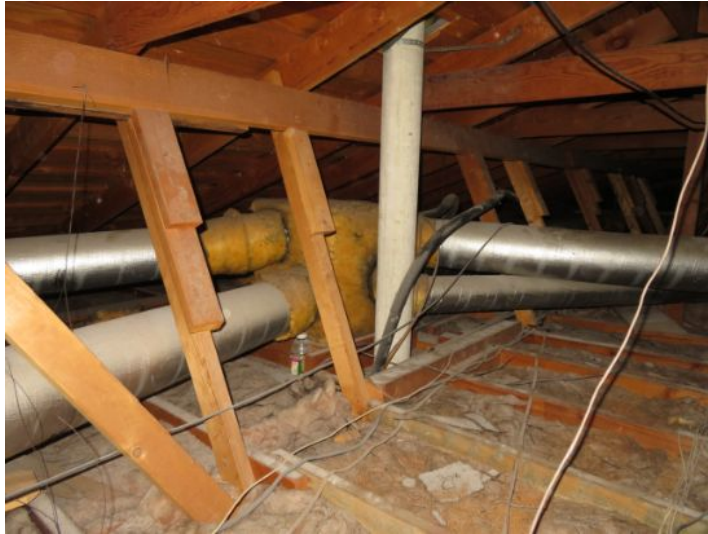
Observations: some ducting is not accessible, **asbestos type ducting present, recommend further evaluation**

asbestos type ducting present, recommend further evaluation

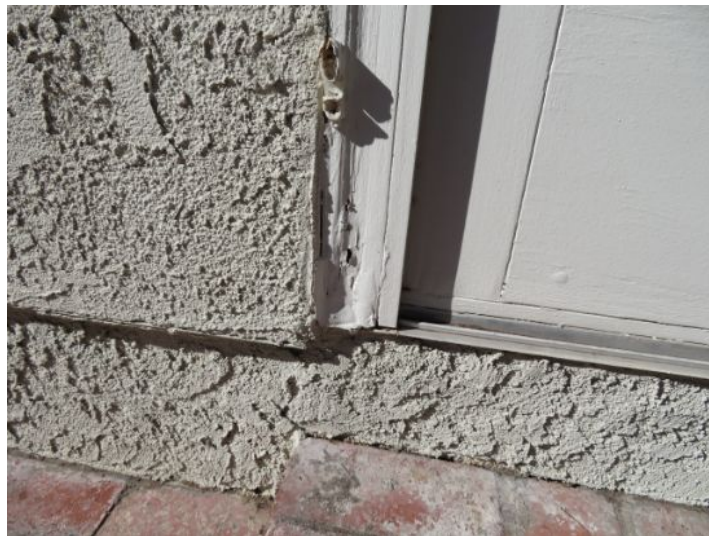
Observations: weathered, **deteriorated wood, consult termite report on all wood area including the patio cover**

deteriorated wood

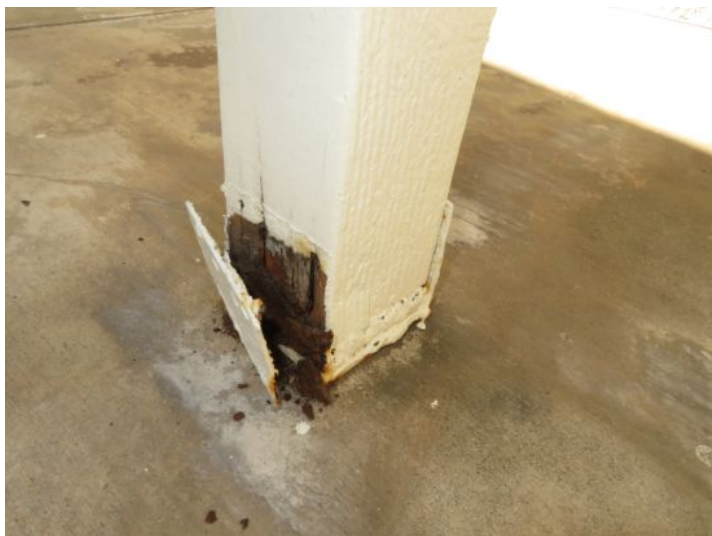
Observations: weathered, **deteriorated wood** , **rusted and broken post ties**

rusted and broken post ties

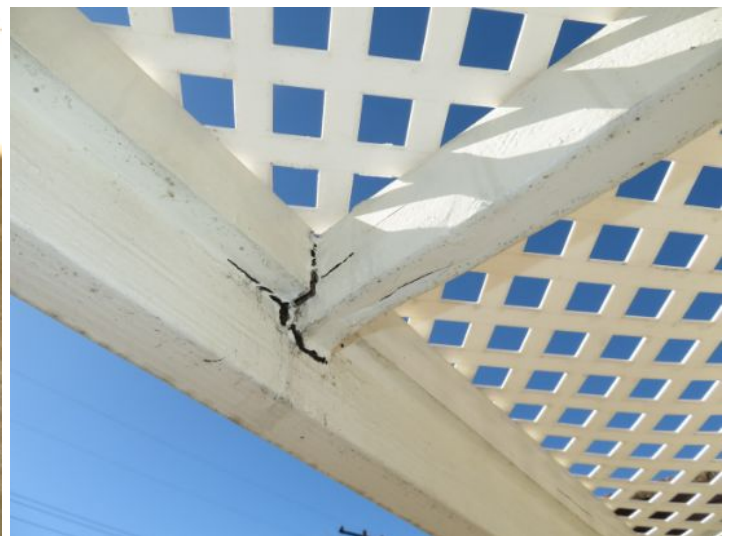
deteriorated wood

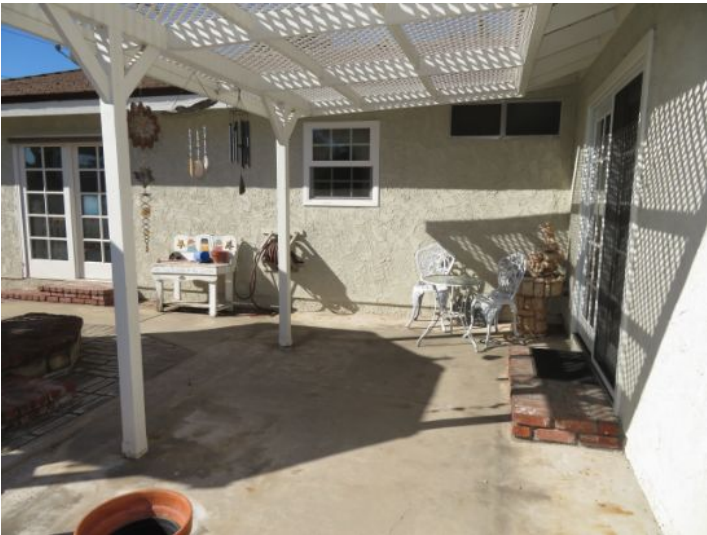
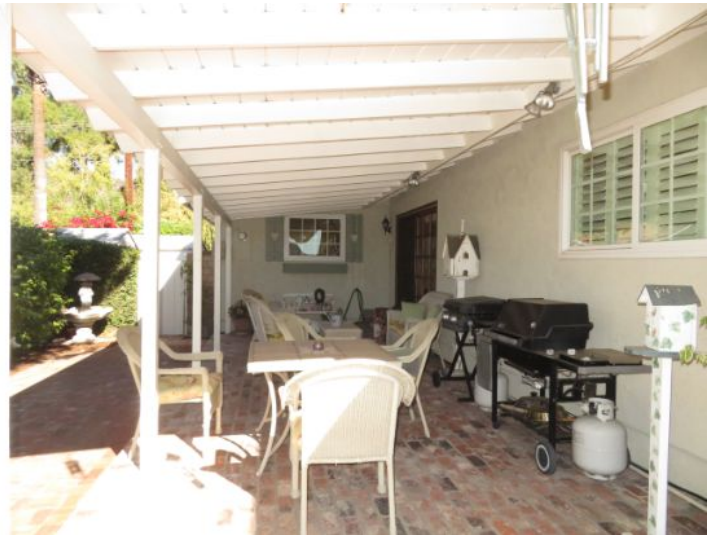
Observations: small cracking, trip hazards

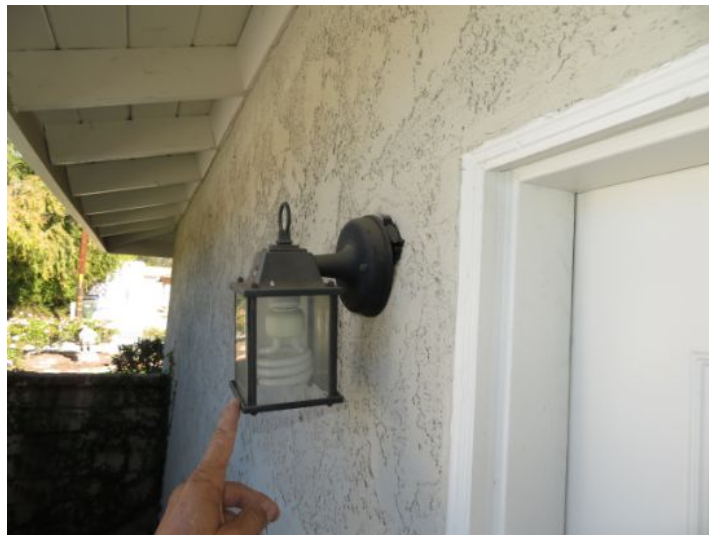
Observations: switches have unknown function, consult the owner, consult the owner on all exterior electrical, any lighting that is on sensors is not tested by the inspector, **loose light fixtures**

loose light fixtures
