PACIFIC CREST HOME INSPECTIONS

INSPECTION REPORT BY PACIFIC CREST INSPECTIONS

1928 Howard Ave
San Diego, CA 92104

Paul Margolis & Don Grant
05/12/2026

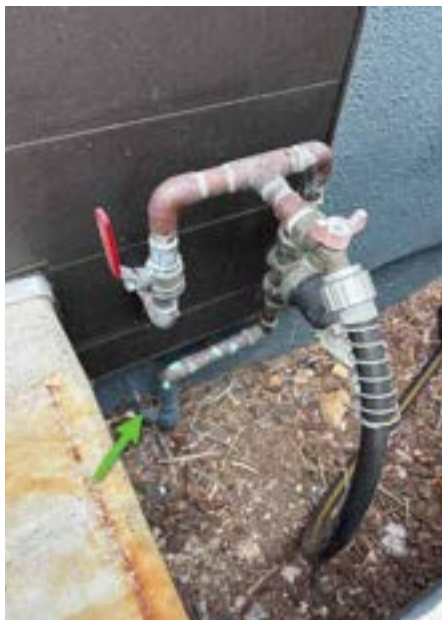
Front of the Building

**Main Water Shut-Off Device
(Describe Location): Main Water
Shut off Location**

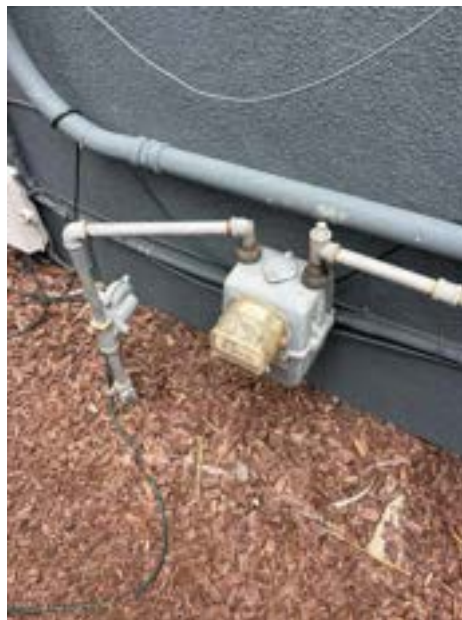
Left Side of the Building

**Main Gas Shut Off Valve
(Describe Location): Main Gas
Shut Off Valve Location**

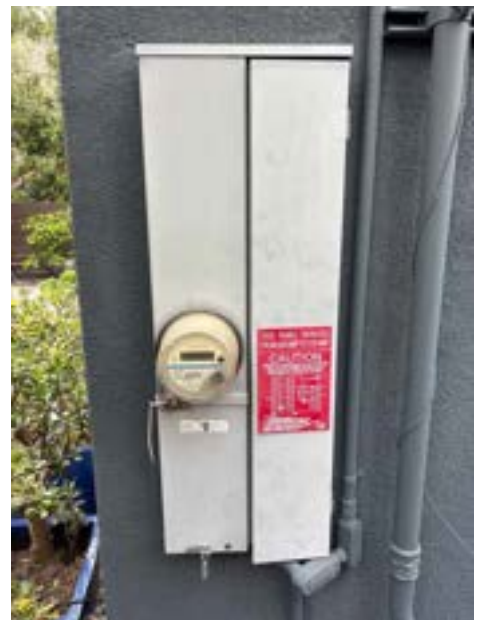
Left Exterior

**Main and Distribution Panels
(Describe Location): Main Panel
Location**

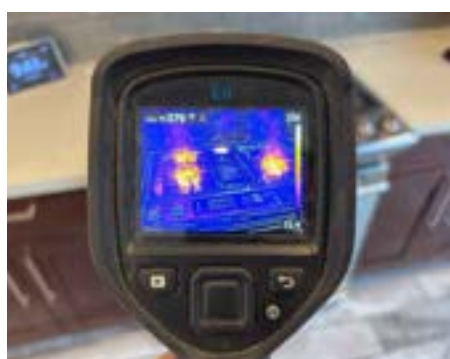
Ranges and Cooktops: Thermal Image Showing Operation

Infrared picture of range/cooktop in operation. This image shows function of the operable range burners.

Stove does work and the top cap was mostly not place back on top of burner correctly when house was cleaned.

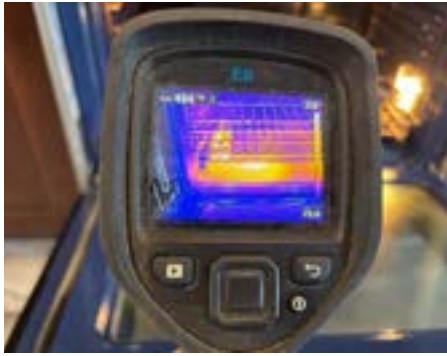
Wall Oven: Thermal Image Showing Operation

Infrared picture of oven in operation. This image shows function of the operable oven heat source.

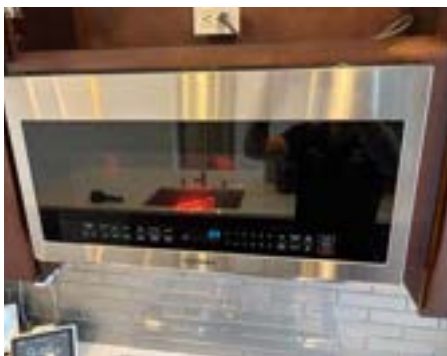
Built-In Microwave : Picture of Microwave During Operation

The operation of the microwave was tested using a microwave tester. This unit appeared functional at the time of inspection.

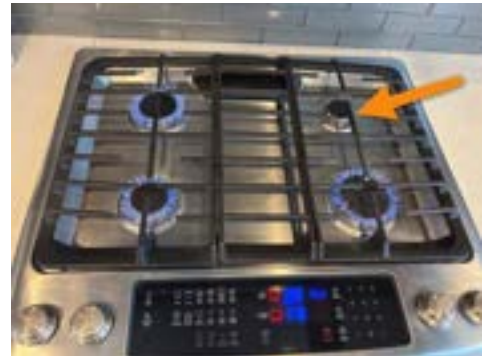
BURNER INOPERABLE

One or more burner was inoperable or did not function properly at the time of the inspection. Unable to determine the exact cause. Recommend further evaluation and servicing/repair by a licensed appliance contractor.

Recommendation

Contact a qualified appliance repair professional.

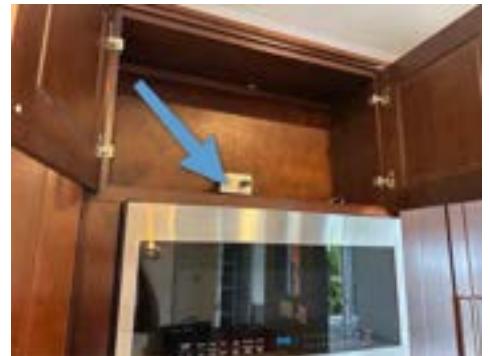
VENT RECIRCULATES

The range hood does not vent to the exterior properly. Advise correction by a licensed appliance contractor as necessary.

Recommendation

Contact a qualified appliance repair professional.

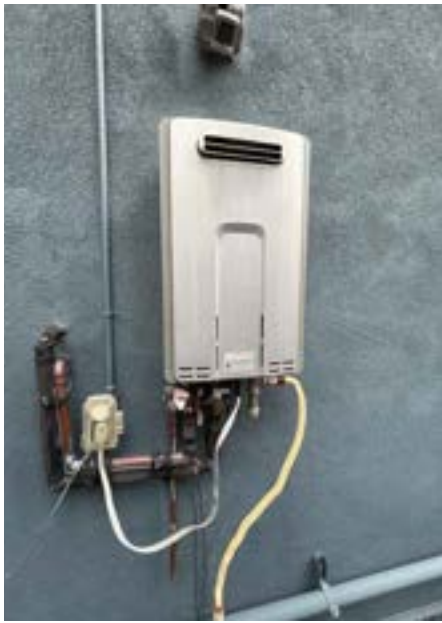
Water Heaters, Controls, Flues and Vents: Picture of Water Heater

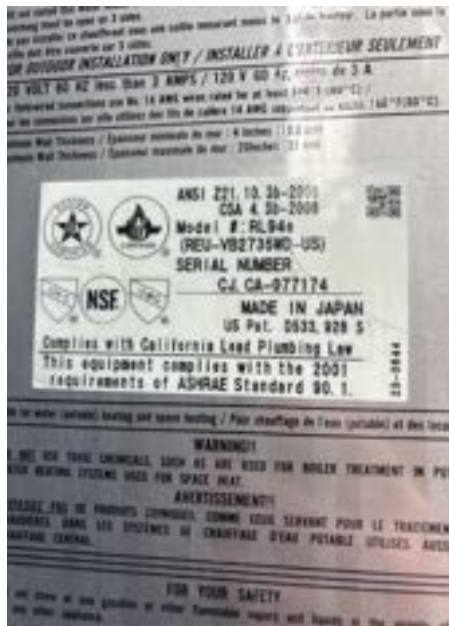
Water Heaters, Controls, Flues and Vents: Tankless Water Heater

This home is equipped with a tankless water heater. These appliances often require frequent, routine maintenance to be performed by a licensed plumbing contractor. If this maintenance is left unperformed, expected life-span of the appliance may be reduced. Recommend asking the sellers for a copy of the maintenance schedule. If documentation can not be provided, it is advised that you consult a licensed plumbing contractor for further evaluation prior to the end of your contingency period.

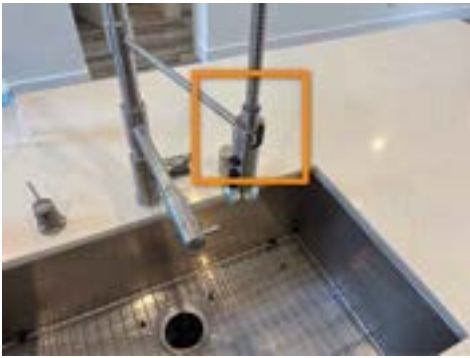
Kitchen Sink

4.3.3 Fixtures and Connected Devices

Spray Head was just replaced and just needs hand tightened

Contact a qualified plumbing contractor.

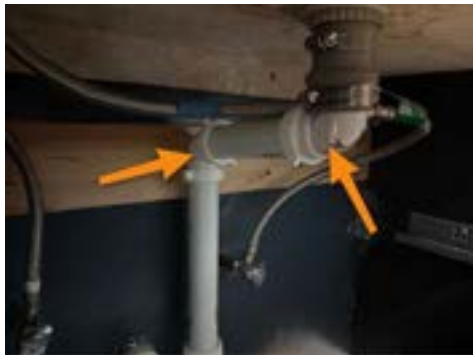
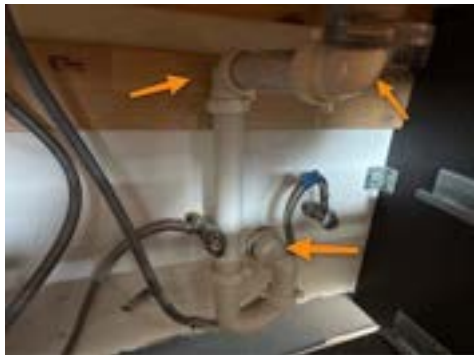
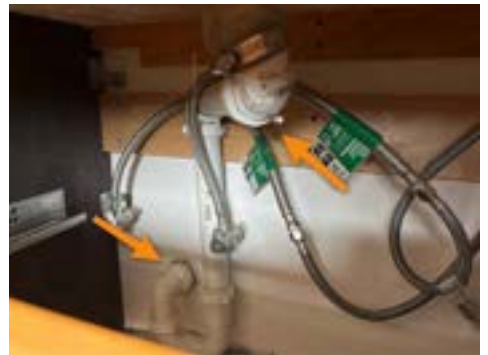
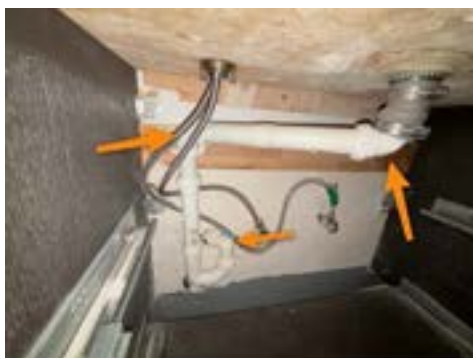
4.5.3 Plumbing Drain, Waste and Vent Systems

These were installed to function inside drawer compartment of floating Vanity

Contact a qualified plumbing contractor.

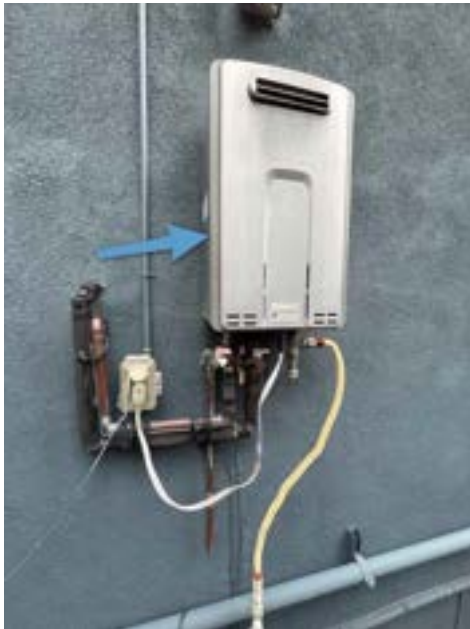
MFD 2011

Previous owners replaced with a tankless water heater.

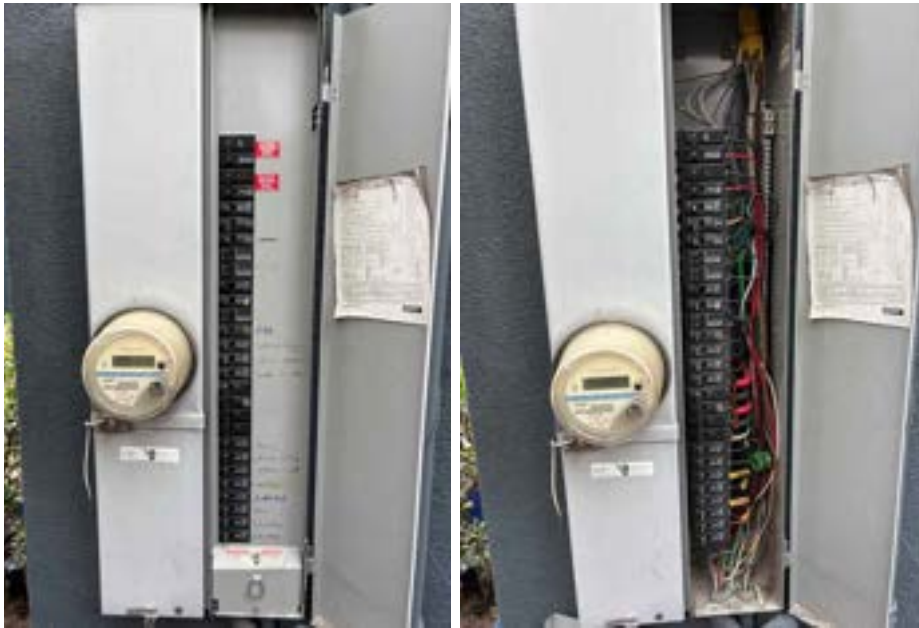
Main and Distribution Panels: Picture of Panels

Pictures of electrical panel(s).

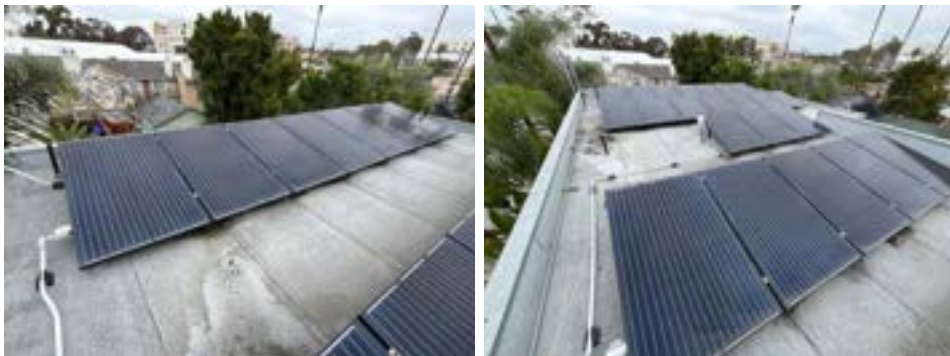
SOLAR

This home is equipped with solar panels. We advise inquiry with sellers about this system: leased/owned, manufacture/installer warranties, etc. Please note: Solar equipment is known to promote moisture intrusion issues when mounted on the roof structure. I was unable to verify the condition of the solar mounts or the roofing below the solar panel areas. You may wish to have this portion of the roof further evaluated by a licensed roofing contractor to determine if latent defects exist.

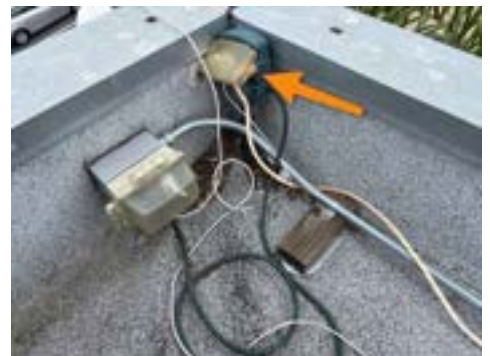
Roof

5.4.1 Branch Circuit Conductors

⊖ Attention Item

Powering upstairs cameras.

Contact a qualified electrical contractor.

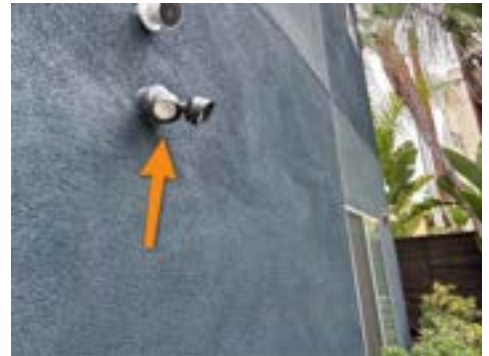
Rear Exterior

5.6.1 Exterior Lighting

Does work Dusk to Dawn Light and comes on at night only.

Contact a qualified electrical contractor.

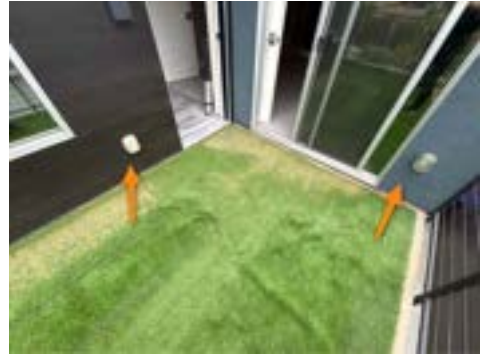
Balcony

5.8.2 Operation of GFCI (Ground Fault Circuit Interrupters)

GFI was tripped and reset is in the right side receptical.

Contact a qualified electrical contractor.

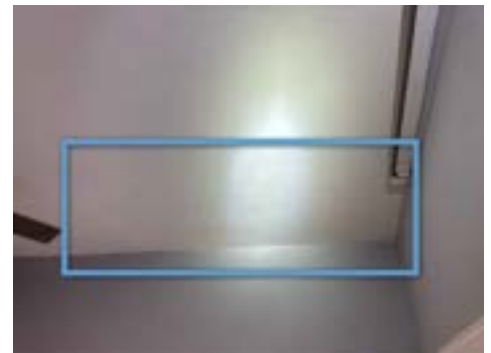
Guest Bedroom Downstairs

No ceiling repairs, paint was touched when house was painted recently and wall. paint was on ceiling

Contact a qualified professional.

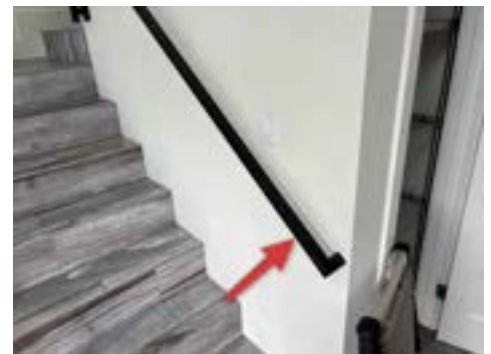
LOOSE HANDRAIL

Loose handrail observed at interior stairway in one or more areas. This is a possible safety concern. Recommend correcting and securing by a qualified/licensed professional, prior to the close of escrow.

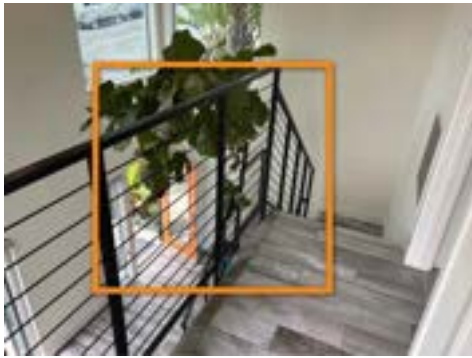
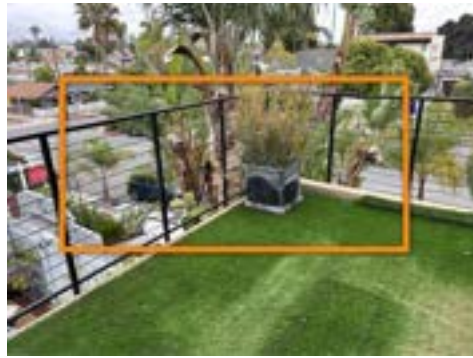
CLIMBABLE RAILINGS

The railings were noted constructed in a manner that may promote climbing. This condition may pose a potential child safety issue. You may wish to view this for yourself and have corrected as necessary.

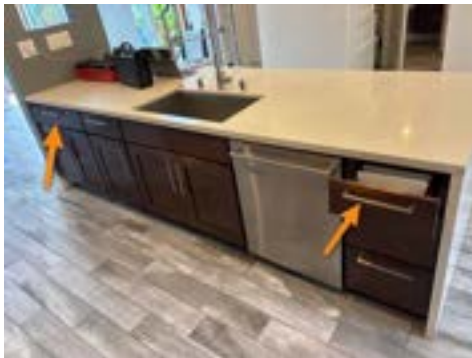
Kitchen

Portions of the kitchen drawers were not functioning properly/in need of adjustment during inspection. Recommend corrections by a qualified professional.

Contact a qualified professional.

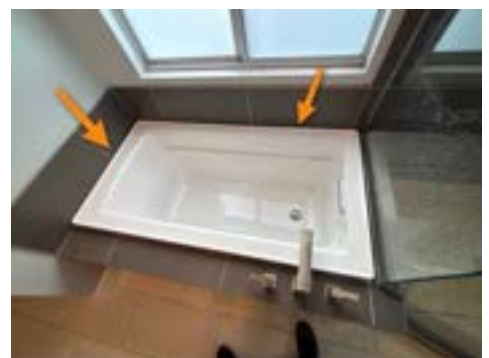
Master Bathroom

The tub/shower enclosures need to be cleaned and recaulked to prevent moisture intrusion beyond the shower enclosure walls.

Contact a qualified professional.

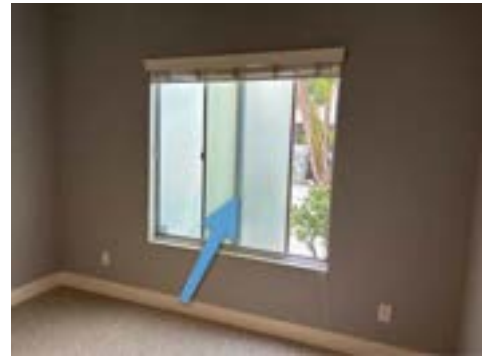
Guest Bedroom

The window tracks and hardware need to be cleaned and/or serviced to function properly and/or smoothly. Recommend further evaluation by a licensed window contractor.

Contact a qualified window repair/installation contractor.

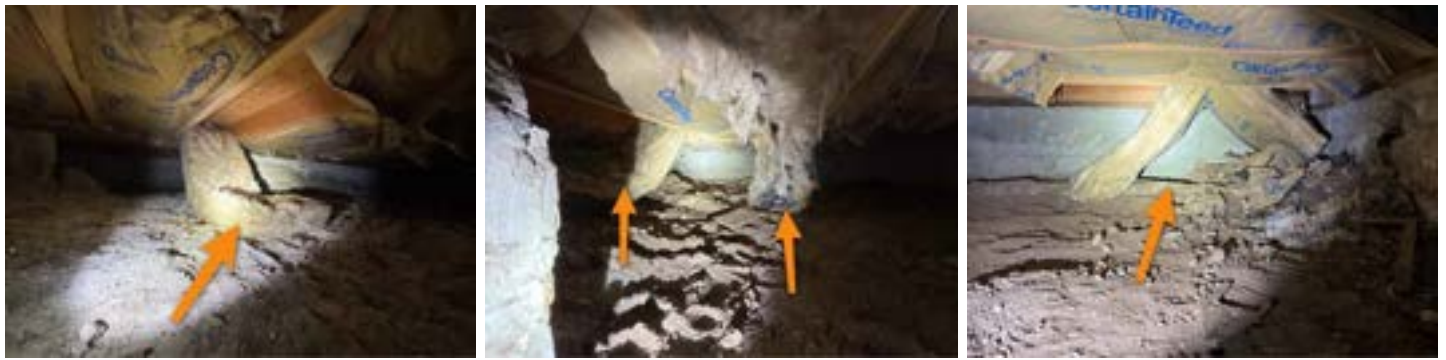
DAMAGED INSULATION

Portions of the flooring installation were noted damaged and/or failing. Advise consulting a licensed specialist for further evaluation and repair.

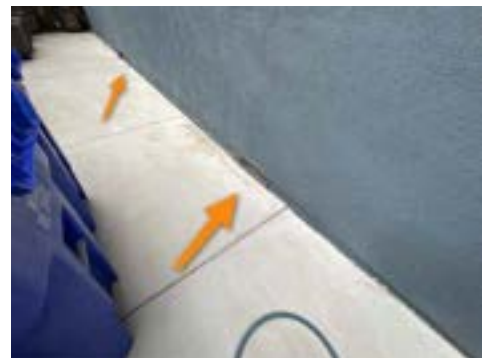
Right Exterior

The foundation vent(s) are installed at or near ground level. Adding mulch or landscape to this area could result in water intrusion, if vent becomes lower than the ground. Should you decide to landscape, or if water intrusion was to occur through vent, I would recommend a half-round window well be installed.

Contact a qualified professional.

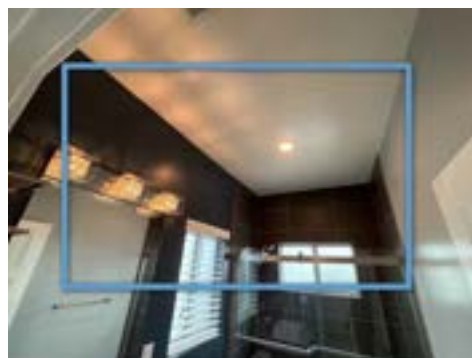
2nd Bedroom Bathroom

One or more bathroom was noted equipped with a window only for ventilation. You may wish to have a powered vent fan installed to reduce the probability of moisture related issues.

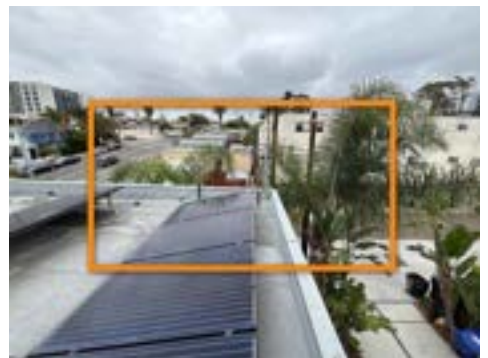
Rear Left Exterior

Vegetation is growing on or overhanging the roof. Leaves and debris can slow or obstruct drainage and cause leaks. Also, vegetation can be a pathway for pests. Advise trimming back the vegetation by a qualified person.

Contact a qualified tree service company.

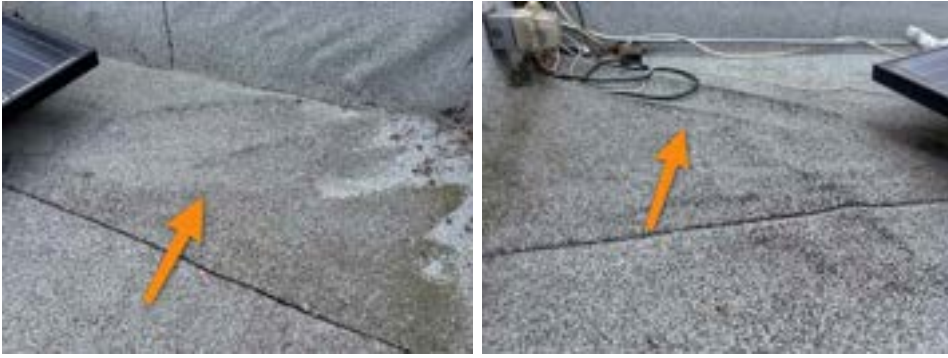
9.2.2 Roof Coverings

LARGE TREES/VEGETATION (GENERAL)

Recommendation

Contact a qualified roofing professional.

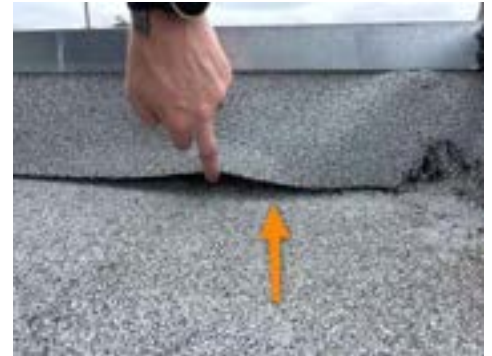
Unconventional installation methods were noted at the roofing in areas. Recommend consulting a licensed roofing contractor to determine if corrections are needed at this time.

Contact a qualified roofing professional.

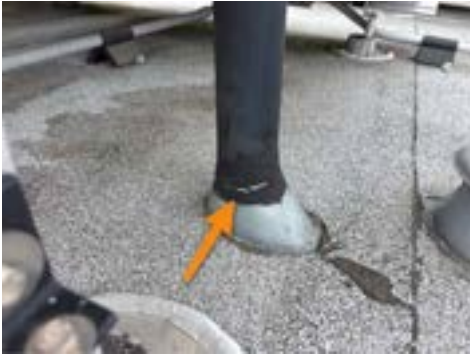
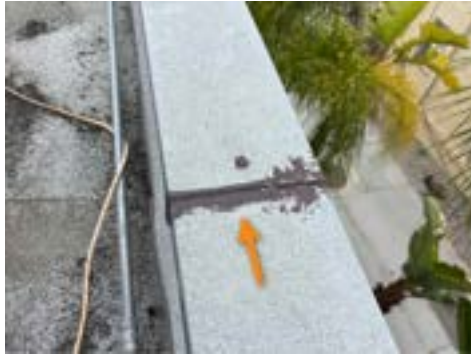
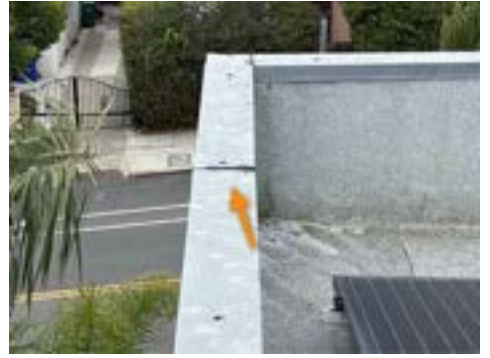
The roof penetrations/flashings need caulking around the perimeter of the flashings where sealant is aged and/or failing. Advise repair by a licensed roof contractor.

Contact a qualified roofing professional.

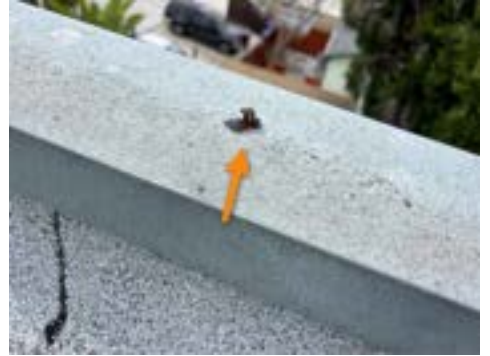
9.3.2 Flashings, Skylights and Roof Penetrations

IMPROPER/EXPOSED FASTENERS

Contact a qualified roofing professional.

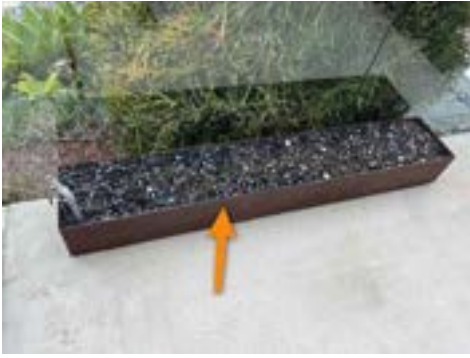
This is the design of the fixture like overhang at door and mailbox, not deterioration

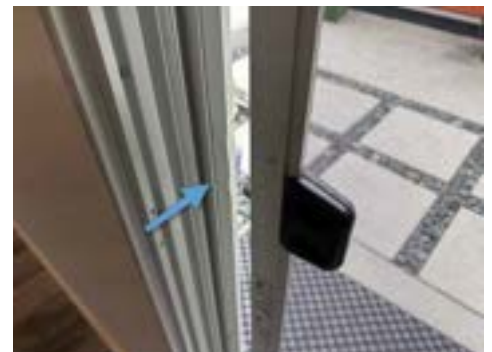
Screen Door never had a lock

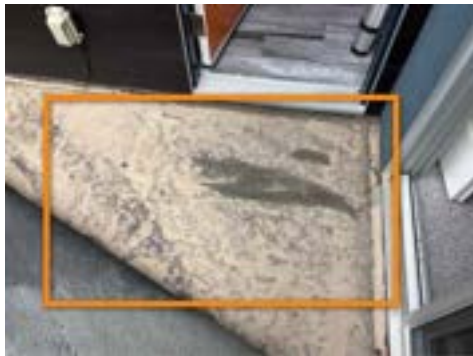
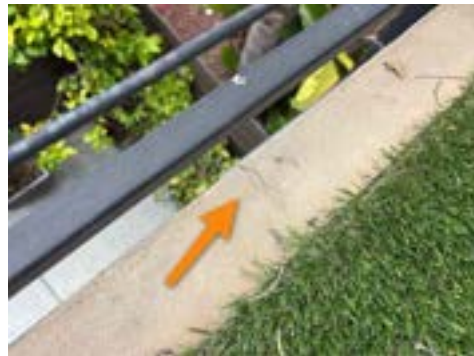
10.7.2 Decks, Balconies, Steps, Porches, Patio Covers and Applicable Railings

Balcony waterproofing was just done by insurance company as water leak at door and corrected.

Recommendation

Contact a qualified waterproofing contractor

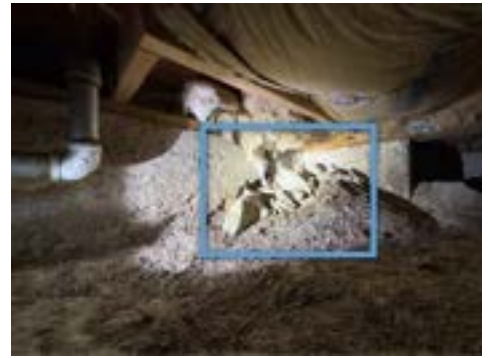
11.3.2 Foundations, Basements and Crawlspaces

no modifications were made as house was built with new foundation on top of old foudation.

Contact a foundation contractor.

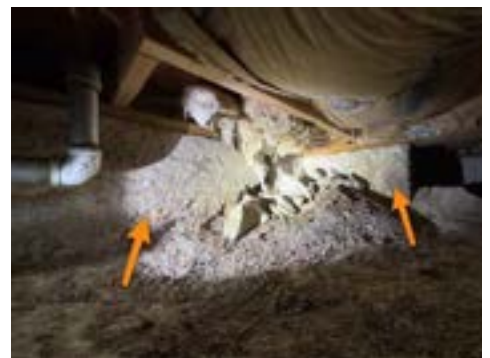
Crawlspace

SPALLING/DETERIORATION

Spalling/deterioration was noted at the foundation walls in various locations. This may be indicative of age and prolonged moisture contact. Advise consulting a licensed foundation contractor to determine if corrections are needed at this time.

Recommendation

Contact a foundation contractor.

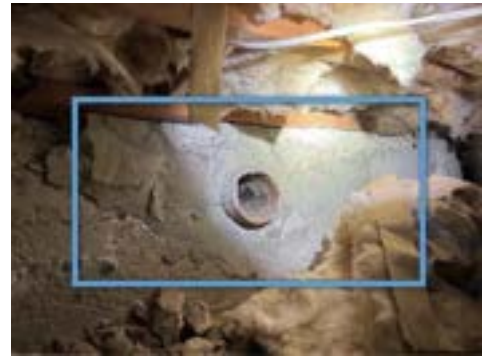
11.3.5 Foundations, Basements and Crawlspaces

These are done at time of build as the old foundation was left and new foundation was added

Contact a foundation contractor.

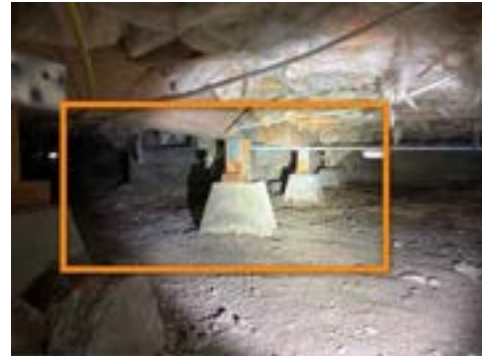
11.4.1 Columns or Piers

These are done at time of build as the old foundation was left and new foundation was added

Contact a foundation contractor.

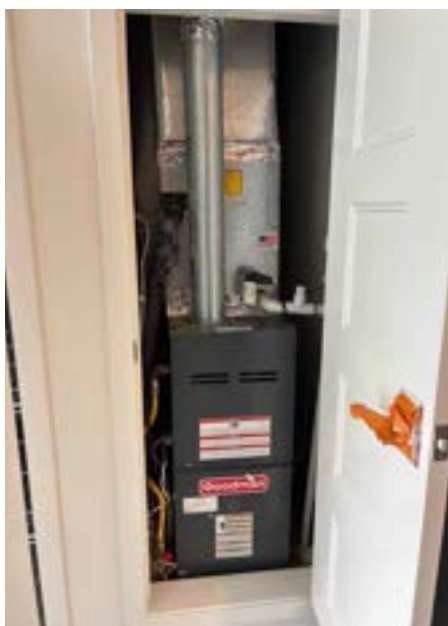
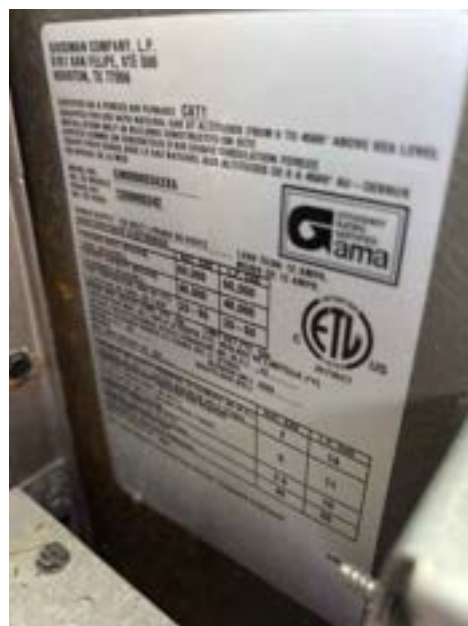
Heating Equipment : Picture of Heating Equipment

Picture of heating equipment.

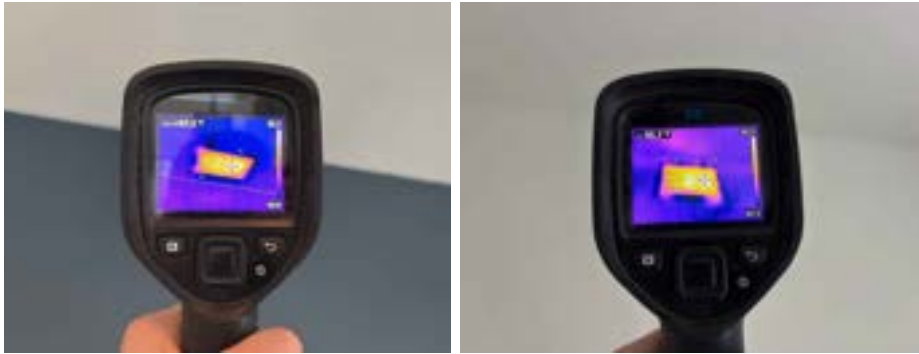
Heating Equipment : Thermal Image Showing Operation

The furnace turned on and produced heat at the time of the inspection.

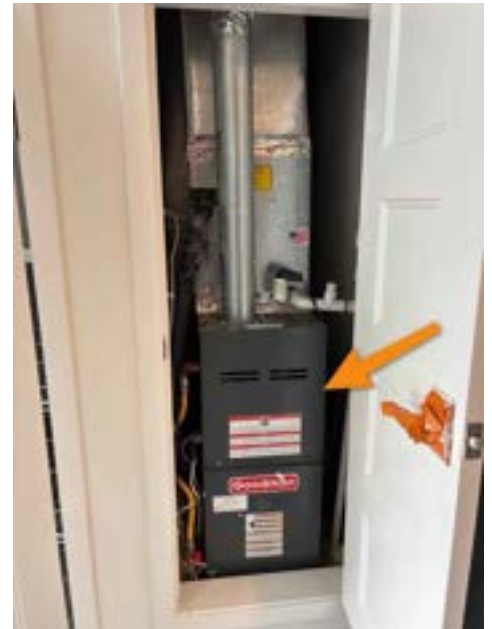
MFD 2012

The heater appeared to function at time of inspection. However, determining the life remaining is beyond the scope of a home inspection. Also, due to the age of the unit, I recommend further evaluation/safety check be performed by a licensed HVAC contractor before the end of your contingency period.

Recommendation

Contact a qualified HVAC professional.

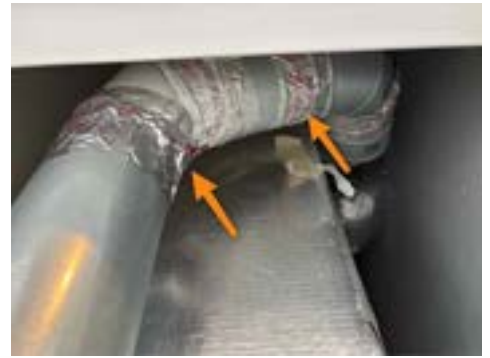
The furnace flue pipe was noted having tape installed. This is not in accordance with the manufacture specifications. Advise removal by qualified contractor.

Recommendation

Contact a qualified HVAC professional.

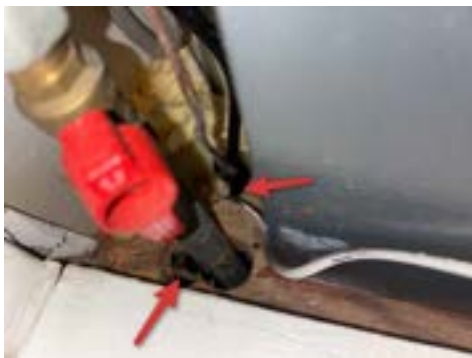
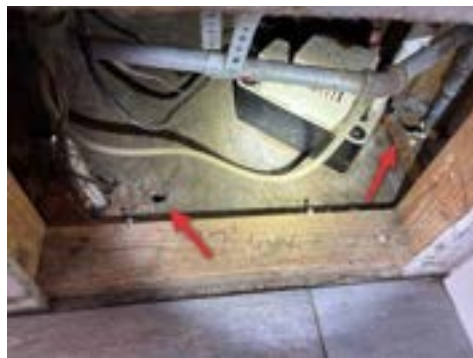
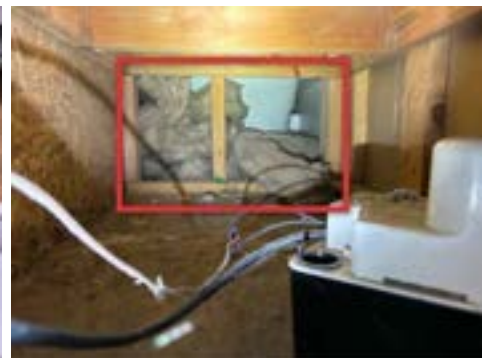
12.6.1 Distribution Systems (HVAC Ducting and Related Equipment)

RETURN AIR NOT SEALED

The return air compartment is not properly sealed. This condition may promote air quality concerns. Recommend consulting with licensed HVAC contractor to determine if corrections are needed at this time.

Recommendation

Contact a qualified HVAC professional.

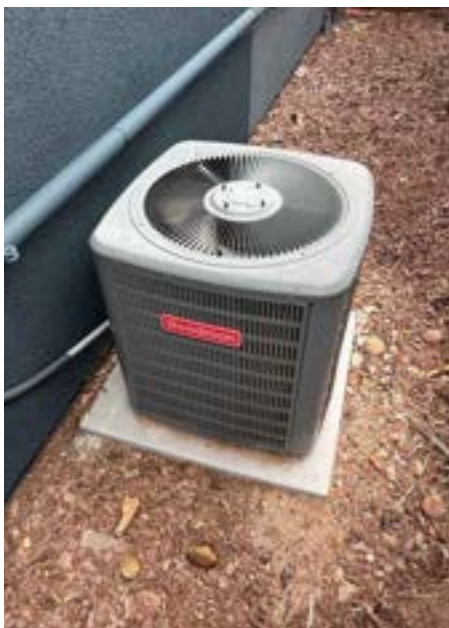
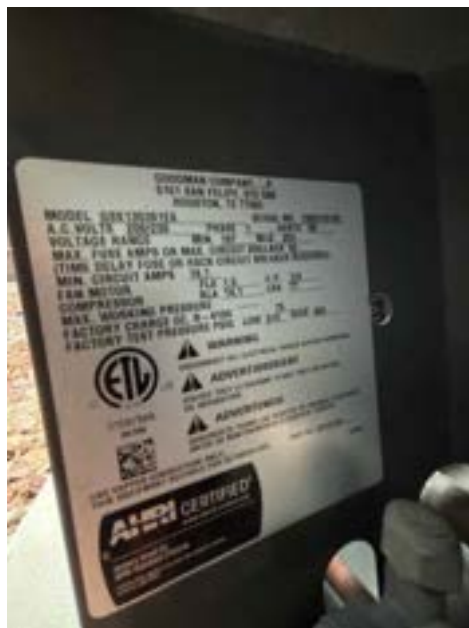
Cooling and Air Handler Equipment: System Information

For HVAC system information, please refer to Heating Equipment.

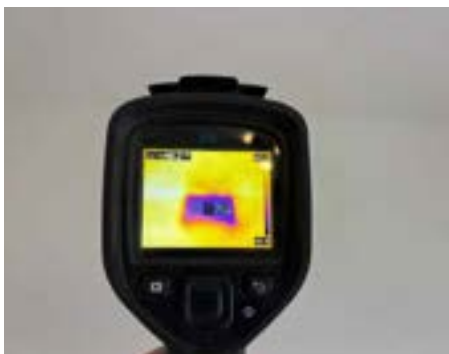
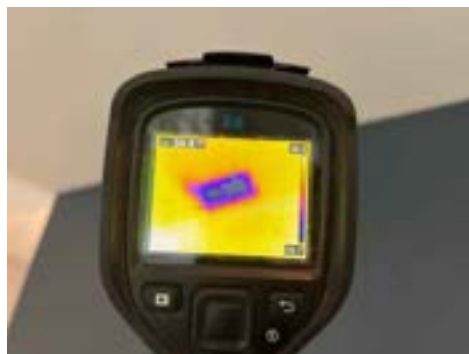
Cooling and Air Handler Equipment: Thermal Image Showing Operation

The AC appeared to turn on and produce cold air at the time of the inspection.

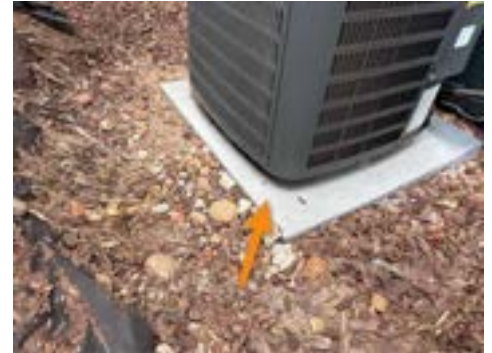
The AC condenser was not properly secured to the platform or the platform was unstable. This condition may promote adverse wear and physical damage. Advise correction by a licensed HVAC contractor.

Recommendation

Contact a qualified HVAC professional.
