# PREFERRED INSPECTION SERVICES

## HOME INSPECTION

20971 Morningside Dr  
Trabuco Canyon, CA 92679

04/28/2026

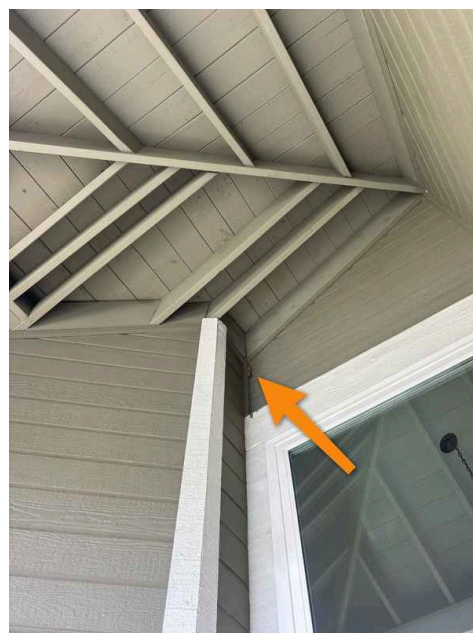
Front door

One or more hornet, bee or wasp nests were found at the eaves or other areas of the exterior, in the attic, or in the crawl space. This is a potential safety hazard. A qualified technician should remove nests or exterminate as needed.

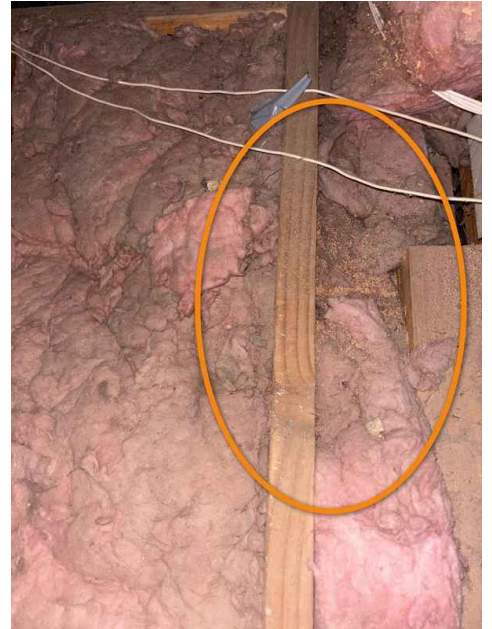
Evidence of termite activity was found in the form of fecal pellets, dead insects, active larvae, and/or wood damage in the attic, crawl space, basement, garage, and/or interior rooms.

Termite dust in attic

A qualified technician should evaluate the property for termite activity and make recommendations for treatment and /or repairs as needed

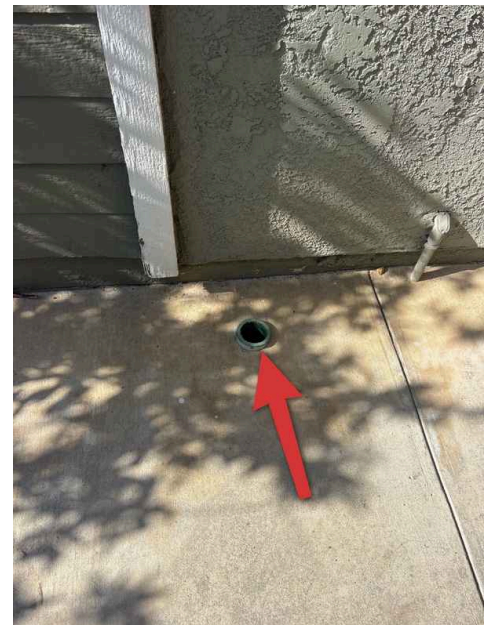
Right side

One or more yard or patio drain strainers is missing or broken. This can allow leaves and other debris to clog the drain. It is also a safety hazard for small children as their feet and legs can fall in. Recommend replacement as needed.

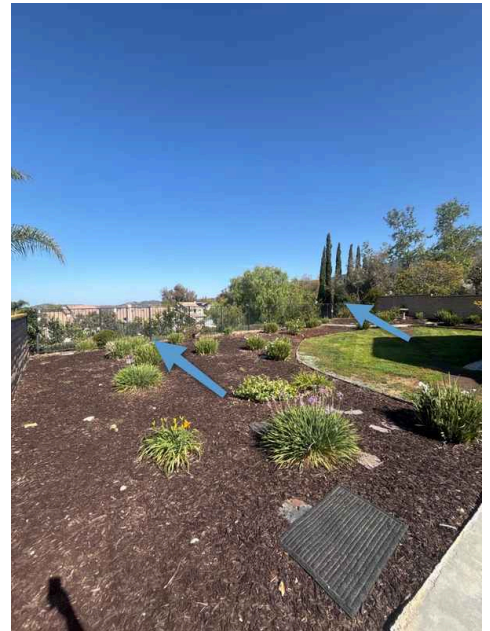
This home is built on or near a slope. As such, minor settling can occur and is often referred to as "slope creep". This can be a common occurrence in this area, and can have various degrees of severity. Issues such as hardscape pulling away from the building, cracks in the foundation, and/or minor cracks in the walls are common. Recommend monitoring in the future. If conditions worsen, a qualified engineer or contractor should be consulted for further evaluation.

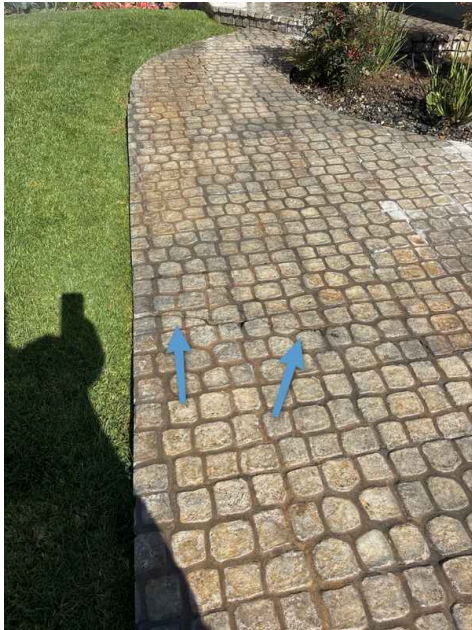
Front yard

Minor signs of deterioration, such as cracks, holes, settling, or heaving, were observed in the sidewalks or patios, but there are no trip hazards present. The client may consider making repairs primarily for cosmetic purposes.

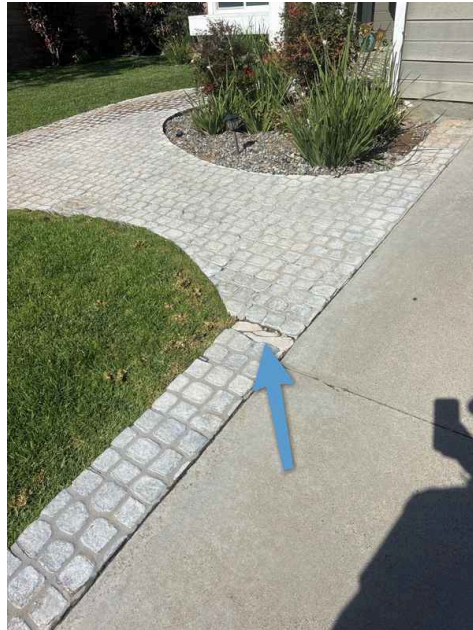
Front yard

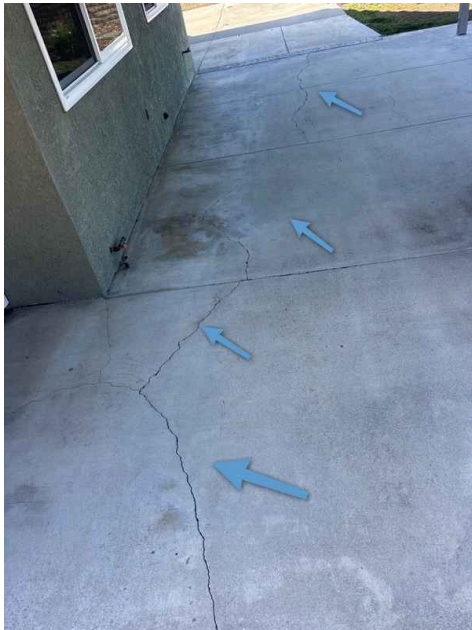
Backyard

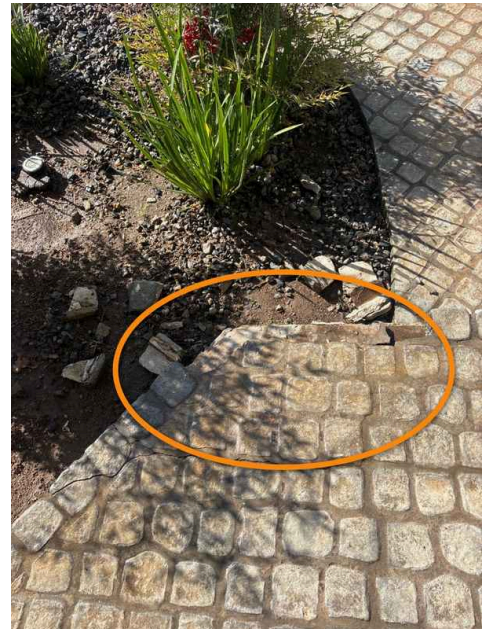
Front entry

Cracks, holes, settling, heaving, and general deterioration have been identified in the sidewalks and/or patios. It is recommended to have a qualified contractor make the necessary repairs as required.

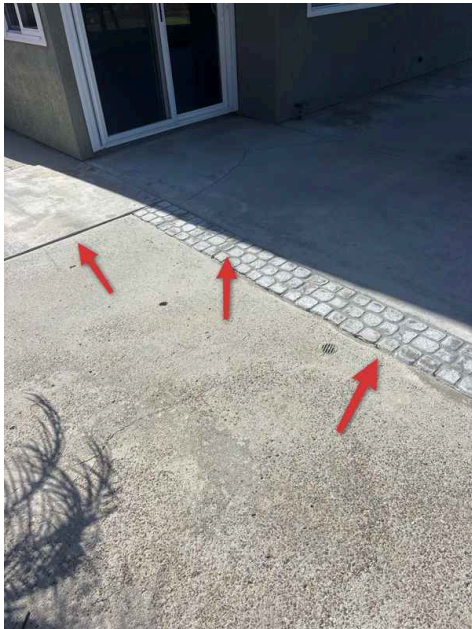
Backyard

Cracks, holes, settling, heaving, and general deterioration have led to trip hazards in the sidewalks or patios. To ensure safety, it is strongly recommended to hire a qualified contractor to make the necessary repairs and eliminate these trip hazards.

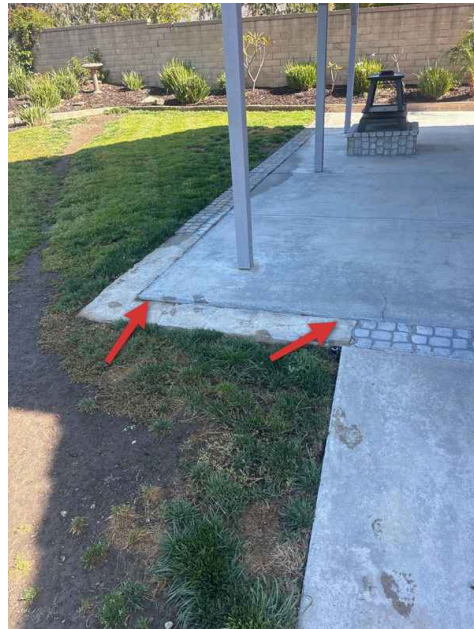
Backyard

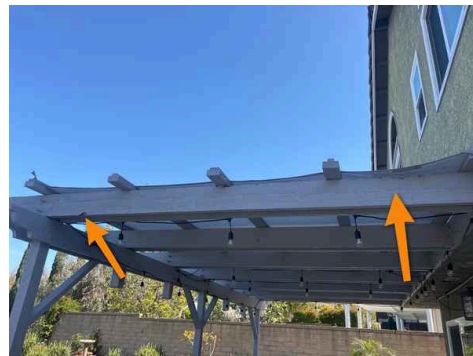
2.6.1 Patio Cover(s)

**WOOD DAMAGE**

Dry rot or other unspecified damage was found in support posts, joists, beams, bracing, lattice boards, trim or ledger boards at one or more structures covering decks, patios and/or porches. Recommend that a qualified person repair as necessary. All damaged wood should be replaced.

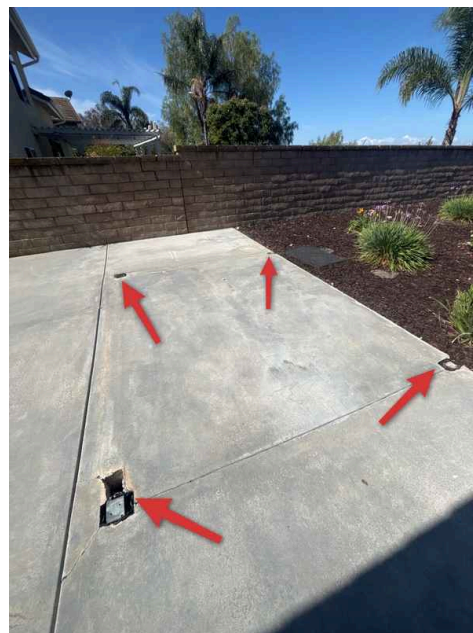
Backyard

Post bracket remnants from an old patio cover exist in the patio . SHarp, rusty metal is exposed and could cause injury. Recommend grinding the metal down below the patio surface and patching as needed.

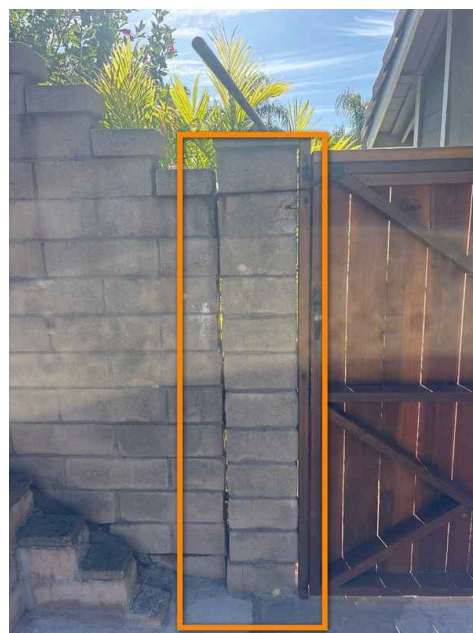
Right side

One or more sections of fencing is deteriorated and unstable. Recommend a qualified contractor repair/replace as needed.

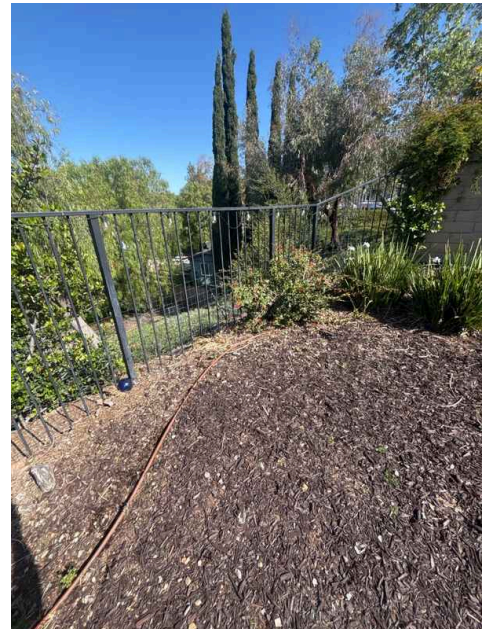
Back right corner

The bottom rails on one or more sections of wrought iron fencing are buried below the soil line. This can accelerate corrosion or corrosion may have already occurred. Recommend regrading soil at least 2" below the bottom rail.

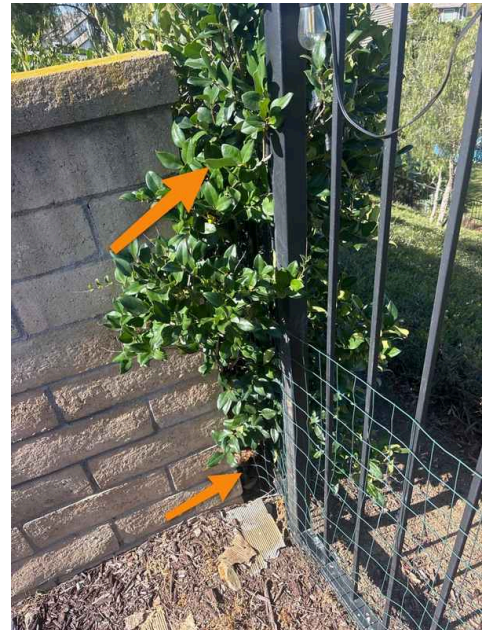
Back left

One or more sections of fencing had large openings in them. Recommend repairing as needed.

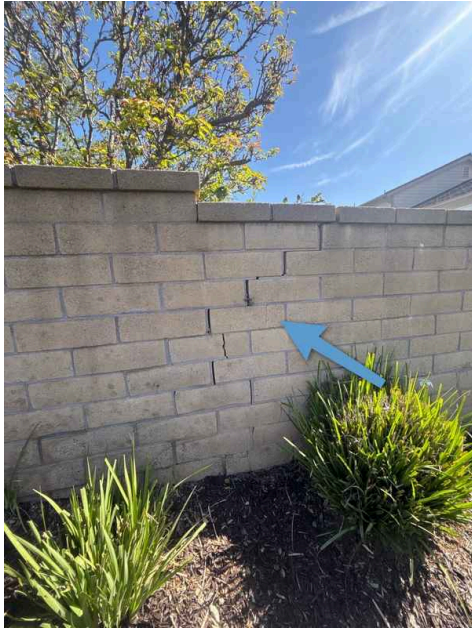
Right side

One or more sections of fencing had minor deterioration.

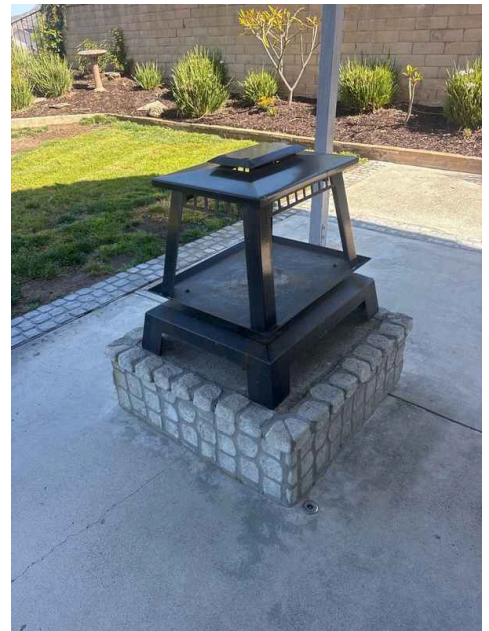
The firepit was inoperable at the time of the inspection

Abandoned

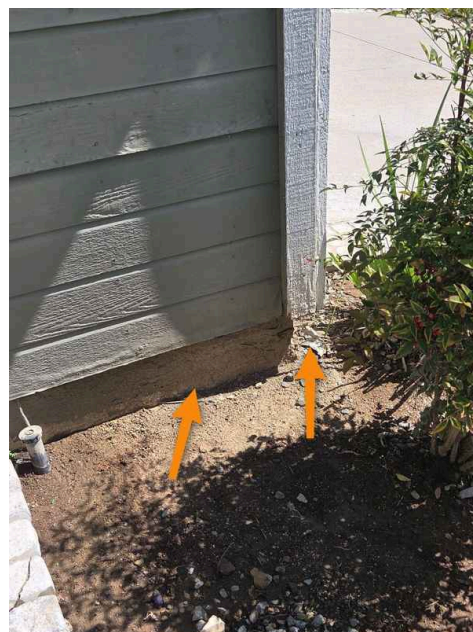
Entry

Certain portions of the siding and/or trim exhibit signs of deterioration, looseness, splitting, warping, absence, damage, or do not meet the expected standards. It is advisable to engage a qualified professional to address these issues by carrying out repairs, replacements, or the installation of new siding or trim components as needed.

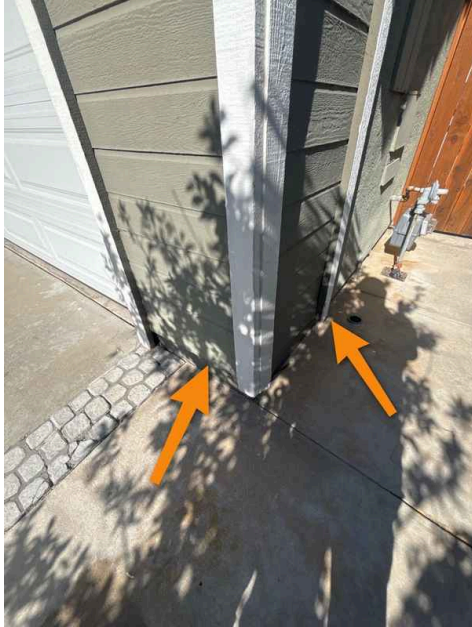
Front right

Fungal rot has been identified in one or more areas of the siding, trim, window sills, window frames, soffits, fascia, gable ends, rafter tails, or exposed beams. To prevent the further development of these conditions, it is essential to address the conducive factors for rot, such as wood-soil contact or a reversed perimeter slope. It is recommended that a qualified professional takes the necessary actions to rectify these issues. Additionally, all deteriorated wood affected by fungal rot should be completely replaced.

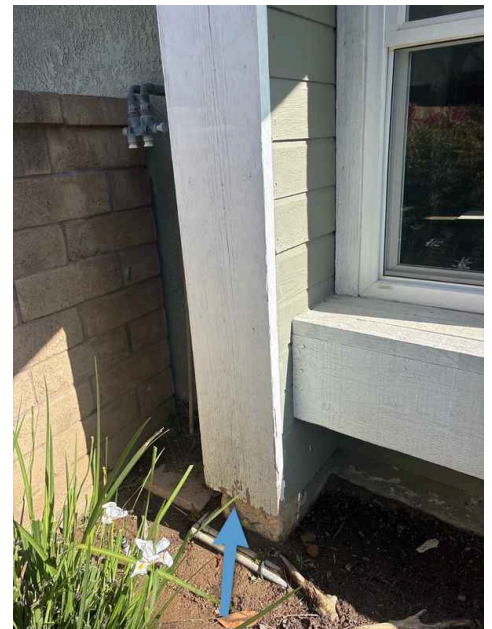
Front left corner

The paint or stain finish on certain parts of the structure is deteriorating, evidenced by issues such as peeling, fading, wear, or thinning. When the finish on the siding and trim is compromised, it becomes susceptible to moisture damage. It is advisable to engage a qualified contractor to carry out the necessary preparations, which may include cleaning, scraping, sanding, priming, and caulking. Following these preparations, a complete repainting or restaining of the entire exterior of the building should be performed in accordance with standard building practices. Any repairs required for the siding or trim should be addressed prior to this refinishing process.

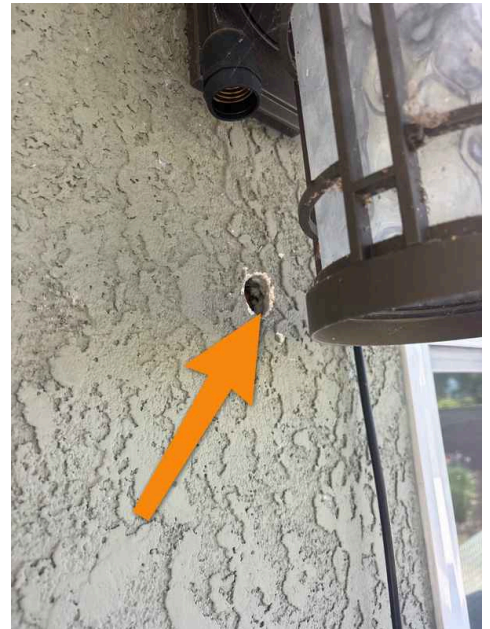
Backyard

Openings in the wall exist , which could allow moisture and pests into the wall cavity. Recommend repair as needed.

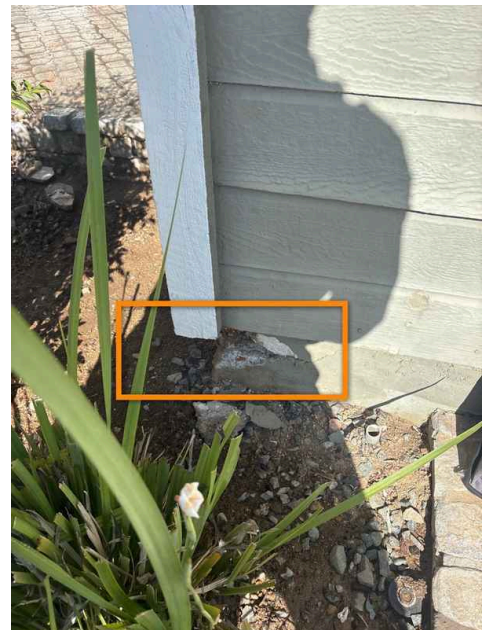
Front of garage

Cracks, deterioration, and/or damage were identified in certain sections of the exterior stucco finish. In regions with high humidity or damp climates, these issues can facilitate the intrusion of moisture into the cracks or damaged regions, potentially exacerbating the deterioration of the stucco. Moreover, the wall concealed behind the stucco can also sustain moisture-related damage. Please be aware that the areas concealed behind the stucco are inaccessible and therefore not included in this inspection.

It is advisable to engage a qualified contractor for a thorough evaluation and to determine the need for repairs or replacement of the stucco as deemed necessary to maintain the structural integrity and appearance of the exterior.

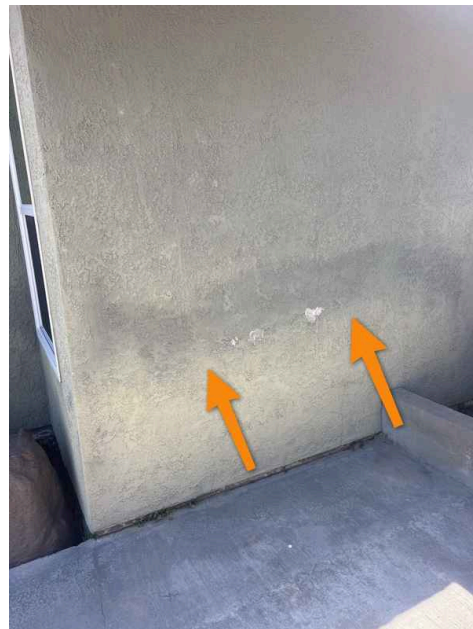
Backyard left side

Efflorescence damaged stucco was found in one or more areas. Moisture wicking from the soil will cause damage to this area of stucco in the form of bubbling and/or powdery residue. Recommend that a qualified contractor treat the area for efflorescence then repair or replace the stucco as necessary.

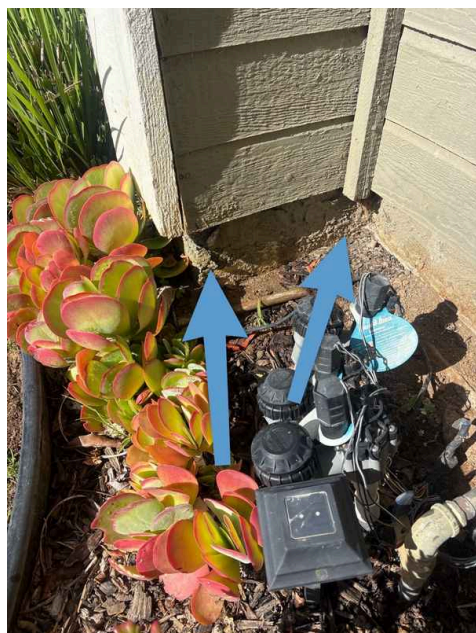
Front of house

Areas of cosmetic stucco deterioration were noted at the foundation below the weep screed metal. The client may wish to have these areas repaired for cosmetic reasons.

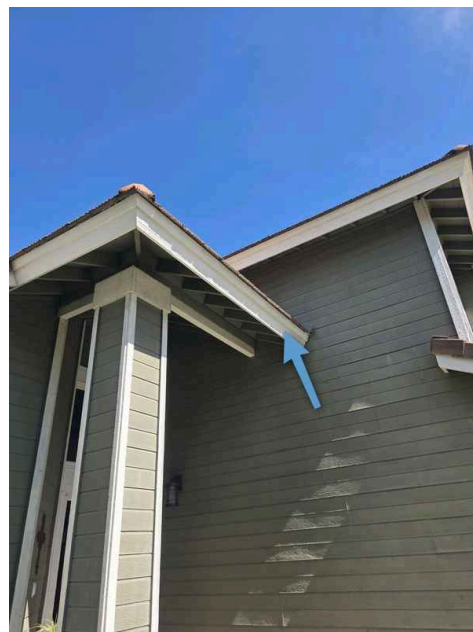
Gutters were found to be missing over one or more entrances. This absence of gutters can lead to people getting wet when entering or exiting the building during rainy periods.

It is advisable to have a complete drainage system in place for most buildings. At a minimum, it is recommended to install gutters over entrances to help channel rainwater away from the entrances and keep those using them dry during inclement weather.

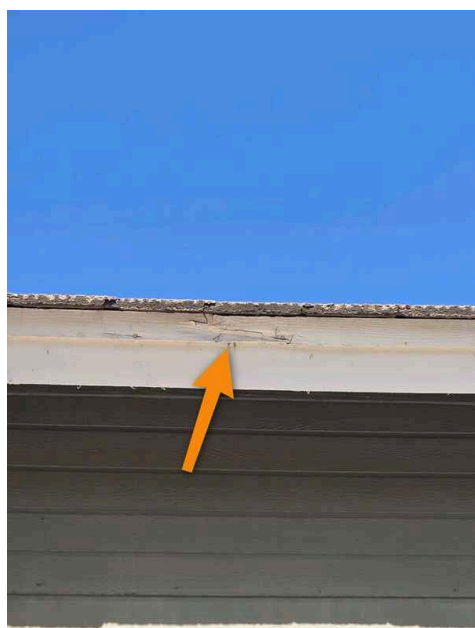
Upper level front over the garage

Fungal rot or termite damage has been detected in one or more roof areas, particularly at the edges of the roof sheathing, rafter tails, and/or fascia boards. To address this issue, it is recommended to engage a qualified contractor who can make necessary repairs.

The repair process may involve replacing all rotten wood, priming and painting new wood, and installing flashing as needed. These repairs are essential to restore the structural integrity of the affected roof areas and prevent further damage from fungal rot or termites.

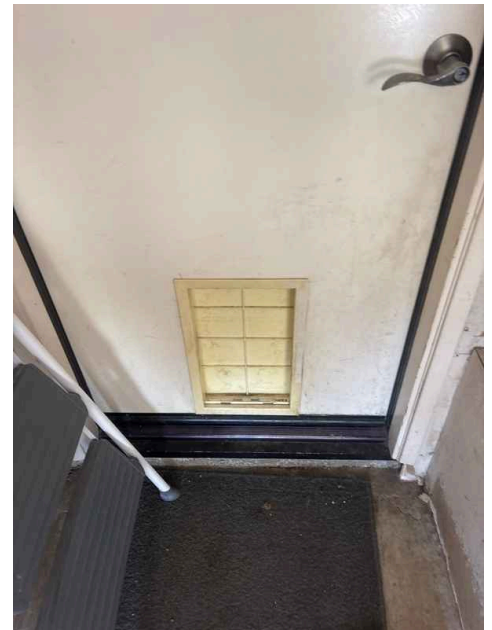
The door between the garage and the house has been altered with the addition of a pet door and/or window, and as a result, it is no longer fire-resistant. This presents a potential safety hazard, as doors separating the house from the garage should be constructed from fire-resistant materials to prevent the spread of fire and fumes from the garage into the interior living space. Typically suitable materials for such doors include solid core wood, steel, honeycomb steel, or doors that are factory labeled as fire-rated.

To address this safety concern and align with standard building practices, it is strongly recommended that a qualified contractor replaces or repairs the door. During this process, any other necessary corrections should be made to reestablish the required fire resistance between the garage and the dwelling, thereby ensuring the safety of the living space in the event of a garage-related fire.

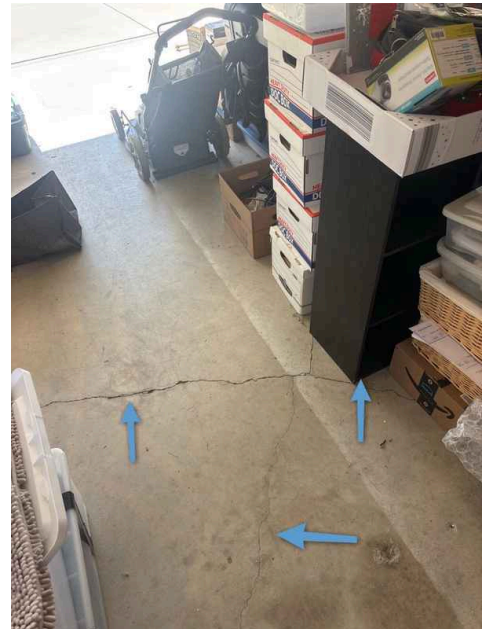
Minor cracks or deterioration were found in the concrete slab floor. These are common and appeared to be only a cosmetic issue.

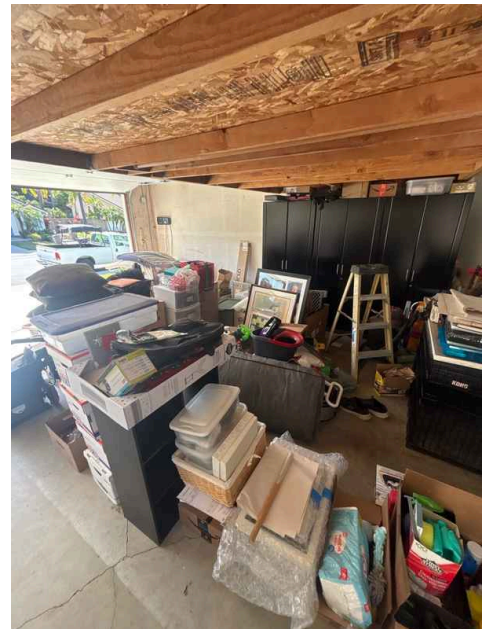
The garage floor was covered with flooring material and/or personal items. A thorough inspection of the garage slab/floor could not be completed as a result. Recommend further inspection once the items have been removed.

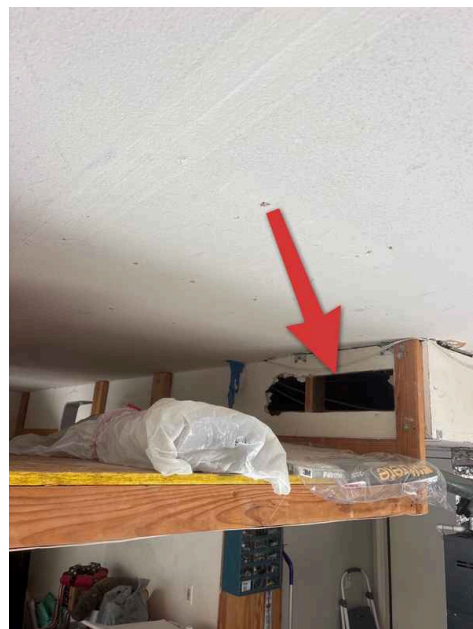
In the attached garage, one or more issues were identified, such as gaps, holes, pet doors, or areas with missing or substandard drywall on the walls or ceilings. Contemporary standard building practices require wooden-framed ceilings and walls that separate the house and garage to offer a limited fire-resistance rating, thus preventing the spread of fire from the garage to the house.

To ensure compliance with these safety standards and maintain the fire-resistant barrier, it is recommended that a qualified individual repairs the identified issues following standard building practices. This may involve patching openings or holes, using fire-resistant caulking to firestop gaps, and installing fire-resistant wall coverings such as Type X drywall where necessary. This will enhance the fire safety of the garage and its separation from the house.

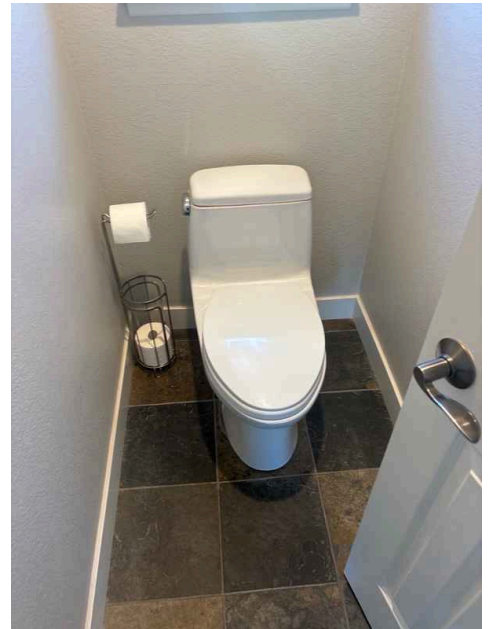
The flow meter at the main water meter had slight movement. This can be an indication of a water supply line leak but can also be something as simple as a leaking faucet or leaking toilet valve. Recommend a qualified plumber evaluate the flow meter after all known plumbing fixture issues have been repaired.

Running toilet causing flow meter movement

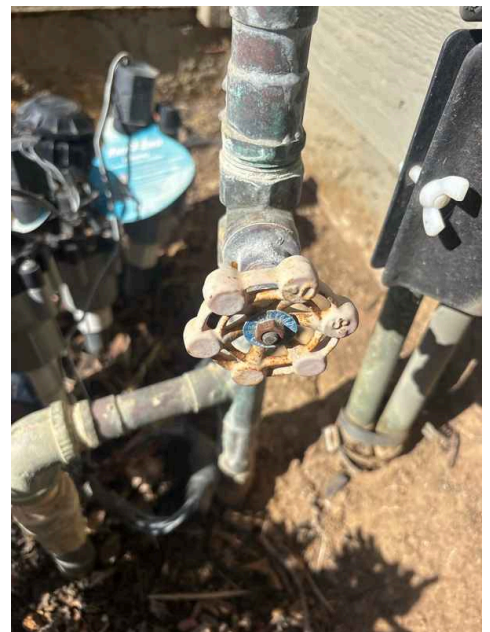
The main water shut-off handle is an older gate valve. These types of valves are unreliable and prone to failure. It is especially important to be able to reliably operate the main water shut-off valve in an emergency, such as when a supply pipe bursts. Recommend that a qualified plumber replace with a newer ball valve .

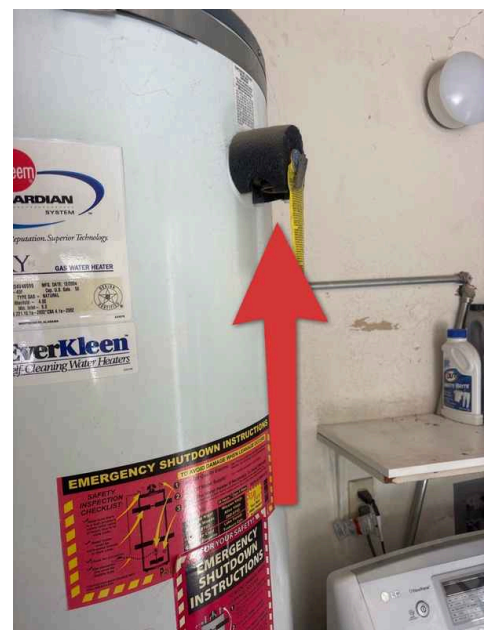
The drain line for the temperature-pressure relief valve was missing. This is a potential safety hazard, as it poses a risk of scalding if someone were to be standing next to the water heater when the valve opens. Recommend that a qualified plumber install a drain line with appropriate material as per standard building practices.

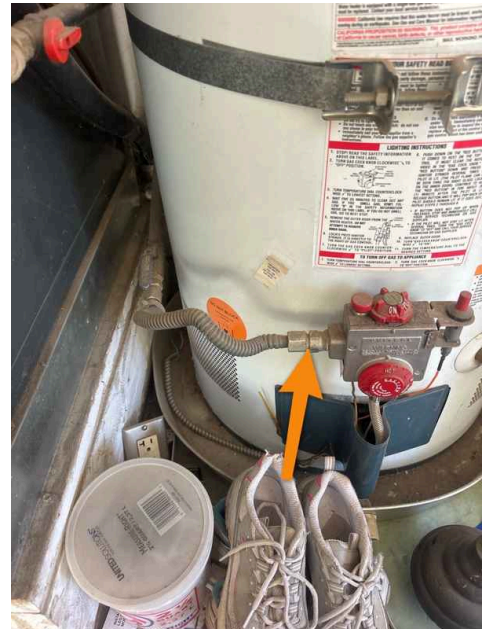
A sediment trap was missing from the gas supply line to the water heater. Sediment traps are required by most plumbing codes to prolong the life of the water heater by trapping oil, scale, water condensation and/or debris. Recommend that a qualified technician install a sediment trap per standard building practices. Note that while sediment traps are part of the uniform plumbing code, the lack of one is not a safety risk. They merely protect the appliances.

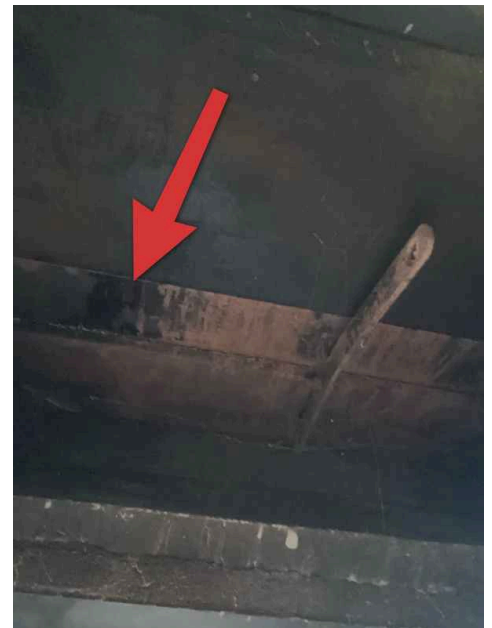
In a fireplace with a gas burner, the presence of a chimney damper that can close is a safety hazard. This situation can allow exhaust gases from the burner or pilot light to enter living spaces. To ensure safety, modifications should be made to prevent the damper from closing. This can be achieved by installing a C-clamp or other "damper clamp" on the damper plate to keep it permanently open and prevent the hazard. Recommend that this modification be made promptly to address the safety concern.

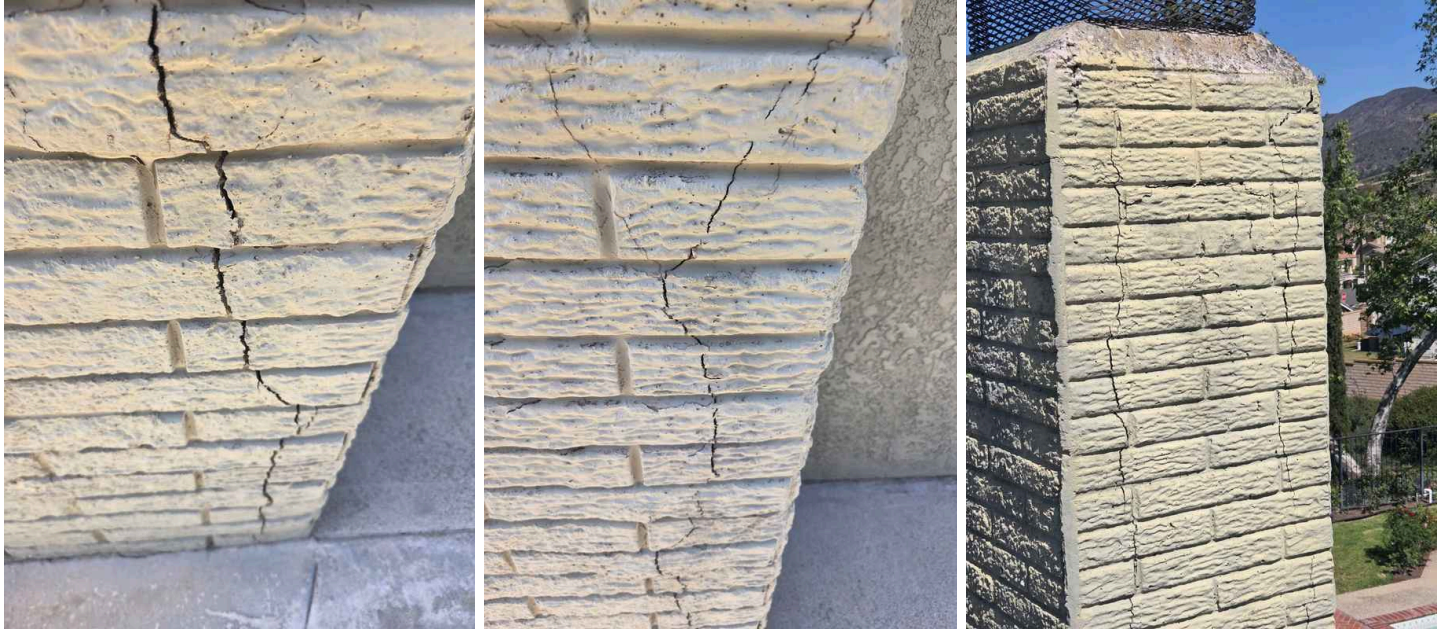
The fireplace and chimney are a "Rampart" pre-cast product, very common from the late 70's to early 90's construction in southern California. Several cracks were noted during the inspection. These fireplace/chimneys are prone to cracking. There is only one approved repair option, called "Thermocrete". If the cracking is severe and the structural integrity is compromised, these structures have to be torn down and rebuilt in a different manner, which can be costly and requires a building permit. It is beyond the scope of the normal home inspection to determine this. Recommend further evaluation by a certified chimney sweep/fireplace inspector who can determine if the fireplace and chimney can be repaired.

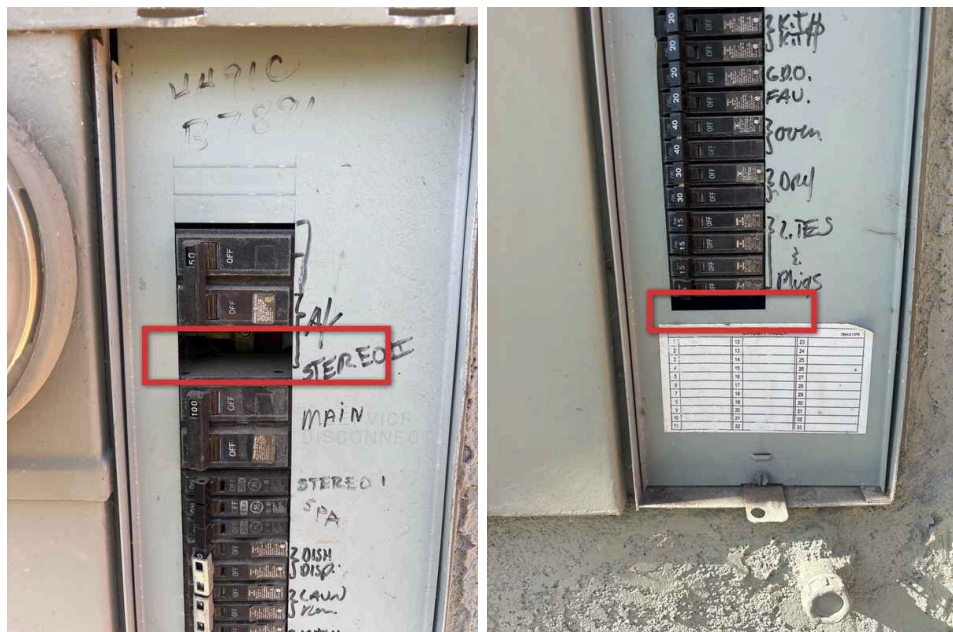
The main electrical panel was found to have one or more open slots where circuit breakers are typically installed. This condition exposes energized electrical equipment, creating a significant shock hazard. To address this safety concern, it is strongly recommended that a qualified person install closure covers in any open slots where circuit breakers are missing. These covers will help protect against electrical shock and enhance the safety of the electrical system.

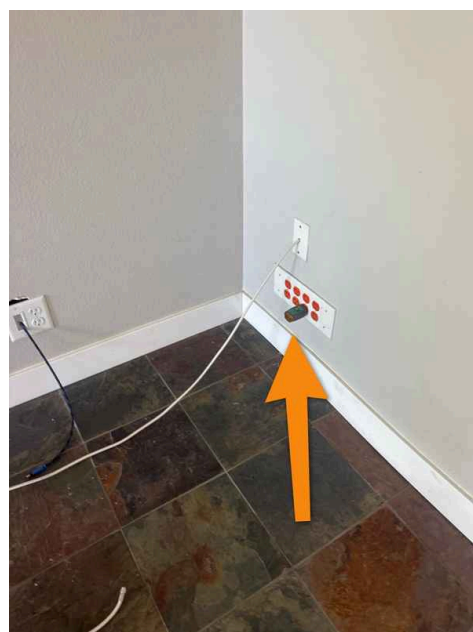
Rear living room

One or more electric receptacles (outlets) were found to have no power. Recommend a qualified electrician evaluate and repair as needed.

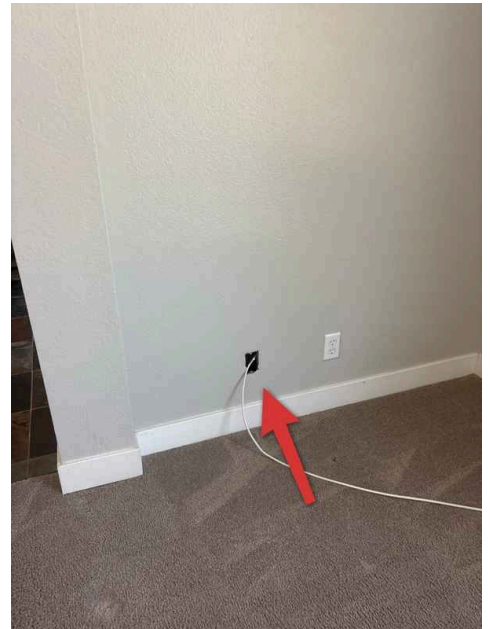
Master Bedroom

Cover plates for switches, receptacles (outlets) or junction boxes were missing or broken in one or more locations. These plates are intended to contain fire and prevent electric shock from occurring due to exposed wires. Recommend that a qualified person install new cover plates as needed.

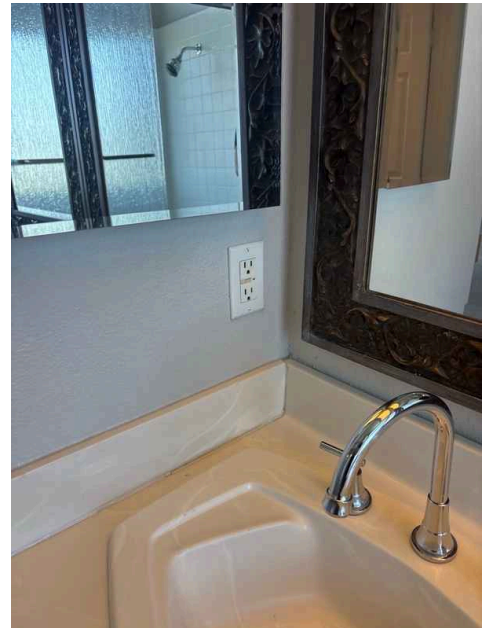
Master Bathroom is connected to 2nd Floor guest bathroom

Recommend replacement of the additional GFCI receptacles with standard receptacles.

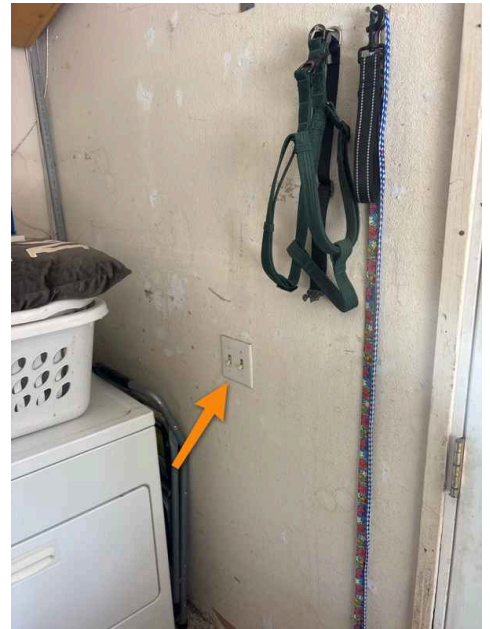
Garage

We cannot verify what one or more switches operates. Recommend a qualified electrician verify where the switch leads

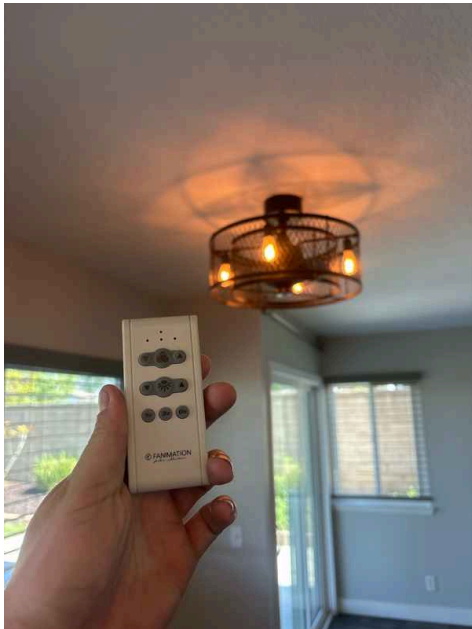
One or more ceiling fans appeared to be inoperable, or the normal controls could not be located. Recommend asking the property owner about their operation. If necessary, a qualified electrician should evaluate and repair as needed.

Dead remote Kitchen

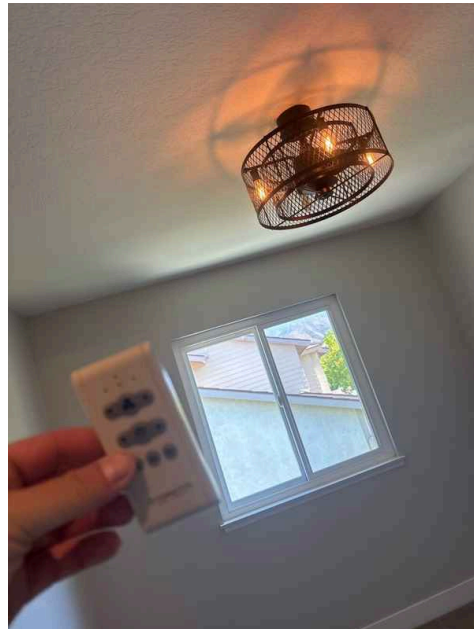
Dead remote middle guest bedroom

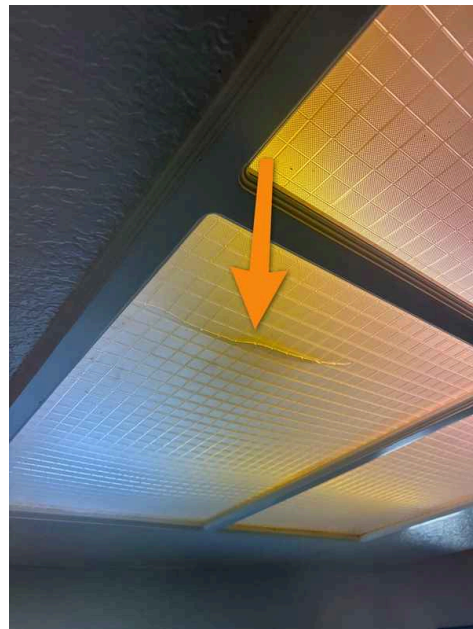
Kitchen

Light fixtures were missing, damaged, deteriorated, loose, substandard in one or more locations. Recommend that a qualified electrician repair or replace light fixtures as needed.

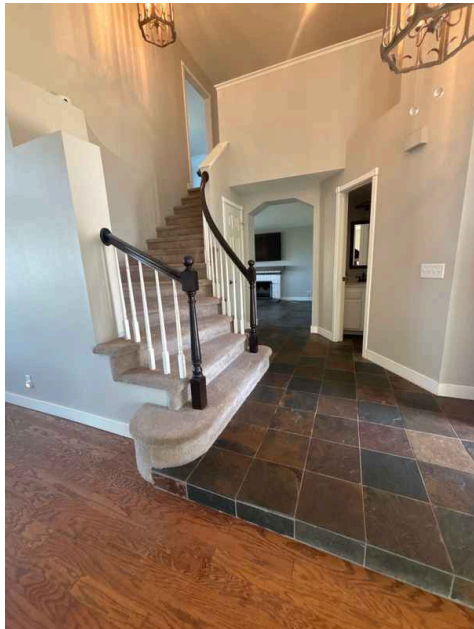
1st Floor

Smoke alarms were missing from one or more areas. This is a potential safety hazard. A qualified electrician should install smoke alarms per standard building practices (e.g. in hallways leading to bedrooms, in each bedroom, and on each floor).

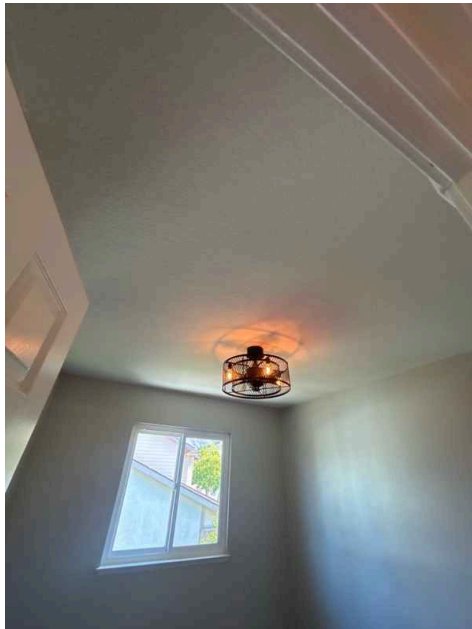
All bedrooms

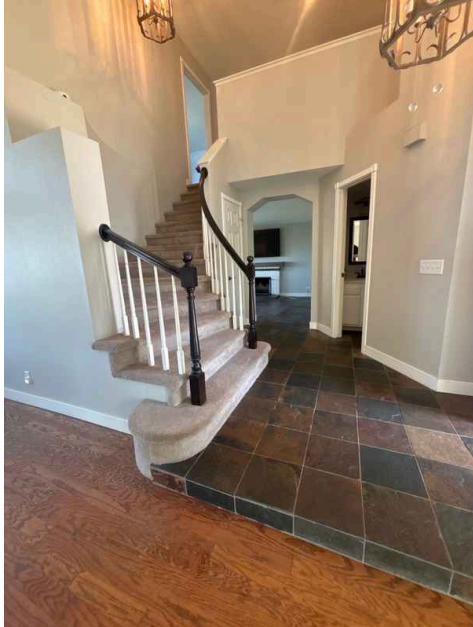
1st Floor

Carbon monoxide alarms were missing from one or more floors/hallways. This is a potential safety hazard. The state of California requires carbon monoxide alarms to be installed for new construction and/or for homes being sold. Recommend installing approved carbon monoxide alarms outside of each separate sleeping area in the immediate vicinity of the bedrooms, and on each level of the home, in accordance with the manufacturer's recommendations.

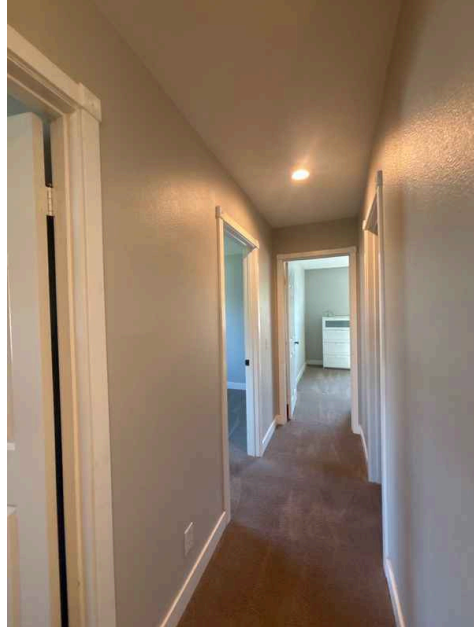
2nd Floor

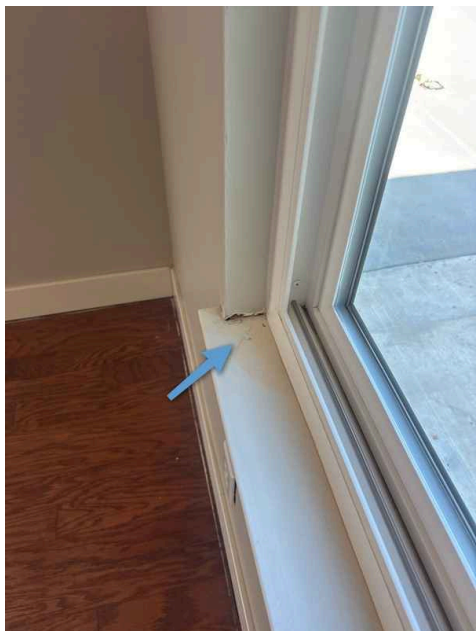
Dining Room window

Minor cracks, nail pops, and blemishes were observed in walls and/or ceilings in one or more areas of the property. These imperfections are often the result of normal settling and changes in humidity, and they are typically not indicative of structural issues. While these issues are generally cosmetic and do not pose a significant concern, some homeowners may choose to repair them for aesthetic reasons.

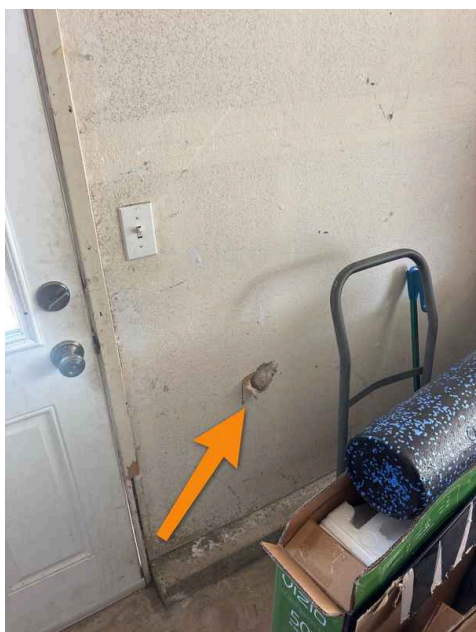
Garage

Walls and/or ceilings were damaged, cracked or had substandard repairs in one or more areas. Recommend that a qualified technician repair as needed.

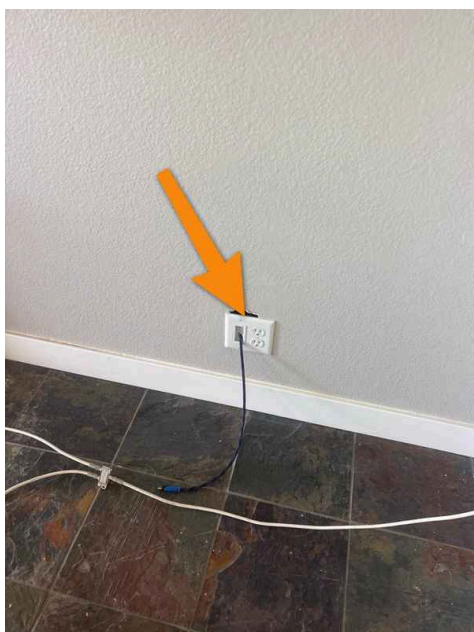
Rear living room

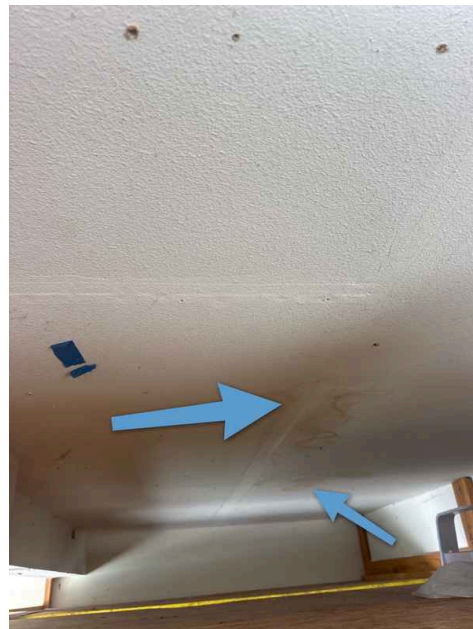
Garage ceiling

One or more wall or ceiling areas were showing water stains. However, no elevated levels of moisture were detected. The stain(s) may be due to past roof and/or plumbing issues. Recommend consulting with the property owner and monitor the stained area(s) in the future, especially after heavy or prolonged rain. If elevated moisture is found in the future, a qualified contractor should evaluate and repair as needed.

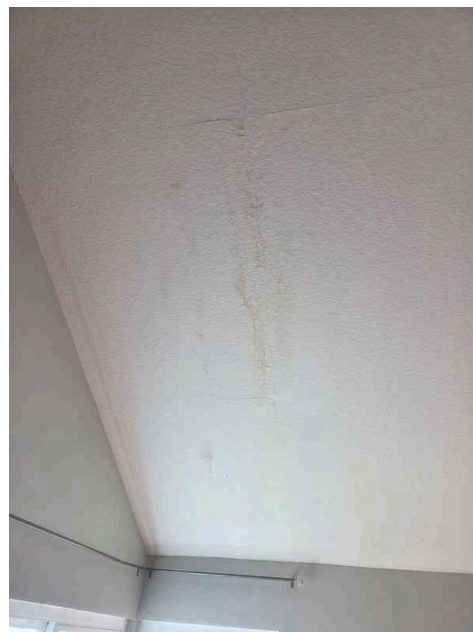
Living Room

Stains were found in wall or ceiling areas in one or more areas. It is unclear if an active leak exists due to recent dry weather or inaccessible height. Recommend consulting with the current owner about these stains, monitoring the stains in the future, and/or having a qualified contractor evaluate and repair as needed.

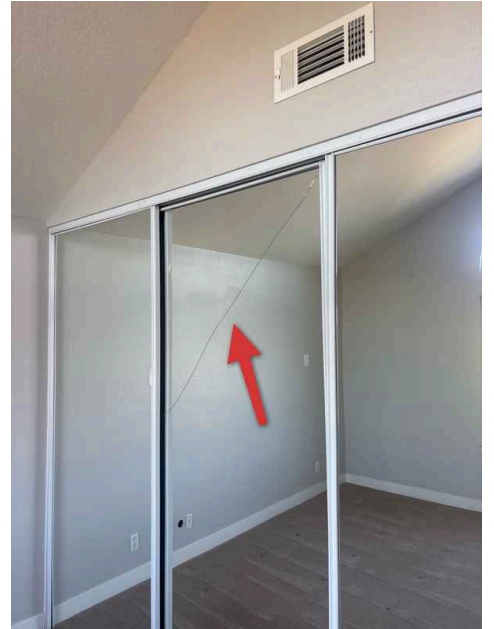
Master Bedroom

Mirror glass in one or more interior closet doors was broken.  
Recommend that a qualified contractor replace glass where necessary.

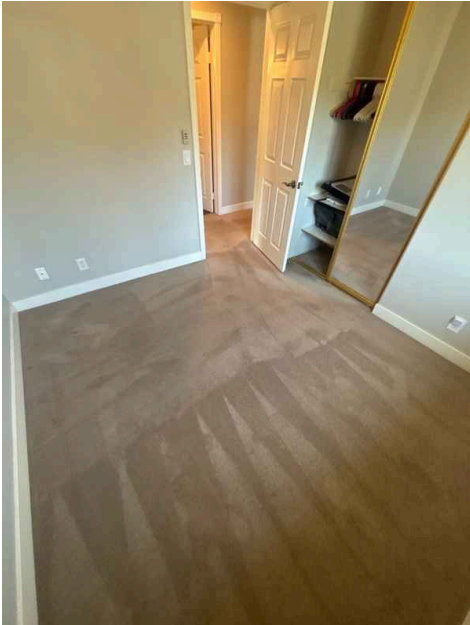
Middle guest bedroom

Squeaking or creaking noises were noted when walking on one or more sections of flooring. These sounds are typically a result of substandard construction practices, such as inadequate fastening of the sub-floor decking to the framing below. Common issues include insufficient use of glue and the use of nails instead of screws. In most cases, this concern is more of an annoyance than a structural problem. The difficulty of repairs depends on factors like the type of floor covering and the accessibility to the underside of the sub-floor.

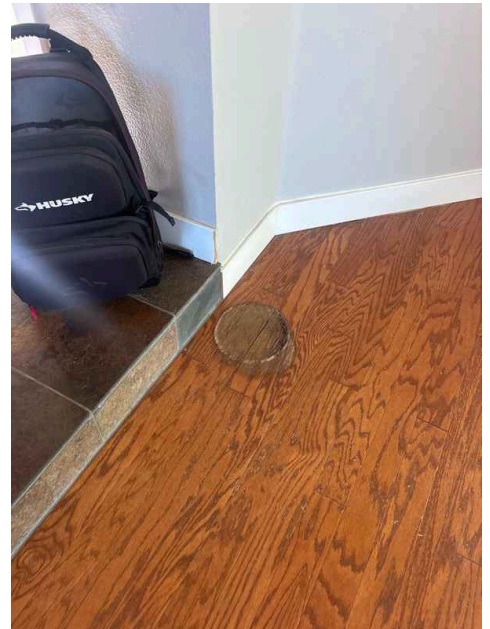
Front door

Additionally, it's important to identify and rectify any moisture-related issues to prevent further damage to the wood flooring. This may involve addressing water leaks, improving ventilation, or using moisture barriers during refinishing or installation.

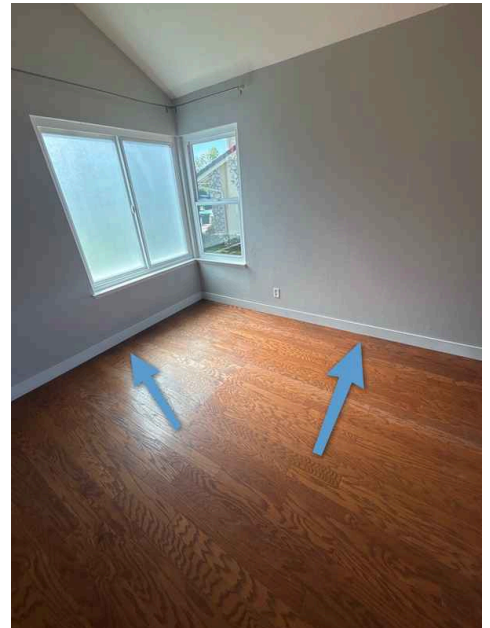
Baseboard was damaged or missing at one or more interior locations. Recommend repair/replacement as needed.

Front living room loose
