# PREFERRED INSPECTION SERVICES

## HOME INSPECTION

20971 Morningside Dr  
Trabuco Canyon, CA 92679

04/28/2026

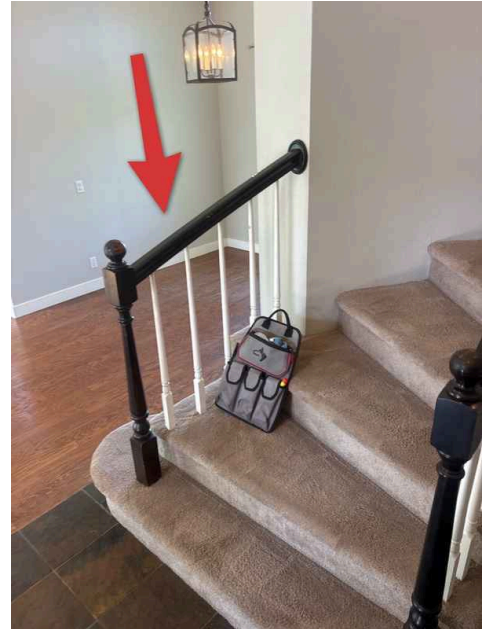
**HANDRAILS LOOSE/WOBBLY**

One or more flights of stairs hand handrails that were loose, wobbly, damaged or deteriorated. This is a safety hazard. Recommend that a qualified technician repair/replace as needed.

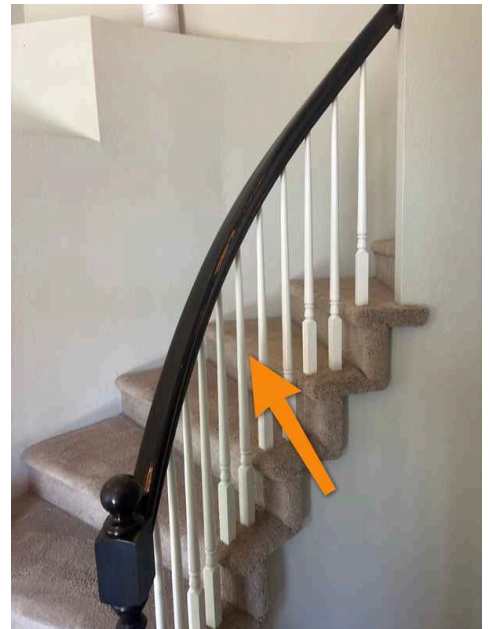
One or more vertical spindles on the stair railing were loose or insecure. Recommend a qualified technician repair as needed.

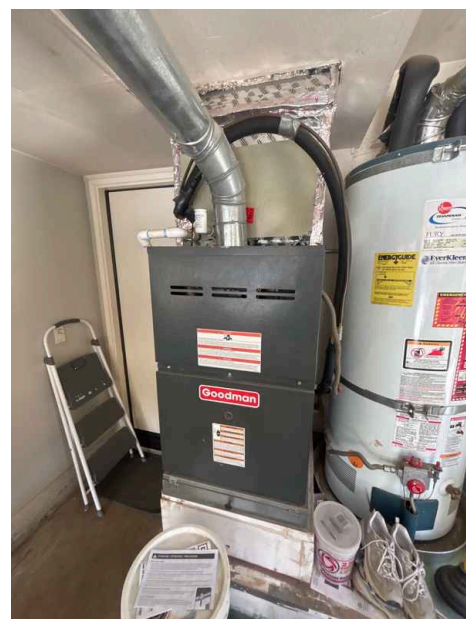
**Forced Air (Heating): Condition**

Serviceable

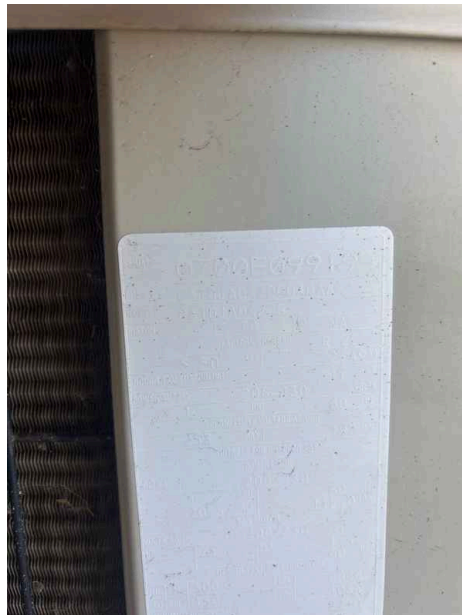
**Air Conditioning: Approximate Age**  
26

**Air Conditioning: Condition**  
Serviceable

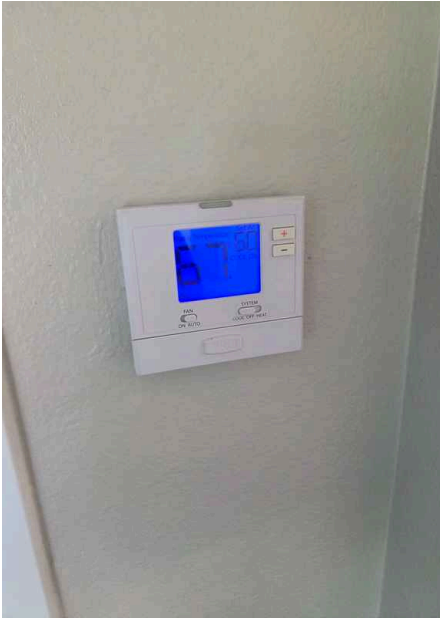
**Thermostat: Condition**  
Serviceable

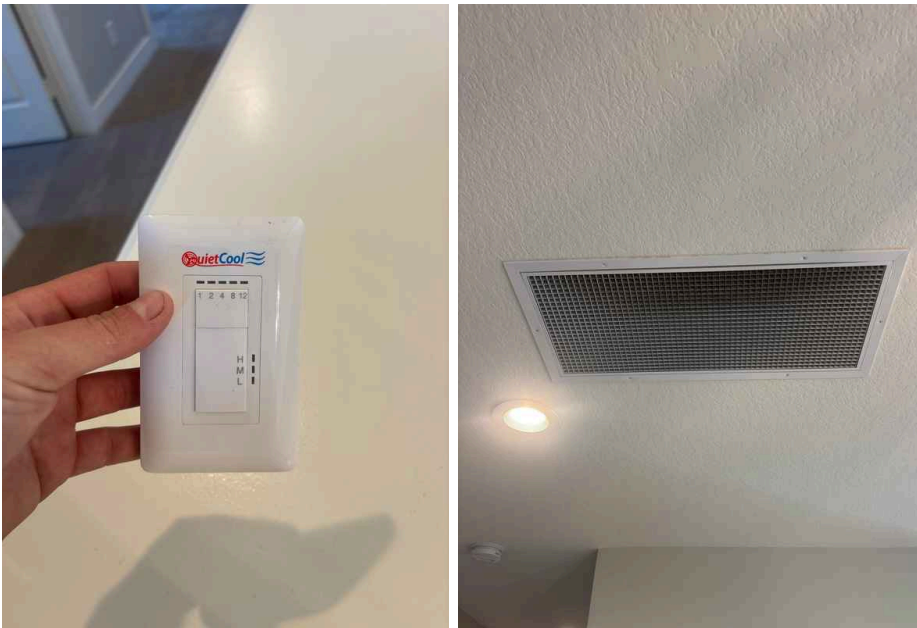
This home is equipped with a whole house fan. These fans provide cooling for interior spaces by pulling hot interior air up into the attic and out through attic vents, and by drawing cooler air in from the outside through open windows. They are intended to operate only when the outside temperature is cooler than inside, typically during the spring and fall months. Multiple windows should be opened to equal or exceed 3 times the area of the fan opening. If air conditioning is installed it should not be operated while the whole house fan is operated. These fans do not dehumidify and can be noisy during operation.

The client should be aware that some routine maintenance is required for whole house fans such as lubrication, and tightening or replacing belts cleaning. Consult with a heating and cooling specialist on this. Note also that motors and other components have a limited lifespan.

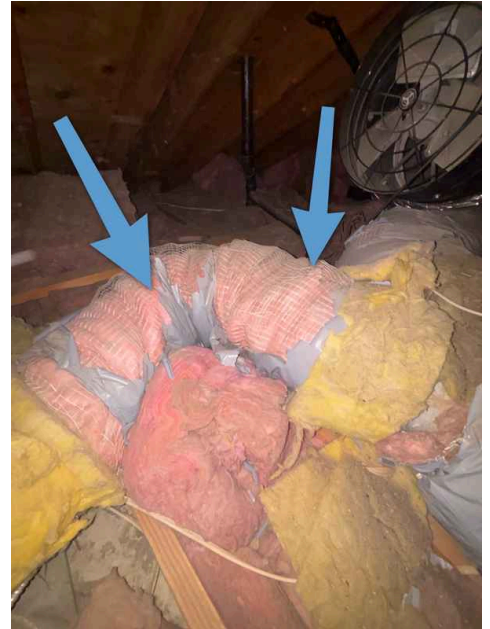
**INSULATION DETERIORATED**

Sections of the heating and cooling ducts in an unconditioned space (e.g. crawl space, attic or basement) were not insulated, or the insulation was damaged or deteriorated. Reduced energy efficiency, moisture inside heating ducts, and/or "sweating" on cooling ducts can occur as a result. Recommend that a qualified technician repair as needed.

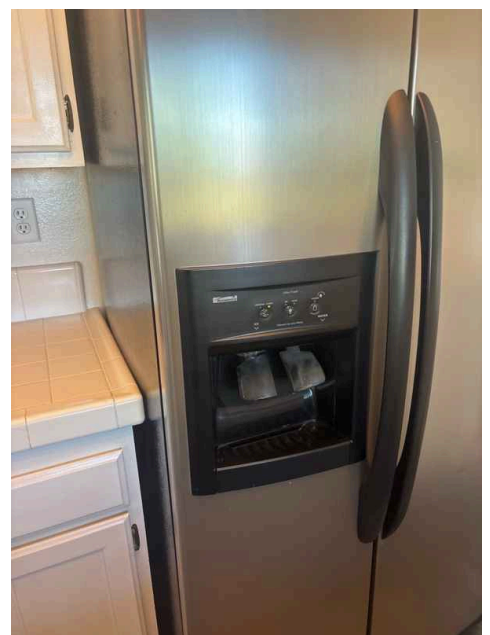
Inoperable

The refrigerator's ice maker, ice dispenser, and/or water dispenser was inoperable/malfunctioning. Recommend that a qualified person repair as necessary.

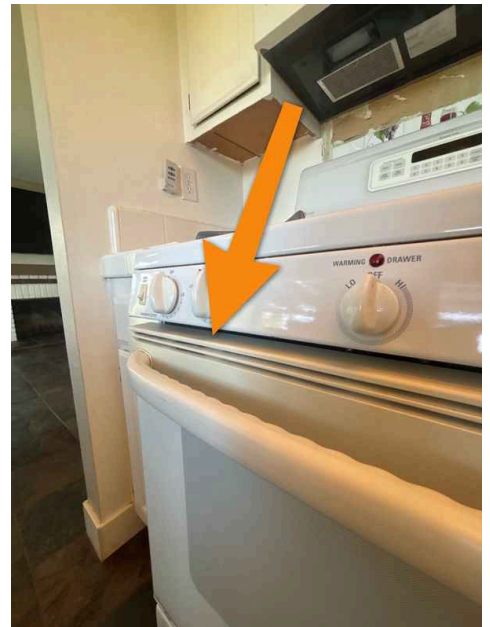
Smoke escaping out of front of oven

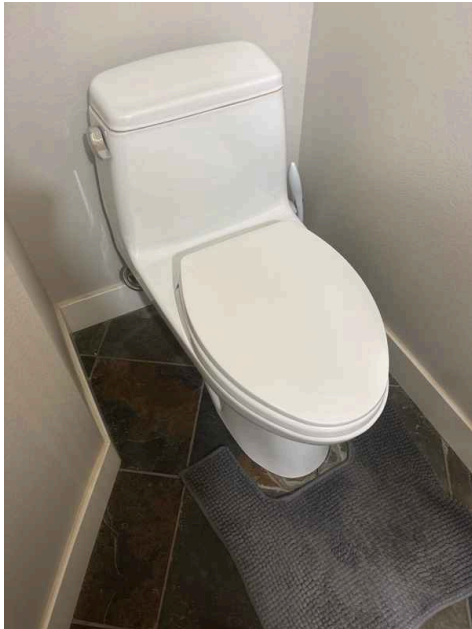
1st Floor powder bathroom

One or more toilets are loose where it attached to the floor. Leaks can occur as a result. Flooring, the sub-floor or areas below may get damaged. Sewer gases can enter living spaces. Recommend that a qualified plumber remove the toilet(s) for further evaluation and install a new wax ring. The toilet should also be caulked at the base of the bowl where it meets the floor to prevent movement and leaking, and for sanitary reasons.

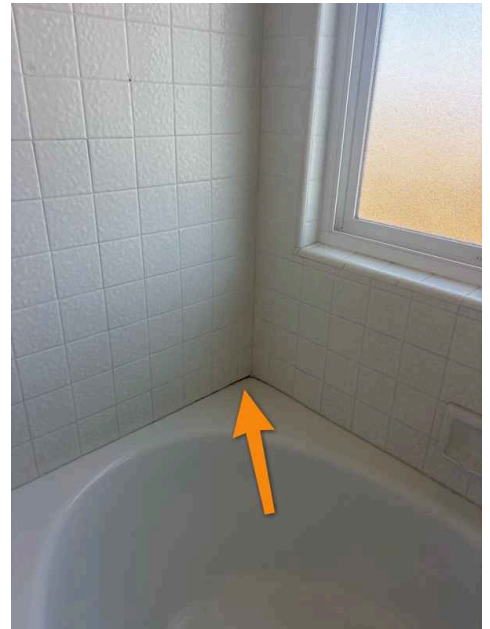
Master Bathroom

Recommendation/Evaluation**TILE/GROUT DETERIORATED**

One or more sections of grout was deteriorated, recommend filling in to avoid water intrusion.
