## LICHI RESIDENTIAL REPORT

27213 Blueridge Dr  
Santa Clarita, CA 91354

Ethylene Duffy  
DECEMBER 19, 2025

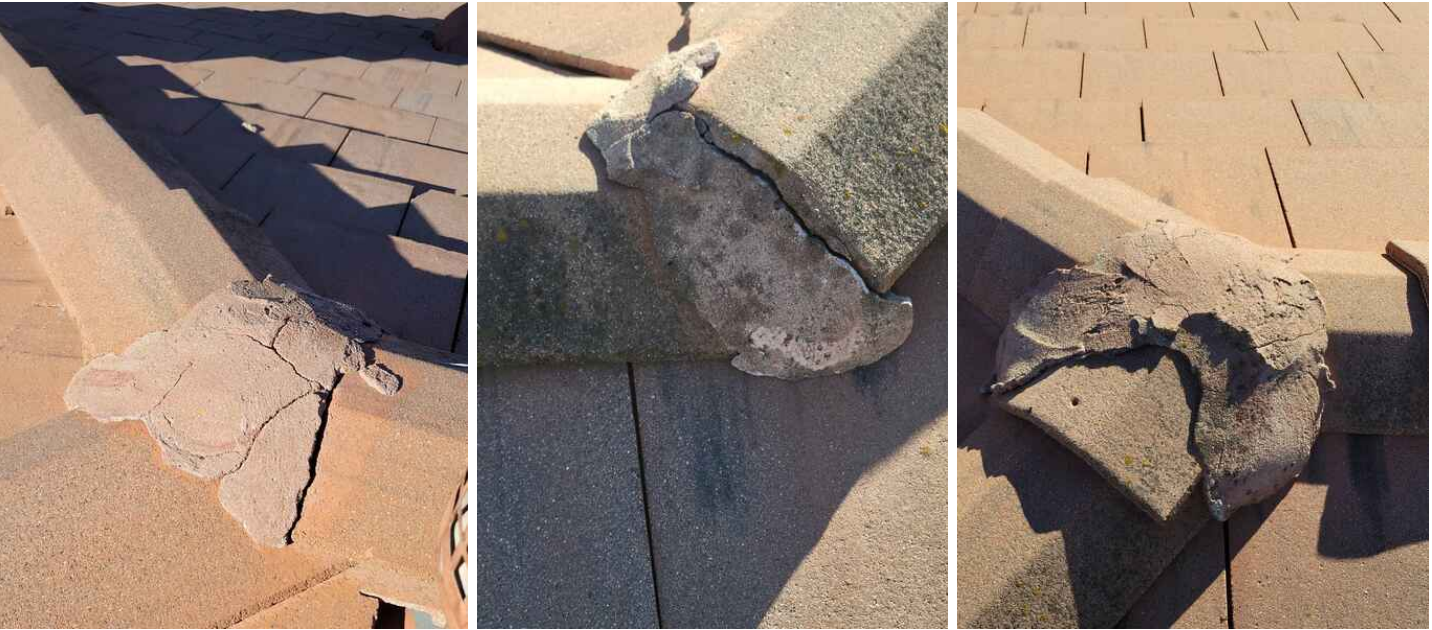
2.2.1 Coverings

**HIP AND RIDGE REQUIRE MAINTENNACE**

Hip and ridge shingles and tiles seal adjacent roof planes. Deficiencies in this area can allow water in at the top of the roof system thus bypassing the waterproof system.

Recommendation  
Contact a qualified roofing professional.

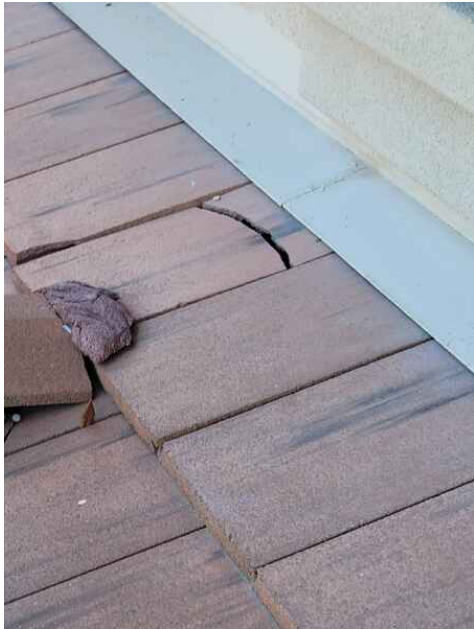
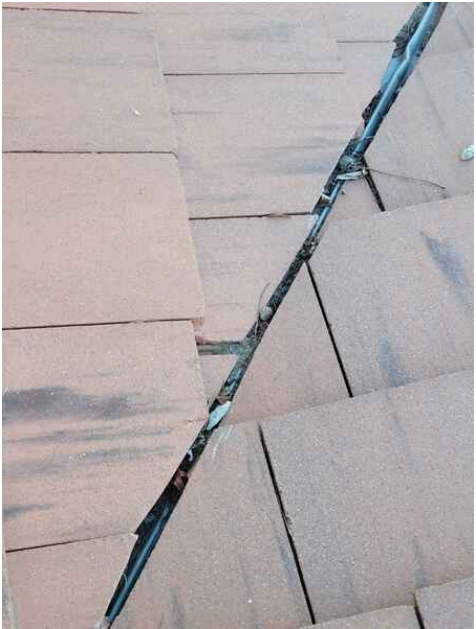
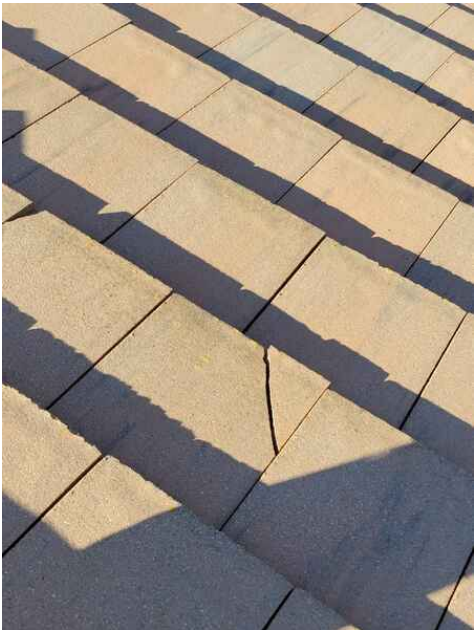
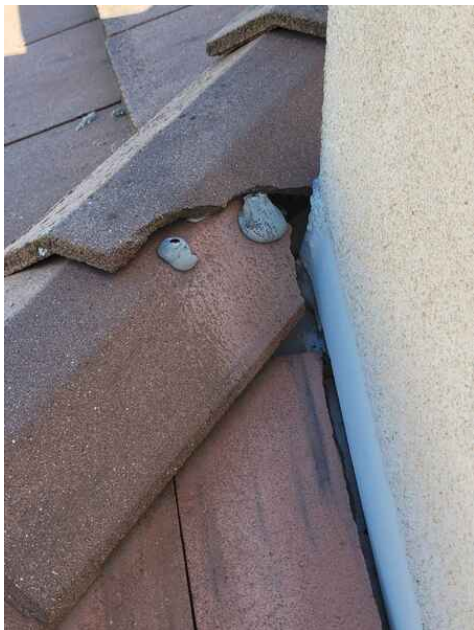
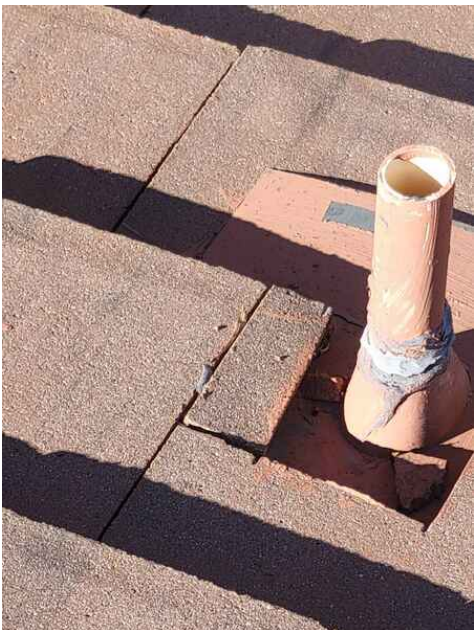
2.2.2 Coverings

**TILES CRACKED/BROKEN**

Roof had cracked/broken tiles. Recommend a qualified roof contractor repair or replace to prevent moisture intrusion.

Recommendation  
Contact a qualified roofing professional.

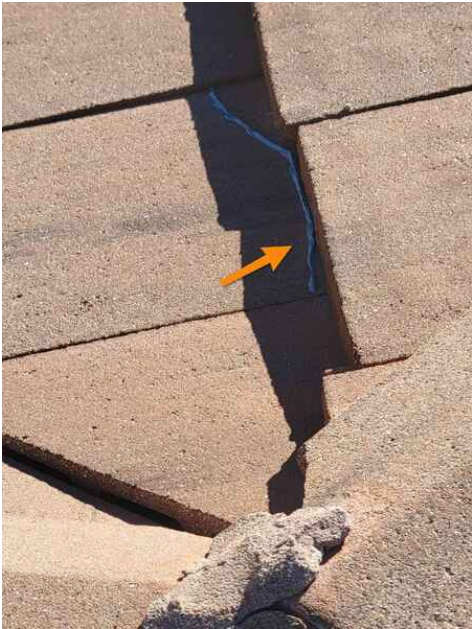
improper repair to broken tile

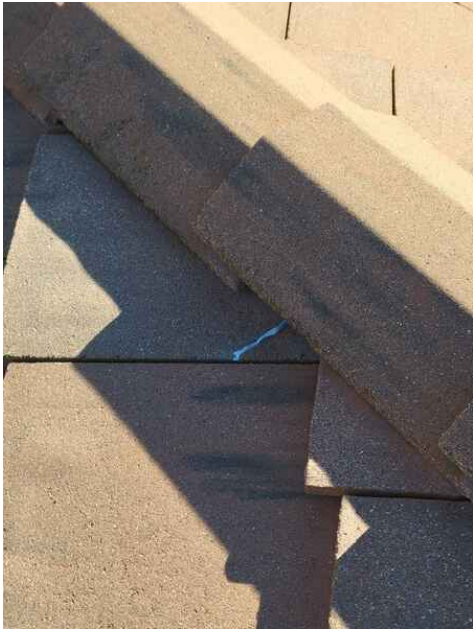
improper repair to broken tile

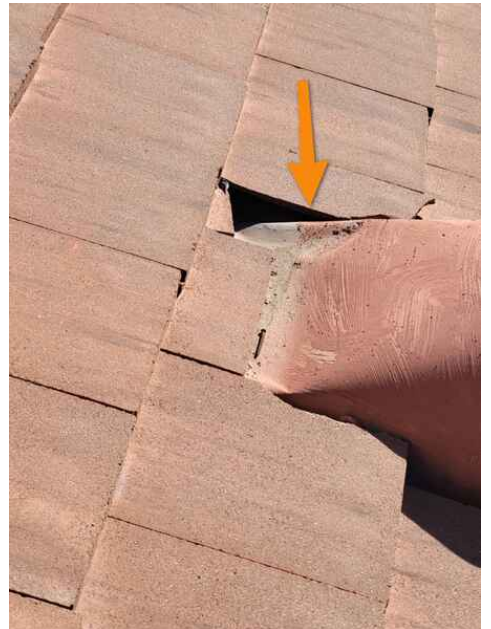
#### 2.4.1 Flashings

Flashings that are damaged do not function as intended and require service or replacement.

this dormer vent is crushed and will pool water

Contact a qualified roofing professional.

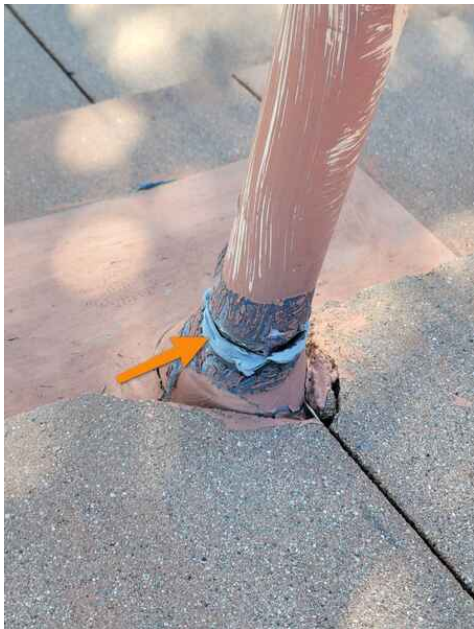
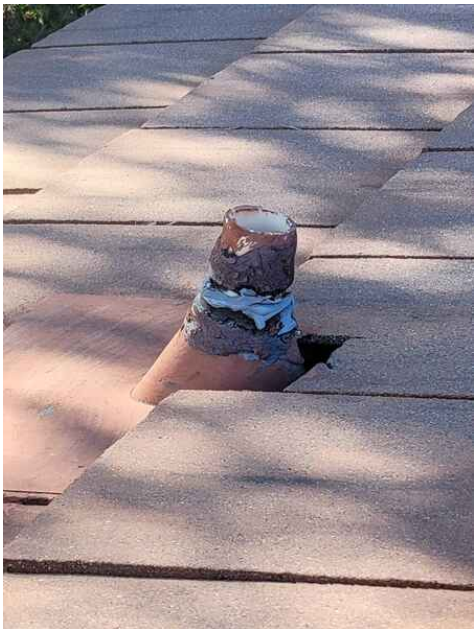
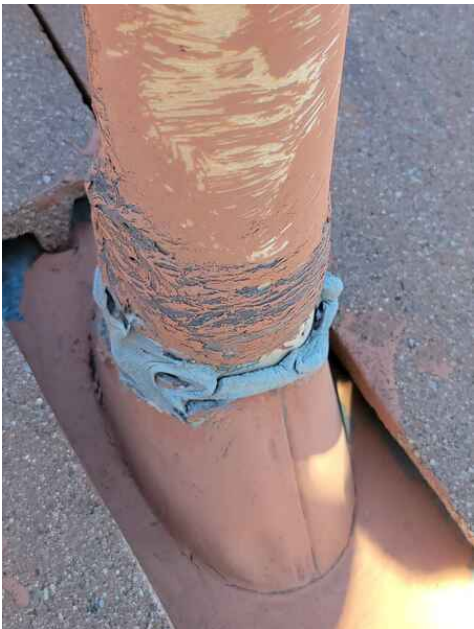
#### 2.5.1 Skylights, Chimneys & Other Roof Penetrations

##### **PIPE FLASHING MISSING/DETERIORATED SEALANT**

Pipe penetrations are flashed with a roof jack. The connection between the pipe and the roof jack requires sealant. This is a maintenance area and requires servicing from time to time.

all pipe penetrarions' sealant is cracked

Contact a qualified roofing professional.

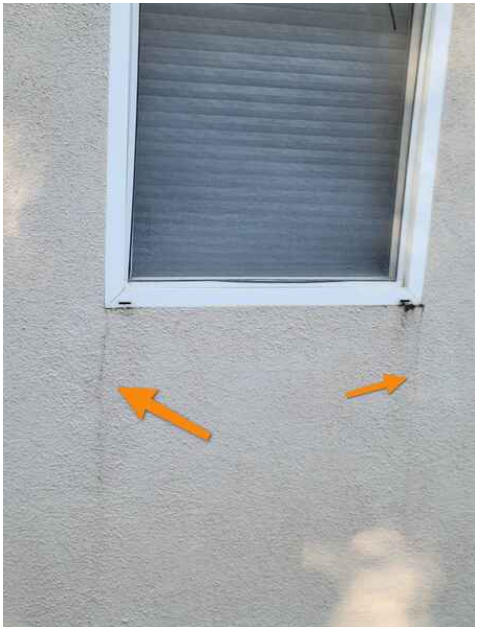
3.2.1 Siding, Flashing & Trim

Stucco showed cracking in one or more places. Minor cracking is typical in stucco applications but should be sealed and monitored for any changes.

vertical cracking requires repair

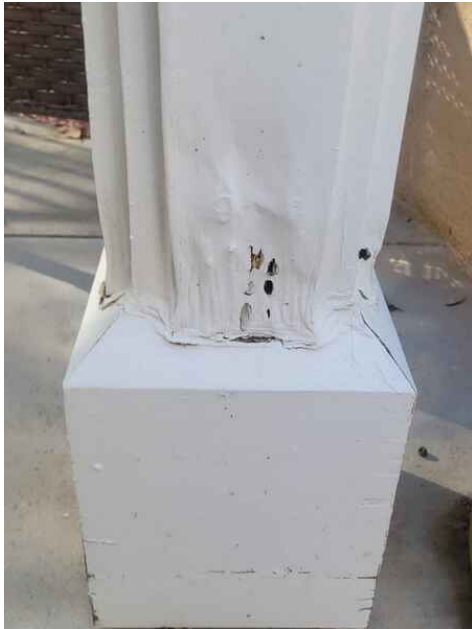
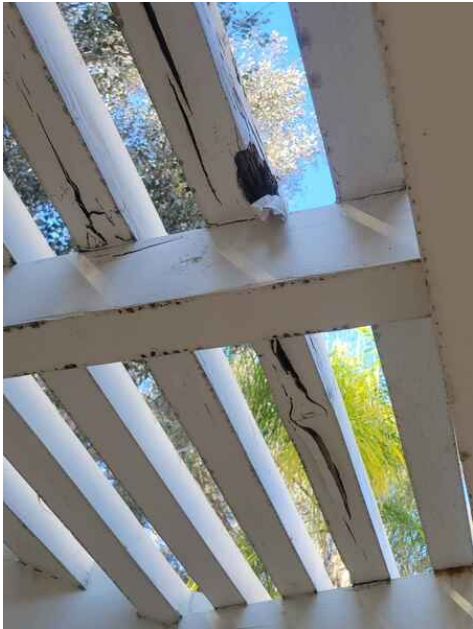
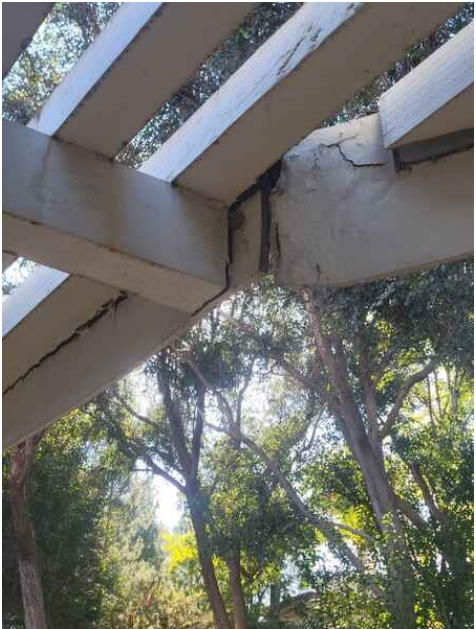
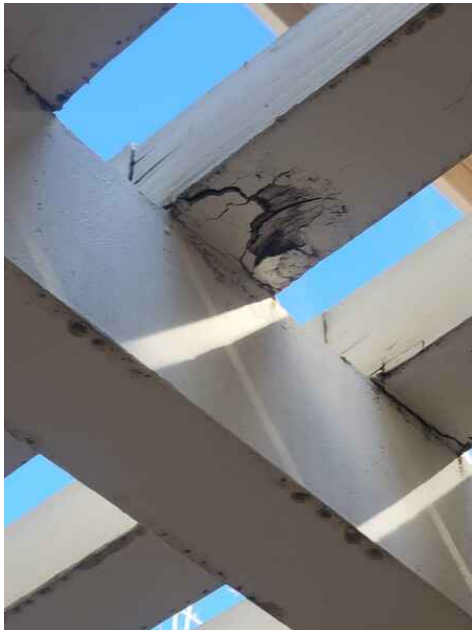
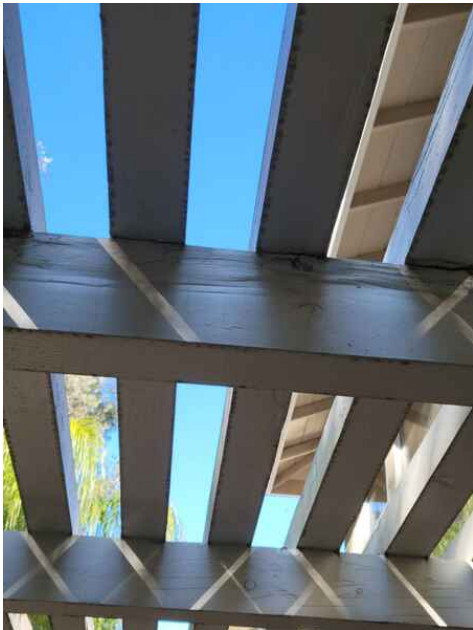
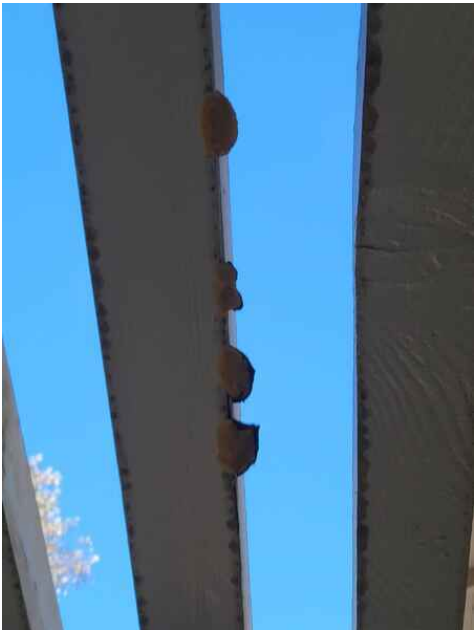
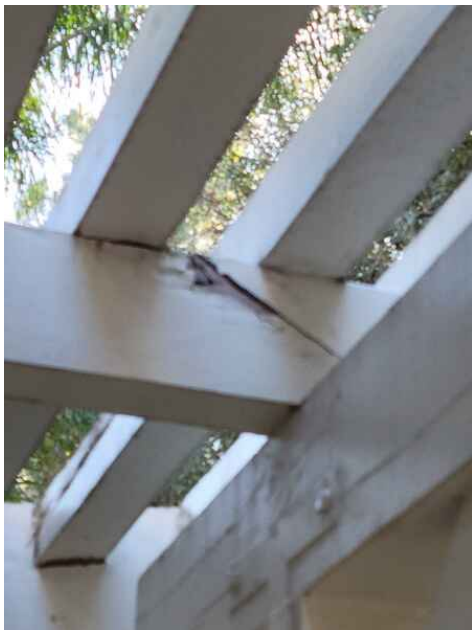
3.2.2 Siding, Flashing & Trim

**WOOD DESTROYING ORGANISM ALERT**

There is major dry rot and termite damage to the patio cover. There are no structural or trim components that have not been affected. This patio cover needs a full replacement. We recommend a WDO inspection to determine if more areas of damage exist.

Contact a qualified professional.

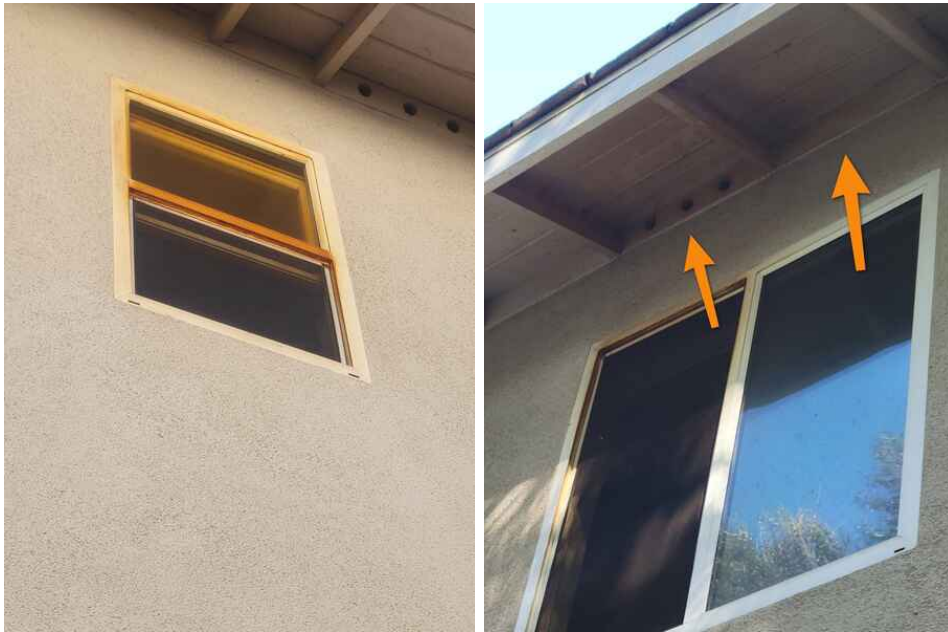
## 3.6.1 Eaves, Soffits &amp; Fascia

**EAVES - DAMAGED**

There are areas of the upper floor eaves that have significant nicotine damage and will require remediation to properly correct.

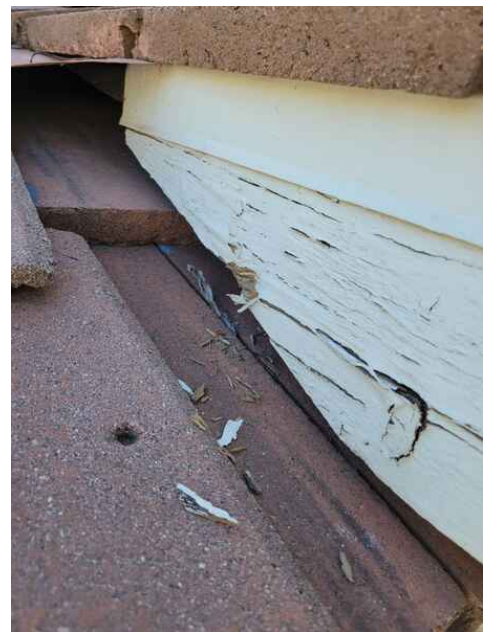
## 3.6.2 Eaves, Soffits &amp; Fascia

**PAINT/FINISH FAILING**

The paint or finish is failing. This can lead to deterioration and rot of the material. Recommend that the areas be properly prepared and painted / finished.

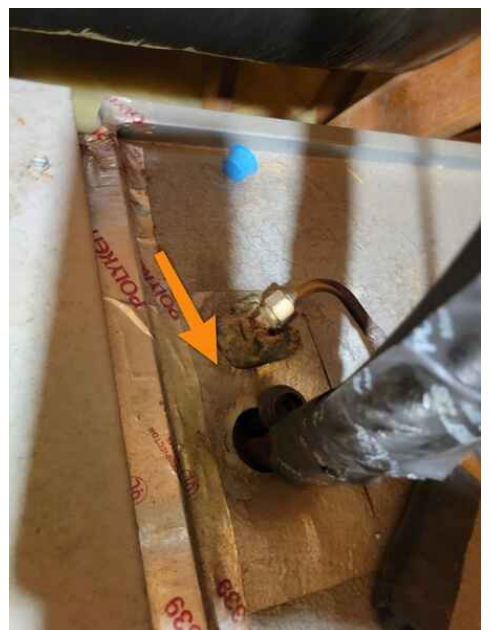
active leak

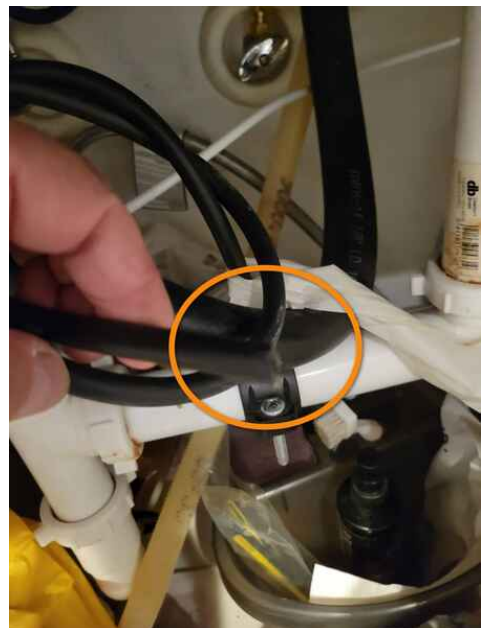
#### IMPROPER CONNECTION

An improper drain connection was observed and requires correction.

uncapped drain tube from previous reverse osmosis type system

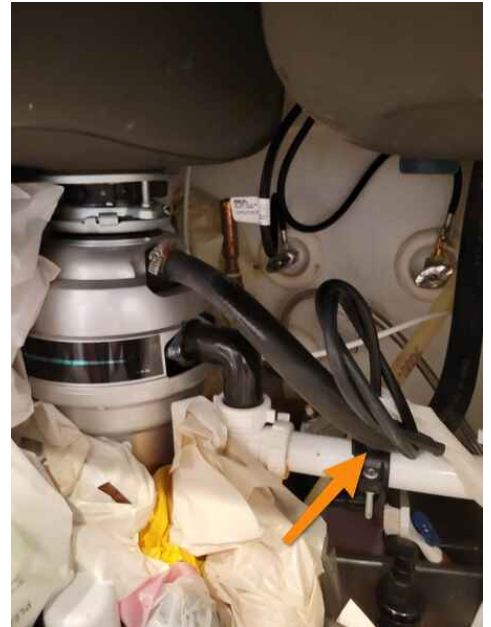
## 7.3.3 Drain, Waste, &amp; Vent Systems

**DISHWASHER AIR GAP MISSING/IMPROPER**

tube does not have continual slope towards drain

Recommendation  
Contact a qualified professional.

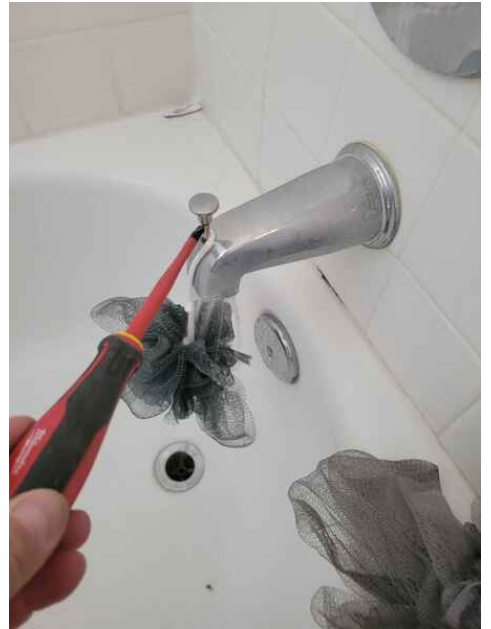
**FAUCET LEAKING/NOT OPERATING CORRECTLY**

tub spouts all stuck in shower position

Recommendation  
Contact a qualified professional.

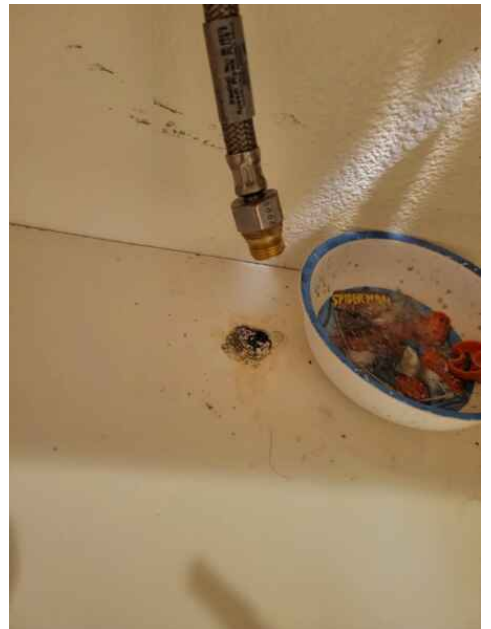
leak under faucet not fully installed

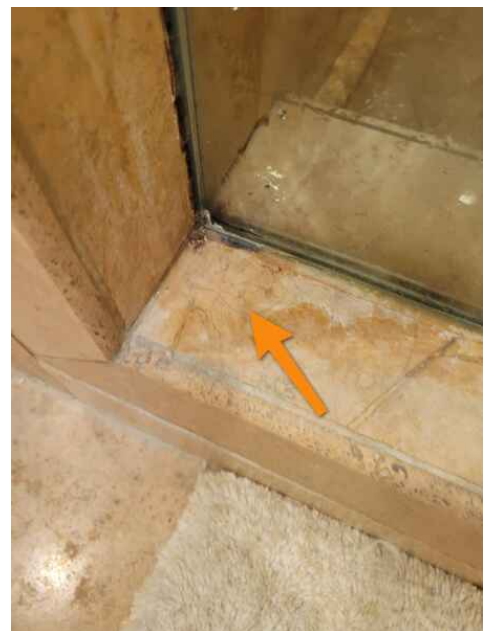
**MISSING SEALANT**

Any gaps between fixtures and adjacent surfaces are to be sealed with approved caulking or silicone to prevent moisture intrusion.

shower leaking at enclosure

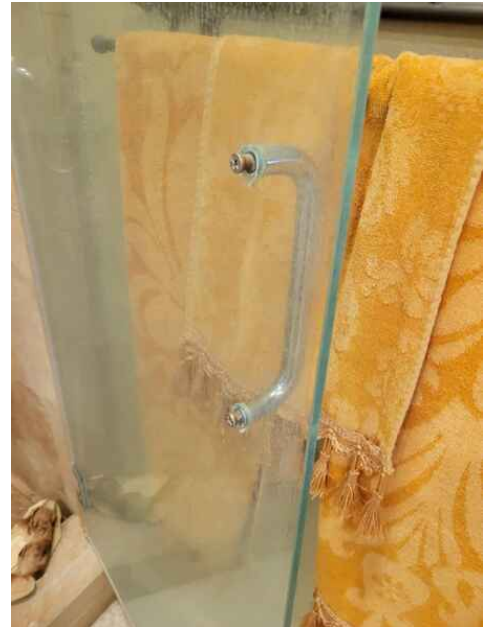
## 7.8.4 Fixtures

**PHYSICAL DAMAGE**

Physical damage to fixtures was observed. While some damages may only be cosmetic, others can lead to further damage or improper function of the fixture. We recommend all physical damage be corrected or replaced.

Contact a qualified professional.

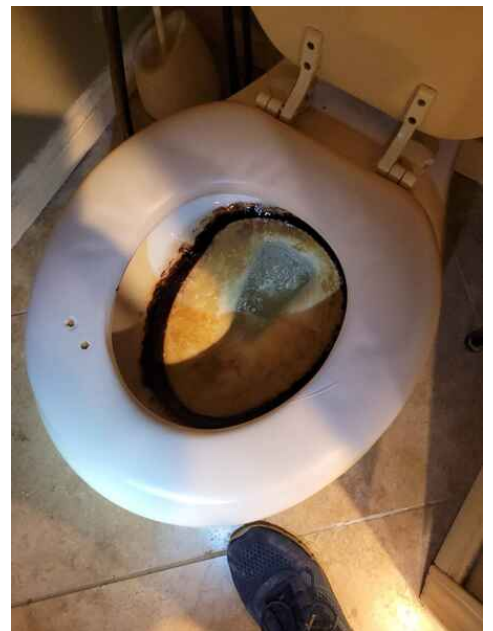
**TOILET DAMAGE**

The toilet interiors are damaged and require replacement.

example of toilet bowl conditions

Contact a qualified professional.

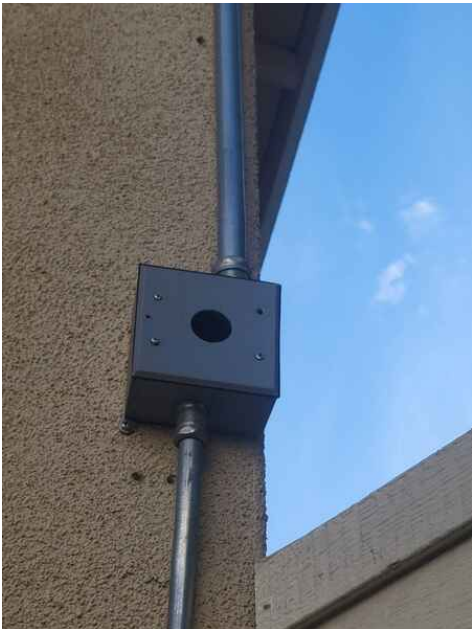
8.3.1 Branch Wiring Circuits, Breakers & Fuses

**IMPROPER WIRING**

Wiring was observed to not be installed per building standards. See photos for comments.

junction boxes open to weather

Recommendation  
Contact a qualified electrical contractor.

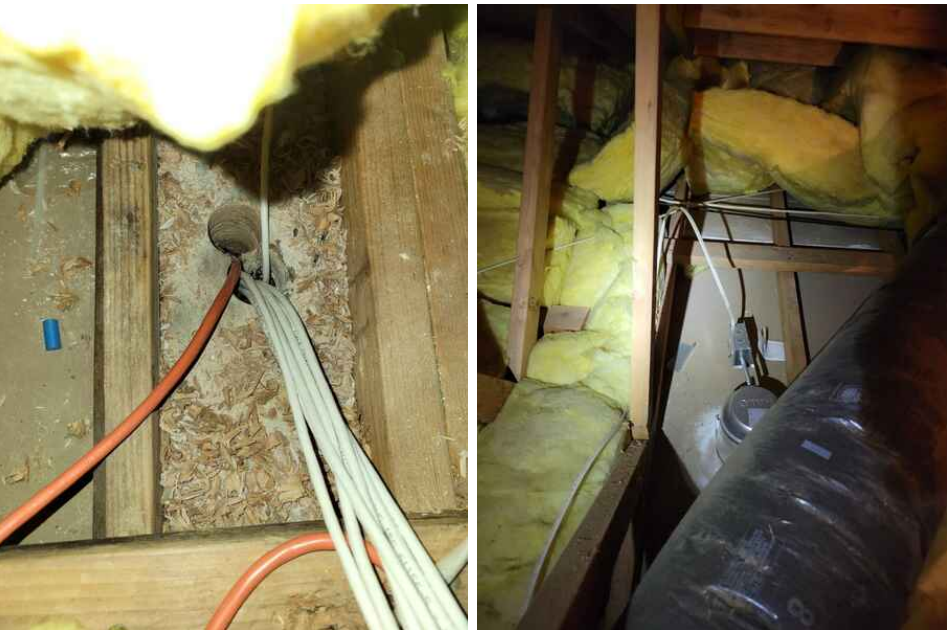
One or more areas of insulation were noted to be displaced. Ceiling insulation is the most effective insulation in a house system. Insulation should be repositioned to restore insulation value of ceiling.

areas around all added recessed lights need improvement

Recommendation  
Contact a qualified professional.

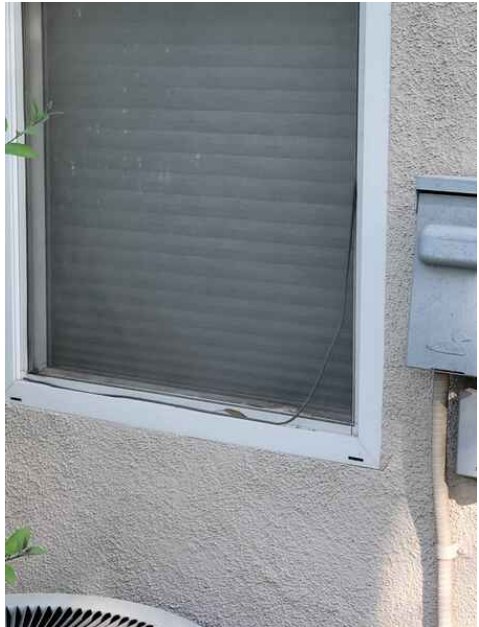
Several of the windows are damaged, not operating properly, or destroyed from nicotine. Moisture intrusion was observed on some of the windows as well. We recommend obtaining an evaluation and estimate on all of the windows from a licensed window contractor so that you can understand the cost of repairs.

damaged screen and water damage

Contact a qualified window repair/installation contractor.

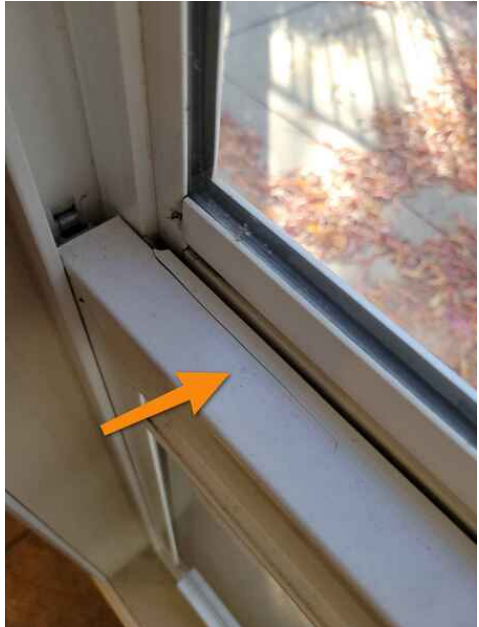
several of the single hung windows have this damage

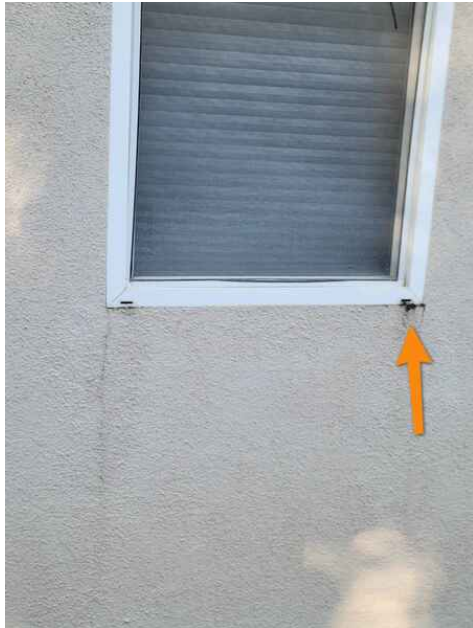
moisture intrusion from this area

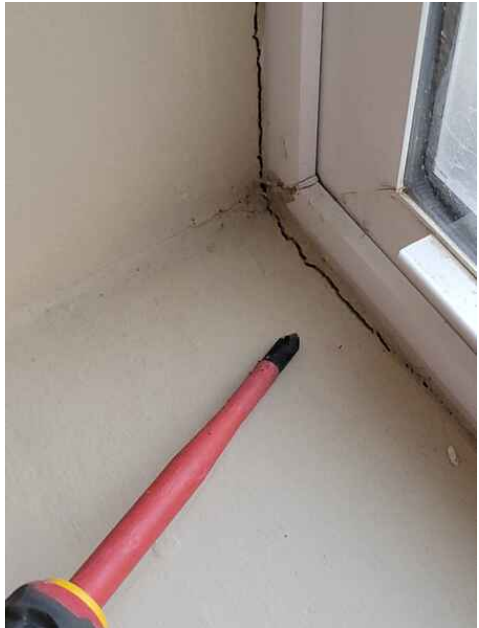
moisture intrusion

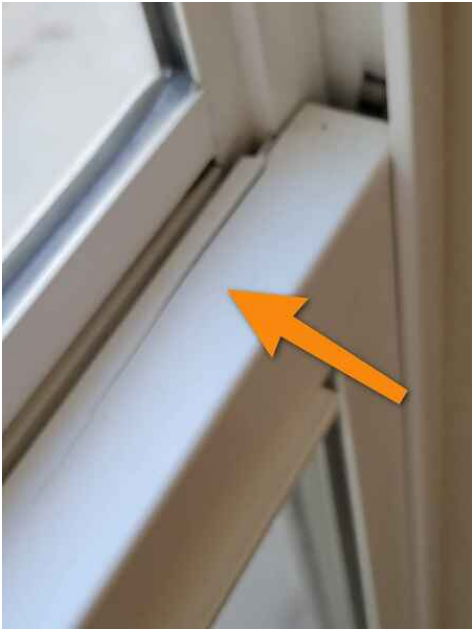
single hung windows are failing in this location throughout

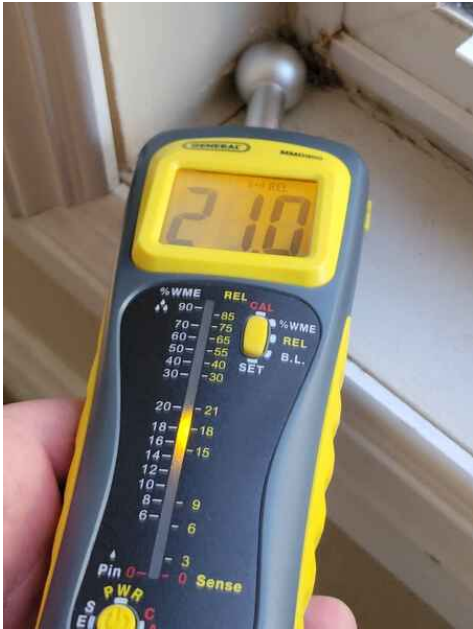
active moisture

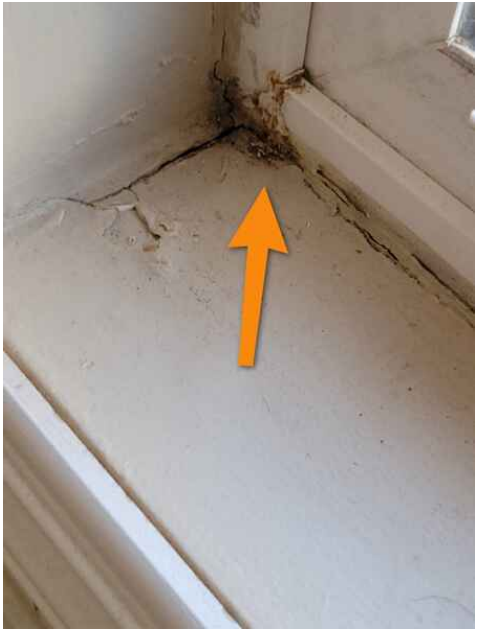
moisture/mold damage

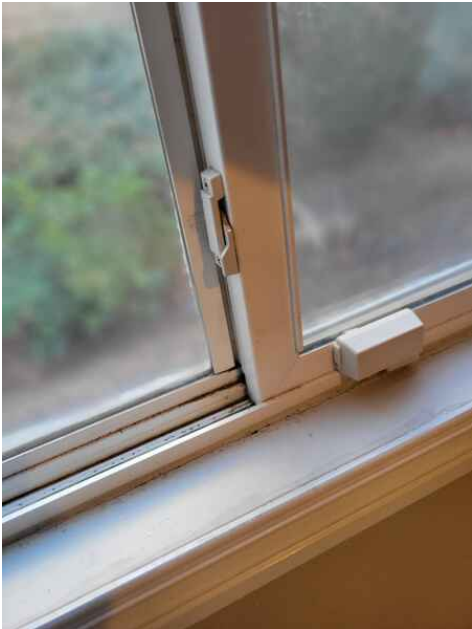
window not operating correctly

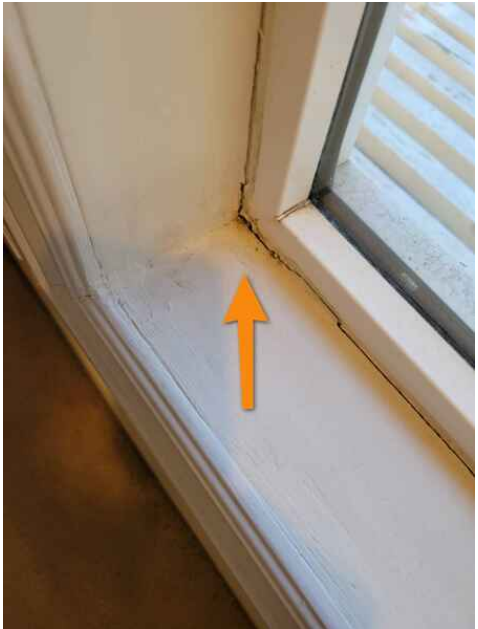
moisture intrusion

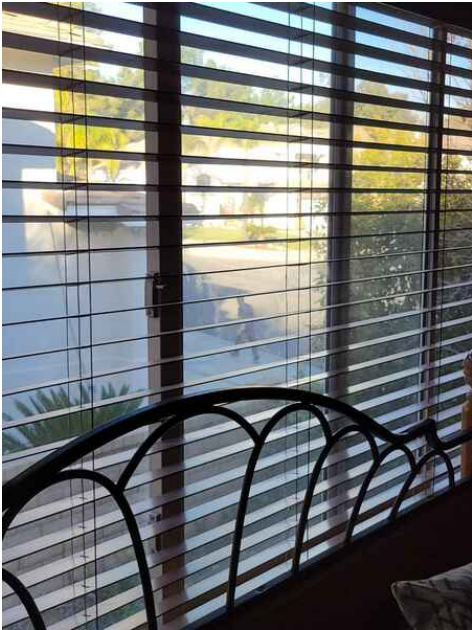
seal failure

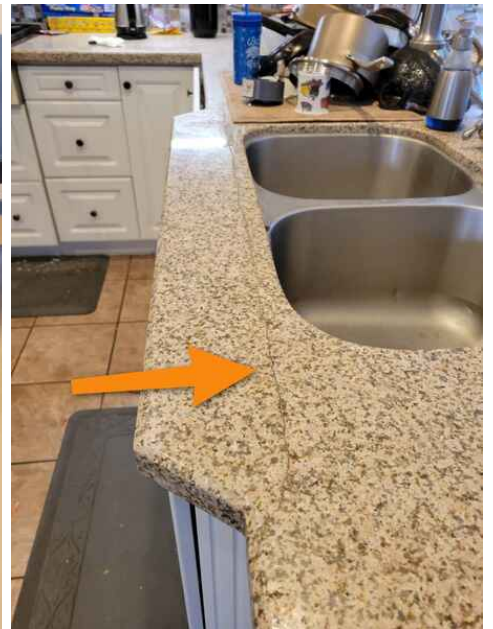
The kitchen is damaged to the extent that the cabinets and countertops need to be replaced. The thermofoil doors have failed. Many of the hinges are loose or stripped. The countertop is cracked and requires replacement. The appliances are in a poor or improper state of condition. The number of repairs required will equal or exceed full replacement in most cases.

countertop is cracked and previous repair attempt has failed

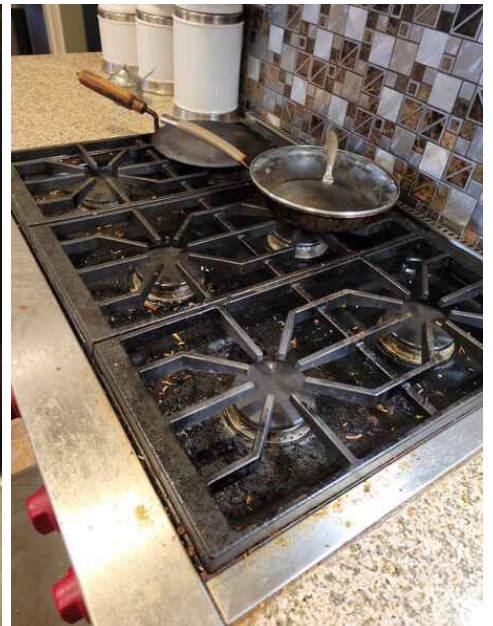
cooktop has not been maintained

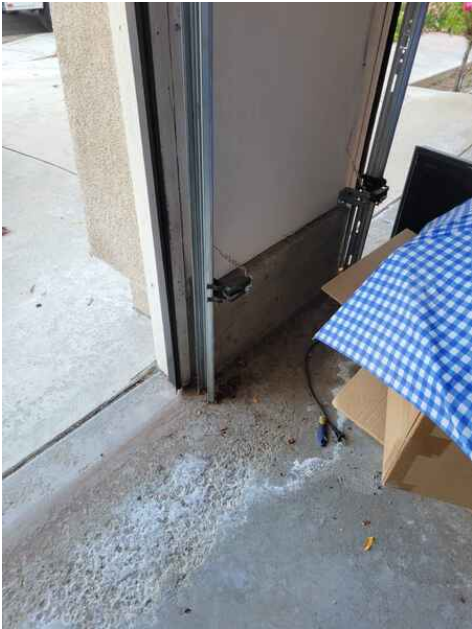
**GARAGE DOOR SAFETY REVERSE IMPROPER**

Contact a qualified professional.

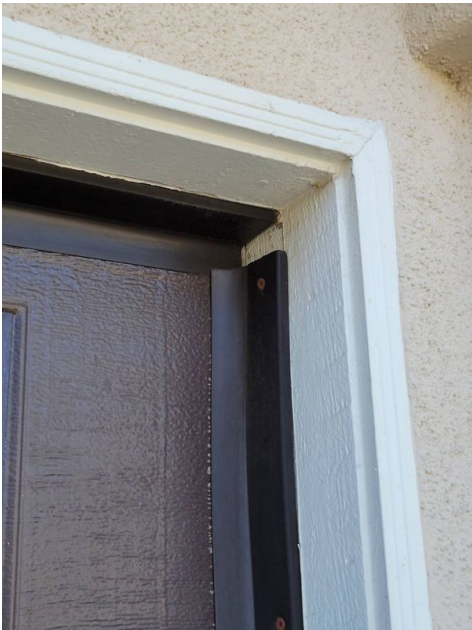
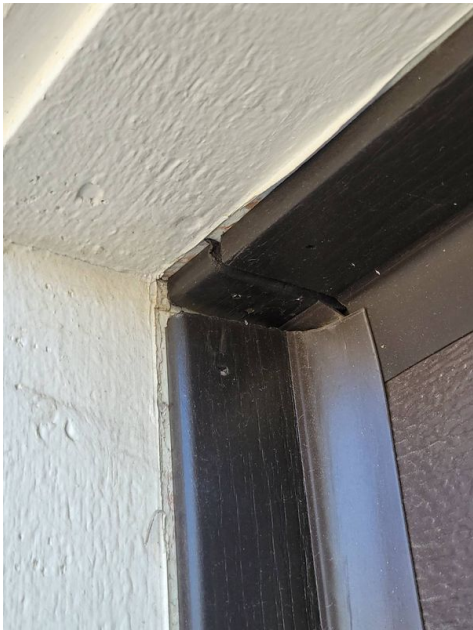
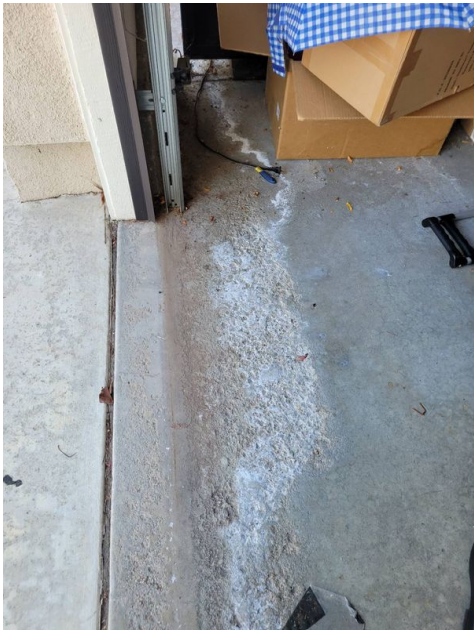
11.10.2 garage

**MISSING/DAMAGED DOOR SEAL**

There is water damage in front of the garage doors.

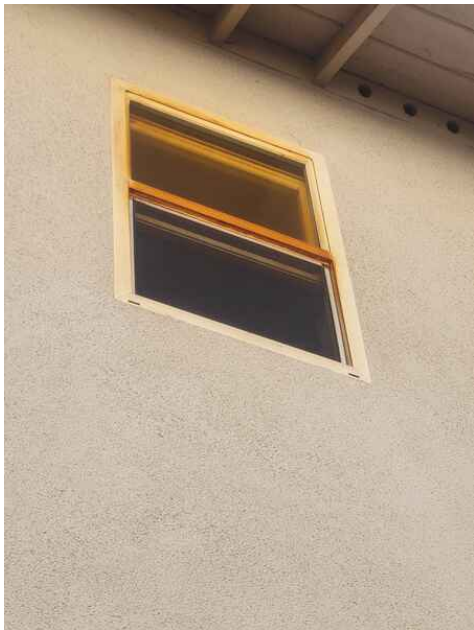
#### EXTENSIVE NICOTINE/TAR DAMAGE

This home has extensive nicotine/tar damage from smoking. The levels observed are concerning and considered a health hazard. Not only can visible areas be affected, but areas such as HVAC ducting, flooring, trim, cabinetry, natural stone, etc. can also be affected. Nicotine damage needs to be professionally remediated, and we strongly recommend an environmental contractor evaluate and develop a scope of work to remediate this issue. While some areas have been photographed, many more exist and will require a specific inspection to identify and document all areas. Due to the severity, we considered this a health and safety item and recommend immediate remediation for the health of the occupants.

nicotine has affected the exterior in this area

Contact a qualified environmental contractor

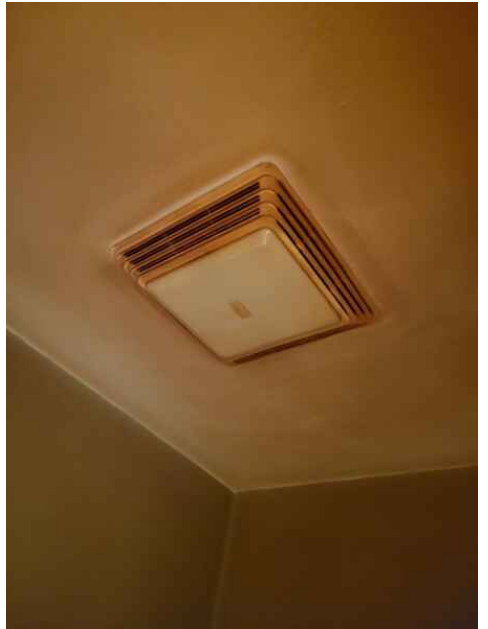
dripping from ceiling and running down walls exhaust fans are beyond repair/cleaning

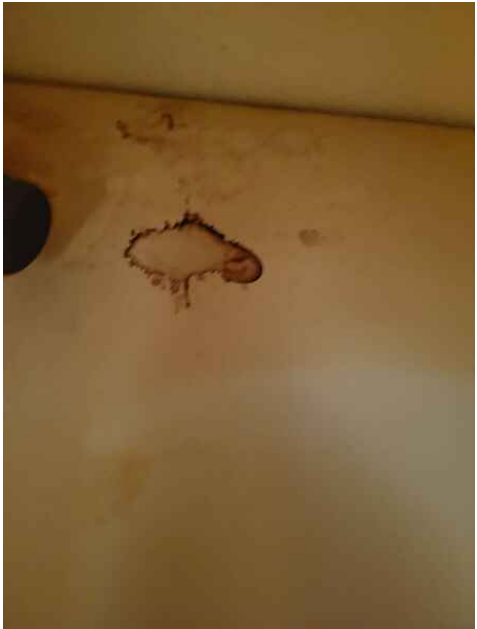
leakage from chimney
