Inspector: Blas Calvillo

4561 Lagoon Drive, Kelseyville, CA 95451

Inspection prepared for: Berlin Fisher

Date of Inspection: 6/15/2026 Time: 09:00 AM

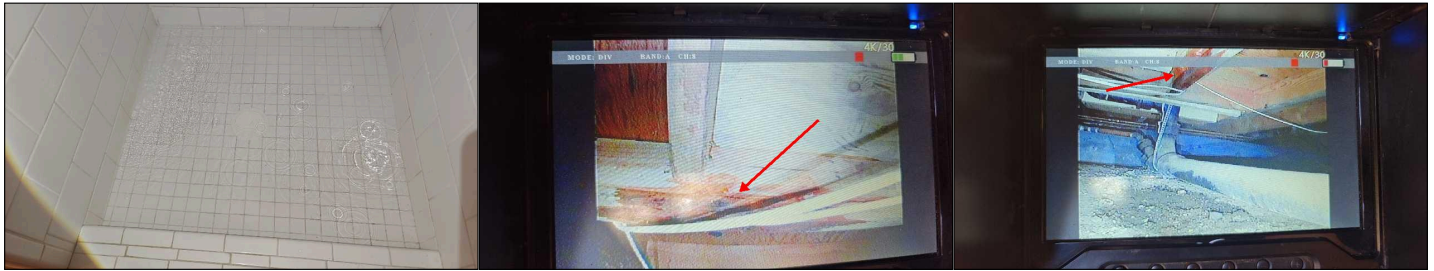
Page 23 Item: 8	Showers	<ul style="list-style-type: none"> <li>• <b>Bathroom / Crawlspace: Tile Shower Pan Leak</b> As part of a standard evaluation, the tile shower pan was plugged and filled with approximately 2 inches of water. During this flood test, an active water leak was observed inside the crawlspace dripping from the framing directly beneath the shower pan area. This indicates a failure of the subterranean tile pan liner, the sub-floor drain assembly, or adjacent plumbing connections. Operating this shower will cause localized flooding, structural wood rot, and fungal growth in the floor joists. Recommendation: Do not use this shower. A licensed plumbing contractor and a qualified tile specialist must immediately evaluate the system, identify the exact failure point, and perform necessary structural and pan liner repairs to restore a completely waterproof enclosure.</li> </ul>

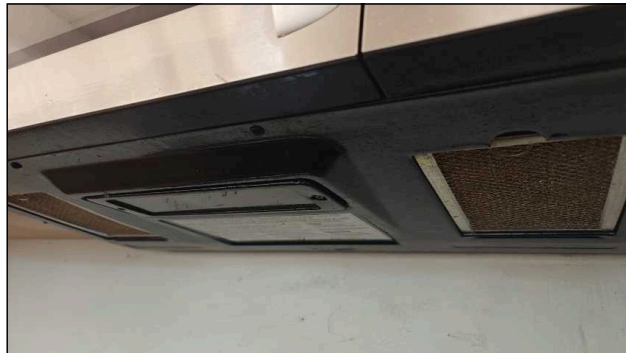
The built-in cooktop surface light on the over-the-range microwave/vent hood assembly did not operate when tested. The light remained inoperative when the control switch was toggled. This may simply be due to a burned-out bulb or it could indicate a faulty light socket, loose wiring, or a failed control board switch.

Recommendation: Replace the bulb during the final walkthrough to verify functionality. If a new bulb fails to resolve the issue, a qualified technician should repair the electrical connection or fixture assembly.

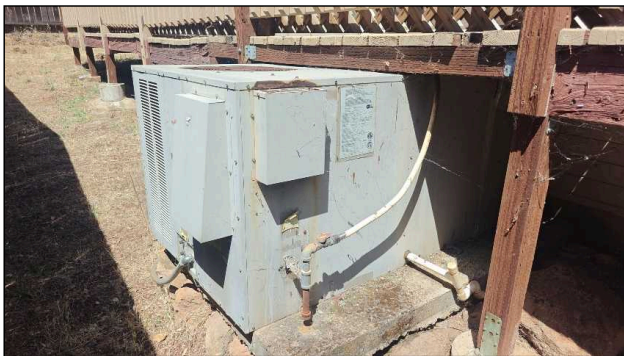
• **HVAC: Heating & Cooling System**  
 The exterior dual HVAC packaged unit, located on the left side of the home, was manufactured in 2000. The system was tested using normal operating controls and operated in both the heating and cooling modes at the time of inspection. However, the system is 26 years old and has far exceeded its typical design life expectancy (generally 15 to 20 years). Because of its advanced age, it operates at lower energy efficiency and is at a significantly higher risk of component failure. Recommendation: Budget for a complete system replacement in the near future. Have a licensed HVAC technician perform a comprehensive service tune-up and heat exchanger safety analysis prior to closing.

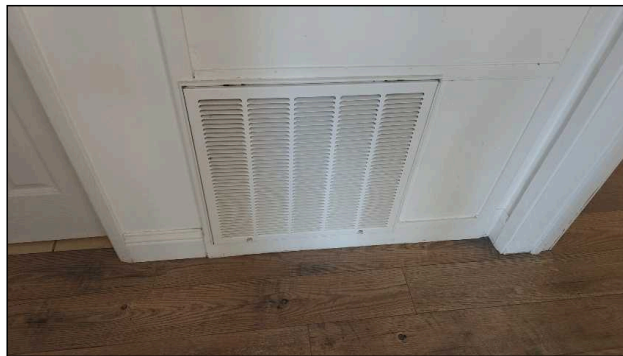
Page 30 Item: 2

• **MAINTENANCE:** The air filter(s) should be inspected at least monthly and cleaned or replaced as required. There are two types of filters commonly used: (1) Washable filters, (constructed of aluminum mesh, foam, or reinforced fibers) these may be cleaned by soaking in mild detergent and rinsing with water. Or (2) Fiberglass disposable filters that must be REPLACED before they become clogged. Remember that dirty filters are the most common cause of inadequate heating or cooling performance.

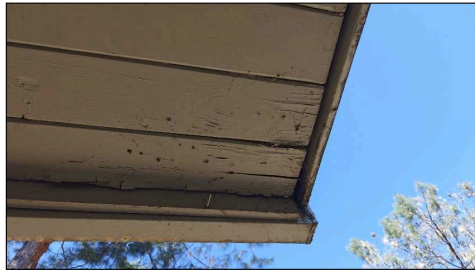
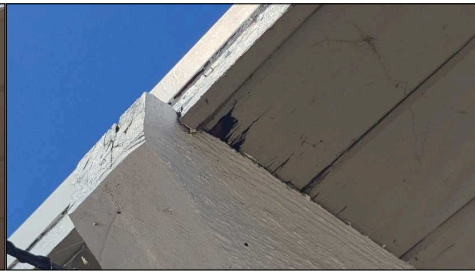
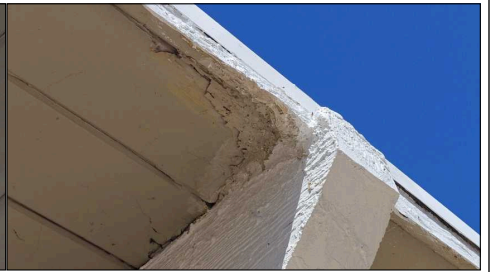
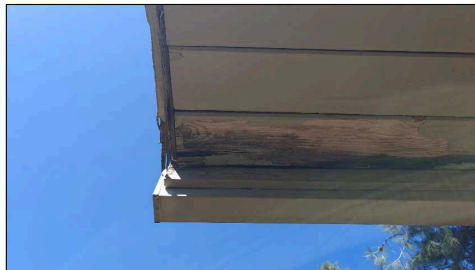
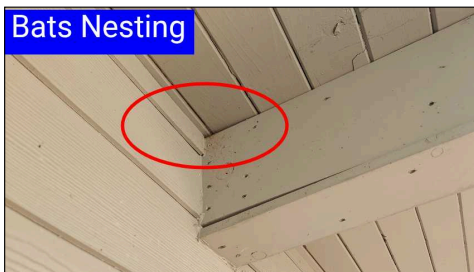
- Exterior / Carport: Structural Support Beam

The main structural support beam of the carport exhibits freshly painted surfaces over existing moisture damage and wood rot. While the paint provides a clean cosmetic appearance, mechanical probing revealed that the underlying wood fibers are soft, decayed, and structurally compromised at critical load-bearing sections and post connections. Covering active wood rot with paint traps moisture inside the timber, accelerating structural decay and creating a severe structural safety and collapse hazard. Recommendation: A licensed framing contractor or structural engineer must evaluate the carport roof structure immediately to determine the full depth of the rot and implement structural reinforcement or total beam replacement.

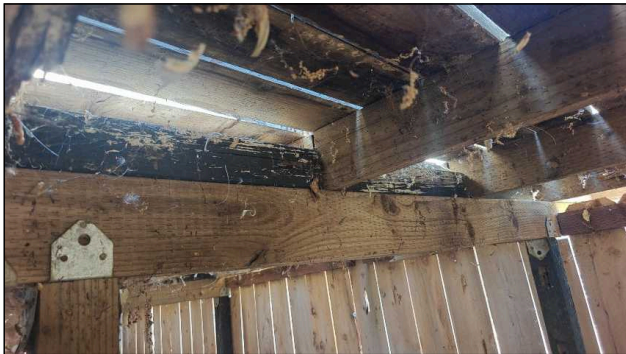
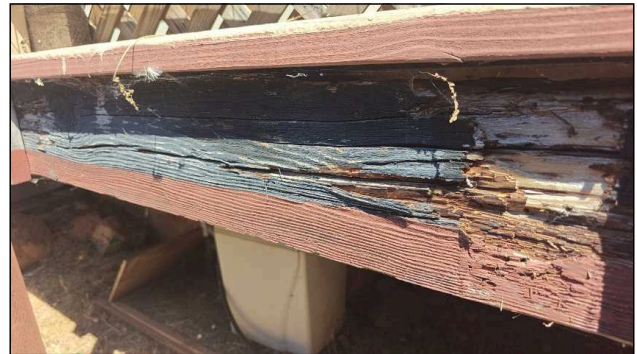
Page 45 Item: 3

Loose guardrails and localized wood deterioration were observed throughout multiple sections of the deck railing system. The guardrails exhibit excessive deflection under light hand pressure, and several attachment points and post bases show visible wood rot, softening, or decay. This significantly compromises the structural integrity of the barrier and represents a severe fall and safety hazard.

Recommendation: A licensed contractor or qualified deck specialist must immediately evaluate the system, cut out and replace all deteriorated wood members, and securely anchor the entire guardrail system using structural bolts and approved tension hardware to ensure it is rigid and safe.

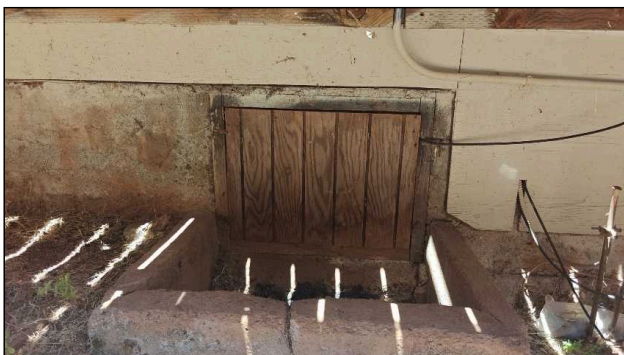
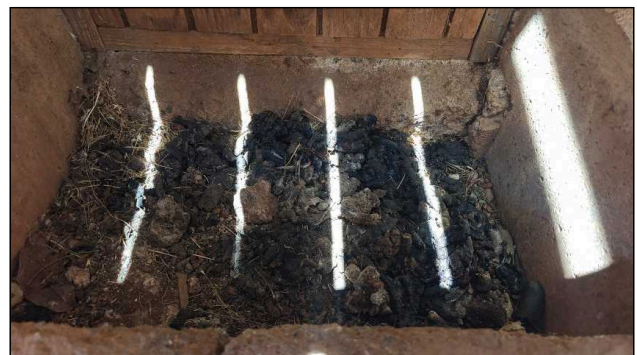
• **Crawlspace / Exterior: Animal Waste Accumulation**  
 A large accumulation of animal feces was observed directly outside the crawlspace entry door. The quantity and size of the waste suggest significant, repeated wildlife or pest activity in the immediate vicinity of the sub-floor access. This represents a notable life safety and biohazard concern, as animal waste can harbor harmful bacteria, parasites, and airborne pathogens that threaten indoor air quality.  
 Recommendation: A licensed pest control company or wildlife mitigation specialist should evaluate the exterior perimeter and crawlspace interior. A certified professional must safely remove and sanitize the biohazard waste, identify the animal species, and implement proper exclusion repairs to prevent animal entry into the crawlspace.

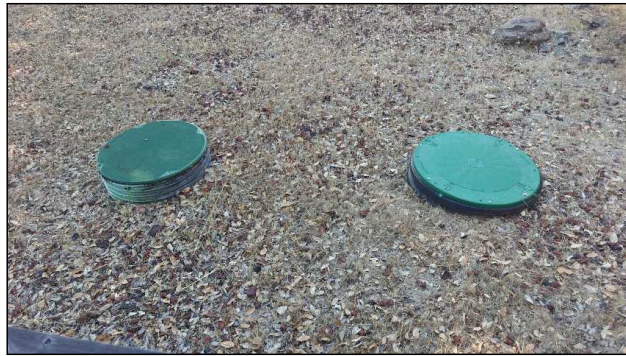
Page 49 Item: 1

• **Septic system noted.** Client is advised to seek the services of a specialist in evaluating this system. [Click here for additional information](#)

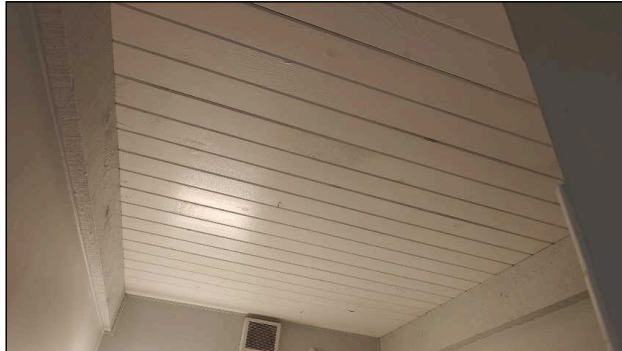
### 5. Exhaust Fan

The exhaust fan for the bathroom terminates inside the added-on laundry room rather than venting directly to the exterior of the home. Bathroom fans discharge large amounts of humid air. Venting this moisture into an enclosed indoor living space can lead to elevated humidity, localized condensation, drywall damage, and hazardous mold growth. Recommendation: A qualified contractor or handyman should modify the ductwork to ensure the bathroom exhaust fan extends fully through an exterior wall or roof cap, terminating safely outside the structure.

Bathroom		
Page 22 Item: 5	Exhaust Fan	<ul style="list-style-type: none"> <li>• <b>Bathrooms / Ventilation: Exhaust Fan Termination</b> The exhaust fan for the bathroom terminates inside the added-on laundry room rather than venting directly to the exterior of the home. Bathroom fans discharge large amounts of humid air. Venting this moisture into an enclosed indoor living space can lead to elevated humidity, localized condensation, drywall damage, and hazardous mold growth. Recommendation: A qualified contractor or handyman should modify the ductwork to ensure the bathroom exhaust fan extends fully through an exterior wall or roof cap, terminating safely outside the structure.</li> </ul>

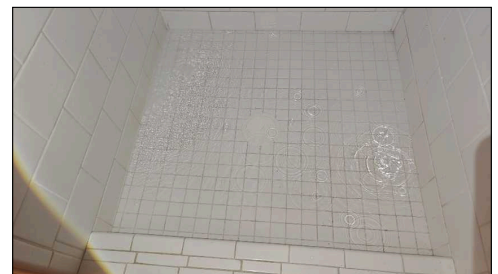
#### • Bathroom / Crawlspace: Tile Shower Pan Leak

As part of a standard evaluation, the tile shower pan was plugged and filled with approximately 2 inches of water. During this flood test, an active water leak was observed inside the crawlspace dripping from the framing directly beneath the shower pan area. This indicates a failure of the subterranean tile pan liner, the sub-floor drain assembly, or adjacent plumbing connections. Operating this shower will cause localized flooding, structural wood rot, and fungal growth in the floor joists.

Recommendation: Do not use this shower. A licensed plumbing contractor and a qualified tile specialist must immediately evaluate the system, identify the exact failure point, and perform necessary structural and pan liner repairs to restore a completely waterproof enclosure.

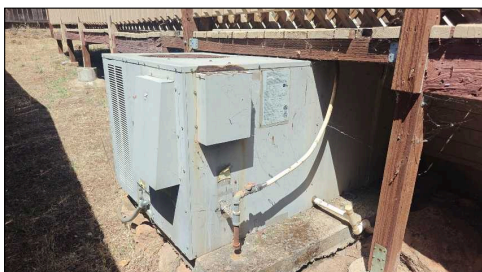
## 1. AC Compress Condition

The exterior dual HVAC packaged unit, located on the left side of the home, was manufactured in 2000. The system was tested using normal operating controls and operated in both the heating and cooling modes at the time of inspection. However, the system is 26 years old and has far exceeded its typical design life expectancy (generally 15 to 20 years). Because of its advanced age, it operates at lower energy efficiency and is at a significantly higher risk of component failure. Recommendation: Budget for a complete system replacement in the near future. Have a licensed HVAC technician perform a comprehensive service tune-up and heat exchanger safety analysis prior to closing.

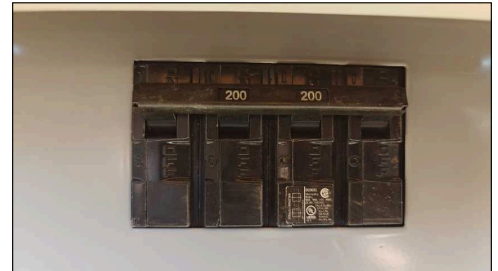
The exterior electric meter and main service panel, equipped with a 200-amp main disconnect, are located on the left side of the home. The equipment appeared to be in good, functional condition at the time of inspection. The enclosure is properly secured, free of significant rust or moisture intrusion, and structural components are intact. No active defects were observed.

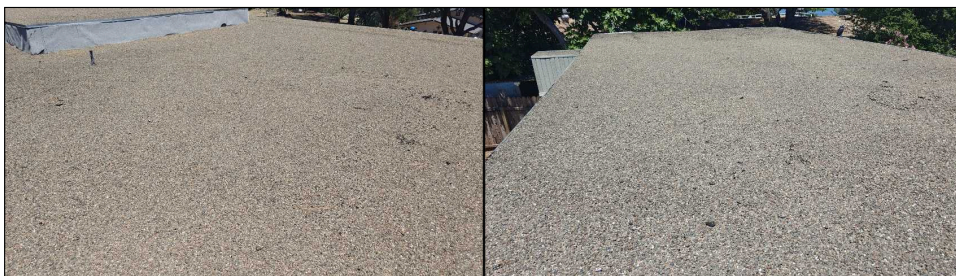
## 1. Roof Condition

Widespread gravel displacement exposing the underlying felt underlayment and open/unsealed metal flashing joints were observed on the low-slope roof. The loss of gravel exposes the underlying bitumen membrane to solar UV degradation, leading to rapid cracking and splitting. Furthermore, the open intersections at the metal flashing lack the proper roofing cement or seals required to prevent water migration. Given that low-slope roofs hold water longer, these defects present a significant risk of active moisture intrusion. Recommendation: A licensed, qualified roofing contractor should evaluate the entire roof surface immediately, repair or replace the unsealed metal flashings, and scrape, seal, and re-gravel the bare spots to restore the roof's waterproof integrity.

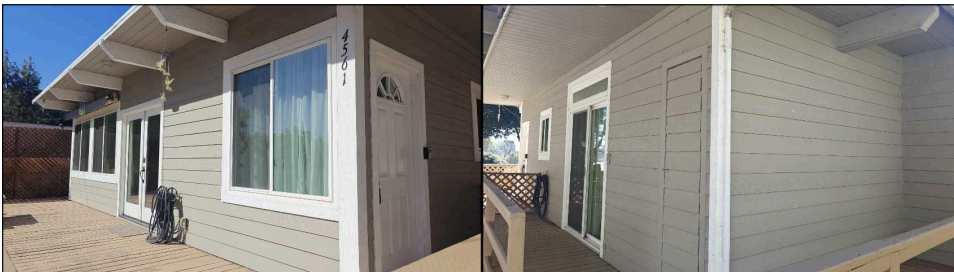
The siding installation shows typical weathering consistent with the age of the home. The protective paint or factory coating is intact, providing adequate resistance against moisture and environmental exposure. No immediate structural defects or installation failures were observed.

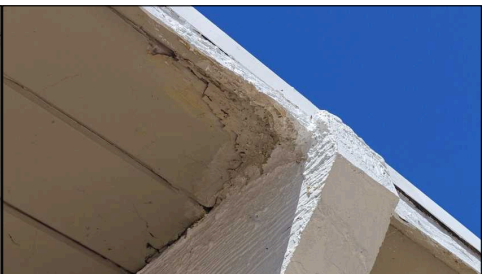
Bats Nesting

Evidence of bats nesting was observed in the gaps between the exposed structural beams and the exterior eaves. This evidence includes localized guano accumulation, staining, and visible entry points. Recommendation: A qualified pest control or wildlife mitigation specialist should evaluate the area. The structure requires professional exclusion (safely sealing entry points after bats exit), sanitation of the affected areas, and repairs to the gaps to prevent future nesting.

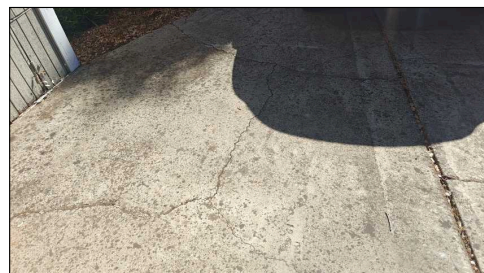
## 1. Driveway/Walkway Condition

- Driveway: Satisfactory (With Typical Wear)

Recommendation:

Monitor: Watch the cracks for signs of widening or vertical shifting.

Seal: Fill all visible cracks with a flexible, exterior-grade concrete caulk or sealant.

Prevent: Sealing prevents water intrusion, which can erode the base soil or cause freeze-thaw damage.

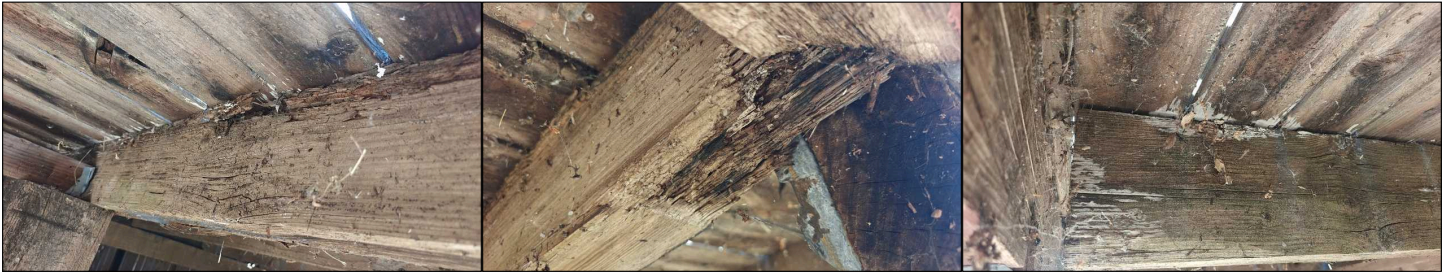
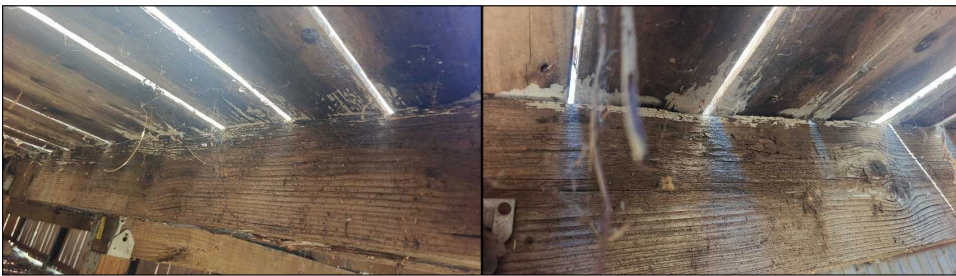
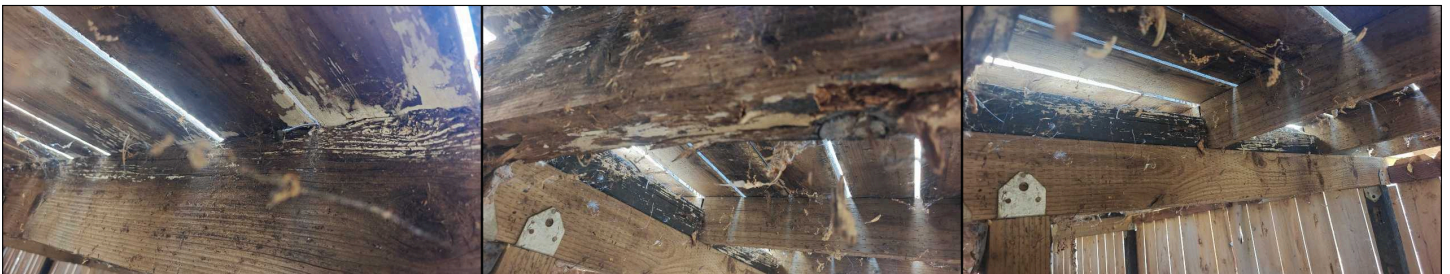
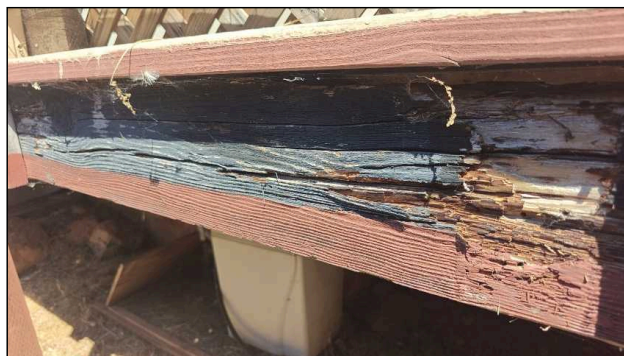
Loose guardrails and localized wood deterioration were observed throughout multiple sections of the deck railing system. The guardrails exhibit excessive deflection under light hand pressure, and several attachment points and post bases show visible wood rot, softening, or decay. This significantly compromises the structural integrity of the barrier and represents a severe fall and safety hazard. Recommendation: A licensed contractor or qualified deck specialist must immediately evaluate the system, cut out and replace all deteriorated wood members, and securely anchor the entire guardrail system using structural bolts and approved tension hardware to ensure it is rigid and safe.

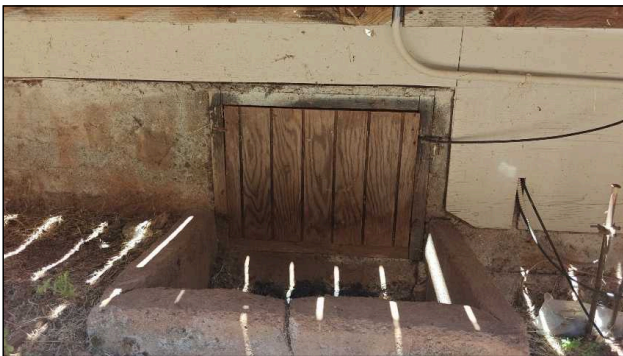
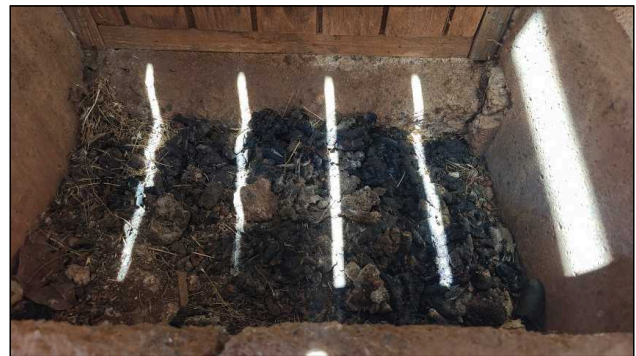
A large accumulation of animal feces was observed directly outside the crawlspace entry door. The quantity and size of the waste suggest significant, repeated wildlife or pest activity in the immediate vicinity of the sub-floor access. This represents a notable life safety and biohazard concern, as animal waste can harbor harmful bacteria, parasites, and airborne pathogens that threaten indoor air quality.

Recommendation: A licensed pest control company or wildlife mitigation specialist should evaluate the exterior perimeter and crawlspace interior. A certified professional must safely remove and sanitize the biohazard waste, identify the animal species, and implement proper exclusion repairs to prevent animal entry into the crawlspace.

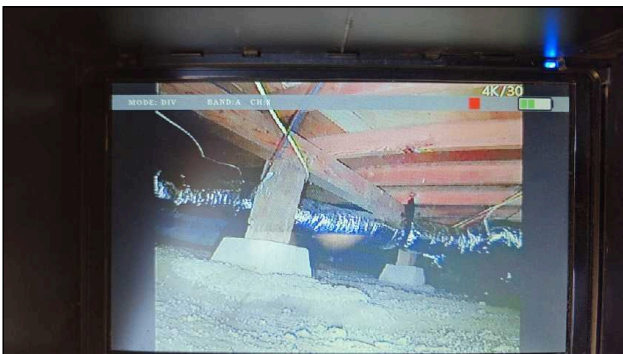
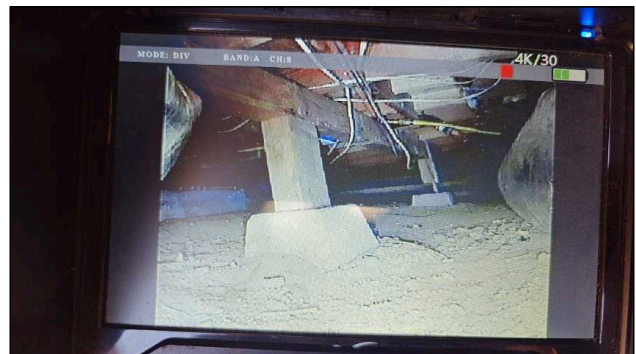
- No deficiencies were observed at the visible portions of the structural components of the home.

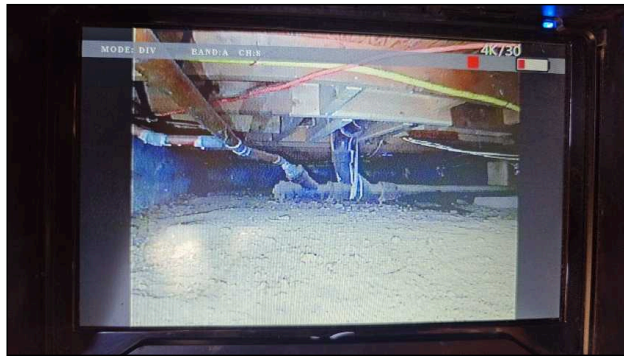
The waste and drain piping visible within the crawlspace consists of a combination of cast iron and copper pipes. A representative number of the visible lines, connections, and hangers were examined, and they appeared to be in functional condition with no active leaks observed at the time of inspection. Note for Buyer: These are traditional, durable plumbing materials. However, because they are older metallic systems, they are naturally subject to long-term internal corrosion, scale buildup, and eventual thinning. The lines should be monitored periodically as part of standard home maintenance. No immediate action is required.

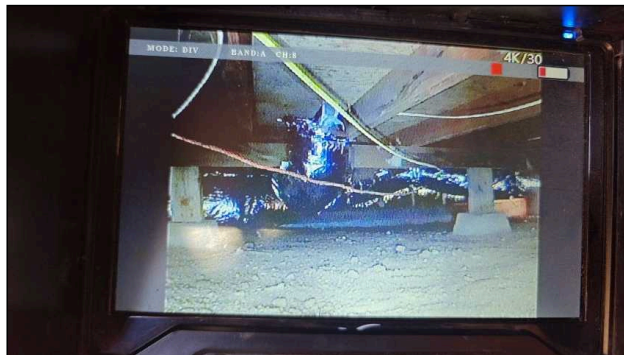
- The HVAC ducting appeared to be in good condition at time of inspection.

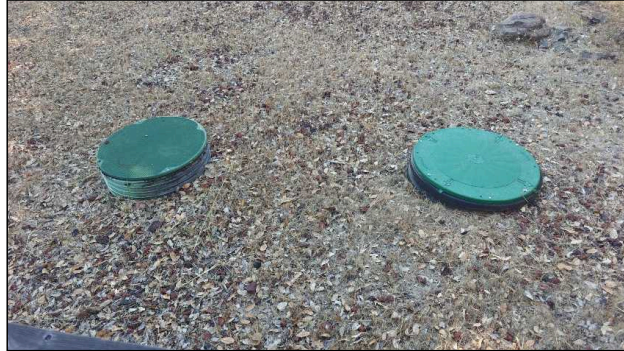
- Septic system noted. Client is advised to seek the services of a specialist in evaluating this system. [Click here for additional information](#)

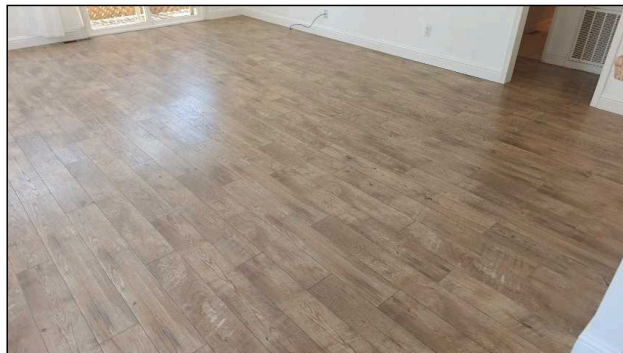
- The livingroom floors appeared to be in good condition at time of inspection.

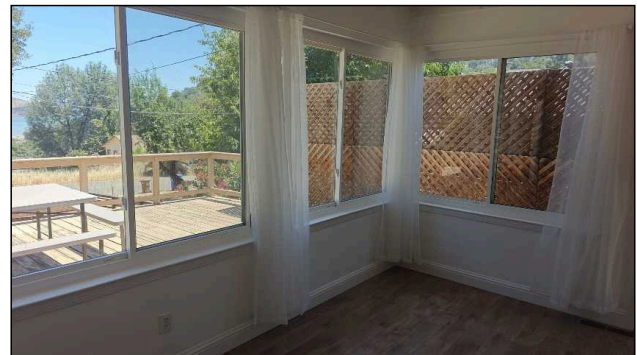
- Operated windows appeared functional, at time of inspection.
