INSPECTION REPORT BY PACIFIC CREST INSPECTIONS

1829 Elevado Rd
Vista, CA 92084

Young & Hong Kim
04/28/2026

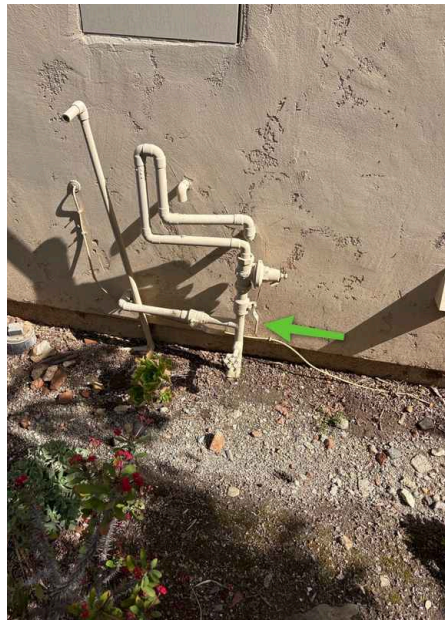
Left Side of the Building

**Main Water Shut-Off Device
(Describe Location): Main Water
Shut off Location**

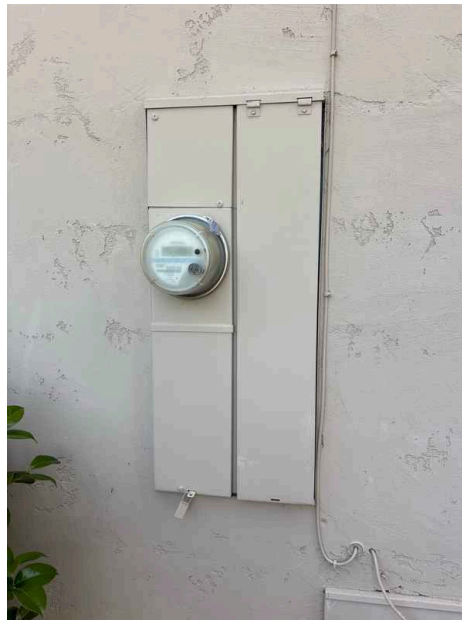
Rear Exterior

**Main and Distribution Panels
(Describe Location): Main Panel
Location**

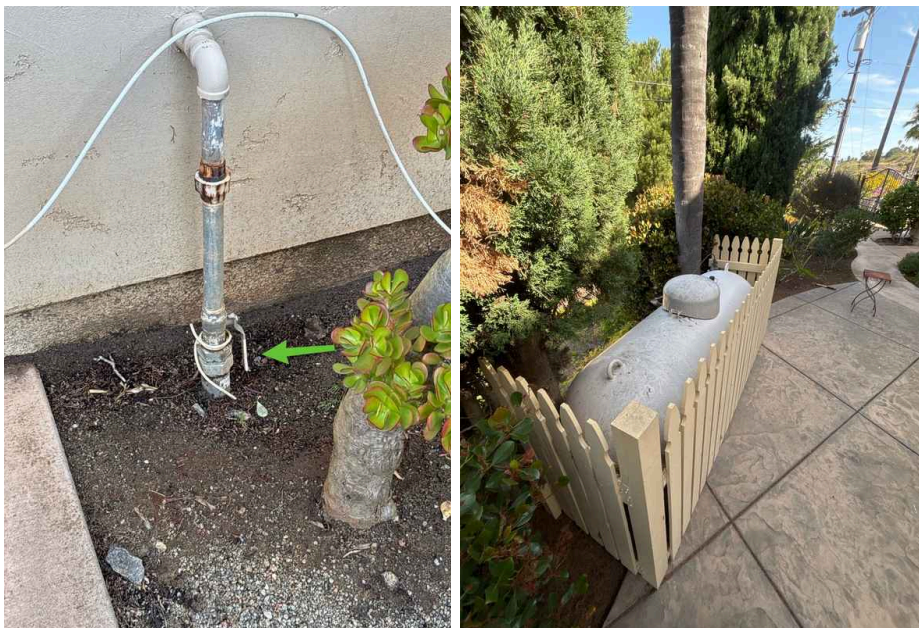
Main Gas Shut Off Valve (Describe Location): Main Gas Shut Off Valve Location

At the Propane Tank, Rear of the Building

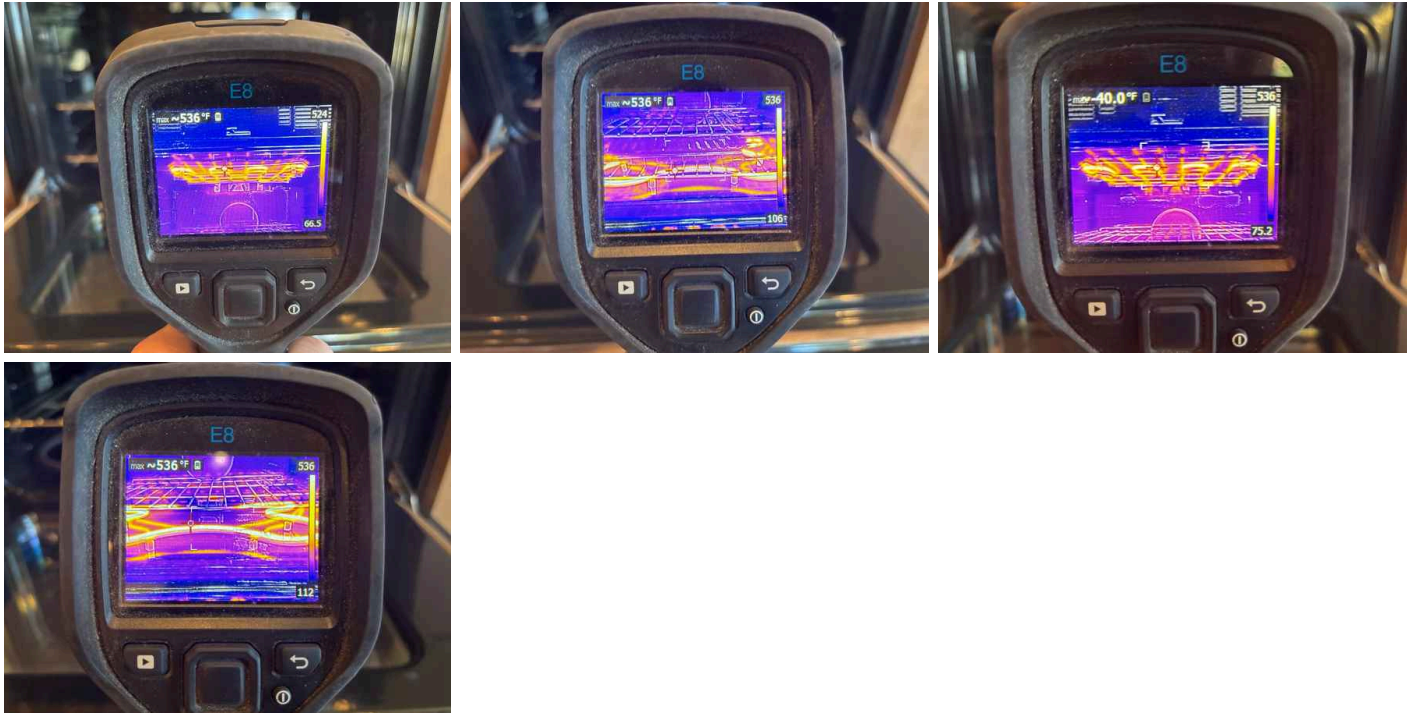
Wall Oven: Thermal Image Showing Operation

Infrared picture of oven in operation. This image shows function of the operable oven heat source.

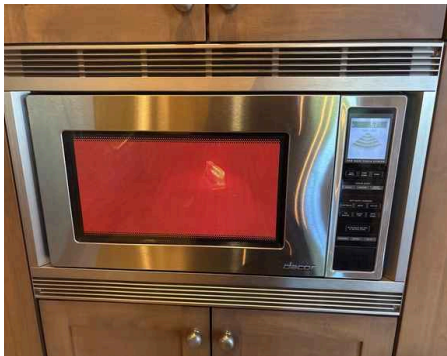
Built-In Microwave : Picture of Microwave During Operation

The operation of the microwave was tested using a microwave tester. This unit appeared functional at the time of inspection.

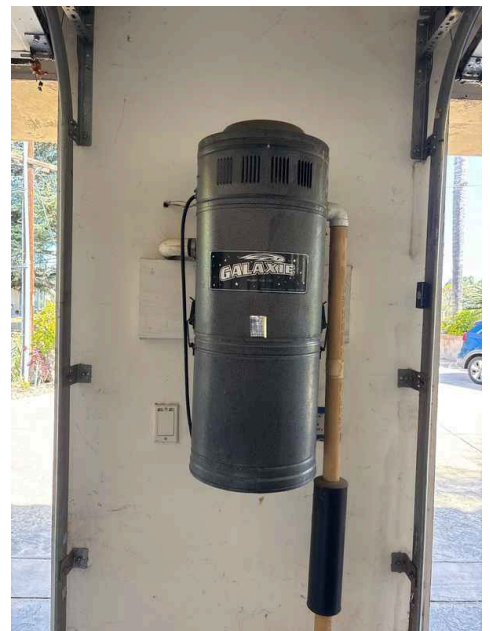
CENTRAL VACUUM NOT INSPECTED

A central vacuum system was noted installed in the home. Inspection of this system is beyond the scope of the inspection. This equipment is prone to blockages and required periodic cleaning/maintenance. Recommend further evaluation as necessary.

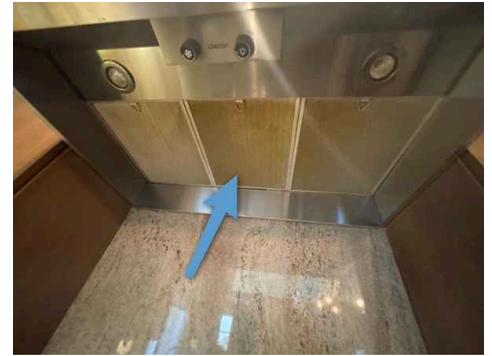
3.3.1 Exhaust Fan/Range Hood/Downdraft

COMPONENTS NEED CLEANED

The vent hood appeared operational at the time of the inspection. However, the unit was noted in need of general cleaning and maintenance. Recommend professional cleaning/maintenance by a licensed appliance contractor as necessary.

Recommendation

Contact a qualified appliance repair professional.

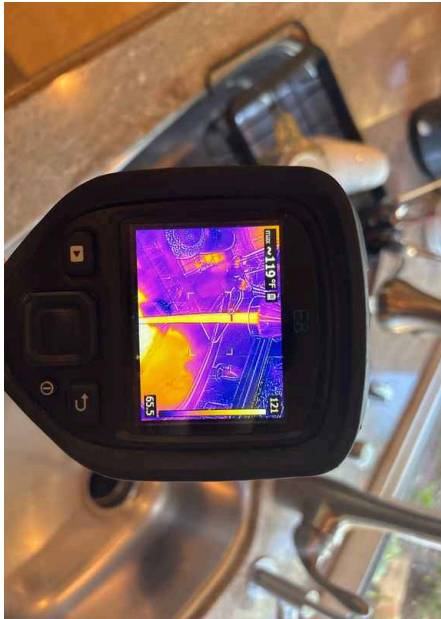
Water Heaters, Controls, Flues and Vents: Thermal Image Showing Operation

Thermal image showing production of hot water at the sink location.

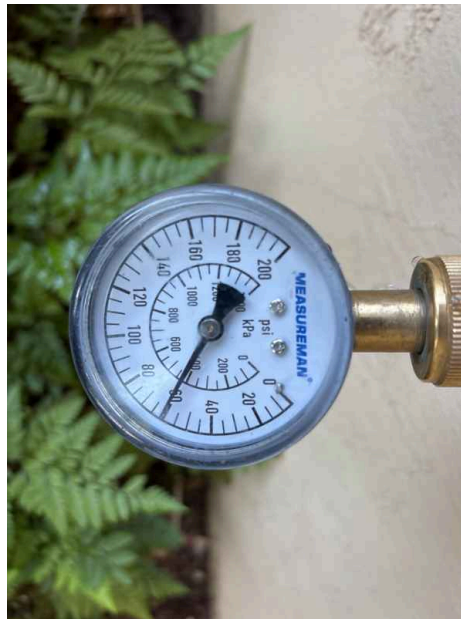
Water Pressure: Water Pressure Normal

Water pressure was noted within normal operation parameters.

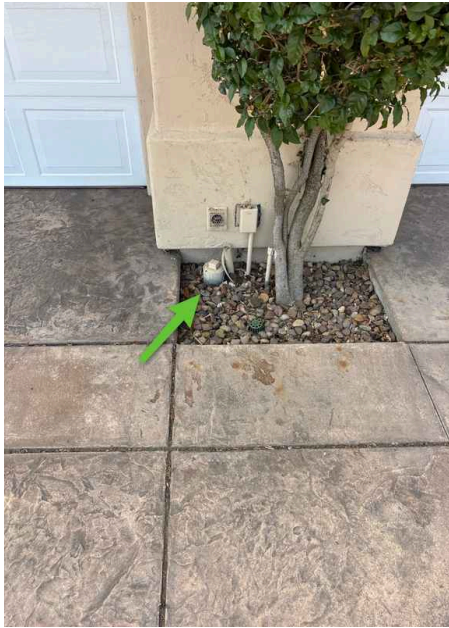
Plumbing Drain, Waste and Vent Systems: Cleanout Location Driveway, Left Side Yard

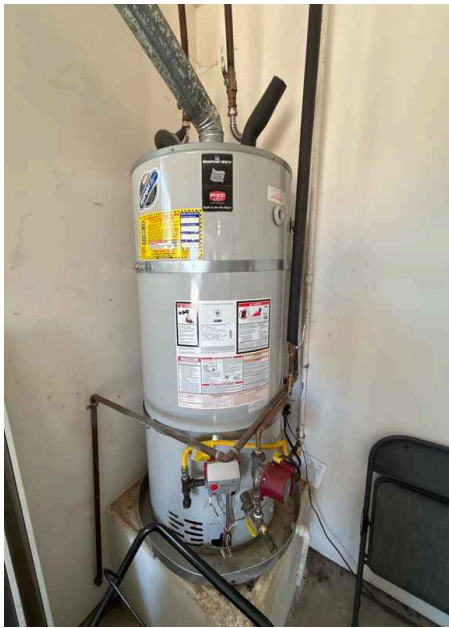
Water Heaters, Controls, Flues and Vents: Picture of Water Heater

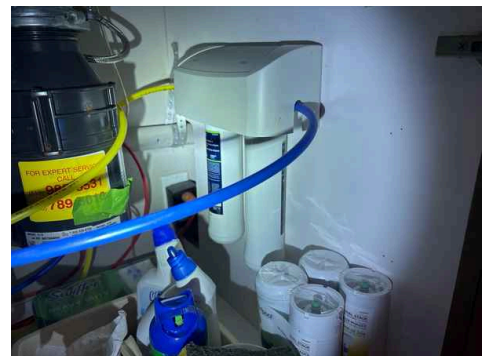
WATER FILTER

We do not inspect water filtration units. Recommend contacting the installer for information on life expectancy or condition.

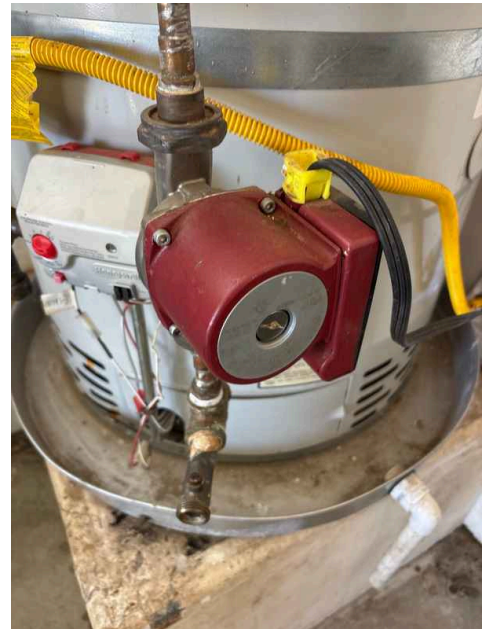
RECIRCULATING PUMP NOT INSPECTED

A hot water recirculating pump was noted present at the water heater area. We do not inspect or evaluate this component as part of the home inspection. Advise asking the seller to demonstration operation and have further evaluated by a licensed plumbing contractor as necessary.

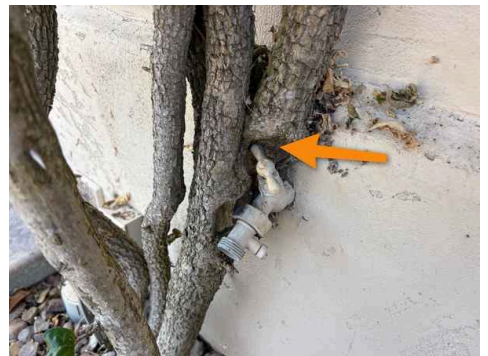
Right Exterior

4.3.4 Fixtures and Connected Devices

Contact a qualified professional.

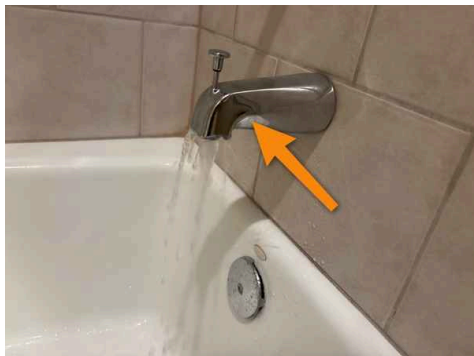
2nd Bedroom Bathroom

4.4.1 Tub/Shower Fixtures

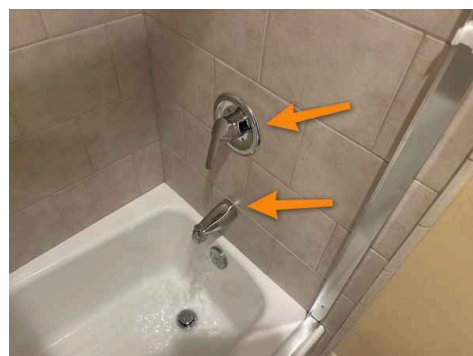
Shared Bathroom

4.4.2 Tub/Shower Fixtures

Contact a qualified plumbing contractor.

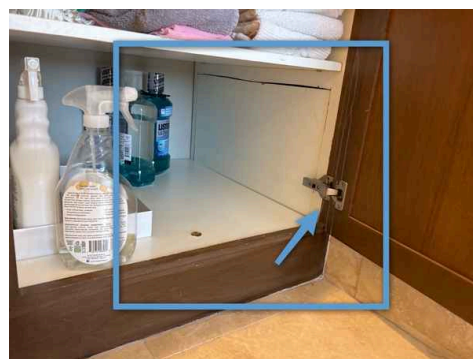
Master Bathroom

4.4.3 Tub/Shower Fixtures

Contact a qualified plumbing contractor.

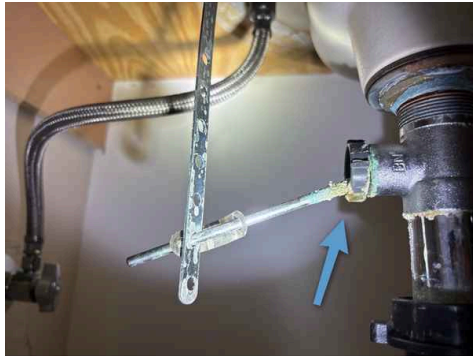
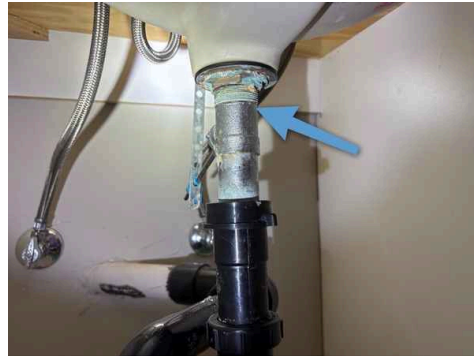
Master Bathroom Sinkstop

4.5.1 Plumbing Drain, Waste and Vent Systems

Contact a qualified plumbing contractor.

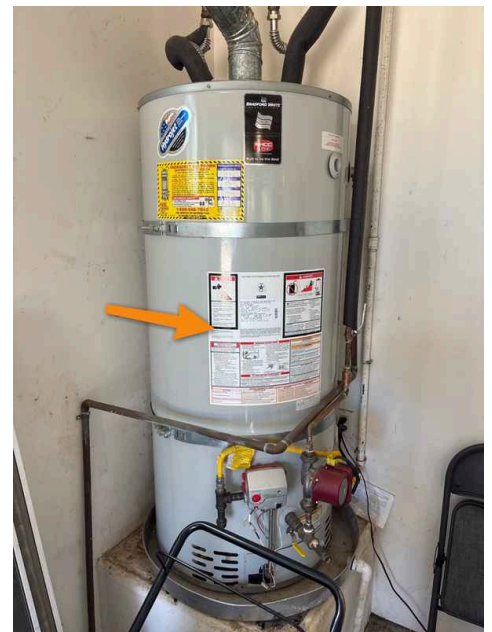
MFD 2016

4.6.1 Water Heaters, Controls, Flues and Vents

Contact a qualified plumbing contractor.

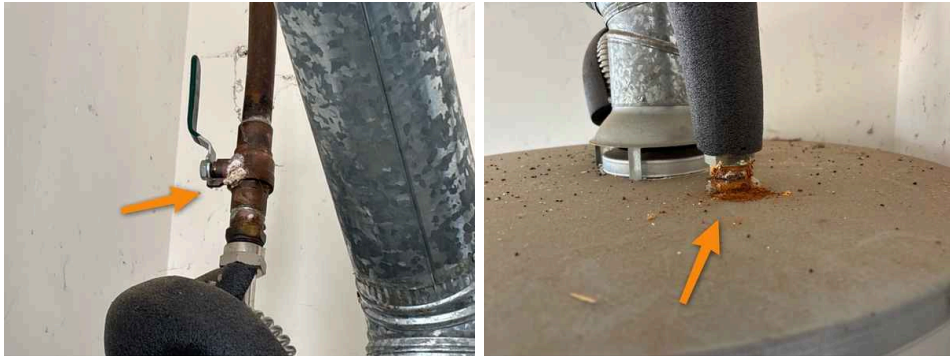
4.6.2 Water Heaters, Controls, Flues and Vents

Contact a qualified plumbing contractor.

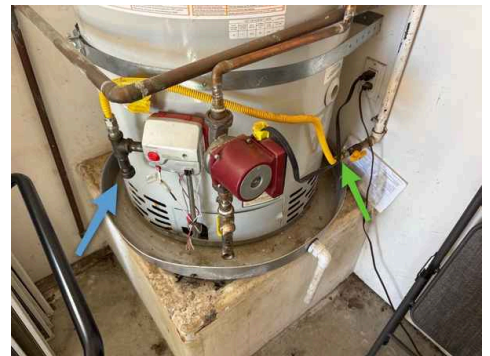
4.6.4 Water Heaters, Controls, Flues and Vents

Contact a qualified plumbing contractor.

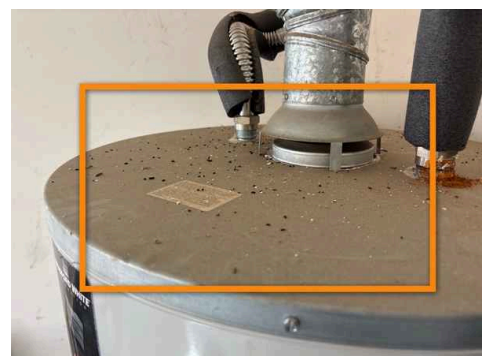
4.6.5 Water Heaters, Controls, Flues and Vents

Contact a qualified pest control specialist.

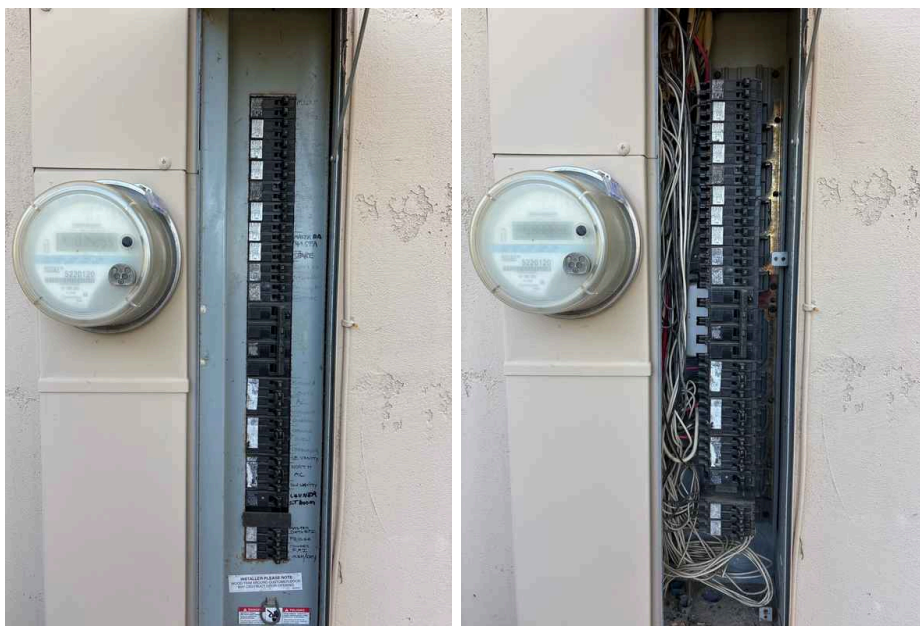
Main and Distribution Panels: Picture of Panels

Pictures of electrical panel(s).

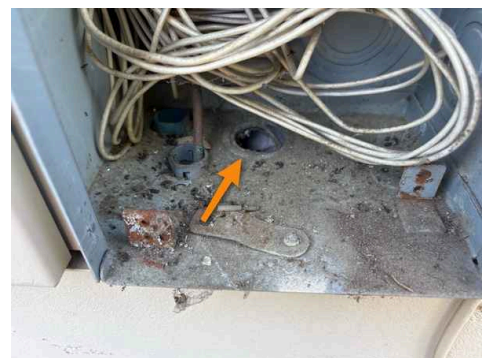
5.1.3 Main and Distribution Panels

KNOCKOUTS MISSING

Recommendation

Contact a qualified professional.

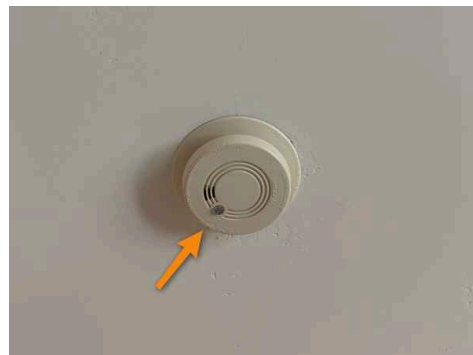
VARIOUS LOCATIONS

We recommend replacing all smoke detectors upon moving into the home. Smoke detectors that are 10 years old or older may have a failure rate as high as 30%, and smoke detectors that are 15 years old or older may have a failure rate as high as 50% according to the National Fire Protection Association www.nfpa.org. We also recommend that a smoke alarm be installed in each bedroom, and at least one on each level outside of bedrooms.

Contact a qualified professional.

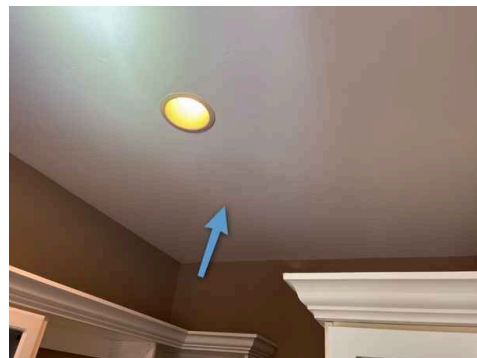
There appeared to be a patch or evidence of a repair noted on the ceiling in one or more location. This could be indicative of a previous leak. The area appeared dry at the time of the inspection. Recommend asking the sellers about this and/or have further evaluated by a licensed contractor. Please note: determining if damaged exist behind the ceiling of any surface is beyond the scope of this inspection.

Recommendation

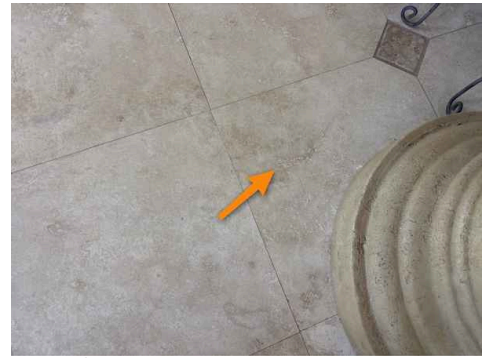
Breakfast Nook

6.4.2 Floor Coverings

Attention Item

Contact a qualified flooring contractor

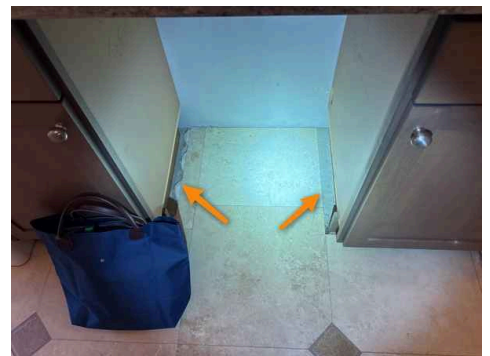
Kitchen/Dining Hall

FLOORING DAMAGED/MISSING

Portions of the flooring was noted missing/damaged. Recommend correction by a licensed flooring contractor.

Recommendation

Contact a qualified flooring contractor

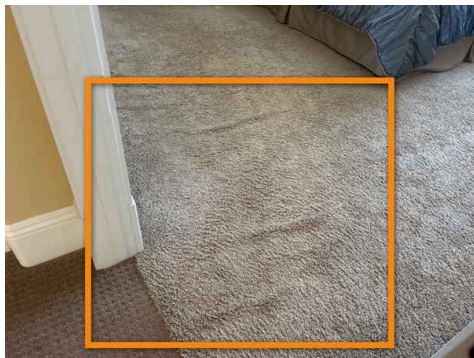
2nd Bedroom

CARPET LOOSE

Portions of the carpeting were noted loose and appeared to need re-stretched. Recommend consulting a licensed flooring contractor for necessary repairs.

Recommendation

Contact a qualified flooring contractor

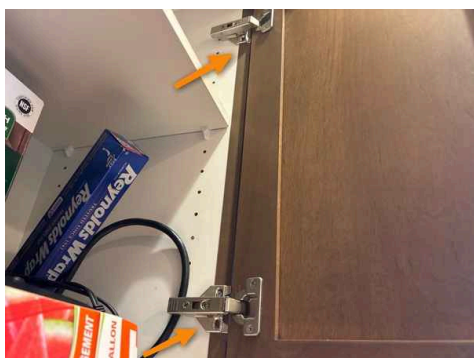
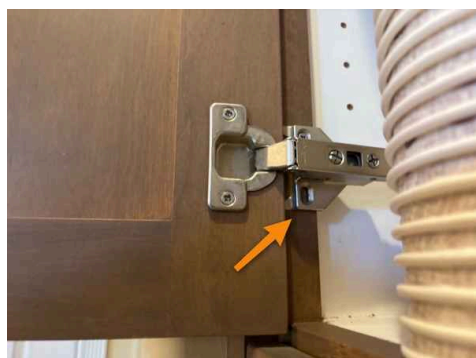
Kitchen

LOOSE/MISSING DOOR HARDWARE

Cabinet door hardware noted loose/missing. Advise necessary corrections.

Recommendation

Contact a qualified professional.

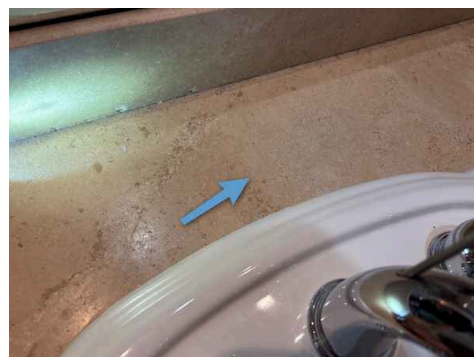
Master Bathroom

COUNTERTOP DAMAGED

Damage/crack was noted in the countertop. You may wish to view this for yourself and have repaired as desired.

Recommendation

Contact a qualified professional.

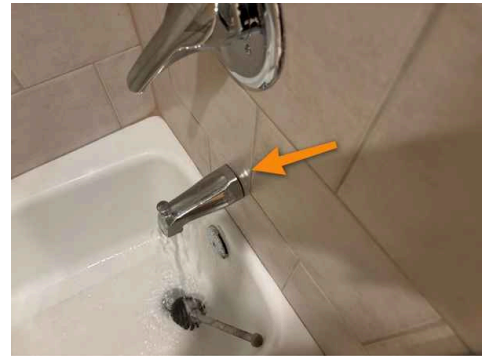
2nd Bedroom Bathroom

The tub/shower enclosures need to be cleaned and recaulked to prevent moisture intrusion beyond the shower enclosure walls.

Recommendation

Contact a qualified professional.

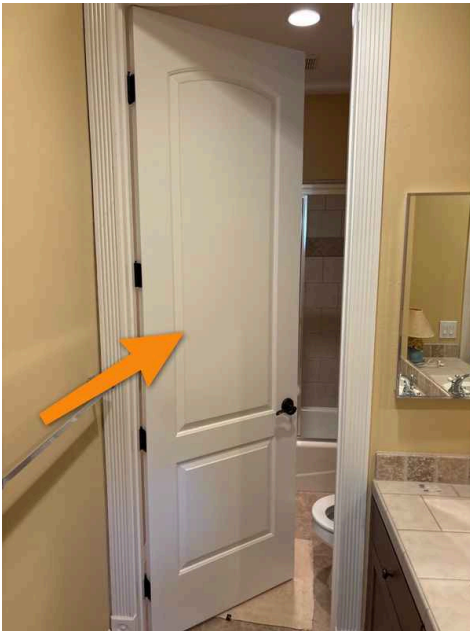
2nd Bedroom Bathroom

One or more interior doors appears to be out of square/plumb. This may be indicative of possible movement in the structure or poor installation. Recommend correction by a licensed door contractor.

Recommendation

Contact a qualified door repair/installation contractor.

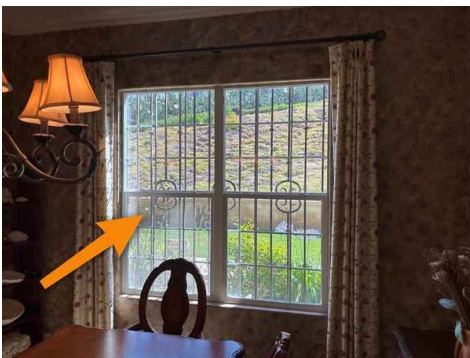
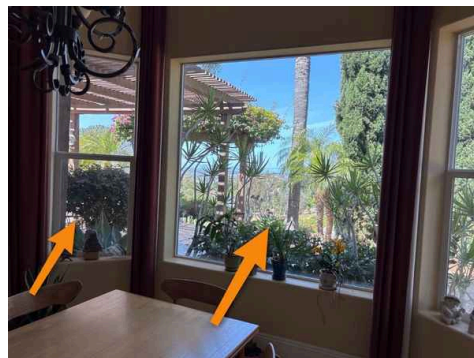
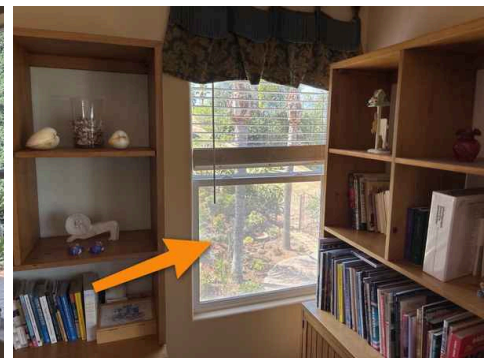
FOGGED OR FAILING WINDOWS

Fogged windows or failing UV coatings were noted. This may be indicative of failed hermetic seals. This condition will reduce the visibility and thermal efficiency of these windows. Recommend further evaluation by a licensed window contractor to determine repairs needed at this time.

Recommendation

Contact a qualified window repair/installation contractor.

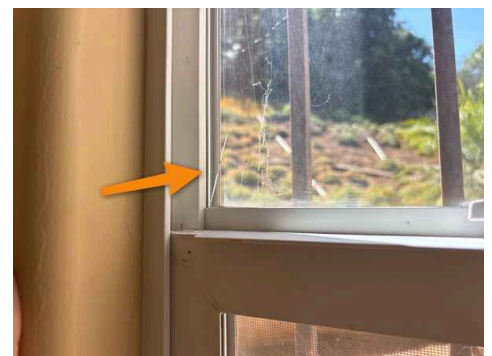
Living Room

CRACKED/BROKEN

Broken/cracked window(s) observed in one or more areas. Recommend correcting and advise repair/replace by a qualified/licensed professional.

Recommendation

Contact a qualified window repair/installation contractor.

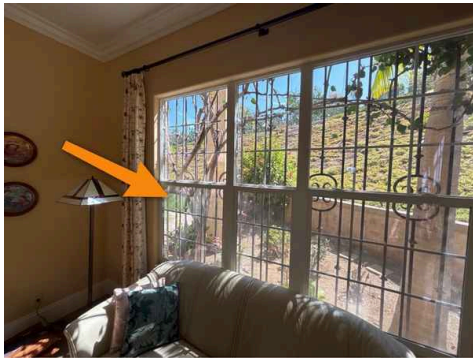
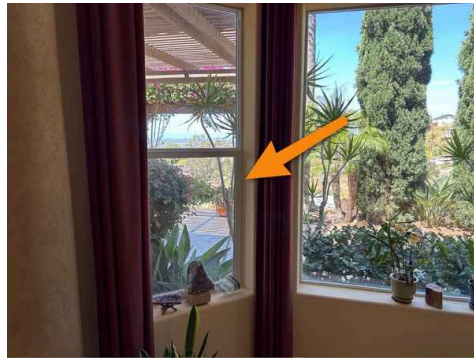
Slipped/damaged sash balance spring noted at one or more single hung window(s). This effects the operation of the window and/or the window will not remain open. Advise further evaluation and repair by a licensed window contractor or qualified professional.

Recommendation

Contact a qualified window repair/installation contractor.

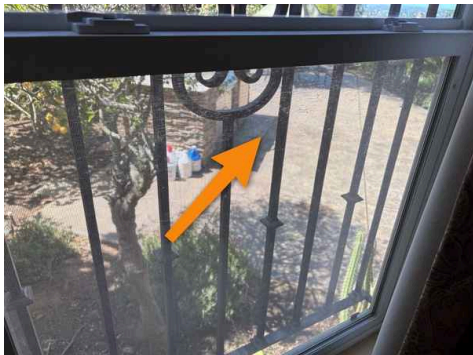
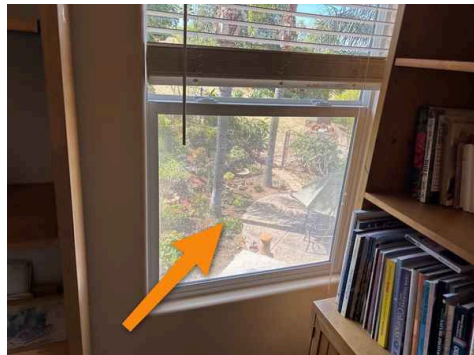
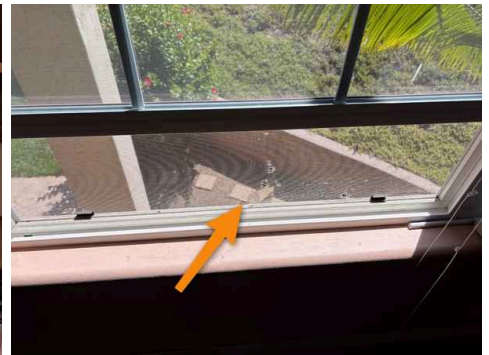
**SCREENS-DAMAGED**

One or more screen was noted bent or damaged. Advise repairing as needed.

Recommendation

Contact a qualified professional.

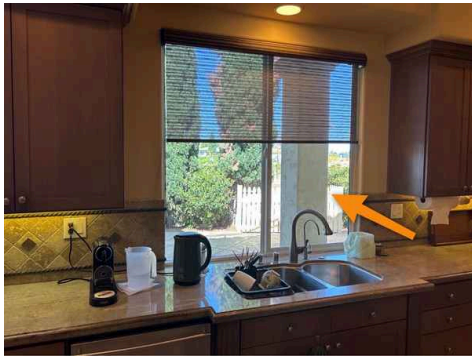
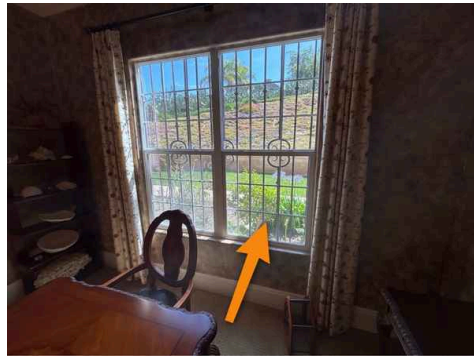
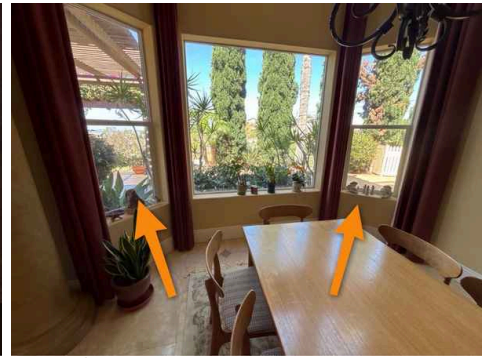
**SCREENS-MISSING**

One or more screen was noted missing/removed. Advise repairing as needed.

Recommendation

Contact a qualified professional.

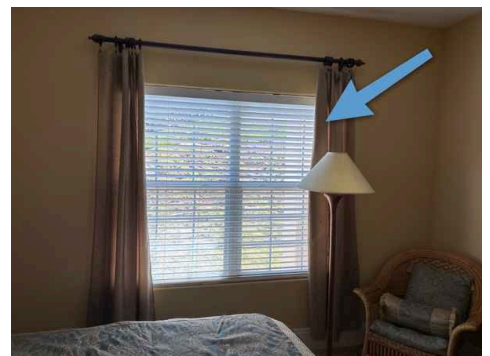
2nd Bedroom

**DAMAGED WINDOW COVERING**

Damaged/missing window coverings noted. These items are beyond the scope of the home inspection. You may wish to do this for yourself and have repaired as desired.

Recommendation

Contact a qualified professional.

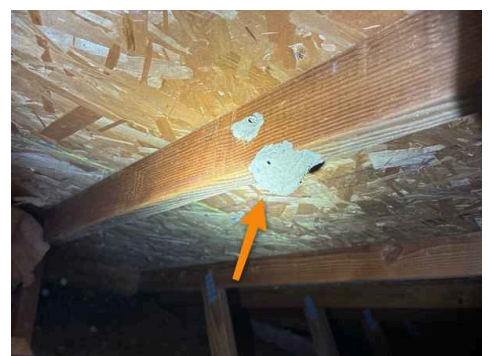
Wasp nests were noted in the attic space. Advise removal by a qualified pest control company.

Recommendation

Contact a qualified pest control specialist.

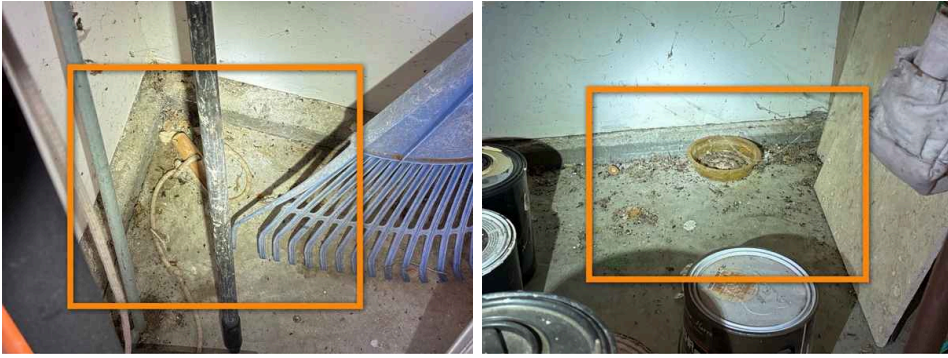
Material which may be rodent droppings was observed in the garage. If present, pests may chew, damage or contaminate components. Rodents have been found throughout San Diego County which have Hantavirus, which is a health hazard, according to [San Diego County Vector Control](#).

Recommendation

Contact a qualified professional.

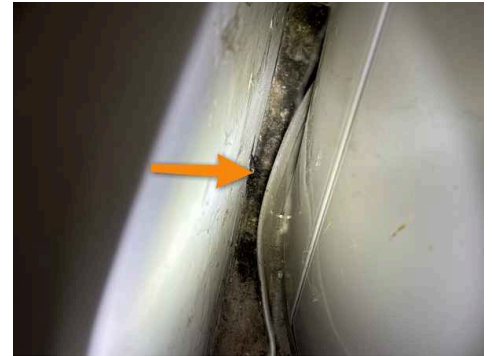
7.3.1 Garage Walls (Including Firewall Separation)

POSSIBLE ORGANIC GROWTH

Contact a qualified environmental contractor

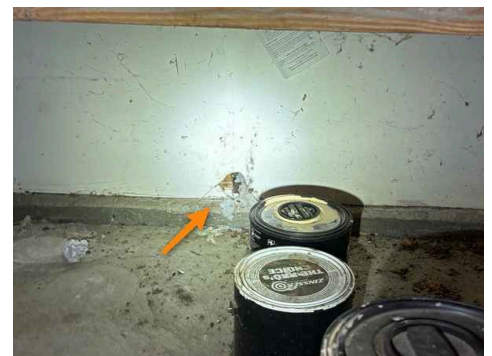
DAMAGED DRYWALL

Damage was noted at the drywall in areas. Recommend consulting a licensed drywall contractor for necessary repairs.

Recommendation

Contact a qualified drywall contractor.

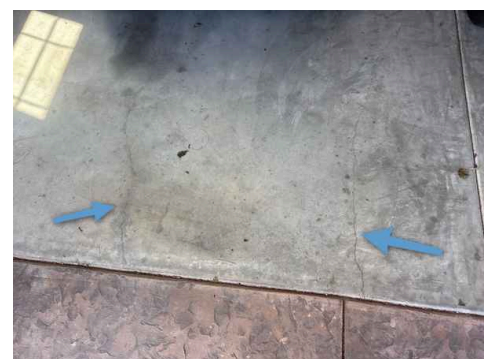
7.4.1 Garage Floor

CRACKS

Contact a qualified professional.

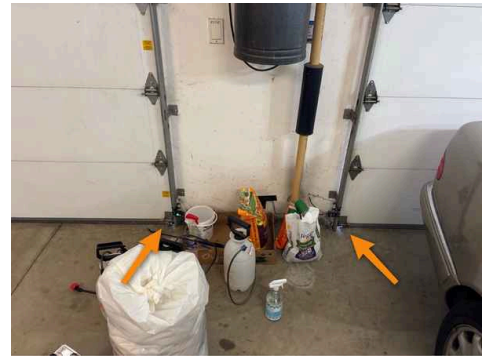
7.5.1 Garage Door

GAPS IN SEAL

Contact a qualified garage door contractor.

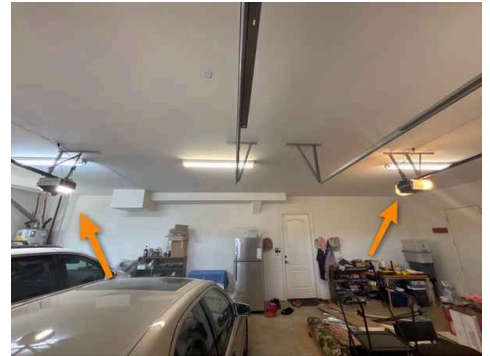
The garage door opener does not appear to be equipped with a back up battery. This is a modern building requirement and is a recommended upgrade for safety. Advise consulting a licensed garage door contractor to determine cost of necessary correction.

Recommendation

Contact a qualified garage door contractor.

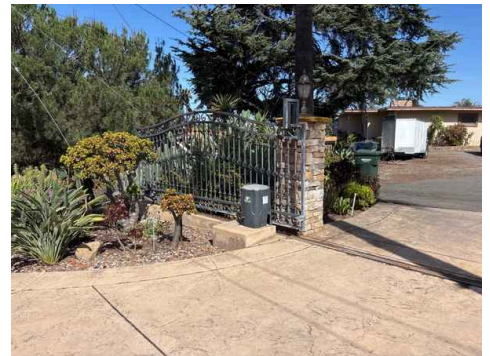
AUTOMATIC GATE

The automatic gate was not tested as part of the inspection process. The equipment appears to be in serviceable condition. Recommend asking the seller to demonstrate operation and have further evaluated by a qualified professional as necessary.

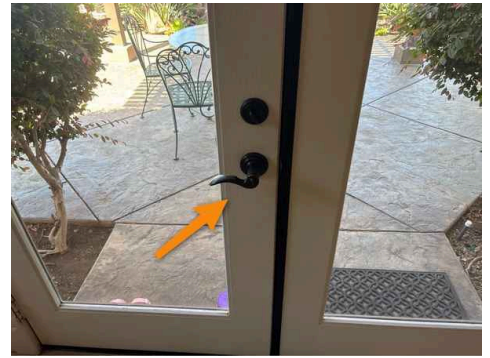
Family Room

HANDLE DAMAGED

The door handle was not a damaged at the time of the inspection. Advise repair/replacement by licensed door contractor.

Recommendation

Contact a qualified door repair/installation contractor.

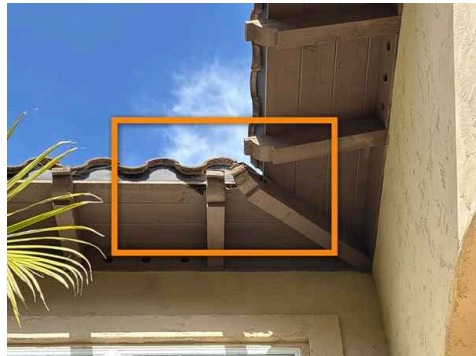
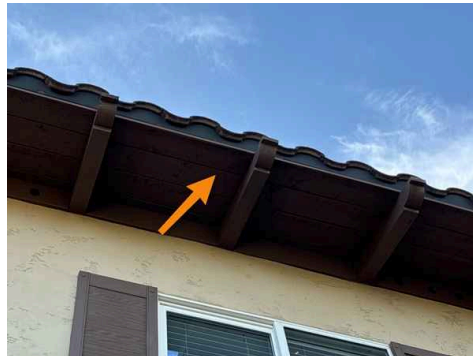
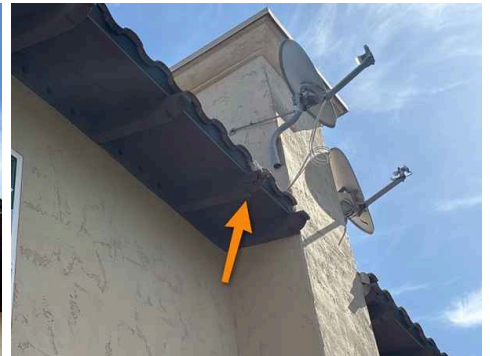
Moisture damaged wood, evidence of possible wood destroying organisms noted. Recommend consulting the termite inspection report for corrective actions needed.

Recommendation

Contact a qualified pest control specialist.

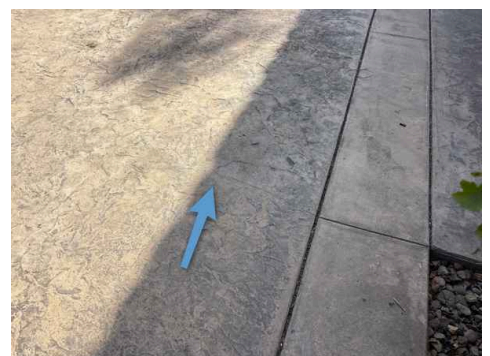
Driveway

CRACKS IN HARDSCAPE

Settlement cracks noted in areas of the hardscape. Advise monitoring and repair when needed.

Recommendation

Contact a qualified masonry professional.

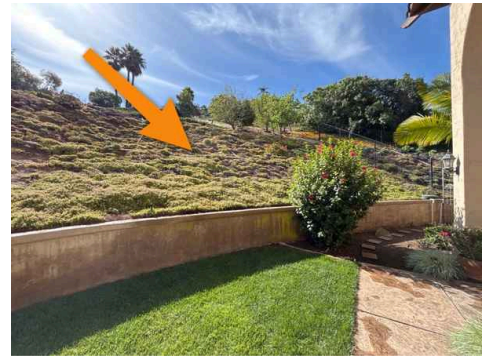
Front Exterior

There is a negative slope noted that can cause or contribute to water intrusion or deterioration. Recommend further evaluation by a licensed grading and drainage contractor to determine corrections needed at this time.

Recommendation

Contact a qualified grading contractor.

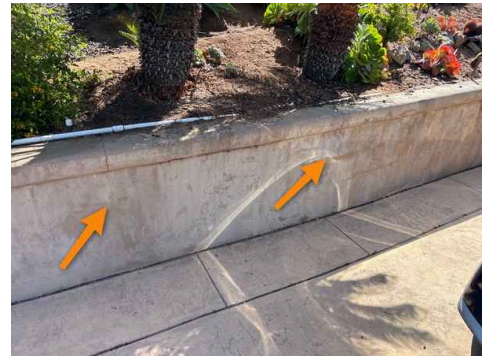
Driveway

RETAINING WALL-CRACKS

The retaining wall shows some settlement cracks, but appears stable. Recommend monitoring and repair as necessary.

Recommendation

Contact a qualified professional.

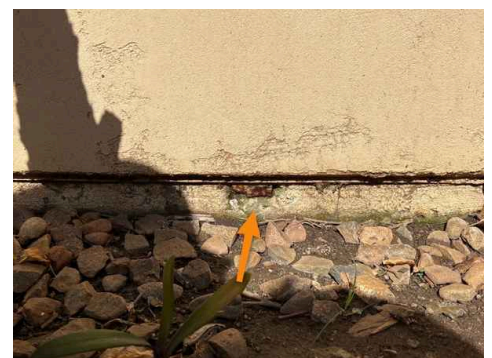
Front Left Exterior

11.7.1 Presence of Foundation Bolts

Recommendation

Contact a foundation contractor.

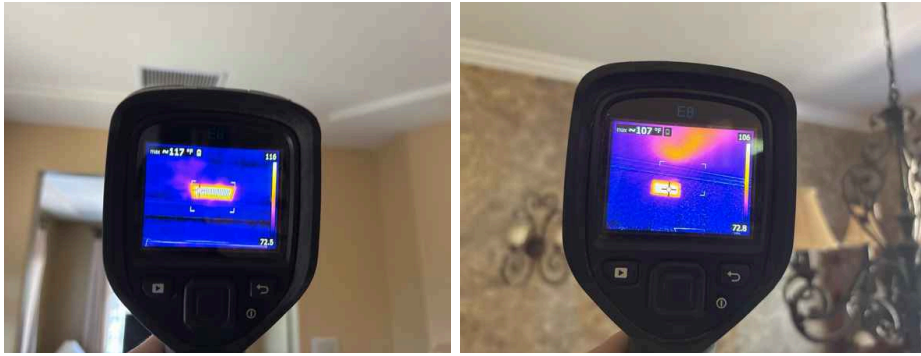
Heating Equipment : Thermal Image Showing Operation

The furnace turned on and produced heat at the time of the inspection.

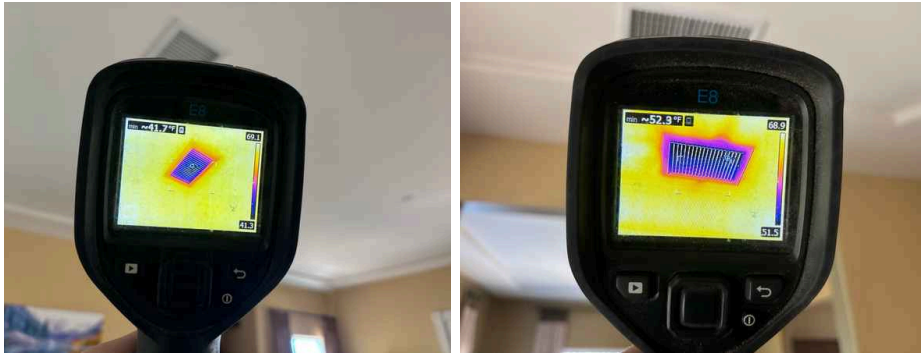
Cooling and Air Handler Equipment: Thermal Image Showing Operation

The AC appeared to turn on and produce cold air at the time of the inspection.

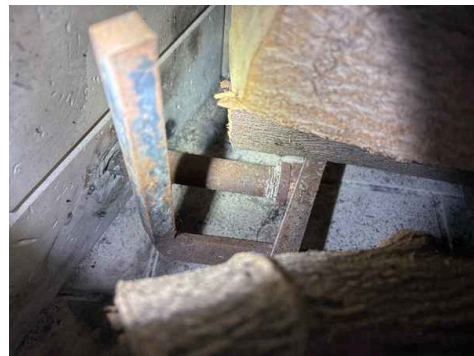
GAS SUPPLY CAPPED

The gas is capped at the fireplace. I was unable to determine function or operation of the gas supply.
