NORCAL INSPECTIONS PLUS

## ALEX R. HOME INSPECTIONS

4971 Maple Spg Rd  
Oroville, CA 95965

APRIL 25, 2026

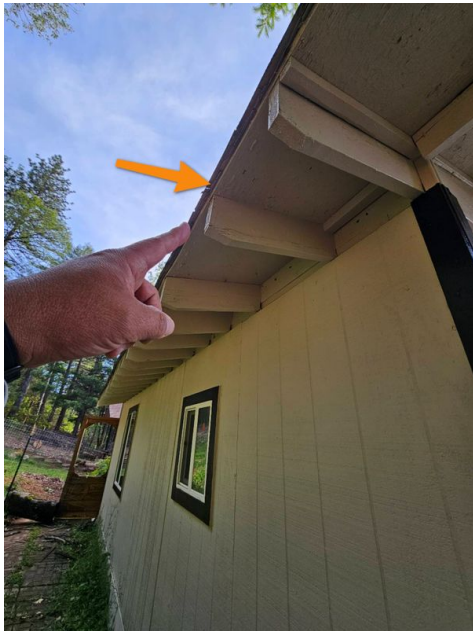
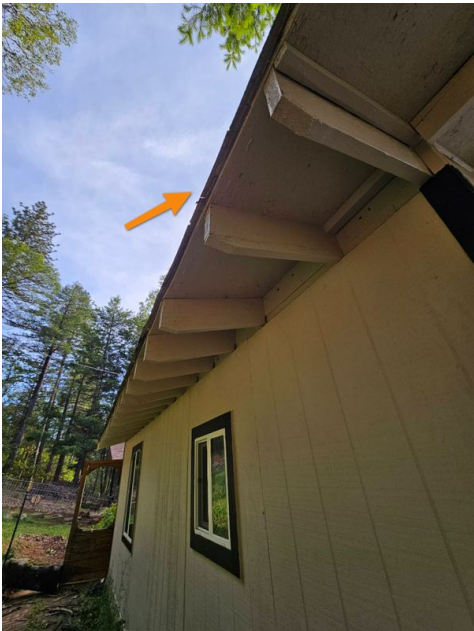
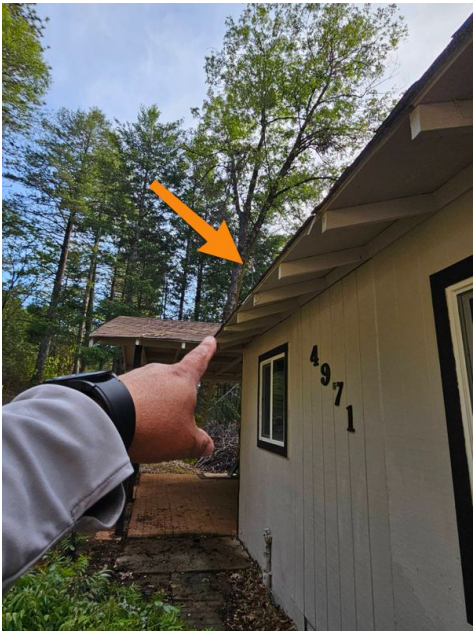
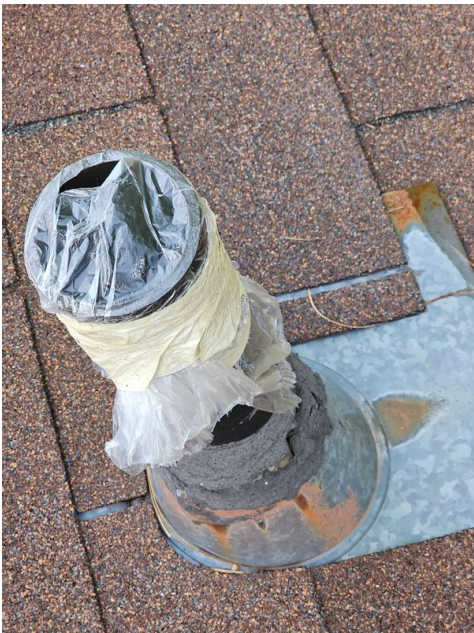
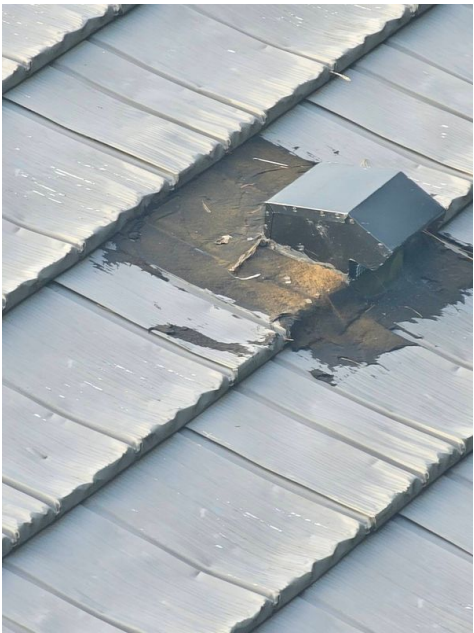
#### **MISSING FLASHING**

I observed areas where flashing was missing. Not installed. Improper installation of flashing. These areas of missing flashing are prone to water penetration. Flashing is installed to provide protection against roof leaks and to divert water away from certain areas. Correction and further evaluation is recommended.

Contact a qualified roofing professional.

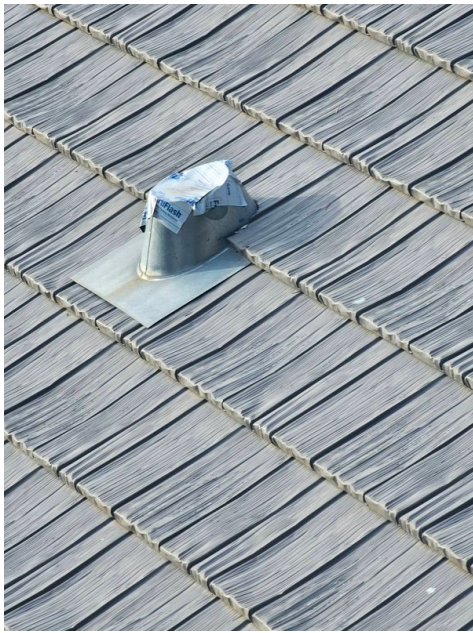
## 2.2.2 Flashing

**CORRODED - SEVERE**

Major Defect

Roof flashing showed signs of severe corrosion, which can lead to moisture intrusion and/or mold. Recommend a qualified roofing contractor evaluate and repair.

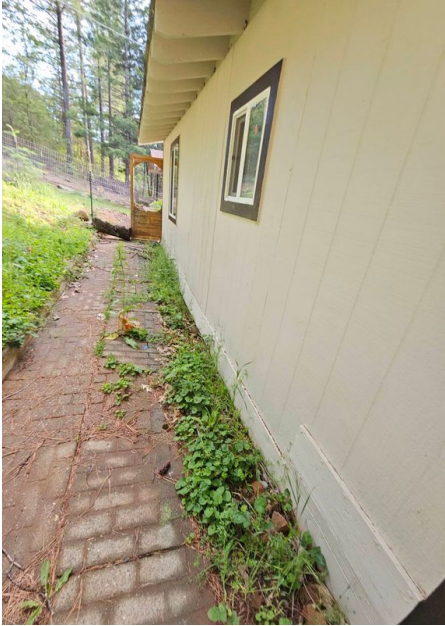
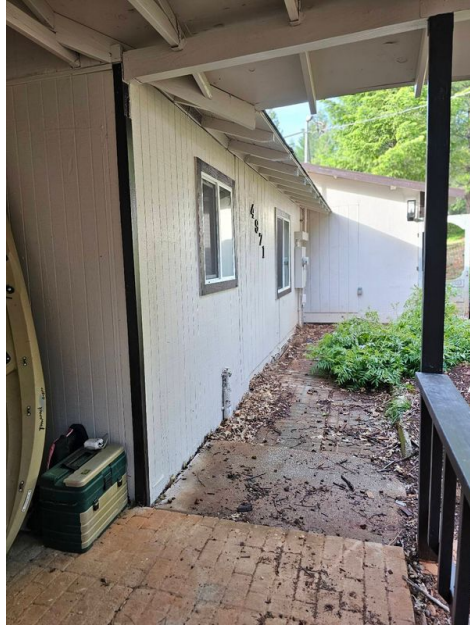
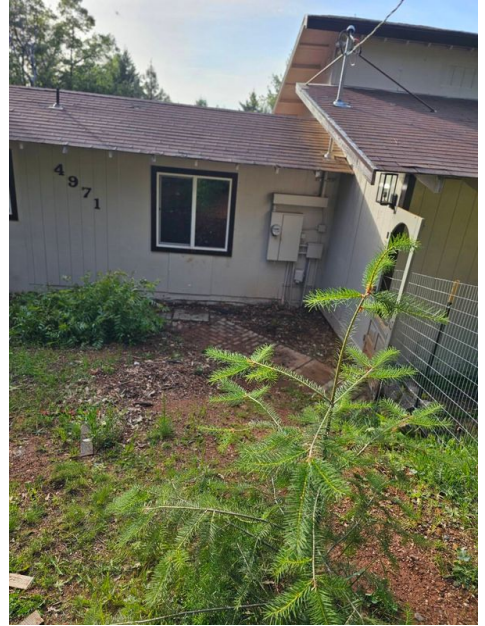
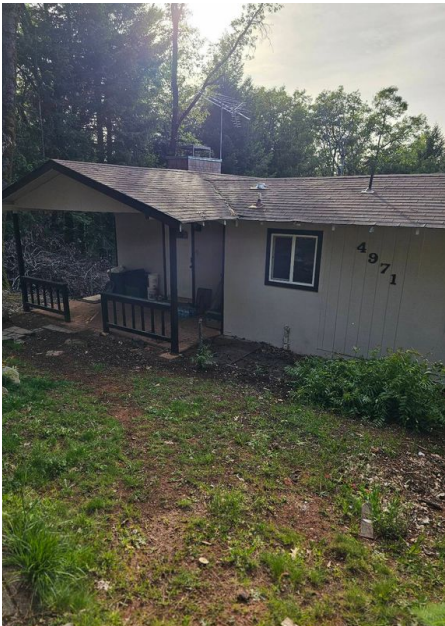
## Vegetation, Surface Drainage, Retaining Walls & Grading: Vegetation, Drainage, Walls & Grading Were Inspected

I inspected the vegetation, surface drainage, retaining walls and grading of the property, where they may adversely affect the structure due to moisture intrusion.

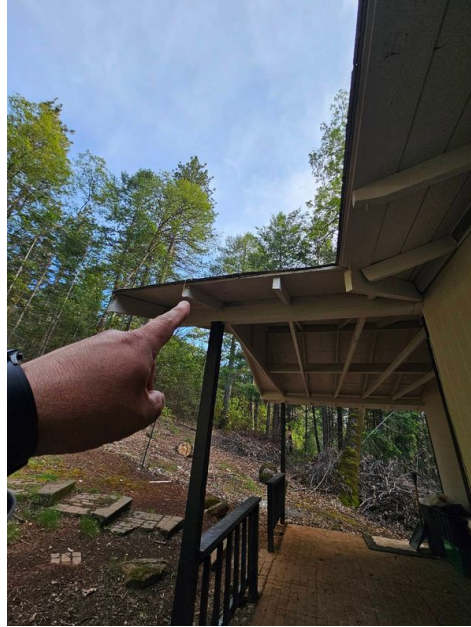
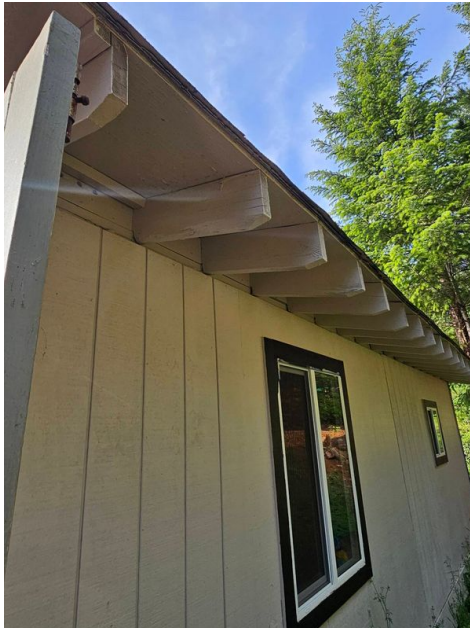
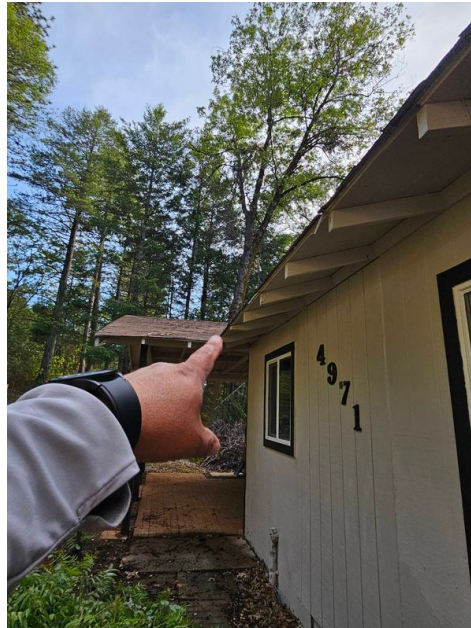
**DAMAGE OBSERVED AT EAVES**

I observed indications that one or more areas of the eaves were damaged.

Correction and further evaluation is recommended.

Contact a qualified general contractor.

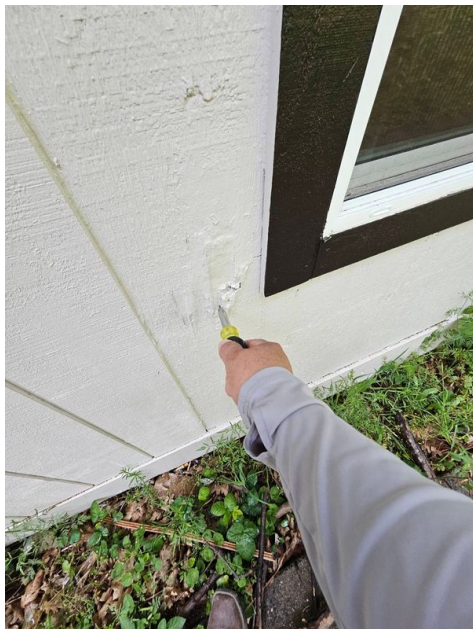
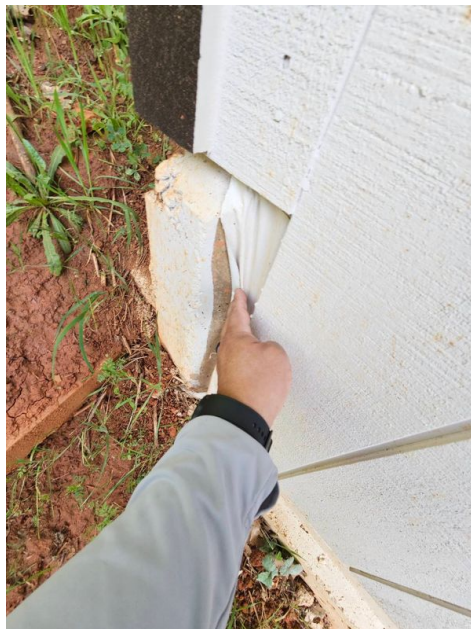
## 3.3.1 Wall-Covering, Flashing &amp; Trim

**DAMAGED WALL-COVERING MATERIAL**

I observed indications of a defect at the exterior wall-covering material.

Correction and further evaluation is recommended.

Contact a qualified professional.

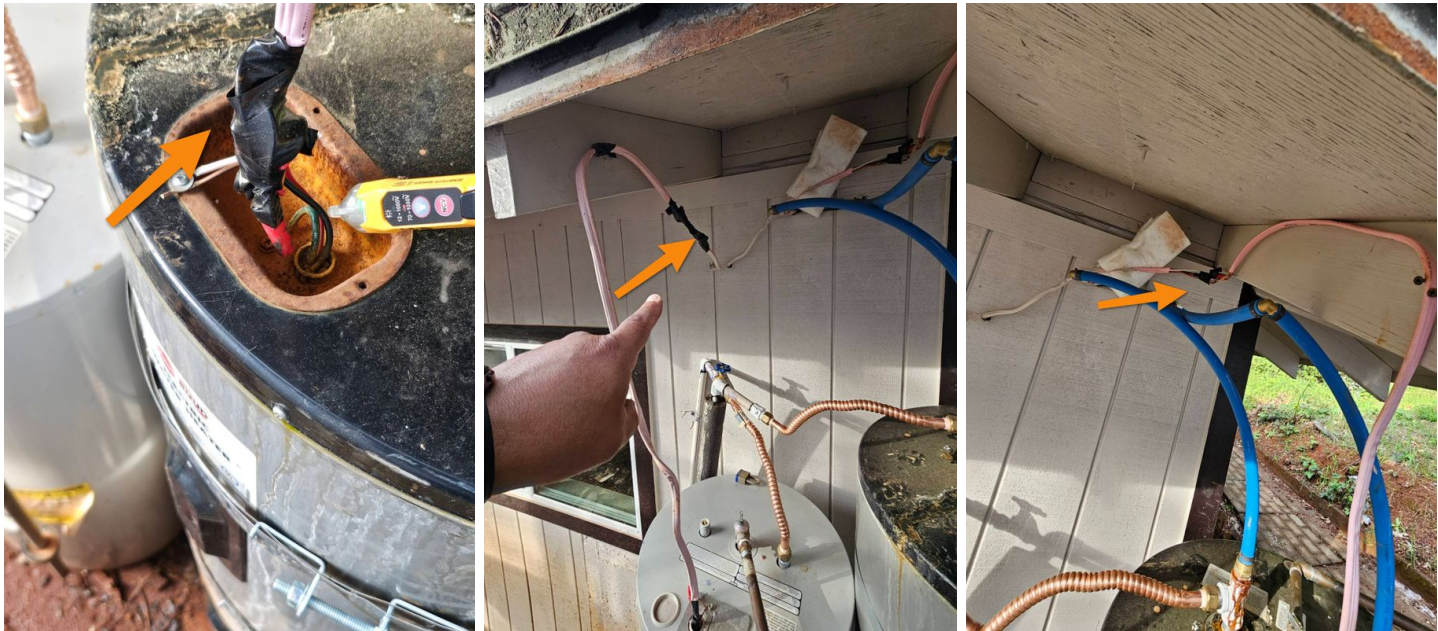
### 3.5.2 GFCIs & Electrical

#### **ELECTRICAL DEFECT**

I observed indications of an electrical defect at the exterior.

Major Defect

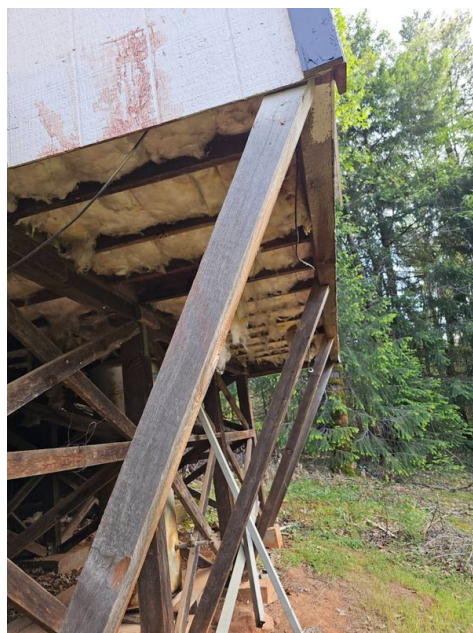
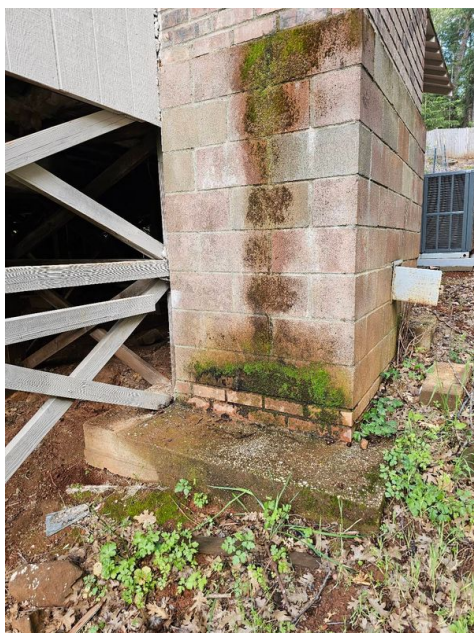
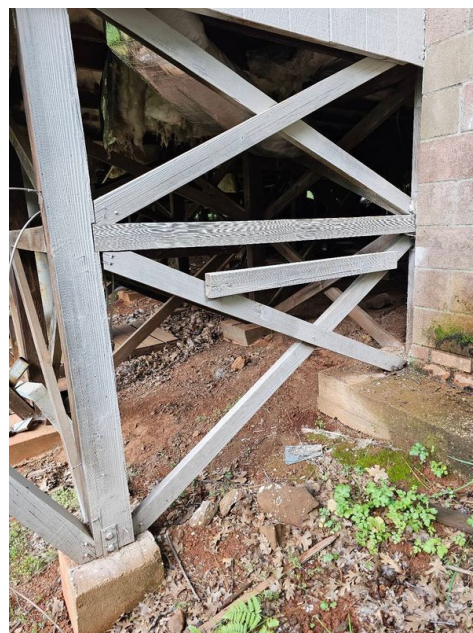
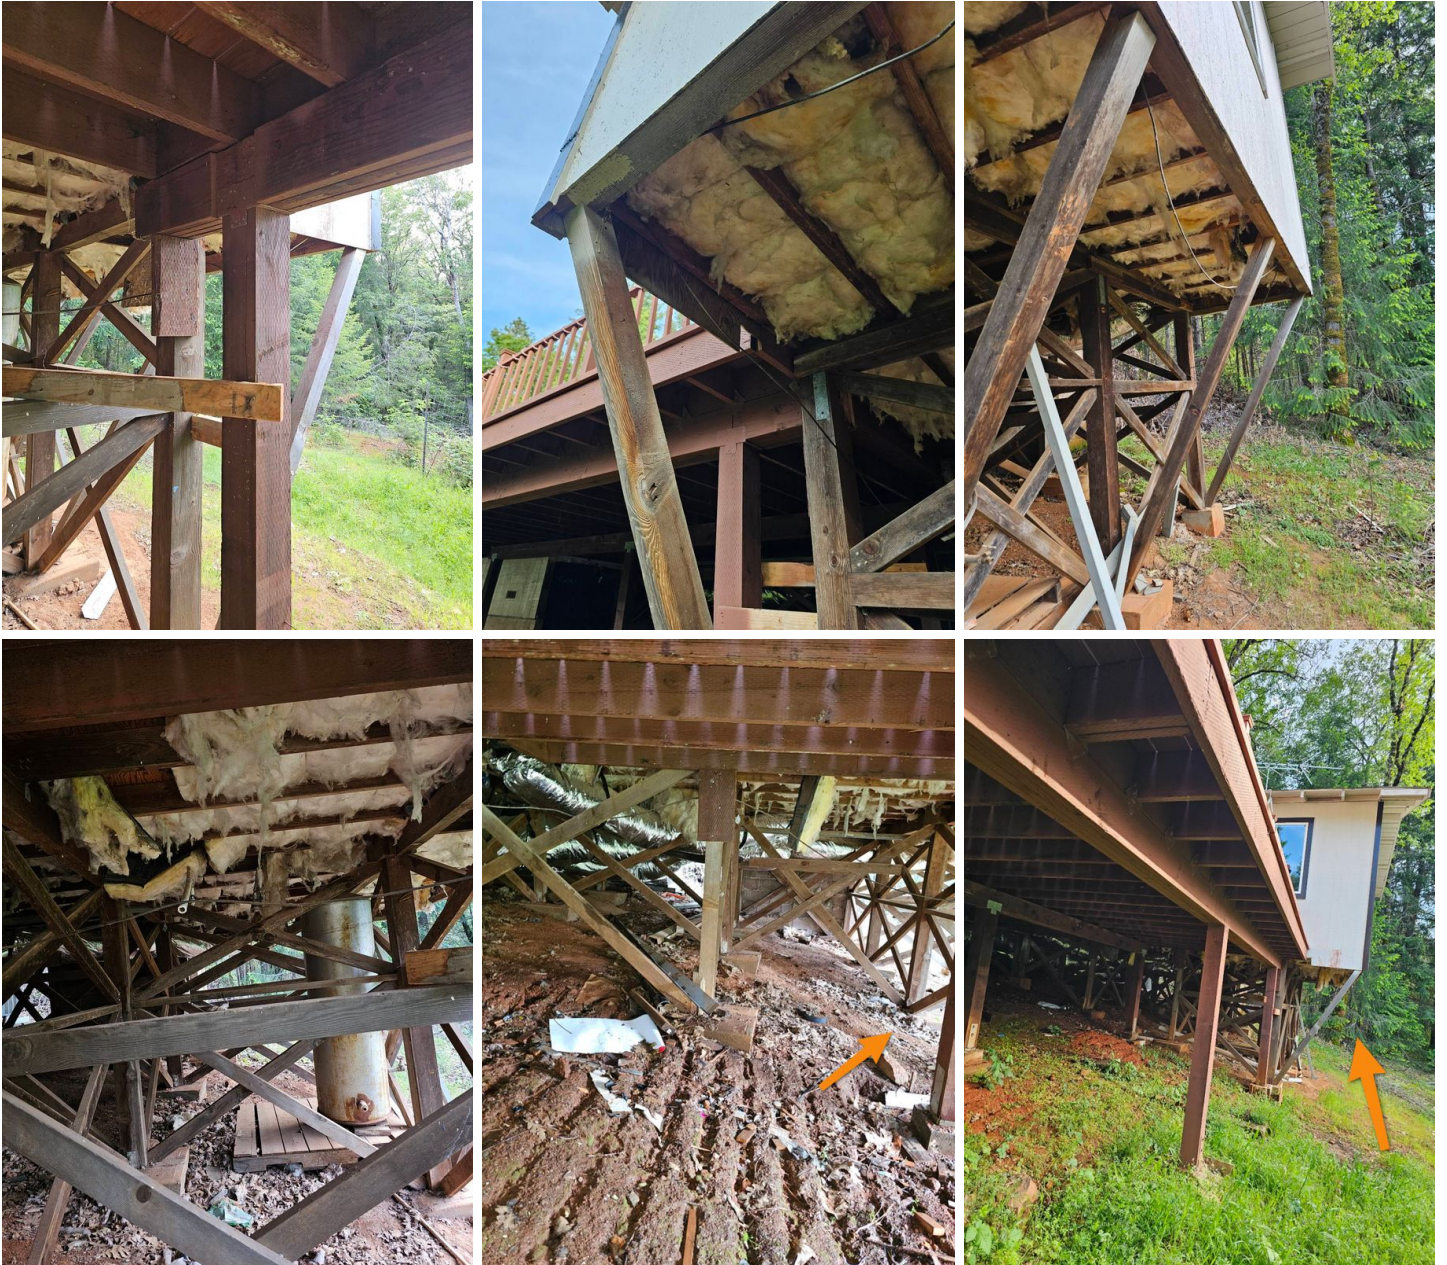
#### IMPROPER CONSTRUCTION PRACTICES

Major Defect

I observed indications of poor workmanship and poor construction techniques. There are structural concerns because of this poor construction and building practice at this area. Major defect.

Correction and further evaluation is recommended.

Contact a qualified professional.

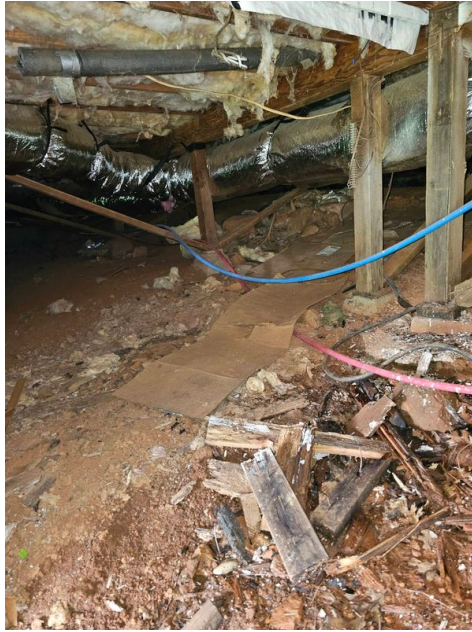
#### 4.2.1 Insulation in Foundation/Basement Area

### **INSULATION HANGING LOOSELY**

Major Defect

I observed that the insulation installed on the floor joists above the foundation area is hanging loosely and falling off.

Contact a qualified insulation contractor.

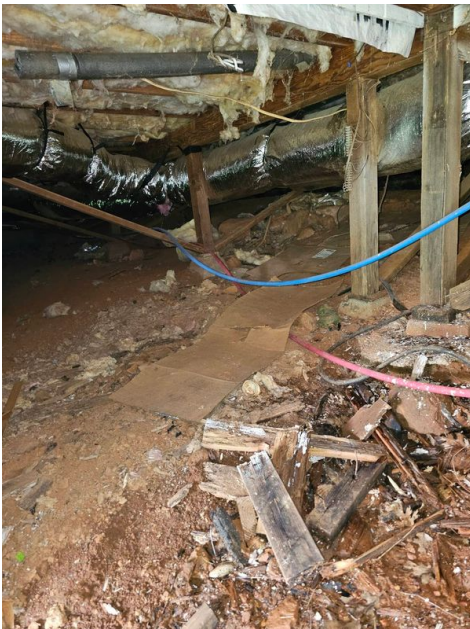
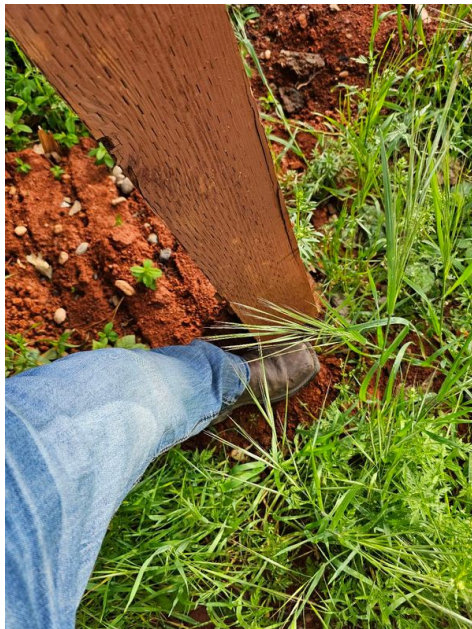
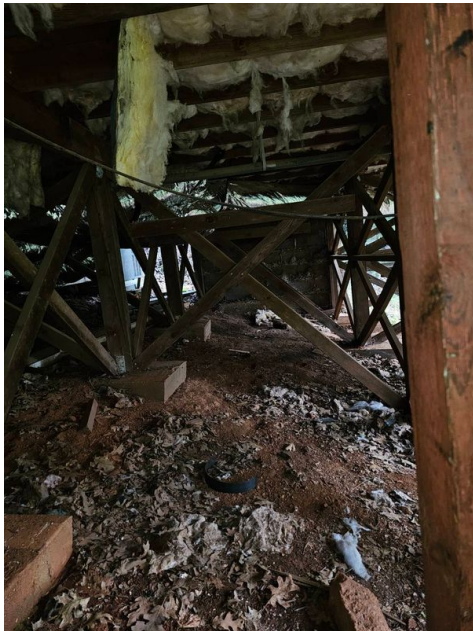
#### 4.5.1 Under-Floor Crawlspace

### IMPROPER CONSTRUCTION PRACTICES

Major Defect

I observed indications of poor workmanship and poor construction techniques. There are structural concerns because of this poor construction and building practice at this area. Major defect.

Correction and further evaluation is recommended.

Contact a qualified professional.

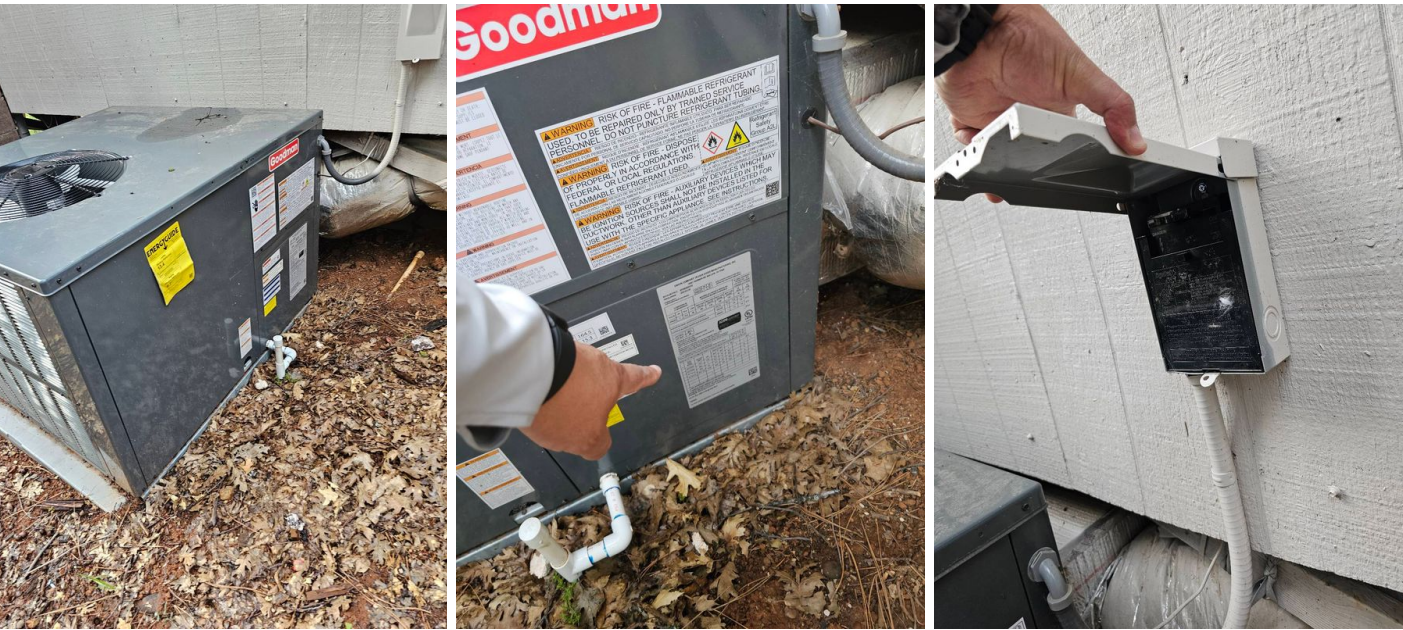
### Heating System Information: Heating Method

Central Air

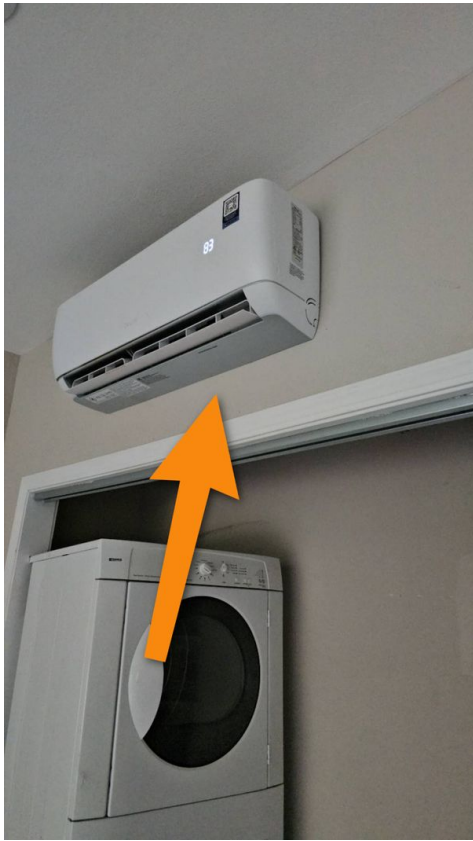
### 5.1.1 Heating System Information

Major Defect

I observed that the heating system did not operate. Correction and further evaluation is recommended.

Contact a qualified HVAC professional.

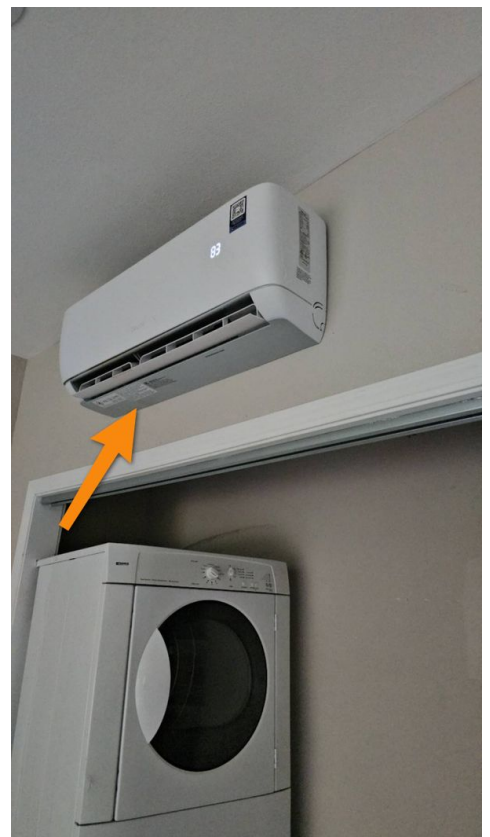
I observed that the heating system did not operate. Correction and further evaluation is recommended.

Major Defect

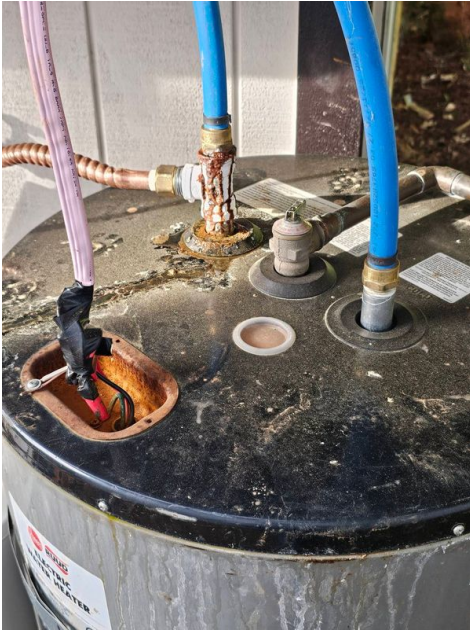
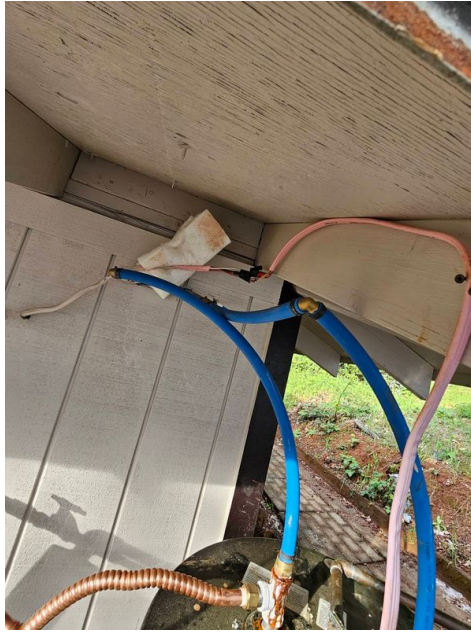
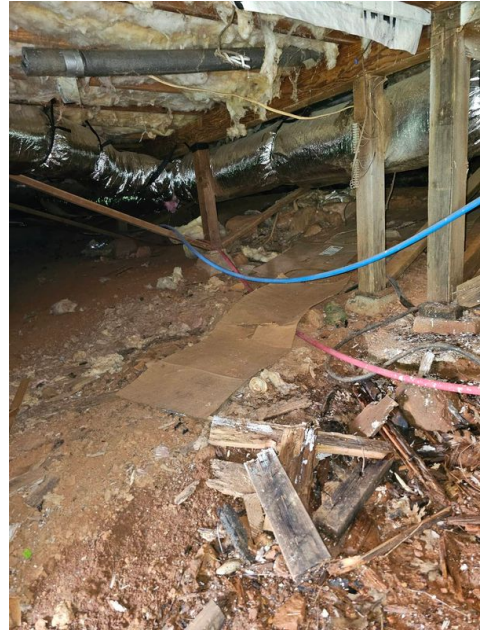
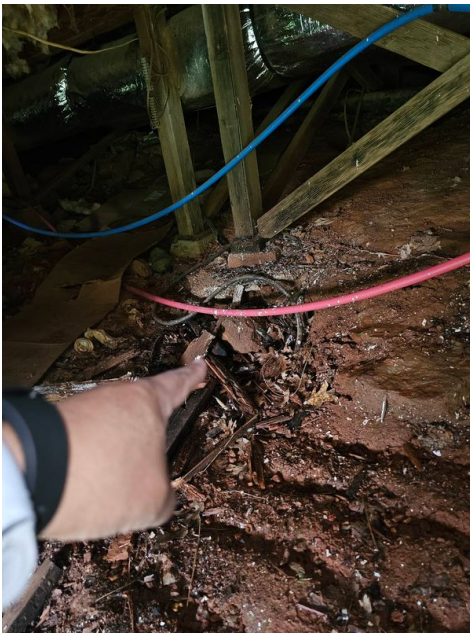
#### IMPROPER INSTALLATION OF WATER PIPES

Major Defect

I observed indications of poor workmanship and improper installation of the water supply pipes. Defect. Correction and further evaluation is recommended.

Contact a qualified plumbing contractor.

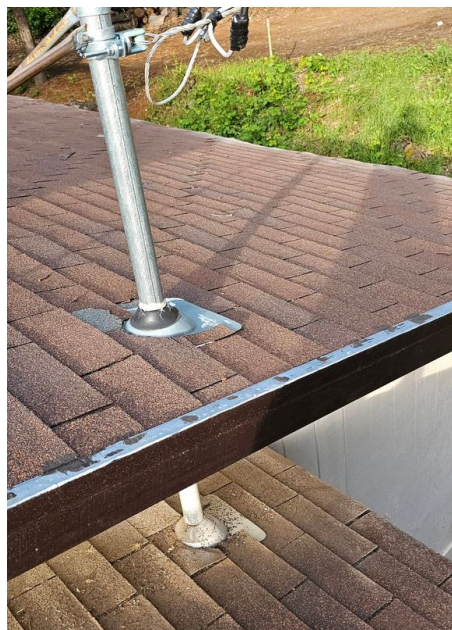
#### Service-Entrance Conductors: Inspected Service-Entrance Conductors

I inspected the electrical service-entrance conductors.

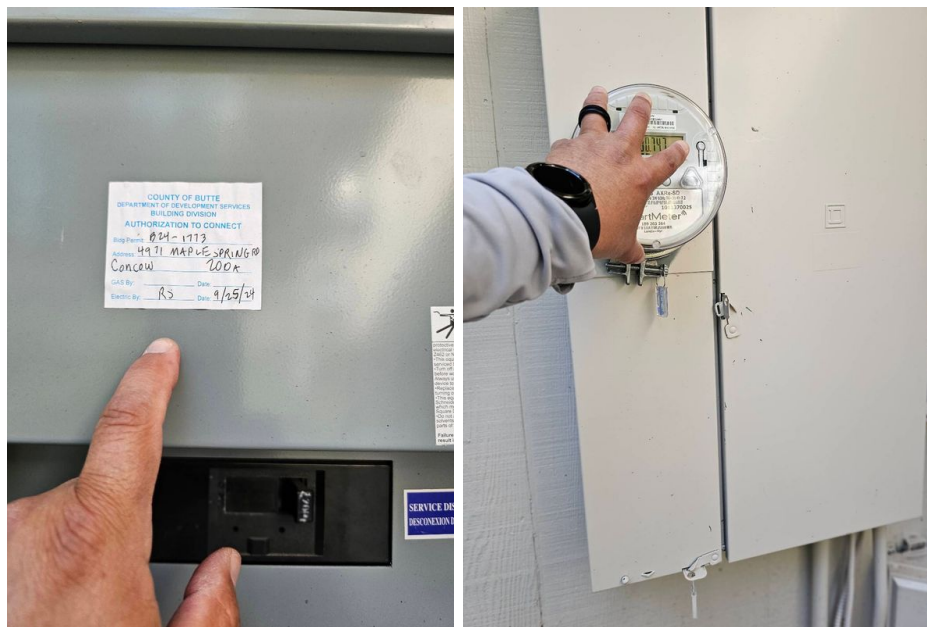
### Panelboards & Breakers: Inspected Main Panelboard & Breakers

I inspected the electrical panelboards and over-current protection devices (circuit breakers and fuses).

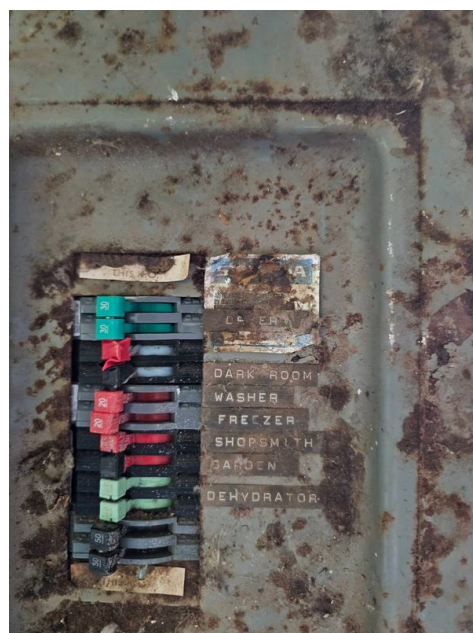
#### RUST, CORROSION, WATER INSIDE CABINET

Major Defect

I observed indications of water intrusion, rust and corrosion inside the electrical panel cabinet. Hazard.

Contact a qualified electrical contractor.

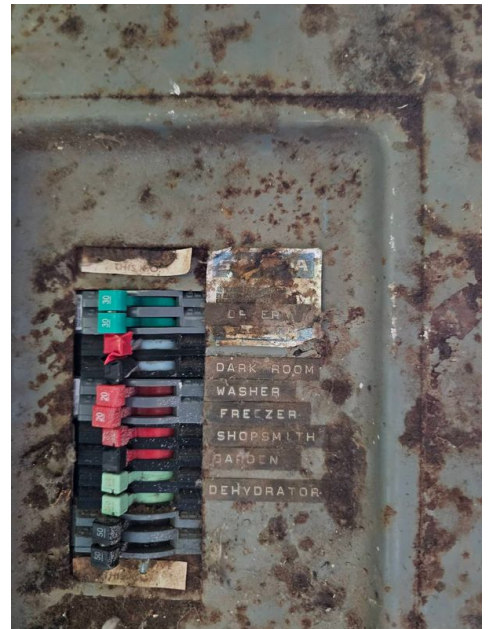
### 8.5.3 Panelboards & Breakers

#### ZINSCO PANEL

Major Defect

I observed indications that the panelboard was manufactured by Zinsco. These panels have a reputation for being problematic and further evaluation by a qualified electrician is recommended. Zinsco panels can generally be identified by a blue and silver "Zinsco" label inside the panel, an embossed "Magnetrip" label at the top of the panel face, and the colorful breakers.

- There may be components of the panel that contain aluminum.
- The connection between the breakers and the bus bar may be defective.
- The bus bar may be corroded.
- Breakers may be turned off, but the circuit could still be live.

The obsolete and unreliable Zinsco panel should be further evaluated and replaced by a licensed electrician.

Contact a qualified electrical contractor.

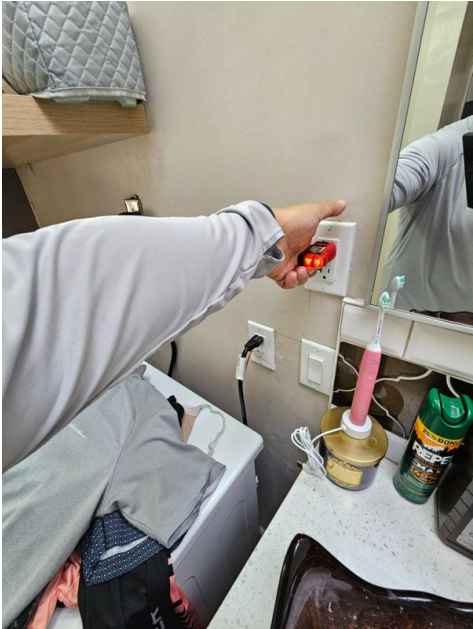
### 8.8.1 GFCIs

#### GFCI DEFECT

Major Defect

I observed indications of a defect at a GFCI.

Contact a qualified electrical contractor.

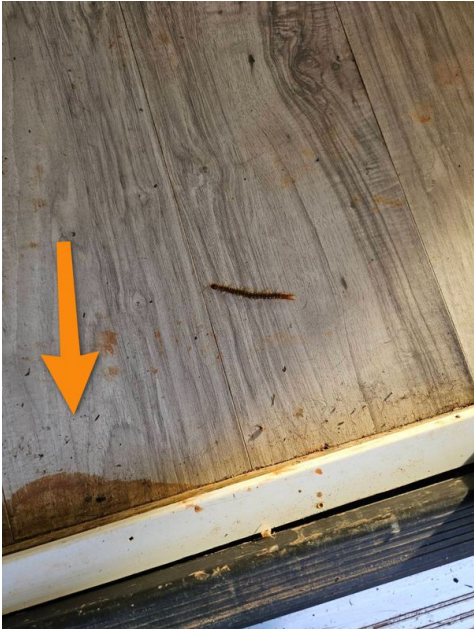
### 11.4.1 Floors, Walls, Ceilings

#### MOISTURE DAMAGE

Floors had areas of visible moisture damage. Recommend a qualified flooring contractor evaluate & repair areas of moisture.

Major Defect
