# WOOD DESTROYING PESTS AND ORGANISMS INSPECTION REPORT

| Building No.<br><b>1778</b> | Street<br><b>11th Street</b> | City<br><b>Los Osos</b> | Zip<br><b>93402</b> | Date of Inspection<br><b>04/20/2026</b> | Number of Pages<br><b>1 of 6</b> |

**Report #: 113247**

| General Description:<br><b>Two story; Single family residence; Stucco exterior; Composition shingle roof; Furnished and occupied.</b> | Inspection Tag Posted:<br><b>Laundry Room</b> |

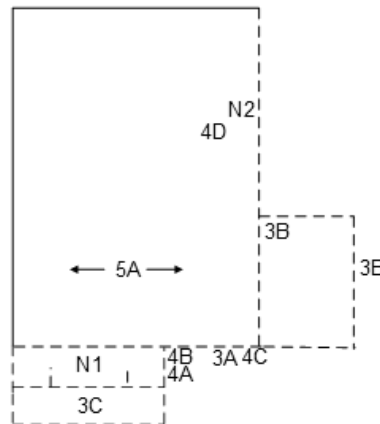
\*\*\*Complete Inspection Report\*\*\*  
 Diagram not to scale  
 Finding locations approximate

| Finding: | 3A | Fungus damage was found at the wood siding. |
| Finding: | 3B | Fungus damage was found at the patio cover framing. |
| Finding: | 3C | Fungus damage was found at the garage door wood siding and trim. |

| Finding: | 4A | An existing and/or potential excessive moisture condition exists due to cracks in the tile and front porch. The deck was not water tested at the time of this inspection. |
| Finding: | 4B | An excessive moisture condition exists due to the base of the wood siding and tile front porch which is embedded in concrete. Moisture may be trapped at the base of the wood siding and may lead to infestation, infection and damage. |
| Finding: | 4C | Moisture damage was noted at the box eave and appears to have been caused by a previous moisture condition. |

| Recommendation: | | Replace the damaged portions of the wood siding. Note: In cases of plywood siding, repair may involve installing wood trim in place of siding removed and/or metal flashing at cut sections of siding replacement. Additional costs will apply if replacement of full sheet(s) of plywood siding is desired by the parties in interest. |
| Recommendation: | | Remove and replace the damaged portions of the patio cover framing as needed to eliminate the fungus infection and damage. |
| Recommendation: | | Replace the damaged portions of the garage door wood siding and trim. Note: In cases of plywood siding, repair may involve installing wood trim in place of siding removed and/or metal flashing at cut sections of siding replacement. Additional costs will apply if replacement of full sheet(s) of plywood siding is desired by the parties in interest. |

| Recommendation: | | Consult a licensed deck coating specialist to inspect and to make any necessary repairs to the tile and front porch to eliminate the excessive moisture condition. |
| Recommendation: | | Seal the base of the wood siding with a durable exterior sealant. This seal must be maintained to remain effective. |
| Recommendation: | | Remove and replace the damaged portions of the boxed eave as needed. |
