# CAL-WEST PROPERTY INSPECTIONS

## CAL-WEST PROPERTY INSPECTIONS HOME MAINTENANCE REPORT

27012 Bottlebrush Ln  
Menifee, CA 92586

06/30/2026

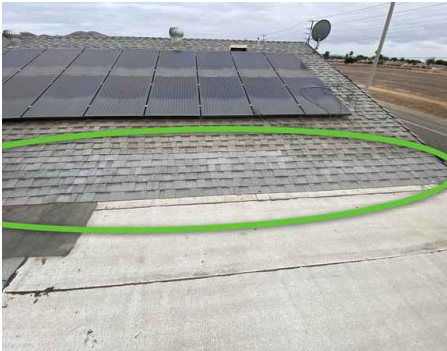
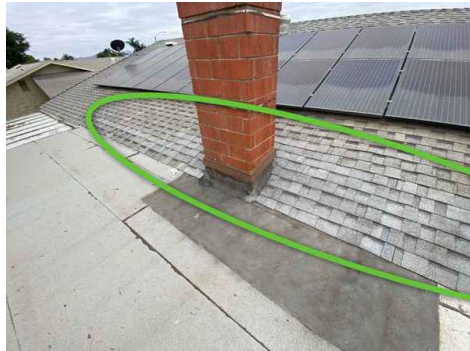
### Roof Coverings: Previous Repairs Made to the Roof Covering.

At the time of inspection there were one or more areas of the roof that had been previously repaired. It is advised to ask seller if they are aware of the original problem that necessitated the repairs and if a licensed contractor performed the repairs. If a licensed roofer made the repairs it is advised to ask for the receipt.

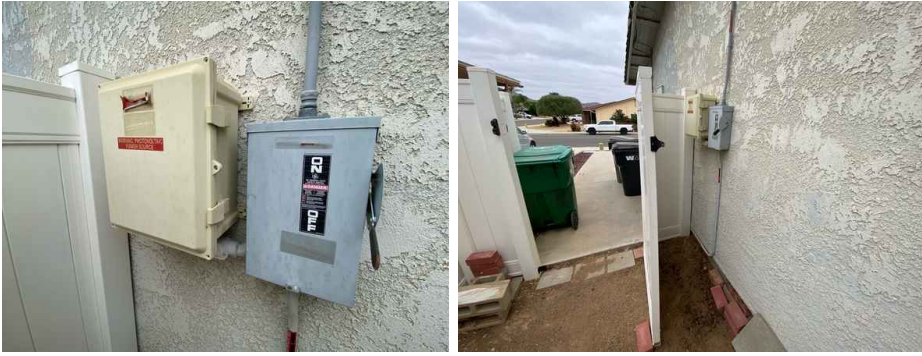
### Solar Panels : Inverter

Southwest

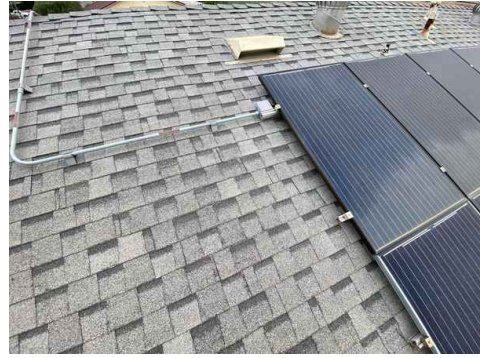
- ⊖ 2.1.1 Roof - Roof Coverings: Aging Asphalt Shingle Roof
- 🔧 2.1.2 Roof - Roof Coverings: Loose Debris on Roof Covering Affecting Surface Drainage
- ⊖ 2.1.3 Roof - Roof Coverings: Two Roof Covering Layers

Contact a qualified roofing professional.

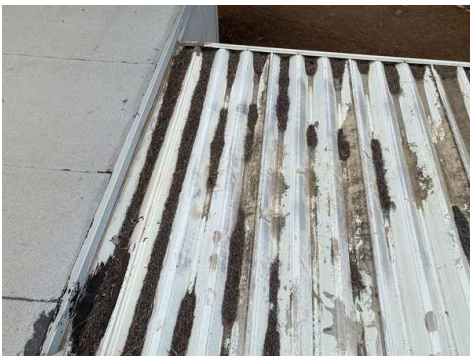
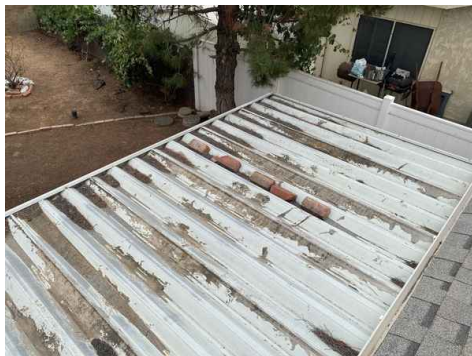
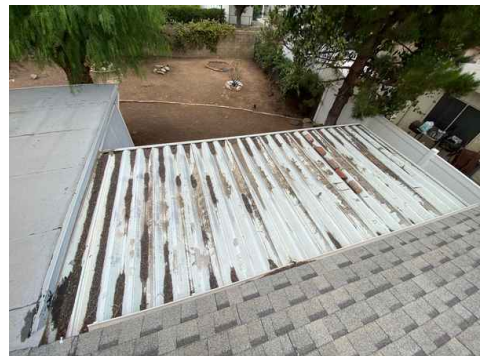
### 2.1.2 Roof Coverings

#### **LOOSE DEBRIS ON ROOF COVERING AFFECTING SURFACE DRAINAGE**

Deferred Maintenance - Minor Repair

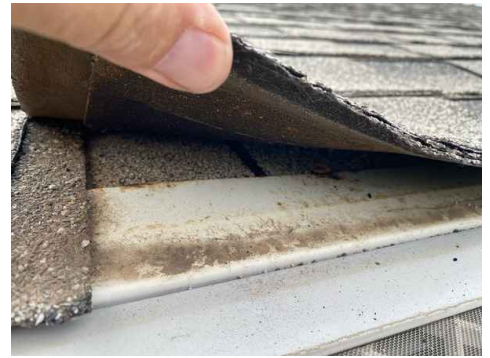
## 2.1.4 Roof Coverings

**ROOF SURFACE PONDING**

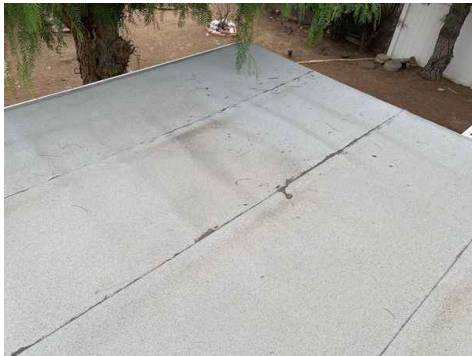
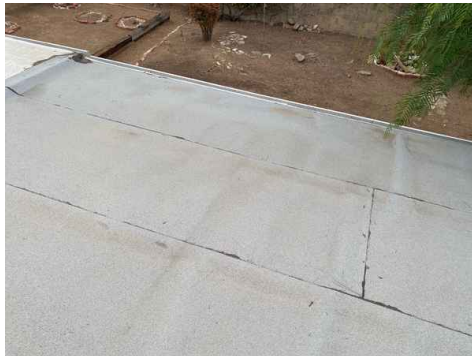
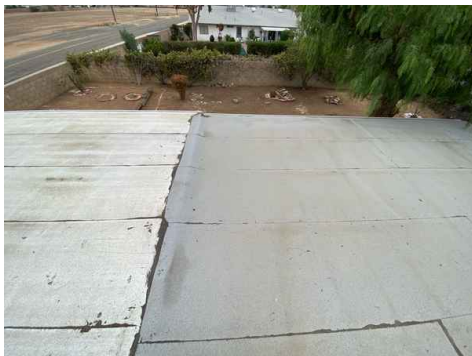
## 2.1.3 Roof Coverings

**TWO ROOF COVERING LAYERS**

Recommended Improvement

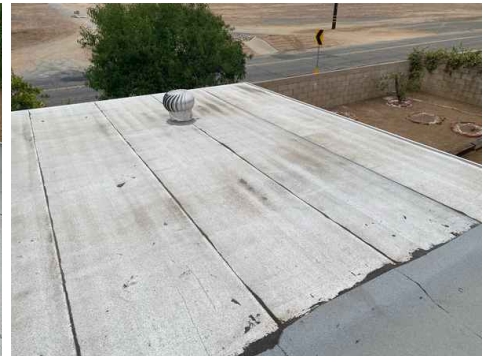
## 2.1.5 Roof Coverings

**TREES OVERHANGING ROOF**

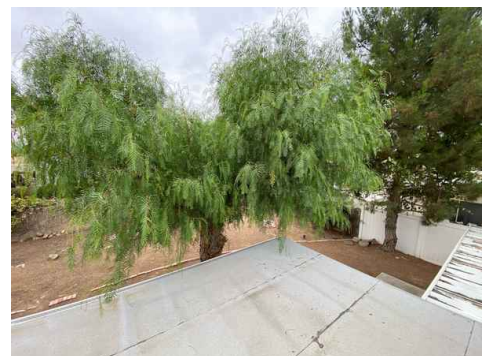
## 2.1.6 Roof Coverings

**EXPOSED NAILS**

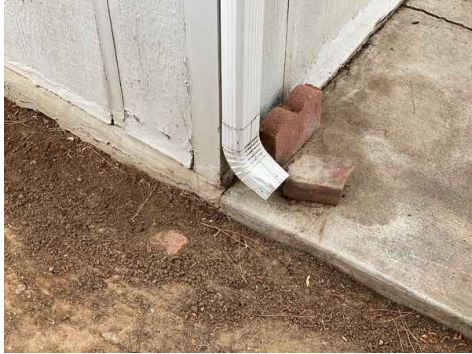
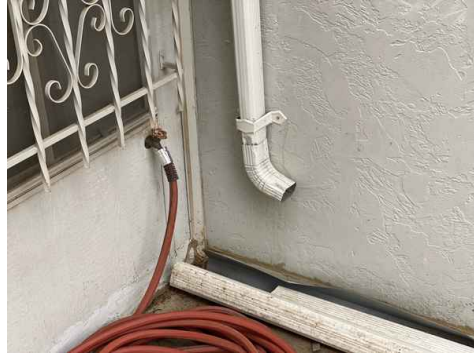
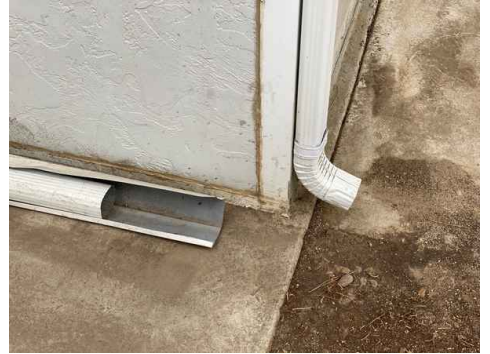
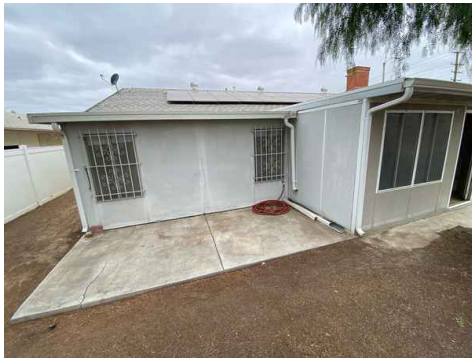
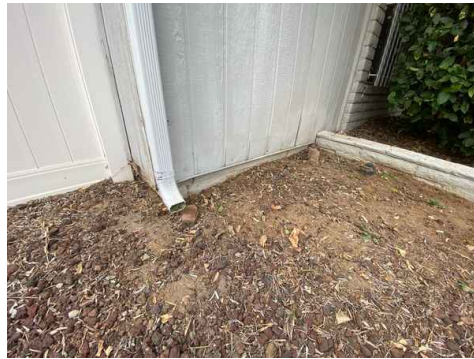
At the time of the inspection one or more downspouts drained too close to the building's foundation. It is best to have gutter downspouts connect to landscaping drainlines if possible. Otherwise, 3-6 foot downspout extensions are advised if it is not possible to connect to landscaping drains. Correction is advised.

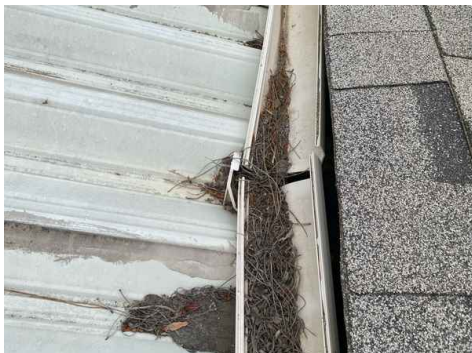
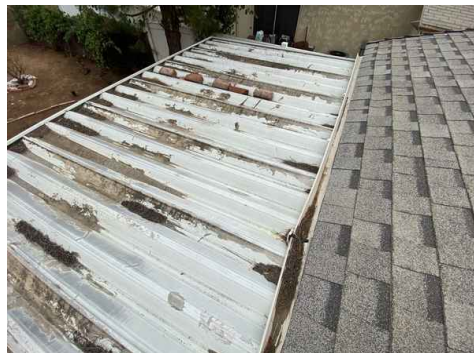
**GUTTER DAMAGED**

At the time of the inspection one or more sections of the gutters were damaged. This can result in excessive moisture in the soil at the foundation, which can lead to erosion and foundation/structural movement. Correction is advised.

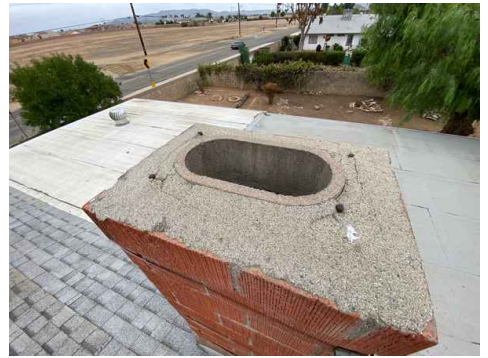
## 2.4.1 Chimneys

**CHIMNEY SPARK  
ARRESTOR/RAIN CAP MISSING**

At the time of inspection the chimney was missing the appropriate spark arrestor/rain cap. Recommend a qualified roofer or chimney professional install. Correction is advised.

Contact a qualified professional.

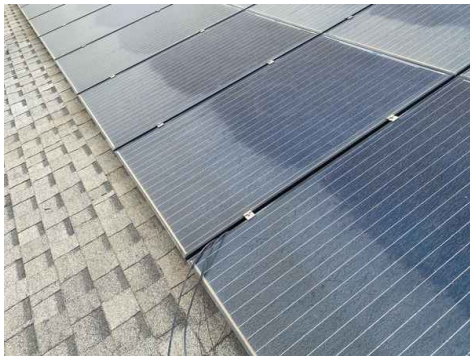
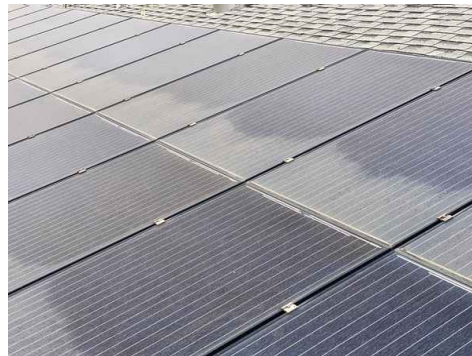
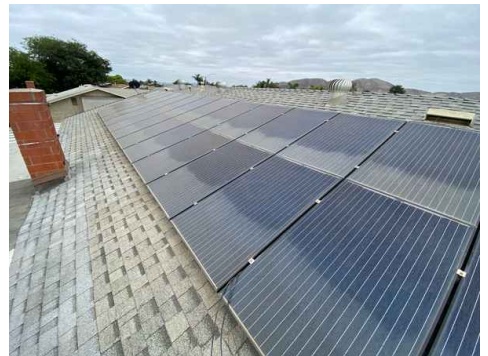
## 2.7.1 Solar Panels

**DIRTY NEEDS CLEANING**

Contact a qualified professional.

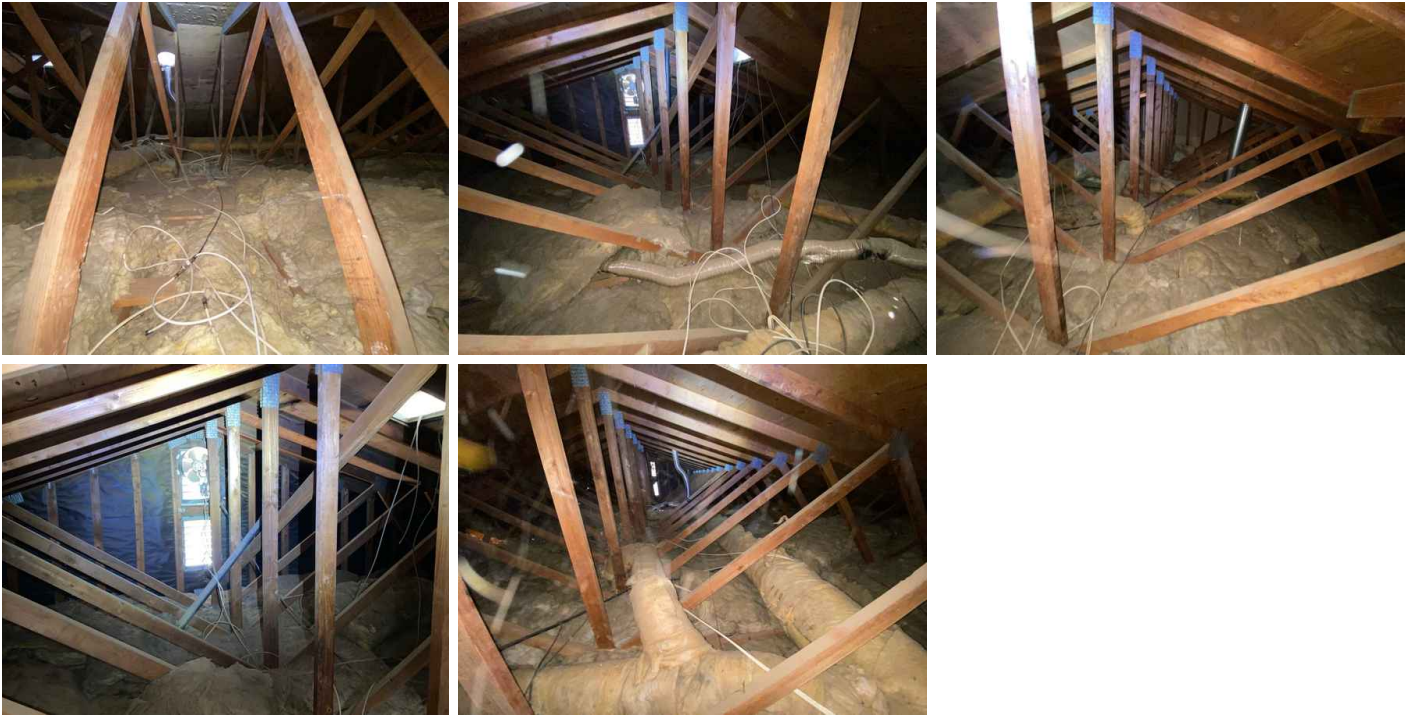
#### Attic Structure: Attic Truss Structure

Generally Satisfactory. Truss system appeared to be aligned and well constructed with no failures or missing pieces observed.

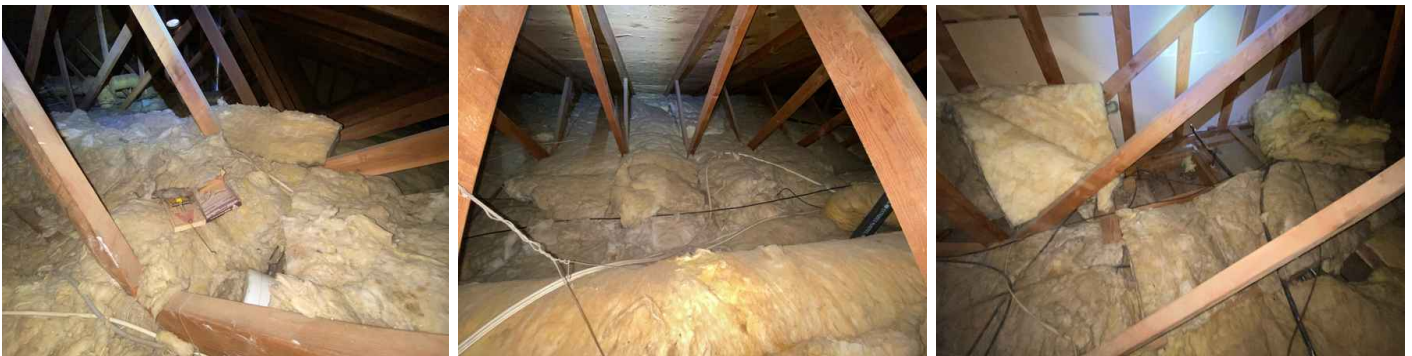
#### Attic Insulation: Insulation Type

Fiberglass Batt

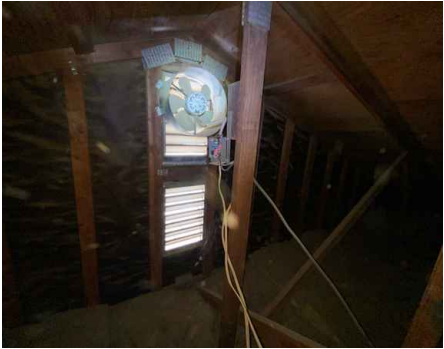
#### Attic Ventilation: Ventilation Type

Ridge Vents, Thermostatically Controlled Fan

Generally Satisfactory.

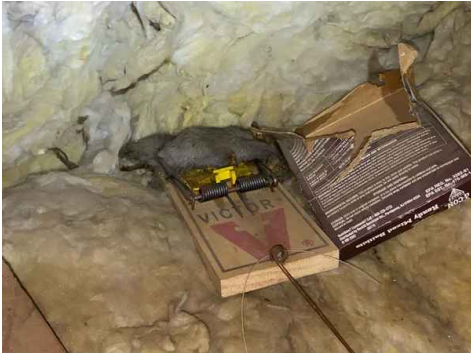
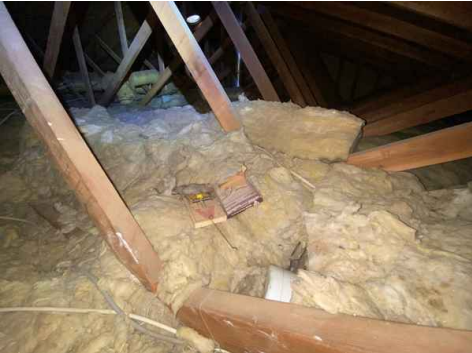
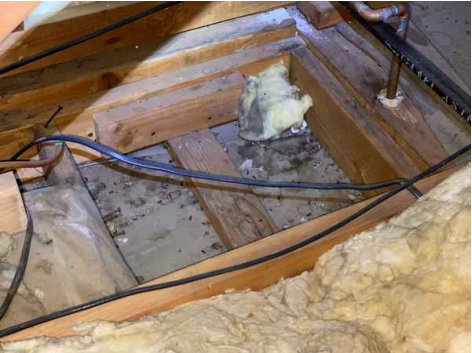
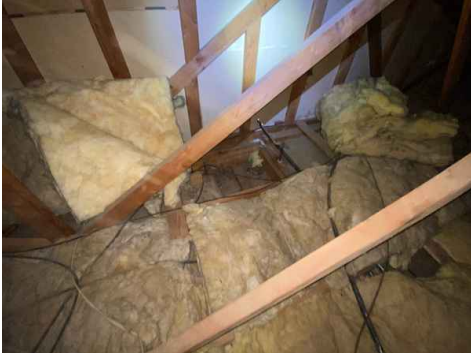
3.1.1 Attic Structure

RODENT ACTIVITY OBSERVED IN THE ATTIC

At the time of the inspection the attic showed signs of rodent intrusion. It is recommended to have a pest control company monitor rodent activity. Correction and cleaning is advised.

Recommendation  
Contact a qualified pest control specialist.

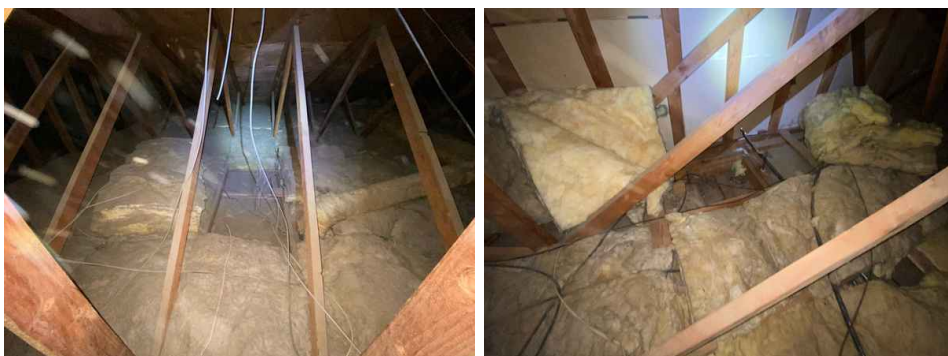
**DISPLACED OR MISSING INSULATION**

Insulation has been moved out of place for prior unrelated repairs and was not put back in place. Missing or displaced insulation can reduce your homes efficiency and lead to higher energy costs. Further evaluation and correction by an insulation professional is advised.

Contact a qualified insulation contractor.

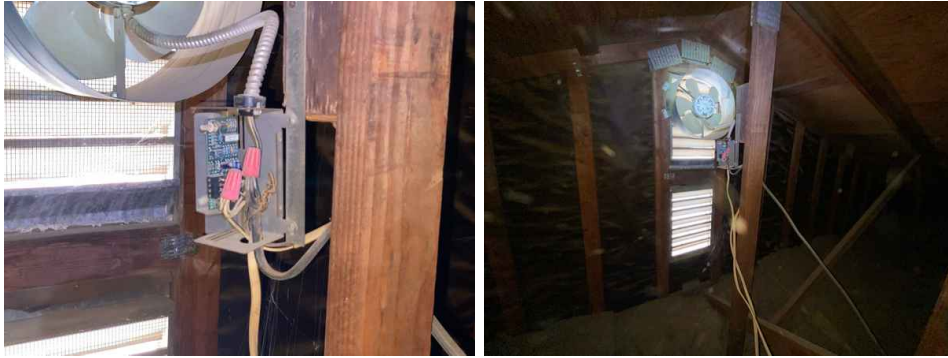
## 3.3.1 Attic Electrical Wiring

**OPEN JUNCTION BOX IN ATTIC**

At the time of inspection a junction box was missing the cover plate in the attic. All junction boxes need to have a cover plate installed correctly to prevent accidental electrocution. It is advised to install a cover plate on the open junction box.

Contact a handyman or DIY project

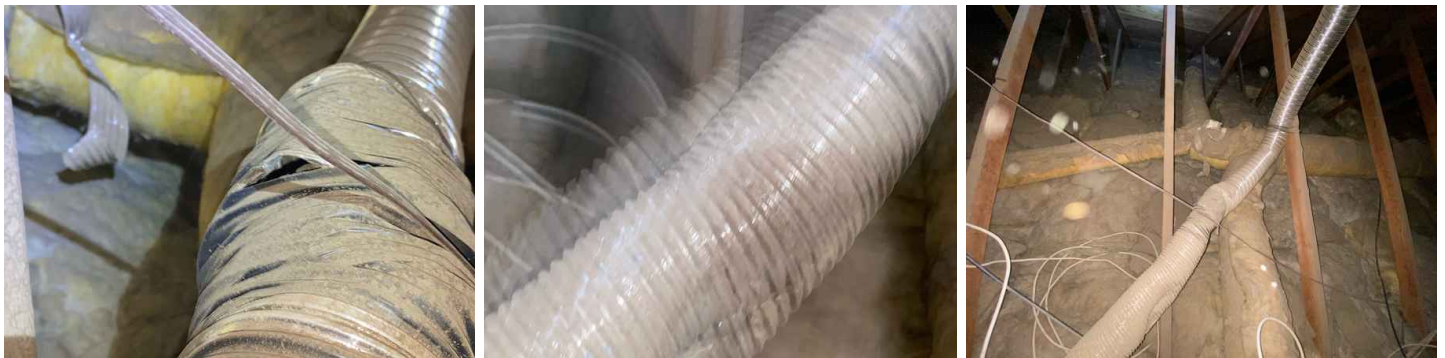
## 3.4.1 Attic Exhaust Systems

**DUCT DAMAGE**

At the time of the inspection the exhaust ducting or the bathroom or Laundry room in the Attic was damaged and in need of repair. Correction is advised

Contact a qualified professional.

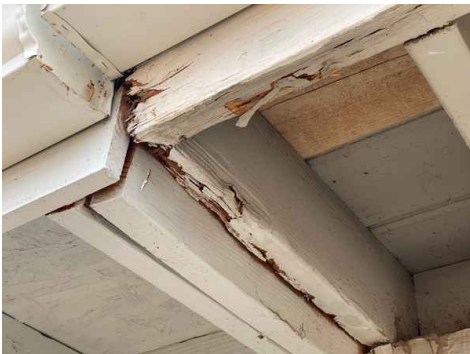
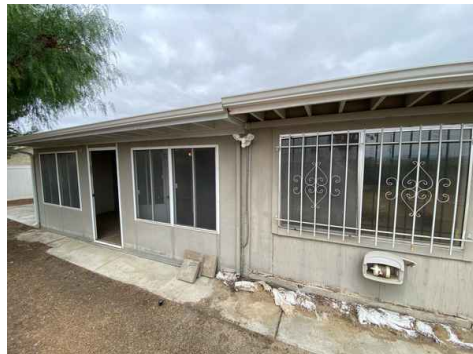
### 4.1.1 Eaves, Soffits & Fascia

#### **TERMITE DAMAGE/WOOD ROT AT EAVES**

Evidence of wood rot and or termite damage was present at time of inspection. Termites and WDO (Wood Destroying Organisms) can cause damage damage to house structures if left untreated. Further evaluation and treatment is advised.

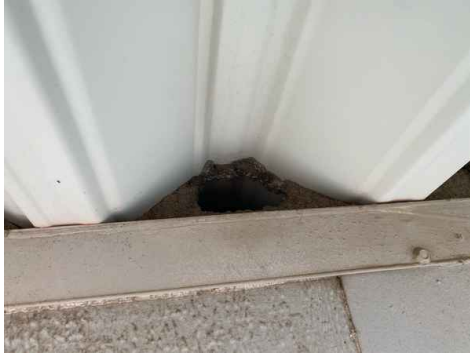
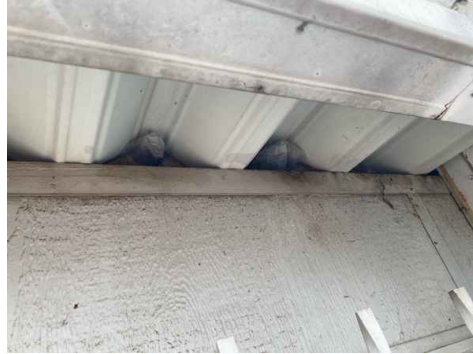
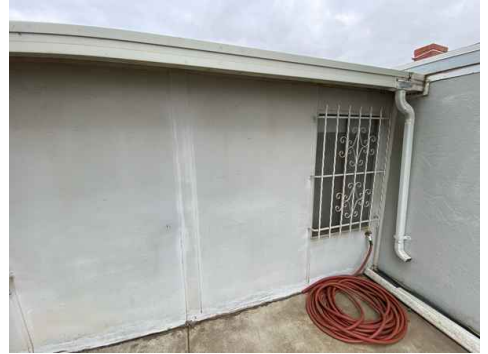
## 4.1.2 Eaves, Soffits &amp; Fascia

**FASCIA/SOFFIT GAPS AND VOIDS**

At the time of the inspection there were one or more openings, gaps or holes in fascia/soffit which should be repaired. This can allow water intrusion and rodent infestation as well as deterioration of the surrounding material. Correction is advised.

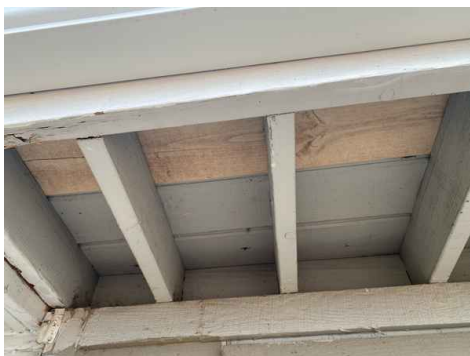
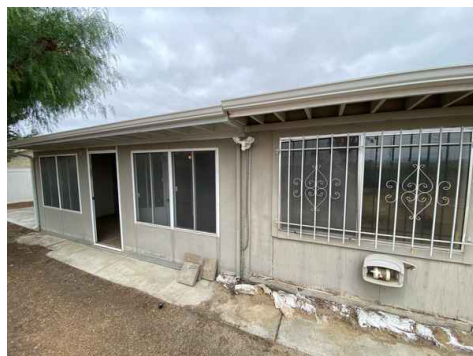
## 4.1.3 Eaves, Soffits &amp; Fascia

**UNPAINTED SECTION OF EAVES**

At the time of inspection there were one or more areas of the eaves with unpainted/unfinished wood. To prevent further deterioration, painting the exposed wood is advised.

Contact a qualified professional.

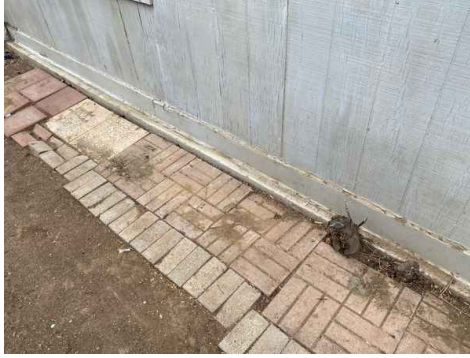
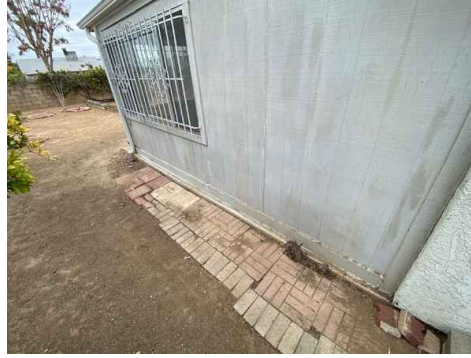
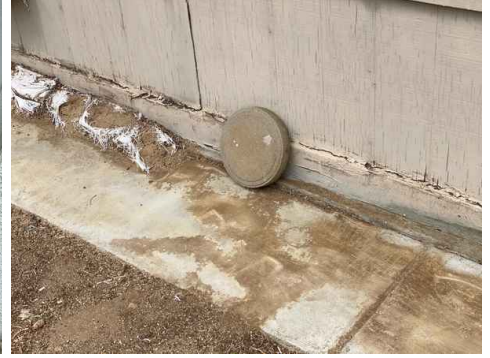
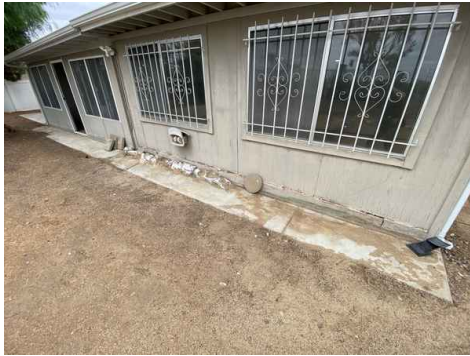
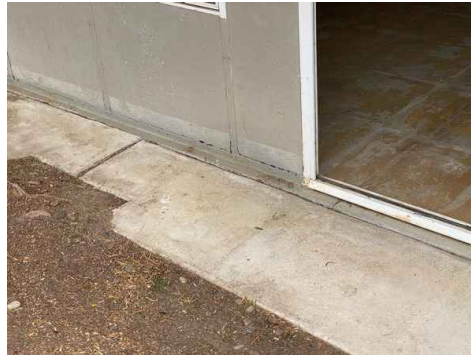
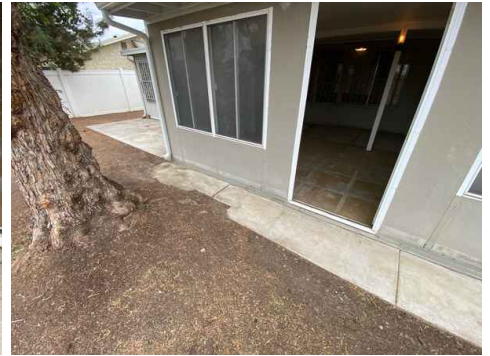
## 4.2.1 Siding, Flashing &amp; Trim

**GROUND CLEARANCE - SIDING AND OR STUCCO EXTENDS TOO CLOSE TO THE GROUND**

EAST

Inadequate clearance between siding and ground. Recommend a minimum ground clearance between bottom of siding and ground of 4". Siding in contact with the ground or soil is a serious concern because that condition can provide direct access for wood destroying insects.

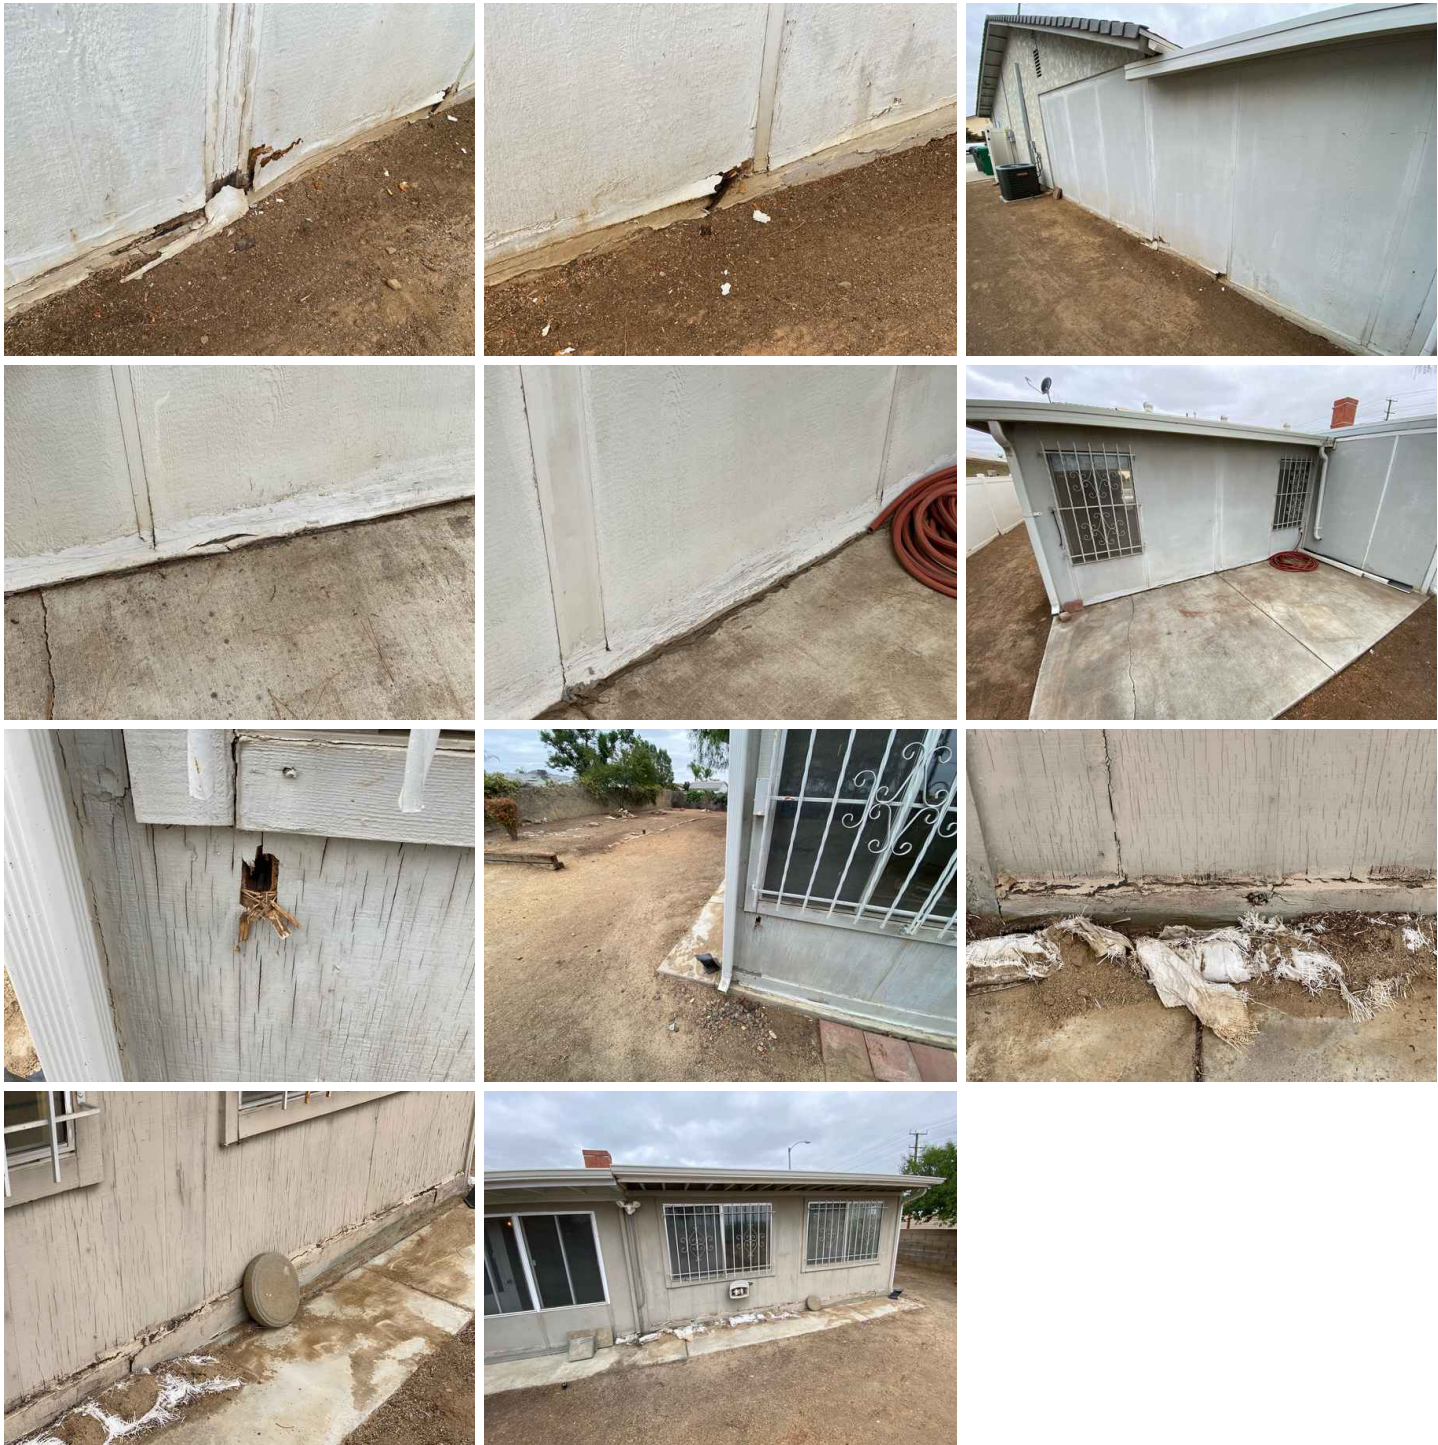
4.2.2 Siding, Flashing & Trim

**SIDING DAMAGE**

At the time of inspection one or more areas of the siding material was damaged. Correction is advised.

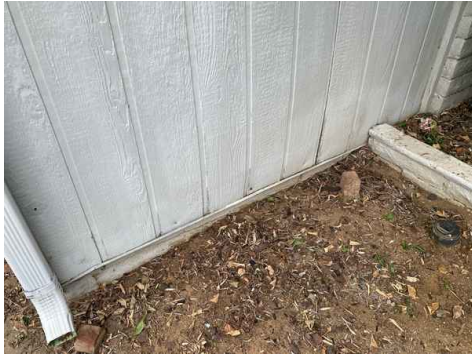
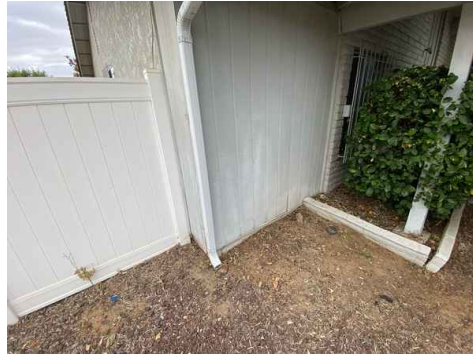
## 4.2.3 Siding, Flashing &amp; Trim

**SIDING DAMAGE 2**

At the time of inspection one or more areas of the siding material was damaged. Correction is advised.

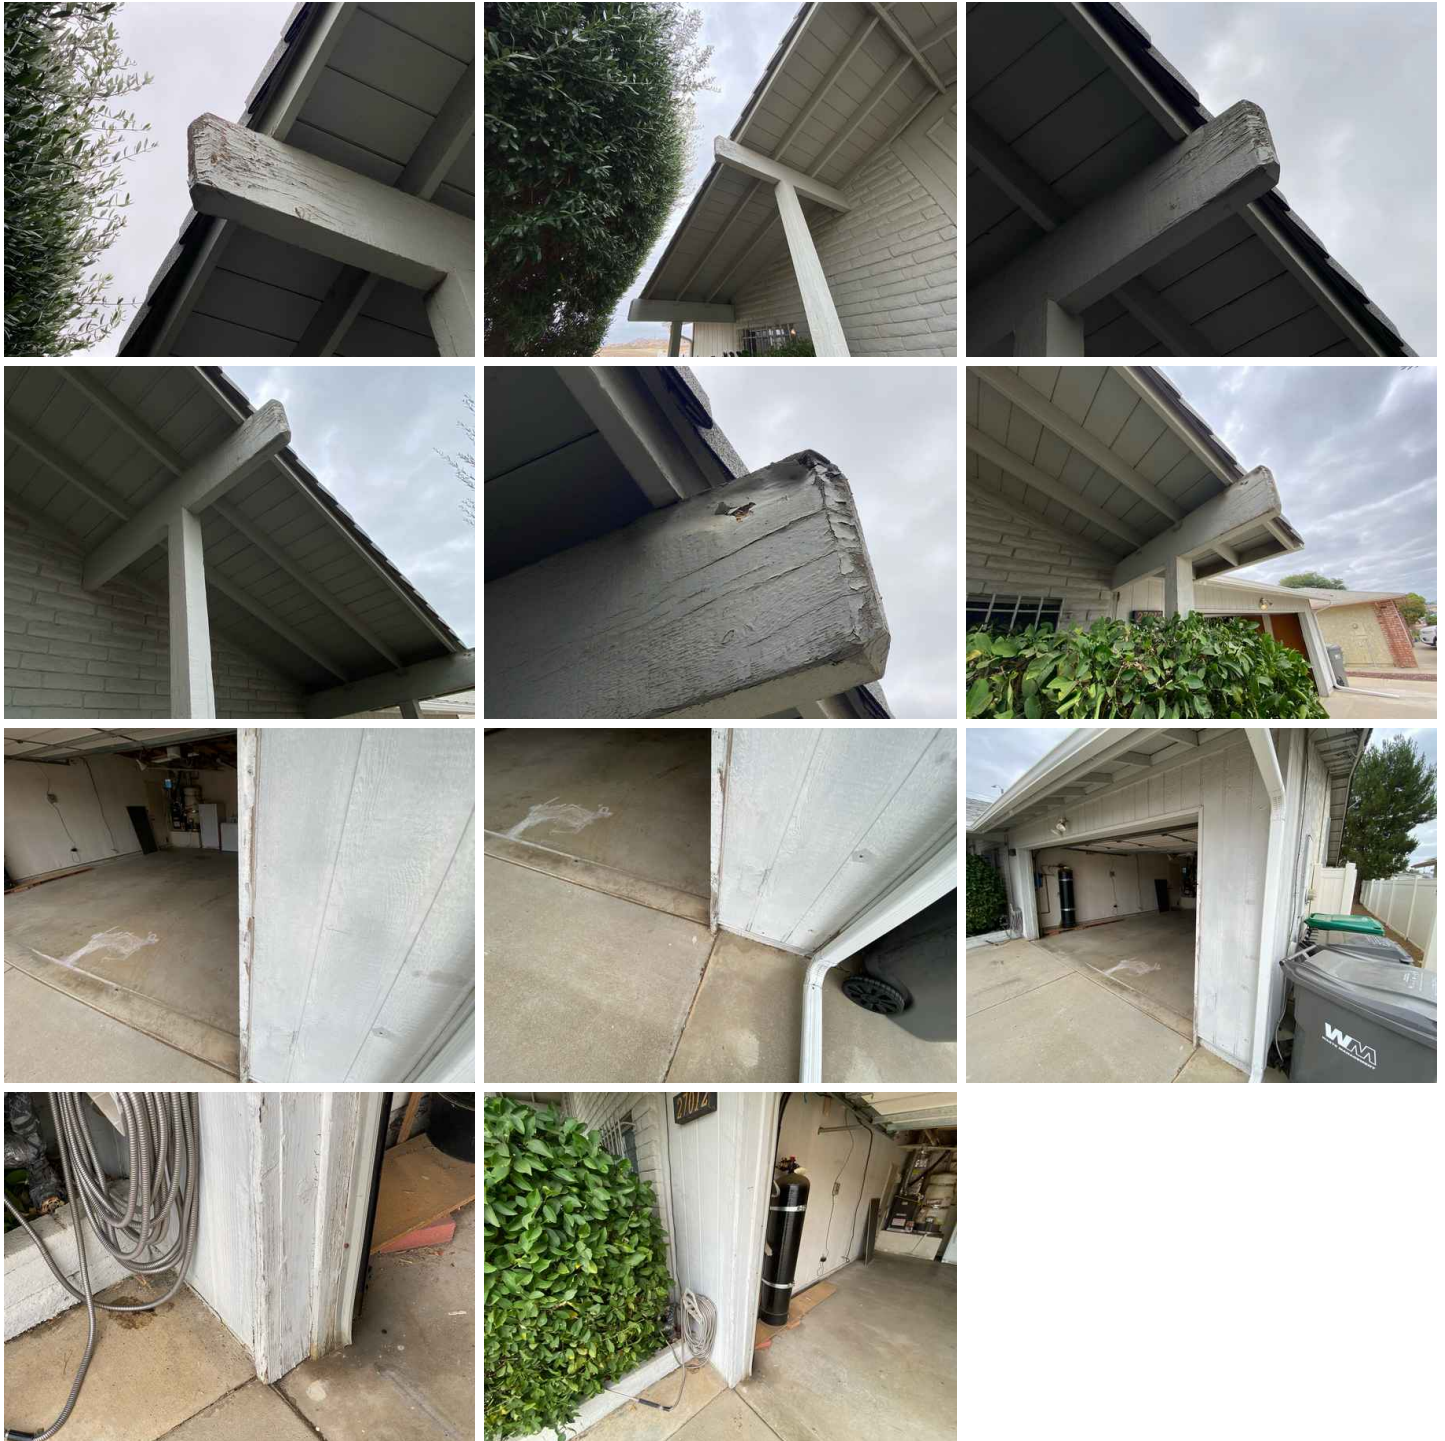
At the time of the inspection there were one or more areas of the of the exterior siding suffering from termite damage and or wood rot. It is advised to defer to the termite and wood report provided by the sellers.

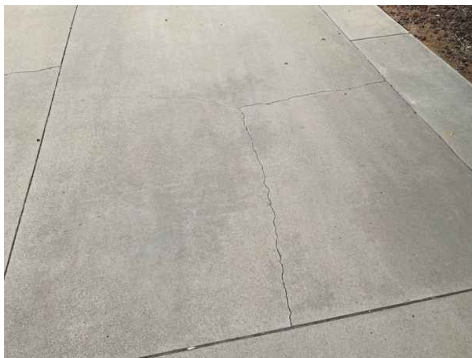
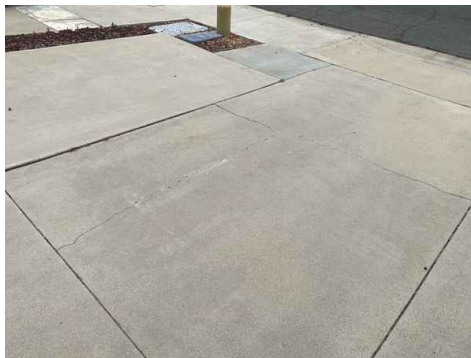
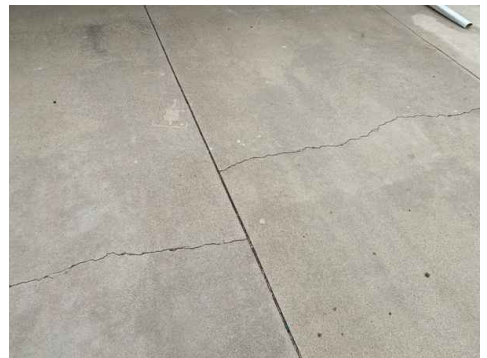
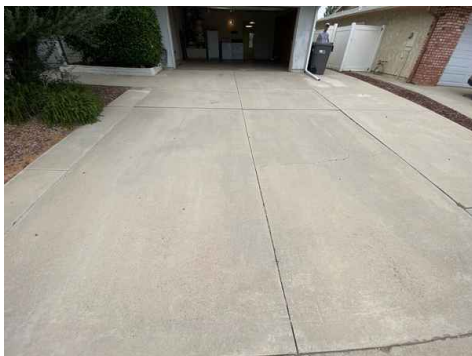
## 4.3.2 Driveway, Walkway, Pavers and Concrete

**MODERATE CRACKING - PATIO SURFACE**

At the time of the inspection there was moderate patio and walkway surface cracking observed. Correction is advised.

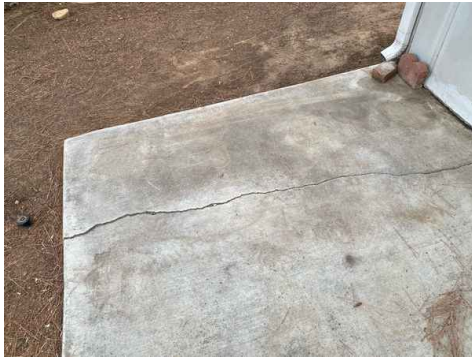
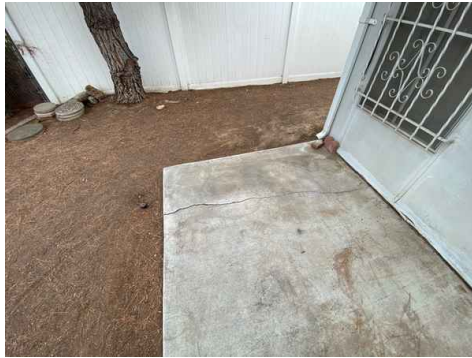
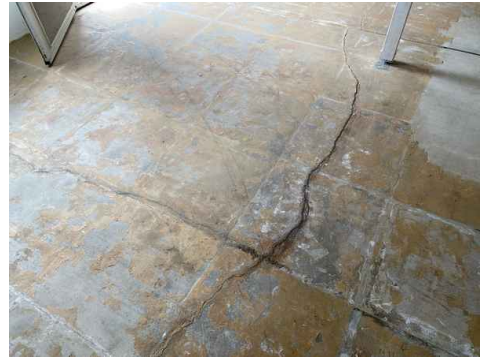
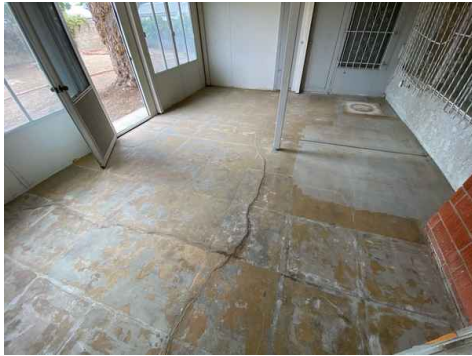
## 4.4.1 Vegetation, Grading, Drainage &amp; Retaining Walls

**DRAINAGE ISSUE**

At the time of the inspection there were one or more drainage issues noted on the property. Correction is advised

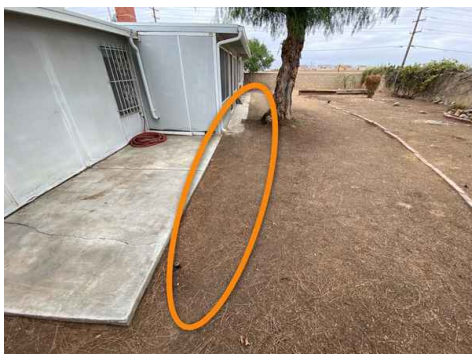
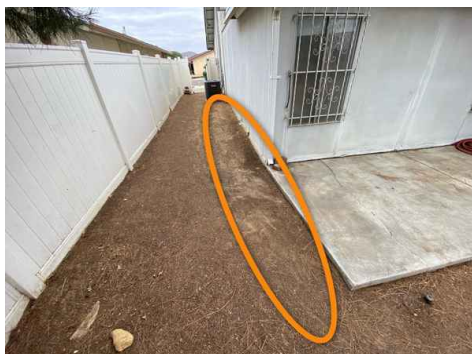
## 4.4.2 Vegetation, Grading, Drainage &amp; Retaining Walls

**PLANTER CURB CRACKED OR DAMAGED**

At the time of the inspection there were one or more areas of the planter boundary curb that were damaged or cracked from root intrusion.

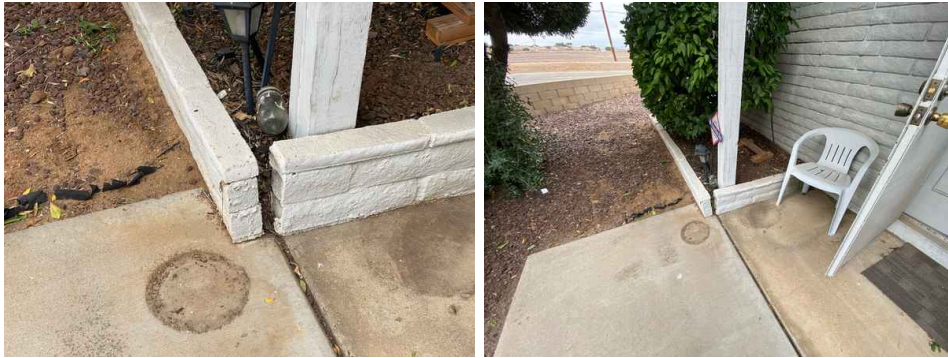
## 4.4.3 Vegetation, Grading, Drainage &amp; Retaining Walls

**SOIL AND OR LANDSCAPING MATERIAL GRADE IS TOO HIGH**

Soils, wood chips or other landscaping materials were installed at too high of an elevation and without the correct positive grade to facilitate drainage away from the foundation of the building. Soil against the weep screed at the bottom edge of the wall creates problems with the weep screed functioning as intended. It is strongly advised to remove soil in contact with the siding to create a 4" - 6" gap from the weep screed to the top of the finished grade. It is also strongly advised to create positive drainage away from the foundation. Further evaluation and correction by a Landscaping Professional is advised

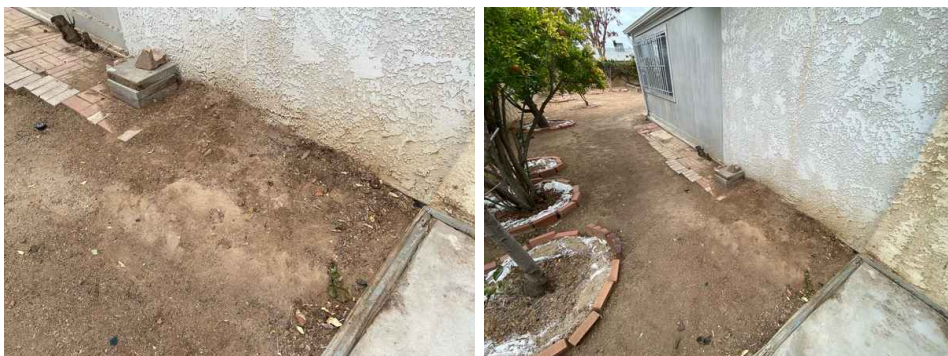
#### 4.4.4 Vegetation, Grading, Drainage & Retaining Walls

### LARGE TREE OR BUSH TOO CLOSE TO FOUNDATION

At the time of the inspection there were one ore more trees/large plants too close to the house foundation. Possible root intrusion could damage the foundation. Correction is advised.

Contact a qualified professional.

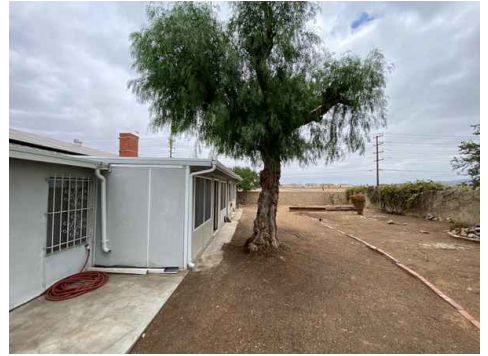
#### 4.5.1 Deck, Balcony, Patio & Exterior Steps

### DIRT IN CONTACT WITH SUPPORT POST

At the time of the inspection one or more of the deck support posts was in contact with soil or vegetation. Correction is advised to prevent deterioration.

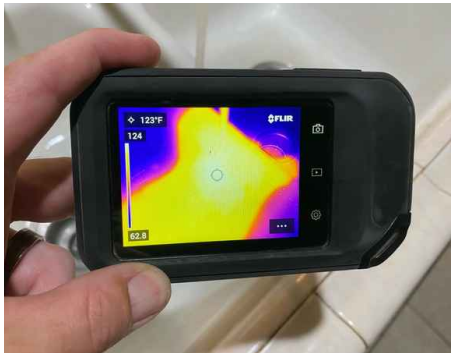
Water temperature recommendation between 120-130 degrees fahrenheit

120 or above to kill microbes  
130 or below to prevent scalding

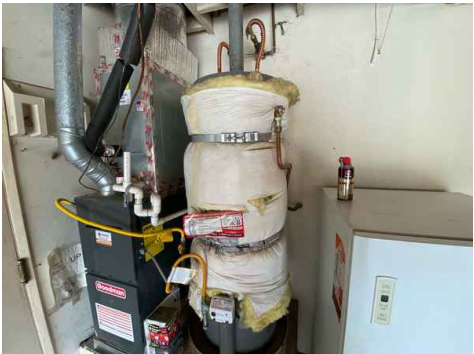
Water heater showed normal signs of wear and tear. Recommend monitoring it's effectiveness and replacing in the near future.

**Inspector Notes: Still functional but approaching end of average life due to age**

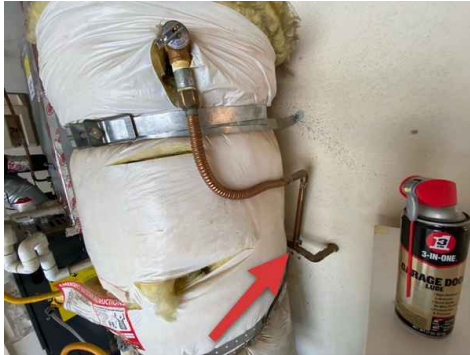
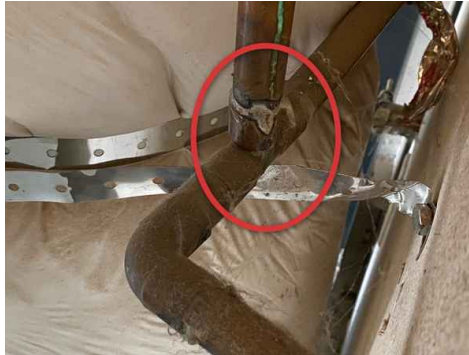
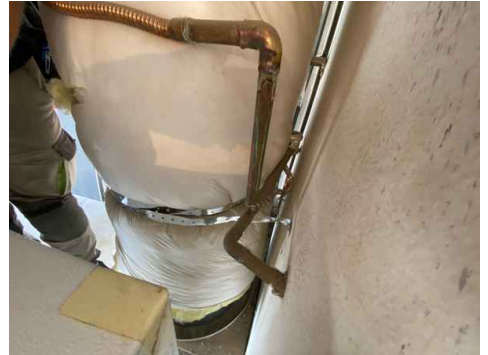
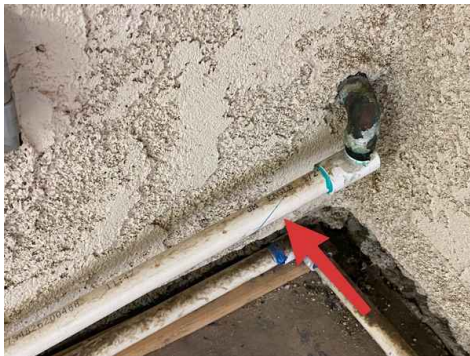
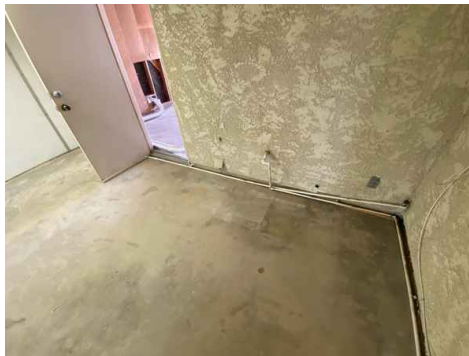
### 5.1.2 Water Heater

#### TPR VALVE NOT PROPERLY PLUMBED TO DISCHARGE PIPE

Major Concern - Safety Hazard

**Inspector Notes: TPR drain line is shared with the AC condensation drain line & improper TPR drain line material (PVC) was used to extend the drain line.**

Contact a qualified plumbing contractor.

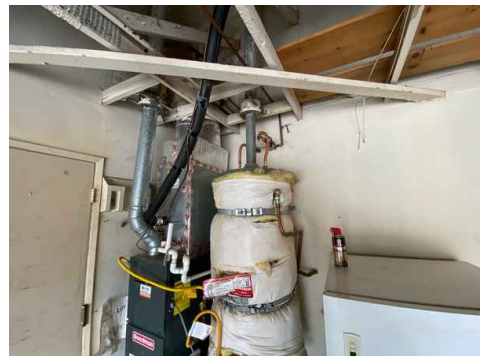
#### 5.1.3 Water Heater

### MISSING EXPANSION TANK

At the time of the inspection there was no expansion tank present. Expansion tanks allow for the thermal expansion of water in the pipes. These are required in certain areas for new installs. Recommend a qualified plumber evaluate and install.

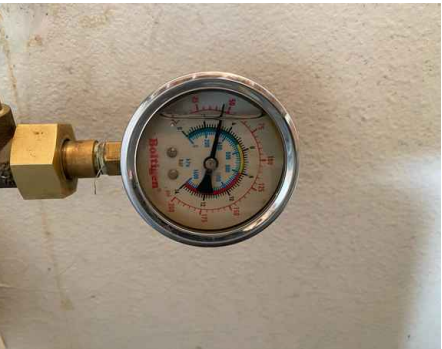
45 PSI

The recommended water pressure is between 40-80 PSI

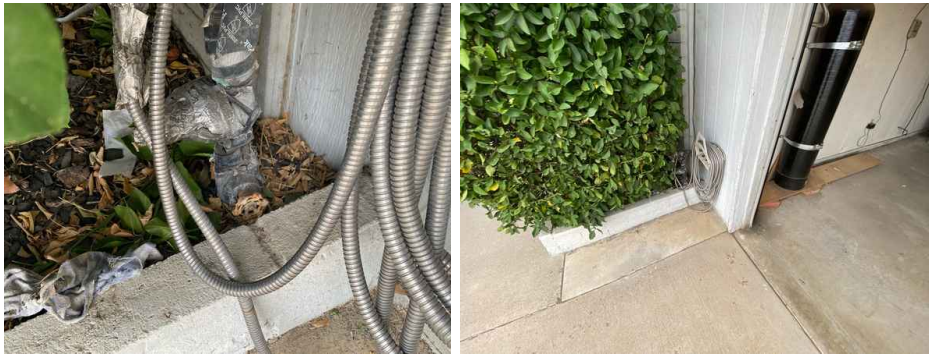
### House Water Shutoff Valve

West

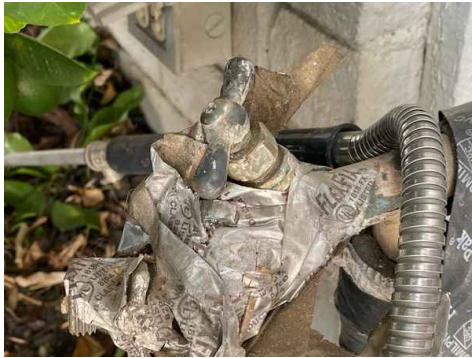
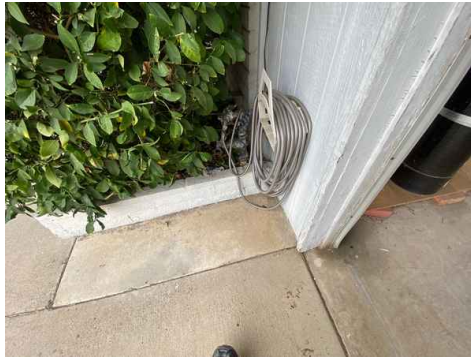
**HOSE SPIGOT LEAKS WHEN ON**

At the time of the inspection one or more of the hose spigots leaked at the handle area when in the on position. Correction is advised.

Recommendation

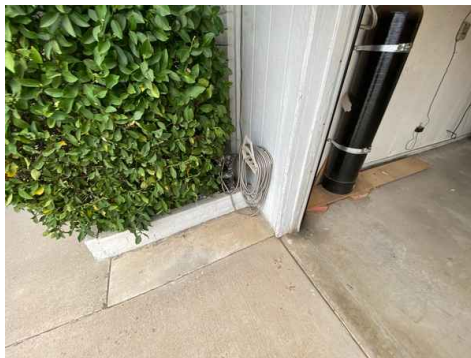
**OLD GATE VALVE PRESENT**

An old gate valve was observed in the water supply distribution system. Gate valves are prone to corrosion and deterioration over time, which can lead to leaks, reduced water flow, or complete failure. Consider having a plumbing contractor evaluate the valve's condition and replace it if it shows signs of age-related wear or malfunction.

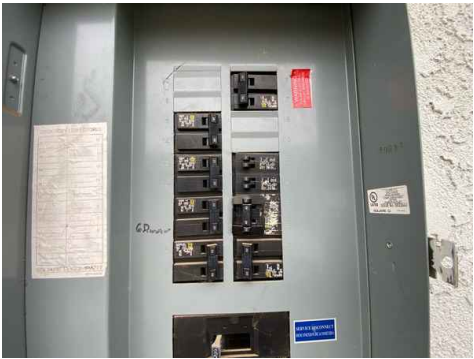
MISSING/INACCURATE LABELS ON PANEL

At the time of inspection, panel was missing appropriate circuit labeling or labeling was inaccurate. Recommend a qualified electrician identify circuit locations.

Inspector Notes: Only partially labeled.

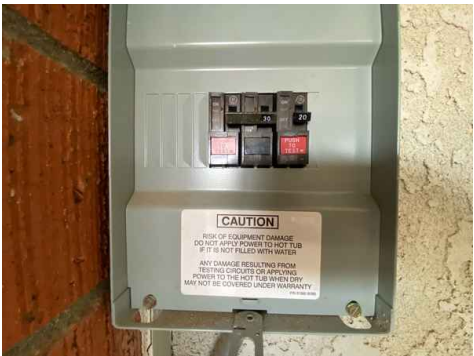
MISSING/INACCURATE  
LABELS ON PANEL

At the time of inspection, panel was missing appropriate circuit labeling or labeling was inaccurate. Recommend a qualified electrician identify circuit locations.

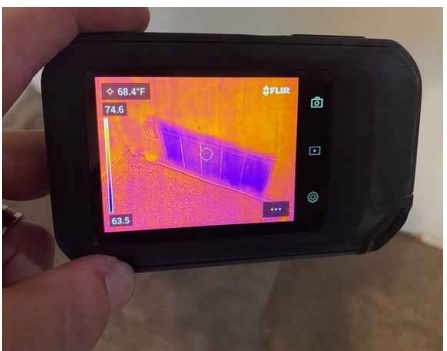
### HVAC Ducting & Registers: Return Air Temps - A/C

At the time of the inspection the AC unit was cycled on and brought to operating temperature. The temperature splits were tested by measuring the temperature of the distribution air and checking the difference from the return air to determine the temperature splits. Temperature splits are a good indicator of how well the AC system is performing. Depending on the humidity of a given day an acceptable temperature split difference could be between 12-20 degrees fahrenheit.

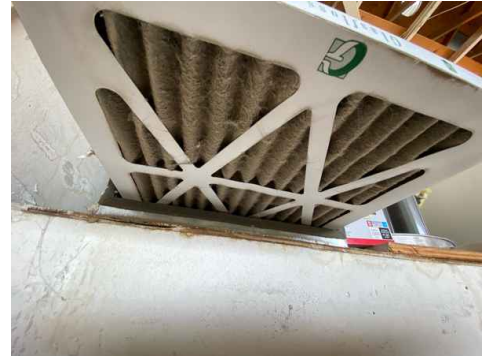
At the time of the inspection there were one or more furnace filter that were dirty and in need of replacement/cleaning. Correction is advised.

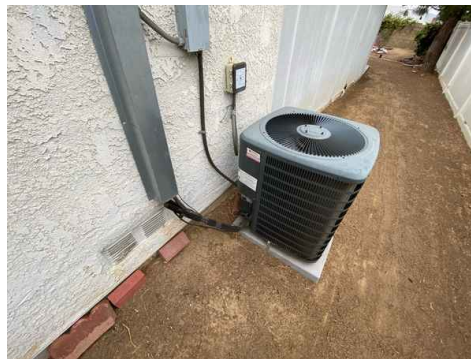
#### **LINESET INSULATION DAMAGE**

Lineset insulation damage or deterioration noted at time of inspection. Exposed refrigerant lines can cause energy loss and excessive condensation. Further evaluation and repair by a qualified professional is advised.

Contact a qualified professional.
