# CAL-WEST PROPERTY INSPECTIONS

## CAL-WEST PROPERTY INSPECTIONS HOME MAINTENANCE REPORT

27012 Bottlebrush Ln  
Menifee, CA 92586

06/30/2026

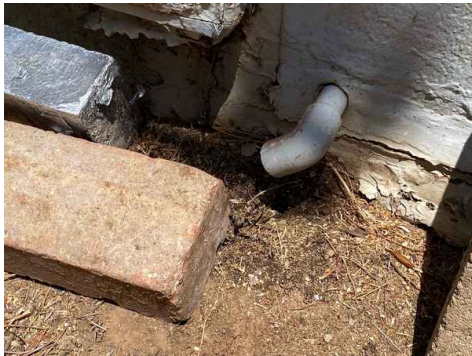
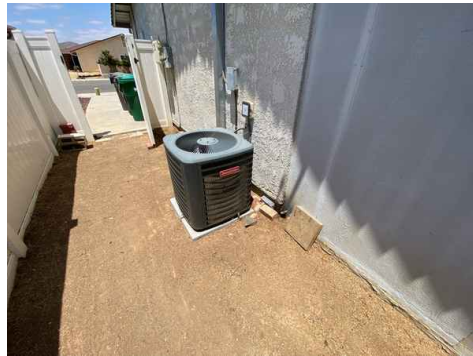
**CONDENSATE DRAINLINE EXIT BY FOUNDATION**

At the time of the inspection the condensate drain line drained next to the foundation of the building. It is advised to avoid having condensate drain lines drain directly to the soil next to the foundation of the building. If possible it is advised to install a landscape drain line to receive the water from the condensation of the AC unit and carry the water away from the foundation to an appropriate discharge area.

**Inspector Notes: Primary condensate drainline drains next to foundation**

Contact a qualified professional.

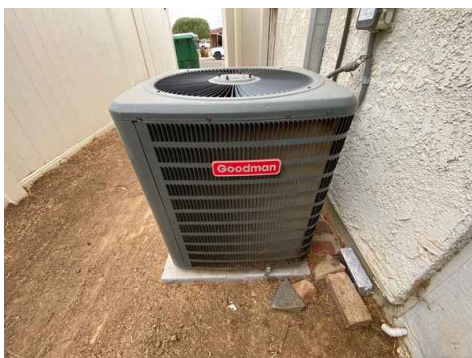
**REGULAR HVAC SERVICE/TUNE UP ADVISED**

**Inspector Notes: AC unit & furnace functional, due to age recommend tuneup/service.**

Contact a qualified HVAC professional.

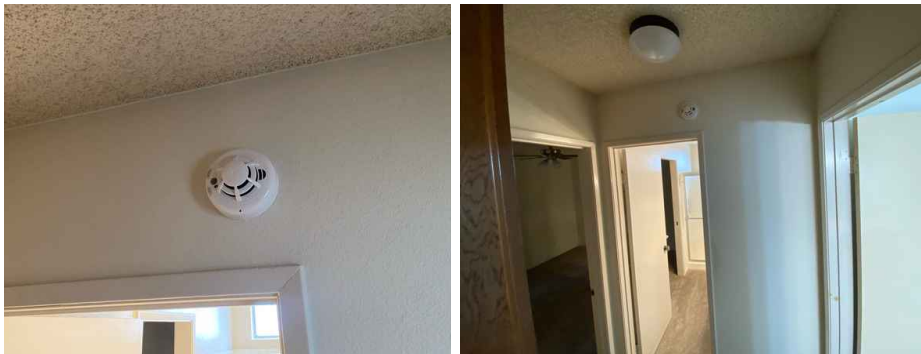
##### **INCORRECT - Missing Or Incorrect Smoke and Carbon Monoxide Alarm Location**

At the time of the inspection one or more smoke and or carbon monoxide detectors were not present at the appropriate locations within the common areas of the building.

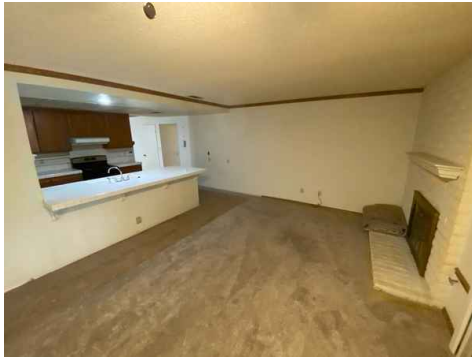
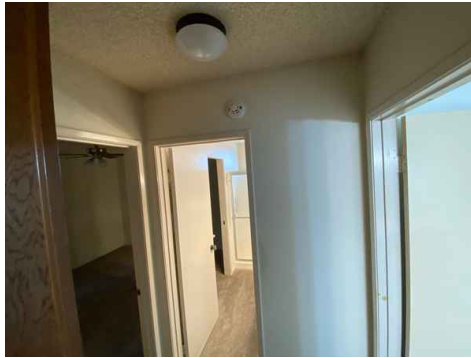
**SMOKE AND CO DETECTOR MISSING**

At the time of inspection one or more smoke detectors and carbon monoxide detectors were missing at the required locations.

Current CA residential building codes state that smoke detectors must be installed near the kitchen, any room with a fireplace, all sleeping rooms, and hallways leading to sleeping rooms. CO detectors must be installed on each level of the property, a 15 feet maximum distance from each and all fuel burning appliances and also any hallway leading to sleeping rooms.

**Inspector Notes: Missing smoke & carbon monoxide detectors in family room & missing carbon monoxide detector in hallway.**

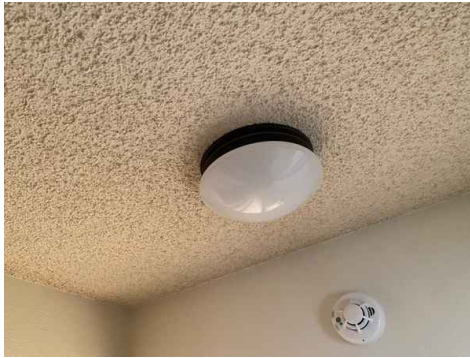
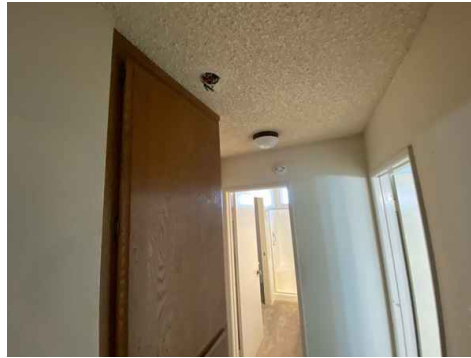
**LIGHT BULB BURNED OUT**

At the time of the inspection one or more light bulbs were burned out and in need of replacement. Correction is advised.

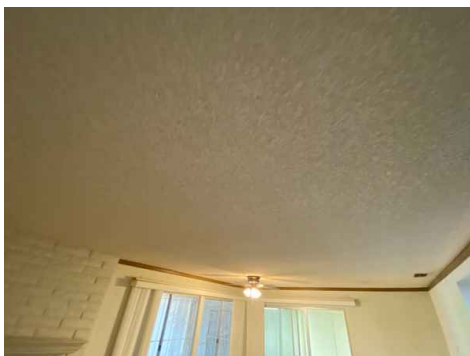
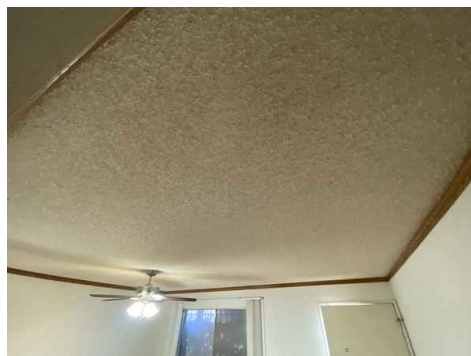
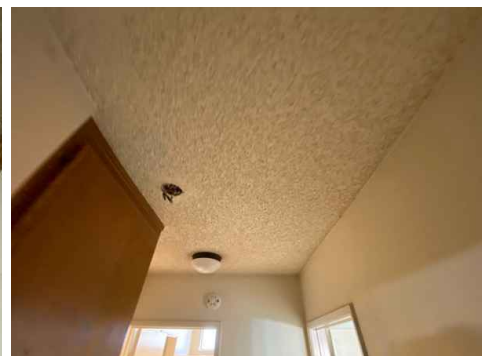
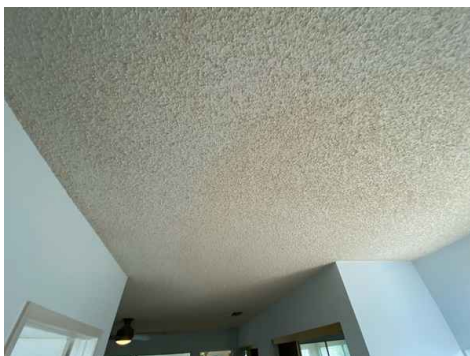
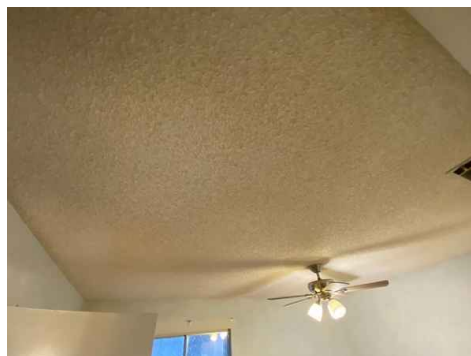
At the time of the inspection there were one or more rooms with popcorn texture material present. Asbestos was a common building product used in popcorn textures and found in materials up through the the early 80's.

Recommendation

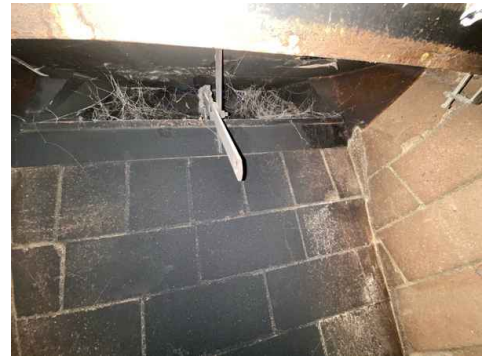
**DAMPER CLAMP MISSING**

*Check out this helpful article on damper clamps at the web link below.*

## Recommendation

Contact a qualified professional.

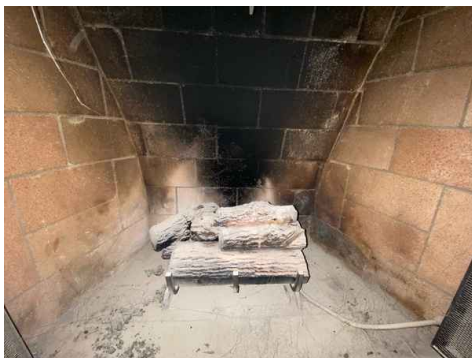
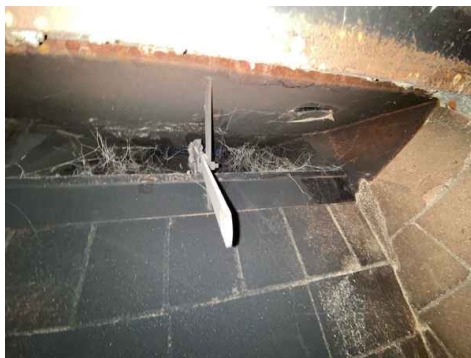
Fireplace chimneys should be regularly serviced considering the risks associated with damaged and or poor performing chimney structures. Regular cleaning is advised depending on use. Most Southern Californian occupants don't use their fireplace enough to regularly clean and or service them so often times they end up dirty and in need of cleaning for the new owners. Since it's not possible to know the true condition of the chimney by visually looking up through the firebox, it is advised to have a cleaning and Level 2 chimney inspection performed prior to use.

## Recommendation

Contact a qualified professional.

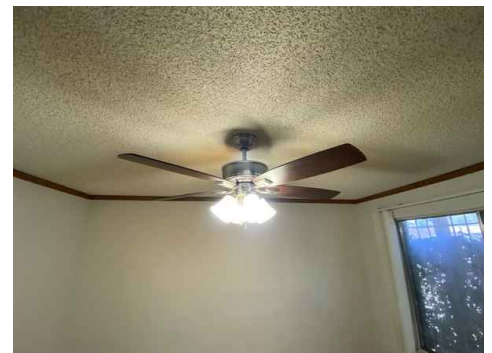
At the time of inspection the fan was not operable with the switch in the room. Further Evaluation and repair is advised

Recommendation

Contact a qualified professional.

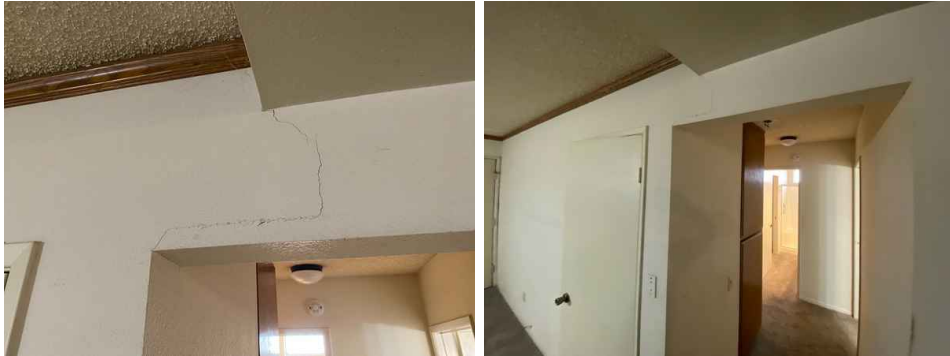
## 11.9.1 Walls

**SETTLEMENT CRACKING/SEPERATION**

At the time of the inspection there were one or more areas of the interior walls suffering from cracks and or separation due to minor to moderate settlement. Correction and repair is advised.

## Recommendation

Contact a qualified professional.

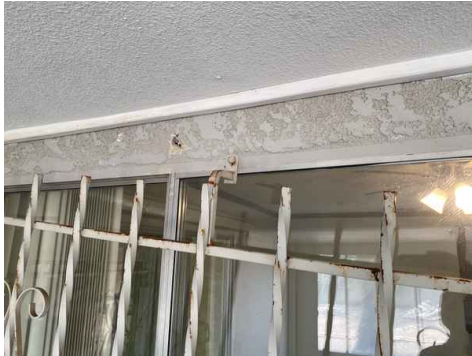
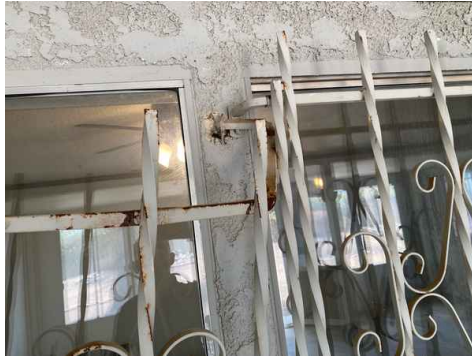
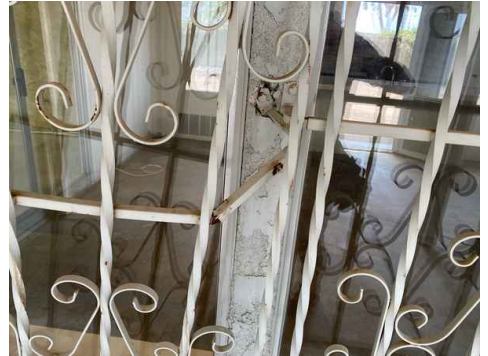
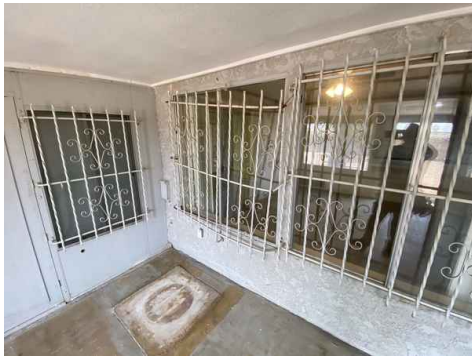
**DAMAGED WINDOW SECURITY BARS**

Damaged security bars were observed on the window during inspection. Compromised security bars reduce the protective function of the window and may create safety concerns. A qualified professional should evaluate and repair or replace the damaged bars to restore proper security and functionality.

## Recommendation

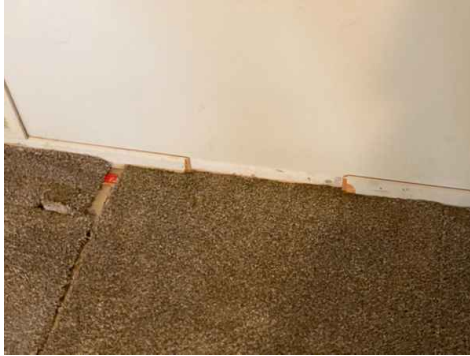
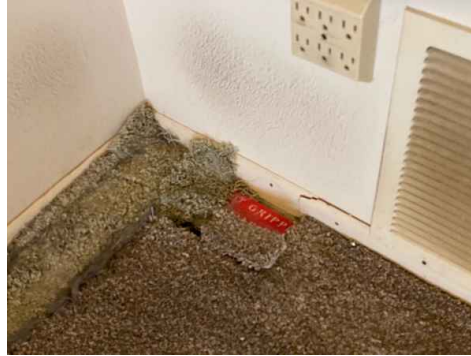
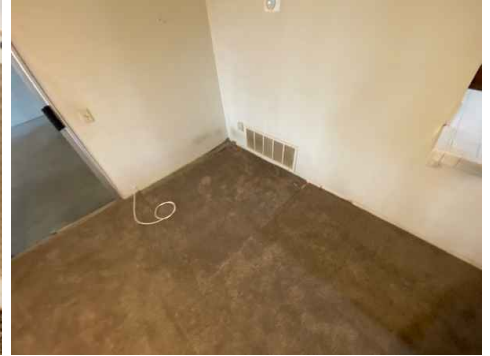
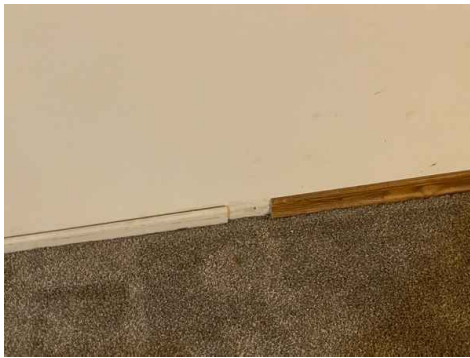
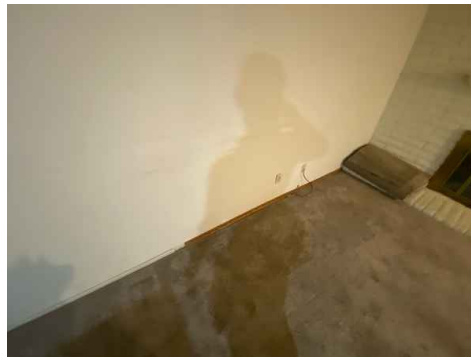
## 12.8.1 Floors

**BASEBOARD DAMAGE**

At the time of the inspection the baseboard was damaged in one or more areas and in need of correction.

## Recommendation

Contact a qualified professional.

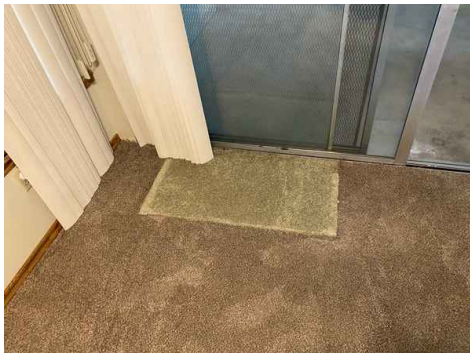
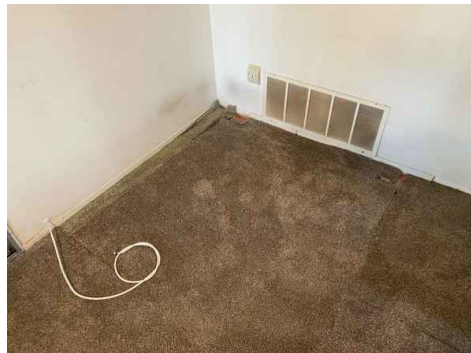
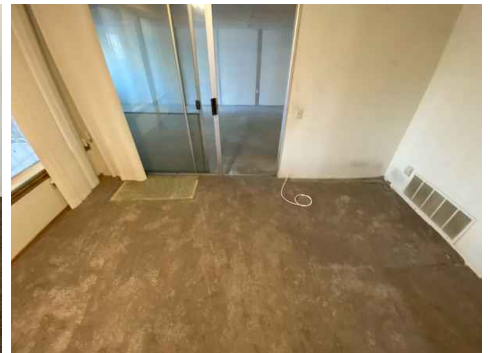
## 12.8.2 Floors

**DAMAGED CARPET**

At the time of the inspection there were one or more areas of the carpet suffering from minor to moderate damage. Correction is advised.

## Recommendation

Contact a qualified flooring contractor

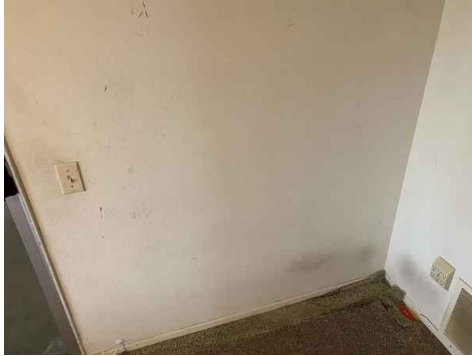
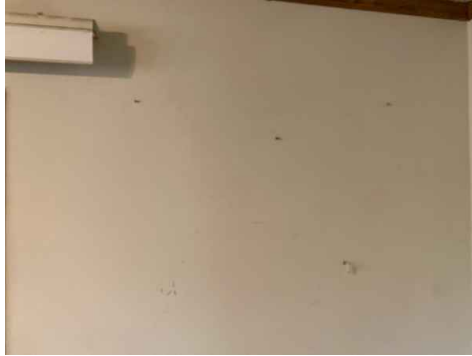
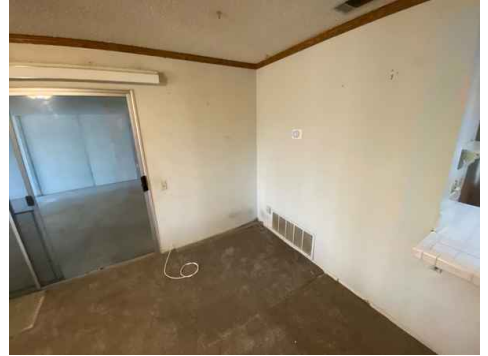
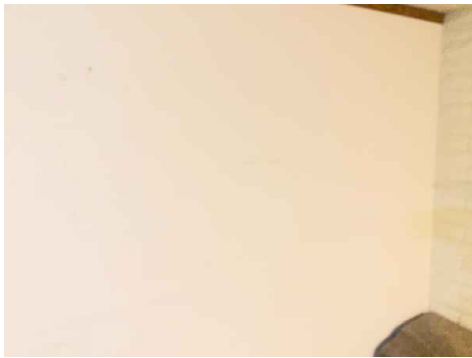
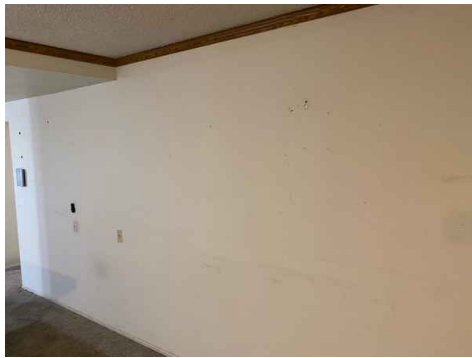
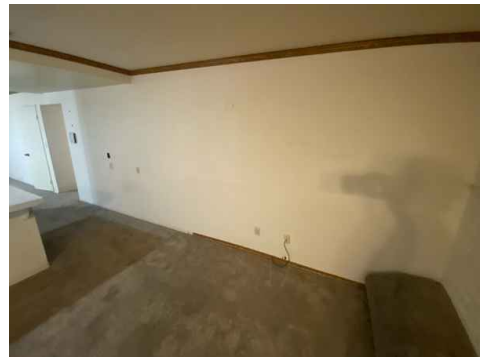
## 12.9.1 Walls

**COSMETIC BLEMISHES, DINGS OR STAINS**

At the time of the inspection there were one or more cosmetic blemishes and or stains that affected the aesthetics of the walls. Correction is advised.

Recommendation

Contact a qualified professional.

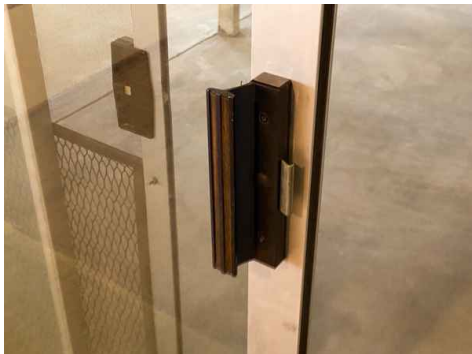
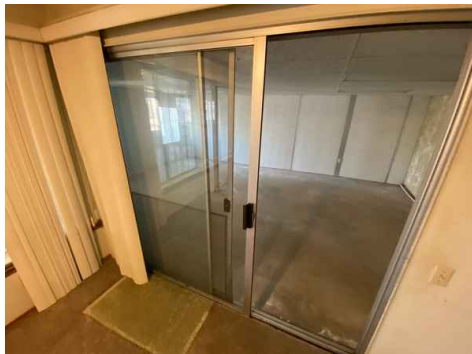
## 12.12.1 Exterior Doors

**LOOSE HARDWARE**

At the time of inspection the hardware for the door was loose and needed adjustment. Correction is advised

Recommendation

Contact a qualified professional.

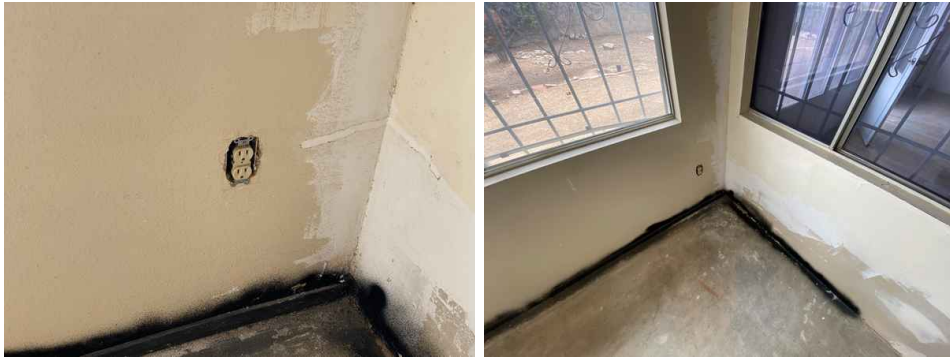
### 13.3.1 Lighting Fixtures, Switches & Receptacles

At the time of the inspection one or more receptacles were missing the appropriate cover plate. Recommend installation of cover plates to prevent accidental electrocution and or damage to the receptacle or light switch. Correction is advised.

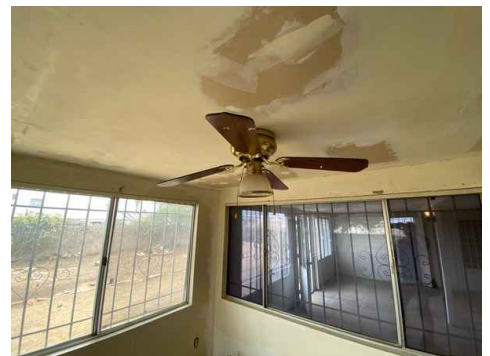
At the time of inspection the fan was not operable with the switch in the room. Further Evaluation and repair is advised

#### Recommendation

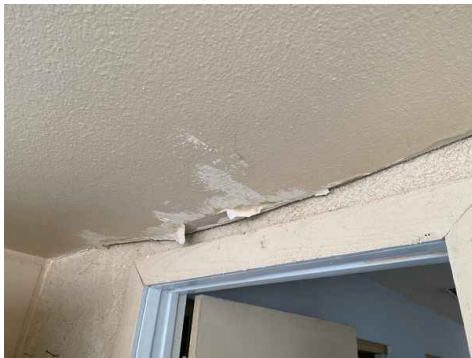
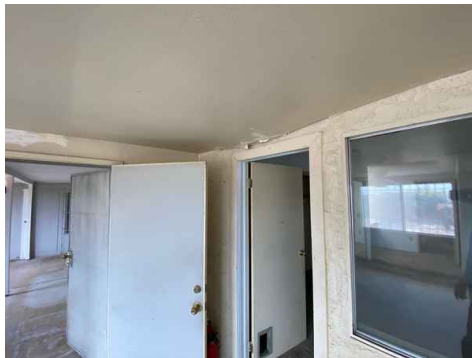
## 13.7.2 Ceilings

**PREVIOUS REPAIR**

At the time of the inspection there were one or more areas of the ceiling with evidence of previous repairs. Repairs could have been due to a roof leak. It is advised to ask the seller for disclosures about previous repairs to the roof and if a licensed roofing contractor performed them. If repairs were not performed it is advised to have a roofing contractor further evaluate to determine if the leak is active.

Contact a qualified professional.

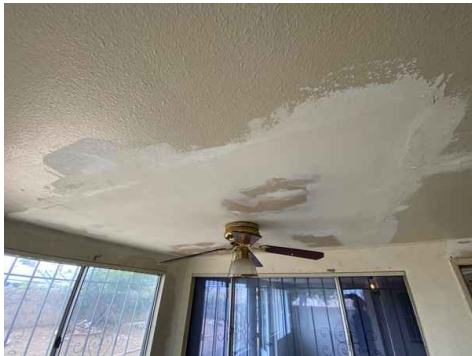
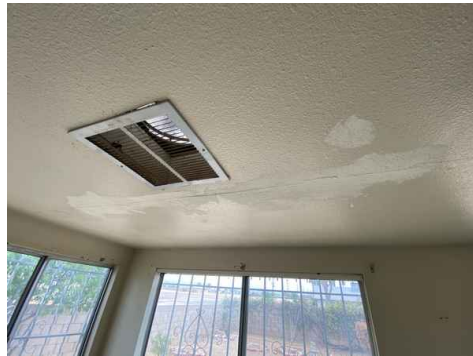
## 13.7.3 Ceilings

**DROP CEILING DAMAGE**

Damage observed on the drop ceiling during inspection. Assess the extent of damage and determine if tiles need replacement or if structural support is compromised.

Contact a qualified professional.

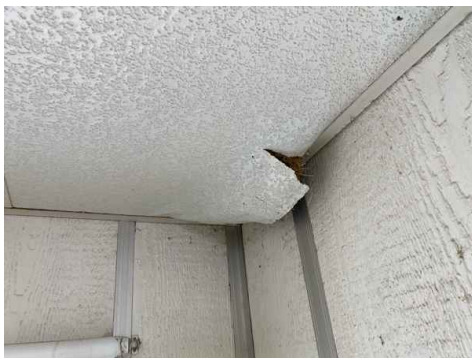
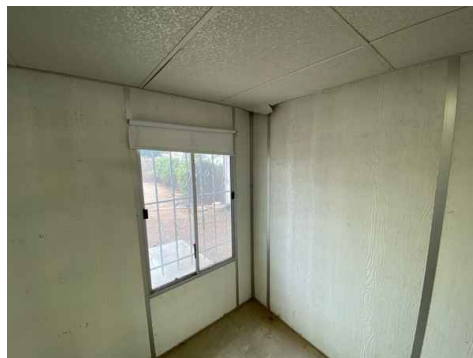
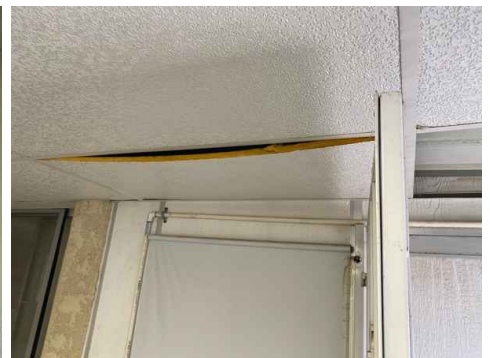
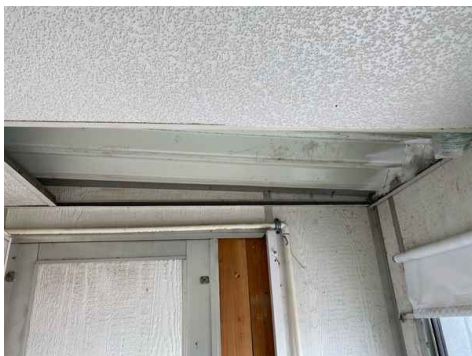
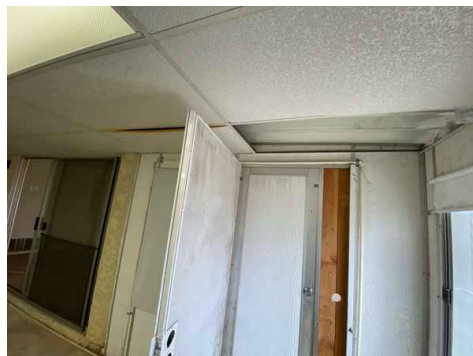
## 13.9.1 Walls

**WALL DAMAGE**

At the time of inspection one or more area of wall were damaged and in need of repair. Correction is advised.

Contact a qualified professional.

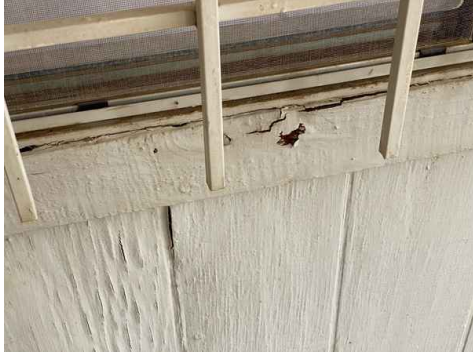
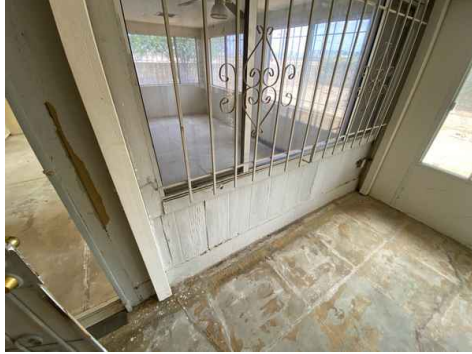
## 13.9.2 Walls

**WATER DAMAGE/WATER INTRUSION**

At the time of the inspection there was evidence of an active water intrusion causing damage to the wall material. Correction is advised.

**Inspector Notes: Moisture levels were not elevated at the time of inspection.**

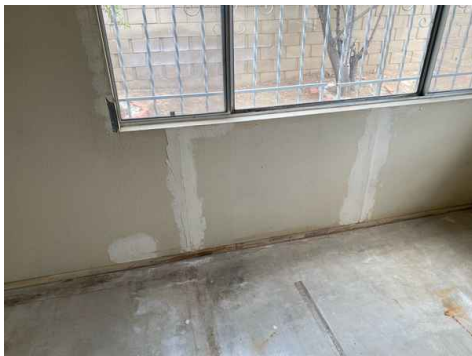
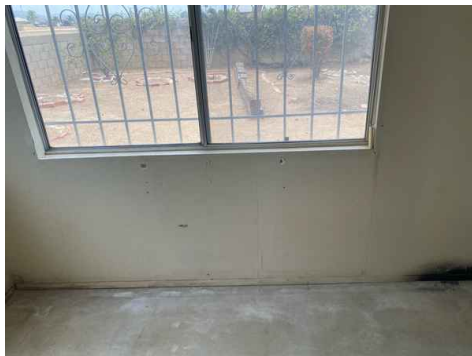
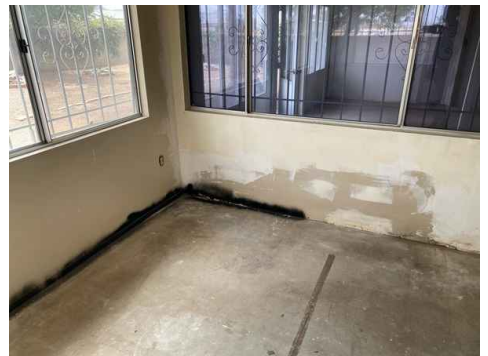
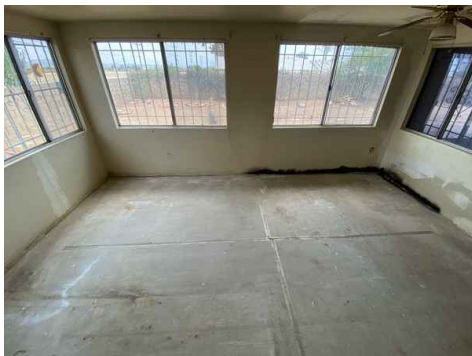
## 13.9.4 Walls

**COSMETIC BLEMISHES, DINGS OR STAINS**

At the time of the inspection there were one or more cosmetic blemishes and or stains that affected the aesthetics of the walls. Correction is advised.

Contact a qualified professional.

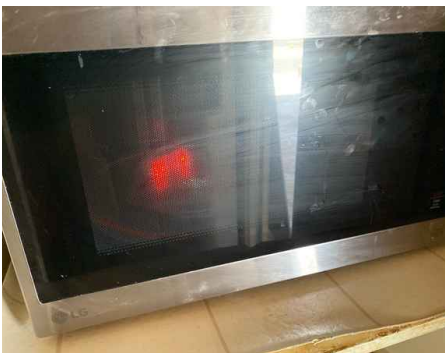
### Microwave: Microwave Function Test - Pass

At the time of the inspection the microwave was tested to confirm its operation. This picture represents the testing tool confirming proper operation of the microwave.

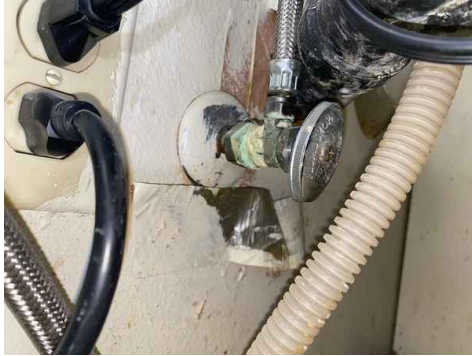
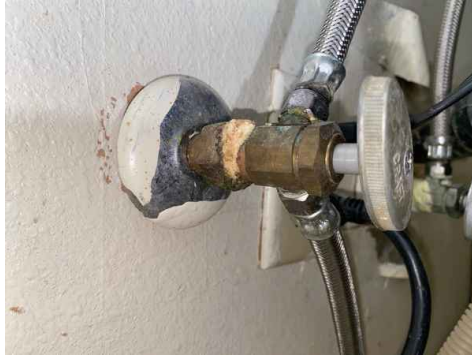
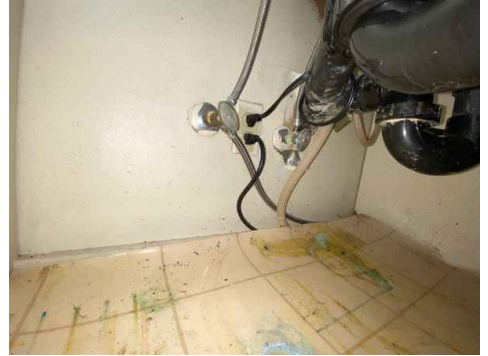
## 14.1.2 Kitchen Sink

**PLUMBERS PUTTY PRESENT**

At the time of the inspection there was plumbers putty present on the drain lines under the sink at one or more locations. Plumbers Putty usually indicates that a minor leak was present at one time or work was performed by a non professional.

It is advised to remove the plumbers Putty and have a licensed plumber make any necessary corrections or repairs.

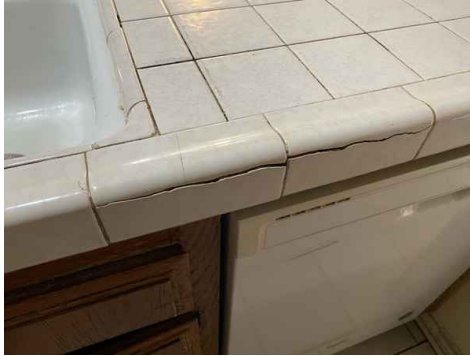
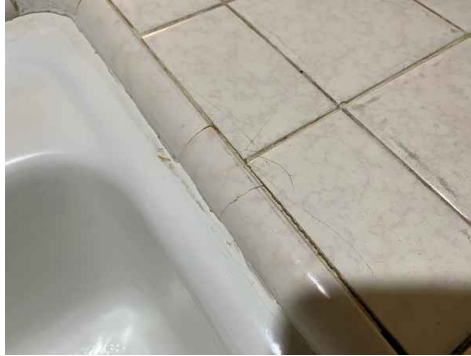
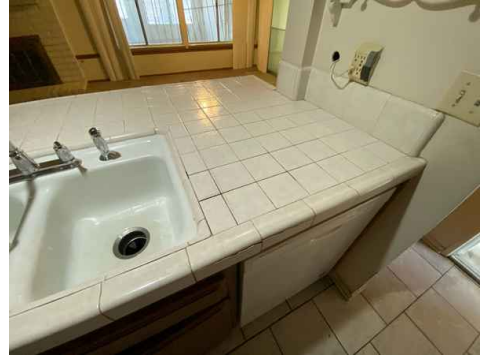
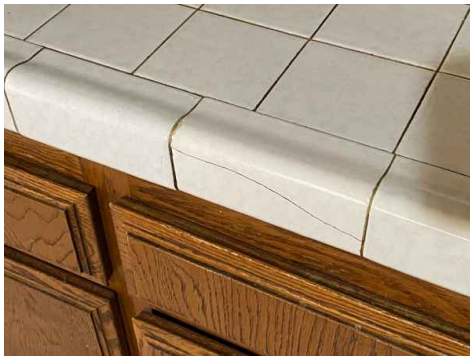
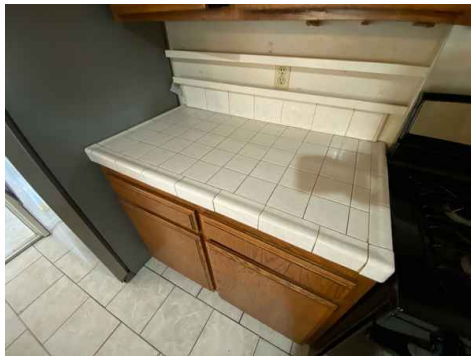
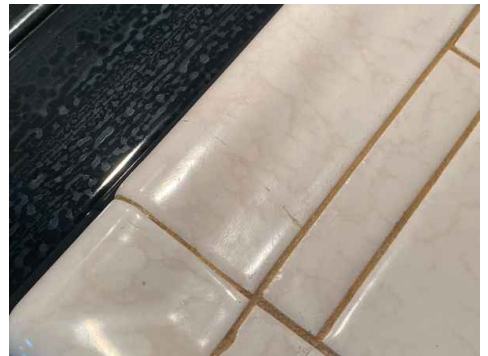
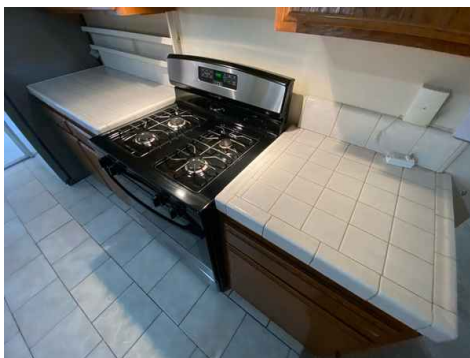
## 14.2.1 Counter Tops

**CRACKED/DAMAGED TILE**

At the time of the inspection there were one or more cracked/damaged tiles at the kitchen countertop. Correction is advised.

Contact a qualified professional.

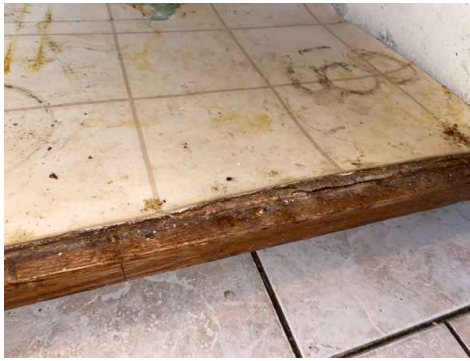
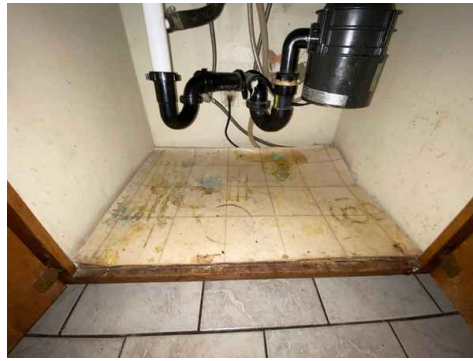
## 14.3.1 Kitchen Cabinetry

**PREVIOUS WATER DAMAGE AND STAINS UNDER KITCHEN SINK**

At the time of inspection there was evidence of a prior leak under the kitchen sink in the form of water damage and staining. The water leak was repaired and is no longer an active leak. Damage at this point is mostly cosmetic.

Contact a qualified professional.

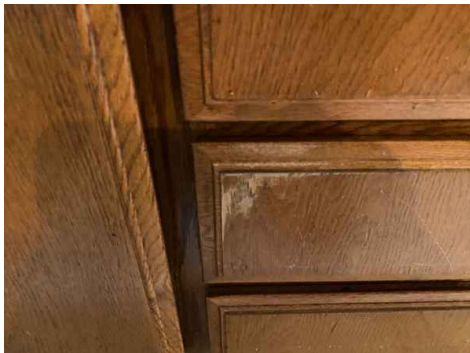
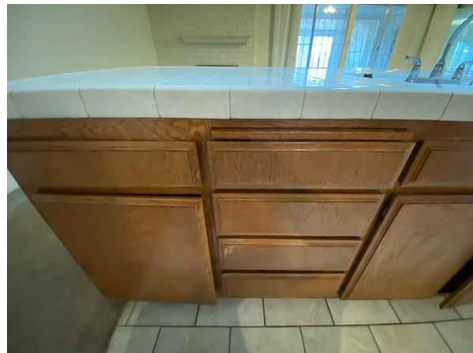
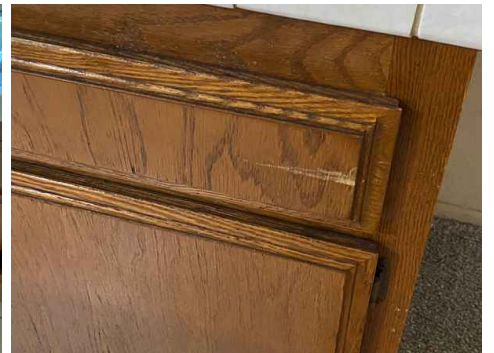
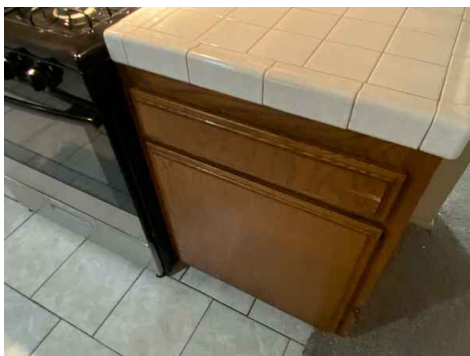
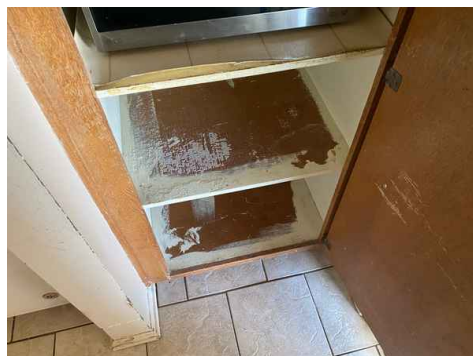
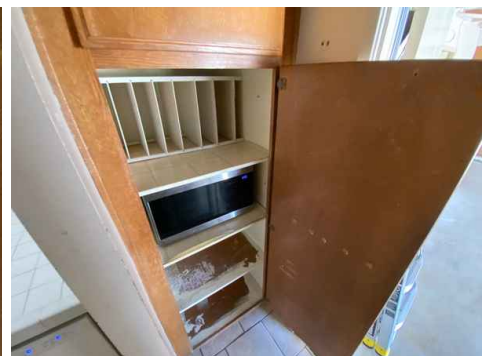
## 14.3.2 Kitchen Cabinetry

**COSMETIC BLEMISHES/MINOR FINISH DAMAGE**

At the time of the inspection the cabinets had minor cosmetic damage to the finish in one or more areas.

Contact a qualified professional.

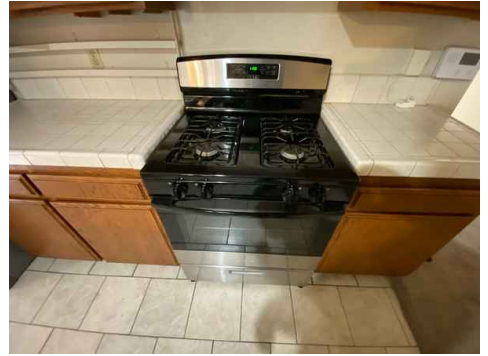
## 14.4.1 Range/Oven

**ANTI TIP BRACKETS  
NOT INSTALLED**

Contact a qualified professional.

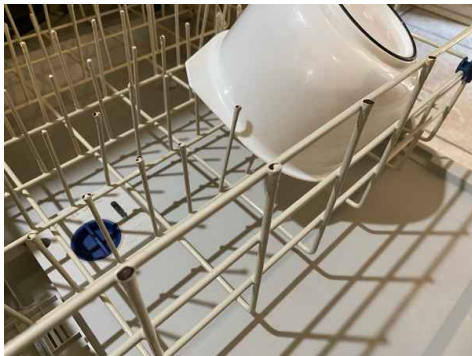
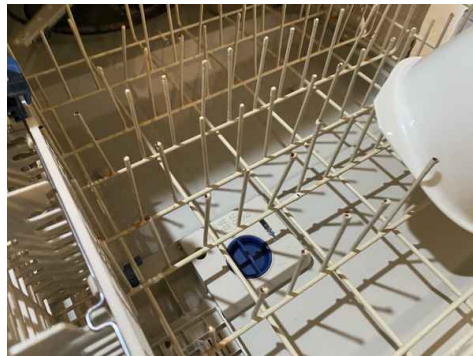
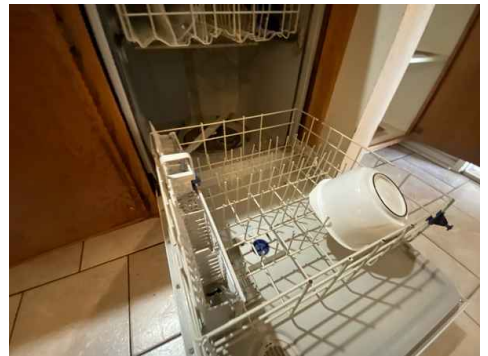
## 14.5.1 Dishwasher

**RUST ON DISHWASHER RACKS**

At the time of inspection the dishwasher racks had evidence of rust and deterioration present in one or more areas.

Contact a qualified professional.

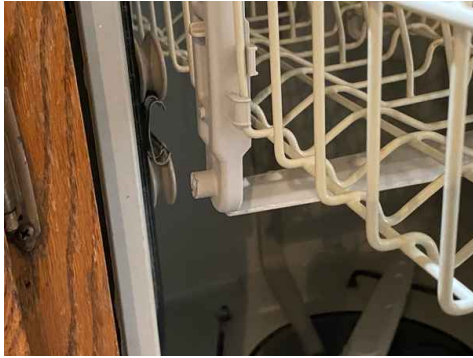
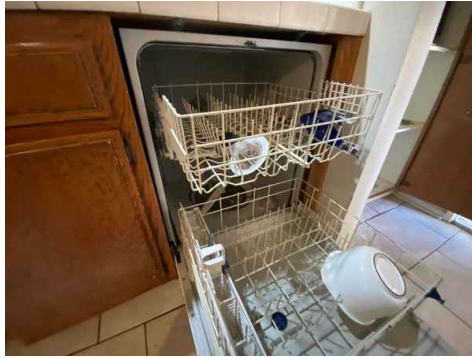
## 14.5.2 Dishwasher

**TRACK DAMAGE FOR RACK**

At the time of the inspection the track for the dishwasher rack was damaged or malfunctioning. Correction is advised.

Contact a qualified professional.

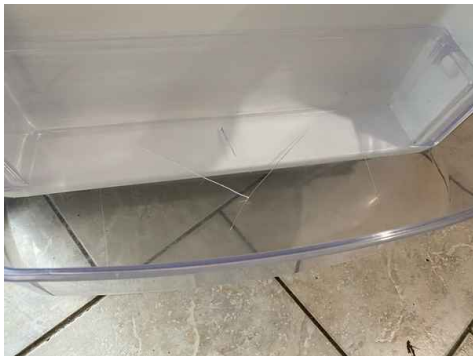
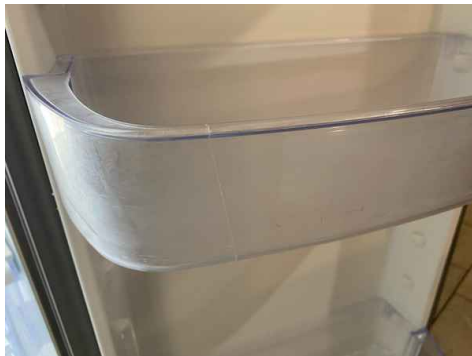
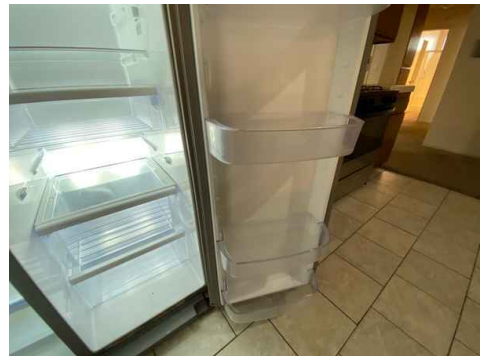
## 14.7.1 Refrigerator

**CRACKED REFRIGERATOR DRAWER**

At the time of the inspection one or more of the refrigerator drawer handles was cracked or damaged.

Contact a qualified professional.

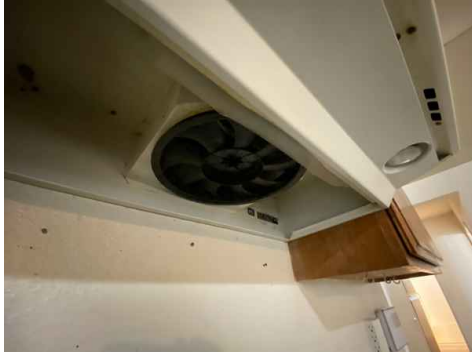
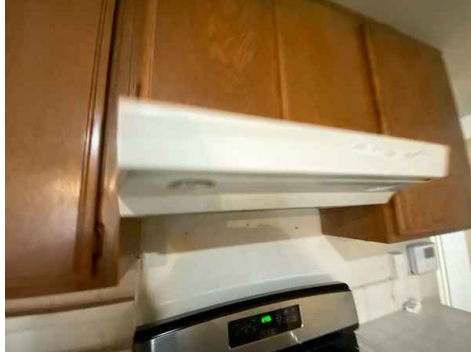
## 14.9.1 Vent Hood

**VENT FAN NON OPERABLE**

Contact a qualified professional.

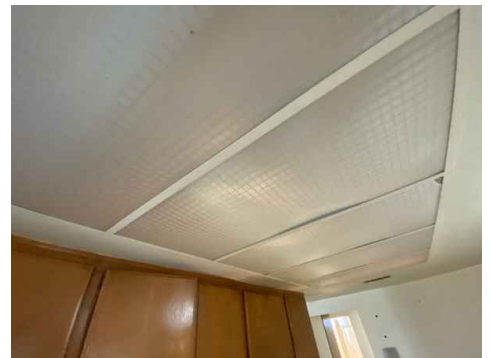
## 14.11.1 Light Fixtures

**BURNED OUT BULB**

At the time of the inspection one or more of the kitchen light bulbs was burned out and in need of replacement. Correction is advised

Contact a qualified professional.

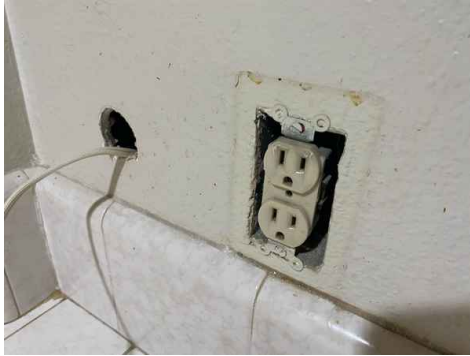
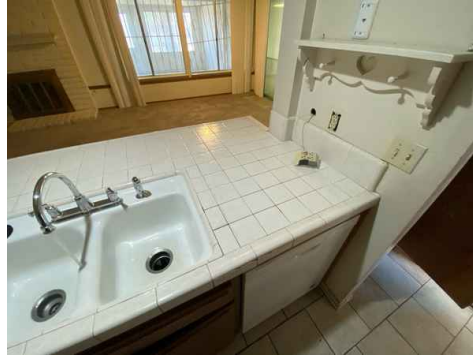
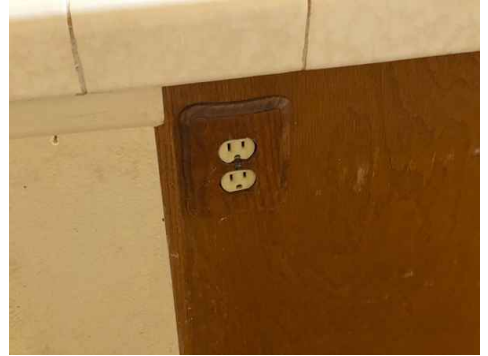
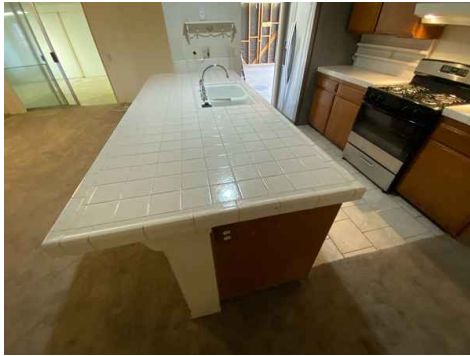
## 14.12.1 Receptacles, Switches and Circuits

**RECEPTACLE NOT GFCI PROTECTED**

Contact a qualified electrical contractor.

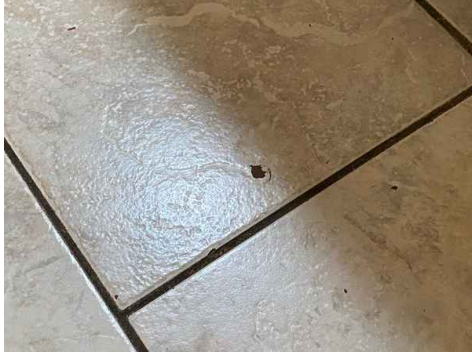
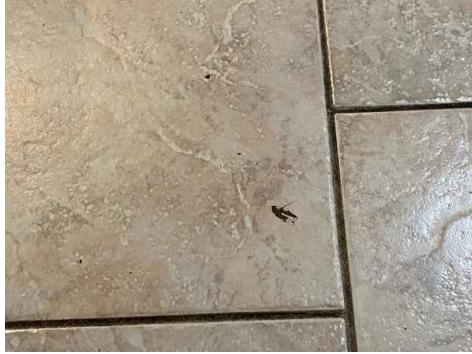
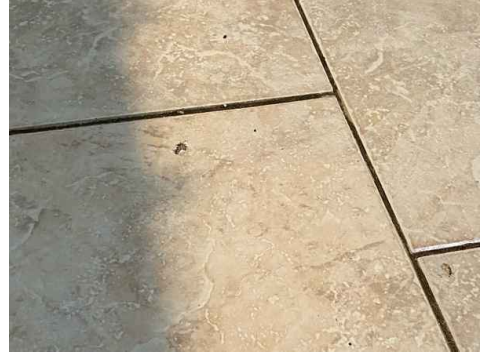
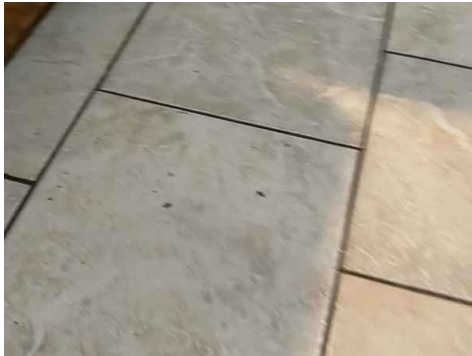
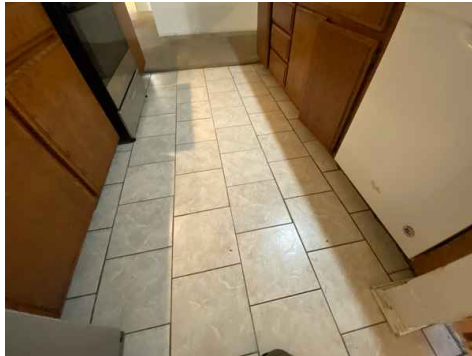
## 14.13.1 Floors

**DAMAGED FLOORING**

At the time of the inspection one or more areas of the flooring was damaged.

Correction or replacement is advised.

Contact a qualified professional.

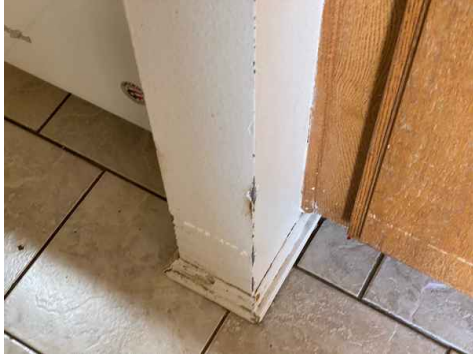
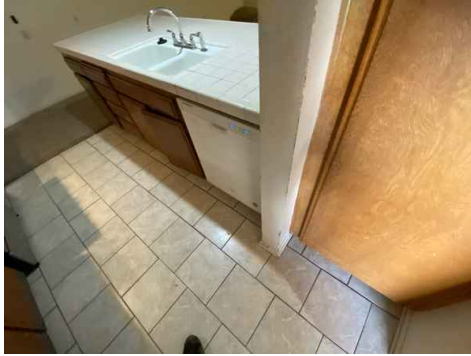
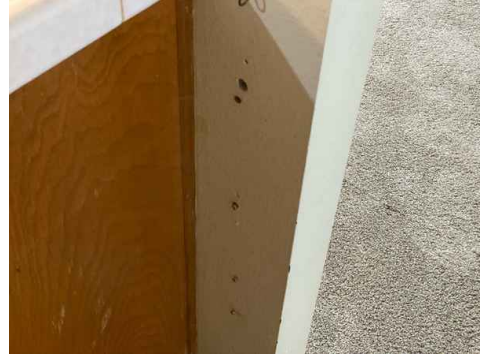
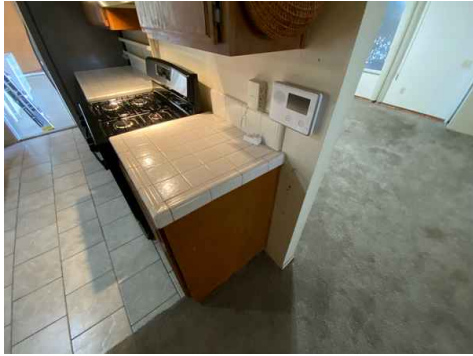
**COSMETIC BLEMISHES, DINGS OR STAINS**

At the time of the inspection there were one or more cosmetic blemishes, dings and or stains that affected the aesthetics of the walls. Correction is advised.

Contact a qualified professional.

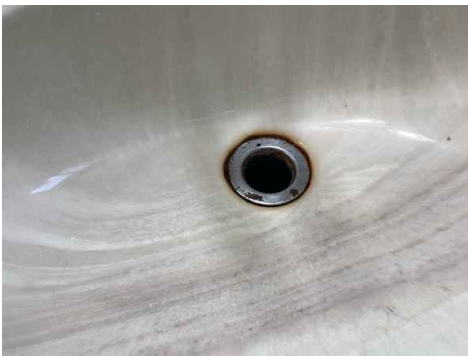
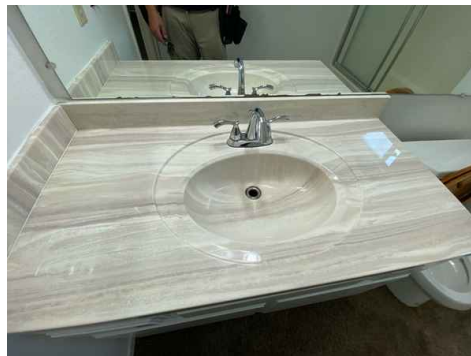
#### DRAIN STOP MISSING

At the time of inspection one or more of the drain stops for the sinks was missing. Correction is advised.

Contact a qualified professional.

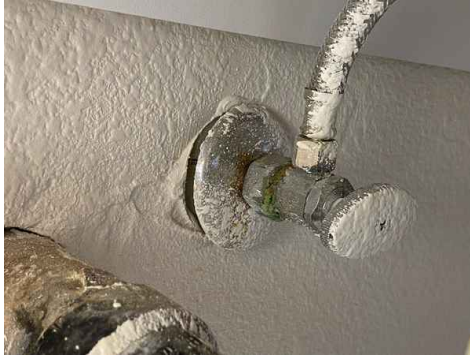
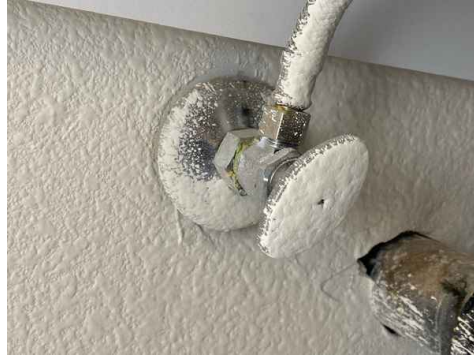
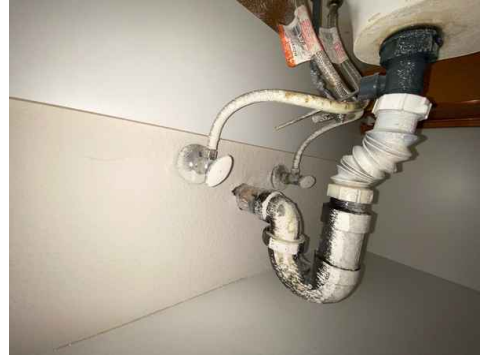
**ANGLE STOP CORROSION**

At the time of the inspection corrosion was present at the angle stop. It is advised to monitor and replace corroded angle stops before they begin leaking. Correction is advised.

Contact a qualified plumbing contractor.

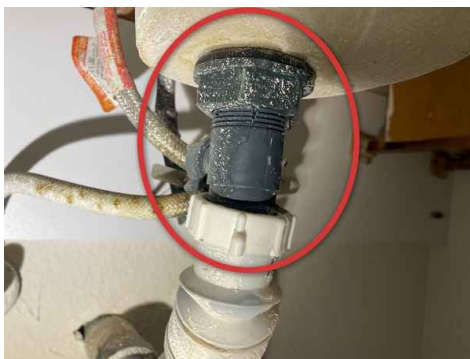
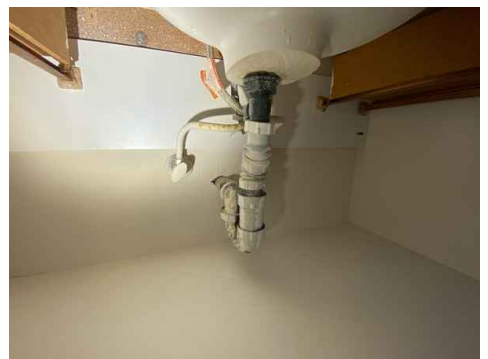
**ACTIVE DRAINLINE LEAK**

At the time of the inspection there were one or more bathroom sinks with an active drain line leak. Correction is advised.

Contact a qualified plumbing contractor.

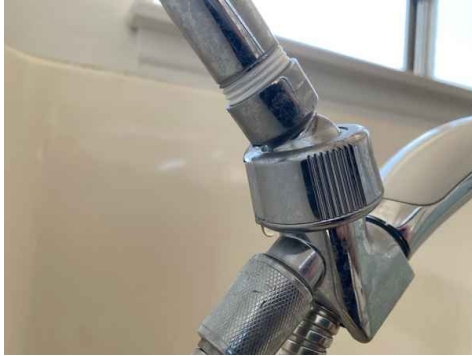
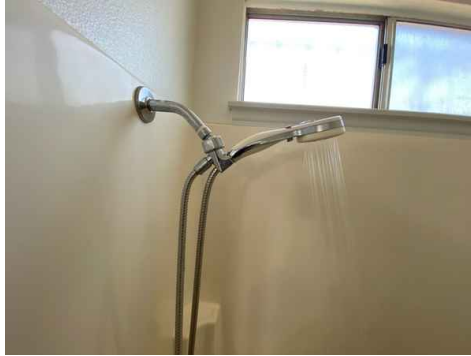
**SHOWER HEAD LEAKS AT THREADS**

At the time of the inspection one or more of the shower heads leaked at threads. Correction is advised.

Contact a qualified plumbing contractor.

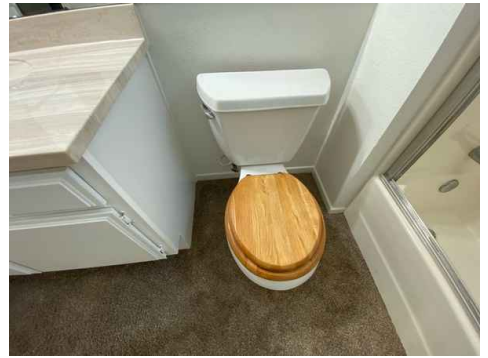
**LOOSE TOILET**

At the time of inspection the toilet bowl was loose at the connection to the floor. This can cause damage to the wax ring. Further evaluation and correction by a plumbing professional is advised.

Contact a qualified plumbing contractor.

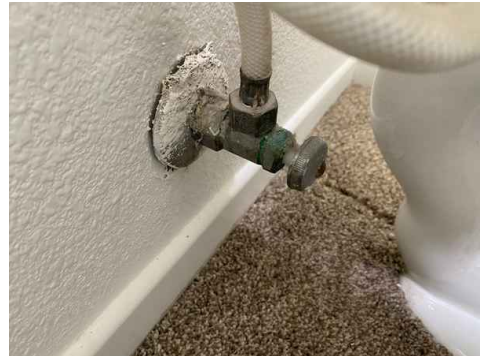
**CORROSION AT ANGLE STOP VALVE**

At the time of the inspection heavy corrosion was noted at the angles stops for one or more toilets. Correction is advised.

Contact a qualified plumbing contractor.

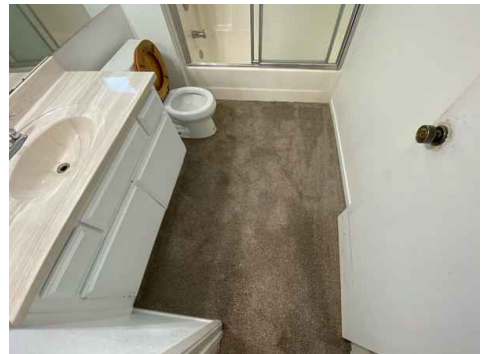
At the time of the inspection the bathroom had carpet installed. Carpet is known to hold allergens and facilitate microbial growth when moisture is introduced. Bathrooms contain several sources of moisture and substantially increase the likelihood of negative effects of carpeting. Areas adjacent to showers and bathtubs have an increased risk of facilitating microbial and/or mold growth. It is advised to remove carpet material from bathrooms. Correction is advised.

**Inspector Notes: No visible microbial growth present at time of inspection. Recommend removal of carpet and replacement with solid surface flooring.**

Contact a qualified flooring contractor

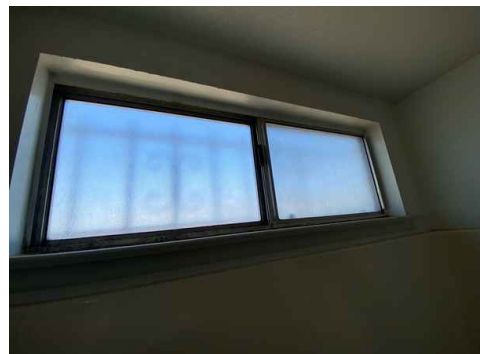
At the time of inspection there were one or more windows that were difficult to operate due to unusual friction between the window and the frame. Further evaluation and repair by a window installer is advised.

Contact a qualified window repair/installation contractor.

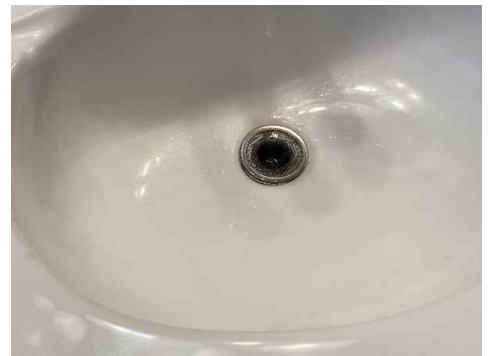
#### DRAIN STOP MISSING

At the time of inspection one or more of the drain stops for the sinks was missing. Correction is advised.

Contact a qualified professional.
