# CAL-WEST PROPERTY INSPECTIONS

## CAL-WEST PROPERTY INSPECTIONS HOME MAINTENANCE REPORT

27012 Bottlebrush Ln  
Menifee, CA 92586

06/30/2026

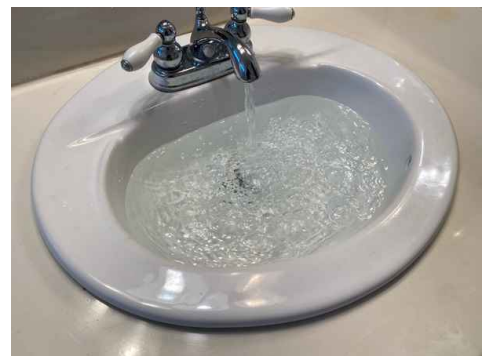
### 16.2.2 Sinks

#### SINK - POOR DRAINAGE

At the time of the inspection one or more bathroom sinks had slow/poor drainage. Recommend a qualified plumber repair.

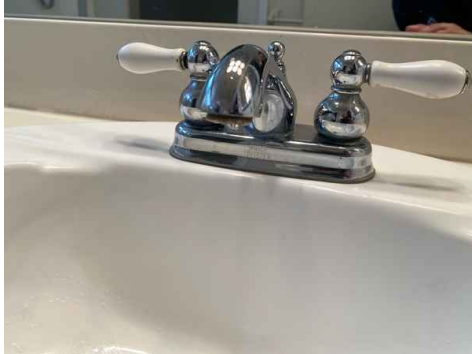
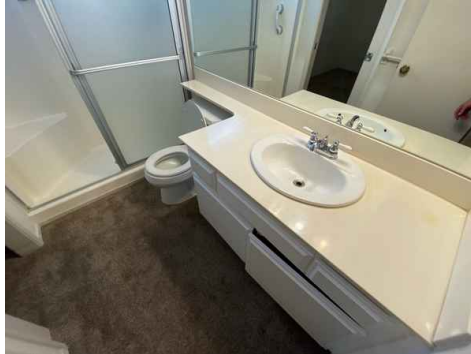
**FAUCET FIXTURE LEAKING**

At the time of the inspection there were one or more sink faucets with a slow drip style leak that could not be stopped. Correction is advised.

Contact a qualified professional.

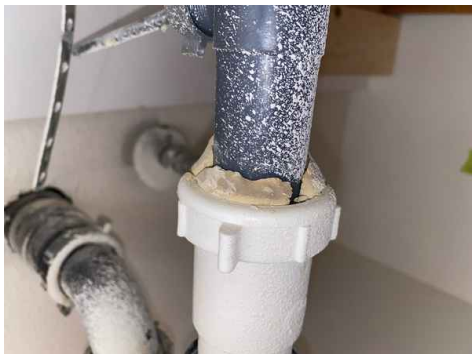
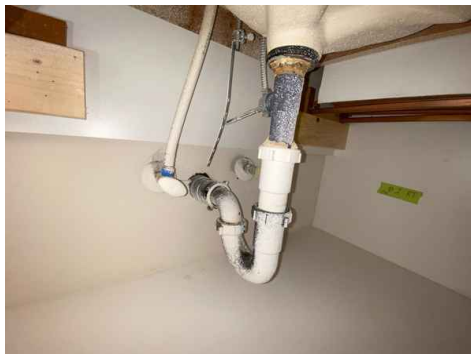
**PLUMBERS PUTTY PRESENT**

At the time of the inspection there was plumbers putty present on the drain lines under the sink at one or more locations. Plumbers Putty usually indicates that a minor leak was present at one time or work was performed by a non professional.

It is advised to remove the plumbers Putty and have a licensed plumber make any necessary corrections or repairs.

Contact a qualified plumbing contractor.

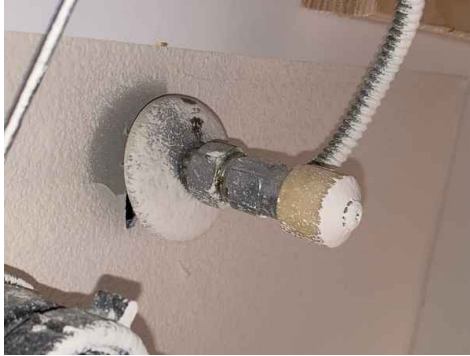
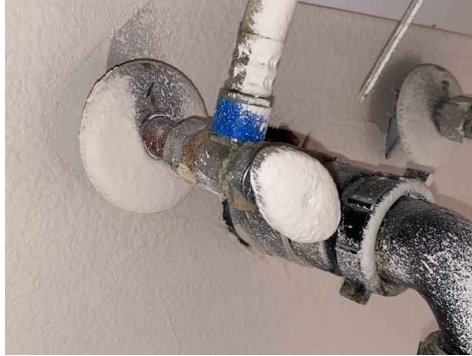
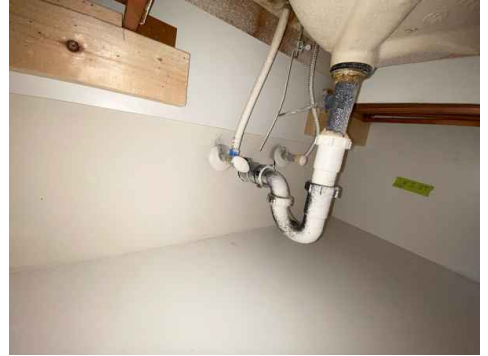
**AGED/BEYOND INTENDED RELIABLE LIFE**

At the time of the inspection there one or more angle stop shut off valves located under the sinks that were beyond their intended reliable lifespan. Even though leaks or corrosion are not present, it is advised to proactively replace the old, dated or original angle stops throughout.

Contact a qualified plumbing contractor.

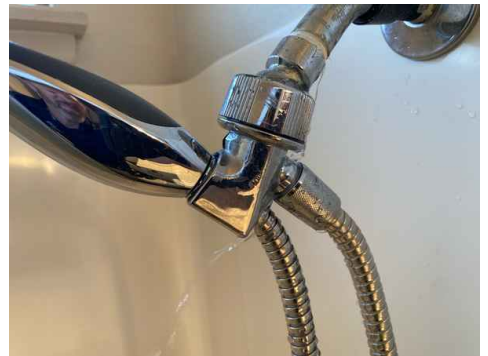
**SHOWER HEAD LEAKS AT THREADS**

At the time of the inspection one or more of the shower heads leaked at threads. Correction is advised.

Contact a qualified plumbing contractor.

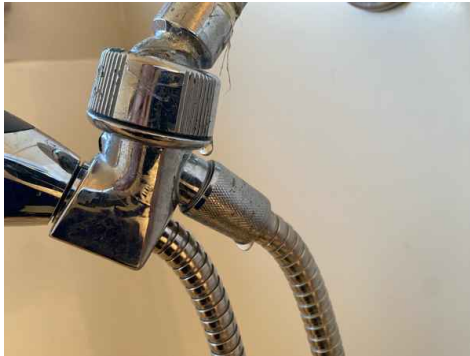
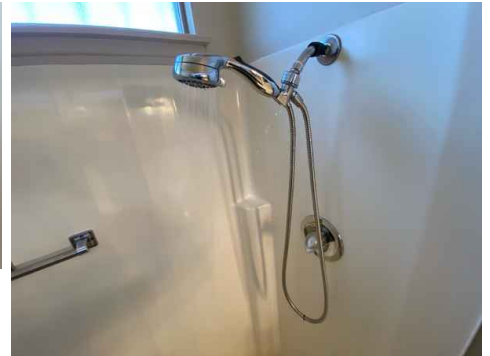
**DRIPPING FAUCET WHEN OFF**

At the time of the inspection one or more of the bathtub/shower faucets suffered from a slow Drip water leak indicating that the control valve could be beginning to fail. Correction is advised.

Contact a qualified professional.

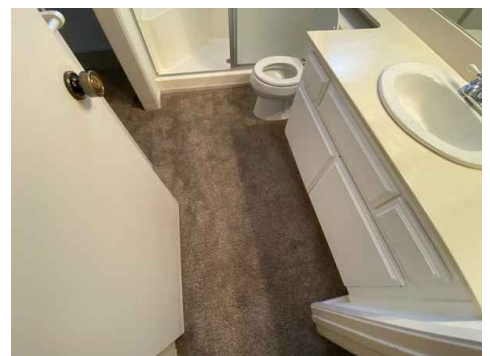
**BATHROOM CARPET**

At the time of the inspection there were one or more bathrooms with carpet installed. Carpet is known to hold allergens and facilitate microbial growth when moisture is introduced. Bathrooms contain several sources of moisture and substantially increase the likelihood of negative effects of carpeting. Areas adjacent to showers and bathtubs have an increased risk of facilitating microbial and or mold growth. It is advised to remove carpet material from bathrooms. Correction is advised.

**Inspector Notes: No visible microbial growth present at time of inspection. Recommend removal of carpet and replacement with solid surface flooring.**

Contact a qualified flooring contractor

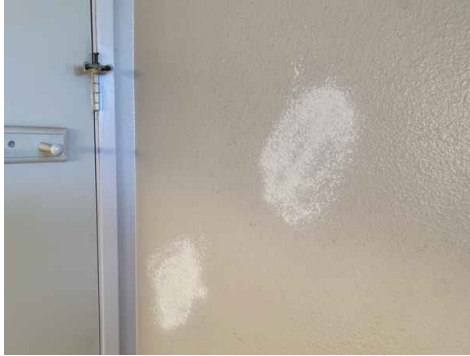
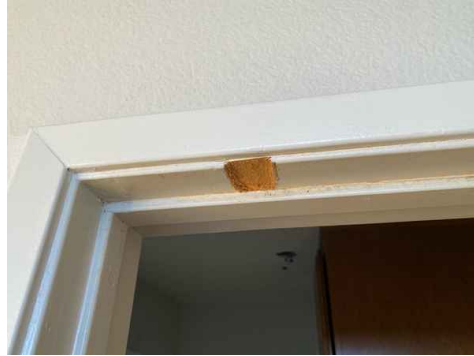
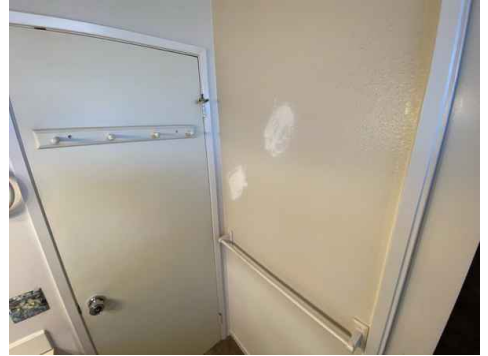
**COSMETIC BLEMISHES, DINGS OR STAINS**

At the time of the inspection there were one or more cosmetic blemishes, dings and or stains that affected the aesthetics of the wall. Correction is advised.

Contact a qualified professional.

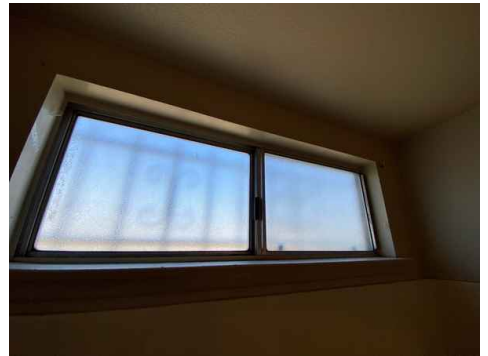
**WINDOW IS DIFFICULT TO OPERATE**

At the time of inspection there were one or more windows that were difficult to operate due to unusual friction between the window and the frame. Further evaluation and repair by a window installer is advised.

Contact a qualified window repair/installation contractor.

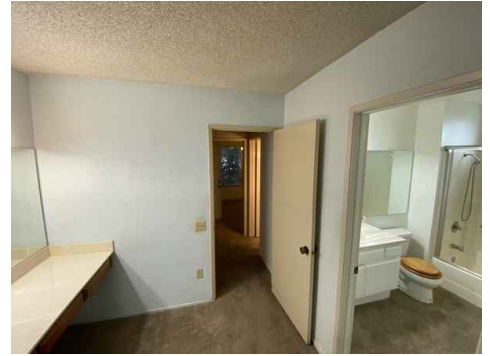
#### SMOKE DETECTOR MISSING

At the time of inspection one or more smoke detectors and or carbon monoxide detectors were missing at the required locations.

Current CA residential building codes state that smoke detectors must be installed near the kitchen, any room with a fireplace, all sleeping rooms, and hallways leading to sleeping rooms. For CO detectors, the requirement is at least one on each level of the property, and a 15 feet maximum distance from each and all fuel burning appliances and sleeping rooms.

Contact a qualified professional.

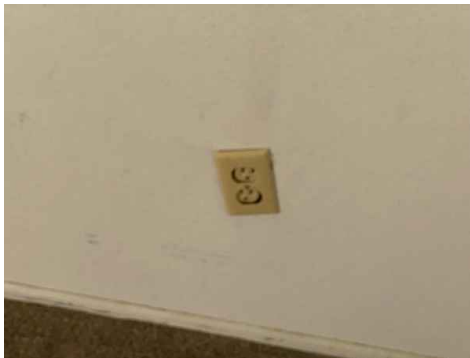
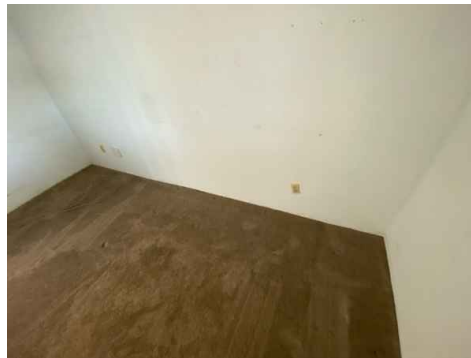
#### COVER PLATES DAMAGED

One or more receptacles and or switches had a damaged cover plate at the time of the inspection. Recommend replacement.

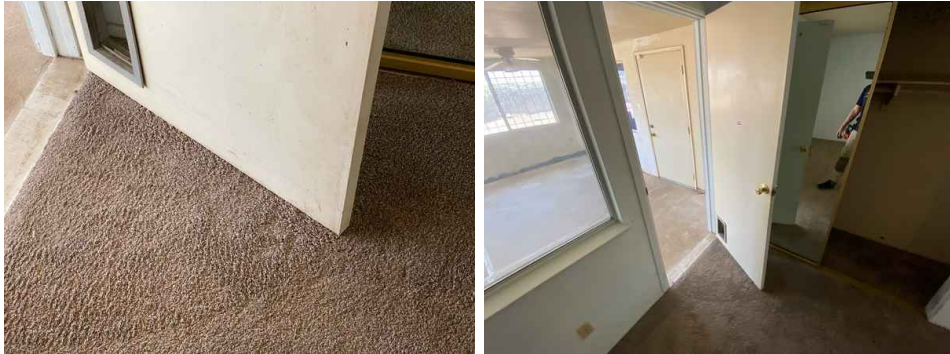
**DOOR DRAGS ON FLOORING**

Bottom of one or more interior door rubs on flooring material. Further evaluation and repair by a door repair and installation contractor is advised.

Contact a qualified door repair/installation contractor.

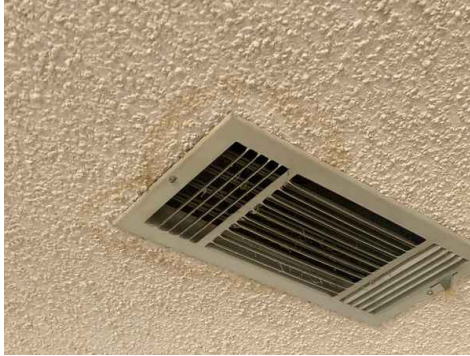
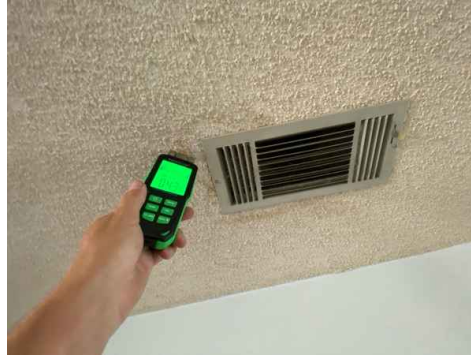
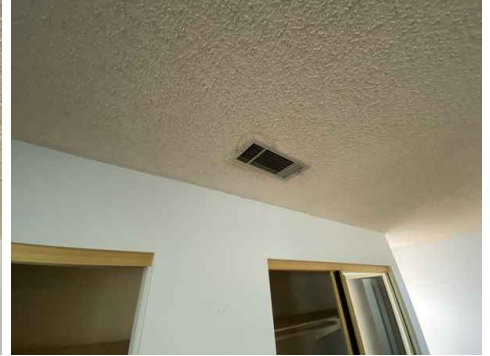
**MOISTURE INTRUSION STAINING**

At the time of inspection there were one or more water stains on the interior ceiling; likely caused from roof leaks and water intrusion. If proof of repairs cannot be confirmed it is advised to have a roofing professional further evaluate the condition of the roof and provide an estimate for the appropriate repairs.

**Inspector Notes: Moisture levels were not elevated at the time of inspection.**

Contact a qualified professional.

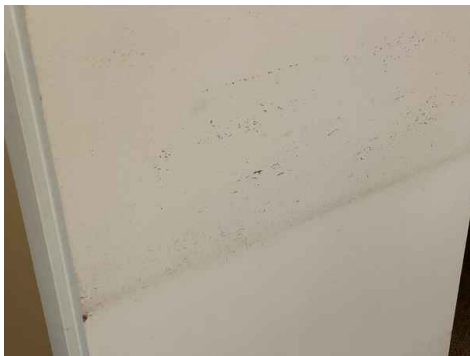
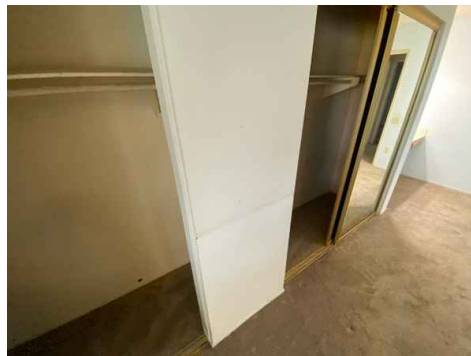
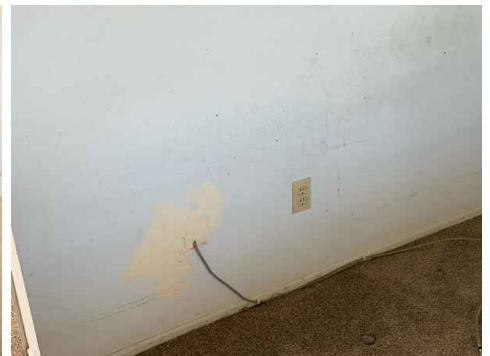
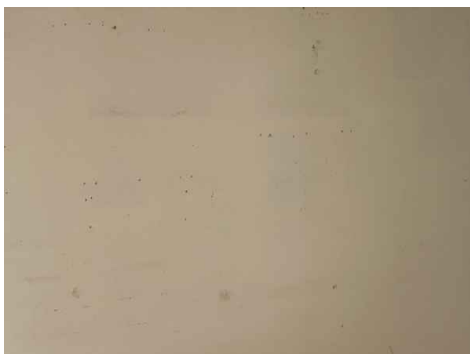
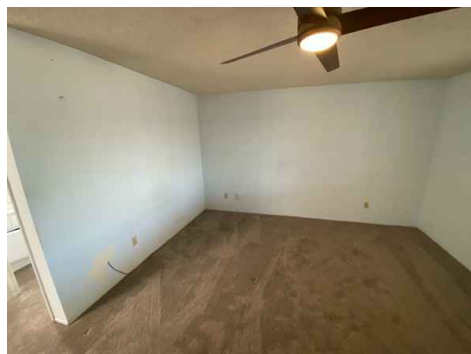
**COSMETIC BLEMISHES, DINGS OR STAINS**

At the time of the inspection there were one or more cosmetic blemishes and or stains that affected the aesthetics of the walls. Correction is advised.

Contact a qualified professional.

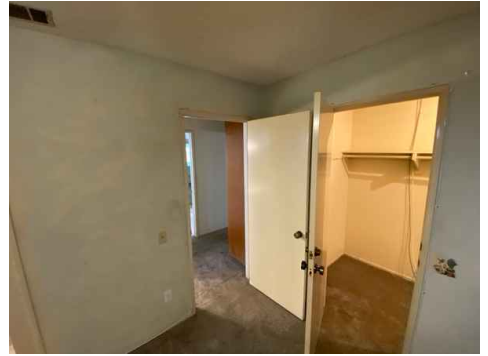
### SMOKE DETECTOR MISSING

At the time of inspection one or more smoke detectors and or carbon monoxide detectors were missing at the required locations.

Contact a qualified professional.

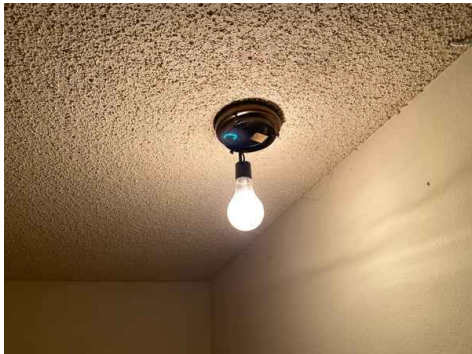
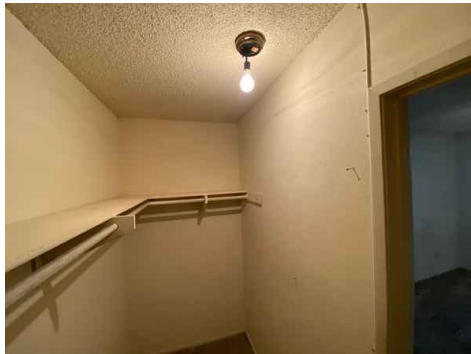
### 18.3.1 Lighting Fixtures, Switches & Receptacles

### LIGHT FIXTURE COVER MISSING

At the time of the inspection one or more of the light fixtures was missing the appropriate cover for the bulb. Correction is advised.

Contact a qualified professional.

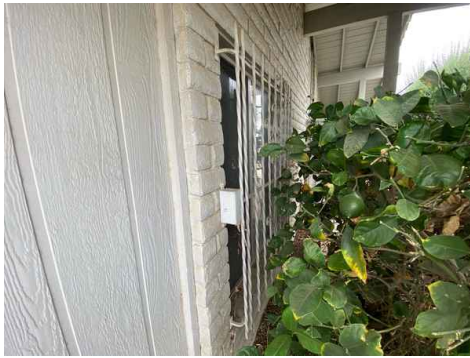
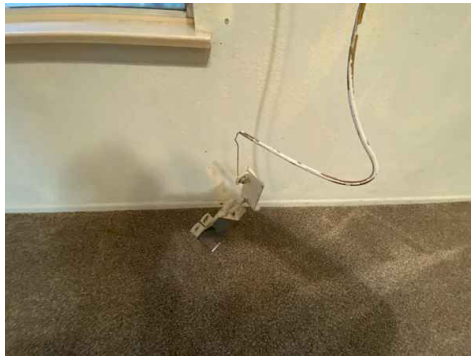
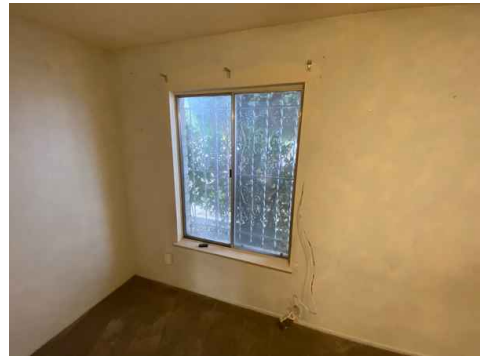
## 18.4.1 Windows

**EGRESS FIRE CODE**

**Inspector Notes: Release mechanism for the security bars are damaged/not working.**

Contact a qualified professional.

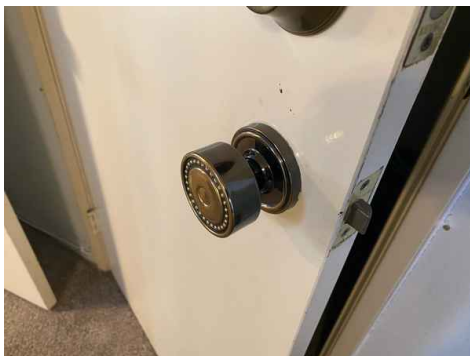
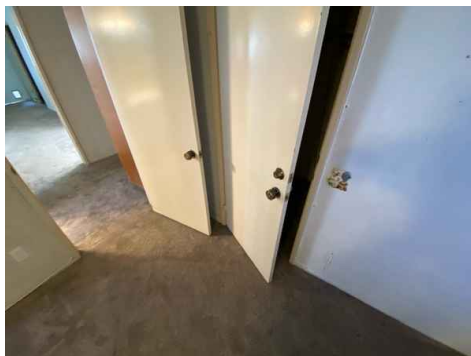
## 18.5.1 Doors

**LOOSE DOOR HARDWARE**

At the time of inspection one or more of the door hardware sets was loose and in need of repair. Correction is advised.

Contact a qualified professional.

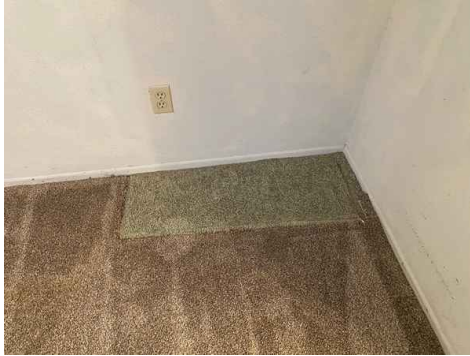
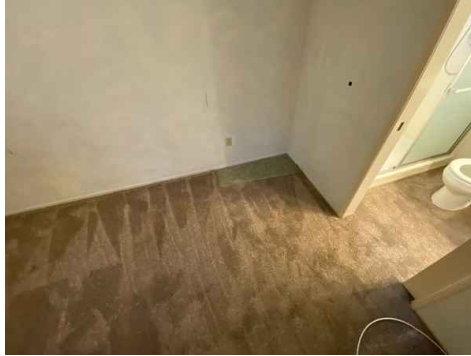
## 18.8.1 Floors

**DAMAGED CARPET**

At the time of the inspection there were one or more areas of the carpet suffering from minor to moderate damage. Correction is advised.

Contact a qualified flooring contractor

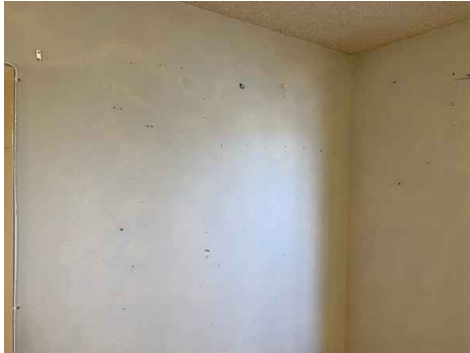
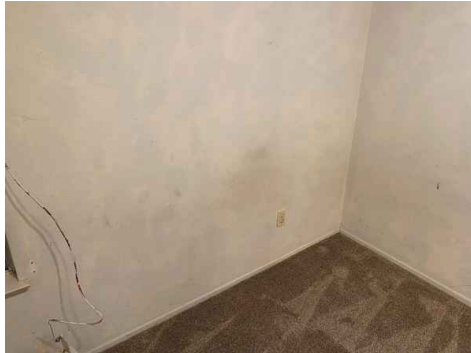
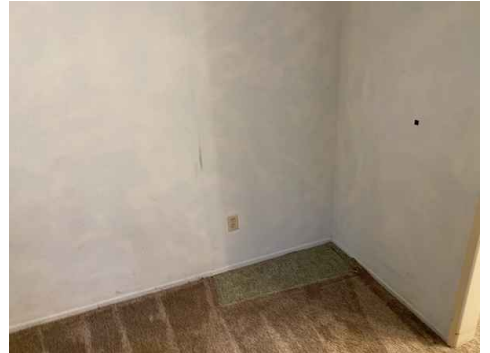
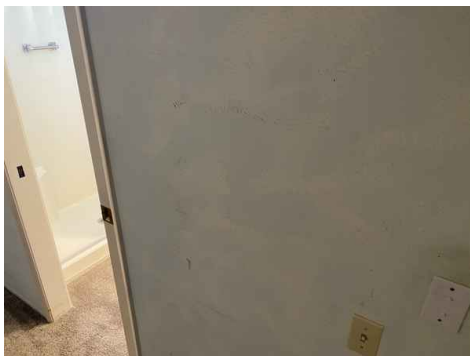
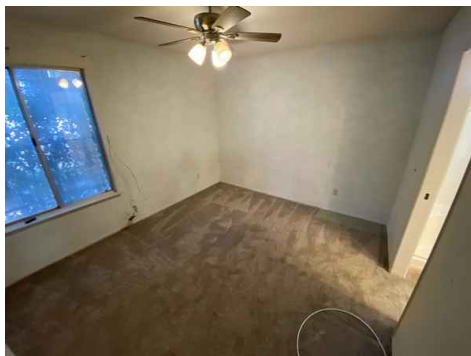
## 18.9.1 Walls

**COSMETIC BLEMISHES, DINGS OR STAINS**

At the time of the inspection there were one or more cosmetic blemishes and or stains that affected the aesthetics of the walls. Correction is advised.

Contact a qualified professional.

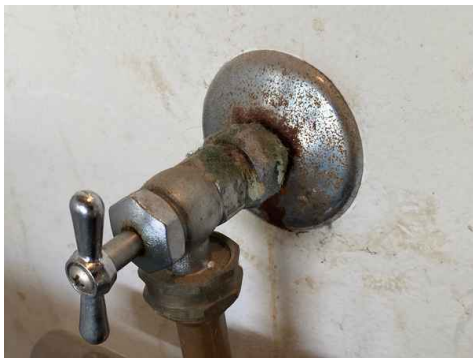
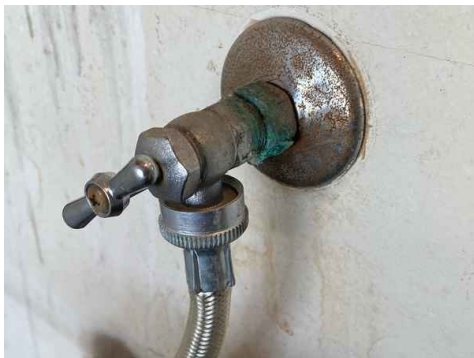
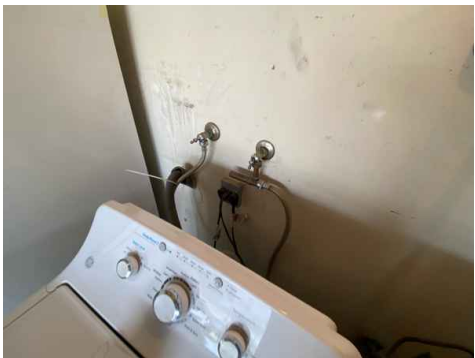
19.1.1 Plumbing Connections

CORROSION AT SHUTOFF

At the time of the inspection there were one or more of the shutoff valves for the washing machine suffering from corrosion. Correction is advised.

Contact a qualified professional.

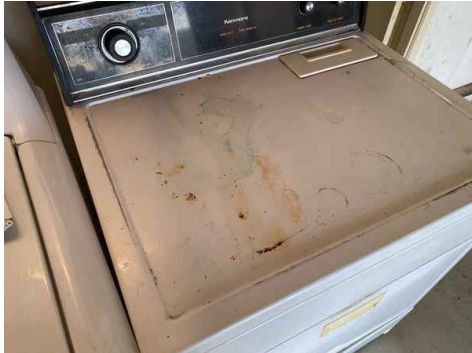
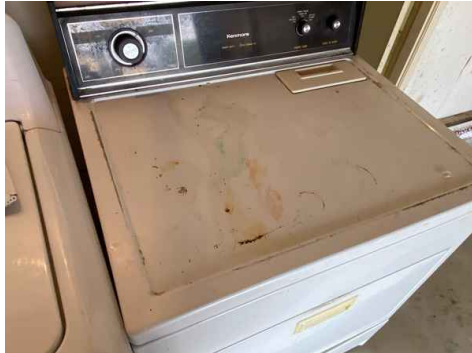
## 19.5.1 Washer/Dryer

**RUST PRESENT AT UNIT**

At the time of the inspection there was rust present on one or both of the units.

Contact a qualified professional.

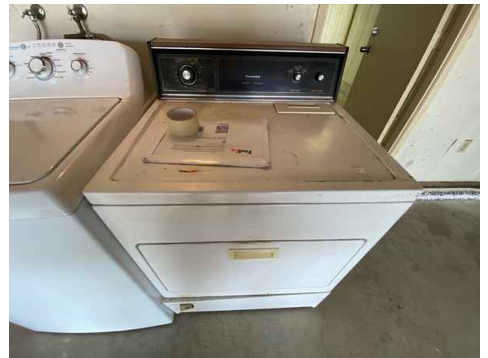
## 19.5.2 Washer/Dryer

**NEAR END OF USABLE LIFE**

At the time of inspection the washer or dryer were aged and nearing the end of their usable life. Future replacement is advised.

Contact a qualified professional.

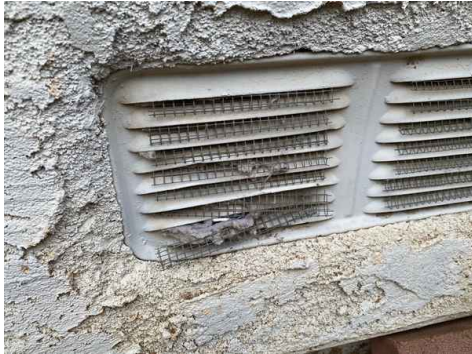
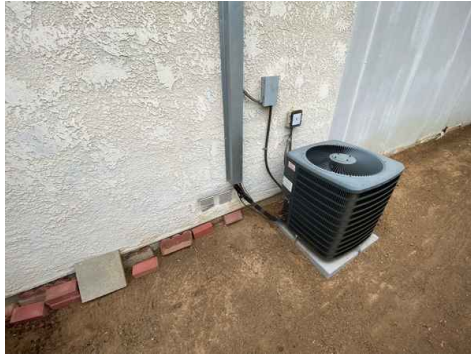
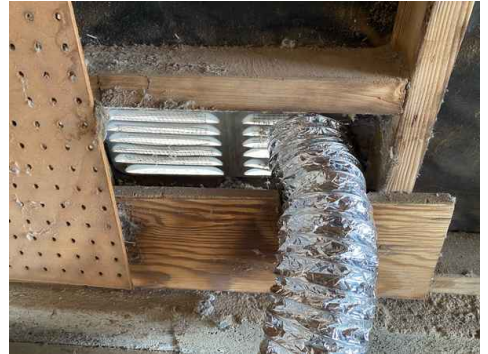
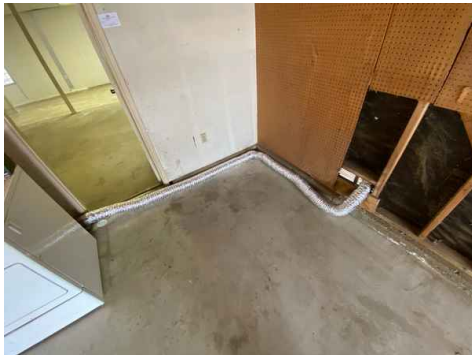
## 19.6.1 Dryer Ducting

**DRYER VENT TERMINATION SCREENED**

At the time of inspection, the dryer vent termination at the exterior was screened. This may cause lint to get trapped and potentially cause a fire. Recommend removal.

Contact a qualified professional.

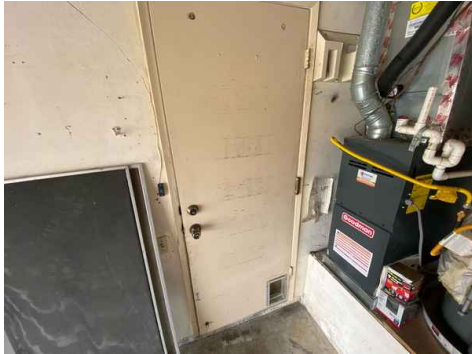
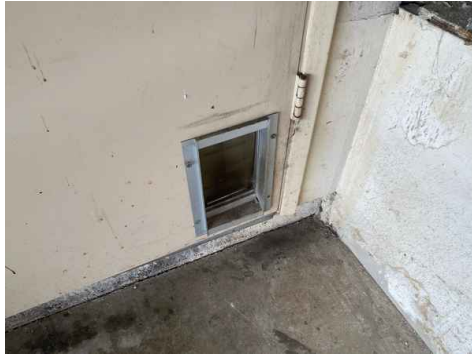
**Major Concern - Safety Hazard**

Door separating garage and home does not meet safety standards. Doors in firewalls must be at least 1 3/8-inch thick, metal/steel, or a 20-minute fire-rated door. Correction is advised.

**Inspector Notes: Doggy Door penetration and not self latching.**

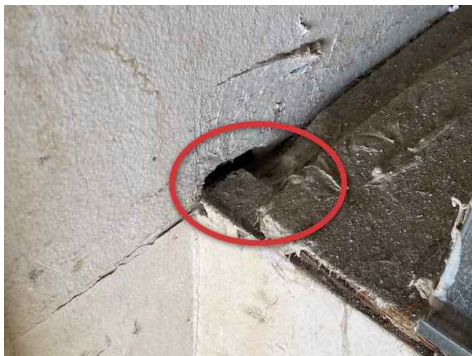
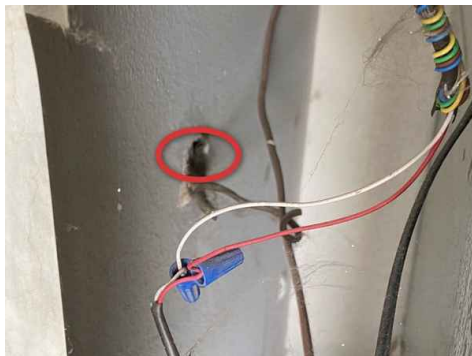
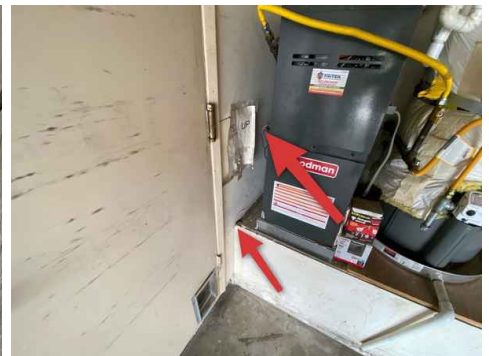
## 20.5.1 Garage Walls &amp; Firewalls

**FIREWALL PENETRATIONS**

**Major Concern - Safety Hazard**

At the time of the inspection, one or more penetrations in the firewall were observed. Firewall penetrations pose a potential hazard to the occupants inside the living area if there is ever a fire in the garage. Firewalls are designed to have a longer burn rating to slow the spread of fires that originate in the garage.

Recommendation

Contact a qualified professional.

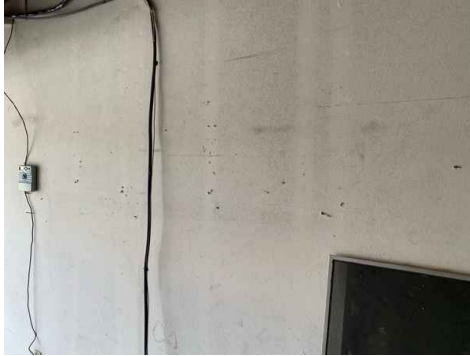
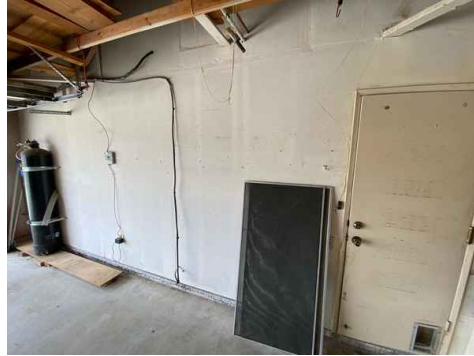
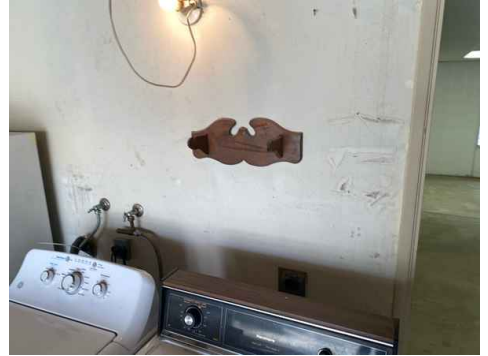
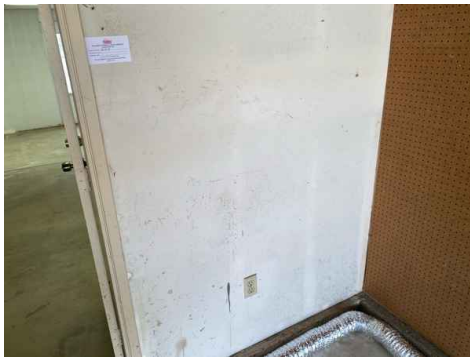
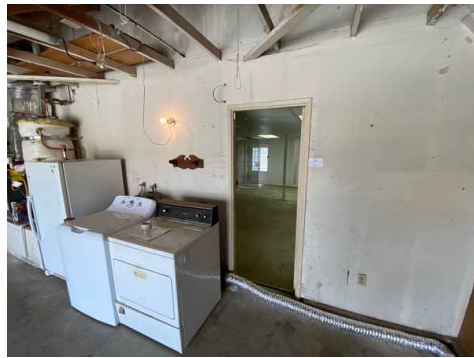
## 20.5.2 Garage Walls &amp; Firewalls

**COSMETIC BLEMISHES ON GARAGE WALL**

Deferred Maintenance - Minor Repair

At the time of the inspection there were one or more cosmetic blemishes and or stains that affected the aesthetics of the garage walls. Correction is advised.

Recommendation

Contact a qualified professional.

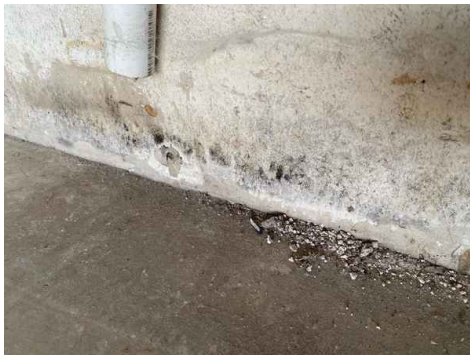
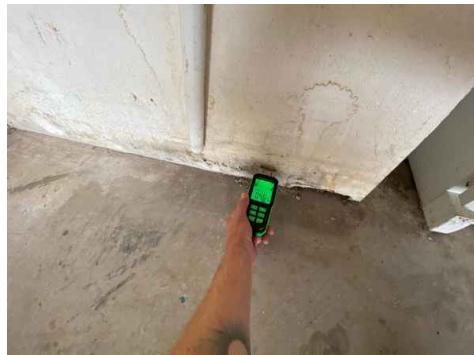
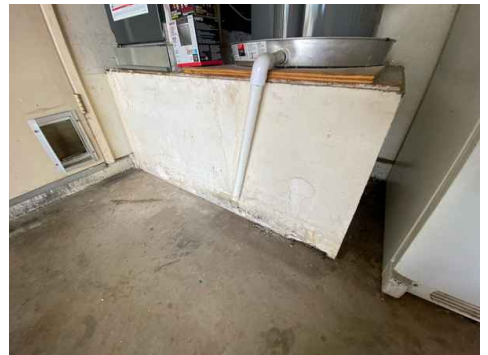
## 20.5.3 Garage Walls &amp; Firewalls

**POSSIBLE MOLD**

Recommended Improvement

At the time of the inspection there were signs of microbial/mold growth on the wall. Recommend a qualified remediation contractor further evaluate. Correction is advised.

**Inspector Notes: Moisture levels were not elevated at the time of inspection.**

Recommendation

Contact a qualified professional.

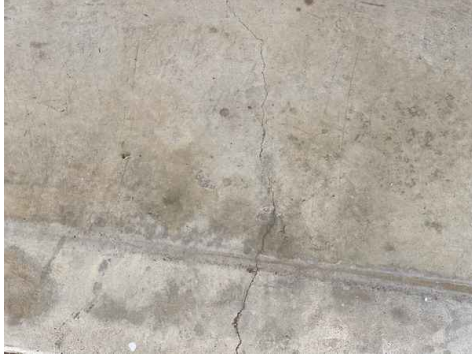
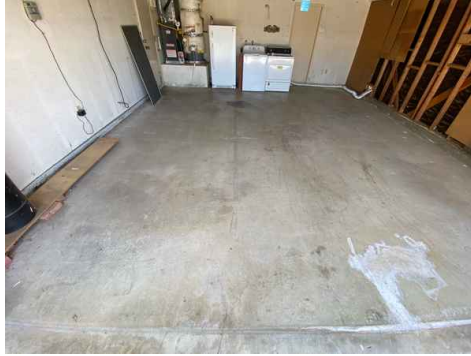
## 20.7.1 Garage Floor

**MINOR CONCRETE CRACKING**

Deferred Maintenance - Minor Repair

At the time of the inspection minor concrete cracking was observed in the garage. Minor cracking is typically not cause for concern. Recommend monitoring for continued cracking and increases in crack width/gaps.

Recommendation

Contact a qualified professional.

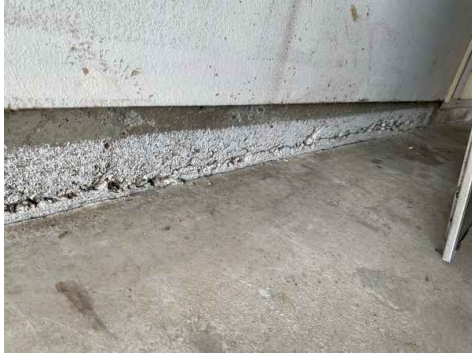
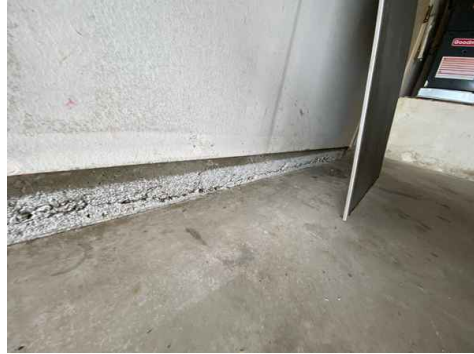
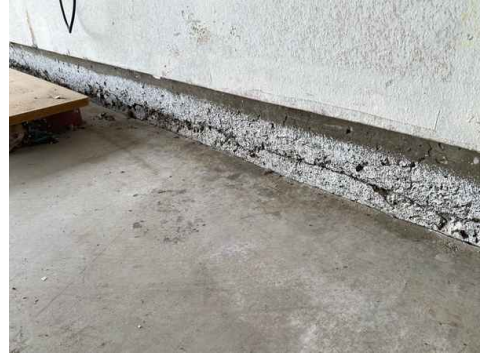
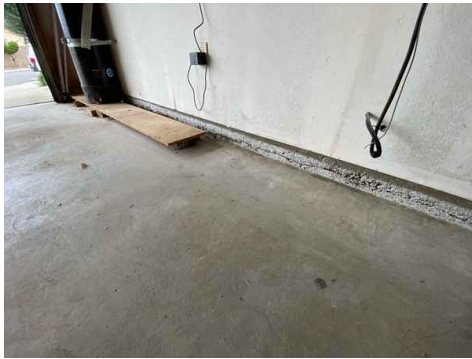
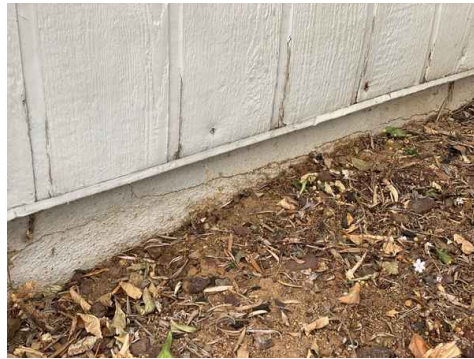
## 21.1.1 Foundation

**FOUNDATION CRACKS**

**Major Concern - Safety Hazard**

At the time of the inspection there was cracking noted at the concrete foundation. This is typically consistent with soil movement and or dated building practices. Further movement could lead to damage of structural components, foundation and/or slabs. Further evaluation by a licensed foundation repair contractor is advised.

**Inspector Notes: Moderate horizontal cracking at foundation stem wall in garage & Northwest exterior.**
