Advanced Group Property Inspections

Property Inspection Report

1368 Spazier ave , Glendale, CA 91201
Inspection prepared for: Scott Woodward
Date of Inspection: 5/30/2026

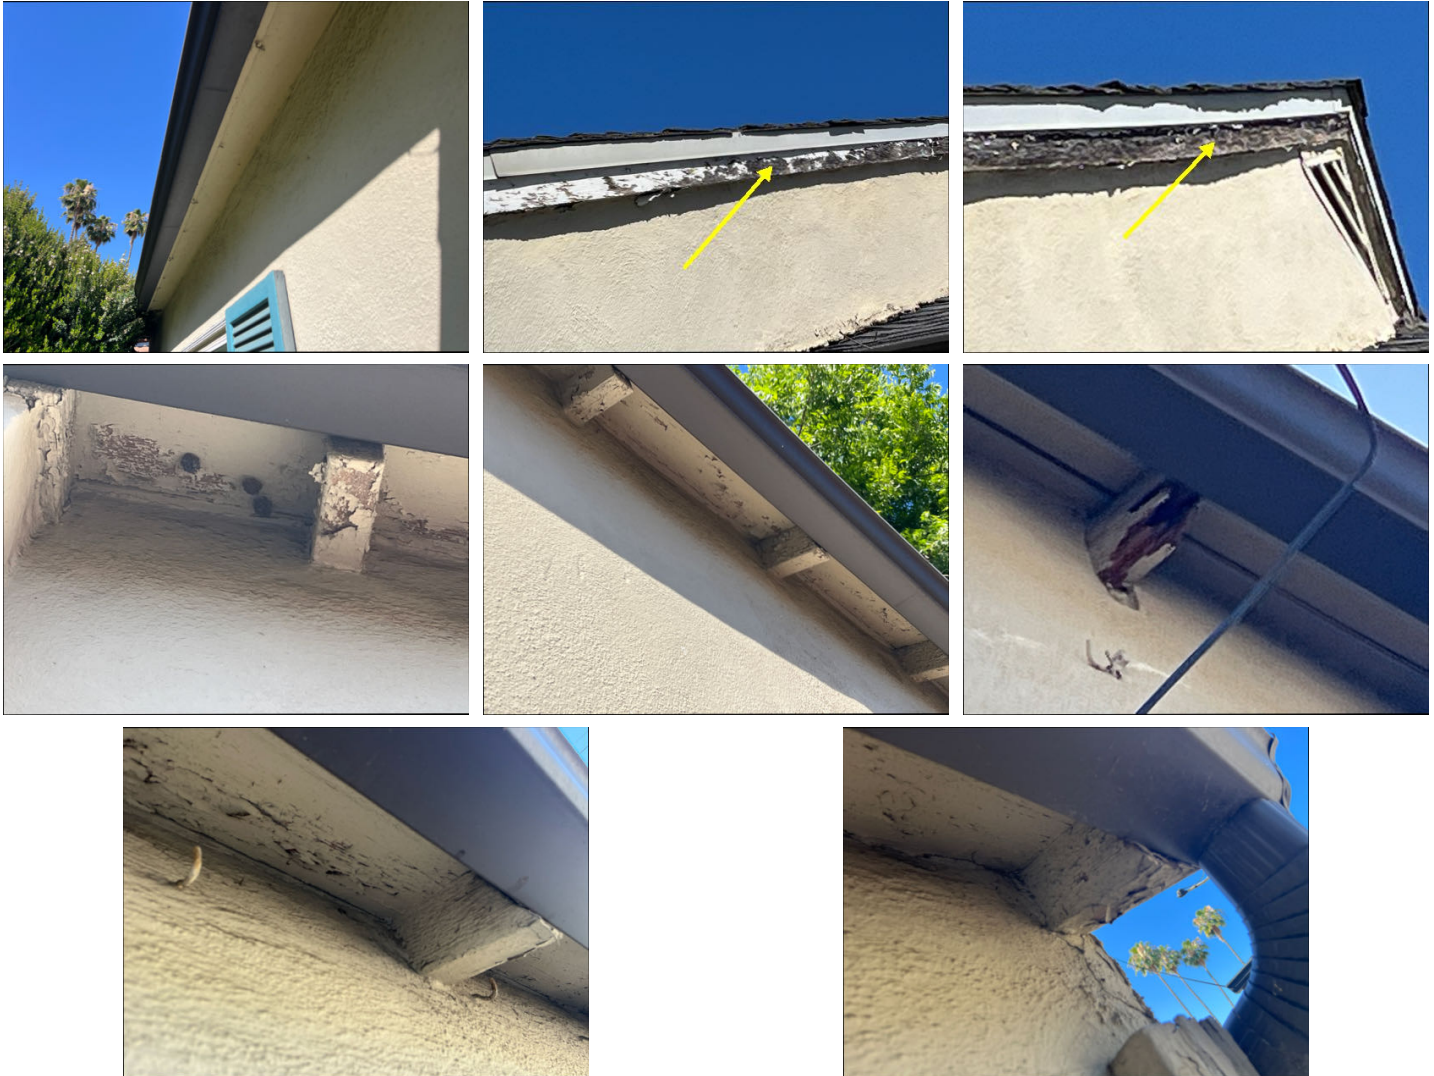
1.1. Age defects, peeling paint and/or moisture stains/damage were noted at the eaves and fascia. Recommend further evaluation/repairs by a qualified Structural Pest Inspector and/or Contractor.

1.2. Wasp nests noted at eaves - recommend to have the removed/cleaned by a Qualified Technician.

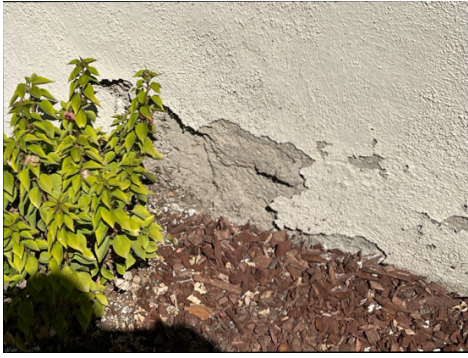
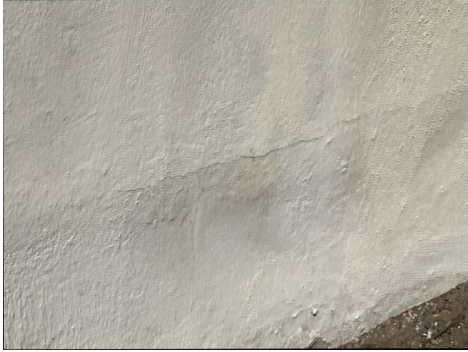
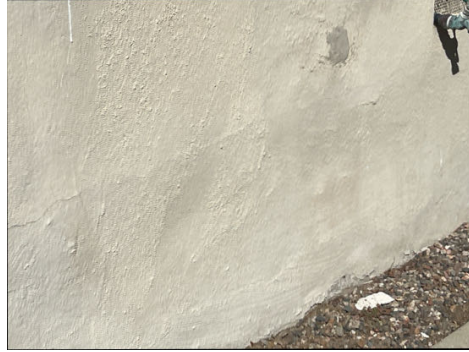
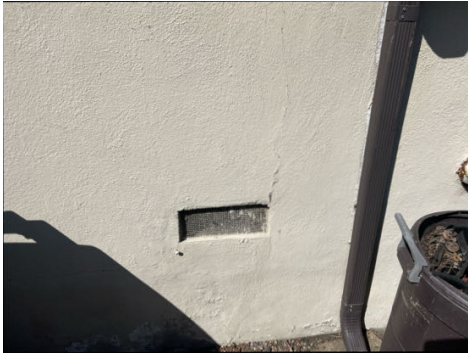
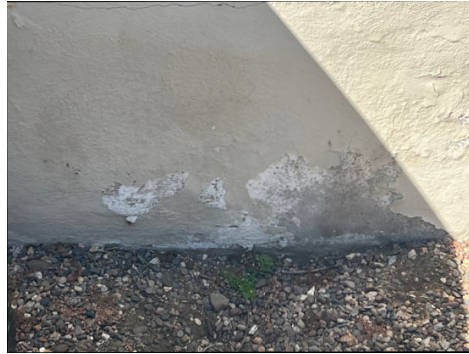
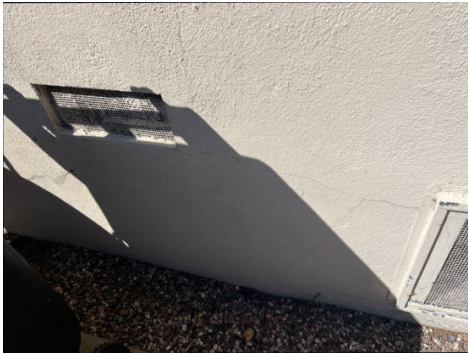
2.1. Cracked, damaged areas noted at stucco walls - In need of patch/paint/ Repair. Have it checked and fixed by a Qualified Contractor(s).

2.2. Patches/repairs noted at exterior wall(s). Check the records with the seller.

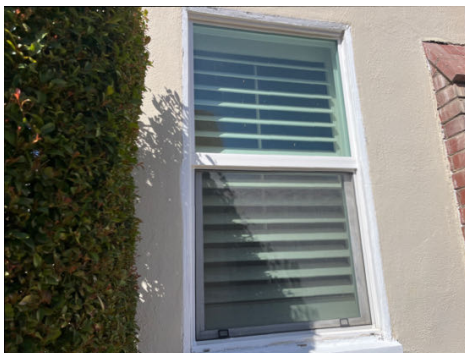
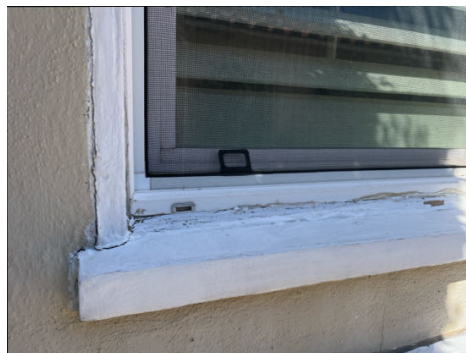
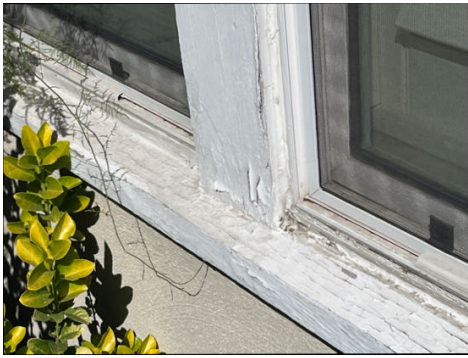
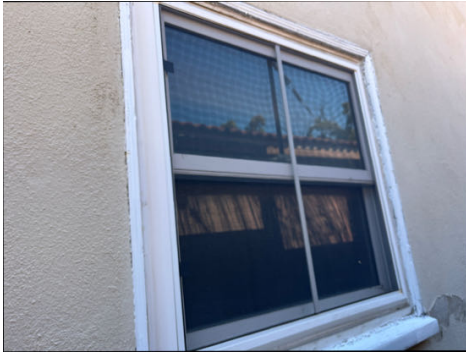
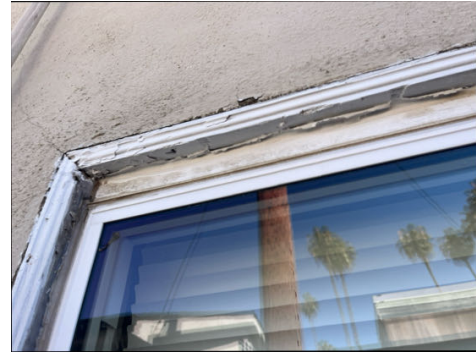
3. Window Trim and Sills (Exterior)

3.4. Building with old Aluminum windows type. Recommend to upgrade. Have it checked by a Qualified Contractor.

3.5. Peeling paint/Damage noted at exterior window sills and framing. Repairs/corrections recommended. Have it checked by a Qualified Structural Pest Inspector and/or Painting Contractor.

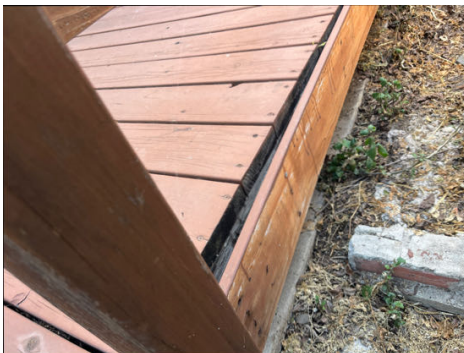
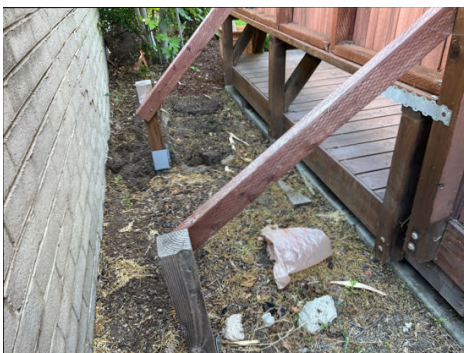
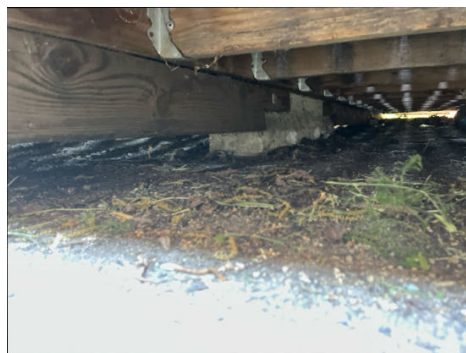
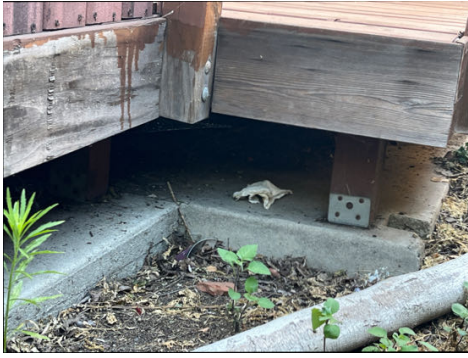
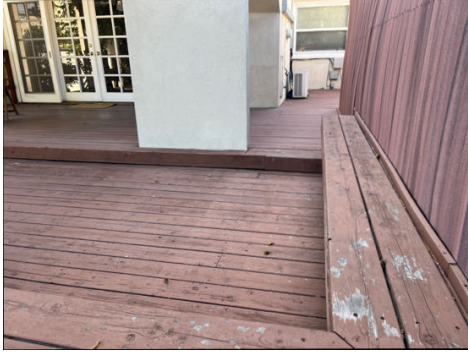
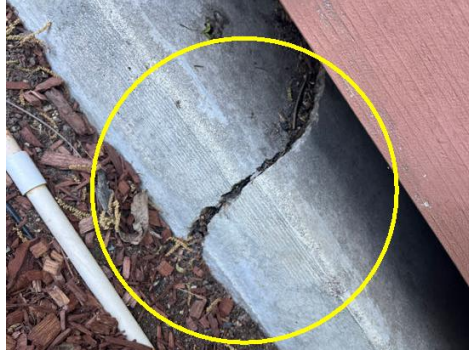
5.3. Deck privacy fencing was loose. Have it checked and repaired by a specialist.

5.4. Loose, worn boards noted. Have it checked and repaired/replaced by a qualified contractor. Wood deck is built on the ground, framing is not visible at this inspection to comment. Check the records with the seller.

5.5. Damaged Wood Present At Balcony/Decking. Have it Checked and repaired by a qualified Structural Pest Inspector and/or Contractor.

5.6. Cracks noted at deck concrete base/ surface. Have it checked and repaired by a specialist.

5.7. Movement noted at upper deck/ balcony structure. Have it checked and repaired by a specialist.

5.8. Defects found at deck(s). Recommend further evaluation and repairs by a Qualified Contractor(s).

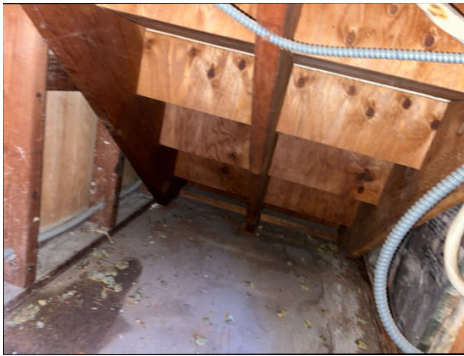
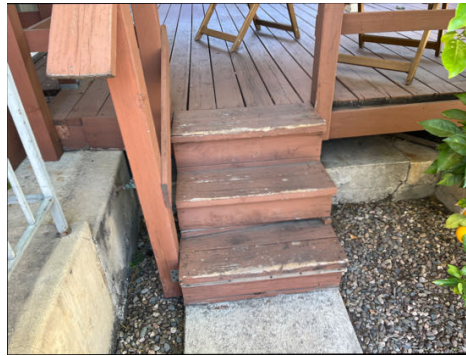
6.2. Uneven rise was noted at the exterior steps - This condition can present trip hazards. Have it repaired by a Qualified Contractor.

6.3. Recommend to install non slip strips at steps for safety. Have it repaired by a Qualified Contractor.

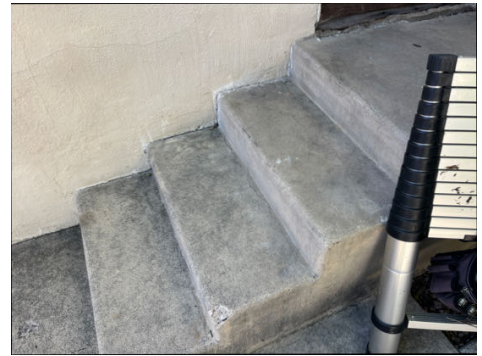
Note: this is a safety/liability concern.

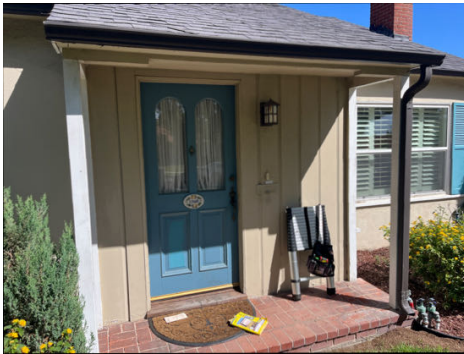
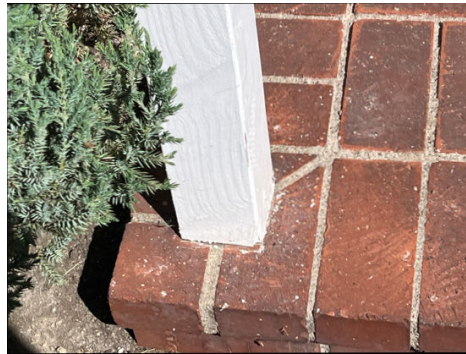
7.1. Front porch Wood posts were not anchored to the slab. Recommend having it checked and fixed for seismic safety by a qualified contractor.

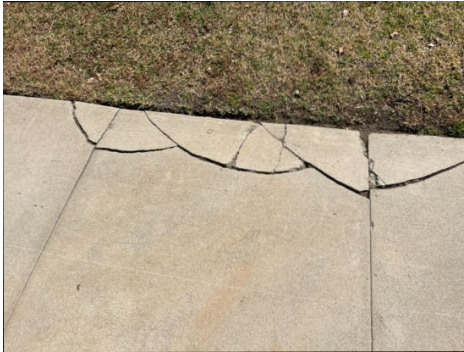
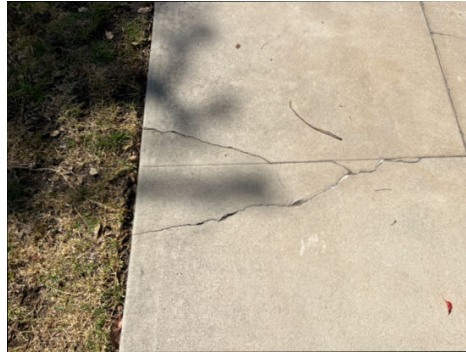
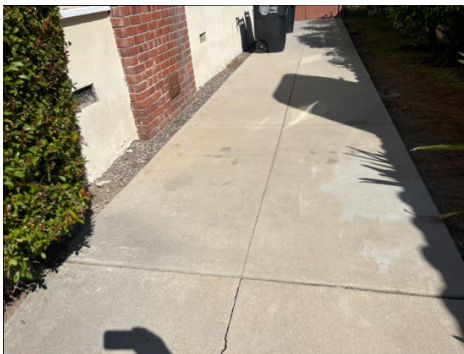
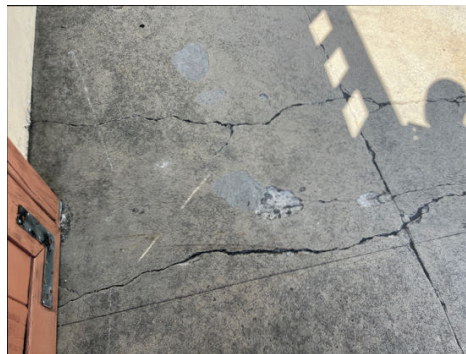
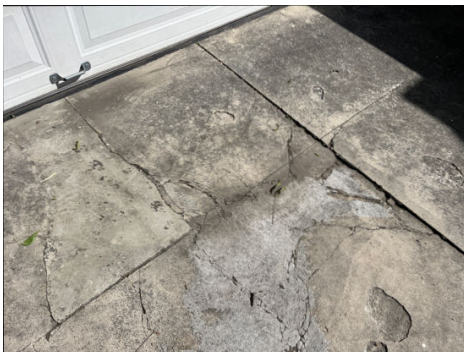
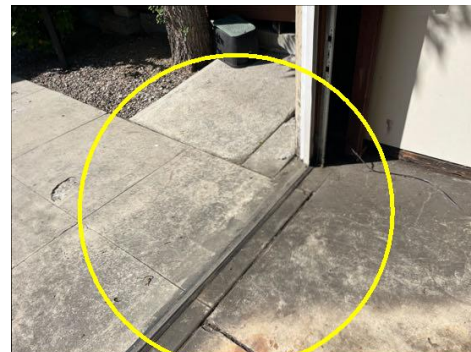
1.1. Walks: uneven surface/trip hazards noted - safety concern. Have it checked and repaired by a Qualified Contractor.

1.2. Evidence of Poor Drainage present at driveway and walkway surfaces. Recommend further evaluation, repair by a Qualified Contractor(s).

1.3. Cracks present at driveway - have it checked and repaired/ replaced by a Qualified Contractor.

1.4. Poor drainage noted at driveway - slopes toward the garage. Have it checked and repaired by a Qualified Contractor.

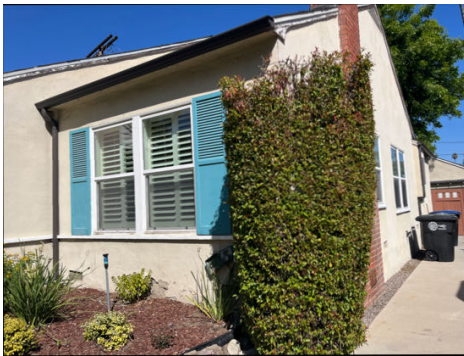
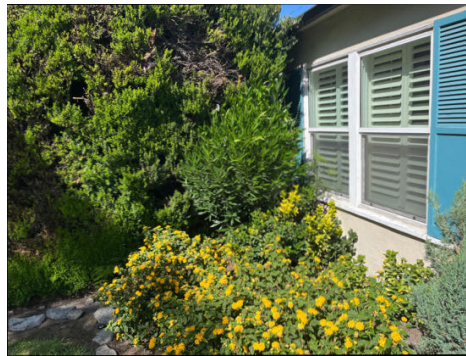
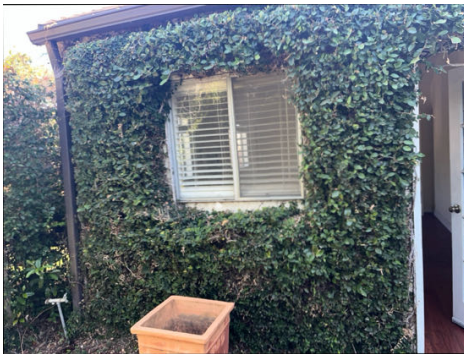
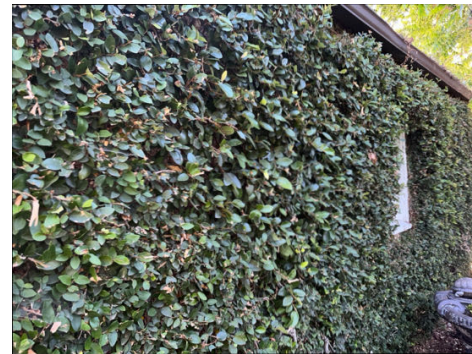
2.1. Plants/shrubs touch structure. Recommend to move sprinklers and vegetation minimum 2' away from structure/foundation to prevent damage.

2.2. Trees noted planted too close to the structure which may require removal in order to prevent damage to the foundation. Have it checked and removed by a Qualified Specialist.

2.3. Tree limbs that are in contact with roof or hanging near roof should be trimmed away. Recommend to trim away and inspect the roof.

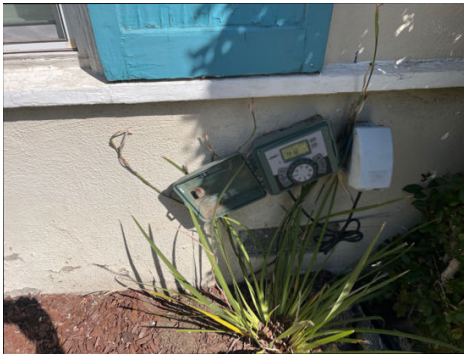
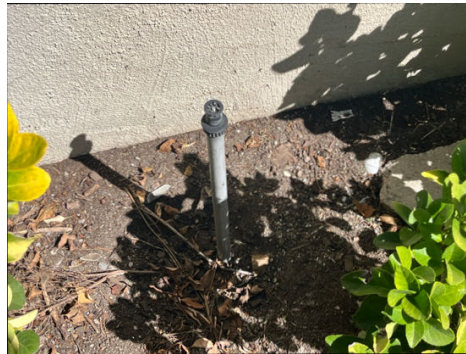
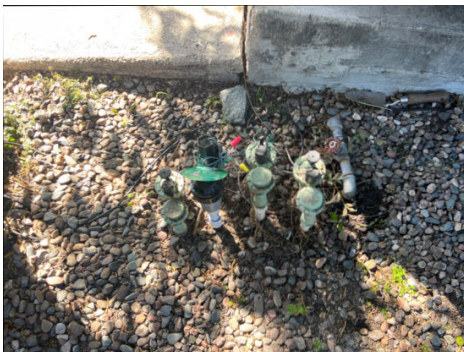
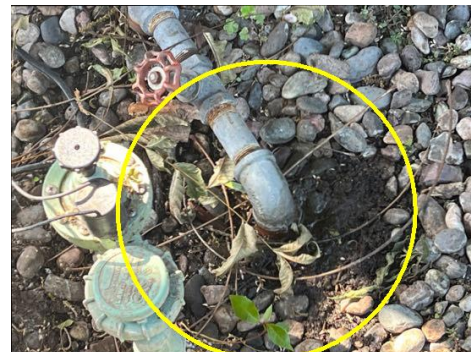
3.2. Sprinklers are set too close to the building/structure. Recommend moving sprinklers minimum 2' away from structure. Recommended to keep water/vegetation away from structure/foundation.

3.3. Exposed **PVC** type pipes noted at the sprinkler system which is subject to UV ray damage - have it covered/ sealed. Sprinkler systems are not a part of this inspection, Information provided as a courtesy.

3.4. Leaking noted at the sprinkler water supply pipe. Have it checked and repaired by a specialist.

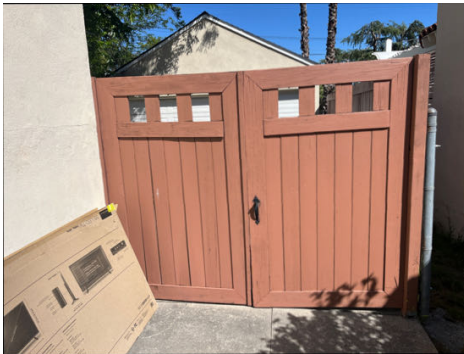
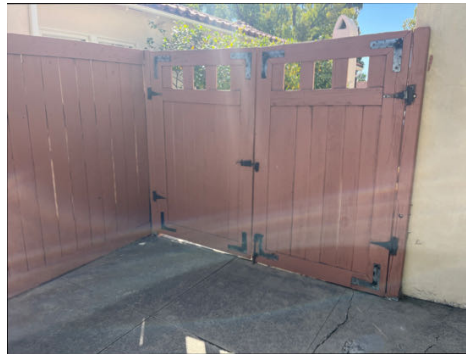
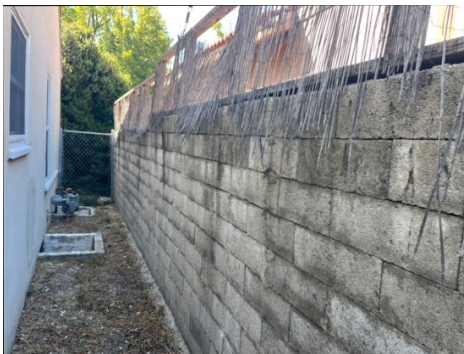
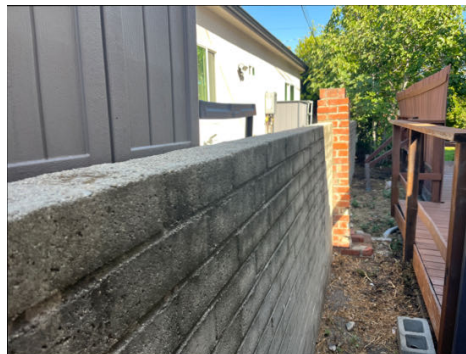
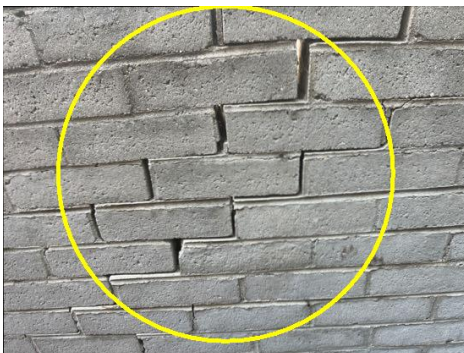
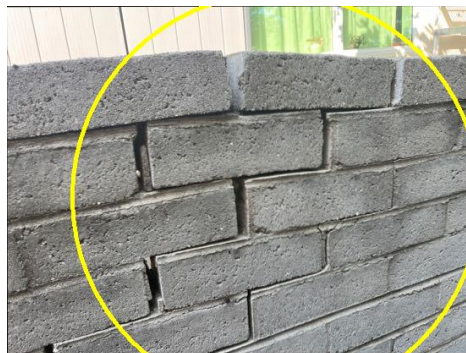
4.2. Cracks found at masonry wall system. Recommend hiring a qualified masonry contractor for complete system evaluation and necessary repairs.

4.3. Gate needs adjustment or repairs. Have it checked and fixed by a qualified specialist.

4.4. Fencing was loose/leaning at areas. Recommend Further Evaluation and repairs by qualified contractor.

4.5. Old/weathered/damaged wood boards noted. Have it checked and repaired by a qualified contractor.

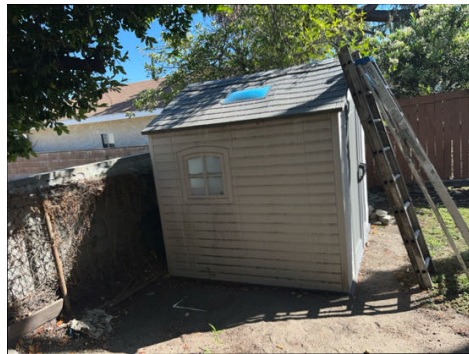
5.2. Storage shed noted. Not part of this inspection. Check the records.

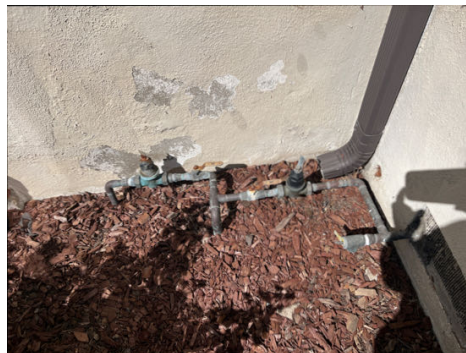
Hose Bibs: Missing anti-siphon valve at hose bibs (An anti-siphon (or, anti-siphon) valve is a device that prevents liquid from returning to the line from which it came if a siphon action occurs). Recommend to install.

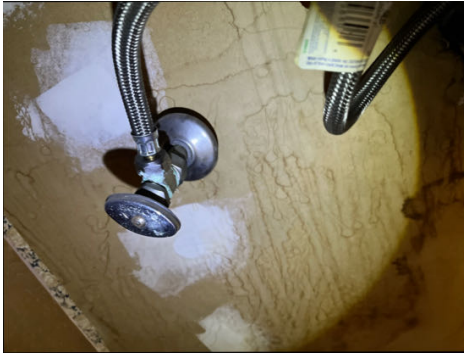
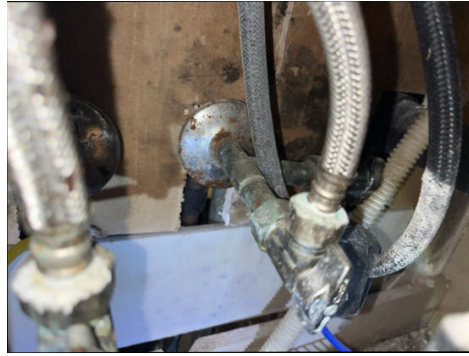
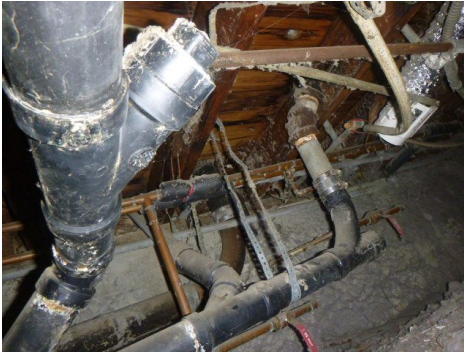
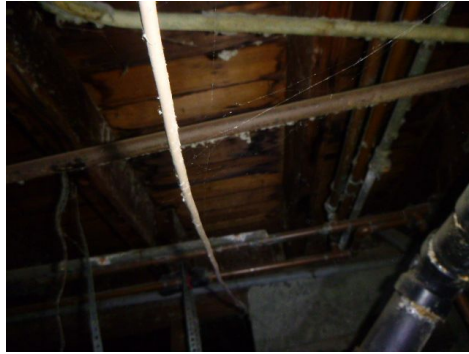
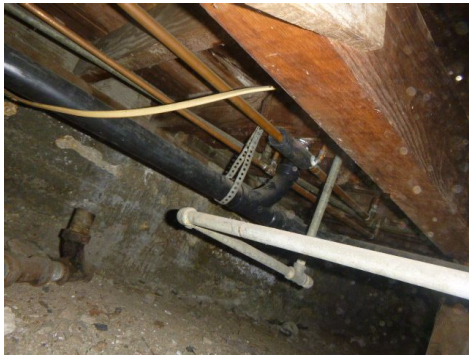
2.2. Newer pipes noted. Recommend to check the records/permits on re-piping and scope of re-piping.

2.3. Some of the pipes were not properly secured/strapped in crawl space. Have it checked and repaired by a qualified plumber.

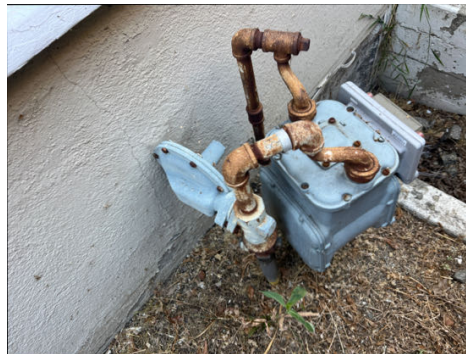
3.2. Gas meter(s) - Seismic shut off was not present at the time of inspection. Recommend to install. Have it checked/installed by a qualified plumber and or retrofitter.

3.3. Underground gas pipes noted - type unknown. Gas leaks or pipe testing not part of this inspection. Recommend to check the building records and permits for any known issues/repairs regarding gas pipes, fuel systems and or have it tested by The Gas Co and/or a qualified plumber.

3.4. Gas lines at exterior were not sealed/painted. Have it checked and repaired by a qualified plumber.

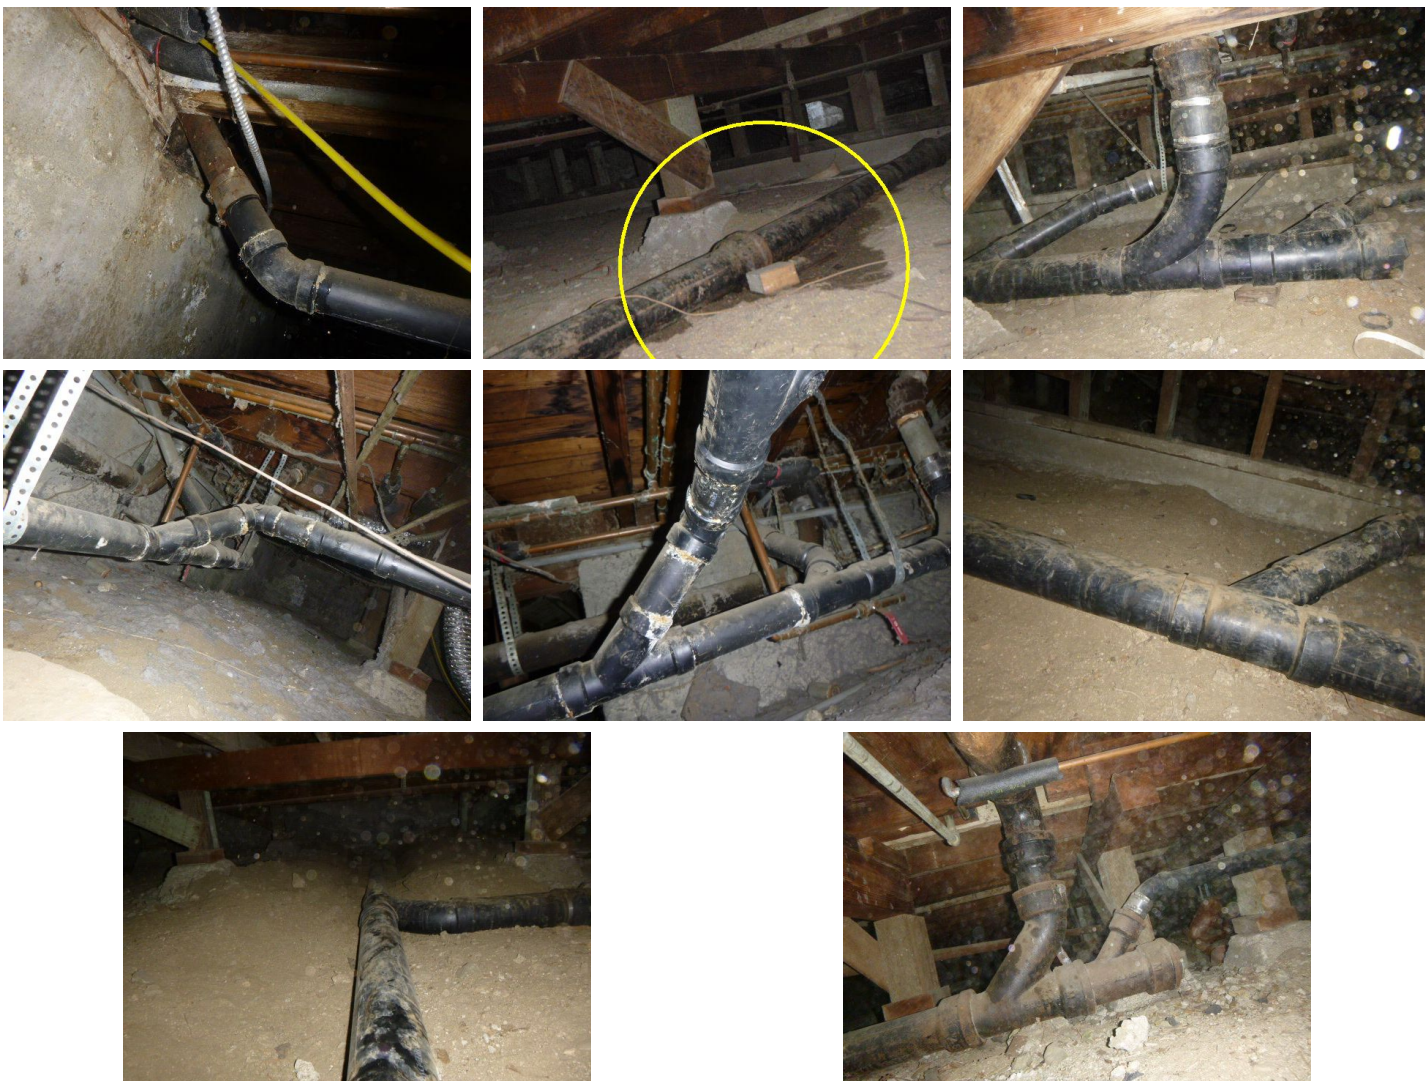
4.6. Support method of the ABS waste pipes in the crawl space are considered to be inadequate - Lacks rigid support. Have it checked/ secure.

4.7. Recommend further and complete System Evaluation and repair/replacement by a qualified plumber.

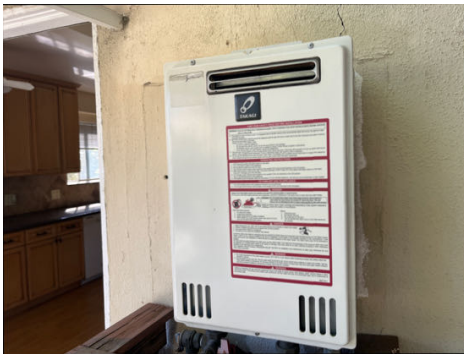
1.3. Tankless water heater noted - to determine if the proper size gas line is used for this application is beyond the scope of Home Inspection. Recommend to check the permits for water heater installation and or have it checked by a Qualified Plumber.

1.4. Water heater installed too close to the doors. Check the records and permits.

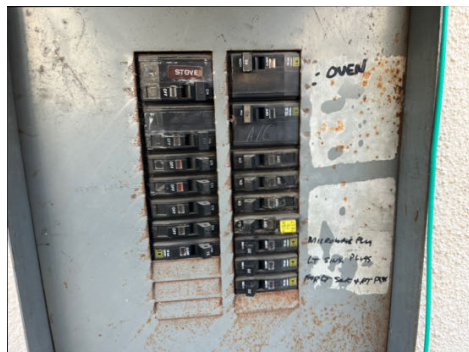
- 200 Amp Main Service

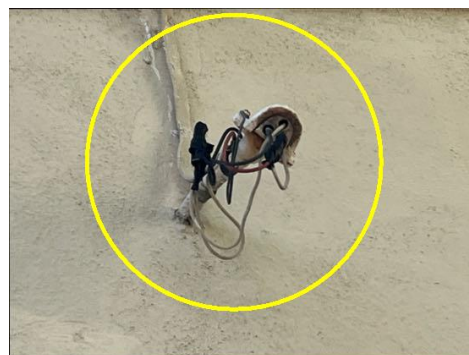
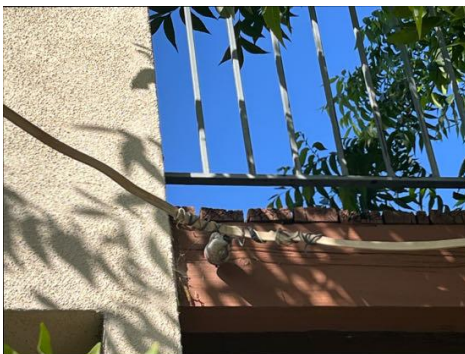
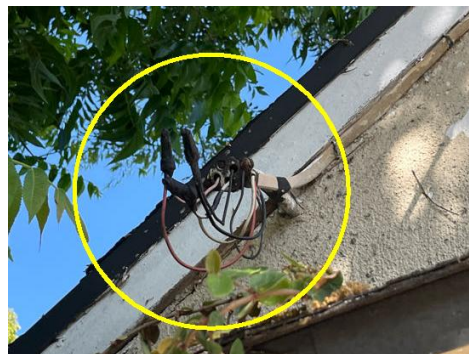
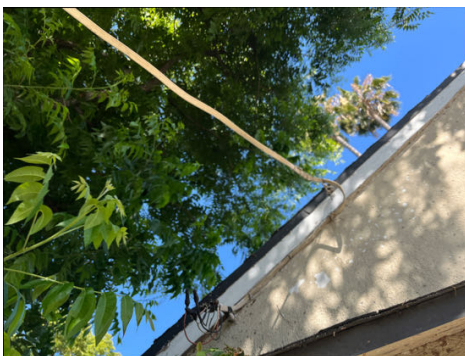
3.2. Improper wiring at garage noted - safety/ fire hazard/ concern. Have it checked and fixed by a qualified electrician.

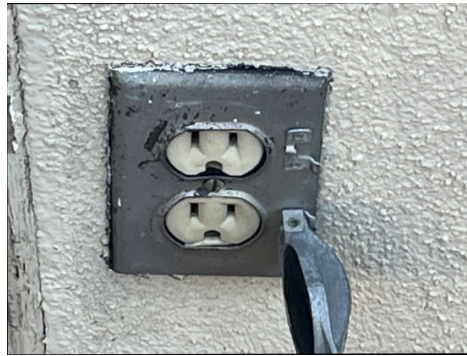
4.1. Exterior outlet without proper water proof cover noted. Recommend to install to prevent water seepage/ damage.

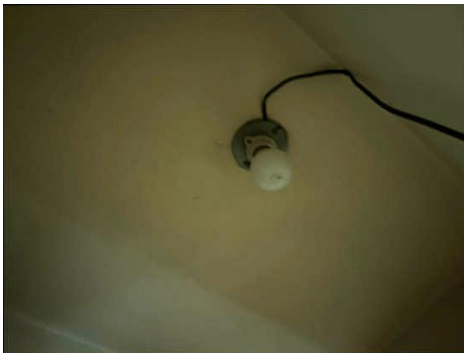
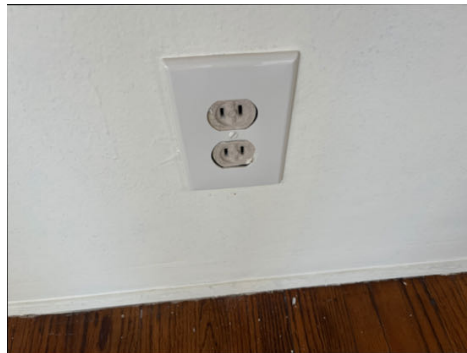
6.2. Closet lights noted - Missing lens/cover - Subject to damage. Recommend to upgrade the fixture for safety.

6.3. Non grounded outlets noted. Recommend to replace/upgrade. Have it checked and replaced by a qualified electrician.

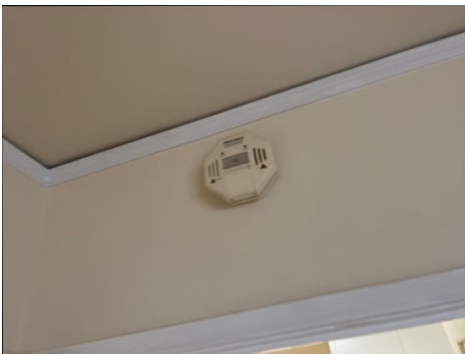
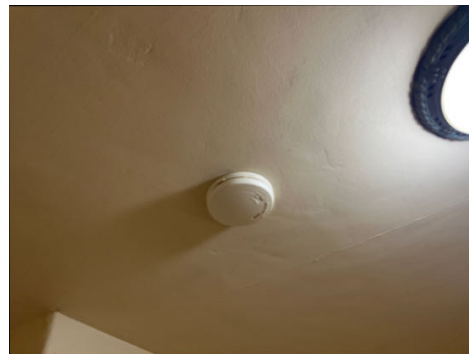
Recommend to have functional smoke and carbon monoxide detectors per City/Manufacturers requirements and test them periodically. **THIS IS A HEALT/SAFETY CONCERN.**

7.2. Recommend to install carbon monoxide detectors per City/Manufacturers requirements and test them periodically.

7.3. Recommend to have operational smoke detectors in bedrooms and hallways and to test them periodically.

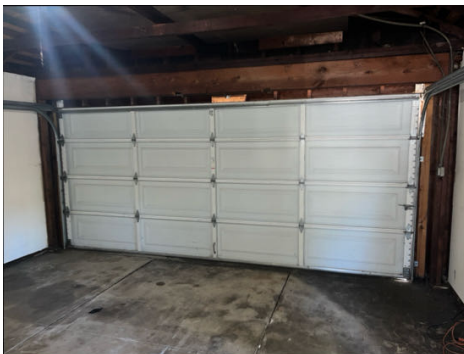
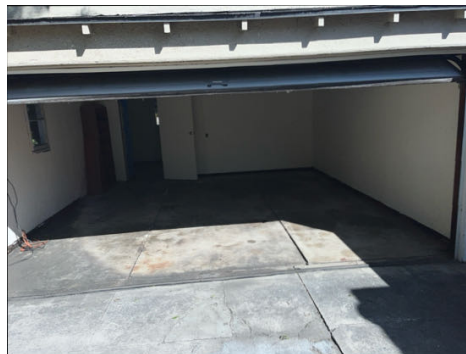
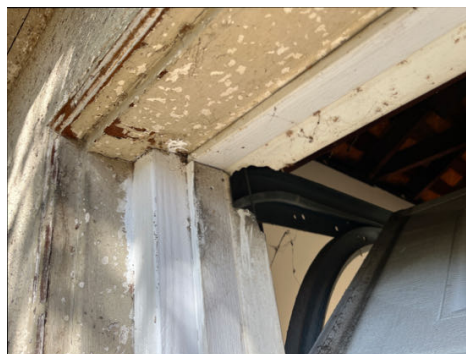
2.2. No automatic opener present - Manual vehicle door type.(FYI)

2.3. Moisture damage at garage door frame/trims noted - Recommend to have it checked by a qualified termite inspector and contractor.

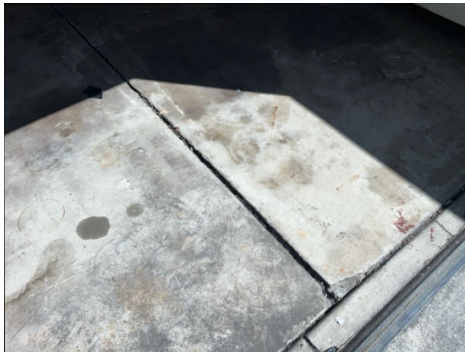
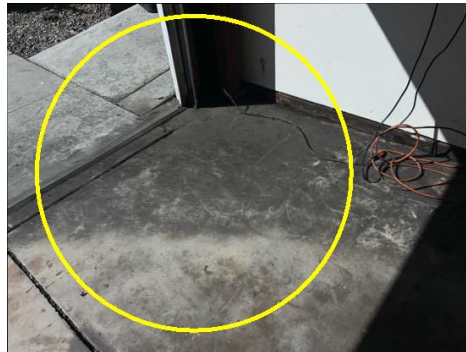
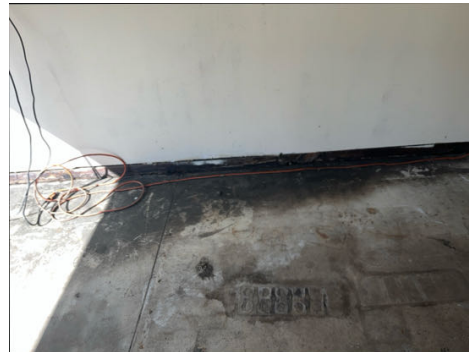
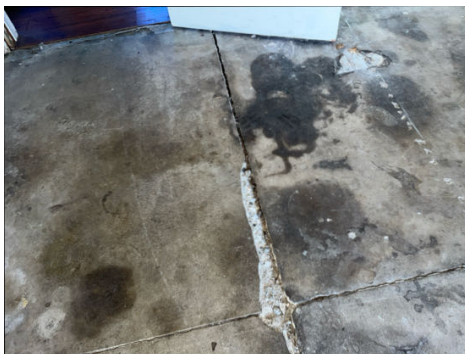
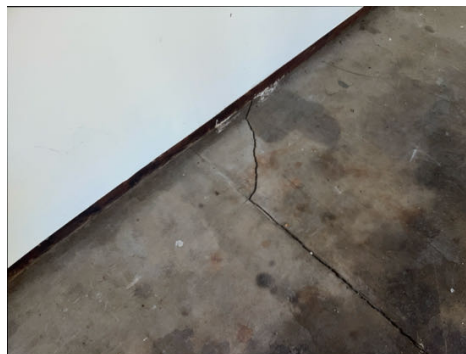
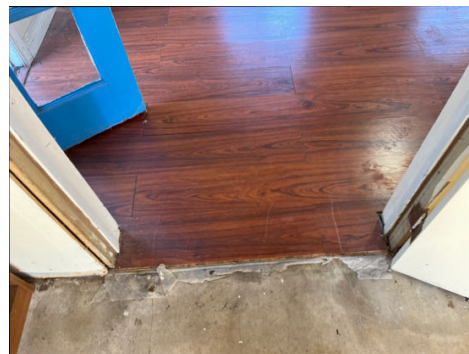
3.1. Water ponding marks noted at garage concrete floor due to seepage from exterior/ driveway. Have it checked and repaired by a specialist.

3.2. Cracks found on the garage floor. In need of further evaluation by a specialist.

3.3. Garage Bonus room Flooring was not visible at the time of inspection due to floor covering. Check the records with the seller.

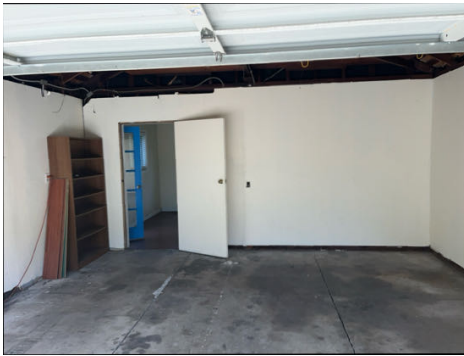
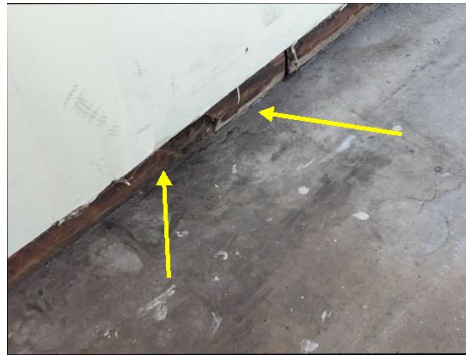
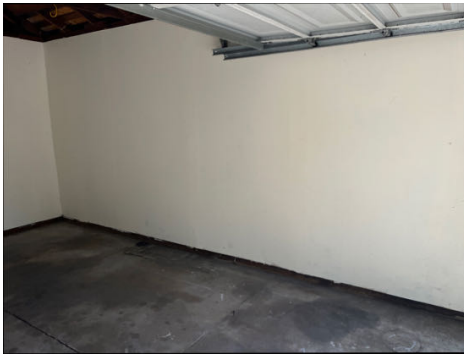
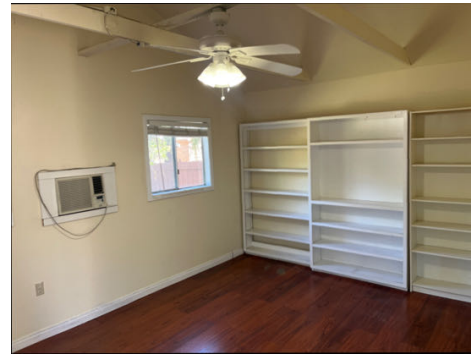
4.1. Moisture damage present at garage foundation plates/ wood boards. Have it checked and fixed by a qualified contractor.

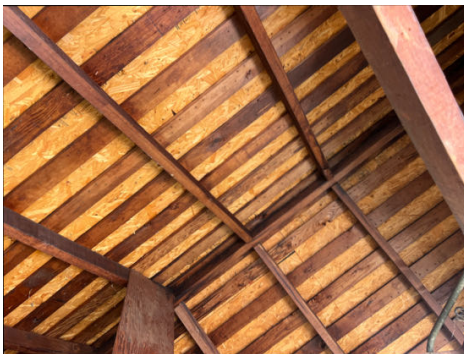
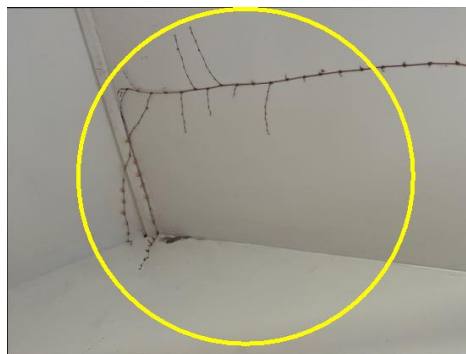
5. Ceiling and Framing

5.1. Signs of MOLD are present on garage ceiling. We did not inspect, test or determine if this MOLD is or is not a health hazard. Recommend you contact a MOLD inspector or expert for investigation or correction if needed.

5.2. Vegetation noted at the garage ceiling. Have it checked and removed.

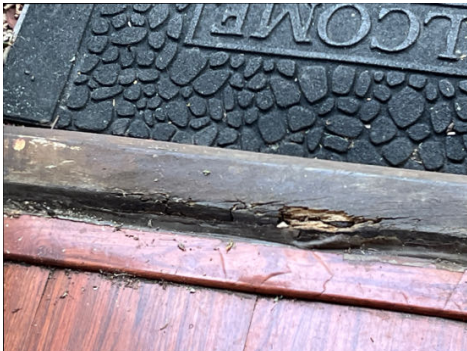
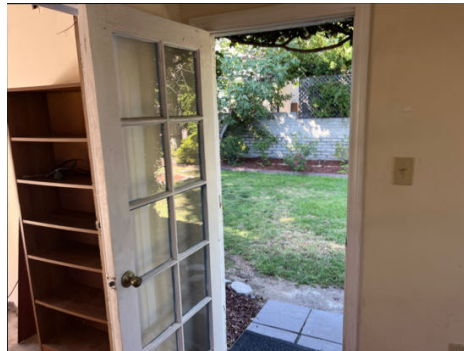
6. Garage To Exterior Door, Window(s)

6.1. Garage to exterior door frame shows moisture damage- In need of repair/replacement. Have it checked and fixed/replaced by a qualified specialist.

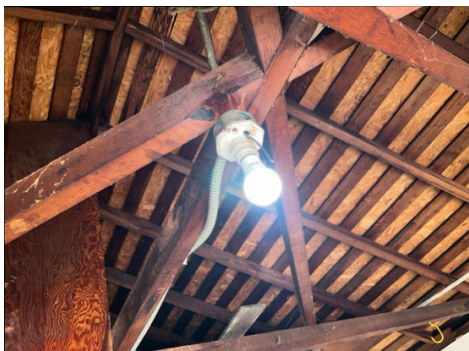
8. Garage Electric

8.1. All garage outlet required to be GFCI protected. Recommend hiring a qualified electrician for further evaluation, & necessary repairs.

8.2. Light fixture(s) missing proper lens - Recommend to install.

8.3. Exposed wires/ missing light fixture noted. Safety Hazard, Have it checked and repaired by a specialist.

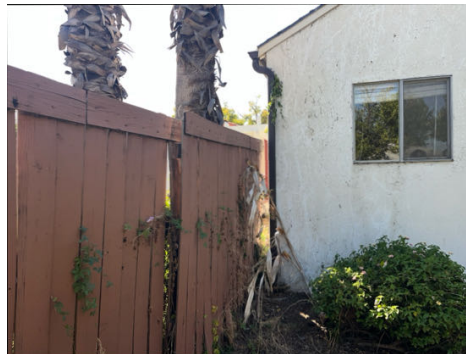
9. Exterior Grading at Garage

9.1. Garage was built on a property line. Side elevation not visible/accessible at the time. Most of the time with this type set up neighbors' side of the soil built high at the garage foundation and or planters or sprinklers set close to the structure. Have it checked by a specialist.

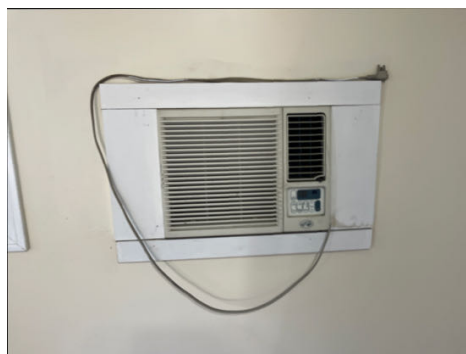
10. Garage Feature

10.1. Installation of wall /Window AC units are not part of this inspection. We have seen cases where rain water seeps inside the framing/unit due to improper installation. Check the records with the seller for any known issues with AC units and or have it checked by a qualified specialist.

10.2. Wall/Window **A/C** noted. No dedicated electric outlet noted for wall A/C - Recommend installing to prevent circuit overload/fire. Wall and Window A/C unit(s) are not tested at this inspection. Check the service/maintenance records and have it checked by a specialist.

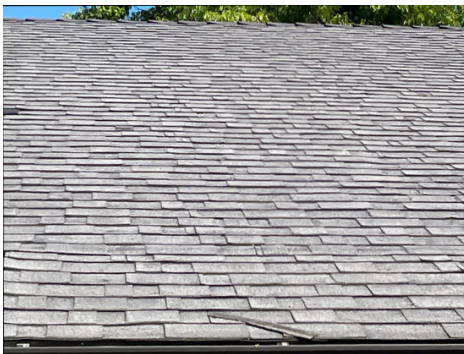
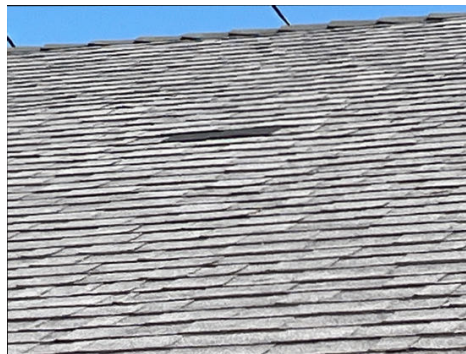
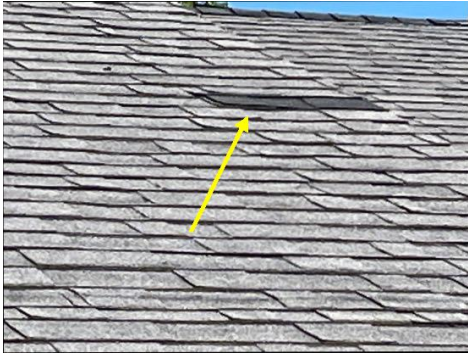
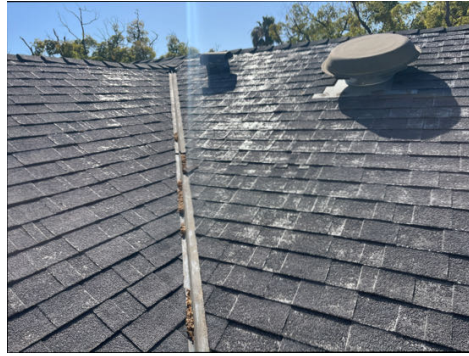
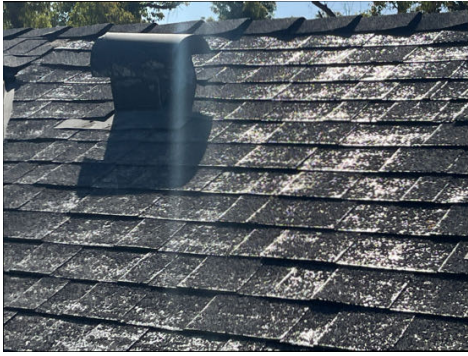
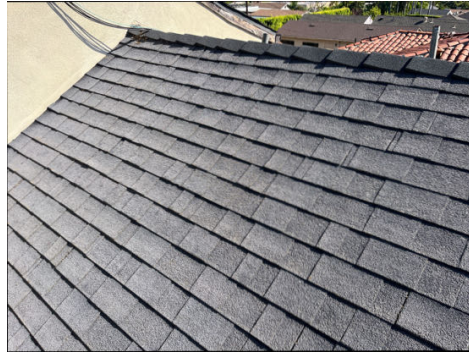
2.1. Some damaged shingles noted. Have it checked and repaired/replaced by a Qualified Roofer.

2.2. Multiple roof layers noted - not recommended, adds extra load to the framing. Have it checked, evaluated and fixed/replaced by a qualified roofer if needed.

2.3. Aged, weathered shingles noted. Lifespan of this type of roof is 20 to 30 years from the date of installation. Check the records/warranties and or have it checked by a qualified roofer for more detailed evaluation.

2.4. Tree limbs that are in contact with roof or hanging near roof should be trimmed away. Recommend to trim away and inspect the roof.

2.5. Debris noted at the Roof. May cause future leaks and/or damage. Recommend to remove/clean and have it inspected by a Qualified Roofer.

2.6. Recommend further and complete evaluation, repair/ replacement by a Qualified Roofer.

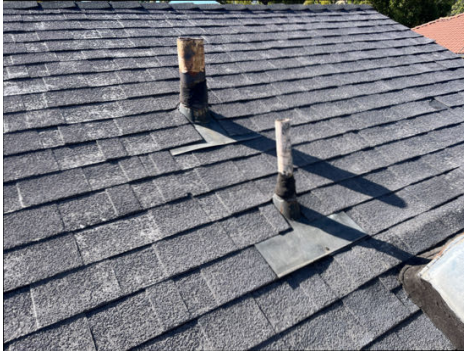
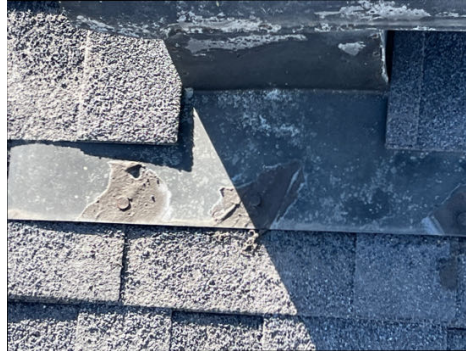
3. Flashings

3.1. Recommend to re-seal at flashings as a part of routine maintenance.

3.2. Exposed fasteners noted at the vent pipe flashing. Recommend to seal to prevent leaks.

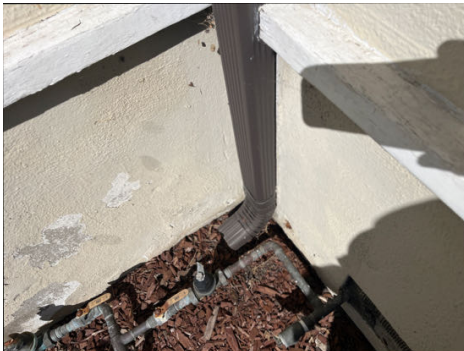
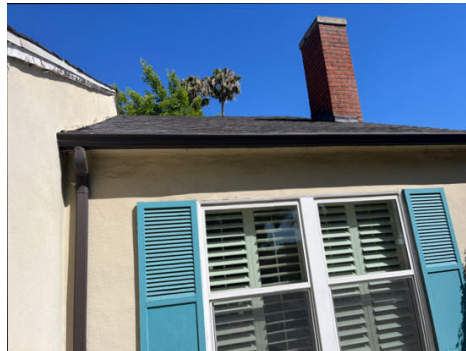
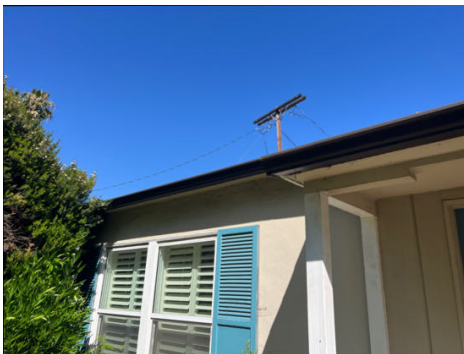
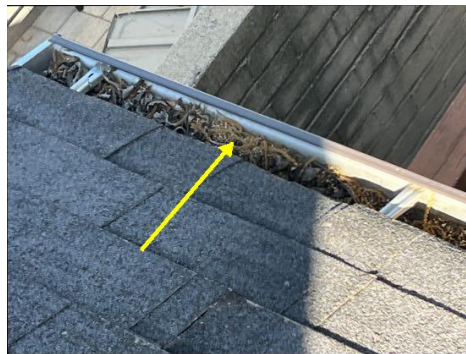
4. Roof Drainage Systems

4.1. Downspouts terminate at foundation- Poor location. Recommend to extend away from structure. Have it checked by a qualified drainage contractor.

4.2. Gutters are full of debris in areas and need to be cleaned. The debris in gutters can also conceal rust, deterioration or leaks that are not visible.

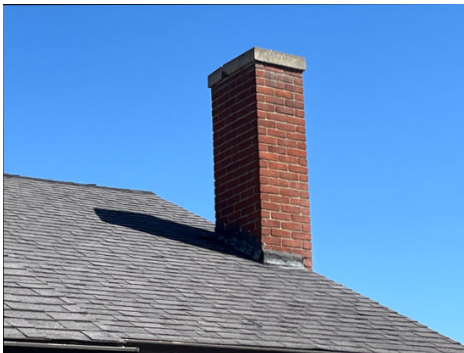
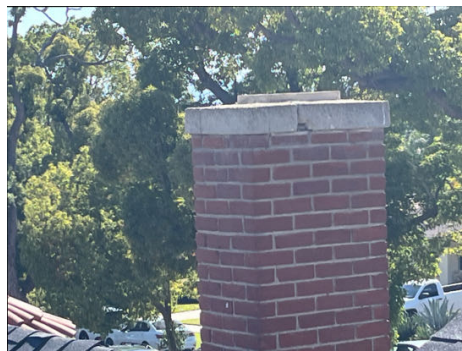
6.1. Chimney/ flue(s) are not fully visible at this inspection. Video inspection of the chimney flue by qualified Chimney Inspector is a Must. This is a limited inspection at readily visible areas of the chimney. For more detailed inspection Recommend hiring a qualified Chimney Inspector. This is a safety and fire hazard concern.

6.2. Chimney is missing spark arrestor/rain cap. Have it checked and install by a qualified specialist.

6.3. Cracked mortar at chimney cap noted. Have it checked and repaired by a qualified specialist.

6.4. Cracked and worn sealant noted at the roof flashing. Have it checked and repaired by a qualified roofer.

6.5. DO NOT USE THE FIREPLACE WITHOUT COMPLETE EVALUATION BY A QUALIFIED CHIMNEY INSPECTOR/CONTRACTOR. Recommend Further and Complete System Evaluation by Qualified Chimney Inspector- This is a safety and fire hazard concern.

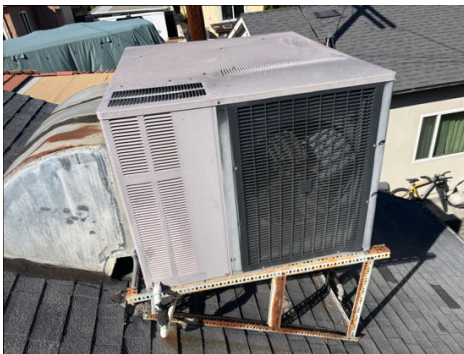
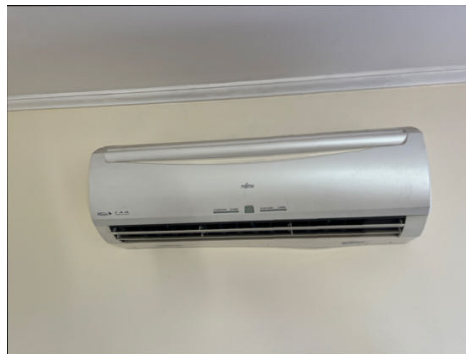
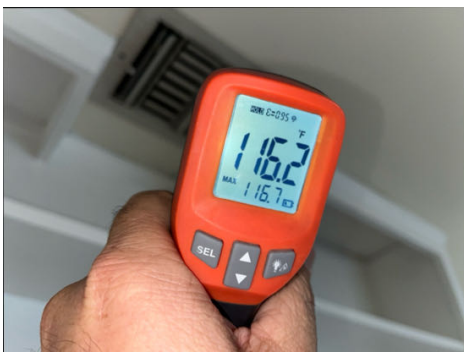
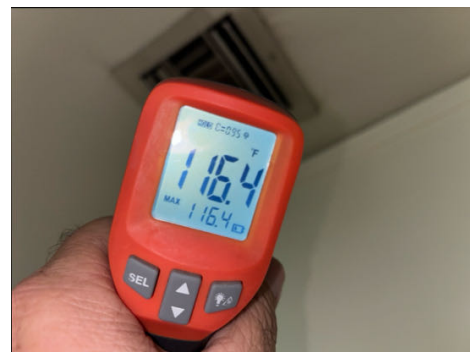
1.1. Recommend checking the service history with the Seller and to have the unit(s) serviced by a qualified HVAC Contractor if not performed in the past year. Air flow is not a part of this inspection. Recommend checking the disclosures regarding day to day functionality. No service tags noted. This is a limited Visual Inspection - Recommend having the unit(s) evaluated by a qualified HVAC Contractor. Annual service/evaluation is recommended.

1.2. Recommend hiring a qualified HVAC contractor/technician for complete system evaluation to determine condition and life expectancy of the units.

1.3. Unit operated at heat mode at the time(FYI).
