Advanced Group Property Inspections

Property Inspection Report

1368 Spazier ave , Glendale, CA 91201
Inspection prepared for: Scott Woodward
Date of Inspection: 5/30/2026

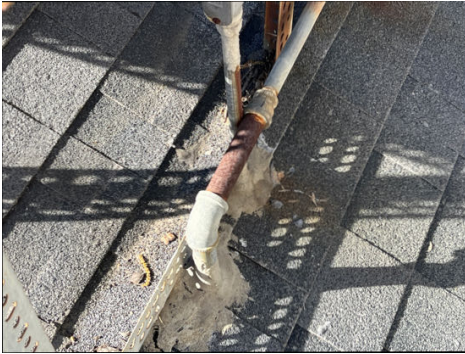
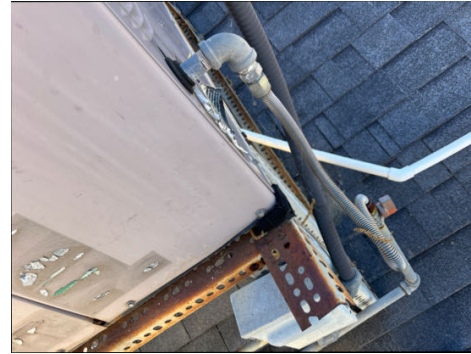
2. Gas Pipe, Closet

2.1. Gas line at heater without sediment trap. Lack of trap may void warranties - check with your Home Warranty provider. Recommend to have it checked and installed by a qualified plumber.

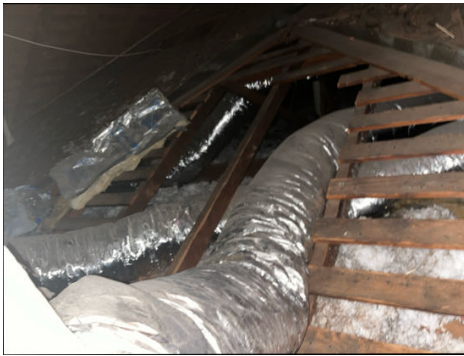
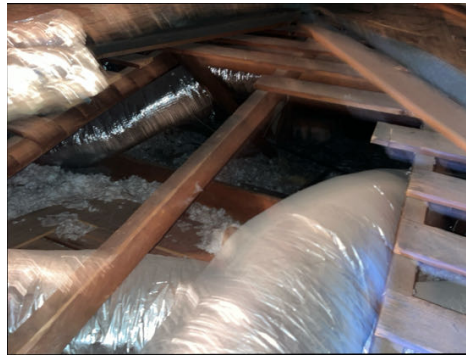
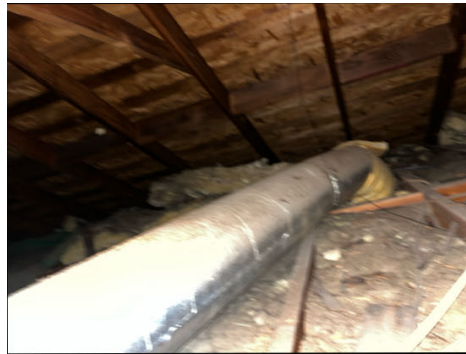
4.2. Interior walls of ducting not visible at this inspection. Recommend to have them checked cleaned/serviced/sanitized by a Qualified HVAC Technician.

4.3. Newer air ducts noted- Recommend checking the records and permits.

4.4. Air ducts are not properly secured/strapped in the attic- poor workmanship noted. Have it checked/repared by a Qualified Technician.

4.5. Dark marks noted at air grills- Indicates dirty ducts, dirty coil, and filter. Have it checked/repared/replaced by a Qualified Technician.

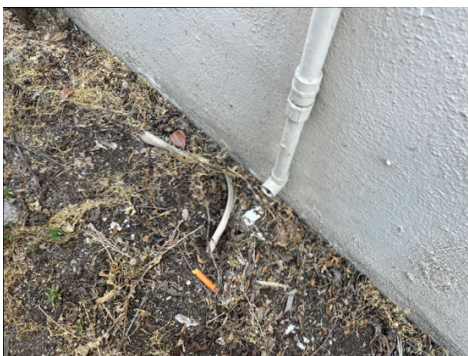
8.1. A/C condensation line drains at foundation - Poor location. Recommend installing gravel pit.

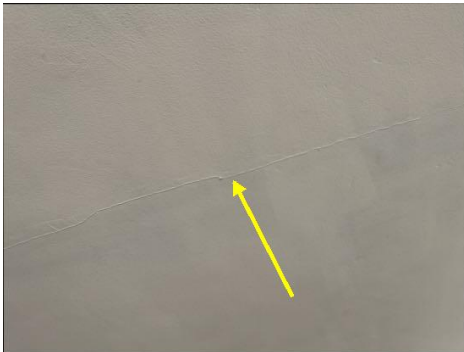
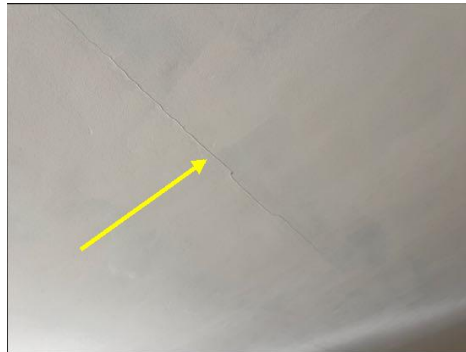
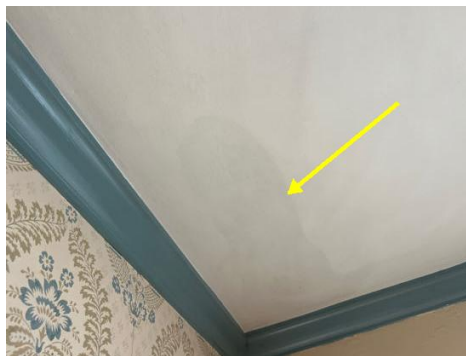
1.1. Cracks noted at interior ceiling. Have it checked and repaired.

1.2. Stains noted at bedroom interior ceiling. Have it checked and repaired by a specialist.

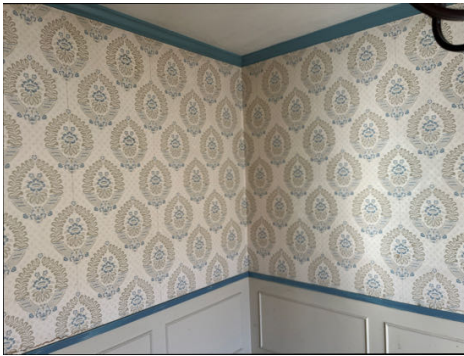
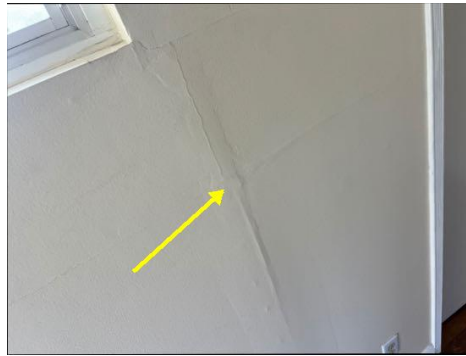
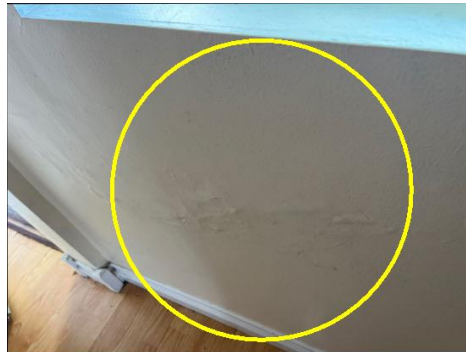
2. Walls

2.1. Wallpaper is installed on the walls, unable to determine condition of the walls behind the coverings.

2.2. Prior patching noted at interior walls. Check the records with the seller.

2.3. Damage noted at interior wall possible due to seepage from window/ frame. Have it checked and repaired by a specialist.

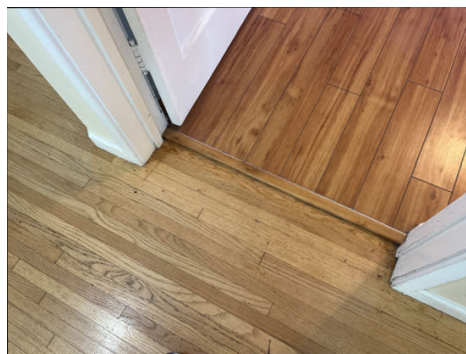
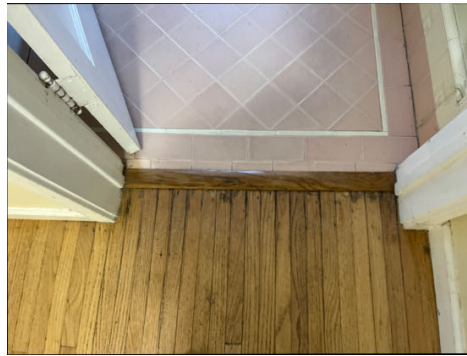
3. Floors

3.1. Trip hazards noted due to differing flooring material heights. Use caution (this type installation is common when different flooring materials are used).

3.2. Common Worn/aged flooring materials noted of the inspected property. May need repair/replacement.

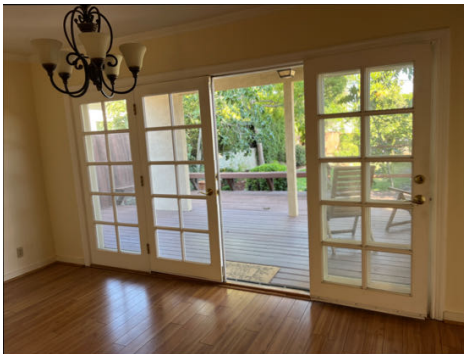
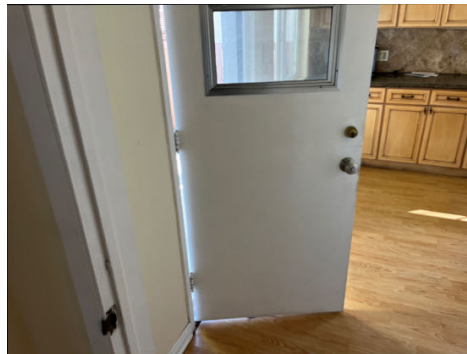
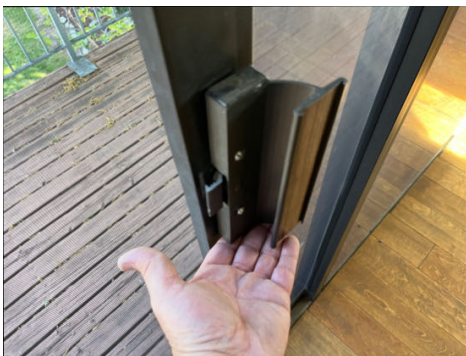
4. Interior/Exterior Doors

4.1. Recommend installing/fixing door stops to prevent wall damage. (FYI)

4.2. Loose handle noted at slider. Have it checked and repaired.

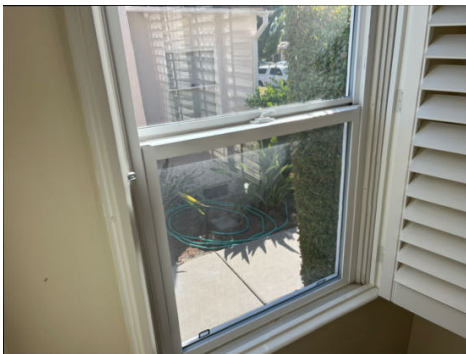
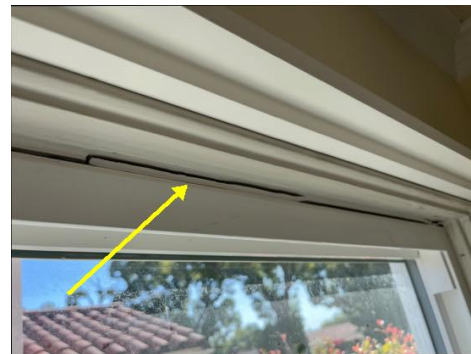
5. Interior Windows

5.3. Dual pane windows noted. It is not always possible to determine fogging of this type of window due to temperature changes, etc. Check with the seller for any know defects/repairs.

5.4. Newer windows noted- check the records/warranties.

5.5. Damage noted at window trim. Have it checked and repaired by a specialist.

5.6. Building with old Aluminum windows type. Recommend upgrading. Have it checked by a Qualified Glazing Contractor.

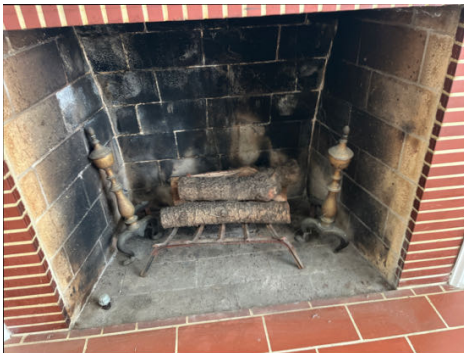
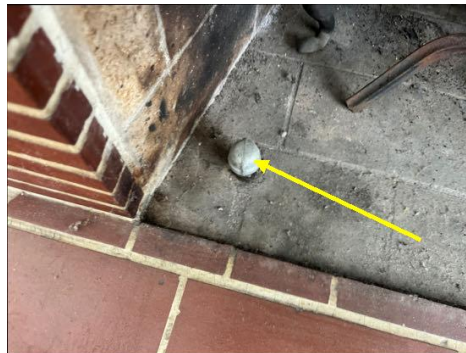
6. Fireplace

6.2. Soot build up noted at walls/mantel- Indicates improper venting- Have it checked by a qualified specialist. This is a safety/fire concern.

6.4. Moisture stains noted at fire bricks- Keep exterior water away from structure. Have it checked by a qualified specialist.

**6.5. DO NOT USE THE FIREPLACE WITHOUT COMPLETE EVALUATION BY A QUALIFIED CHIMNEY INSPECTOR/CONTRACTOR.
Recommend Further and Complete System Evaluation by Qualified Chimney Inspector- This is a safety and fire hazard concern.**

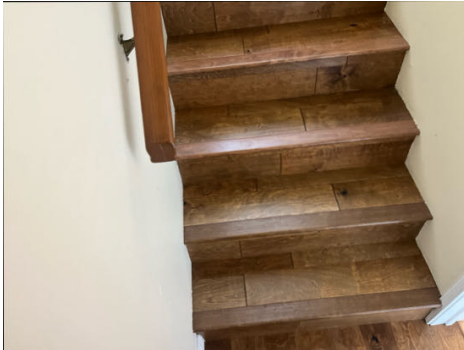
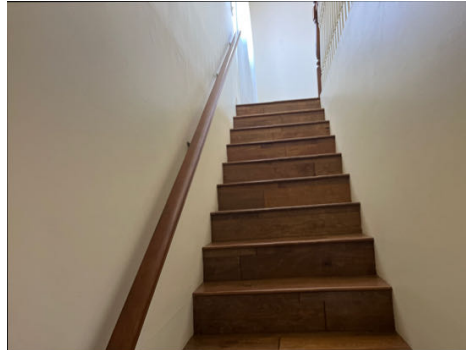
7. Steps, Stairways, and Railings

7.1. Handrail at interior stairs is not to current safety standards - Does not return to wall at top landing (trip hazard). Correction/Safety upgrade recommended.

7.2. Handrails were not today's standards for safety. Were not grippable type. Recommend upgrading.

7.3. Movement noted at the railing. Safety Concern. Have it checked and repaired.

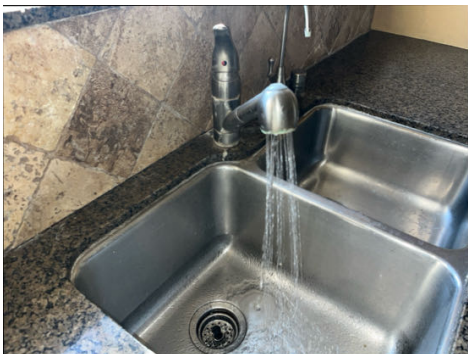
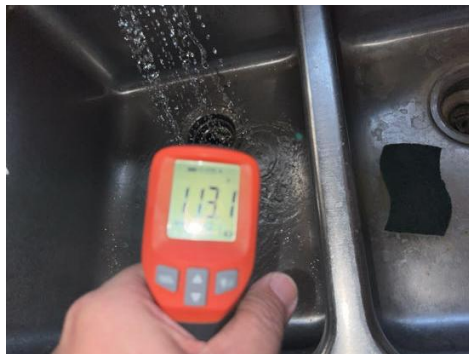
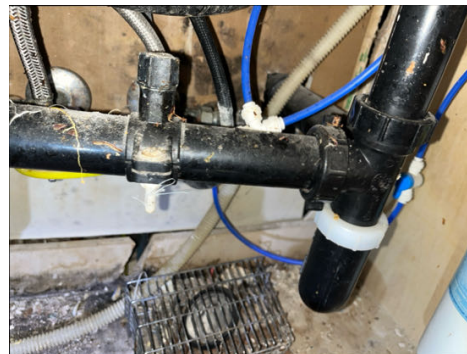
4.1. Sink faucet was functional at the time. (FYI)

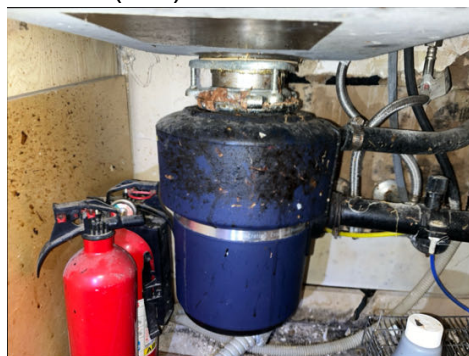
5. Food Waste Disposer

5.1. Disposer was functional at the time. (FYI)

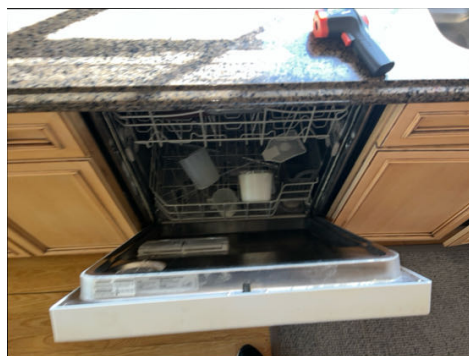
6. Dishwasher

6.1. Dishwasher operated at the time.

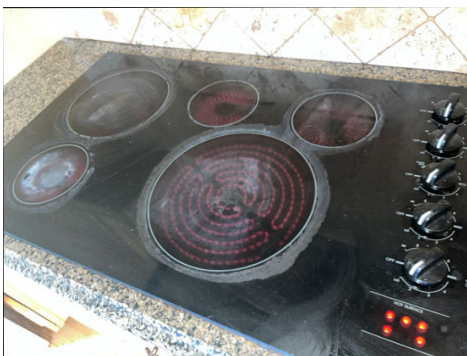
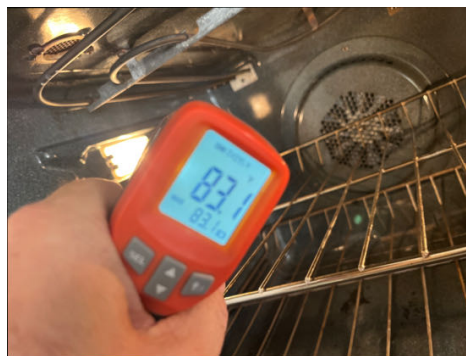
7. Ranges/Oven/Cook Tops

7.1. Oven was operational at the time.(FYI)

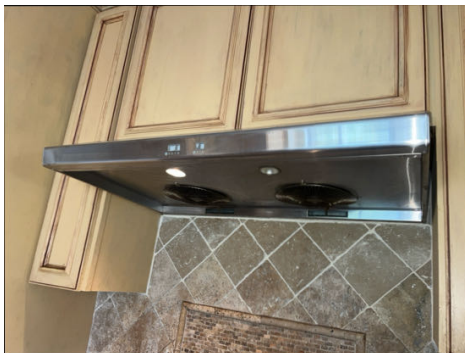
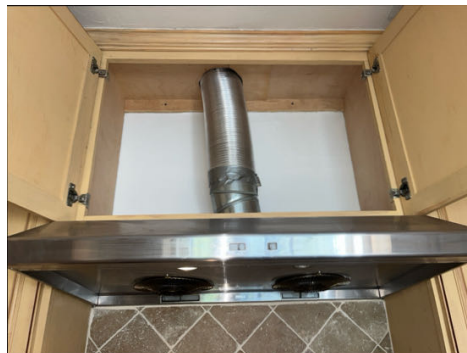
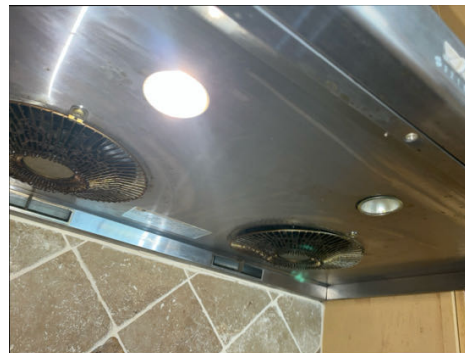
8. Range Hood

8.1. Range hood was functional at the time. (FYI)

8.2. One Hood light didn't work. Have it checked and repaired by a qualified specialist.

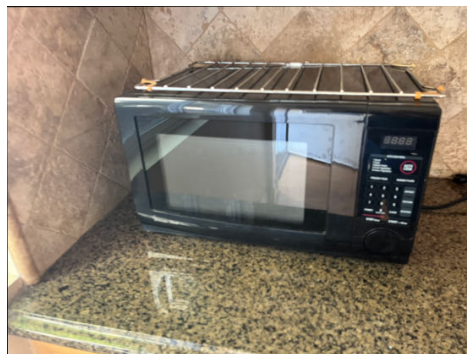
9. Microwave

9.1. Microwave noted - not part of this inspection. Check with the seller. Proper operation and or microwave leak is not part of this inspection. We turn the unit on and off and check for visual defects.

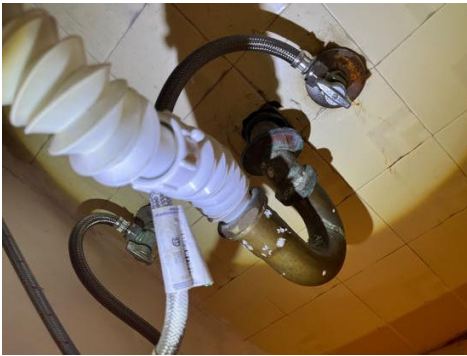
2.1. Flex type tubing was used at sink drain (flex tubes designed for temporary fixes- Not recommended for permanent use due to possible trapping/growing of bacteria). Recommend replacing with solid tube type.

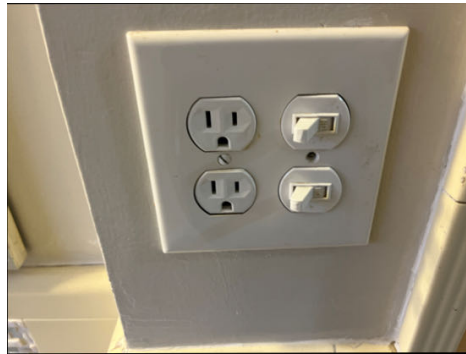
3.1. Recommend installing GFCI type outlet at Bathroom(s) and test it periodically. This is a safety concern.

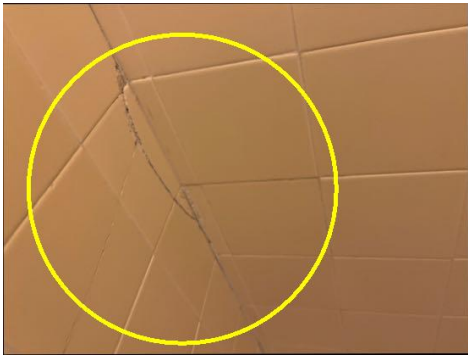
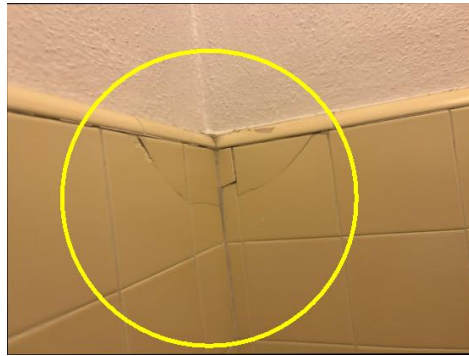
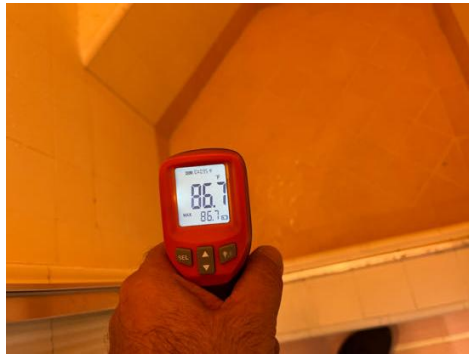
6.1. Cracked wall tiles noted- hidden damages may exist. Have it checked and repaired/ replaced by a qualified contractor/ specialist.

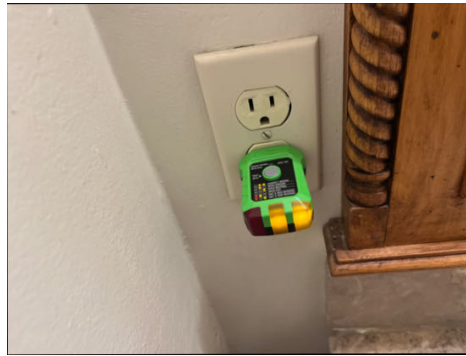
- 3.1. Recommend installing GFCI type outlet at Bathroom(s) and test it periodically. This is a safety concern.

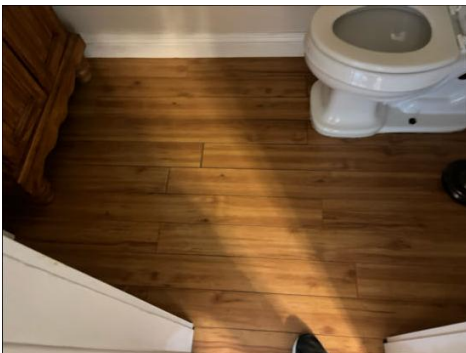
5.1. Wood/laminate floors at bathroom noted- not recommended. Periodic care required- may warp due to moisture. (FYI)

5.2. Some expanded gaps noted at flooring material joints. In need of further evaluation by a qualified floor specialist.

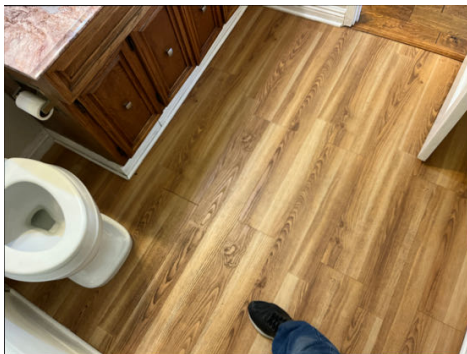
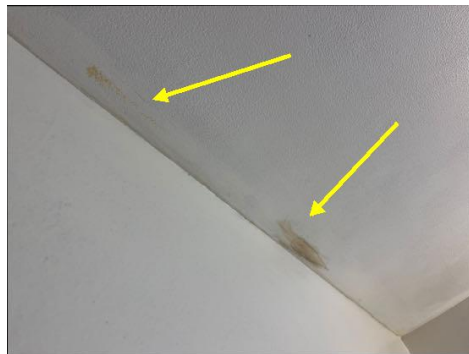
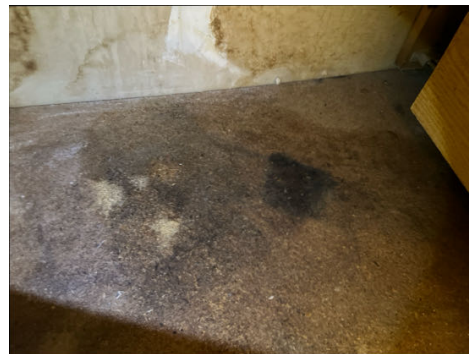
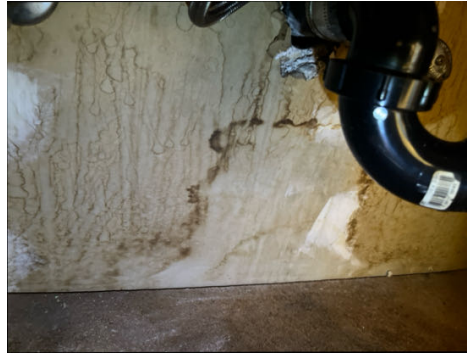
5.1. Wood/laminate floors at bathroom noted- not recommended. Periodic care required- may warp due to moisture. (FYI)

5.2. Moisture stains noted at bathroom ceiling. Have it checked and repaired by a specialist.

5.3. Old water stains noted under sink cabinet. No active leak noted at the time. Check the records with the seller.

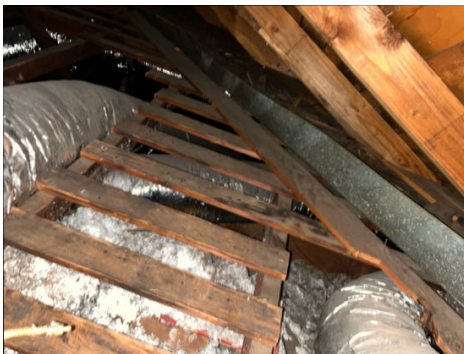
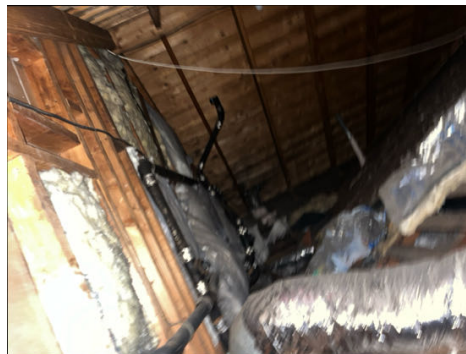
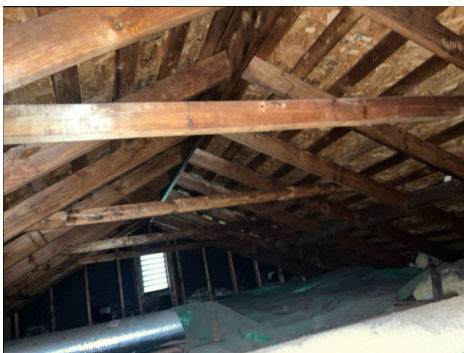
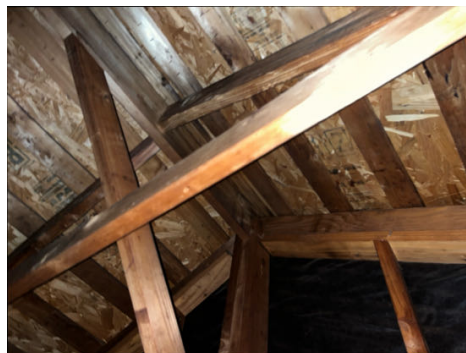
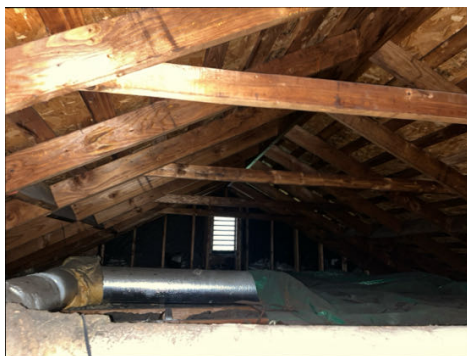
2.1. Water staining was noted to the structure at the time of inspection. Unable to determine if leak is present and/or been fixed. Check with the seller for any known roof leaks/repairs and have it checked by a qualified roofer to make sure roof is free of leaks.

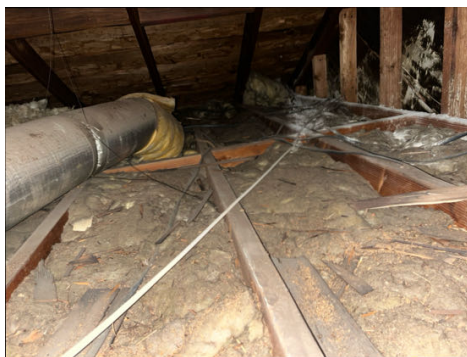
- Fiberglass

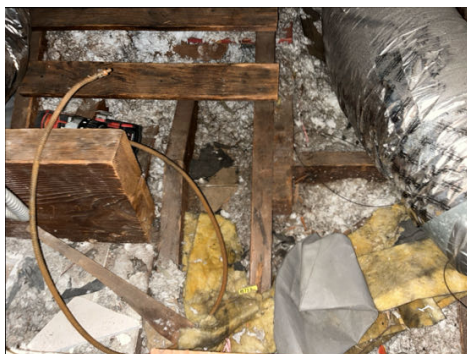
5.2. Evidence of pest droppings noted in the attic - safety/health concern. Have it inspected and cleaned by a qualified specialist(s).

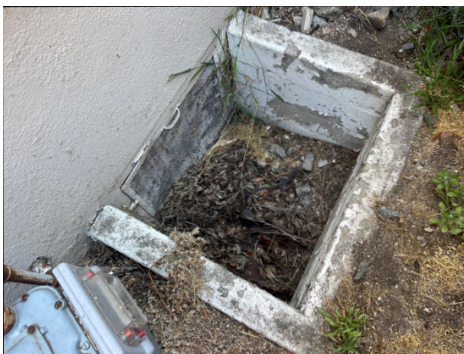
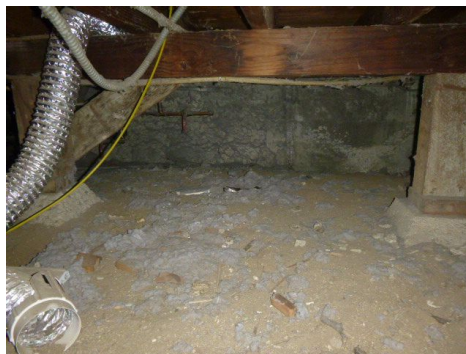
1.3. Construction debris noted in the crawl space which should be removed.

1.4. Efflorescence was noted present on the foundation walls. Recommend to keep moisture around the inspected property to a minimum.

1.5. Water seepage from access openings noted. Recommend installing proper cover with vents to prevent the seepage. Have it checked and corrected by a qualified specialist.

1.6. Dryer vents under the house. Lint/ build up noted in crawlspace, Fire Hazard. Have it checked and repaired by a specialist.

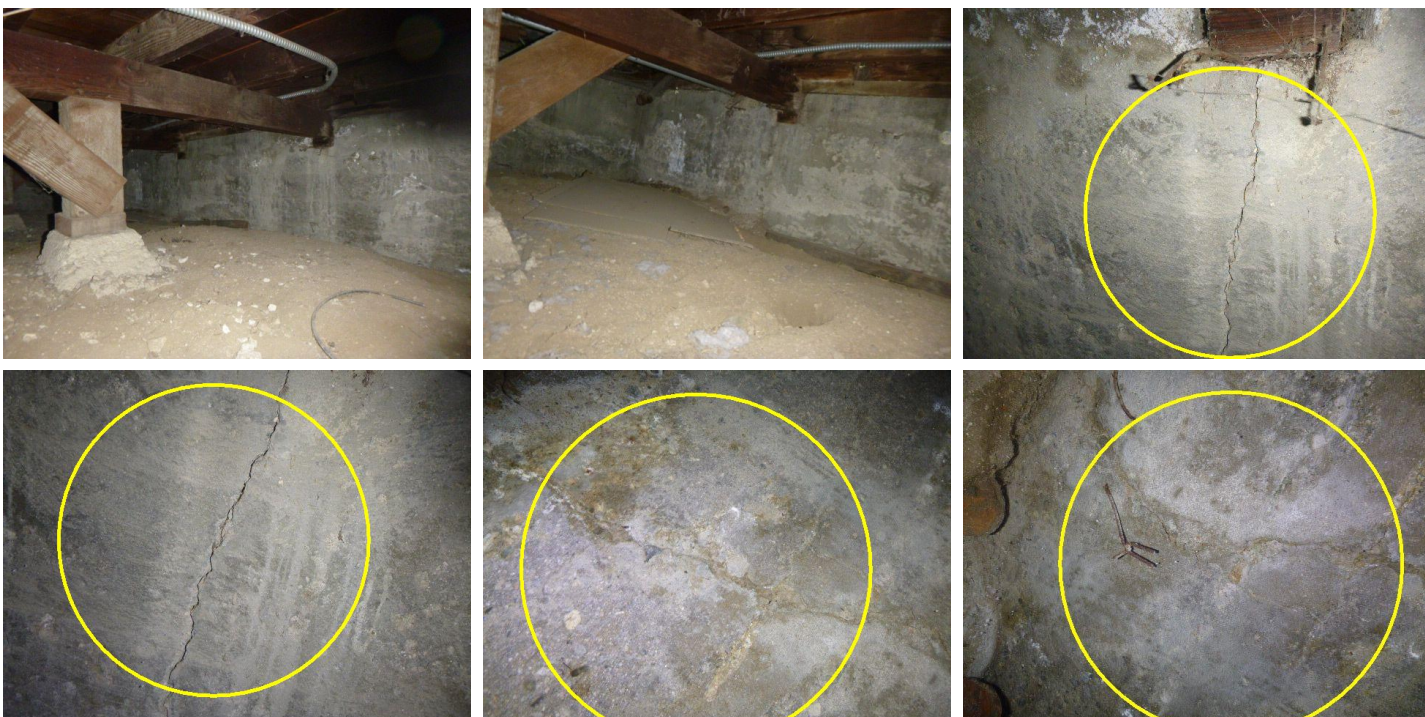
2.3. Cracks/deterioration at foundation walls noted. Have it checked by probing. In need of further evaluation by a qualified foundation Contractor.

2.4. Recommend further and complete Foundation System Evaluation by a Qualified Foundation Contractor.

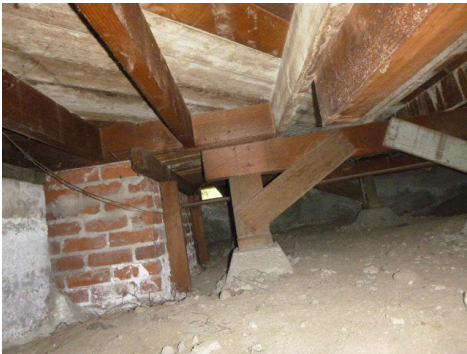
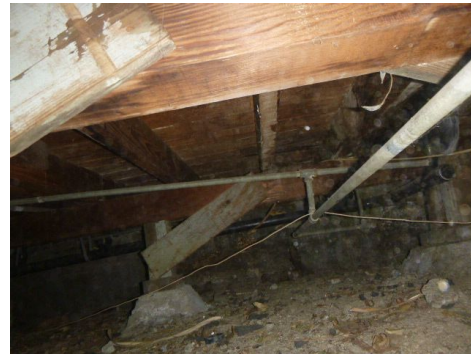
3.1. This is an Old raised Foundation type structure. Further evaluation of foundation walls and framing by a qualified foundation contractor/ inspector is recommended by This Inspection Co.

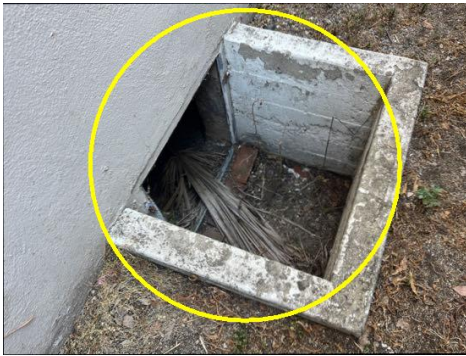
5.2. Some vent screens noted damaged. Repairs/replacement of damaged screens is recommended.

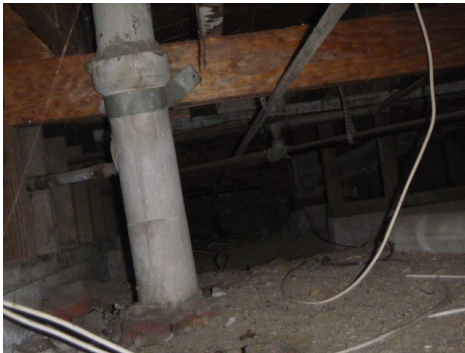
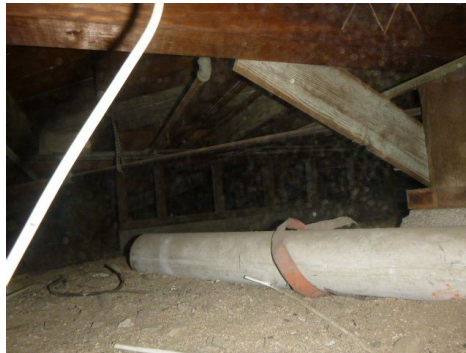
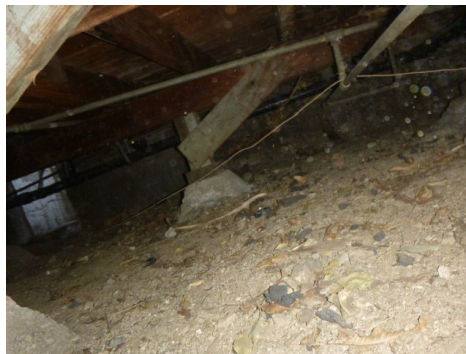
6.3. Old, disconnected/not in use floor heater with Transite pipe noted in crawl space(Transite pipe is an asbestos-cement product which was used for both Water heater, HVAC ducts and for chimney or flue material to vent gas-fired appliances). Recommend to remove and capped the gas pipe.

6.4. Evidence of pest droppings noted in crawl space - safety/health concern. Have it inspected and cleaned by a qualified specialist(s).

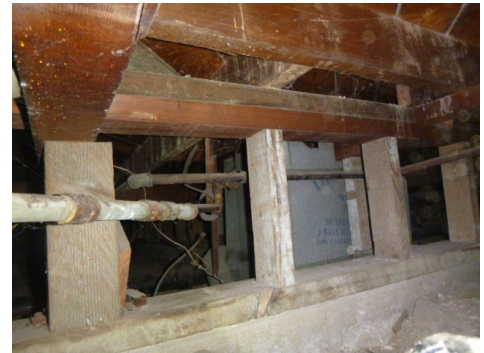
6.5. Recommend further and complete Foundation System Evaluation by a Qualified Foundation Contractor.
