## GENERAL RESIDENTIAL INSPECTION

1920 W Spring St  
Long Beach, CA 90810

Sai Tong  
12/07/2025

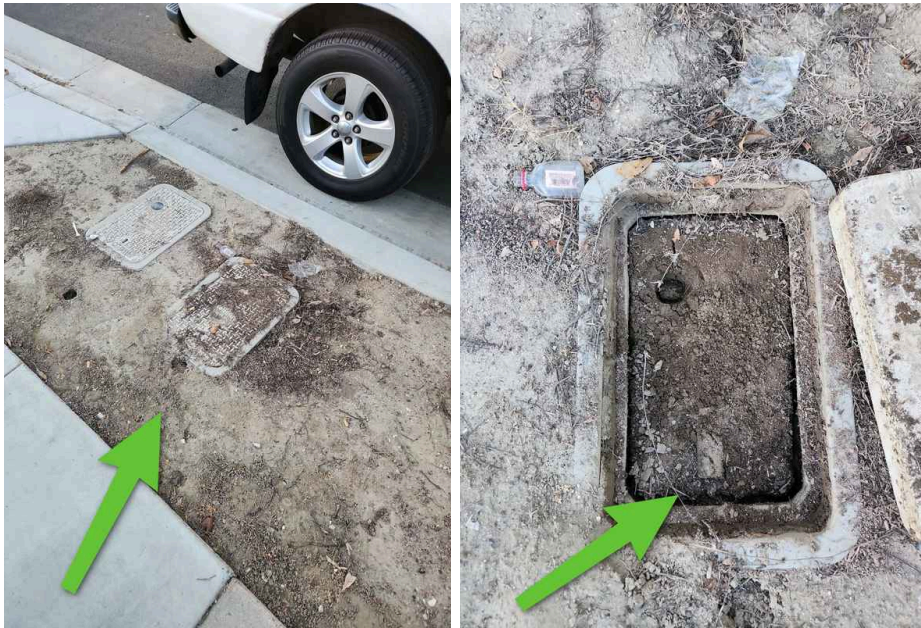
Front Curbside

The shutoff valve stops the flow of water at the meter.

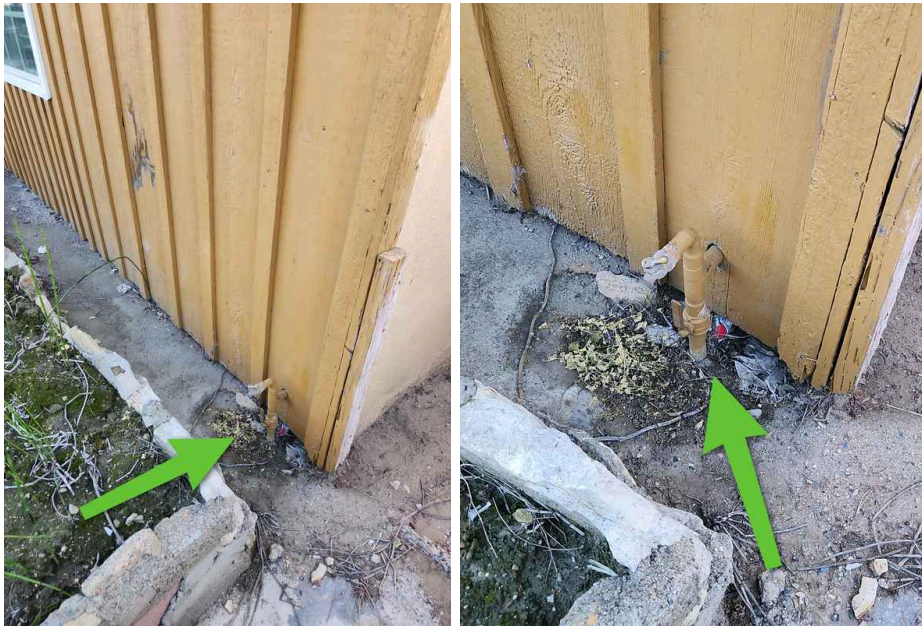
Front

### Shut-Offs: Main Water Shutoff

The shutoff valve located outside the home shuts off water to the house, It prevents flooding when you are planning to repair a fixture such as a faucet or toilet or when you are faced with a plumbing emergency, like a leak from a water heater or supply line.

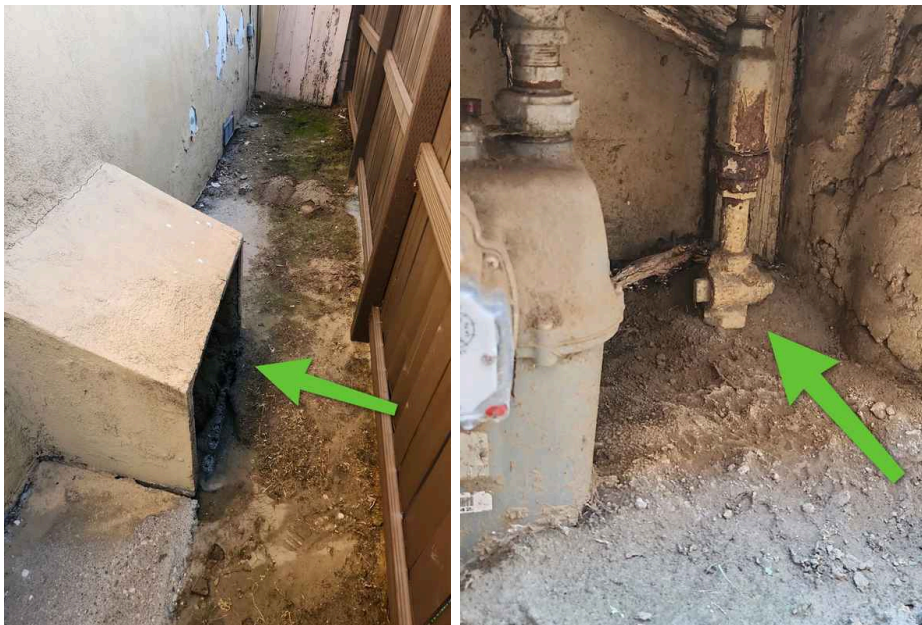
Right

### Shut-Offs: Gas Meter Shutoff

A gas meter shutoff valve is a valve located above ground and before the gas meter that can be used to stop the flow of gas into a house. Valve is a device that isolates natural gas sources for plumbing equipment to allow for maintenance, repairs, or emergencies.

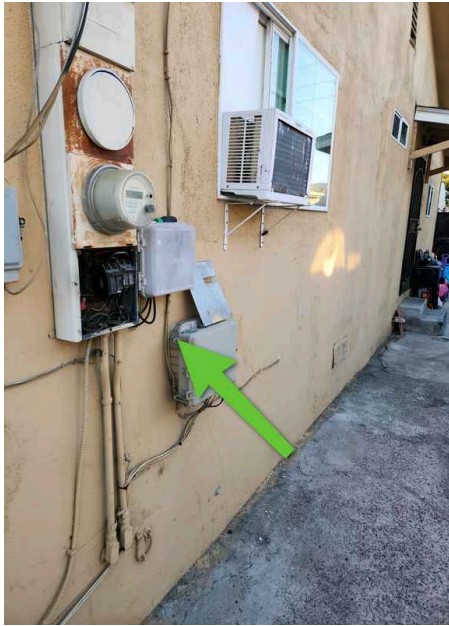
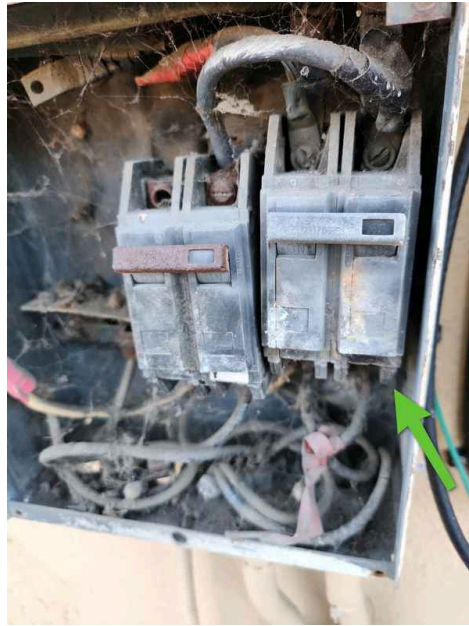
Rear Left

### Shut-Offs: Electrical Shutoff

Electrical shut off, also known as an electrical disconnect, is a safety device that isolates power sources for electrical equipment to allow for maintenance, repairs, or emergencies.

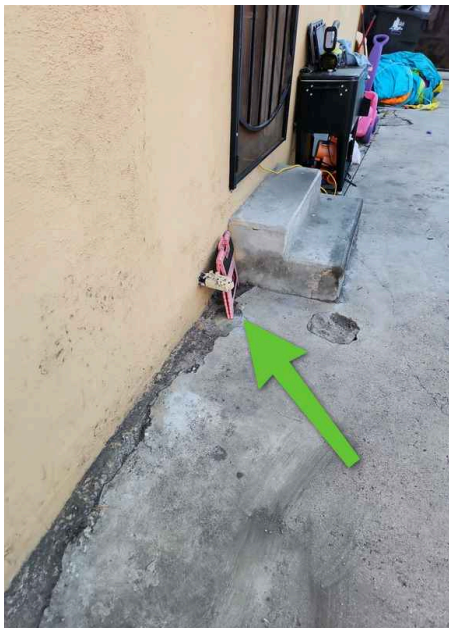
Left

### Main Drain Cleanout

A drain cleanout provides access to your main sewer line. One uses this access to run cameras for servicing, hydrojetters or snakes/augers for maintenance and to clear out blockages.

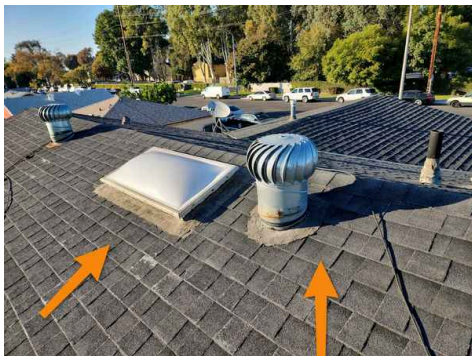
**EVIDENCE OF REPAIRS**

Repairs observed. We cannot determine the cause or effectiveness of these repairs. We suggest contacting the seller and verify the reasoning/cause by a qualified roofer.

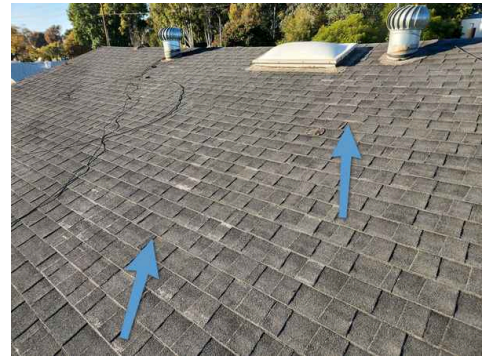
Degranulation indicates advanced surface wear on roofing materials where protective granules are separating from asphalt shingles. This accelerates potential moisture vulnerability and reduces overall roof performance. We suggest monitoring and verifying the remaining life span of the roof with a qualified roofer.

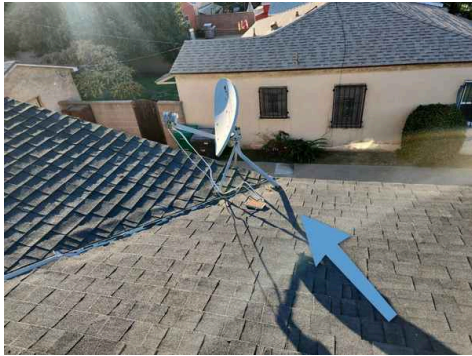
Front Right

**SATELLITE DISH FASTENED TO ROOFING MATERIAL**

Satellite dish/hardware is bolted through the roof deck. Suggest removal/relocating or periodic sealing of the penetrations to prevent leaking.

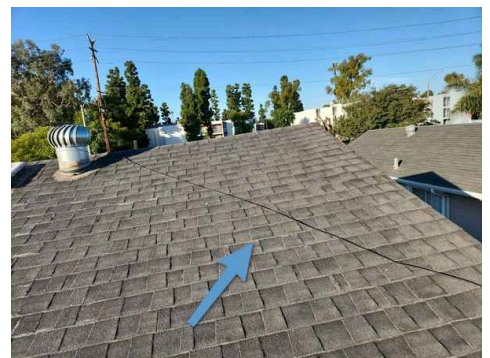
Rear Left

Low voltage wiring observed lying on the roof surface. Suggest removal or relocating off the roofing material to prevent wear and to allow for enhance drainage.

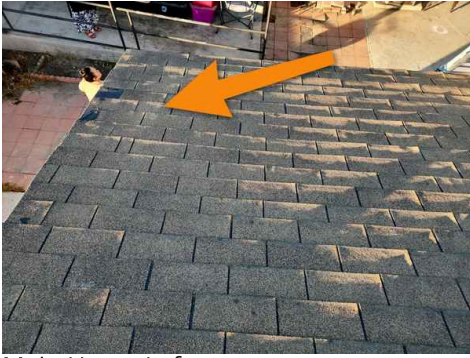
Main Home Left

**DETERIORATED SHINGLES**

Deteriorated or torn shingles were noted. Recommend repair or replacement of the torn or damaged/deteriorated shingles.

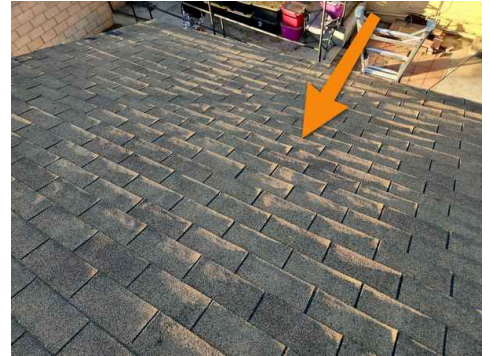
ADU

Uneven/ununiform or waviness observed at the roofing material. We recommend verifying if this meets manufacturer's installation standards or we recommend further evaluation by a qualified roofing professional, prior to the release of contingencies.

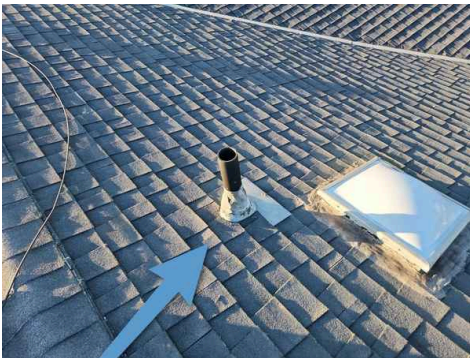
Front

**DETERIORATED SEALANT TRANSITIONS**

IN A NUMBER OF AREAS

Deteriorated sealant was noted at a number of roof penetrations where the vent transitions to the jack roof flashing. Suggest sealing or periodic re-sealing to prevent water intrusion into the areas below.

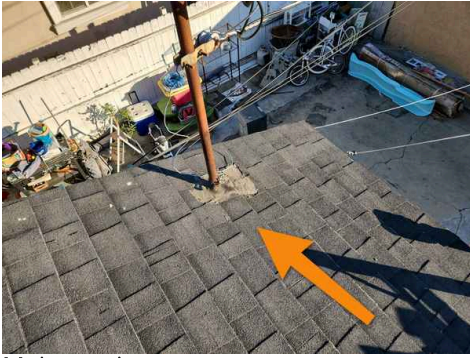
Main service

**IMPROPER PENETRATION - APRON FLASHING**

Roof vent/penetration(s) are incorrectly flashed/sealed. Roofing material should be installed around the flashing. Recommend correcting to prevent leaking.

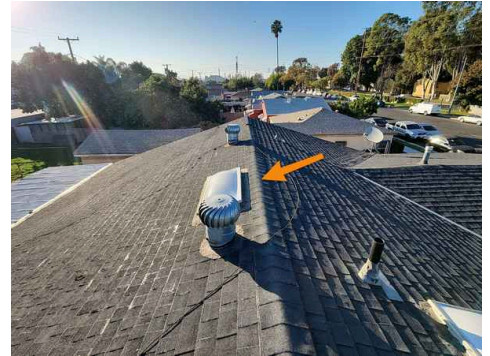
Inadequate installation of flashing observed. When a chimney, skylight or HVAC platform is wider than 30 inches, the flashing should divert water around the structure for proper drainage. Recommend installing/correcting.

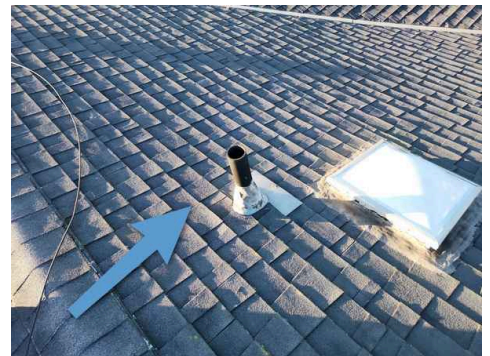
Front

ABS plumbing vents are not painted and exposed to the UV light. Suggest painting to prevent cracking or deterioration.

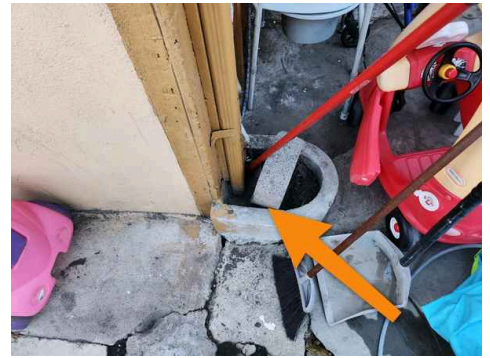
Front

Downspout termination point incorrectly directs water too close to the home. We recommend installing the termination point to sub surface drainage or installing a splash block at the base of the downspouts to divert water away from the exterior walls/foundation.

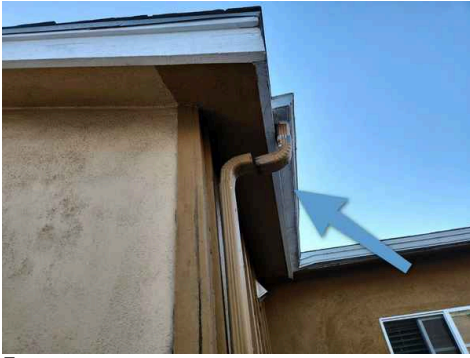
Front

**POOR CONNECTION DOWNSPOUTS**

Poorly fitted connection. Suggest raising or replacement of the connection.

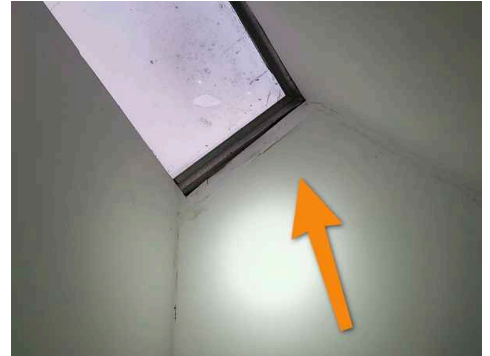
**EVIDENCE OF LEAKING**

Evidence of leaking or past leaking observed; hidden damages may not be observable. Recommend further review by a qualified roofer, prior to release of contingencies.

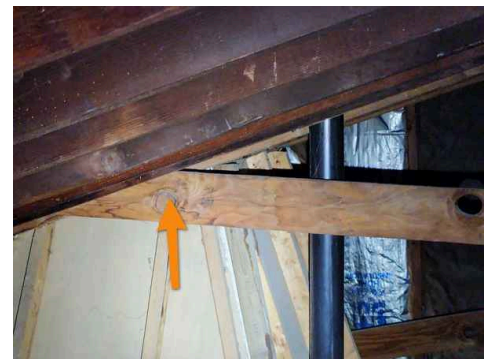
**WATER STAINING**

Water staining observed at the sheathing. We are unable to determine if this is from active leaking or older water staining. We recommend further review of the entire roofing system by a qualified roofer, prior to the release of contingencies.

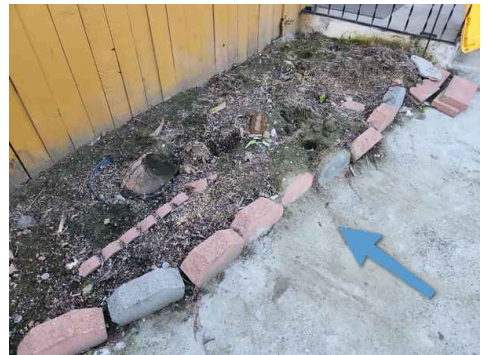
Front Left

**PLANTER CRACKED/LOOSE MATERIAL**

Cracking and or loose material at the planter(s). Suggest repair/securing.

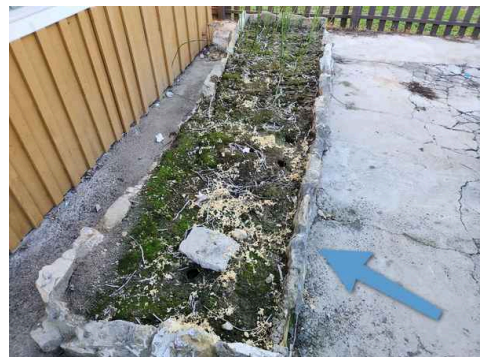
Front

**NO DRAINAGE AT PLANTERS**

Drain holes are not installed at the planter. Suggest installing proper drainage.

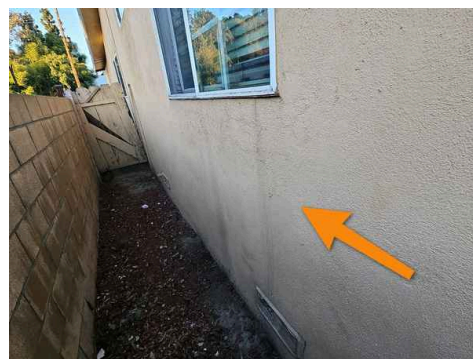
Left

Discoloration/stains and or growth observed. Recommend maintenance/correcting.

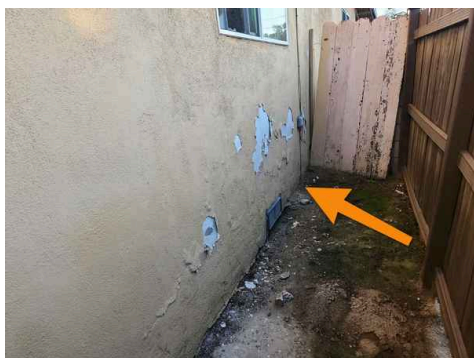
Right

**DETERIORATED SIDING EXCESSIVE**

Deteriorated siding observed. Recommend further review by a qualified contractor, prior to release of contingencies.

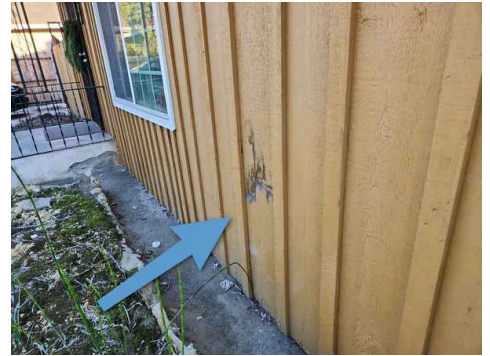
Front

Deteriorated siding or wall cladding observed. Suggest repair.

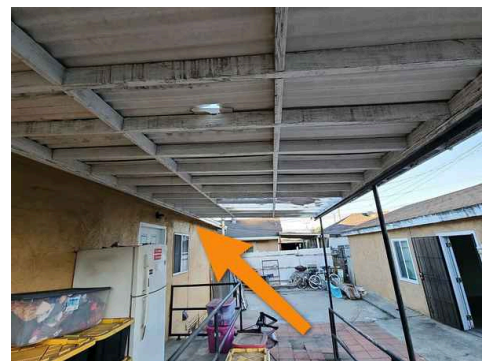
Rear

Stairs/platform or patio cover is not correctly installed or supported. Recommend reinforcement or further review by a qualified contractor, prior to release on contingencies.

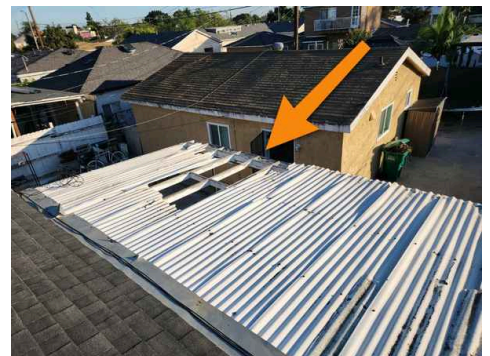
Rear

Deterioration observed at patio cover. Recommend repair.

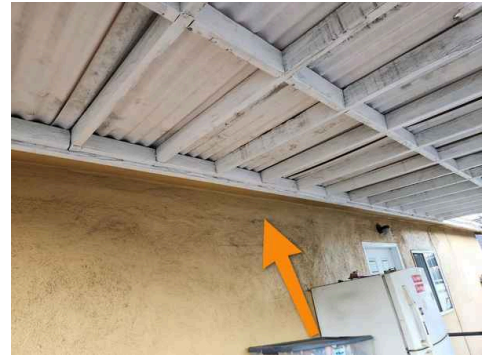
Rear

Patio is not installed directly to the structure of the home. Recommend further review by a qualified contractor, prior to the end of the contingency period.

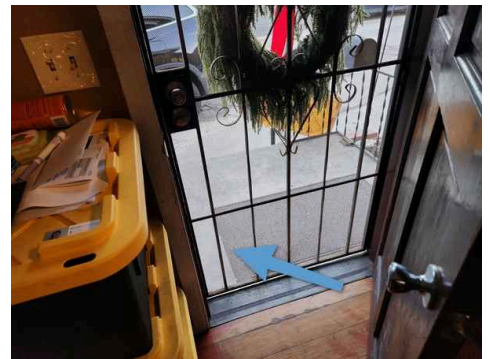
Unit 1 Front

Weather stripping is not installed; gaps observed. Suggest installing.

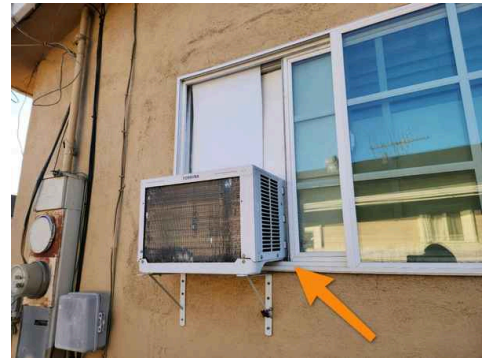
Left

Window is not correctly sealed. Recommend correcting.

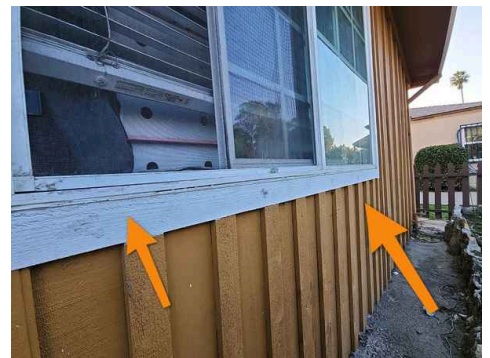
Front

Weep holes are covered. Recommend clearing for proper drainage.

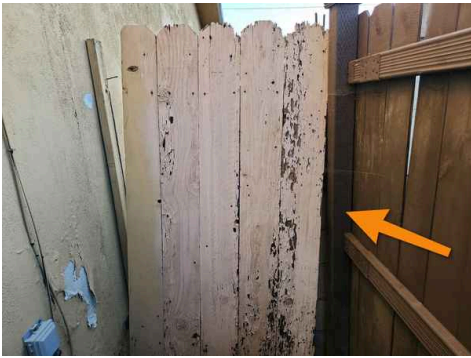
Right

**FENCING DETERIORATED**

Deteriorated fencing observed. Recommend repair/replacement or maintenance.

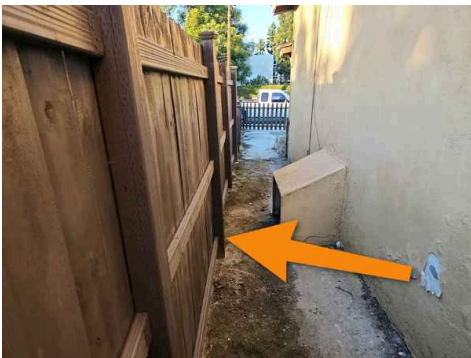
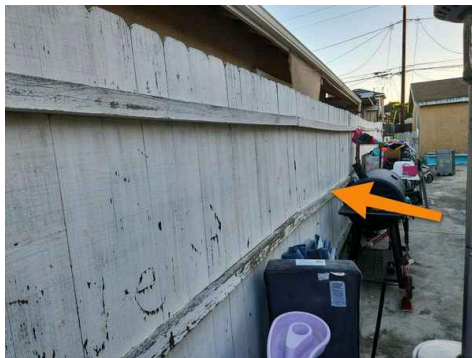
Fencing is leaning or not correctly supported. Recommend reinforcement/correcting.

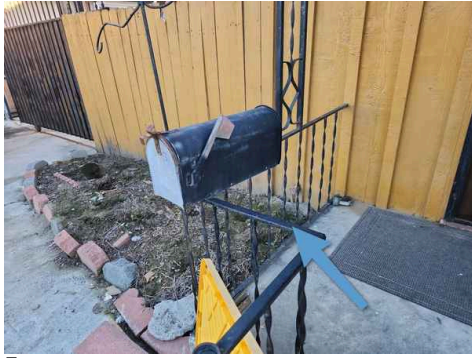
Front

**DAMAGED ADDRESS OR LOOSE MAILBOX**

Loose/not secured mailbox. Suggest securing.

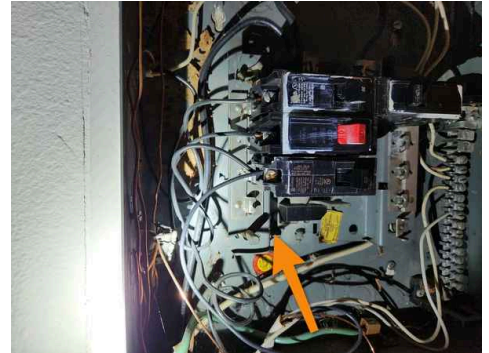
Double wiring observed at breaker(s). Wiring should be separated into independent breakers. Recommend correcting.

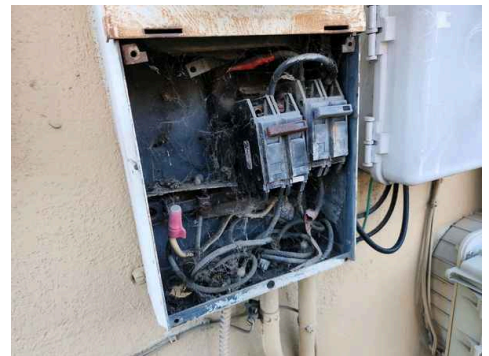
Loose breakers observed - safety concern. Recommend further review by a qualified electrician, prior to the release of contingencies.

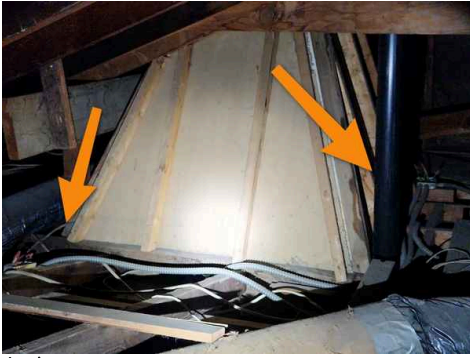
Attic

**WIRING - J-BOX COVER MISSING**

Open junction box observed. Recommend covering.

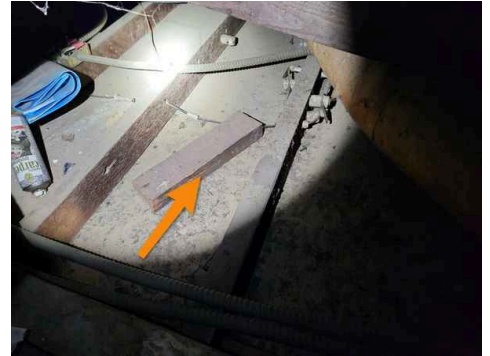
Knob and tube wiring observed and appears to be abandoned where visible. Recommend verifying that all the original wiring has been abandoned by a qualified electrician, prior to the release of contingencies.

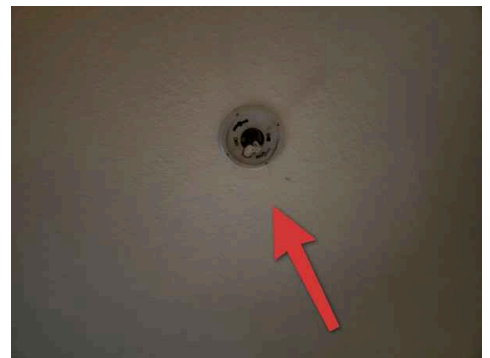
Primary Bedroom

Smoke detector(s) is not installed. Recommend installing.

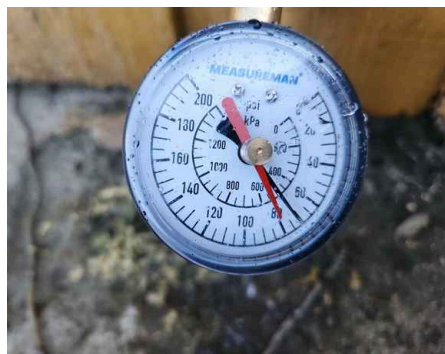
### WATER SOURCE: Water Pressure

Water pressure between the recommend range of 40-80 PSI

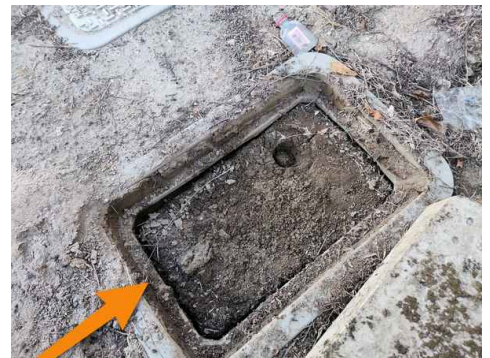
Front Curbside

Shut off valve handle is buried beneath the soil. Recommend exposing to prevent corrosion.

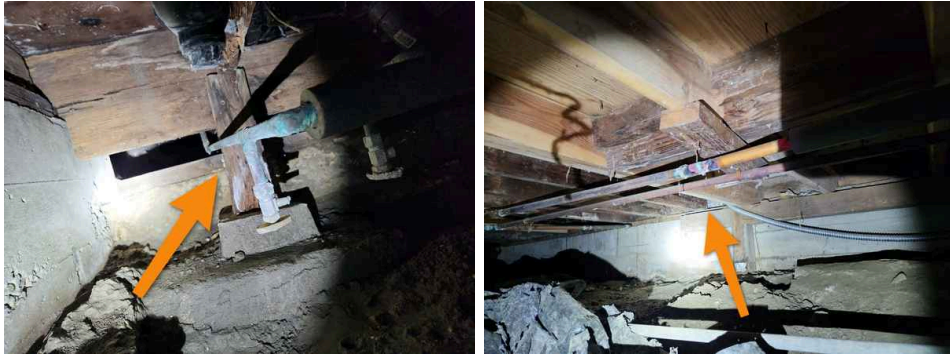
Corrosion observed on the water supply piping. Recommend repair/maintenance.

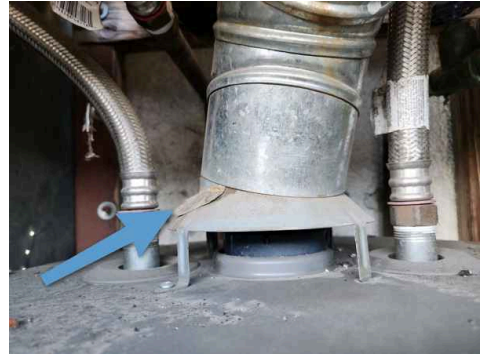
Vent pipe is not secured at fitting(s) using screws. Suggest correcting.

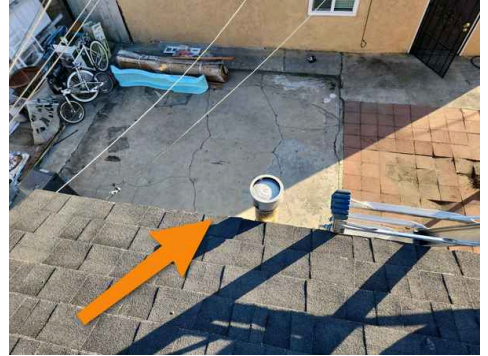
Inadequate termination of exhaust vent pipe. Vent should terminate at least 12 inches above the roof, to allow for proper drafting. Recommend correcting.

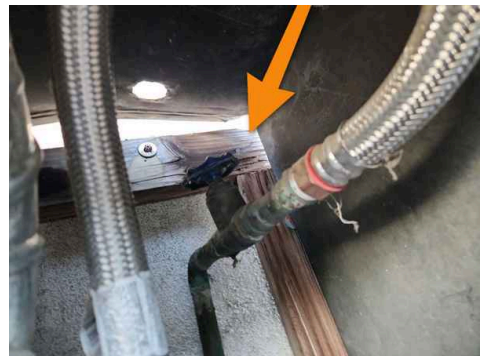
The gate type valve is installed. Recommend upgrading to a ball valve type.

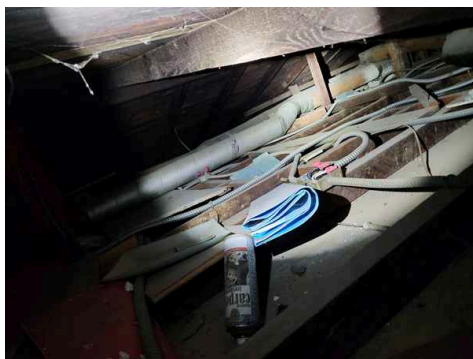
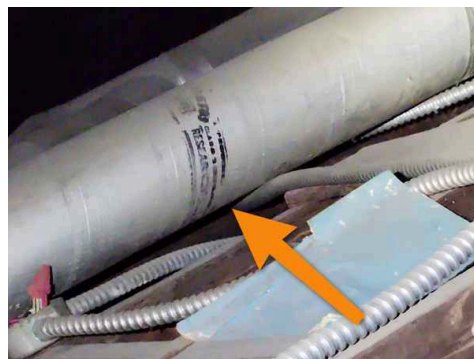
While asbestos and other chemical testing is beyond the scope of this inspection, my experience leads me to suspect the central air ducting may contain asbestos. Recommend further review by a qualified professional, prior to the end of the contingency period.

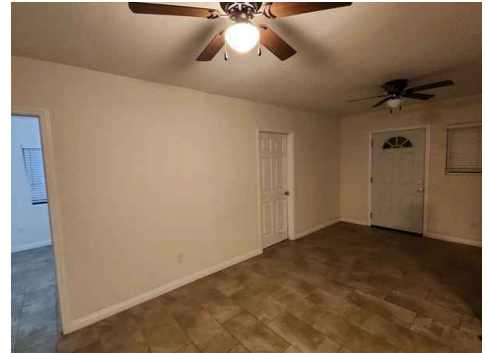
Heating system is not installed. Recommend installing a heat source in all areas.

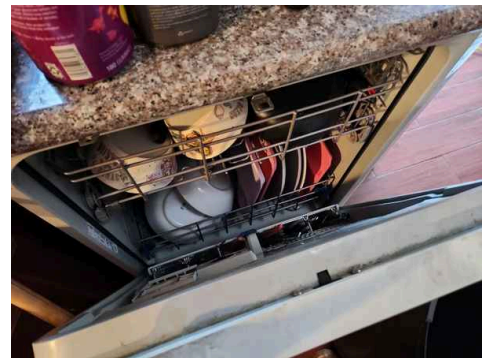
Unable to inspect or run the appliance due to personal items. Suggest removal and verify its condition.

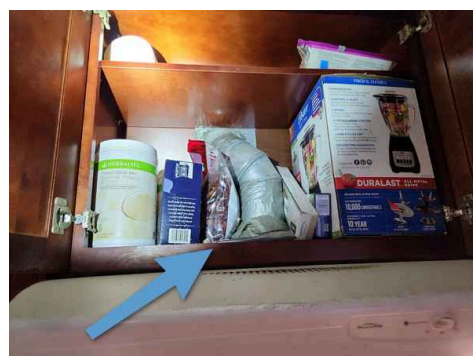
**DUCT TAPE**

The vent is incorrectly sealed at the fittings using duct tape. Suggest correcting.

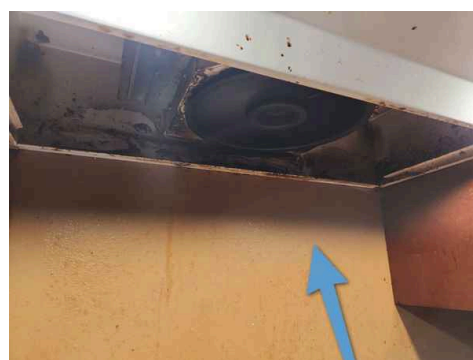
Exhaust vent screen(s) missing. Suggest installing.

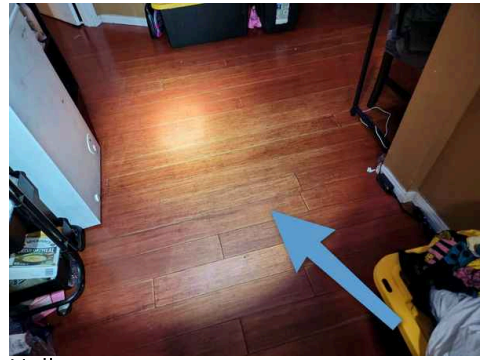
Hallway

Worn flooring observed. Suggest maintenance

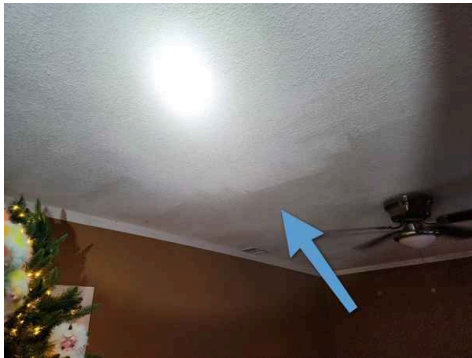
IN A NUMBER OF AREAS

Scuffs and uneven paint observed in a number of areas. Suggest repainting or maintenance.

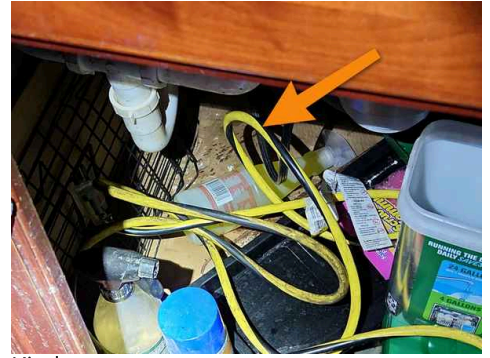
Kitchen

Moisture damage/dark stains. Hidden damage may not be observable. Recommend further review by a qualified professional, prior to the end of the contingency period.

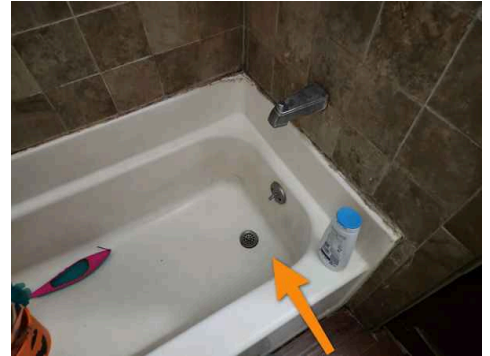
Hallway Bathroom

Slow drain observed. Recommend further review by a qualified plumber, prior to the release of contingencies.

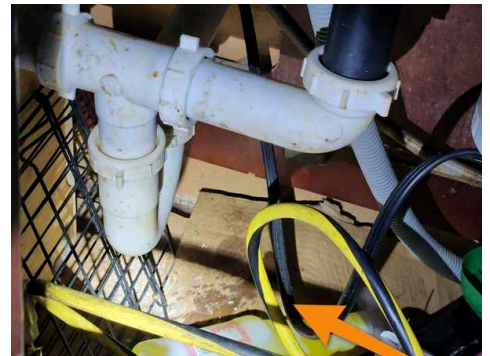
Main Home Kitchen

Leaking drain line observed. Recommend repair.

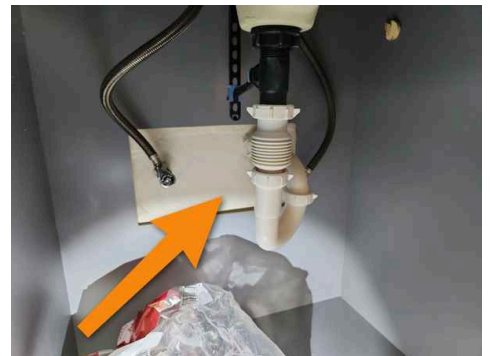
ADU Bathroom

Incorrect installation of flexible drain piping observed. Recommend correcting.

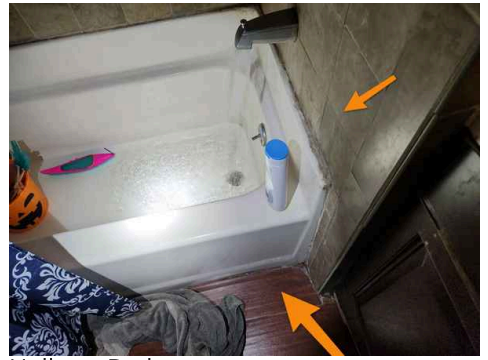
Hallway Bathroom

Caulking/grout is deteriorated. Recommend repair.

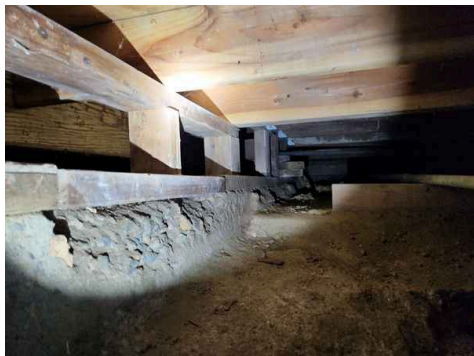
#### RESTRICTIVE CLEARANCES - LIMITED REVIEW

Limited evaluation of the crawlspace due to restrictive clearances such as ducting/plumbing/personal items or height of area. Recommend correcting and verifying condition of the crawlspace and all components, prior to release of contingencies.

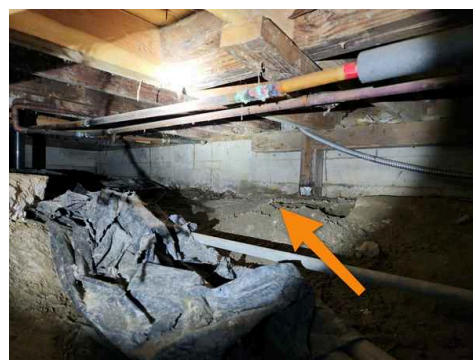
Efflorescence observed on foundation walls or moisture at the soil. This is an indication of poor drainage and past/present water intrusion. See grading/drainage comments in the exterior category and gutter comments in the roofing section of this report.

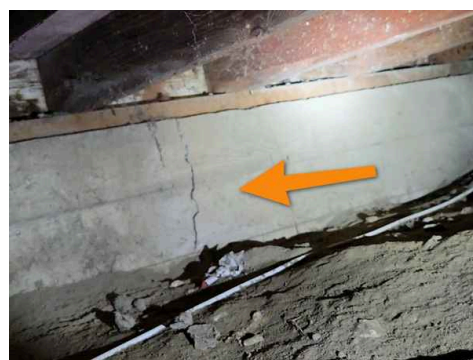
Cracking observed. Recommend repair

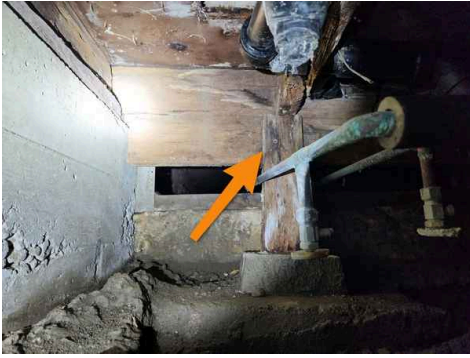
**DETERIORATION/EVIDENCE OF TERMITES**

Deterioration/evidence of termites observed. Recommend further review by a qualified termite contractor, prior to the end of the contingency period.

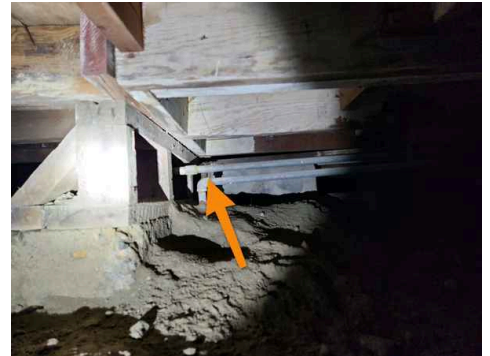
Inadequate end bearing observed at the girder/beam. Recommend reinforcement by the installation a pier/post under the beam.

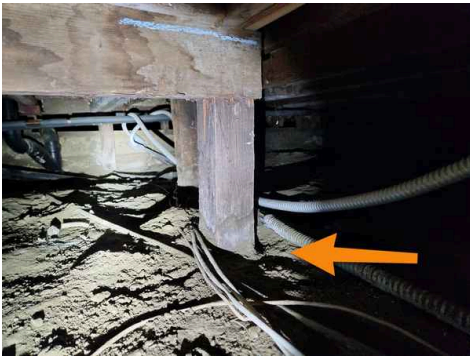
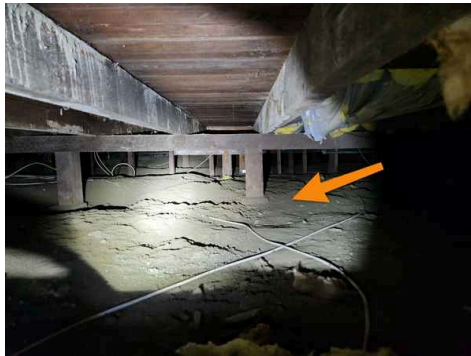
**WOOD POST IN CONTACT GRADE/SOIL**

Wood post are in contact with soil. Recommend correcting.

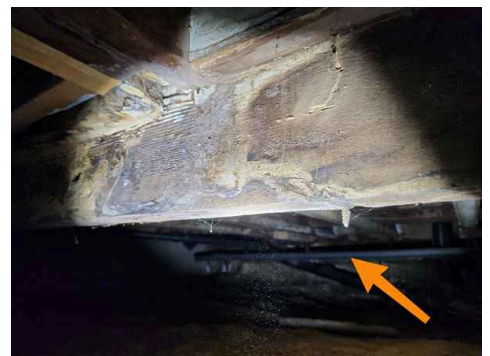
Evidence of subterranean termites observed. Recommend further review by a qualified termite specialist, prior to release of contingencies.

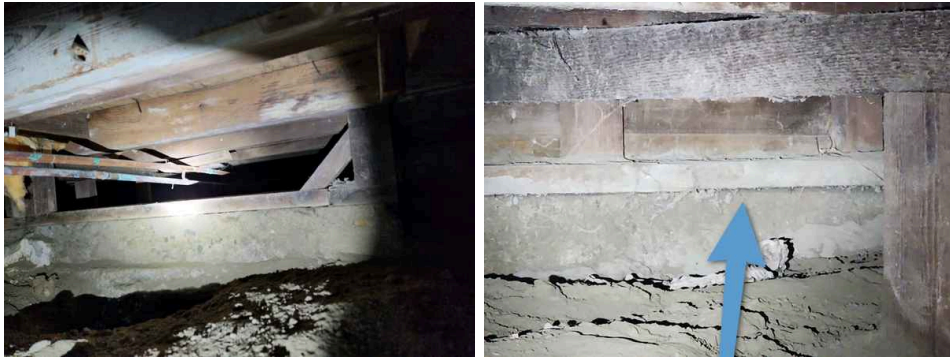
**CRIPPLE WALLS NOT BRACED**

Cripple walls are not braced. We suggest bracing to prevent racking/lateral movement as this enhanced earthquake seismic safety.

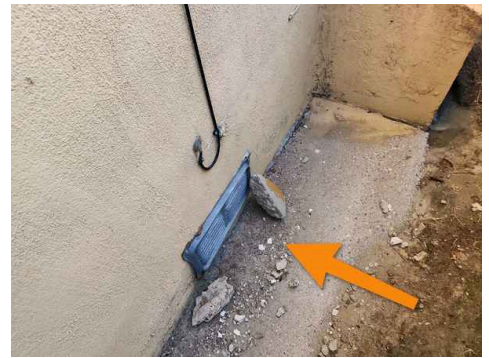
Right

Open, torn or missing screens observed at vents/penetrations. Recommend repair/screening to prevent nesting/pest.

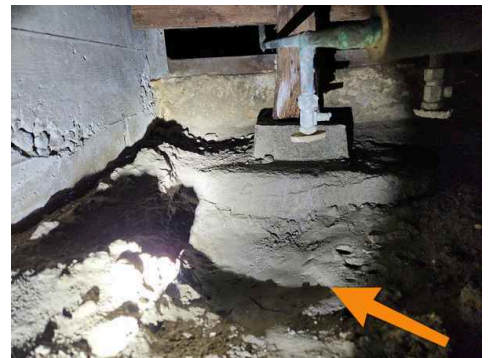
Moisture or microbial growth observed at the soil. This is indication of inadequate drainage and poor ventilation. We recommend further review by a qualified professional, prior to the release of contingencies.
