WOOD DESTROYING PESTS AND ORGANISMS INSPECTION REPORT

Building No. 215	Street Boeker Avenue	City Pismo Beach	ZIP 93449	Date of Inspection 02/10/2026	Number of Pages 4
Prize Pest Control 163 Surf Bird Court Guadalupe CA 93434 (805) 300-9099 Prizepestcontrolservices@gmail.com				Report # : 10238 Registration # : PR9432 Escrow # : <input type="checkbox"/> CORRECTED REPORT	
Ordered by: Robert Dickerson 215 Boeker Avenue Pismo Beach CA 93449 United States		Property Owner and Party of Interest:		Report sent to:	
COMPLETE REPORT <input checked="" type="checkbox"/>		LIMITED REPORT <input type="checkbox"/>		SUPPLEMENTAL REPORT <input type="checkbox"/>	
REINSPECTION REPORT <input type="checkbox"/>		GENERAL DESCRIPTION: One-story single family residence, wood siding, composition roof, vacant, detached garage		Inspection Tag Posted: Garage	
				Other Tags Posted:	
An inspection has been made of the structure(s) shown on the diagram in accordance with the Structural Pest Control Act. Detached porches, detached steps, detached decks and any other structures not on the diagram were not inspected.

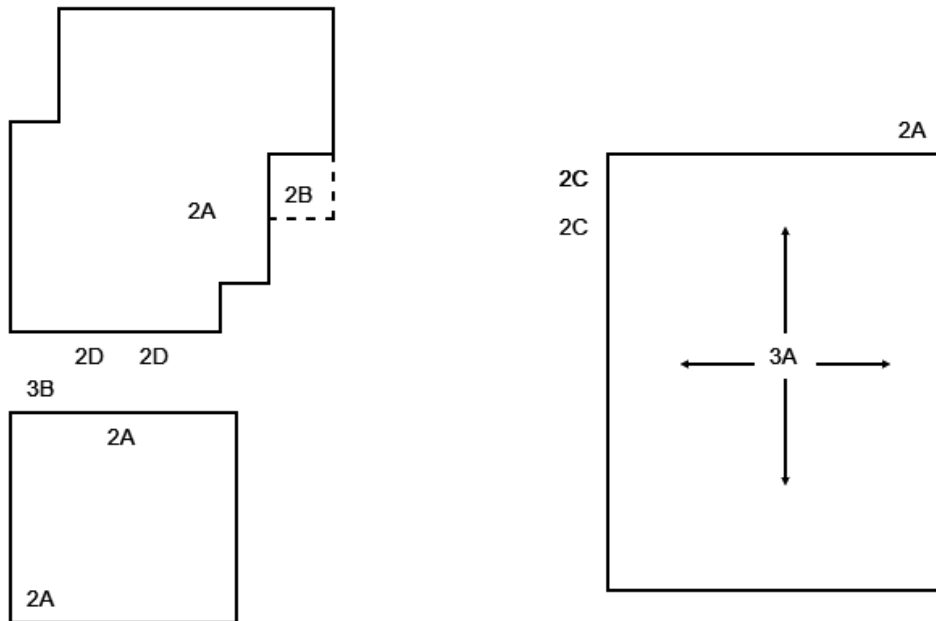
Diagram Not To Scale

FINDING: Evidence of drywood termites was noted at/in water heater closet, wood siding, baseboard and rafter.

FINDING: Drywood termite damage was found at the wood siding. **RECOMMENDATION:** Remove and replace or reinforce damaged wood members. painting is included, color may not be an exact match.

FINDING: Drywood termite damage was found at the shiplap. **RECOMMENDATION:** Remove and replace or reinforce damaged wood members. painting is included, color may not be an exact match.

FINDING: Drywood termite damage was found at the rafter. **RECOMMENDATION:** Remove and replace or reinforce damaged wood members. painting is included, color may not be an exact match.

FINDING: Fungus damage was found at wood framing under the subarea.

FINDING: Fungus damage was found at the shiplap.

RECOMMENDATION: Remove or cover accessible drywood termite fecal pellets.

RECOMMENDATION: Fumigate the structure with a gas lethal to drywood termites, with Vikane or Zythor (Sulfuryl Fluoride). Remove or cover drywood termite fecal pellets in accessible areas. Owner / agent to prepare for fumigation as per list of instructions to be furnished by this company. The structure must be vacated until release for re-entry by the licensed fumigator. 3 year warranty upon completion date.

RECOMMENDATION: Remove and replace or reinforce damaged wood members. painting is included, color may not be an exact match.
