# A BETTER LOOK HOME INSPECTIONS

## A BETTER LOOK HOME INSPECTION

37540 Vía El Dorado  
Temecula, CA 92592

Jill Downs  
05/11/2026

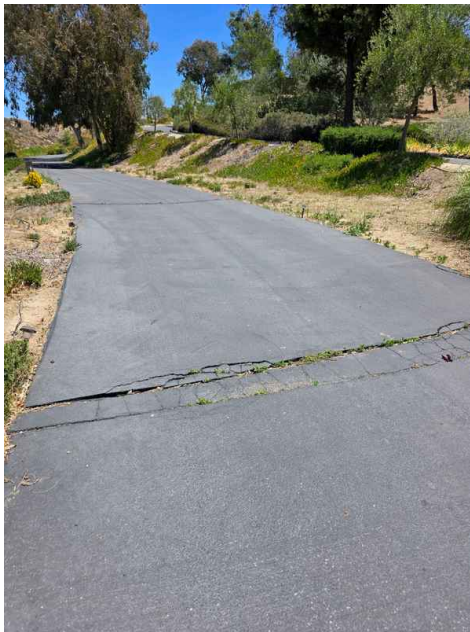
There were many areas of the concrete and asphalt driveway that had major cracking. We recommend having a California licensed paving/asphalt professional further evaluate and repair as needed.

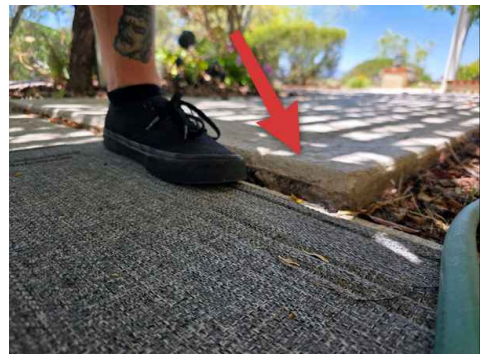
## 2.2.1 Sidewalks/Walkways

**SIDEWALKS/WALKWAY - LIFTING**

There appeared to be lifting at the sidewalk/walkway. This could be a trip hazard.

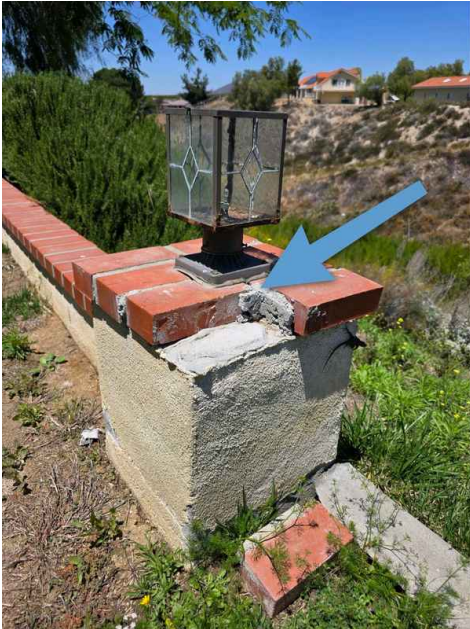
## 2.3.1 Retaining Walls

**RETAINING WALL - TOP CAP(S) LOOSE**

There appeared to be one or more top cap blocks loose at the retaining wall.

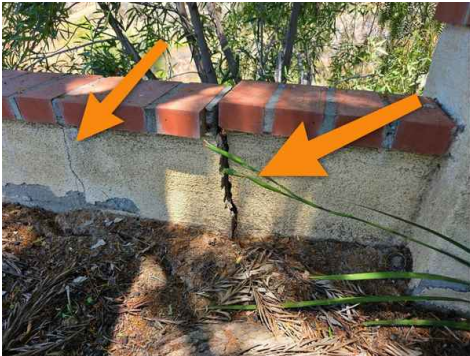
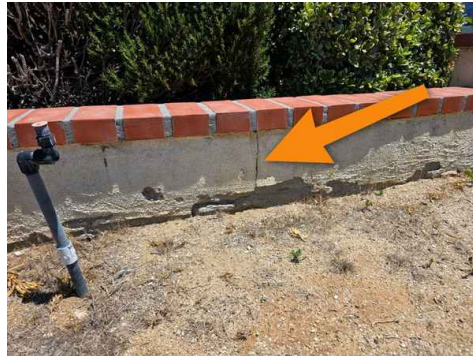
### 2.3.2 Retaining Walls

#### RETAINING WALLS - SETTLEMENT CRACKS

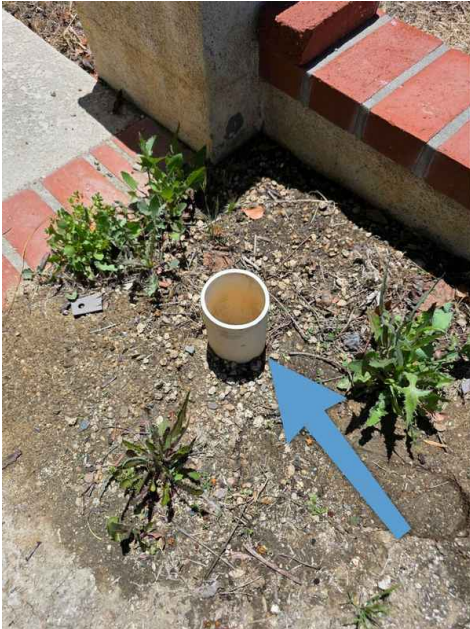
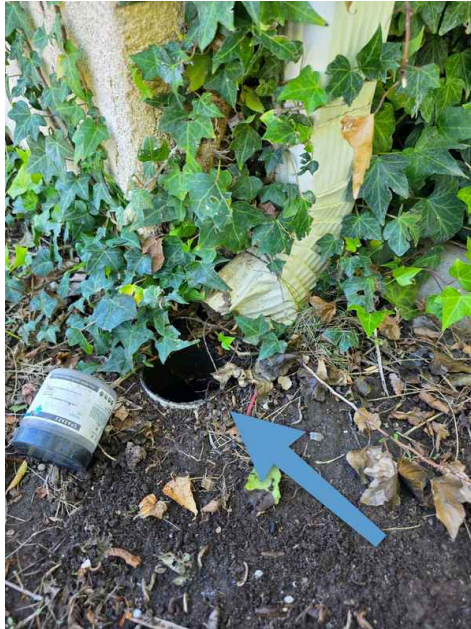
### 2.4.1 General Grading/Drainage

#### DRAINAGE - MISSING COVERS/DRAINS ABOVE GRADE

There were a couple underground drain covers that were missing and a couple that were above grade. We believe there may be some underground drains that were covered. We recommending replacing the missing drain covers to prevent debris from entering and clogging the drain line.

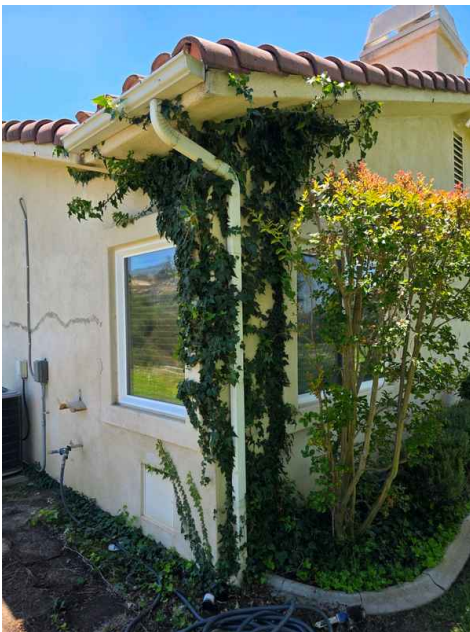
### 2.5.1 Trees & Shrubs

#### TREES & SHRUBS - MAINTENANCE

The trees, shrubs, and vines were overgrown. We recommend always keeping all growth off and away from the home and fencing.

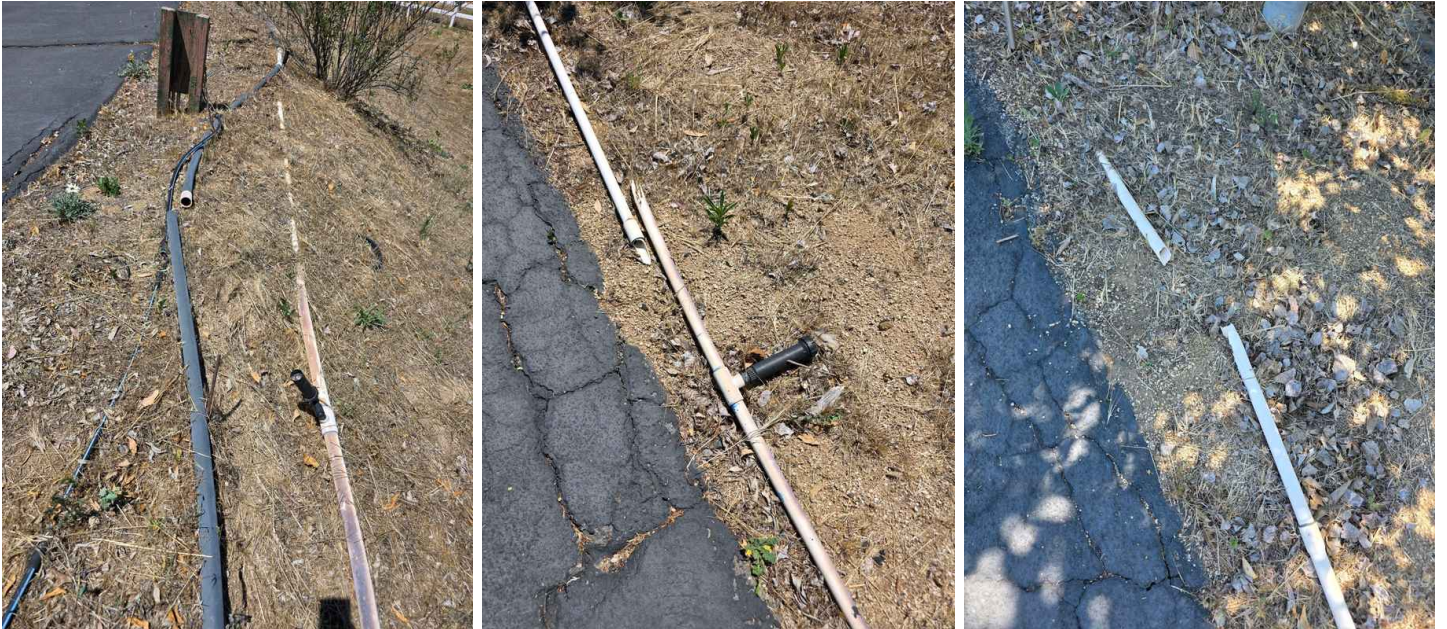
#### IRRIGATION - PIPES DISCONNECTED

There appeared to be several sprinkler pipes that were separated at the time of the inspection. We recommend having a qualified landscaping professional further evaluate and repair or replace as needed.

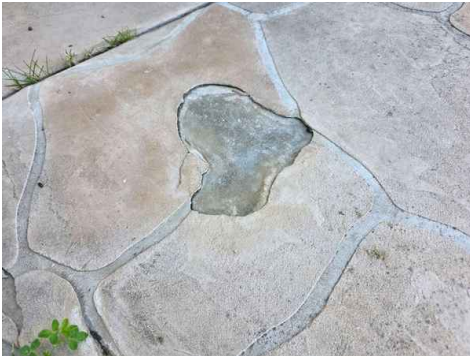
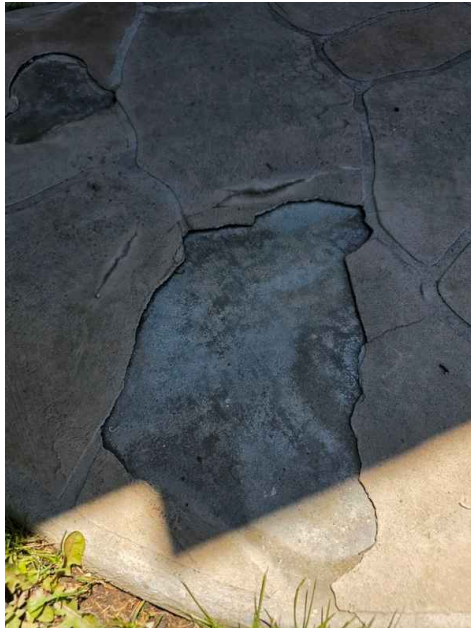
There was some deterioration at the texture of the stamped concrete at the patio slab.

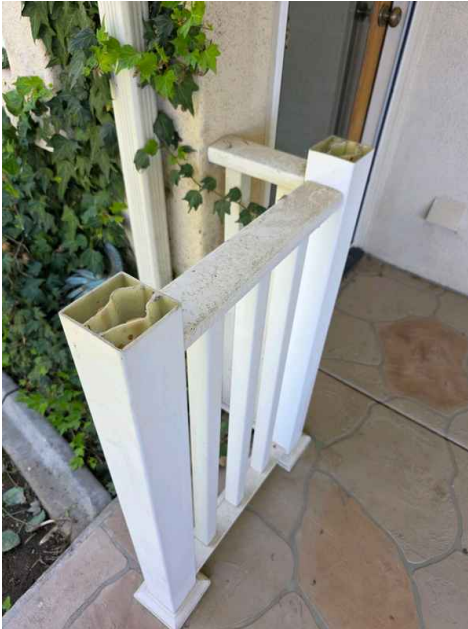
#### 2.9.1 Fences/Gates

### FENCE - DAMAGED VINYL FENCING

The vinyl fence at the patio slab appeared to be missing post top caps and a section of the fence appeared warped due to exposure to extreme high temperatures like a BBQ or Heater.

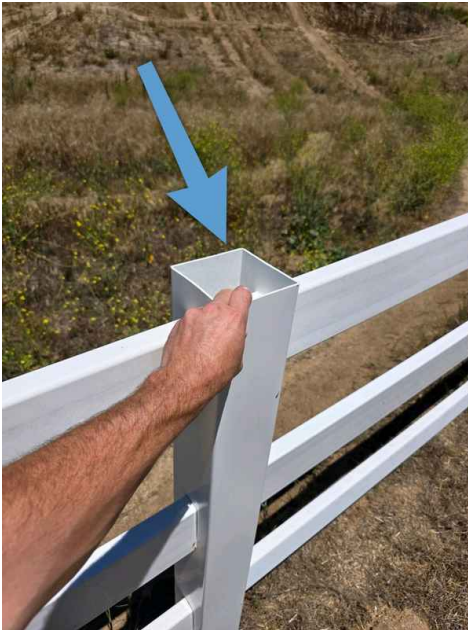
### 2.9.2 Fences/Gates

#### **WALL - POST CAP BROKEN OR MISSING**

There appeared to be a few vinyl fence post cap(s) that were broken or missing at the time of the inspection.

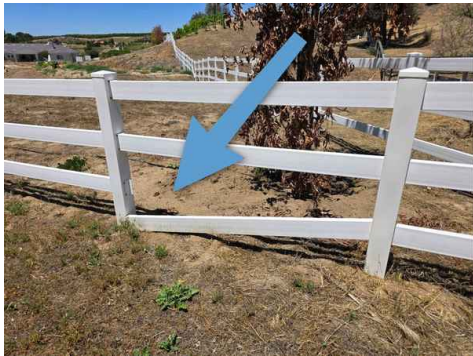
### 2.9.3 Fences/Gates

#### **LOOSE SECTION OF FENCE**

There appeared to be a section of the vinyl pvc fence loose and should be put back in place and properly fastened.

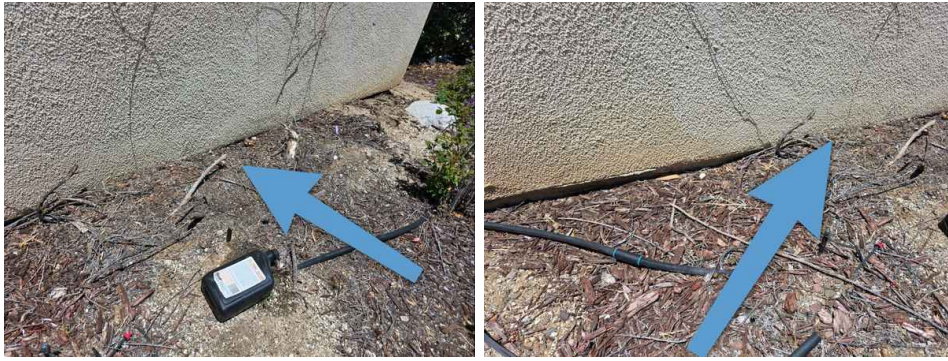
**FOUNDATION - HIGH SOIL/MULCH NEXT TO THE HOME**

Ground cover materials such as soil, rock, bark, and mulch should be kept several inches below the foundation siding and weep screed to allow proper drainage and to help prevent moisture intrusion and pest activity.

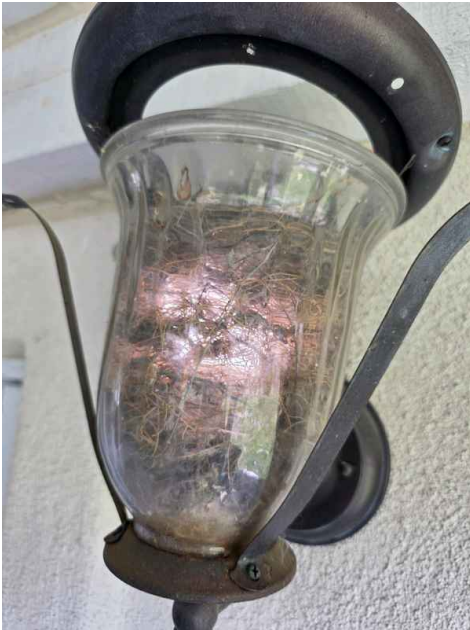
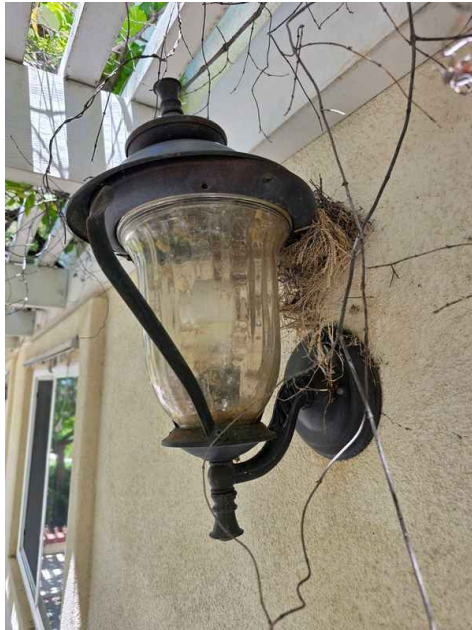
#### 4.4.1 Exterior Plugs/Exterior Light Fixtures

##### **EXTERIOR LIGHT(S) - BIRD'S NESTS**

There appeared to be birds nests in a few of the exterior light fixtures.

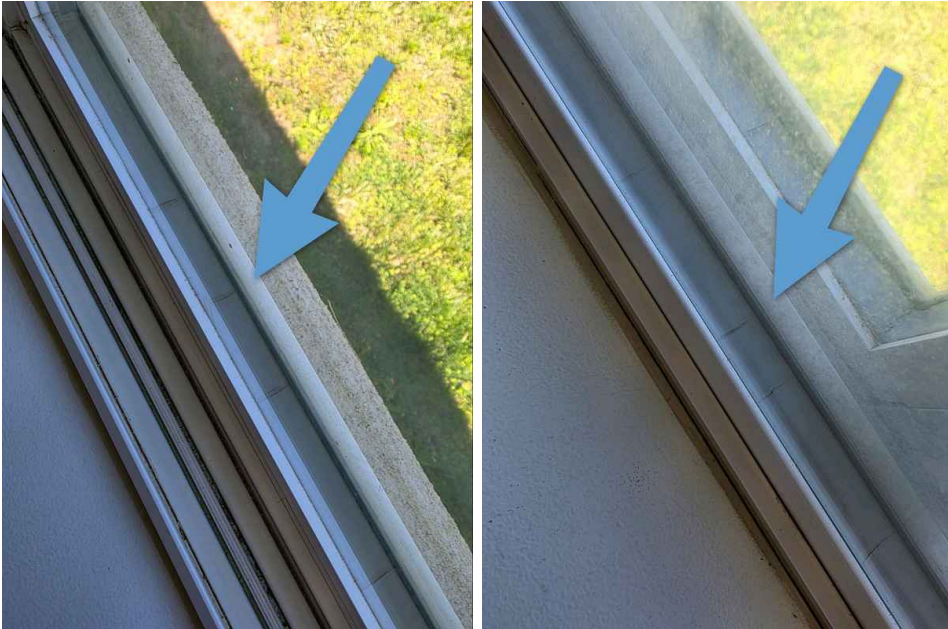
#### 4.5.1 Exterior Windows

##### **WINDOW(S) - CRACKED AND EXPANDED RUBBER SEALS**

There were a few windows that appeared to have cracked and expanded rubber seals.

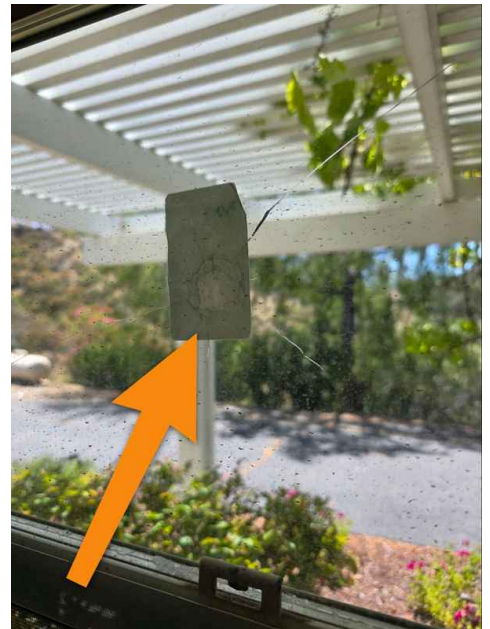
#### 4.5.2 Exterior Windows

##### **WINDOW(S) - HOLE IN WINDOW**

There appeared to be a hole in the outer pane of the window in the laundry room from possibly an air gun or rock. We recommend having a California licensed window professional replace the damaged window.

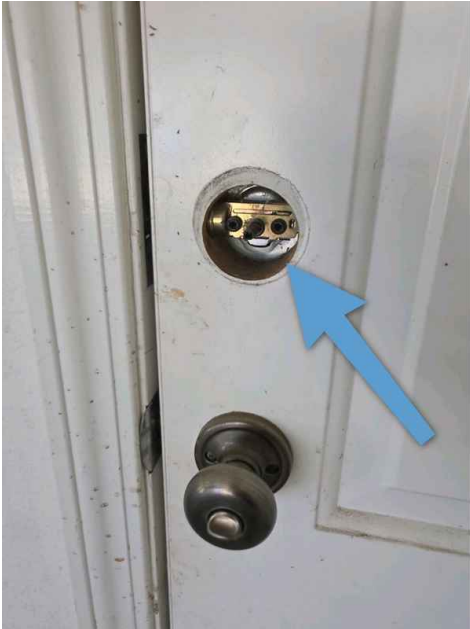
##### **EXTERIOR DOOR(S) - DEADBOLT MISSING COMPONENTS**

There was a deadbolt at the man door that was was missing some of the components. We recommend replacing the deadbolt.

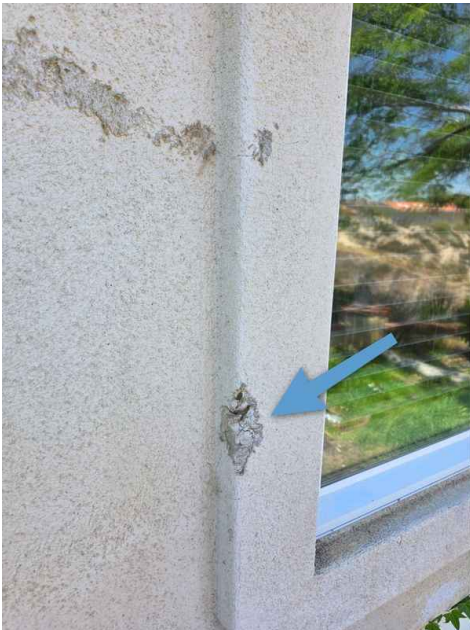
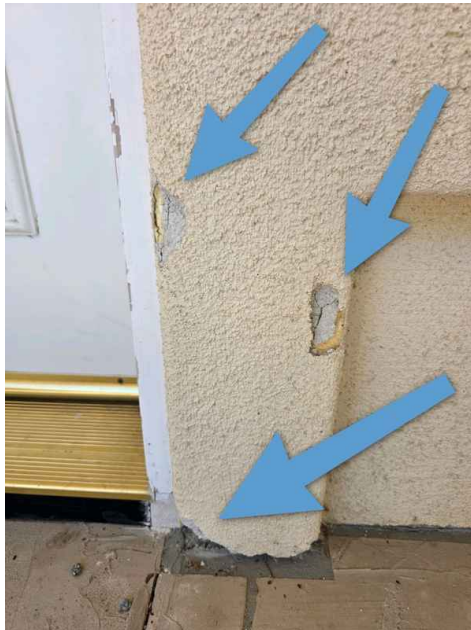
#### 4.7.1 Trim/Fascia

### TRIM/FASCIA - MINOR STUCCO DAMAGE

There were areas of the stucco over foam trim around the doors and windows that had some minor stucco damaged. We recommend having these areas repaired to prevent moisture intrusion.

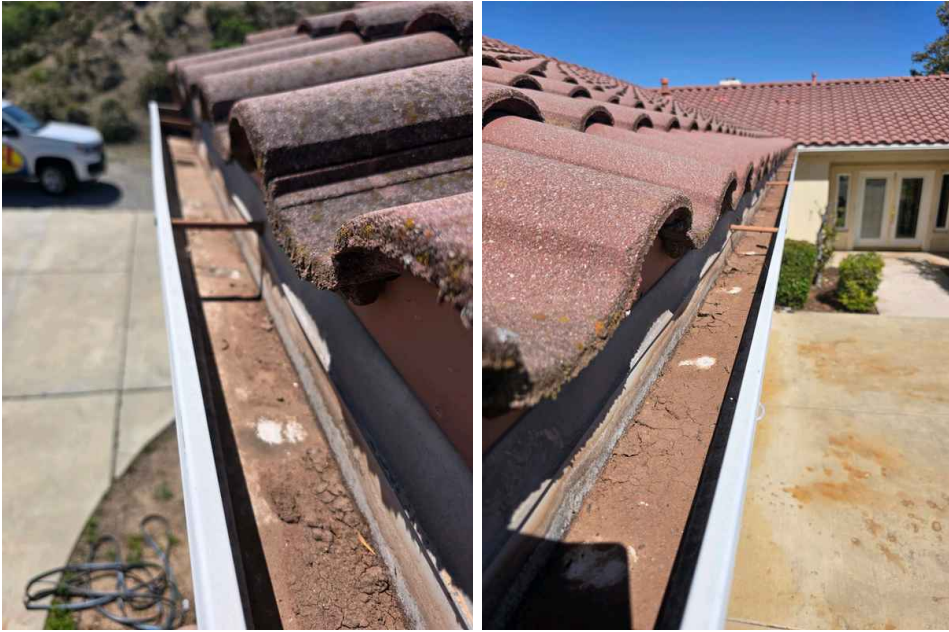
### GUTTERS/DOWNSPOUTS - DEBRIS

The gutters have debris in them that needs to be cleaned out so that water can flow properly.

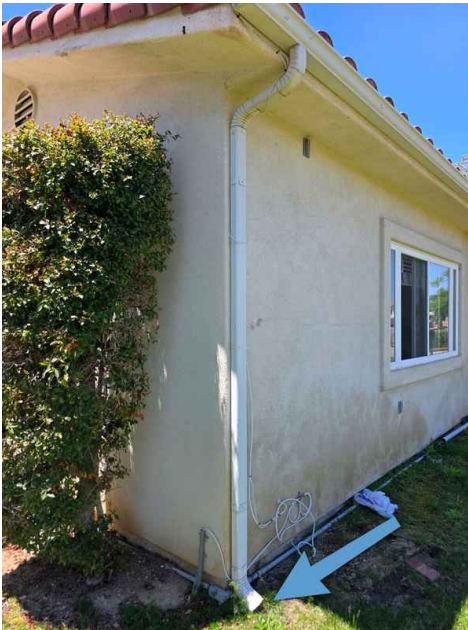
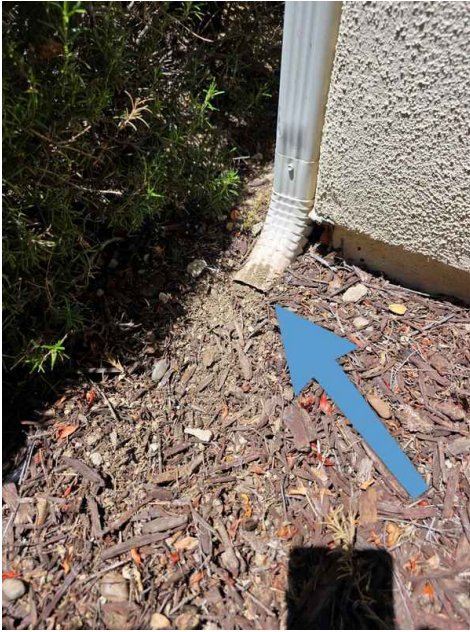
##### **GUTTERS/DOWNSPOUTS – DAMAGED/DISCONNECTED**

Several downspouts appeared to be damaged, disconnected, not secured, and not properly extended from the home. We recommend having a qualified gutter professional further evaluate and repair the gutter downspout system to promote proper drainage off and away from the home.

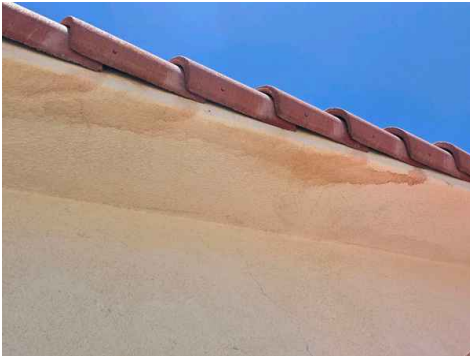
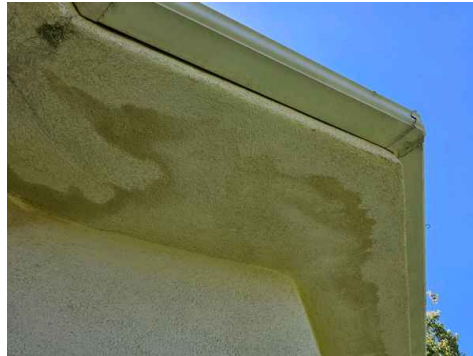
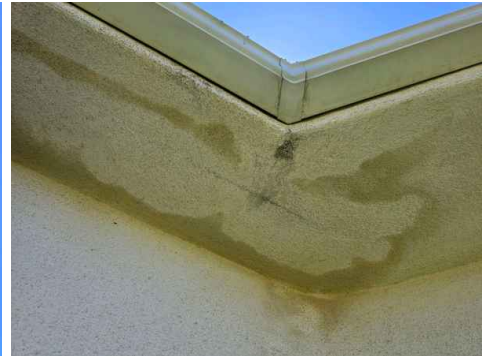
#### 4.9.1 Eaves/Soffits

### SOFFITS - STAINED

There were a few areas of the stucco soffits that appeared stained from roof run off or potentially a roof leak.

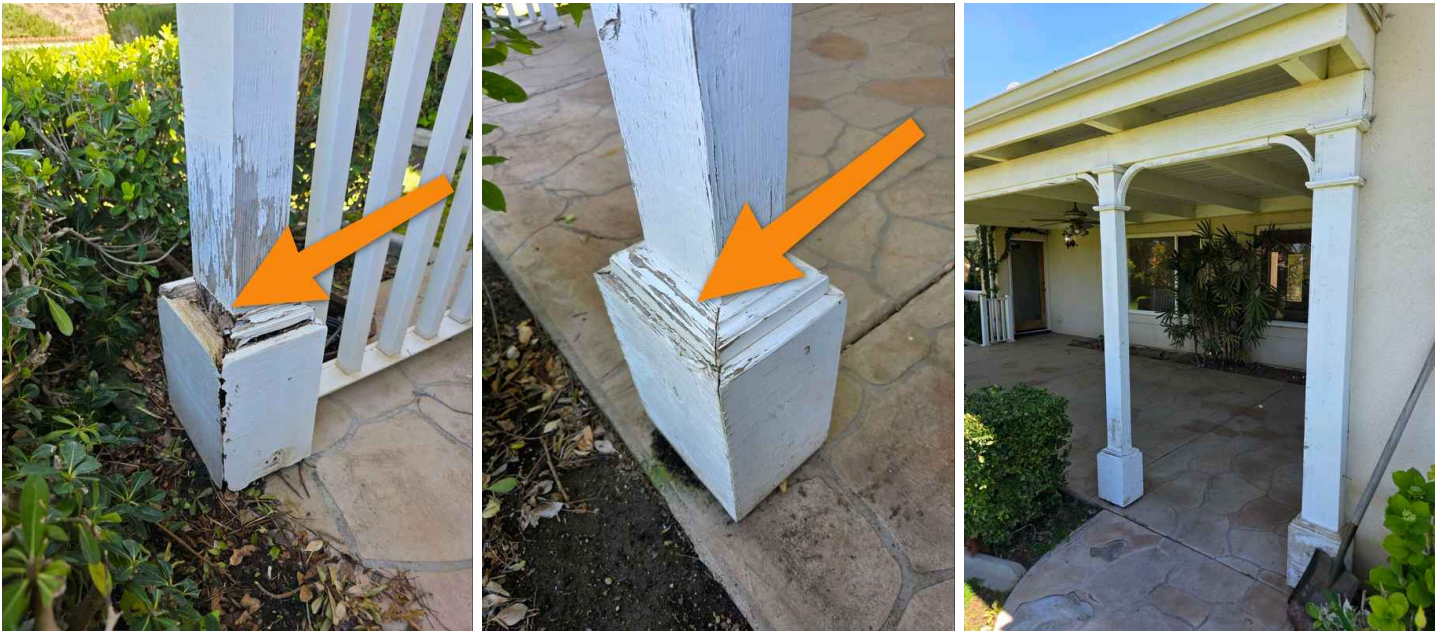
There appeared to be damage to the base of the columns/posts from sprinklers and/or rain splash back. We recommend having the damaged areas repaired to prevent further deterioration.

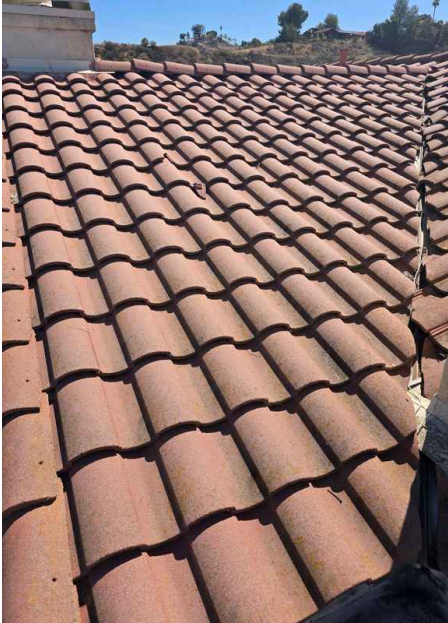
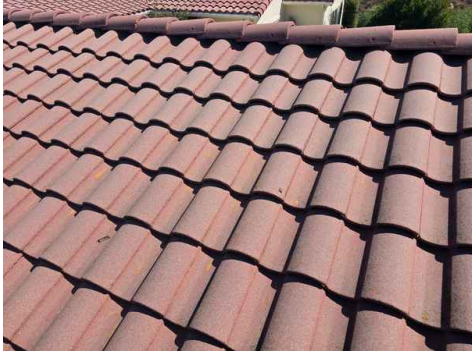
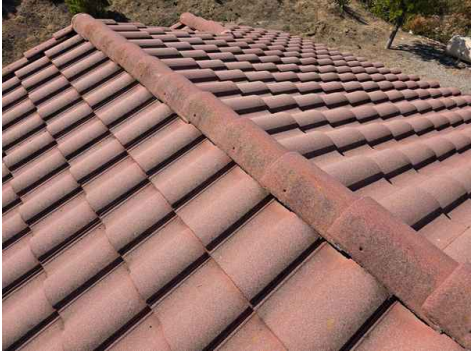
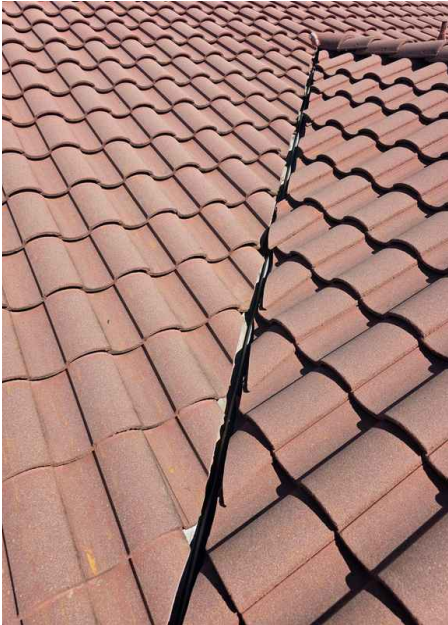
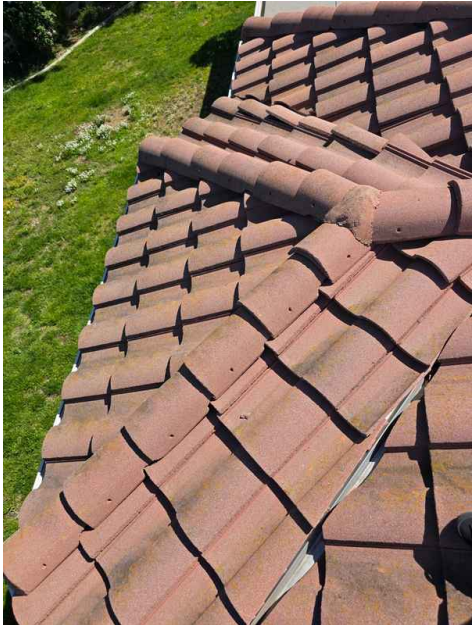
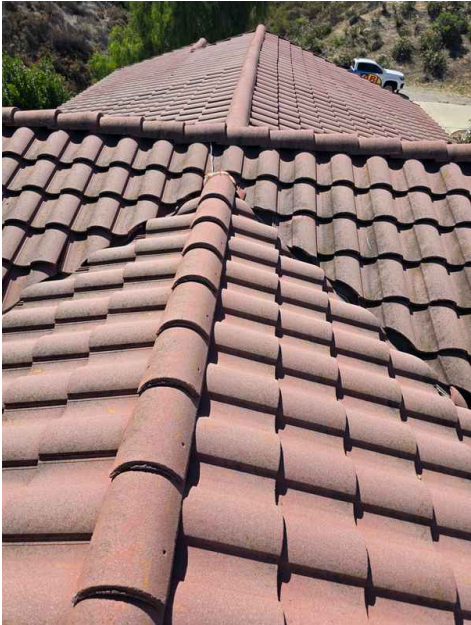
Roof Covering: Roof Covering

| <b>Roof Covering: Type</b><br>Concrete Tile, "S" Style | <b>Roof Covering: Approximate Age</b><br>2000 | <b>Roof Covering: Condition</b><br>Satisfactory, Needs Maintenance, Professional Consultation |

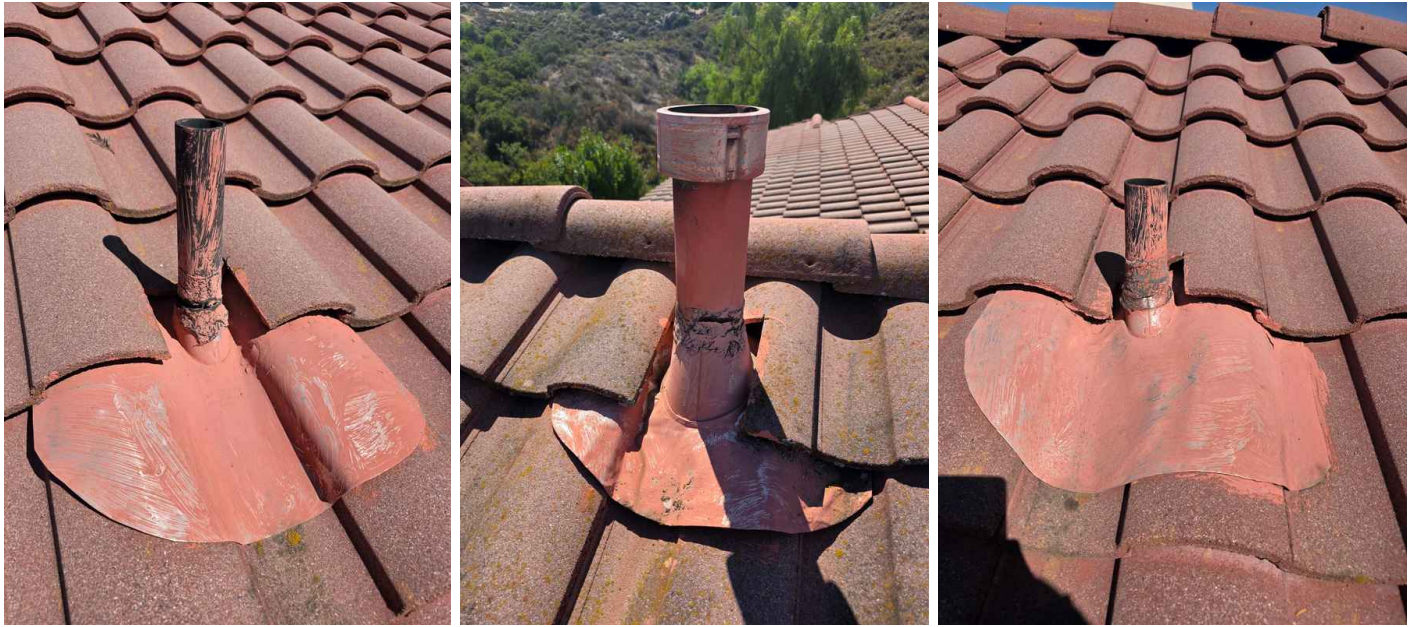
## Exposed Flashing: Exposed Flashing

| <b>Exposed Flashing: Condition</b><br>Satisfactory | <b>Exposed Flashing: Roof Mastic Dry and Cracked</b><br>Yes | |

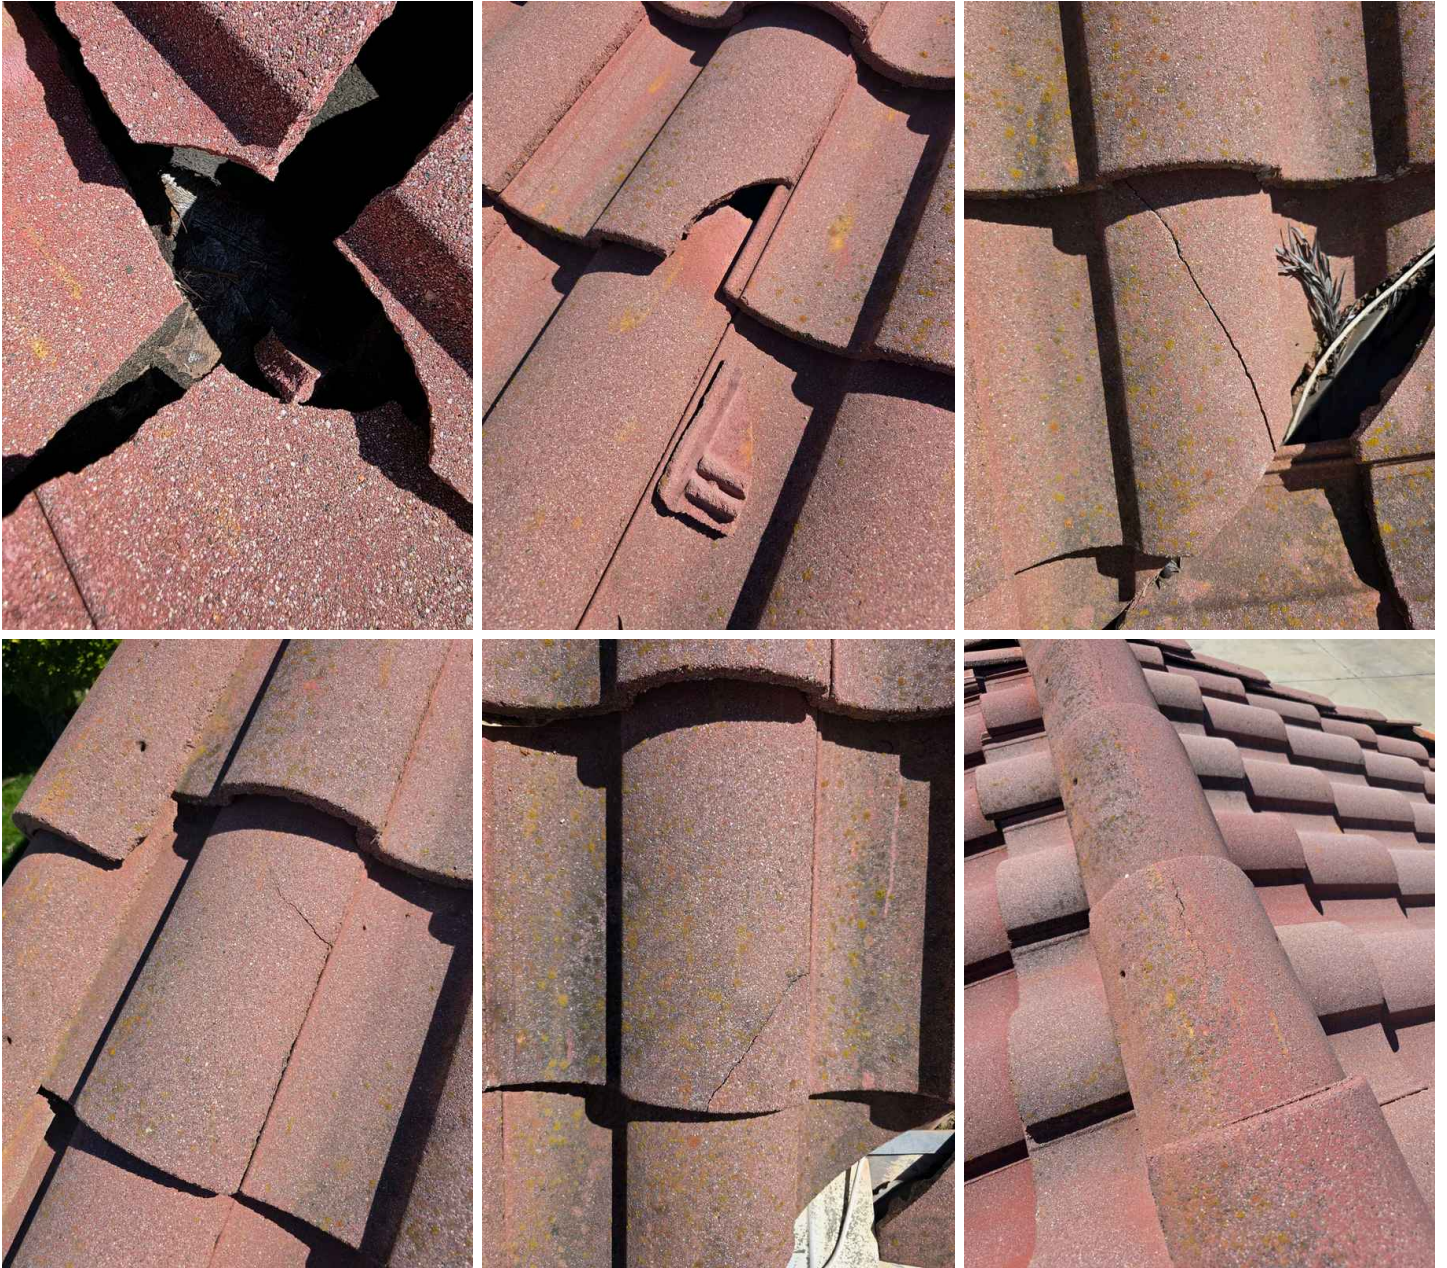
#### ROOF COVERING - TILE(S) BROKEN/CRACKED

There appeared to be one or more broken/cracked roof tiles. **We recommend having a California licensed roofer further evaluate and repair as needed.**

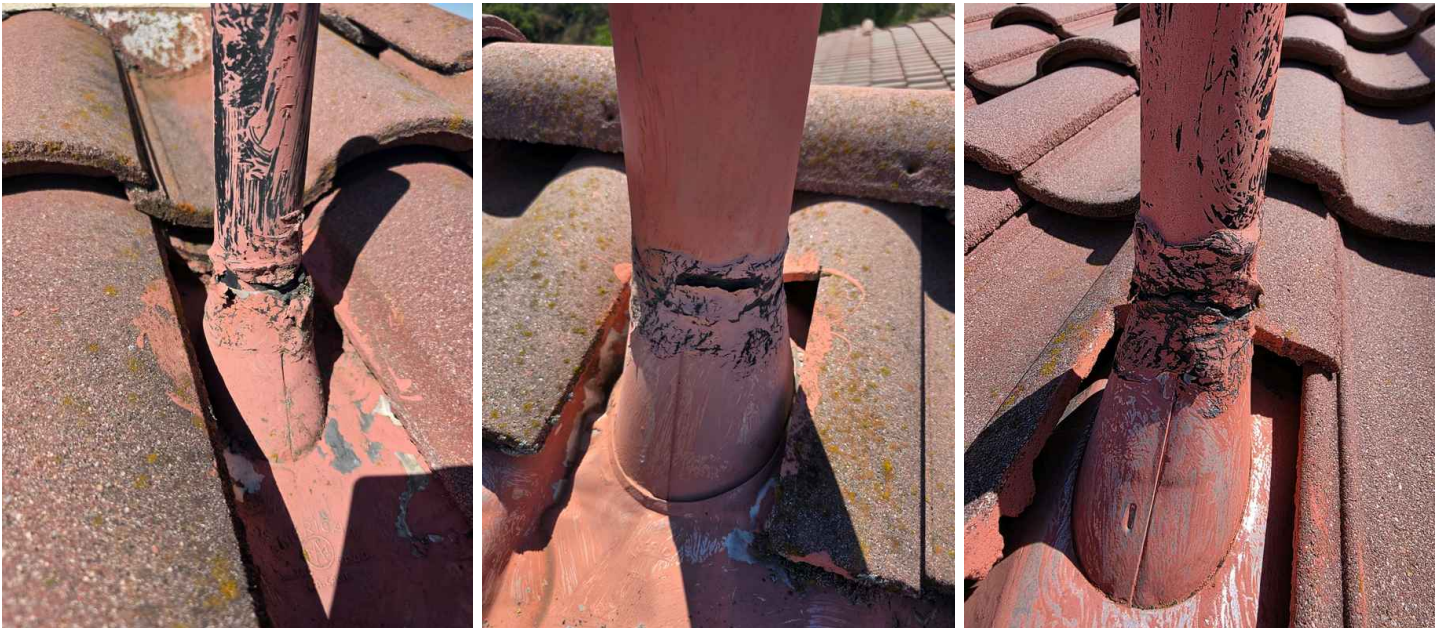
It appeared the mastic around all the pipe penetration flashings was dry and cracked in need of a new coat.

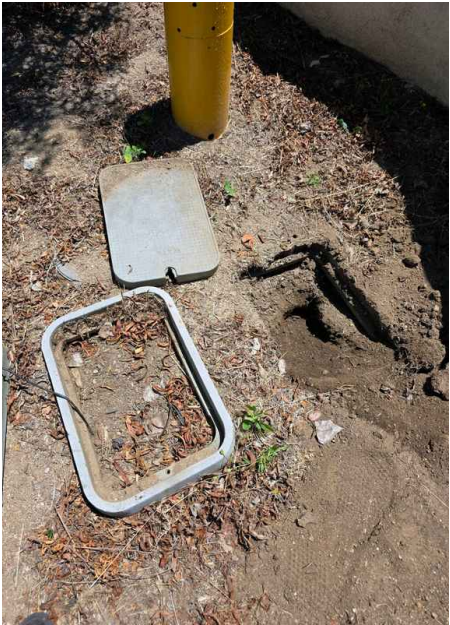
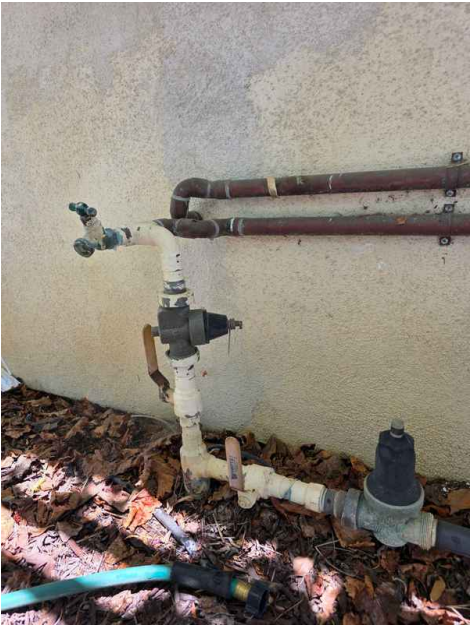
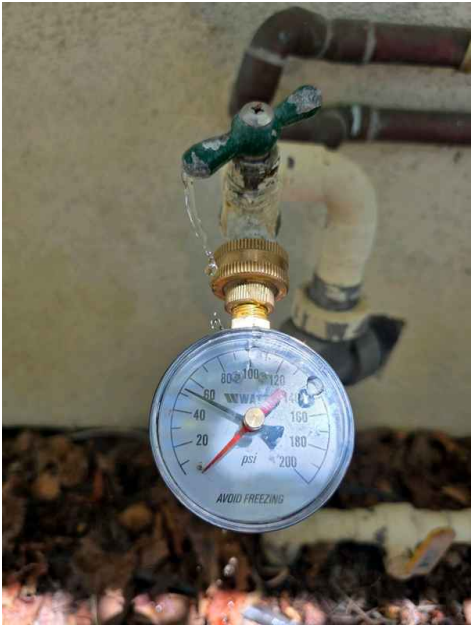
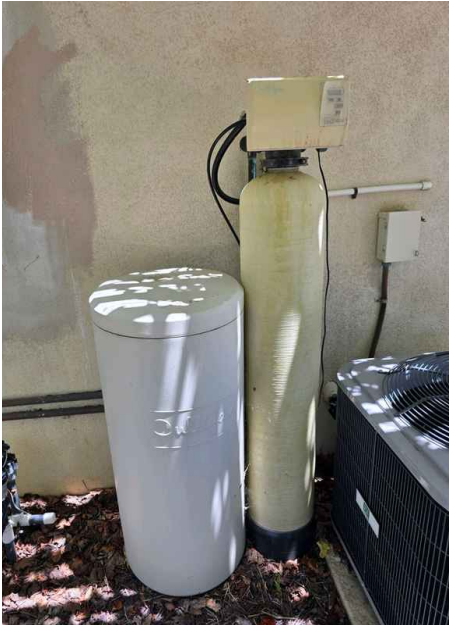
Water Service/Water Entrance: Water Service/Water Entrance

The water meter box appeared to be backed filled with dirt. We were unable to visibly see the water meter. We recommend clearing out the dirt and exposing the water meter and shut off valve.

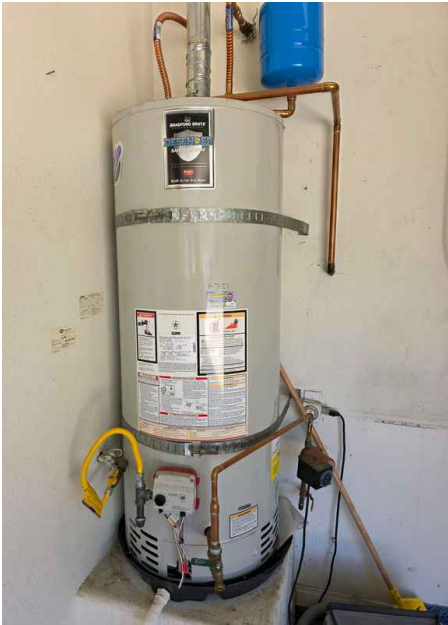
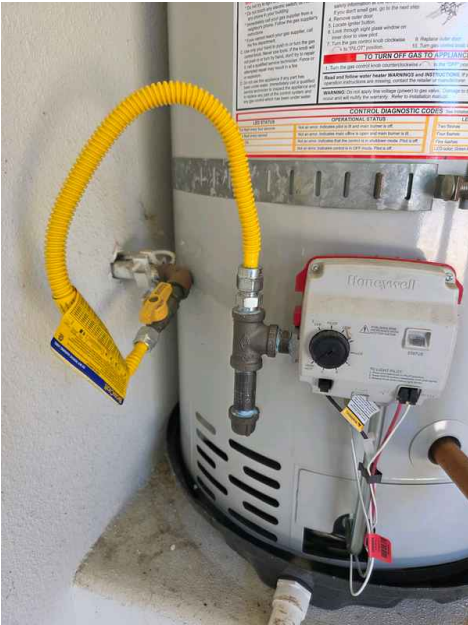
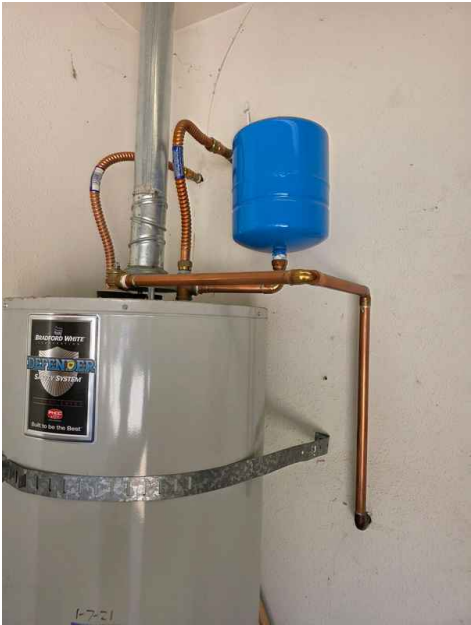
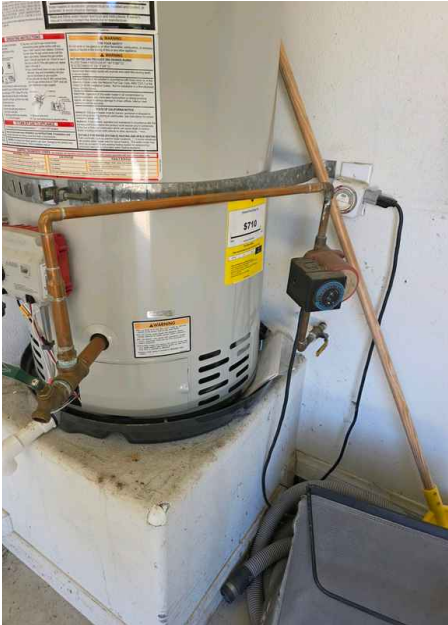
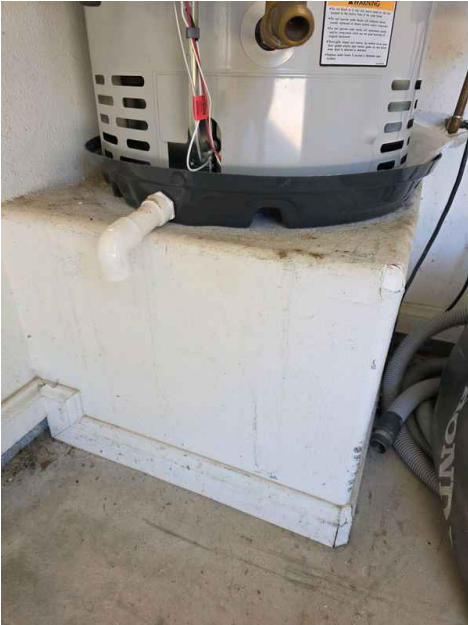
Water Heater: Water Heater

**Water Heater: Condition**
Needs Maintenance,  
Unsatisfactory
**Water Heater: Fuel Type**

We recommend flushing & servicing your water heater tank annually for optimal performance. Water temperature should be set to at least 120 degrees Fahrenheit to kill microbes and no higher than 130 degrees F to prevent scalding.

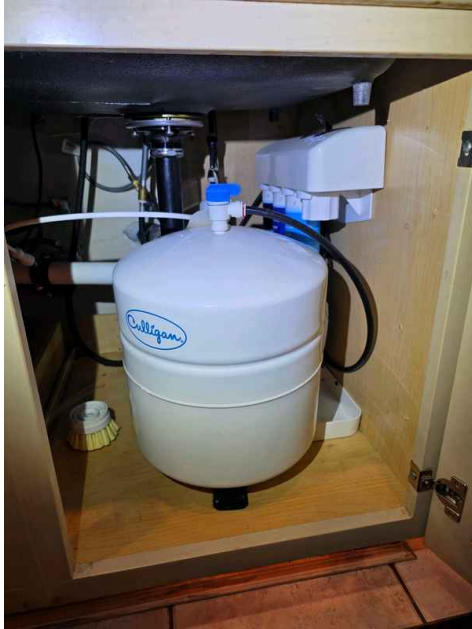
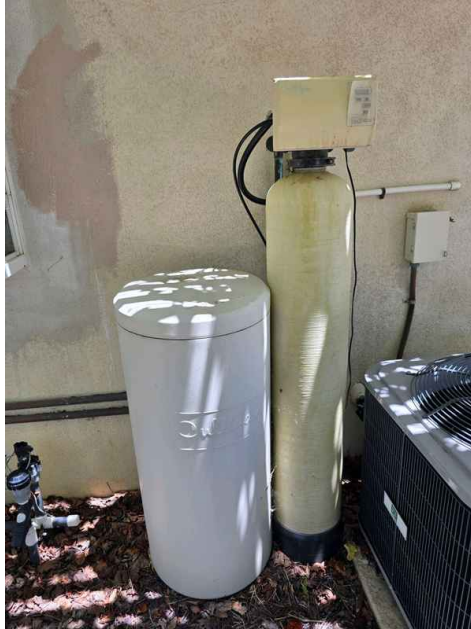
## 6.1.2 Water Service/Water Entrance

**WATER SUPPLY - WATER SOFTENER/FILTERS**

There appeared to be a water softener installed on the exterior of the home. And in line filters under the kitchen sink. We have no way of determining if these are working properly or when the filters were replaced. We recommend replacing any filters.

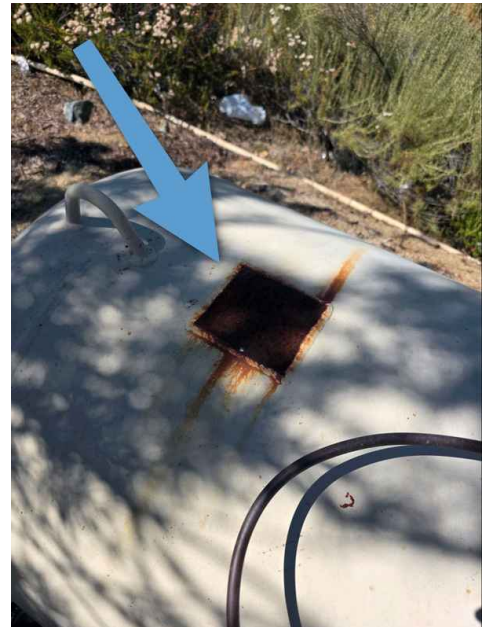
We recommend painting the rusted exterior propane tank to prolong the pipe life and integrity. We suggest checking with the propane leasing company, they may want to do it themselves.

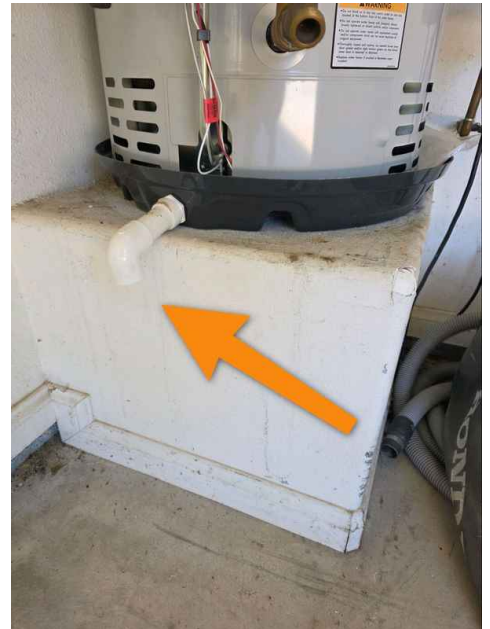
## 6.4.1 Water Heater

The drain pan under the water heater does not have a drain line that terminates to the floor. We recommend that a drain line to the floor be installed to prevent water from damaging the finish materials around the water heater.

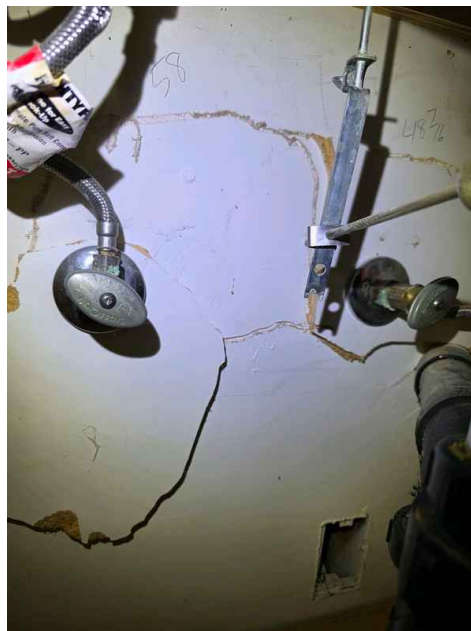
Some of the water supply valves under the sinks were the gate valve style. We recommend replacing these with 1/4 turn water supply valves as some have been upgraded already. The gate valve water supply valves are known to fail. We shut off the gate valves to the master bathroom sink #1(right) and the flow continued.

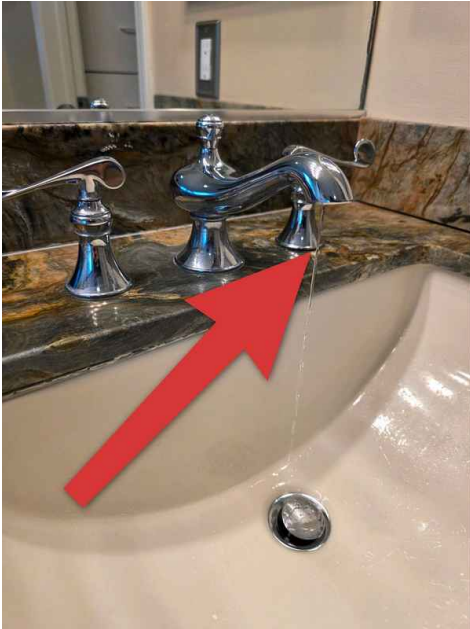
#### 6.7.1 Fixtures, Faucets, & Shower Valves

### FIXTURE/FAUCET - ACTIVE LEAK

Sink #1(right) in the master bathroom was actively dripping/leaking. **We recommend having a California licensed plumber further evaluate and repair is needed.**

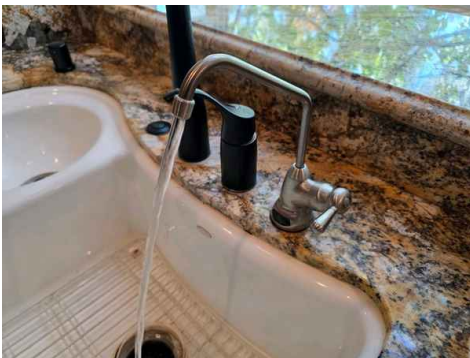
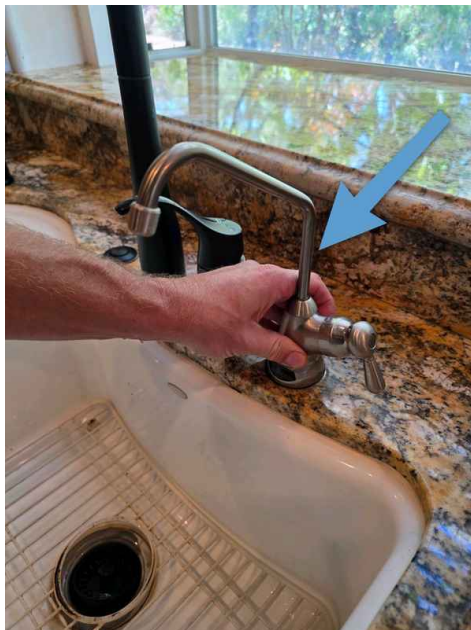
#### 6.7.2 Fixtures, Faucets, & Shower Valves

##### **FIXTURE/FAUCET - DRINKING WATER FAUCET LOOSE**

The drinking water faucet at the kitchen sink was loose and needs to be secured in place and caulked.

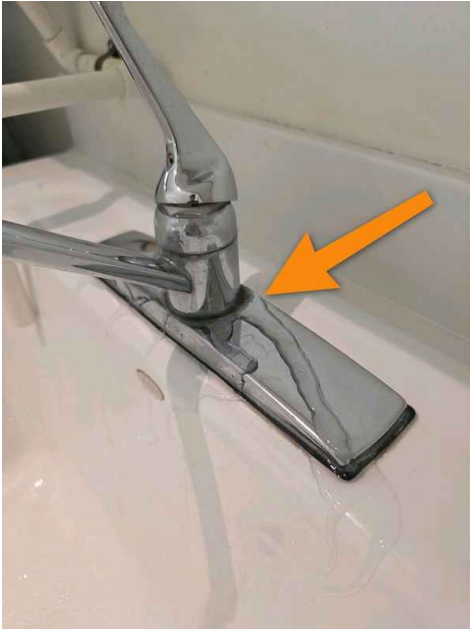
#### 6.7.3 Fixtures, Faucets, & Shower Valves

##### **FIXTURE/FAUCET - SINK FAUCET HANDLE LEAKED**

The sink faucet handle in the laundry room leaked when tested. **We recommend having a California licensed plumber further evaluate and repair as needed.**

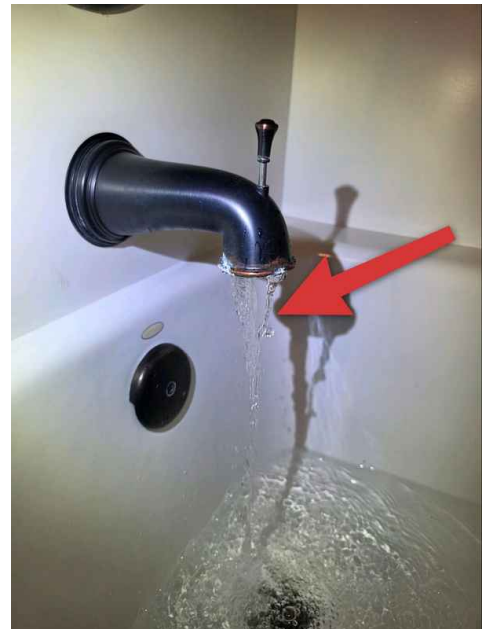
The tub faucet in the bathroom #2 leaked when diverted to the showerhead when tested. The tub faucet actively dripped/leaked when shut off. **We recommend having a California licensed plumber further evaluate and repair as needed.**

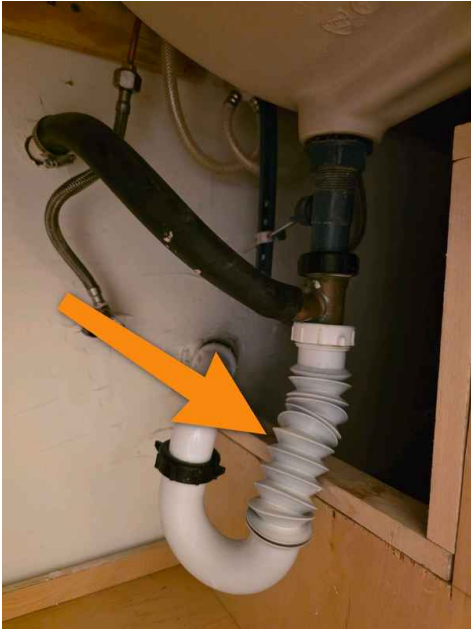
The drain under the sink of bathroom #2 had a flexible accordion style that is known to have issues with clogging due to build up in the grooves. We recommend having a California license plumber further evaluate and replace as needed.
