# A BETTER LOOK HOME INSPECTIONS

## A BETTER LOOK HOME INSPECTION

37540 Vía El Dorado  
Temecula, CA 92592

Jill Downs  
05/11/2026

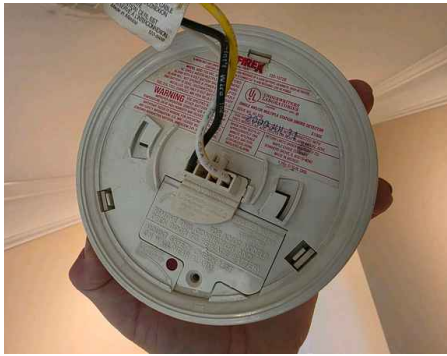
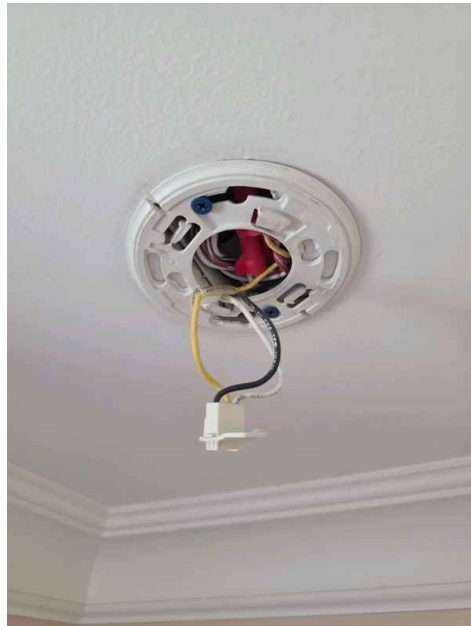
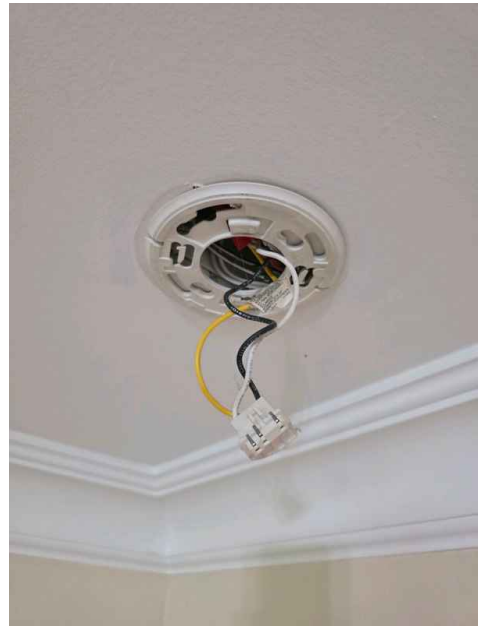
## Smoke Detectors: Smoke Detectors

California state law requires a working smoke detector in every bedroom, in every hallway leading to a bedroom, and on every floor.

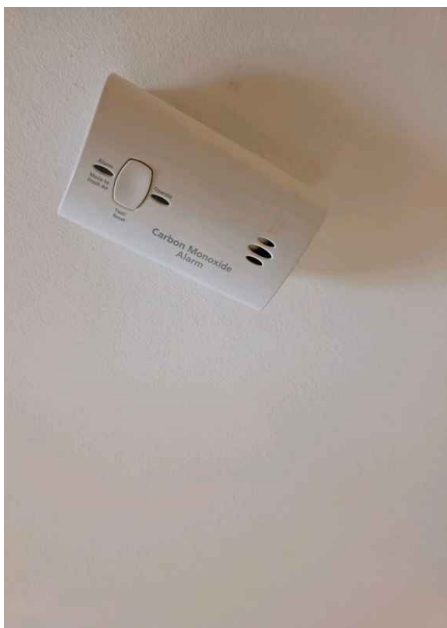
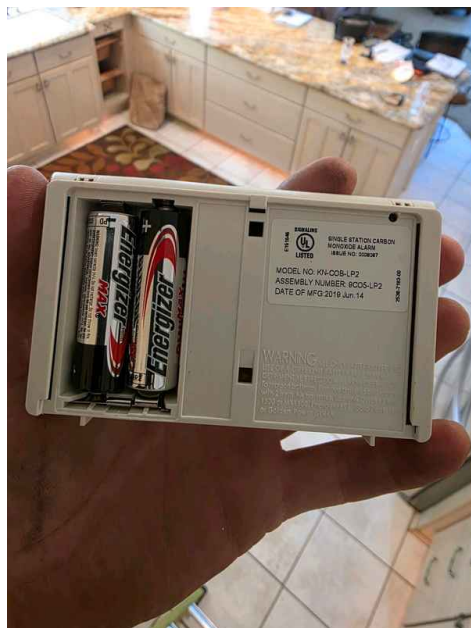
## Carbon Monoxide Detectors: Carbon Monoxide Detectors

California state law requires carbon monoxide detectors outside of all bedroom- sleeping areas and one per floor.

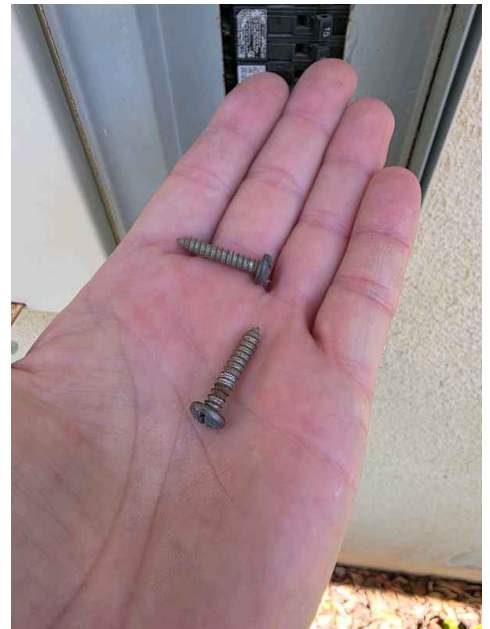
The screw(s) at the dead front panel for the main panel were incorrect. The dead front panel screws should have a dull tip, as to not penetrate any wire sheathing when screwing the panel back on. We recommend replacing the sharp tipped screws with the correct screws.

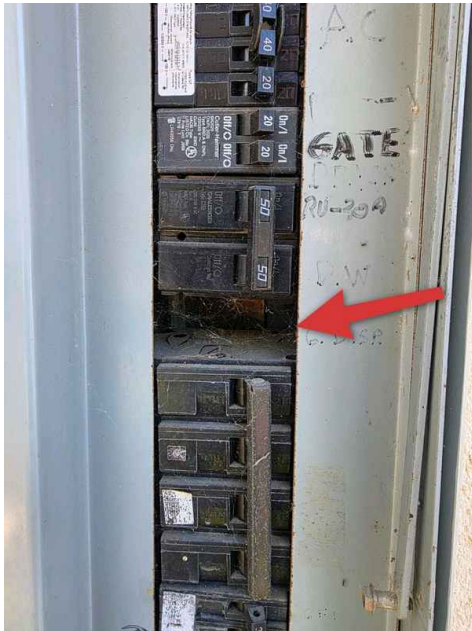
There was one a circuit breaker knockout at the main panel that has been removed and was left open. We recommend installing plastic knockout filler plate to fill the open breaker knockout in the dead front panel of the main panel.

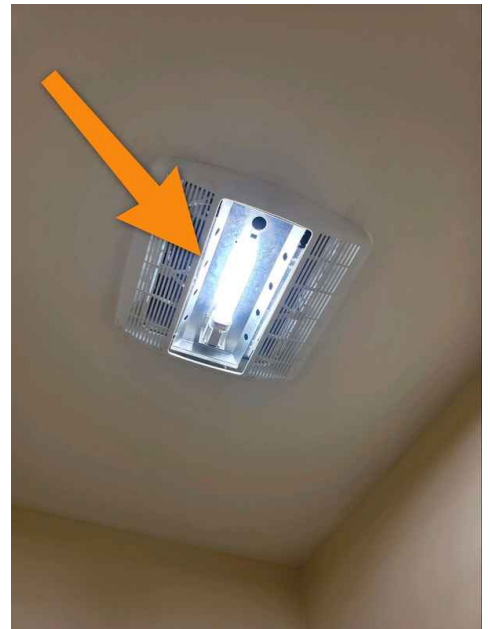
The exhaust fan/light in the master bathroom did not have a protective dome/globe. We recommend installing a dome/globe or replace the exhaust fan.

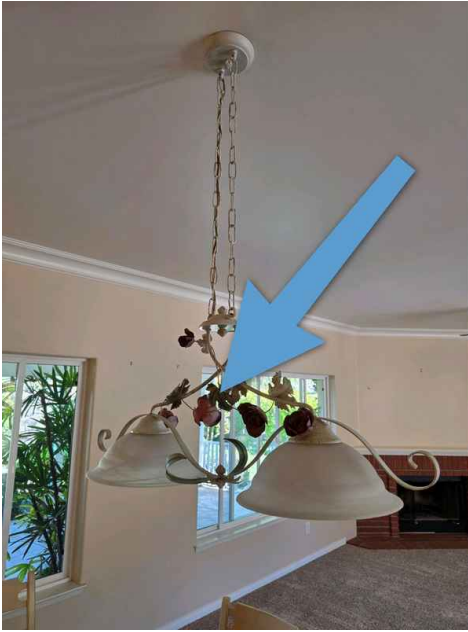
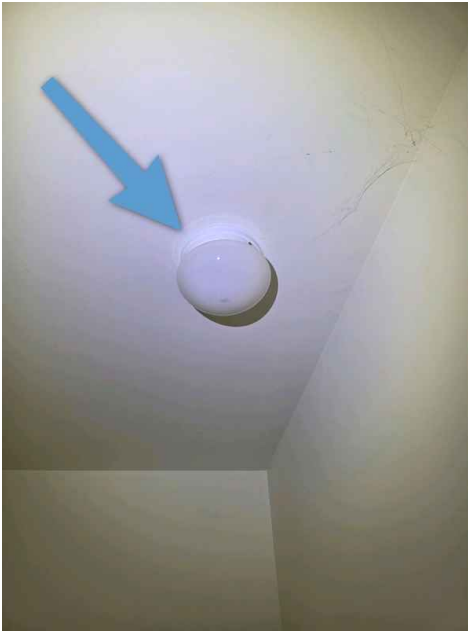
There were a few of the exterior lights and one or more lights in bedroom #2, bedroom #3, bathroom #2, and bathroom #3 that did not turn on when tested; the bulbs may need to be replaced.

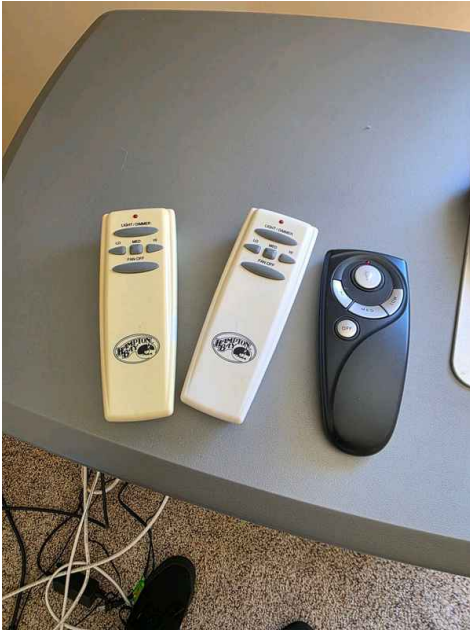
### **CEILING FAN/LIGHT(S) - DID NOT TURN ON (REMOTE)**

We were unable to get the ceiling fan/lights in bedroom #2 and #3 to operate from the remotes when tested; the bulbs and/or remote batteries may need to be replaced.

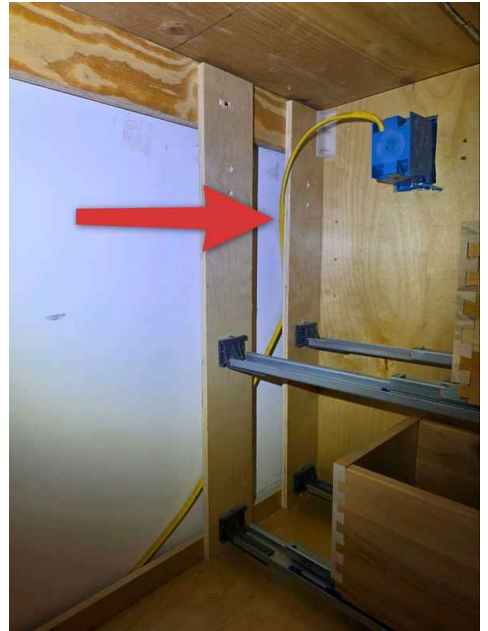
### ELECTRICAL - IMPROPER INSTALL

There appeared to be Romex that should be in conduit in the cabinet under the sink in bathroom #2 were installed improperly. **We recommend a California licensed electrician further evaluate and repair as needed.**

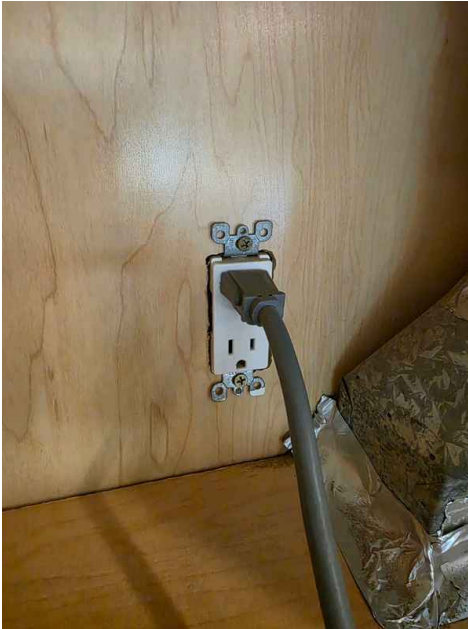
### WALL PLUG COVER PLATE(S) - DAMAGED/MISSING

The plug cover plate above the microwave was missing and there appeared to be an open junctionbox under sink #2 (left) in the master bathroom. We recommend replacing the cover plate(s).

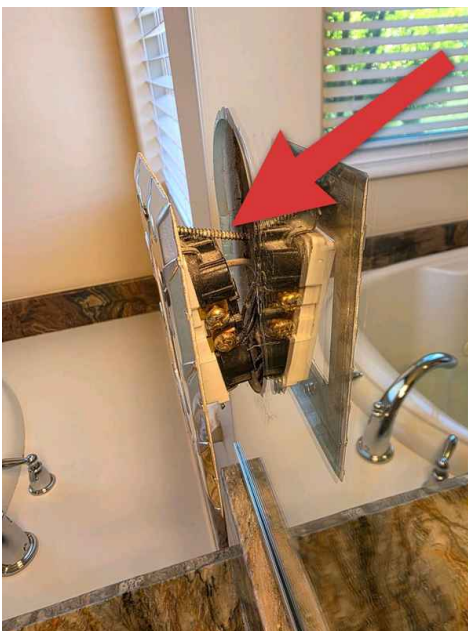
### WALL SWITCH - LOOSE

There was a wall switch in the master bathroom that was loose. We recommend having a California licensed electrician further evaluate and repair as needed.

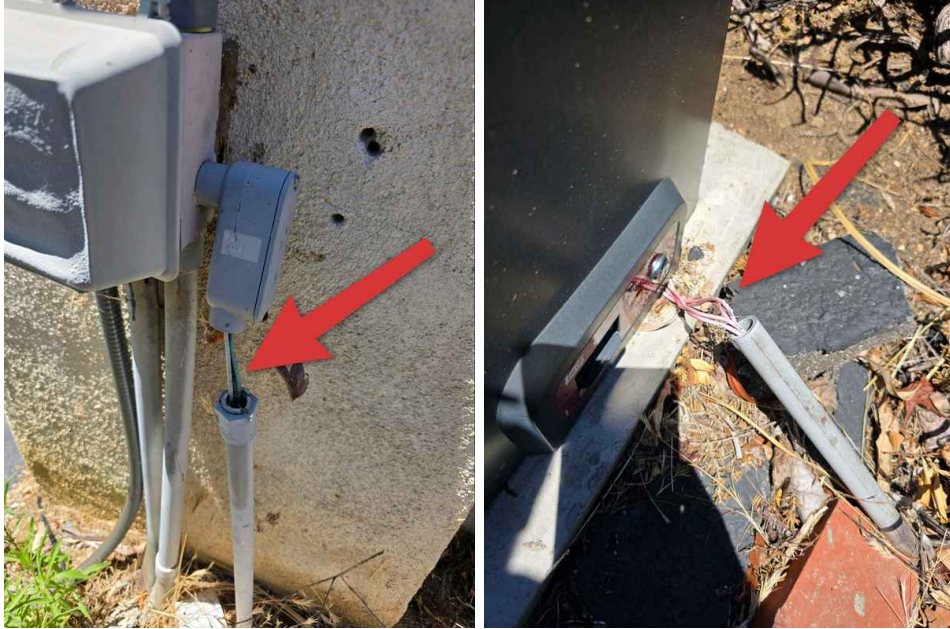
**EXTERIOR ELECTRICAL - CONDUIT AT THE AUTOMATIC GATE OPENER DISCONNECTED**

There appeared to be a couple sections of electrical conduit at the gate, automatic openers that were disconnected and wires were exposed to the outdoor elements. **We recommend having a California, licensed electrician further evaluate and repair as needed.**

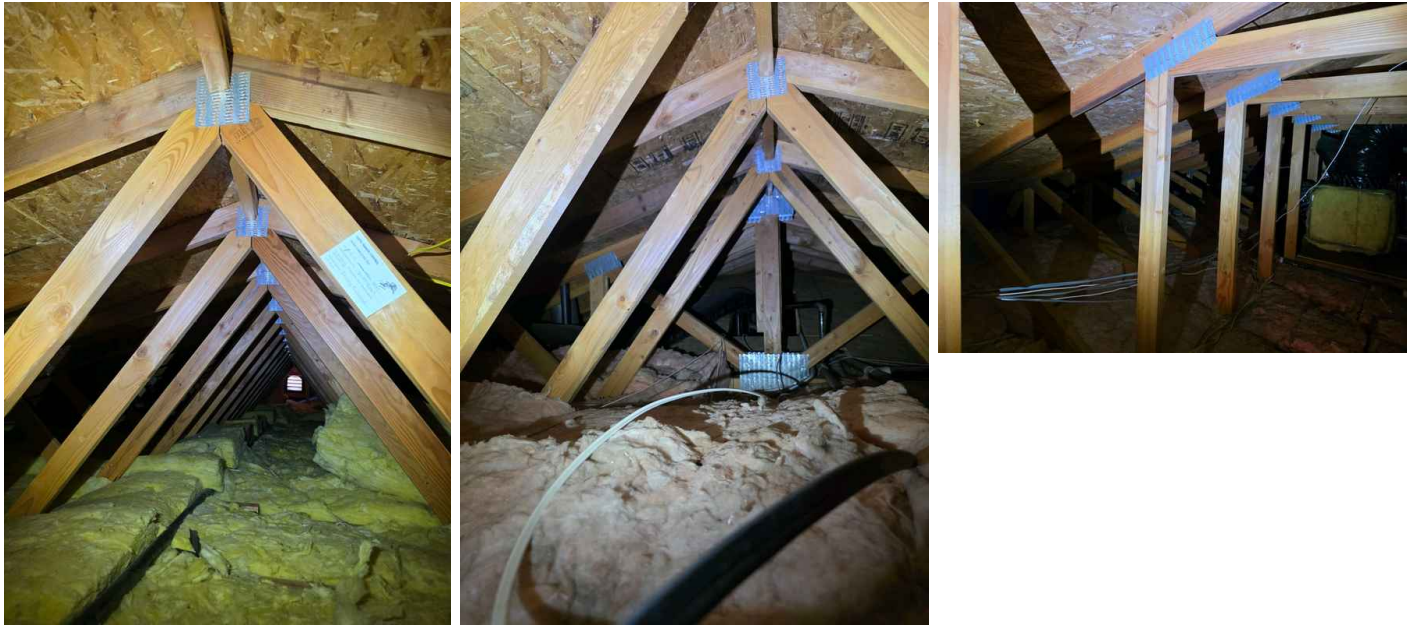
Roof/Ceiling Frame: Roof/Ceiling Frame

**Roof/Ceiling Frame: Condition**  
Satisfactory

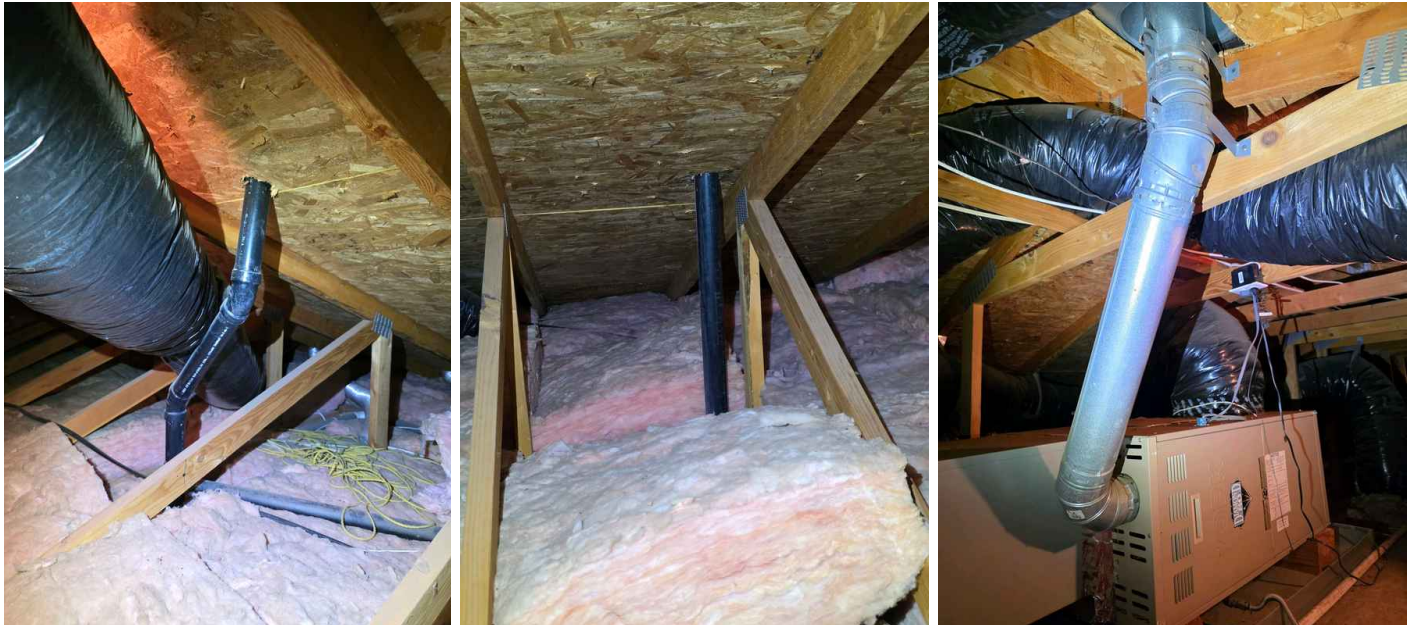
Vent Pipes/Flashing: Vent Pipes/Flashing

**Vent Pipes/Flashing: Condition**  
Satisfactory

**Vent Pipes/Flashing: Leaks Observed**  
No

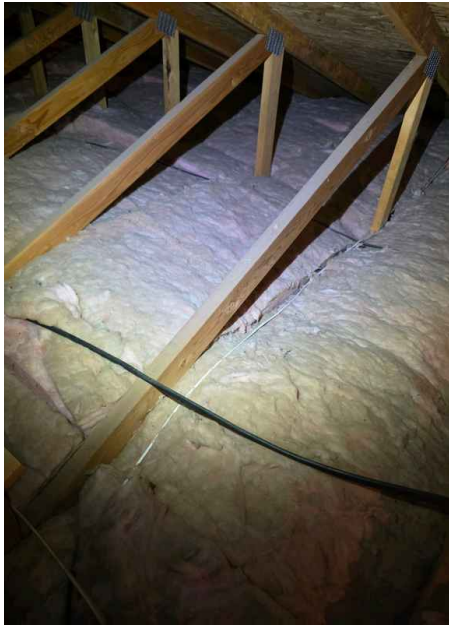
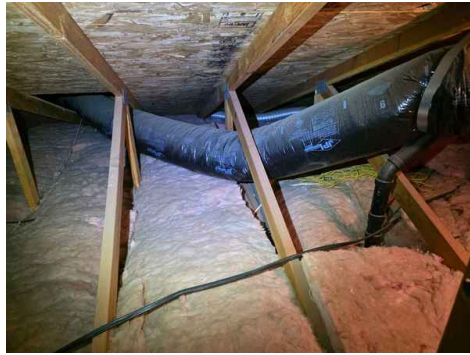
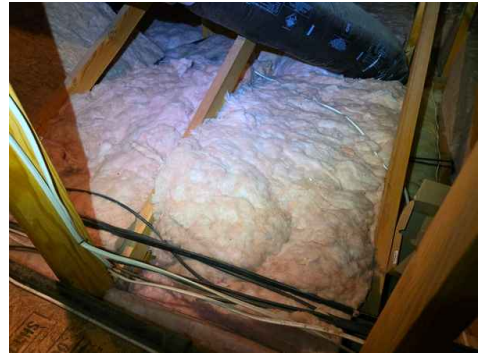
## Attic Insulation: Attic Insulation

**Attic Insulation: Condition**  
Satisfactory, Needs Maintenance

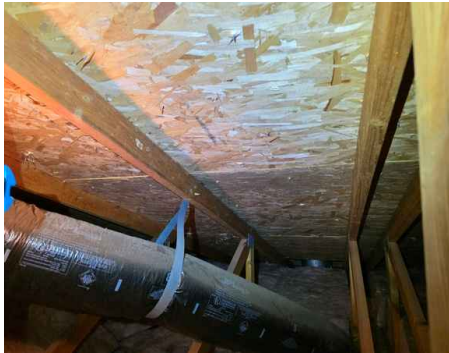
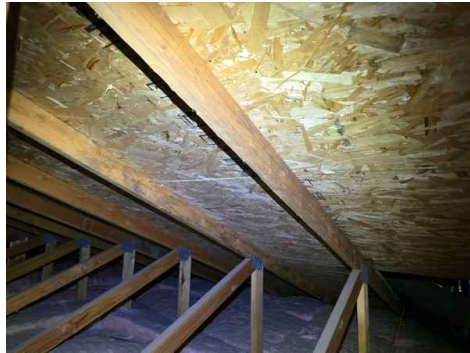
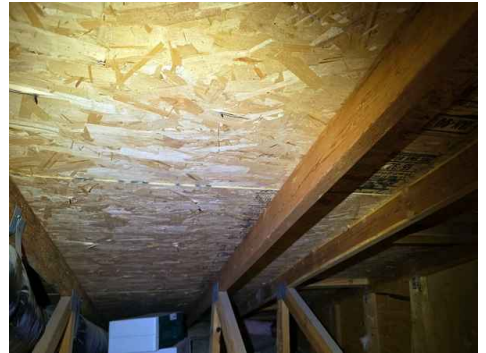
## Attic Sheathing: Attic Sheathing

**Attic Sheathing: Condition**  
Satisfactory

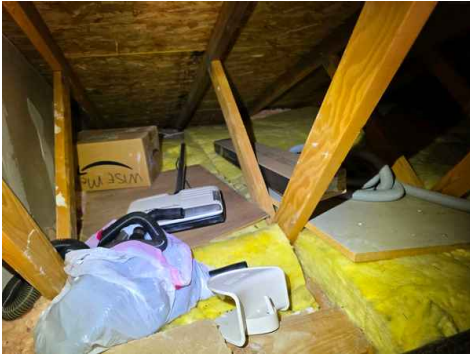
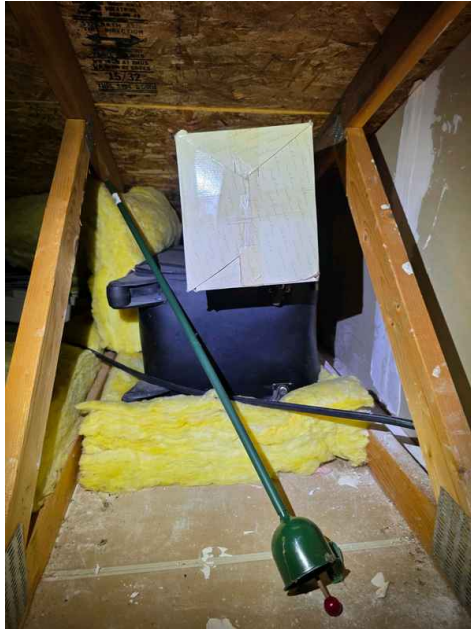
8.1.1 Attic Access - Attic

There appeared to be personal property in both attic access spaces that should be removed.

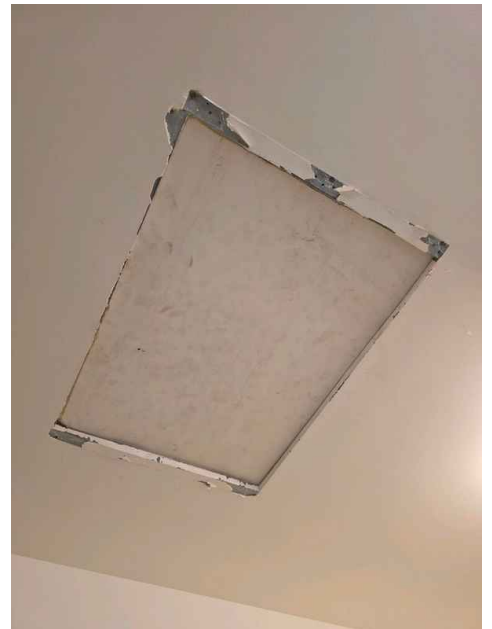
The drywall texture around the attic access corner bead in the master bathroom closet appeared to be peeling and flaking off. We recommend having the texture around the attic access corner bead.

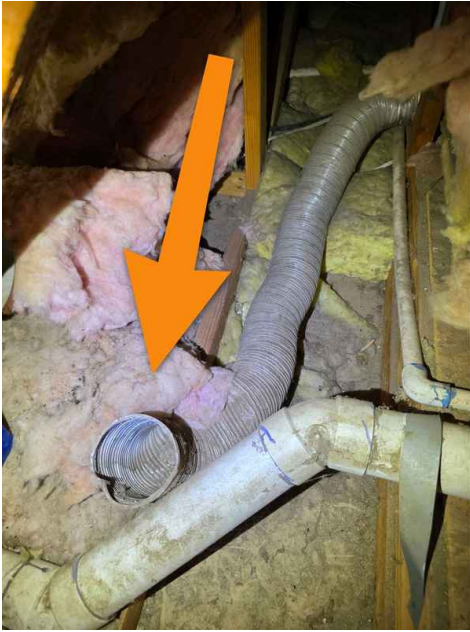
It appeared there were a couple exhaust fan vents that terminated into the attic space.

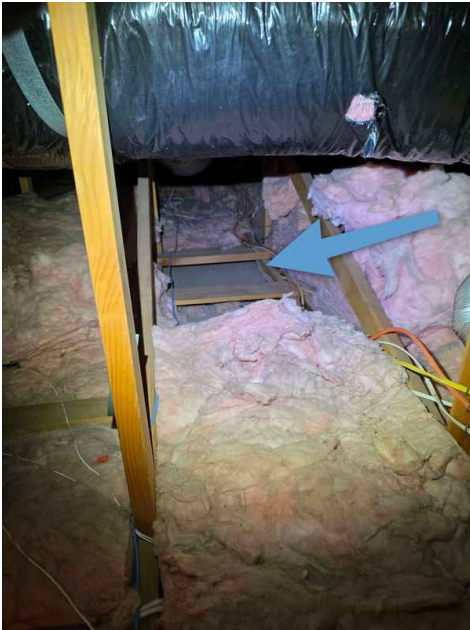
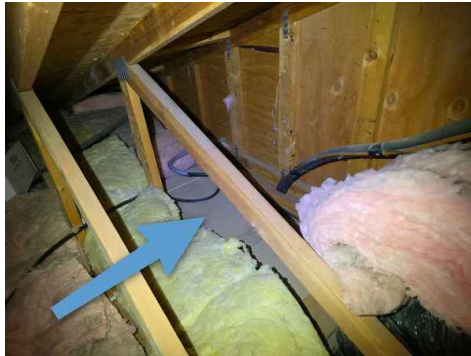
### INSULATION - INSULATION MOVED AROUND

It appeared that there were some insulation batts that had been moved around for electrical upgrades and not put back into place. We recommend putting the insulation back in place to work at the most efficient level.

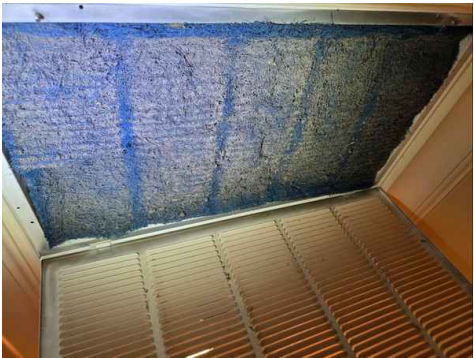
The HVAC air filter appeared to be dirty. We recommend replacing the filters with pleated filters.

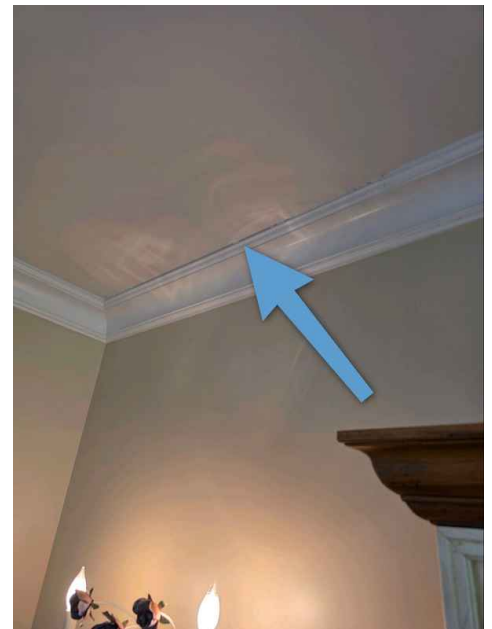
There were sections of crown moulding caulking that needs maintenance in a few rooms.

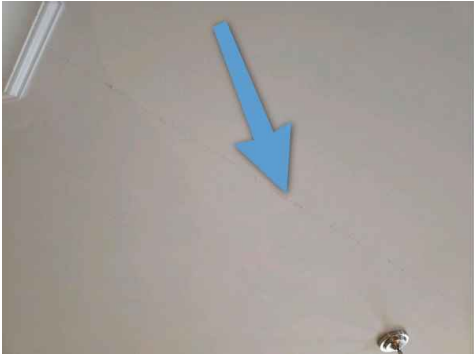
#### **WALLS - CEILING DEFLECTION CRACKS**

There appeared to be some deflection cracking at the drywall ceiling in a few different rooms. While cosmetic, we recommend repairing the drywall deflection cracks in the drywall texture.

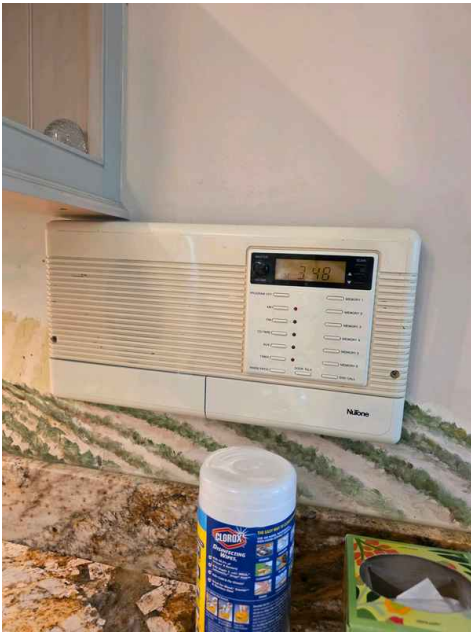
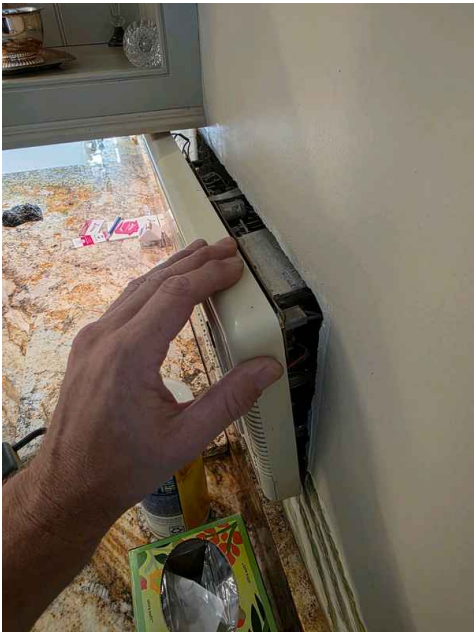
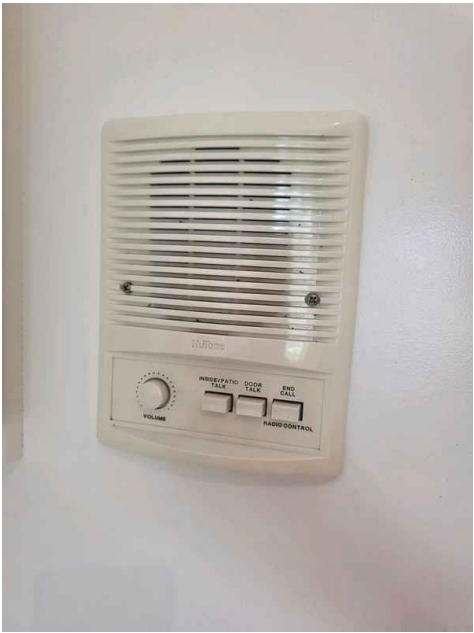
There appeared to be an intercom system throughout the home with the control station located in the kitchen. The control panel appeared to be loose and needs to be secured.

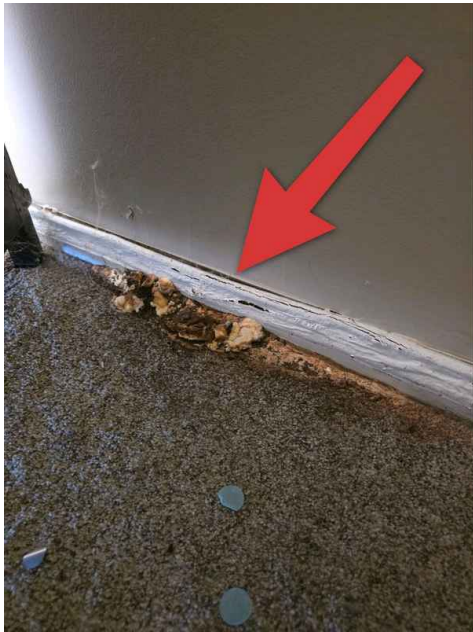
WALL - ACTIVE MOISTURE PRESENT

There was active moisture and biological growth present at the wall in the living room. It appeared to be from the shower in enclosure in bathroom #3 leaking. **We recommend having a California licensed remediation professional further evaluate and repair as needed.**

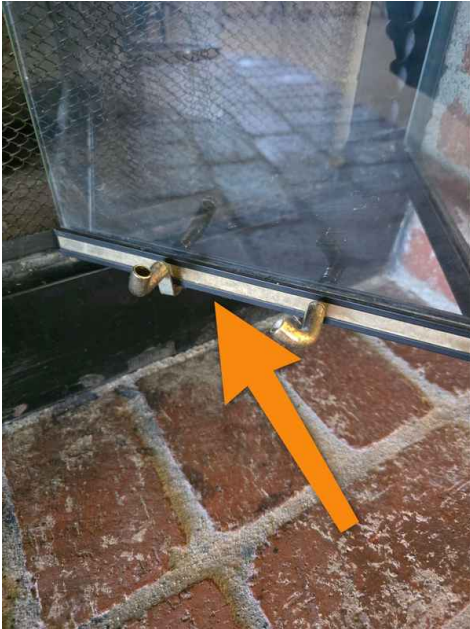
11.5.1 Family Room

FIREPLACE - ENCLOSURE DOOR HANDLE MISSING

One of the fireplace glass enclosure door handles in the family room was missing

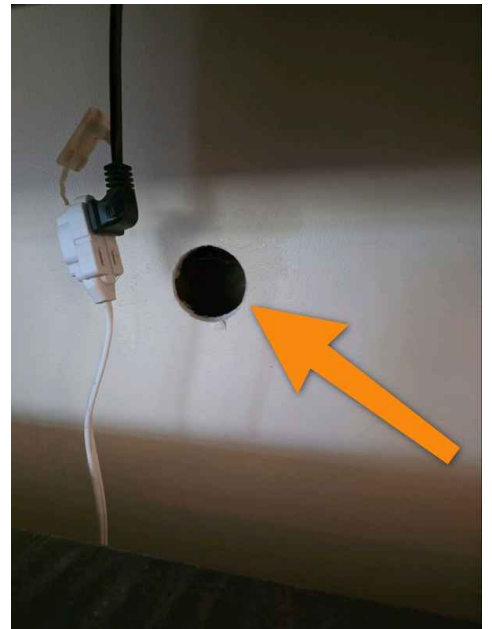
#### 11.5.2 Family Room

### WALL - HOLE IN DRYWALL

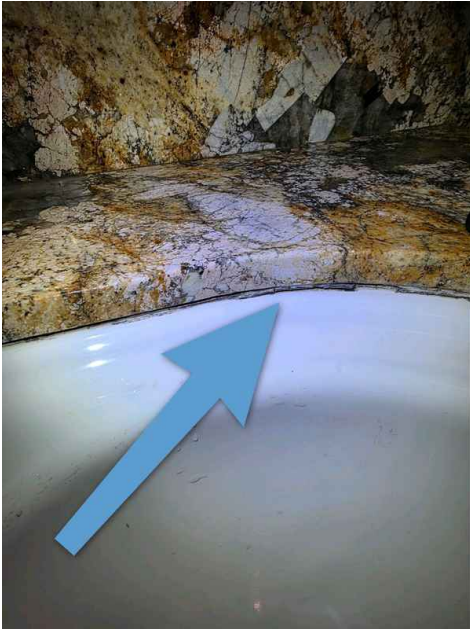
#### 11.6.1 Kitchen

### COUNTERTOP - CAULKING NEEDS MAINTENANCE

The caulking at the kitchen countertop to sink transition was dry and cracked and needs maintenance.

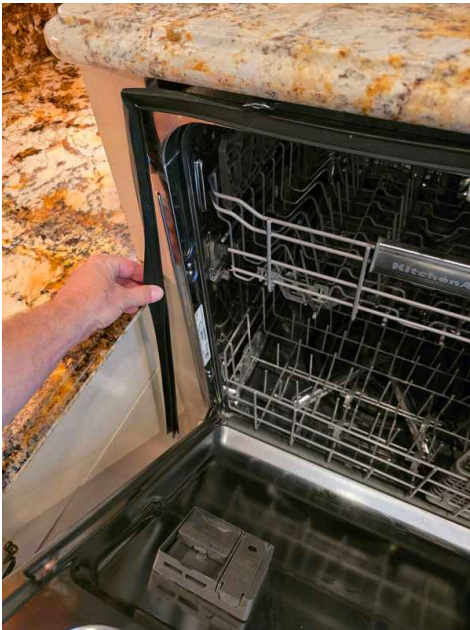
## 11.6.2 Kitchen

**DISHWASHER - NOT SECURED**

The dishwasher was loose and not secured in place. The dishwasher weatherstripping seal was loose. We recommend securing the weatherstripping in place and dishwasher to the countertop. **We did not test the dishwasher due to risk of leaks from the loose weatherstripping seal.**

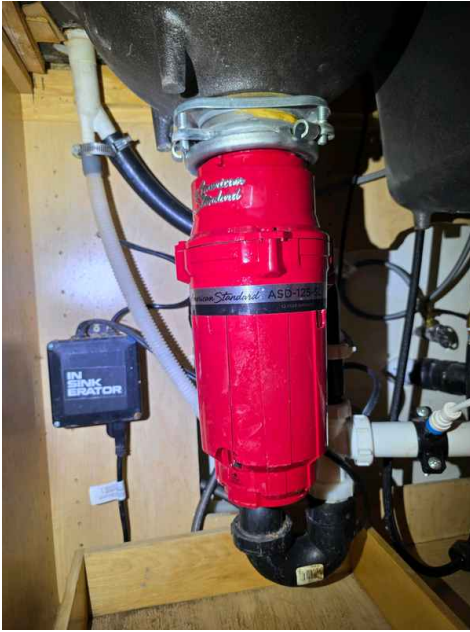
## 11.6.3 Kitchen

**GARBAGE DISPOSAL - EXCESSIVE NOISE**

Garbage disposal appeared to have something stuck in the blades and was excessively noisy. **We recommend a California licensed plumber further evaluate and repair as needed.**

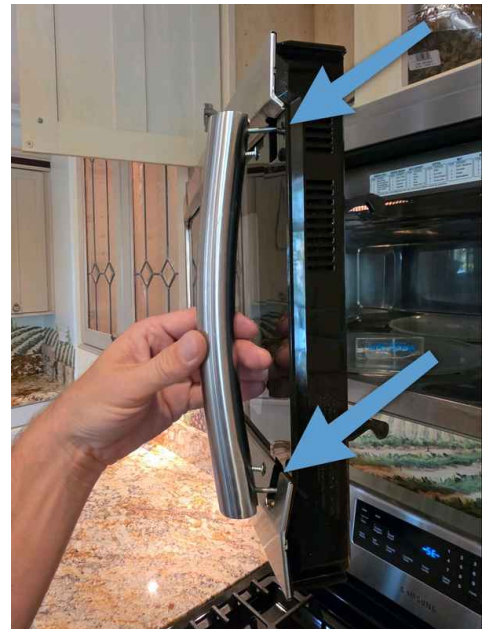
## 11.6.4 Kitchen

**MICROWAVE - LOOSE HANDLE**

The microwave door handle was loose.

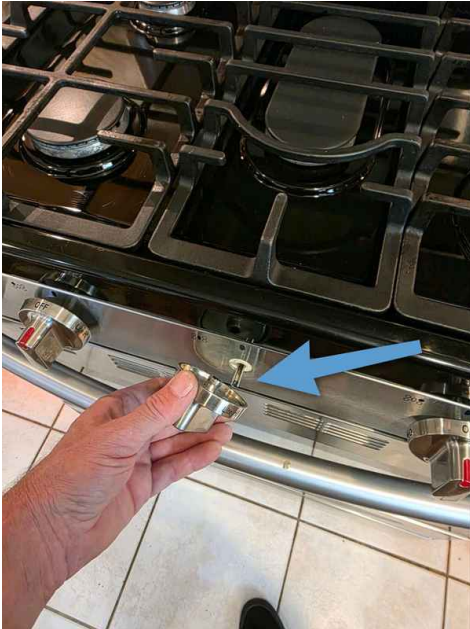
## 11.6.5 Kitchen

**OVEN - BROKEN CONTROL KNOB**

The middle cooktop burner knob did not engage and turn properly. We recommend replacing the knob.

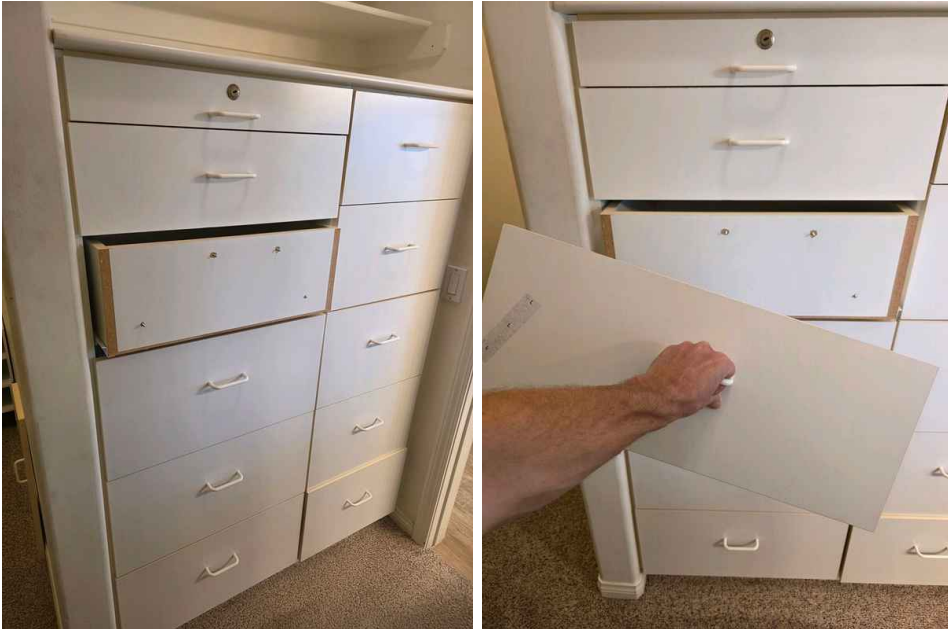
**CLOSET - DRAWER FACE REMOVED AND CLOTHES POLE LOOSE**

One of the cabinet drawer faces in the master bathroom closet had been removed. One of the clothes bars was pulling away. We recommend repairing the drawer face and clothes bar.

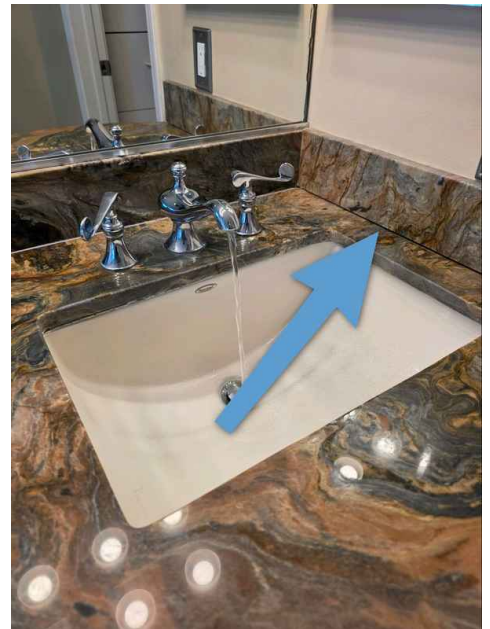
The caulking at the master bathroom countertop to backsplash transition was dry and cracked and needs maintenance.

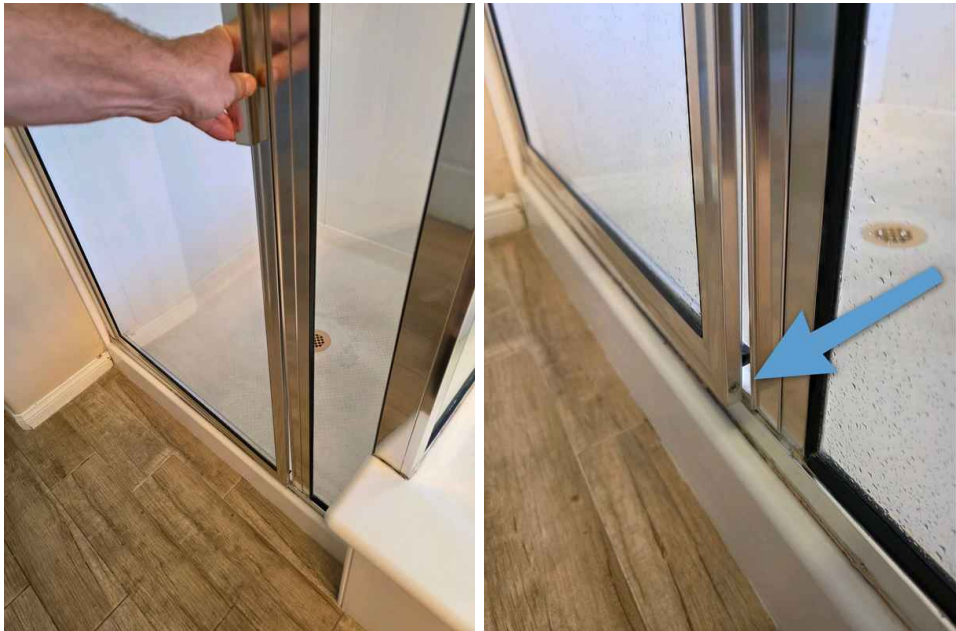
**SHOWER DOOR - STICKS**

The master bathroom shower door sticks and was tough to open. We recommend having the door adjusted

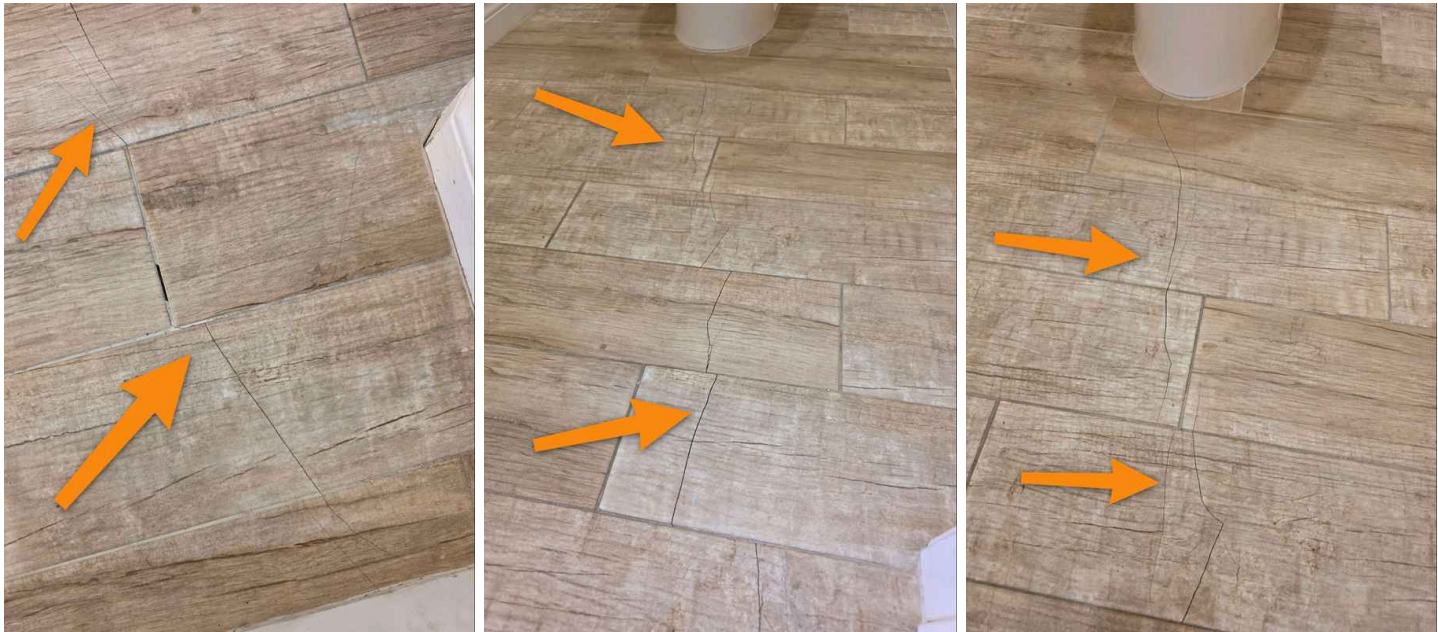
11.10.4 Master Bathroom  
**FLOOR - CRACKED TILE**

There appeared to be several cracked tiles in the master bathroom that extends from the shower enclosure to the toilet in the water closet. We recommend having a California licensed tile professional further evaluate and repair and replace as needed.

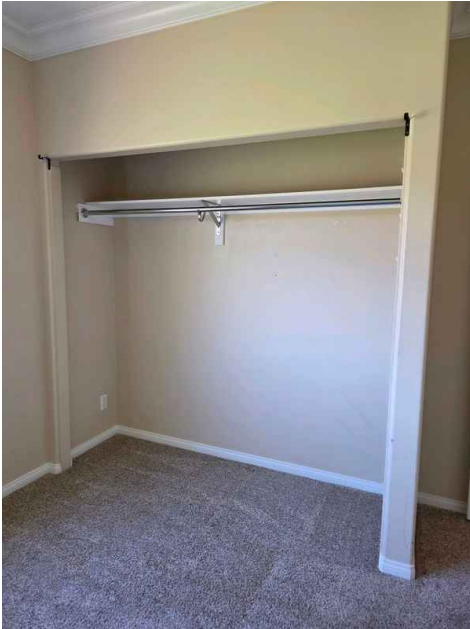
11.13.1 Bedroom #4  
**CLOSET - DOORS MISSING**

The closet doors in bedroom #4 were missing at the time of the inspection.

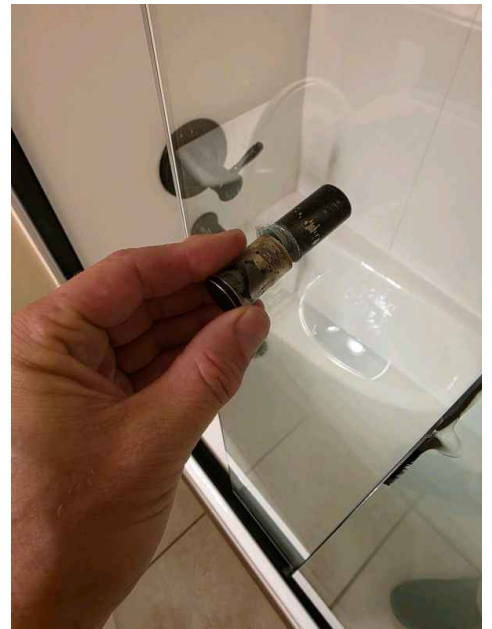
The shower enclosure handle in bathroom #2 was loose at the time of the inspection. We recommend tightening the handle.

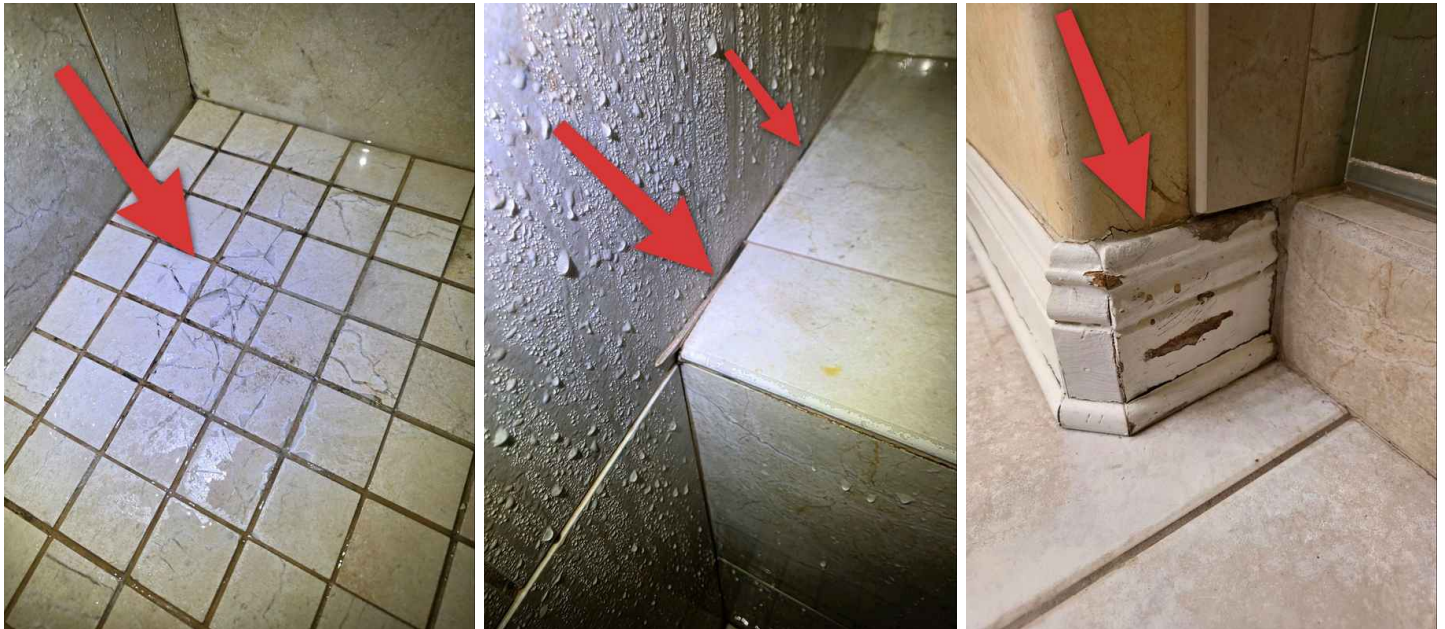
**SHOWER FLOOR - CRACKED TILE & GROUT**

There were several cracked tiles and grout in the bathroom #3 shower tile enclosure. The water was leaking through to the wall in the living room. We recommend having a California licensed plumber further evaluate and repair as needed.

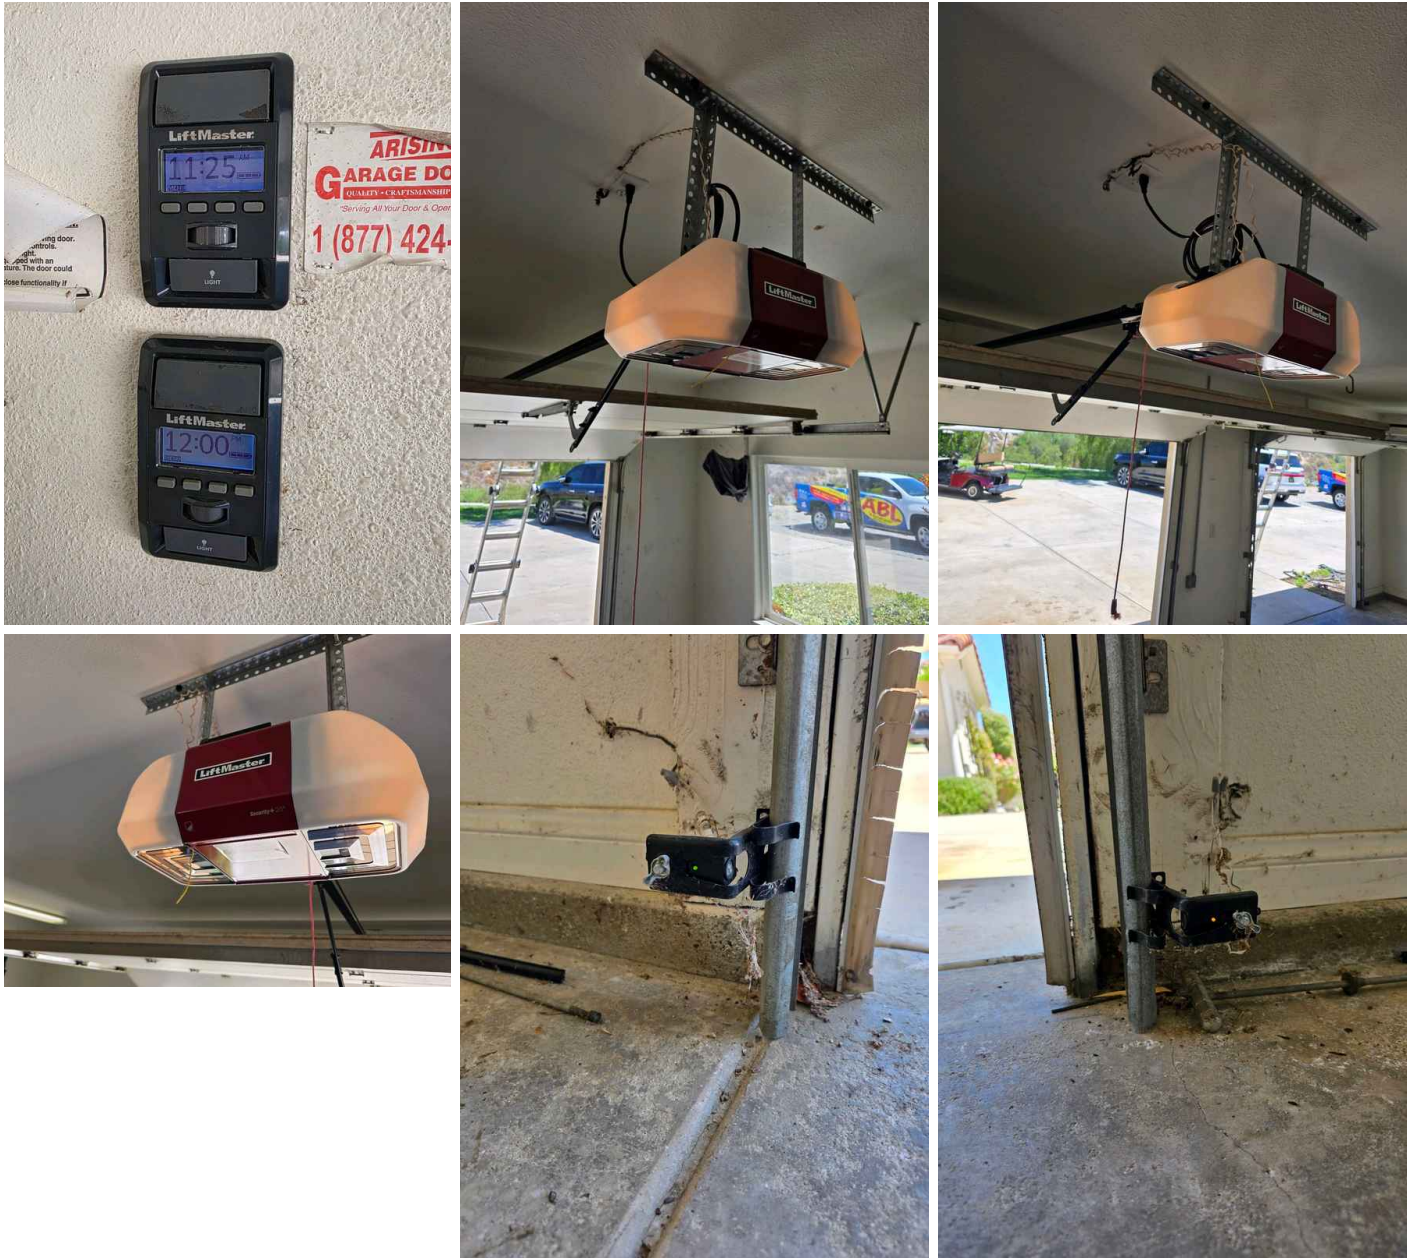
Door Opener: Door Opener

Door Opener: Condition  
Satisfactory

Door Opener: Sensor  
Satisfactory

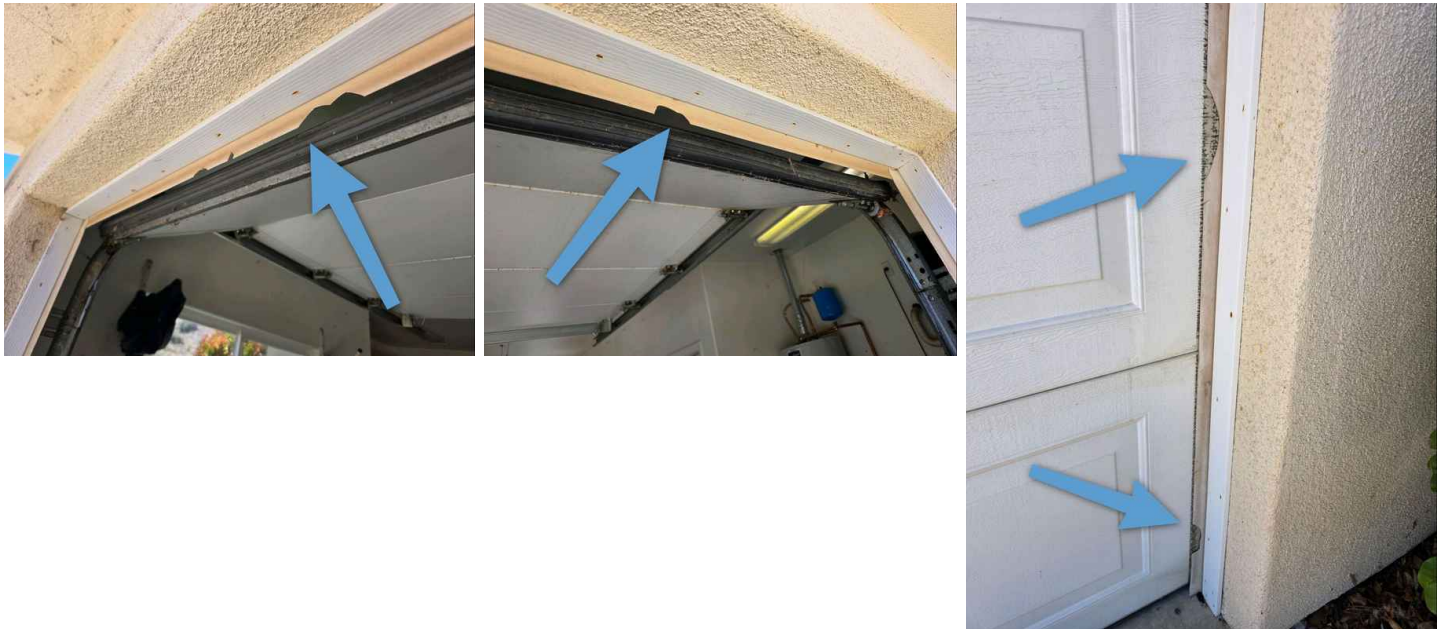
The weatherstripping at the sides and tops of the garage door frames were damaged. We recommend replacing the weatherstripping around the sides and tops of the garage door frames.

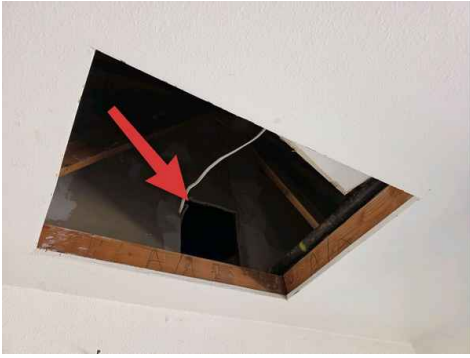
The attic access located in the garage appeared to have an opening to the adjacent living space and not properly sealed. This condition can allow the migration of air, moisture, and potentially harmful gases (including carbon monoxide) from the garage into the home. It also reduces the effectiveness of the required fire separation between the garage and living areas. **We recommend having a California licensed general contractor further evaluate and repair as needed.**

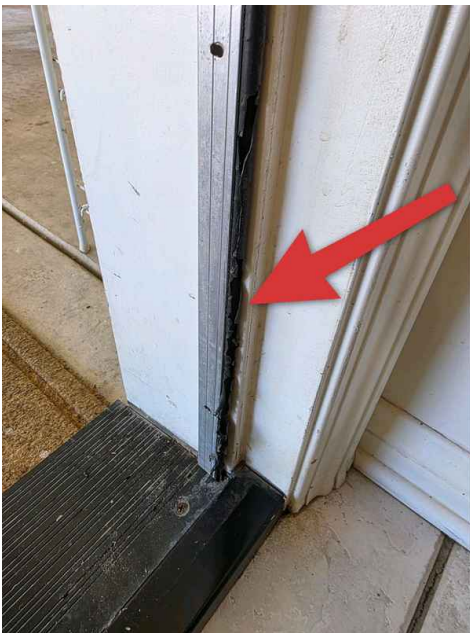
#### 12.6.1 Door to Living Space/Man Door

##### **FIRE DOOR - WEATHERSTRIPPING TORN**

The fire door weatherstripping was torn and some of the weatherstripping metal strip screws were loose. We recommend replacing the torn weatherstripping and tightening the loose screws to prevent carbon monoxide and garage fumes from entering the home through the fire door.
