ELITE GROUP
INSPECTION PROFESSIONALS

PROPERTY LOCATION: 27951 Sycamore Creek Dr Valencia, CA 91354

INSPECTION REPORT

Date of Inspection: 5/31/2026 at 10:00 AM

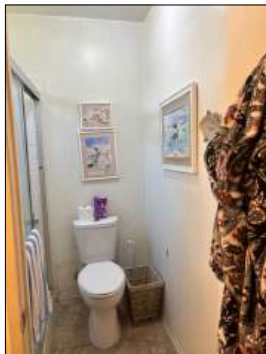
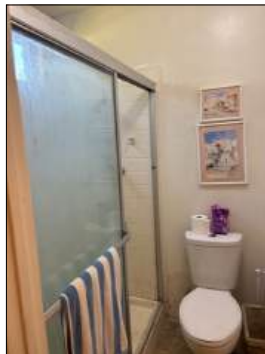
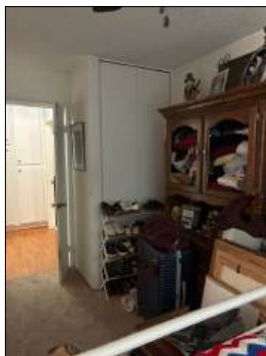
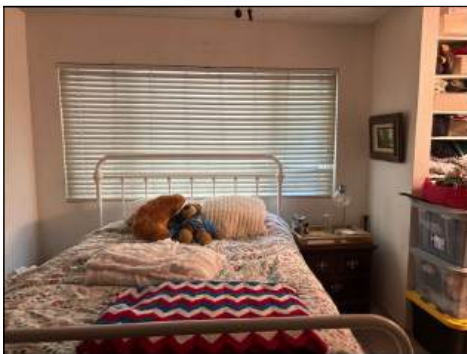
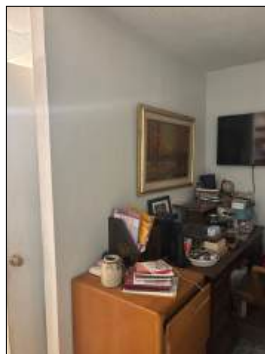
- Small cracks/holes/chipped/dirty areas/cosmetic blemishes observed - typical for age of structure
- Patched/partial painted areas present - consult seller regarding patched areas

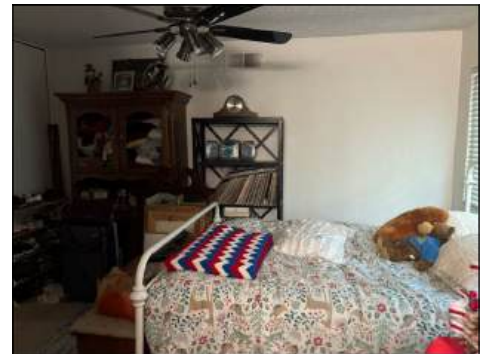
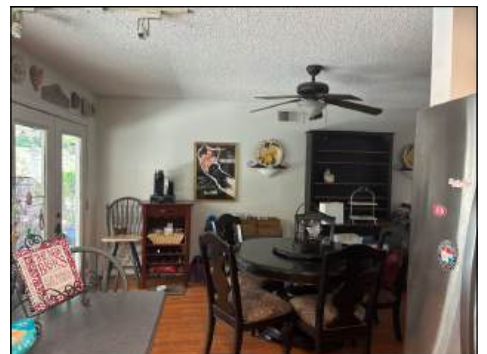
2. Wall Conditions

Patched/partial painted areas present - consult seller regarding patched areas

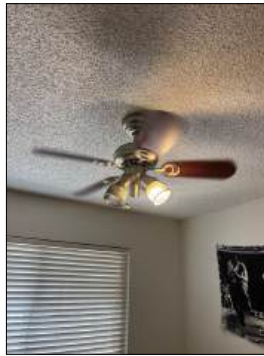
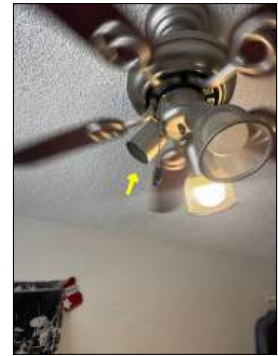
Missing light fixture globe(s) north bedroom

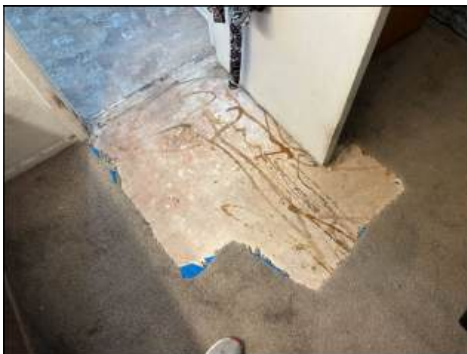
Torn/frayed carpet - typical for age of materials, signs of wear

- Worn/stained heavily in areas - needs to be serviced
- Torn/frayed carpet - typical for age of materials, signs of wear
- Missing flooring transition(s) - needs to be serviced
- Recommend flooring contractor review for repair or replacement as necessary

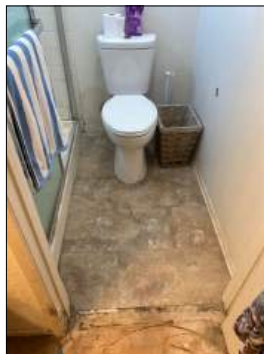
Missing flooring transition(s) - needs to be serviced

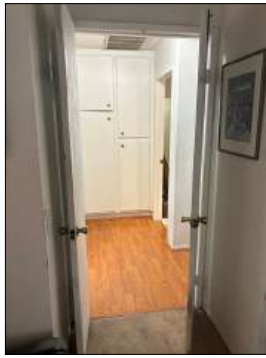
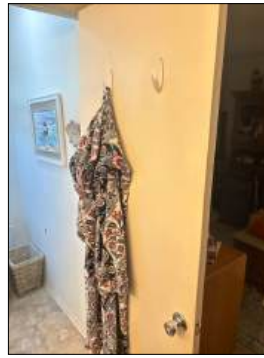
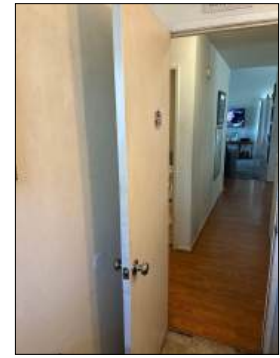
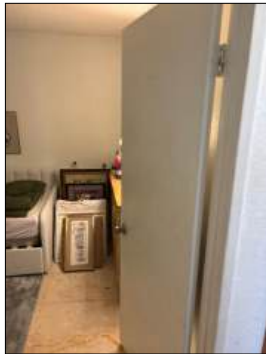
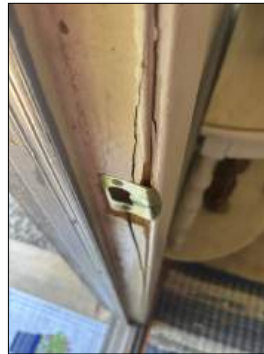
- Operated at time of inspection
- Loose/worn hardware needs minor service - typical for age
- **Damaged jamb - needs to be serviced**

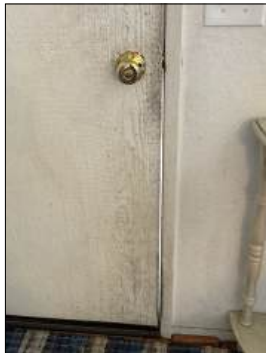
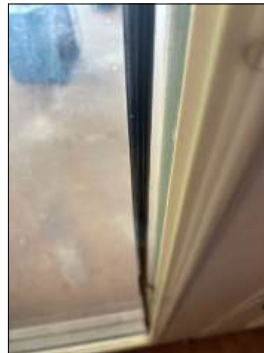
Damaged jamb - needs to be serviced

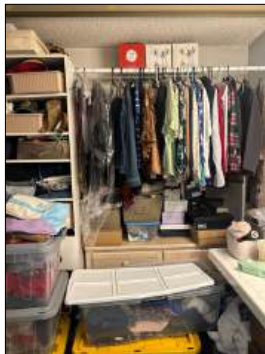
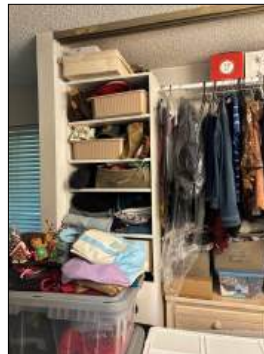
- Worn closets with loose/worn hardware - typical for age
- **Missing closet doors - needs to be serviced**

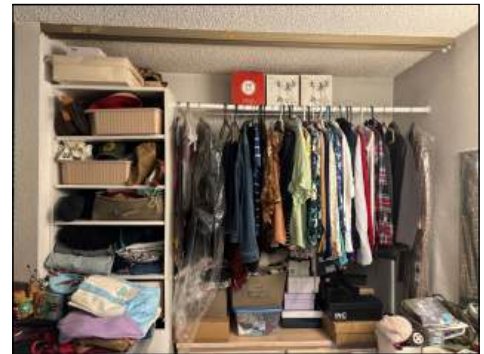
Missing closet doors - needs to be serviced master

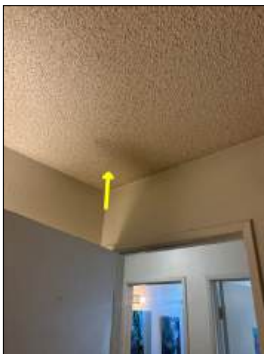
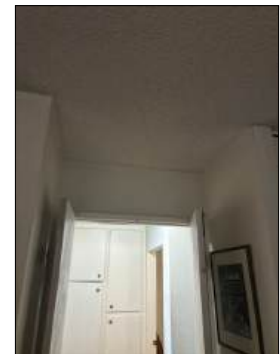
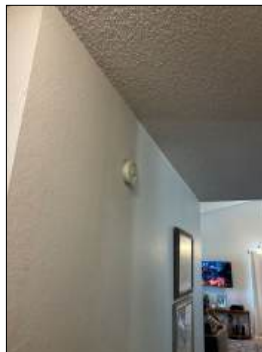
- For safety purposes we recommend that smoke detectors be placed in all hallways outside of sleeping areas (bedrooms) and on all levels of multi-level dwellings. For longer hallways and/or oddly located bedrooms, multiple smoke detectors are suggested and should be placed at each end of the hallways to ensure optimum safety alert.
- Did not operate - needs to be serviced or replaced
- Worn/older model suggest replacement with modern devices
- Recommend upgrading all smoke detectors to the new 10-year battery life units
- **Missing at all bedrooms - needs to be installed**

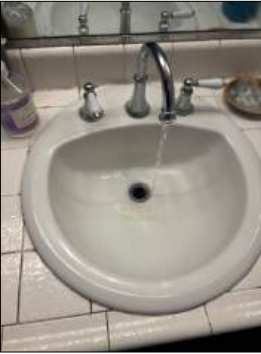
- Fixture operated at the time of the inspection
- Worn fixture/sink - typical for the age
- Drain stopper missing - needs to be serviced
- Surface cracking present in sink - signs of age/wear

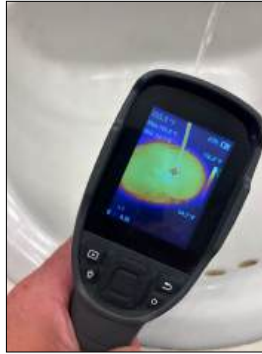
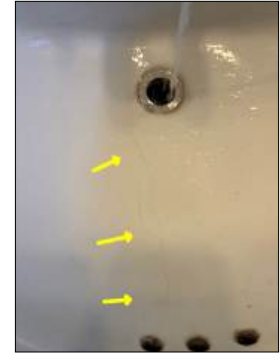
Drain stopper missing - needs to be serviced

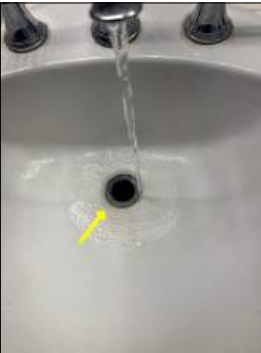
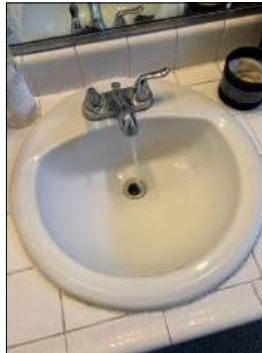
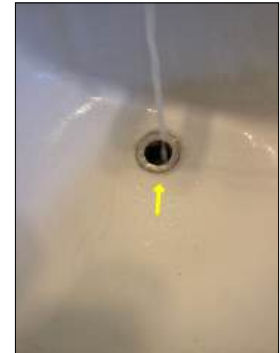
Surface cracking present in sink - signs of age/wear

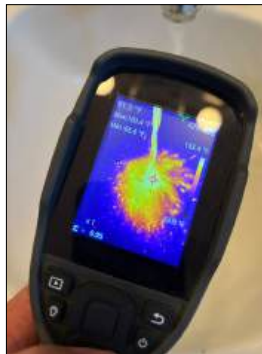
Drain stopper missing - needs to be serviced

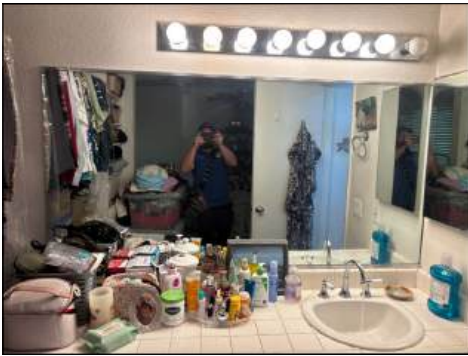
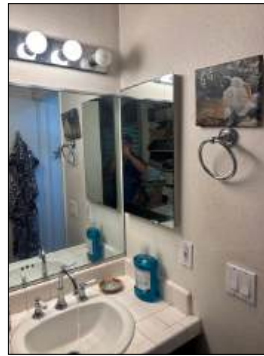
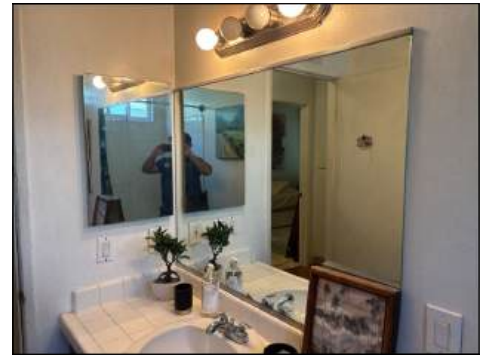
- Mirror functional at time of inspection
- Fading spots present

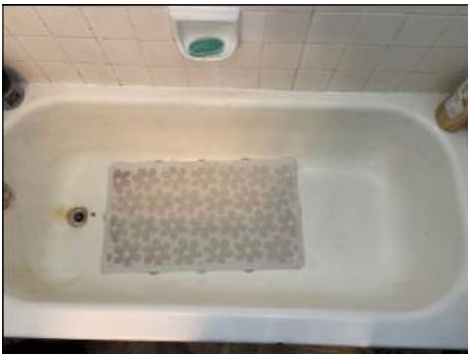
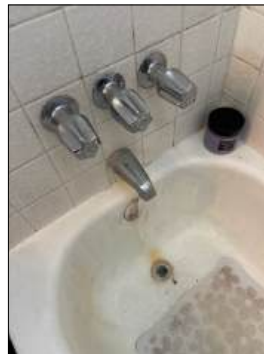
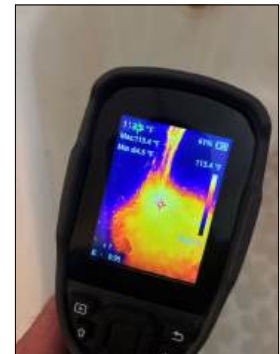
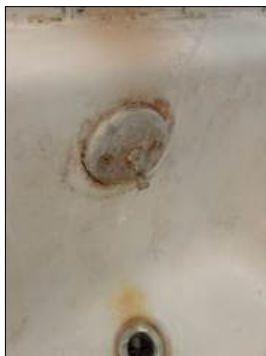
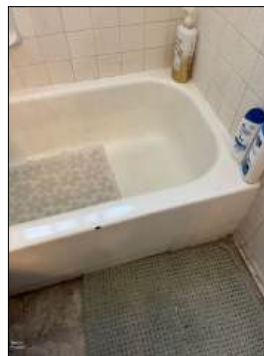
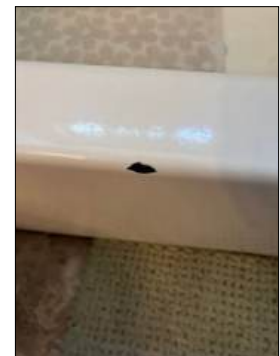
6. Bath Tubs

- Fixture was in a worn/older condition at the time of the inspection - typical for age
- Tub is worn/older/stained/scratched/chipped - typical for the age
- **Drain stopper missing - needs to be serviced**
- **Damaged/rusted/chipped/cracked areas more than typical - needs to be serviced**

Drain stopper missing - needs to be serviced

Damaged/rusted/chipped/cracked areas more than typical - needs to be serviced

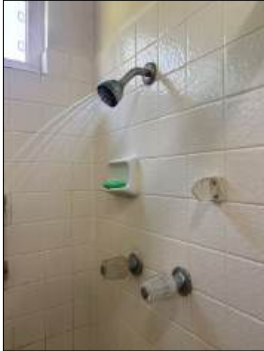
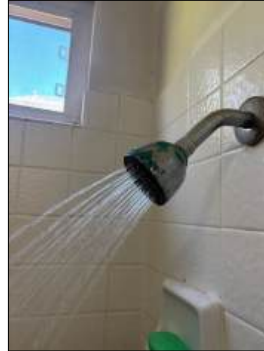
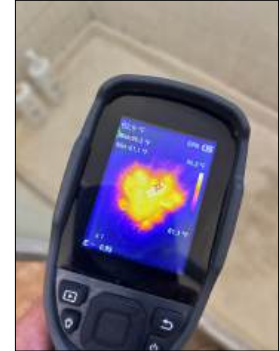
7. Showers

- Fixture was tested and operating at time of inspection via normal fixture controls
- Fixture was in a worn and older condition - typical for the age
- **Corrosion present at fixture(s) - needs to be serviced**

**Corrosion present at fixture(s) -
needs to be serviced master**

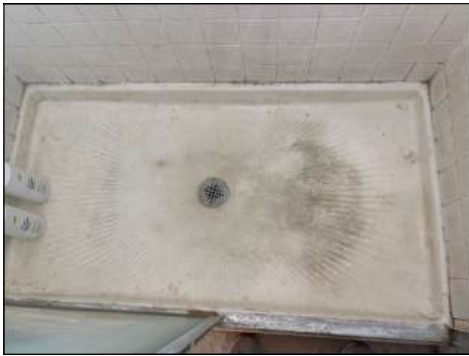
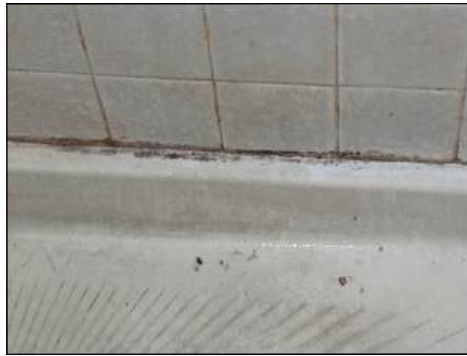
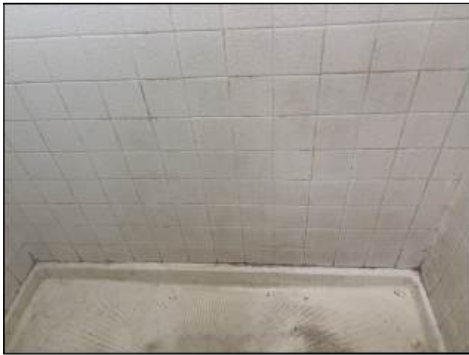
- Solid surface (fiberglass/plastic/etc.) shower pan present
- Tile and grout present
- Wall materials in a worn/stained-faded/old condition - typical for age - recommend routine grout and sealer maintenance
- Shower pan is in a worn/stained/older condition - typical for the age - recommend routine grout and sealer maintenance
- **Grout/caulking is dirty or stained - recommend cleaning and drying all surfaces that may accumulate moisture**

Grout/caulking is dirty or stained - recommend cleaning and drying all surfaces that may accumulate moisture

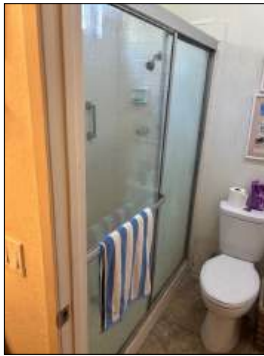
9. Enclosures / Shower doors

- Operational at time of inspection - Cannot determine if tempered
- Enclosure door(s) in a worn/older condition with loose/worn hardware - typical for the age
- **Corrosion present in areas - signs of wear and moisture accumulation**

Corrosion present in areas - signs of wear and moisture accumulation

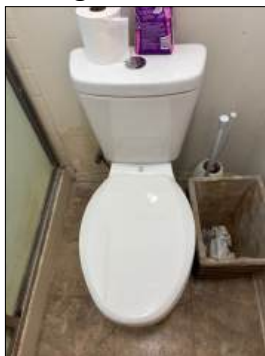
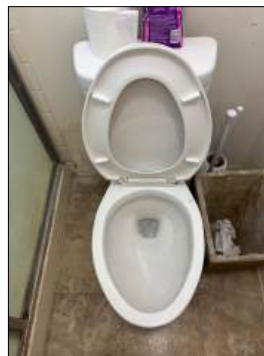
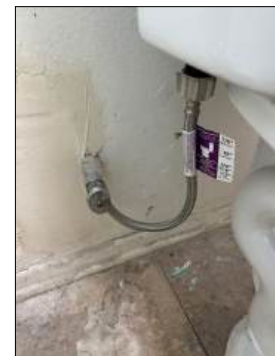
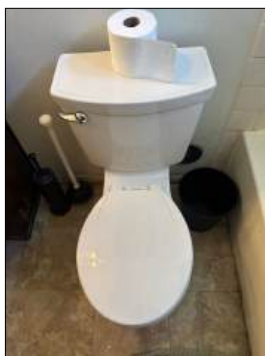
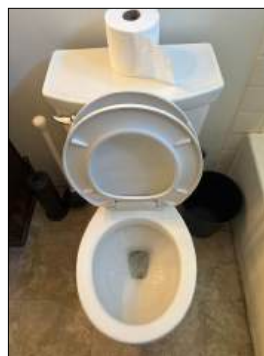
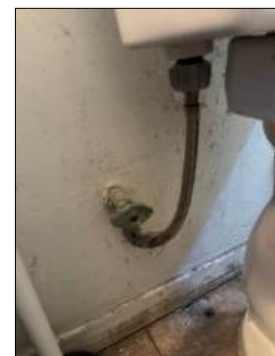
10. Toilets

- Tested and operational at time of inspection via normal fixture controls, flush test performed
- Toilet is in a worn and older condition at the time of the inspection - typical for age
- No visible leaking at the time of inspection and flush testing
- Water shutoff under toilet corroded - needs to be serviced - this will be an ongoing maintenance issue for ALL plumbing valves

Water shutoff under toilet corroded - needs to be serviced - this will be an ongoing maintenance issue for ALL plumbing valves hall bath

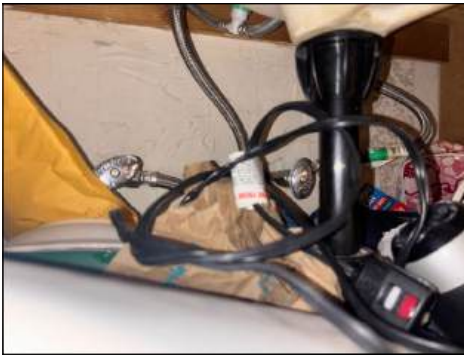
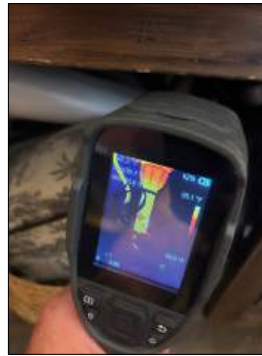
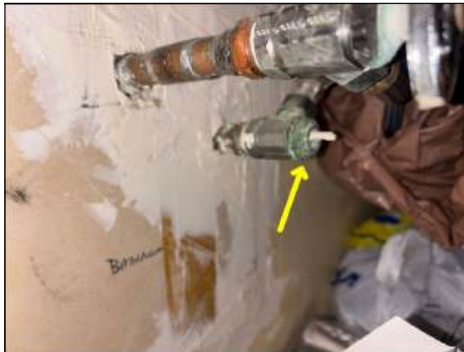
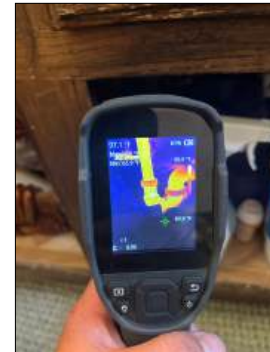
11. Plumbing

- Operational at time of inspection via normal fixture controls with no major visible defects
- Angle stops/hoses/drain pipes are worn/older - recommend upgrading these areas with new fixtures
- No visible leaks found at the time of the inspection after running water at fixtures
- **Shutoffs under sink corroded - needs to be serviced - this will be an ongoing maintenance issue for ALL plumbing valves**

Shutoffs under sink corroded - needs to be serviced - this will be an ongoing maintenance issue for ALL plumbing valves missing shut off knob- needs to be serviced

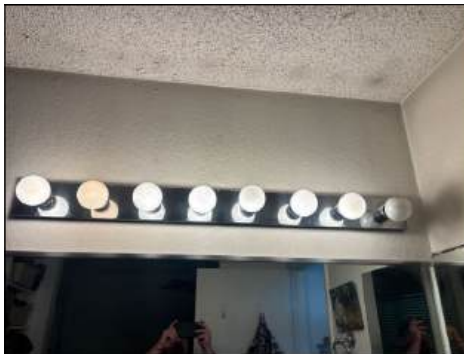
12. Electrical

- A representative number of receptacles and switches were tested and found to be operational at time of inspection
- Loose/worn outlets/switches - typical for age consider upgrading
- **Some bulbs defective/missing/light(s) did not function - check bulbs/consult electrician to further evaluate**

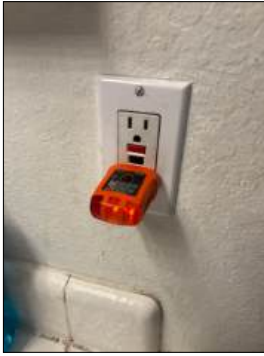
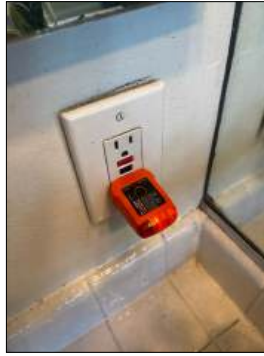
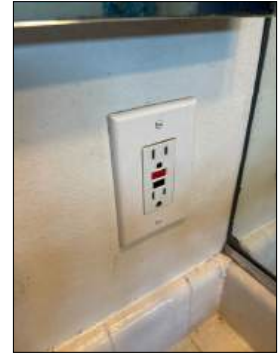
13. GFCIs

- Recommend upgrading all receptacle to **GFCI** protection within 6 feet of all potential wet locations
- Tested and operational at time of inspection via normal control
- Master control GFCI located in: hall bath gfi
- Older style GFCI present - recommend upgrading with newer style

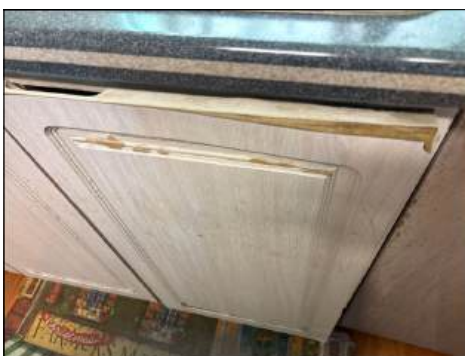
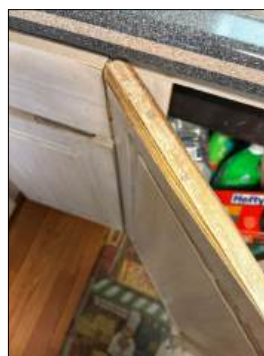
2. Cabinets

- Worn cabinets with loose/worn hardware - typical for age
- Doors and drawers did not close properly - normal for age of materials
- Recommend appropriate licensed contractor for further evaluation
- **Stained areas below sink - dry at time of inspection**

Stained areas below sink - dry at time of inspection

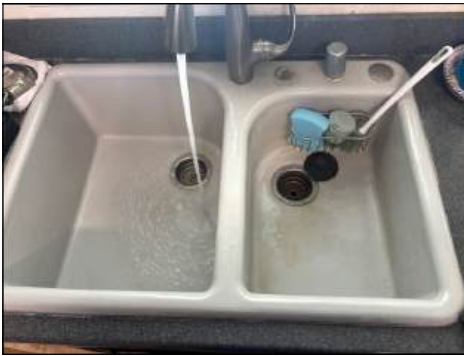
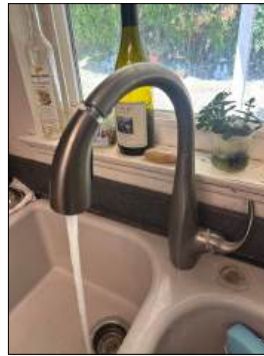
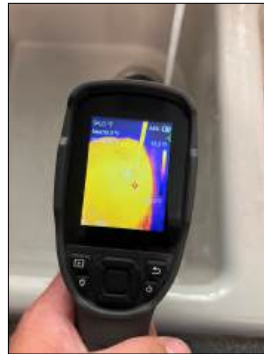
3. Sinks

- Fixture operated at the time of the inspection
- Loose/worn fixture - needs minor maintenance

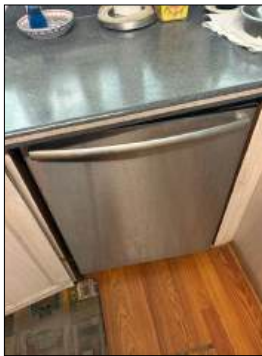
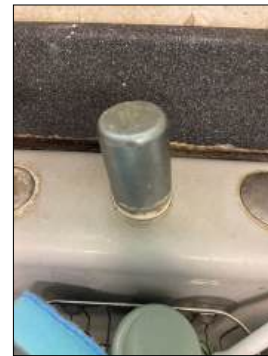
4. Dishwashers

- **Not operating - needs to be serviced**

Not operating - needs to be serviced

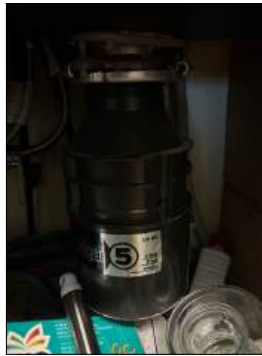
5. Garbage Disposals

- The garbage disposal has a limited inspection, the Inspector cannot predict the remaining life of the garbage disposal nor determine how well the garbage disposal disposes of food or other items. The sharpness or adequacies of the internal blades is not determined during the home inspection.
- Tested and operational at time of inspection via normal controls
- Worn/older unit - typical wear for age and use
- No visible leaks at the time of the inspection

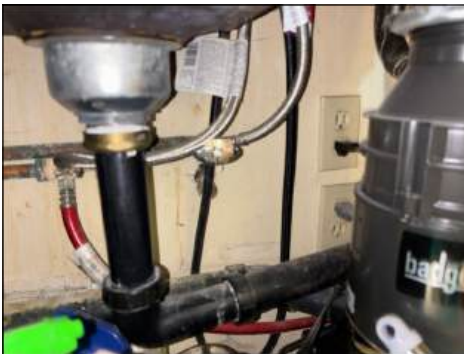
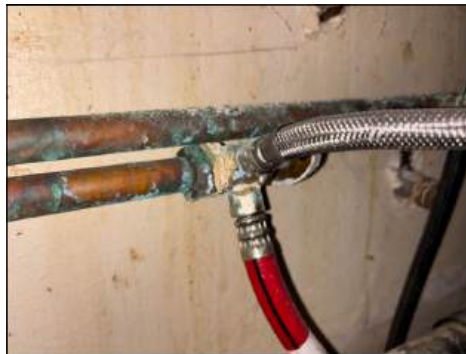
6. Plumbing

- Operational at time of inspection via normal fixture controls with no major visible defects
- Angle stops/hoses/drain pipes are worn/older - recommend upgrading these areas with new fixtures
- **Corrosion is present at plumbing areas - this is a sign of slow leaking and should be further evaluated by a plumber**

Corrosion is present at plumbing areas - this is a sign of slow leaking and should be further evaluated by a plumber

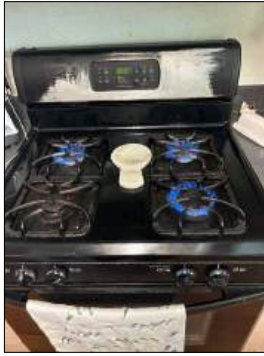
7. Ranges

- The range or cooktop has a limited inspection, the Inspector cannot predict the remaining life of the unit nor determine the BTUs output by each burner or if/how well the burners will cook food. For gas units - gas leaks cannot be detected with this inspection - a full evaluation by the Gas Company of all gas supplied appliances is recommended beyond this inspection.
- Gas supplied unit
- Tested and operational at time of inspection via normal controls
- Unit is worn beyond its expected useful life - recommend replacement
- **Left front element/burner not operating - needs to be serviced**

Left front element/burner not operating - needs to be serviced

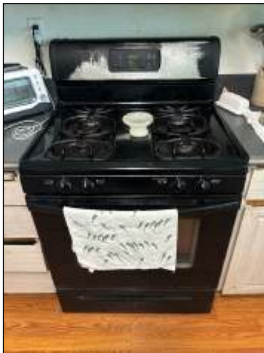
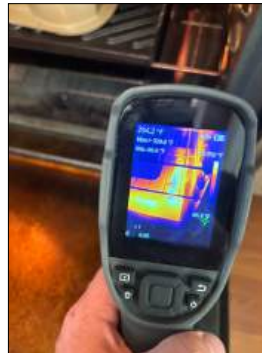
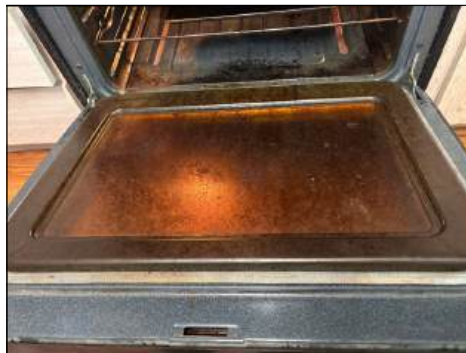
8. Ovens

- The "Bake" feature is the only feature operated during a home inspection; convection, browning, rotisserie, warming drawers and other features are not tested during the oven inspection. Ovens are tested for basic heating element functionality. The oven cannot be tested to each incremental temperature setting or determine if adequate cooking temperatures can be achieved, nor if temperatures are calibrated with oven settings. We cannot determine if or how well the oven cooks food nor can we predict the remaining life left for the unit. For gas units - gas leaks cannot be detected with this inspection - a full evaluation by the Gas Company of all gas supplied appliances is recommended beyond this inspection.
- Gas supplied unit
- Tested and operational at time of inspection via normal controls
- Worn/older unit - replacement/repairs/maintenance will be required in the near future

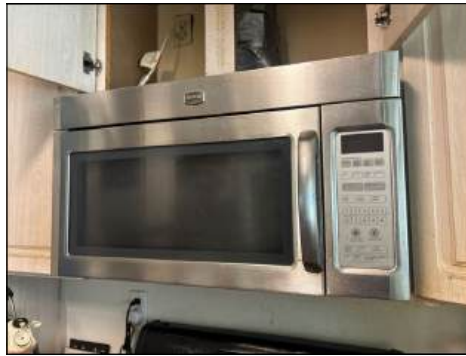
9. Microwaves

- **Not operating - needs to be serviced**

Not operating - needs to be serviced

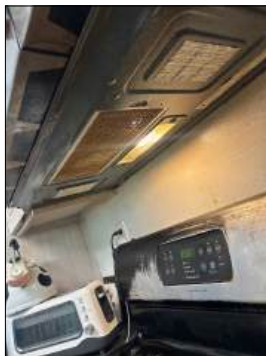
10. Exhaust Vents

- Tested and operational at time of inspection via normal controls
- Worn/older unit - replacement/repairs/maintenance will be required in the near future
- Worn/dirty filters, recommend cleaning or replacing
- Recommend charcoal filters for optimum air filtration
- Greasy/dirty unit - recommend cleaning

Recommend charcoal filters for optimum air filtration

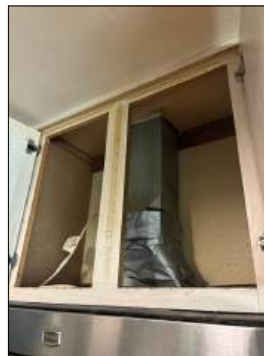
Worn/dirty filters, recommend cleaning or replacing

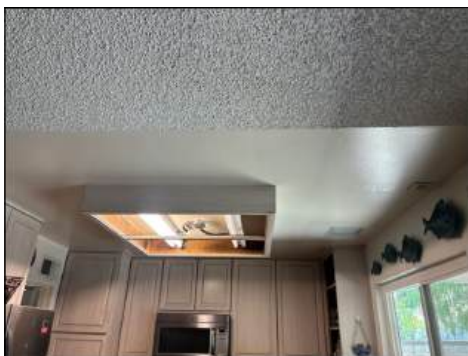
- Loose/worn outlets/switches - typical for age consider upgrading
- Some bulbs defective/missing/light(s) did not function - check bulbs/consult electrician to further evaluate

Some bulbs defective/missing/light(s) did not function - check bulbs/consult electrician to further evaluate

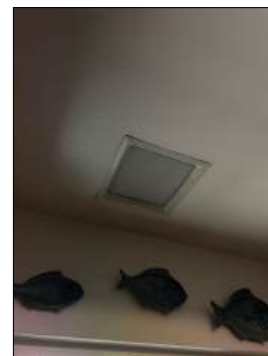
11. Electrical

Some bulbs defective/missing/light(s) did not function - check bulbs/consult electrician to further evaluate

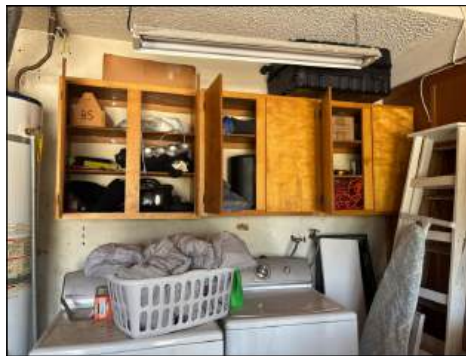
- Worn cabinets with loose/worn hardware - typical for age

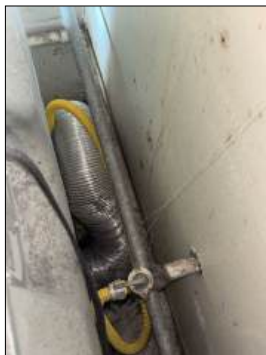
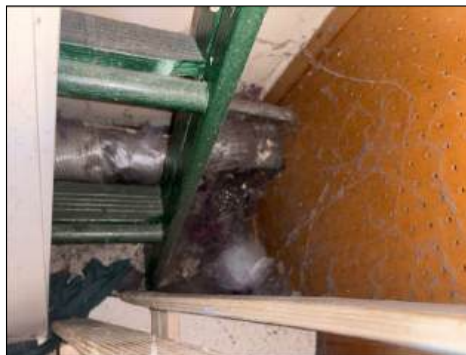
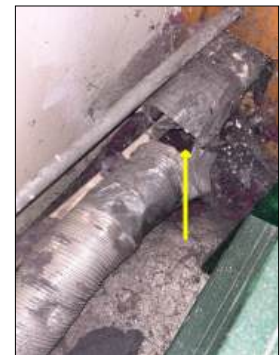
- Dryer vent should be cleaned periodically to prevent lint fire hazards
- **Lint build up present behind washer and dryer - recommend thorough cleaning of the area and sealing any openings in the dryer vent**
- **Dryer vent disconnected - needs to be serviced**

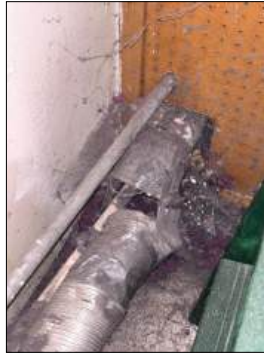
Dryer vent disconnected - needs to be serviced

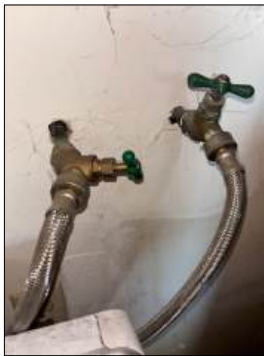
4. Plumbing

- No visible leaks at time of inspection
- Visible fixtures were worn/old - typical wear for age

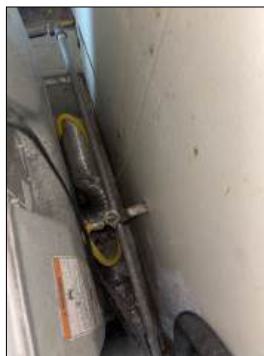
5. Gas Valve

- The inspector does not check for gas leaks, consult the Gas Company to evaluate all gas areas prior to occupancy
- Worn valve - recommend upgrading to newer style valve
- No sediment trap present

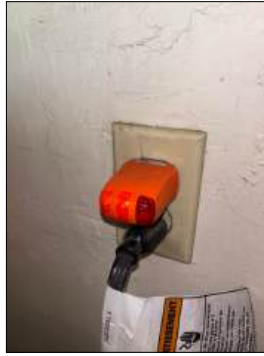
6. Electrical

- Loose/worn outlets/switches - typical for age consider upgrading

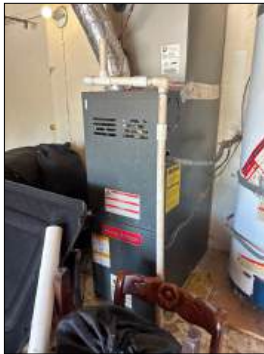
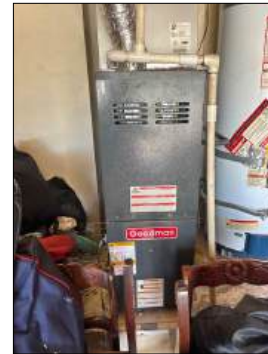
- Operated at time of inspection
- Visible areas of unit have normal wear for age at the time of the inspection - no major visible defects - recommend seasonal service and maintenance to extend the life of the unit
- Newer unit/not original to the structure - check all installation permits to ensure that this unit was installed to proper code

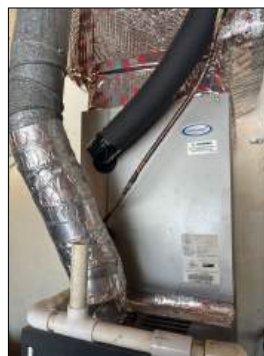
2. A/C Evaporator Coil Box

- The visible areas of the coil box have normal wear at the time of inspection - no major visible defects
- **No secondary drain or cut-out switch present - needs to be serviced**

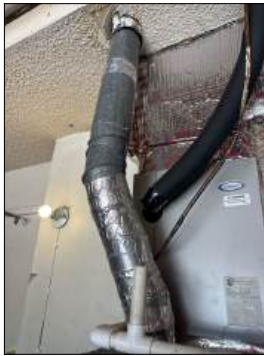
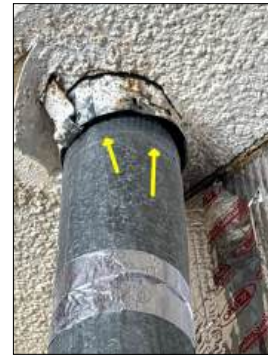
3. Venting

- The visible areas of the vent are worn/older - typical for the age of the material, recommend upgrading
- **Recommend securing and sealing all vent connections**

Recommend securing and sealing all vent connections

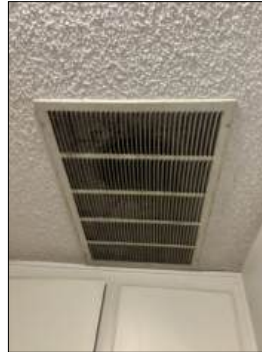
4. Air Supply

- *Recommend seasonal service and maintenance to ensure that all areas are sealed/cleaned/dry and functioning normally at all times*
- Visible areas have normal at time of inspection - no major visible defects

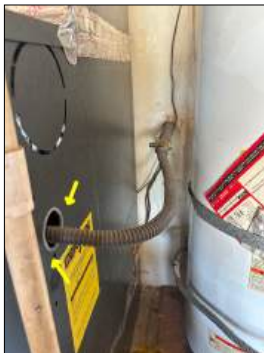
5. Gas Supply Valves and Pipes

- Worn valve, consider upgrading to newer style valve
- Older type of flex line is present - we recommend that you upgrade to a new teflon coated flex line
- No sediment trap at gas supply - may have not been required at time of original installation, but is recommended
- **Flexible connector through sheet metal cabinet - needs to be serviced**

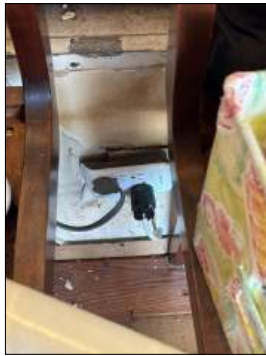
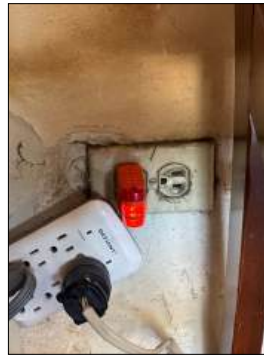
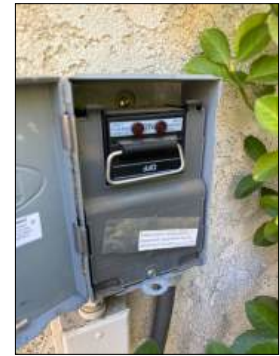
6. Electrical

- Operating properly at the time of the inspection - no major visible defects
- Loose/worn outlet(s)/switch(s) - typical for age

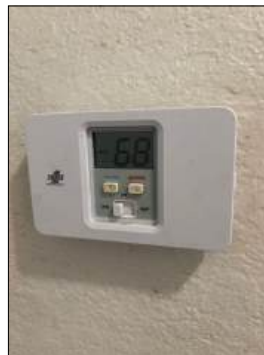
7. Thermostats

- Digital type present - functional day of the inspection

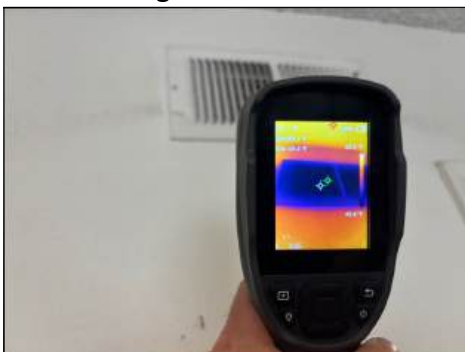
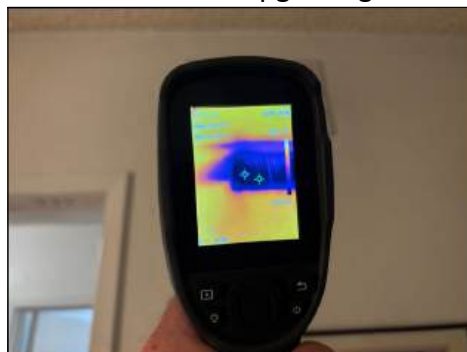
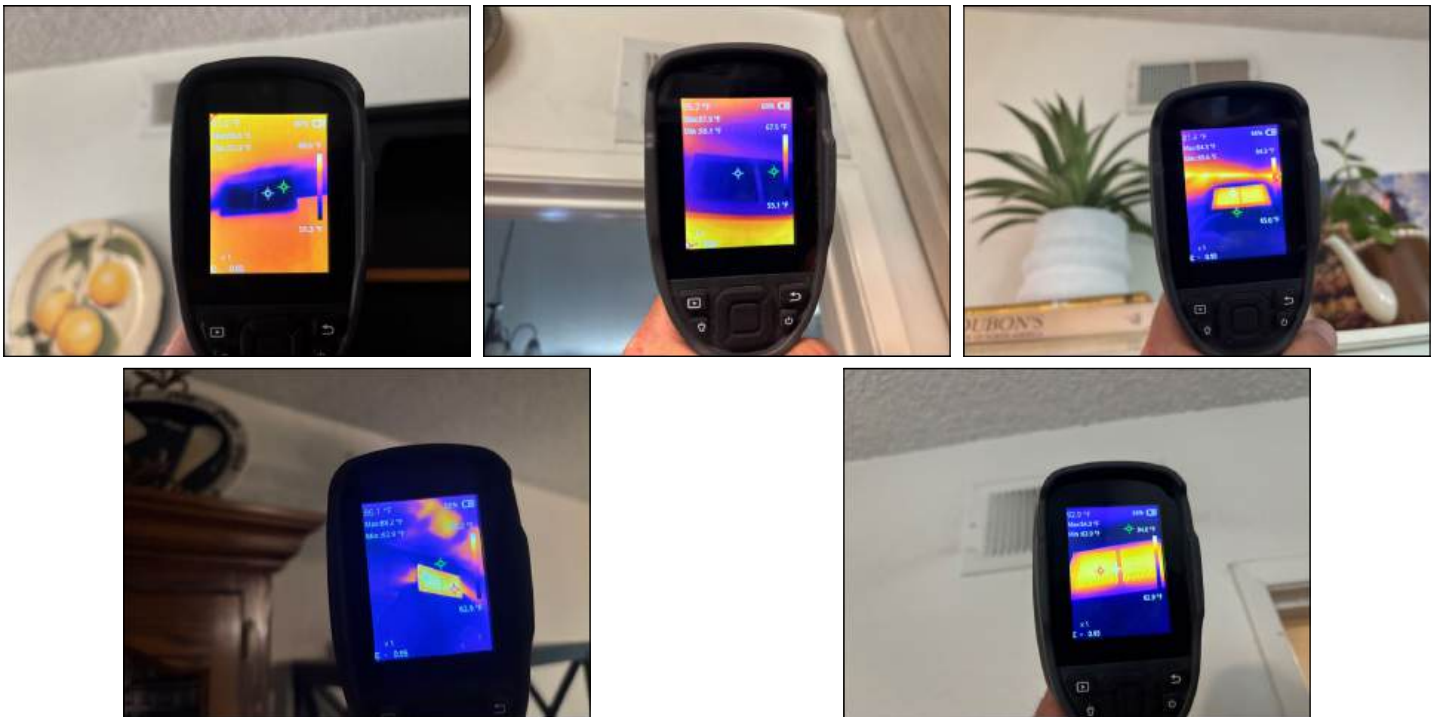
- **A/C** Temperature at Registers: 50 degrees
- Heater Temperature at Registers: 100 degrees
- Temperature at Air Return: 70 degrees
- Representative number tested and functional day of the inspection
- Visible register covers are worn and older - consider upgrading to newer style registers

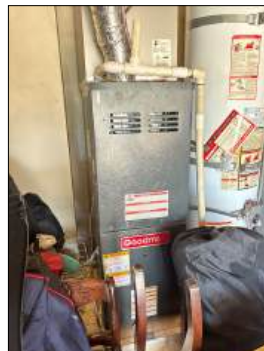
10. Combustion Air

- **Combustion air** appears to be adequate at the time of the inspection

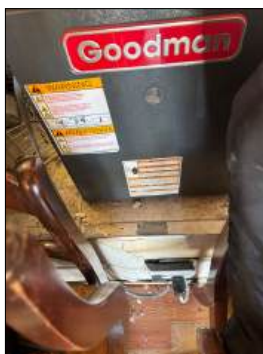
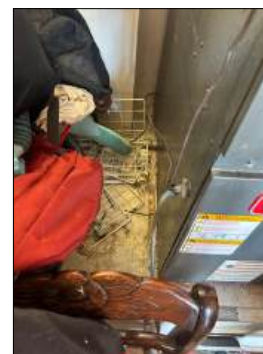
11. Platforms/Bases

- Recommend seasonal servicing and maintenance to ensure sealing holes and gaps in the heater base
- Visible areas are worn/dirty - recommend cleaning the base areas and sealing the base of the unit as part of the preventative maintenance

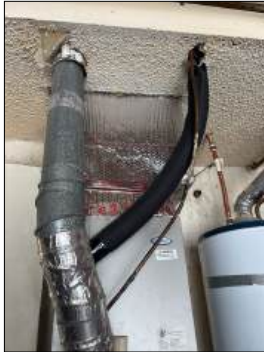
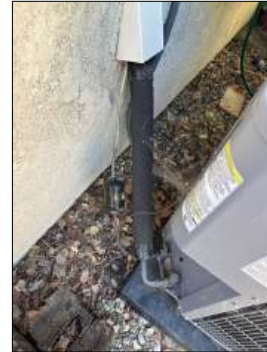
12. Refrigerant Lines

- Normal wear day of the inspection - no major visible defects - recommend annual/seasonal maintenance to check and service insulation on refrigerant lines as needed

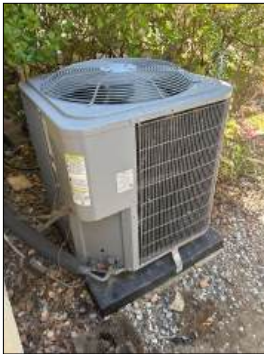
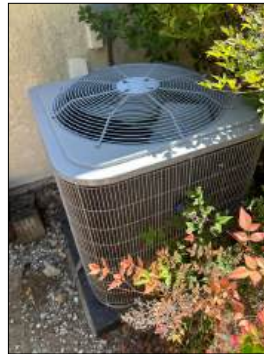
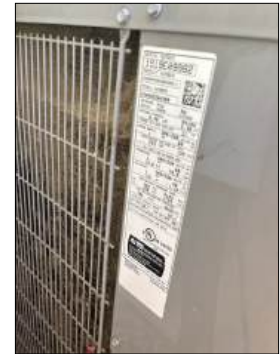
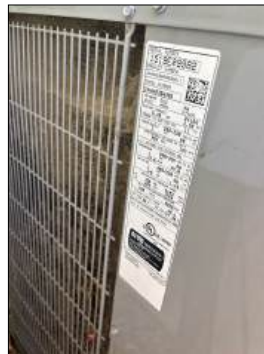
13. Air Conditioning Compressors

Location: Electric unit - exterior west

- Operated at the time of inspection
- Visible areas of unit have normal wear for age at the time of the inspection - no major visible defects - recommend seasonal service and maintenance to extend the life of the unit

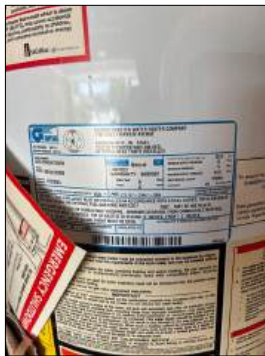
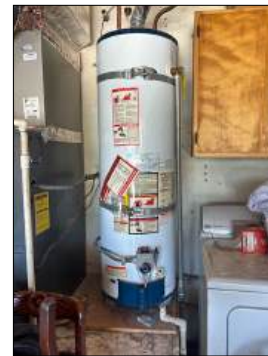
1. Water Heaters Condition

- Operated at the time of the inspection - Gas unit
- The unit is worn/older - consult a plumber for general maintenance recommendations to extend the life of the unit

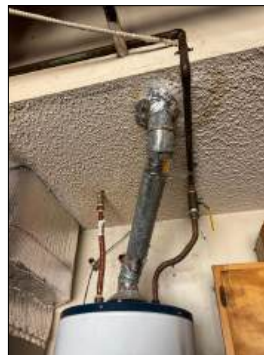
2. Venting

- Vent is worn and older - consider upgrading vent

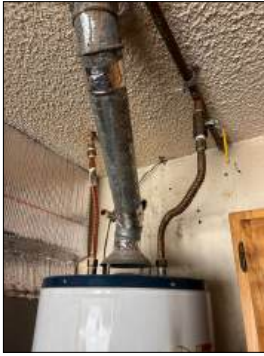
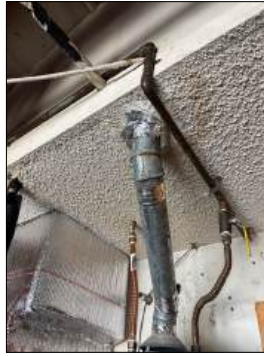
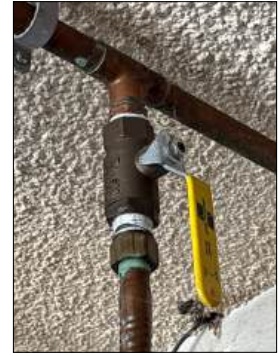
3. Plumbing

Material type: Copper • Copper flex lines

- Worn valve/piping/connections - typical for age - no visible leaks found at the time of the inspection

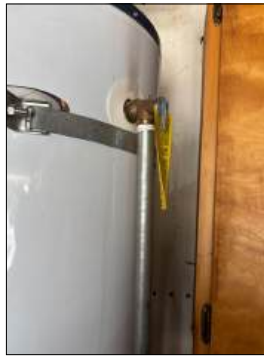
4. Temperature Pressure Release Valves

- Worn/older valve present - consider upgrading

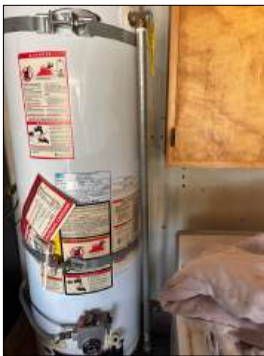
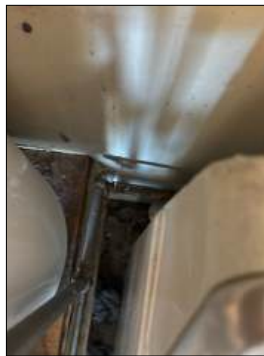
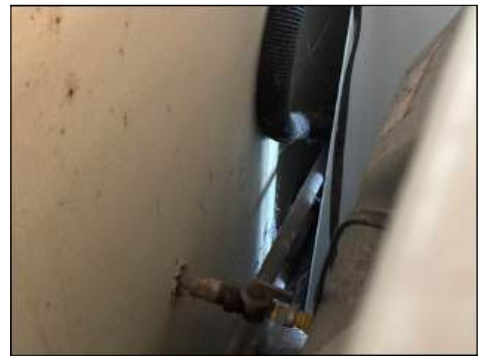
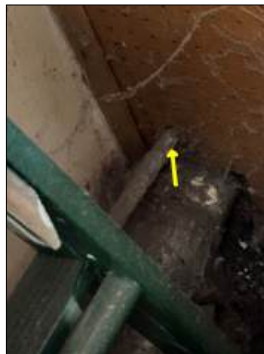
- Worn piping - typical for age

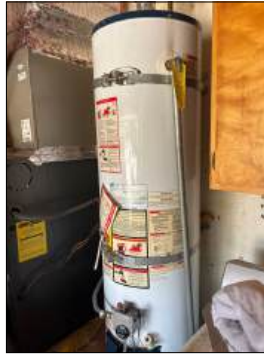
- Standard metal type straps present - normal wear on the day of the inspection - no major visible defects

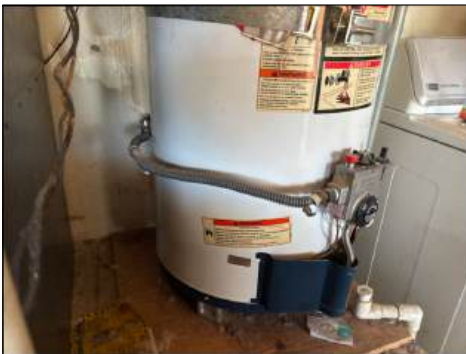
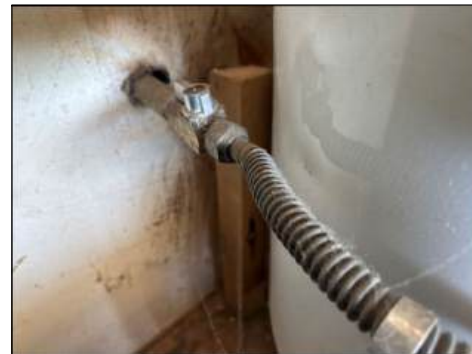
8. Gas Supply Valves and Pipes

- Older style valve - may require a tool to operate - recommend upgrading to newer type of valve
- Older type of flex line is present - we recommend that you upgrade to a new Teflon coated flex line
- No sediment trap at gas supply - may have not been required at time of original installation, but is recommended

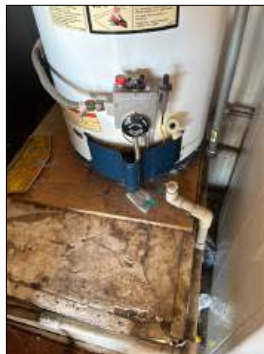
9. Combustion Air

- Combustion air appears to be adequate at the time of the inspection

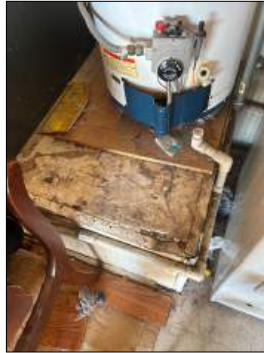
10. Platforms/Bases

- Worn/dirty – recommend cleaning
- Platform top drywall damaged - needs to be serviced
- Missing drywall for fire-separation at garage - needs to be serviced
- No catch pan and drain: unit is installed over finished living space - recommend installing pan and drain accordingly

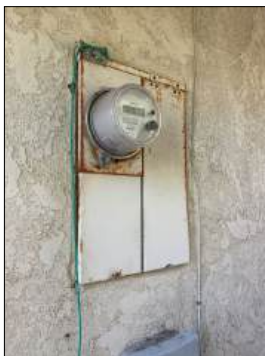
- Worn/older panel - consider upgrading services
- Recommend upgrading services due to age of electrical system
- **Heavy rusting or rust damage present - needs to be serviced**

Heavy rusting or rust damage present - needs to be serviced

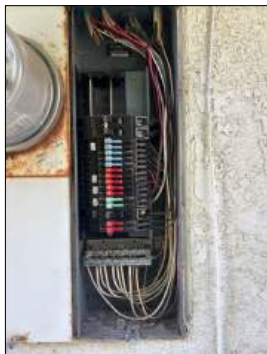
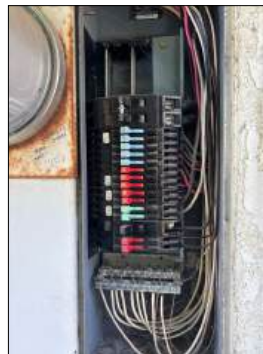
2. Panel Wiring

- Wiring type: copper
- Wiring method: non-metallic sheathed cable (romex)
- Grounded panel - main ground/bonding wire observed and appears to be normal for the age of the panel
- Visible wiring is worn and older - consider upgrading the electrical services

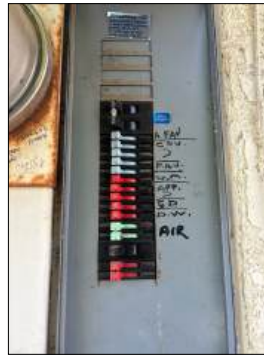
3. Breakers

- Labels are present on panel cover - the inspector does not confirm accuracy of labels
- Loose/worn breakers - typical for age

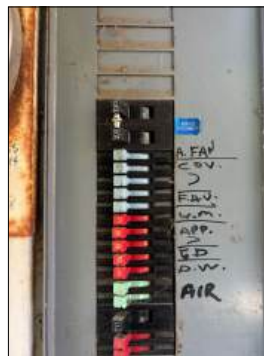
4. Breaker Amp Capacity

- 100 amp - while common for many structures, this may be considered low capacity for today's electrical uses - consider upgrading services

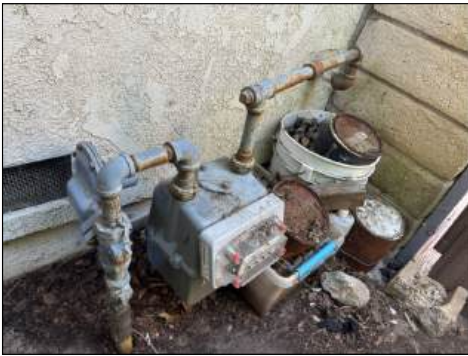
- Natural gas present
- Worn valve - typical for age
- Recommend gas valve wrench be placed near valve for optimal preparedness
- Seismic safety valve present - inspector cannot determine if valve is installed properly (seismic valves cannot be tested with this inspection)
- **Minor rusting - typical for exterior weathering - recommend rust treatment**

Minor rusting - typical for exterior weathering - recommend rust treatment

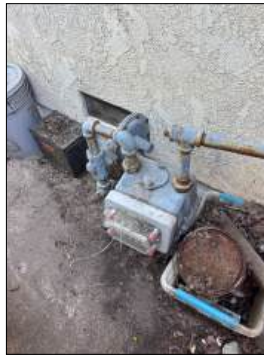
Seismic safety valve present - inspector cannot determine if valve is installed properly (seismic valves cannot be tested with this inspection)

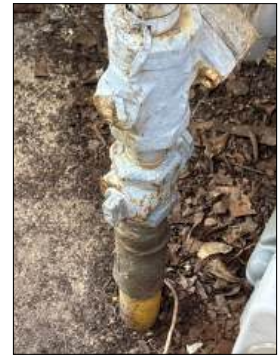
Recommend gas valve wrench be placed near valve for optimal preparedness

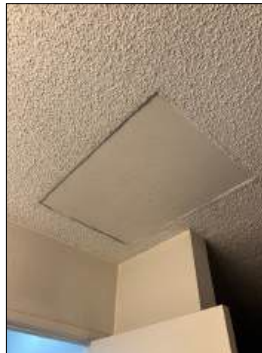
- Inspection method: Inspected from access hole only - access limitations prevented complete entry into the attic - limited inspection
- Location of access: Bedroom closet ceiling

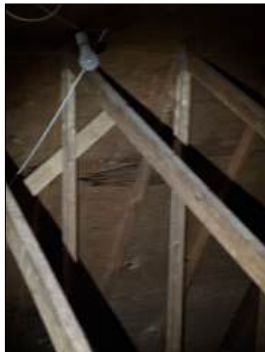
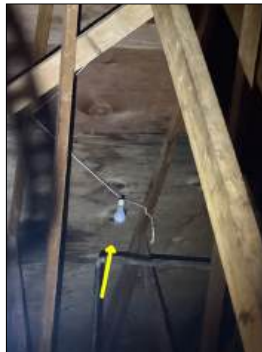
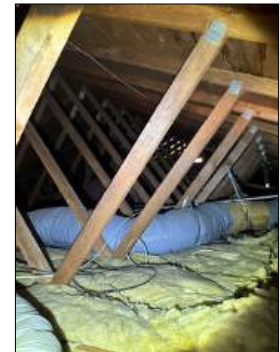
2. Structure

- **Consult termite report for all wood areas in the attic**
- Manufactured trusses present, normal wear at time of inspection - no major visible defects
- **Limited attic inspection - many areas are not accessible to to limited space, lack of proper walk boards, electrical, plumbing, ductwork, etc.**
- **Stains present on wood members of structure - evidence of past moisture entering structure - recommend further inquiry, consult seller and disclosures for past leaks**

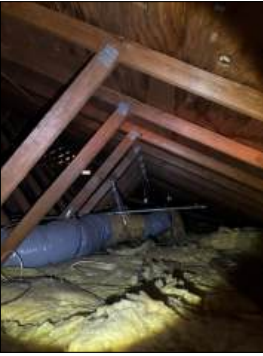
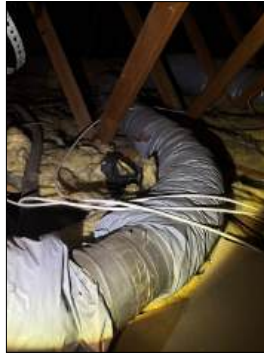
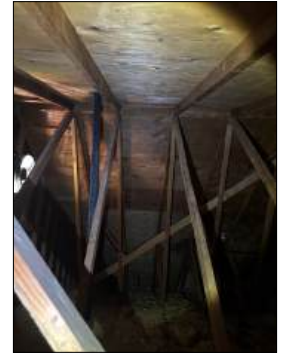
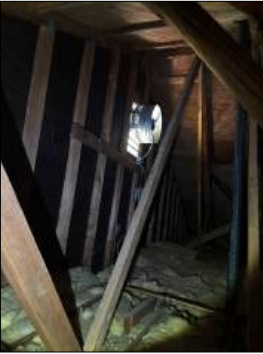
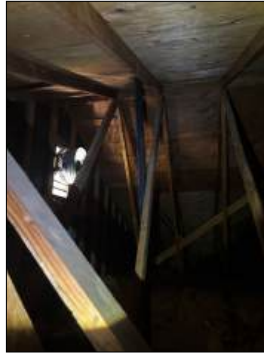
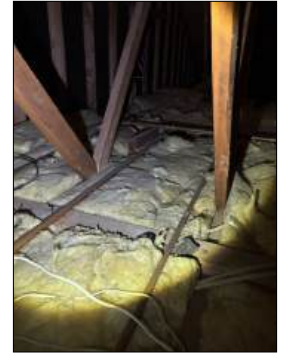
Stains present on wood members of structure - evidence of past moisture entering structure - recommend further inquiry, consult seller and disclosures for past leaks

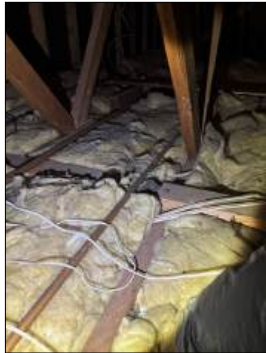
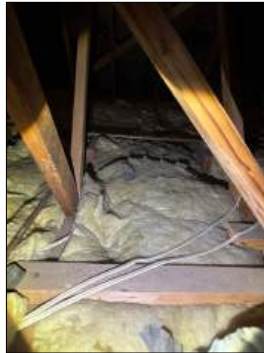
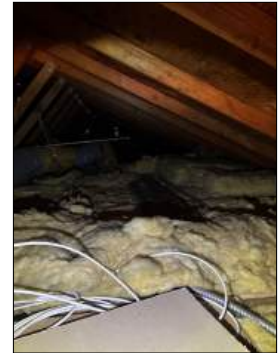
3. Insulation

- All visible insulation is worn/older/dirty - typical for the age of the structure

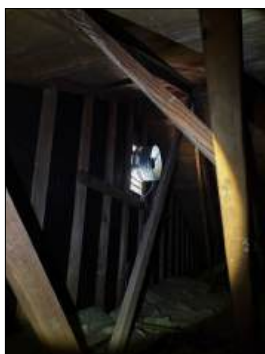
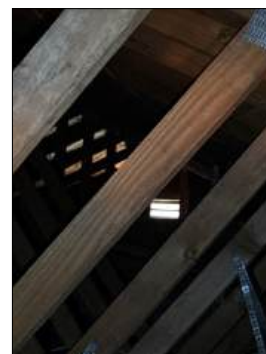
4. Ventilation

- Existing ventilation appeared to be adequate on the day of the inspection

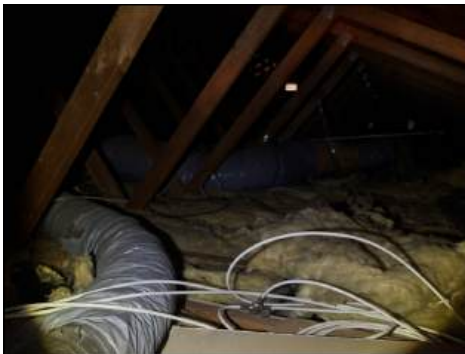
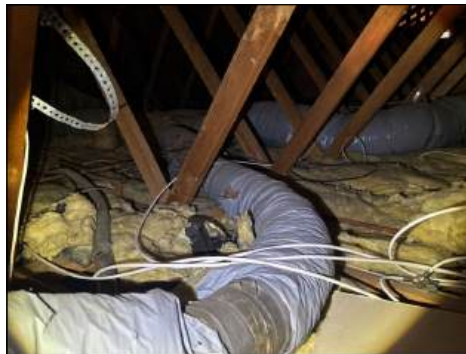
- Older ducts present, possibly original to the structure - recommend further evaluation and pressure/leak test due to the age of the ducts
- **Outer wrap damaged - recommend servicing**

Outer wrap damaged - recommend servicing

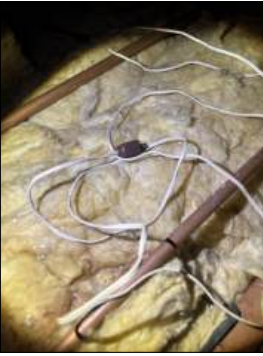
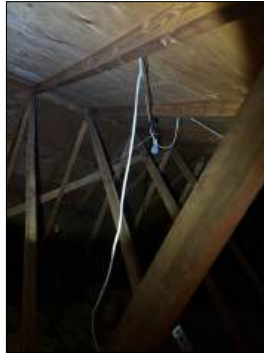
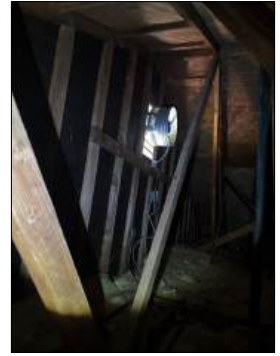
8. Electrical

- Evidence of electrical alterations in the attic - check all permits for electrical alterations to ensure that all electrical was installed to city/county electrical code
- Visible electrical areas appear to have normal wear for age with no major visible defects at the time of the inspection
