ELITE GROUP
INSPECTION PROFESSIONALS

PROPERTY LOCATION: 27951 Sycamore Creek Dr Valencia, CA 91354

INSPECTION REPORT

Date of Inspection: 5/31/2026 at 10:00 AM

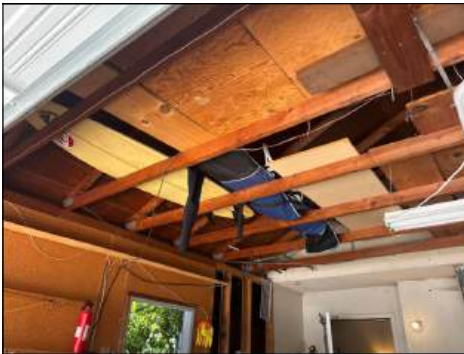
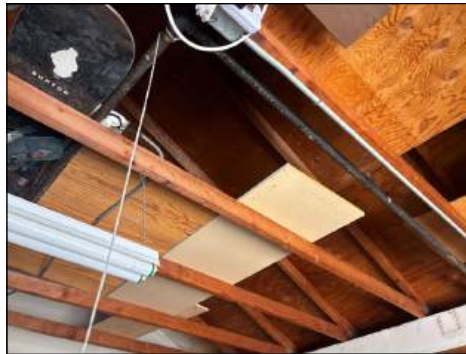
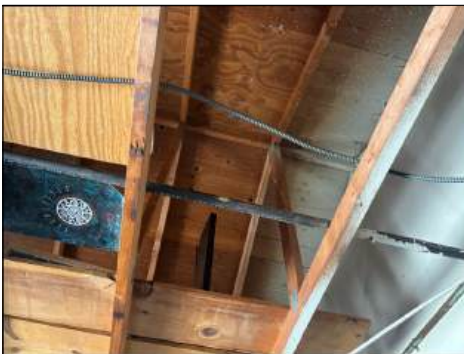
- **Exposed wood rafters/joists - consult termite report for all wood areas**
- Cosmetic blemishes observed
- **Stains present – not accessible for moisture testing – monitor for possible moisture intrusion**

Stains present – not accessible for moisture testing – monitor for possible moisture intrusion

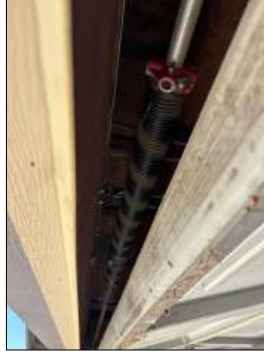
4. Hardware/Springs

- Worn/older hardware present - we recommend upgrading to more modern hardware

- ***Garage doors require periodic maintenance and is recommended to ensure that all hardware is properly lubricated and secured***

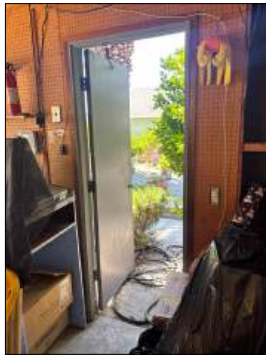
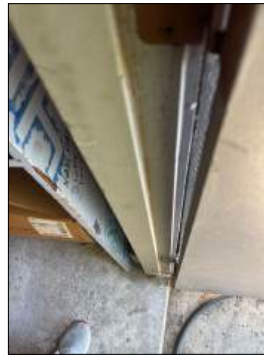
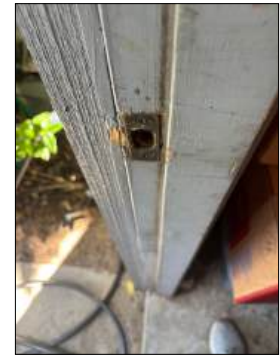
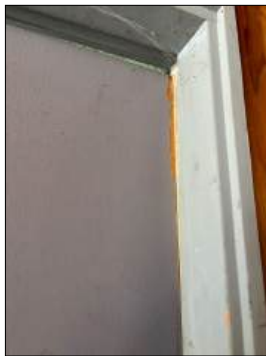
Recommend weather tight service/maintenance to prevent moisture intrusion

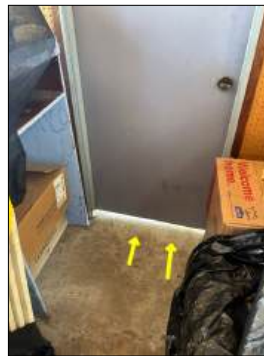
Not square in jamb

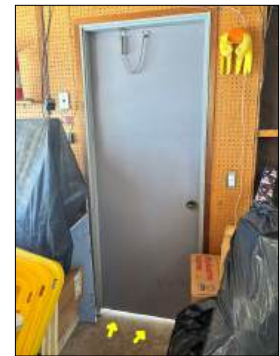
Visible daylight is present around the exterior door. Recommend proper weatherstrip seal and/or maintenance.

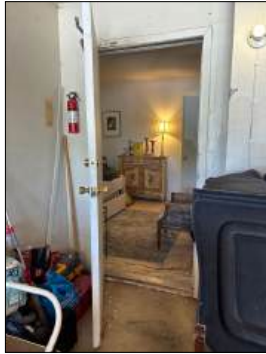
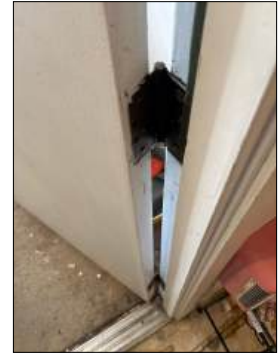
Door did not properly self-close and latch - needs to be serviced

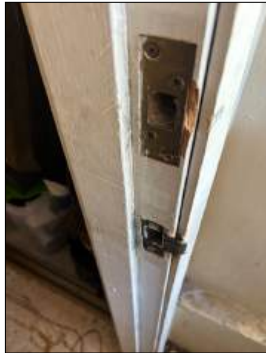
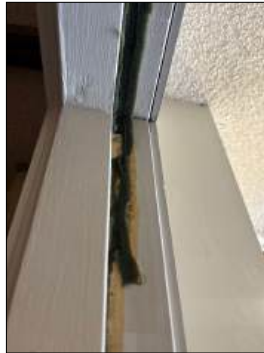
Missing air tight seals - needs to be serviced

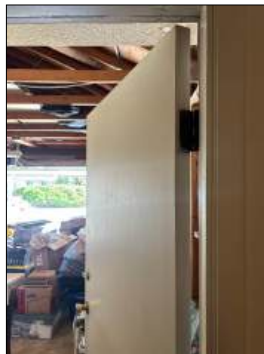
Door rating label painted over/missing - Inspector cannot determine fire rating

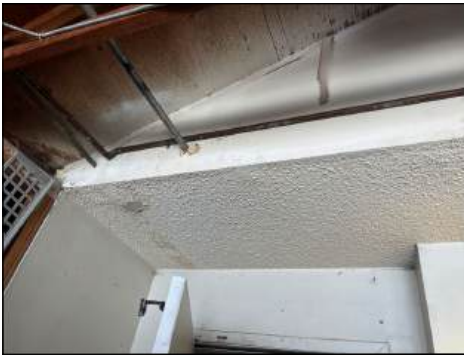
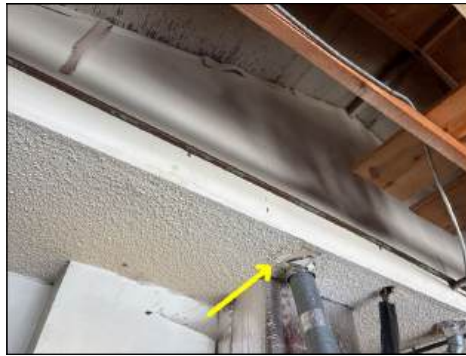
Holes present - needs to be serviced to retain integrity of fire separation

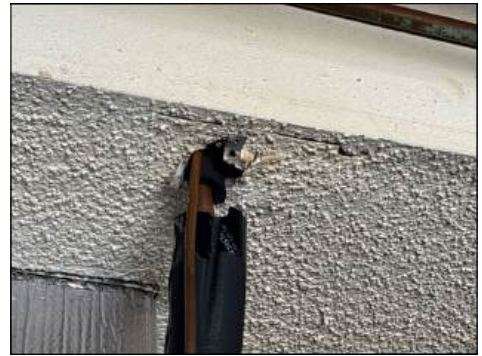
- Holes present - needs to be serviced to retain integrity of fire separation
- Small cracks/holes/chipped/dirty areas/cosmetic blemishes observed - typical for age of structure
- Stains present - tested dry at time of inspection - monitor for future moisture

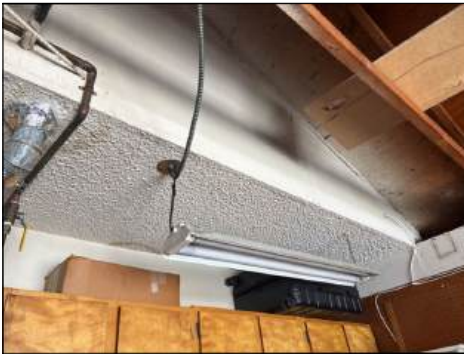
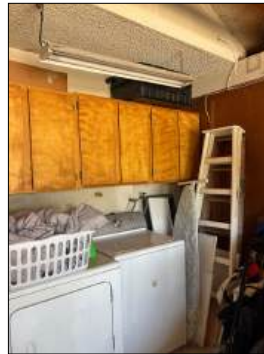
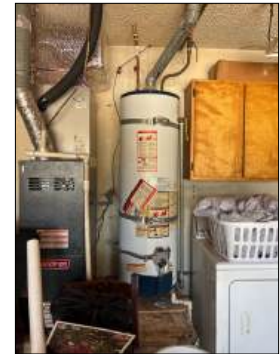
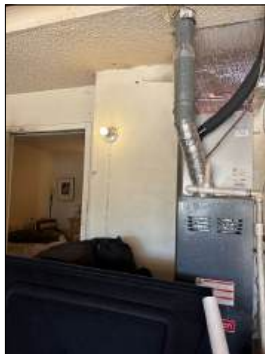
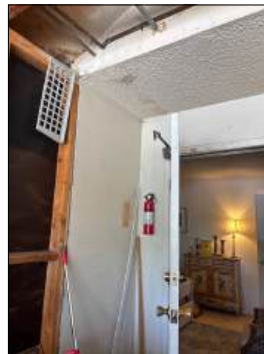
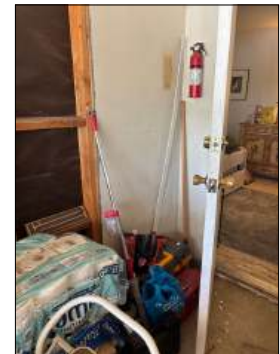
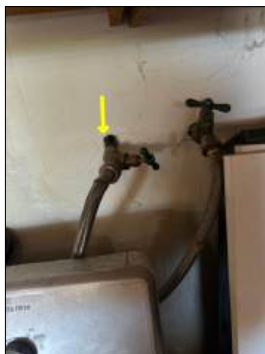
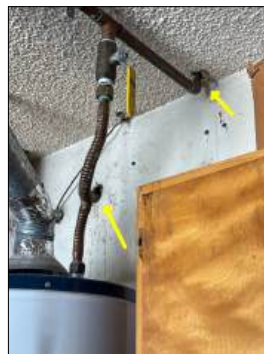
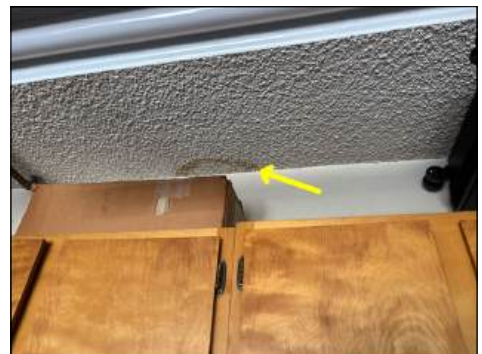
Holes present - needs to be serviced to retain integrity of fire separation

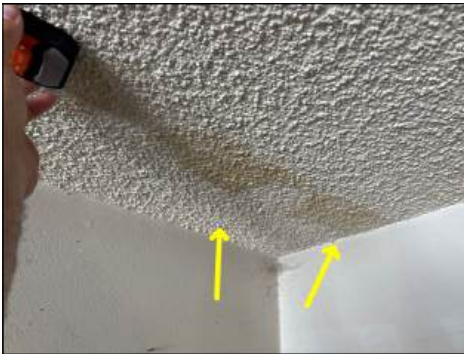
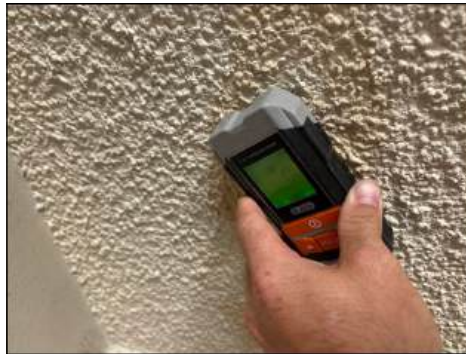
Stains present - tested dry at time of inspection - monitor for future moisture

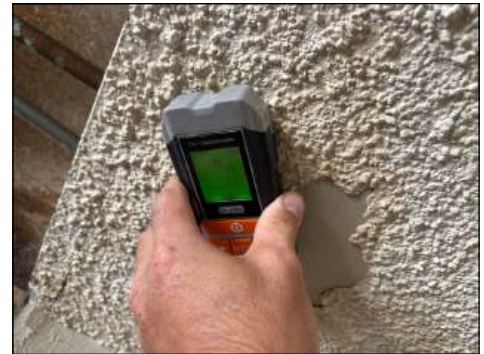
Stains present - tested dry at time of inspection - monitor for future moisture

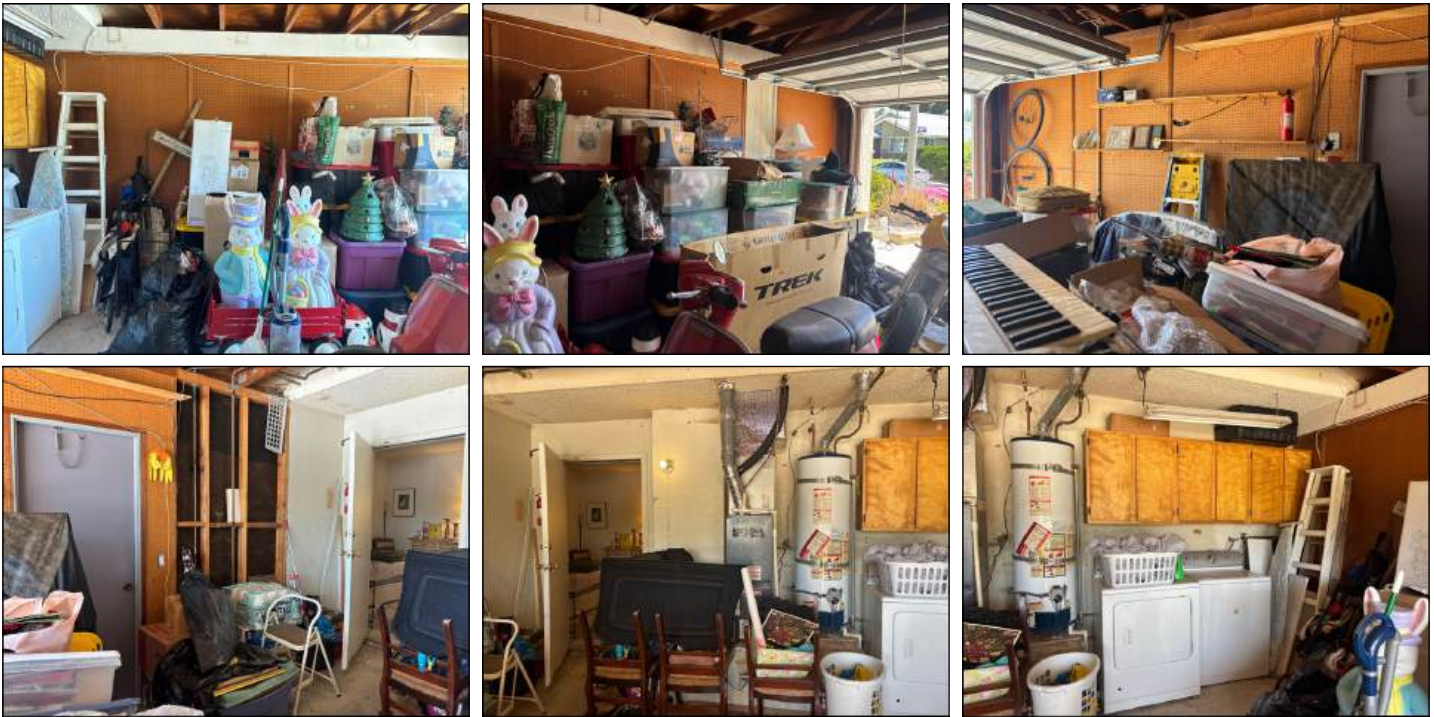
12. Walls

- ***Personal items/storage/etc. are present and prevent a complete inspection of wall areas***
- Small cracks/holes/chipped/dirty areas/cosmetic blemishes observed - typical for age of structure

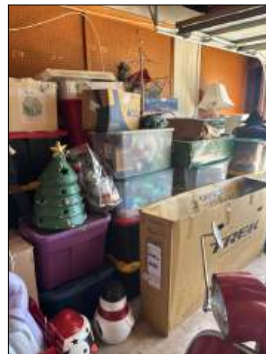
13. Anchor Bolts

Could not access or not visible due to wall coverings - not inspected

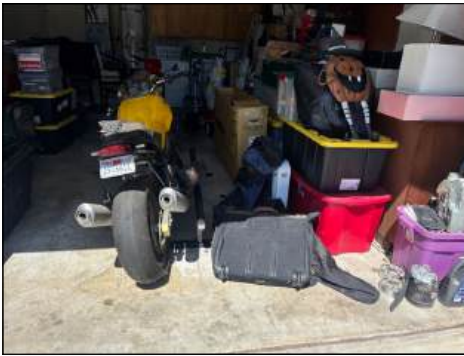
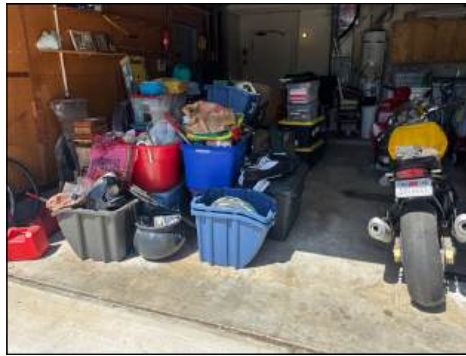
14. Slab

- ***Personal items/storage/vehicles prevent complete inspection of floor areas***
- Worn and stained areas - typical for age of the material

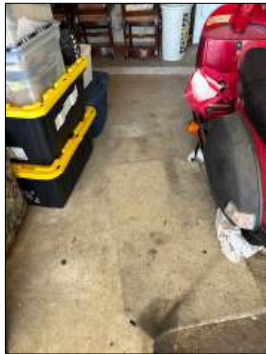
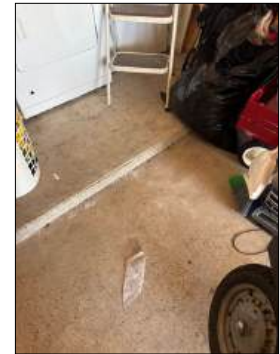
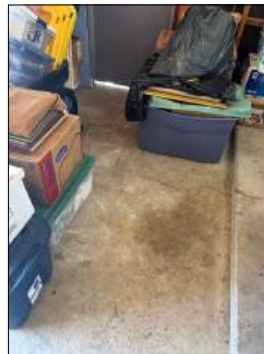
Personal items/storage/vehicles prevent complete inspection of floor areas

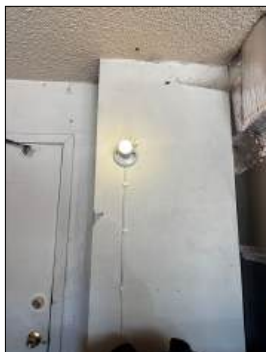
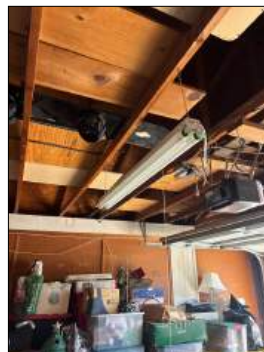
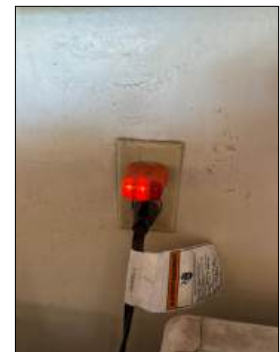
15. Electrical

- A representative number of receptacles and switches were tested and found to be operational at time of inspection
- Loose/worn outlets/switches - typical for age consider upgrading

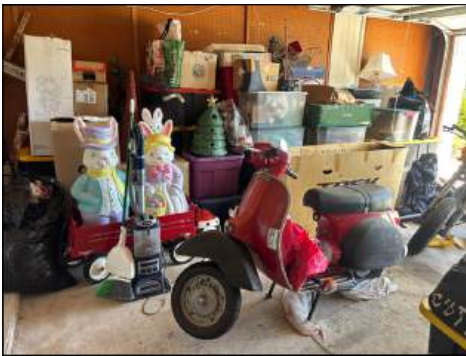
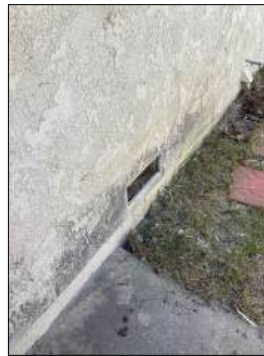
- **Vents obstructed - drywall/panel covered - needs to be serviced**

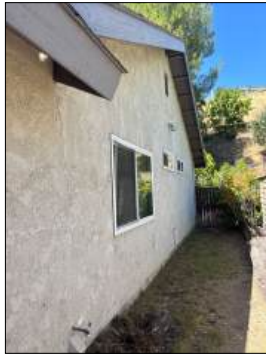
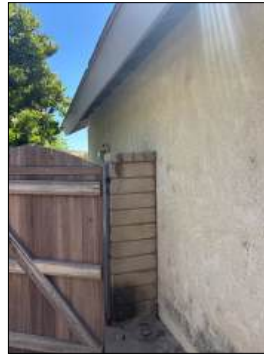
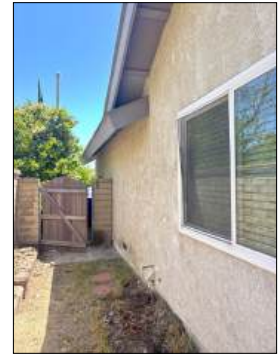
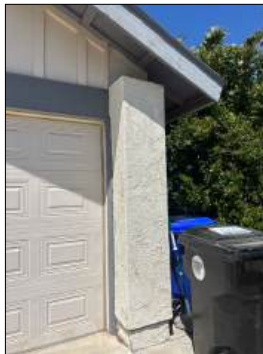
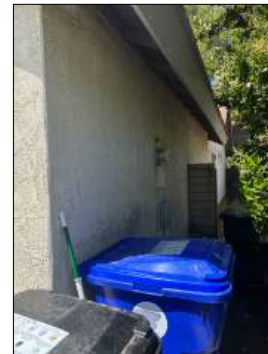
- Worn/weathered at time of inspection where visible
- Small cracking/chipping/holes present in areas - recommend stucco service/**maintenance**

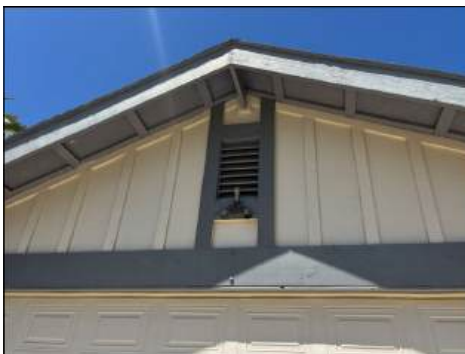
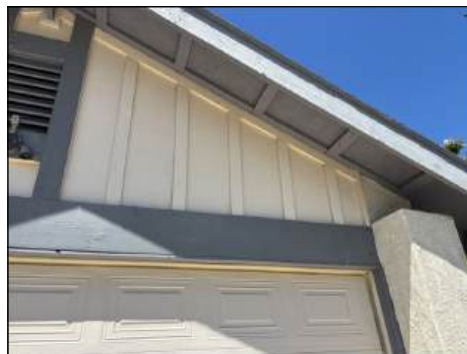
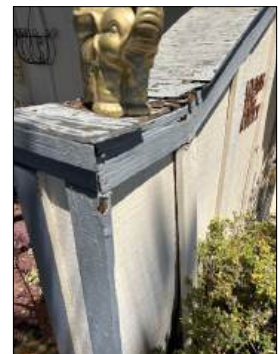
2. Siding

- **Consult termite report for all exterior wood**
- Worn/weathered/cracked materials where visible – recommend siding **maintenance**
- **Deteriorated wood - needs to be serviced - consult termite inspection**

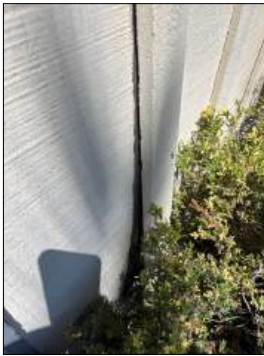
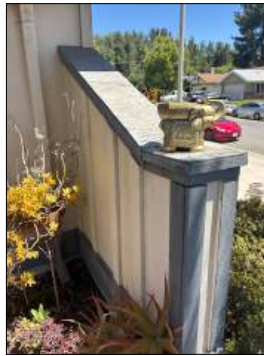
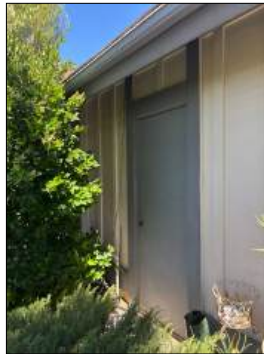
Deteriorated wood - needs to be serviced - consult termite inspection

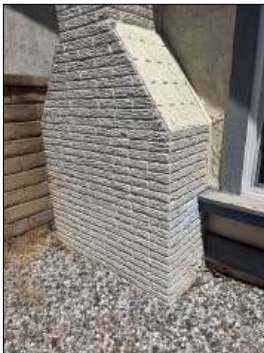
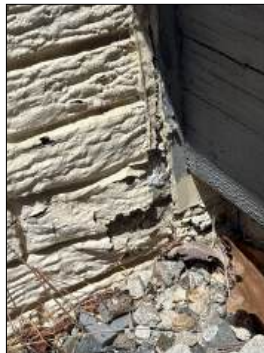
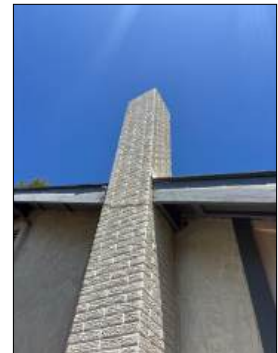
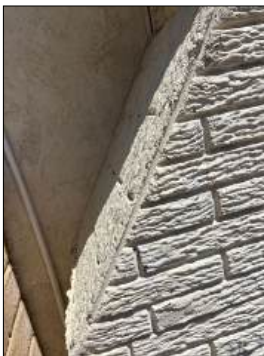
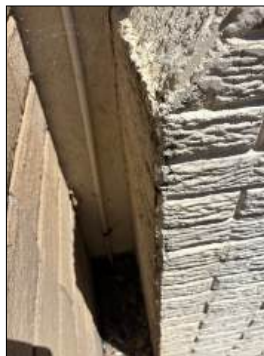
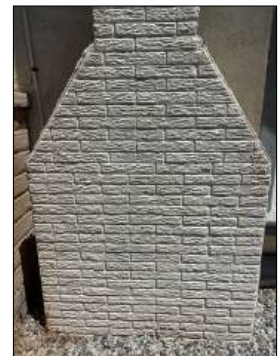
- Worn/weathered at time of inspection where visible - typical for age
- Pre-Fab concrete Rampart General fireplace present; known to be problematic suggest further review by CSIA certified chimney contractor

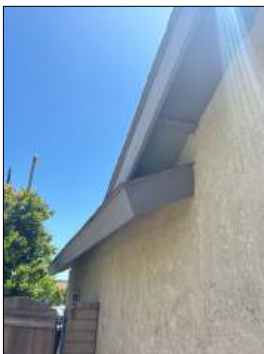
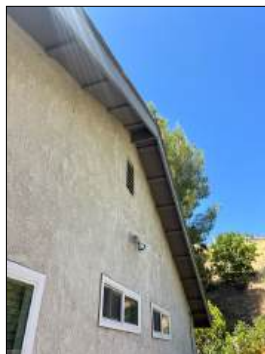
- **Consult termite report for all wood areas at the structure**
- Cracking/weathering/worn where visible - typical for age and weather exposure
- Recommend paint and **maintenance** repair
- Exposed exterior wood requires periodic seasonal **maintenance** and paint - recommend servicing
- **Cracking/deterioration - more than normal - needs to be serviced**

Cracking/deterioration - more than normal - needs to be serviced

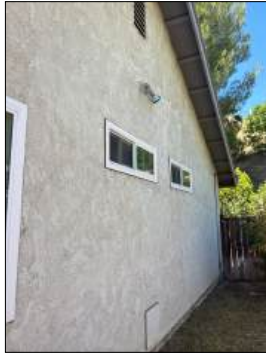
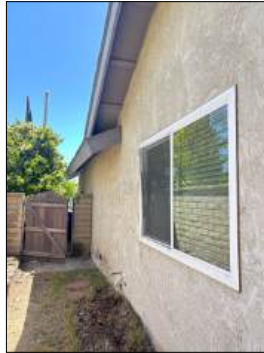
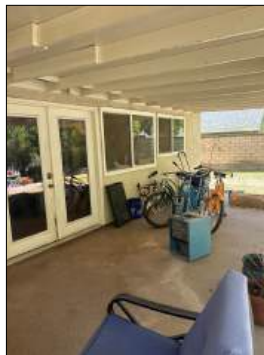
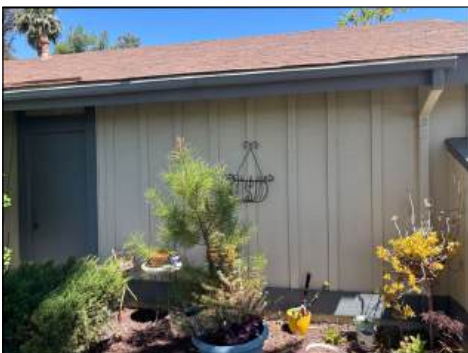
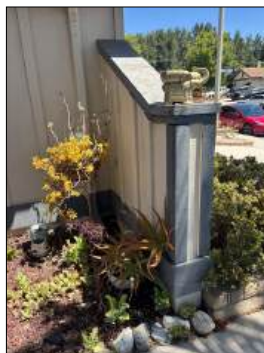
- Weathered and worn areas - typical for age and weather exposure, the structure would benefit from new paint
- Recommend caulking around doors and windows as necessary seasonally
- Paint faded and typical for the age

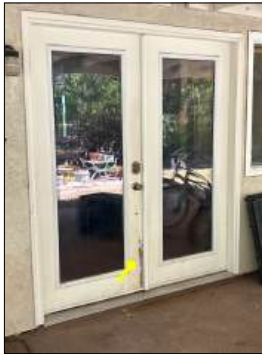
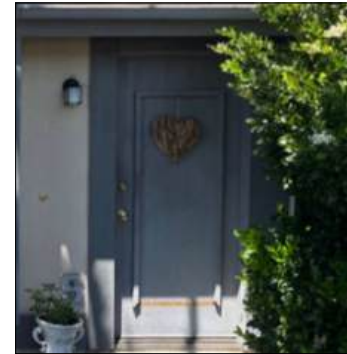
- **Exterior doors require seasonal maintenance to extend lifespan and maintain weather tight seals**
- **Consult the termite report for all wood doors/frames at this structure**
- Loose/worn hardware needs minor service and/or adjustment
- **Pet damaged - needs to be serviced or replaced**

Pet damaged - needs to be serviced or replaced

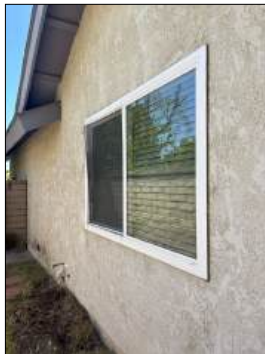
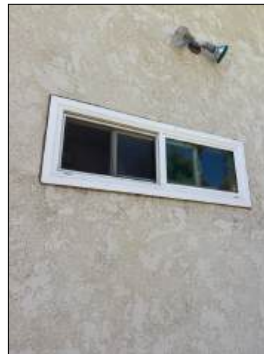
8. Exterior Windows

- Windows are not original to structure – check permits for all replacements to ensure proper installation in accordance with local building codes (may not include all windows at the structure)
- Worn windows/screens - typical for age
- **Exterior windows require seasonal maintenance to extend lifespan and maintain weather tight seals**
- **Torn/bent/worn screens - needs maintenance/repair**

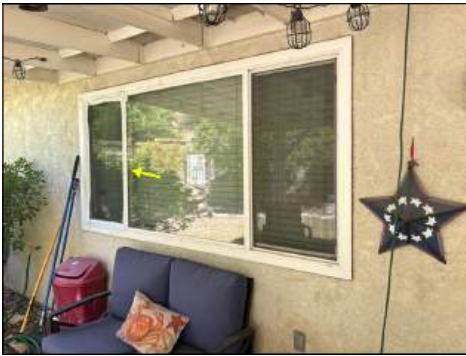
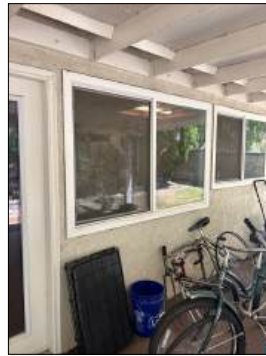
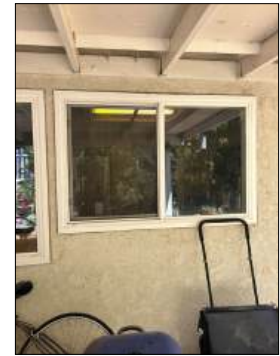
Torn/bent/worn screens - needs maintenance/repair

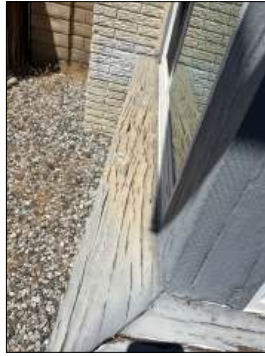
Weathered/worn more than normal - needs to be serviced

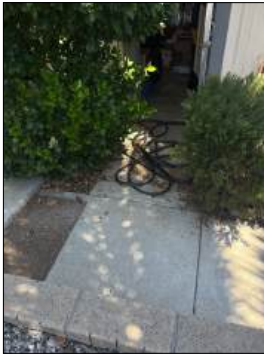
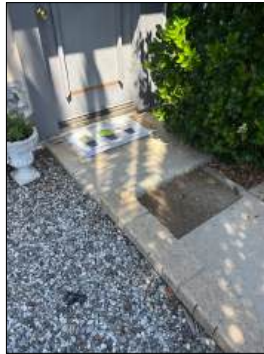
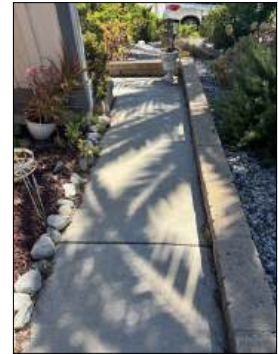
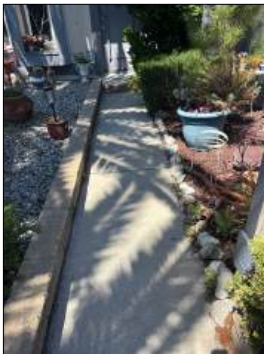
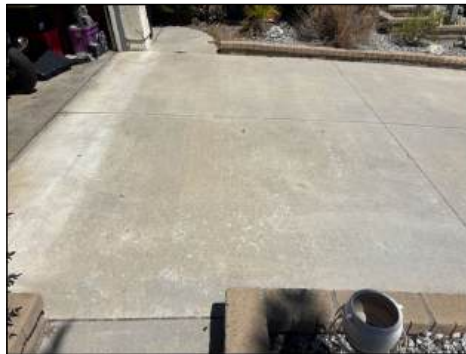
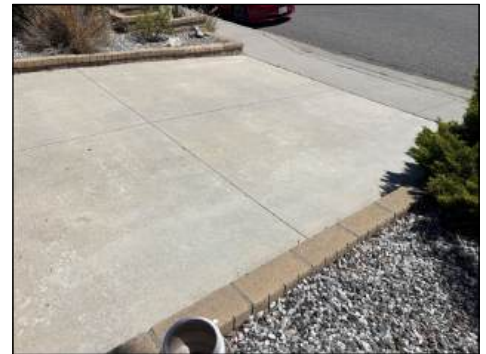
- Worn with common cracks/chips - typical for age of material

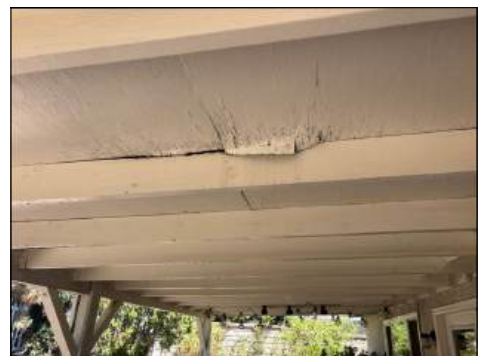
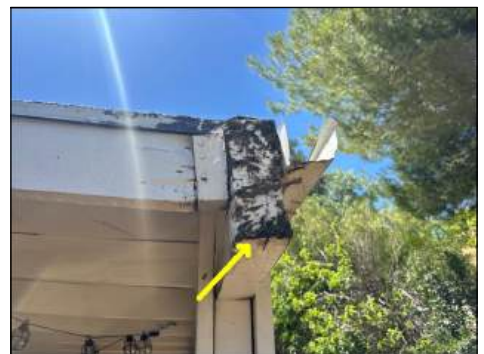
- See main roof page for porch/patio areas as observations may be applicable to patio/porch structure and materials
- Worn/weathered materials - typical for age
- Consult termite report for all exterior wood conditions
- **Wood deterioration observed - consult termite report**

Wood deterioration observed - consult termite report

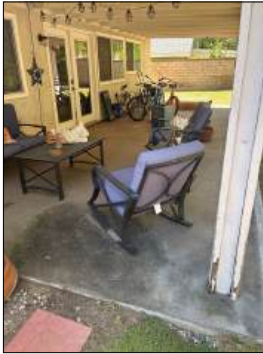
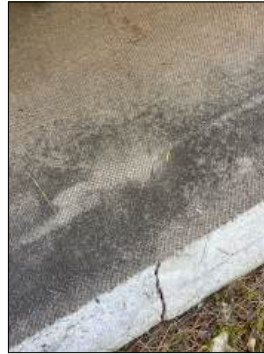
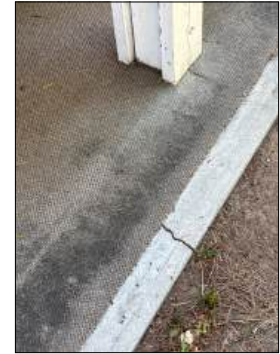
3. Patio and Porch Decks

- Worn with common cracks/chips - typical for age of material
- Cracking/chipping small and typical for age
- **Displaced/lifted/uneven areas trip hazard - needs to be serviced**

Displaced/lifted/uneven areas trip hazard - needs to be serviced - covered but concret is uneven and cracked

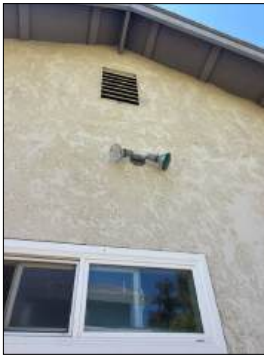
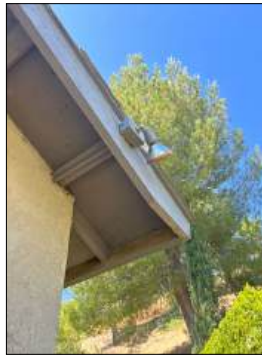
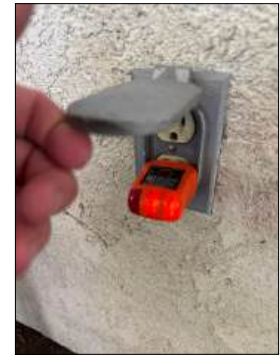
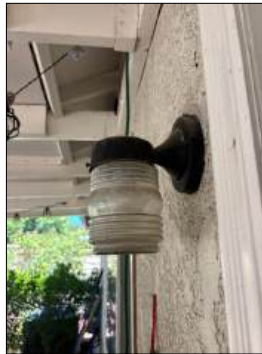
- The visible and tested fixtures/switches/outlets were in a loose/worn condition - typical for age
- Electrical fixtures need to be caulked/sealed to wall attachments to help prevent moisture entry
- **Some light(s) did not function (some may be on sensors or timers) - check bulbs first, then consult an electrician to further evaluate as needed**

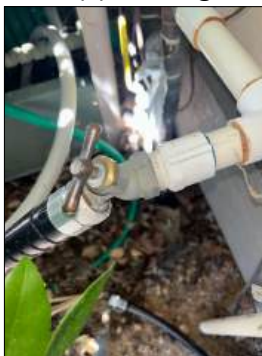
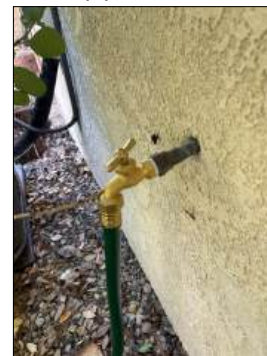
- Exterior plumbing is present and not original to the structure - check all installation permits to ensure installation to building code
- Accessible exterior faucets operated with normal wear at time of inspection via normal fixture controls
- Exterior hose faucet(s) missing anti-siphon device(s) or back flow preventer(s) - recommend servicing

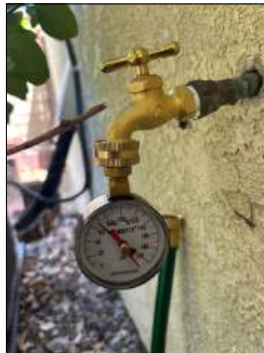
- Approximate pounds per square inch: 75

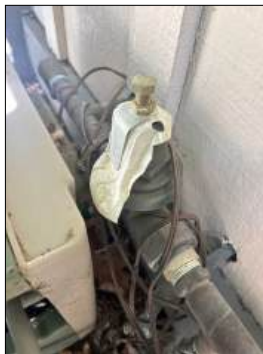
9. Pressure Regulator

- Location: east side
- Regulator appears to be worn and older, consult with a plumber regarding upgrade options

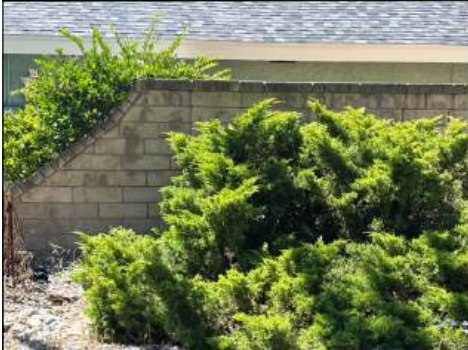
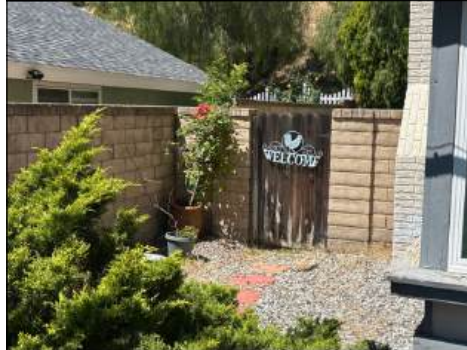
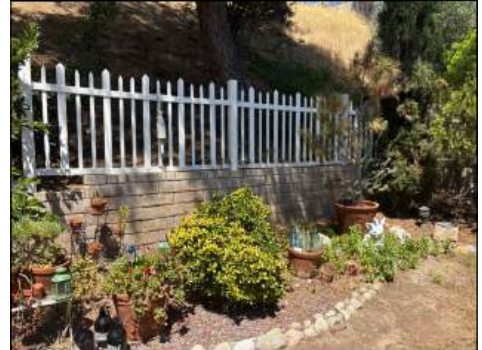
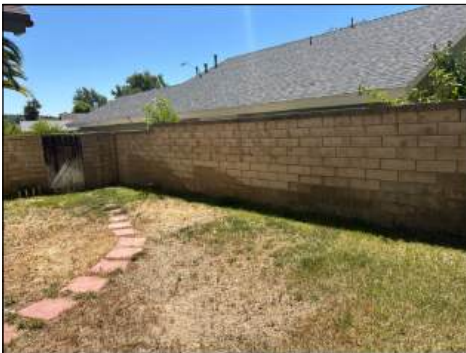
11. Fencing and Walls

- Visible fencing/wall areas are worn and weathered - typical for the age of the materials

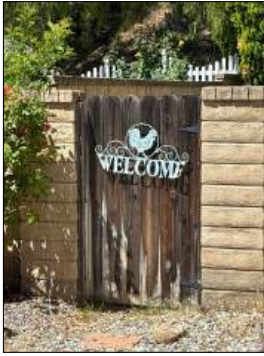
Gate not closing properly - recommend servicing

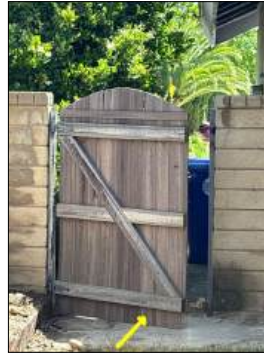
Gate is sagging - recommend servicing

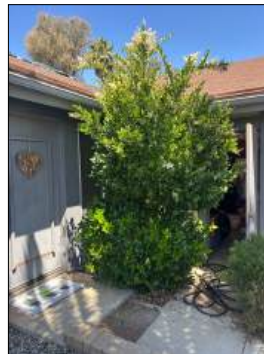
- Recommend pruning or remove any plants or trees that are in contact or proximity to structure to eliminate pathways of wood destroying insects and moisture
- Recommend trimming trees or bushes that are in contact or proximity to home, as branches can abrade roofing or siding

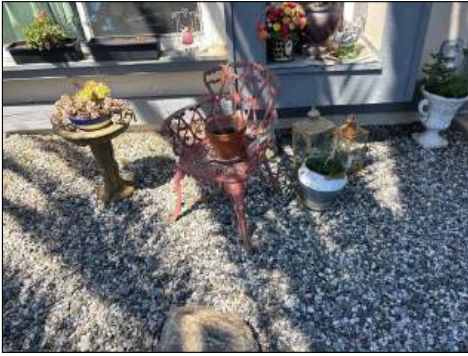
- No drains visible at the property at the time of the inspection, drains are recommended to divert water away from structure
- Small localized water ponding may occur in areas - monitor these areas as drains may be needed

Small localized water ponding may occur in areas - monitor these areas as drains may be needed

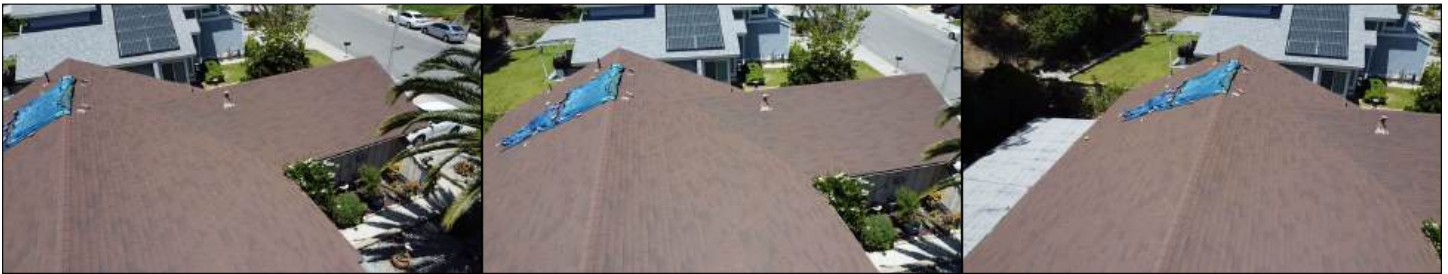
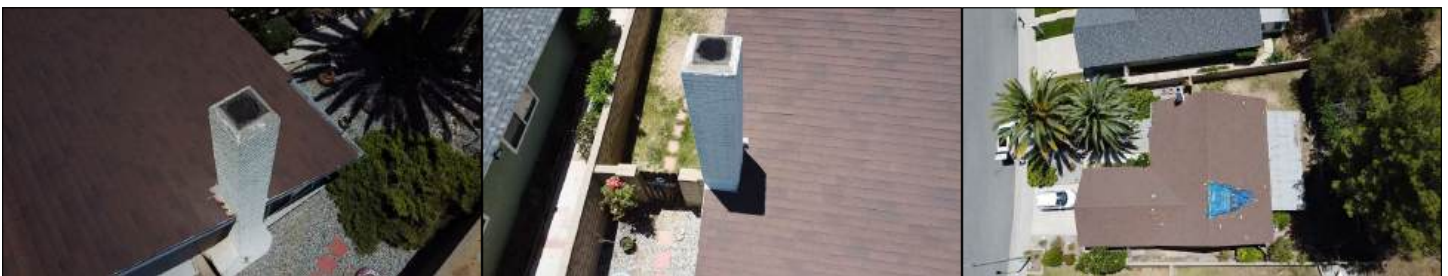
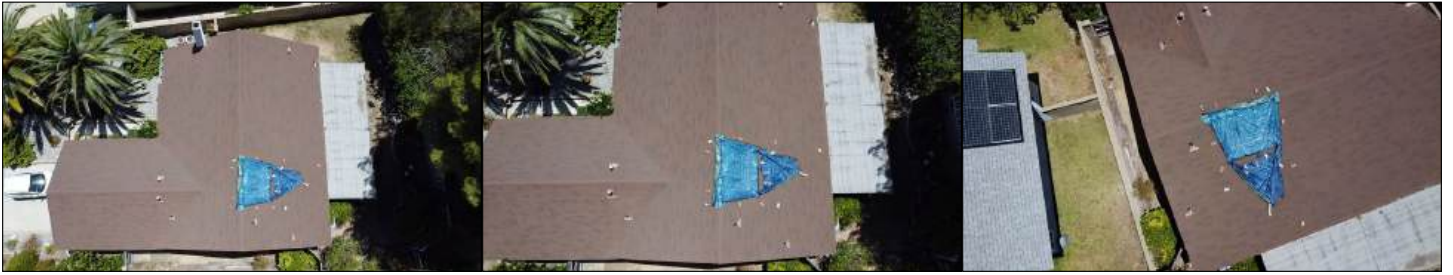
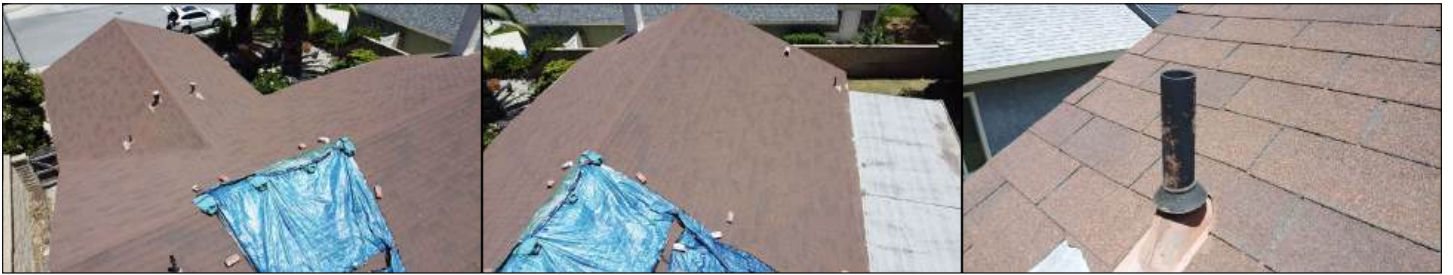
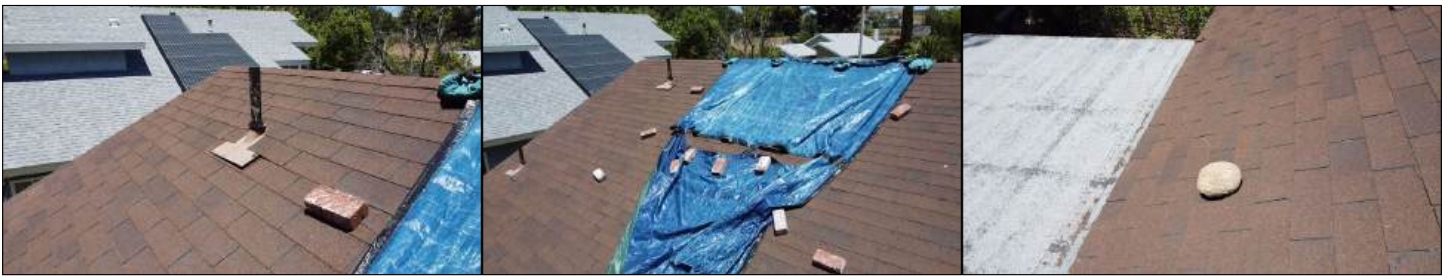
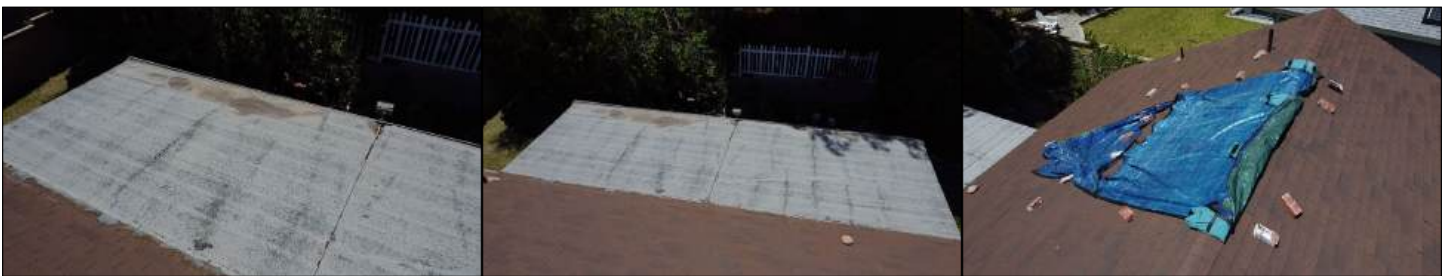
- Worn and weathered materials present - typical for age and weather exposure - roof needs maintenance
- **Recommend roofing contractor to further evaluate**
- **Evidence of prior repair/patching observed - consult seller for all past repairs and roof service history**

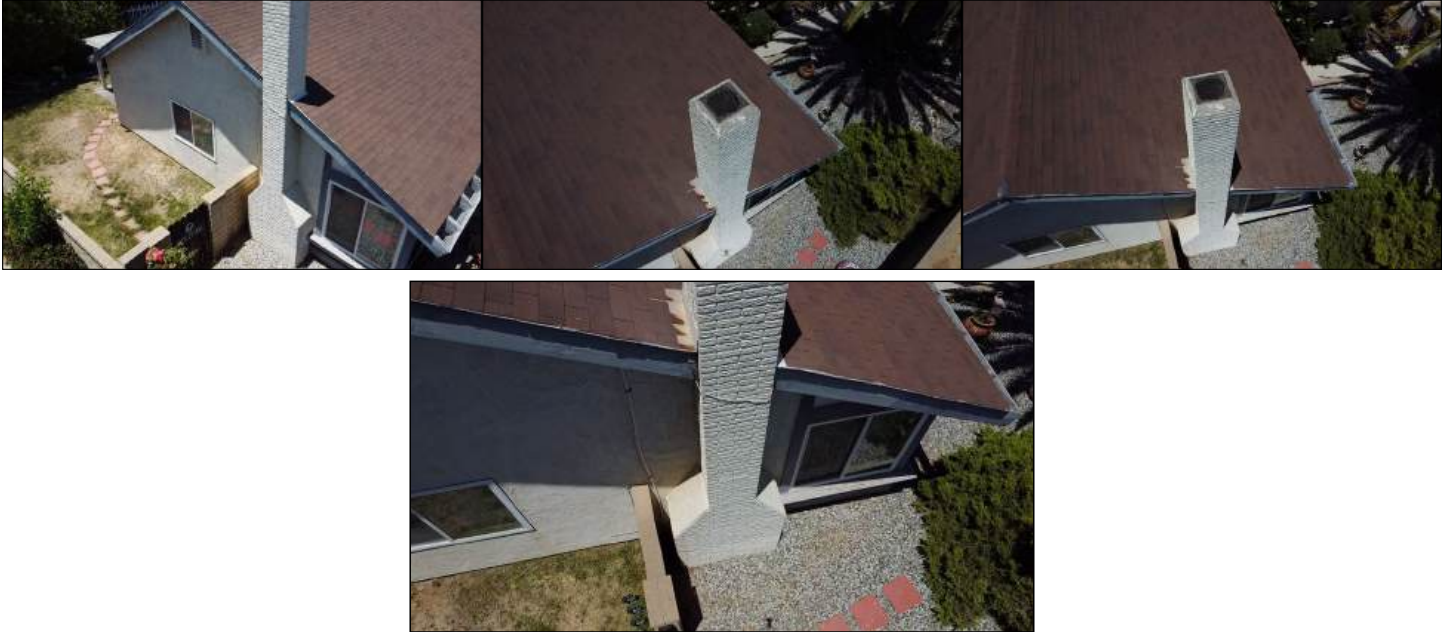
3. Chimneys

- Worn/weathered chimney – recommend seasonal maintenance and care
- Cracks in bricks - appear to be minor but should be sealed and monitored as part of regular home maintenance

- Minor deterioration - typical for age and weather exposure
- Recommend appropriate licensed contractor for further evaluation
- Pre-Fab concrete Rampart General fireplace/chimney present; known to be problematic - recommend further review by CSIA or other certified chimney sweep or other licensed chimney contractor

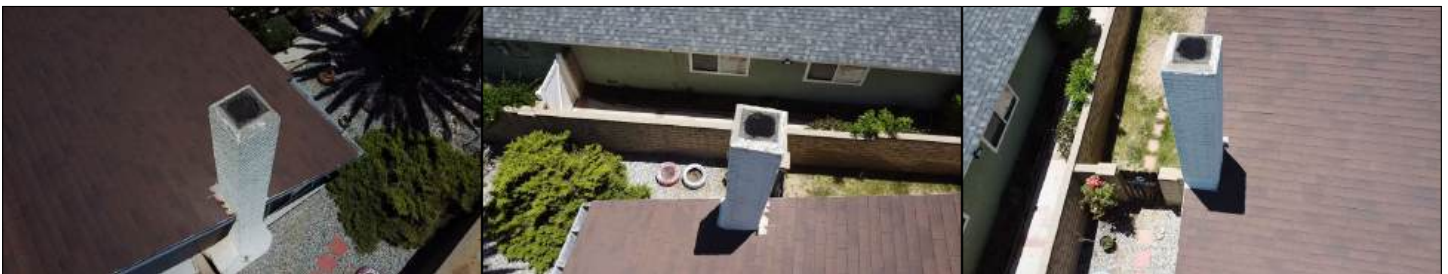
4. Spark Arrestors

- No spark arrestor/rain cap present - recommend installation
- Wire mesh only is installed as a spark arrestor, this is considered to be inadequate and a proper spark arrestor should be installed

Wire mesh only is installed as a spark arrestor, this is considered to be inadequate and a proper spark arrestor should be installed

• Wire mesh only is installed as a spark arrestor, this is considered to be inadequate and a proper spark arrestor should be installed
