SUMMARY

7801 E Bridgewood Dr, Anaheim, CA

Robert Kruger
InterNACHI Certified Home Inspector
Pivot Property Inspection
714-992-6363
rob@pivotpropertyinspection.com

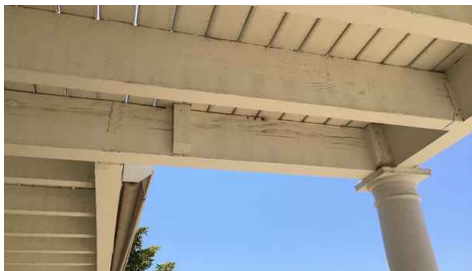
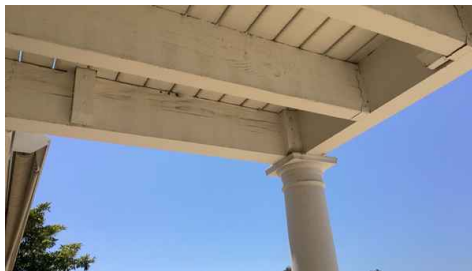
3.4.1 Deck/Balcony

MOISTURE DAMAGED WOOD

There is moisture and/or insect damage at the deck/balcony. I recommend evaluation by a licensed contractor. Refer to a qualified structural pest control report for additional information.

Contact a qualified professional.

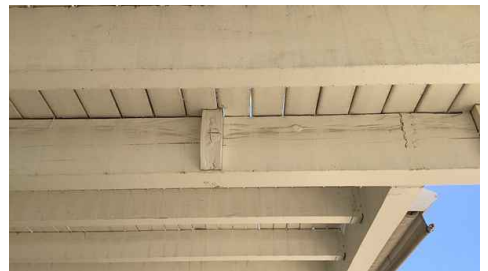
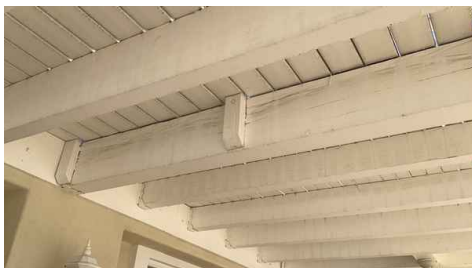
3.7.1 Deck/Patio Cover

MOISTURE/INSECT DAMAGE

There is moisture and/or insect damaged wood at the patio cover. I recommend evaluation by a licensed contractor. Refer to a qualified structural pest control report for additional information.

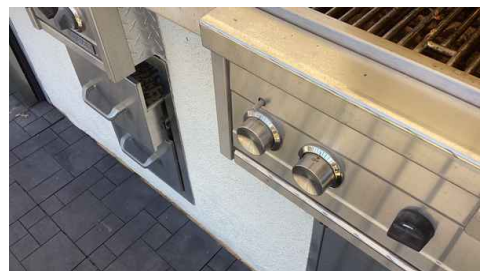
3.8.1 Barbeque

ELECTRONIC IGNITION INOPERABLE

The electronic ignition is not functional at the barbeque. I recommend evaluation by a qualified technician.

Contact a qualified professional.

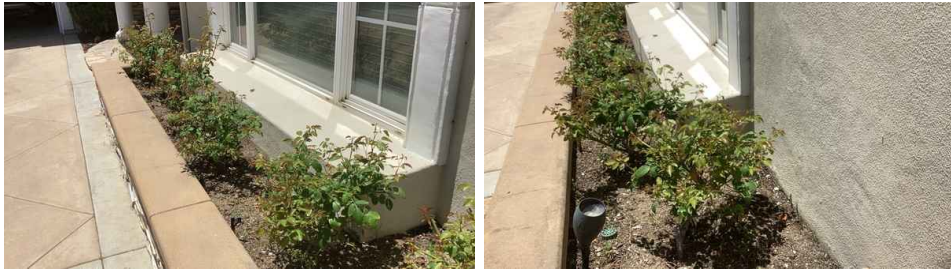
4.1.1 Exterior Walls

ABOVE GRADE PLANTERS

Contact a qualified professional.

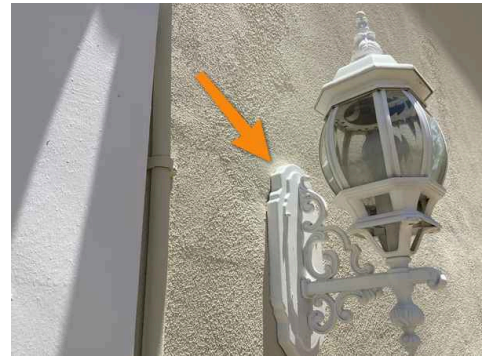
4.8.1 Exterior Lighting

MISSING CAULKING

Outdoor fixture is missing caulking around base. Recommend evaluation by a general contractor.

Contact a qualified professional.

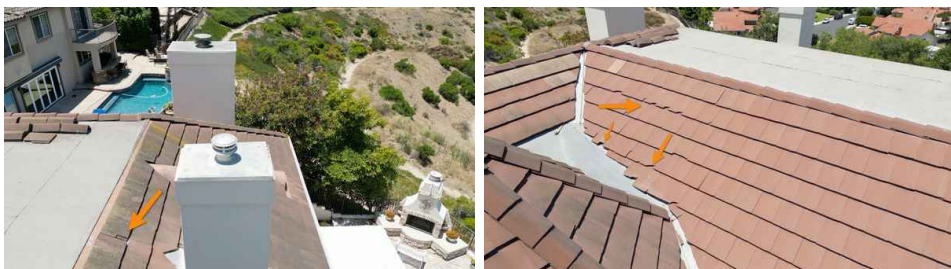
6.1.1 Roof

CRACKED, DAMAGED, BROKEN TILES

There are many cracked, damaged, or slipped tiles on the roofing system. The cracked, damaged, or broken tiles should be replaced. The foregoing is an opinion of the general quality and condition of the roofing material. The inspector cannot and does not offer an opinion or warranty as to whether the roof leaks or may be subject to future leakage. This report is issued in consideration of the foregoing disclaimer. The only way to determine whether or not a roof is watertight is to observe it during a prolonged rainfall. I recommend evaluation by a licensed roofing contractor.

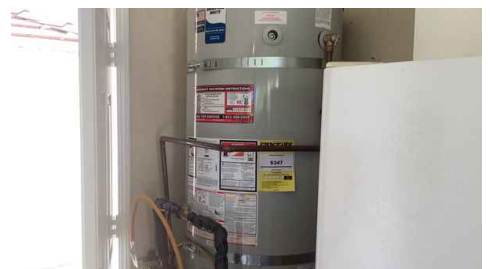
8.5.1 Strapped/Braced

NOT STRAPPED - OVER 50 GALLON

The water heater is not properly strapped to resist movement during seismic activity. Water heaters with a capacity between 50 and 75 gallons require three straps. I recommend evaluation by a licensed contractor.

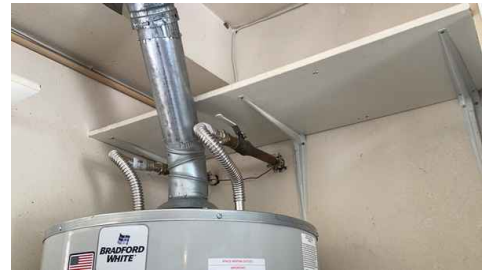
8.10.1 Expansion tank

EXPANSION TANK NOT PRESENT

Expansion tanks are required for all new and replacement water heaters installed in a closed plumbing system after 2018. Recommend evaluation by licensed plumber.

A thermal expansion tank is a simple fix: it's a small tank (looks like a mini version of your water heater) connected to the cold water inlet. Inside, there's a rubber bladder and air cushion that absorbs the extra water volume without letting pressure spike. Think of it as a "pressure sponge" for your system. Installing one prevents these issues, keeps everything running smoothly, and is often required by current plumbing codes for homes like yours.

Contact a qualified professional.

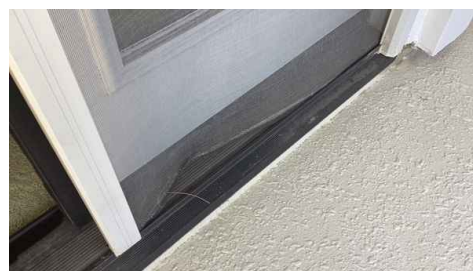
11.4.1 Windows

DOOR SCREENS DAMAGED

The screen door off the front bedroom is damaged. I recommend evaluation and repair by a qualified technician.

Contact a qualified professional.

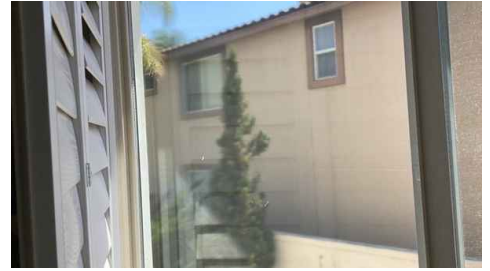
11.4.2 Windows

TINTING FILM INSTALLED ON GLASS

Tinting film has been applied to the glass at many of the windows. The installation of tinting film leads to increased thermal expansion of the glass sealant resulting in failed seals. The installation of tinting film on dual glazed windows voids the manufacturer's warranty. I recommend removing the tinting film.

Contact a qualified professional.

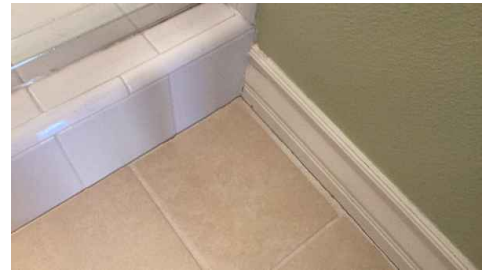
11.5.1 Floors

GROUT IN UPSTAIRS FRONT BATHROOM NEEDS TO BE RESEALED

Contact a qualified professional.

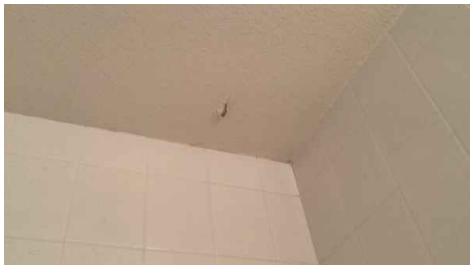
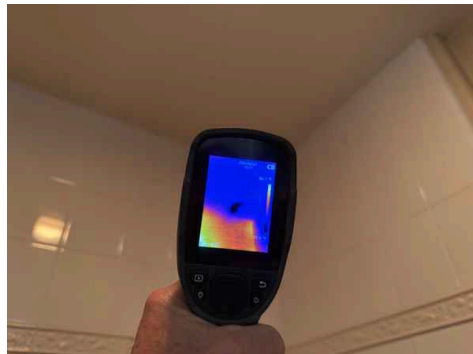
11.7.1 Ceilings

DAMAGED DRYWALL

There is damaged drywall on the ceiling in the downstairs bathroom. Recommend evaluation by the general contractor.

Contact a qualified professional.

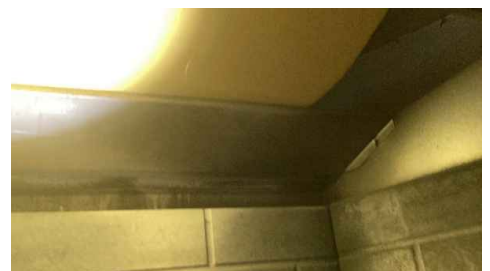
11.9.1 Fireplace

DAMPER NOT PERMANENTLY OPEN

A vented natural gas log set has been installed within the fireplace. The damper has not been blocked permanently open, as required. I recommend evaluation by a licensed contractor.

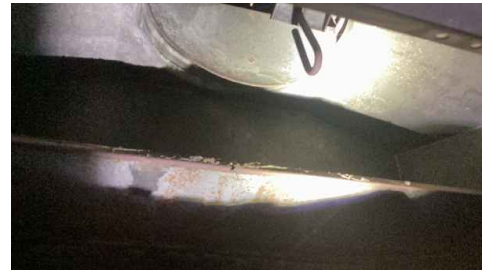
11.10.1 Fireplace

DAMPER NOT PERMANENTLY OPEN

A vented natural gas log set has been installed within the fireplace. The damper has not been blocked permanently open, as required. I recommend evaluation by a licensed contractor.

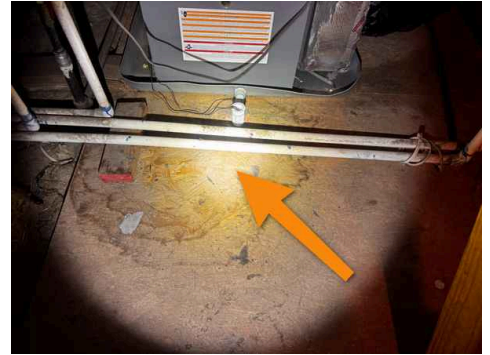
11.16.1 Attic

MOISTURE STAINING

There is moisture staining on the floor/deck sheathing within the attic. I recommend evaluation by a licensed HVAC contractor.

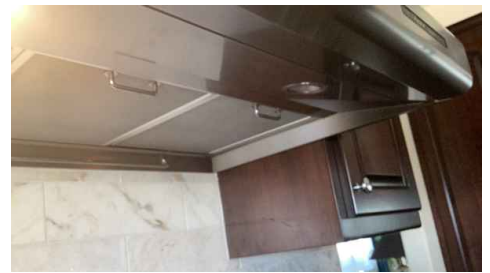
12.5.1 Ranges/Ovens/Cooktops

LIGHTS WITHIN THE EXHAUST HOOD DID NOT RESPOND

The light fixtures within the exhaust hood did not respond to the controls. I recommend evaluation by a qualified appliance technician.

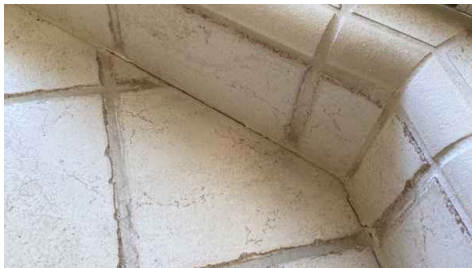
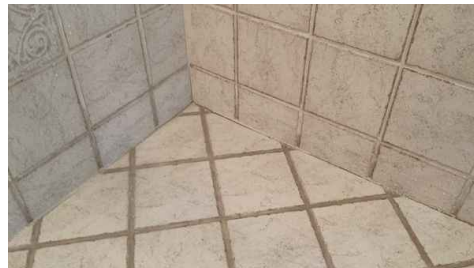
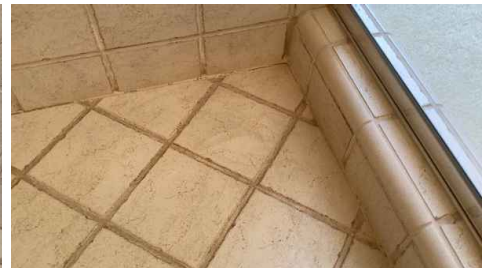
13.6.1 Tub/Shower Walls

CAULKING/GROUT DETERIORATED

The caulking and/or grout at the shower floor/walls is deteriorated. I recommend evaluation by a licensed contractor.

Contact a qualified professional.

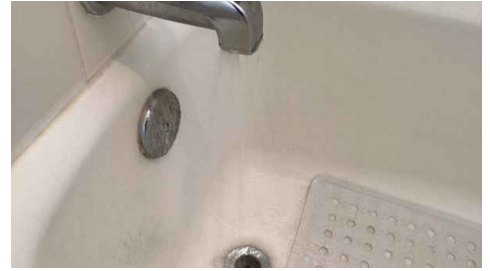
14.5.1 Tub/Shower Fixtures

SHOWER DIVERter STUCK ENGAGED POSITION

The shower diverter is stuck in the engaged position. I recommend evaluation by a licensed plumbing contractor.

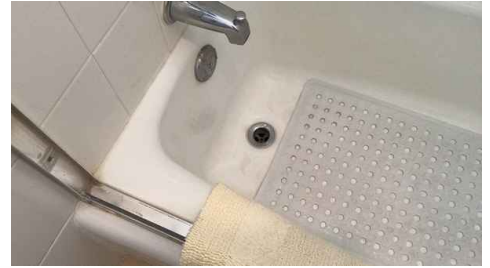
14.5.2 Tub/Shower Fixtures **MISSING DRAIN PLUG**

The bathtub is missing a drain stop, recommend evaluation by plumber.

Recommendation
Contact a qualified professional.

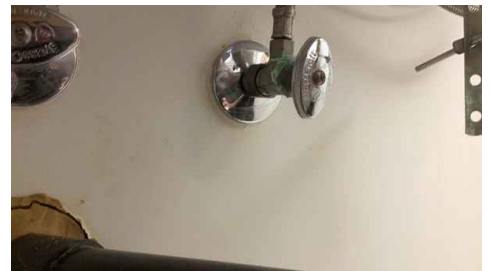
15.3.1 Sink Plumbing **HEAVY CORROSION**

There is heavy corrosion at the angle stop valves below the sinks. I recommend evaluation by a licensed plumbing contractor.

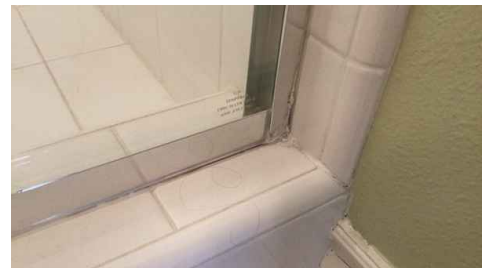
15.7.1 Shower Enclosure **GASKET/SEALANT DAMAGED**

The shower enclosure gasketing and sealant are damaged. The enclosure appears to leak along the lower track. I recommend evaluation by a licensed contractor.

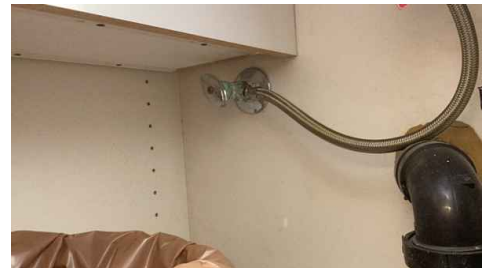
16.3.1 Sink Plumbing **HEAVY CORROSION**

There is heavy corrosion at the angle stop valves below the sinks. I recommend evaluation by a licensed plumbing contractor.

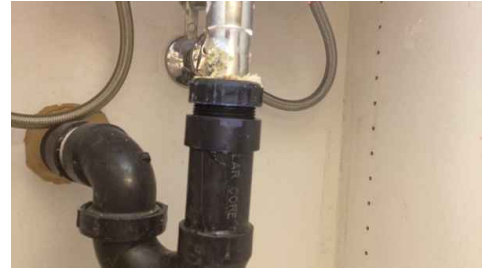
16.3.2 Sink Plumbing

WASTE PIPING CORRODED

The waste piping is corroded and has been poorly patched. The sink drains slowly. I recommend evaluation by a licensed plumbing contractor.

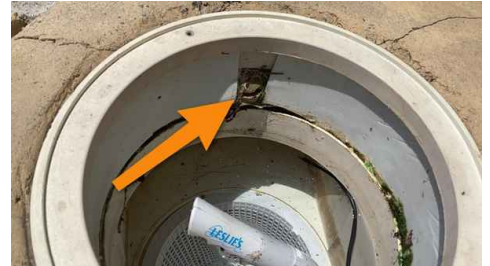
19.3.1 Filter

CRACKED SKIMMER RING

A crack was observed in the skimmer ring during pool inspection. This damage can allow water to leak from the skimmer system and may permit debris or contaminants to enter. The skimmer ring should be replaced or repaired by a pool professional to restore proper function and prevent further water loss.
