**ELITE GROUP**  
INSPECTION PROFESSIONALS

PROPERTY LOCATION: 1123 N Florence St Burbank, CA 91505

# INSPECTION REPORT

Year Built: 1939 Sq Ft: 1463

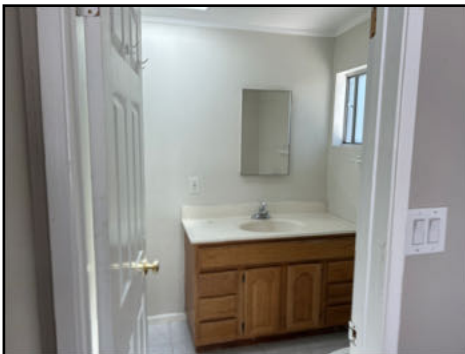
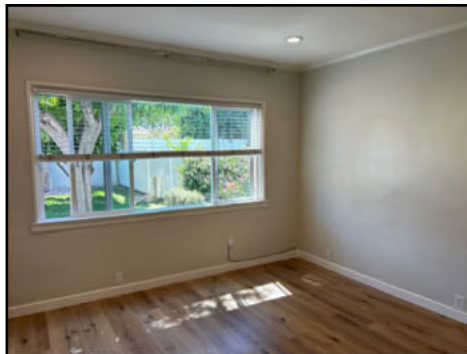
## 2. Wall Conditions

**Large cracks or holes present – larger than typical - needs to be further evaluated/serviced**

| INTERIOR | | |
|---|---|---|
| Page 13 Item: 2 | Wall Conditions | • Large cracks or holes present – larger than typical - needs to be further evaluated/serviced |

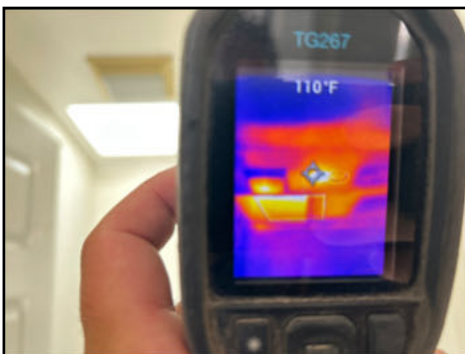
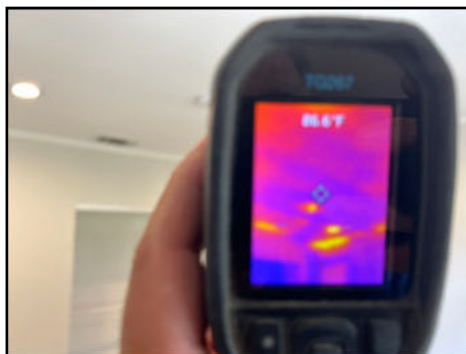
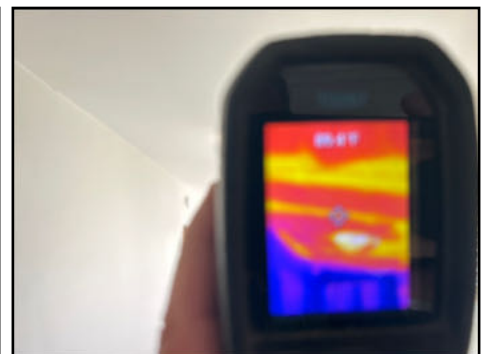
### 3. Ceiling Conditions

- Recently painted throughout structure
- No major visible defects observed at the time of inspection
- Remodeled areas observed - check all necessary permits
- Check for permits for any alterations
- Recent paint or patching may cover known past defects - consult the seller/disclosures for all past repairs
- Small cracking may be found throughout the structure, this is normal for California construction and generally caused by settling, earthquake, and wind conditions.
- Recommend licensed contractor for further evaluation

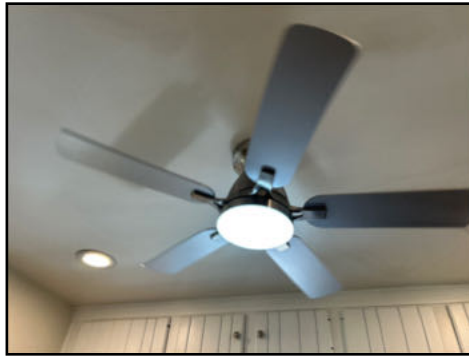
#### 4. Ceiling Fans

- Note: It is not possible to determine the method of attachment to the ceiling. These units are heavy and due to the designed movement, must have the proper style mounting boxes for correct and safe attachment. Recommend confirming the method of attachment prior to use. This may require the removal of the fan or insulation to visually verify proper support.
- Operated at time of inspection
- Normal wear for age, no major visible defects

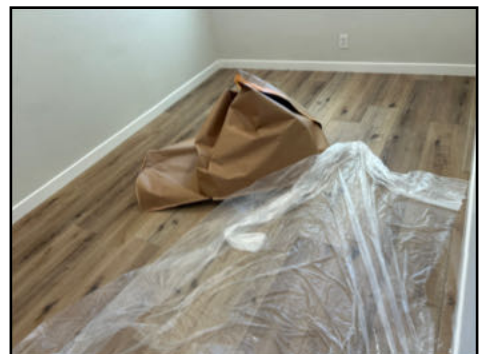
### 5. Floor Conditions

• Loose floor plank - needs to be serviced

Loose floor plank - needs to be serviced

| INTERIOR | | |
|---|---|---|
| Page 17 Item: 5 | Floor Conditions | • Loose floor plank - needs to be serviced |

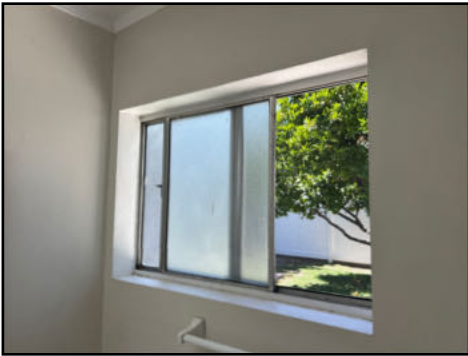
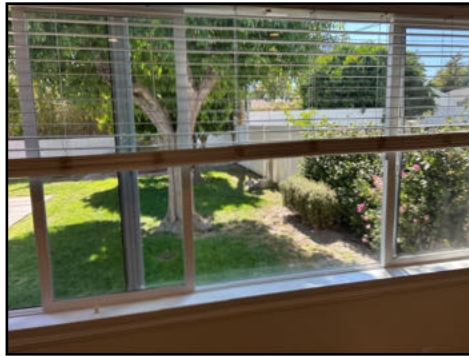
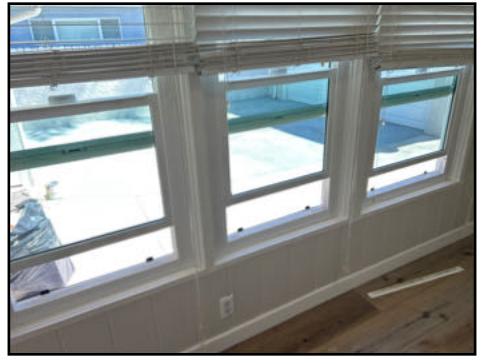
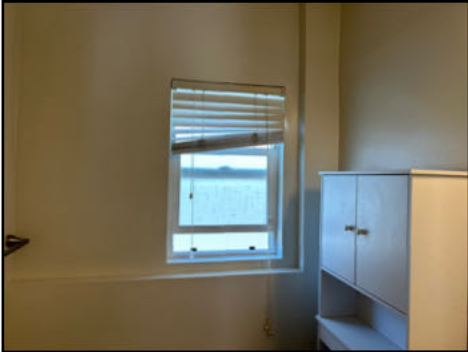
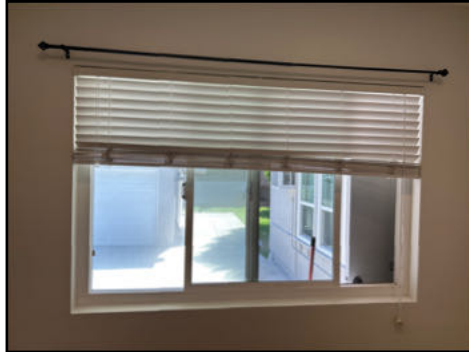
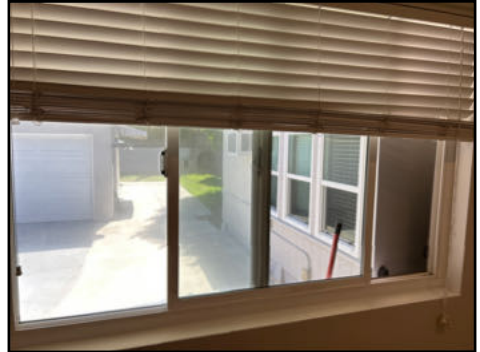
## 6. Window Conditions

**Visible internal condensation or hazy glass inside window - needs to be serviced/evaluated by a window contractor - recommend all windows be checked as others may exist**

- Recommend window contractor for further evaluation

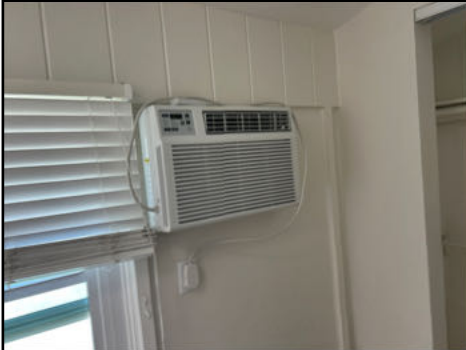
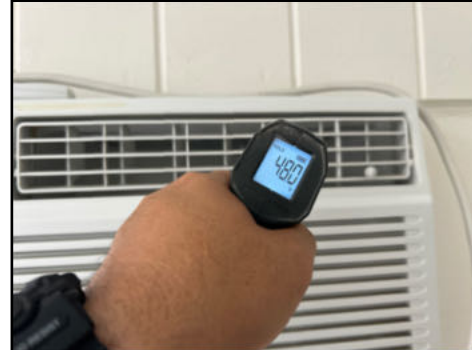
## 7. Window-Wall A/C or Heat Units

- Operated at time of inspection using normal controls
- Unit is worn/older - typical wear for age, recommend cleaning and **maintenance** to extend unit life

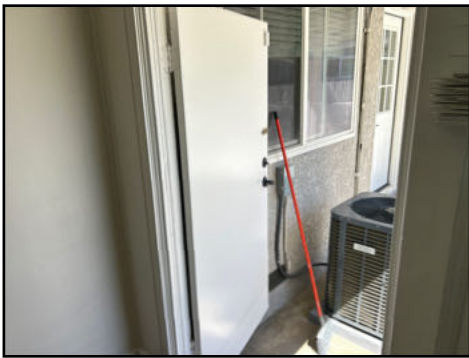
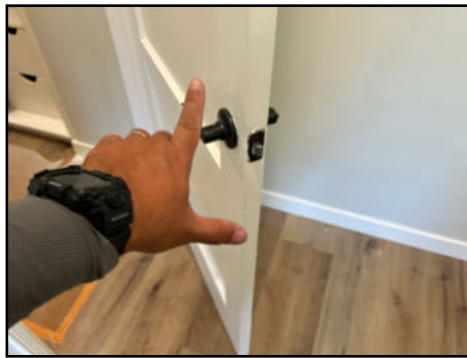
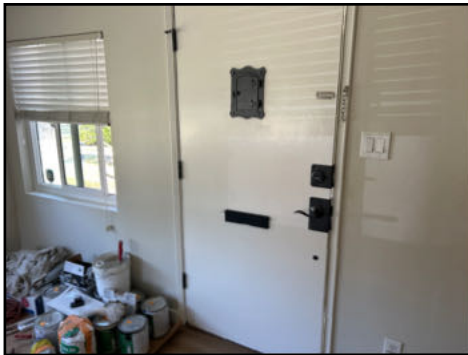
## 8. Doors

Loose/worn hardware needs minor service - typical for age

Sticks at jamb - needs to be serviced

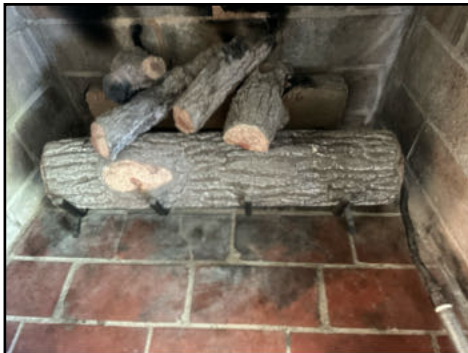
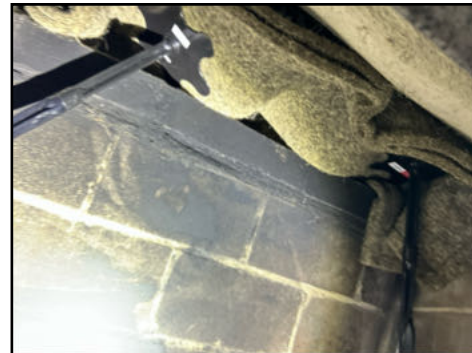
## 9. Fireplaces

- Recommend fireplace professional evaluate and repair any issues found before attempting to use fireplace
- Glass or spark screen door was worn and difficult to operate
- Flue sealed off did not test - needs further evaluation
- Check for permits for any alterations
- Recommend evaluation by licensed masonry contractor

Flue sealed off did not test - needs further evaluation

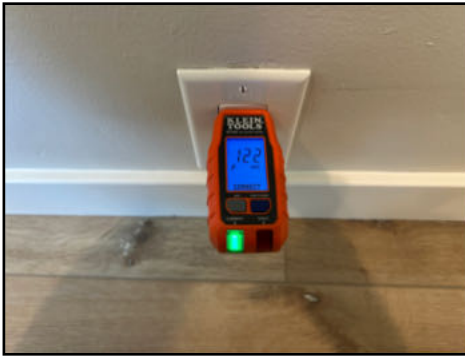
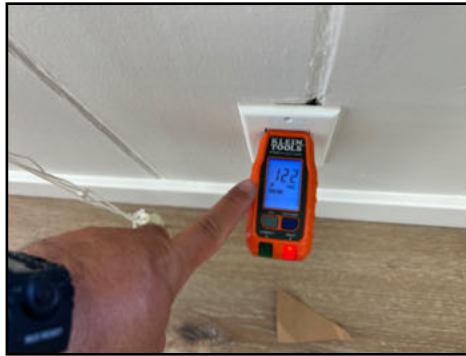
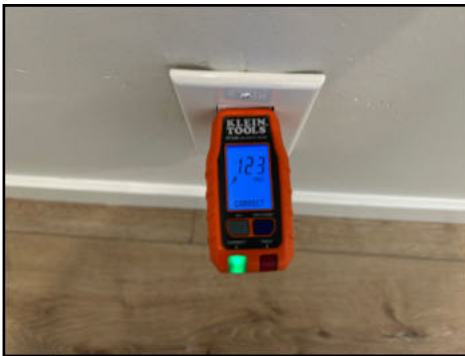
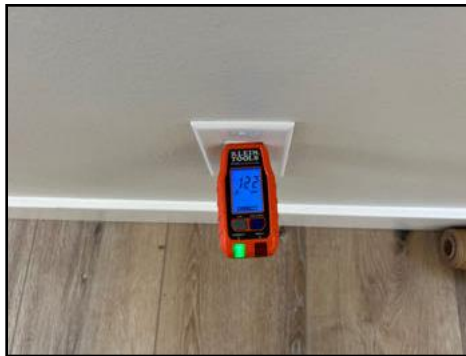
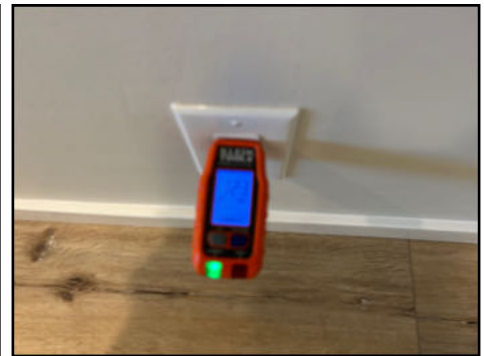
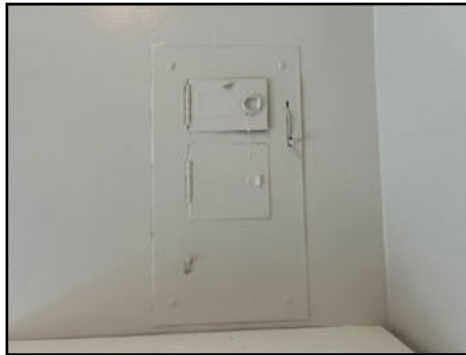
## 10. Electrical

**Three prong outlet(s) not grounded - needs to be serviced**

- Some outlets not accessible - not inspected
- Some switches not accessible - not inspected
- Recommend licensed electrician to further evaluate
- **Three prong outlet(s) not grounded - needs to be serviced**

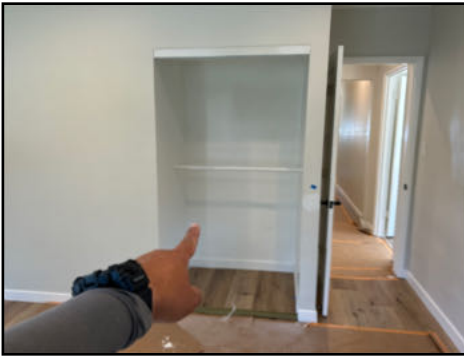
Missing closet doors - needs to be serviced

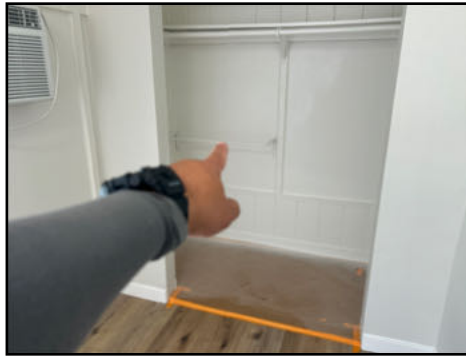
Missing closet doors - needs to be serviced

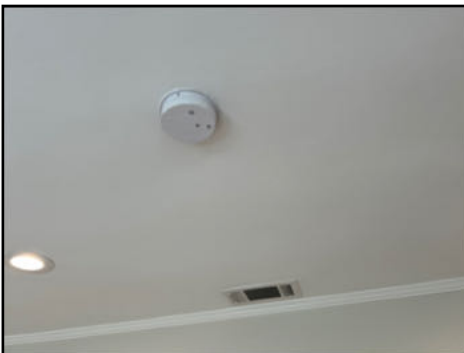
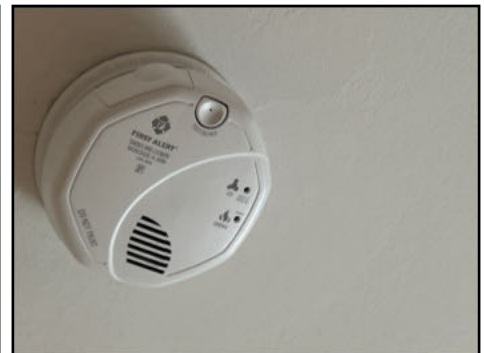
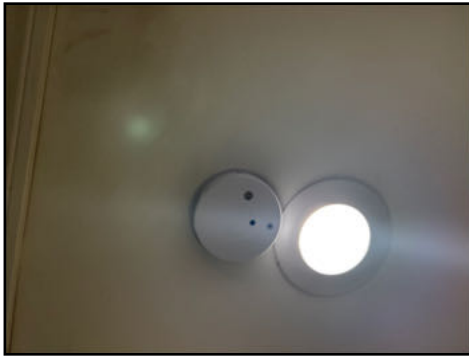
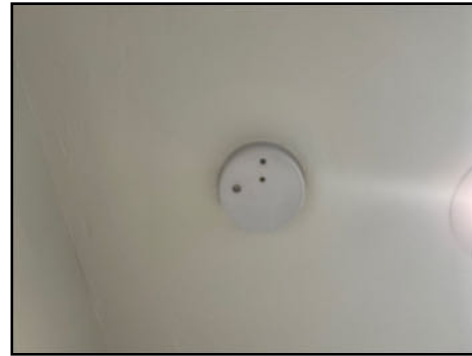
- For safety purposes we recommend that smoke detectors be placed in all hallways outside of sleeping areas (bedrooms) and on all levels of multi-level dwellings. For longer hallways and/or oddly located bedrooms, multiple smoke detectors are suggested and should be placed at each end of the hallways to ensure optimum safety alert.
- Present at time of inspection
- Smoke and Carbon Monoxide combo unit is present
- **Missing at hall - needs to be installed**

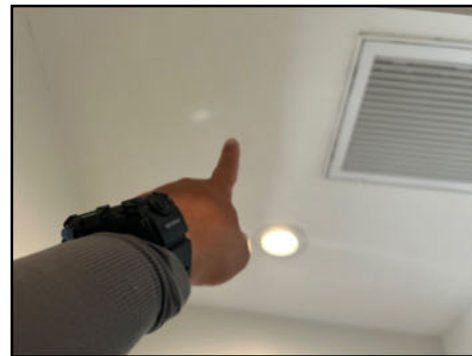
Missing at hall - needs to be installed

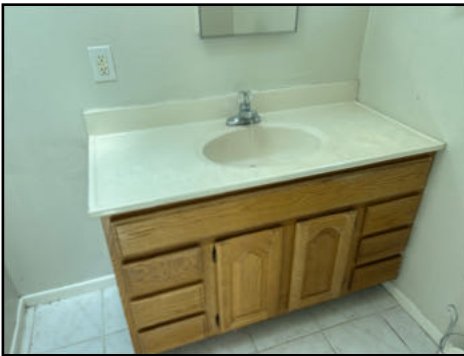
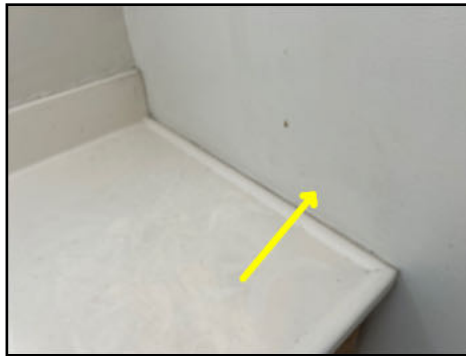
**Counter does not have a back or side wall splash prevention materials - potential moisture damage may occur in these areas**

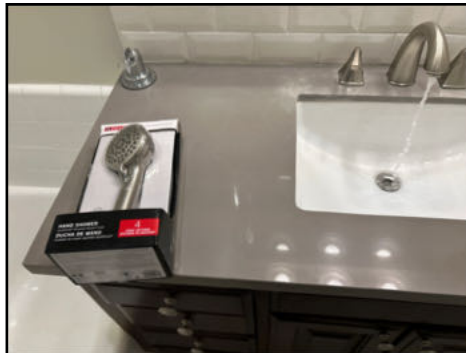
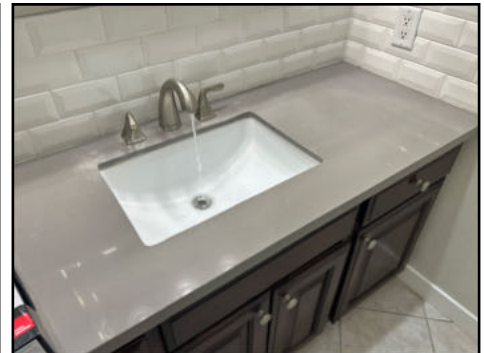
**Gap at backsplash to countertop joint - needs to be serviced**

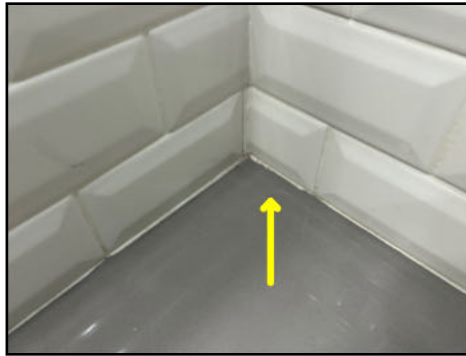
Gap at backsplash to countertop joint - needs to be serviced

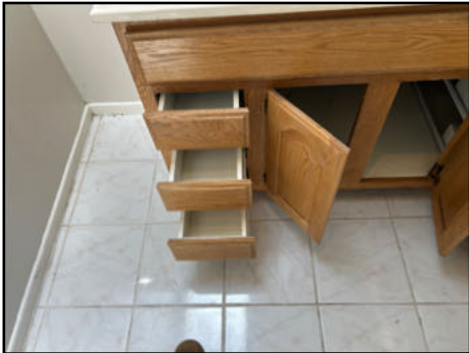
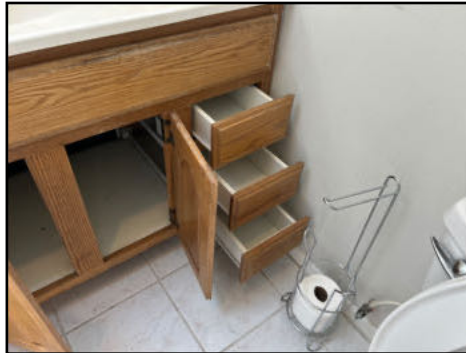
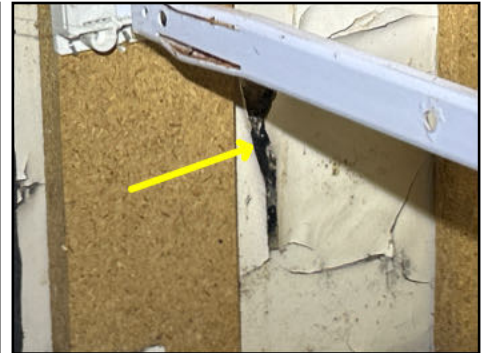
Microbial growth/irregular staining present- further evaluation is recommended

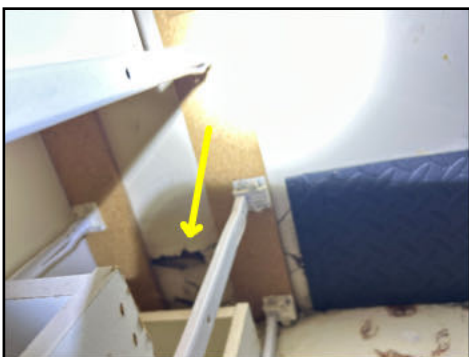
Moisture damage - needs to be serviced - hidden defects may exist

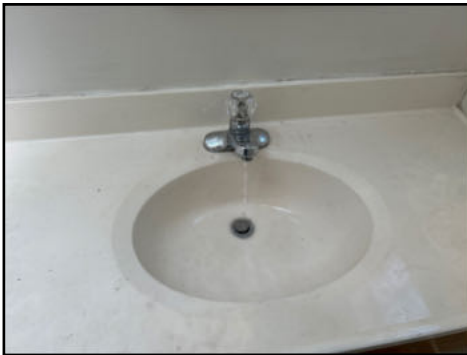
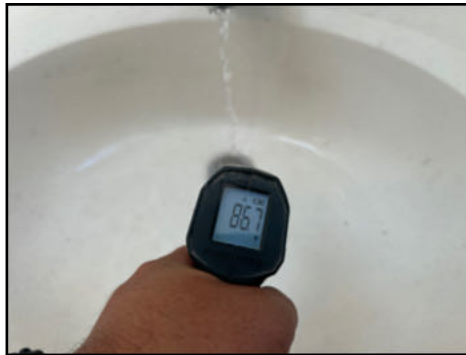
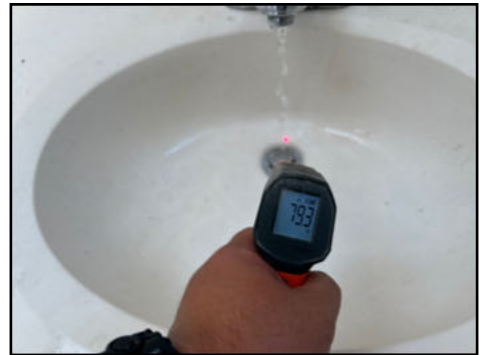
Hot valve did not function properly - needs to be serviced

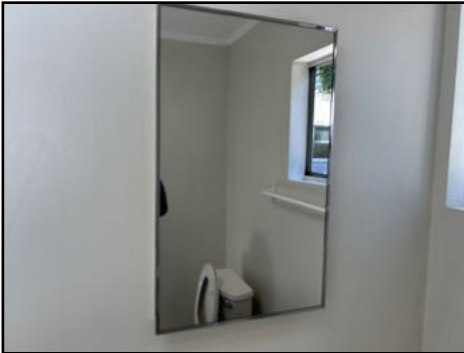
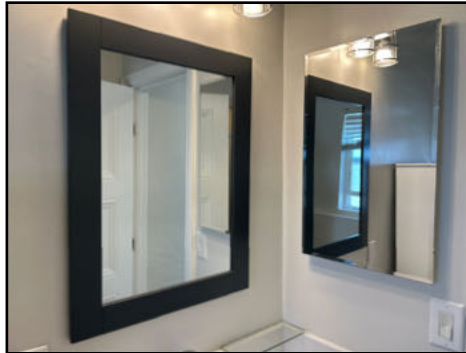
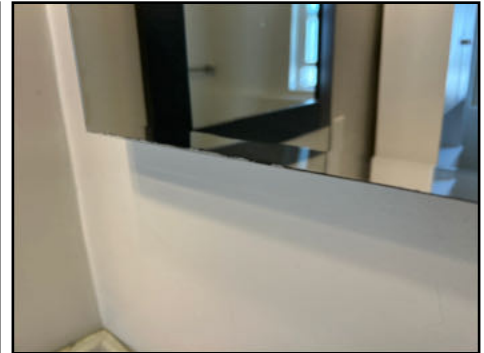
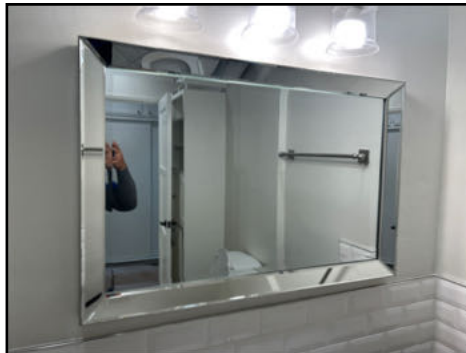
- Mirror functional at time of inspection
- Worn/older - typical wear for age
- Fading spots present

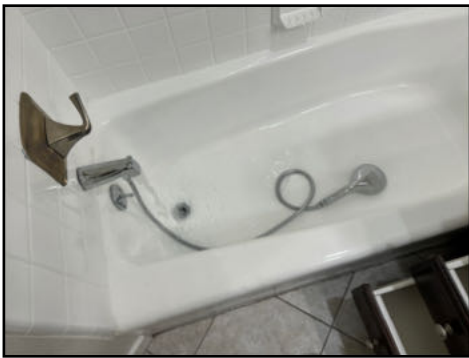
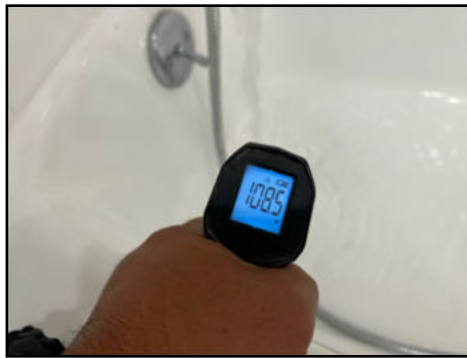
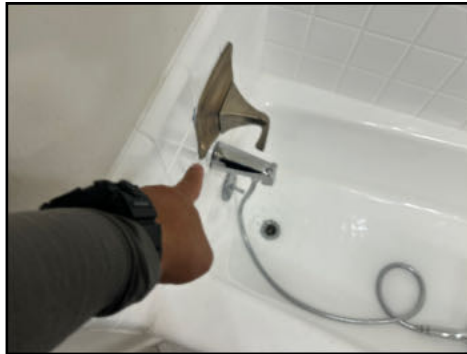
Caulk **maintenance** needed at wall to fixture juncture

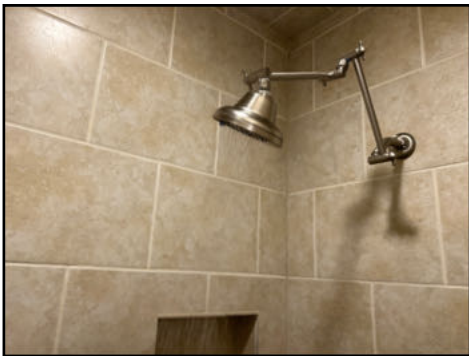
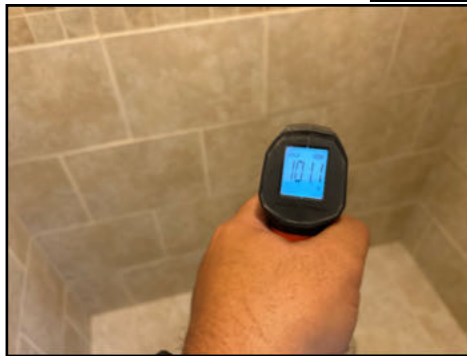
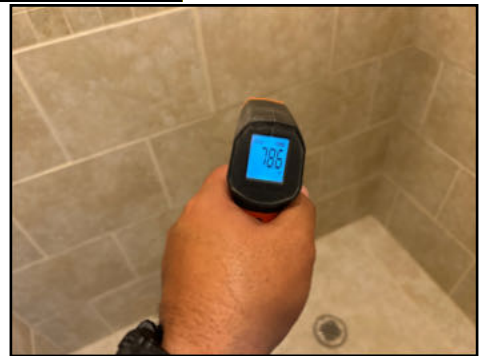
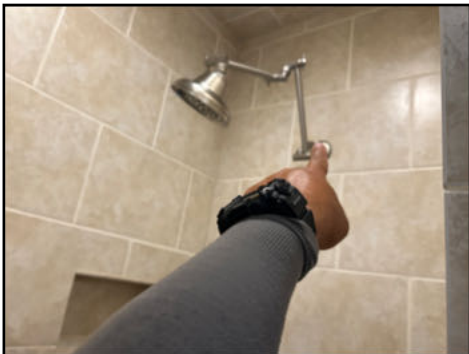
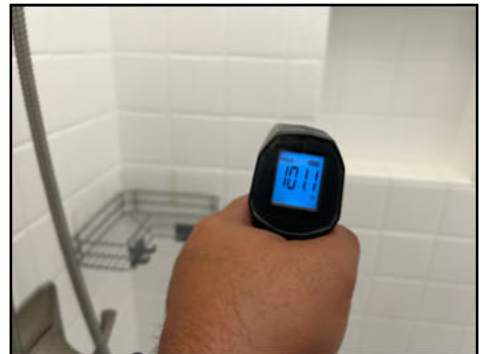
Caulk **maintenance** needed at wall to fixture juncture

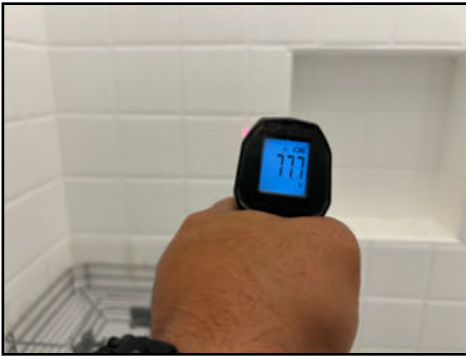
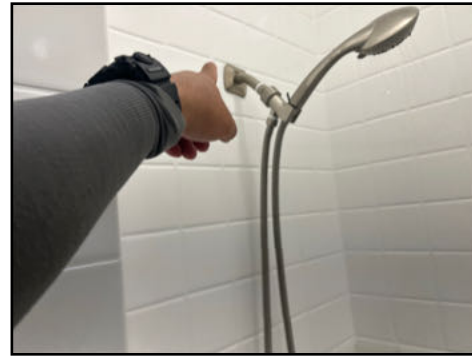
Caulk **maintenance** needed at wall to fixture juncture

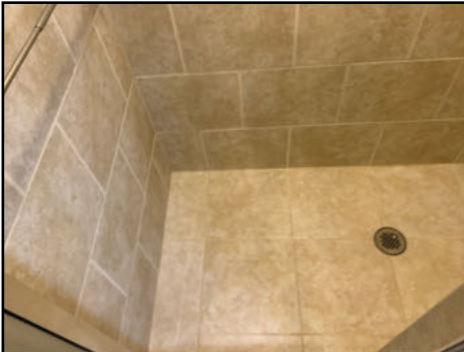
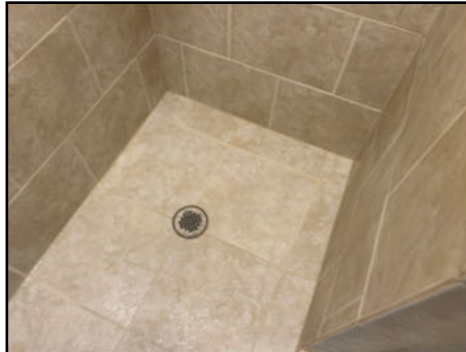
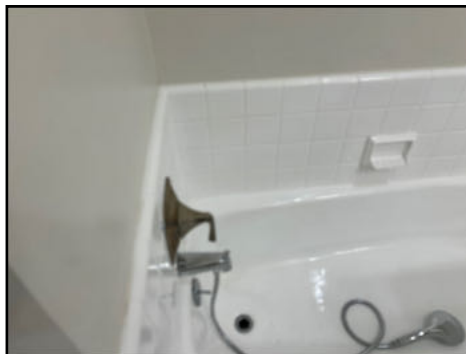
- Shower pans are not long-term water tested for leaking - consult the termite report
- Tile and grout present
- Shower walls have normal wear for age at the time of the inspection - no major visible defects - recommend routine grout and sealer **maintenance**
- Shower pan has normal wear for age at the time of the inspection - no major visible defects - recommend routine grout and sealer **maintenance**
- Appears tile has been painted/refinished - special care may be needed
- Recommend grout and sealer maintenance

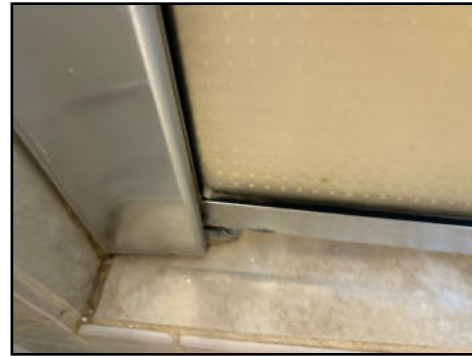
- Operational at time of inspection - Tempered glass label observed
- Enclosure door(s) in a worn/older condition with loose/worn hardware - typical for the age
- Corrosion present in areas - signs of wear and moisture accumulation

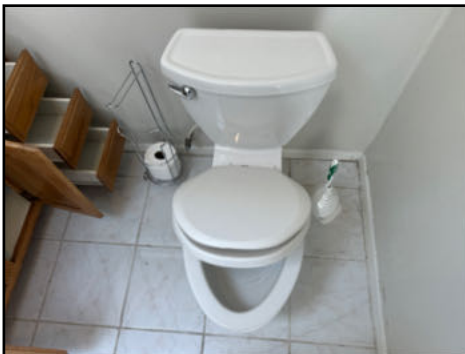
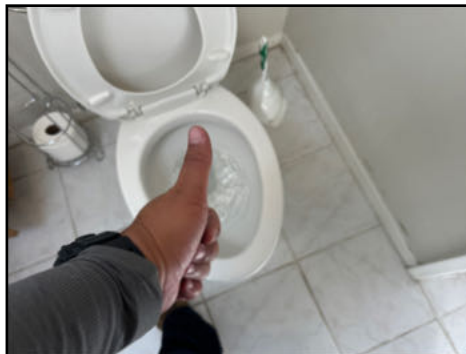
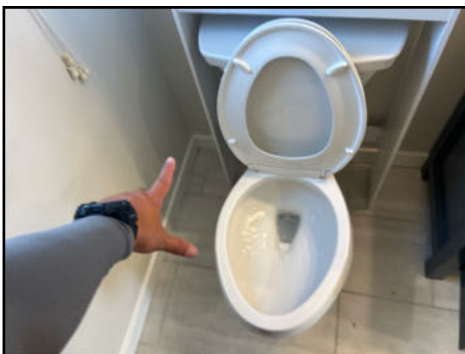
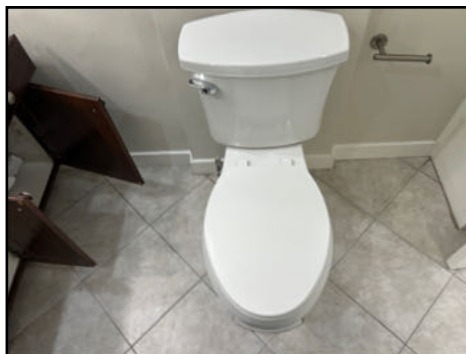
- Tested and operational at time of inspection via normal fixture controls, flush test performed
- Toilet is in a worn and older condition at the time of the inspection - typical for age
- No visible leaking at the time of inspection and flush testing
- Toilet slightly loose- recommend tightening to prevent water damage

**Toilet slightly loose- recommend tightening to prevent water damage**

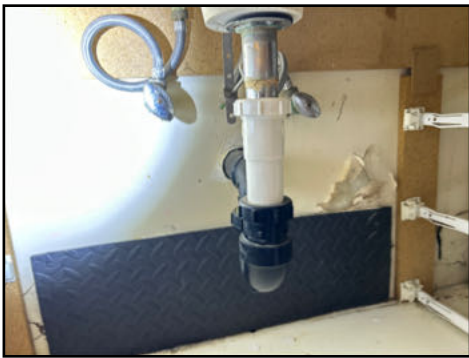
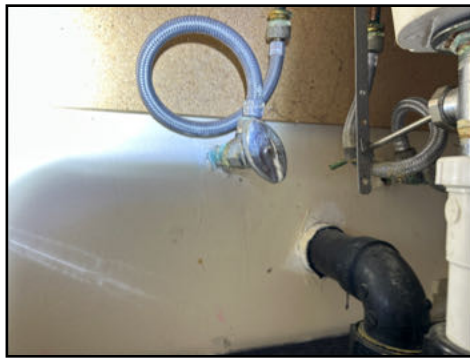
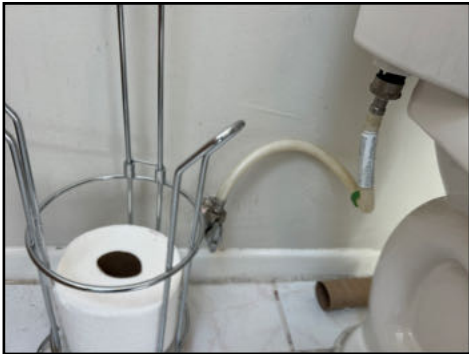
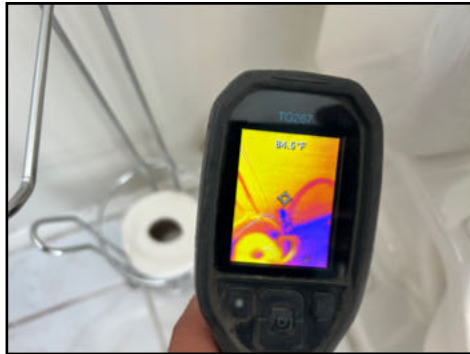
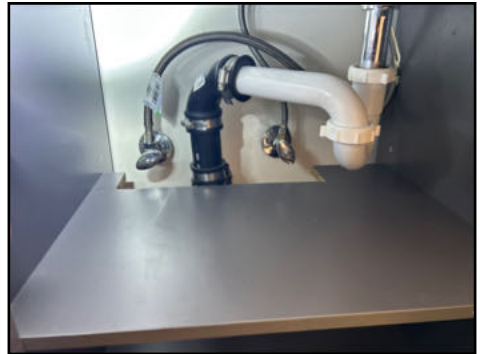
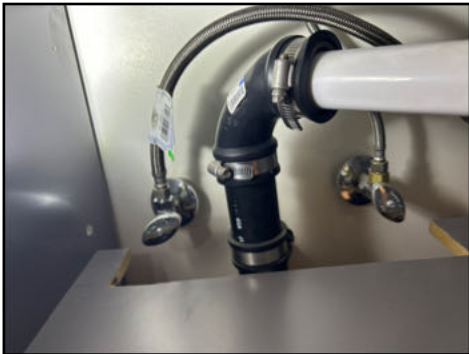
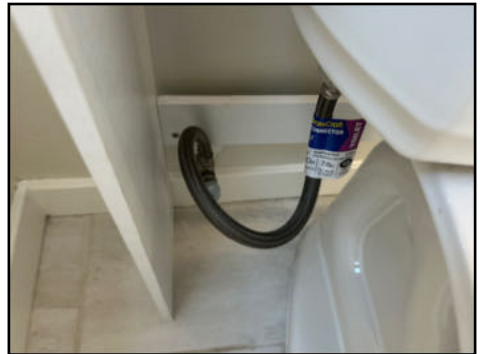
- Angle stops/hoses/drain pipes are worn/older - recommend upgrading these areas with new fixtures
- No visible leaks found at the time of the inspection after running water at fixtures
- Rubber drain connections present - these are not for long term use - recommend upgrading connections
- Corrosion is present at plumbing areas - this is a sign of slow leaking and should be further evaluated by a plumber
- **Galvanized** water piping present - recommend complete water distribution system evaluation due to age

Rubber drain connections present - these are not for long term use - recommend upgrading connections

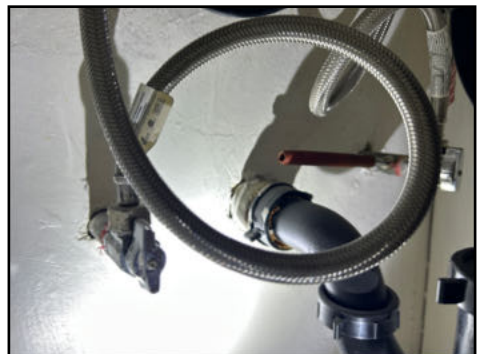
**Galvanized** water piping present - recommend complete water distribution system evaluation due to age

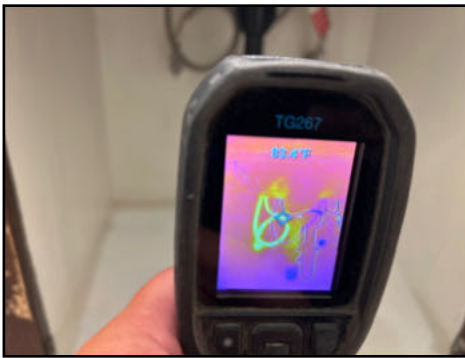
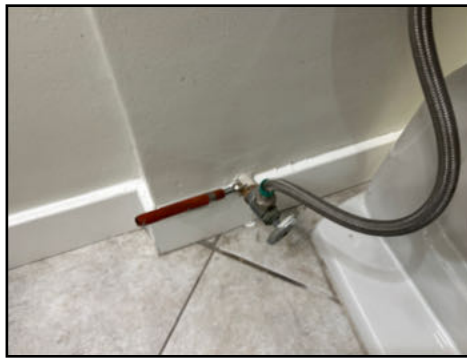
**Galvanized** water piping present - recommend complete water distribution system evaluation due to age

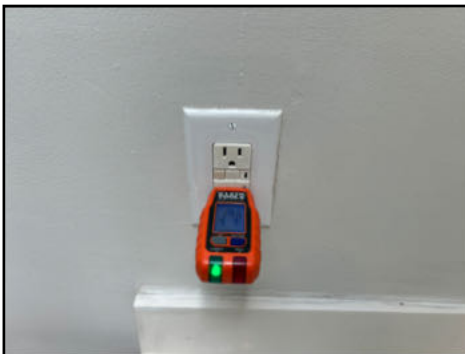
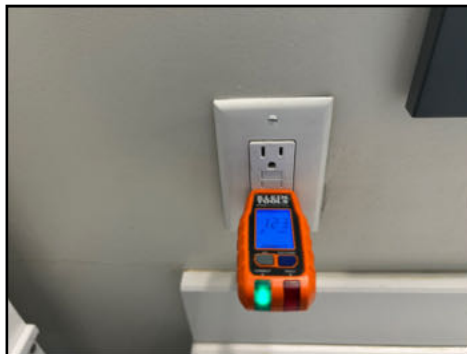
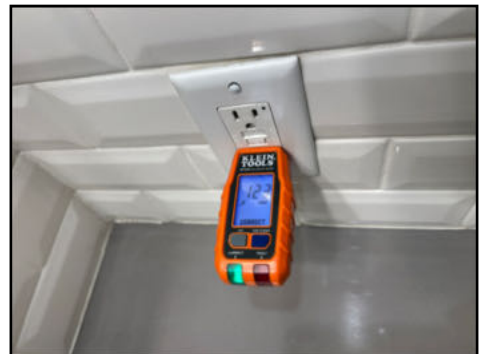
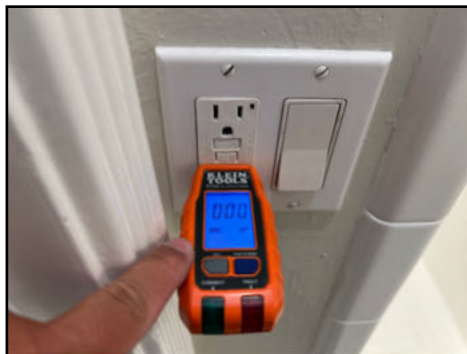
- A representative number of receptacles and switches were tested and found to be operational at time of inspection
- Loose/worn outlets/switches - typical for age consider upgrading
- Check for permits for any alterations
- Some outlets not accessible - not inspected
- Some switches not accessible - not inspected
- Only the visible and accessible switches/outlets are testing during this inspection, personal items/furnishings are not moved to access any outlets/switches behind them.
- **Non-energized (dead) outlet(s) - needs to be serviced**

**Non-energized (dead) outlet(s) - needs to be serviced**

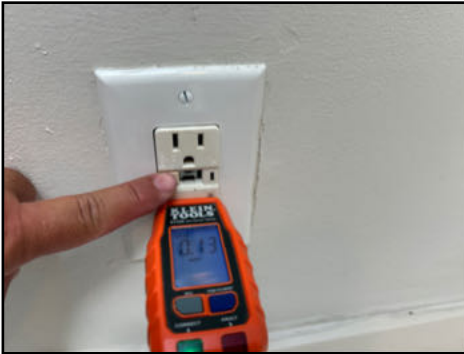
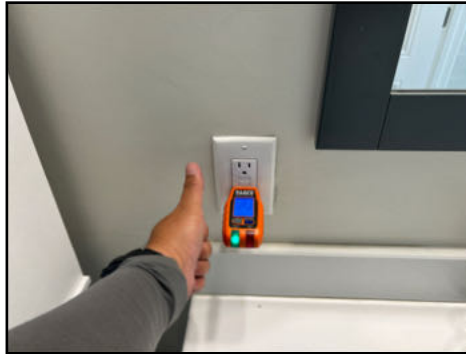
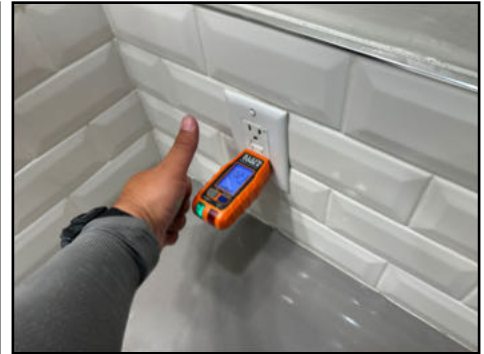
- Recommend licensed electrician for further evaluation
- **Damaged - needs to be serviced**

**Damaged - needs to be serviced**

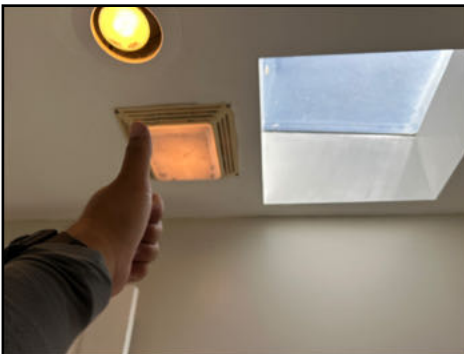
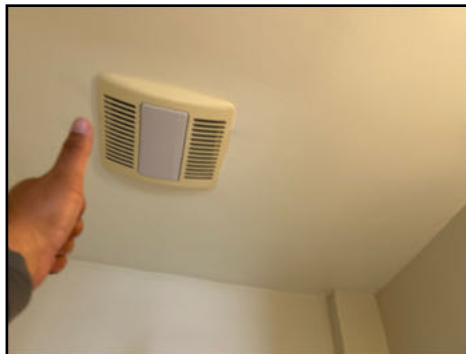
- Operated at time of inspection
- Worn/older fan - typical wear for age
- Recommend upgrading the existing fan(s) for optimum moisture ventilation

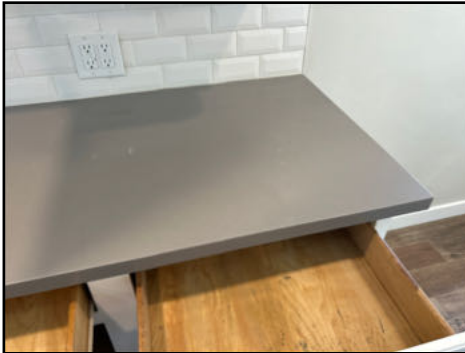
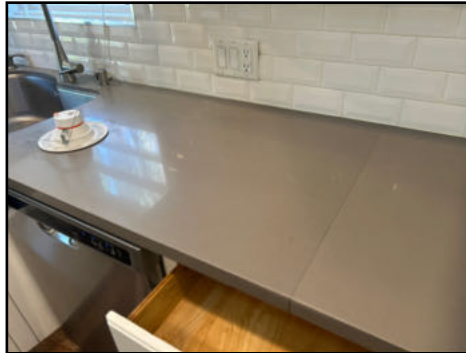
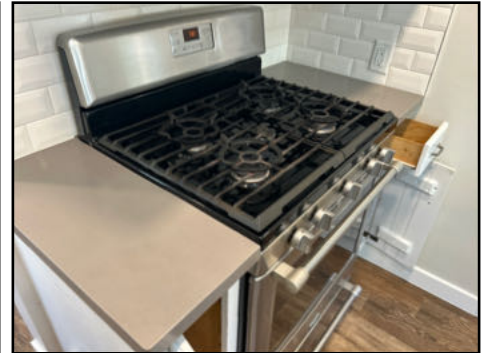
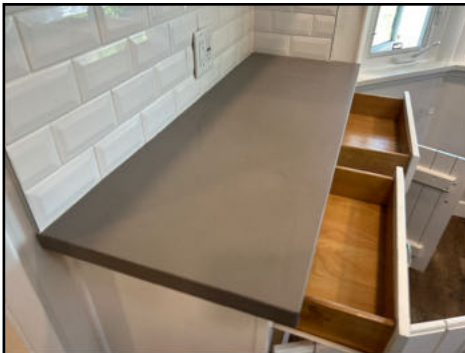
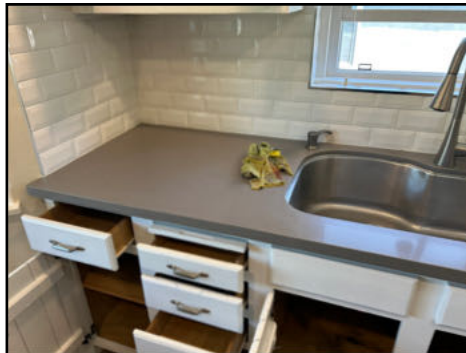
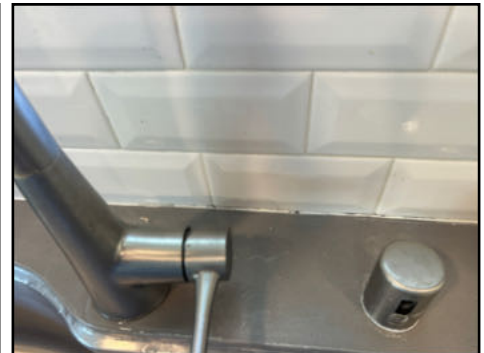
- Counter is worn and has typical wear for age
- Recommend grout/sealer/stone **maintenance**

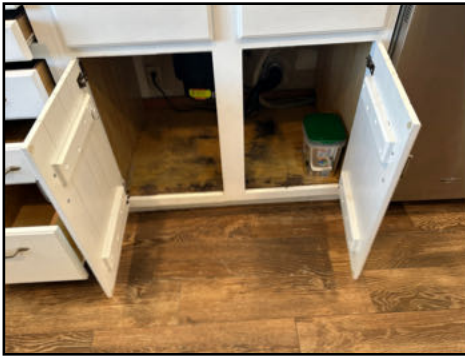
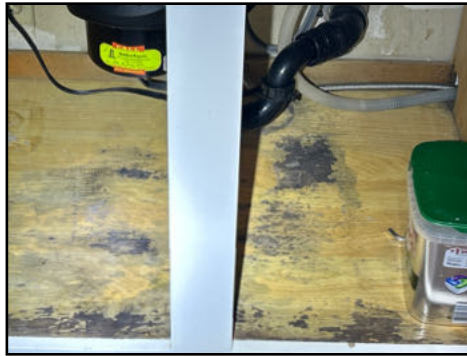
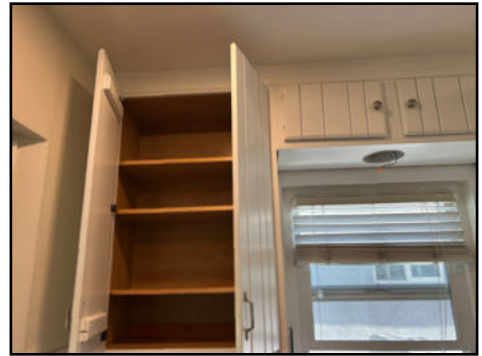
- Worn cabinets with loose/worn hardware - typical for age
- Cabinet base inside damaged - needs to be serviced
- Evidence of past moisture in the cabinet under the sink - needs to be serviced/further evaluated - hidden defects may exist
- Moisture damage - needs to be serviced - hidden defects may exist

**Moisture damage - needs to be serviced - hidden defects may exist**

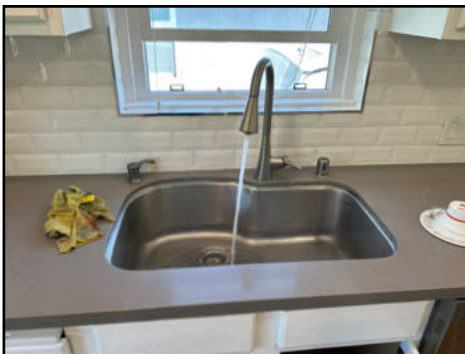
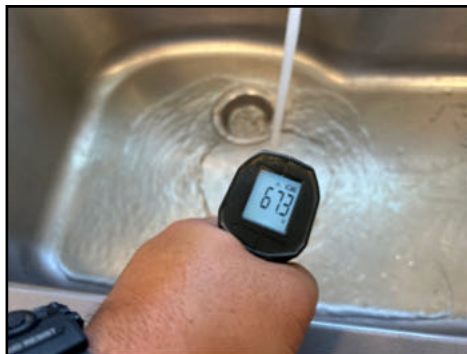
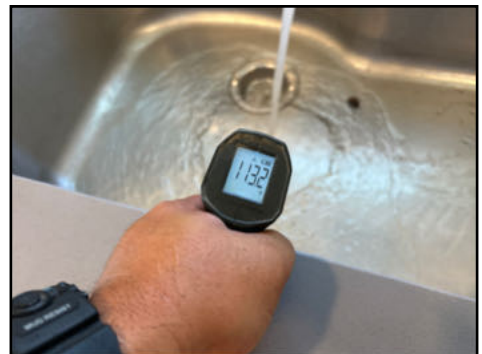
- Fixture operated at the time of the inspection
- Worn fixture/sink - typical for the age
- **Fixture leaks when operating - needs to be serviced**

**Fixture leaks when operating - needs to be serviced**

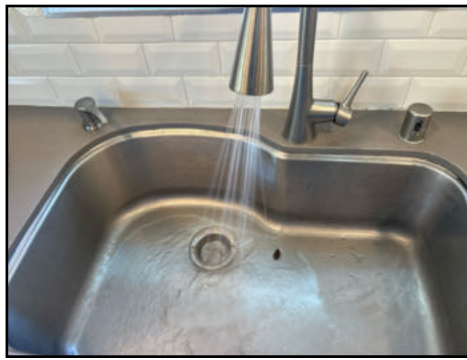
- Operational at time of inspection

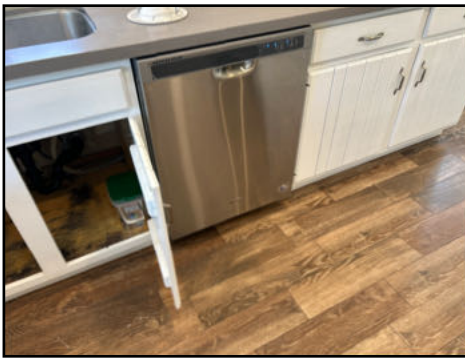
- The dishwasher inspection is limited and does not include an inspection of the water pump or any hoses inside or beneath the unit. The home inspector cannot predict the remaining life of the dishwasher or any parts within the dishwasher; nor can the home inspector tell you if or how well the dishwasher actually cleans or dries dishes. This inspection allows for one fill and one drain cycle only, the Inspector does not run the dishwasher for any full cycles.
- Tested and operational (one fill and drain cycle only, not full cycle) at time of inspection via normal controls
- Worn/older unit - typical wear for age and use

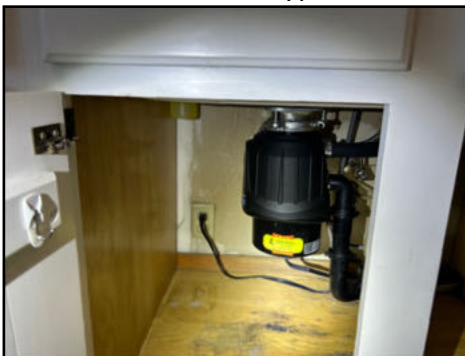
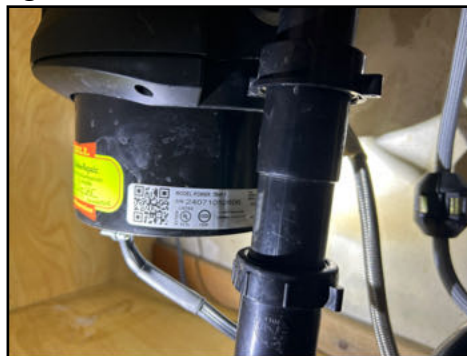
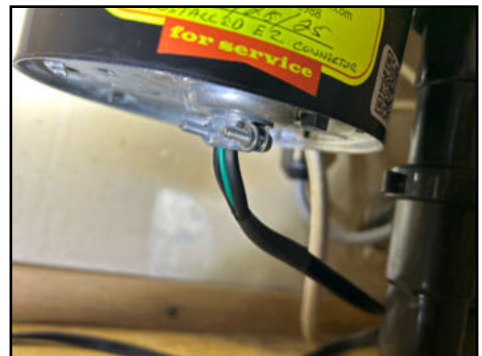
- The garbage disposal has a limited inspection, the Inspector cannot predict the remaining life of the garbage disposal nor determine how well the garbage disposal disposes of food or other items. The sharpness or adequacies of the internal blades is not determined during the home inspection.
- Tested and operational at time of inspection via normal controls
- Worn/older unit - typical wear for age and use

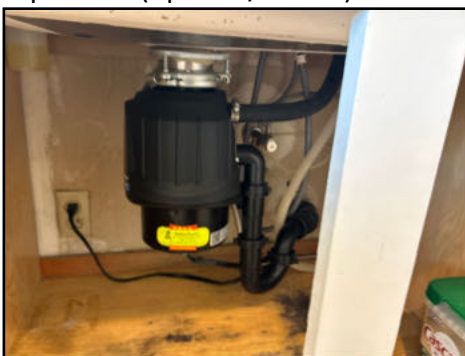
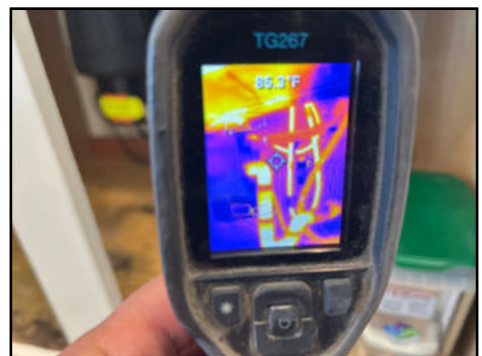
- Angle stops/hoses/drain pipes are worn/older - recommend upgrading these areas with new fixtures
- No visible leaks found at the time of the inspection after running water at fixtures
- **Check permits** for any alterations
- Patched areas on wall below sink indicate past repairs have been made - consult the seller/disclosures for all past repairs in this area
- The plumbing supply valves are visually inspected only and are not tested for functionality due to the potential for leakage - valves that are not used often will seize or freeze and are likely to leak when operated (opened/closed).

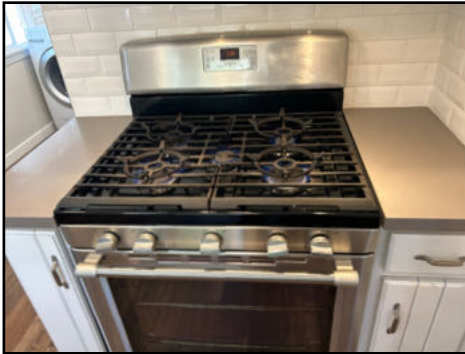
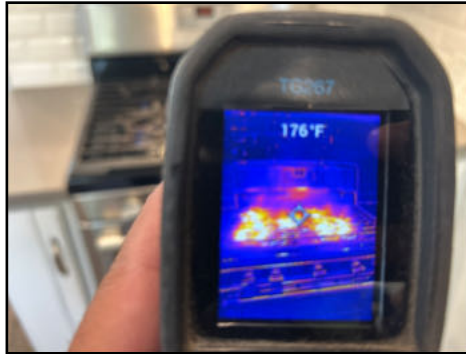
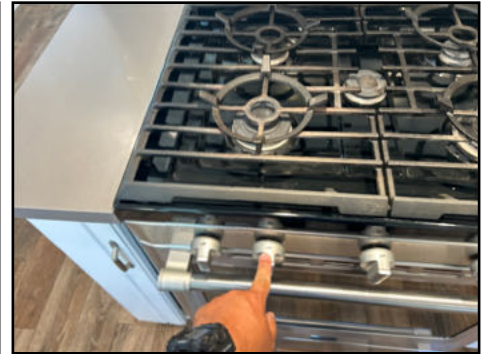
- Gas supplied unit
- Tested and operational at time of inspection via normal controls
- Electric ignitor does not appear to function - needs to be serviced
- Worn/older unit - typical wear for age and use
- Recommend appliance technician or other appropriate contractor to further evaluate
- **Left front element/burner not operating - needs to be serviced**

**Left front element/burner not operating - needs to be serviced**

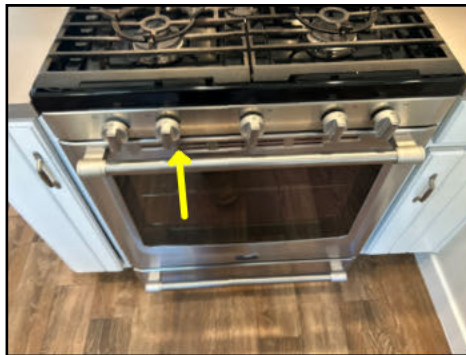
**Electric ignitor does not appear to function - needs to be serviced**

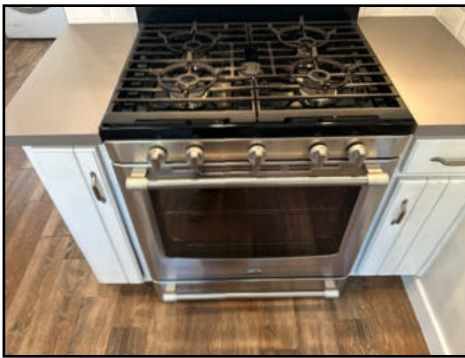
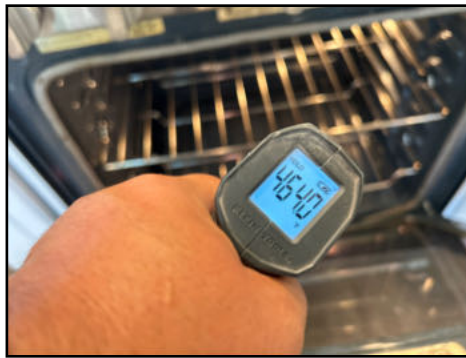
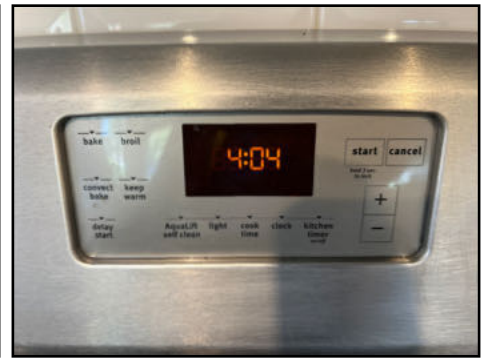
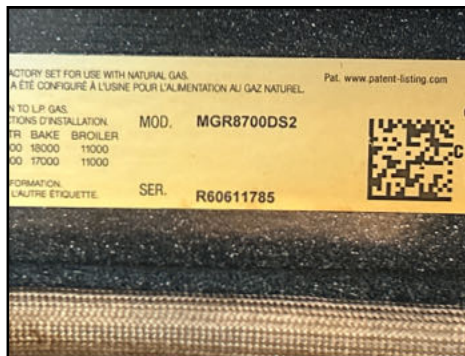
- Gas supplied unit
- Tested and operational at time of inspection via normal controls
- Worn/older unit - typical wear for age and use
- Anti-tip device is not visible/not tested - we recommend that an anti-tip device be installed to prevent a possible tip hazard

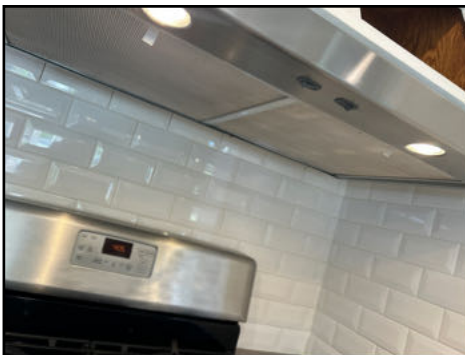
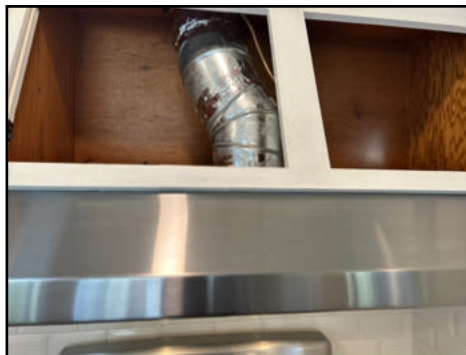
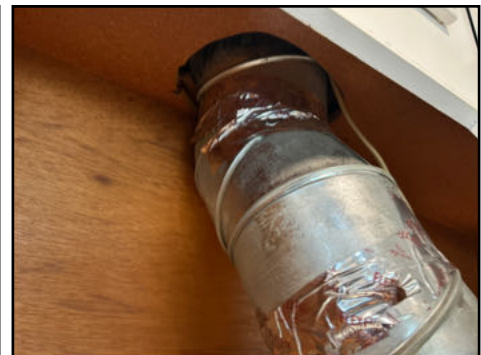
- The exhaust fan/vent is tested using the normal controls only. No smoke testing or other testing is done to determine the CFMs or how well the unit evacuates air. The home inspector cannot predict the remaining life left in the unit.
- Tested and operational at time of inspection via normal controls
- Worn/older unit - typical wear for age and use
- Recommend charcoal filters for optimum air filtration
