**ELITE GROUP**  
INSPECTION PROFESSIONALS

PROPERTY LOCATION: 1123 N Florence St Burbank, CA 91505

# INSPECTION REPORT

Year Built: 1939 Sq Ft: 1463

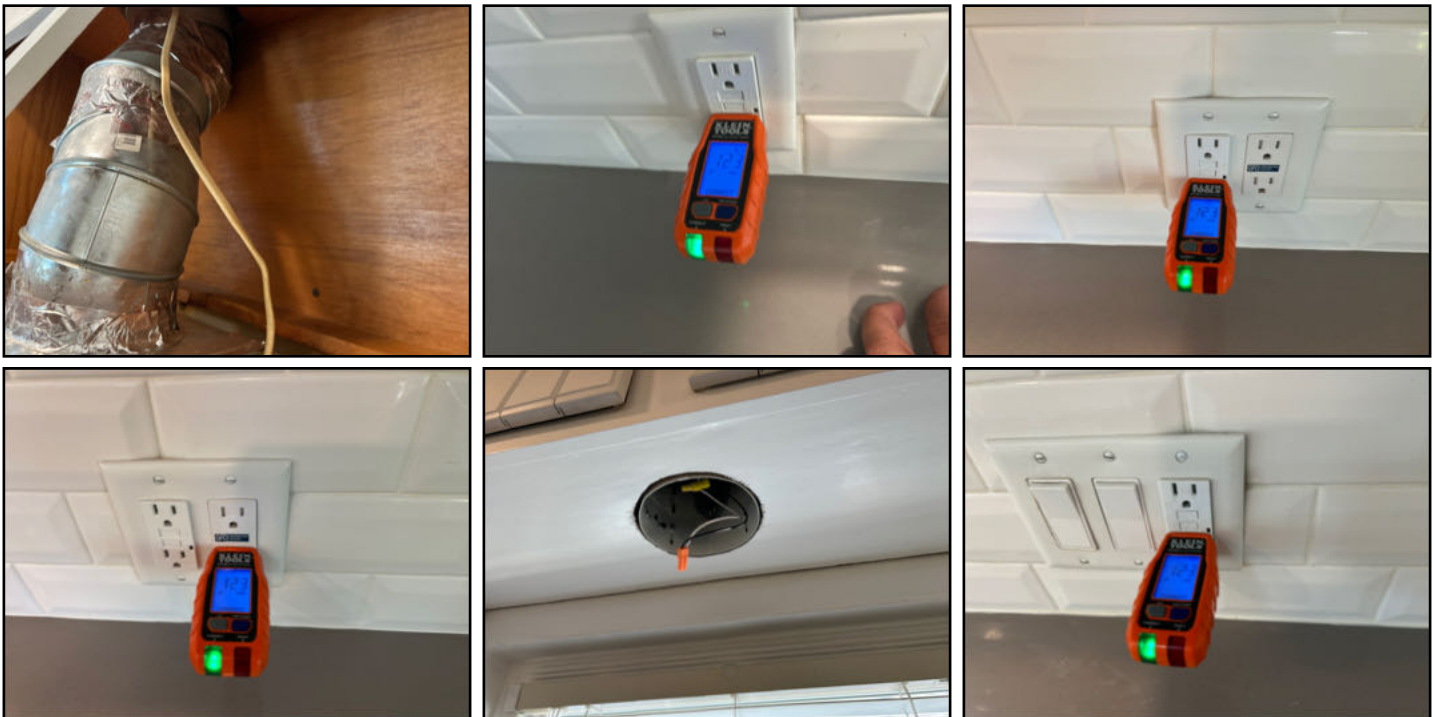
Exposed connections - potential hazard - needs to be serviced

| INTERIOR | | |
|---|---|---|
| Page 40 Item: 12 | Electrical | • Exposed connections - potential hazard - needs to be serviced |

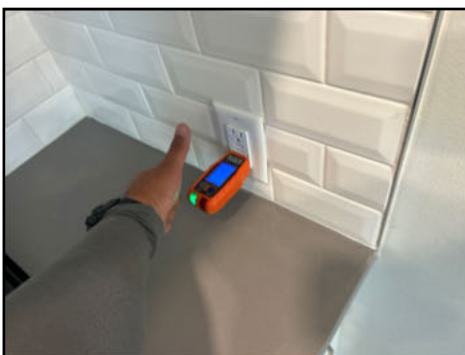
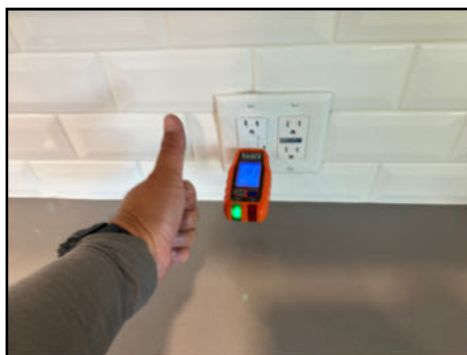
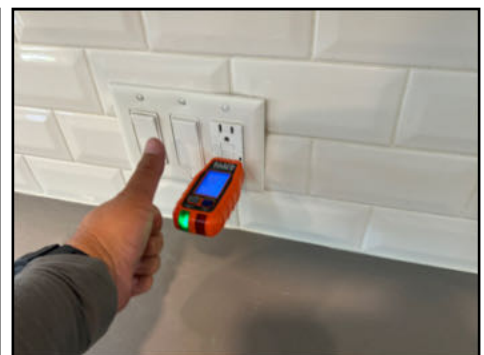
- Recommend upgrading all receptacle to **GFCI** protection within 6 feet of all potential wet locations, unless the receptacle is on a circuit dedicated for a specific appliance.
- Tested and operational at time of inspection via normal control
- Recommend licensed electrician to further evaluate

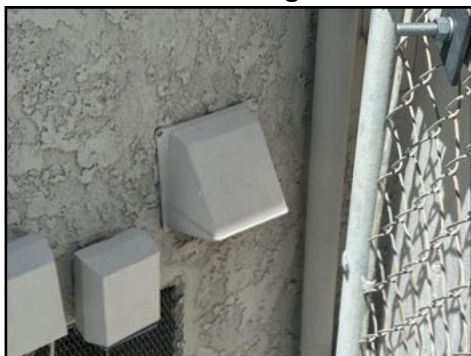
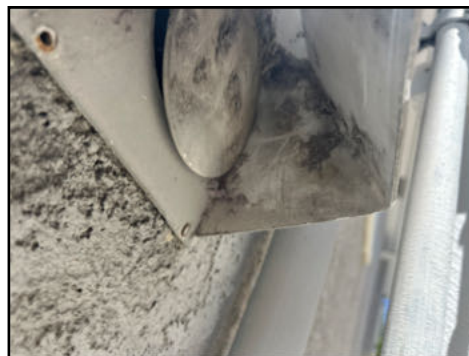
- Dryer vent should be cleaned periodically to prevent lint fire hazards
- Could not fully inspect the dryer vent in the laundry area, it is obscured by cabinetry/washer/dryer
- Worn exterior cover - typical for age
- Loose exterior cover - needs to be secured and sealed
- Recommend sealing exterior cover at wall with exterior caulking

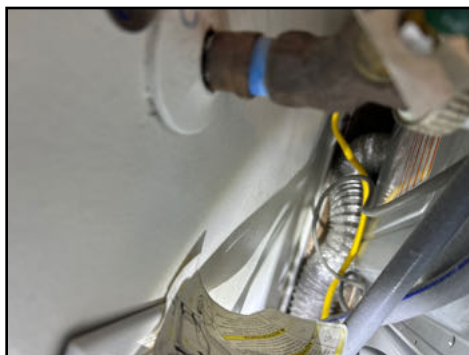
**Loose exterior cover - needs to be secured and sealed**

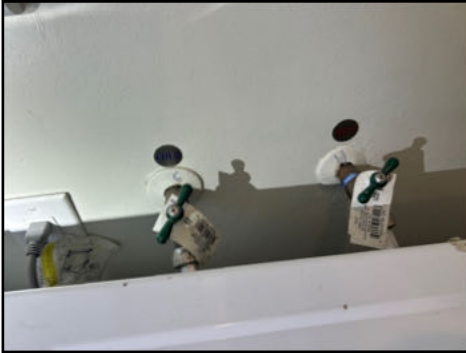
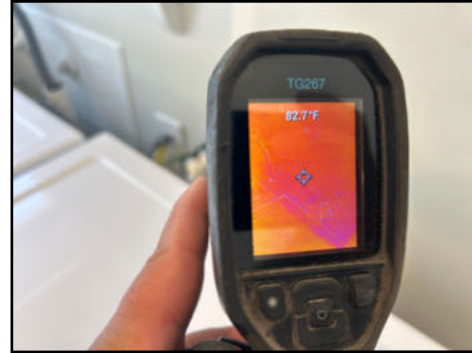
- Washer/dryer unit(s) present during inspection and obstruct the view of the wall/plumbing areas
- No visible leaks at time of inspection
- Shutoffs corroded - needs to be serviced - this will be an ongoing **maintenance** issue for ALL plumbing valves
- Drain trap is not visible at the time of the inspection - **n/a** - note: laundry drains are not water or pressure tested during this inspection
- Recommend upgrade to braided steel washing machine supply hoses
- The plumbing supply valves are visually inspected only and are not tested for functionality due to the potential for leakage - valves that are not used often will seize or freeze and are likely to leak when

operated (opened/closed). The laundry drain cannot be tested at this inspection. The washer and dryer (if present) are not tested or inspected.

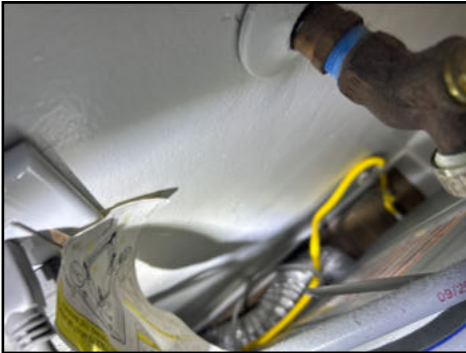
- The inspector does not check for gas leaks, consult the Gas Company to evaluate all gas areas prior to occupancy
- Normal wear at valve - no major visible defects at the time of the inspection
- Washer/dryer unit(s) present during inspection and obstruct the view of the wall/plumbing areas

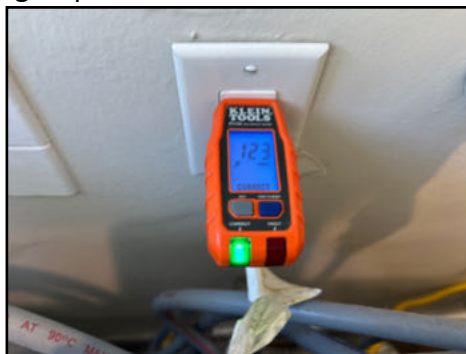
- Representative number of receptacles and switches tested and operational at time of inspection
- Loose/worn outlets/switches - typical for age consider upgrading
- Washer/dryer unit(s) present during inspection and obstruct the view of the wall/electrical areas

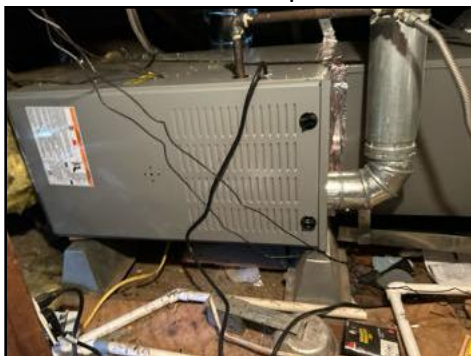
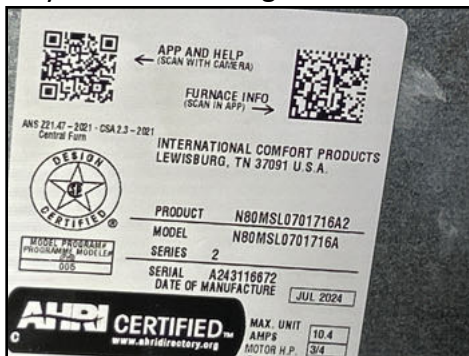
- Operated at time of inspection
- Visible areas of unit are worn - recommend seasonal service and **maintenance** to extend the life of the unit
- Newer unit/not original to the structure - check all installation permits to ensure that this unit was installed to proper code
- Check for permits for any alterations
- *Recommend regular service/**maintenance** to extend the life of the unit(s)*
- *Inspector does not examine heat exchanger or determine the presence of a cracked heat exchanger - this is not a complete evaluation of the internal areas of the heater - consult an HVAC contractor for further evaluation if you have concerns about the heat exchanger.*
- Recommend a complete evaluation by licensed heating contractor due to the age/condition of the unit

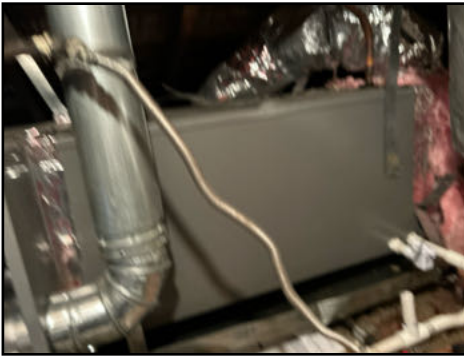
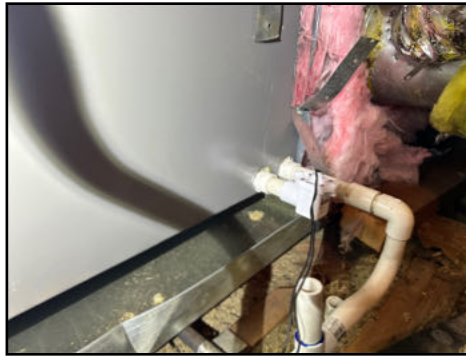
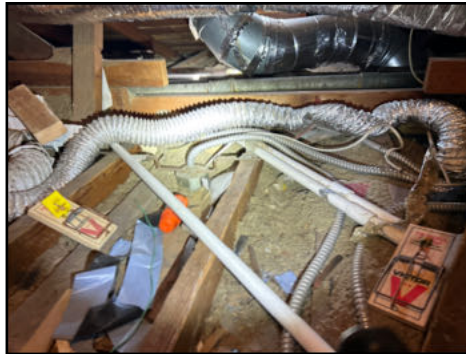
## 2. A/C Evaporator Coil Box

- The visible areas of the coil box are worn/dirty/deteriorated and typical for the age of the older unit
- Condensation lines cannot be traced to all locations by the inspector, often times there are several areas of the condensate lines that are not visible to the inspector - **consult a HVAC contractor** to further evaluate as needed
- *This inspection does not determine if the evaporator coil BTU size is the same as condensing unit size - **consult a HVAC contractor** for further evaluation as needed*
- **Limited access to all sides prevents a complete inspection of the coil box**
- **Check permits** for any alterations
- Recommend licensed HVAC contractor to evaluate

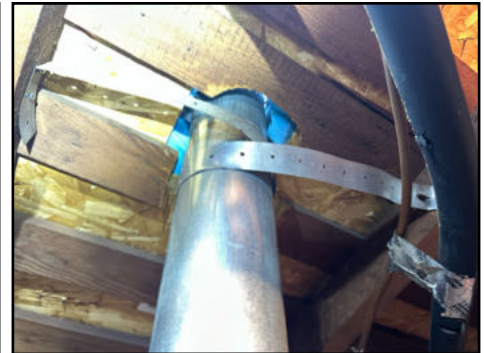
### 3. Venting

- The visible areas of the vent are worn/older - typical for the age of the material, recommend upgrading
- Small/minor dented areas on vent piping
- Recommend securing and sealing all vent connections
- *Some areas not visible due to limited access and cannot be viewed for inspection*
- Recommend licensed HVAC contractor to evaluate

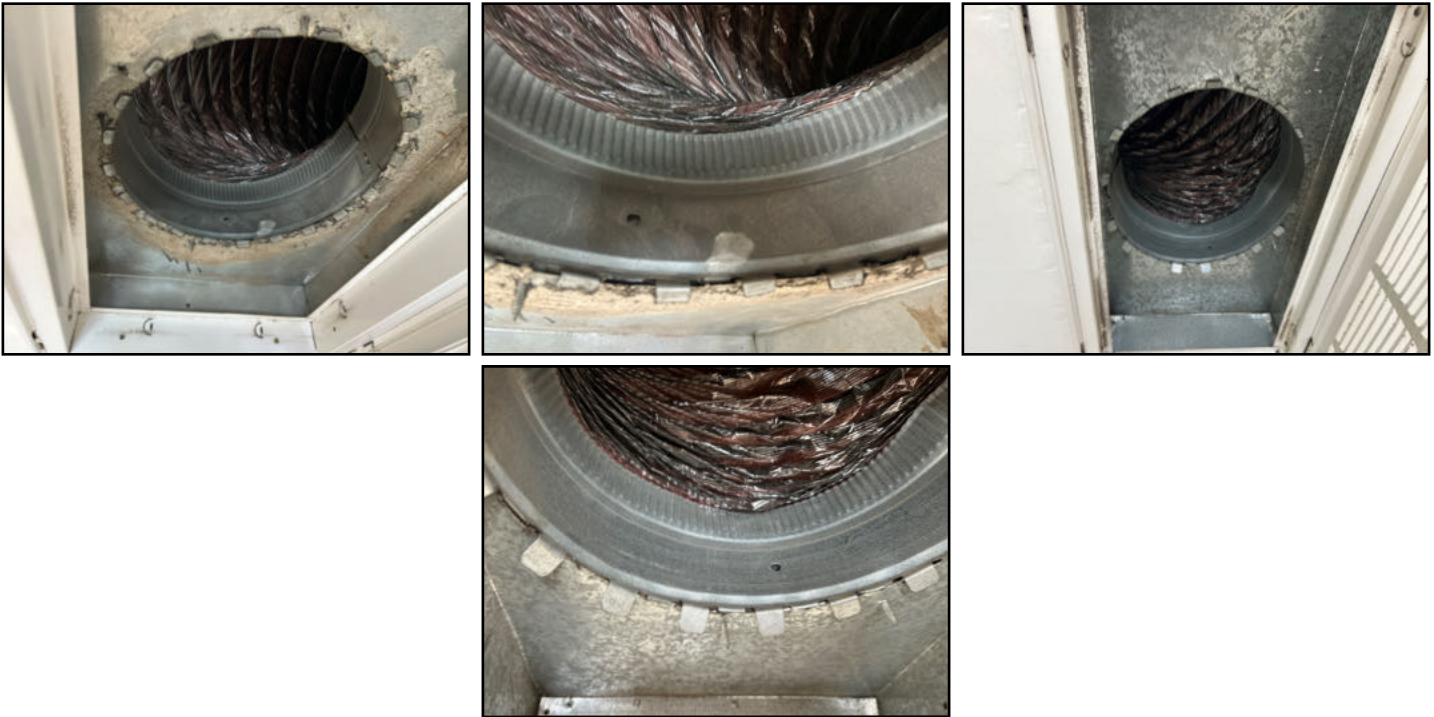
### 4. Air Supply

- *Recommend seasonal service and **maintenance** to ensure that all areas are sealed/cleaned/dry and functioning normally at all times*
- Small air leaks are present - typical for age - recommend service/**maintenance** for optimum efficiency
- Some areas not visible due access limitations or insulation outer wrapping

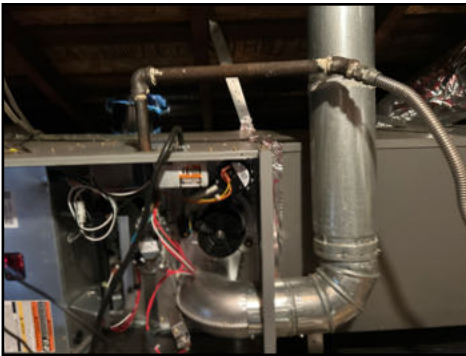
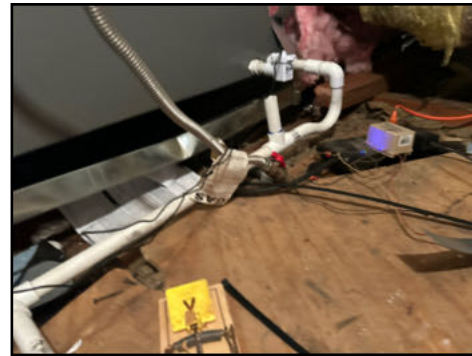
## 5. Gas Supply Valves and Pipes

- Normal wear at time of inspection - no major visible defects
- Older type of flex line is present - we recommend that you upgrade to a new teflon coated flex line
- No sediment trap at gas supply - may have not been required at time of original installation, but is recommended
- **Check permits** for any alterations
- Recommend licensed heating contractor or Gas Co. to evaluate

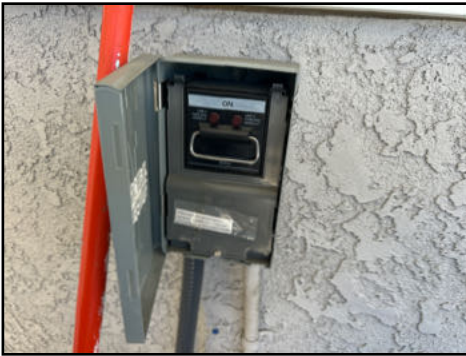
## 6. Electrical

- Operating properly at the time of the inspection - no major visible defects
- Check for permits for any alterations
- Recommend licensed electrician to further evaluate

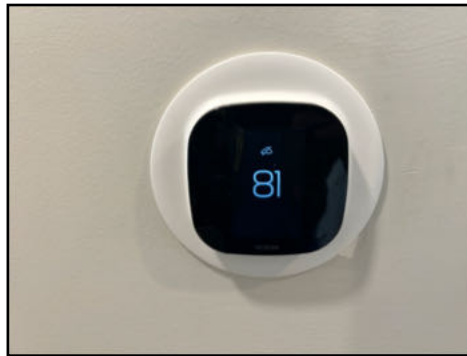
## 7. Thermostats

- Digital type present - functional day of the inspection
- Recommend licensed HVAC contractor to evaluate
- **Not operating properly - needs to be serviced**
- **Unit(s) are not responding to thermostat commands - recommend further evaluation by a licensed HVAC contractor**

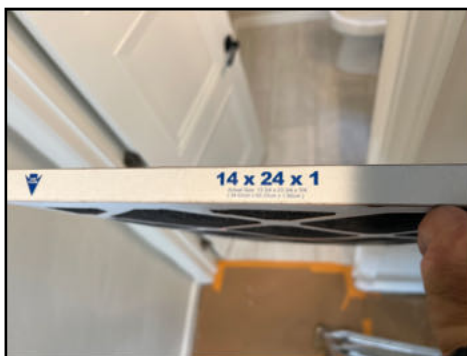
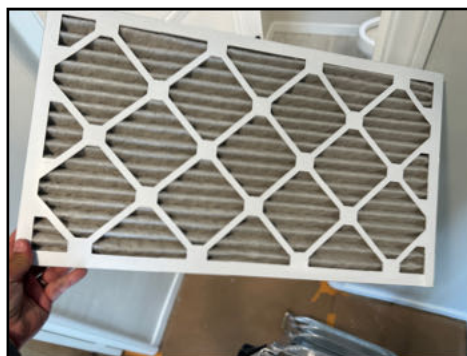
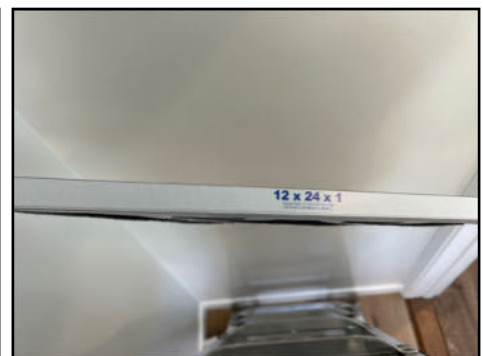
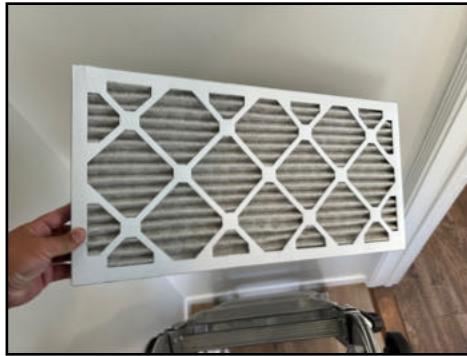
## 8. Filters

- A seasonal HVAC service contract is recommended to ensure that all filters are changed/cleaned regularly or as needed
- We recommend that the filters be changed or cleaned every 3 to 6 months depending on the usage of the heating and air conditioning systems
- Filter is worn/dirty and will likely need changing soon
- Recommend licensed HVAC contractor to evaluate

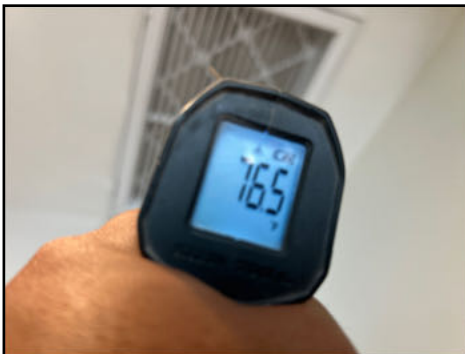
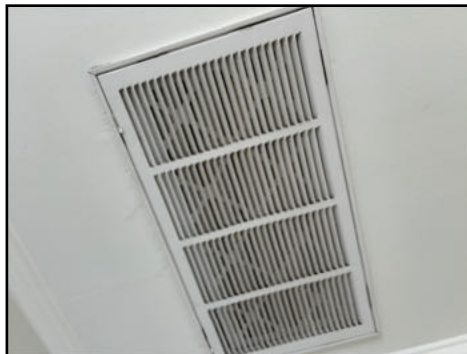
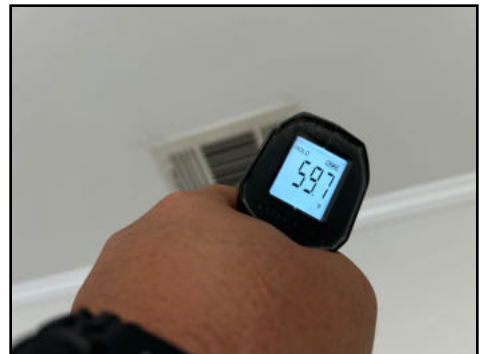
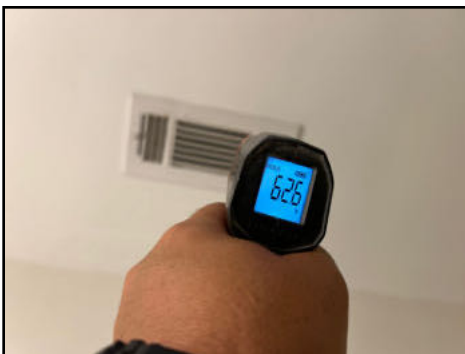
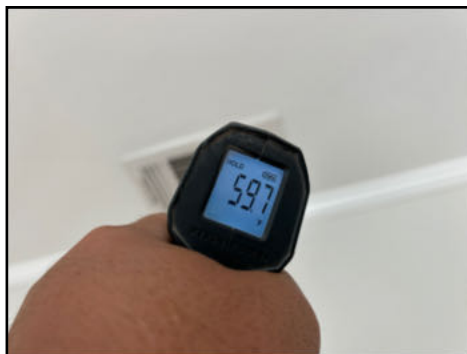
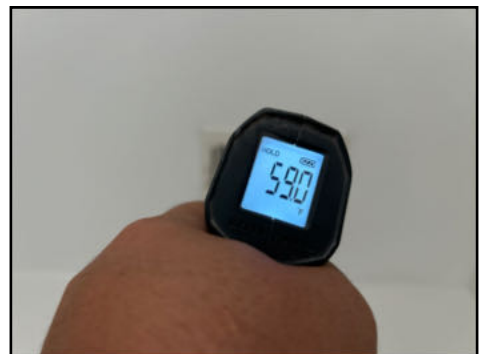
## 9. Registers

- Representative number tested and functional day of the inspection
- Visible register covers are worn and older - consider upgrading to newer style registers
- Dirty/dusty registers - possible sign that ducts need cleaning - needs to be serviced
- Check for permits on all alterations
- Note: The inspector cannot determine if asbestos exists in any part of the HVAC system - consult an asbestos testing company if you have concerns about asbestos
- Adjustable louvers in registers are not tested for functionality - those closed for long periods of time may not operate properly
- Not all registers are tested for air flow due to location, access, etc.
- Recommend licensed HVAC contractor to evaluate

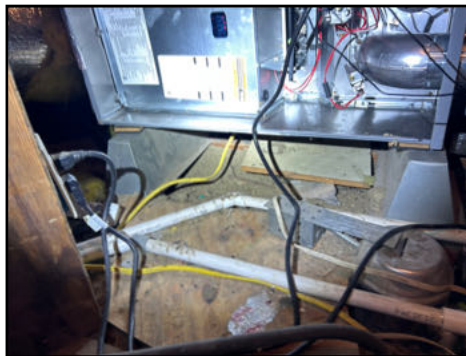
- Recommend seasonal servicing and **maintenance** to ensure sealing holes and gaps in the heater base
- Visible areas are worn/dirty - recommend cleaning the base areas and sealing the base of the unit as part of the preventative **maintenance**
- Horizontal heater in the attic, we recommend adding a heat shield below this unit to prevent any heat damage to the materials below the unit.
- **Check permits** for any alterations
- Not fully visible due to personal storage and/or access limitations
- Recommend licensed HVAC contractor to evaluate

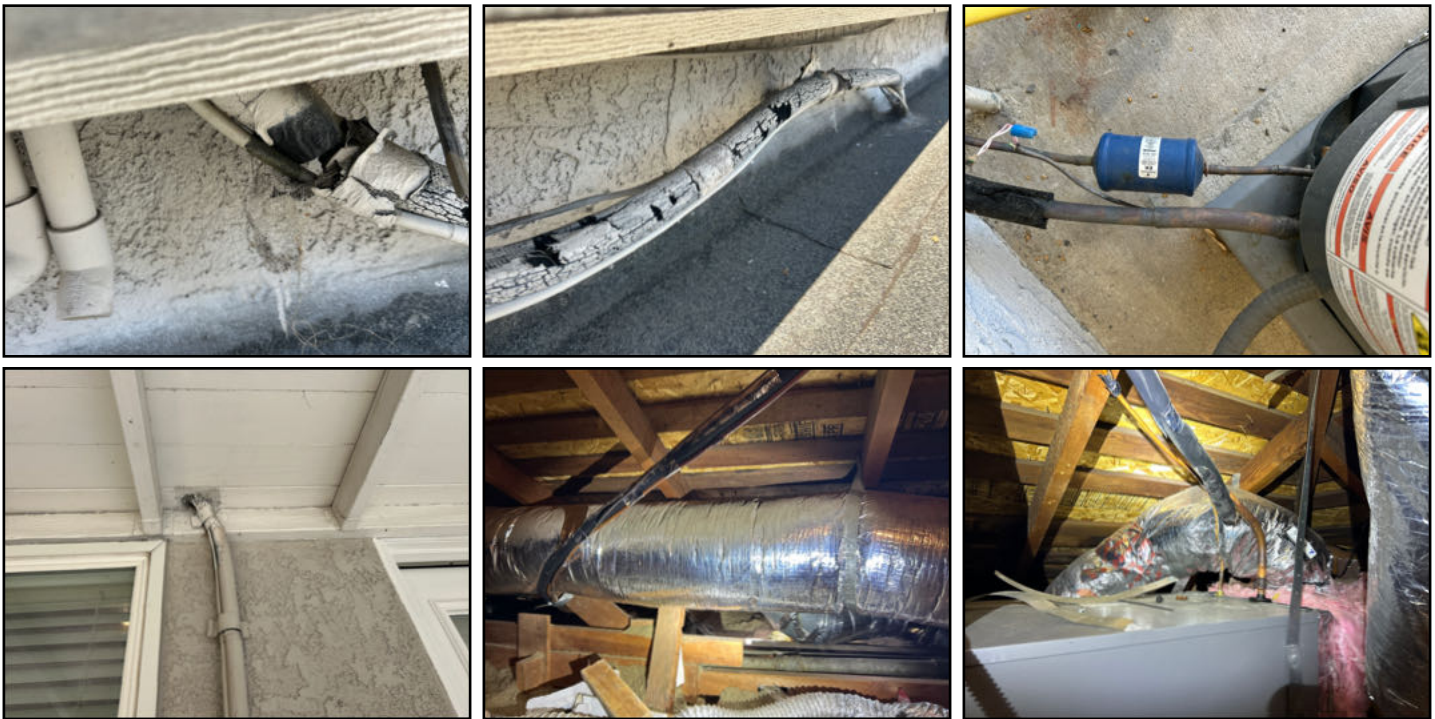
Insulation gaps observed in areas - needs to be serviced

| INTERIOR | | |
|---|---|---|
| Page 51 Item: 13 | Refrigerant Lines | • Insulation gaps observed in areas - needs to be serviced |

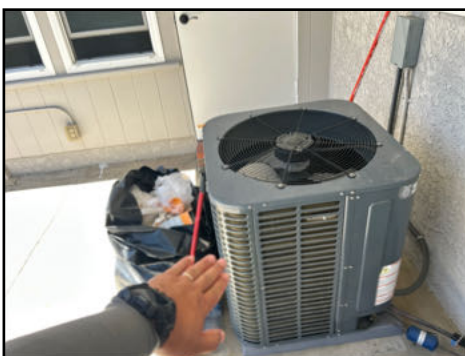
**14. Air Conditioning Compressors**

- Operated at the time of inspection
- Visible areas of unit are worn and weathered – recommend seasonal service and **maintenance** to extend the life of the unit
- Unit is a newer unit/not original to the structure - check all installation permits to ensure that this unit was installed to code
- Unit is not level, this can affect system performance - needs to be serviced
- **Check permits** for any alterations
- Recommend regular service/**maintenance** to extend the life of the unit(s)
- This inspection does not determine if the evaporator coil BTU size is the same as condensing unit size - **consult a HVAC contractor** for further evaluation as needed
- Recommend licensed HVAC contractor to evaluate
- **Unit is not secured - we recommend strapping the unit to a base**

Unit is not level, this can affect system performance - needs to be serviced

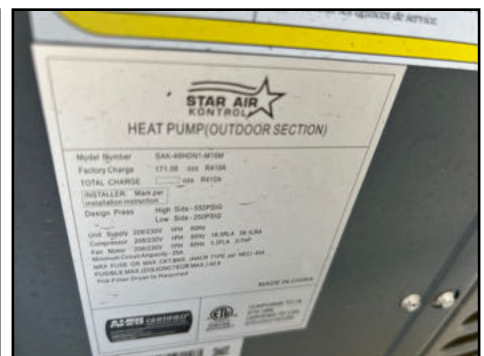
Unit is not secured - we recommend strapping the unit to a base

| INTERIOR | | |
|---|---|---|
| Page 52 Item: 14 | Air Conditioning Compressors | • Unit is not secured - we recommend strapping the unit to a base |

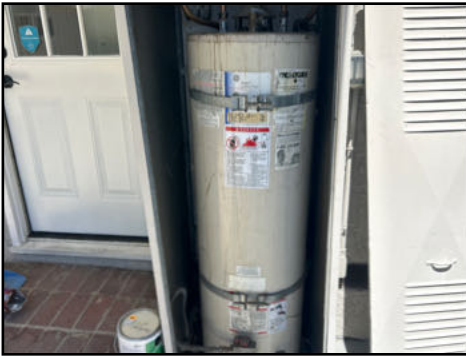
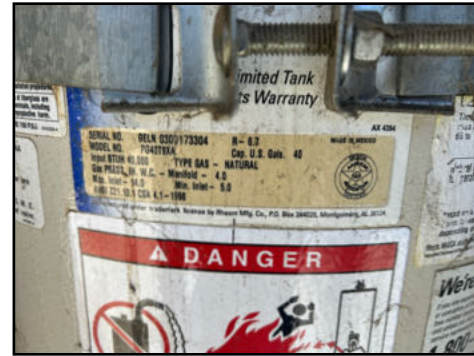
## 1. Water Heaters Condition

- The unit is worn/older - consult a plumber for general **maintenance** recommendations to extend the life of the unit
- Rust noted in areas at water heater, monitor for further deterioration or leaks

- Rusting at base - needs to be serviced
- Check for permits for any alterations/upgrades
- **The water heater is visually inspected only, the combustion/pilot doors are not removed for flame or burner condition inspection due to the potential for draft to burn out the pilot flame. The Inspector does not estimate the age and cannot predict the remaining life of the unit.**

**Unit old and appears to be nearing end of useful life - we recommend that you budget for a replacement**

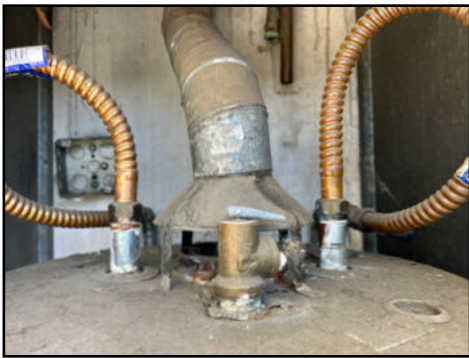
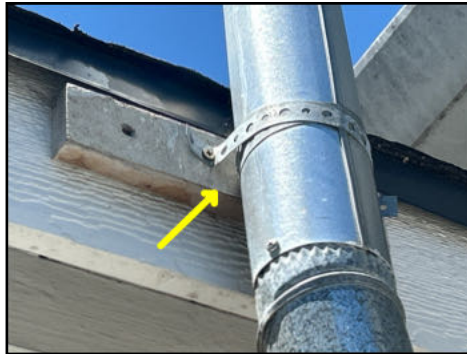
## 2. Venting

- Vent is worn and older - consider upgrading vent
- Recommend sealing all connections at venting
- Missing screws at vent connections - needs to be serviced, three screws are recommended at all vent connections
- Recommend adding heat shields around vent to prevent contact with other materials and reduce heat damage to surrounding materials
- **Check permits** for any alterations
- Recommend further evaluation by a licensed plumber
- **Minimum water heater single-wall vent pipe clearance from combustibile material is 6" - needs to be serviced**

Minimum water heater single-wall vent pipe clearance from combustable material is 6" - needs to be serviced

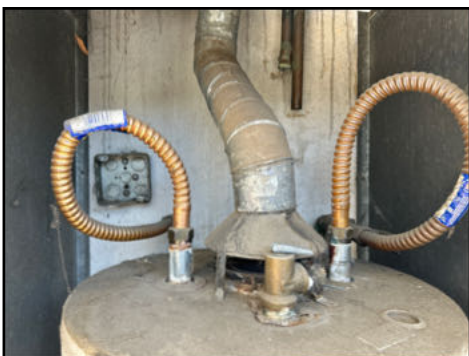
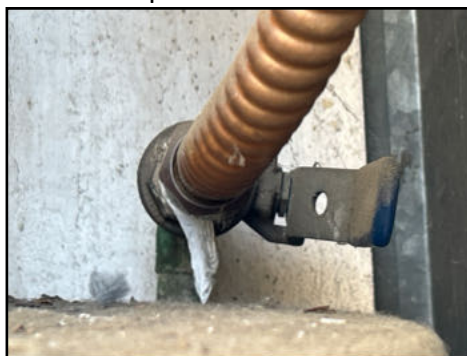
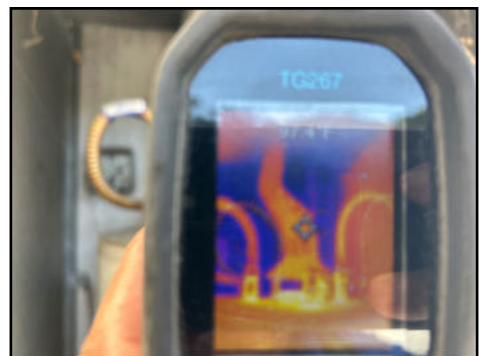
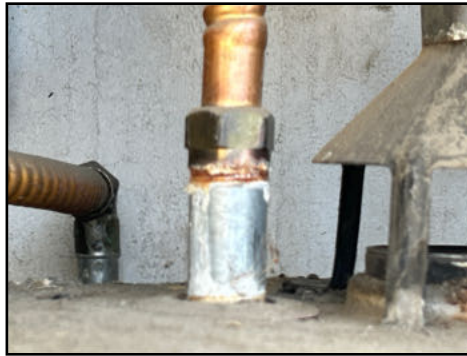
### 3. Plumbing

- Worn valve/piping/connections - typical for age - no visible leaks found at the time of the inspection
- Corrosion present - signs of wear - monitor for moisture
- **Check permits** for any alterations/upgrades
- **Not visible/accessible due to personal items/storage**
- Recommend further evaluation by a licensed plumber

Corrosion present - signs of wear - monitor for moisture

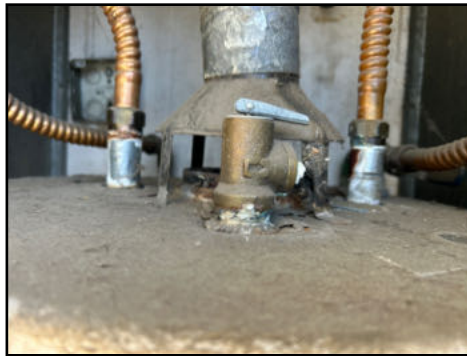
#### 4. Temperature Pressure Release Valves

- Worn/older valve present - consider upgrading
- Visibly corroded - needs to be serviced
- **Check permits** for any alterations
- *The inspector visually inspects the TPRV only - this valve is not opened or tested during the inspection*
- Recommend further evaluation by a licensed plumber

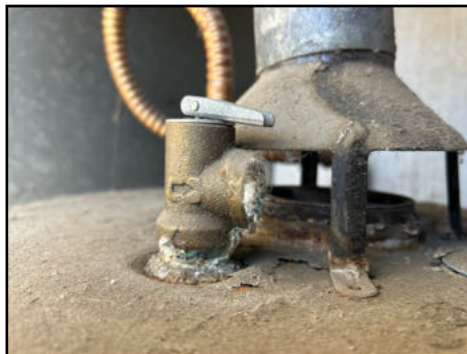
#### 5. Overflow Line/s

- **Check permits** for any alterations
- **Recommend upgrading this line to a copper line for optimum safety and performance**
- Recommend further evaluation by a licensed plumber
- **None - needs to be serviced/installed**

None - needs to be serviced/installed

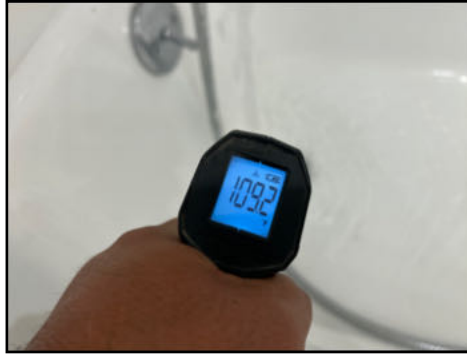
#### 6. Water Heater Temperature

110 F (Average or approximate)

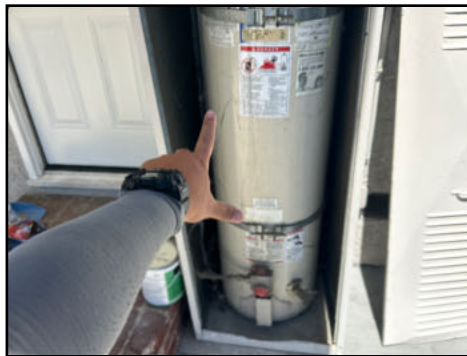
## 7. Strapping

- Standard metal type straps present - normal wear on the day of the inspection - no major visible defects
- Recommend blocking in areas where the water heater is not touching the walls
- Poorly located (should be upper and lower 1/3 of tank) - needs to be serviced
- Check for permits on all alterations
- Recommend further evaluation by a licensed plumber
- **Loose strapping - needs to be serviced**

Loose strapping - needs to be serviced

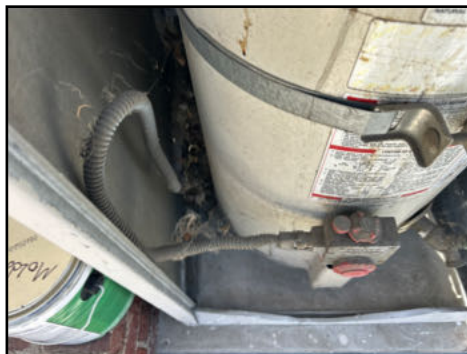
## 8. Gas Supply Valves and Pipes

- Worn valve, consider upgrading to newer style valve
- Older type of flex line is present - we recommend that you upgrade to a new Teflon coated flex line
- No sediment trap at gas supply - may have not been required at time of original installation, but is recommended
- **Check permits** for any alterations
- Recommend licensed plumbing contractor or Gas Co. to evaluate

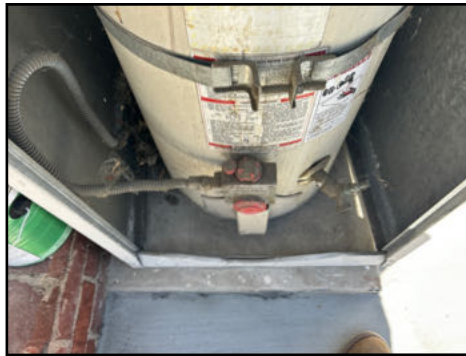
- None/not applicable - unit is sitting on concrete
- Worn/dirty – recommend cleaning
- Recommend catch pan be installed the next time the water heater is changed
- **Check permits** for any alterations
- **Not visible/accessible due to personal items/storage**
- **Some areas not visible due to personal storage and/or access limitations**
- Recommend further evaluation by a licensed plumber

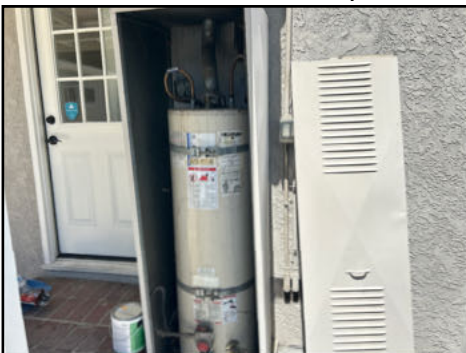
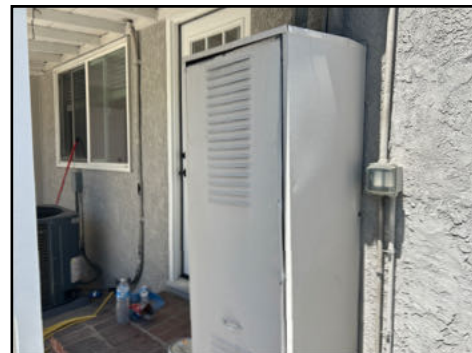
## 11. Enclosures

- Worn/dirty areas - recommend cleaning
- Recommend sealing any holes/gaps if otherwise discovered in this area
- Metal enclosure is worn/bent - typical for age and weather exposure
- **Check permits** for any alterations
- **Some areas not visible due to personal storage and/or access limitations**
- **Not visible/accessible due to personal items/storage**
- Recommend further evaluation by a licensed plumber

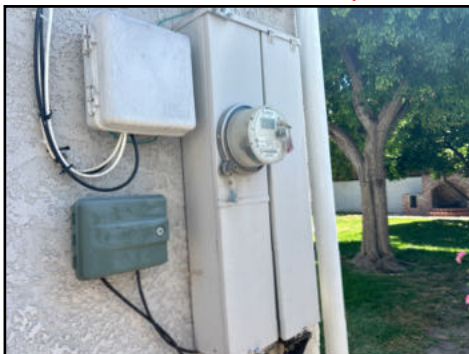
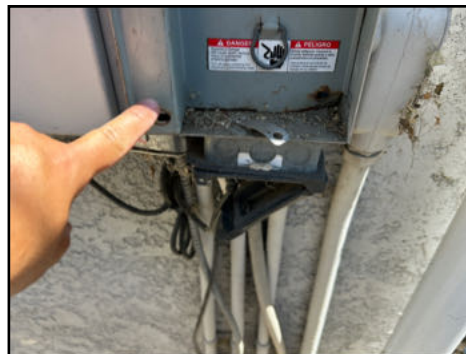
- Worn/weathered panel - typical for age and weather exposure
- Recommend upgrading services due to age of electrical system
- Panel appears to have been upgraded/newer panel present – check all installation permits for electrical upgrades to ensure that all items are installed to code
- Panel cover screw(s) missing - recommend installing appropriate screws
- Minor rusting - typical for age - recommend rust treatment and weather tight service
- Check for permits for any alterations
- **Panels are visually inspected only, the inspector does not perform a load calculation to determine service capacity adequacy**
- **Electrical fires due to poor installation of wiring cannot be determined by inspector**
- **Recommend further evaluation by licensed electrician**

Panel cover screw(s) missing - recommend installing appropriate screws

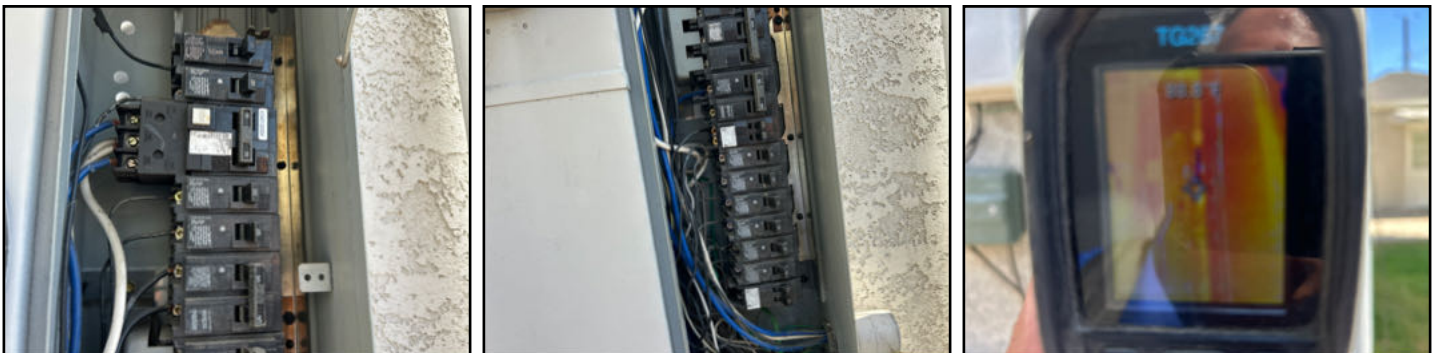
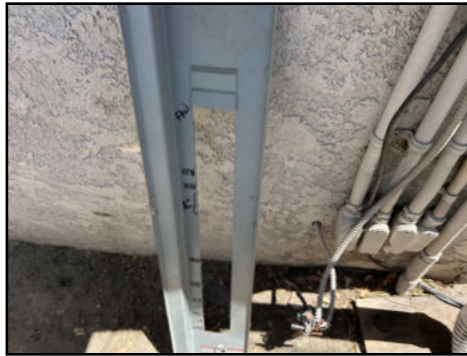
- Number of breakers in off position: 1
- Number of unused breakers: 0
- Panel is partially labeled - the inspector does not confirm accuracy of labels, it is recommended to label all breakers
- Loose/worn breakers - typical for age
- Worn/old breakers - may require replacement at any time
- Check for permits for any alterations
- **Breakers are visually inspected only - the inspector does not perform any electrical stress tests on the system to determine if a breaker trips properly (consult an electrician for further evaluation, if this is a concern)**
- **GFCI breakers present - not tested as doing so would de-energize circuits and interrupt connected equipment**
- **Recommend licensed electrician for further evaluation**

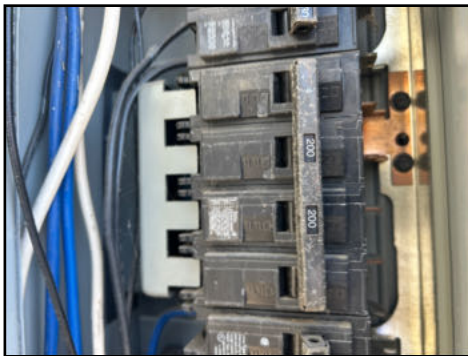
200 amp

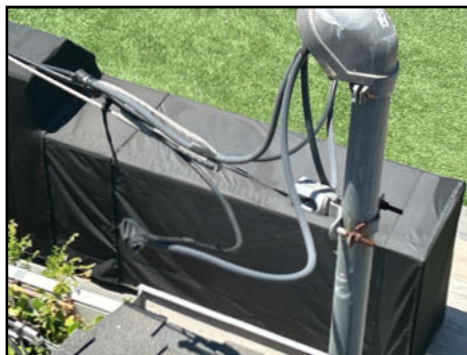
- Overhead - worn/weathered - needs service/**maintenance**
- **Drip loop not proper configuration - needs to be serviced**
- Check for permits for any alterations
- **Recommend licensed electrician to evaluate**
- **Trees/vegetation close/in contact with service entrance - needs to be serviced**

Trees/vegetation close/in contact with service entrance - needs to be serviced

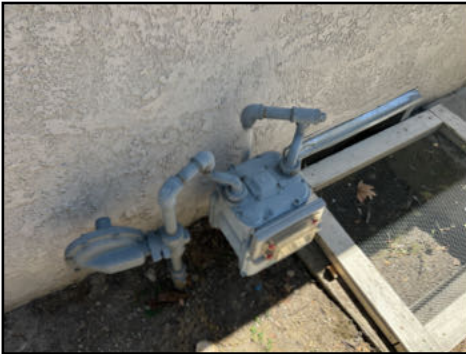
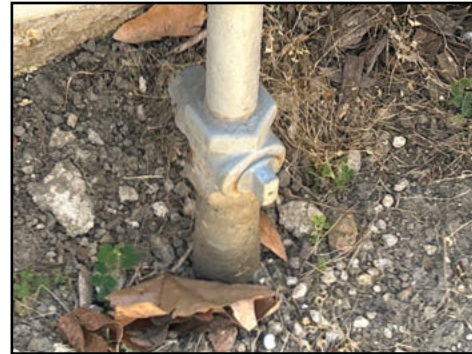
- Natural gas present
- Worn valve - typical for age
- Gas wrench located at gas meter
- Minor rusting - typical for exterior weathering - recommend rust treatment

- **Recommend Gas Company to evaluate**

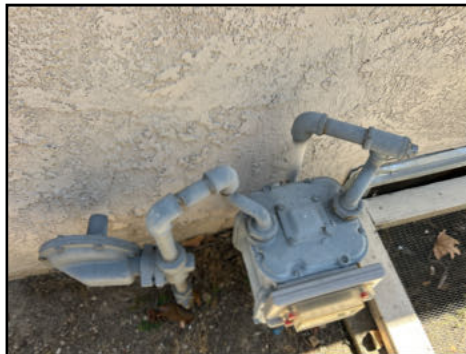
- Worn meter/piping - typical for age and exterior weathering
- Minor rusting - typical for age - recommend rust treatment
- Check for permits for any alterations
- ***We recommend the gas supplier be contacted to safety check all fuel gas systems/appliances during the contingency period or at least prior to purchase and occupancy. Note: The Inspector cannot determine if a gas leak is present in any area of the home at any time during the inspection. Note: The inspector cannot determine if all gas lines are properly protected in the ground.***
- ***Exterior gas lines, fire pits, BBQs, etc. are not included as part of this inspection - consult your gas supplier company to further evaluate these areas and **check permits** for any added gas lines, fire pits, BBQs, etc.***
- **Recommend Gas Company to further evaluate**

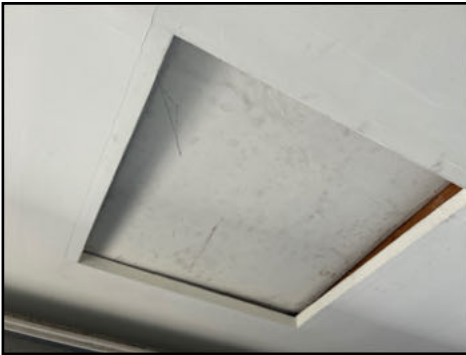
- **Could not access all areas of the attic due to limited space or insulation covering joist chords**
- **Structure inspection limited due to access hindrances such as insulation/ductwork/pipes/wires**

- Recommend appropriate licensed contractor to further evaluate
- **Limited attic inspection - many areas are not accessible due to limited space, lack of proper walk boards, electrical, plumbing, ductwork, etc.**

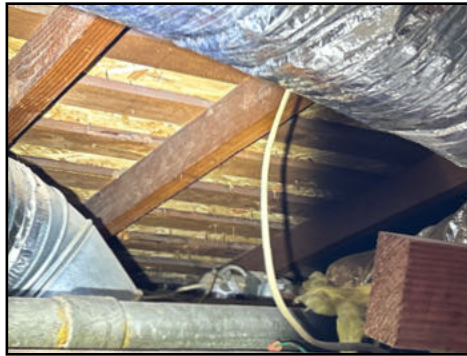
Skylight disconnected - needs service

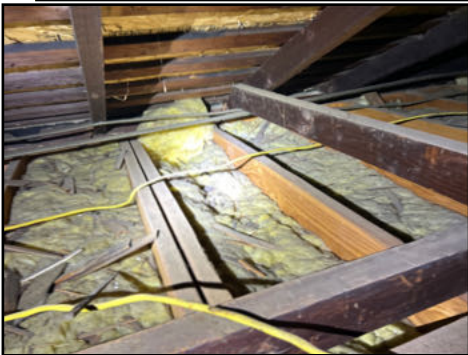
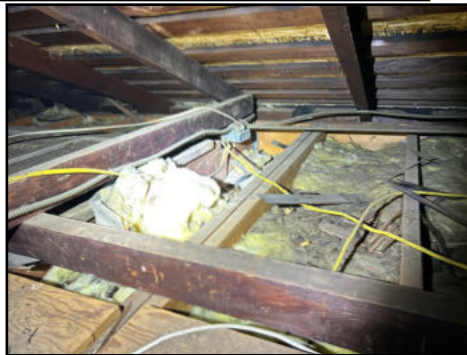
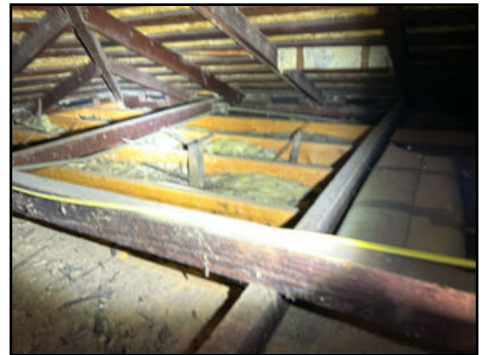
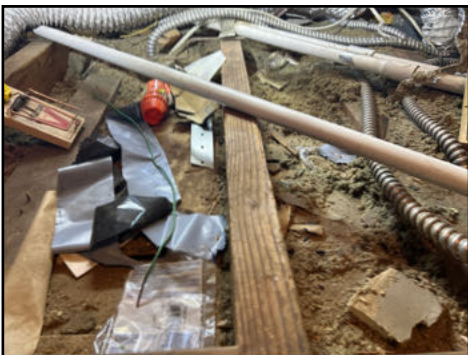
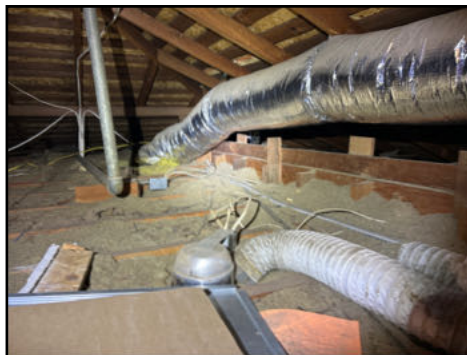
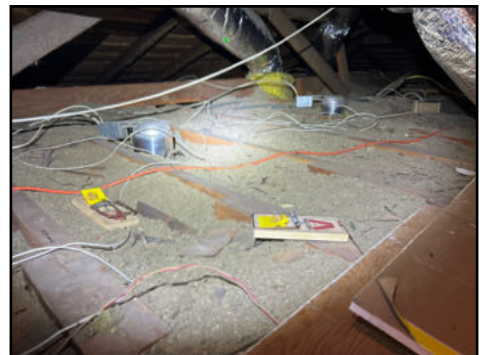
- All visible insulation is worn/older/dirty - typical for the age of the structure
- Debris throughout attic lying on insulation - recommend cleaning the attic and insulation of all debris
- This structure would benefit from new insulation
- Loose/displaced insulation in areas - recommend repair/replacement as needed for best efficiency
- Gaps in insulation - recommend servicing
- Check for permits on all alterations
- **Note: The inspector does not determine the presence of asbestos or any other hazardous materials in the building**
- **The inspector does not determine R-value of the insulation**
- **Insulation generally blocks visible inspection access to framing or components below level of insulation**
- **Limited access/access hindrances prevent visible inspection of areas of insulation**
- **Recommend appropriate licensed contractor for further evaluation**

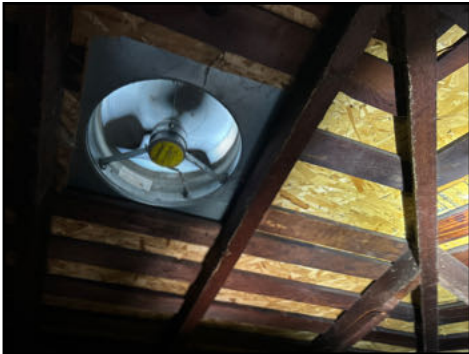
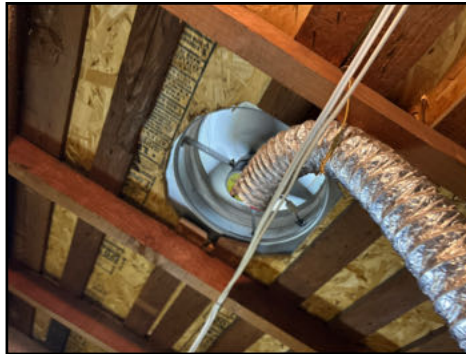
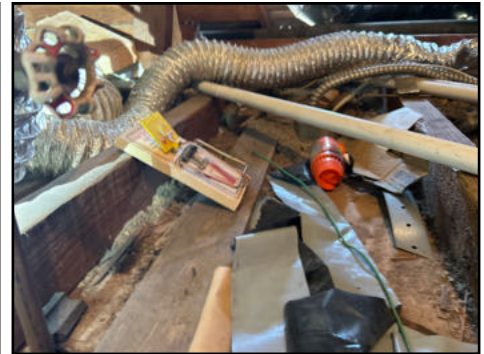
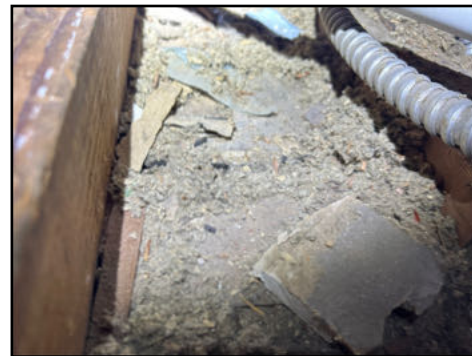
Evidence of rodents/insects/birds/pests -  
recommend further evaluation by pest services  
company

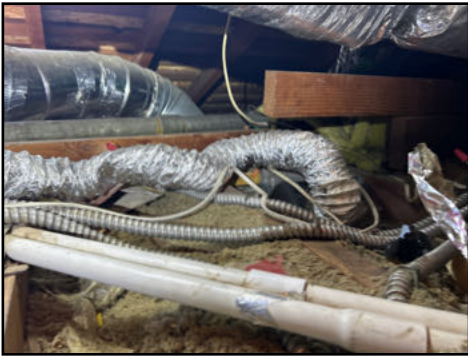
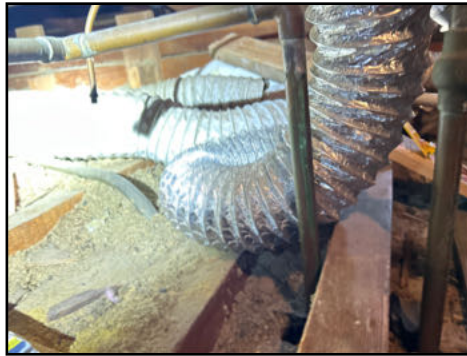
- Some vents are not visible or accessible and cannot be inspected - **N/A**
- Visible vents are older and worn - typical for the age of the structure - consider upgrading
- **Check permits** for any alterations
- **Some areas not visible due to access hindrances or limitations**
- **Recommend appropriate licensed contractor for further evaluation**

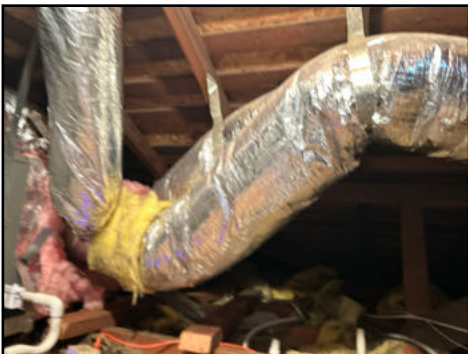
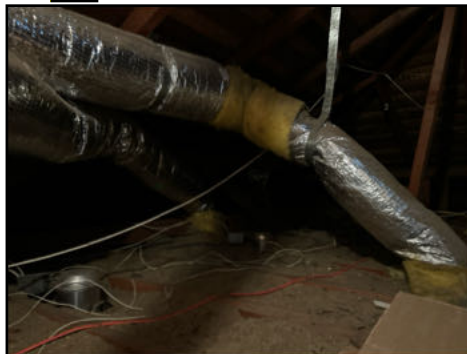
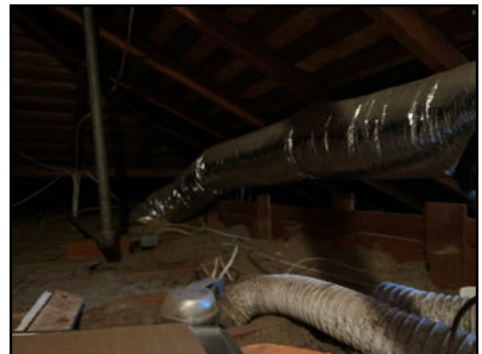
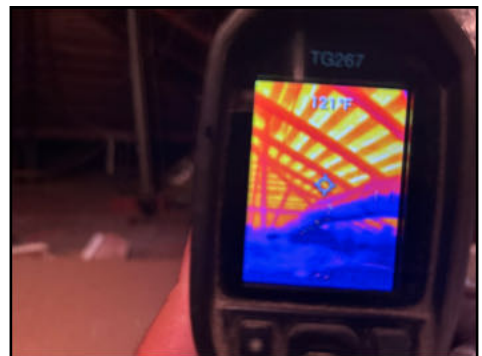
- New/newer duct work present, evidence of alterations observed - check all installation permits to ensure that all areas were installed to city/county building codes
- All visible/accessible duct areas have normal wear for age at the time of the inspection - no major visible defects
- Check for permits on all alterations
- ***The inspector cannot determine efficiency or effectiveness of the duct layout - check all installation permits***
- ***Some areas not visible due to access hindrances or limitations***
- ***Limited inspection/access due to structure and duct layout***
- **Recommend evaluation by Heating &

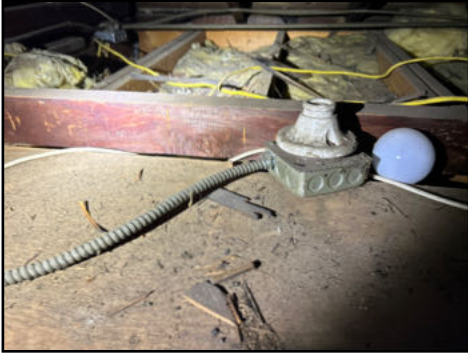
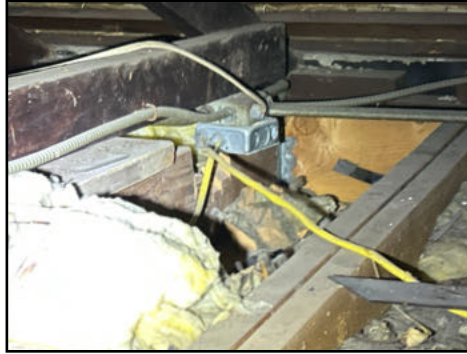
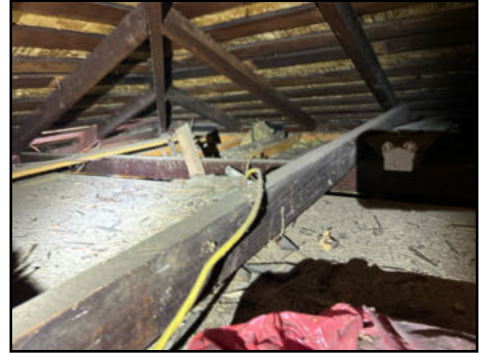
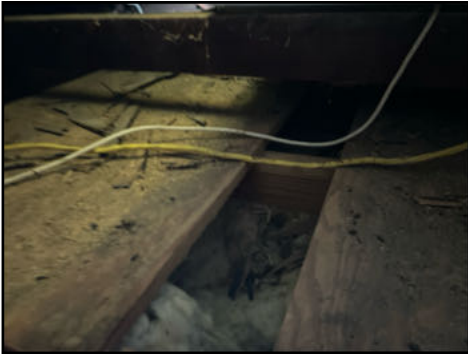
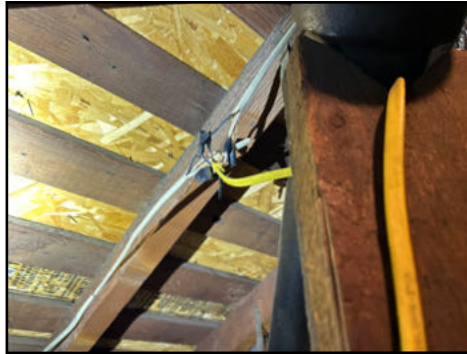
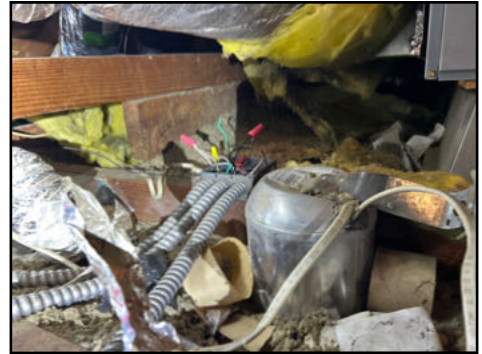
**Exposed connections (splices) not properly installed with a junction box - potential hazard - needs to be serviced**

**Cover missing at junctions box(es) exposing connections - needs to be serviced**

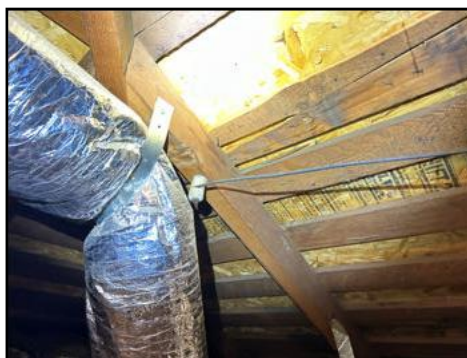
**Knob and tube wiring present - old technology, cannot be sure if it has been disconnected - consult an electrician to further evaluate**

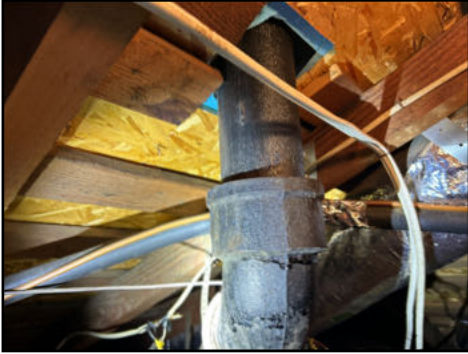
- Evidence of altered plumbing/piping in the attic - check all installation permits to ensure that all plumbing was installed to city/county building code
- Worn/older piping system present - consider upgrading plumbing

- No visible leaking at the time of inspection
- ***Some areas not visible due to access hindrances or limitations***
- **Recommend licensed plumber to further evaluate**
