**ELITE GROUP**  
INSPECTION PROFESSIONALS

PROPERTY LOCATION: 1123 N Florence St Burbank, CA 91505

# INSPECTION REPORT

Year Built: 1939 Sq Ft: 1463

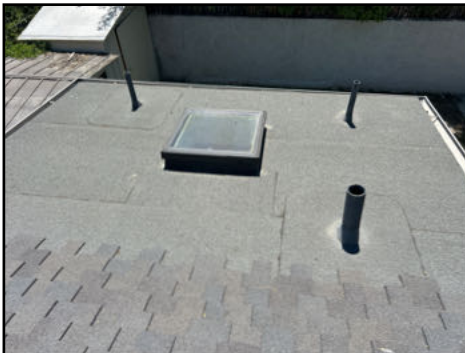
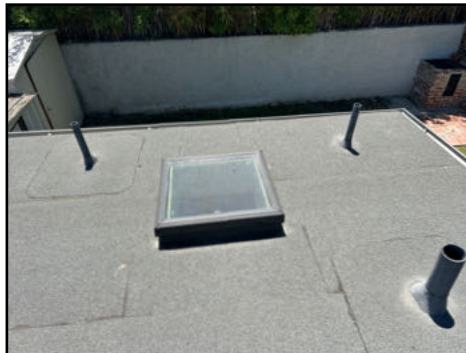
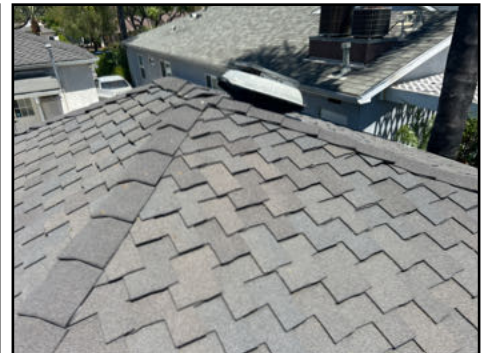
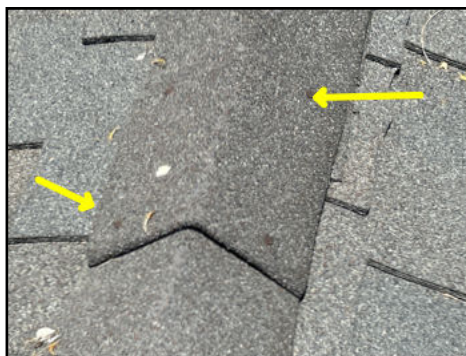
- Shingles exhibited moderate granule loss - normal for age of material
- **Check permits** for any alterations
- *Some areas not visible from inspection level - recommend further inspection/evaluation by licensed roofer*

**Exposed nails/staples/screws on roofing material - recommend sealing all fastener heads**

- Recommend seasonal **maintenance** to extend the life of the current materials
- Recommend mastic **maintenance** at all flashing areas
- Worn and weathered materials present - typical for age and weather exposure - **roof needs maintenance**

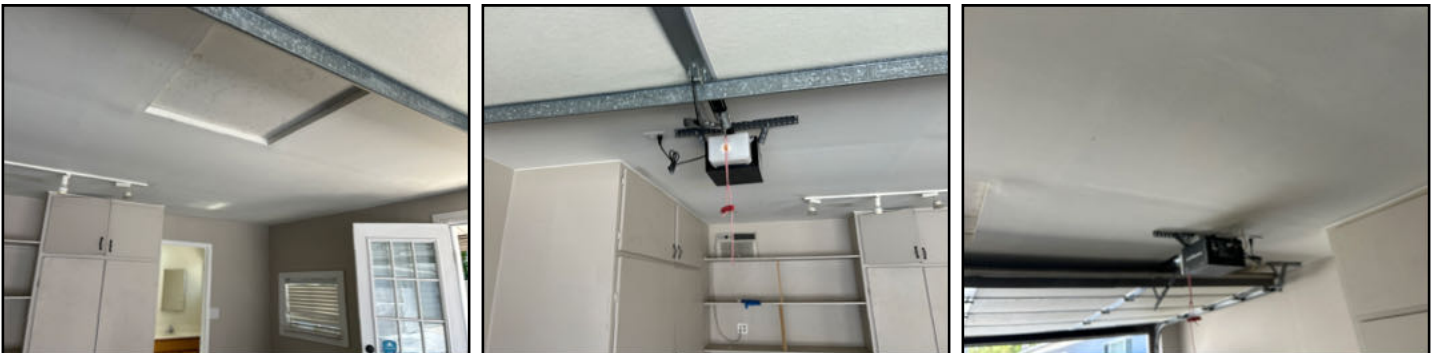
- Drywall present – no visible access to view rafters (see firewall notes for additional information)
- Cosmetic blemishes observed
- Check for permits for any alterations
- **Some ceiling/rafter areas are not visible or accessible/inspected due to personal storage/wood boards**
- **Recommend framing contractor to evaluate**

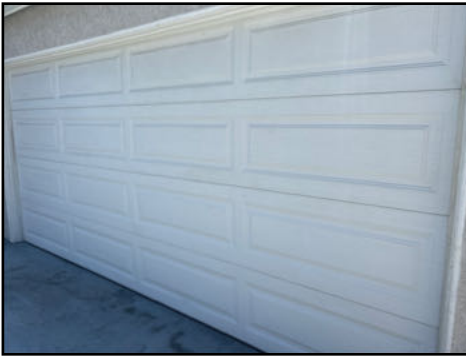
## 3. Main Automotive Doors

- Worn/weathered door - typical for age and exposure to weather
- Recommend weather tight service/**maintenance** to prevent moisture intrusion around main door areas

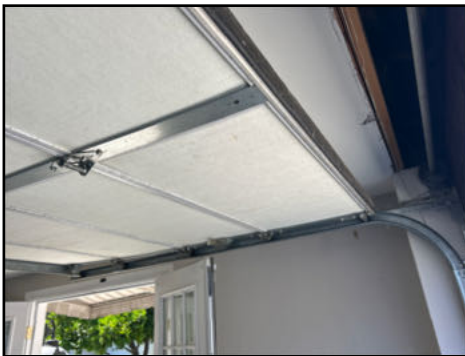
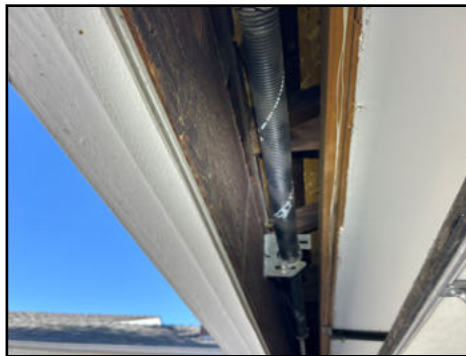
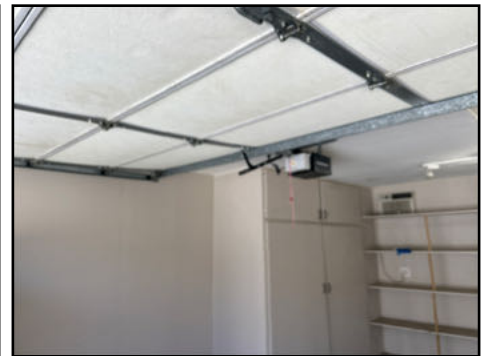
#### 4. Hardware/Springs

- **Garage doors require periodic maintenance and is recommended to ensure that all hardware is properly lubricated and secured**
- Door hardware is in a worn or loose condition - recommend standard service/lubrication

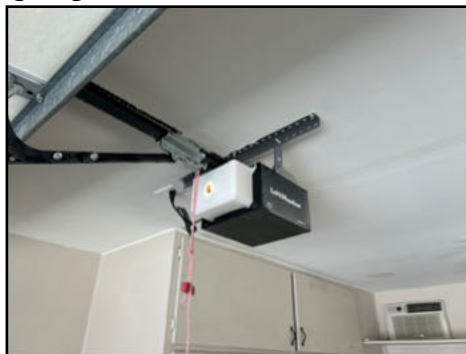
#### 5. Garage Door Openers

- Opener(s) were tested using the normal wall button on the day of the inspection (remote controls are not tested)
- One unit present
- Opener(s) operated at the time of the inspection
- Normal wear at time of inspection - no major visible/functional defects
- **Battery back up systems cannot be confirmed without dismantling the opener unit - we recommend having a general garage door service completed prior to regular use. Installing a battery back up unit is an advised new addition that we recommend for safety.**
- **Door opener activator button should be minimum 54-inches above floor for safety**
- **Door opener radio control devices not tested - inquire with seller regarding existence and operation**
- Recommend further evaluation by garage door contractor

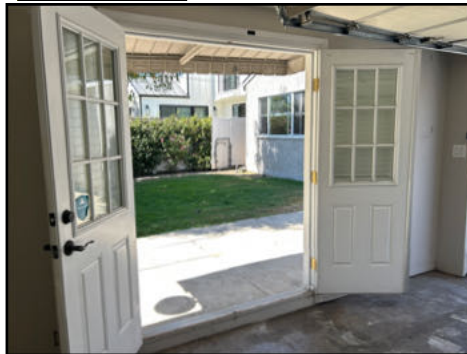
- Operated at the time of inspection
- Worn/weathered door - typical for age, dented areas
- Recommend weather tight service/**maintenance** to prevent moisture intrusion

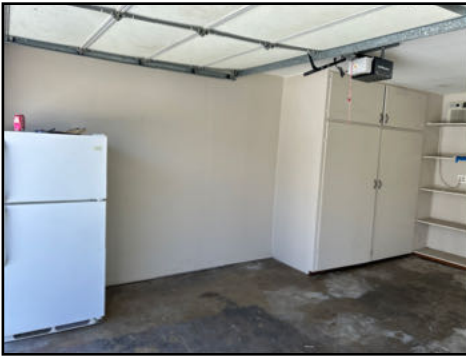
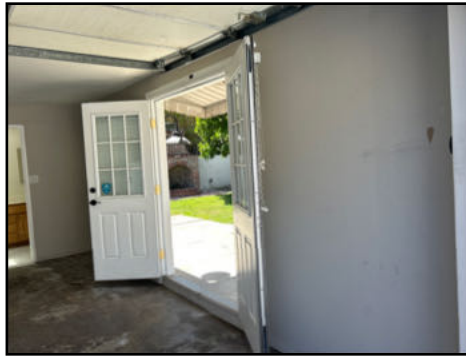
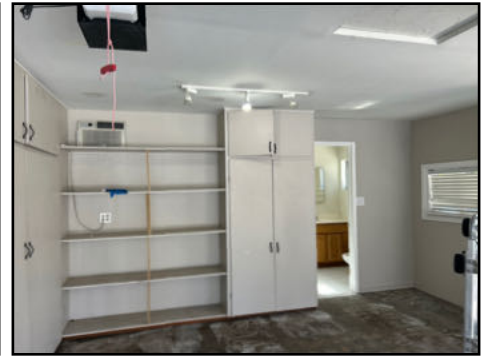
## 8. Walls

- Check for permits on all additions/alterations/sub-walls/converted areas
- **Consult termite report** for any wood areas in garage
- Small cracks/holes/chipped/dirty areas/cosmetic blemishes observed - typical for age of structure
- Cracking small - typical for age
- **Recommend appropriate licensed contractor for further evaluation**

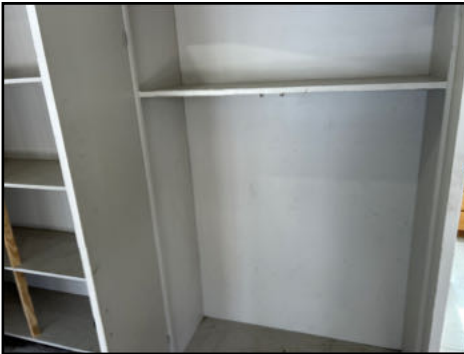
- Worn closets with loose/worn hardware - typical for age

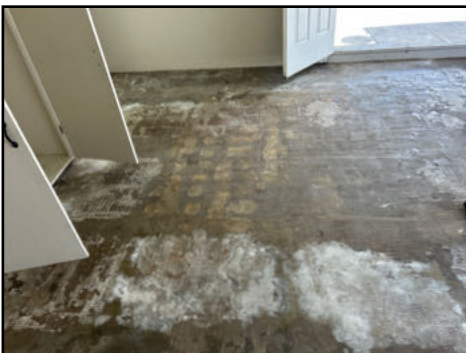
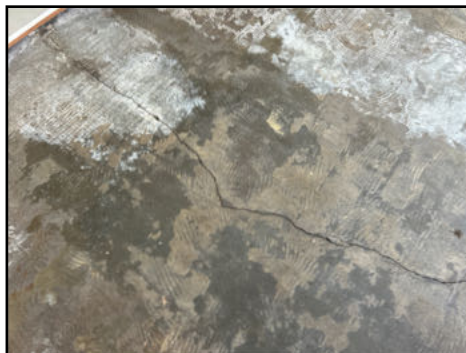
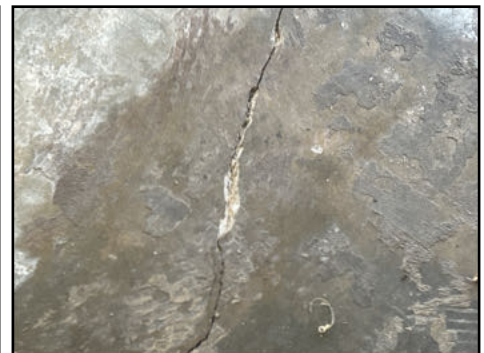
## 12. Slab

- Small cracks/chipped areas - typical for the age of the materials
- Worn and stained areas - typical for age of the material
- Recommend licensed concrete contractor to further evaluate

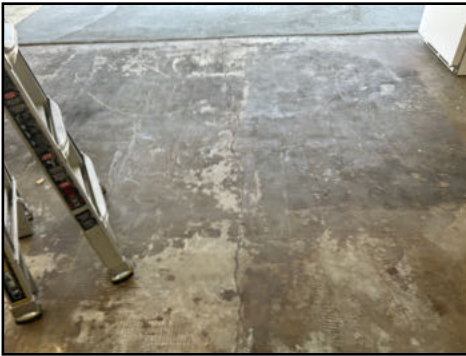
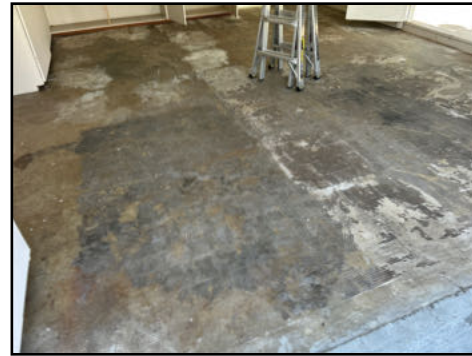
Small cracks/chipped areas -  
typical for the age of the materials

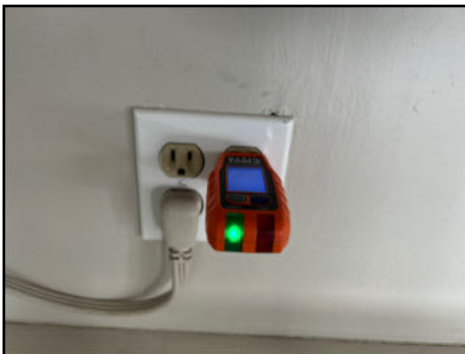
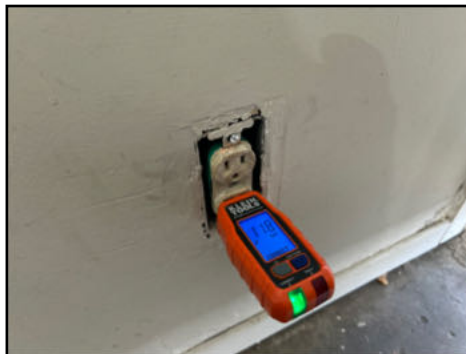
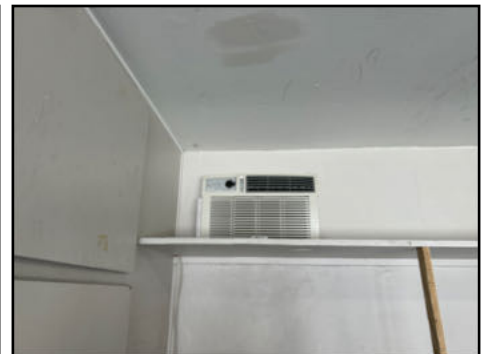
### 13. Electrical

- Evidence of electrical alterations in the garage - check all permits for electrical alterations to ensure that all electrical was installed to city/county electrical code
- A representative number of receptacles and switches were tested and found to be operational at time of inspection
- Loose/worn outlets/switches - typical for age consider upgrading
- Check for permits for any alterations
- Some outlets not accessible - not inspected
- Some switches not accessible - not inspected
- **Only the visible and accessible switches/outlets are testing during this inspection, personal items/furnishings are not moved to access any outlets/switches behind them.**
- Recommend licensed electrician to further evaluate
- **Outlet cover missing - needs to be serviced**

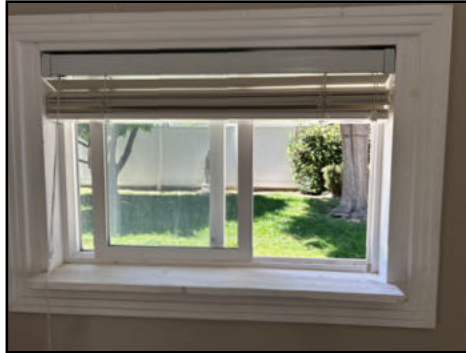
- Operated at time of inspection
- Worn frames/hardware/tracks - typical for age of material
- Recommend weather tight service
- Missing screen - recommend installation of an appropriate screen
- Check for permits for any alterations
- **Recommend appropriate licensed contractor for further evaluation**

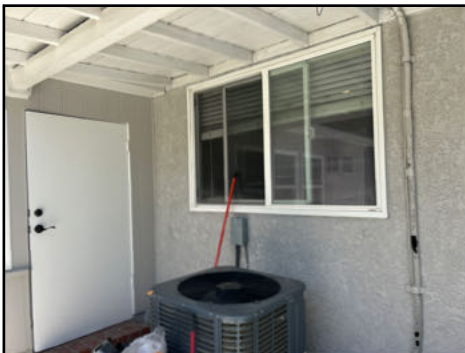
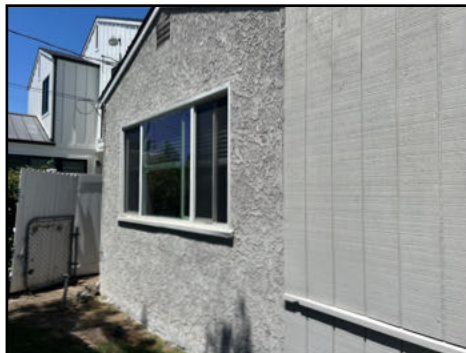
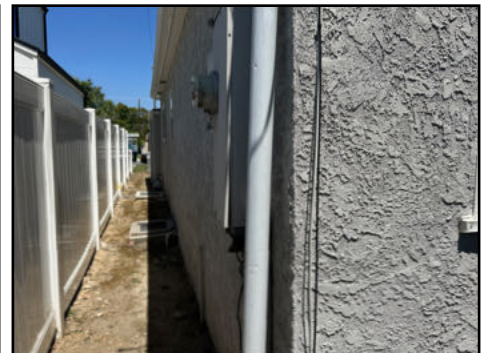
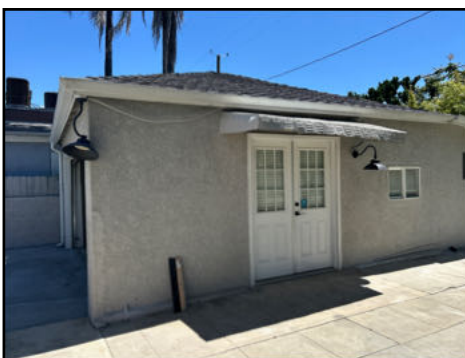
- Recently painted structure
- Worn/weathered at time of inspection where visible
- Recommend sealing any holes/gaps or cracks to prevent moisture or pest entry
- **Cold joint** cracking present - evidence of past patchwork or addition - **check permits** and seal joint regularly to ensure against moisture intrusion
- Patching present - consult seller for past repaired areas
- **Check permits** for any alterations
- **Stucco requires periodic seasonal maintenance, consult an exterior finish contractor for maintenance tips/schedules/suggestions**
- **Inspector does not use specialized instruments to detect moisture, if any, under stucco surface**
- **Some not accessible for inspection due to vegetation/personal items/height/limited access - these areas cannot be visually inspected**
- **Cracking/chipping/holes more than typical - needs to be serviced**

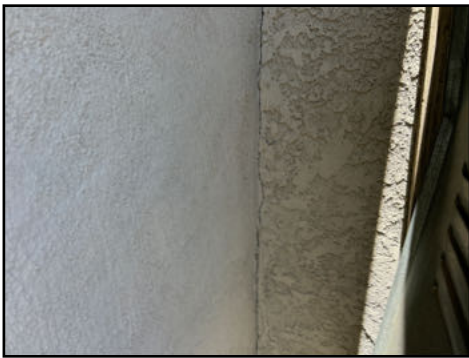
**Cold joint** cracking present - evidence of past patchwork or addition - **check permits** and seal joint regularly to ensure against moisture intrusion

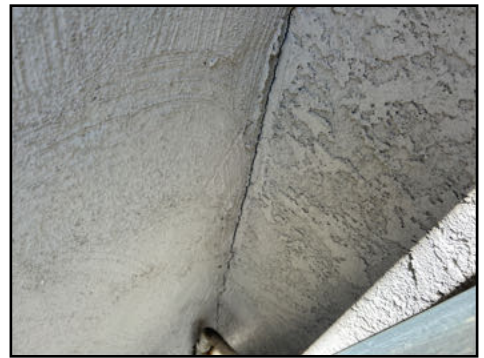
**Cold joint** cracking present - evidence of past patchwork or addition - **check permits** and seal joint regularly to ensure against moisture intrusion

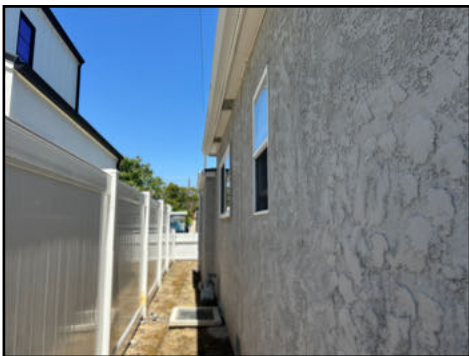
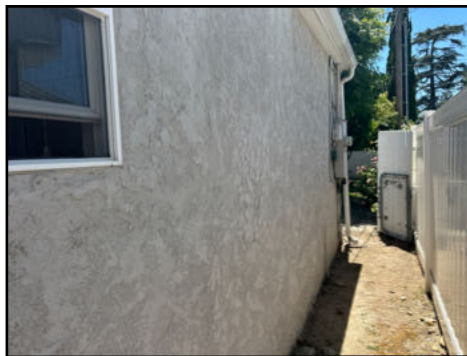
**Cold joint** cracking present - evidence of past patchwork or addition - **check permits** and seal joint regularly to ensure against moisture intrusion

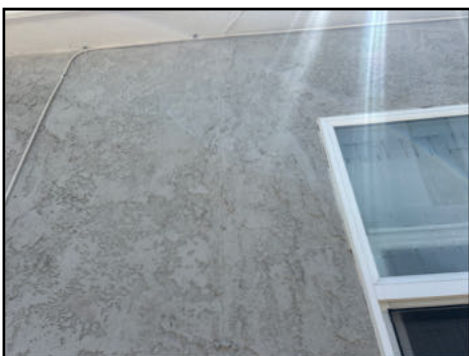
**Cold joint** cracking present - evidence of past patchwork or addition - **check permits** and seal joint regularly to ensure against moisture intrusion

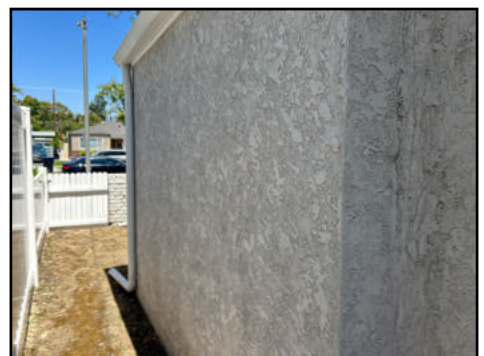
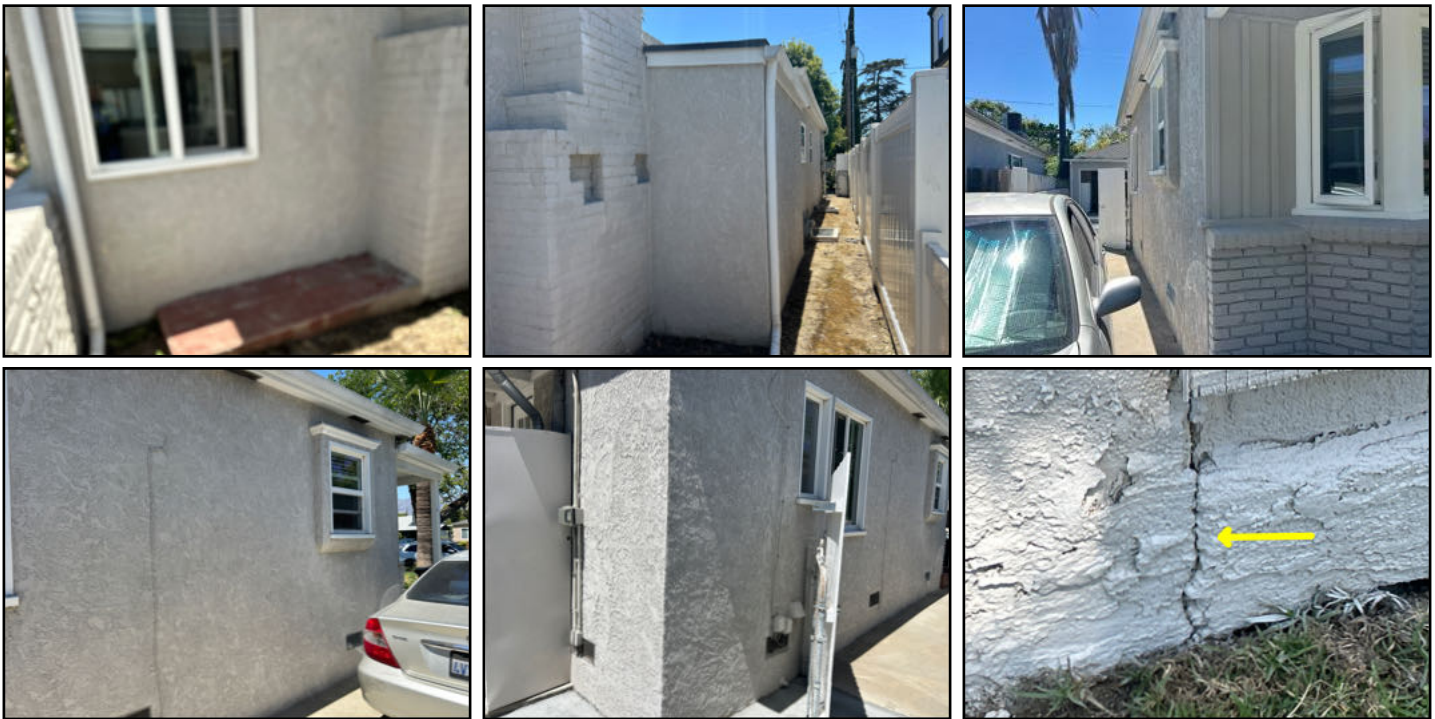
Cracking/chipping/holes more than typical - needs to be serviced

| Page 76 Item: 1 | Stucco | <ul style="list-style-type: none"> <li>Cracking/chipping/holes more than typical - needs to be serviced</li> </ul> |

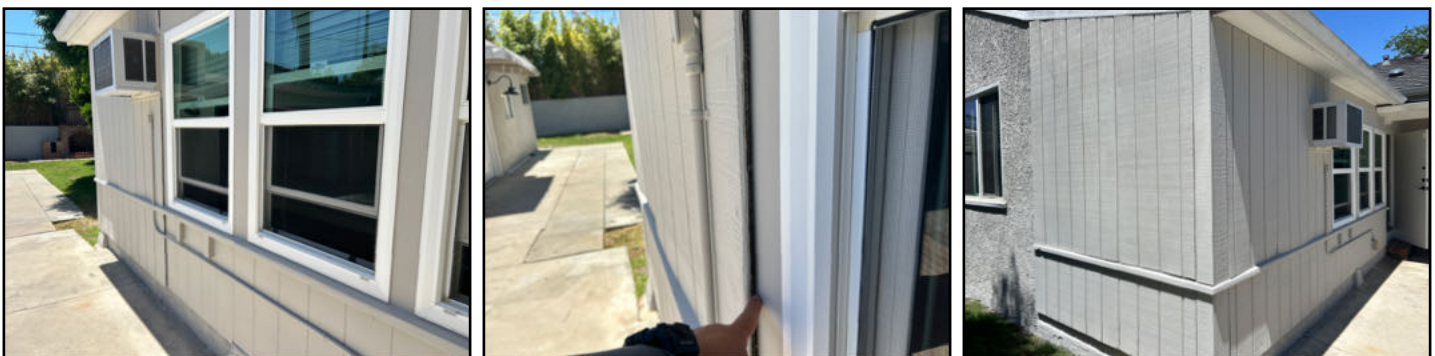
Gaps in siding at joints and around windows/doors - recommend servicing to prevent moisture entry

| Page 78 Item: 2 | Siding | <ul style="list-style-type: none"> <li>Gaps in siding at joints and around windows/doors - recommend servicing to prevent moisture entry</li> </ul> |

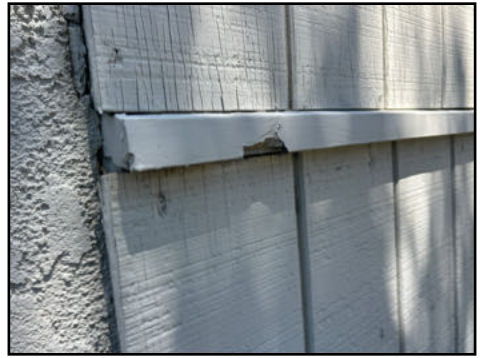
Gaps in siding at joints and around windows/doors - recommend servicing to prevent moisture entry

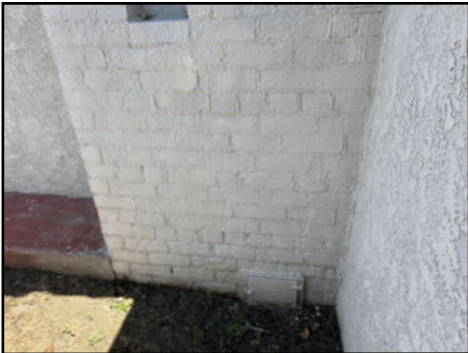
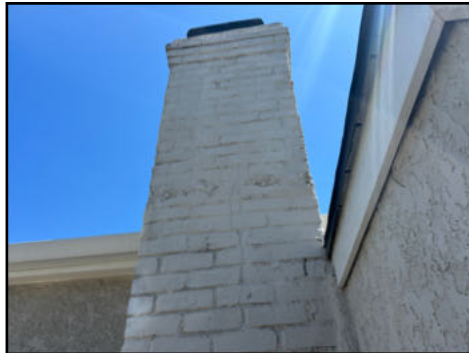
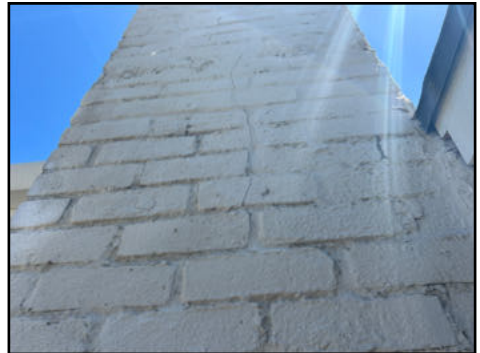
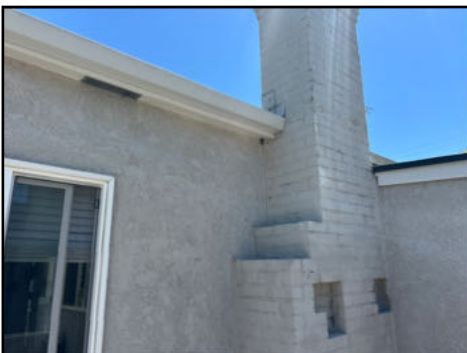
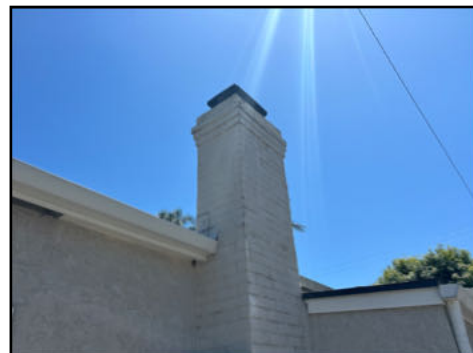
- Worn/weathered at time of inspection where visible - typical for age
- Small cracking or chipping observed - typical of age - recommend **maintenance**/sealing
- **Check permits** for installation or alterations
- **Recommend appropriate licensed contractor for further evaluation**

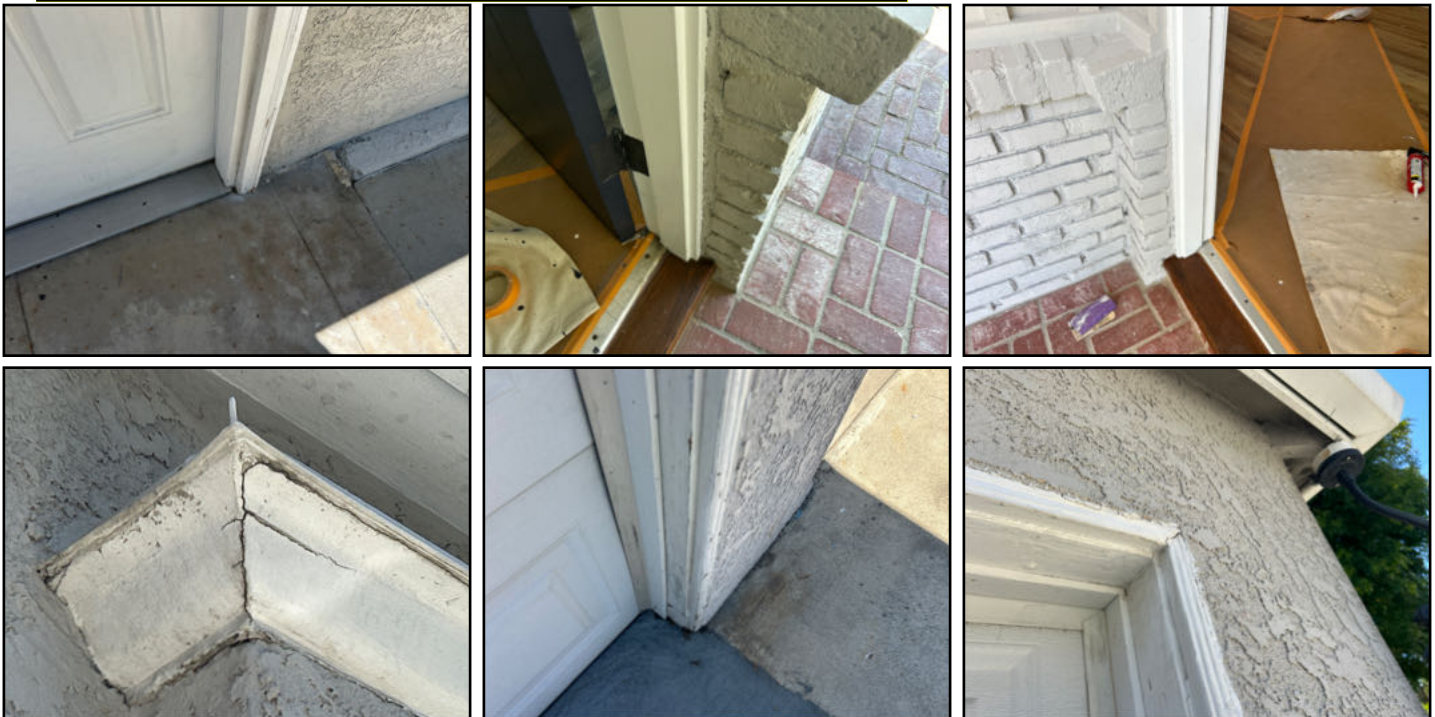
#### 4. Wood Trim

- **Consult termite report** for all exterior wood
- Recommend general trim **maintenance** and sealing any holes/gaps
- **Check permits** for any alterations
- *For damaged wooden areas and moisture problems always obtain a structural pest control inspection; Inspector does not determine wood destroying organism presence or damage - always obtain a structural pest control inspection; Inspector does not use specialized instruments to detect moisture, if any, under siding/trim surface*
- *Some not accessible for inspection due to vegetation/personal items/height/limited access - not visible for inspection*
- **Recommend appropriate licensed contractor for further evaluation**

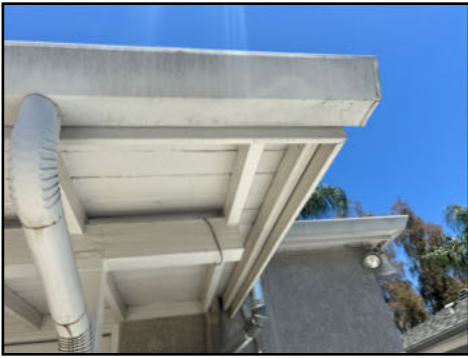
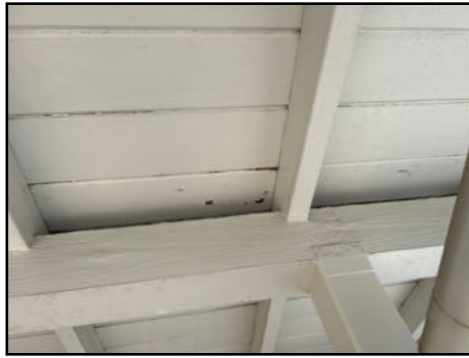
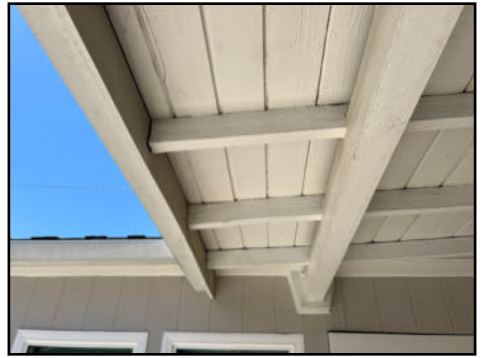
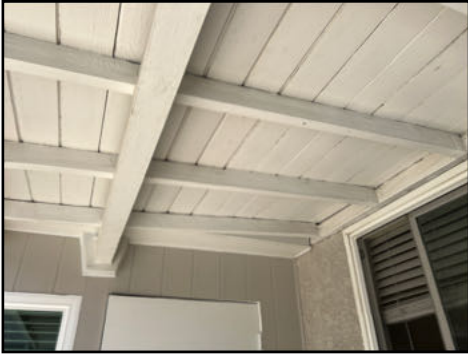
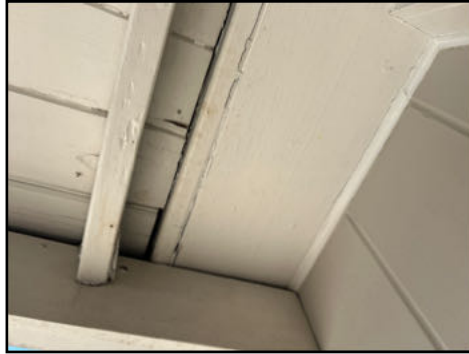
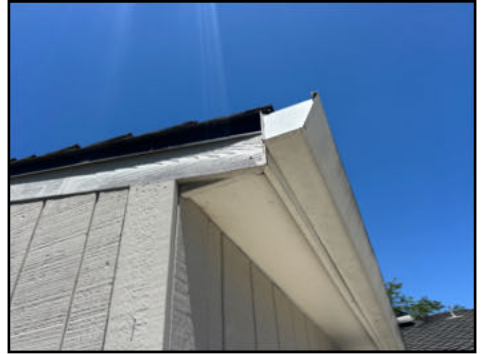
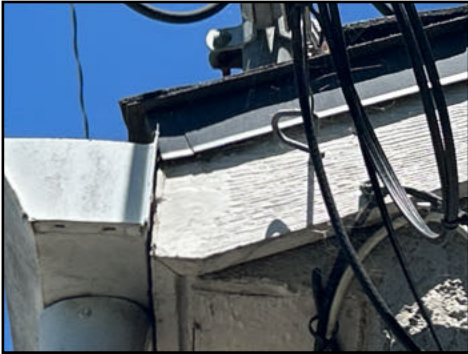
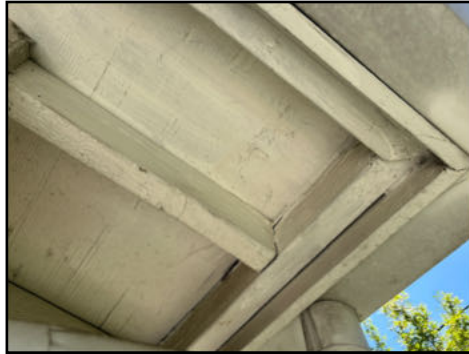
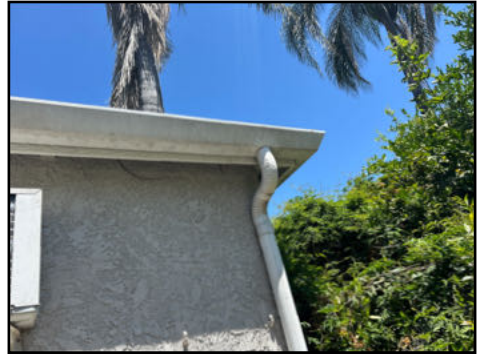
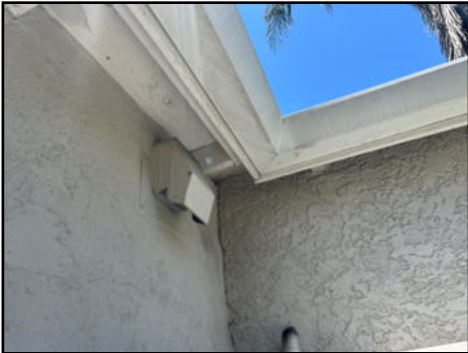
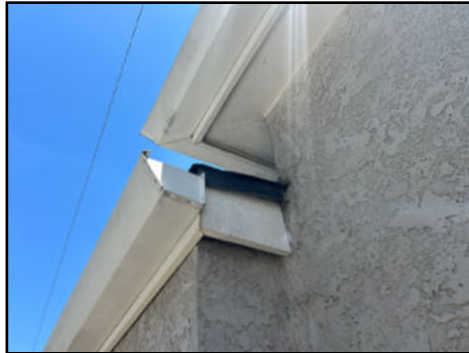
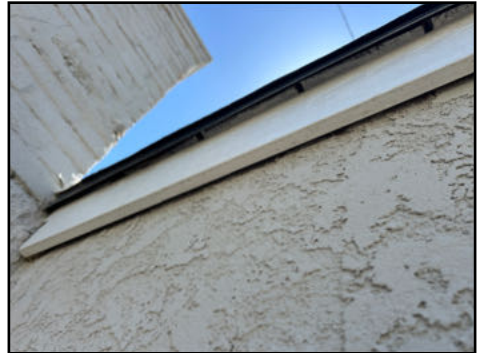
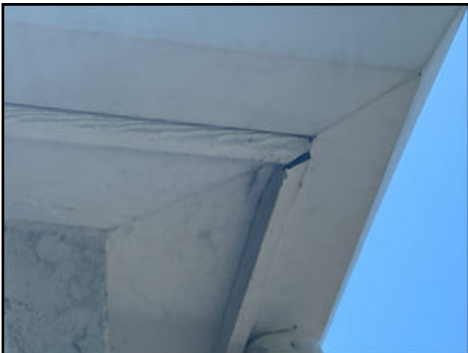
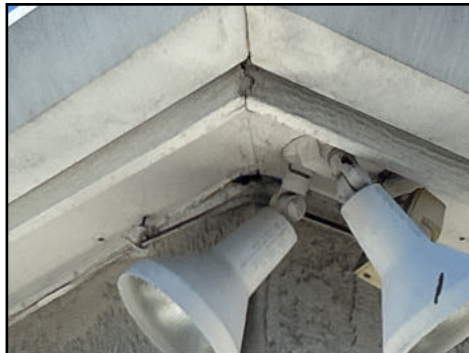
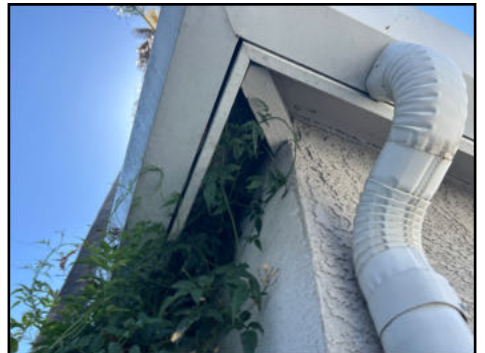
- **Consult termite report** for all wood areas at the structure
- Cracking/weathering/worn where visible - typical for age and weather exposure
- Weathering and staining present in areas
- Warped wood / twisted wood - signs of age and wear - recommend servicing
- **Check permits** for any alterations
- *Inspector does not determine wood destroying organism presence or damage - always obtain a structural pest control inspection*
- *Inspector does not use specialized instruments to detect moisture, if any, under siding/trim surface*
- *Some not accessible or visible for inspection due to vegetation/personal items/height/angle*
- **Recommend appropriate licensed contractor for further evaluation**

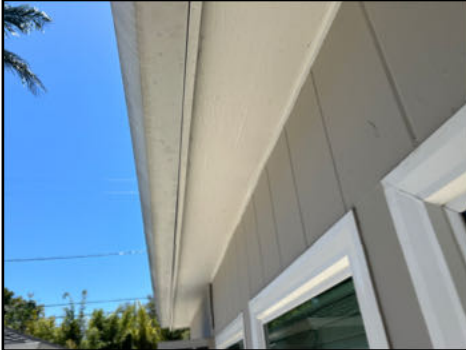
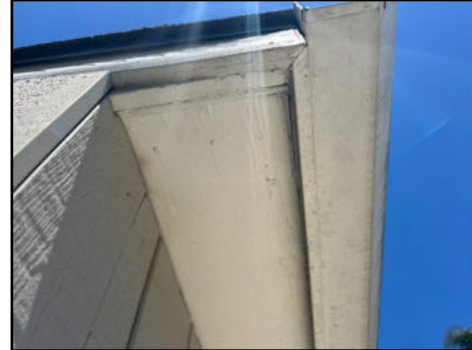
## 6. Soffits

- Weathered and worn materials - typical for age
- Cracking/weathering - typical
- ***Some not accessible or visible for inspection due to vegetation/personal items***
- ***Inspector does not determine wood destroying organism presence or damage - always obtain a termite inspection***
- ***For damaged wooden areas and moisture problems always obtain a structural pest control inspection***
- ***Inspector does not use specialized instruments to detect moisture, if any, under siding/trim/soffit surfaces***
- **Recommend appropriate licensed contractor for further evaluation**

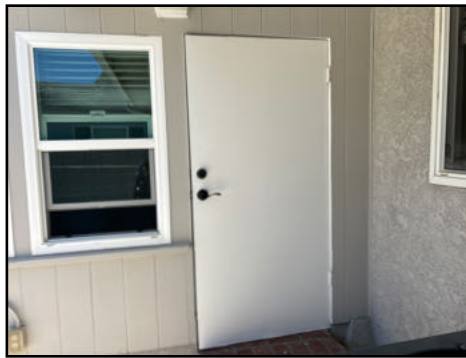
- ***Exterior doors require seasonal maintenance to extend lifespan and maintain weather tight seals***
- See interior section for more information
- **Consult the termite report for all wood doors/frames at this structure**
- Newer doors/sliders present at structure – **check permits** for proper installation (may not include all doors at the structure)
- All visible and accessible doors were tested during this inspection
- Loose/worn hardware needs minor service and/or adjustment
- Maintain weather tight seals at all doors
- Check for permits for any alterations
- **Recommend appropriate licensed contractor for further evaluation**

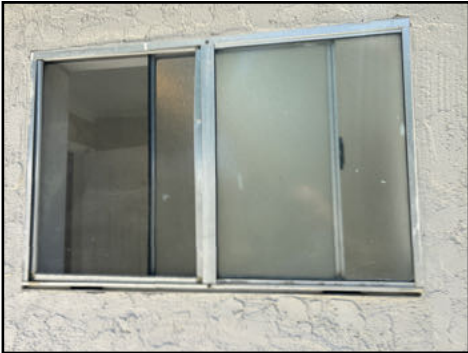
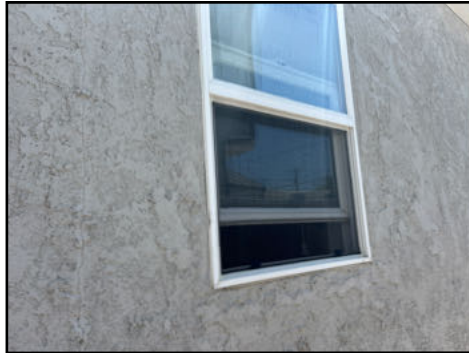
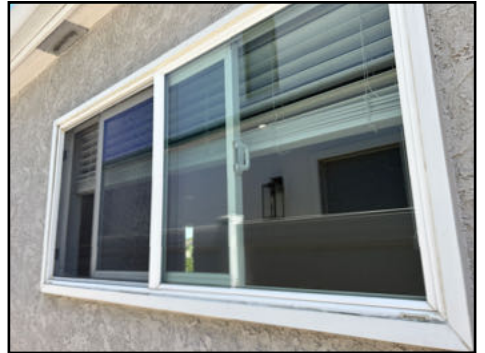
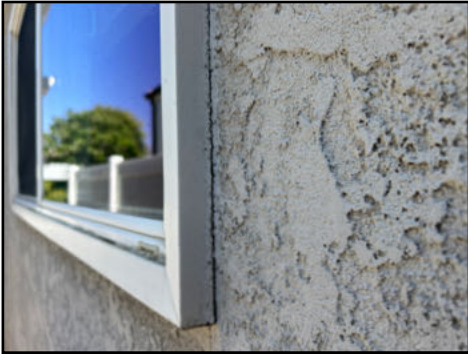
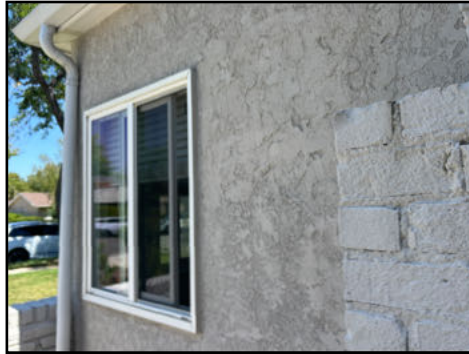
**Gaps around windows - recommend servicing to prevent moisture entry**

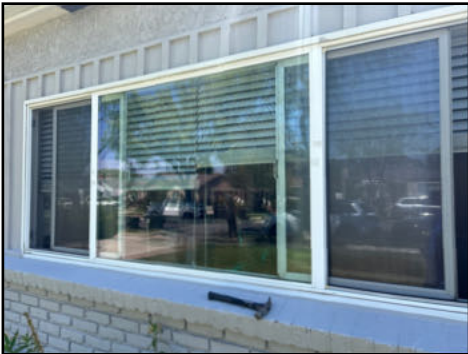
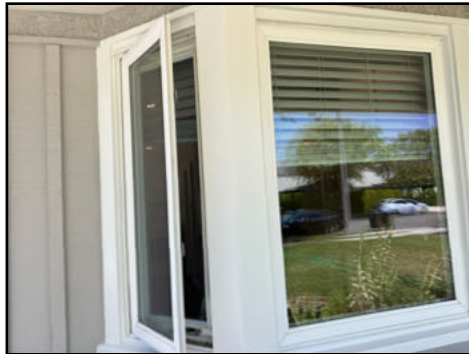
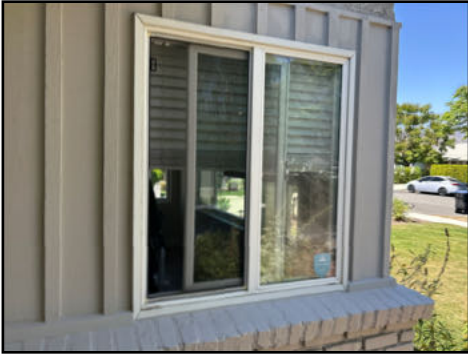
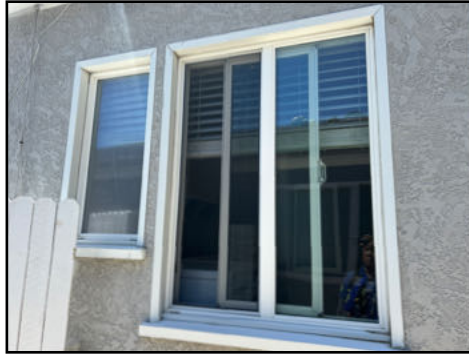
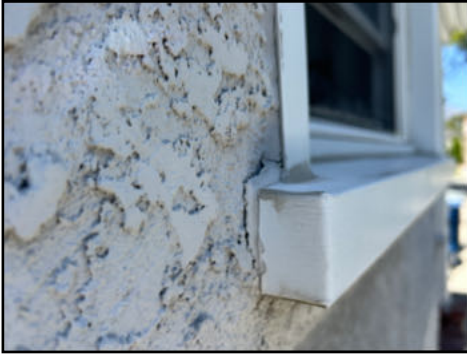
**Gaps around windows - recommend servicing to prevent moisture entry**

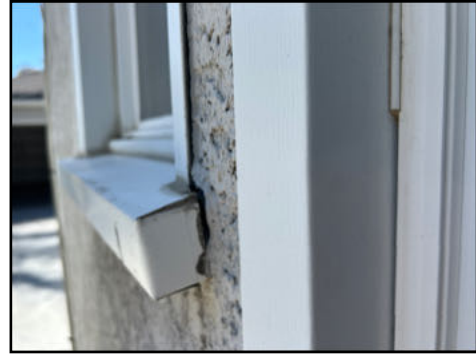
**Gaps around windows - recommend servicing to prevent moisture entry**

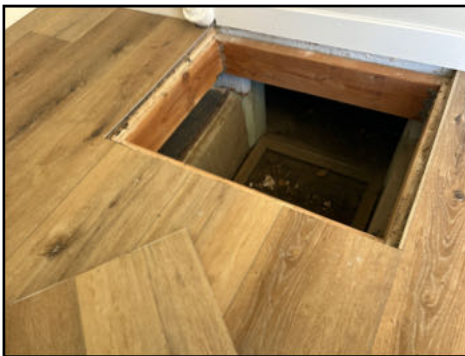
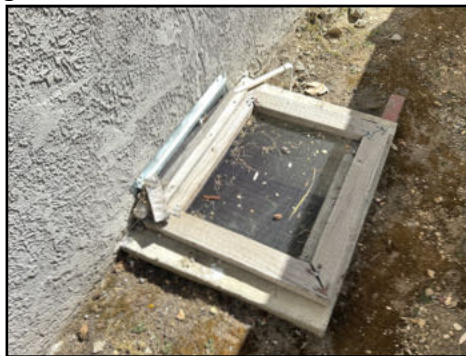
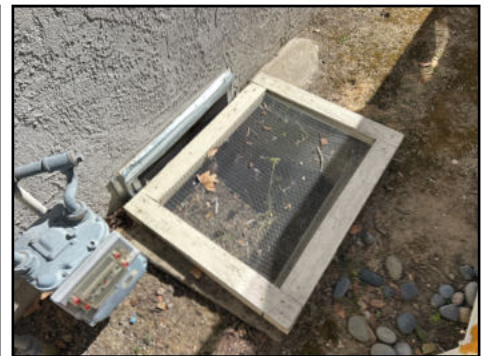
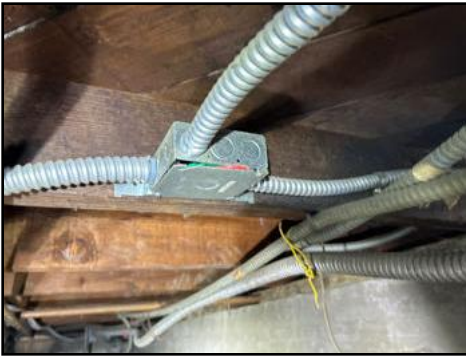
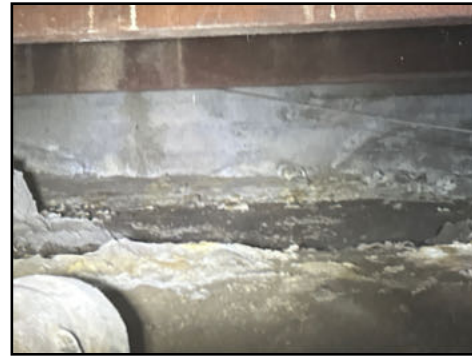
- **Limited inspection - some areas under the structure are not accessible/visible due to piping/electrical/duct work, insulation or inadequate service space - **N/A****
- Inspection method: partially traversed due to height limitations/ductwork/plumbing blocking complete access or view to some areas - limited inspection
- Access entry is worn/weathered/bent – recommend service/repair to prevent pest access to under structure
- Loose cover - recommend servicing

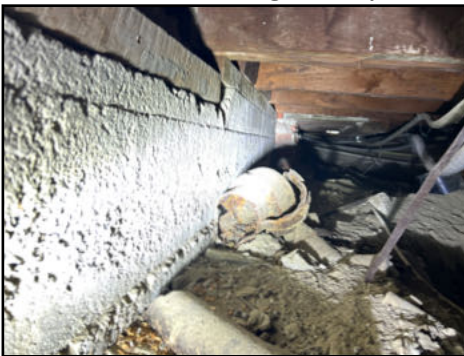
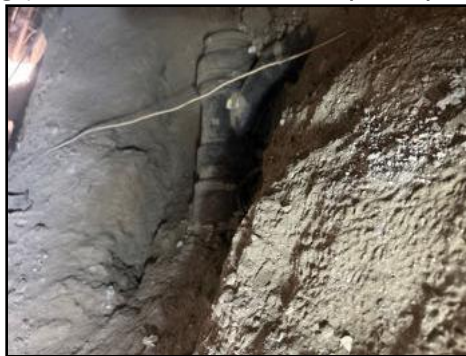
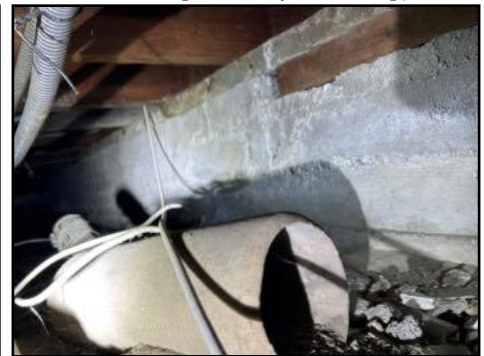
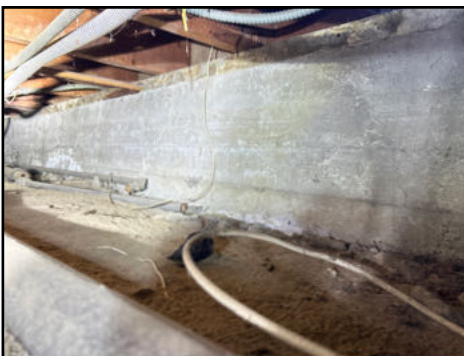
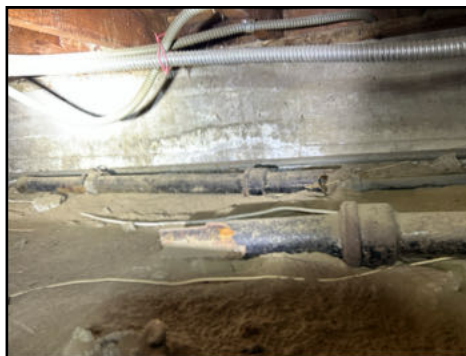
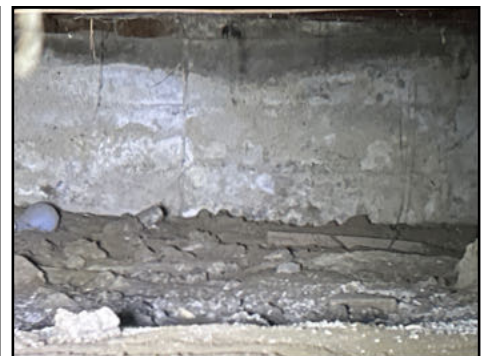
- Constructed of: concrete
- Visible foundation wall areas are worn and stained areas - typical for age of the structure and material
- Stained/worn areas - typical for age
- **Efflorescence** present - indicates past moisture accumulation - monitor for further moisture intrusion
- **Exposed/undermined wall footings - needs to be serviced**
- *All accessible areas of foundation walls were visibly inspected during this inspection (some areas may not be accessible due to limited space/plumbing piping/duct work obstructions)*
- *Vegetation or storage present - some areas of foundation walls not completely visible for inspection*
- *Large trees/bushes/vegetation around the structure areas may have a long term effect on the foundation walls and the underground plumbing (recommend a sewer scope inspection for underground plumbing).*

Exposed/undermined wall footings  
- needs to be serviced

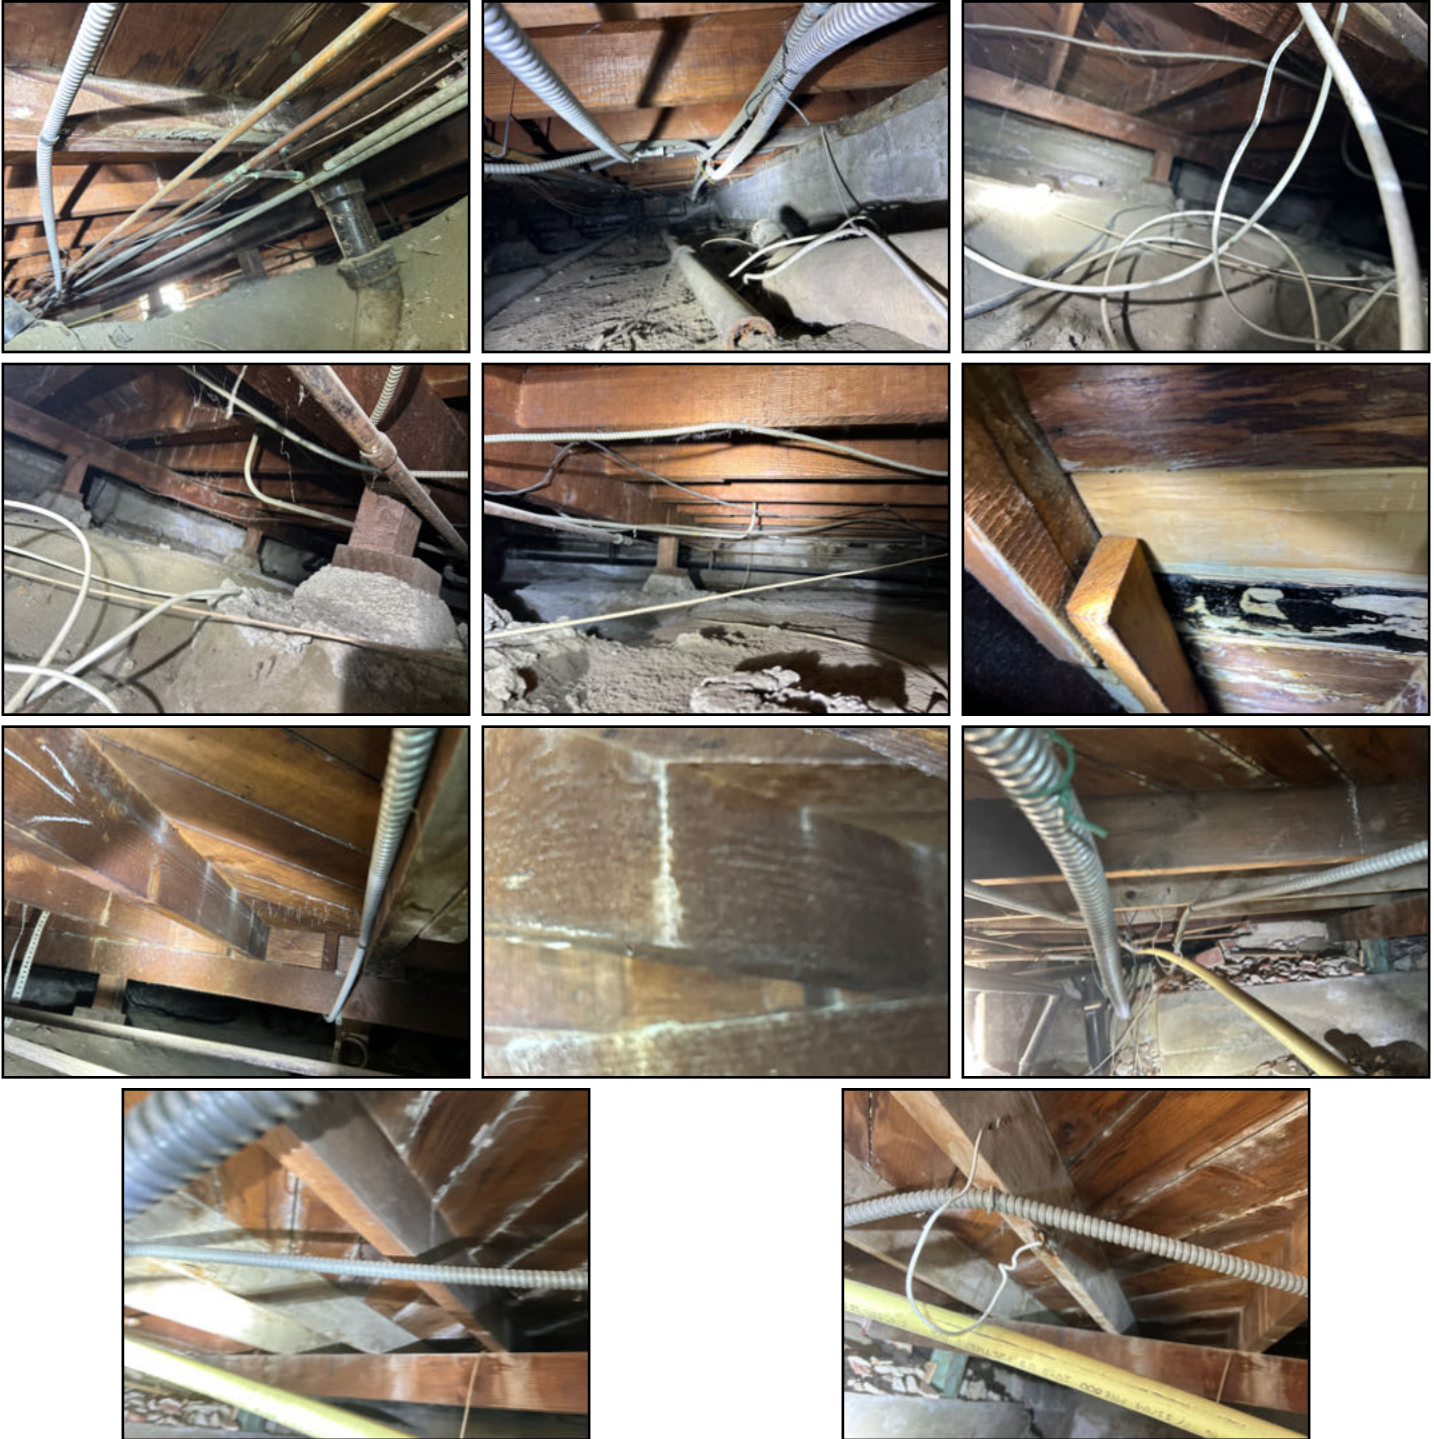
- Some areas of the sub floor are not visible or inspected
