**ELITE GROUP**  
INSPECTION PROFESSIONALS

PROPERTY LOCATION: 1123 N Florence St Burbank, CA 91505

# INSPECTION REPORT

Year Built: 1939 Sq Ft: 1463

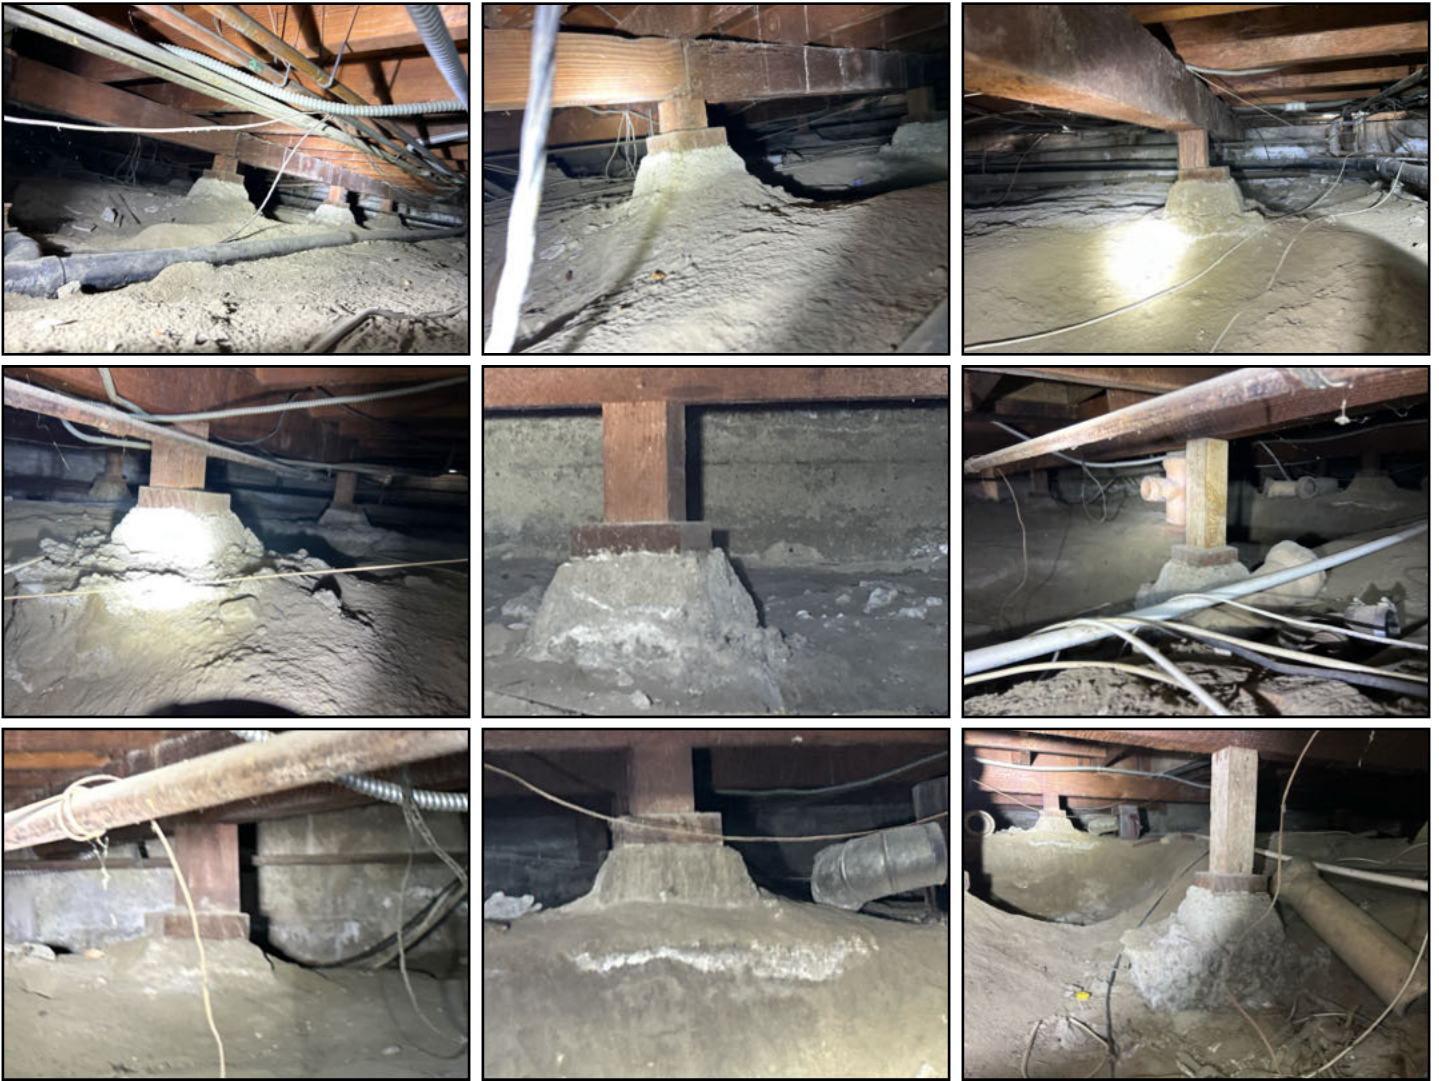
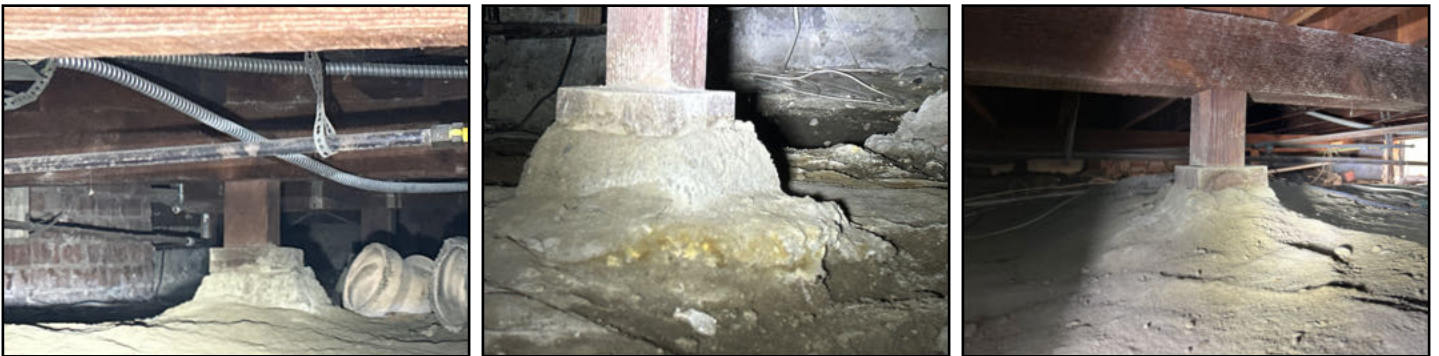
**Exposed/undermined post footings  
- needs to be serviced**

| Page 89 Item: 6 | Posts and Girders | <ul style="list-style-type: none"> <li>Posts off centered and not aligned over concrete piers - recommend brackets for added support</li> <li>Exposed/undermined post footings - needs to be serviced</li> </ul> |

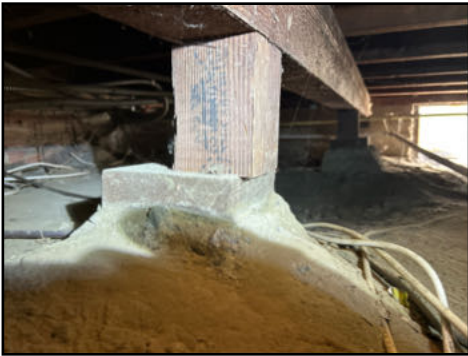
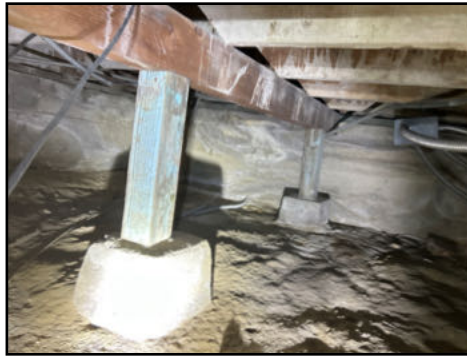
**Posts off centered and not aligned over concrete piers - recommend brackets for added support**

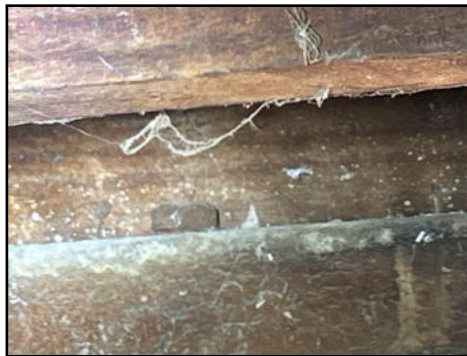
- Anchor bolts present - worn with rust present - typical for age

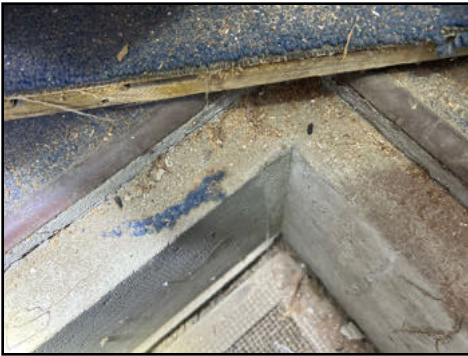
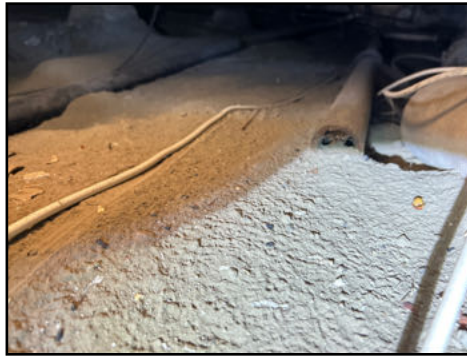
**Evidence of rodent/pest activity in the crawlspace - recommend further evaluation by pest services company**

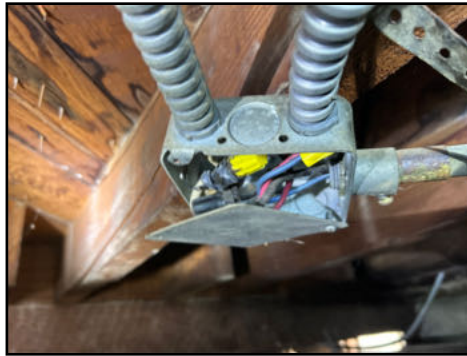
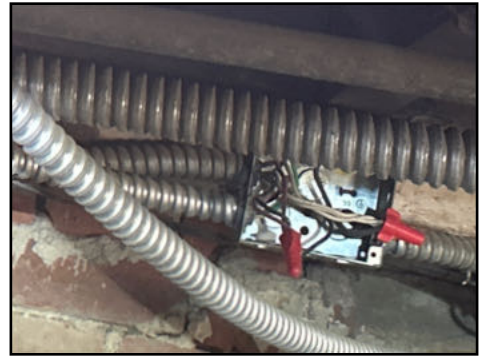
**Exposed connections (splices) not properly installed with a junction box - potential hazard - needs to be serviced**

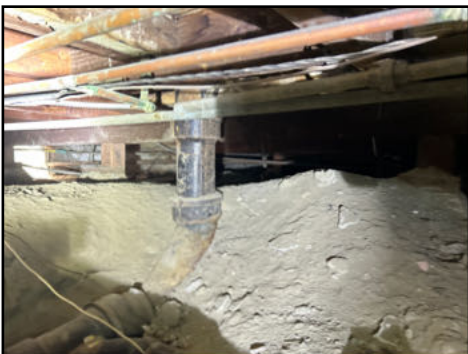
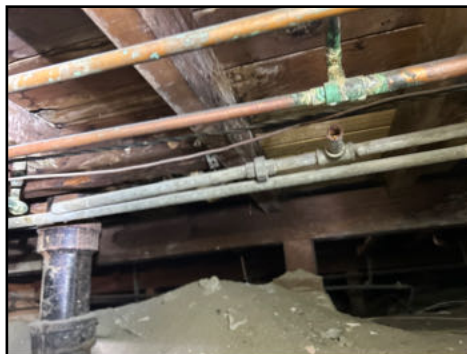
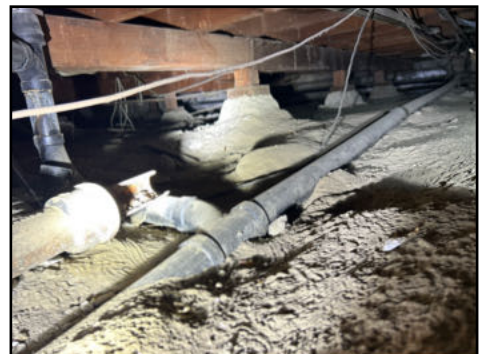
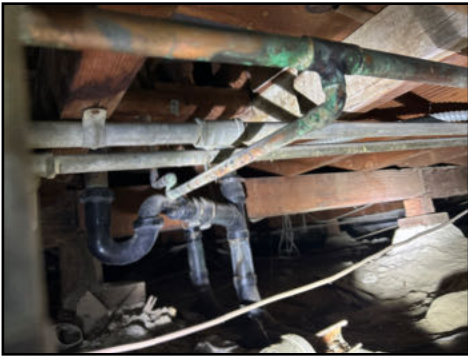
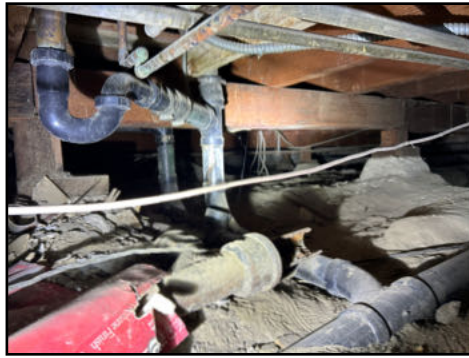
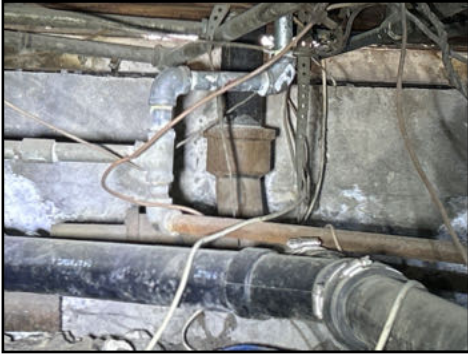
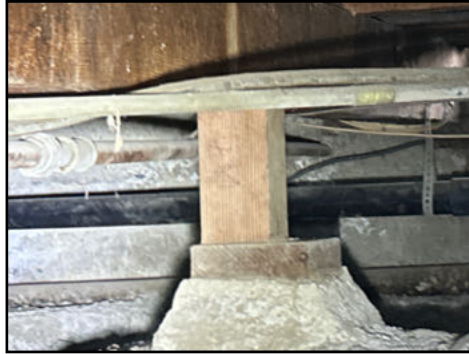
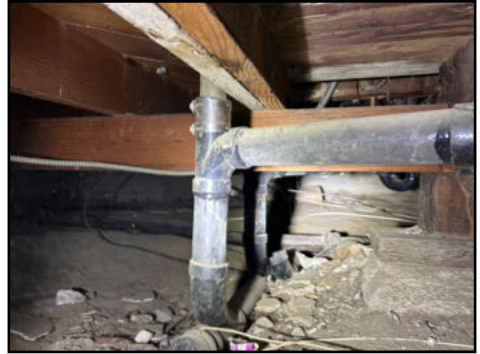
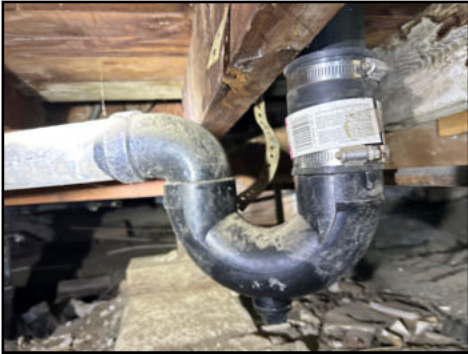
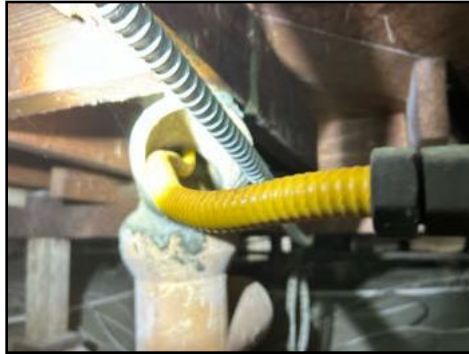
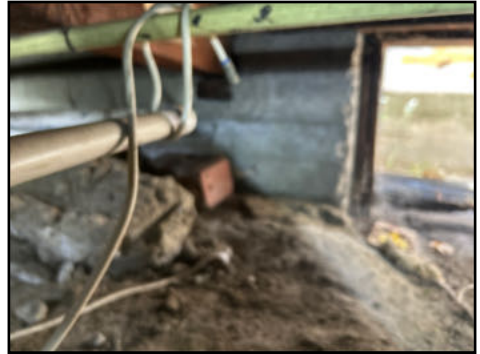
- **Galvanized** water piping present - recommend complete water distribution system evaluation due to the age of this material

Rubber drain connections present - these are not for long term use - recommend upgrading connections

**CSST** gas line observed - proper bonding or grounding cannot be confirmed by the Inspector, we advise you to **check permits** for installation of this type of gas line and that proper bonding or grounding has been completed.

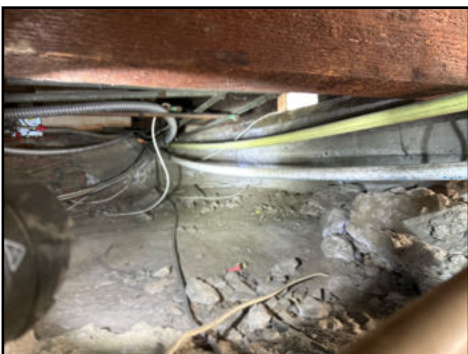
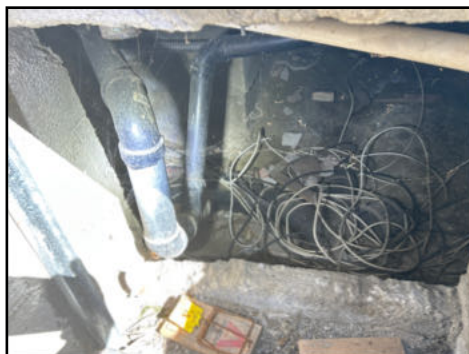
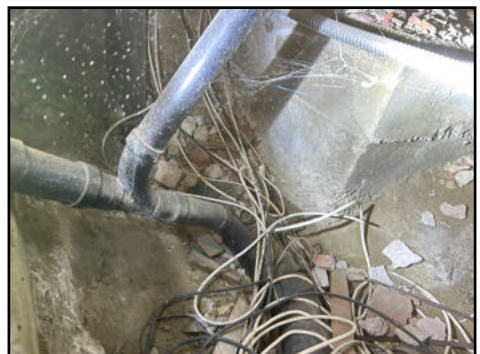
**Rubber drain connections present - these are not for long term use - recommend upgrading connections**

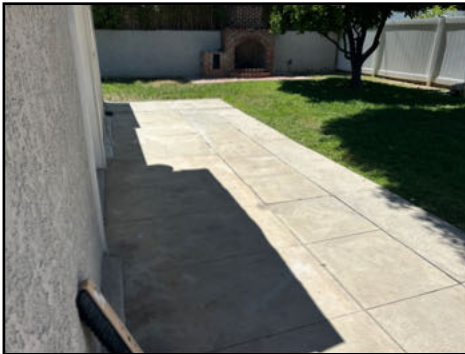
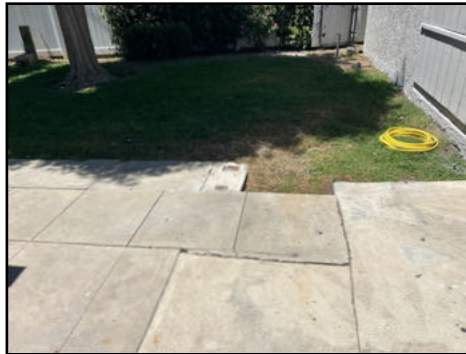
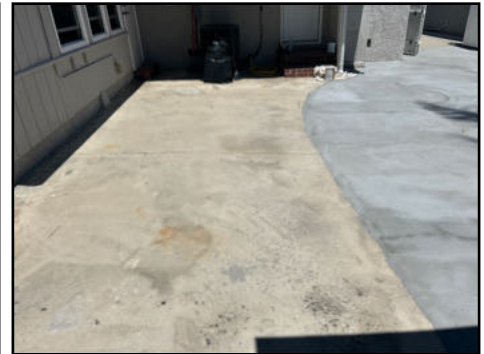
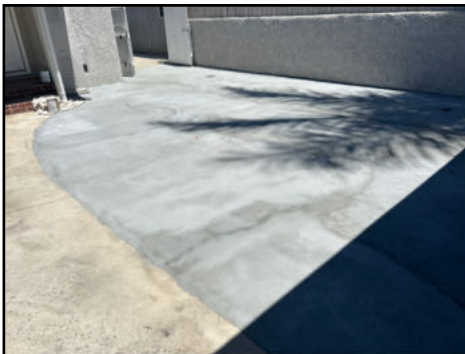
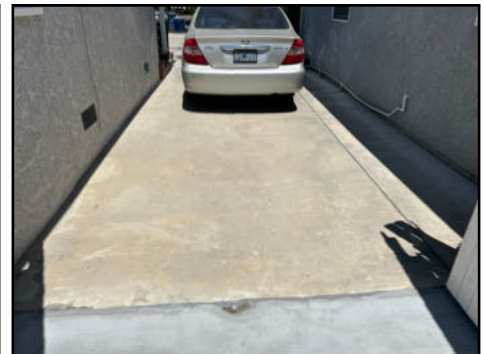
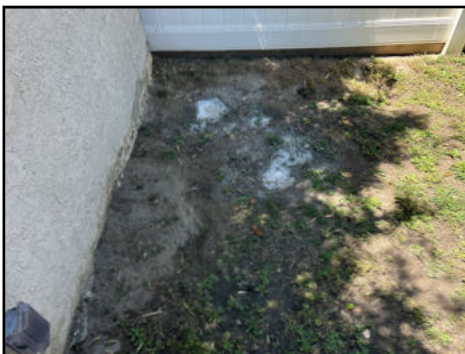
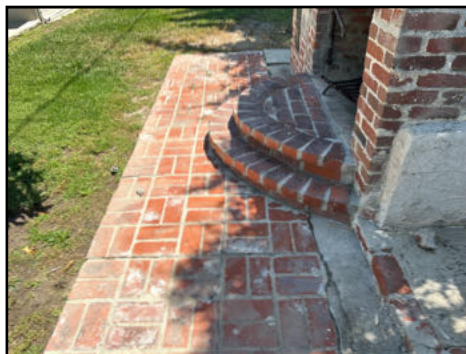
- Worn with common cracks/chips - typical for age of material
- Moderate cracking in areas - recommend **maintenance** and patching as needed
- Driveway stained in areas
- Walkways stained in areas
- Small localized water ponding may occur in areas - area drains may be needed, monitor and address as needed
- Patched areas - consult the seller for any past repairs or reasons for patchwork
- **Check permits** on any additions/alterations/modifications
- **Recommend concrete contractor to evaluate**
- **Cracking/chipping large - recommend servicing**
- **Walkway displacement/uplifted/uneven areas - potential trip hazard - needs to be serviced**

Cracking/chipping large - recommend servicing

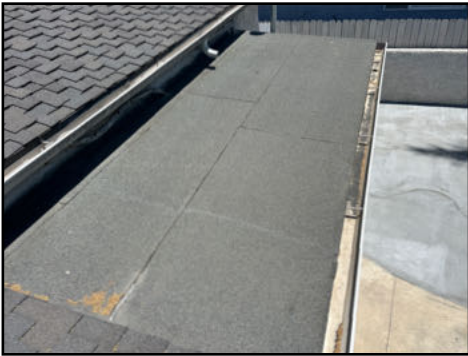
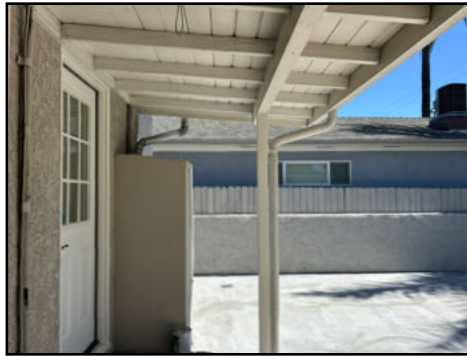
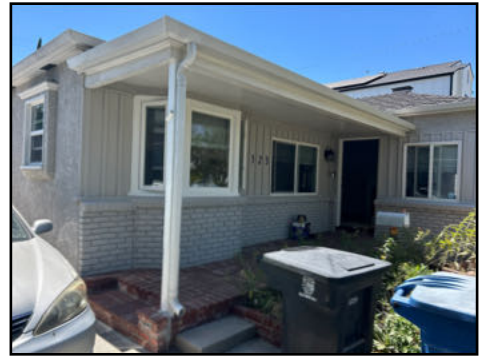
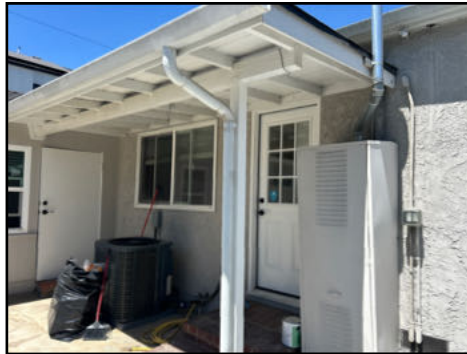
- See main roof page for porch/patio areas as observations may be applicable to patio/porch structure and materials
- Worn/weathered materials - typical for age
- **Consult termite report** for all exterior wood conditions
- **Check permits** for any alterations/roof replacement
- Rolled roofing materials present – recommend regular **maintenance**
- **Inspector cannot determine if patio/porch roofs are water-tight, no water testing of any kind is performed at this inspection**
- Recommend consulting with appropriate licensed contractor for further consultation and repair options

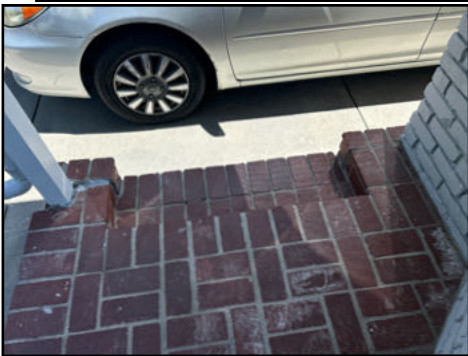
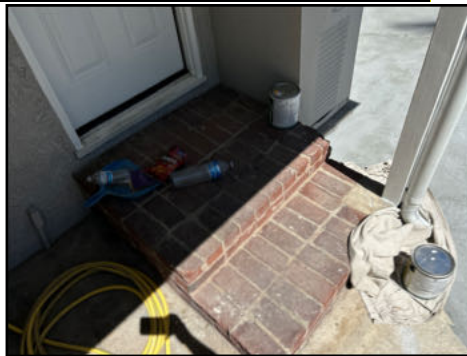
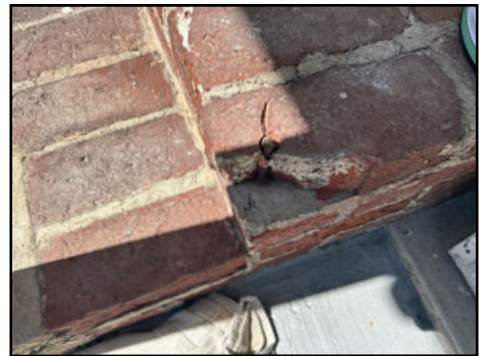
- Stairs are worn/weathered - typical for the age of the materials
- Cracking present at stairs/steps areas
- **Damaged steps - unsafe - needs to be serviced**
- **Recommend appropriate licensed contractor for further evaluation**

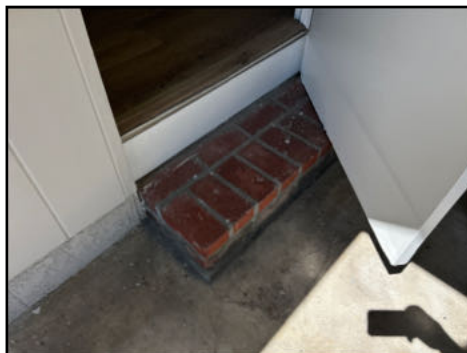
**Damaged steps - unsafe - needs to be serviced**

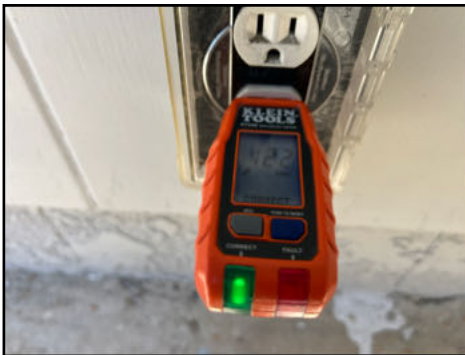
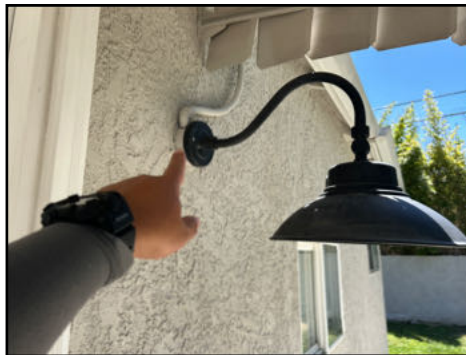
Electrical fixtures need to be caulked/sealed to wall attachments to help prevent moisture entry

Loose fixture(s) - needs to be serviced

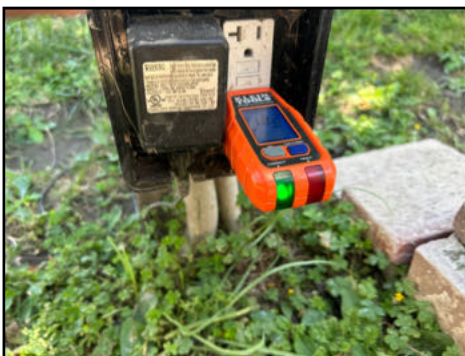
Electrical fixtures need to be caulked/sealed to wall attachments to help prevent moisture entry

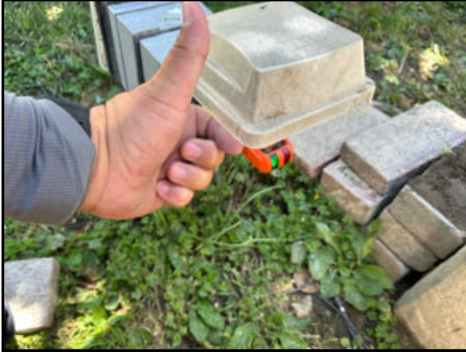
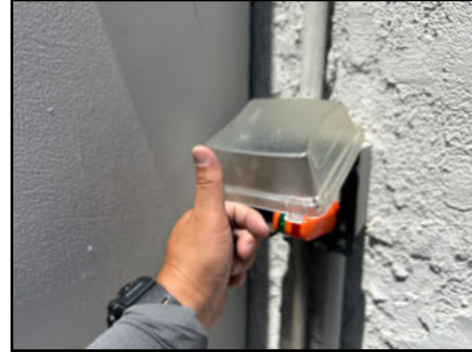
- **GFCI** upgrades are recommended on exterior outlets for increased safety
- Tested and operational at time of inspection via normal control
- **Check permits** for any alterations
- Recommend a licensed electrician to evaluate

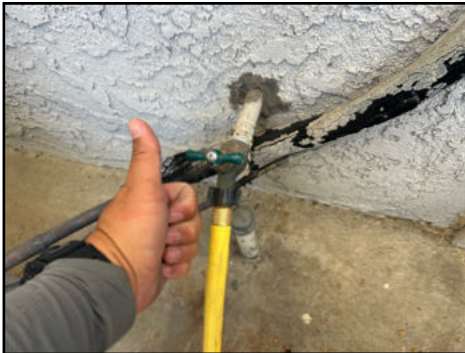
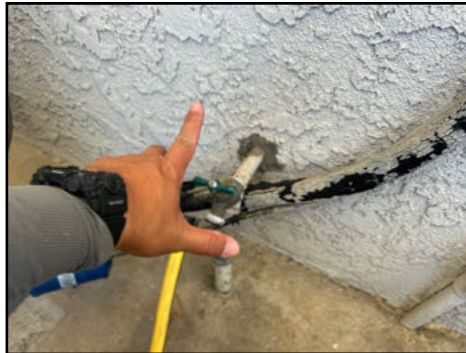
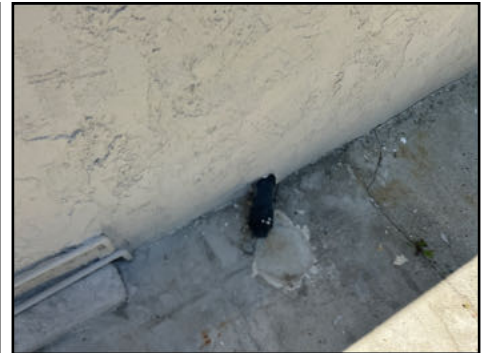
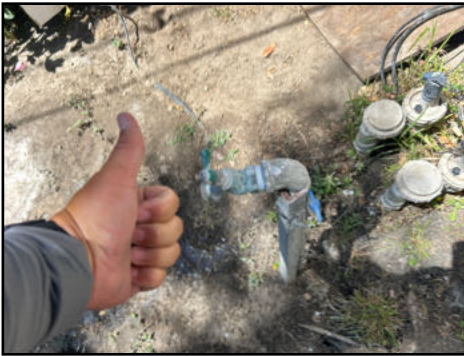
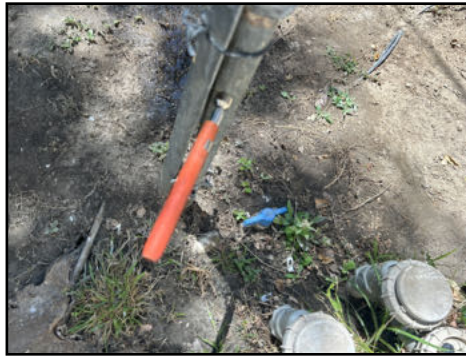
- Exterior plumbing is present and not original to the structure - check all installation permits to ensure installation to building code
- Accessible exterior faucets operated/worn at time of inspection via normal fixture controls
- **Check permits** for any alterations
- **We recommend adding anti-siphon/backflow preventers (if not already present) on all exterior hose bibs for optimum potable water protection**
- Recommend a sewer camera inspection
- **Galvanized water piping present - recommend complete water distribution system evaluation beyond the scope of this inspection due to age/type**

**Galvanized** water piping present -  
 recommend complete water  
 distribution system evaluation  
 beyond the scope of this  
 inspection due to age/type

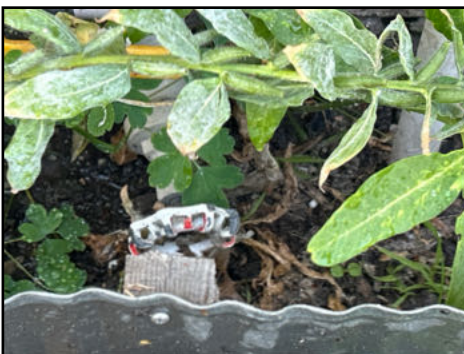
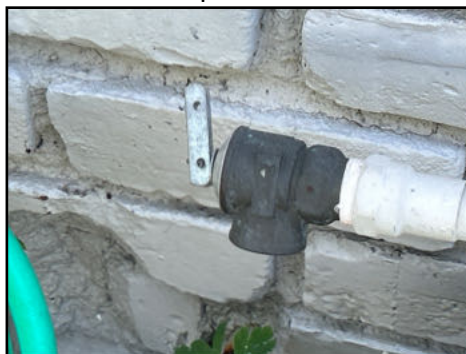
- Location: west side
- No visible leaking found at the main valve area at the time of the inspection
- **Gate valve** present/worn (these types of valves are known to fail internally) - consider upgrading to a ball valve

- Pressure relief valve present on exterior line - not tested
- **Check permits** for any alterations
- *Main water shutoff is visibly inspected only - the valve(s) is not tested for operation due to the potential for leakage*

- Recommend further consultation with a licensed plumber

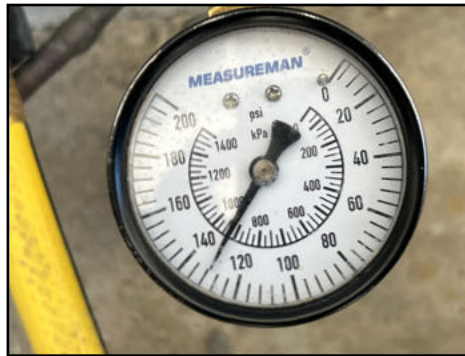
**Pressure is higher than 120 psi, we recommend that a plumber further evaluate this high pressure as soon as possible**

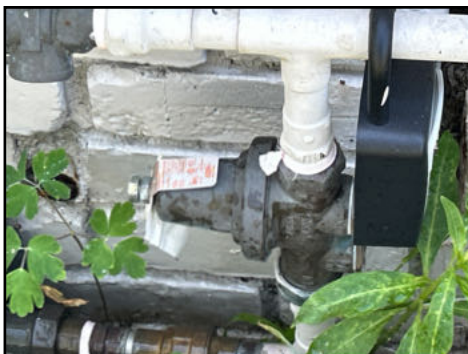
- Location: west side
- Location: at main valve area
- Regulator appears to be worn and older, **consult with a plumber** regarding upgrade options
- **Check permits** for any alterations
- **Visibly inspected only - the regulator is not tested for adjustment operation due to the potential for leakage**
- Recommend further consultation with a licensed plumber
- **Installed but pressure is above 80 PSI - recommend further evaluation by a plumbing contractor**

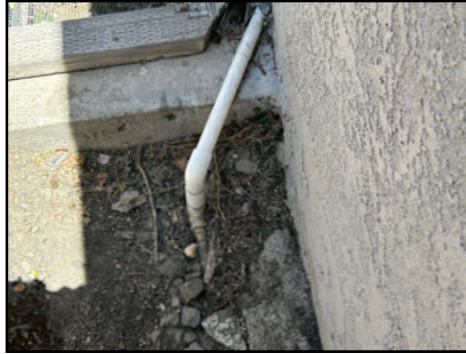
- Exposed PVC piping present – recommend servicing
- Sprinklers are beyond the scope of this home inspection. However, defects or problems were visible at the time of inspection. It is recommended that a qualified landscape contractor fully evaluate and service as needed.
- Check permits for any alterations
- Recommend landscape contractor or plumber to further evaluate

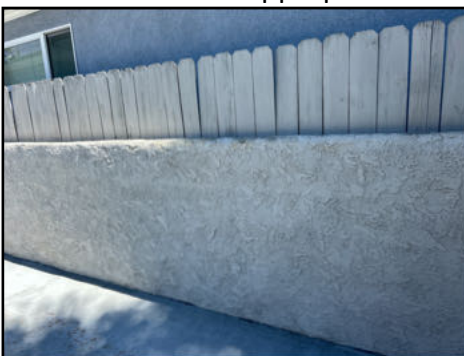
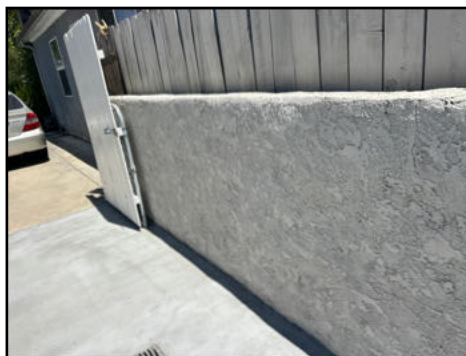
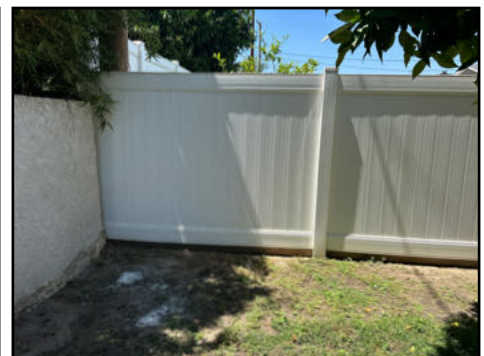
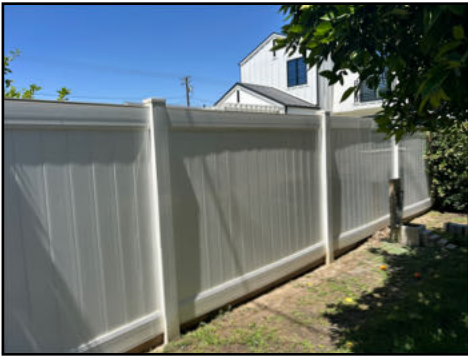
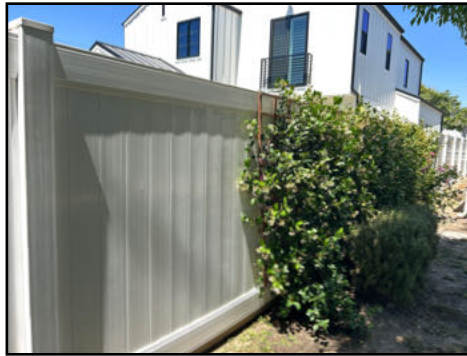
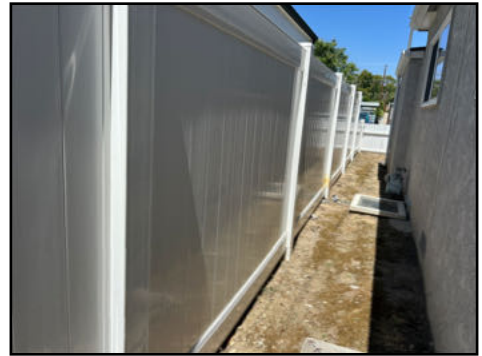
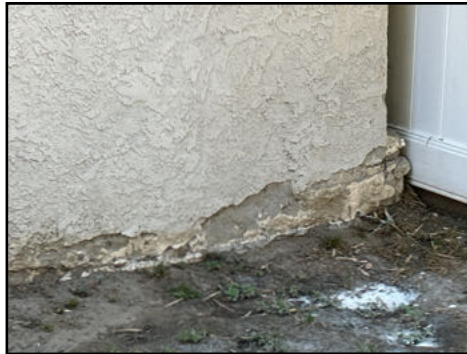
- Visible fencing/wall areas are worn and weathered - typical for the age of the materials
- Some wall/fence areas not visible for inspection due to vegetation/personal items

- Cracking/chipping small and typical for age at block - monitor for further cracking and repair as needed
- Vegetation or trees are affecting the fencing/walls in areas - recommend servicing

- Efflorescence present at masonry/concrete wall - this may be a sign of moisture intrusion or lack of drainage – further evaluation recommended
- Check for permits on all alterations

**Efflorescence** present at masonry/concrete wall - this may be a sign of moisture intrusion or lack of drainage – further evaluation recommended

- Recommend an appropriate licensed contractor for further evaluation

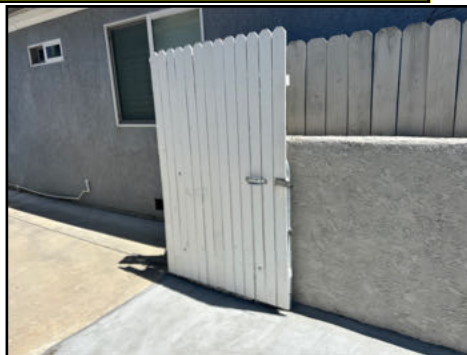
- Operated on the day of the inspection
- Loose/worn hardware - typical for age
- Gate is sagging - recommend servicing
- Gate rubs at side/bottom - recommend servicing
- Check for permits on all alterations/modifications
- **Gates are not evaluated for security adequacy**
- **Recommend appropriate licensed contractor for further evaluation**

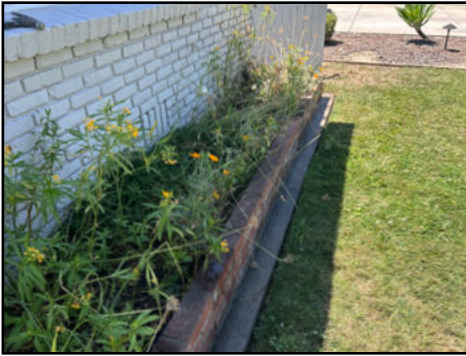
Trees or vegetation too close to structure areas - recommend servicing

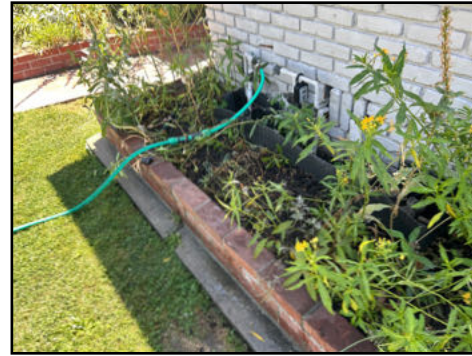
Trees or vegetation too close to structure areas - recommend servicing

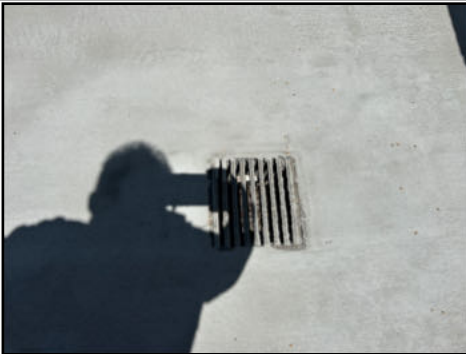
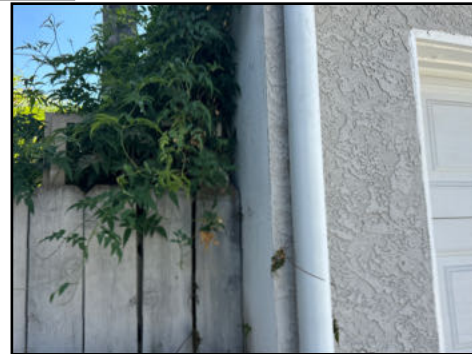
- No drains visible at the property at the time of the inspection, drains are recommended to divert water away from structure
- Zero Lot Line present - some areas around the structure are not accessible and not inspected
- Large trees/bushes/vegetation around the structure areas may have a long term affect on structure perimeter areas and the underground plumbing (recommend a sewer scope inspection for underground plumbing as needed).
- Check for permits on all alterations
- *This inspection cannot determine adequate drainage needs, the addition of drains may be needed in areas to help divert water away from the structure*
- *Steep hillsides, fire safety study and inaccessible areas on the grounds are excluded from this inspection.*
- **Recommend appropriate licensed contractor for further evaluation**

Zero Lot Line present - some areas around the structure are not accessible and not inspected

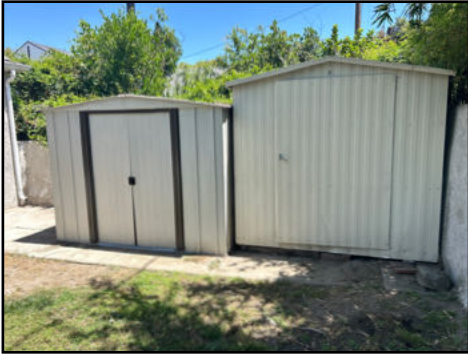
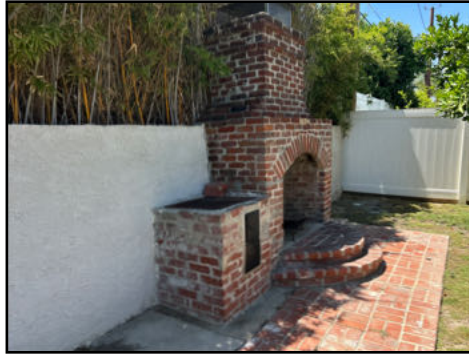
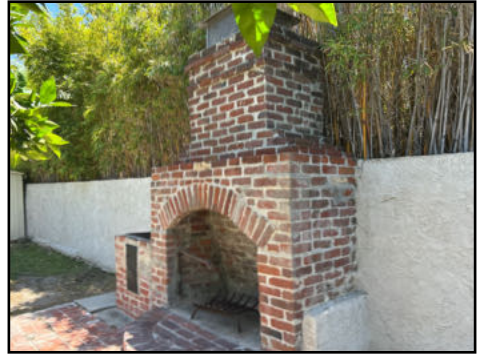
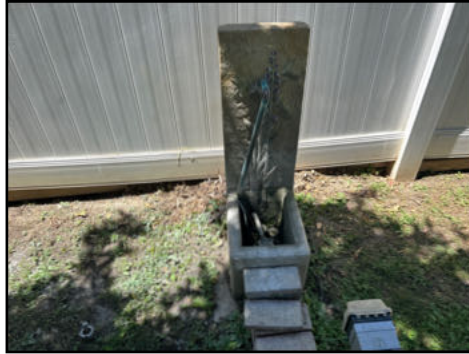
- **Out buildings, detached structures, play equipment, exterior BBQ areas, fire pits, bird baths, fountains/water features and above ground pools are not inspected. You are advised to **check permits** for any out structure(s) present - the home inspector is not a building code violation inspector**
- Shed present
- Exterior fire pit
- Pond/fountain present
- **Check permits** for the out structure(s) present - the home inspector is not a building code violation inspector

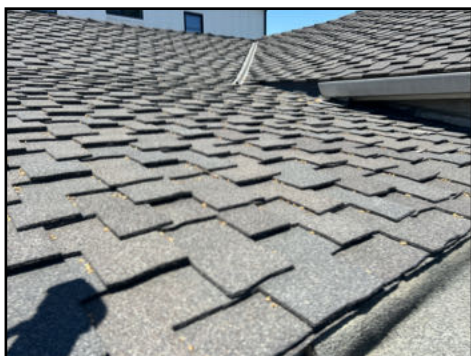
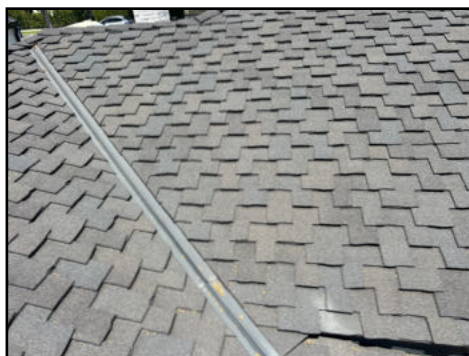
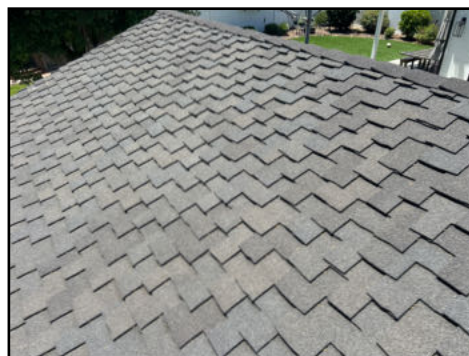
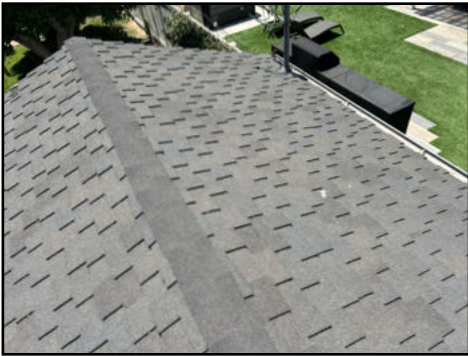
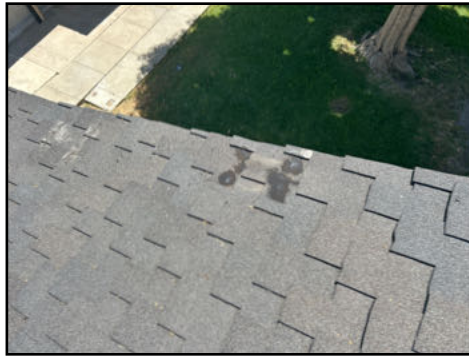
- Worn and weathered materials present - typical for age and weather exposure - roof needs **maintenance**
- Evidence of prior repair/patching observed - consult seller for all past repairs and roof service history
- Patching observed in areas on roof materials - inspector is unable to guarantee the adequacy of these repairs - recommend maintaining a continuous water tight seal in these areas
- Debris present in areas - recommend cleaning roof area of all debris
- **Check permits** for any alterations/roof replacement
- **Some areas are not visible due to height/angle - recommend roofer to evaluate as needed**
- Recommend roofer to evaluate and determine remaining life of the roof materials
- **Exposed nails/staples/screws on roofing material - recommend sealing all fastener heads**

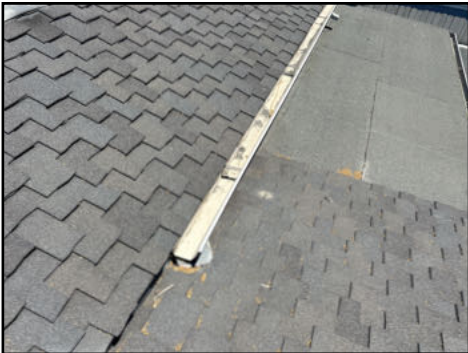
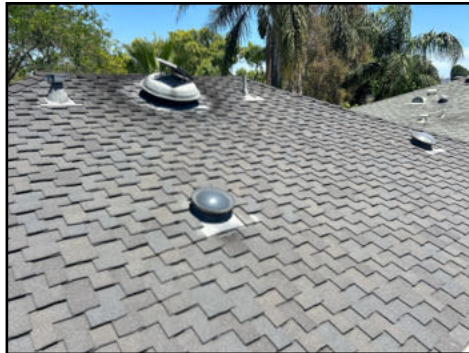
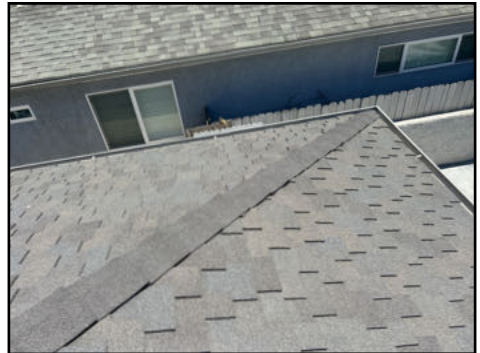
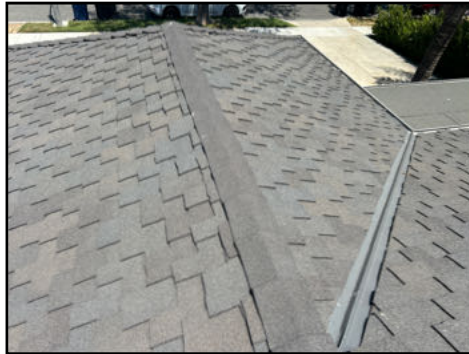
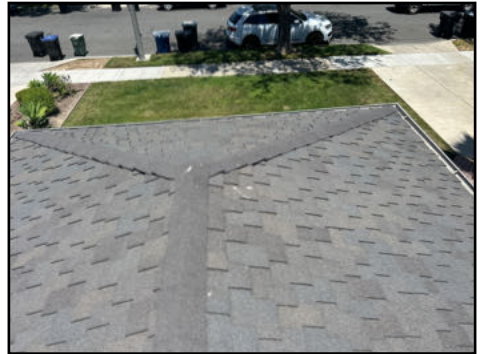
**Patching observed in areas on roof materials - inspector is unable to guarantee the adequacy of these repairs - recommend maintaining a continuous water tight seal in these areas**

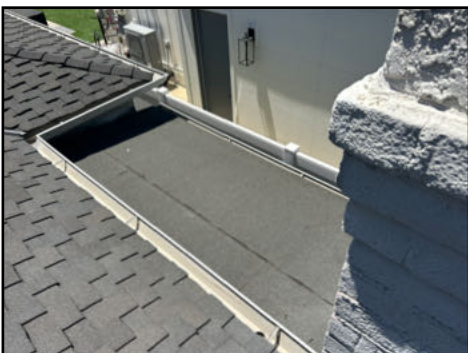
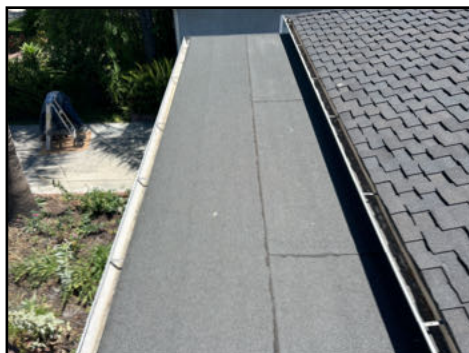
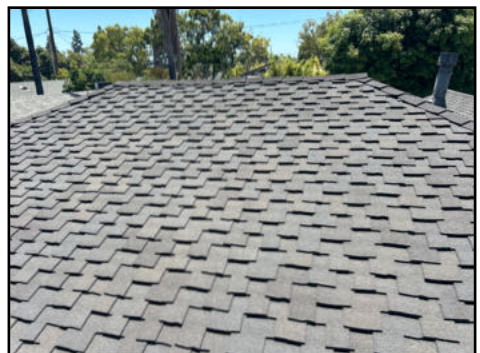
**Exposed nails/staples/screws on roofing material - recommend sealing all fastener heads**

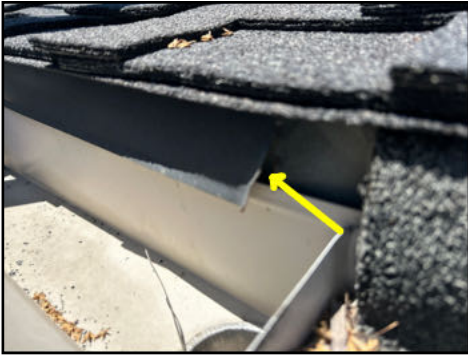
- Worn/weathered/rusted/bent - typical for age - recommend seasonal mastic **maintenance** to prevent moisture intrusion
- **Check permits** for any alterations/roof replacement
- **Recommend further evaluation by a licensed roofer**
- **Flashings lifting in areas - needs to be serviced as part of your preventative roof **maintenance****
- **No saddle/cricket at high side of chimney - needs to be serviced**
- **No kick-out flashing at roof to wall connection - needs to be serviced**

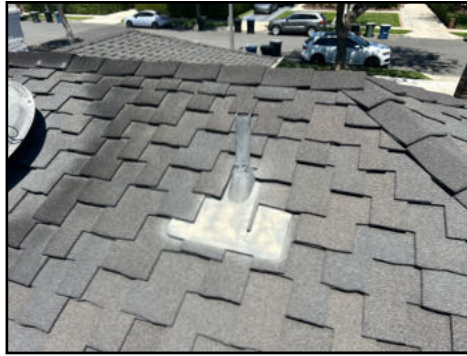
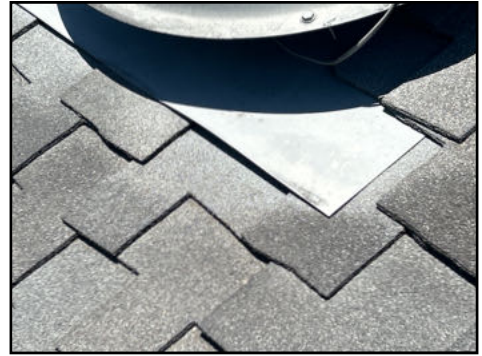
Flashings lifting in areas - needs to be serviced as part of your preventative roof **maintenance**

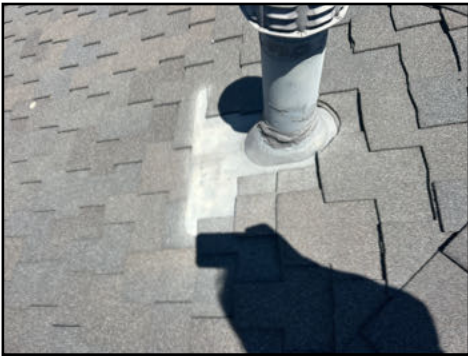
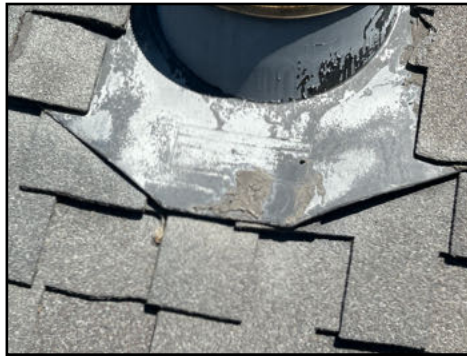
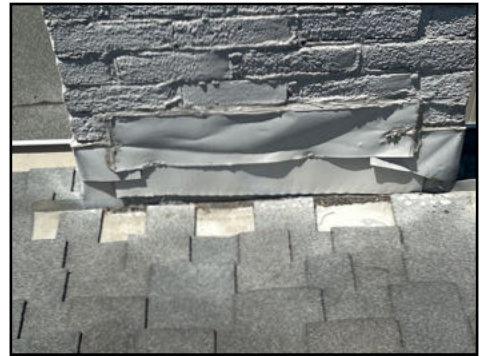
Flashings lifting in areas - needs to be serviced as part of your preventative roof **maintenance**

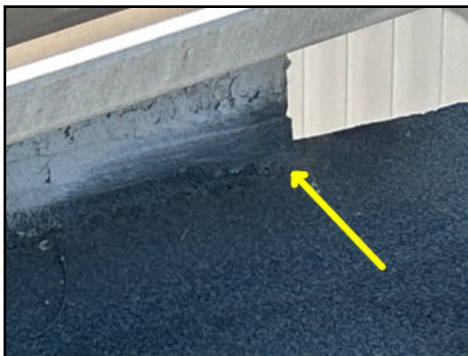
No saddle/cricket at high side of chimney - needs to be serviced

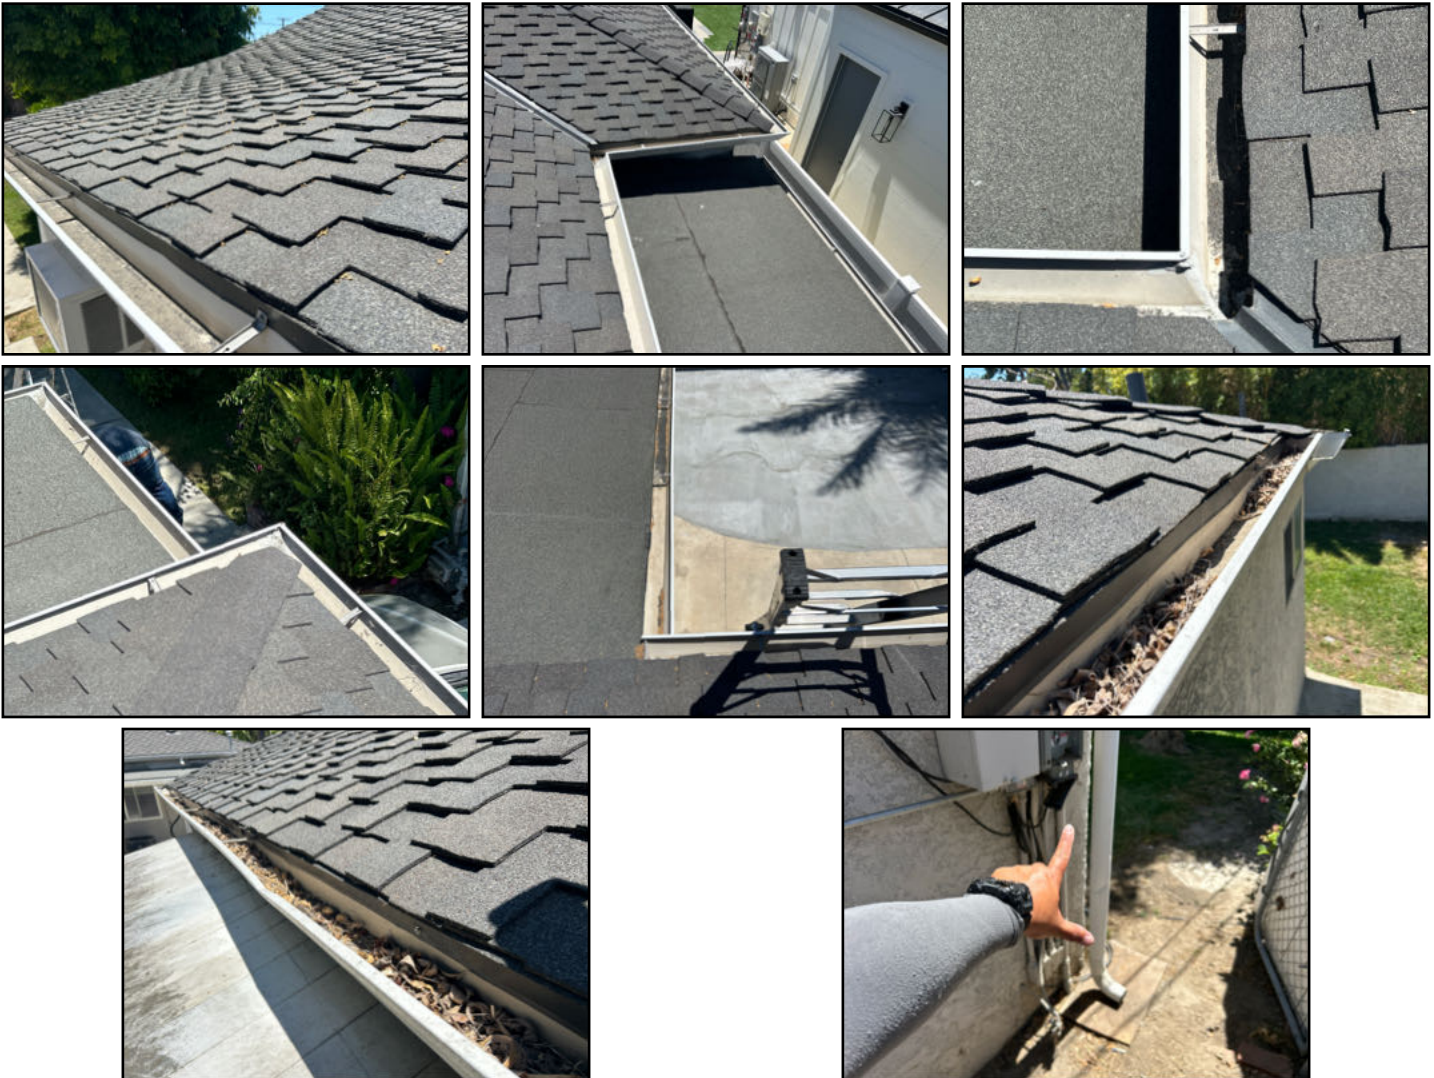
Separating from structure/loose in areas - needs to be serviced

| Page 110 Item: 3 | Gutters and Down Spouts | <ul style="list-style-type: none"> <li>• Separating from structure/loose in areas - needs to be serviced</li> </ul> |

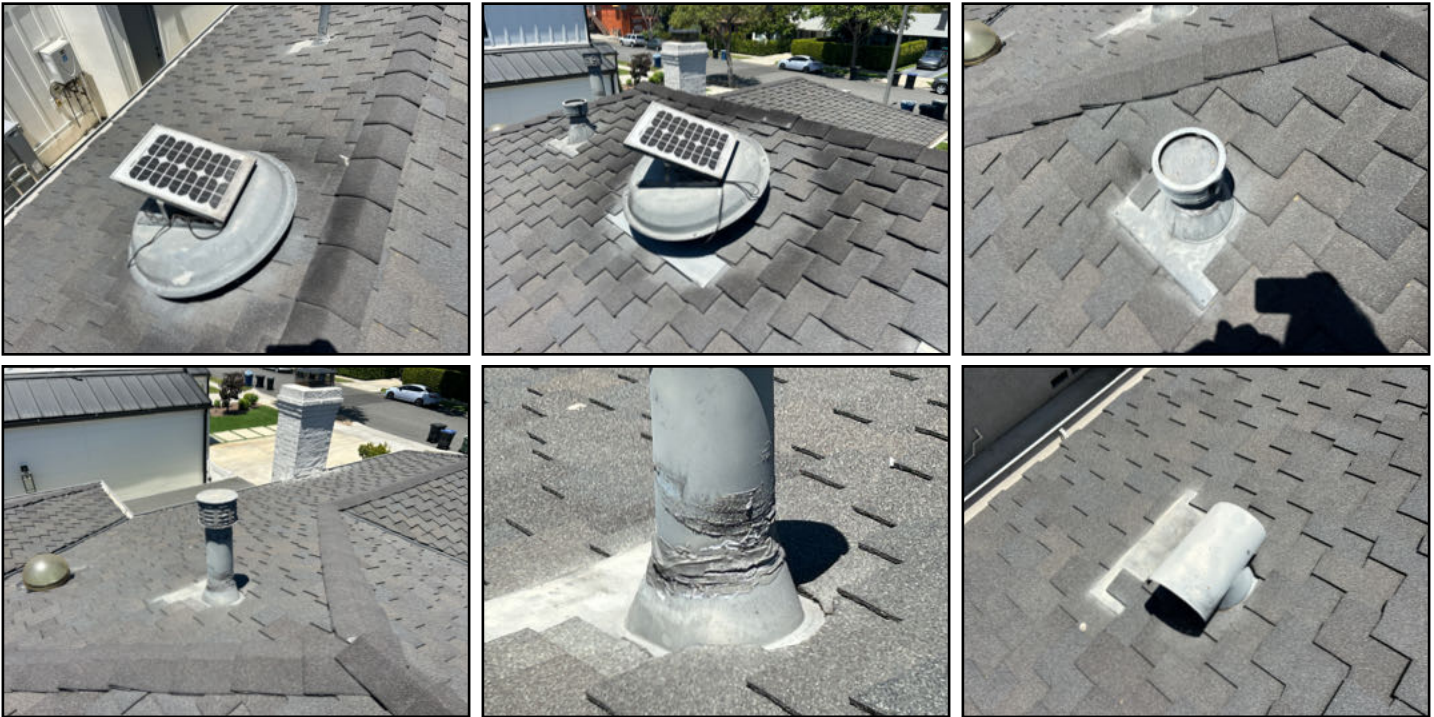
- Worn/weathered cap(s) – recommend seasonal **maintenance** to ensure that caps do not become loose or develop other defects
- **Check permits** for any alterations
- **Recommend appropriate licensed contractor for further evaluation**
- **Mastic at vent(s) is weathered and cracked - needs to be serviced and resealed at all penetration points**

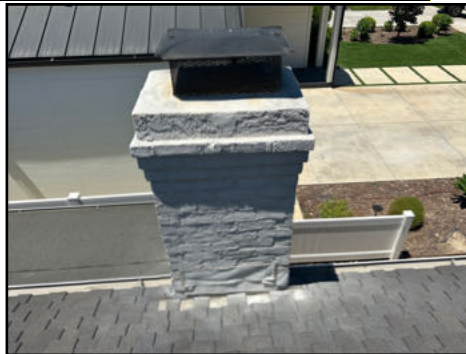
- Worn/weathered chimney – recommend seasonal **maintenance** and care
- Flashing at base of chimney appears to need some **maintenance** to ensure a continued waterproof seal
- Minor deterioration - typical for age and weather exposure
- Check for permits for any alterations
- **Chimney inspection includes all exterior accessible areas of chimney - interior cavity/flue is not inspected, consult a licensed chimney sweep contractor for further investigation and inspection of the internal areas of the chimney.**
- **Recommend appropriate licensed contractor for further evaluation**

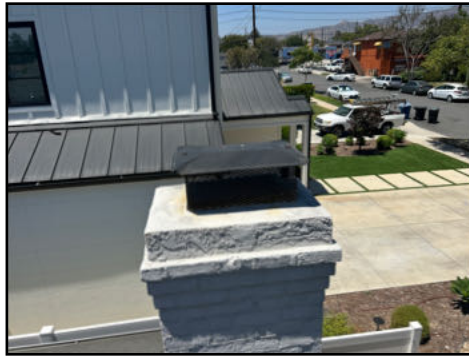
- Worn/weathered - typical for age and weather exposure
