ELITE GROUP
INSPECTION PROFESSIONALS

800-494-8998

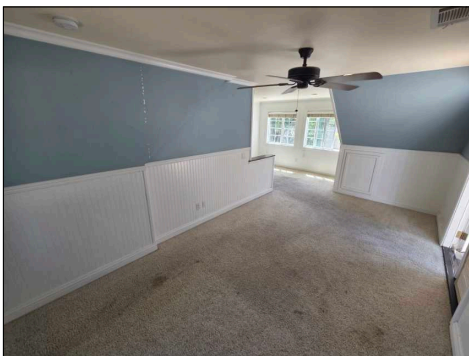
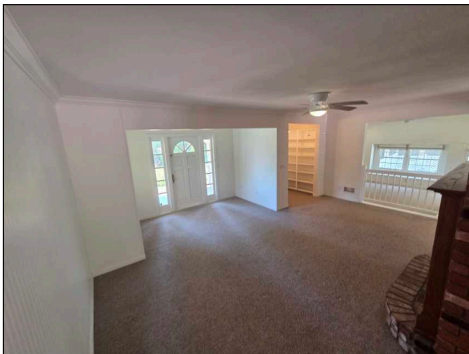
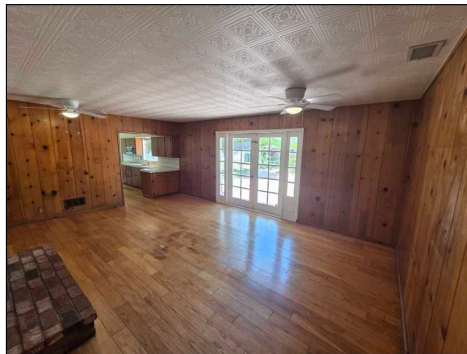
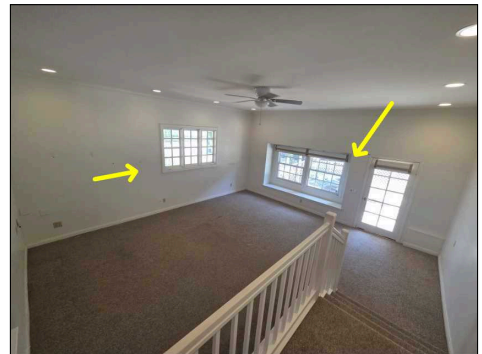
Large cracks present - signs of settlement - needs to be serviced

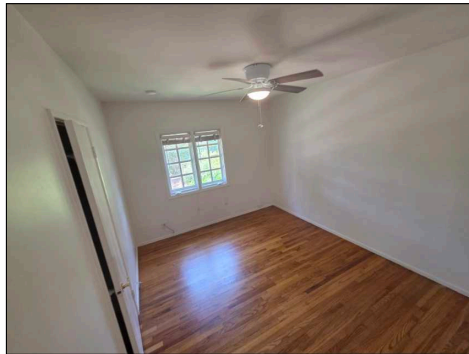
2. Ceiling Conditions

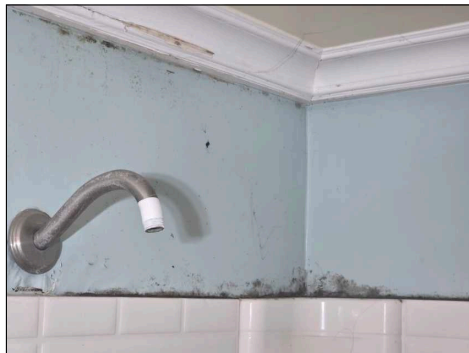
Microbial growth/irregular staining present - needs to be serviced @ ADU bathroom

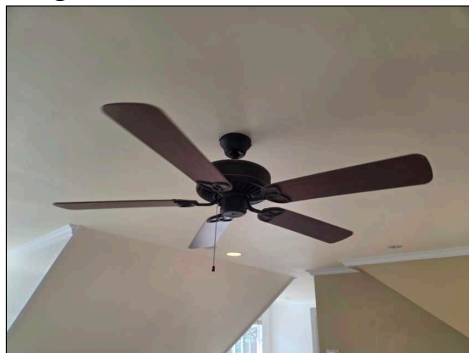
- Note: It is not possible to determine the method of attachment to the ceiling. These units are heavy and due to the designed movement, must have the proper style mounting boxes for correct and safe attachment. Recommend confirming the method of attachment prior to use. This may require the removal of the fan or insulation to visually verify proper support.
- Operated at time of inspection
- Worn/older unit(s) - typical wear for age

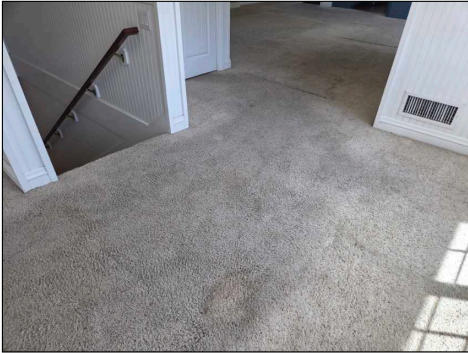
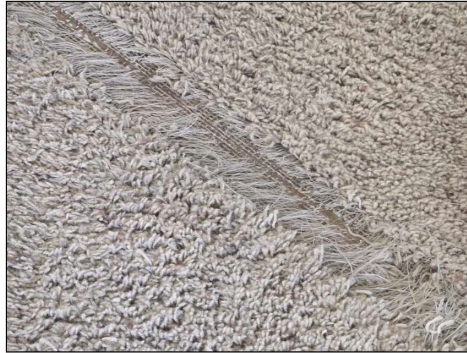
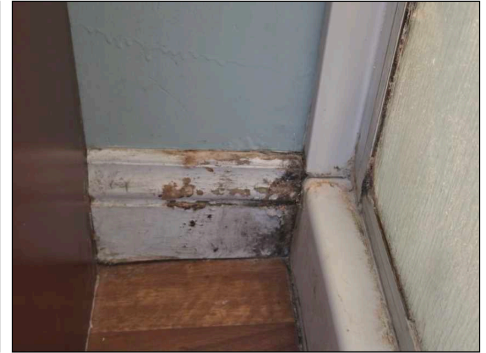
Torn/frayed carpet - needs to be serviced @ ADU

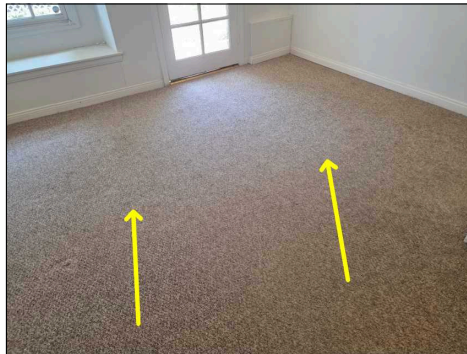
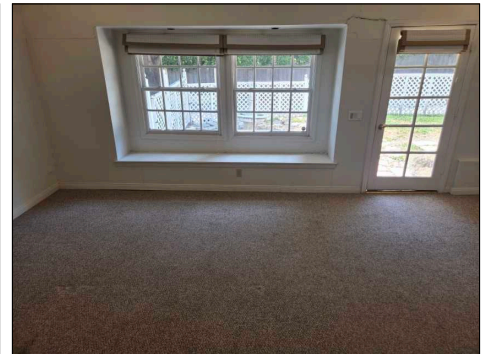
Uneven floors at east side of the structure - signs of settlement - needs to be serviced/further evaluated (see foundation section)

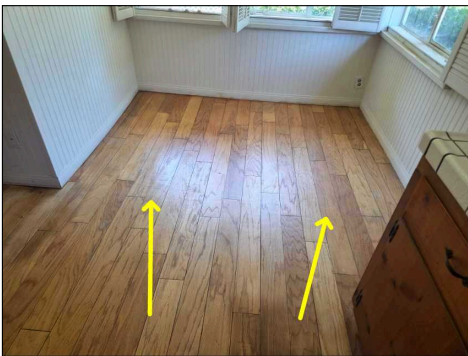
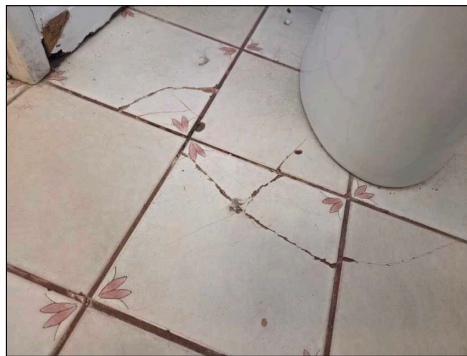
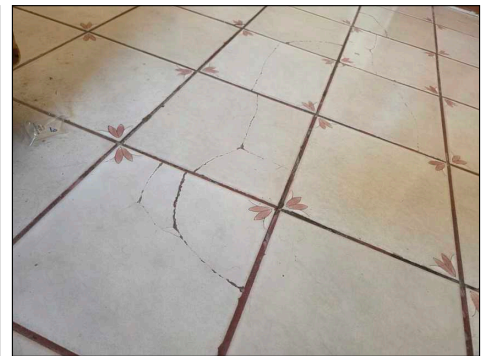
Uneven floors at east side of the structure - signs of settlement - needs to be serviced/further evaluated (see foundation section)

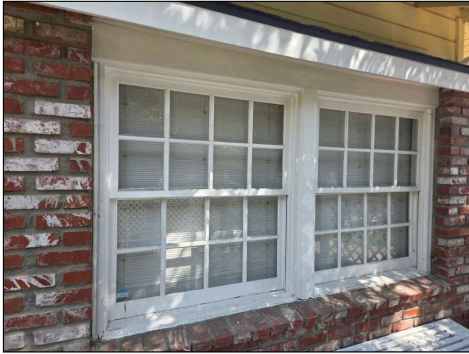
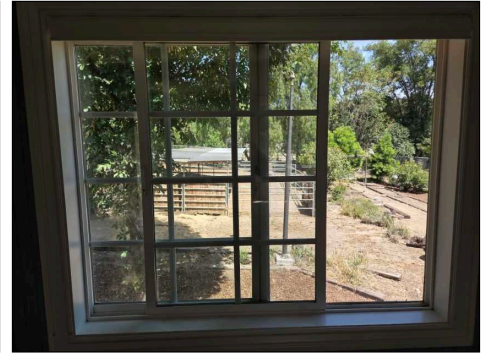
Older single pane windows present - we recommend upgrading

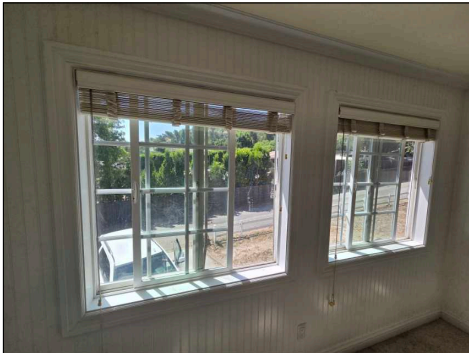
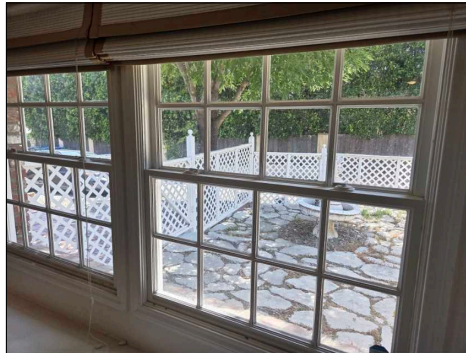
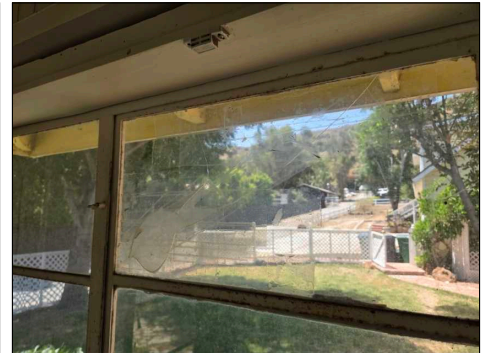
Cracked glass- needs to be serviced

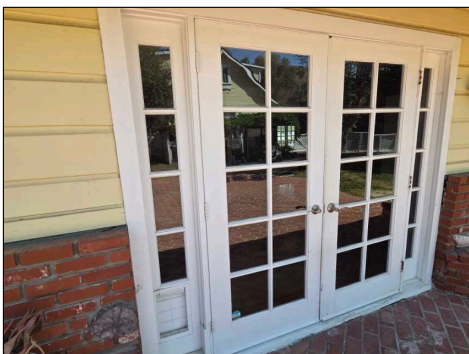
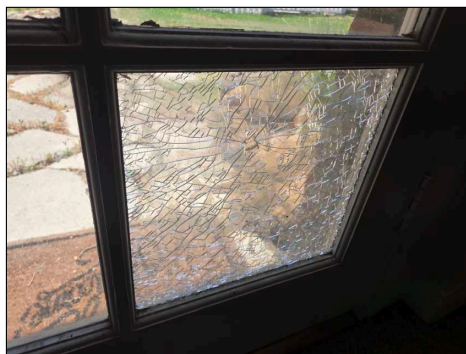
Older doors present - recommend upgrading

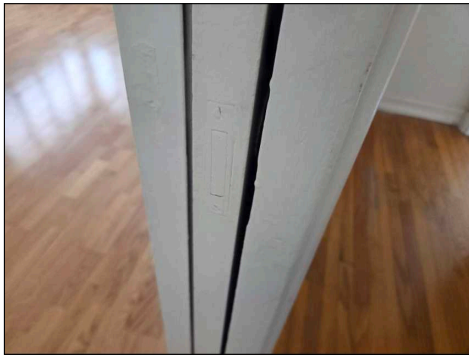
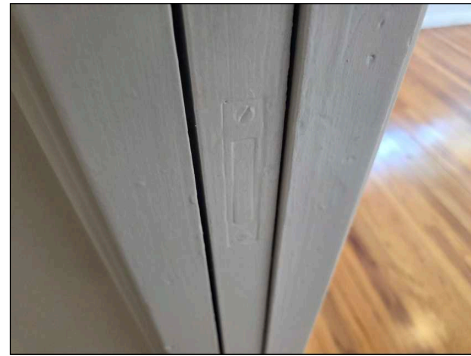
Pocket doors stuck in position - needs to be serviced **Pocket doors stuck in position - needs to be serviced**

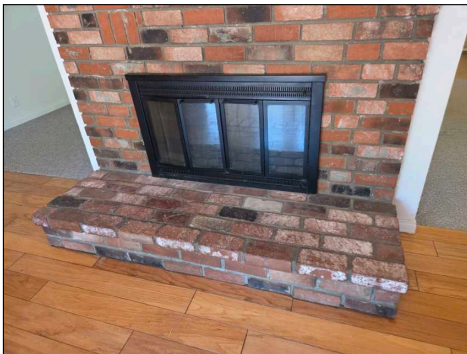
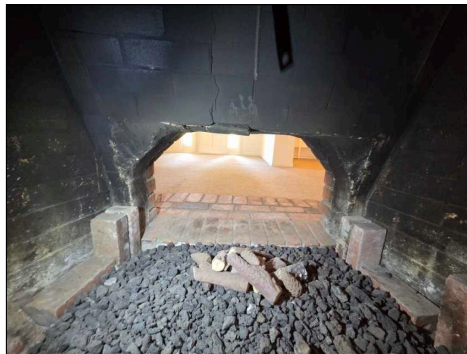
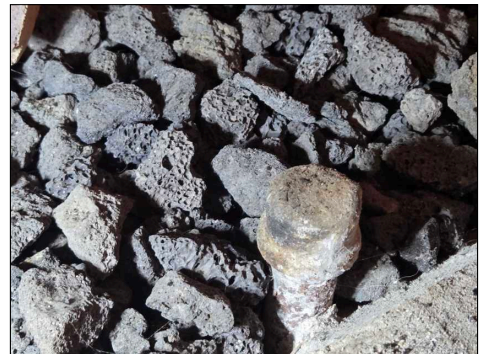
Gas line capped - no test

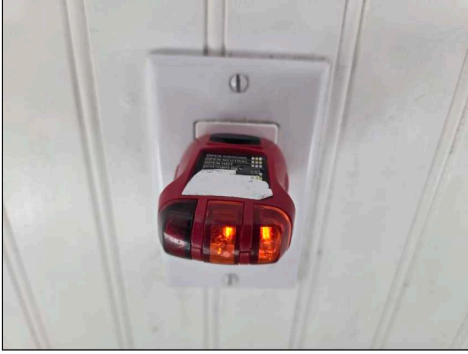
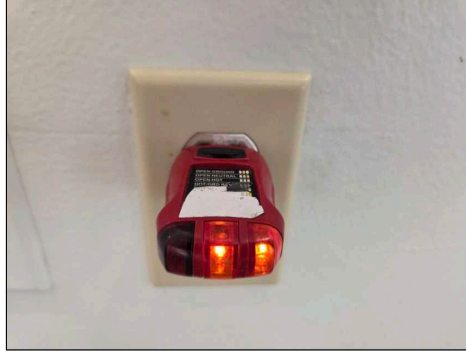
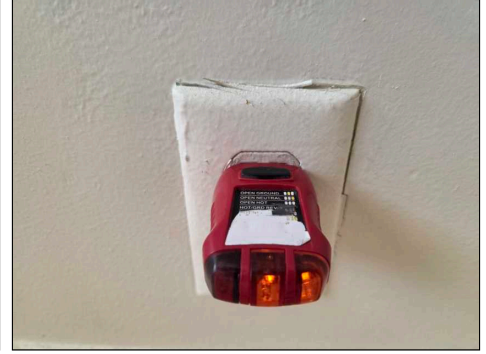
9. Stairs & Handrails

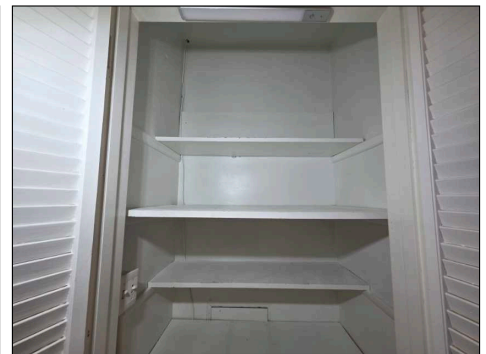
- Normal wear for age with no major visible defects

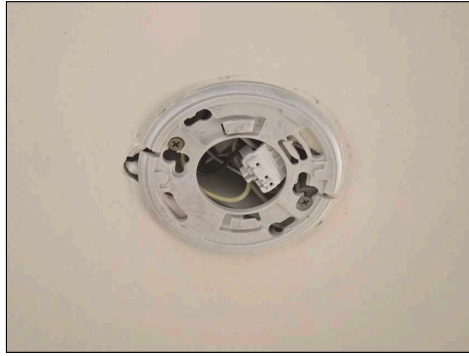
Missing - needs to be installed @ ADU

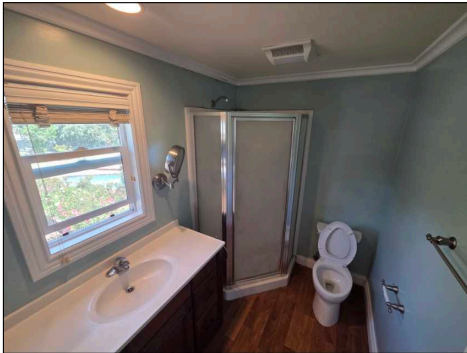
- Some counter areas not visible for inspection due to personal storage
- Counter is worn and has typical wear for age

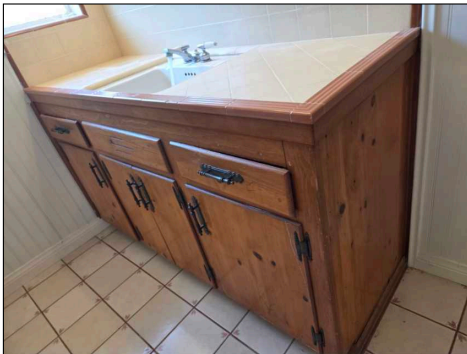
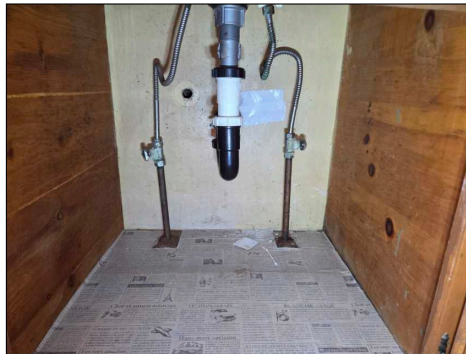
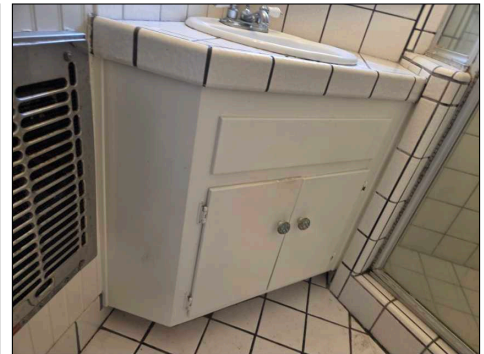
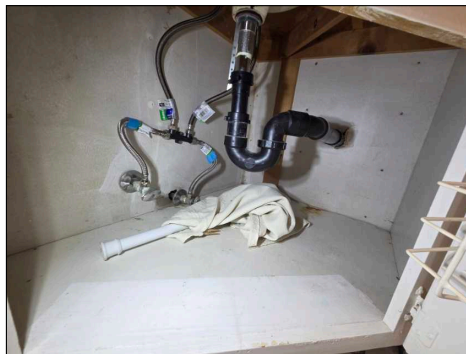
- Worn cabinets with loose/worn hardware - typical for age

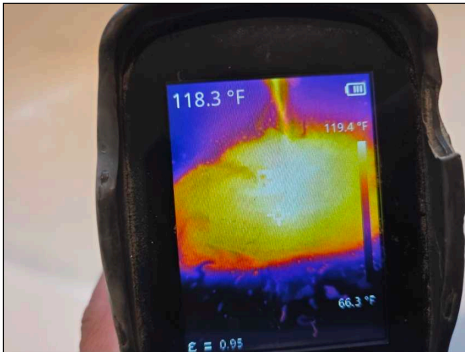
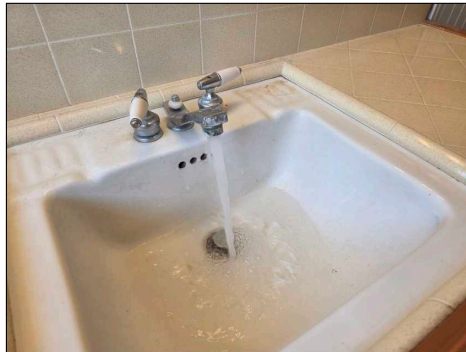
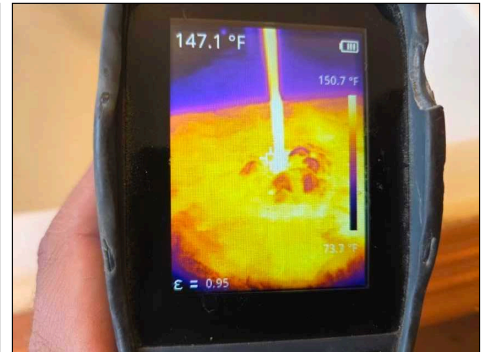
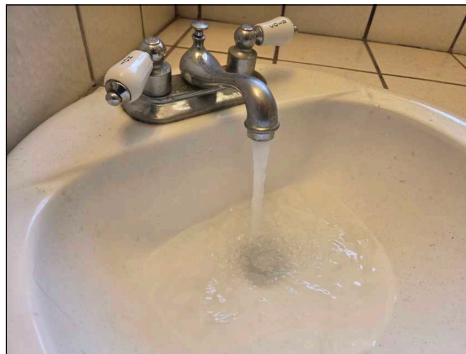
- Fixture operated at the time of the inspection
- Worn fixture/sink - typical for the age

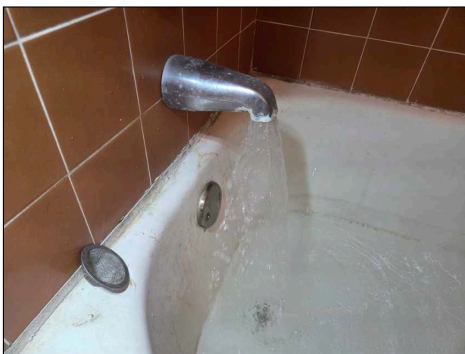
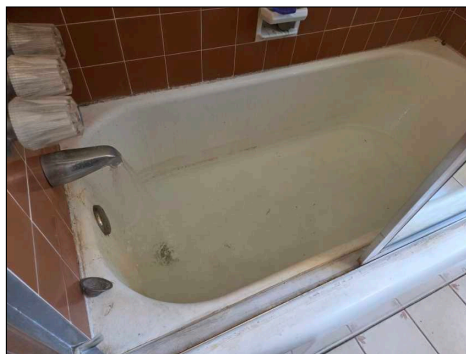
Fixture was tested and operating at the time of the inspection

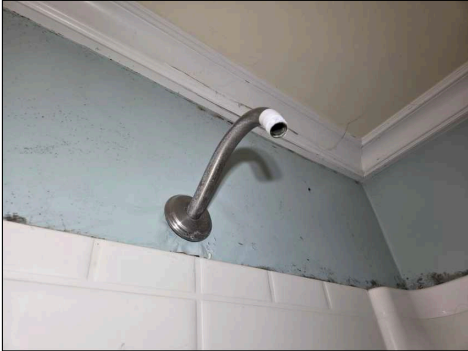
Missing shower fixture - needs to be serviced @ ADU

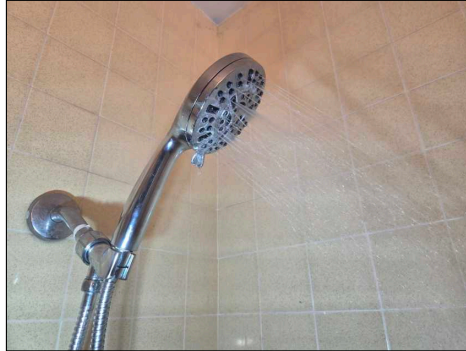
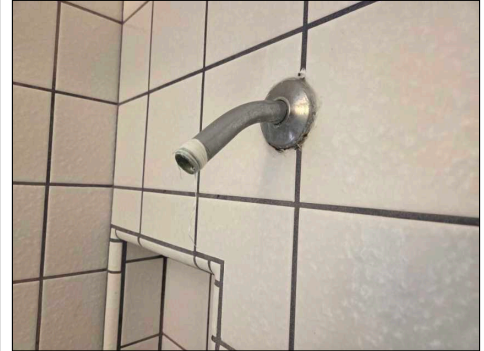
Missing shower fixture - needs to be serviced @ kitchen

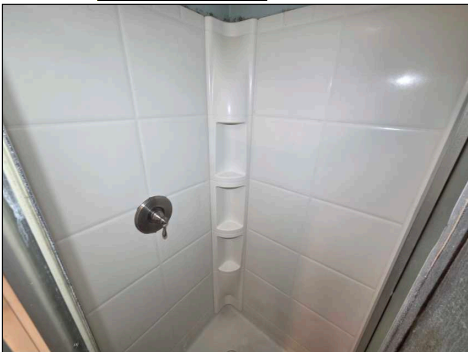
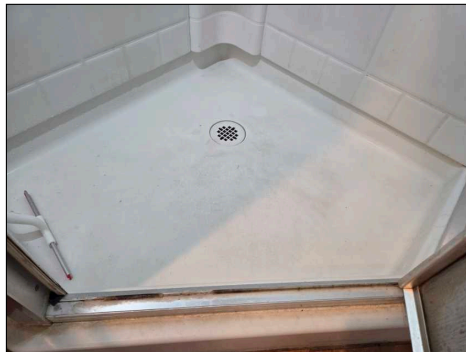
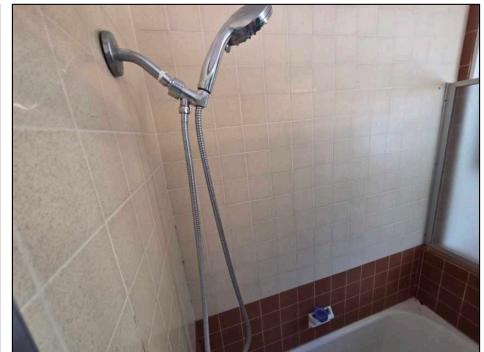
8. Enclosures / Shower doors

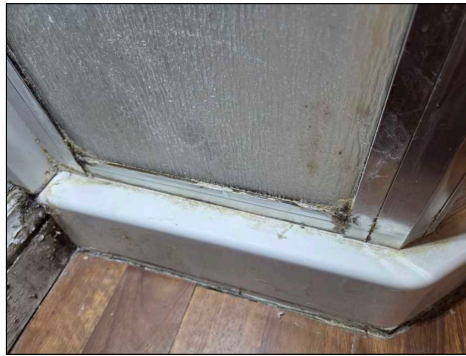
Evidence of past leaking - recommend resealing the enclosure to prevent further leaking @ ADU

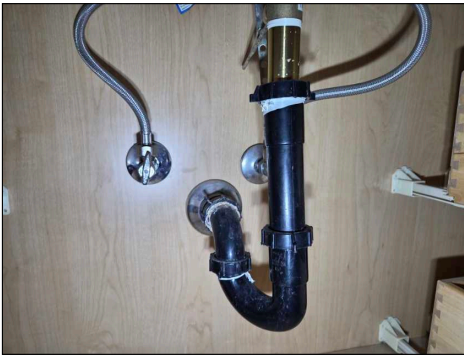
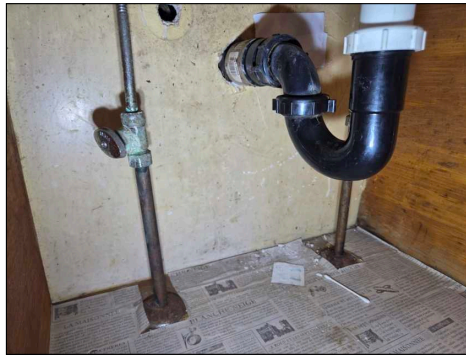
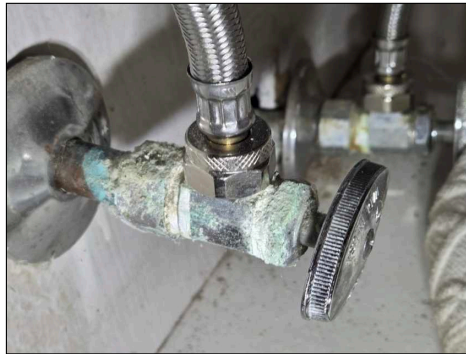
- The plumbing supply valves are visually inspected only and are not tested for functionality due to the potential for leakage - valves that are not used often will seize or freeze and are likely to leak when operated (opened/closed).
- Angle stops/hoses/drain pipes are worn/older - recommend upgrading these areas with new fixtures

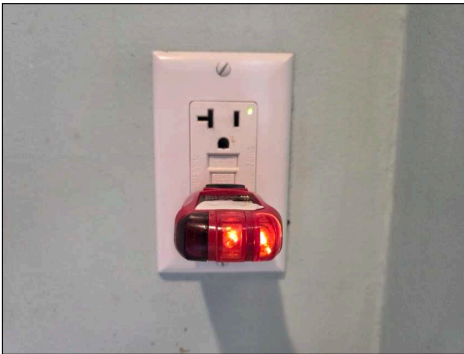
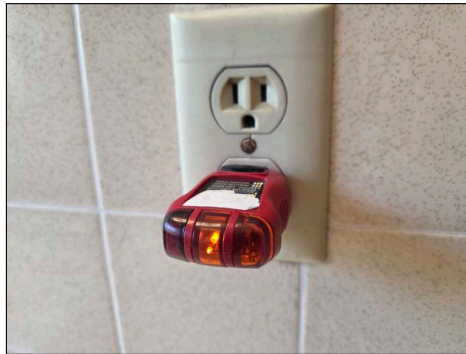
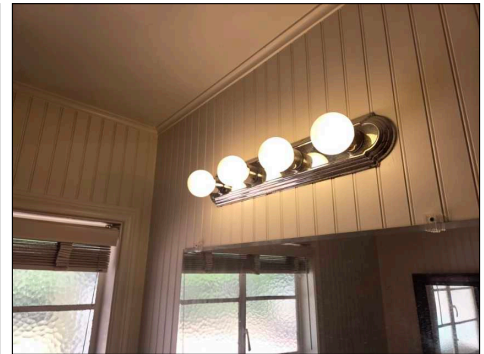
- A representative number of receptacles and switches were tested and found to be operational at time of inspection
- Outlets/switches had normal wear for age - no major visible defects

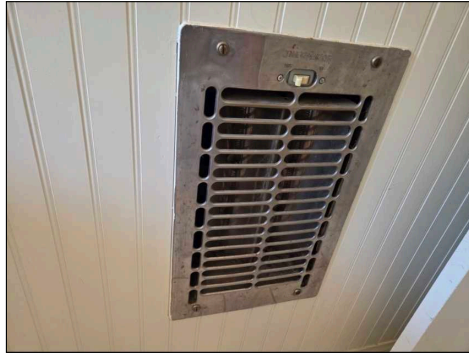
- **Recommend removal of the electric wall heating unit due to potential safety/burn hazard**

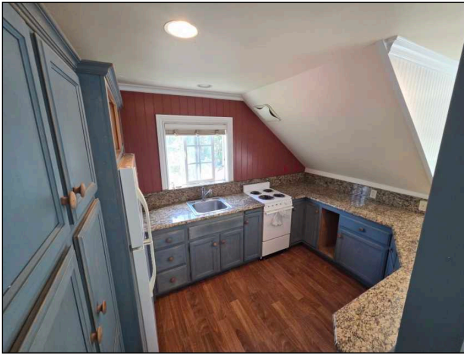
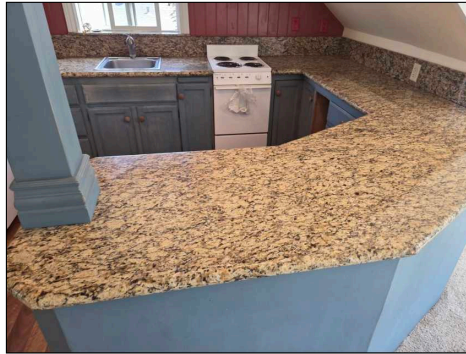
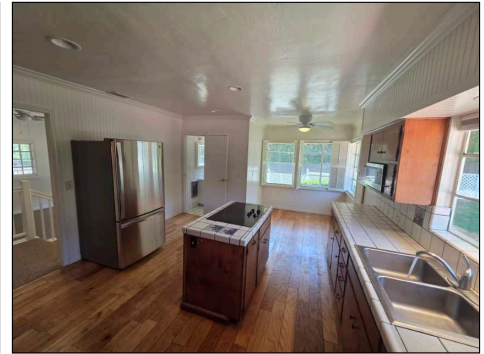
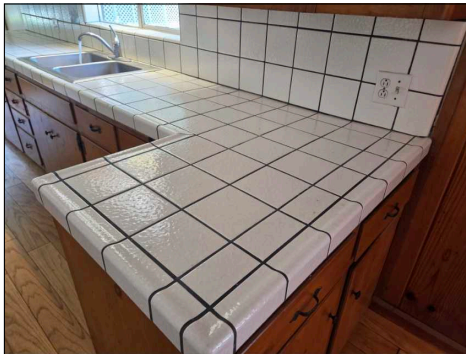
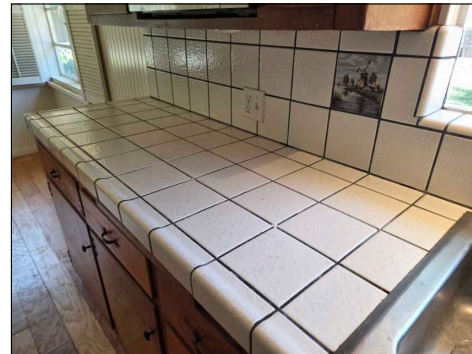
- Counter is worn and has typical wear for age
- Tile and grout is worn - recommend grout and sealer **maintenance**
- Scratched/Worn/Chipped/Stained areas - signs of age and wear

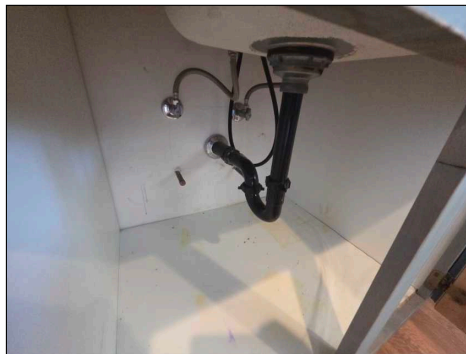
- Worn cabinets with loose/worn hardware - typical for age
- Stained areas below sink - dry at time of inspection

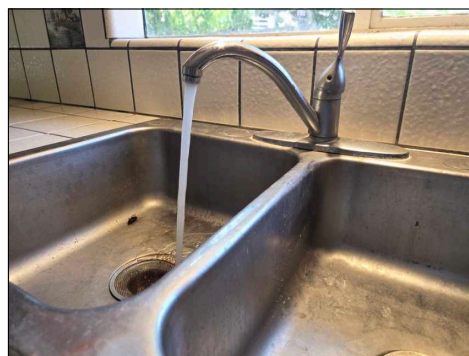
Fixture operated at the time of the inspection

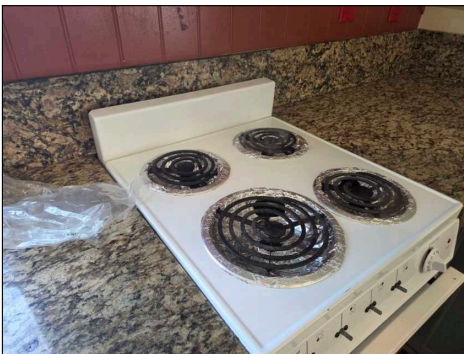
Electric supplied unit

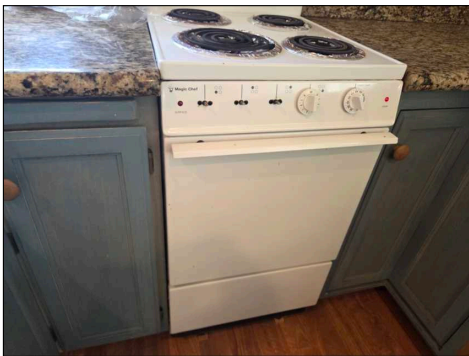
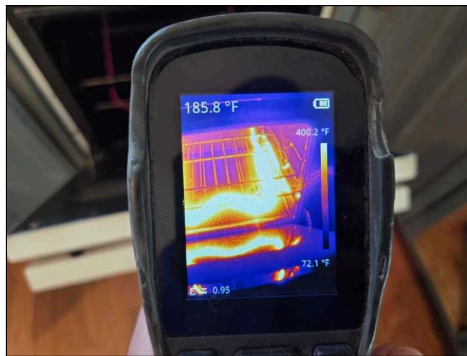
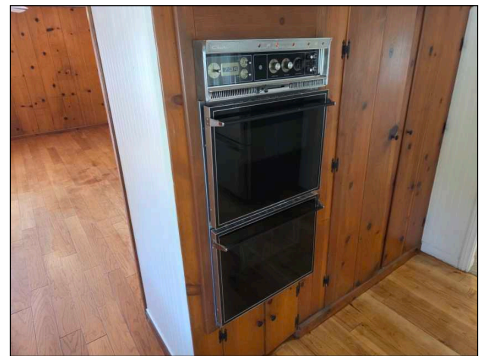
Tested and operational at time of inspection via normal controls

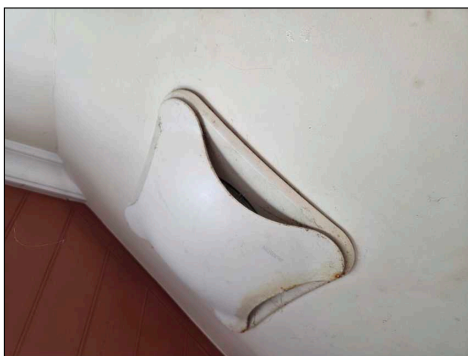
Does not operate - needs to be serviced @ ADU

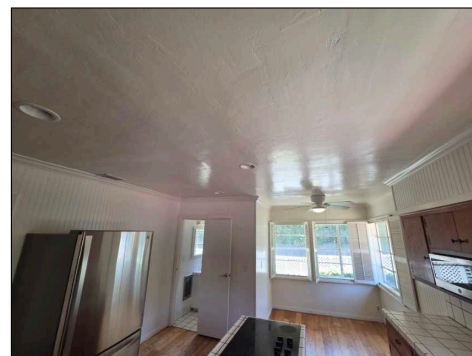
None present - recommend installing an exhaust vent system @ main

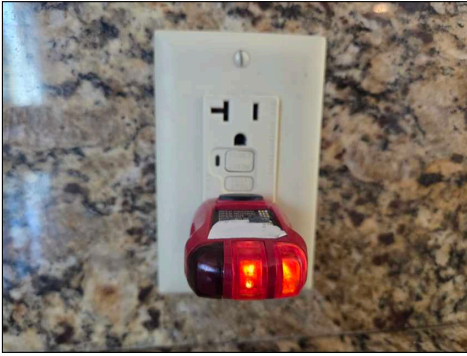
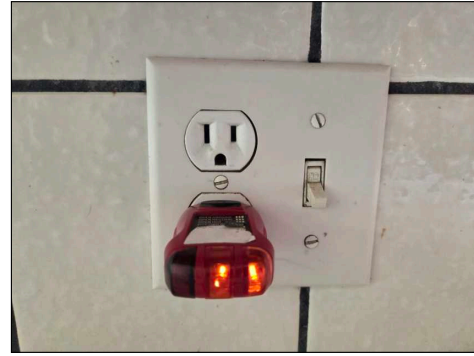
- A representative number of receptacles and switches were tested and found to be operational at time of inspection
- Outlets/switches had normal wear for age - no major visible defects

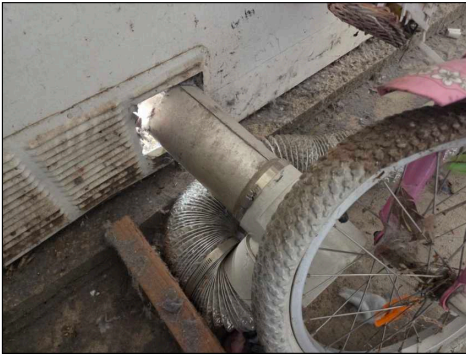
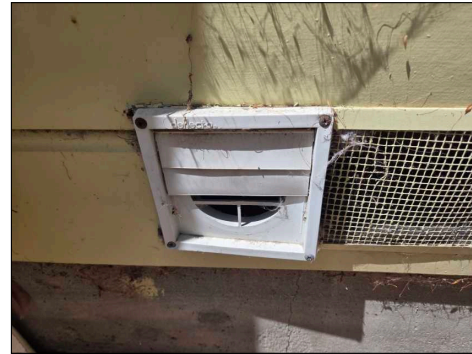
- Dryer vent should be cleaned periodically to prevent lint fire hazards
- Worn exterior cover - typical for age

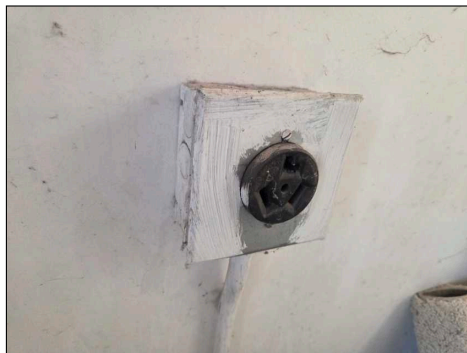
- Representative number of receptacles and switches tested and operational at time of inspection
- Visible switches/outlets have normal wear for their age - no major visible defects visible at the time of the inspection
- Has 240v service

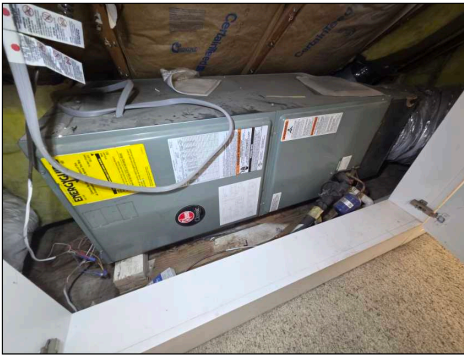
Operated at time of inspection

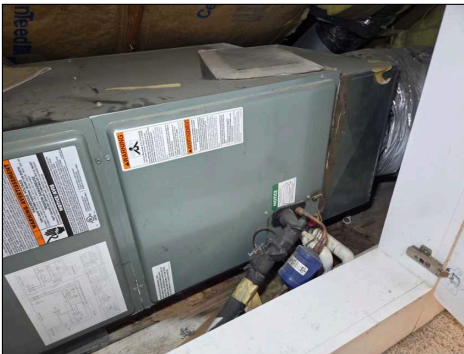
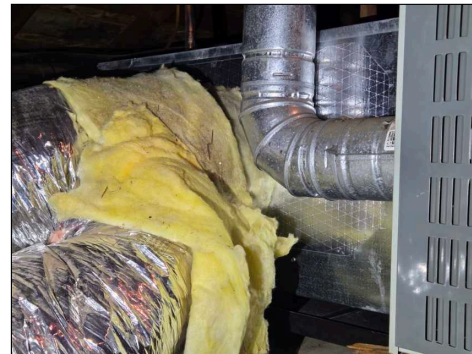
- The visible areas of the coil box have normal wear at the time of inspection - no major visible defects
- The **a/c** coil box is only examined on the exterior - an internal inspection is not completed on the coil box - **consult a HVAC contractor** to further evaluate as needed
- This inspection does not determine if the evaporator coil BTU size is the same as condensing unit size - **consult a HVAC contractor** for further evaluation as needed
- Limited access to all sides prevents a complete inspection of the coil box

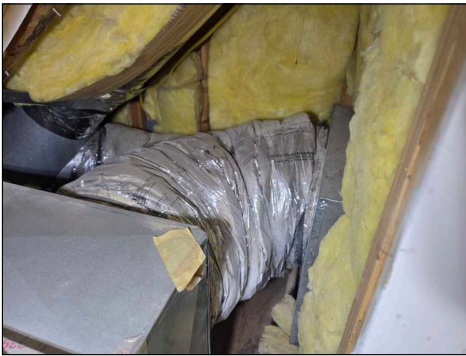
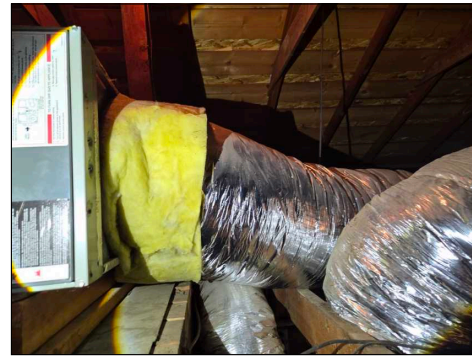
5. Gas Supply Valves and Pipes

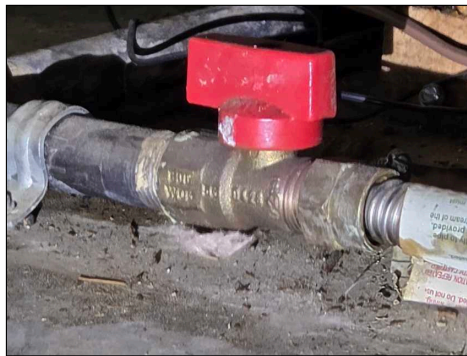
- Normal wear at time of inspection - no major visible defects

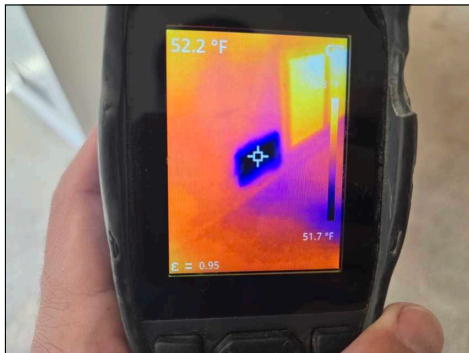
A/C Temperature 53° @ ADU

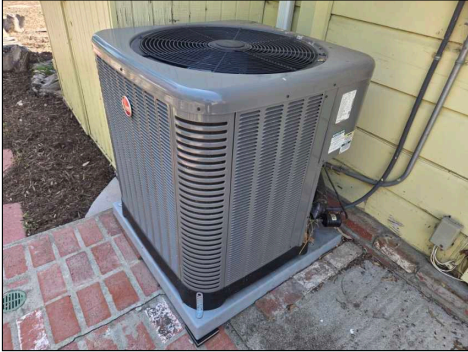
Operated at the time of inspection

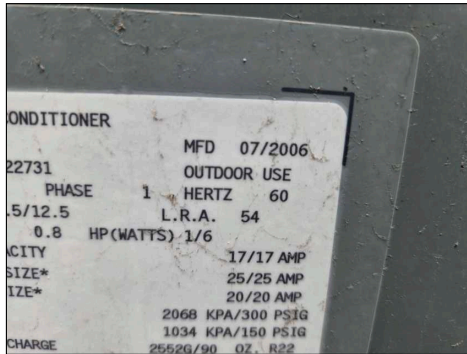
Unit old and appears to be nearing end of useful life - will likely need replacement soon @ ADU

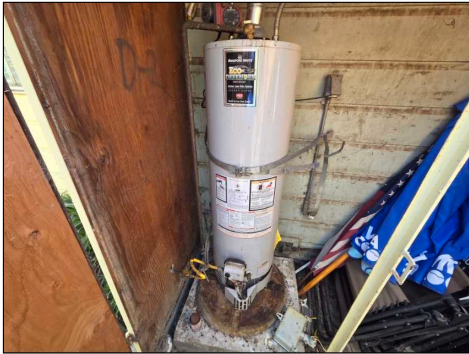
Operated at the time of the inspection - Gas unit

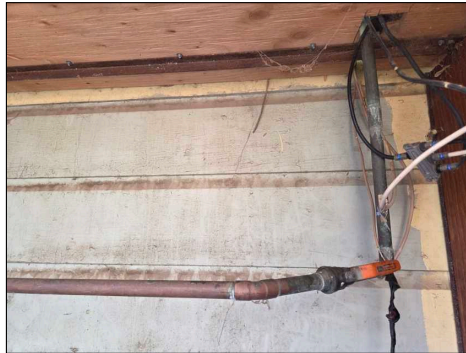
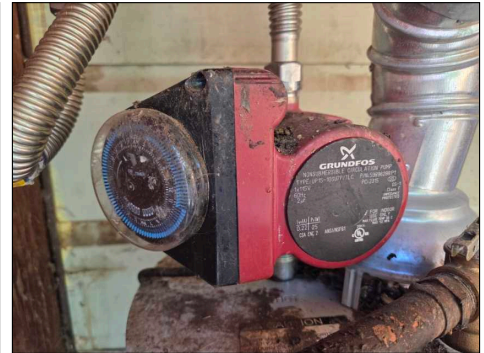
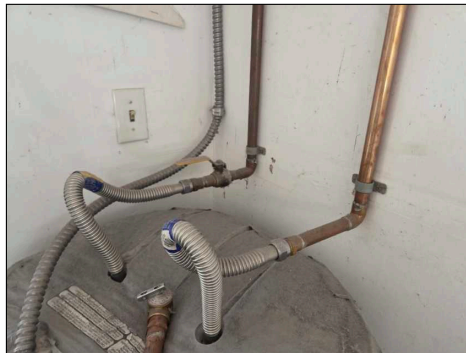
- Normal wear at time of inspection - no major visible defects or leaks found at the time of the inspection

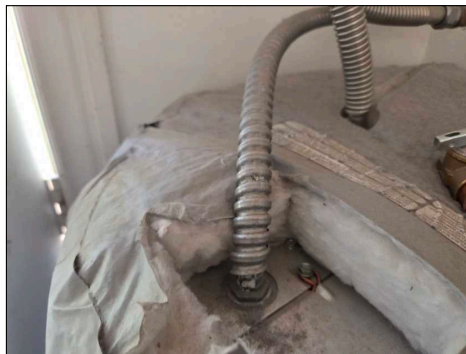
5. Temperature Pressure Release Valves

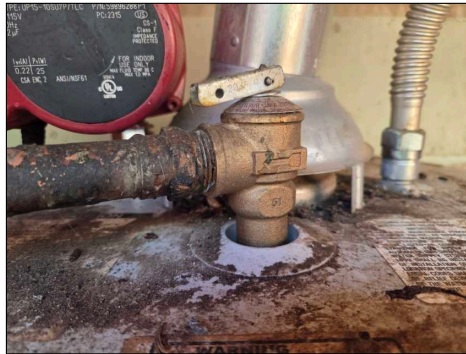
- Normal wear on the day of the inspection - no major visible defects
- *The inspector visually inspects the TPRV only - this valve is not opened or tested during the inspection*

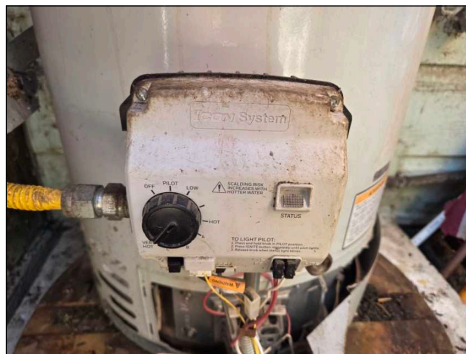
- 115 F (Average or approximate) @ ADU
- Temperature was above 120 F at the unit, this a potential scald hazard - needs to be serviced/adjusted - consult a plumber @ main

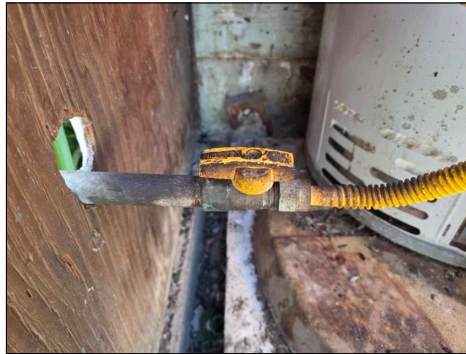
- Normal wear at time of inspection - no major visible defects
- Worn valve, consider upgrading to newer style valve

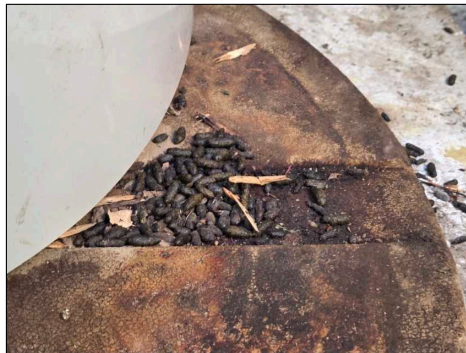
Evidence of rodents on or around the water heater base - recommend pest services inspection for further evaluation

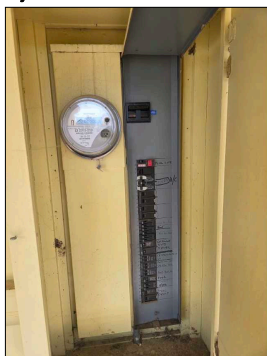
- Normal wear for age at time of inspection - no major visible defects
- **Panels are visually inspected only, the inspector does not perform a load calculation to determine service capacity adequacy**

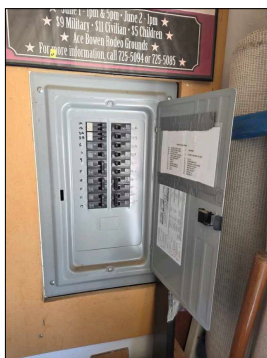
- Normal wear for age at time of inspection - no major visible defects

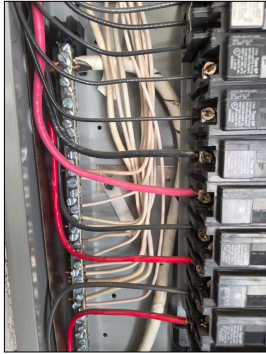
- Wiring type: copper
- Grounded panel - main ground/bonding wire observed and appears to be normal for the age of the panel
- Visible wiring has normal wear for age with no major visible defects at the time of the inspection

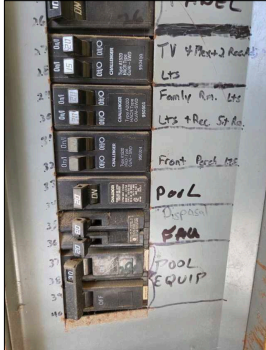
5. Breaker Amp Capacity

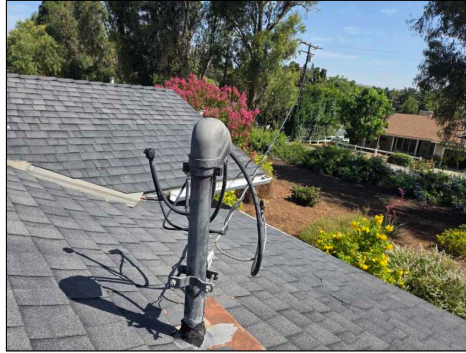
- Overhead - normal wear for the age on day of the inspection - no major visible defects

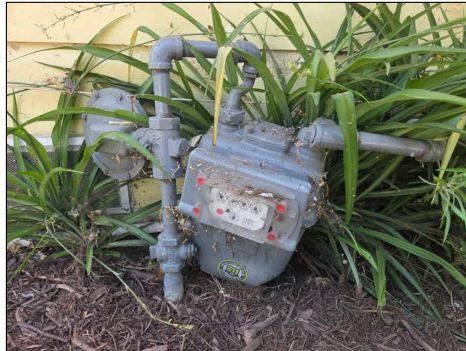
8. Gas Pipes and Valves

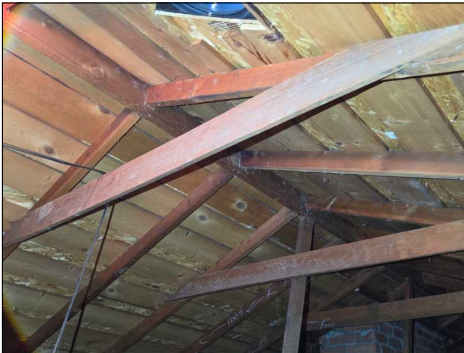
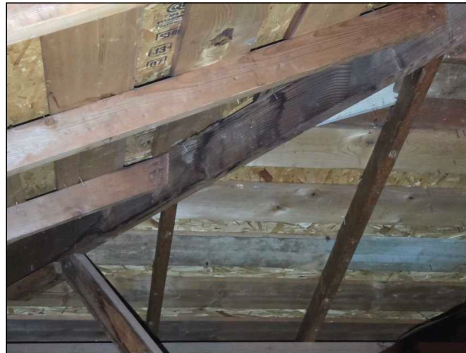
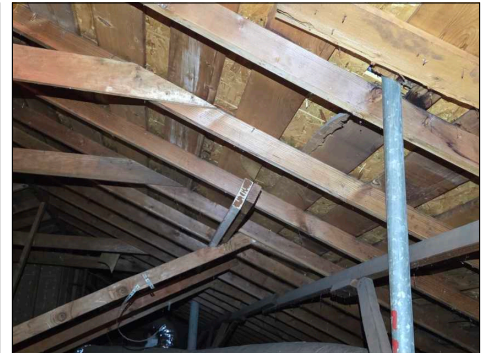
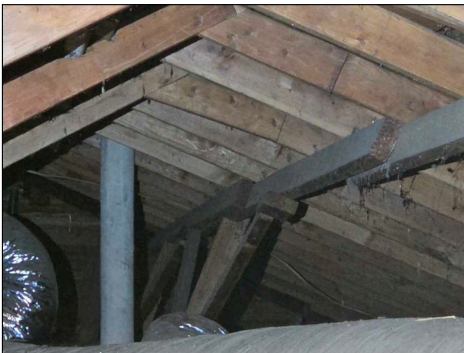
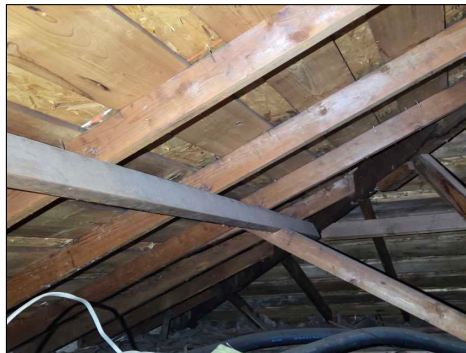
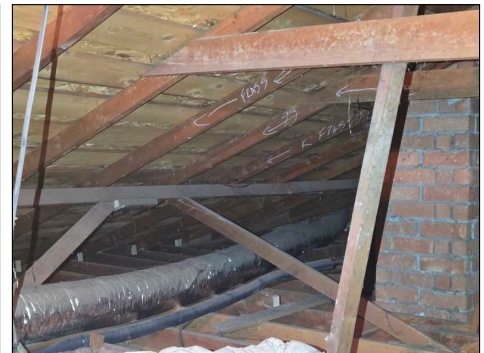
- **Consult termite report** for all wood areas in the attic
- Cracking small at wood members - typical for age
- **Limited attic inspection - many areas are not accessible to to limited space, lack of proper walk boards, electrical, plumbing, ductwork, etc.**
- No major visible defects observed
- Conventional framing is worn/older - typical for the age

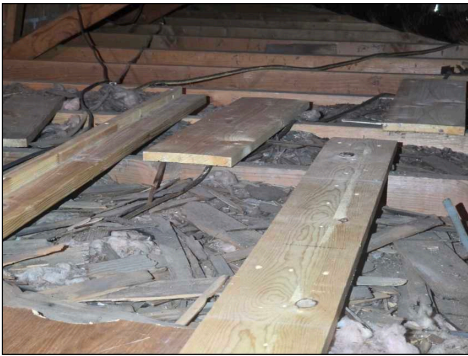
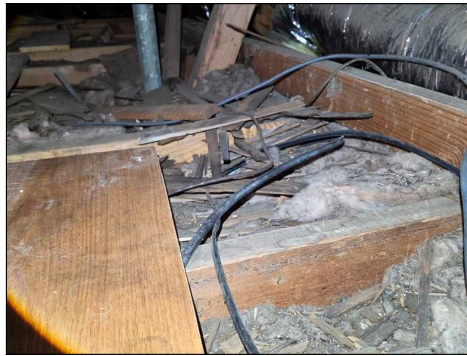
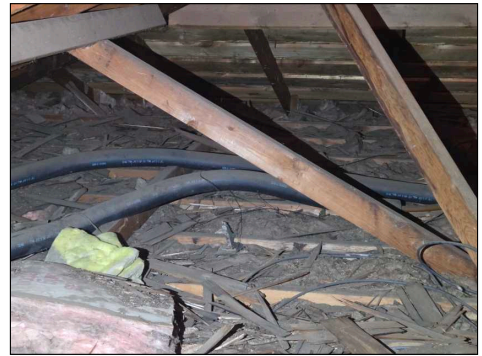
Inadequate insulation - recommend upgrading

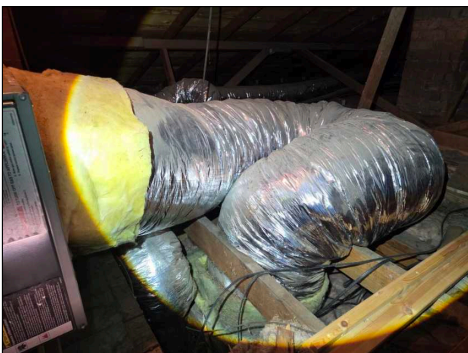
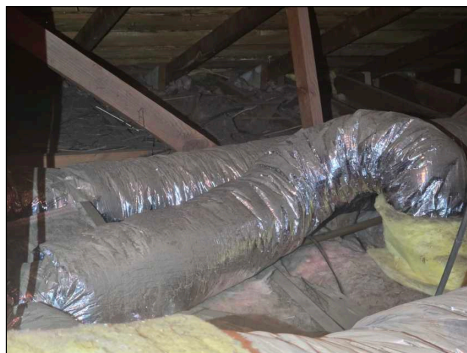
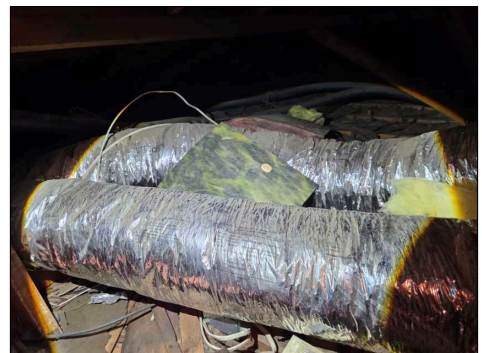
- New/newer duct work present, evidence of alterations observed - check all installation permits to ensure that all areas were installed to city/county building codes
- All visible/accessible duct areas have normal wear for age at the time of the inspection - no major visible defects

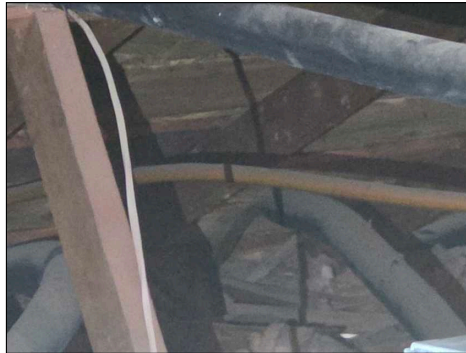
GARAGE AND/OR CARPORT

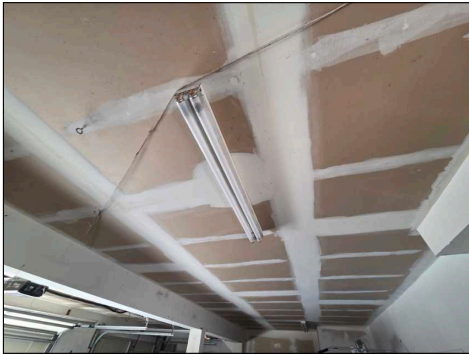
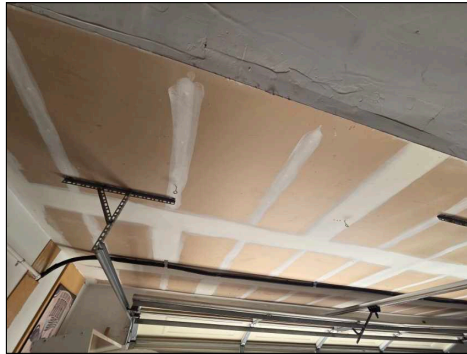
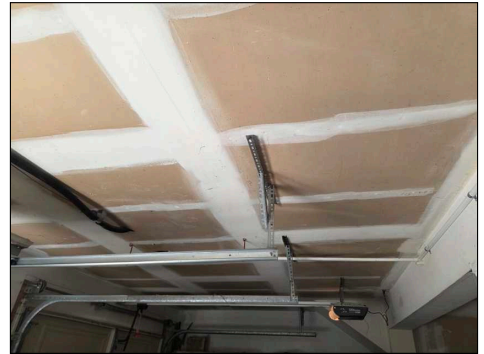
2. Main Automotive Doors

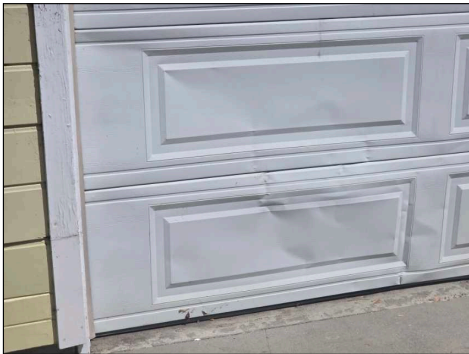
Dented/damaged areas - didn't affect performance - recommend servicing

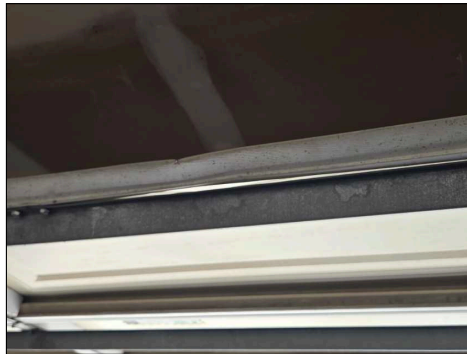
Tested manually only

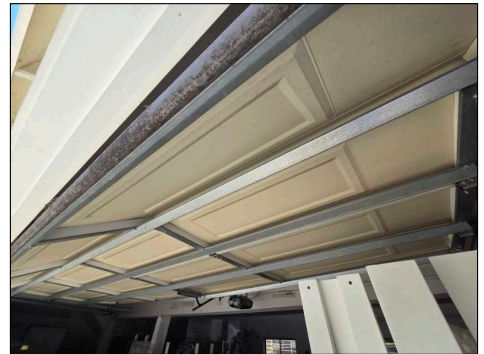
Dented/damaged areas - didn't affect performance - recommend servicing

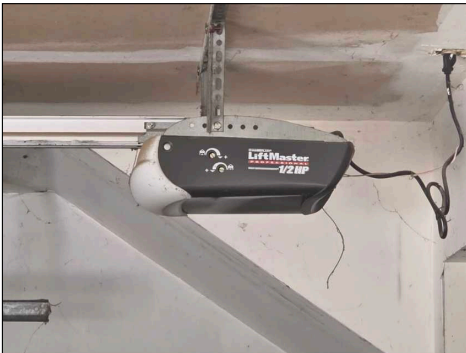
Did not operate - needs to be serviced - hardware not latching

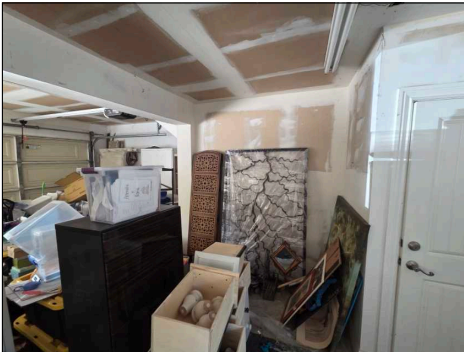
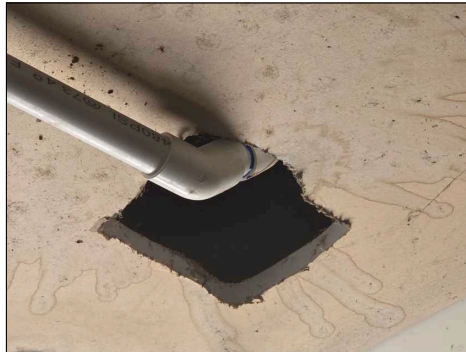
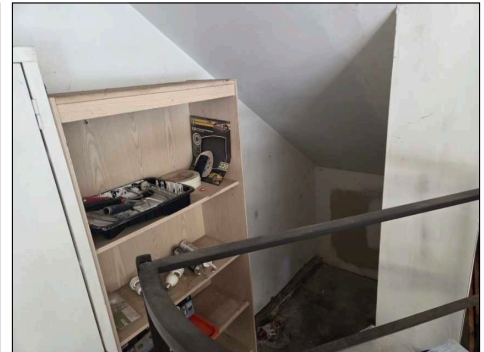
Holes present - needs to be serviced to retain integrity of fire separation

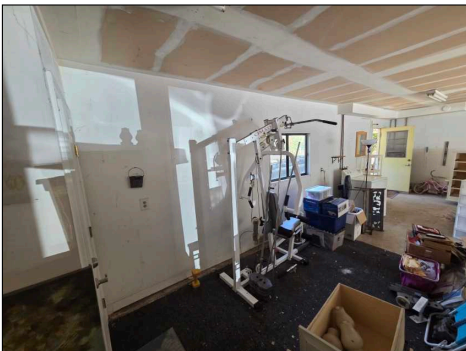
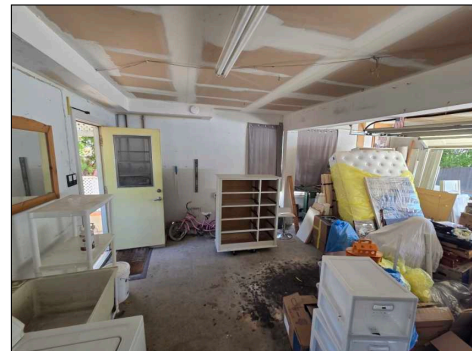
- **Personal items/storage/etc. are present and prevent a complete inspection of wall areas**
- **Consult termite report** for any wood areas in garage
- Normal wear at the time of the inspection - no major visible defects

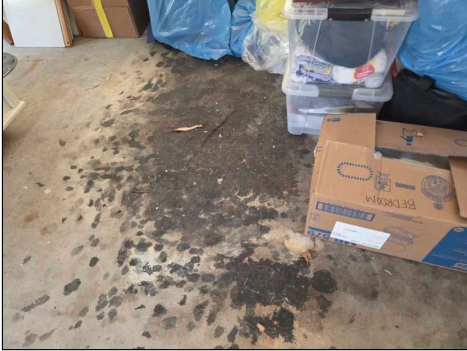
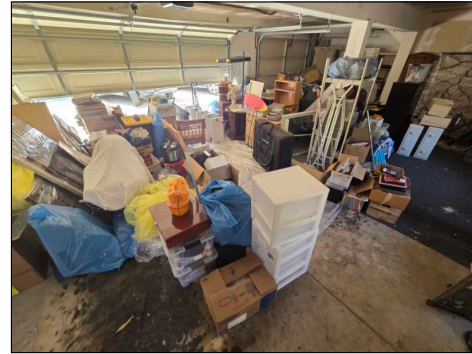
- **Personal items/storage/vehicles prevent complete inspection of floor areas**
- Normal wear at time of inspection - no major visible defects
- Worn/stained heavily - needs to be serviced

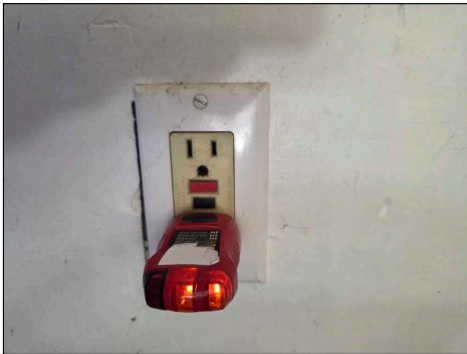
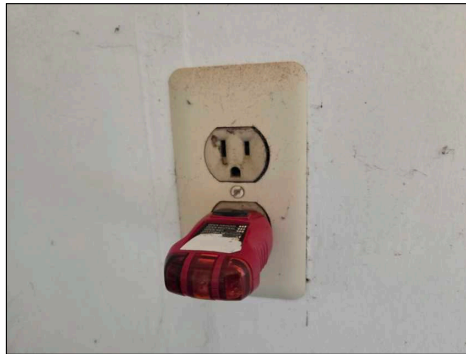
Non-energized (dead) outlet(s) - needs to be serviced
