ELITE GROUP
INSPECTION PROFESSIONALS

800-494-8998

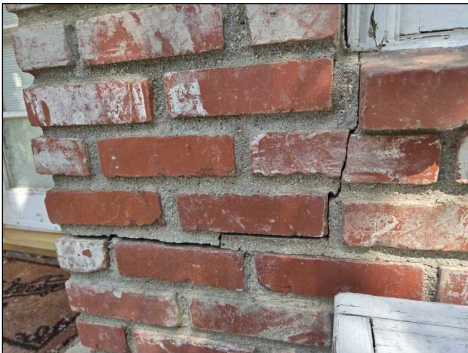
Cracking more than typical - needs to be serviced - signs of settlement at east side of the structure

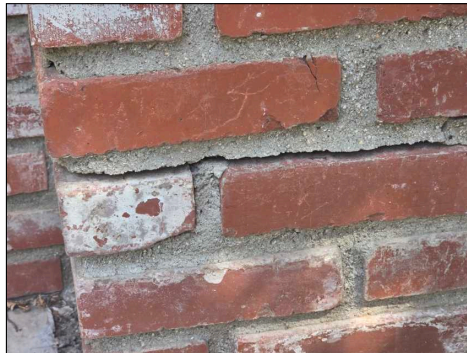
Cracking more than typical - needs to be serviced - signs of settlement at east side of the structure

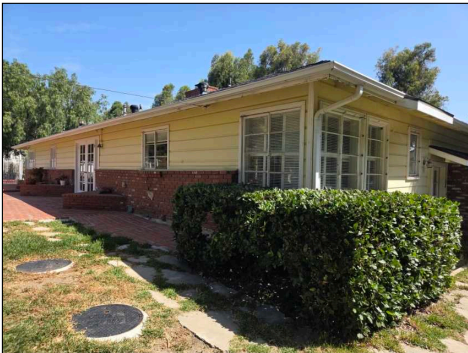
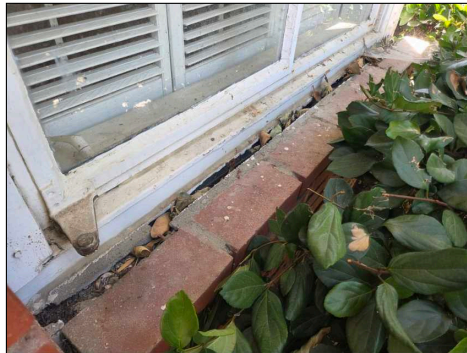
Gaps in areas - needs to be serviced

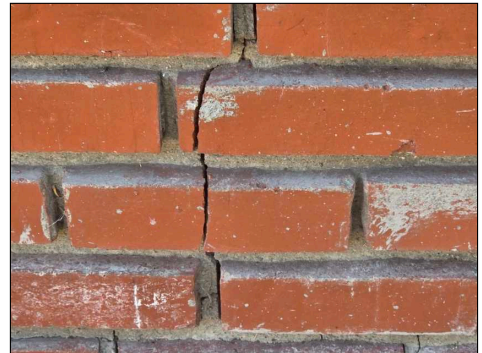
Cracking more than typical - needs to be serviced

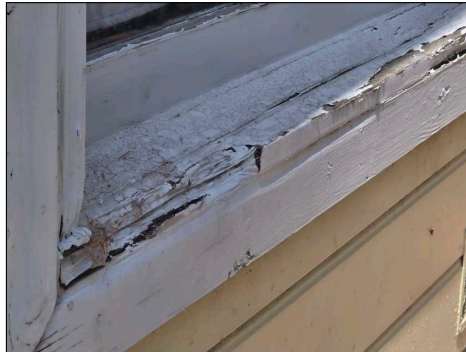
Cracking/deterioration - more than normal - needs to be serviced @ garage

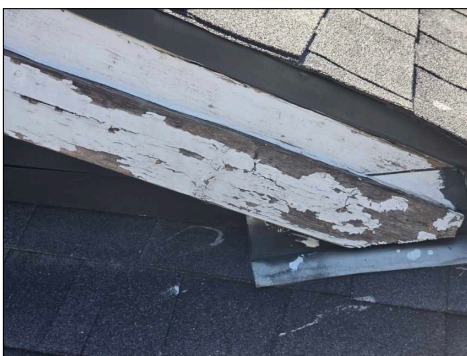
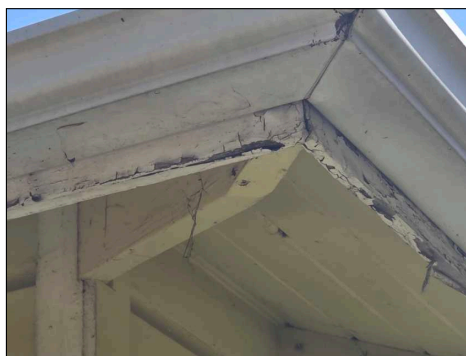
- **Consult termite report** for all wood areas at the structure
- *Inspector does not determine wood destroying organism presence or damage - always obtain a structural pest control inspection*
- *Inspector does not use specialized instruments to detect moisture, if any, under siding/trim surface*
- *Some not accessible or visible for inspection due to vegetation/personal items/height/angle*
- **Exposed exterior wood requires periodic seasonal maintenance and paint - recommend servicing**

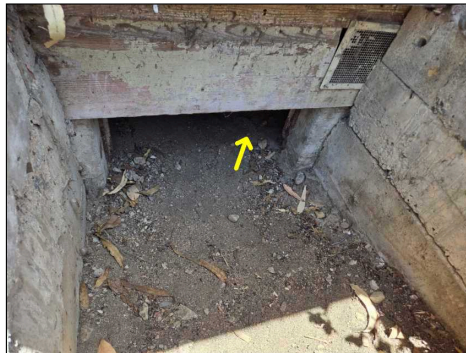
Inadequate clearance at entry - may be problematic

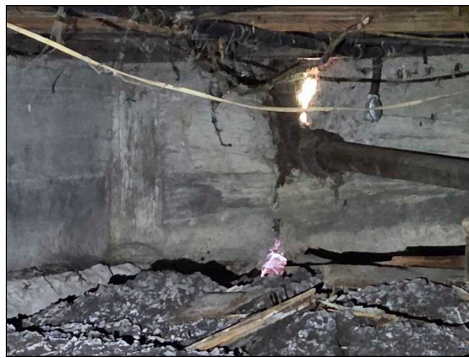
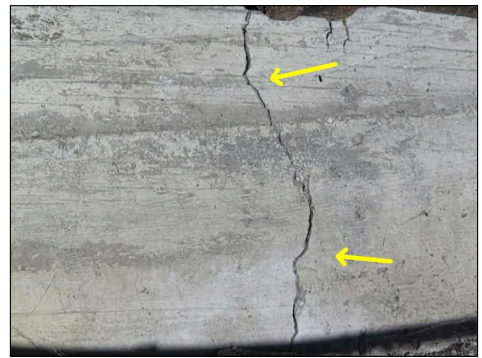
Cracked more than typical - needs to be serviced/further evaluated

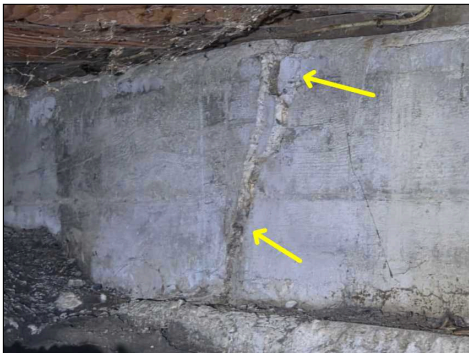
Cracked more than typical - needs to be serviced/further evaluated

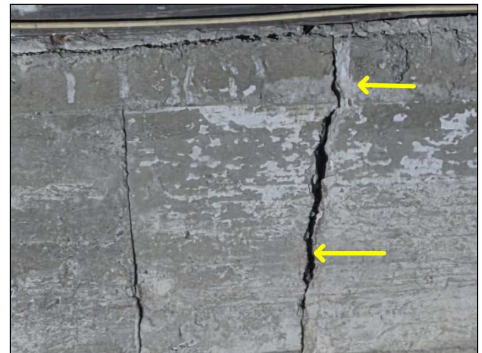
Cracked more than typical - needs to be serviced/further evaluated

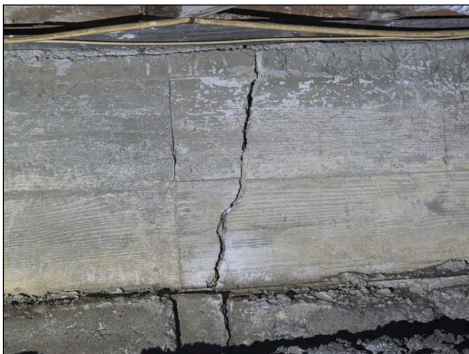
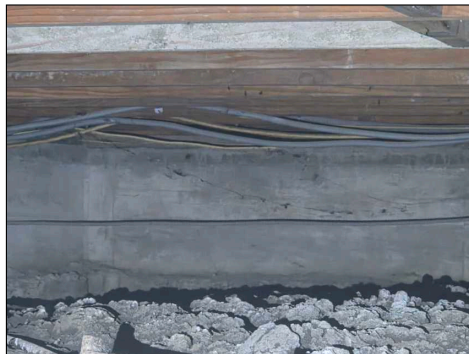
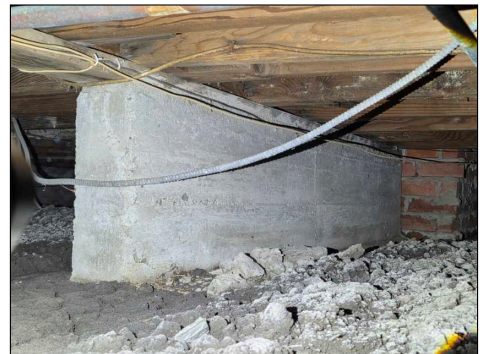
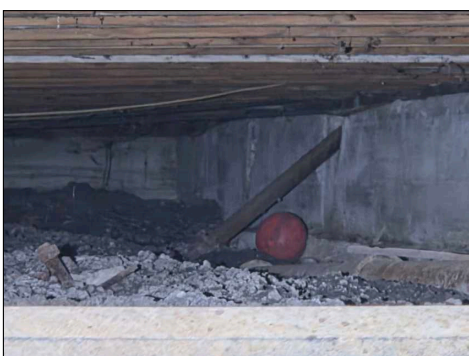
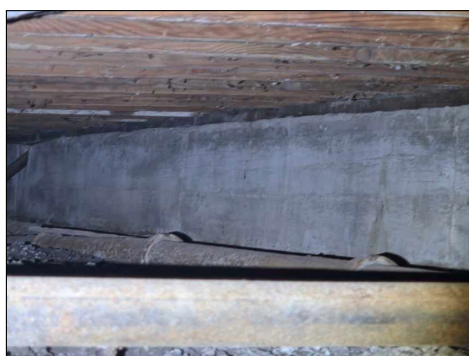
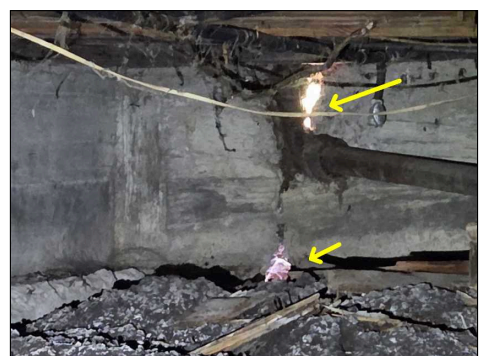
Damaged areas present - needs to be serviced

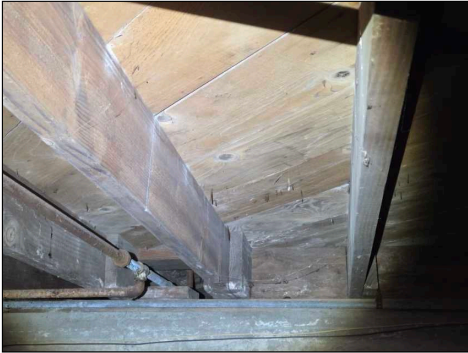
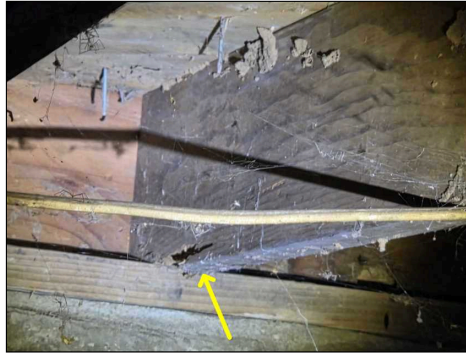
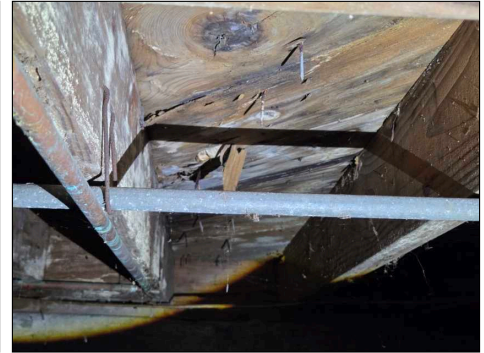
Deteriorated wood observed - consult the termite report for all wood deterioration/moisture damage under structure

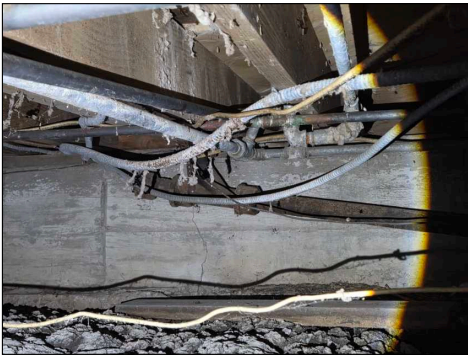
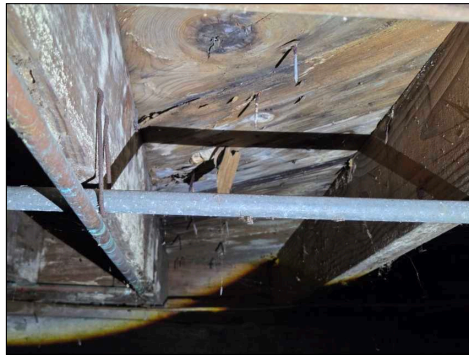
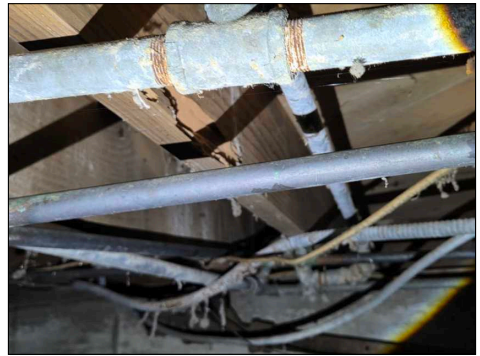
Galvanized water piping present - recommend upgrading all older pipes @ kitchen

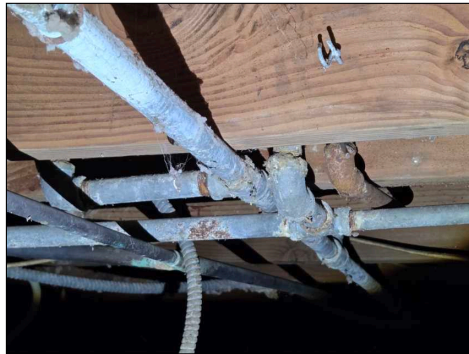
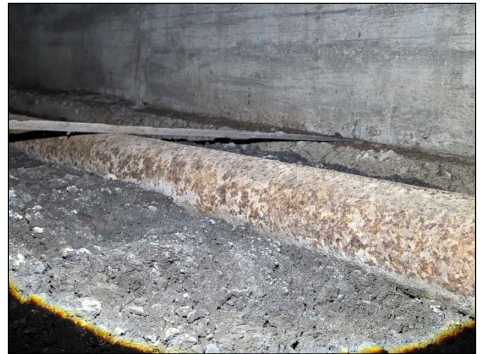
Older/corroded cast iron pipes present - materials nearing the end of their useful life

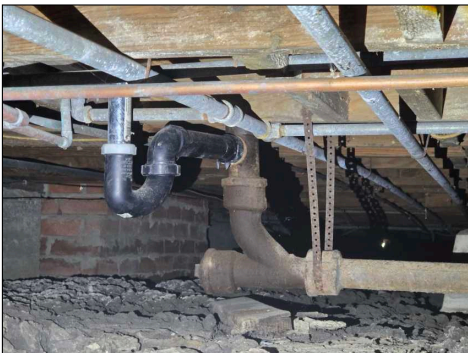
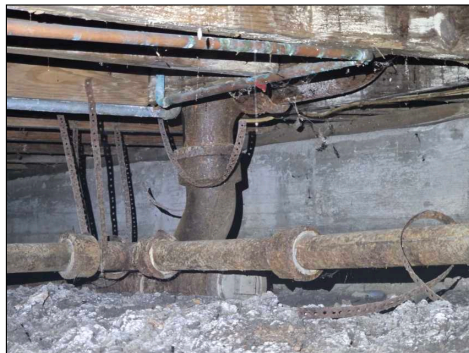
Copper piping present in areas - partial upgrade

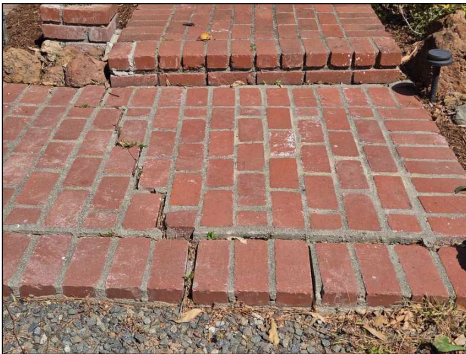
Walkway displacement/uplifted/uneven areas - potential trip hazard - needs to be serviced

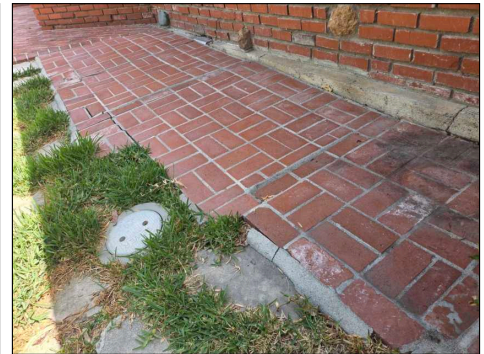
Cracking/chipping large - recommend servicing

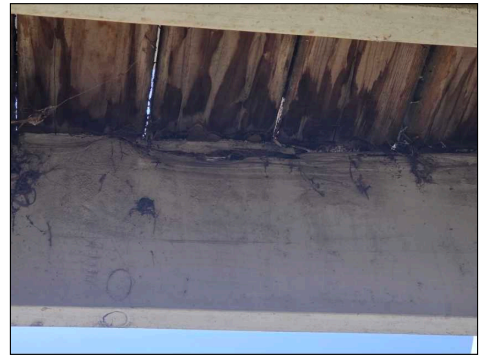
Deteriorated wood - **consult termite report** - needs to be serviced

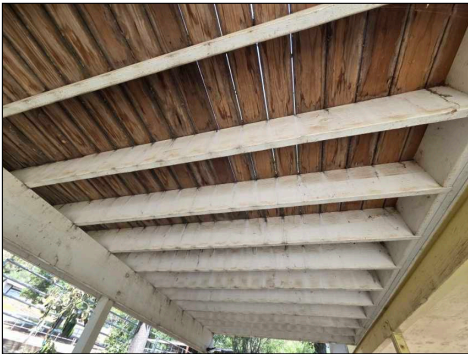
Deteriorated wood - **consult termite report** - needs to be serviced

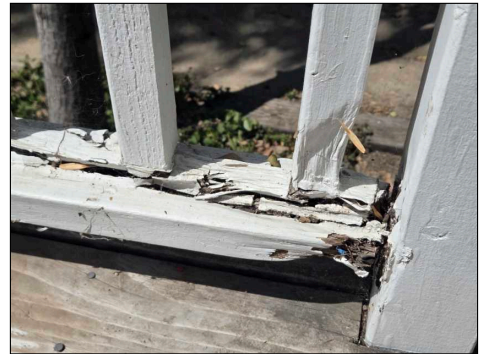
Deteriorated wood - **consult termite report** - needs to be serviced

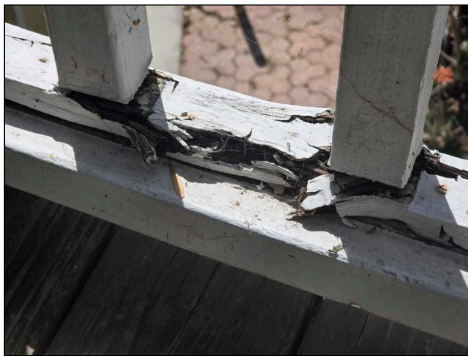
Deteriorated wood - **consult termite report** - needs to be serviced

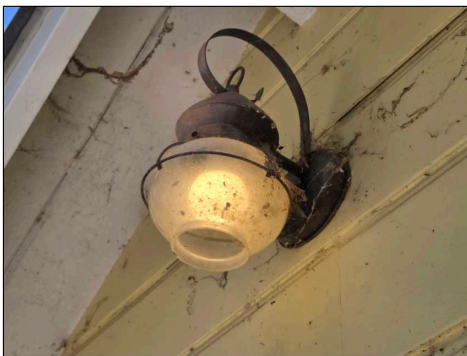
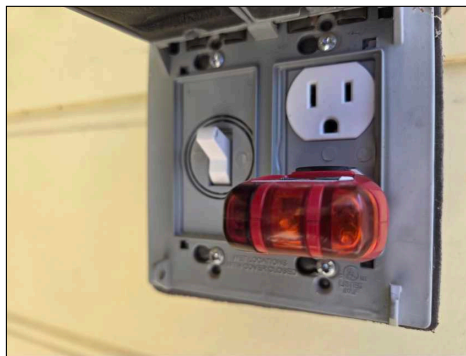
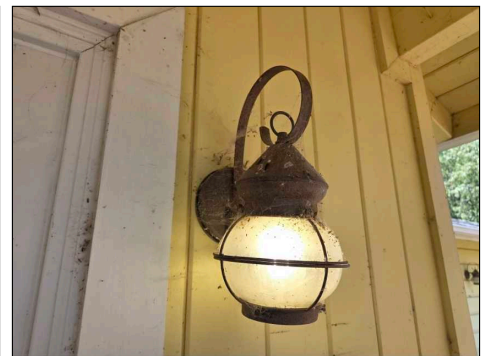
Non- energized (dead) outlet(s) - needs to be serviced

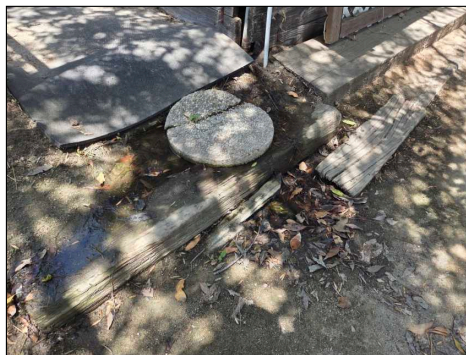
Evidence of water pipe leaking beneath the surface - water ponding in areas - needs to be serviced

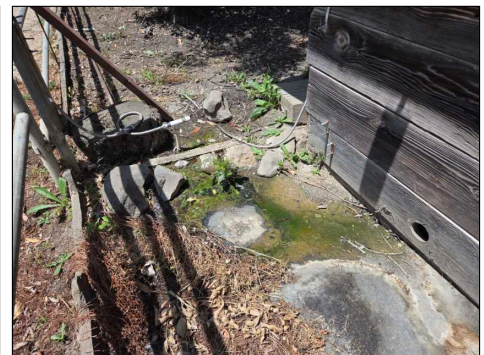
Evidence of water pipe leaking beneath the surface - water ponding in areas - needs to be serviced

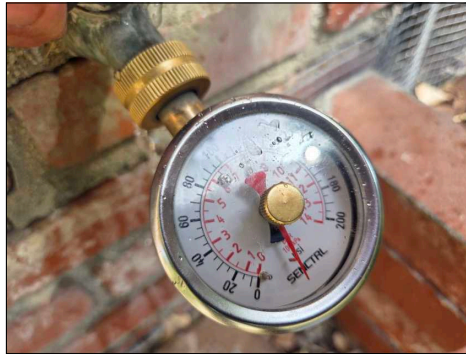
9. Pressure Regulator

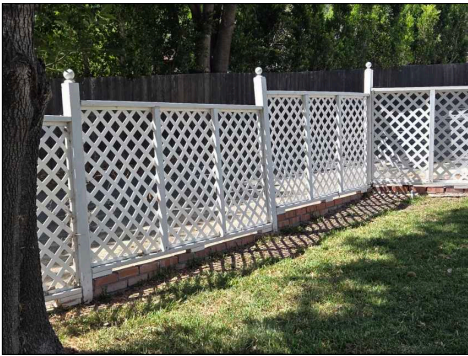
Loose/leaning areas of fencing/walls – needs to be serviced

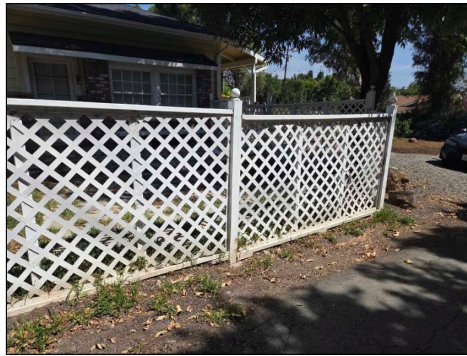
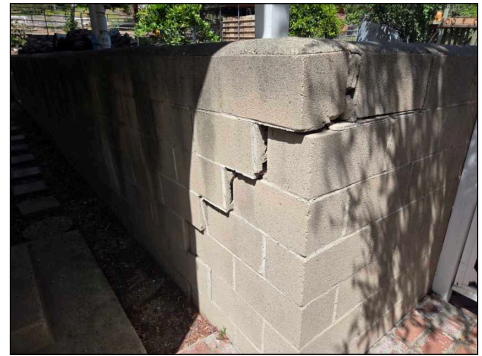
Leaning retaining wall - needs to be serviced

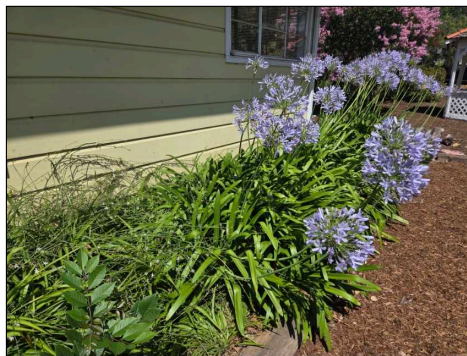
- Recommend trimming trees or bushes that are in contact or proximity to home, as branches can abrade roofing or siding

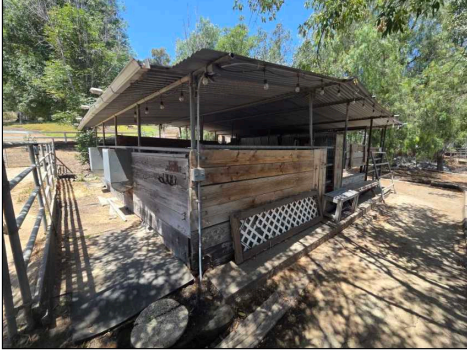
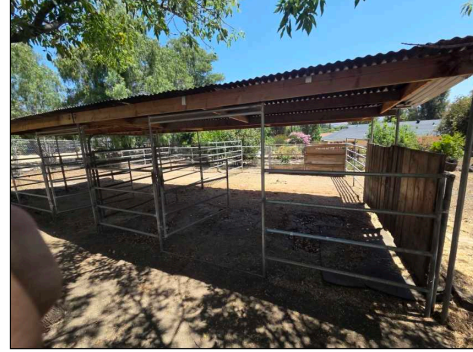
Horse stalls outside the scope of this inspection

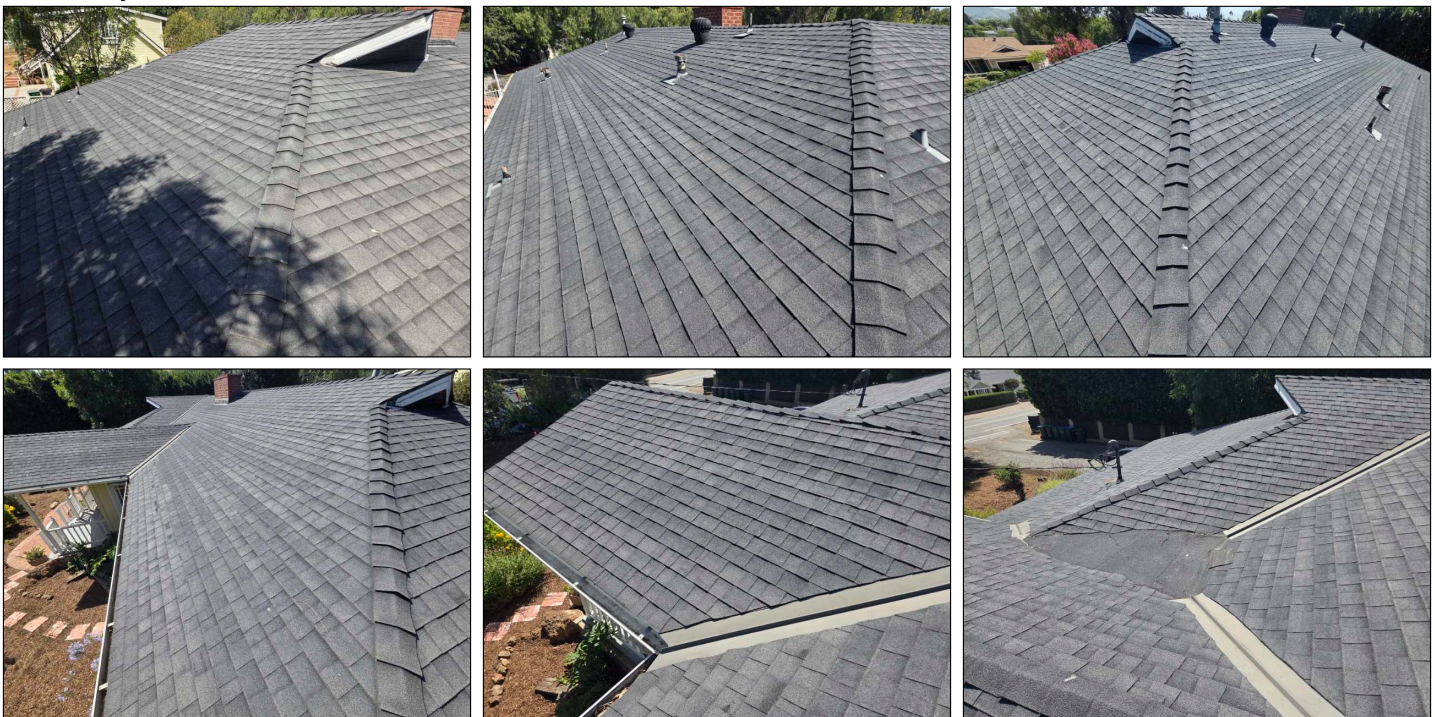
- Visible materials show signs of normal wear for the age of the materials at time of inspection - no major visible defects - Regular seasonal **maintenance** is recommended to extend the life of the roof
- Worn and weathered materials present - typical for age and weather exposure
- Shingles have moderate granule loss at ADU - older materials present
- No major visible defects observed

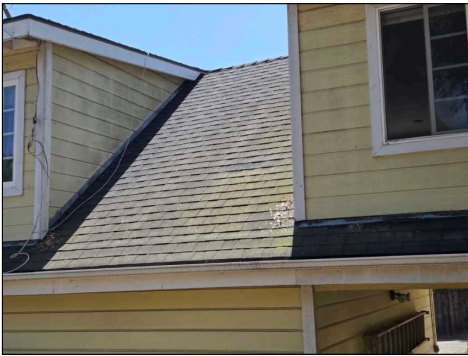
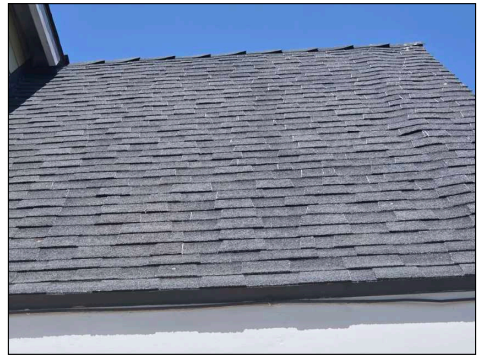
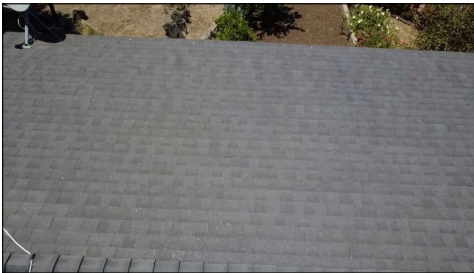
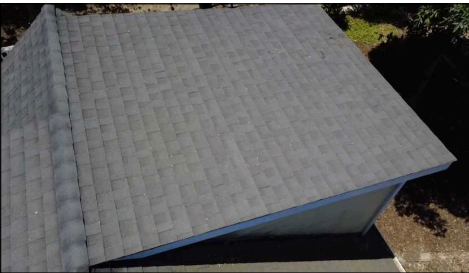
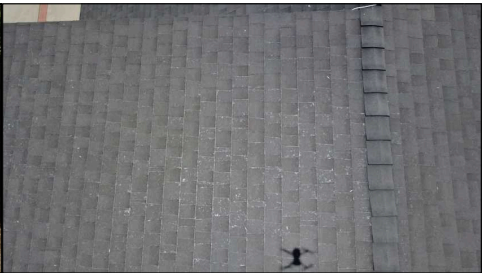
Shingles have moderate granule loss at ADU - older materials present

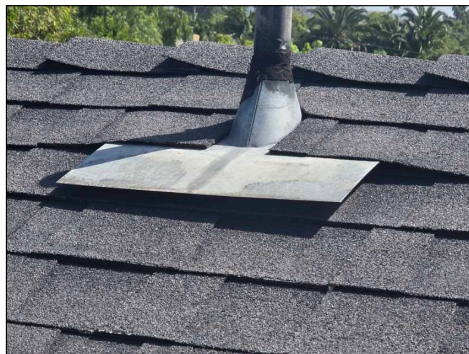
Flashings lifting in areas - needs to be serviced as part of your preventative roof **maintenance**

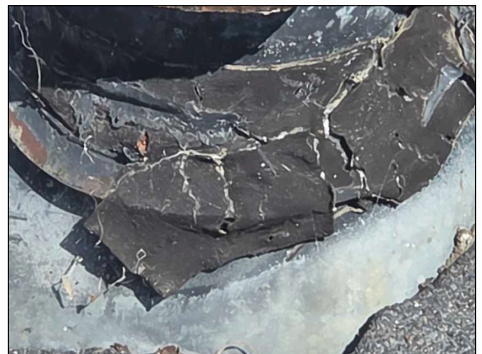
Deteriorated mastic at flashings - needs to be serviced and resealed at all penetration points

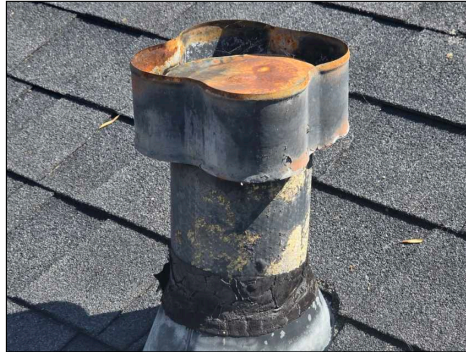
- Worn/weathered cap(s) – recommend seasonal **maintenance** to ensure that caps do not become loose or develop other defects

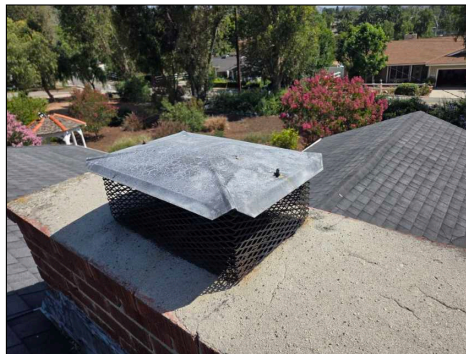
- Worn/weathered - typical for age and weather exposure

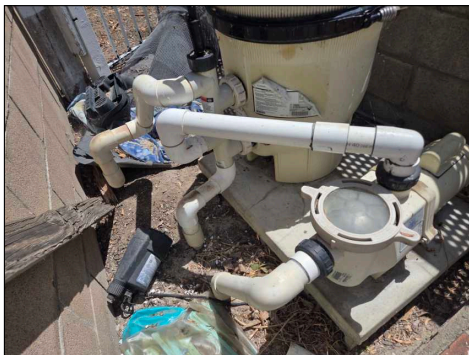
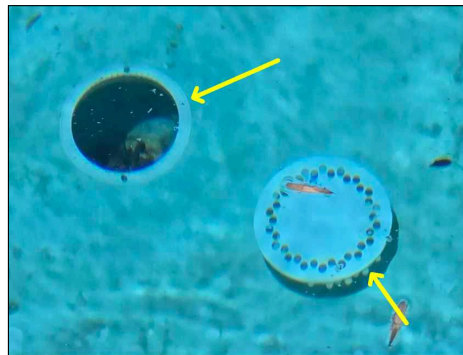
Main drain cover missing - needs to be serviced - drain clogged

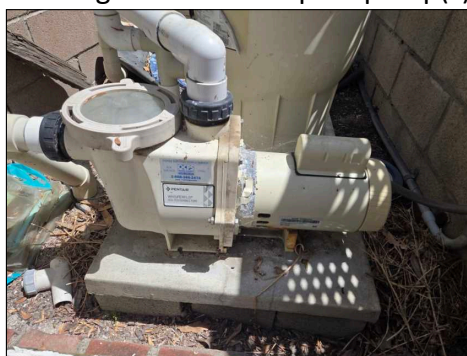
- Operated on the day of the inspection
- Worn pump(s) - typical for the age
- Inspector cannot determine the remaining life left in the pool pump(s)

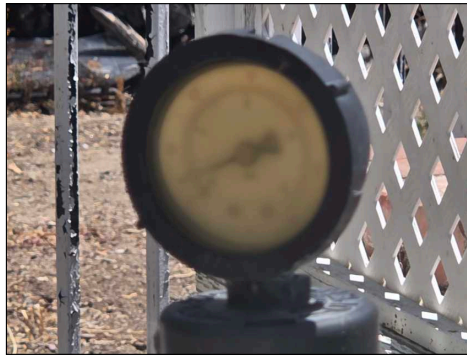
Fogging - needs to be serviced/replaced for optimum readability

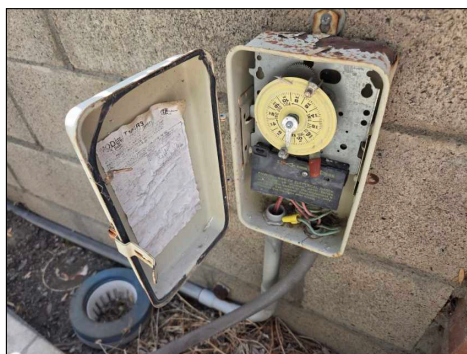
- Manual timer switch present - worn/weathered
- Missing interior shock cover - needs to be serviced

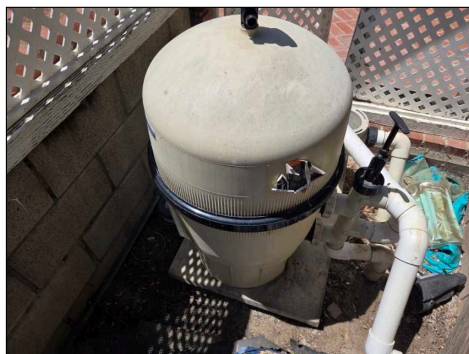
9. Skimmers and Baskets

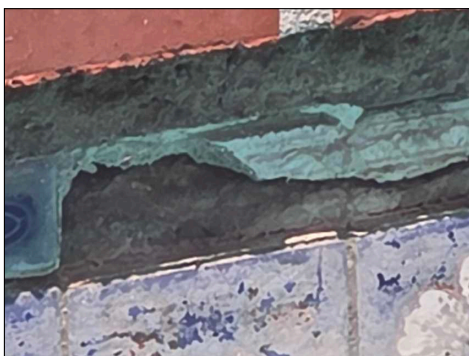
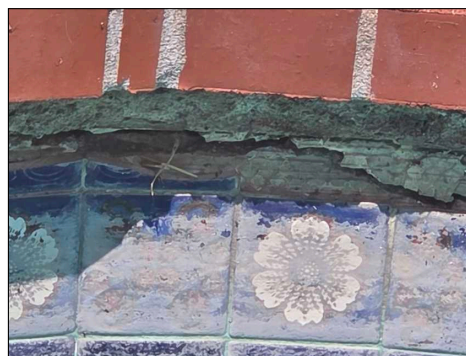
Worn tile/grout present - cracked/chipped in areas - needs **maintenance** Worn tile/grout present - cracked/chipped in areas - needs **maintenance**

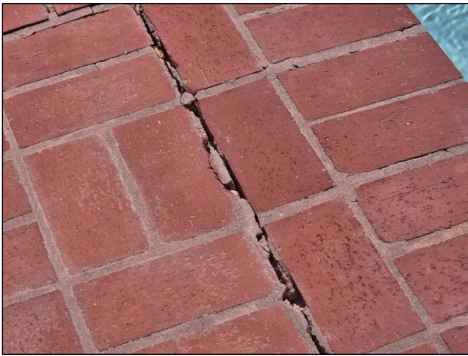
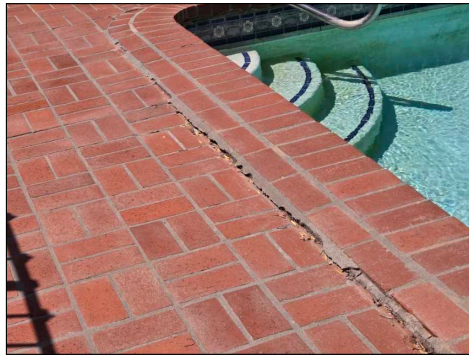
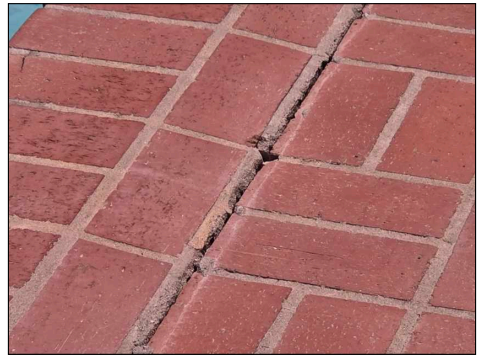
**Gaps between coping and decking
- needs to be serviced**

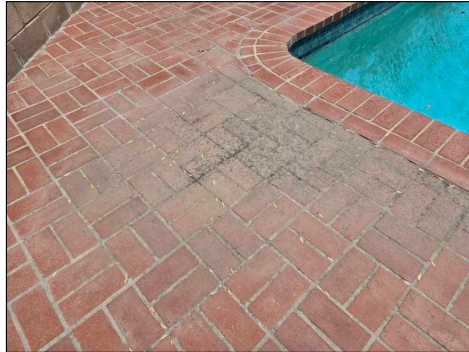
Evidence of poor drainage around pool areas - needs to be serviced

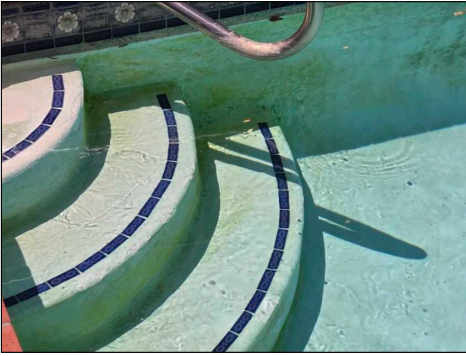
Stained more than normal in areas - needs to be serviced/cleaned

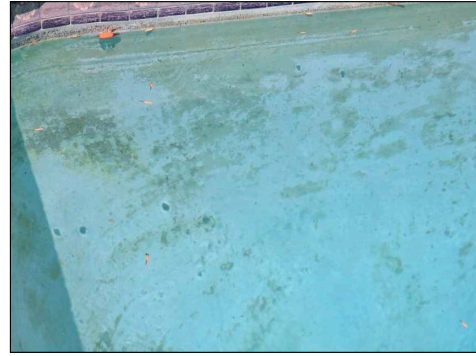
Flaking/peeling surface in areas - plaster is in a worn/older condition

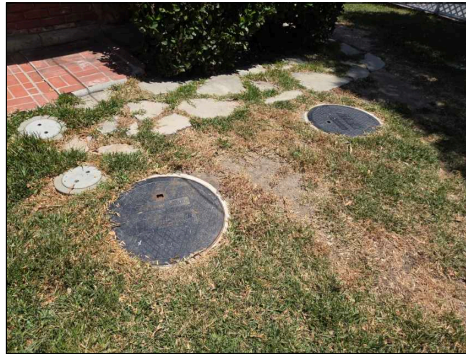
Per sellers disclosures septic tank is older and undersized - recommend specialist for further evaluation and possible upgrade - septic tank outside the scope of general inspection.

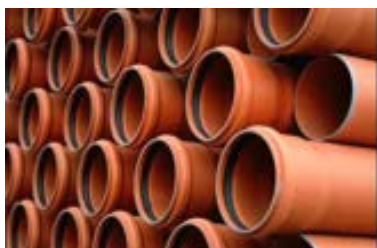
Even older homes might have newer plastic sewer pipe. As the years wear on, sewer systems deteriorate. When replacement happens, it typically will happen with plastic pipe.
