PROPERTY LOCATION: 14657 Channing St Baldwin Park, CA 91706

# INSPECTIONREPORT

Date of Inspection: 7/16/2026 at 2:00 PM

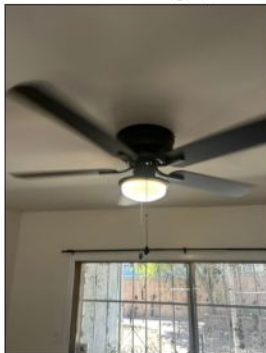
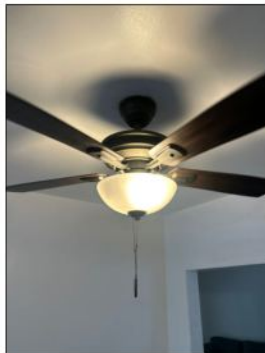
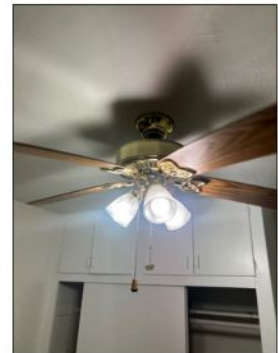
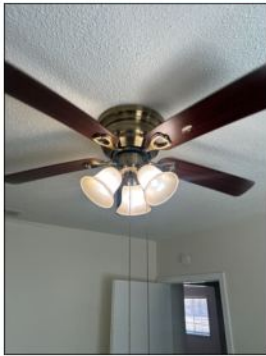
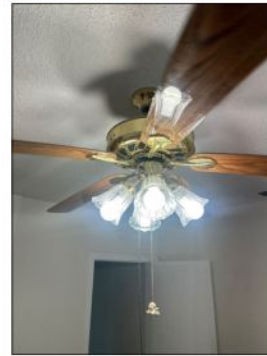
- Note: It is not possible to determine the method of attachment to the ceiling. These units are heavy and due to the designed movement, must have the proper style mounting boxes for correct and safe attachment. Recommend confirming the method of attachment prior to use. This may require the removal of the fan or insulation to visually verify proper support.
- Operated at time of inspection
- Normal wear for age, no major visible defects

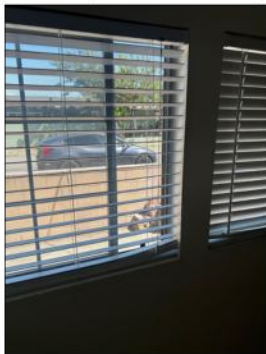
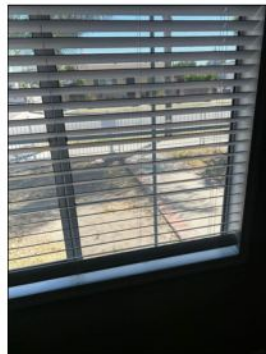
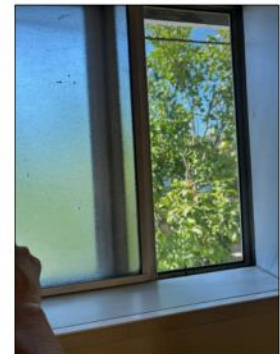
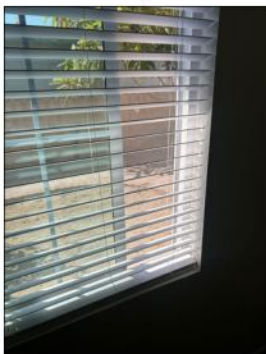
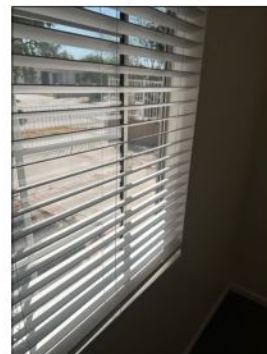
#### 5. Window Conditions

- Accessible windows were tested and operated at time of inspection
- Visible/accessible windows have worn frames/hardware/sills/tracks - typical for age
- Recommend general window maintenance/lubrication and weather tight service
- Small cracks/worn areas/chipped paint observed around sill or frame

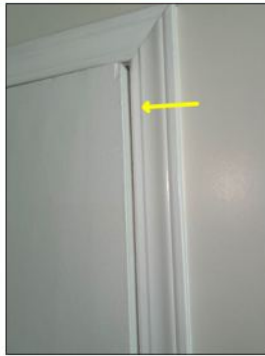
#### 6. Doors

**Sticks at jamb - needs to be serviced - bedrooms**

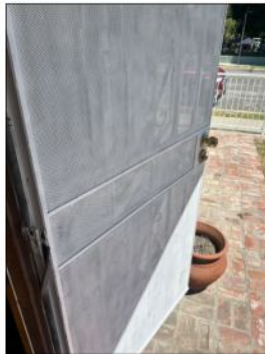
## 7. Screen Doors

- Security screen present
- Operated at time of inspection
- Loose/worn hardware - typical for age

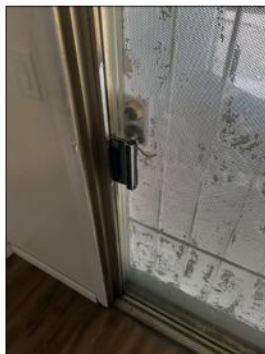
## 8. Sliding Glass Doors

- Slider operated at the time of the inspection
- Worn door with loose/worn hardware/frames/rollers/tracks - typical for age
- Difficult to slide/operate- needs to be serviced
- Cannot determine or verify if tempered

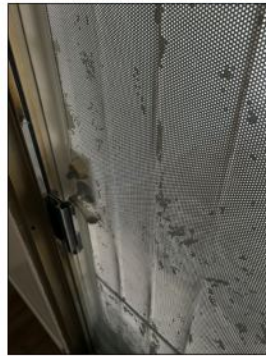
## 9. Sliding Door Screens

- Security screen present
- Operated at time of inspection
- Worn screens with loose/worn hardware/frame/rollers/tracks - typical for age

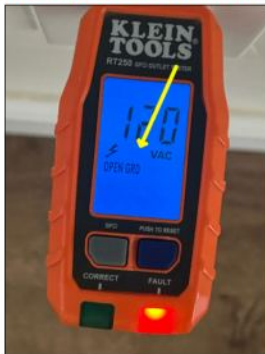
**Three prong outlet(s) not grounded - needs to be serviced**

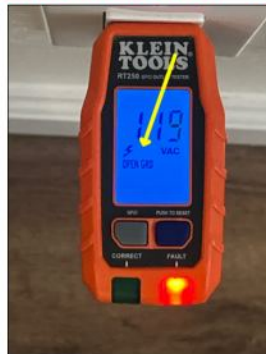
**Three prong outlet(s) not grounded - needs to be serviced**

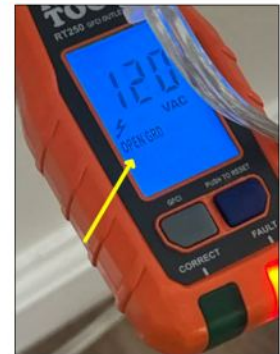
**Three prong outlet(s) not grounded - needs to be serviced**

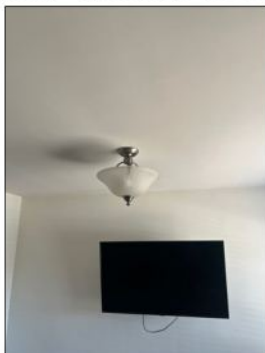
**Some bulbs defective/missing/light(s) did not function - check bulbs/consult electrician to further evaluate**

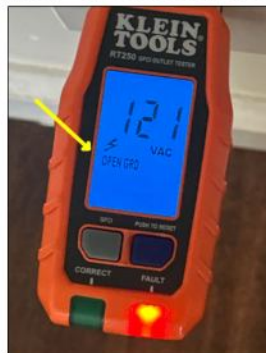
**Three prong outlet(s) not grounded - needs to be serviced**

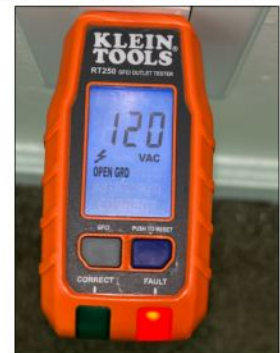
**Three prong outlet(s) not grounded - needs to be serviced**

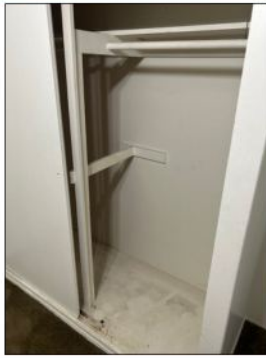
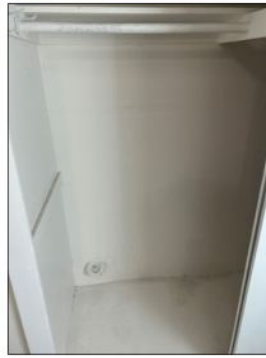
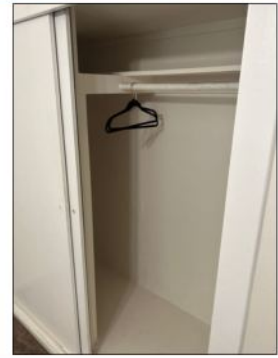
## 11. Closets

- Worn closets with loose/worn hardware - typical for age

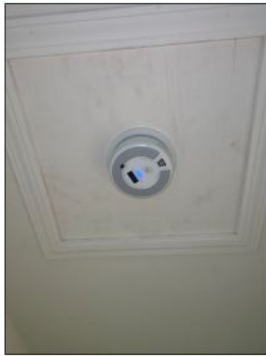
**Did not operate - needs to be serviced or replaced - hall**

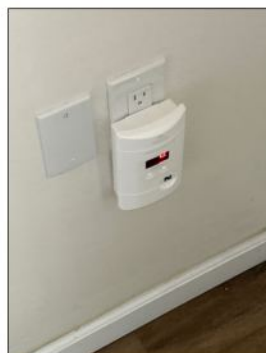
- Carbon monoxide detectors are tested via the accessible test button only, they are not tested/measured/evaluated per manufacturer specifications for installation height or suggested locations.
- For safety purposes we recommend that carbon monoxide detectors be placed in all hallways outside of sleeping areas (bedrooms) and on all levels of multi-level dwellings. For longer hallways and/or oddly located bedrooms, multiple carbon monoxide detectors are suggested and should be placed at each end of the hallways to ensure optimum safety alert.
- Operational at time of inspection via factory installed test button
- **Not in proper position/location - needs to be serviced**
- **Not permanently mounted - needs to be serviced**
- **Missing at hall - needs to be installed**

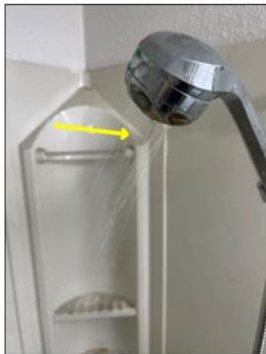
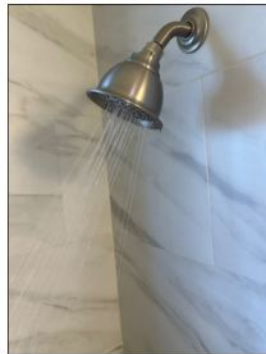
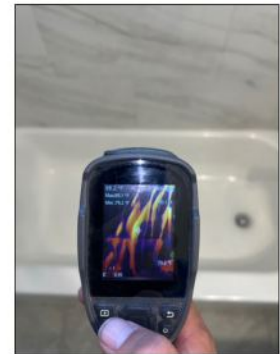
**Low pressure at shower fixture -  
needs to be serviced - garage**

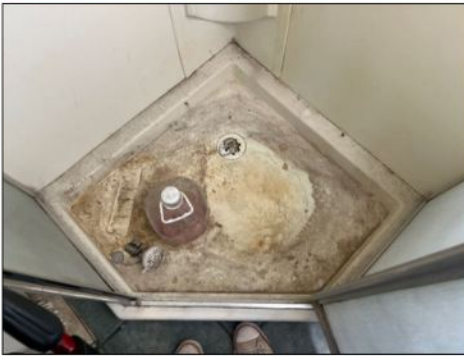
**Shower pan is in a worn/stained/older condition - typical for the age - recommend routine grout and sealer maintenance**

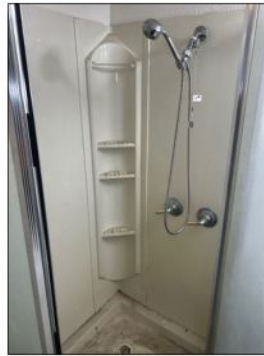
**Wall materials in a worn/stained-faded/old condition - typical for age - recommend routine grout and sealer maintenance**

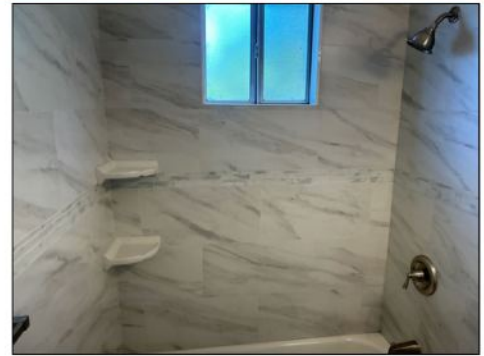
**Shower walls have normal wear for age at the time of the inspection - no major visible defects - recommend routine grout and sealer maintenance**

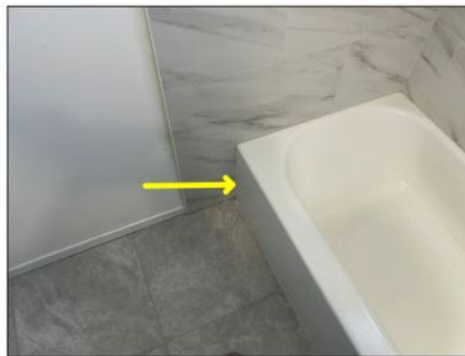
**Caulking needed around perimeter**

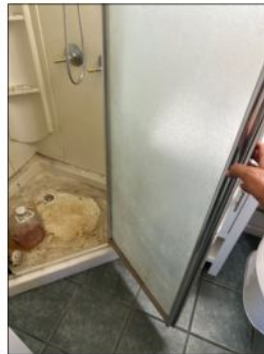
- Operational at time of inspection - Cannot determine if tempered
- Enclosure door(s) in a worn/older condition with loose/worn hardware - typical for the age
- Adjustment and maintenance is needed at the existing door(s) to ensure proper operation and water tight seals

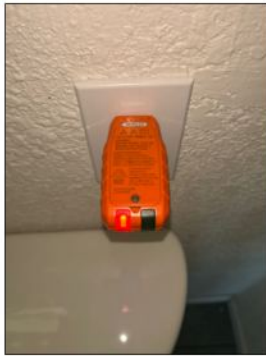
Outlet hot wired in reverse with neutral - needs to be serviced - garage

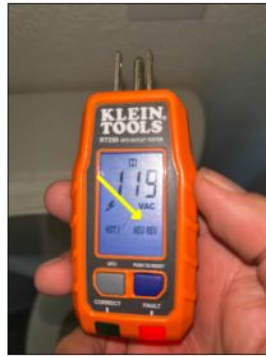
Outlet hot wired in reverse with neutral - needs to be serviced - garage

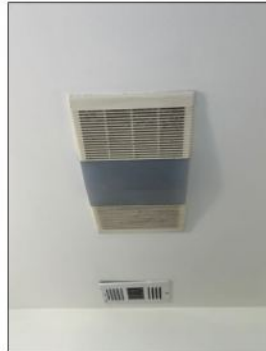
- Operated at time of inspection
- Dirty or dusty fan – Preventive maintenance is recommended to avoid possible overheating or possible safety hazard

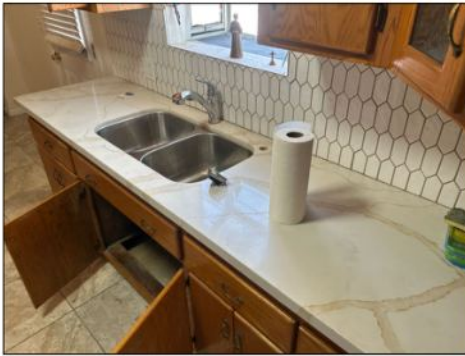
**Missing cap - needs to be serviced**

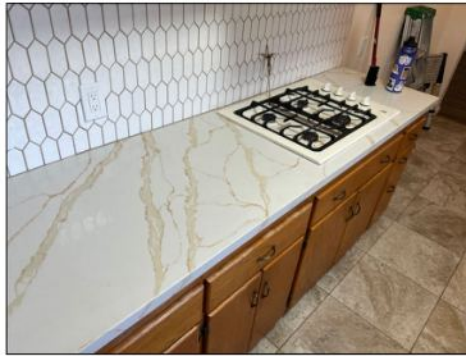
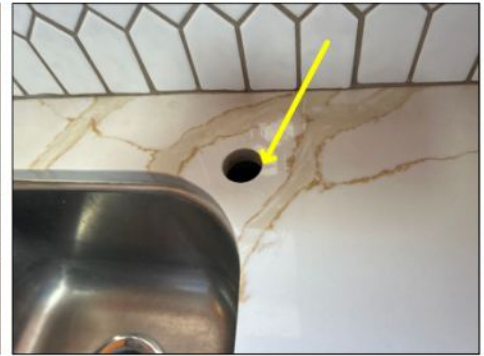
- Counter is worn and has typical wear for age
- Recommend grout/sealer/stone maintenance
- **Missing cap - needs to be serviced**

| INTERIOR | | |
|---|---|---|
| Page 24 Item: 1 | Counters | • Missing cap - needs to be serviced |

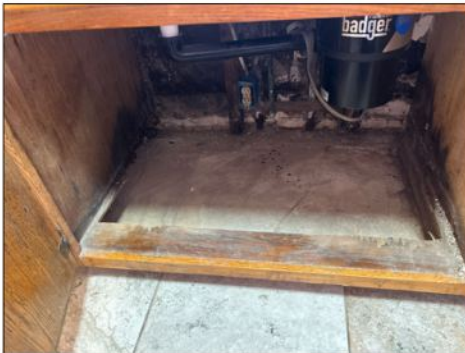
**Moisture damage - needs to be serviced - hidden defects may exist**

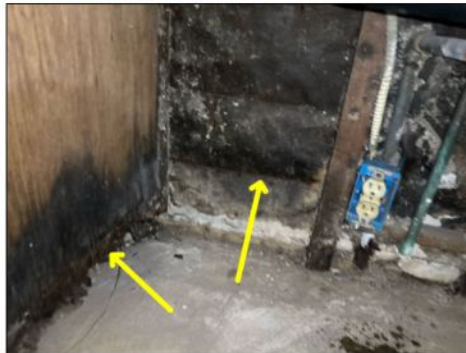
**Microbial growth/irregular staining present - further evaluation is recommended**

- **RECOMMEND A COMPLETE MICROBIAL GROWTH AND MOISTURE EVALUATION. Contact our office to schedule at 800-494-8998. Upon inspection the Home Inspector found reason to believe that this structure needs further evaluation for microbial growth and moisture.**

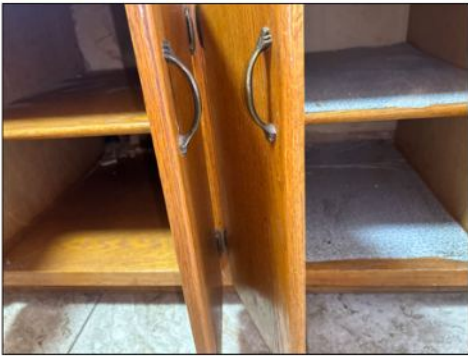
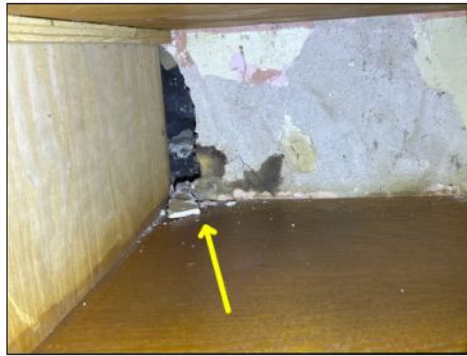
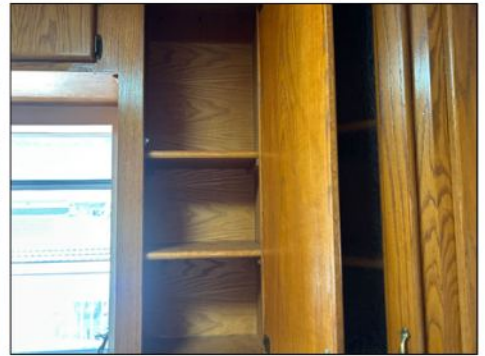
**Moisture damage - needs to be serviced - hidden defects may exist**

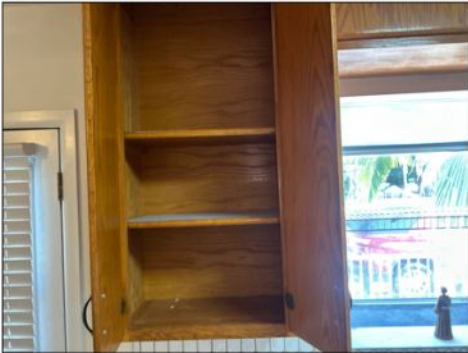
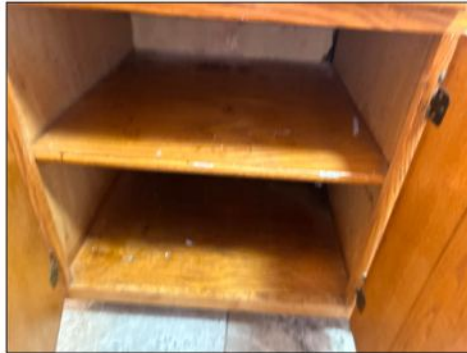
**Moisture damage - needs to be serviced - hidden defects may exist**

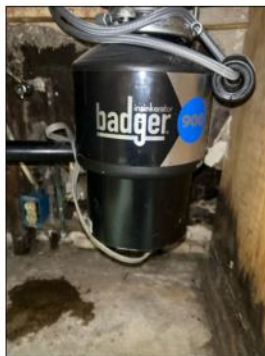
- Worn/older unit - typical wear for age and use
- Electric off to unit not tested

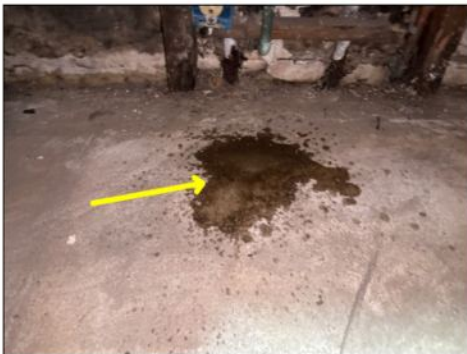
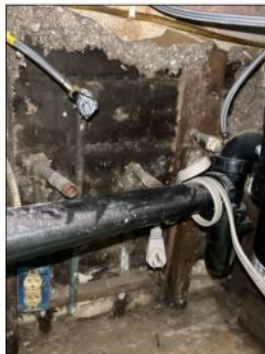
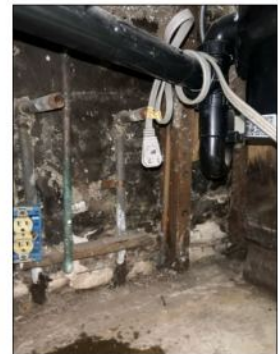
- Angle stops/hoses/drain pipes are in a normal condition for their age - no major visible defects
- Visible leaking under sink - recommend licensed plumbing contractor for further evaluation and repair

**Visible leaking under sink -  
recommend licensed plumbing  
contractor for further evaluation  
and repair**

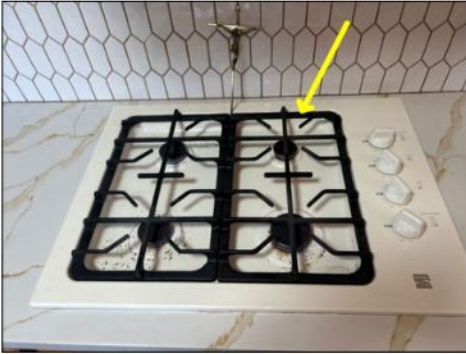
- Tested and operational at time of inspection via normal controls
- Normal wear for age - no major visible defects
- Right rear element/burner not operating - needs to be serviced

**Right rear element/burner not operating - needs to be serviced**

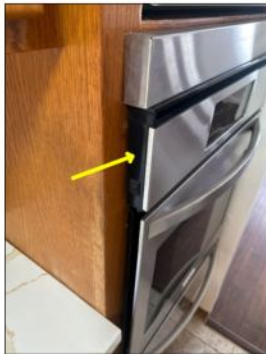
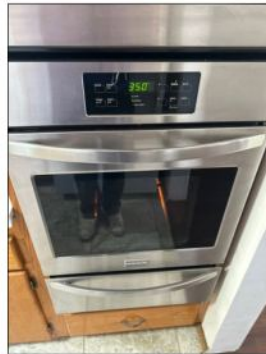
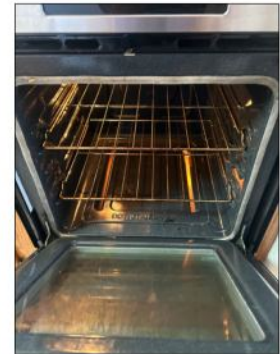
- The "Bake" feature is the only feature operated during a home inspection; convection, browning, rotisserie, warming drawers and other features are not tested during the oven inspection. Ovens are tested for basic heating element functionality. The oven cannot be tested to each incremental temperature setting or determine if adequate cooking temperatures can be achieved, nor if temperatures are calibrated with oven settings. We cannot determine if or how well the oven cooks food nor can we predict the remaining life left for the unit. For gas units - gas leaks cannot be detected with this inspection - a full evaluation by the Gas Company of all gas supplied appliances is recommended beyond this inspection.
- Gas supplied unit
- Tested and operational at time of inspection via normal controls
- Normal wear for age - no major visible defects
- **Loose in cabinet - needs to be serviced**

**Loose in cabinet - needs to be serviced**

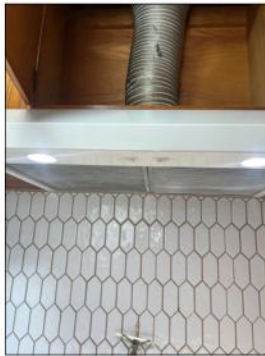
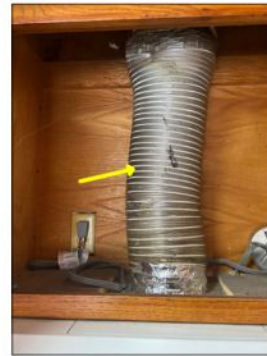
- The exhaust fan/vent is tested using the normal controls only. No smoke testing or other testing is done to determine the CFMs or how well the unit evacuates air. The home inspector cannot predict the remaining life left in the unit.
- Tested and operational at time of inspection via normal controls
- Normal wear for age - no major visible defects
- **Improper vent materials used (ribbed flexible) must be smooth metal pipe - needs to be serviced**

**Improper vent materials used (ribbed flexible) must be smooth metal pipe - needs to be serviced**

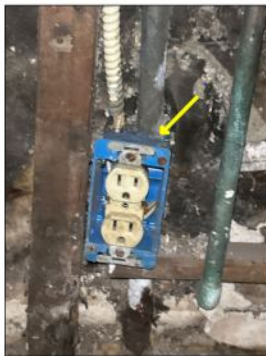
**Outlet cover missing - needs to be serviced - below sink**

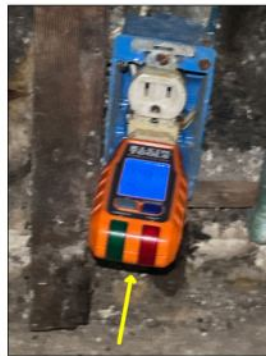
**Non-energized (dead) outlet(s) - needs to be serviced - below sink**

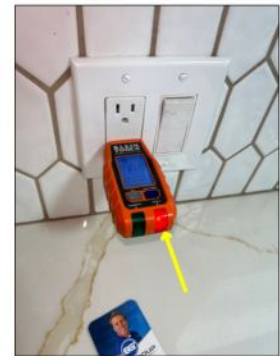
**Three prong outlet(s) not grounded - needs to be serviced**

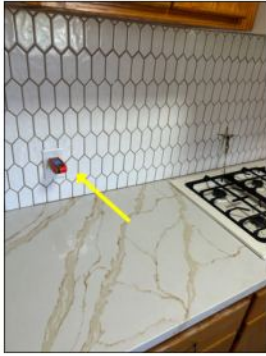
**Outlet hot wired in reverse with neutral - needs to be serviced**

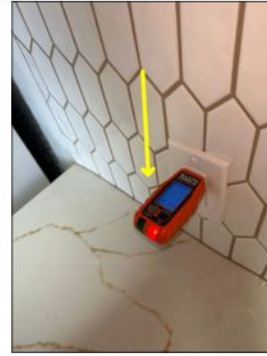
**Outlet hot wired in reverse with neutral - needs to be serviced**

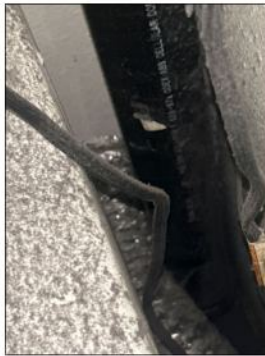
- Dryer vent should be cleaned periodically to prevent lint fire hazards
- **Does not extend to the exterior - needs to be serviced**

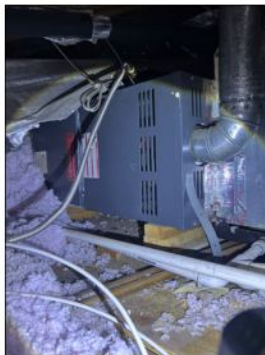
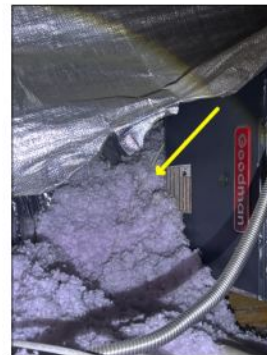
- Operated at time of inspection
- Visible areas of unit have normal wear for age at the time of the inspection - no major visible defects - recommend seasonal service and maintenance to extend the life of the unit
- *Recommend regular service/maintenance to extend the life of the unit(s)*
- *Inspector does not examine heat exchanger or determine the presence of a cracked heat exchanger - this is not a complete evaluation of the internal areas of the heater - consult an HVAC contractor for further evaluation if you have concerns about the heat exchanger.*
- **Combustible materials too close/touching unit - needs to be serviced**

**Combustible materials too close/touching unit - needs to be serviced**

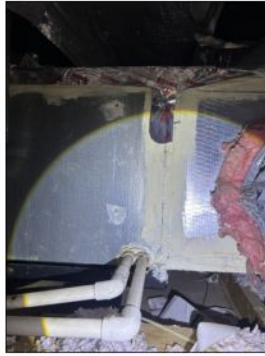
- The visible areas of the coil box are worn/dirty/deteriorated and typical for the age of the older unit
- Condensation lines cannot be traced to all locations by the inspector, often times there are several areas of the condensate lines that are not visible to the inspector - **consult a HVAC contractor** to further evaluate as needed
- *The a/c coil box is only examined on the exterior - an internal inspection is not completed on the coil box - **consult a HVAC contractor** to further evaluate as needed*
- *This inspection does not determine if the evaporator coil BTU size is the same as condensing unit size - **consult a HVAC contractor** for further evaluation as needed*
- Limited access to all sides prevents a complete inspection of the coil box

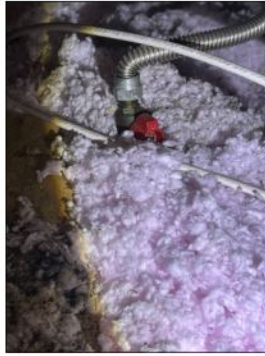
- Normal wear at time of inspection - no major visible defects
- No sediment trap at gas supply - may have not been required at time of original installation, but is recommended

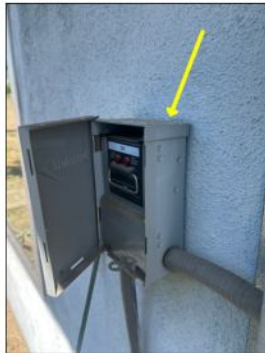
- Operating properly at the time of the inspection - no major visible defects
- **Disconnect box is loose on wall and missing proper weather sealing**

**Disconnect box is loose on wall and missing proper weather sealing**

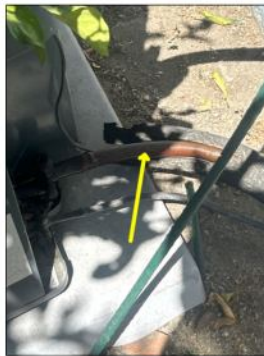
- Worn/weathered insulation where visible - may need servicing/repair soon - recommend annual/seasonal maintenance to check and service insulation on refrigerant lines as needed
- Missing insulation at compressor unit - needs to be serviced

**Missing insulation at compressor unit - needs to be serviced**

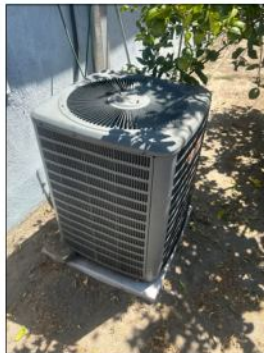
## 13. Air Conditioning Compressors

- Operated at the time of inspection
- Visible areas of unit are worn and weathered – recommend seasonal service and maintenance to extend the life of the unit
- Recommend regular service/maintenance to extend the life of the unit(s)
- This inspection does not determine if the evaporator coil BTU size is the same as condensing unit size - **consult a HVAC contractor** for further evaluation as needed

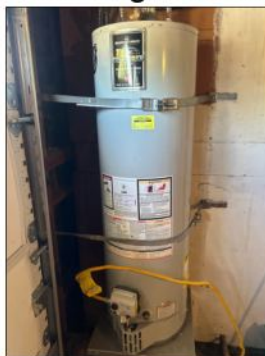
## 1. Water Heaters Condition

- Operated at the time of the inspection - Gas unit
- Visible areas of unit have normal wear for the age at the time of the inspection with no major visible defects
- **The water heater is visually inspected only, the combustion/pilot doors are not removed for flame or burner condition inspection due to the potential for draft to burn out the pilot flame. The Inspector does not estimate the age and cannot predict the remaining life of the unit.**

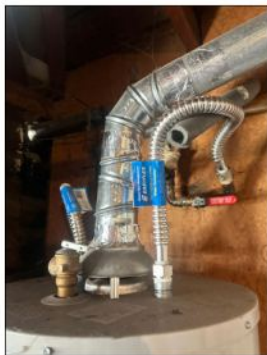
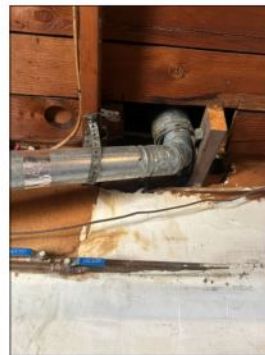
## 2. Venting

- Normal wear day of the inspection - no major visible defects
- Recommend sealing all connections at venting

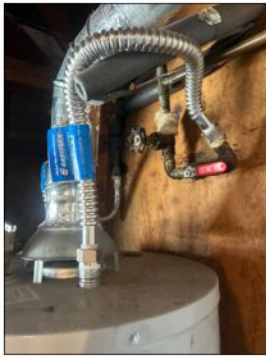
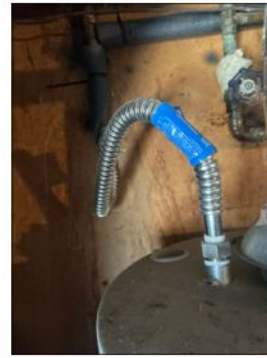
## 3. Plumbing

- Normal wear at time of inspection - no major visible defects or leaks found at the time of the inspection

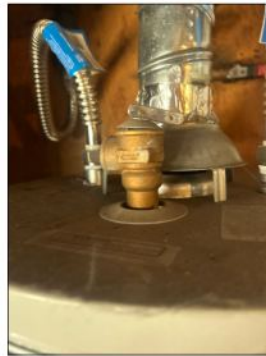
#### 4. Temperature Pressure Release Valves

- Normal wear on the day of the inspection - no major visible defects

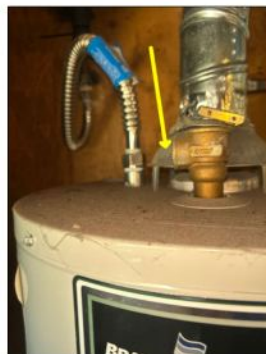
#### 5. Overflow Line/s

- None - needs to be serviced/installed

None - needs to be serviced/installed

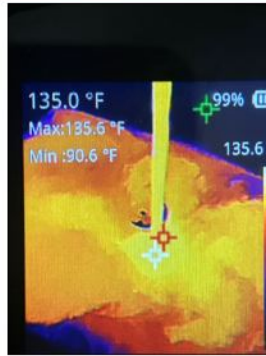
#### 6. Water Heater Temperature

- Temperature was above 120 F at one or more fixtures within the structure, this a potential scald hazard - needs to be serviced/adjusted - consult a plumber

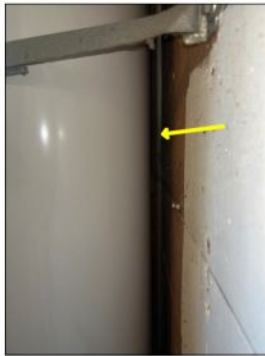
**Recommend blocking in areas where the water heater is not touching the walls**

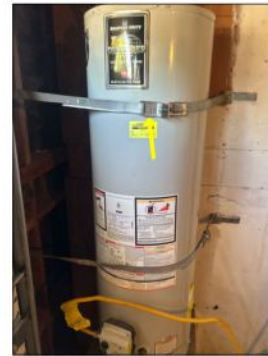
**Loose strapping - needs to be serviced**

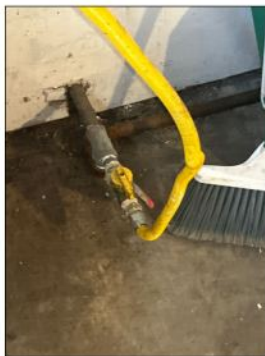
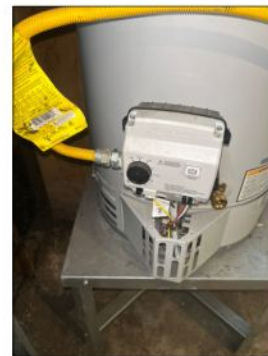
## 8. Gas Supply Valves and Pipes

- Normal wear at time of inspection - no major visible defects
- No sediment trap at gas supply - may have not been required at time of original installation, but is recommended

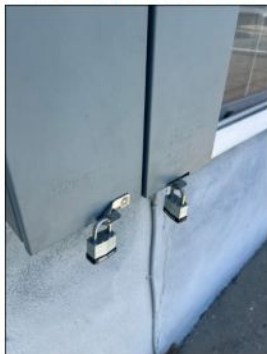
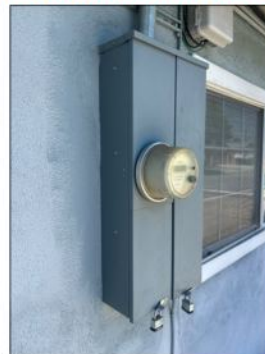
- Normal wear for age at time of inspection - no major visible defects
- **Panels are visually inspected only, the inspector does not perform a load calculation to determine service capacity adequacy**
- **Electrical fires due to poor installation of wiring cannot be determined by inspector**
- **Panel locked at time of inspection - not inspected - needs further evaluation by a licensed electrician**

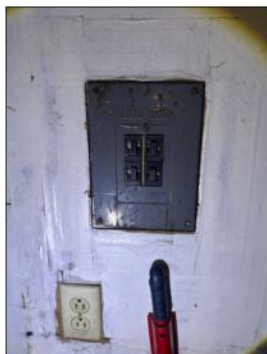
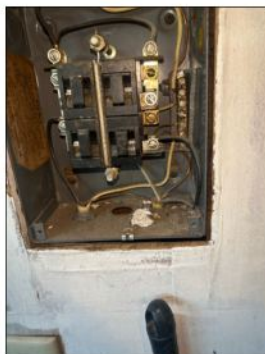
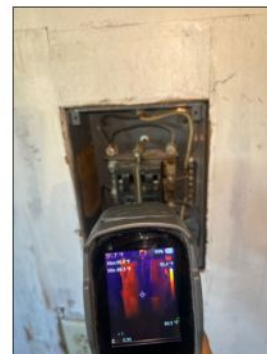
## 2. Sub Panels

- Recommend upgrading services due to age of electrical system
- **Grounds and neutrals not on separate bus bars - needs to be serviced**

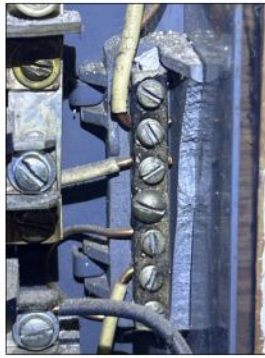
Grounds and neutrals not on separate bus bars - needs to be serviced

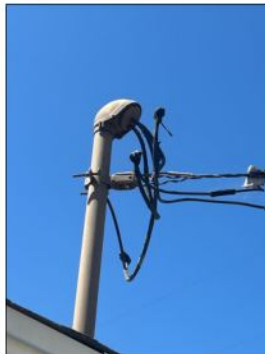
- Overhead - worn/weathered - needs service/maintenance

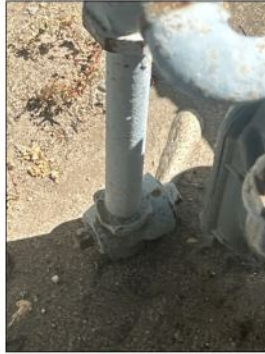
### 7. Main Gas Valve

- Natural gas present
- Worn valve - typical for age
- Recommend gas valve wrench be placed near valve for optimal preparedness
- No seismic safety valve present - recommend installation for increased safety
- ***The Inspector cannot determine if gas piping is properly protected in the ground - consult the Gas Company for further evaluation***
- ***Exterior gas lines, fire pits, BBQs, etc. are not included as part of this inspection - consult your gas supplier***

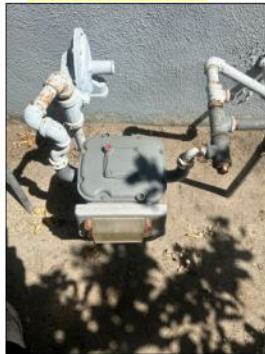
## 8. Gas Pipes and Valves

- Worn meter/piping - typical for age and exterior weathering
- Minor rusting - typical for age - recommend rust treatment
- *We recommend the gas supplier be contacted to safety check all fuel gas systems/appliances during the contingency period or at least prior to purchase and occupancy. Note: The Inspector cannot determine if a gas leak is present in any area of the home at any time during the inspection. Note: The inspector cannot determine if all gas lines are properly protected in the ground.*
- *Exterior gas lines, fire pits, BBQs, etc. are not included as part of this inspection - consult your gas supplier company to further evaluate these areas and **check permits** for any added gas lines, fire pits, BBQs, etc.*

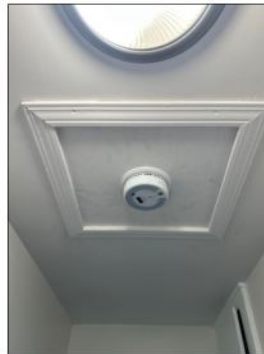
- Inspection method: Inspected from access hole only - access limitations prevented complete entry into the attic - limited inspection
- Location of access: Hall ceiling
- Normal wear at access door - no major visible defects
- Insufficient insulation on top of entry panel
- **Limited attic inspection - many areas are not accessible due to limited space, lack of proper walk boards, electrical, plumbing, ductwork, etc.**

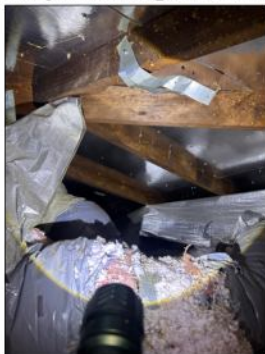
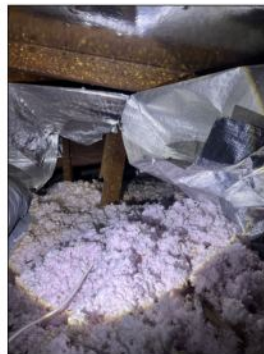
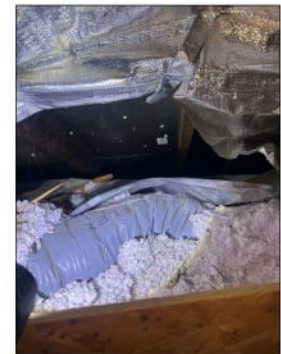
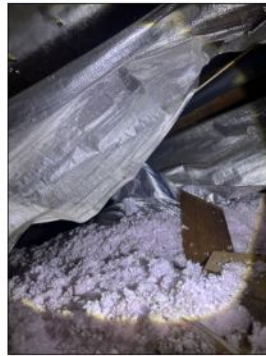
## 2. Structure

- **Consult termite report** for all wood areas in the attic
- Cracking small at wood members - typical for age
- **Limited attic inspection - many areas are not accessible to to limited space, lack of proper walk boards, electrical, plumbing, ductwork, etc.**

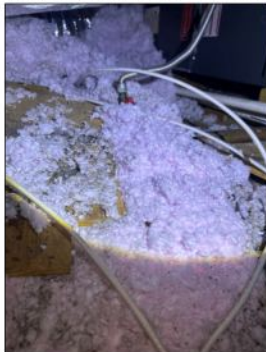
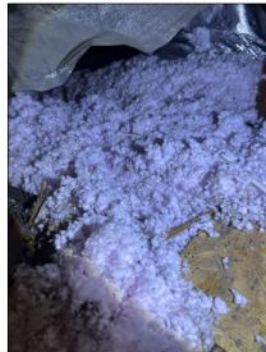
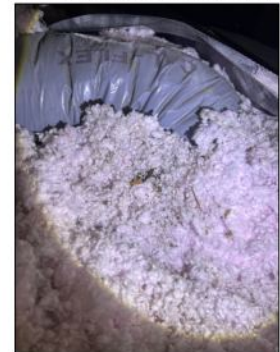
### 3. Insulation

- No visible signs of rodents at this inspection - we recommend pest services seasonally as part of your regular home maintenance
- All visible insulation appears to have normal wear for age with no major visible defects at the time of the inspection
- ***Note: The inspector does not determine the presence of asbestos or any other hazardous materials in the building***
- ***The inspector does not determine R-value of the insulation***
- ***Insulation generally blocks visible inspection access to framing or components below level of insulation***

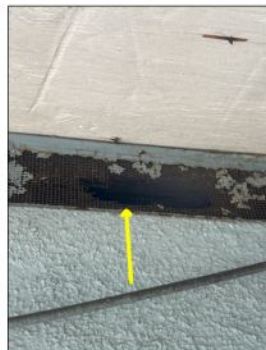
- **Torn mesh/screens - recommend servicing to prevent pest entry**

**Torn mesh/screens - recommend servicing to prevent pest entry**

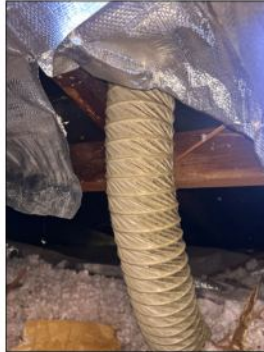
## 6. Exhaust Vents

- Some vents are not visible or accessible and cannot be inspected - N/A
- Visible vents are older and worn - typical for the age of the structure - consider upgrading

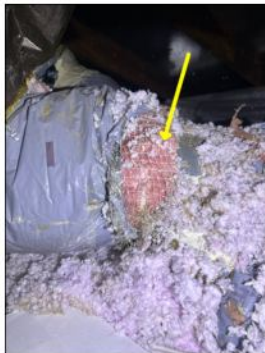
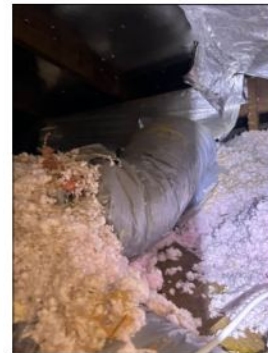
## 7. Duct Work

- Outer wrap damaged - recommend servicing
- **Note: The inspector does not determine the presence of asbestos or any other hazardous materials in the duct work - if there is any concern about asbestos in the duct work we recommend that the client have the ducts tested as needed.**
- **The inspector cannot determine efficiency or effectiveness of the duct layout - check all installation permits**
- **Some areas not visible due to access hindrances or limitations**

Outer wrap damaged - recommend servicing

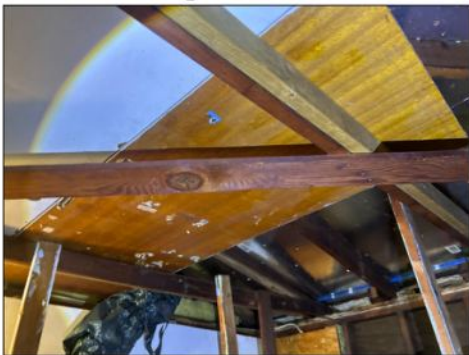
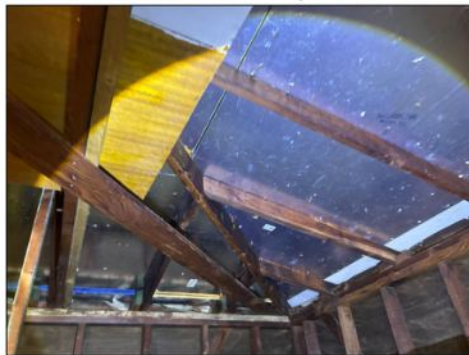
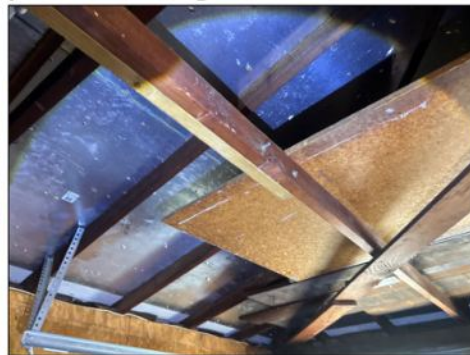
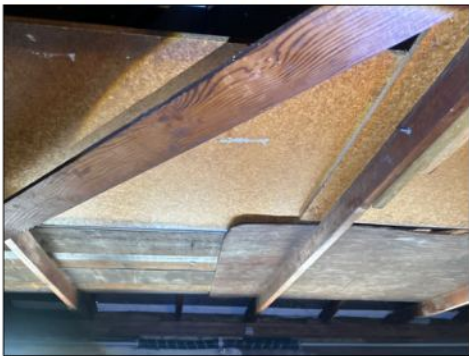
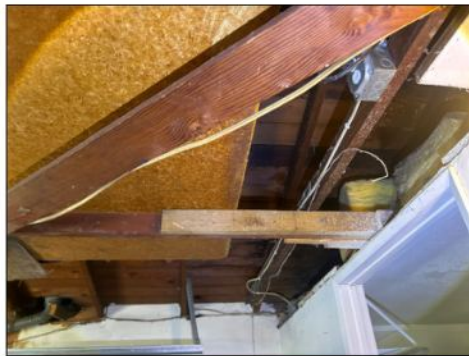
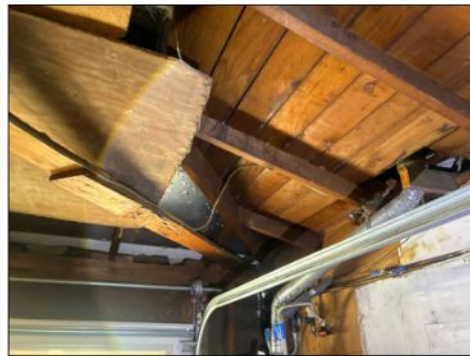
- Exposed wood rafters/joists - **consult termite report** for all wood areas
- Cosmetic blemishes observed
- *Some ceiling/rafter areas are not visible or accessible/inspected due to personal storage/wood boards*

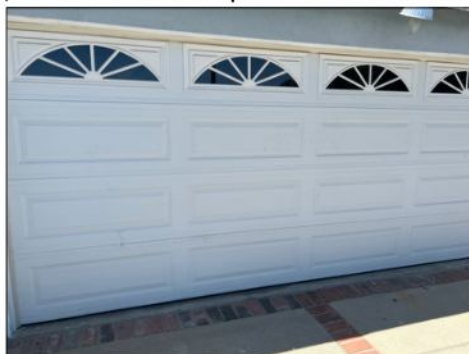
## 3. Main Automotive Doors

- Normal wear for age at the time of the inspection - no major visible defects
- Recommend weather tight service/maintenance to prevent moisture intrusion around main door areas

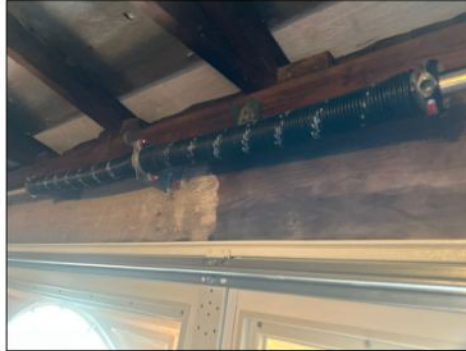
#### 4. Hardware/Springs

- ***Garage doors require periodic maintenance and is recommended to ensure that all hardware is properly lubricated and secured***
- Normal wear at time of inspection - no major visible defects

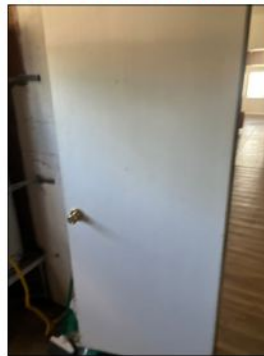
- Maintain air tight seals at all times
- **Door did not properly self-close and latch - needs to be serviced**
- **Does not appear to be a listed fire-rated door - needs to be further evaluated**

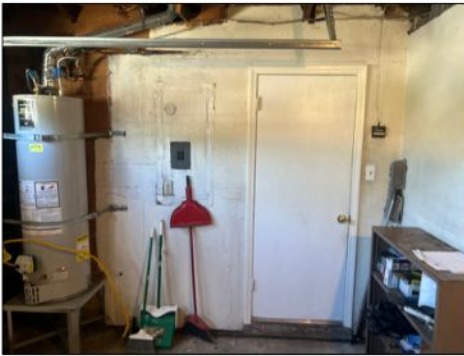
#### 7. Firewalls

- Recommend sealing any holes/gaps/cracks/loose tape – all areas of the firewall should be properly sealed with the correct fire-rated materials
- **Missing fire rated materials - needs to be serviced to retain integrity of fire separation**
- **Nonmetallic sheathed wiring penetrating firewall areas - needs to be serviced to retain firewall integrity**
- **Fire caulk needed at plumbing/electrical penetrations**

Fire caulk needed at plumbing/electrical penetrations

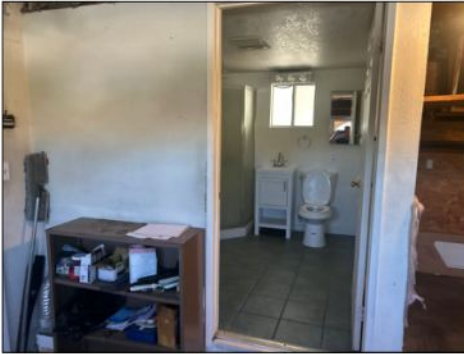
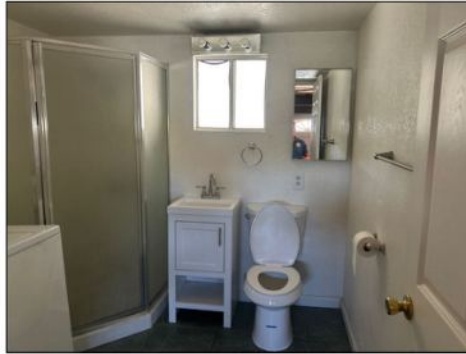
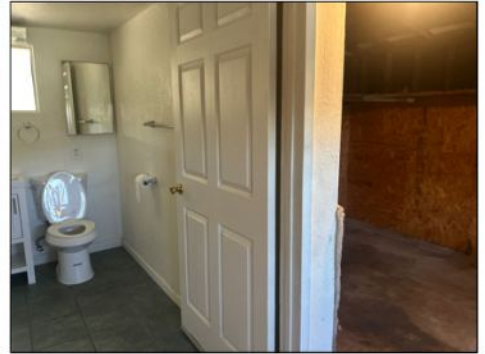
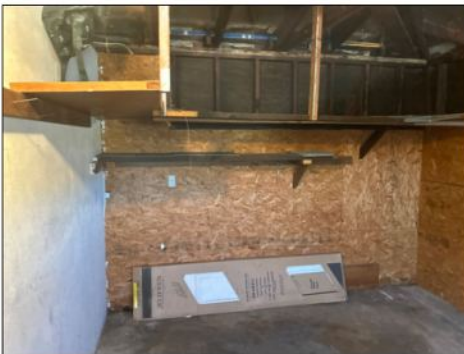
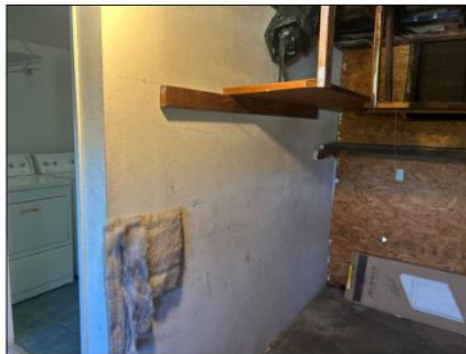
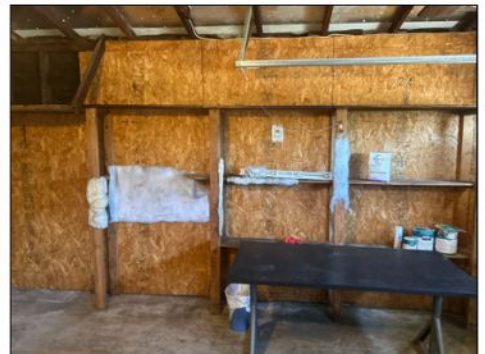
## 8. Walls

- *Personal items/storage/etc. are present and prevent a complete inspection of wall areas*
- **Consult termite report** for any wood areas in garage
- Small cracks/holes/chipped/dirty areas/cosmetic blemishes observed - typical for age of structure

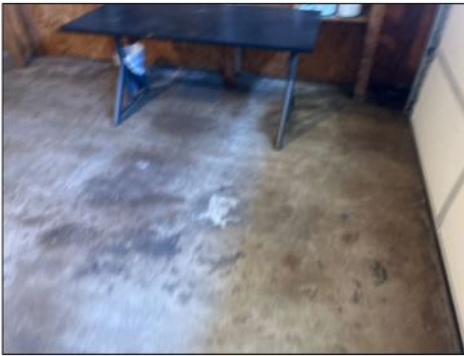
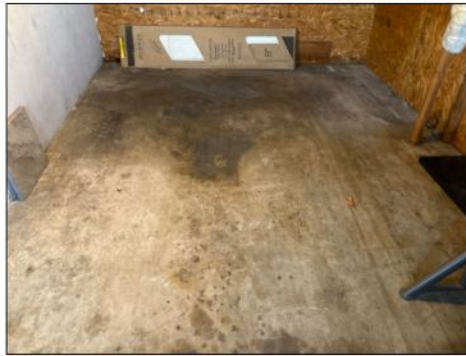
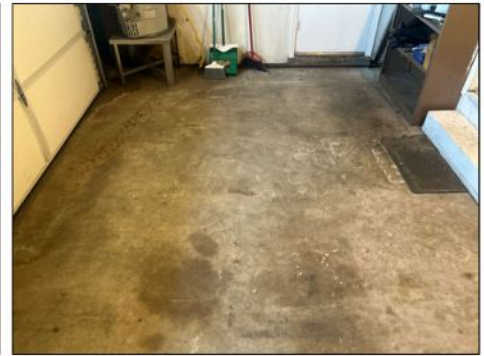
- Worn and stained areas - typical for age of the material

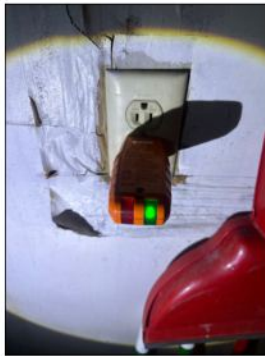
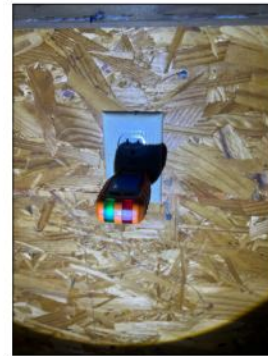
## 11. Electrical

- A representative number of receptacles and switches were tested and found to be operational at time of inspection
- Loose/worn outlets/switches - typical for age consider upgrading

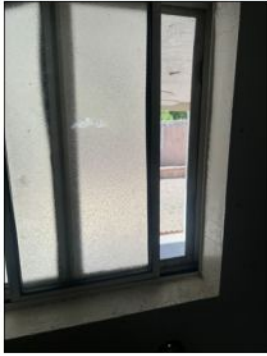
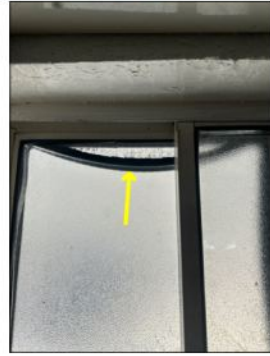
- Operated at time of inspection
- Worn frames/hardware/tracks - typical for age of material
- Recommend weather tight service
- Inner seal at dual pane windows are bulging due to heat - needs to be serviced

**Inner seal at dual pane windows are bulging due to heat - needs to be serviced**

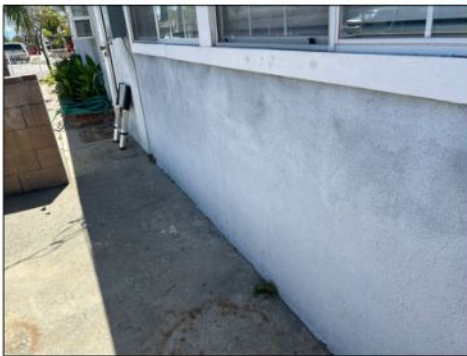
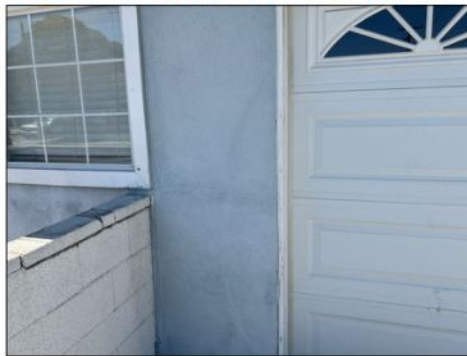
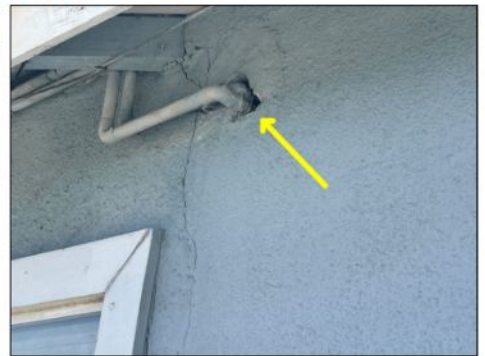
- Worn/weathered at time of inspection where visible
- Recommend sealing any holes/gaps or cracks to prevent moisture or pest entry
- Small cracking/chipping/holes present in areas - recommend stucco service/**maintenance**
- **Stucco requires periodic seasonal maintenance, consult an exterior finish contractor for maintenance tips/schedules/suggestions**
- **Inspector does not use specialized instruments to detect moisture, if any, under stucco surface**
- **Some not accessible for inspection due to vegetation/personal items/height/limited access - these areas cannot be visually inspected**
- **Holes more than typical - needs to be serviced**
- **Cracking - more than normal - needs to be serviced - by main electrical panel**

**Recommend sealing any holes/gaps or cracks to prevent moisture or pest entry**

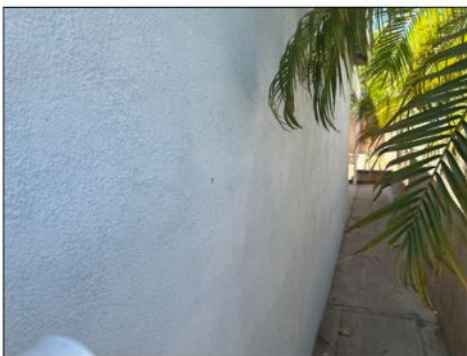
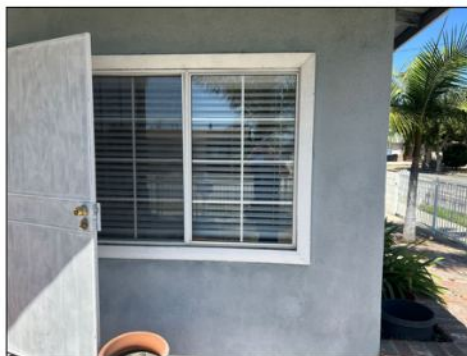
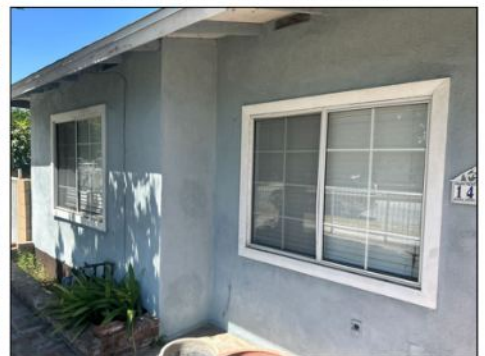
Holes more than typical - needs to be serviced

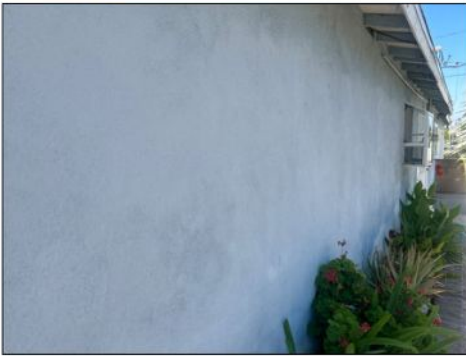
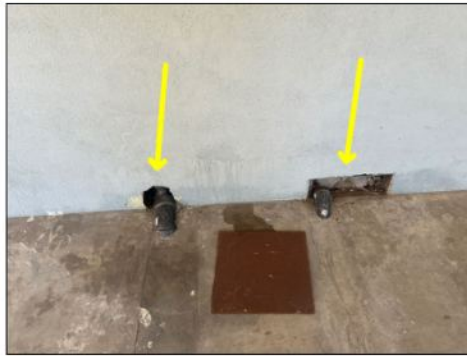
Holes more than typical - needs to be serviced

| Page 52 Item: 1 | Stucco | • Holes more than typical - needs to be serviced<br>• Cracking - more than normal - needs to be serviced - by main electrical panel |

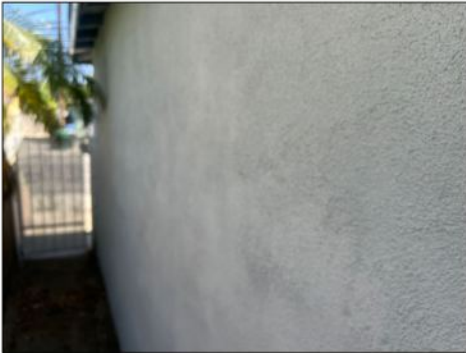
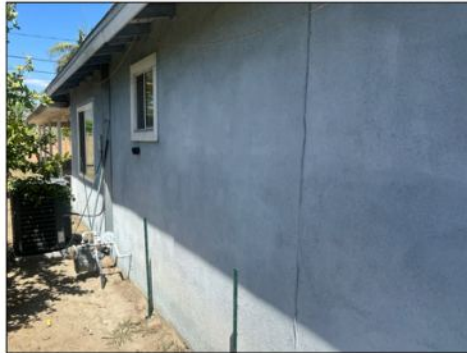
Cracking - more than normal - needs to be serviced - by main electrical panel

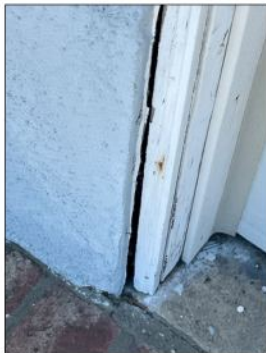
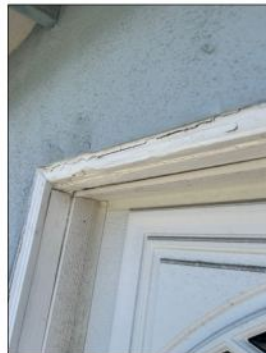
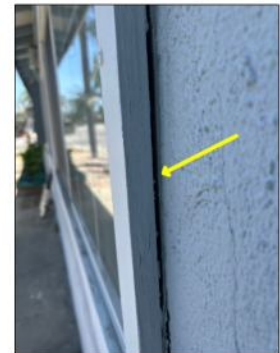
## 2. Wood Trim

- **Consult termite report** for all exterior wood
- Worn/weathered at time of inspection where visible – recommend service and water tight maintenance
- Gaps present at some trim areas - recommend service and water tight maintenance
- Loose trim - recommend servicing

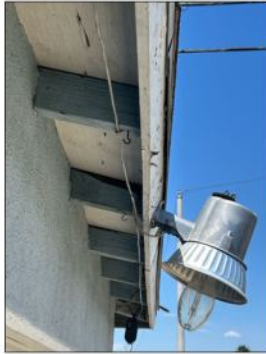
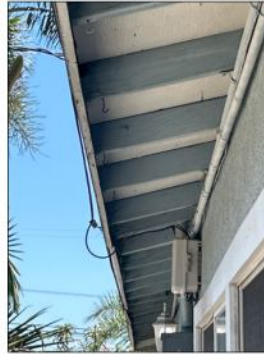
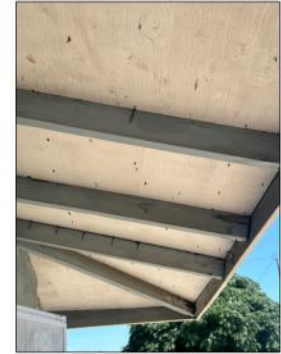
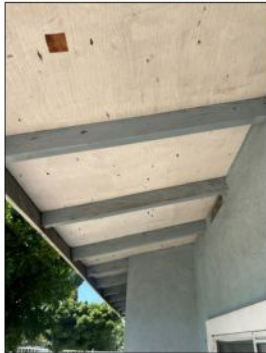
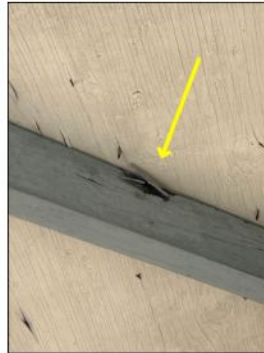
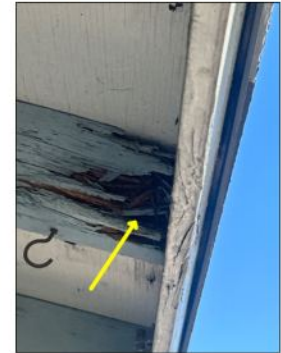
**Deteriorated in areas - needs to be serviced - consult the termite report**

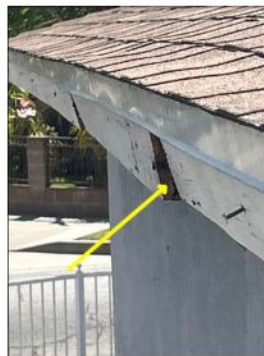
**Warped wood / twisted wood - signs of age and wear - recommend servicing**

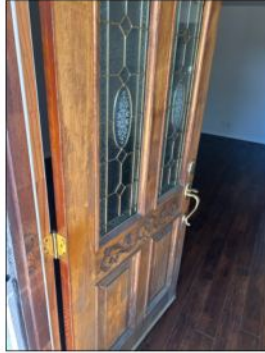
- **Consult the termite report for all wood doors/frames at this structure**
- All visible and accessible doors were tested during this inspection
- Loose/worn hardware needs minor service and/or adjustment
- Worn/weathered – recommend weather tight service/maintenance

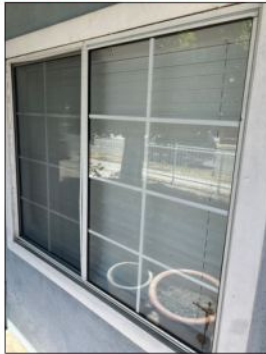
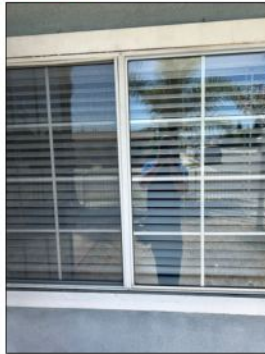
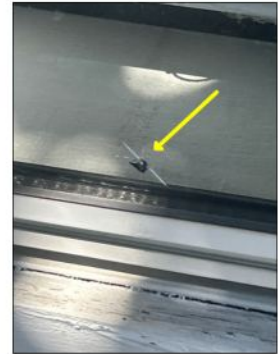
**Cracked glass - needs to be serviced - south side**
