PROPERTY LOCATION: 14657 Channing St Baldwin Park, CA 91706

# INSPECTIONREPORT

Date of Inspection: 7/16/2026 at 2:00 PM

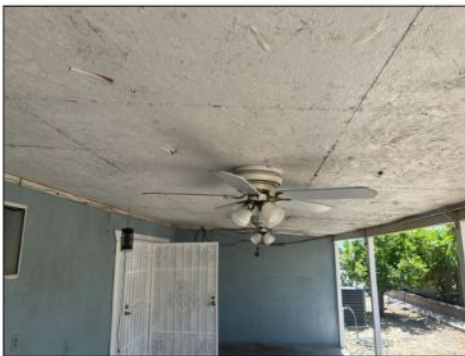
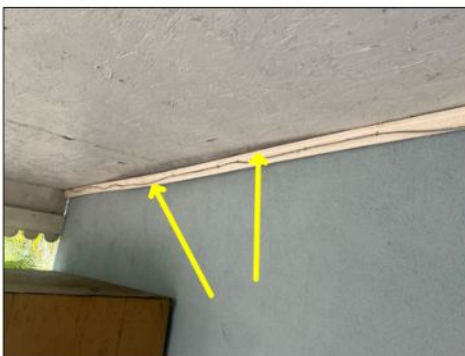
**Structure attached to house with no ledger board – irregular installation – recommend licensed contractor to evaluate**

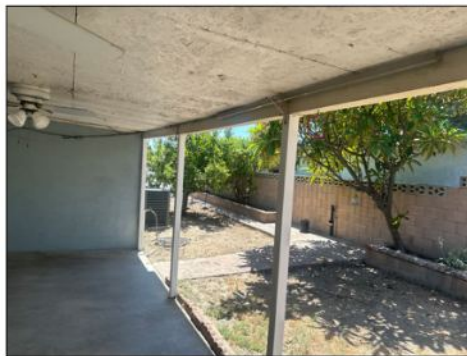
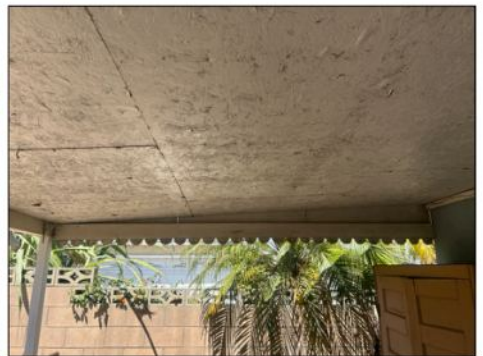
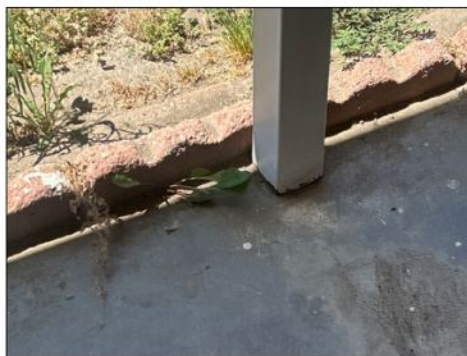
## 2. Patio and Porch Roofs

- Worn/weathered materials - typical for age
- **Consult termite report** for all exterior wood conditions
- No visible brackets used for support - typical for the age of this structure - we recommend adding brackets as needed for additional stability and support
- **Structure attached to house with no ledger board – irregular installation – recommend licensed contractor to evaluate**

| Page 58 Item: 2 | Patio and Porch Roofs | <ul style="list-style-type: none"><li>• Structure attached to house with no ledger board – irregular installation – recommend licensed contractor to evaluate</li></ul> |

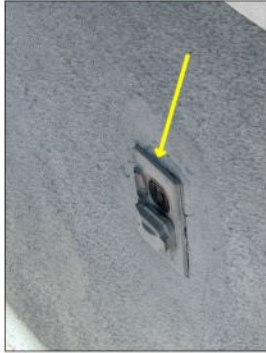
Exterior outlet/switch covers are missing or not of proper exterior weather proof type - needs to be serviced

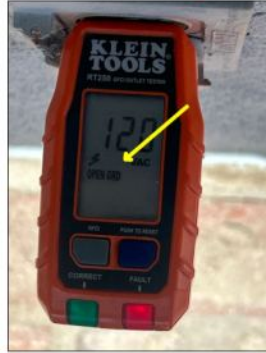
Three prong outlets not grounded - needs to be serviced

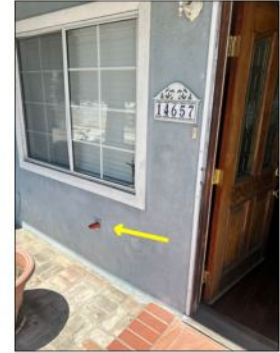
Three prong outlets not grounded - needs to be serviced

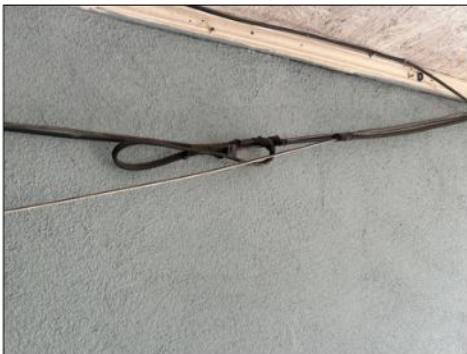
Interior rated wiring used outside - recommend servicing

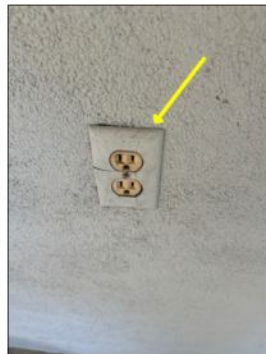
Exterior outlet/switch covers are missing or not of proper exterior weather proof type - needs to be serviced

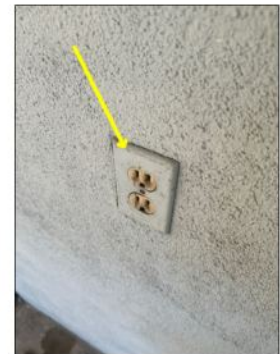
Exterior outlet/switch covers are missing or not of proper exterior weather proof type - needs to be serviced

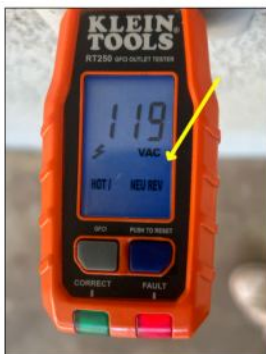
Outlet hot wired in reverse with neutral - needs to be serviced

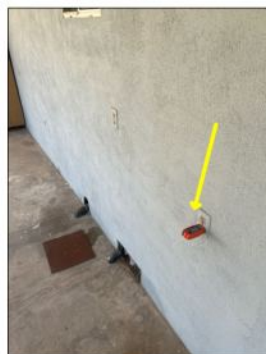
Outlet hot wired in reverse with neutral - needs to be serviced

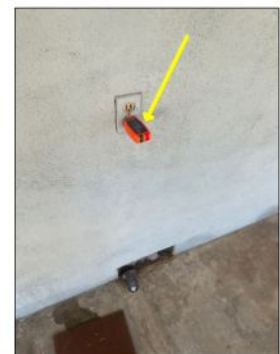
Outlet hot wired in reverse with neutral - needs to be serviced

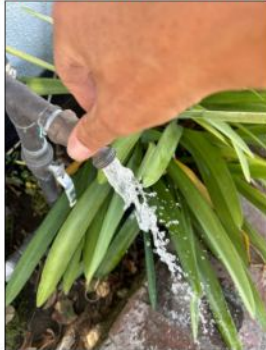
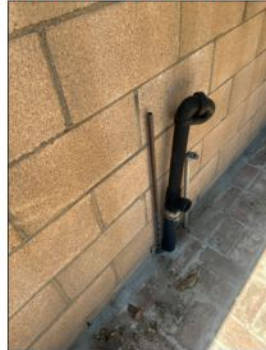
Plumbing pipes at exterior of structure are uncapped and not properly secured - needs to be serviced

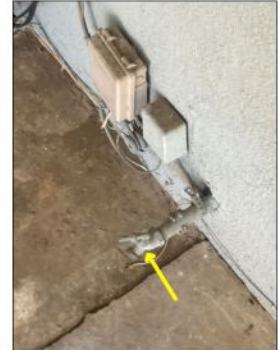
Bibb(s) not functional at one or more locations - needs to be serviced

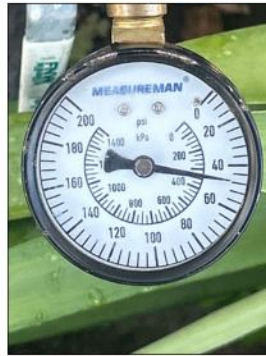
- Recommended water pressure is between 55 to 80 pounds per square inch (psi)
- Water Pressure can fluctuate depending upon time of day and municipal service adjustments
- Approximate pounds per square inch: 50 - low

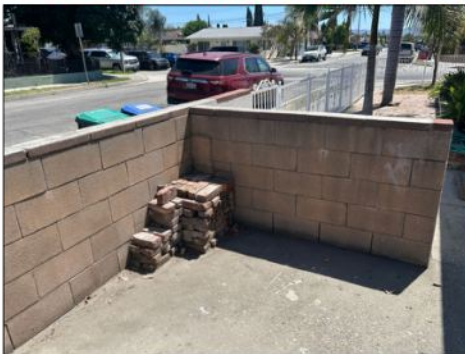
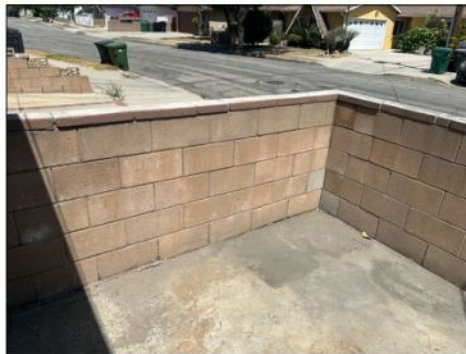
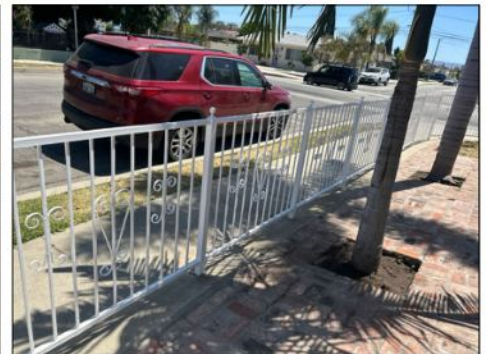
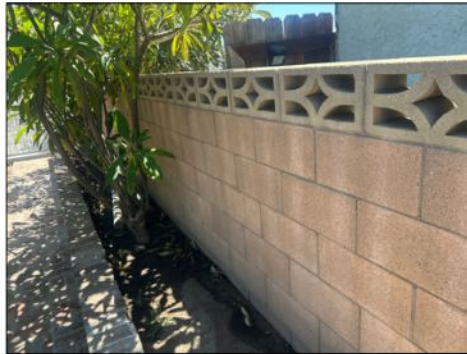
- Visible fencing/wall areas are worn and weathered - typical for the age of the materials
- **Fence enclosures are not evaluated for security adequacy**
- **Some wall/fence areas not visible for inspection due to vegetation/personal items**
- **Property boundary lines and encroachment determinations are beyond the scope of a home inspection and are not inspected or included in this report. It is recommended that qualified professionals are consulted for evaluation if concerns exist in this area.**
- **Cracking large/separation cracks present - needs to be serviced**

Cracking large/separation cracks present - needs to be serviced

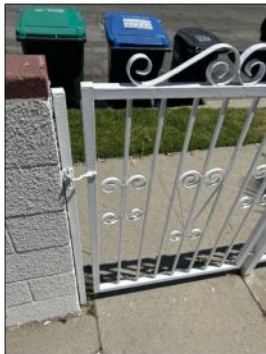
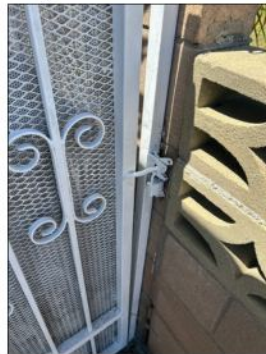
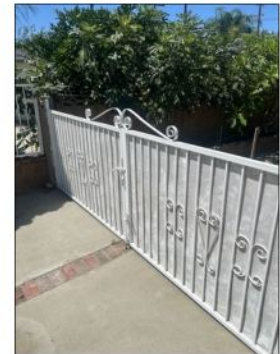
- Gate(s) locked - not tested
- Operated on the day of the inspection
- Weathered and worn materials - typical for age
- **Gates are not evaluated for security adequacy**

Gate(s) locked - not tested

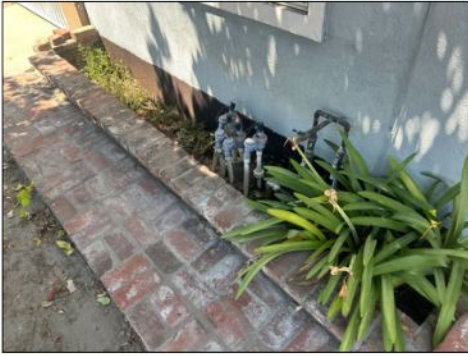
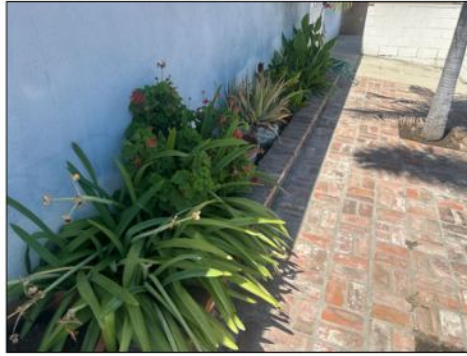
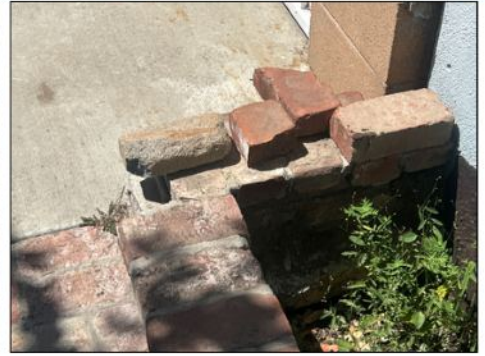
- Recommend adding drainage in planter areas to direct moisture away from the structure
- Recommend pruning or remove any plants or trees that are in contact or proximity to structure to eliminate pathways of wood destroying insects and moisture
- **Damaged areas - needs to be serviced**

**Damaged areas - needs to be serviced**

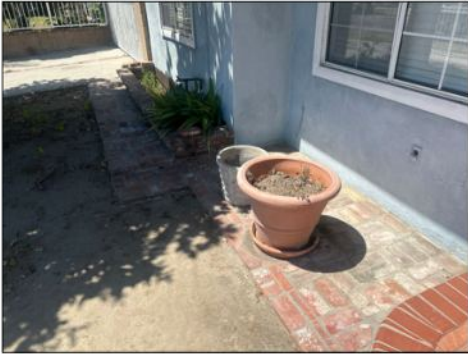
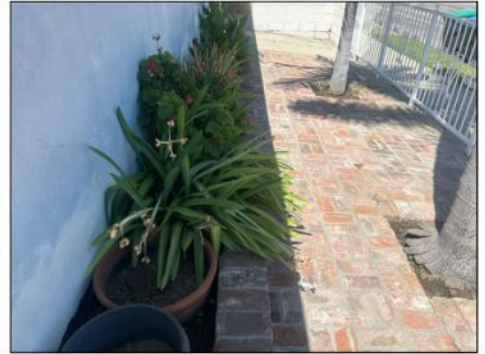
## 12. Grading

- No drains visible at the property at the time of the inspection, drains are recommended to divert water away from structure
- Small localized water ponding may occur in areas - monitor these areas as drains may be needed

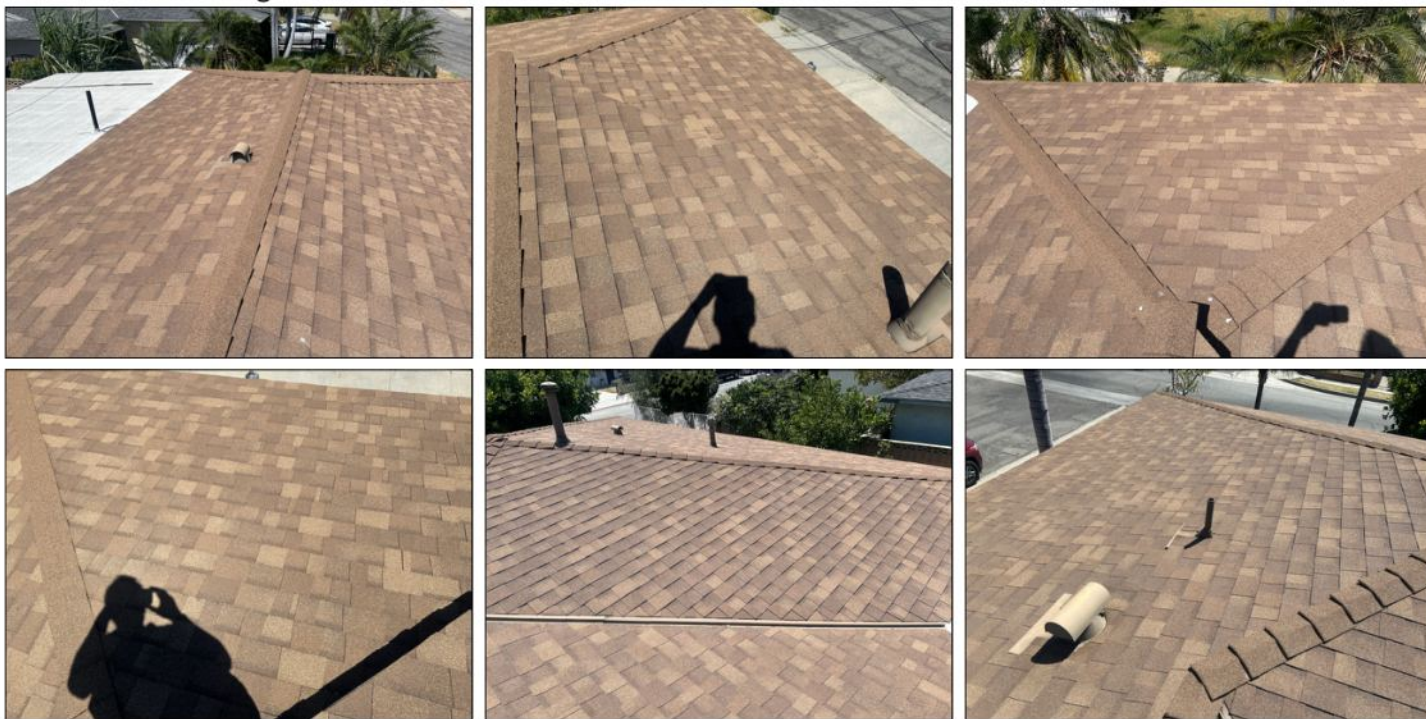
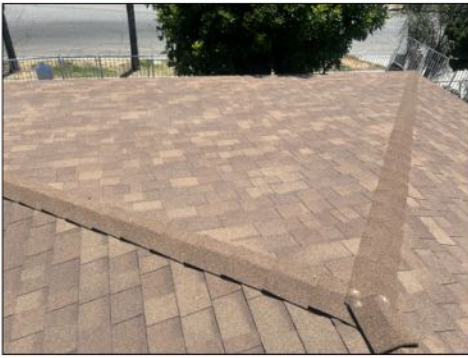
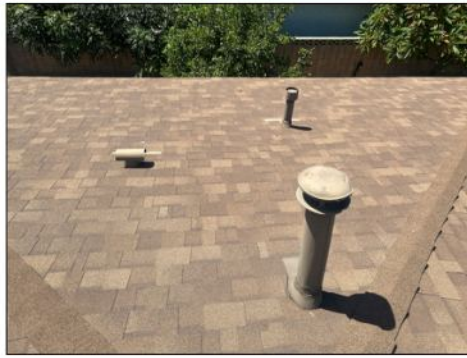
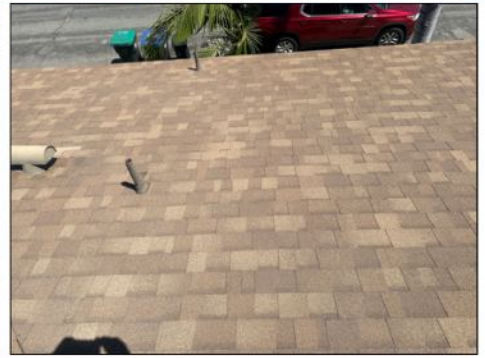
## 1. Condition

- Visible materials show signs of normal wear for the age of the materials at time of inspection - no major visible defects - Regular seasonal maintenance is recommended to extend the life of the roof

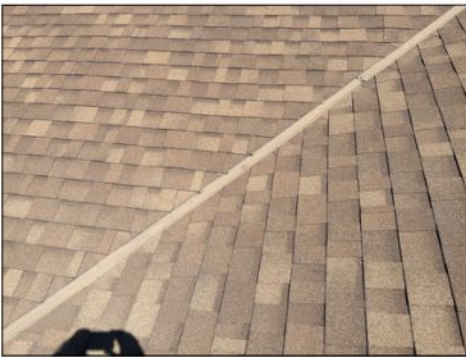
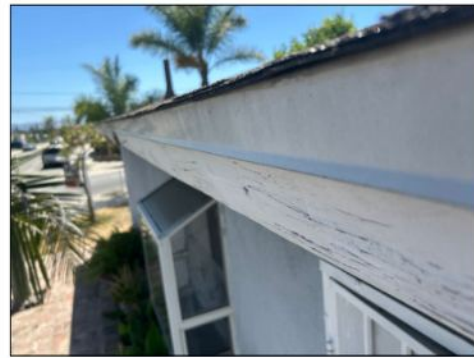
## 2. Flashings

- Normal wear at time of inspection - no major visible defects - recommend seasonal mastic maintenance to prevent moisture intrusion

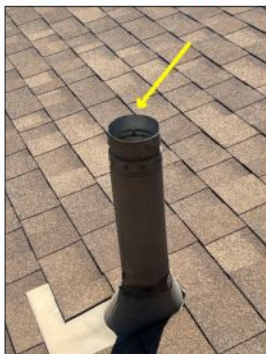
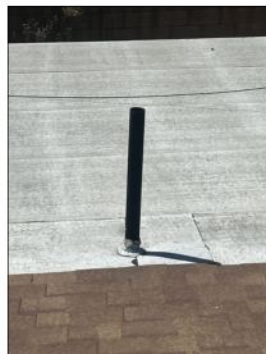
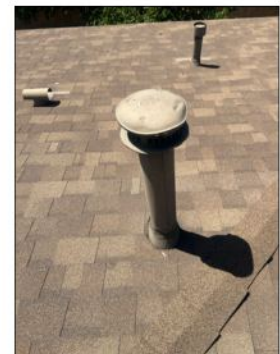
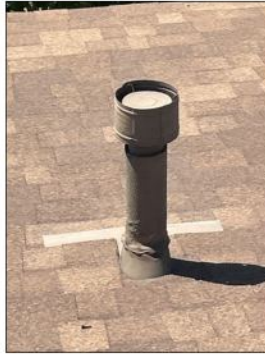
- Missing gas vent cap(s) - needs to be serviced

Missing gas vent cap(s) - needs to be serviced
