**Service:** Full Home Inspection

**Prepared for:** Gabriel Amparan

Site Address: 352 Campbell Avenue, Redlands, CA, 92373

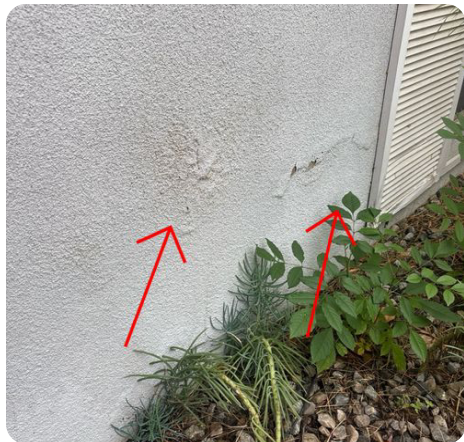
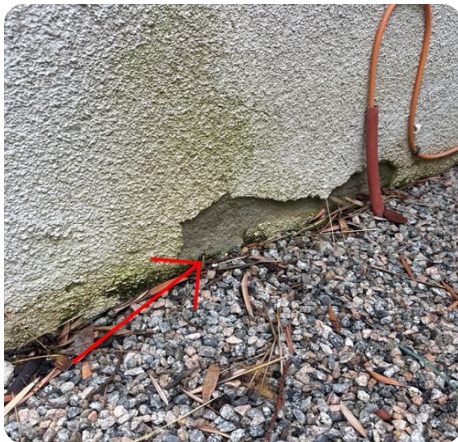
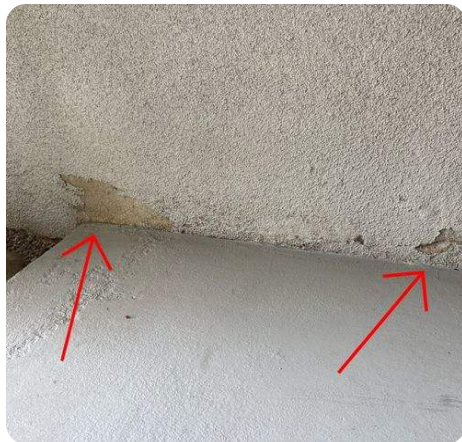
### 1 Stucco Deteriorating/Loose

There is loose/deteriorating stucco in various areas around the structure. Contacting a qualified stucco specialist for an evaluation and repair is recommended to prevent further issues.

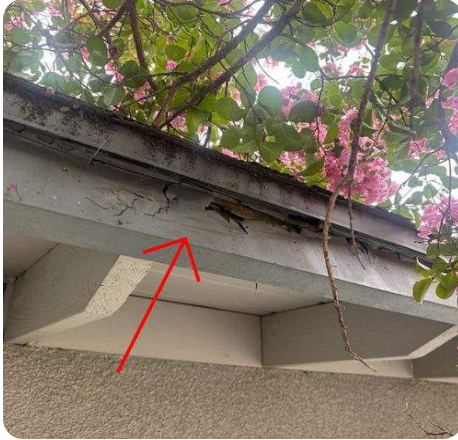
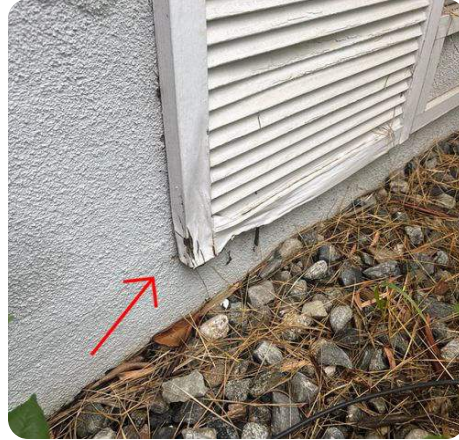
### 2 Moisture Damage On Fascia

The fascia in some areas has moisture damage. It is important to evaluate and repair this issue promptly to prevent further water intrusion and potential structural damage. We recommend hiring a qualified contractor to assess the extent of the damage and make necessary repairs to restore the integrity of the fascia.

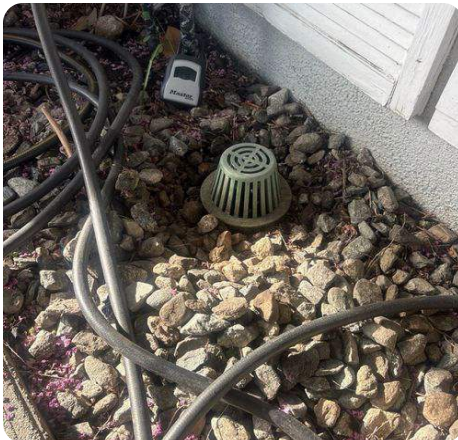
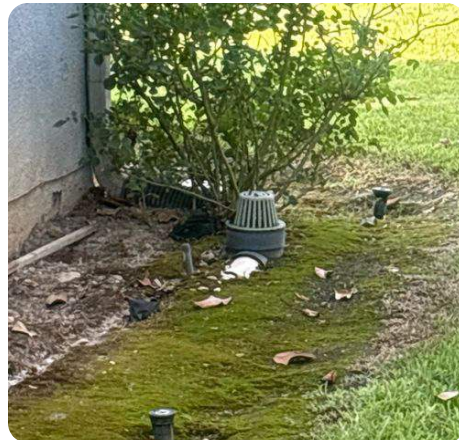
### 3 Underground Drainage

There is an underground drained system in the front yard area. The drainage caps will need to be adjusted to allow water to enter the drained system. Contacting a qualified landscape specialist for an evaluation and to properly adjust the drain caps is recommended to allow for proper water drainage.

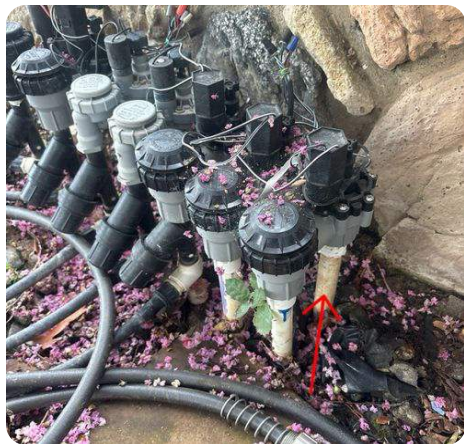
There is a leaking sprinkler valve near the main entry door. Contacting a qualified trades person for an evaluation and repair is recommended to prevent further issues.

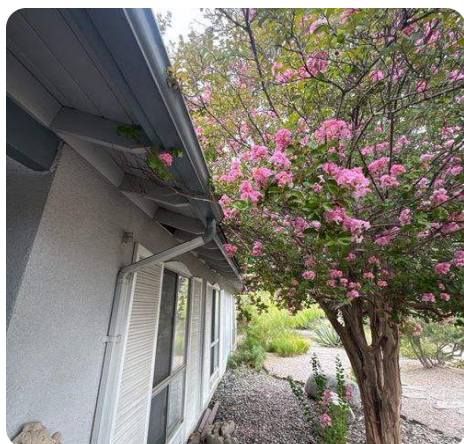
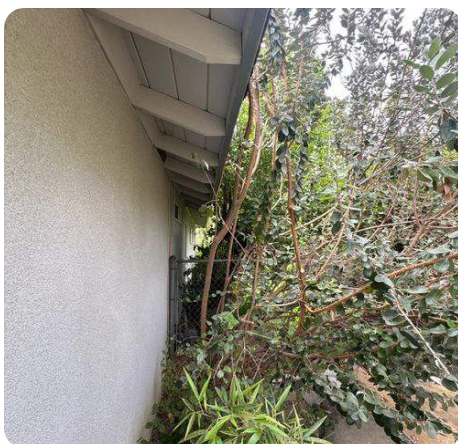
## 5 Vegetation Recommendations

All vegetation should be kept trimmed 12 inches away from the structure to eliminate a common avenue for pest infestation and damage to the exterior structure material. Maintenance of overhanging trees, vines and other plant material is recommended.

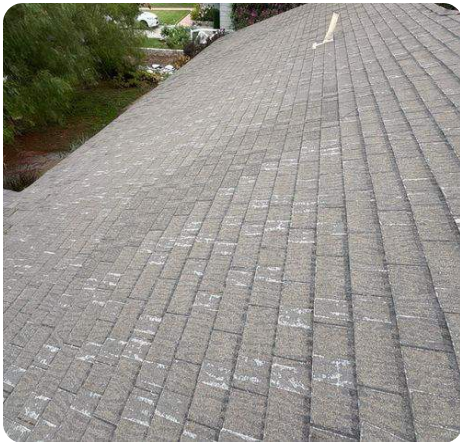
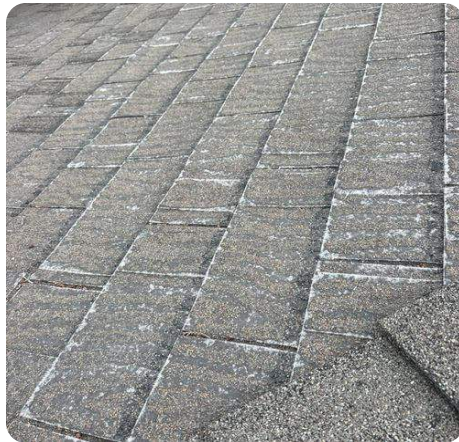
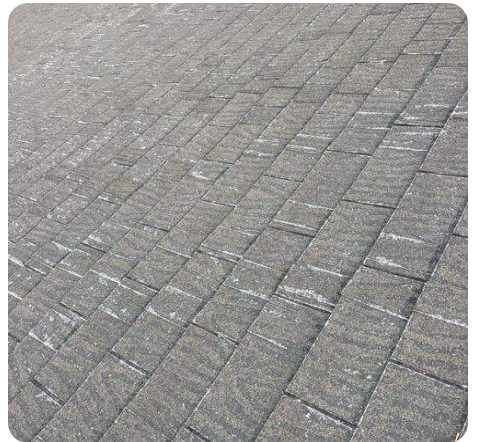
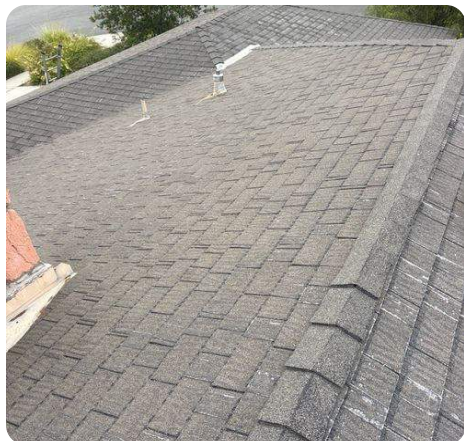
7

Granular loss was observed on the shingles of the roof. This issue can occur due to various factors like age and weather. It may expose the shingles to UV light, increasing the risk of damage. While some wear over time is typical, significant granular loss suggests the need for a professional evaluation and possible repairs. Contacting a qualified roofer to assess the extent of the issue and recommend necessary maintenance is advised.

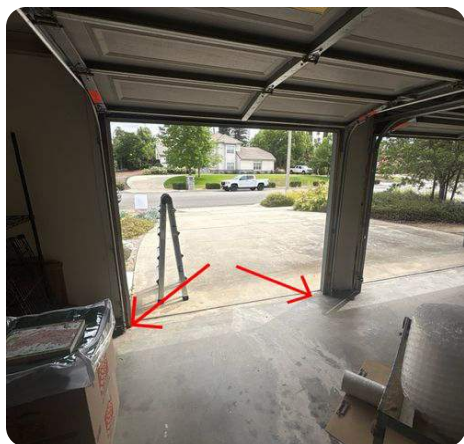
### 8 Garage Door Safety Sensor Alignment

The single garage door safety sensors appear to be misaligned or not operating properly. The sensors are located near the bottom of the garage door tracks. Misaligned sensors can prevent the door from closing properly. It is recommended to evaluate and repair the alignment of the safety sensors to ensure proper functionality. A qualified trade can adjust and align the sensors accurately.

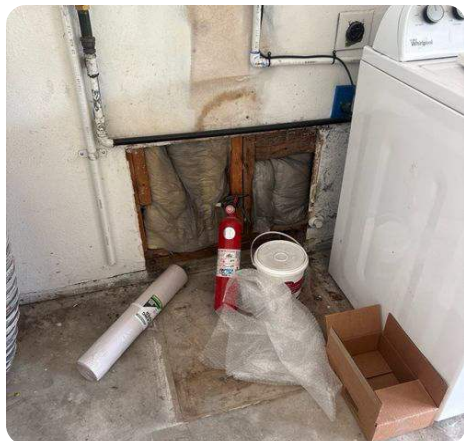
### 9 Damaged Wall Area In Garage

The common wall surfaces between the house and the garage appear to be a firewall system; however, there is damage to the drywall which needs repair. All openings of more than 1/8", are recommended to be sealed. We recommend the area(s) be repaired in order to provide intended serviceability. Contact a qualified trade or handyperson for repairs.

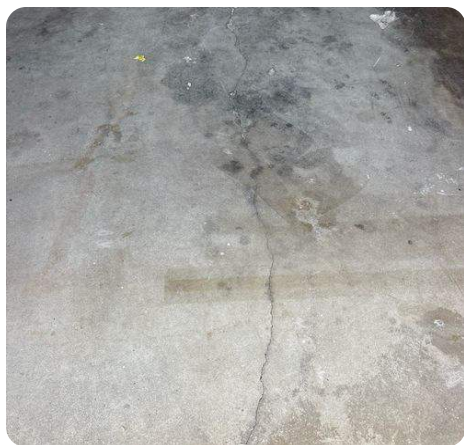
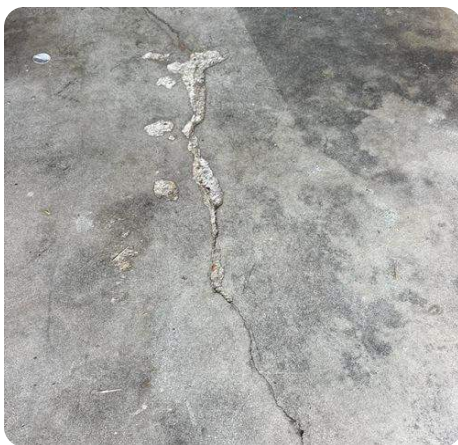
## 10 Cracks In Garage Floor

The presence of cracks in the garage floor is noted. These cracks can be a result of the natural settling of the house over time. It is recommended to evaluate the severity of the cracks, especially if they are widening or showing signs of structural issues. Repairing the cracks with a concrete filler can help prevent water seepage and further damage. If the cracks continue to widen or pose structural concerns, consulting with a qualified concrete contractor is advised.

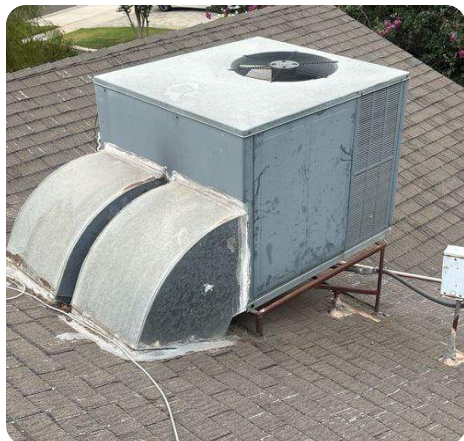
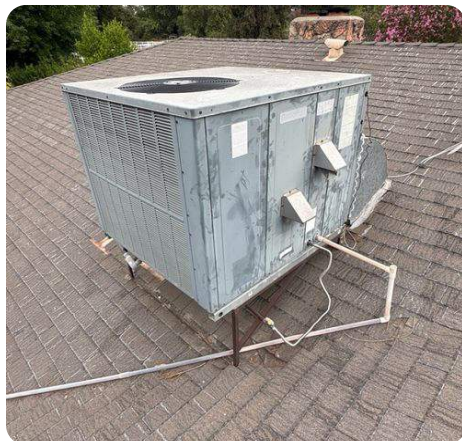
**13 No Service Notes**

There are no visible posted service notes attached to the HVAC system. It is recommended to inquire with the seller about the last servicing of the heating/cooling systems. If not serviced recently, a qualified technician should perform a service cleaning, tune-up, full unit evaluation, and review of the HVAC system prior to closing.

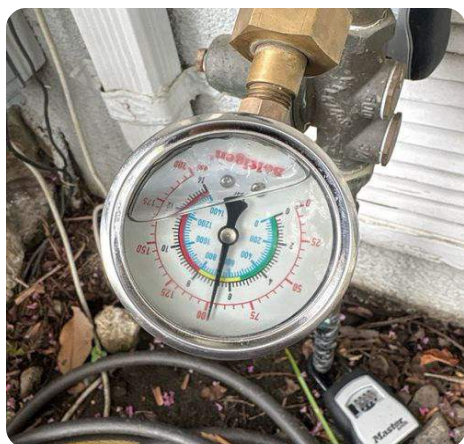
### 14 High Water Pressure Issue

The water pressure in the house is measured at 100 psi, which is above the recommended pressure for residential properties (generally between 40-80 psi). High water pressure can lead to pipe damage, leaks, and premature wear on appliances. It is recommended to have a licensed plumber evaluate and install a pressure regulator to reduce the pressure to a safe level.

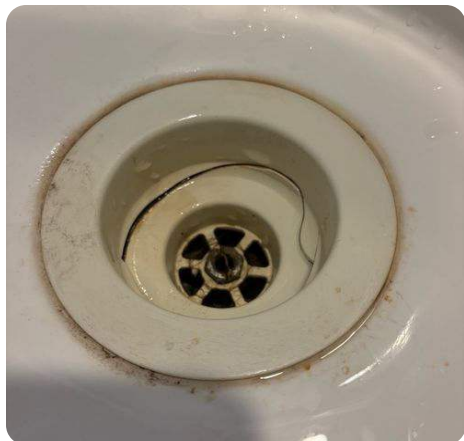
### 15 Kitchen Sink Drain

The kitchen sink drain has a damaged drain cover. Contacting a qualified plumbing contractor for an evaluation and repair/replacement is recommended to prevent further issues.

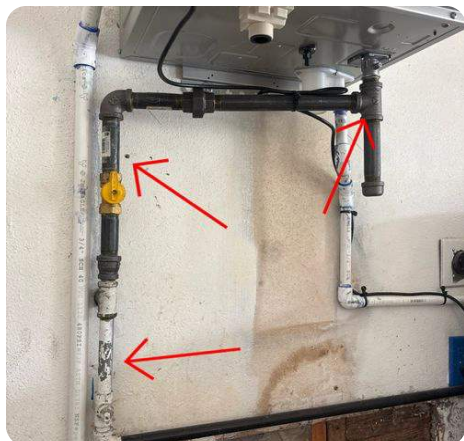
16 Hard Plumbed

The water and gas plumbing lines to the water heater are considered hard plumbed. Flexible gas and water lines are required around the gas appliance. Contacting a qualified plumbing contractor for an evaluation and repair is recommended for safety.

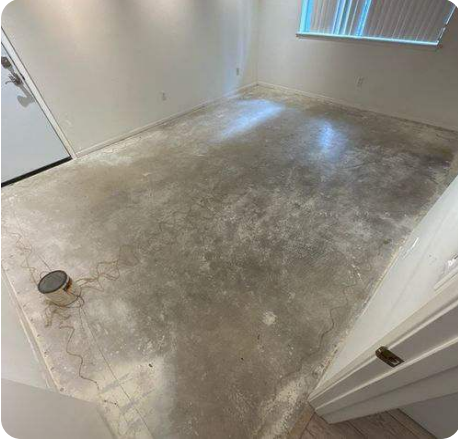
17 Flooring Removed

There is a guest bedroom where the flooring has been removed. Contacting a qualified trades person for an evaluation and replacement is recommended.

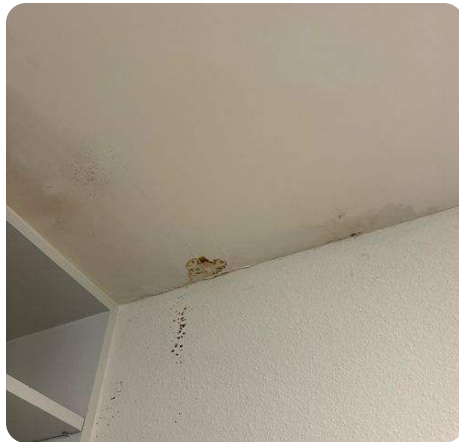
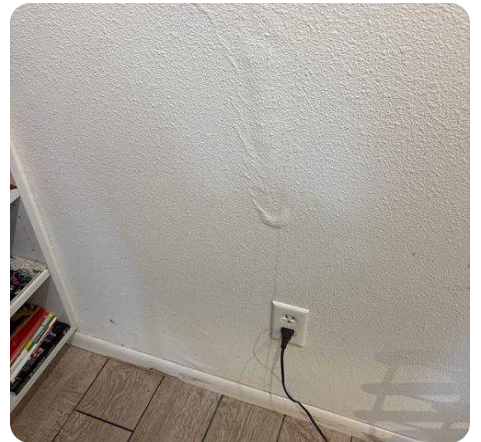
**18 Moisture Damage**

Moisture damage was noted to the ceiling and wall in the living room area. Moisture was detected as the area was checked with a moisture meter. Contacting a qualified trades person for an evaluation and repair is recommended to prevent further issues.

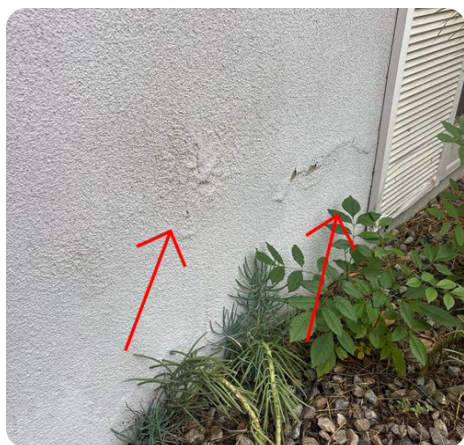
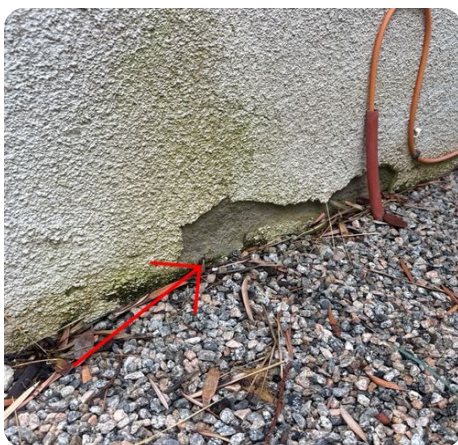
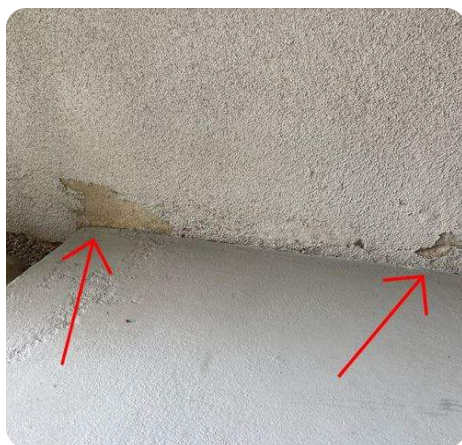
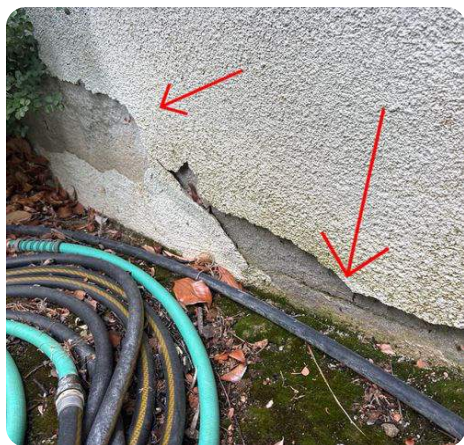
#### Stucco Deteriorating/Loose

There is loose/deteriorating stucco in various areas around the structure. Contacting a qualified stucco specialist for an evaluation and repair is recommended to prevent further issues.

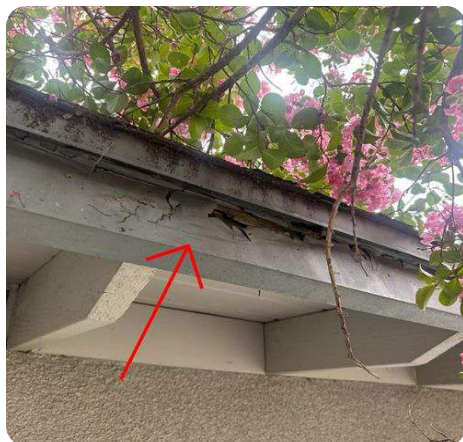
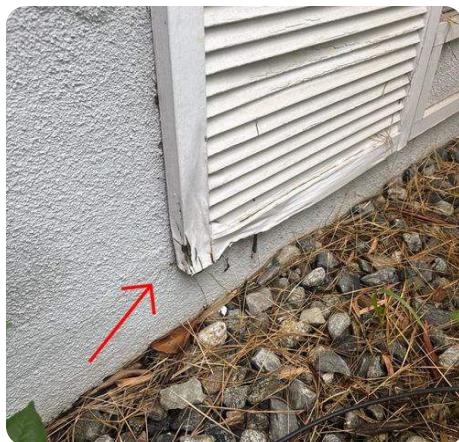
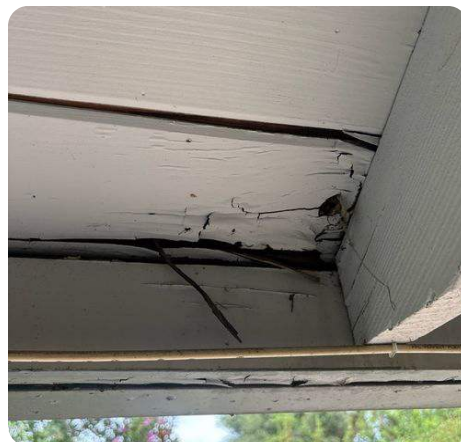
### Moisture Damage On Fascia

The fascia in some areas has moisture damage. It is important to evaluate and repair this issue promptly to prevent further water intrusion and potential structural damage. We recommend hiring a qualified contractor to assess the extent of the damage and make necessary repairs to restore the integrity of the fascia.

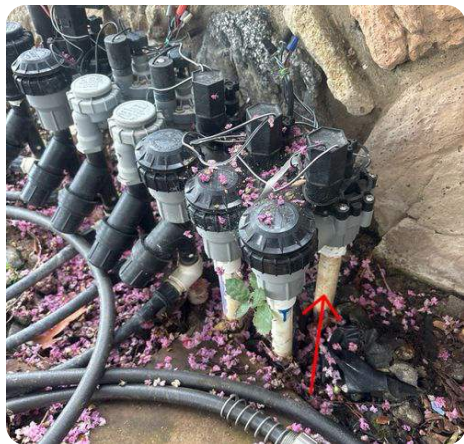
### Sprinkler System

There is a leaking sprinkler valve near the main entry door. Contacting a qualified trades person for an evaluation and repair is recommended to prevent further issues.

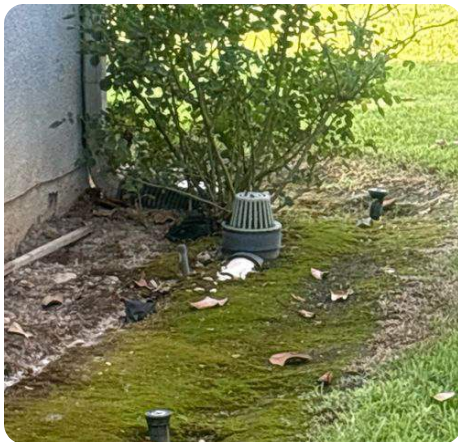
### Underground Drainage

There is an underground drained system in the front yard area. The drainage caps will need to be adjusted to allow water to enter the drained system. Contacting a qualified landscape specialist for an evaluation and to properly adjust the drain caps is recommended to allow for proper water drainage.

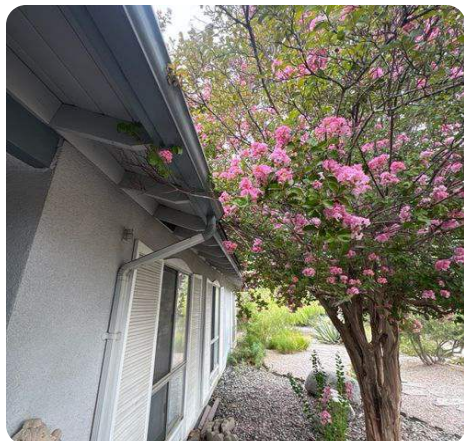
### Vegetation Recommendations

All vegetation should be kept trimmed 12 inches away from the structure to eliminate a common avenue for pest infestation and damage to the exterior structure material. Maintenance of overhanging trees, vines and other plant material is recommended.

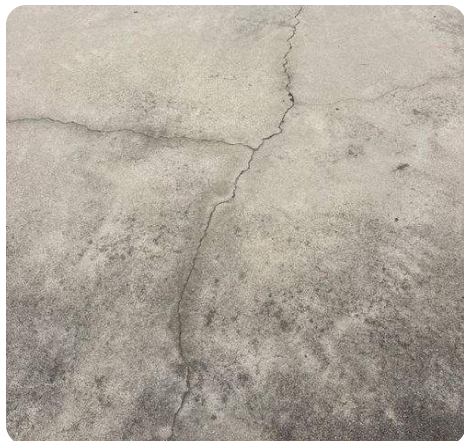
### Cracked/Lifting Concrete

Lifting concrete was noted at the front entry walkway. Taking caution when walking is advised as the lifting concrete can be a trip hazard. If the buyers have further concerns contacting a qualified trades person for evaluation and recommendations is recommended.

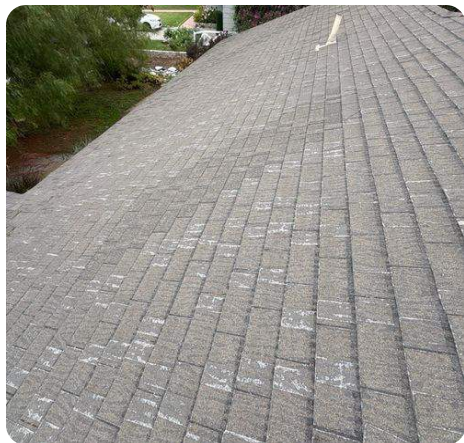
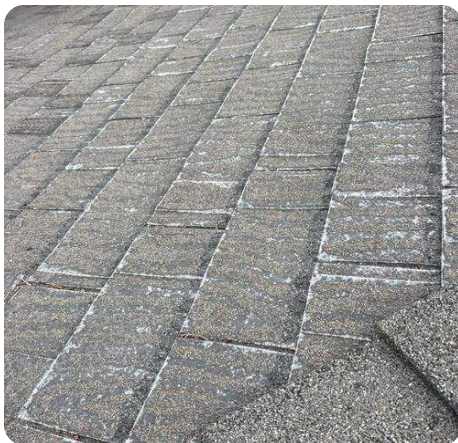
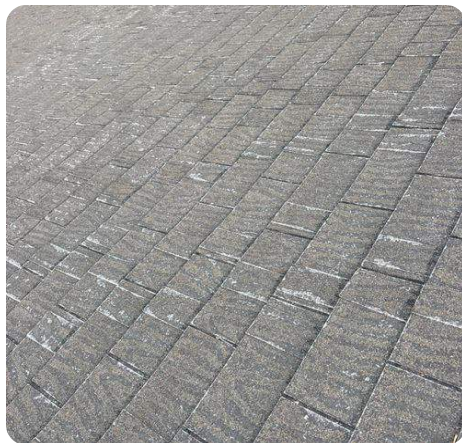
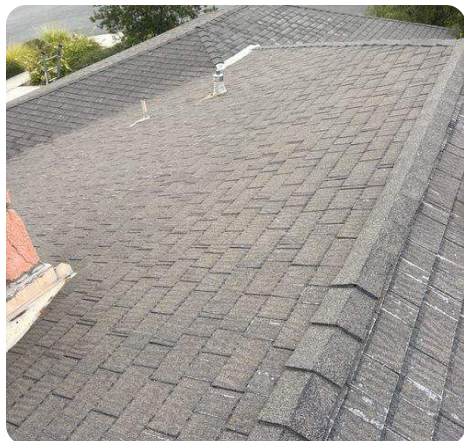
Granular loss was observed on the shingles of the roof. This issue can occur due to various factors like age and weather. It may expose the shingles to UV light, increasing the risk of damage. While some wear over time is typical, significant granular loss suggests the need for a professional evaluation and possible repairs. Contacting a qualified roofer to assess the extent of the issue and recommend necessary maintenance is advised.

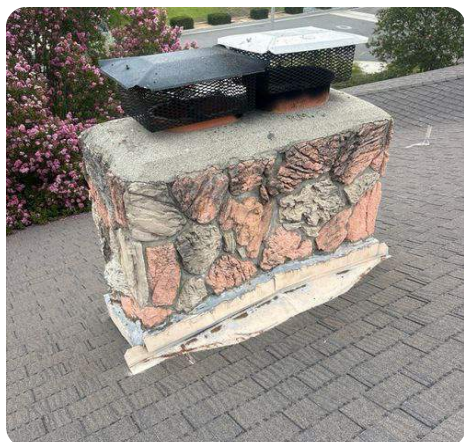
The chimney's exterior was visually inspected and the exterior chimney was found to be free of any significant defects at the time of the inspection.

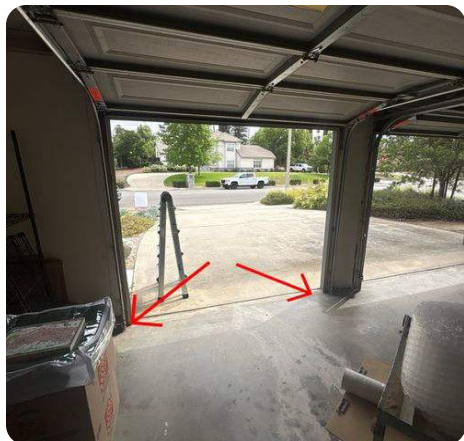
The single garage door safety sensors appear to be misaligned or not operating properly. The sensors are located near the bottom of the garage door tracks. Misaligned sensors can prevent the door from closing properly. It is recommended to evaluate and repair the alignment of the safety sensors to ensure proper functionality. A qualified trade can adjust and align the sensors accurately.

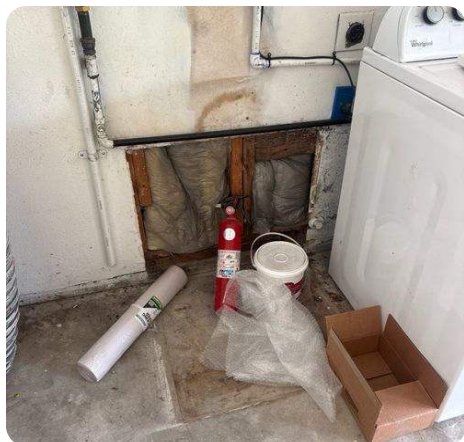
##### Damaged Wall Area In Garage

The common wall surfaces between the house and the garage appear to be a firewall system; however, there is damage to the drywall which needs repair. All openings of more than 1/8", are recommended to be sealed. We recommend the area(s) be repaired in order to provide intended serviceability. Contact a qualified trade or handyperson for repairs.

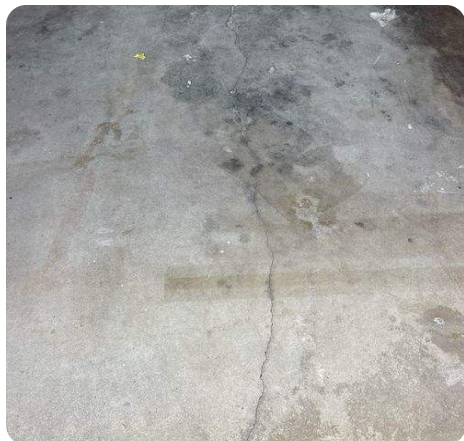
##### Cracks In Garage Floor

The presence of cracks in the garage floor is noted. These cracks can be a result of the natural settling of the house over time. It is recommended to evaluate the severity of the cracks, especially if they are widening or showing signs of structural issues. Repairing the cracks with a concrete filler can help prevent water seepage and further damage. If the cracks continue to widen or pose structural concerns, consulting with a qualified concrete contractor is advised.

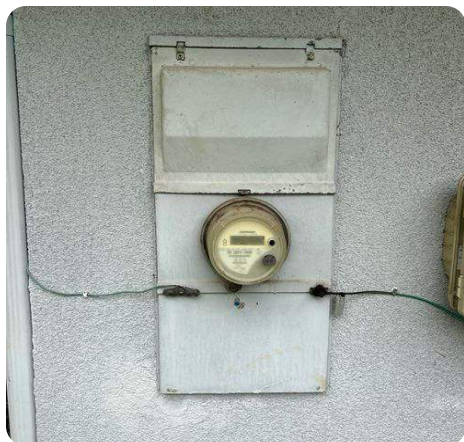
The service entrance components and grounding system were in serviceable condition at the time of the inspection.

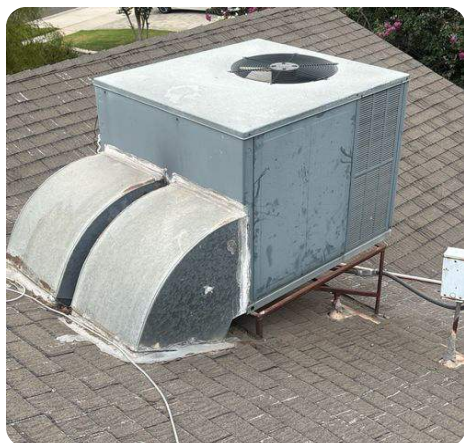
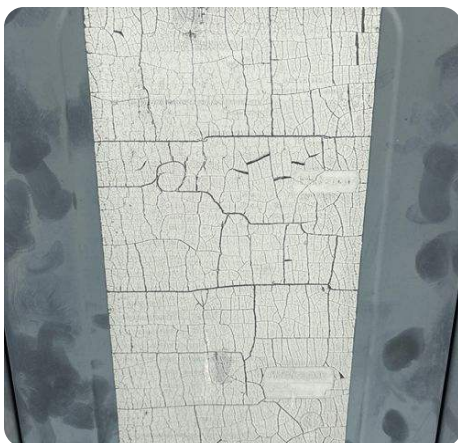
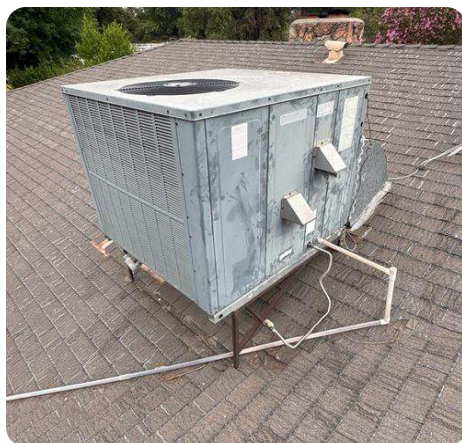
There are no visible posted service notes attached to the HVAC system. It is recommended to inquire with the seller about the last servicing of the heating/cooling systems. If not serviced recently, a qualified technician should perform a service cleaning, tune-up, full unit evaluation, and review of the HVAC system prior to closing.

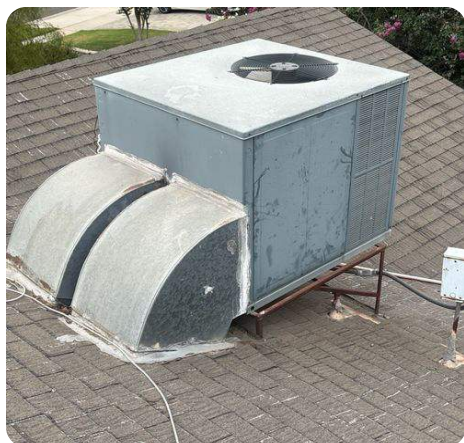
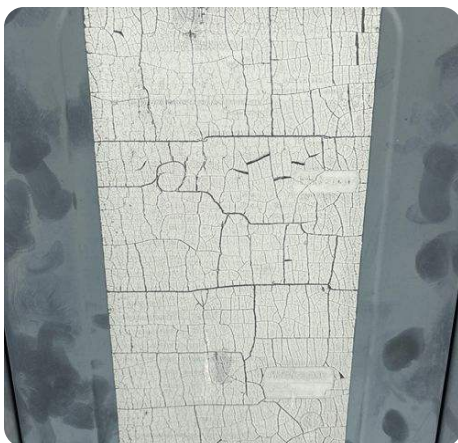
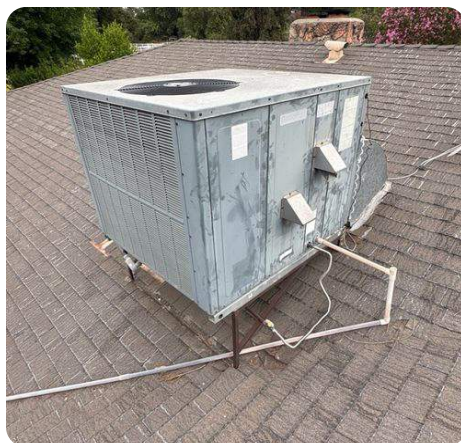
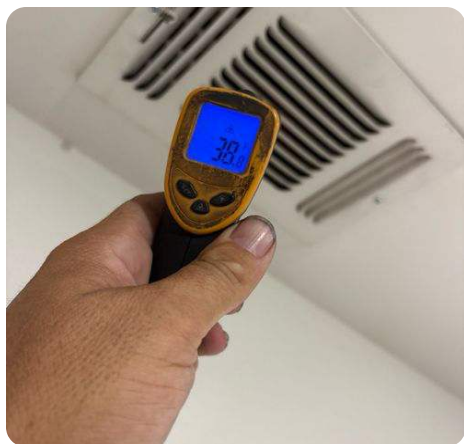
The recommended temperature differential is typically between 15-22 degrees. The temperature differential is the difference of the air temperature in the return air grill, and air temperature out of the registers in the structure. If the unit does not fall within these recommendations, service by a qualified HVAC technician is recommended.

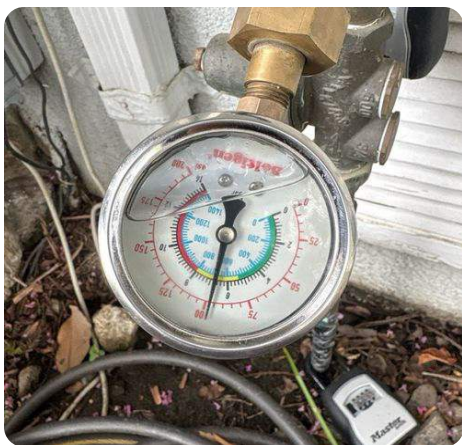
The water pressure in the house is measured at 100 psi, which is above the recommended pressure for residential properties (generally between 40-80 psi). High water pressure can lead to pipe damage, leaks, and premature wear on appliances. It is recommended to have a licensed plumber evaluate and install a pressure regulator to reduce the pressure to a safe level.

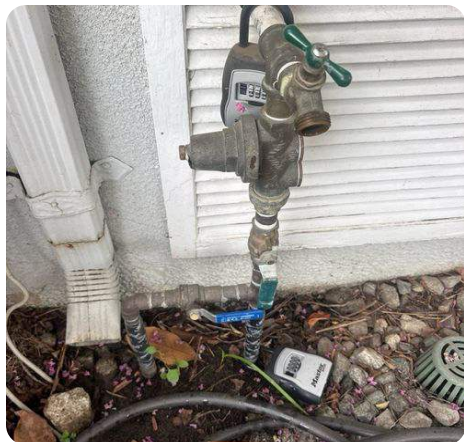
The water main shut-off valve was located and was functional. It is important to know the location and condition of the shut-off valve in case of emergencies or repairs. We recommend testing the shut-off valve periodically to ensure proper functionality.

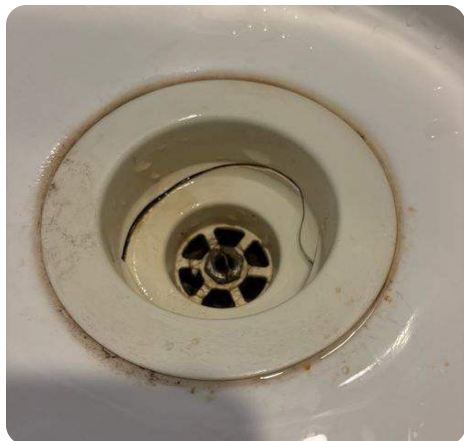
The kitchen sink drain has a damaged drain cover. Contacting a qualified plumbing contractor for an evaluation and repair/replacement is recommended to prevent further issues.

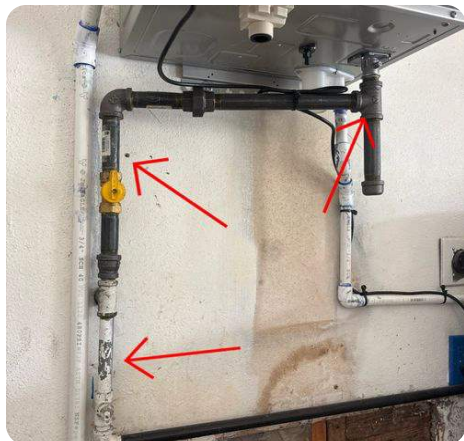
The water and gas plumbing lines to the water heater are considered hard plumbed. Flexible gas and water lines are required around the gas appliance. Contacting a qualified plumbing contractor for an evaluation and repair is recommended for safety.

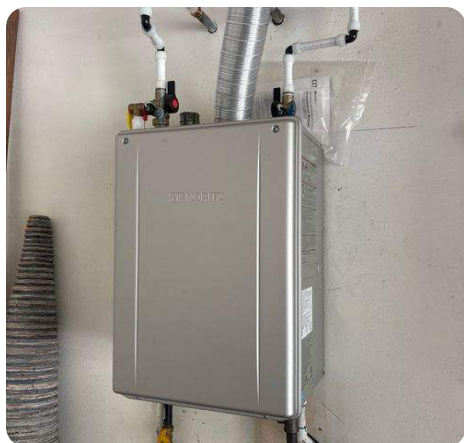
## Gas Tankless Water Heater Inspected

The average life expectancy of a tankless water heater is 15-20 years from the date of installation. Tankless water heaters do not store water in a tank like conventional water heaters. When a hot water fixture is opened in the home, water flows into the water heater where it is heated by gas burners before flowing to the open hot water fixture. Tankless water heaters save energy by avoiding the stand-by losses associated with conventional water heaters which must maintain water in a tank at a minimum temperature. Due to calcium build-up on components, tankless water heaters typically require service annually. Failure to service the water heater in a timely manner typically results in a reduced hot water flow rate. The tankless water heater was functional and supplied hot water as intended. Manufacturers recommend annual service and cleaning of the system by a qualified contractor (scaling inside the heat exchanger from calcium deposits may occur).

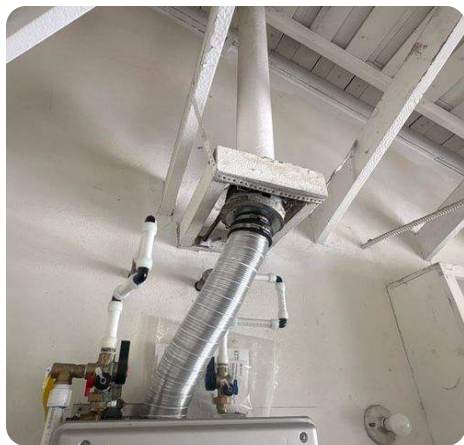
#### Exhaust Flue Piping Evaluated

The exhaust flue piping of the water heater was visually examined to ensure it was properly installed. The piping appeared secure, free from obstruction, and correctly venting exhaust gases outside.

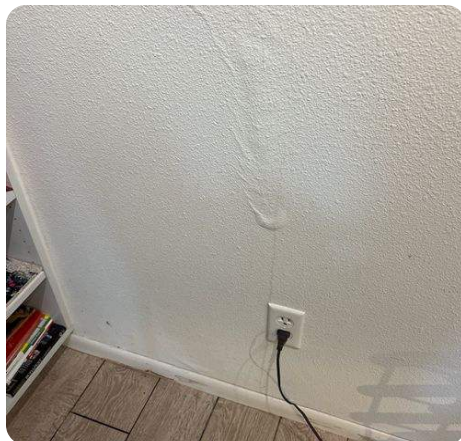
#### Moisture Damage

Moisture damage was noted to the ceiling and wall in the living room area. Moisture was detected as the area was checked with a moisture meter. Contacting a qualified trades person for an evaluation and repair is recommended to prevent further issues.

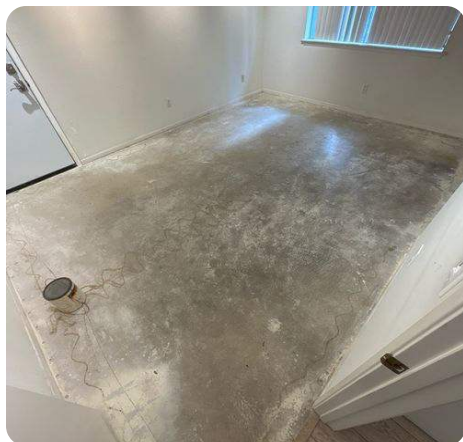
#### Flooring Removed

There is a guest bedroom where the flooring has been removed. Contacting a qualified trades person for an evaluation and replacement is recommended.

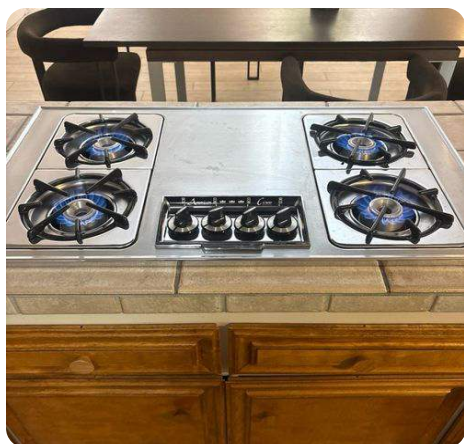
An on / off test was performed to determine if the cooktop was functioning. Periodic cleaning and maintenance is recommended for continued use.

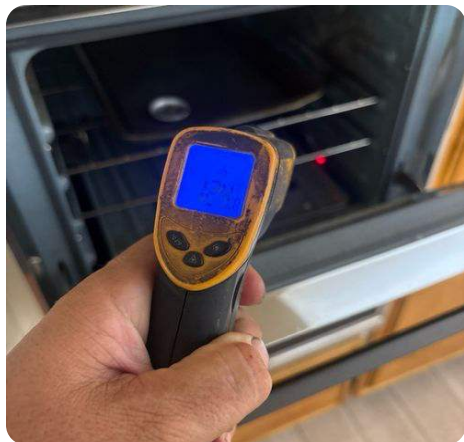
Timers, clocks, convection fans, and self-cleaning systems are not tested and are beyond the scope of a home inspection.

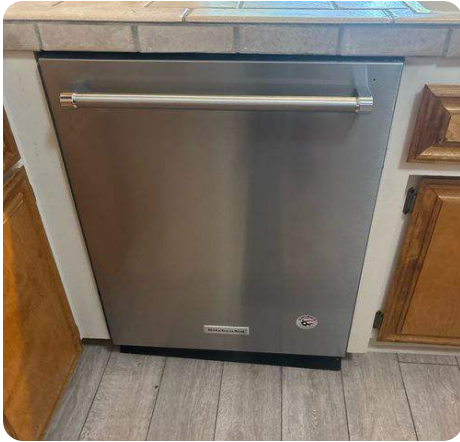
The dishwasher was tested and appears to be working. A simple on/off check of the dishwasher was performed to determine if it was operational. A full cycle check is often not possible at the time of this inspection; therefore, we cannot comment on the full extent of its functions or its ability to clean. The average life of a dishwasher is 8-12 years. Periodic cleaning of the interior filters is required to extended use.
