## SCOPE RESIDENTIAL INSPECTION

3768 Wood Duck Cir  
Stockton, CA 95207

07/06/2026

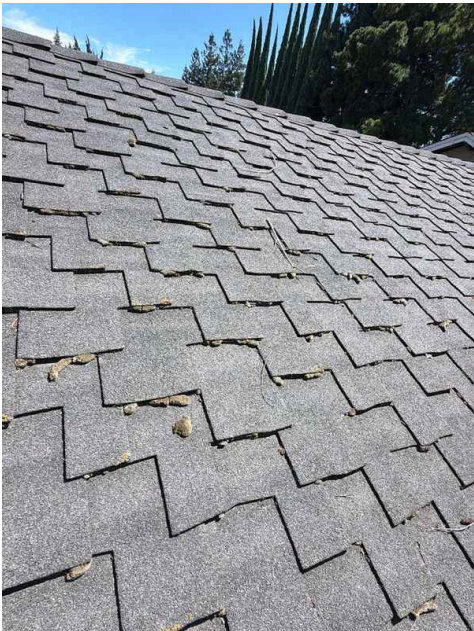
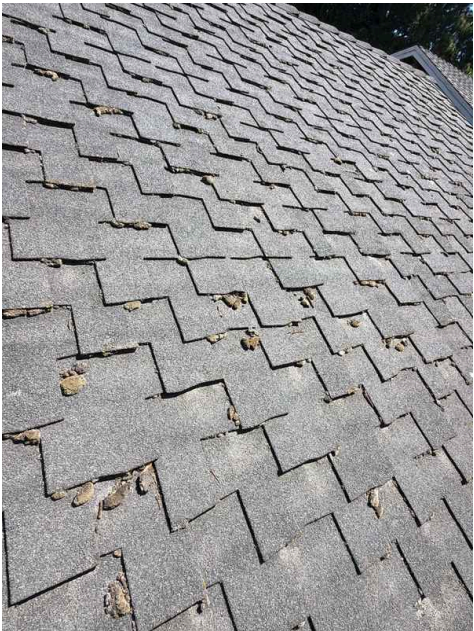
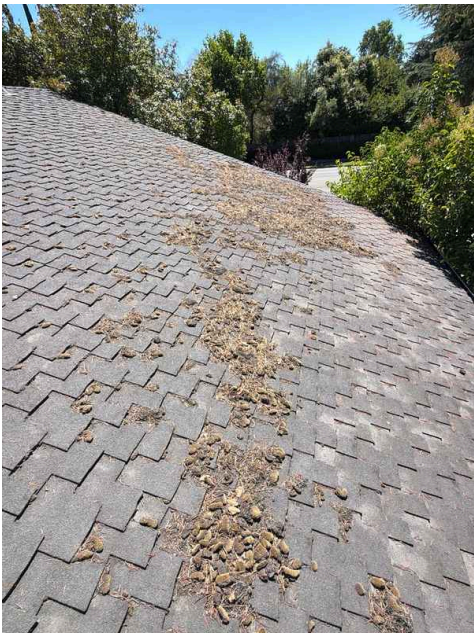
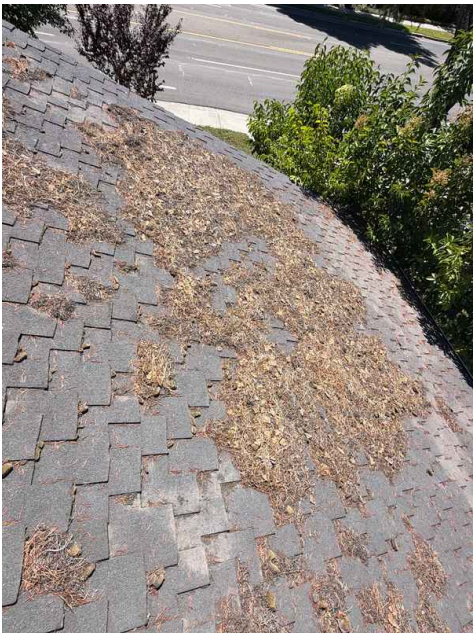
### 5.2.1 Coverings

Debris accumulation was observed on the roof surface. Accumulated debris may impede drainage, retain moisture, contribute to deterioration of roofing materials, and conceal defects. Recommend cleaning and maintenance as needed.

Contact a qualified professional.

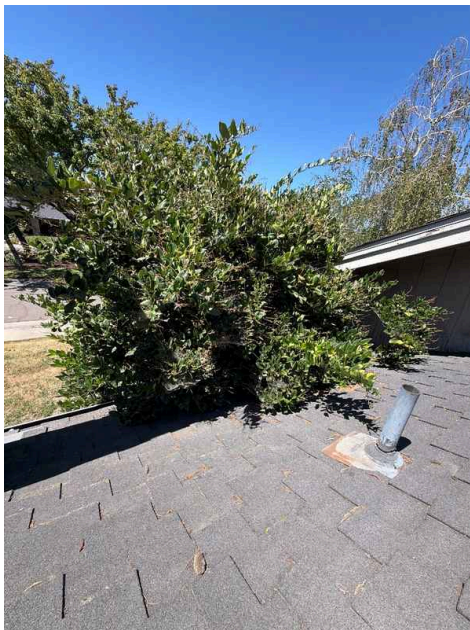
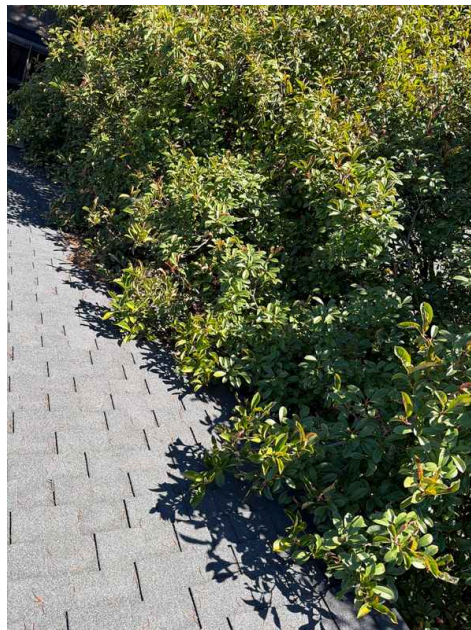
## 5.2.3 Coverings

Tree branches or vegetation were observed contacting or overhanging the roof surface. Vegetation contact may contribute to physical damage, moisture retention, debris accumulation, pest activity, and accelerated deterioration of roofing materials. Recommend trimming and maintenance as needed.

Contact a qualified professional.

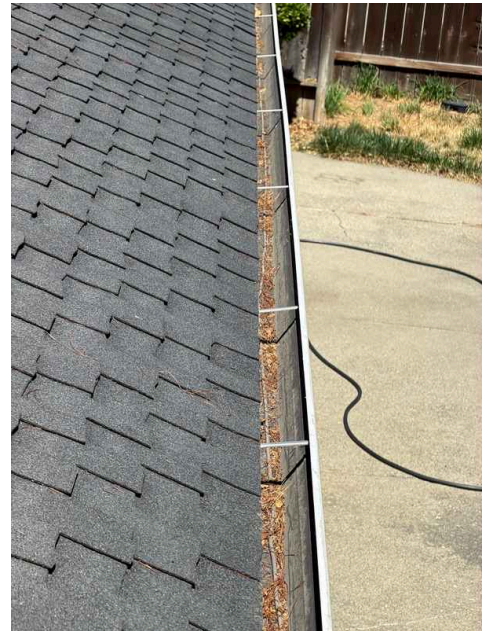
## 5.5.1 Roof Drainage Systems

Debris accumulation was observed within the roof drainage system. Accumulated debris may restrict water flow, contribute to blockage, promote deterioration, and reduce system performance. Recommend cleaning and maintenance as needed.

Contact a qualified professional.

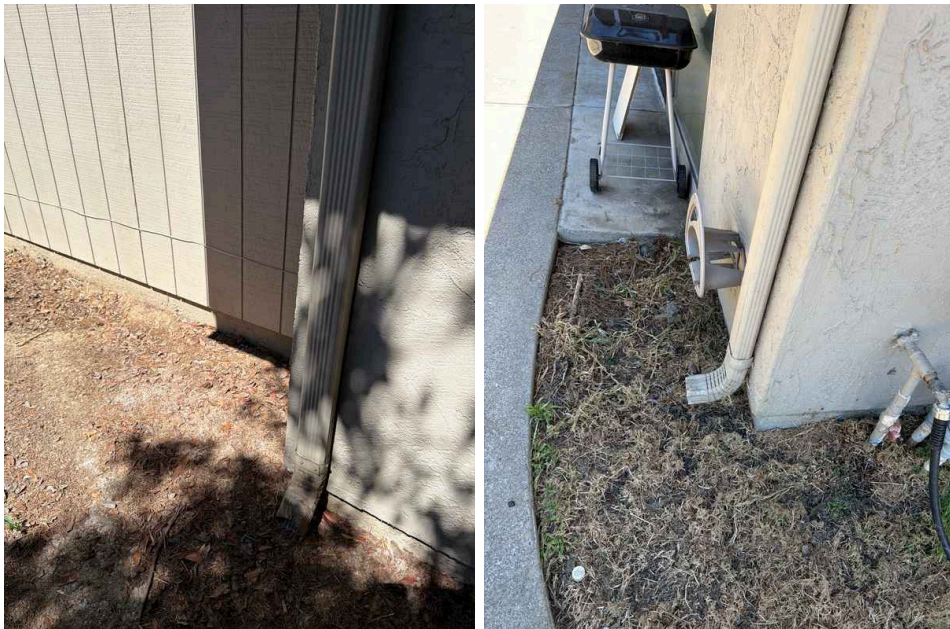
### 5.5.2 Roof Drainage Systems

#### **IMPROPER DOWNSPOUT DISCHARGE**

One or more downspouts discharged too close to the structure, into areas susceptible to moisture accumulation, or in a manner that may not effectively direct water away from the foundation. Recommend further evaluation and correction by a qualified professional.

Contact a qualified professional.

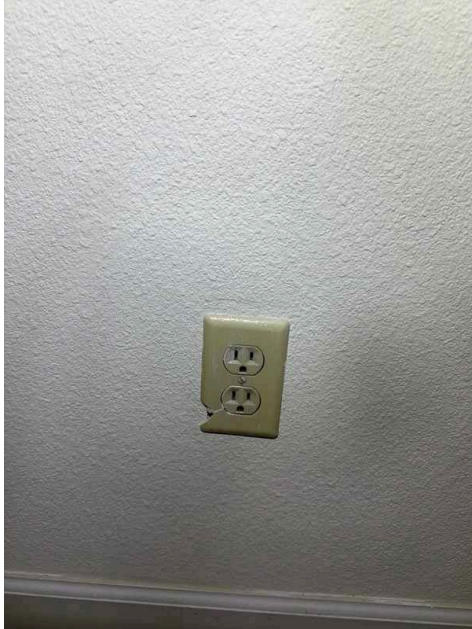
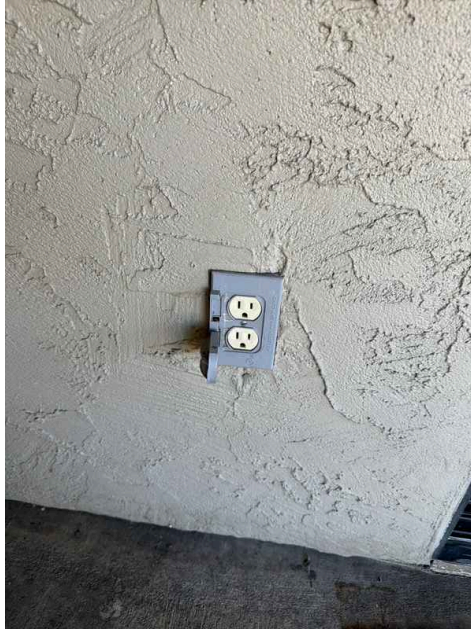
### 9.2.1 Receptacles, Switches & Lighting

#### **COVER PLATES DAMAGED**

One or more receptacles have a damaged cover plate. Recommend replacement.

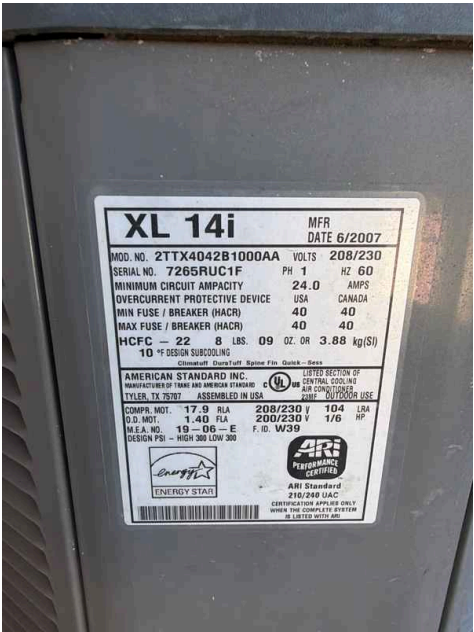
10.6.1 Cooling Equipment & Distribution

The condenser for the cooling system showed signs of aging along with sun damage. This would suggest that it's nearing the end of its life cycle. The label was also faded. Recommend the entire cooling system be tested and checked by a qualified HVAC technician.

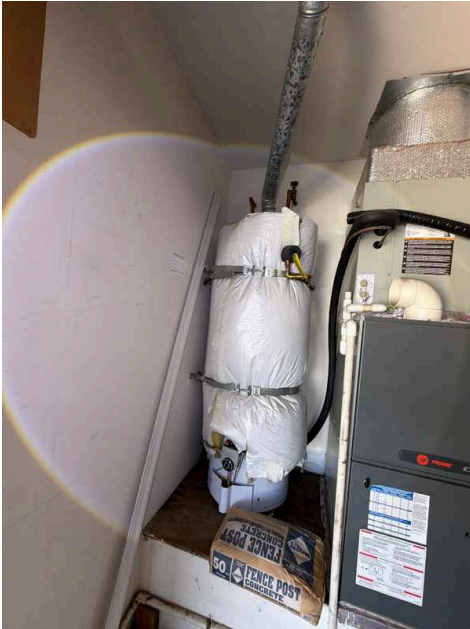
### **WATER HEATER - WRAPPED IN INSULATION**

Water heater was wrapped in insulation during time of inspection.  
Water heater appears to be very old and near end of life.

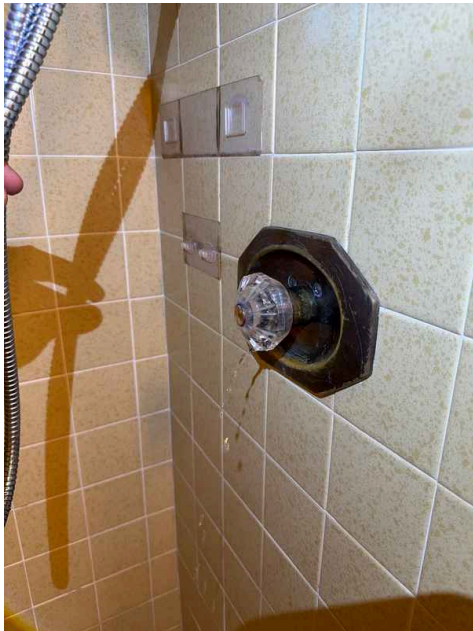
### 11.7.1 Showers & Bathtubs

#### **SHOWER VALVE/HANDLE LEAK**

Water was leaking from the shower control handle area. This may indicate a worn cartridge, failed valve seal, or improper trim seal, and can allow moisture into the wall cavity. Recommend evaluation and repair by a qualified professional.

Contact a qualified professional.

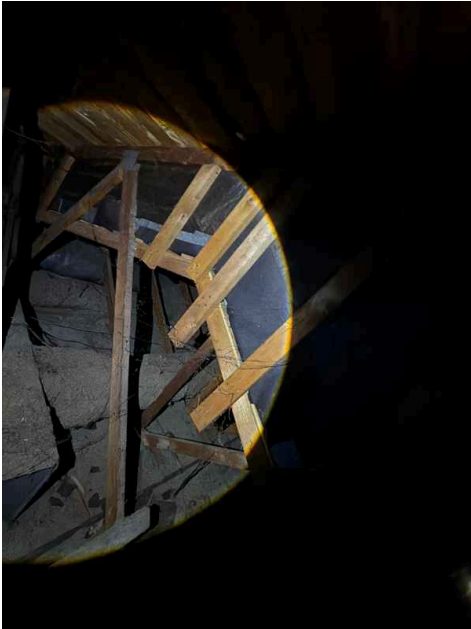
### **LOW CLEARANCE IN ATTIC**

Low attic clearance restricted movement and limited the ability to inspect some areas of the attic.
