# ONE STOP HOME INSPECTIONS & CONST.

## INSPECTION

22707 Ronan Ave  
Carson, CA 90745

04/02/2025

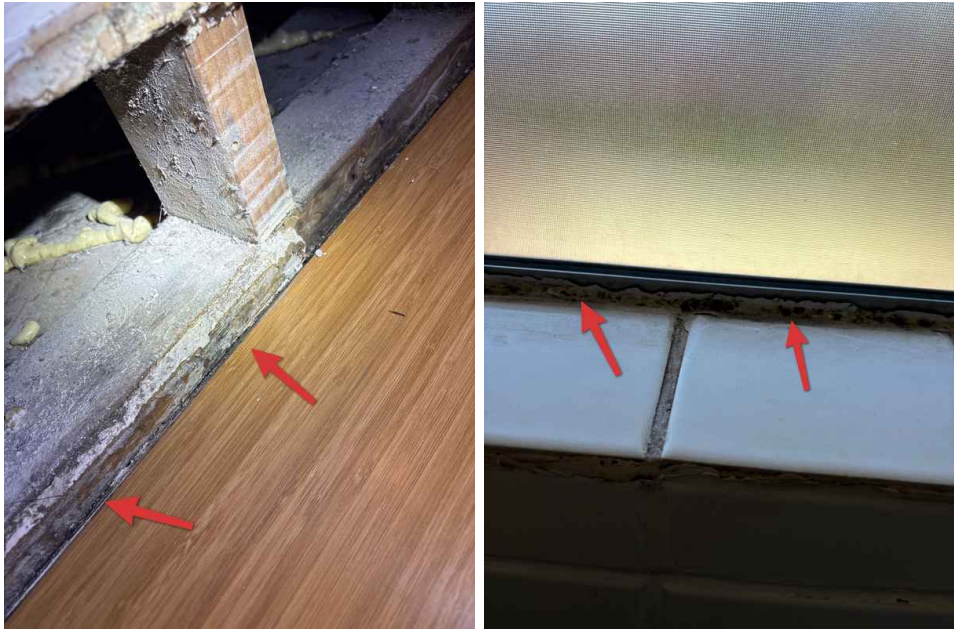
Hallway Bathroom

Microbial like growths and/or a musty odor were found at one or more locations. It is beyond the scope of this inspection to identify what substance or organism this staining is. However such staining is normally caused by excessively moist conditions, which in turn can be caused by plumbing or building envelope leaks and/or substandard ventilation. These conducive conditions should be corrected before making any attempts to remove or correct the staining. For evaluation and possible mitigation, consult with a qualified industrial hygienist or mold/moisture mitigation specialist.

Contact a qualified mold inspection professional.

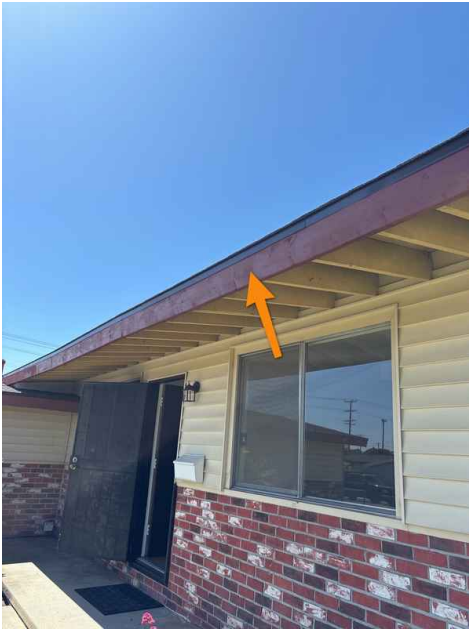
GUTTER INSTALLATION  
RECOMMENDED

No roof drainage system was installed. Rainwater may come in contact with the building exterior or accumulate around the building foundation as a result.

Contact a qualified gutter contractor

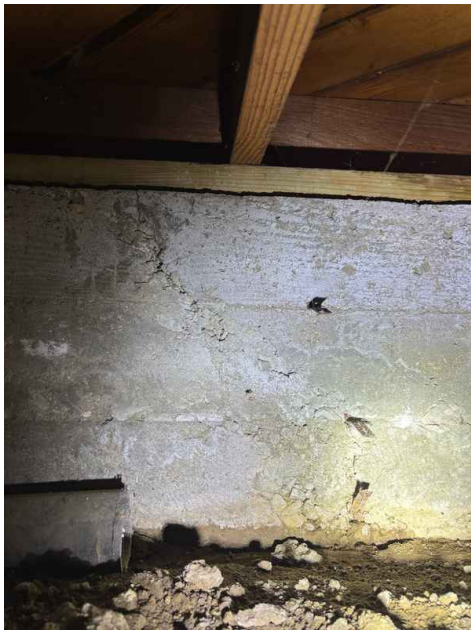
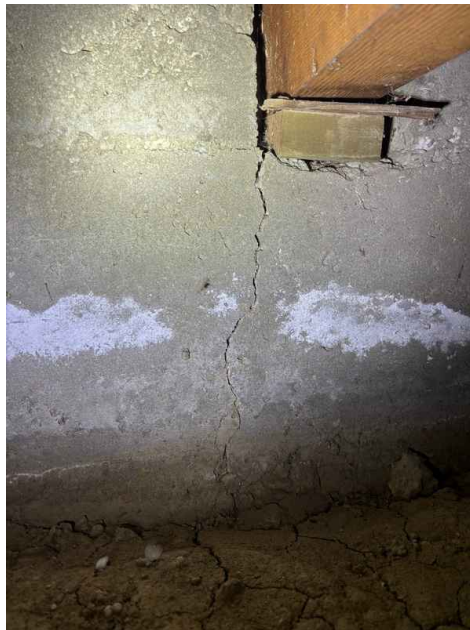
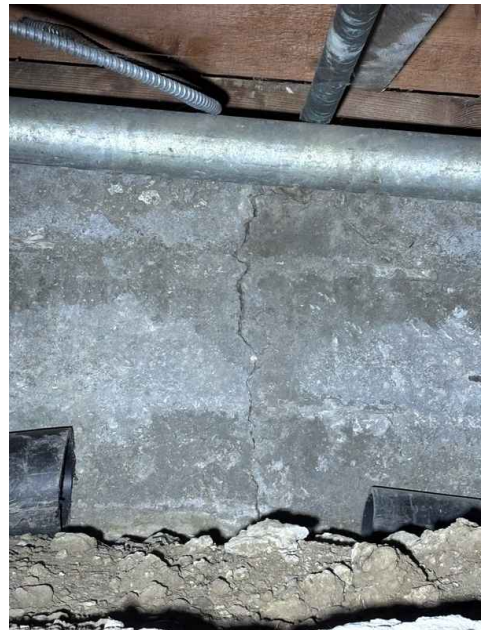
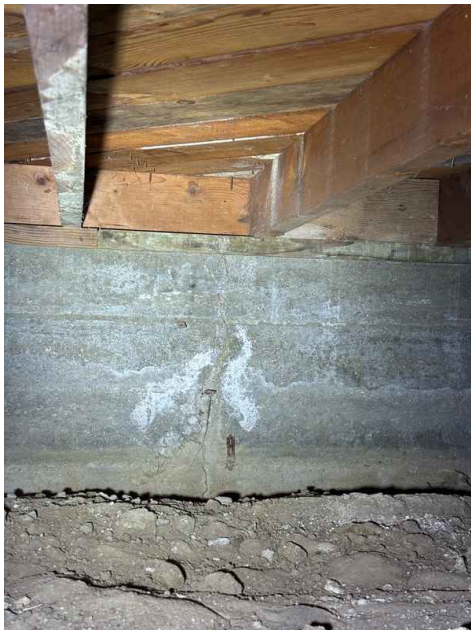
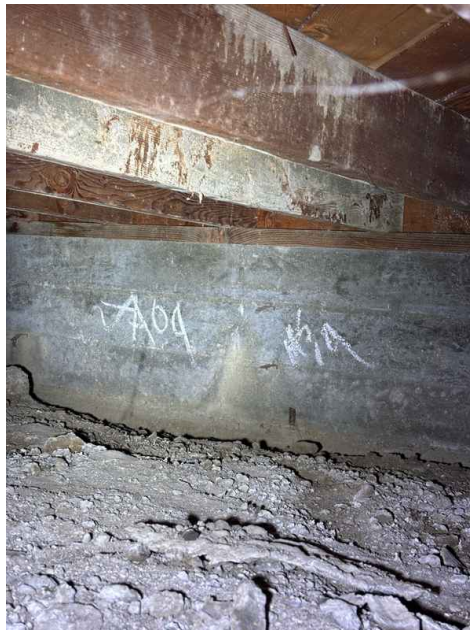
## 6.1.2 Foundation

**CRACKS 1/8" OR LESS**

Crack(s) of 1/8" or less was observed on the foundation wall. The cracking implies that foundation movement has occurred. Recommend masonry sealing and monitoring for any further movement. Although no obvious evidence suggesting "immediate concern was observed, this does not however guarantee future conditions. The exact / precise measurements of such conditions are not within of our inspection. Past or future movement may be related to soil and geological issues, which are beyond the scope of our expertise.

Contact a foundation contractor.

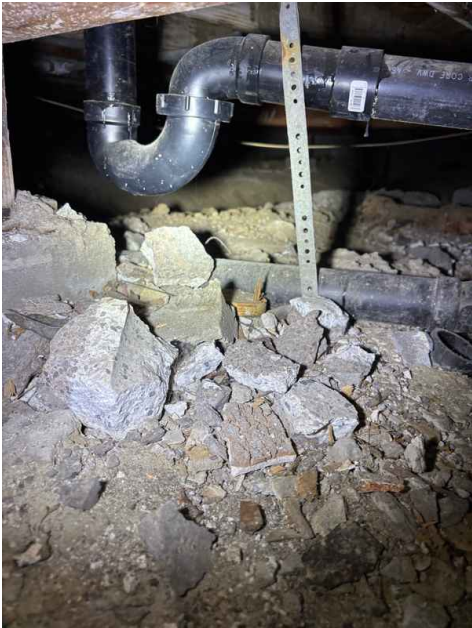
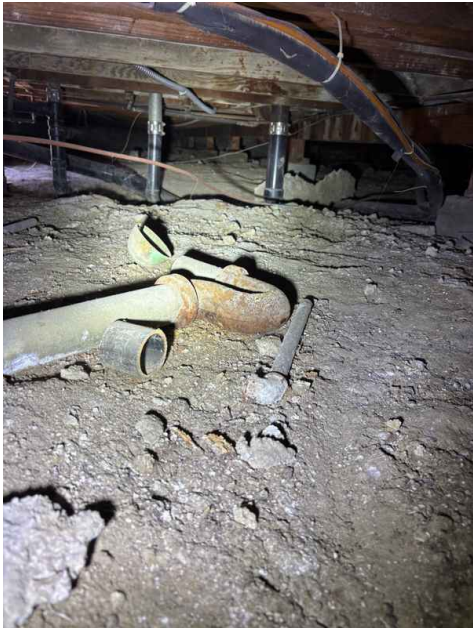
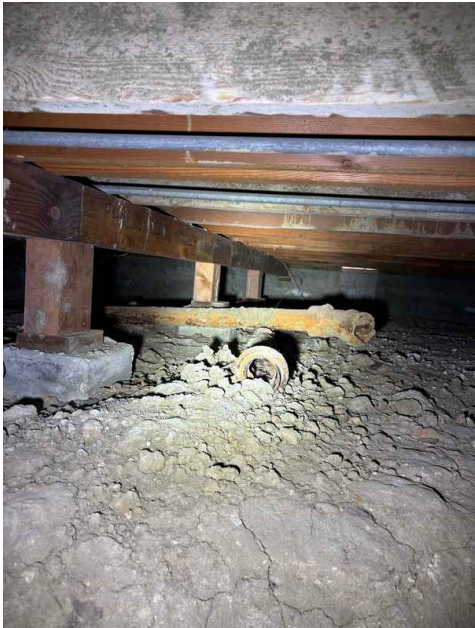
Debris was observed in the crawlspace. Recommend having it cleaned out.

Contact a qualified handyman.

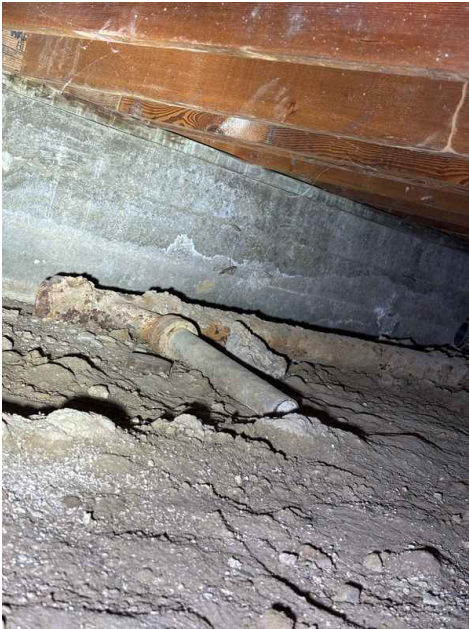
#### 7.2.1 Substructure

### DRY STAINS / CAN'T DETERMINE

One or more dark stains were found at the subfloor in the crawl space. The inspector was not able to determine with a moisture meter if this is an active leak, or a prior leak. Client should consider their options such as having a qualified contractor evaluate these areas prior to closing.

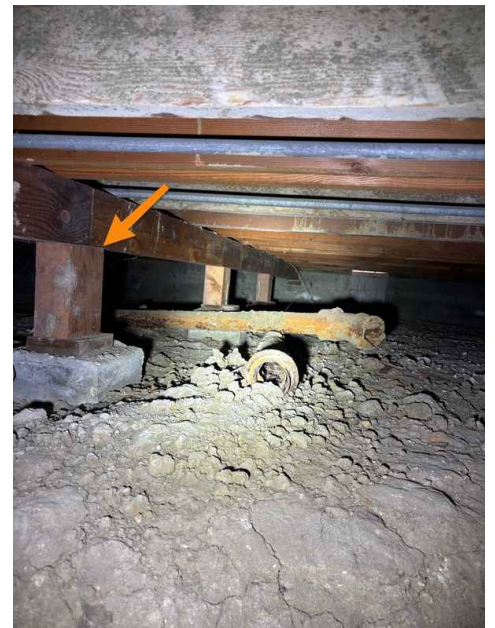
### POST TO BEAM MISSING TIES

One or more support posts were not positively secured to the beam above. While this is common in older homes, current standards require positive connections between support posts and beams above for earthquake reinforcement. Recommend that a qualified contractor repair per standard building practices.

Contact a qualified professional.

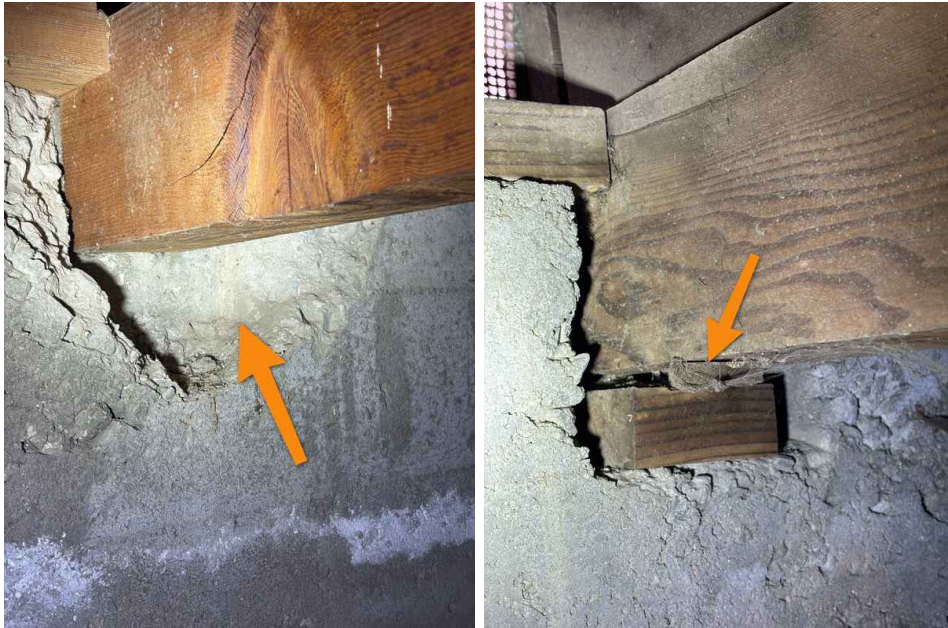
#### 7.2.3 Substructure

### FRAMING SETTLEMENT / MOVEMENT

Evidence of framing settlement and/or movement at one or more locations in the crawl space.  
Recommend further evaluation and needed repairs be made by a qualified licensed contractor.

Contact a qualified general contractor.

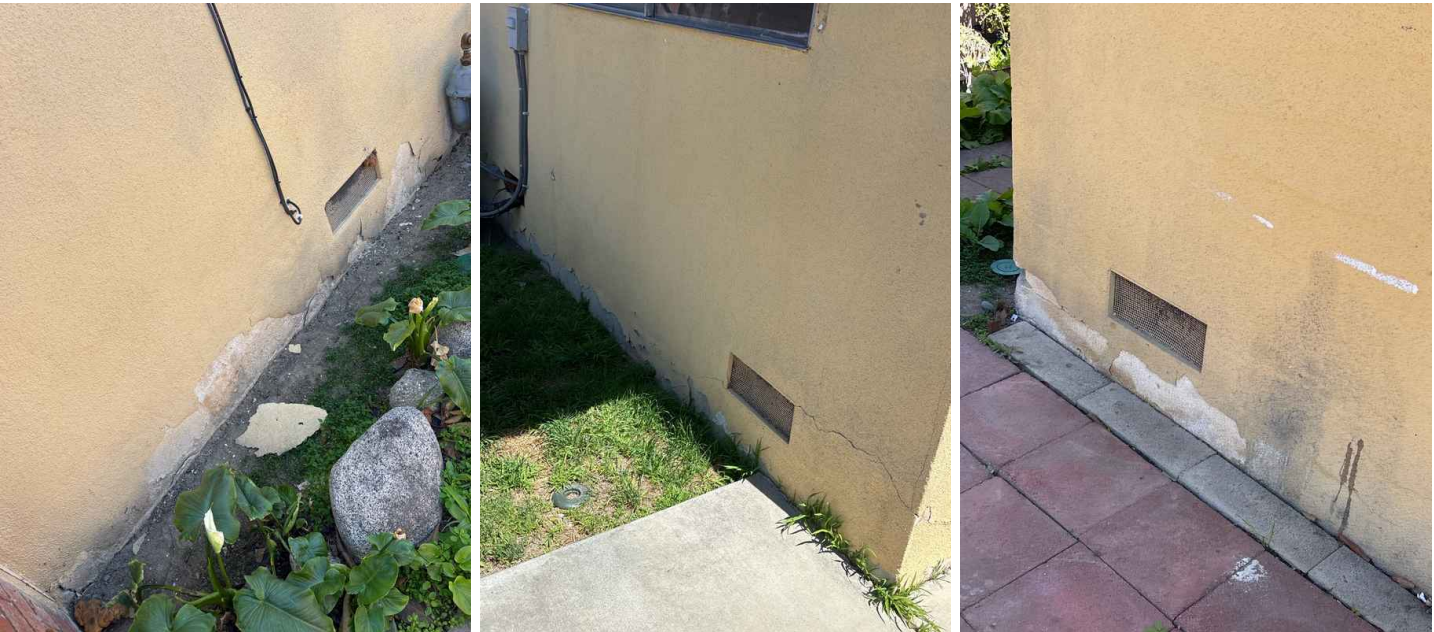
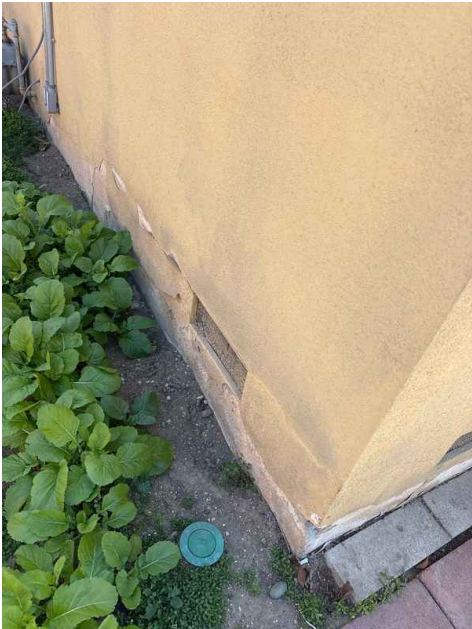
**STUCCO CRACK(S) / DAMAGE NEEDS REPAIR**

Cracks, deterioration and/or damage were found in one or more areas of the exterior stucco finish. Moisture can enter cracks or damaged areas and further deteriorate the stucco. The wall behind the stucco can become damaged from moisture. Recommend further evaluation and repair by a qualified professional.

Contact a stucco repair contractor

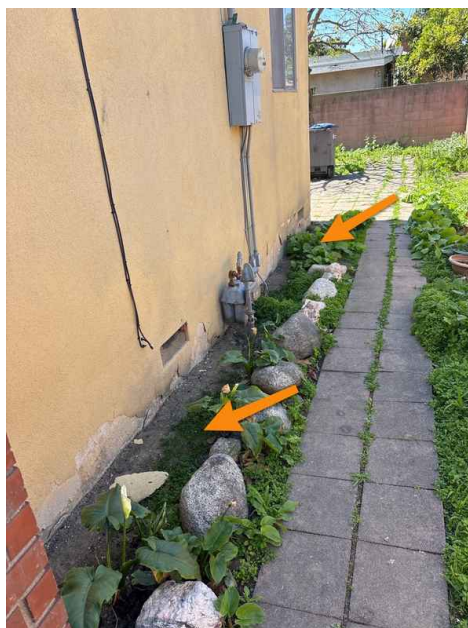
The soil or grading sloped down towards building perimeters in one or more areas. This can result in water accumulating around building foundations or underneath buildings. Recommend grading soil so it slopes down and away from buildings.

Grade shall fall a minimum of 6 inches within the first 10 feet from the foundation walls.

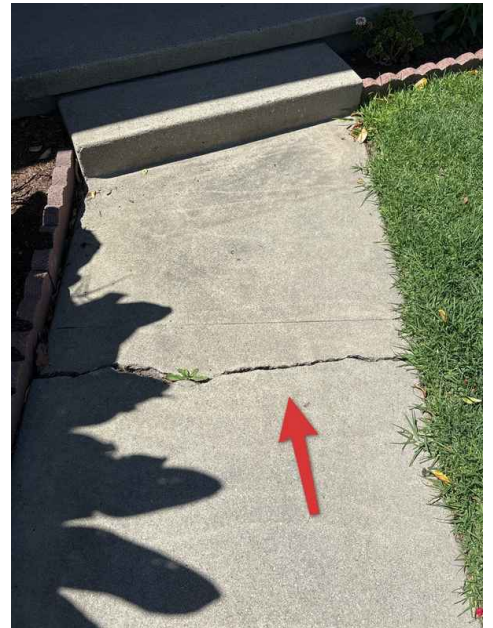
**SIDEWALK / PATIO CRACKS /  
DETERIORATION - TRIP HAZARD - REPAIR**

Cracks, holes, settlement, heaving and/or deterioration resulting in trip hazards were found in the sidewalks or patios. Recommend immediate Repair.

Contact a qualified concrete contractor.

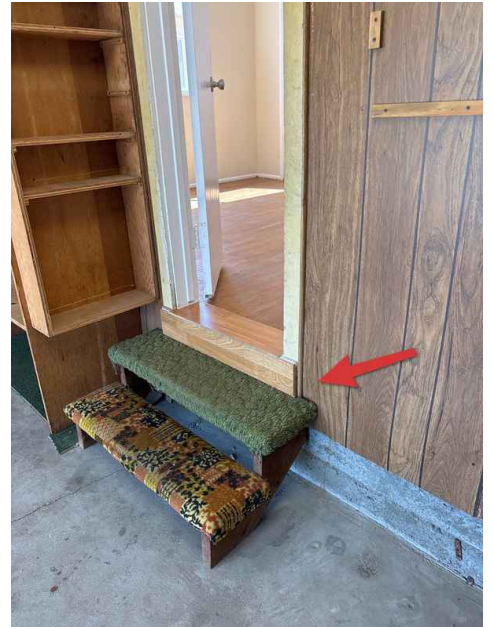
## 9.4.1 Porches / Steps / Stoops

**HANDRAILS MISSING MORE THAN 3 STEPS**

Handrails at one or more flights of stairs were missing. This is a potential fall hazard. Handrails should be installed at stairs with three or more risers or where stairs are greater than 30 inches high. Recommend further evaluation and repair by a qualified professional.

Contact a qualified general contractor.

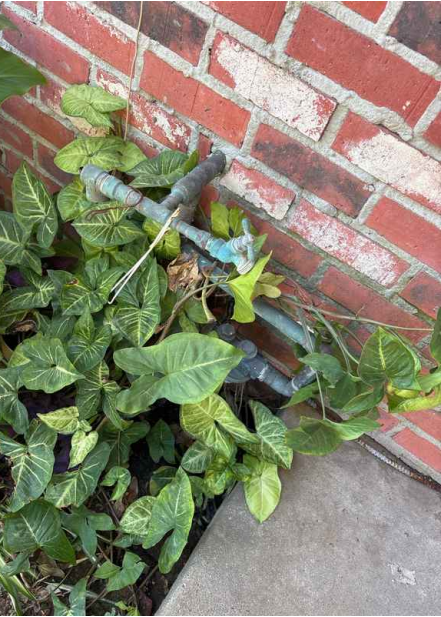
Service: Water Pressure

70-80 PSI

View of water pressure at the time of the inspection. 50 to 80 PSI is acceptable 60 to 75 PSI is ideal.

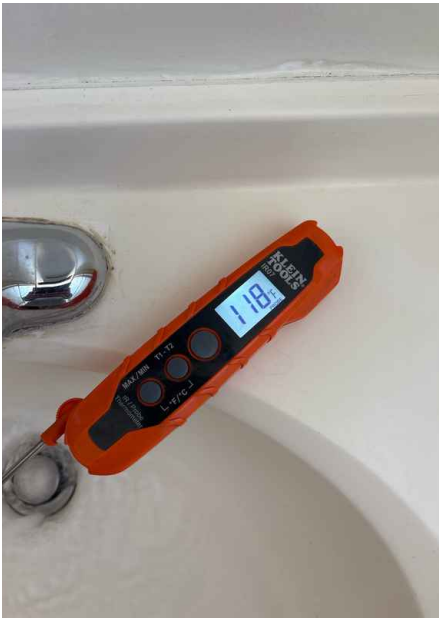
## Water Heater: Water Temperature

110-120 Degrees

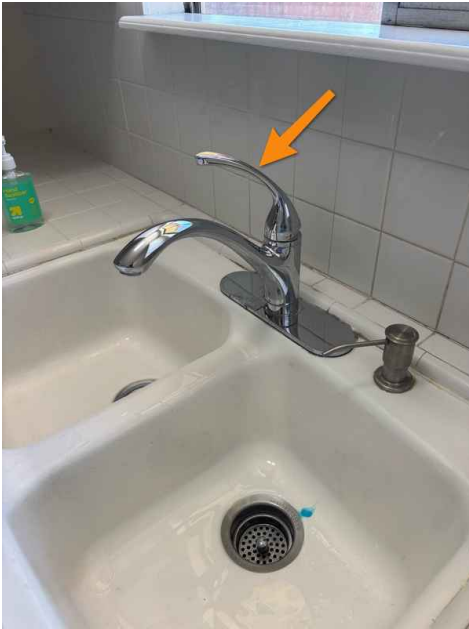
The water supply line was noisy / knocking when in use. Recommend further evaluation and repair by a qualified professional.

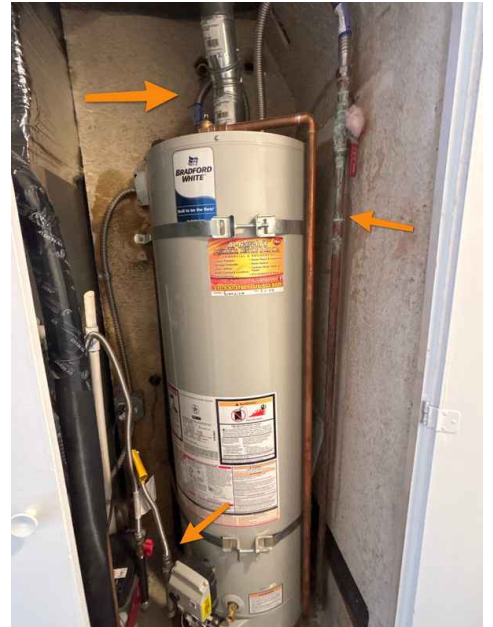
The water heater does not appear to be "bonded". Bonding is recommended; however, the local authorities have jurisdiction. Bonding provides a path to clear faults and protect against shock.

Contact a qualified electrical contractor.

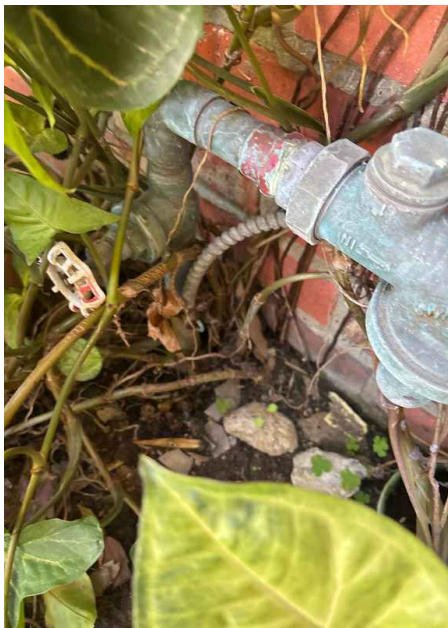
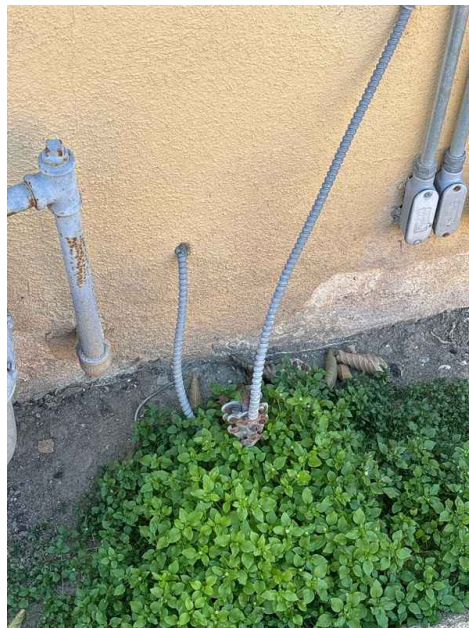
### Service: Information

1 phase 3 wire Voltage, System Ground via Cold Water Line, System Ground via Ground Rod

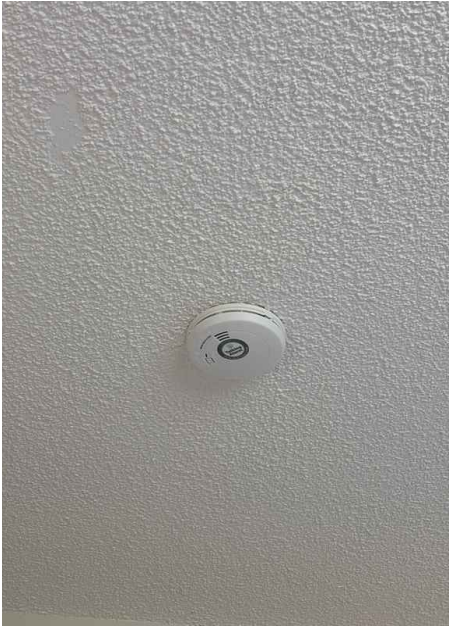
Primary Bedroom

**Note:** Smoke detectors are tested only for audibility and not tested using actual smoke.

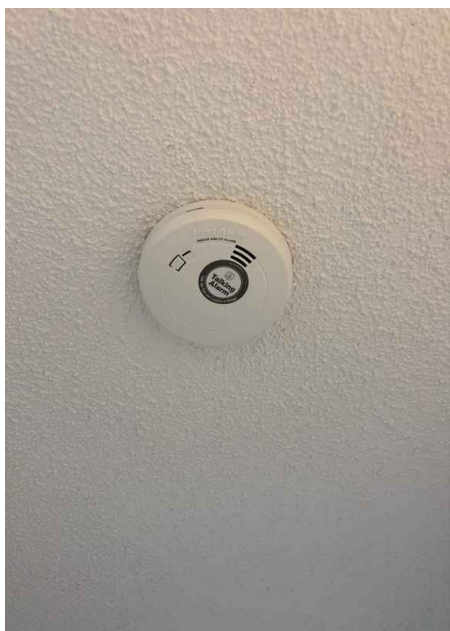
Yes, Hallway

**Note:** Carbon Monoxide alarms are tested only for audibility and not tested using actual Carbon Monoxide.

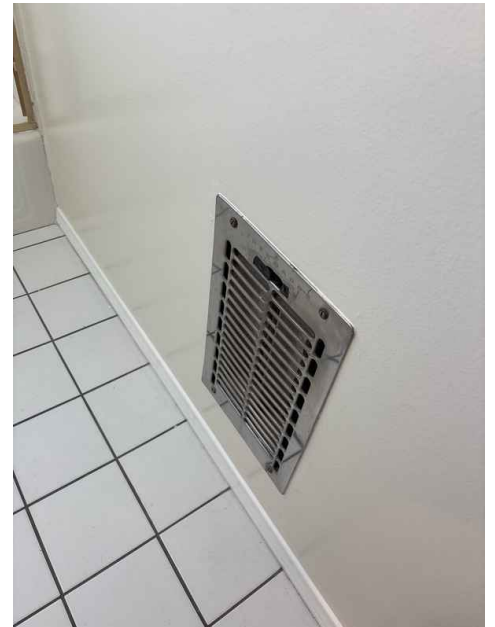
Hallway Bathroom

**THERMADOR WALL HEATER**

Electric heaters were observed in one or more rooms. These heaters are a fire hazard. Recommend removal.

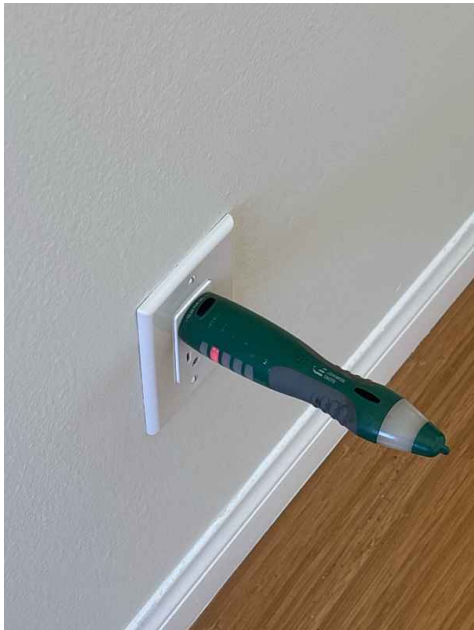
Living Room

3-slot receptacles (outlets) were installed in one or more areas without a ground wire hookup. These do not have an equipment ground. These outlets should either be swapped out with a 2 prong outlet, or upgrade to grounded receptacles, which typically requires installing new wiring from the main panel. The NEC (National Electric Code) also allows these outlets to be replaced with GFCI protection as a repair to use grounded appliances with them. Appliances that require a ground should not be used with ungrounded receptacles. Examples of such appliances include computers and related hardware, refrigerators, freezers, portable air conditioners, clothes washers, aquarium pumps, and electrically operated gardening tools. The client should be aware of this limitation when planning use for various rooms, such as an office. Consult with a qualified electrician about upgrading to 3-wire, grounded circuits or installing GFCI protection.

Recommendation  
Contact a qualified electrical contractor.

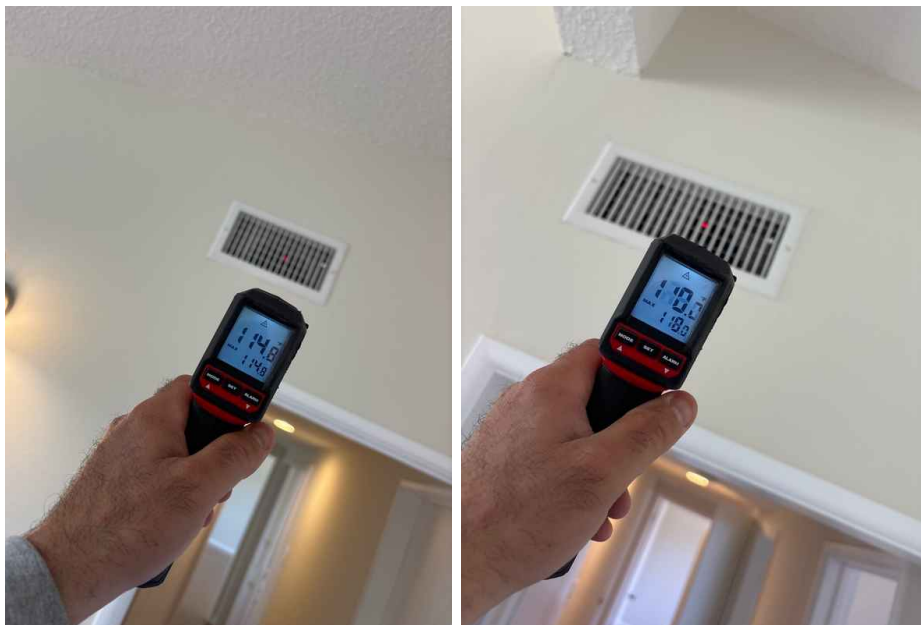
Heat system appears to be in working order. Supply air from the heating system should be 100 degrees Fahrenheit or higher.

The photo(s) below is/are a thermal image of the supply air temperature at register(s) at the time of this inspection.

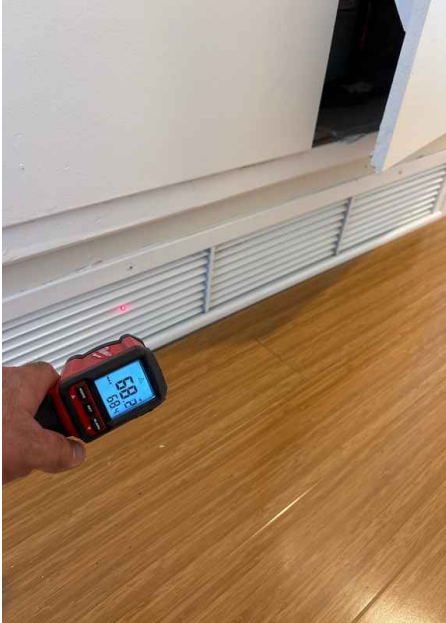
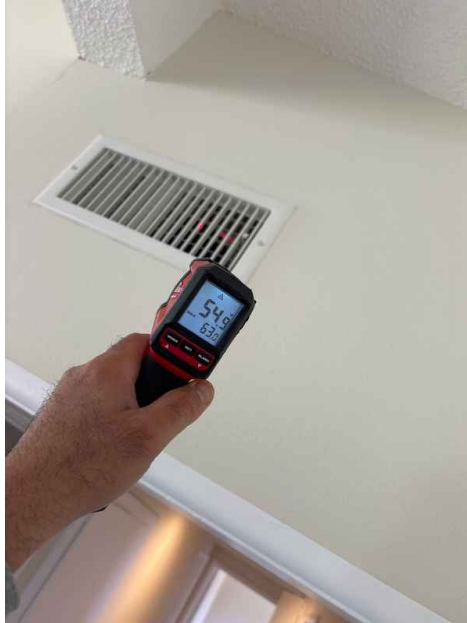
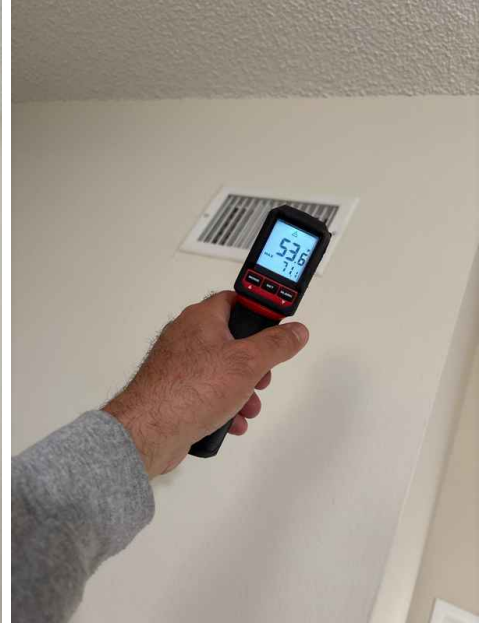
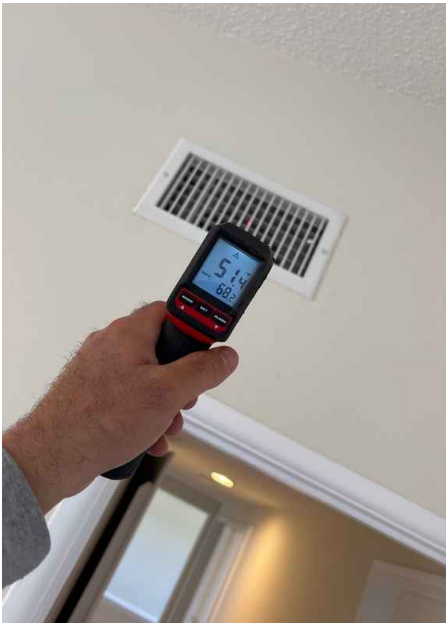
The temperature split differential between the return air and supply registers was within the 14-22 degree (F) range at time of inspection.

The photo(s) below is/are a thermal image of the air temperature at supply and return air register(s) at the time of this inspection.

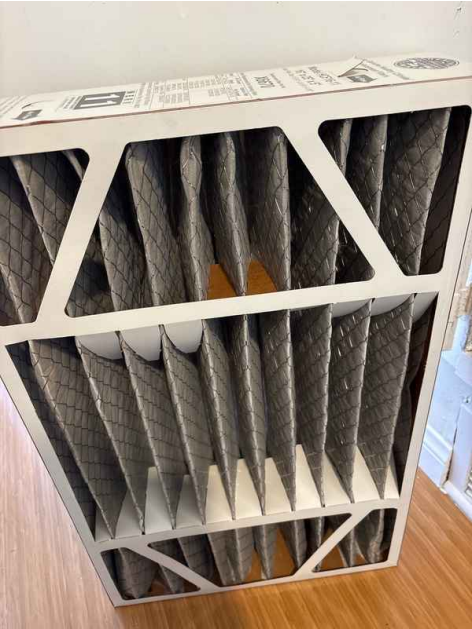
Air filters for the heating and/or cooling system were dirty at one or more locations. Recommend Replacement

Recommended DIY Project

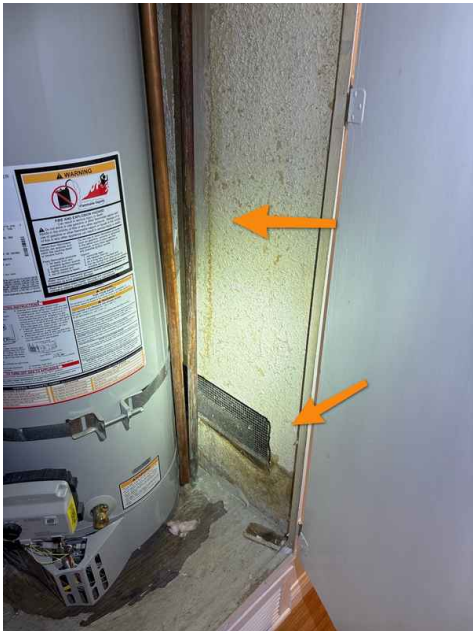
Safety Hazard

The furnace / Water Heater closet ceiling was open into the attic. This is a fire safety hazard. Recommend further evaluation and repair by qualified professional.

Contact a qualified professional.

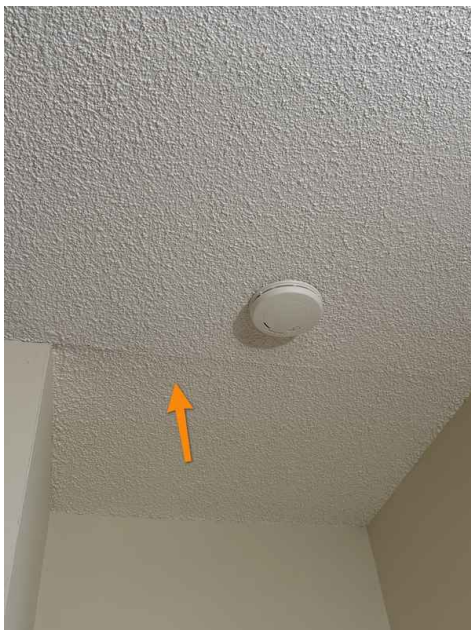
Bedroom

#### **STRESS / SETTLEMENT CRACK**

Contact a qualified professional.

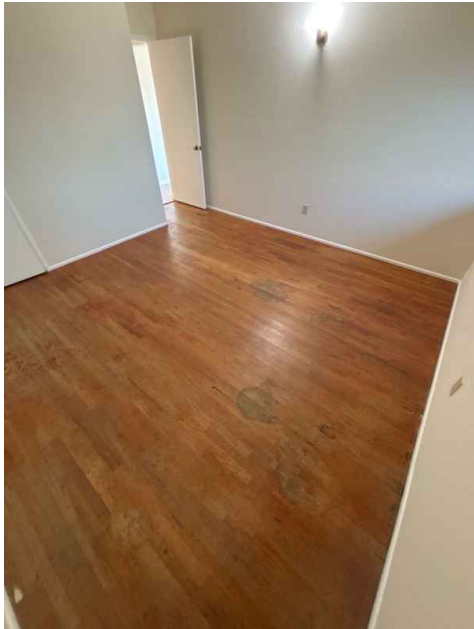
Bedroom

Floors in the home exhibited moderate surface wear along major paths of travel. Recommend a qualified flooring contractor evaluate for possible re-finish.

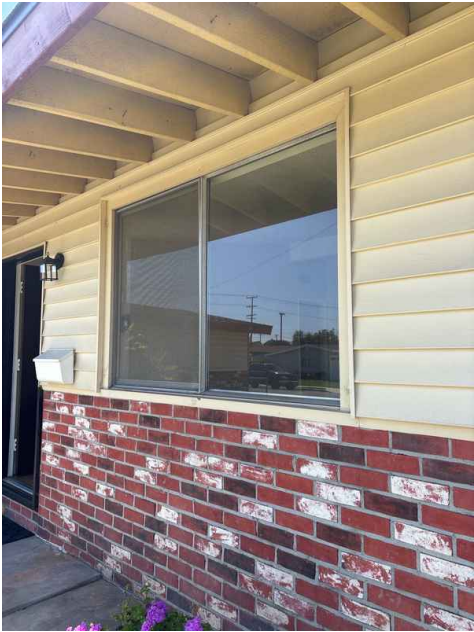
One or more single pane windows were observed at the time of inspection. Recommend updating Windows for energy efficiency.

Contact a qualified professional.

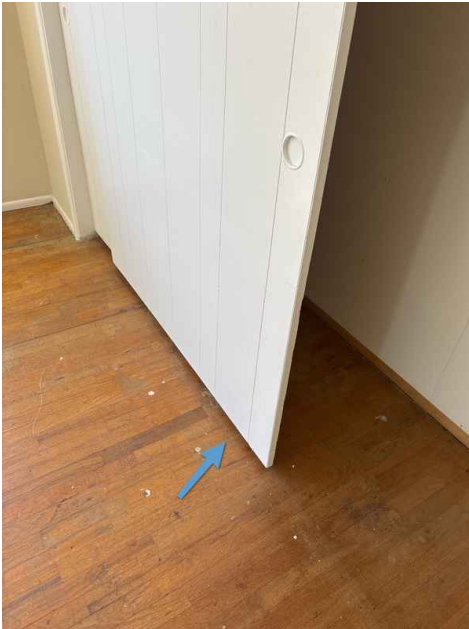
Bedroom

The closet door guide rail was missing / damaged. Recommend repair.

Contact a qualified handyman.

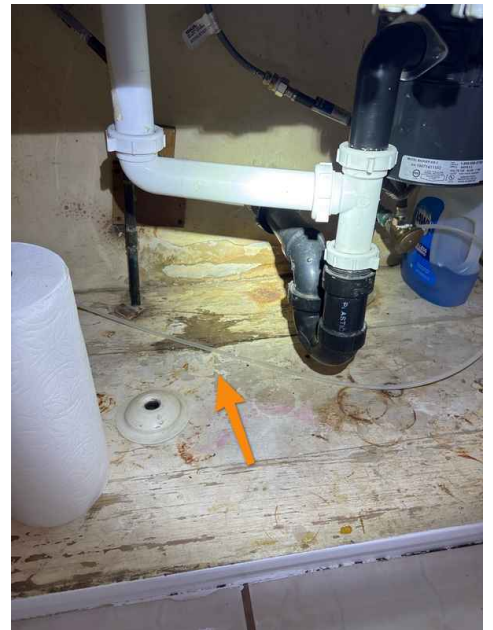
Kitchen

Cabinets had visible damage at time of inspection. Recommend a qualified cabinets contractor evaluate and repair.

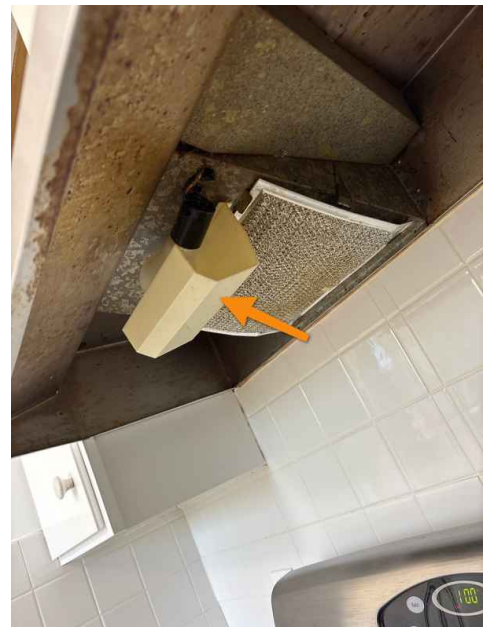
## 14.5.2 Exhaust / Ventilation

**EXHAUST HOOD LIGHT INOPERABLE / MISSING BULBS**

Contact a qualified appliance repair professional.

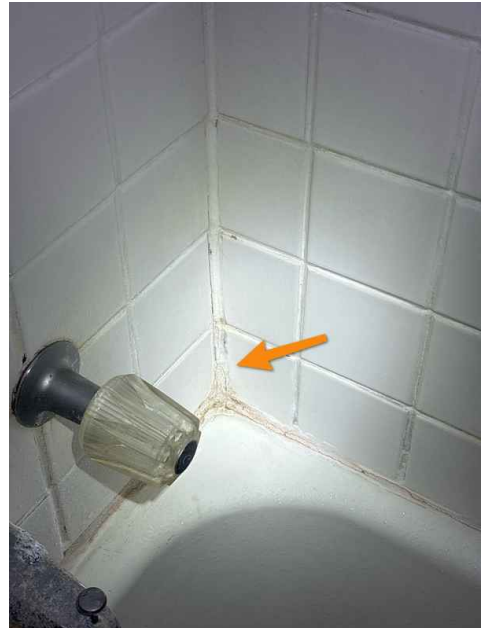
Hallway Bathroom

Grout was substandard, damaged, or missing in one or more areas. Water can or may have damaged wall surfaces behind tile. Recommend contractor evaluate and repair.

Contact a qualified general contractor.

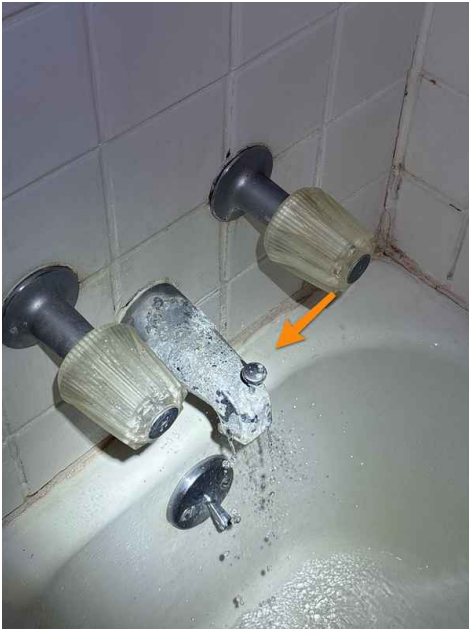
Hallway Bathroom

The diverter pull was not functioning properly. Recommend repair.

Contact a qualified plumbing contractor.

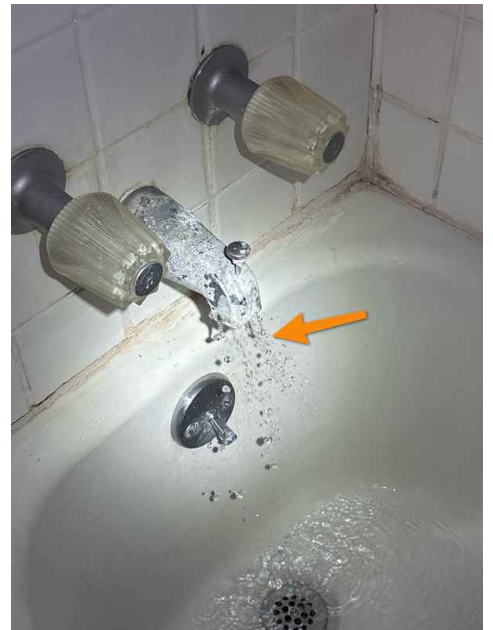
Water came out of the bathtub spout when the shower was turned on. The diverter valve is likely defective. Recommend further evaluation and repair by a qualified professional.

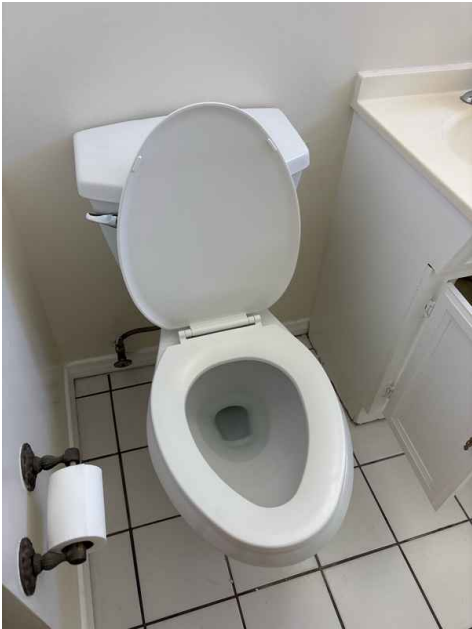
Hallway Bathroom

Toilet was noted as being loose where it attached to the floor. Leaks can occur. As the inspector cannot determine the condition of the wax ring underneath which seals the toilet, it is recommended that a qualified contractor remove the toilet(s) for further evaluation and repair if deemed necessary. A new wax ring should be installed and toilet(s) should be securely anchored to the floor to prevent movement and leaking.

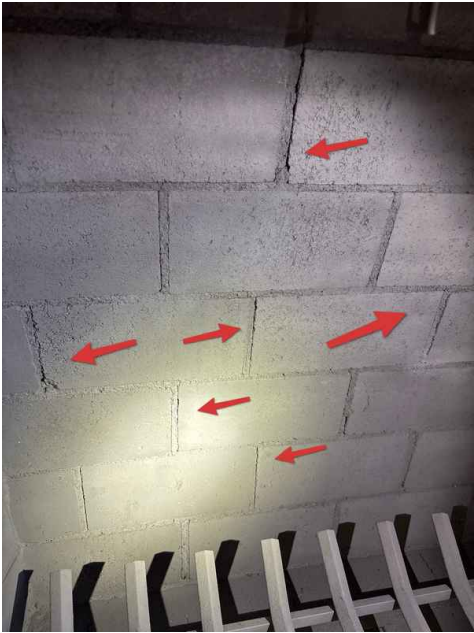
The fireplace's firebox was deteriorated (loose, cracked, pitted or broken firebricks, gaps between bricks and/or missing mortar) in one or more areas. Heat from the fireplace may penetrate the firebox. This is a potential fire hazard. Recommend further evaluation and repair by a qualified professional.

Safety Hazard

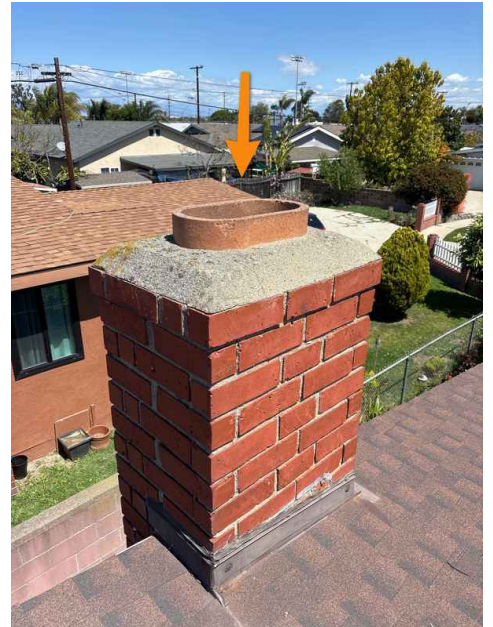
No rain cap was installed at one or more chimney flue terminations. Rain caps prevent water from entering flues, mixing with combustion deposits and creating caustic chemicals which can corrode flues. They also prevent damage to masonry from freeze-thaw cycles and prevent metal components (e.g. dampers, metal firebox liners) from rusting. Recommend that a qualified person install rain caps per standard building practices where missing.

Contact a qualified chimney contractor.

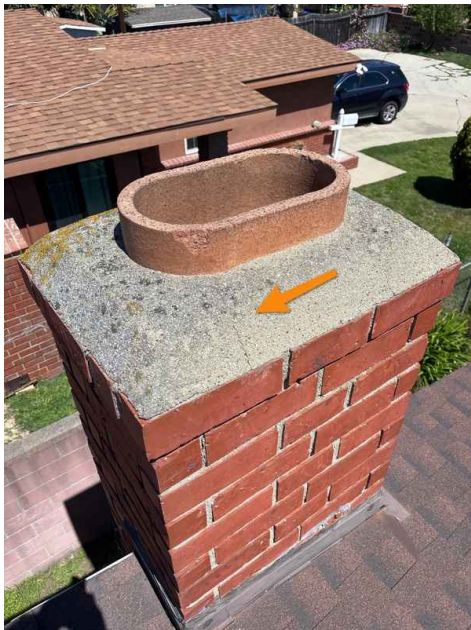
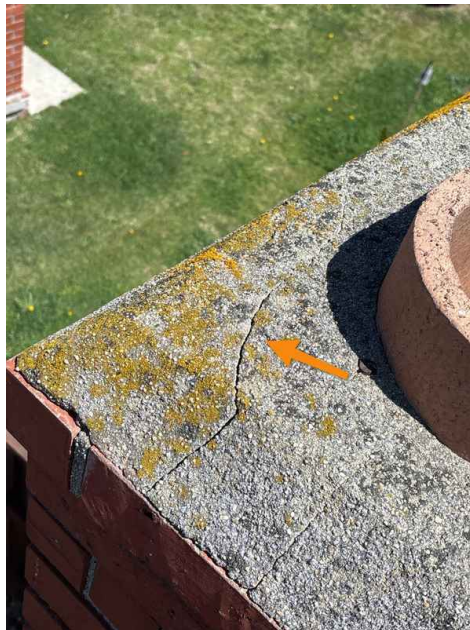
The chimney crowns were worn, cracked, missing, deteriorated and/or substandard. Crowns are meant to keep water off of the chimney structure. Recommend further evaluation and repair by a qualified professional.

Contact a qualified chimney contractor.

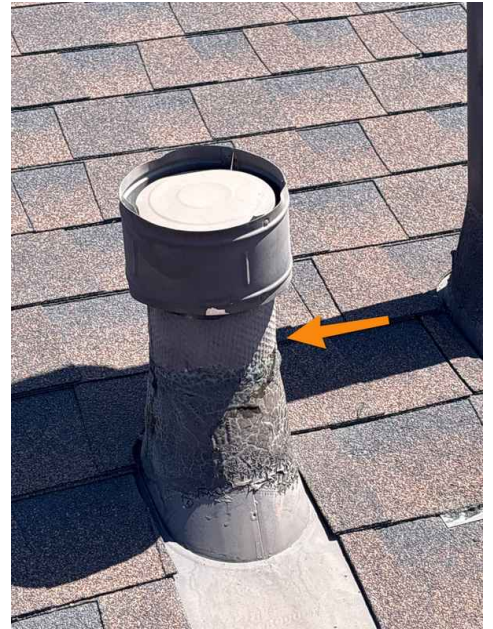
Transite heating vent pipes were observed. Transite vent pipes are known to contain asbestos. Recommend further evaluation by a asbestos specialist.

Contact a qualified professional.

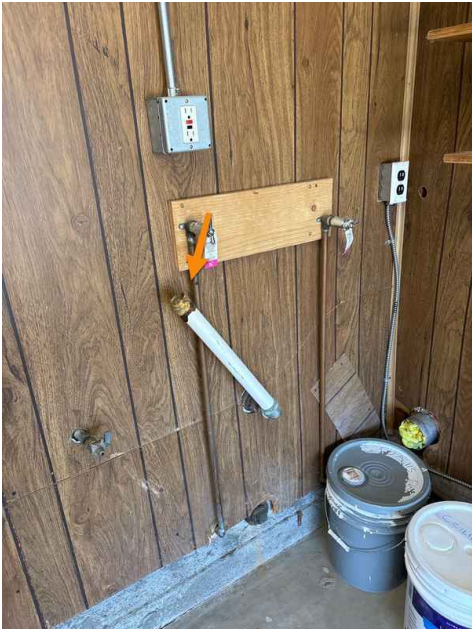
The washing machine standpipe was too narrow. Older homes typically have smaller diameter pipes which may not be able to handle the discharge from today's high capacity drumless washing machines and may need a plumber to repair. Client should consider upgrading this as necessary per their needs.

Contact a qualified plumbing contractor.

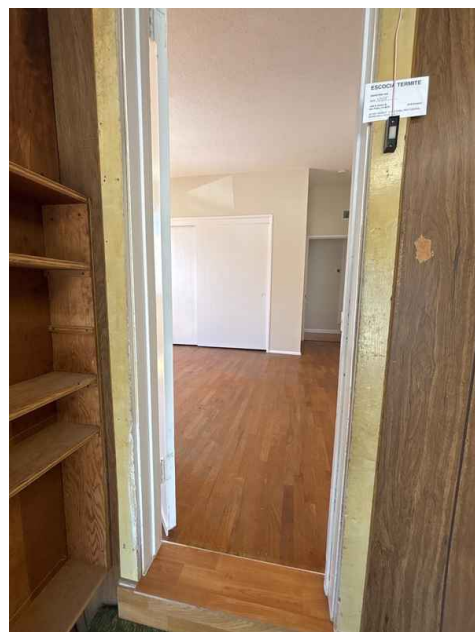
Safety Hazard

A door was installed between the attached garage and a bedroom. Normally, this configuration is prohibited due to the risk of vehicle fumes and/or fire entering rooms where people are sleeping. This is a significant safety hazard. Recommend further evaluation and repair by a qualified professional.

Contact a qualified general contractor.

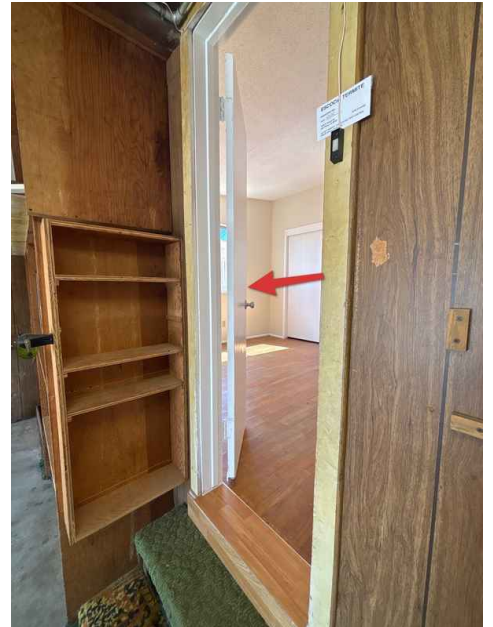
## 18.3.2 Occupant Doors

**DOOR NOT FIRE RESISTANT**

Contact a qualified door repair/installation contractor.

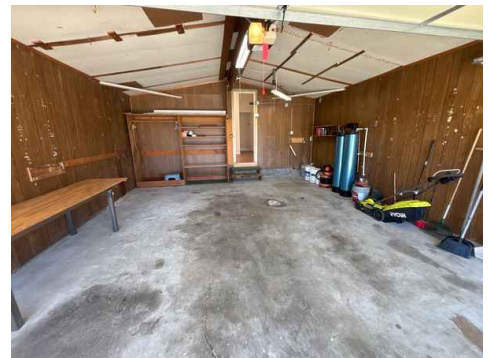
## 18.6.1 Floor, Walls, Ceiling

**FLOORS / WALLS OBSCURED**

Floor and / or wall areas were obscured by stored items and couldn't be fully evaluated.
