# Inspection Report

**Property Address:**  
380 Dearborn Street  
Pasadena, CA 91104

**Scotland Yard Home Inspections**

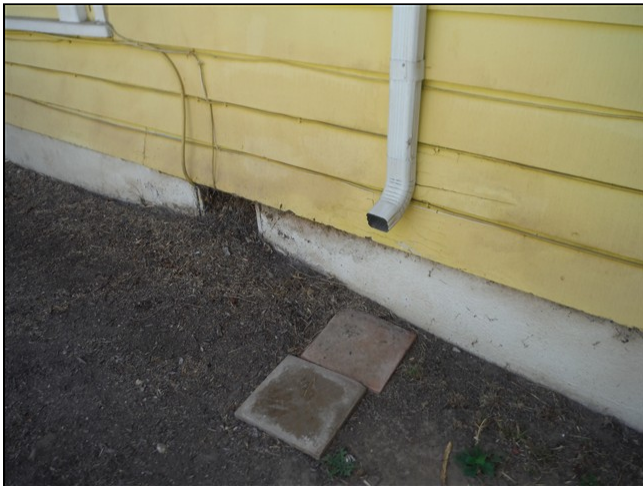
1.3 Item 1(Picture)

**1.3** (1) Gutters, downspouts and splash blocks are not properly installed in all areas or missing. These items are not required in the state of California suggest installing to divert water away form the foundation.

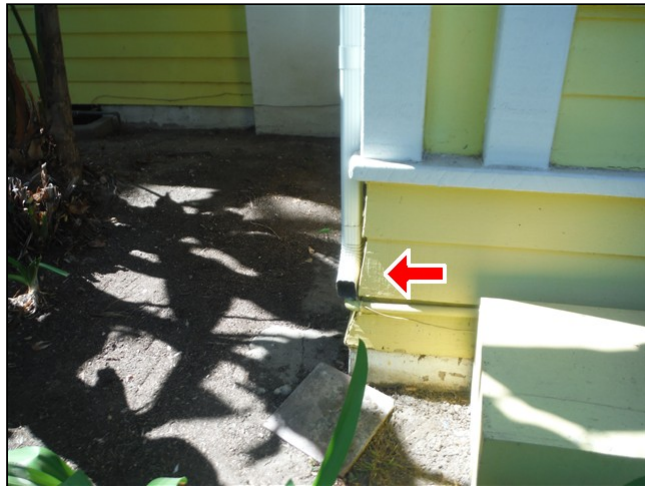
1.3 Item 2(Picture)

(2) Vegetation/debris observed in gutters suggest cleaning to enhance drainage.

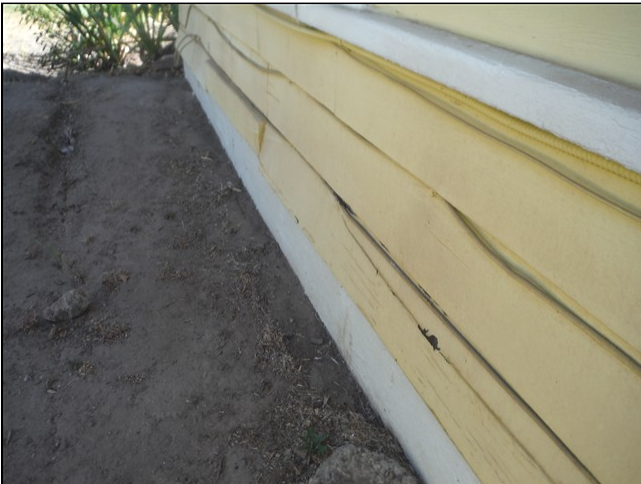
2.4 Item 1(Picture)

**2.4** (1) Deterioration observed in areas recommend repair and further review by a licensed tradesperson, prior to the close of escrow.

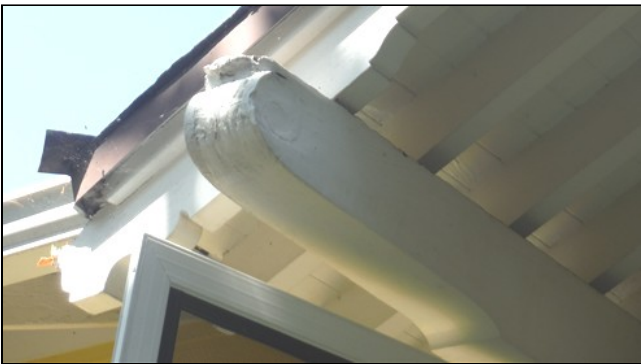
2.5 Item 2(Picture)

(2) Repairs observed at trim in areas unable to determine cause and effectiveness of repairs, suggest further review by a licensed tradesperson that specializes in this field.

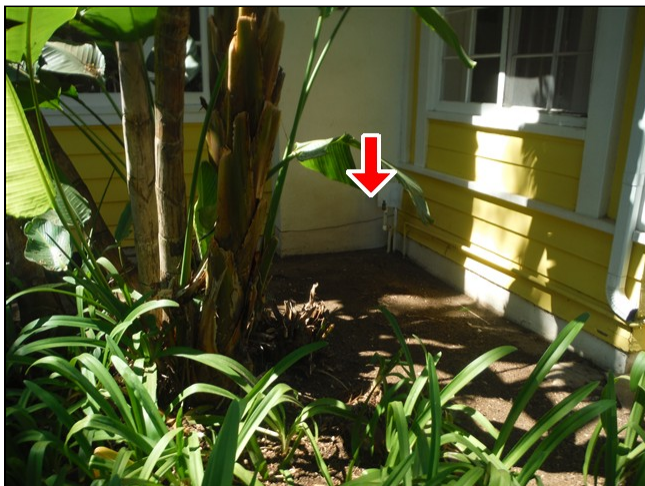
2.9 Item 1(Picture)

**2.9** Inadequate grade observed in areas of the home recommend correcting to assure all water drains away from the foundation.

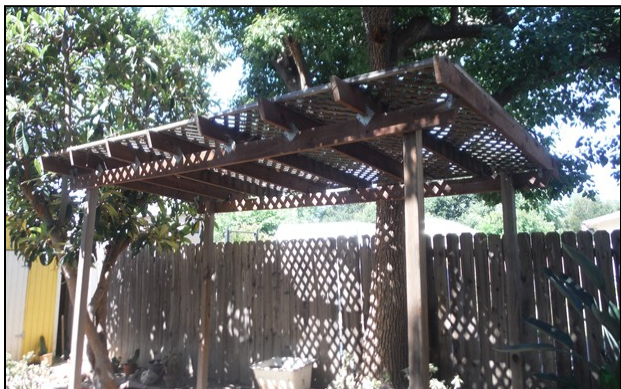
2.11 Item 1(Picture)

(2) Rear wood patio cover does not appear to be properly installed recommend further review by a licensed tradespersons that specializes in this field, prior to the close of escrow.

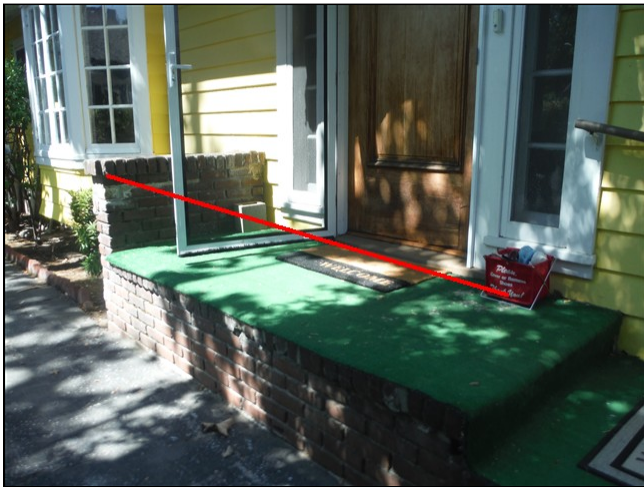
2.11 Item 2(Picture)

(3) Guard rail not installed at front exterior steps suggest installing.

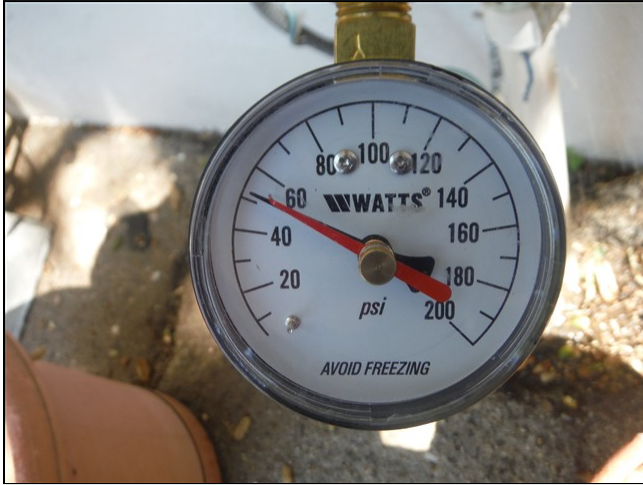
3.0 Item 1(Picture)

**3.0** (1) Note: Main shut off observed at front of home.

(2) Water pressure at the time of inspection was under 60 PSI, water pressure is between the recommend range of 35 to 80 PSI.

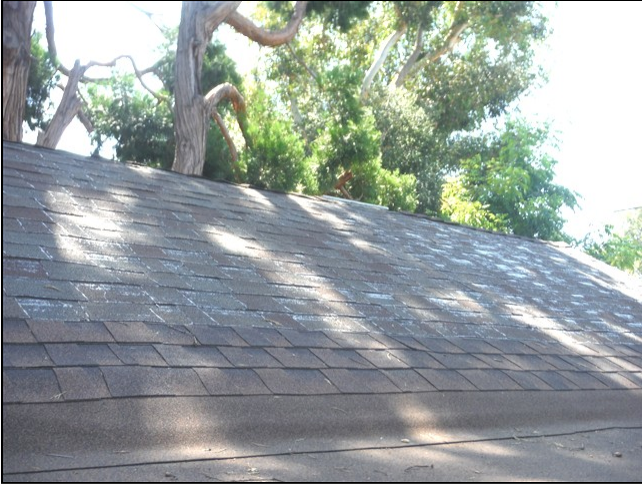
5.0 Item 1(Picture)

**5.0** (1) Roofing material appears to be at the end of it's useful life recommend further review by a licensed roofer, prior to the close of escrow.

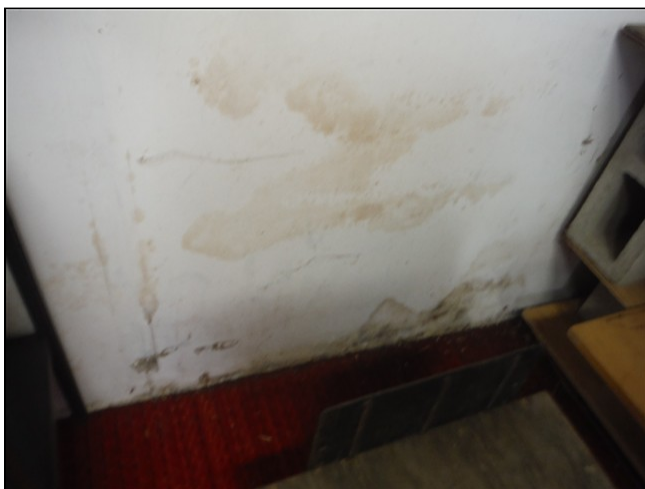
5.4 Item 1(Picture)

**5.4** Black spots observed in areas recommend further review by a licensed tradesperson, prior to the close of escrow.

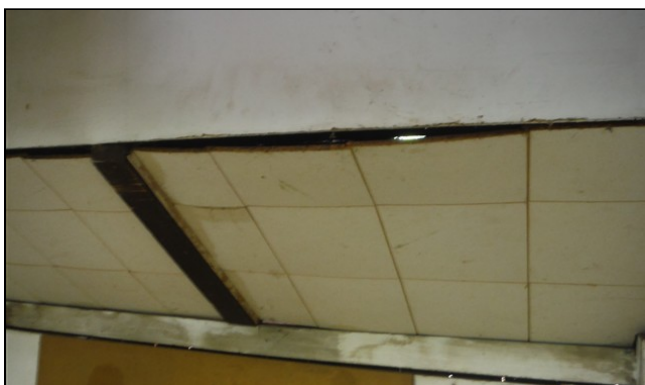
5.6 Item 1(Picture)

**5.6** (1) Daylight observed in areas of garage recommend further review by a licensed roofer, prior to the close of escrow.

(2) Missing material observed at ceiling in areas recommend further review by a licensed tradesperson that specializes in this field.

(3) While asbestos and other chemical testing is beyond the scope of this inspection, my experience leads me to suspect that ceiling tile may contain asbestos. This material was used widely during this period of construction and is considered to be safe unless damaged or deterioration has occurred recommend further review by a licensed tradesperson that specializes in this

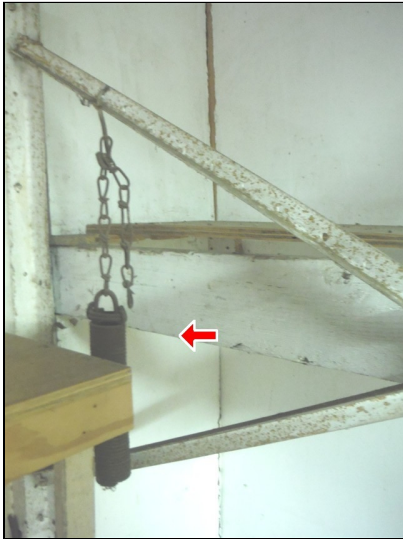
5.9 Item 1(Picture)

**5.9** Garage door hardware is not operable (not properly connected) recommend correcting.

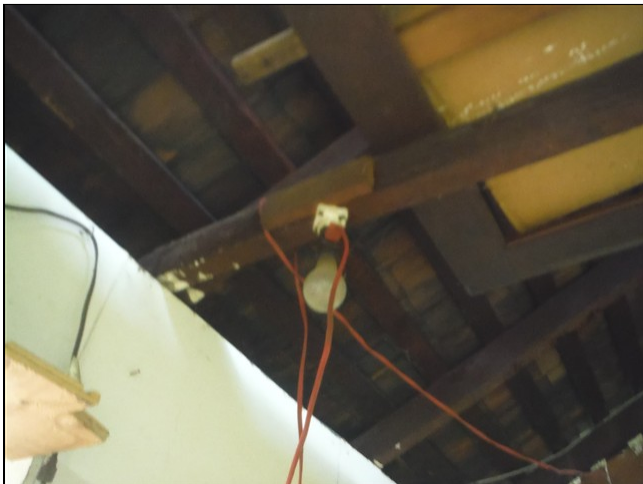
5.10 Item 1(Picture)

**5.10** (1) Exposed wiring observed recommend correcting.

(2) Improper wiring of light fixture with extension cord recommend correcting.

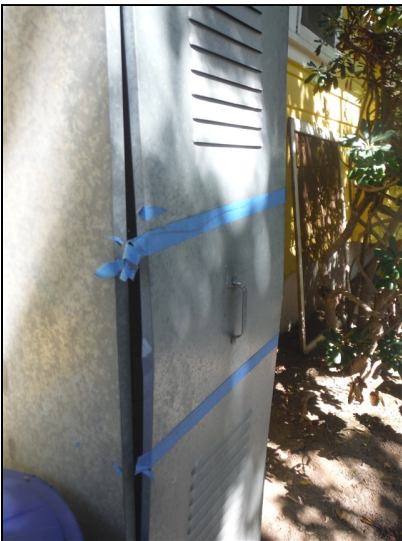
6.7 Item 1(Picture)

**6.7** Physical damage observed at platform/compartment suggest maintenance or replacement.

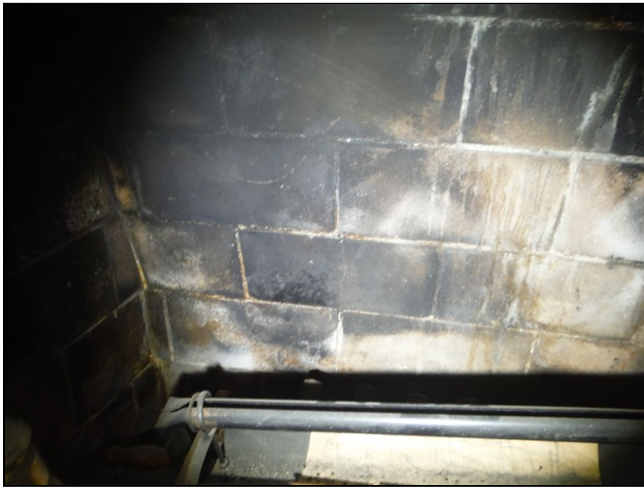
7.0 Item 1(Picture)

**7.0** (1) Mortar is missing in areas of the firebrick recommend repair.

(2) Cracks observed recommend further review by a chimney specialist.

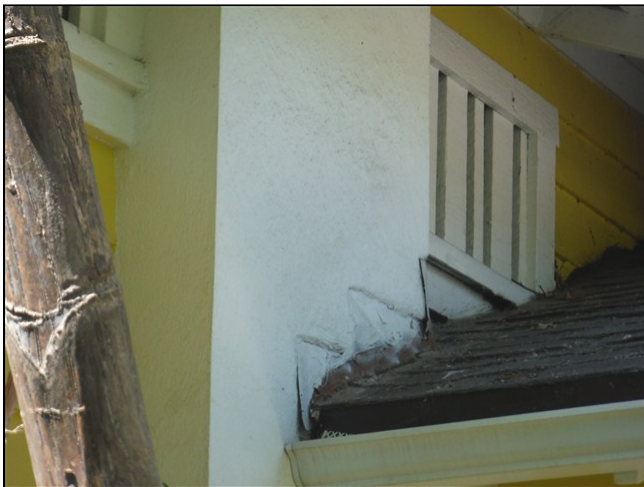
7.5 Item 1(Picture)

**7.5** Gaps observed at flashing suggest repair.

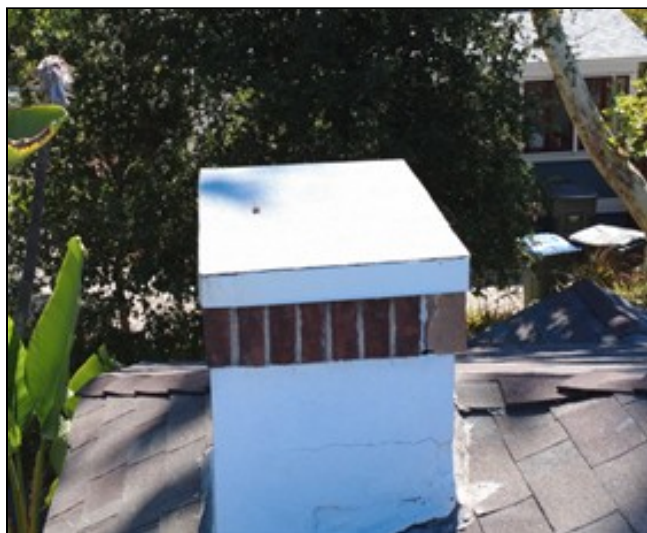
7.9 Item 1(Picture)

**7.9** Chimney is closed off at cap - **DO NOT USE.**

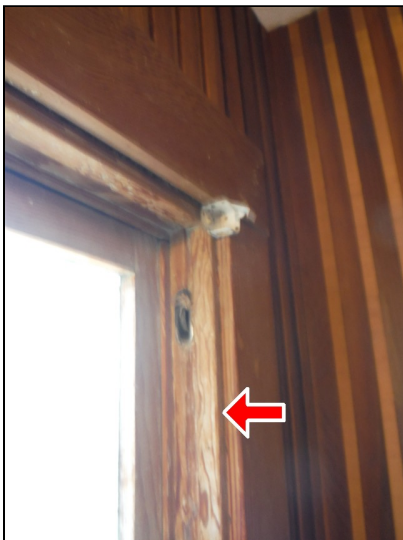
8.3 Item 1(Picture)

**8.3** (1) Deterioration of wood observed at window and frames recommend maintenance or replacement.  
 (2) Inoperable sash wires/cords observed (broken or missing) recommend repair or replacement.

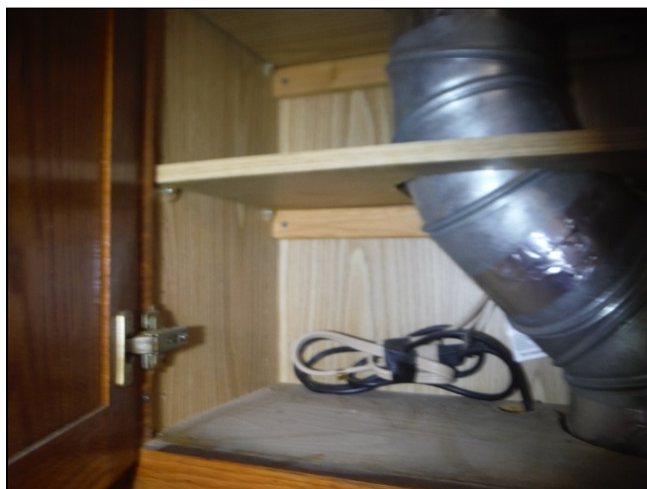
8.16 Item 1(Picture)

**8.16** Fan is improperly wired using an extension cord recommend further review by a licensed appliance specialist.

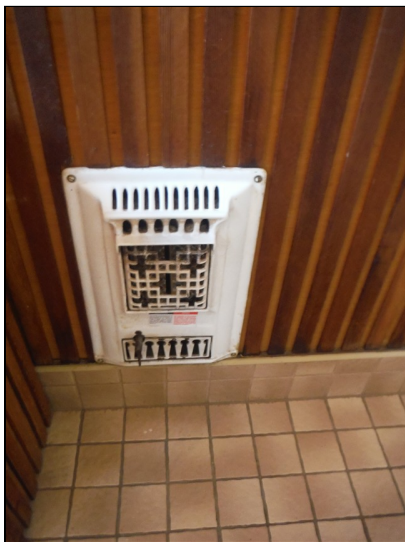
10.17 Item 1(Picture)

**10.17** Wall heater observed - **not tested** - beyond the scope of this inspection.

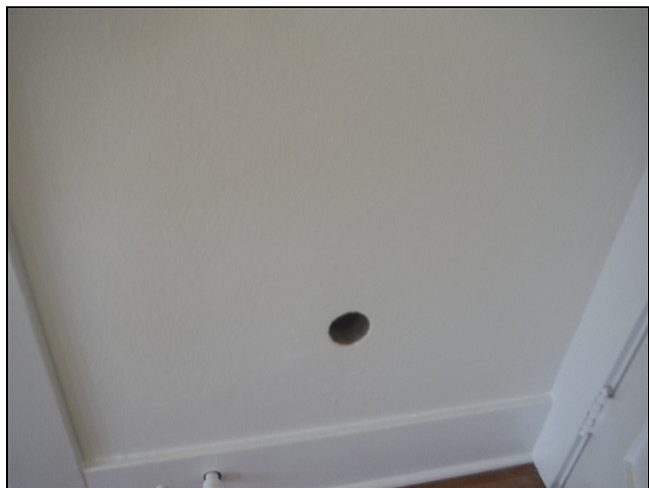
11.1 Item 1(Picture)

- 11.0** Floors are not **level throughout the home**. It appears to be normal settling (if you have any further concerns) further review by a licensed tradesperson is recommended prior to the close of escrow.
- 11.1** (1) Evidence of repairs observed at walls in various rooms unable to determine the cause or effectiveness of the repairs.
- (2) Hole(s) observed in rear bedroom recommend repair.

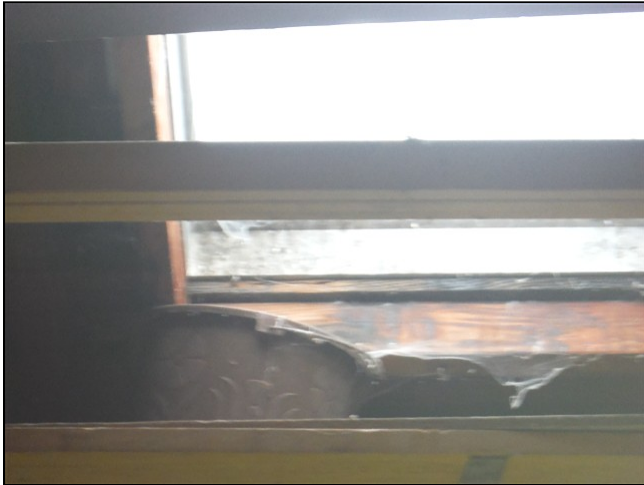
11.3 Item 1(Picture)

**11.3** (1) Deterioration observed at **various window frames and sills** recommend maintenance or replacement.

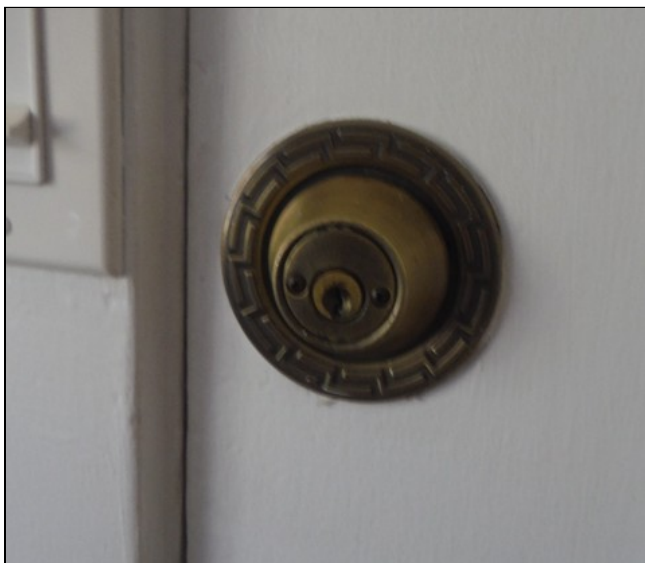
11.5 Item 1(Picture)

(5) Keyed locking device observed at front door - **safety concern** - suggest replacement.

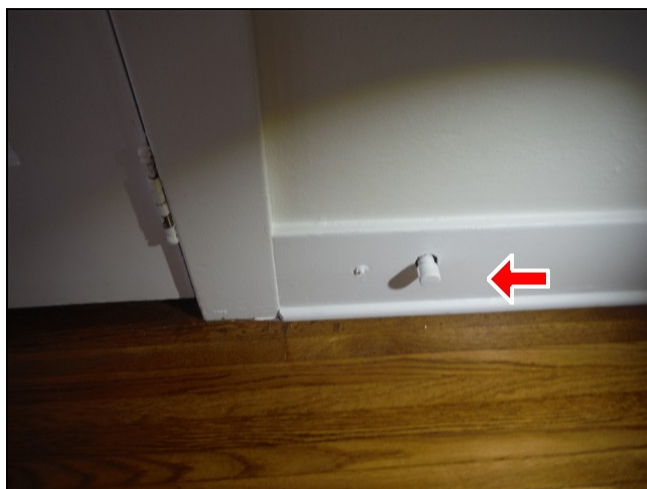
11.11 Item 1(Picture)

**11.11** NOTE; Capped gas lines observed in various rooms.

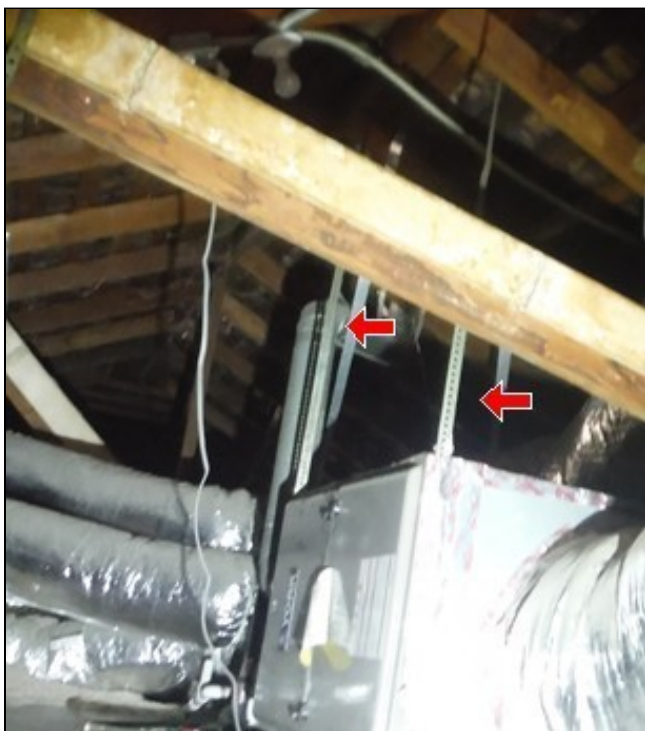
12.0 Item 1(Picture)

**12.0** Heating unit is not properly supported recommend correcting.

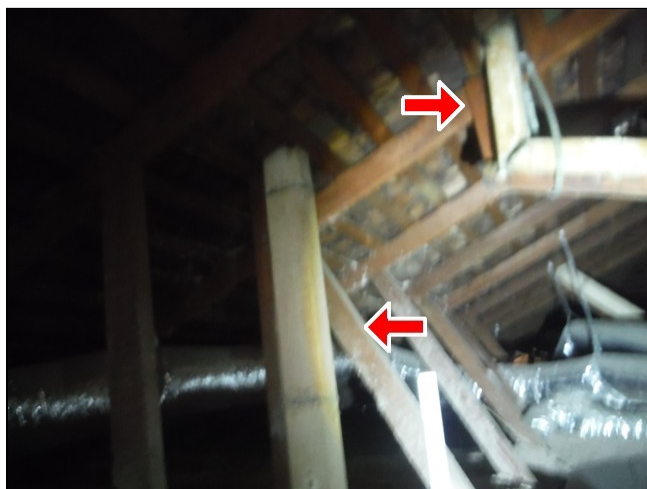
13.10 Item 1(Picture)

**13.10** (1) While asbestos and other chemical testing are beyond the scope of this inspection, my experience leads me to suspect that **vent pipe** may contain asbestos. This material was used widely during this period of construction and is considered to be safe unless damaged or deterioration has occurred recommend further review by a licensed plumber.

(2) Recommend further review by a licensed termite/rodent professional prior to the close of escrow.

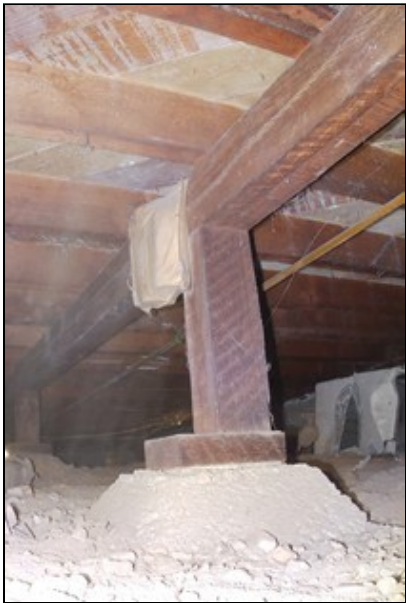
14.2 Item 1(Picture)

(2) Crack observed recommend strapping as needed.
- 14.2 Several posts are off center, recommend repair.

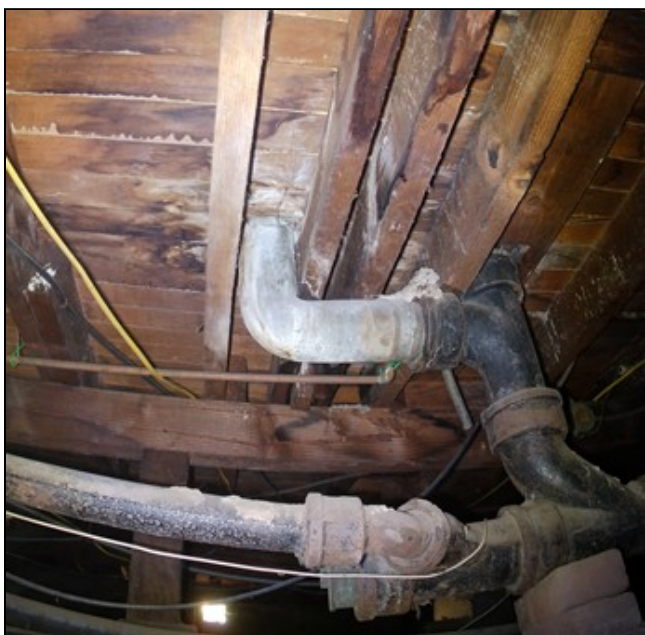
14.7 Item 1(Picture)

**14.7** (1) Rust/Corrosion observed on waste lines recommend repair or replace.

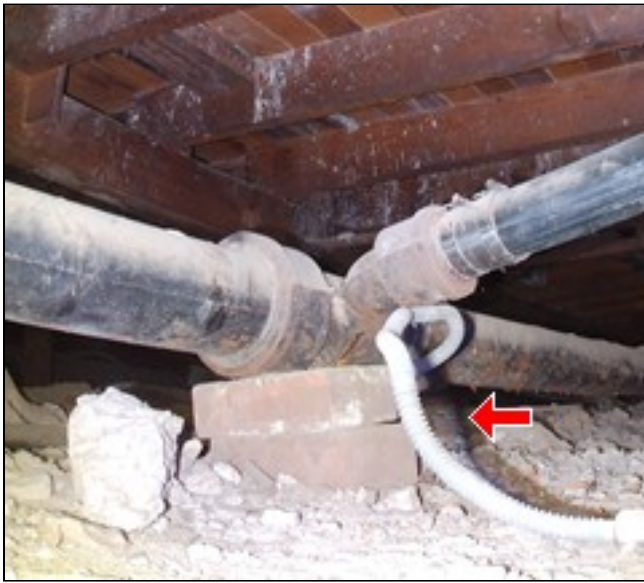
14.7 Item 3(Picture)

(2) Improper strapping of waste piping suggest correcting.

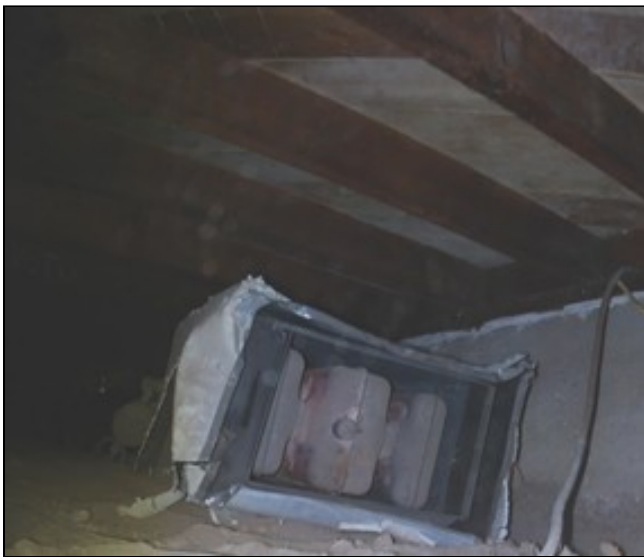
14.8 Item 1(Picture)

**14.8** Debris/old furnaces observed in crawlspace, suggest removal.
