Inspection reference: 5716 Sunmist Dr., RPV, CA 90275

Confidential Inspection Report
5716 Sunmist Dr.
Rancho Palos Verdes CA 90275

July 5, 2026

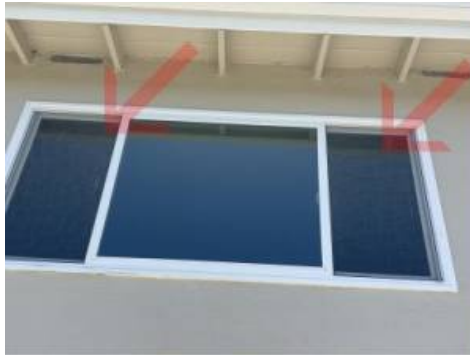
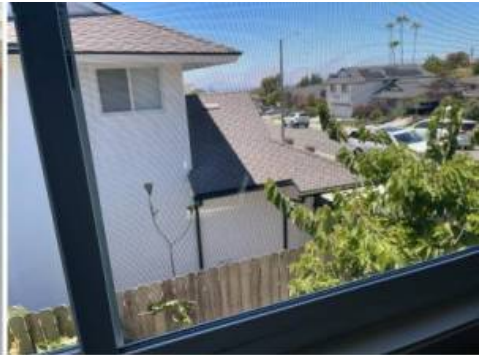
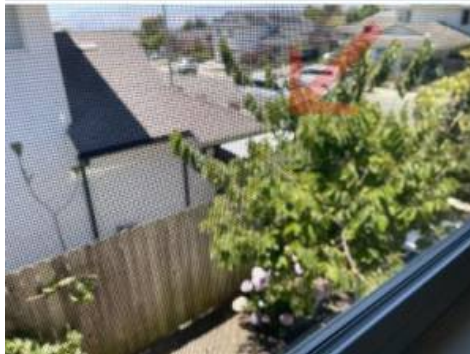
SERVICEABLE.
North side, West side bedroom.
MAINTENANCE: Screen was damaged at one or more windows sampled.

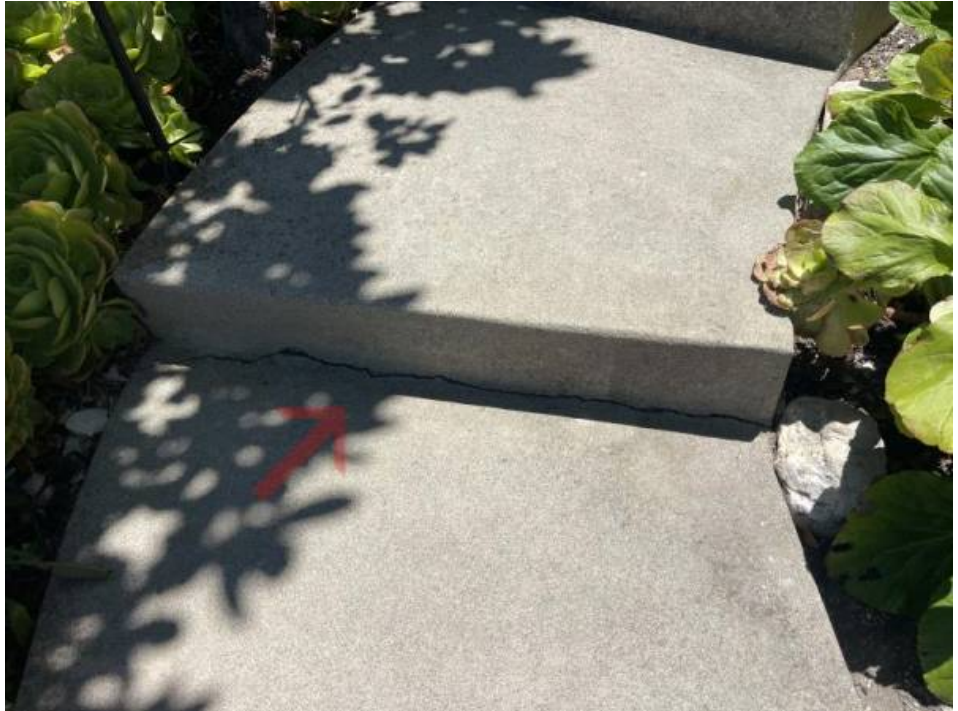
Small settlement crack.

MONITOR: Hairline or moderate sized cracks observed. These appear to be typical settlement and shrinkage cracks. We suggest monitoring and obtaining further evaluation by a licensed waterproofing contractor if a change in size or number is noticed.

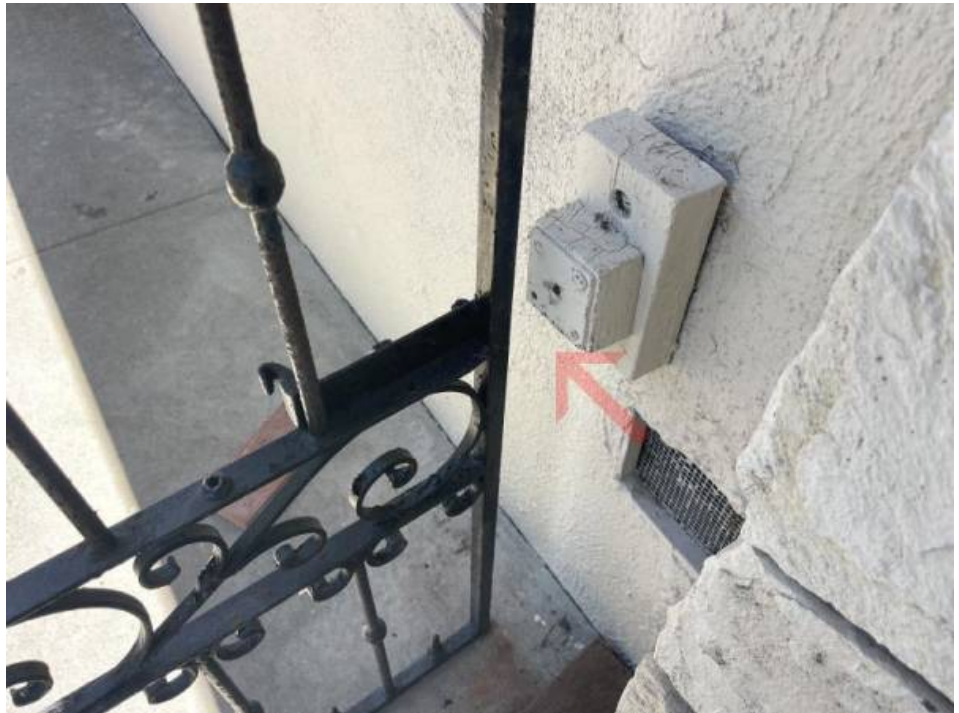
MAINTENANCE: Needs adjusting or minor repair.

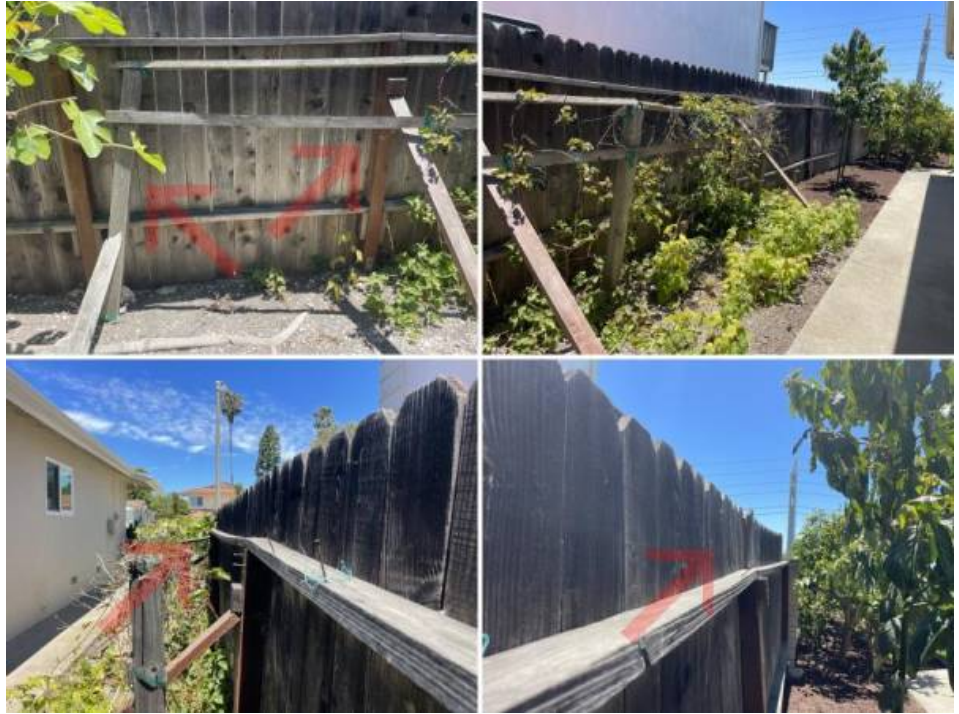
South side, leaning, supports added to support posts.

MAINTENANCE: Some loose/rotted posts and/or broken/missing boards.

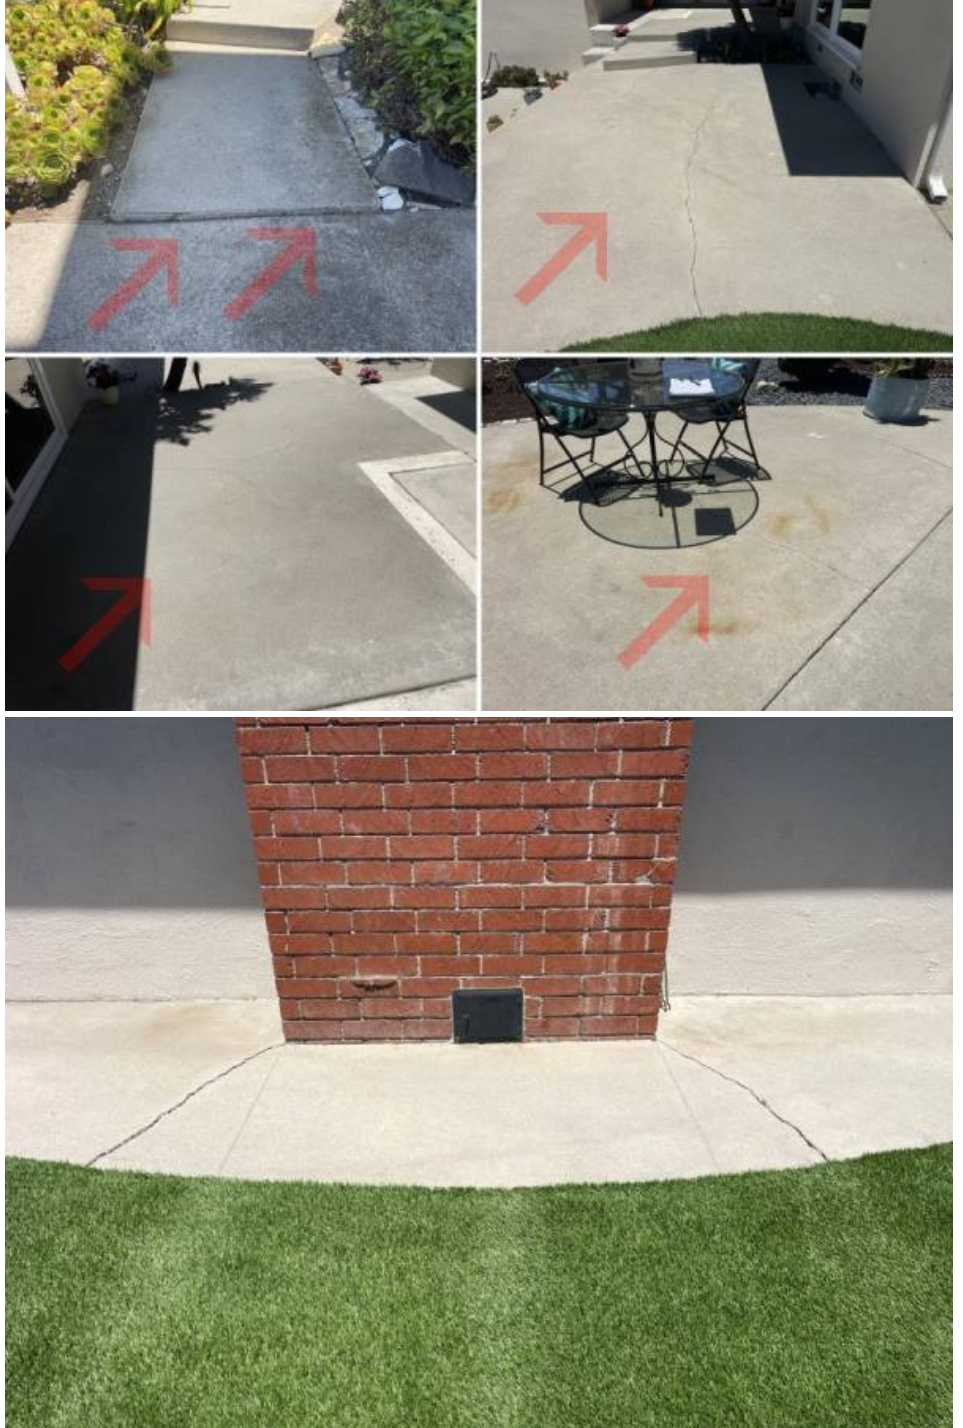
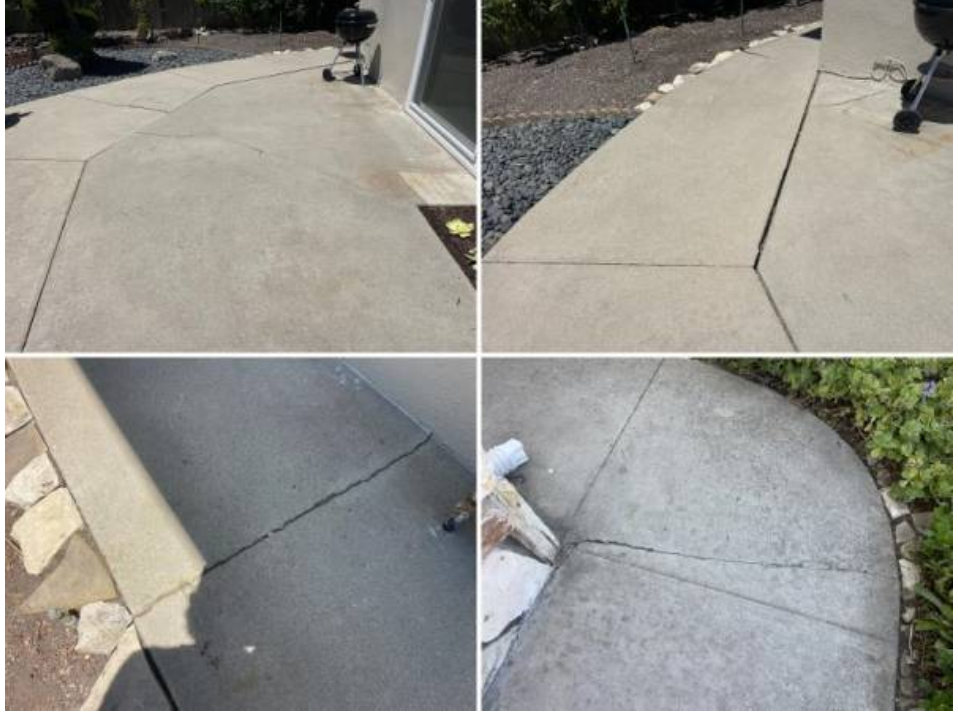
SAFETY: Vertical displacement resulting in a trip hazard at one or more locations. We recommend repairing trip hazards where or whenever they occur. Where displacement is caused by tree roots we recommend consulting with a licensed landscaping contractor or arborist for remedial advice.

MONITOR: Small cracks viewed in the paving appear to be typical of settlement or shrinkage. We recommend monitoring cracks from time to time. Change in the size or number of cracks may be symptomatic of other conditions such as defective drainage, settlement or soil movement and should be further evaluated by a licensed masonry contractor.

This section may have cracked from the moisture issue.

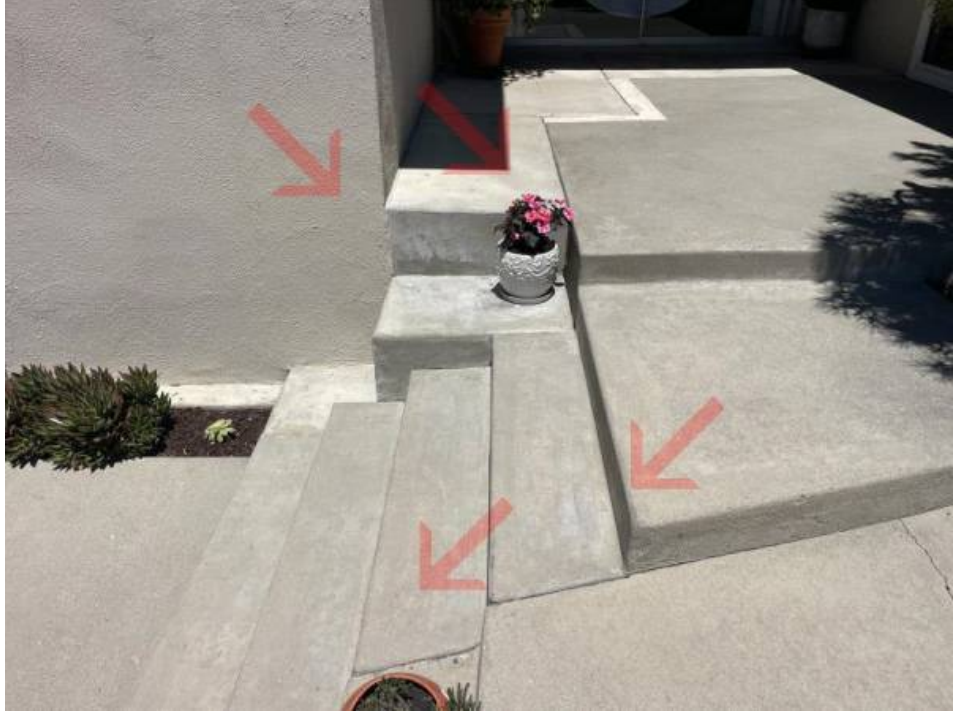
DEFECTIVE: No handrail present. We recommend installing a handrail at all stairs where there are three or more risers.

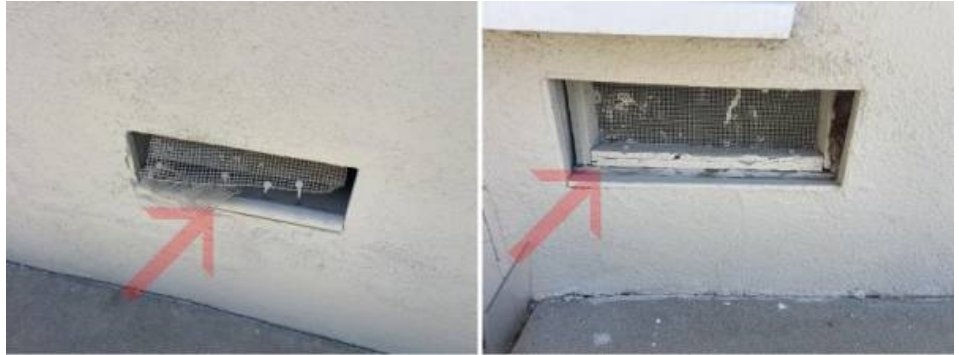
Type: Screened vents to the exterior. South side and north side of living room.
 MAINTENANCE: Some screens were damaged or missing. We recommend maintaining screens in good repair for proper ventilation and to prevent animal or rodent entry.

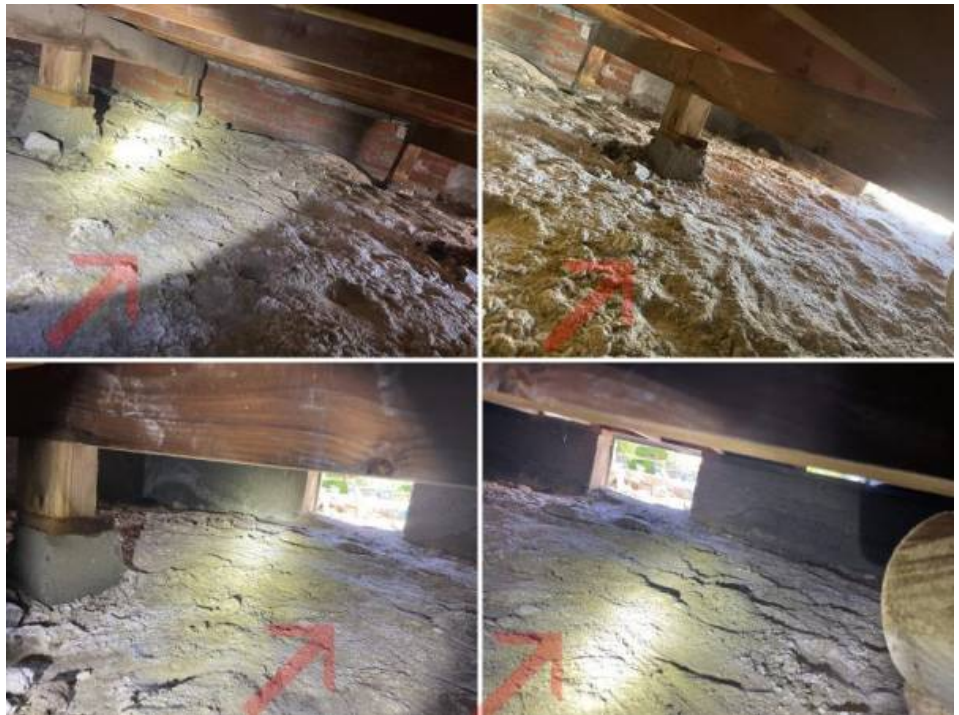
The west end of the sub area has efflorescence, dirt is dry. Likely from a past plumbing leak under kitchen or moisture issue from the exterior of foundation and seeped in. Recommend asking seller for any information on past moisture issues.
DEFERRED: Crystalline like substance viewed on the wet earth. This appears to be efflorescence, however, it may also be or contain microbial matter (mold, fungi, etc.). Environmental issues are beyond the scope of our physical inspection. You will need to consult with an environmentalist or industrial hygienist if you have concerns.

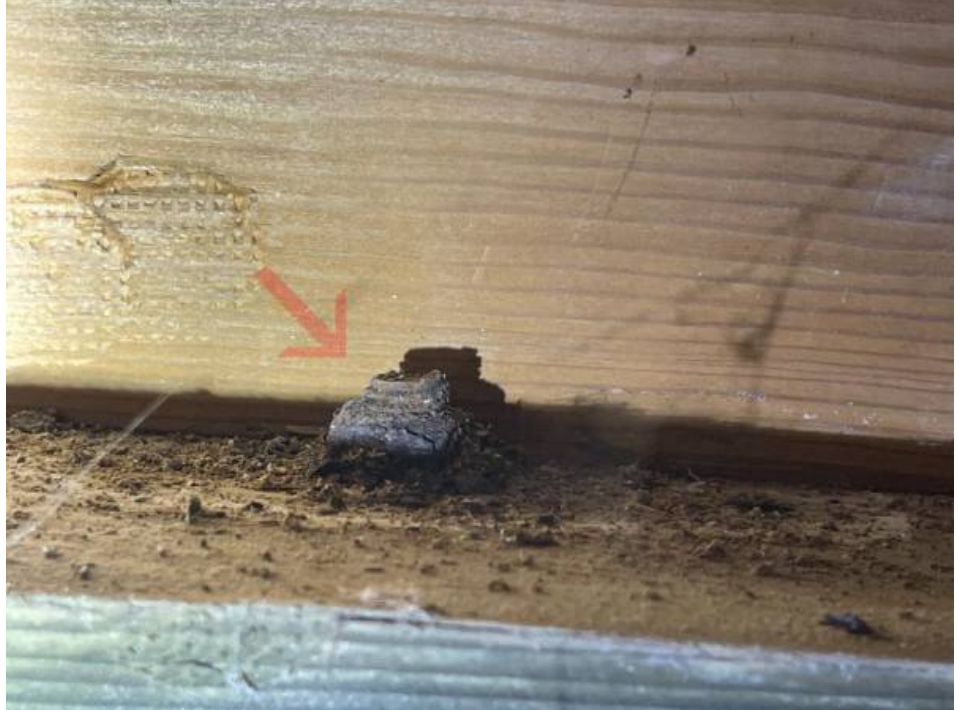
Foundation anchor bolts were observed at the main structure and primary parking structure, not evaluated.

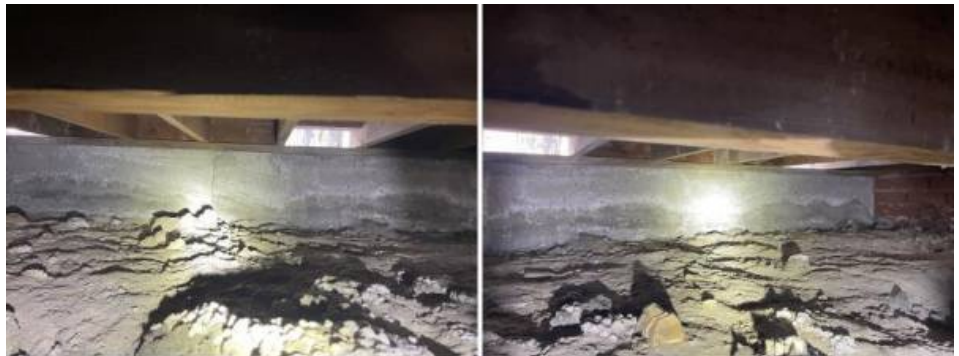
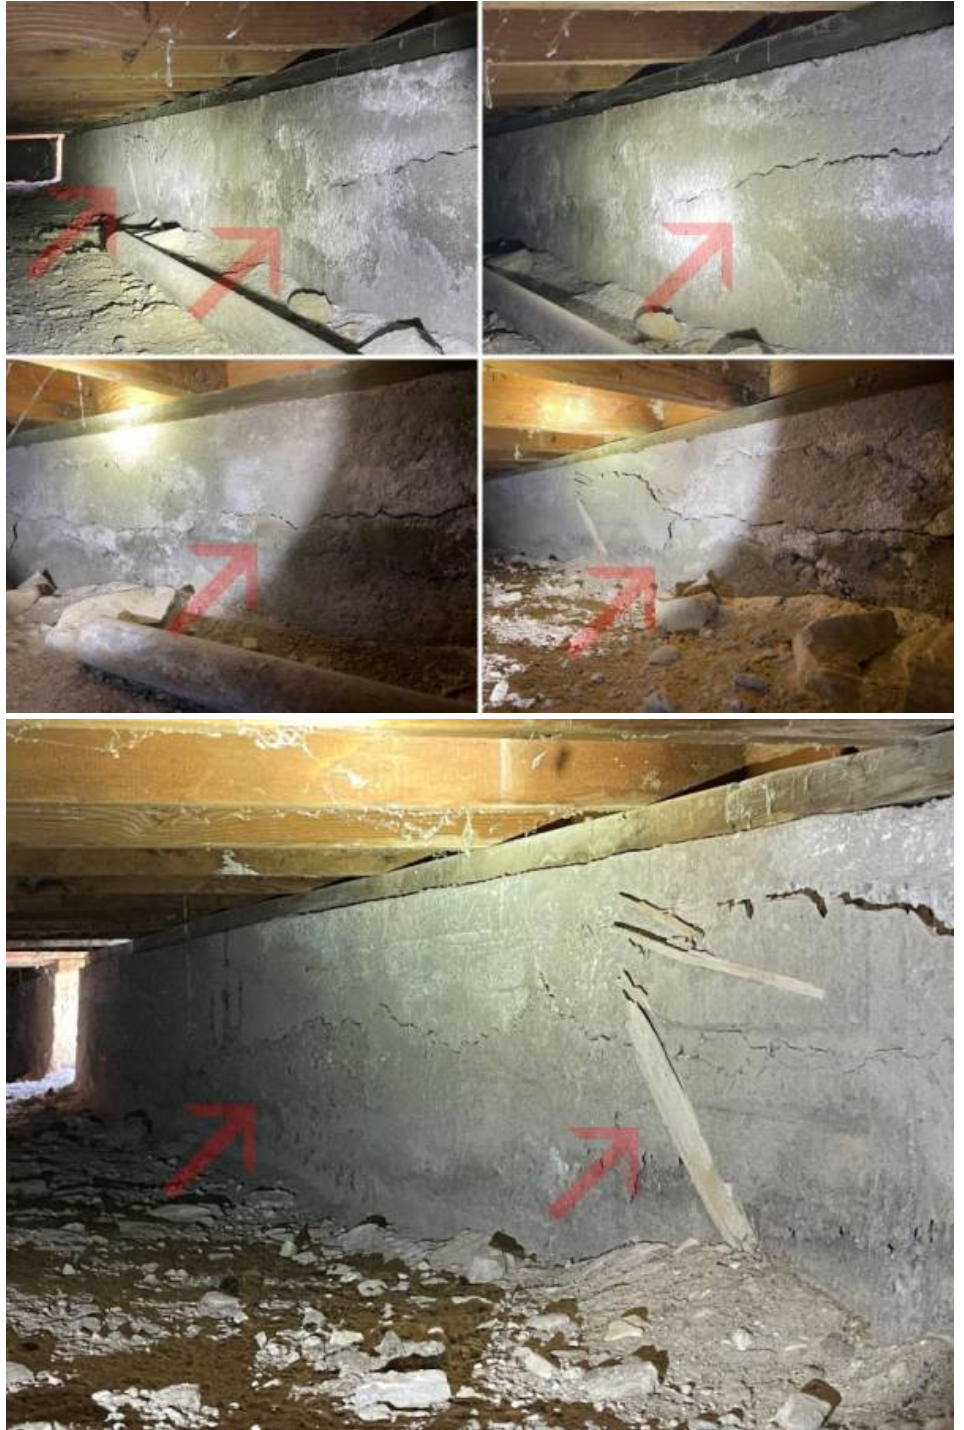
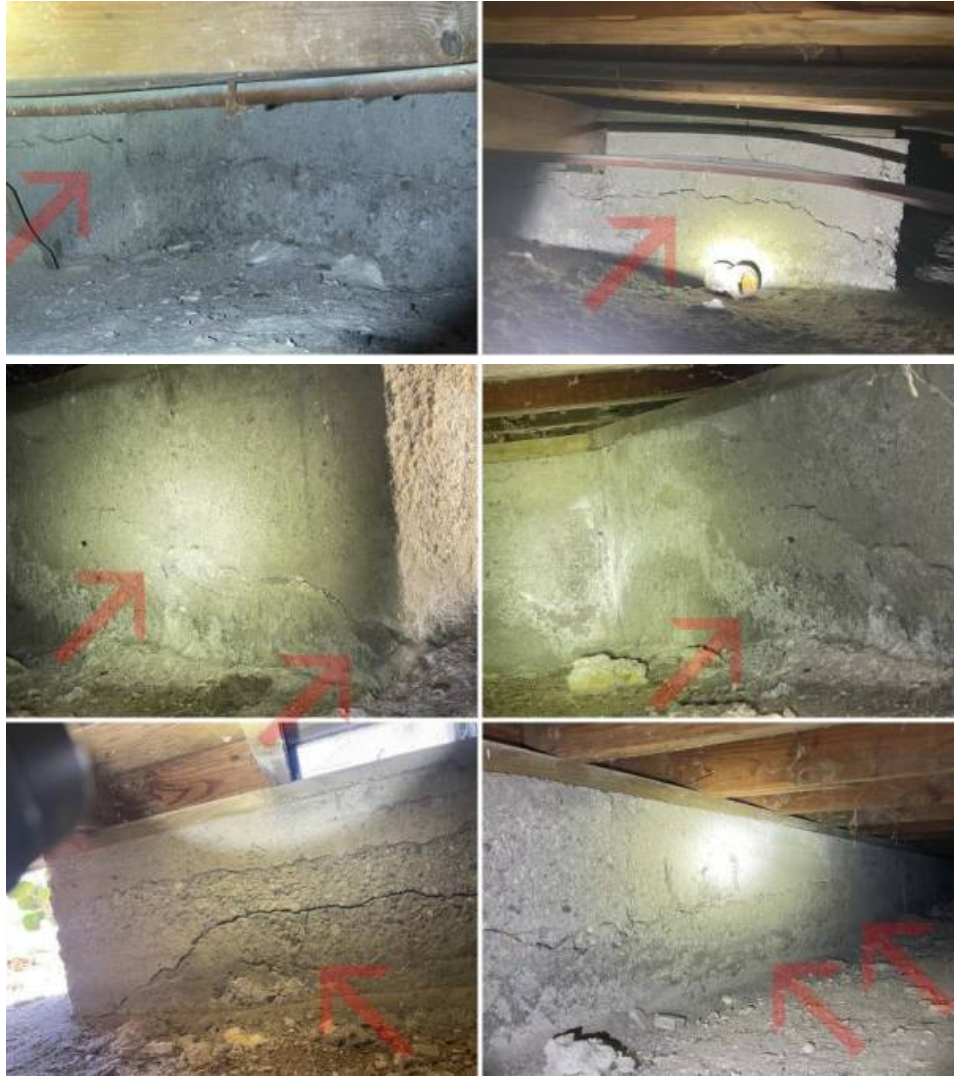
Entry exterior wall.

Under the west end of the living room. The north wall and the entry exterior wall have horizontal cracks. This could have been caused by a moisture issue that had been wet for a long period of time and the bottom of the wall settled. Dry at the time of the inspection.

DEFECTIVE: Horizontal crack to approximately 1/4 inches. Horizontal cracks usually have structural significance and may require repair. We recommend further evaluation by a licensed foundation contractor.

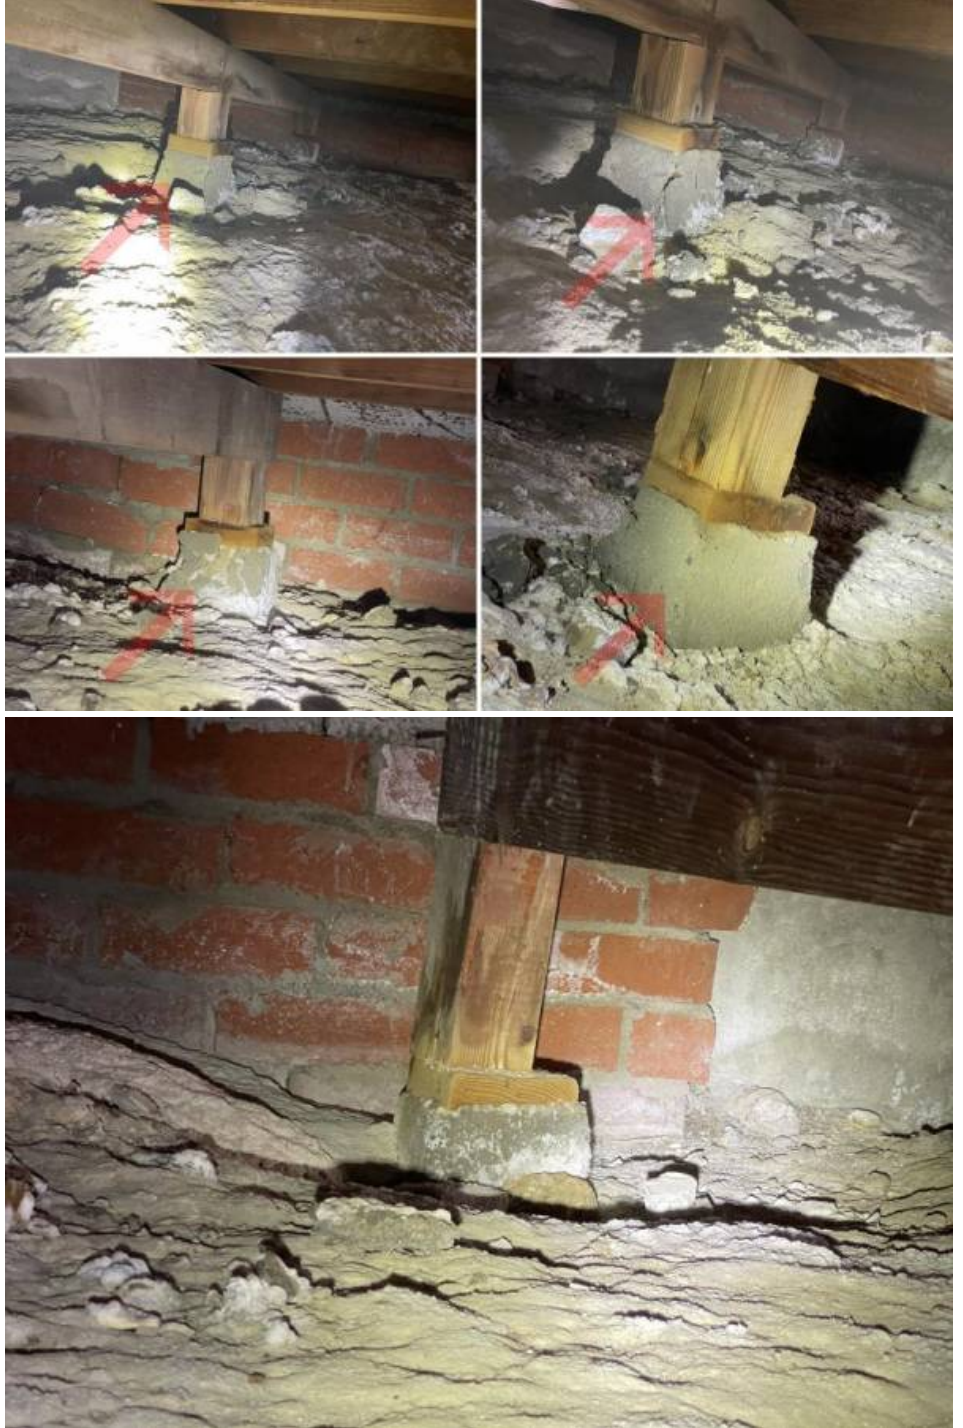
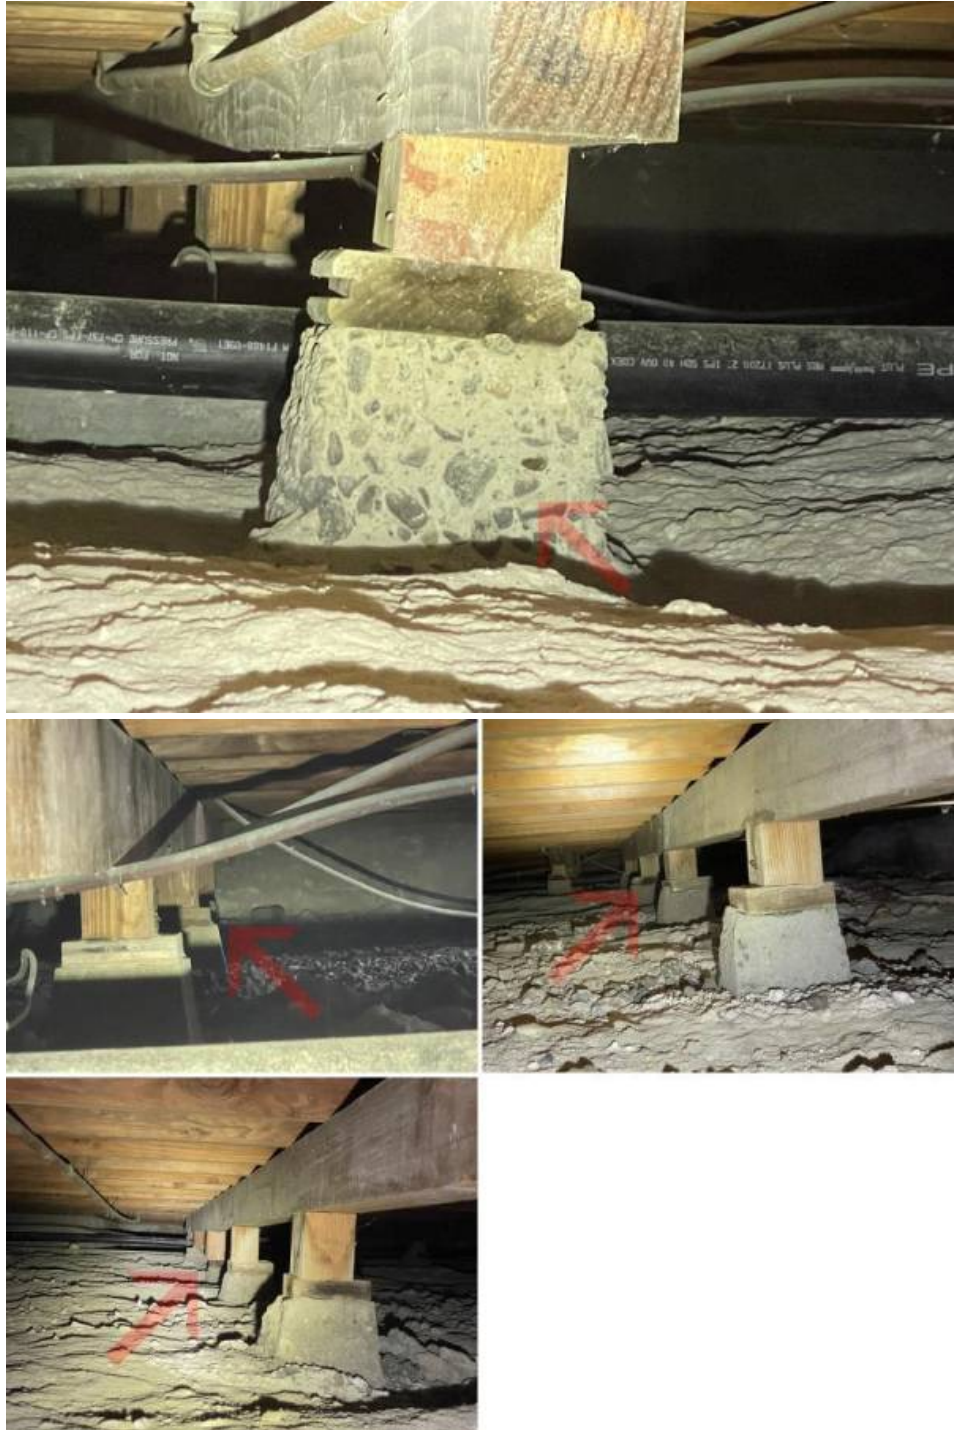
5-6 piers have moisture damage and are deteriorated. Piers will likely need to be replaced.

DEFERRED: Moisture damage viewed. Recommend further inspection and repairs as needed.

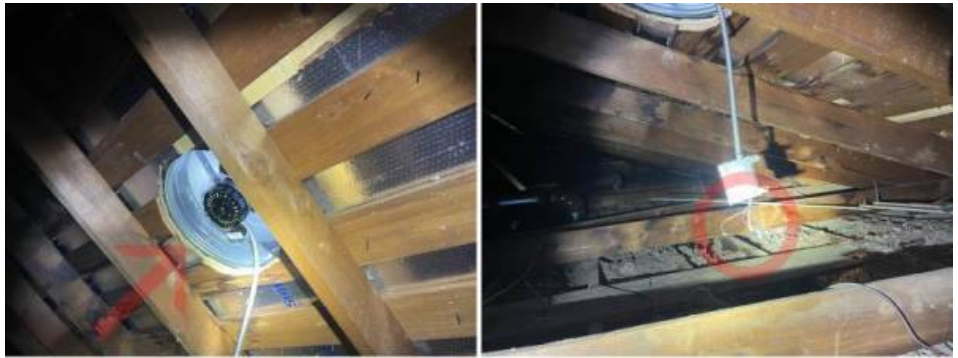
Ventilation SERVICEABLE.
Top attic.
Fan appears new and not connected. Recommend further inspection and finishing install.
DEFERRED: Thermostat controlled attic fan viewed. We do not evaluate or operate thermostat controlled attic fans. We suggest reviewing the fan operation with the current owner.

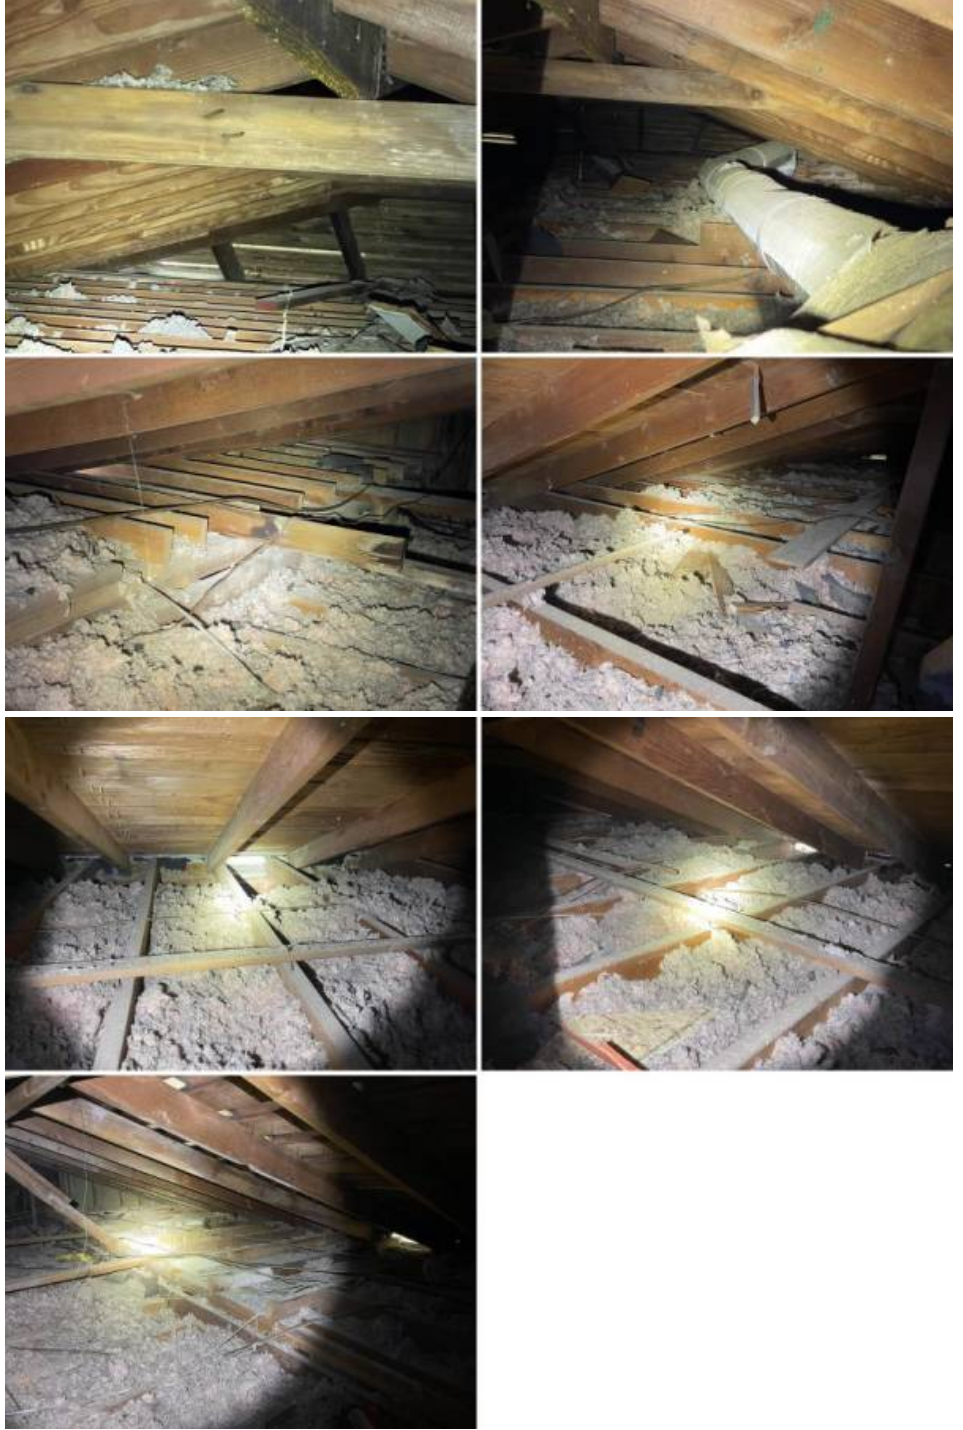
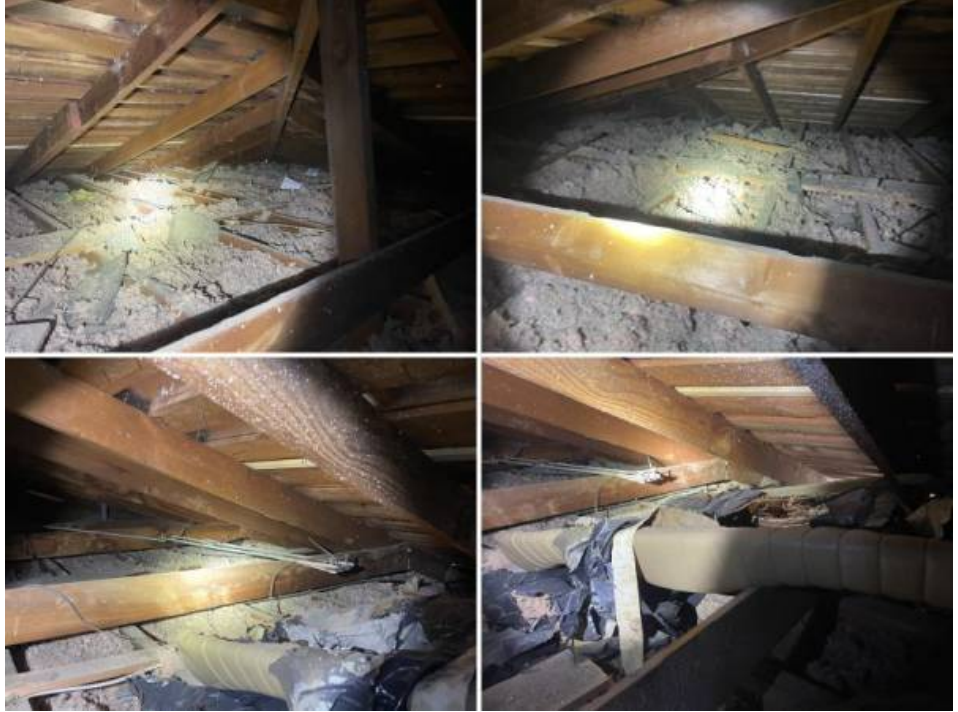
Framing SERVICEABLE.
Conventional framing. Solid sheathing over spaced sheathing.

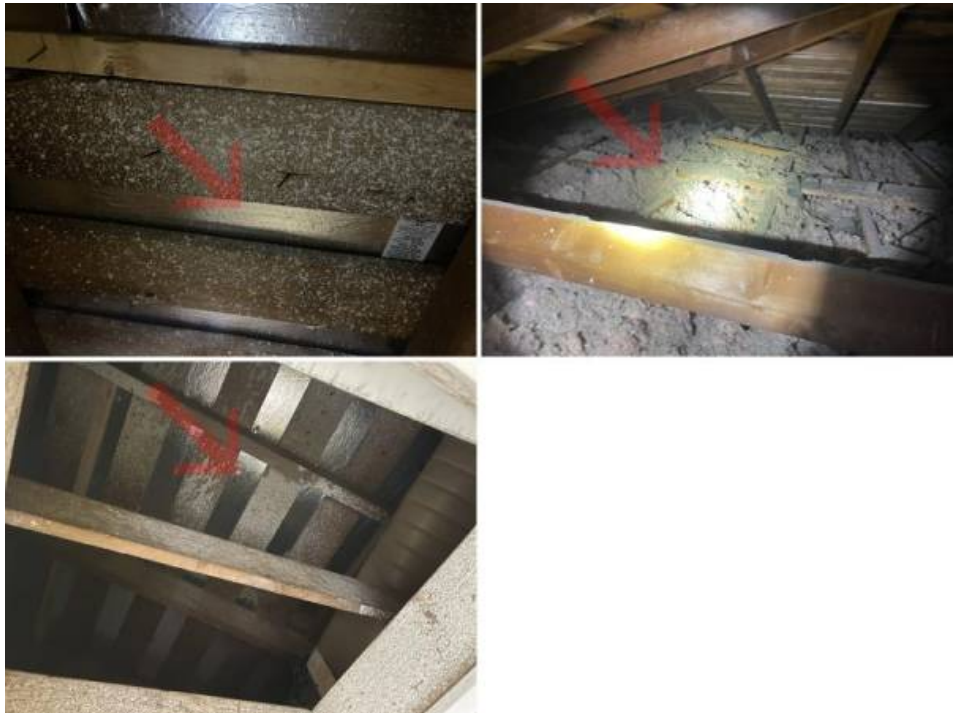
4x8 sheet insulation under sheathing.
Type: Loose fill. Approximate thickness: 6-8 inches.

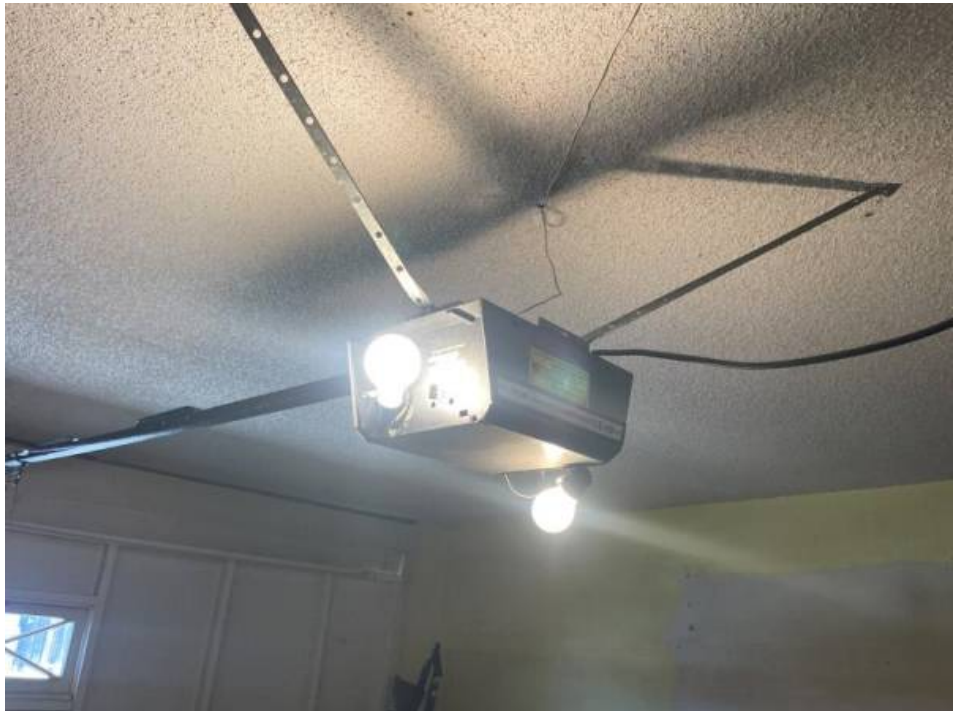
SAFETY: We recommend upgrading this opener. Modern openers have improved safety features including electronic safety beams and automatic reversing to prevent injury to children, pets and property.

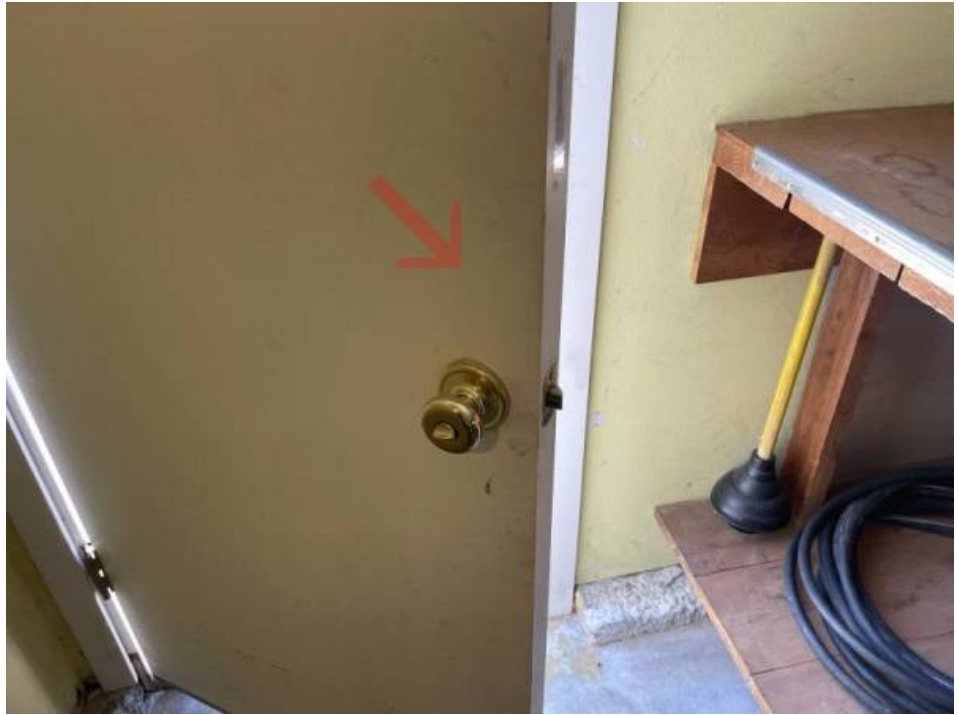
DEFECTIVE: Door did not self close and latch as required for fire protection. We recommend adjustment/repair prior to occupancy.

SAFETY: No deadbolt installed. We recommend installing a modern deadbolt that meets current security standards.

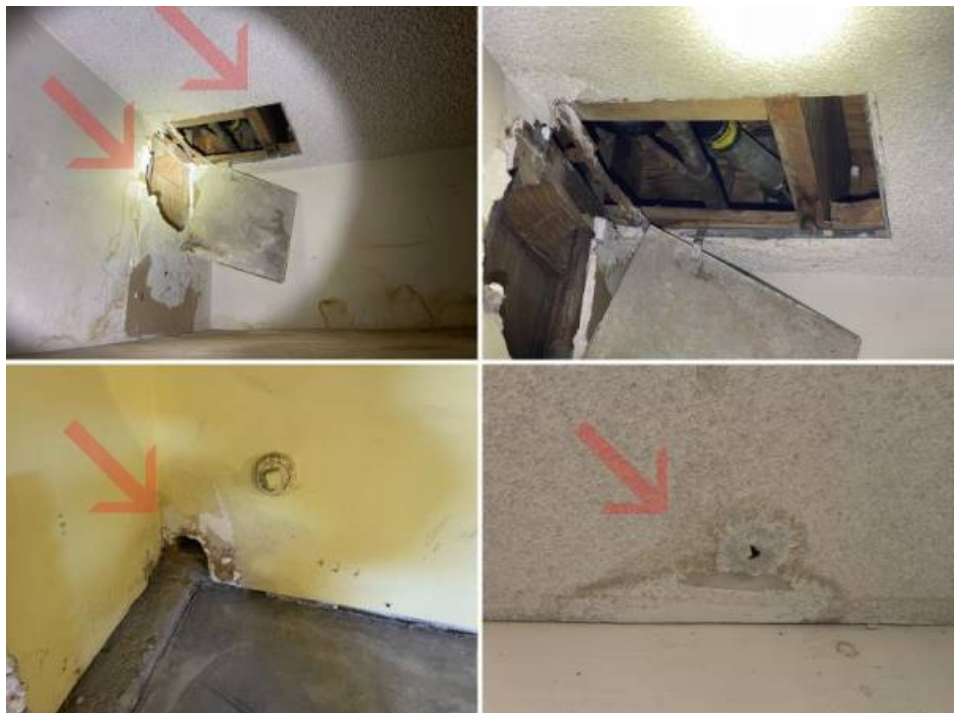
DEFECTIVE: Holes or other damage noted. Fire separation is designed to slow the spread of fire originating in the garage. We recommend repairs as needed by a licensed drywall or plastering contractor prior to occupancy for safety concerns.

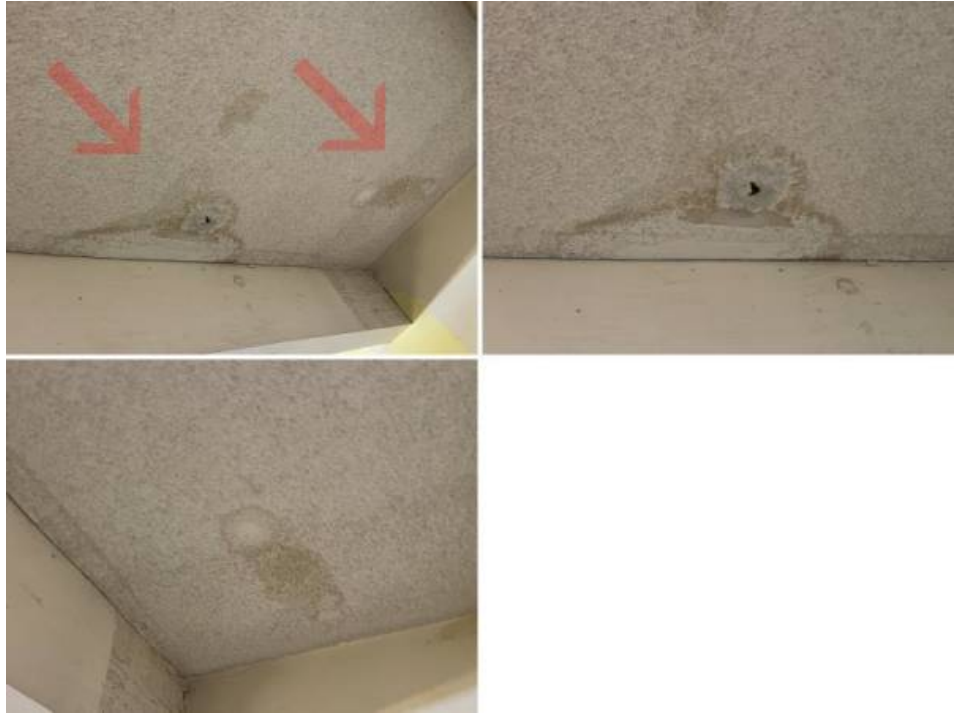
Stains and hole in ceiling. Dry, doesn't appear any repairs were made.
DEFERRED: Moisture stains noted at the ceiling/walls appear to be from a plumbing leak and were dry at the time of our inspection. We could not determine if the stains are from an intermittent or repaired leak. Recommend further inspection and repairs as needed.

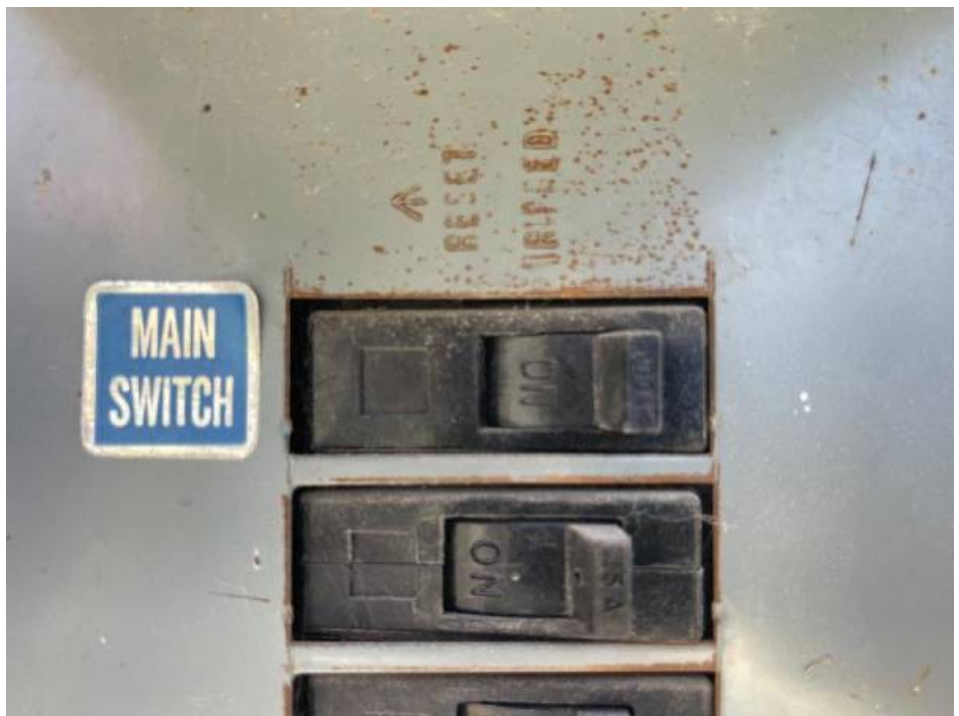
<i>Location</i>	S east corner.
<i>Type of service</i>	Underground service. 120/240 Volt.
<i>Service conductors</i>	SERVICEABLE. Copper.
<i>Service disconnect</i>	100 Amp. main breaker.

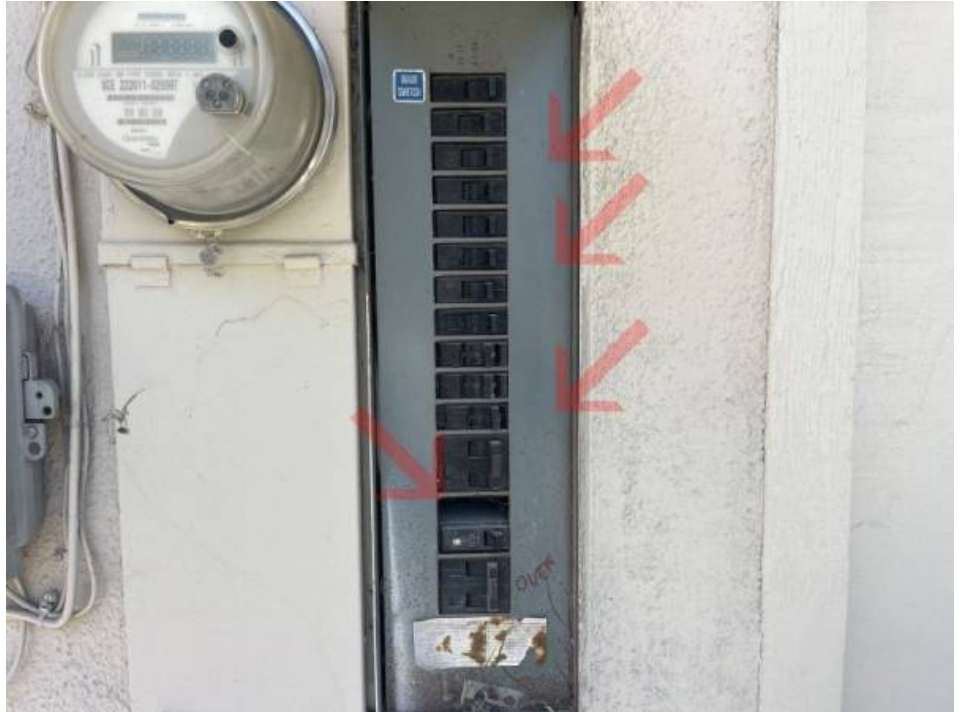
<i>Panel observations, exterior</i>	<p>SAFETY: Circuit breakers are not adequately labeled for area/items served. We recommend permanently labeling each breaker for emergency needs.</p> <p>DEFECTIVE: Unused openings in the panel are missing covers and exposing energized parts to accidental contact.</p> <p>DEFERRED: Electrical panel is outdated by today's standards and will likely need to be upgraded if the house is remodeled.</p>
-------------------------------------	---

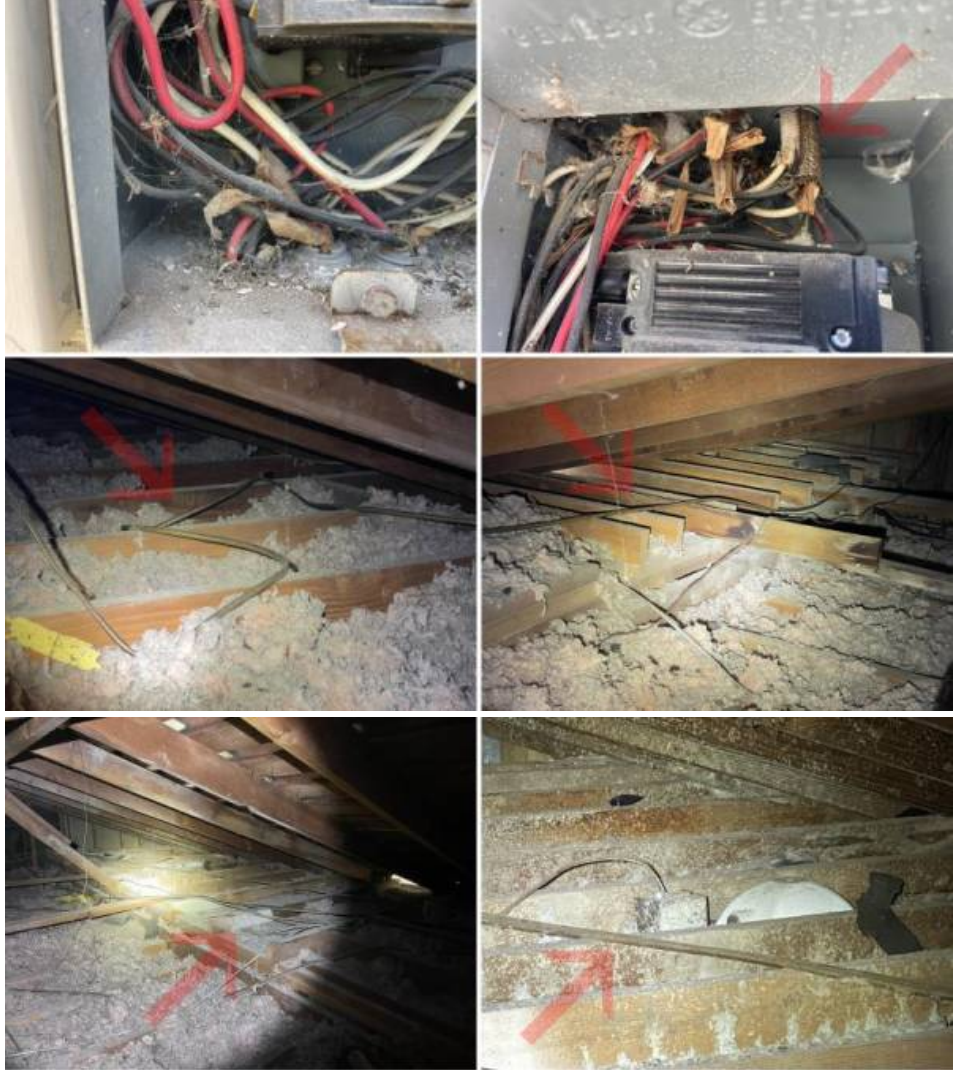
DEFERRED: Cloth covered wiring. This type of covering (no longer used) can become brittle and deteriorate with age. Most of the wiring is concealed and we routinely recommend further evaluation by a licensed electrician.

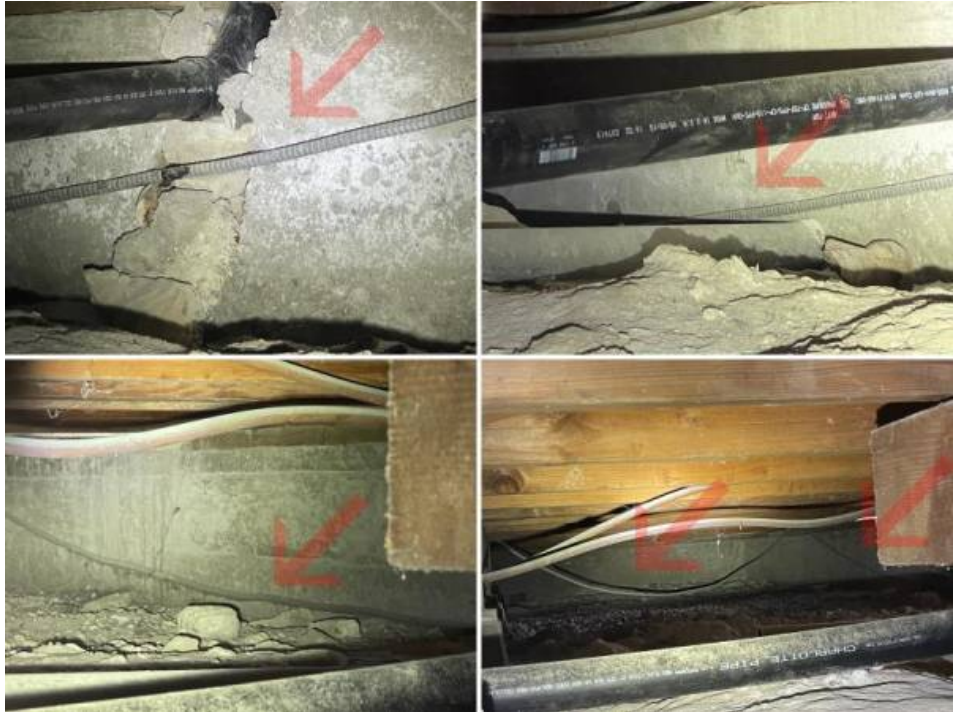
DEFECTIVE: Unsecured wiring. Flexible conduit should be fastened within 12" of each end and every 4-1/2 feet. Non-flexible conduit should be fastened within 36" of each end and every 10-feet.
