Inspection reference: 5716 Sunmist Dr., RPV, CA 90275

Confidential Inspection Report
5716 Sunmist Dr.
Rancho Palos Verdes CA 90275

July 5, 2026

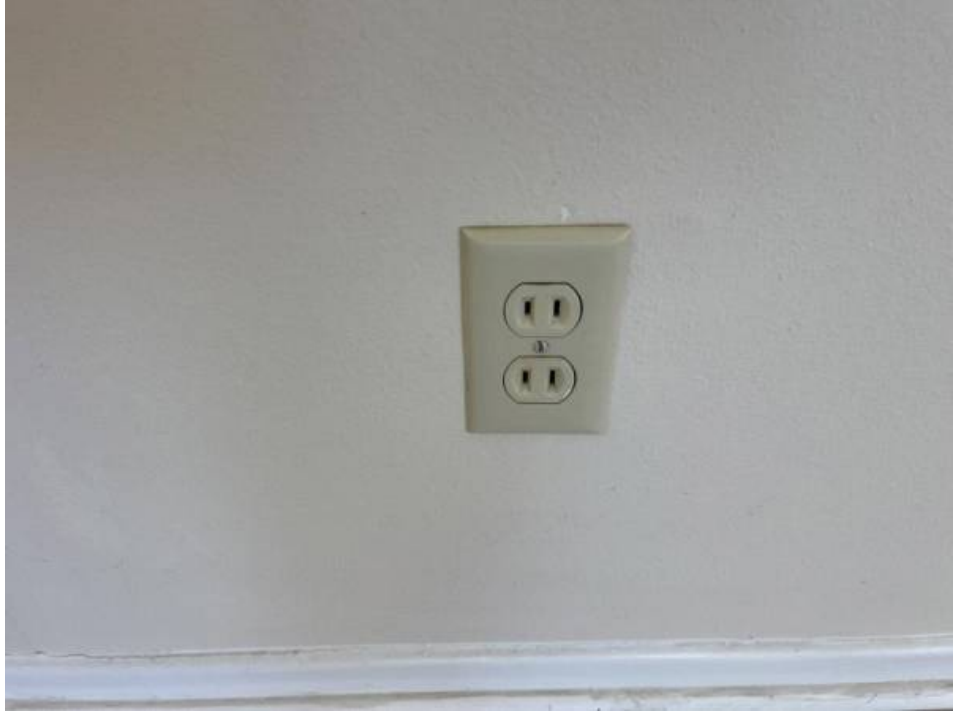
DEFECTIVE: 3-prong grounded type receptacle sampled at all locations was not properly grounded.

DEFECTIVE: Receptacle sampled at one or more locations was not operational.

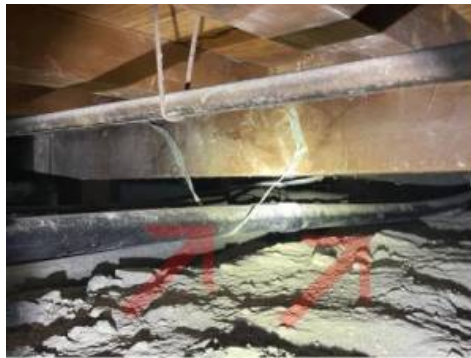
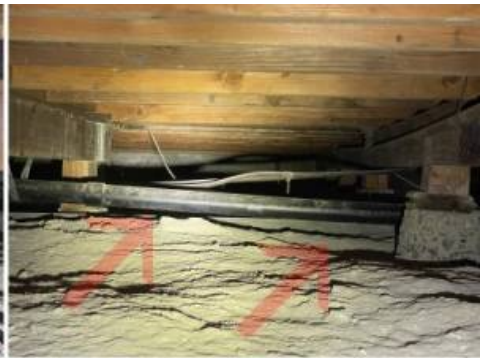
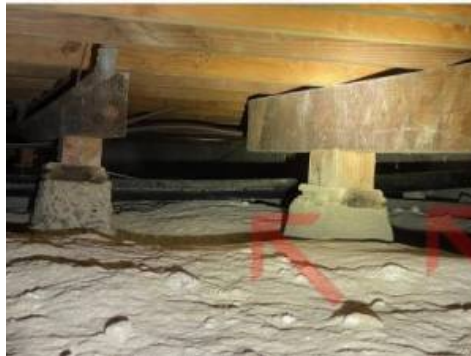
Kitchen line is sagging.
MAINTENANCE: Pipes are not adequately supported or strapped. Recommend repairs before a leak occurs.

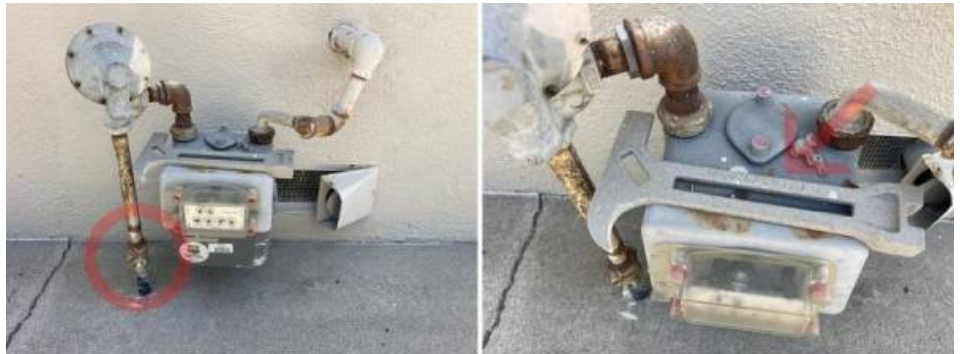
SAFETY: No seismic shutoff valve. We recommend installing a seismic shutoff valve on the gas meter for protection against fire loss in the event of a damaging earthquake. Wrench present.

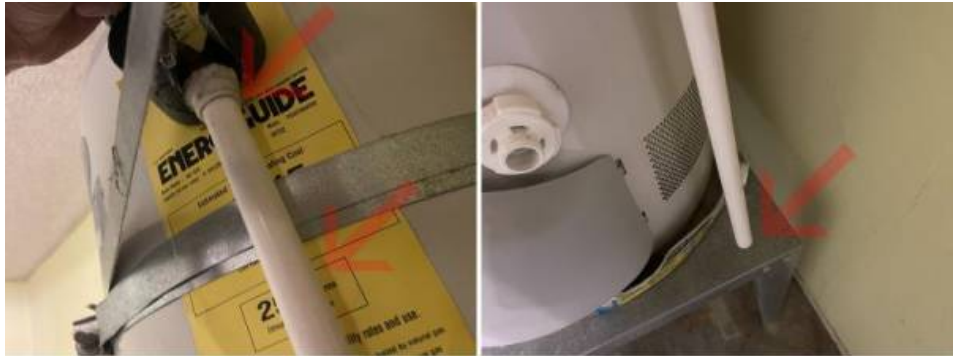
DEFECTIVE: Improper or no discharge line. The discharge piping should be of hard drawn copper or steel or other type approved for hot water distribution. It should be no smaller than the outlet of the valve and must pitch downward to allow complete drainage of the safety relief valve and discharge line. The end of the discharge line should not be threaded and should terminate below the controls at the exterior of the building and within 6" of the ground or other approved location. Valves, reducer couplings, or flexible connectors should not be installed on the discharge line.

DEFECTIVE: Improper termination of discharge line. The end of the discharge line should terminate at the exterior of the building or other approved location.

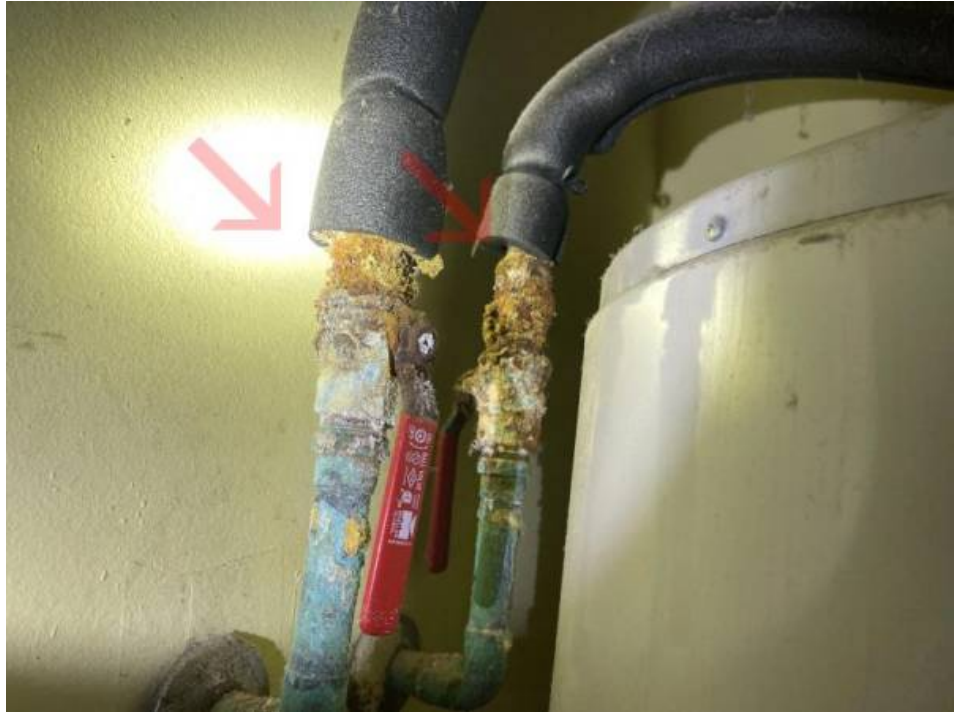
MAINTENANCE: Shutoff valve or connectors are corroded. We recommend replacing corroded components when observed as preventative maintenance.

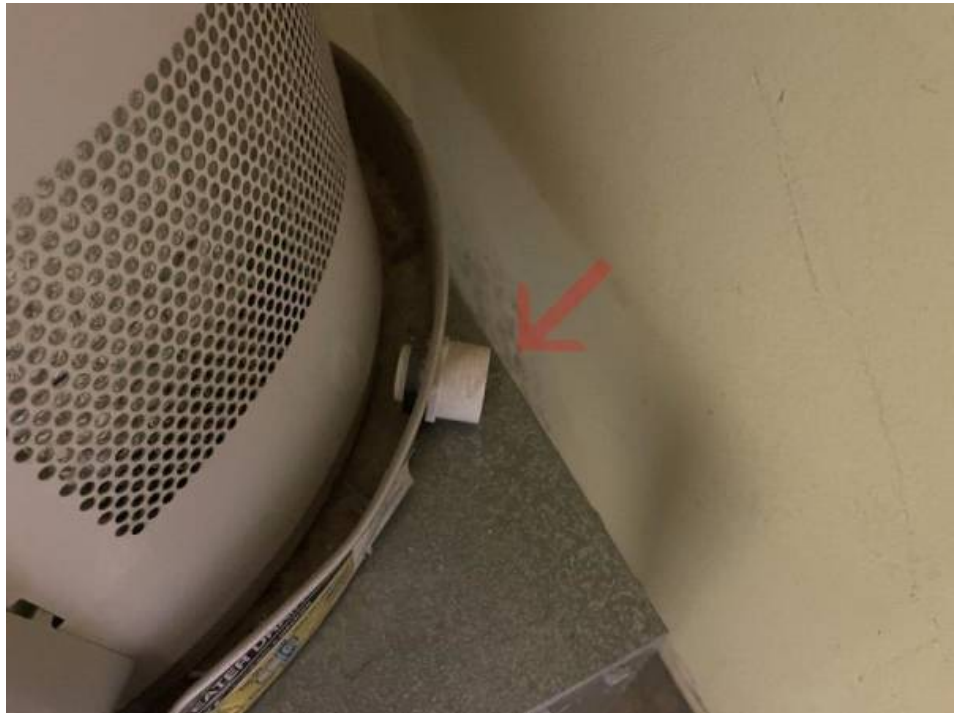
DEFECTIVE: We recommend connecting the drain of the catch pan to a drain line that terminates at the exterior of the building to prevent damage to the structure or personal belongings if the water heater leaks.

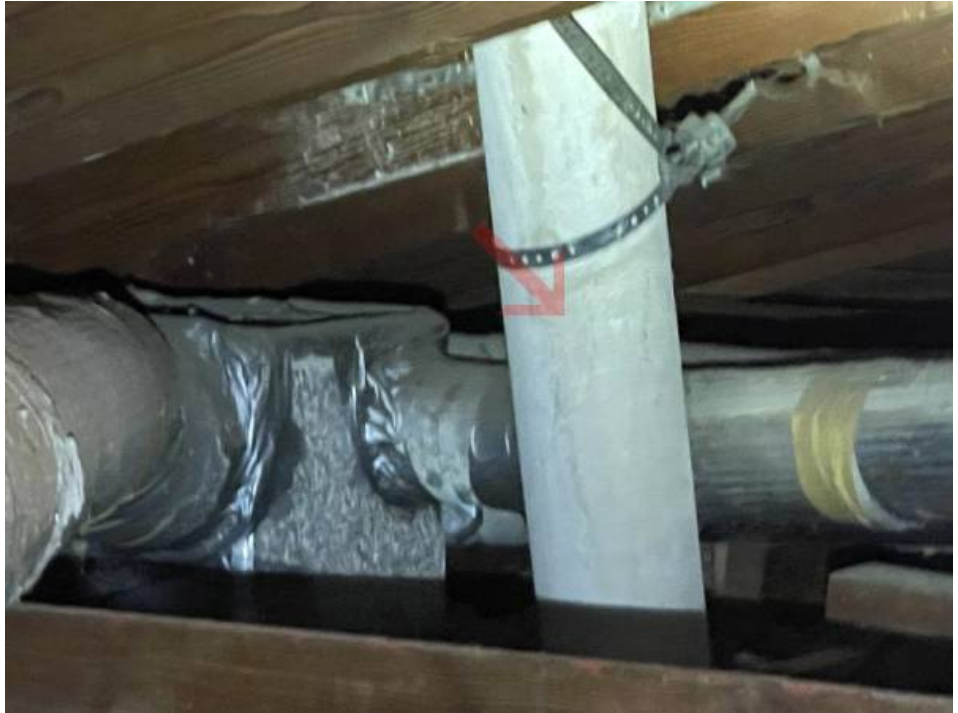
SAFETY: Transite vent pipe(s) observed. Transite is known to contain asbestos and will need special handling if removed or repaired.

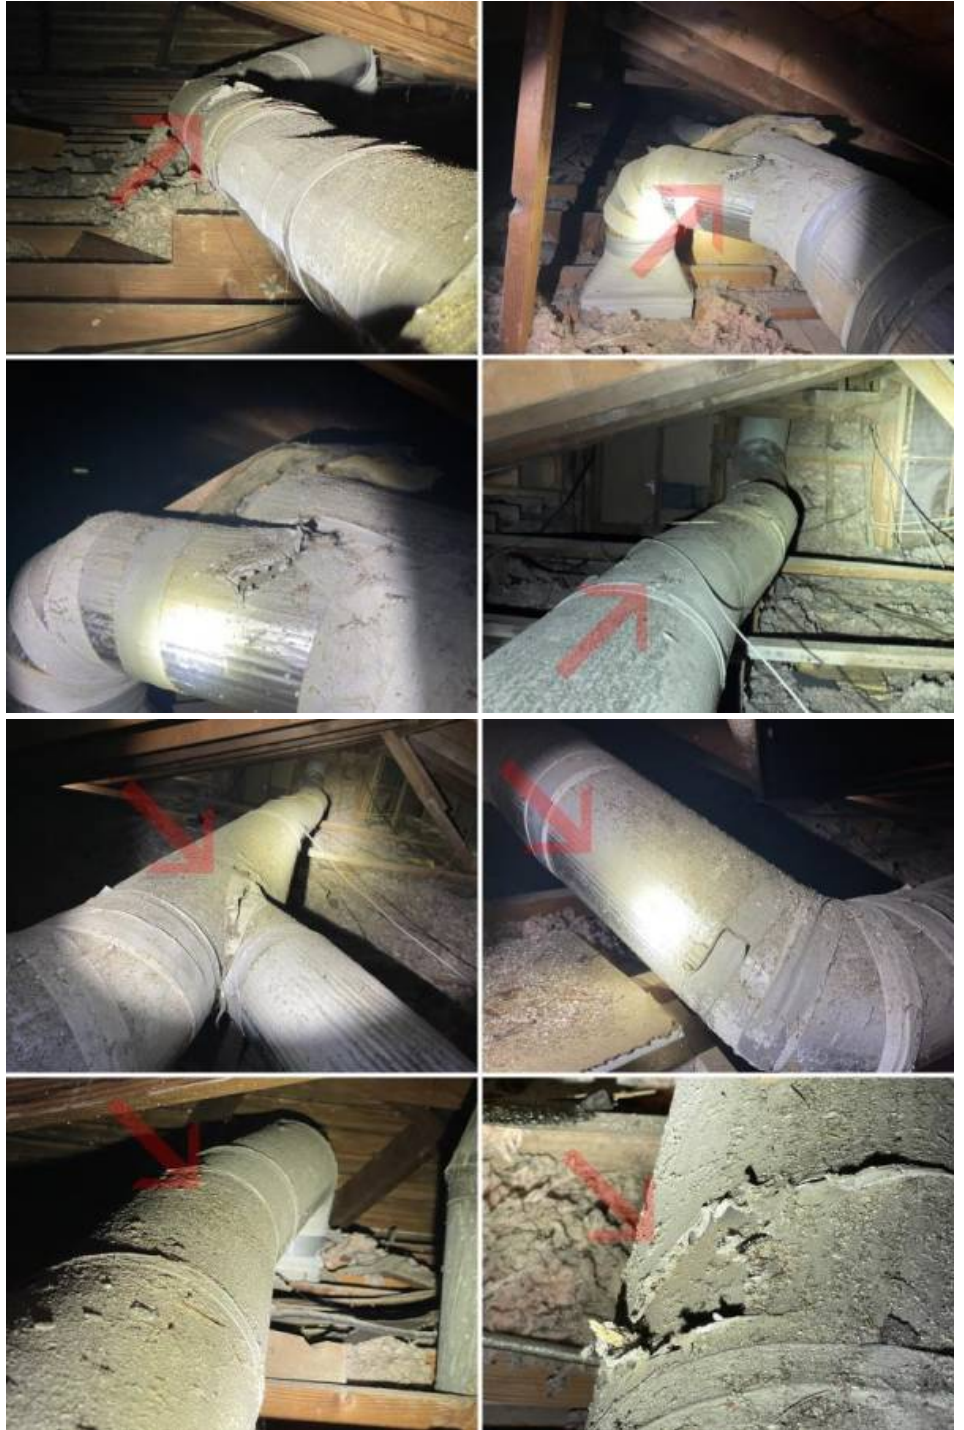
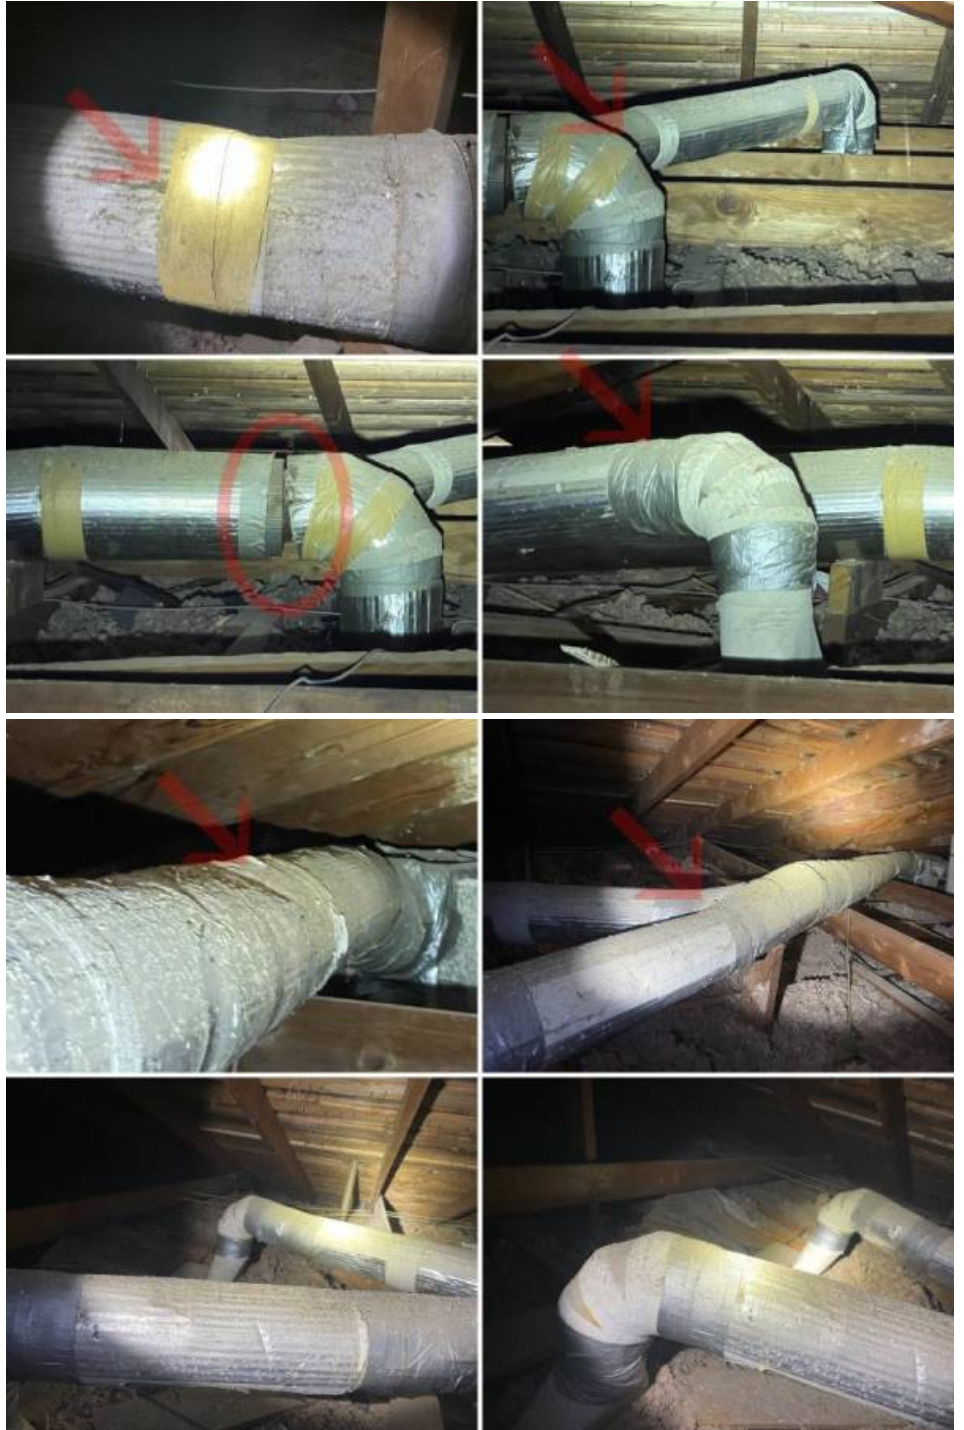
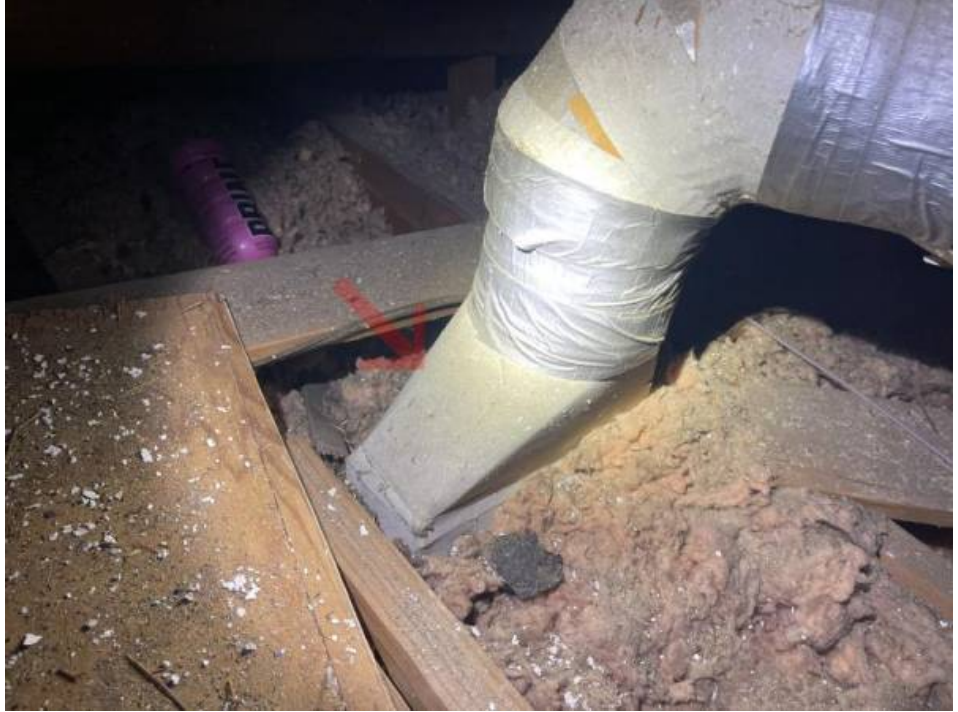
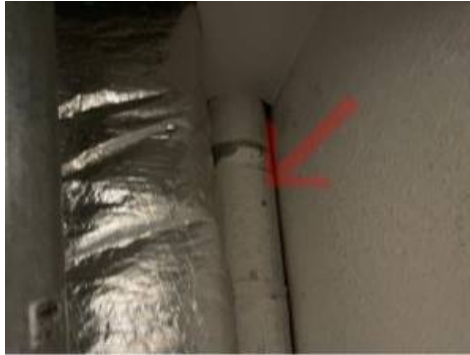
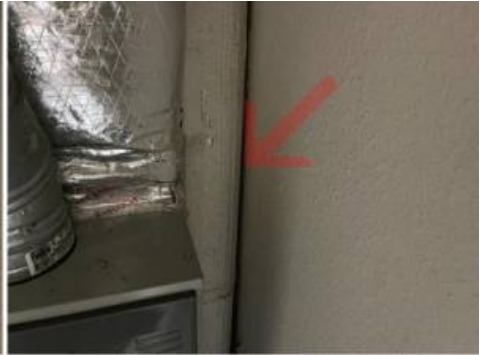
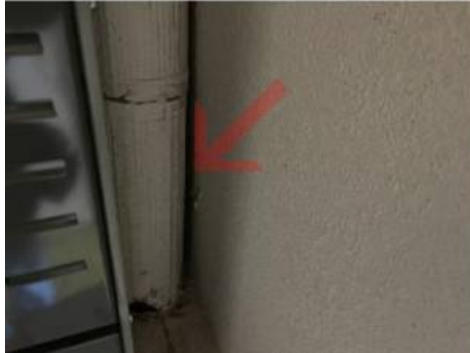
SAFETY: Suspect asbestos material damaged, loose or in friable condition. We recommend further evaluation by a licensed asbestos assessor.
MAINTENANCE: Disconnected section(s) or leaky joints noted in the attic. We recommend sealing all joints at this time for energy conservation.

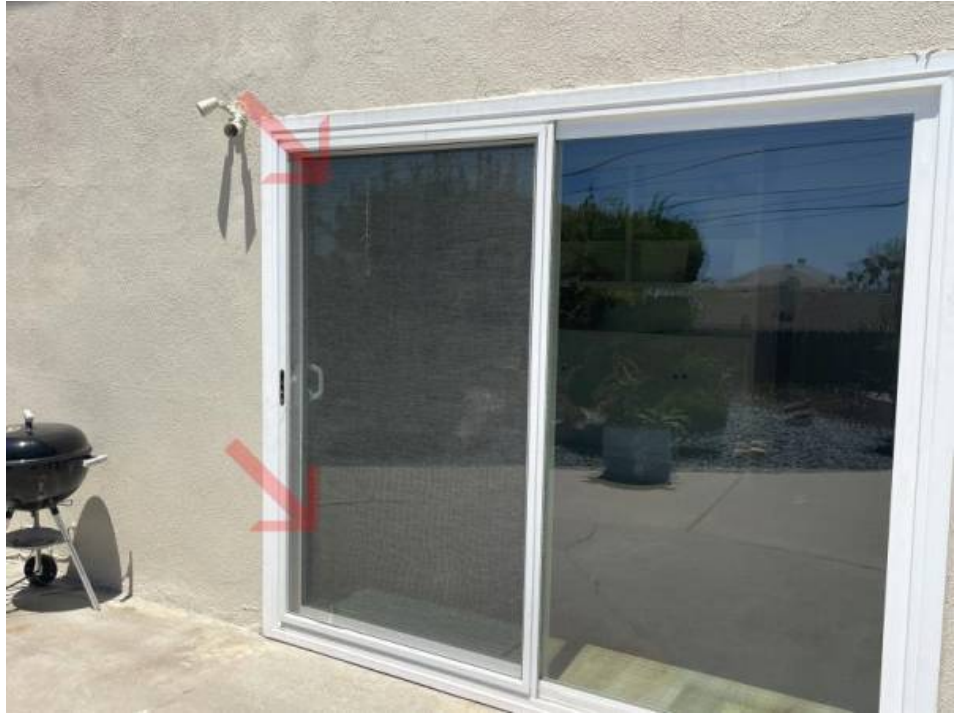
MAINTENANCE: Screen door is damaged or missing at one or more doors sampled.

Entry hall slider missing handle and not tested.

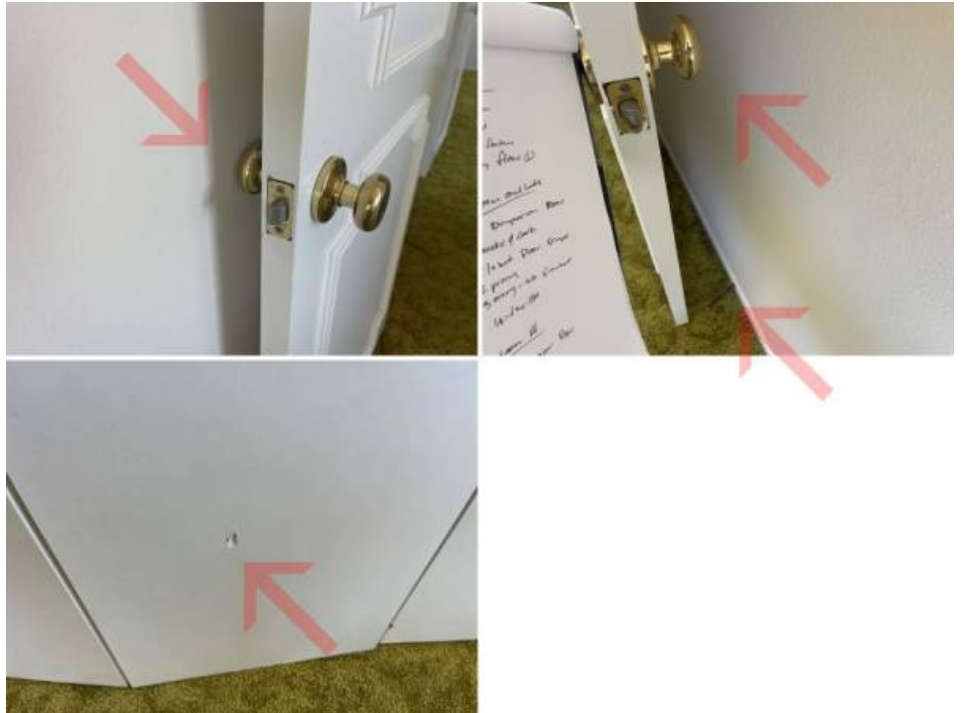
Bedroom end left and right bedroom.
MAINTENANCE: Some doors are missing bumpers and knobs hit the wall.
Bedroom end left.
DEFERRED: Ding in the door.

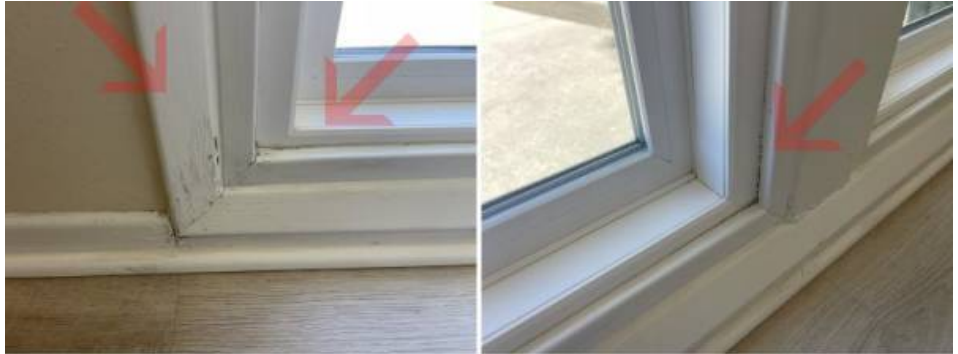
Living room tall windows, far left/west base has moisture stains.
DEFERRED: Water stains/damage present might indicate moisture intrusion.
All others
SERVICEABLE. At windows sampled.

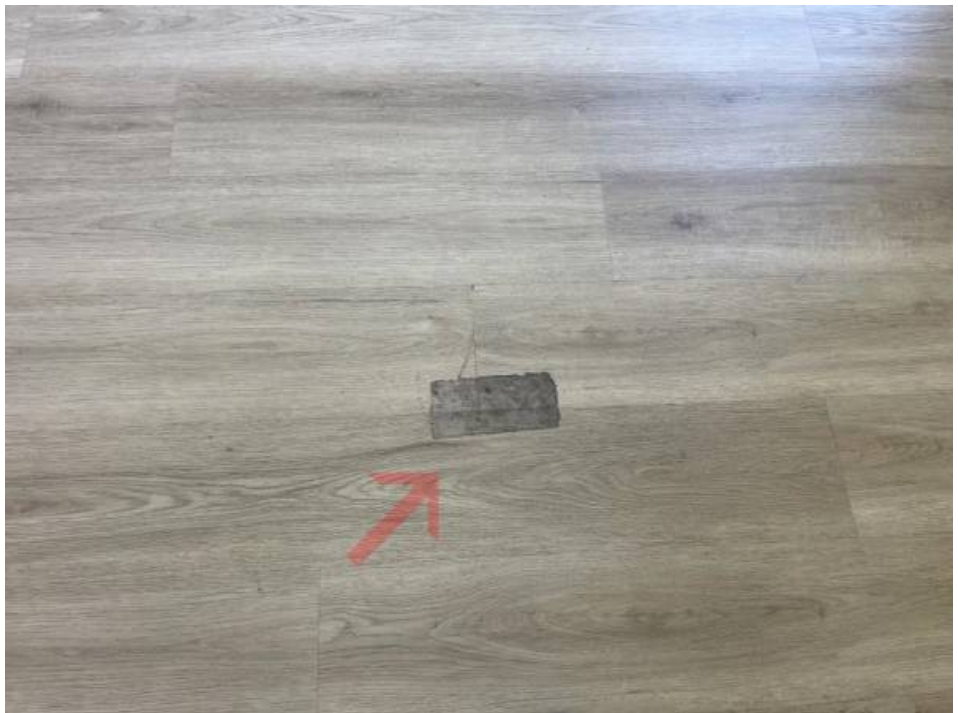
Lower family room.
MAINTENANCE: Taped over a seam or carpet tape? Recommend repairs if needed.

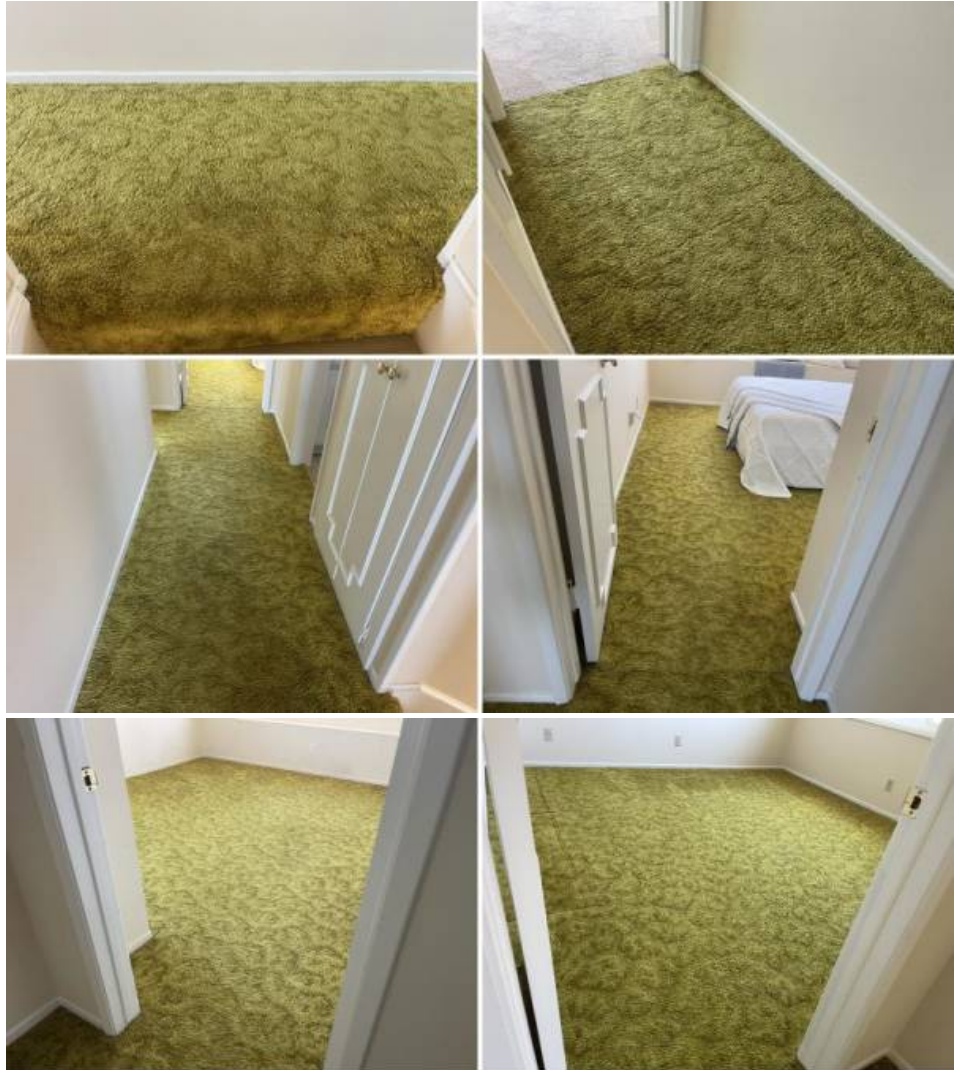
MAINTENANCE: Squeaks noted at various locations. Squeaks can generally be greatly reduced or eliminated by screwing the subfloor to the floor joists and is most practical to do when changing the floor covering.

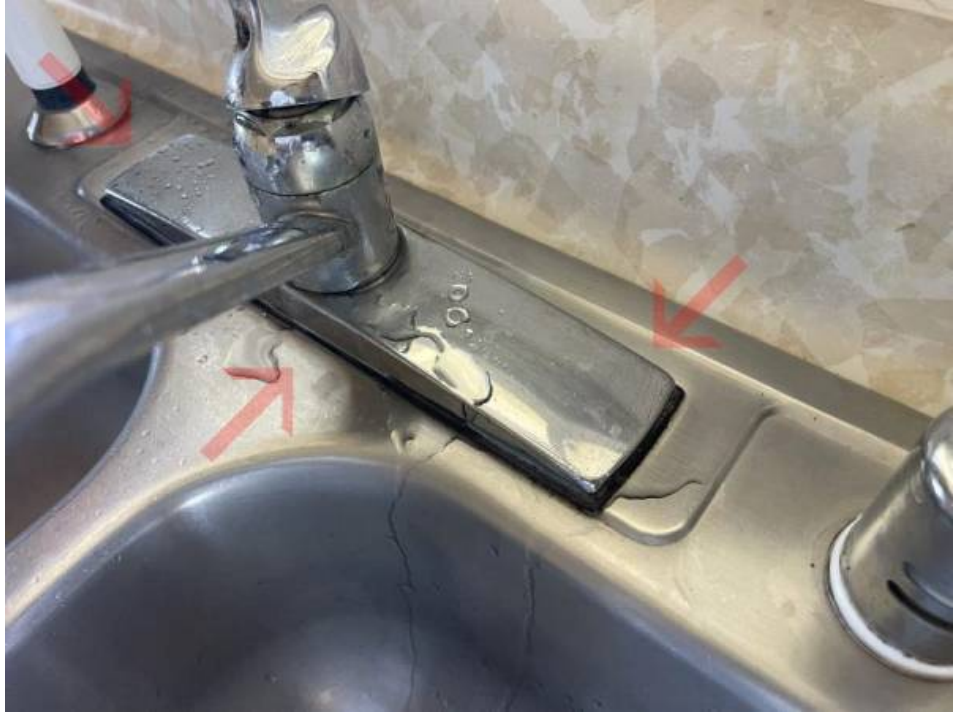
MAINTENANCE: Faucet leaks at the handle or spout base.

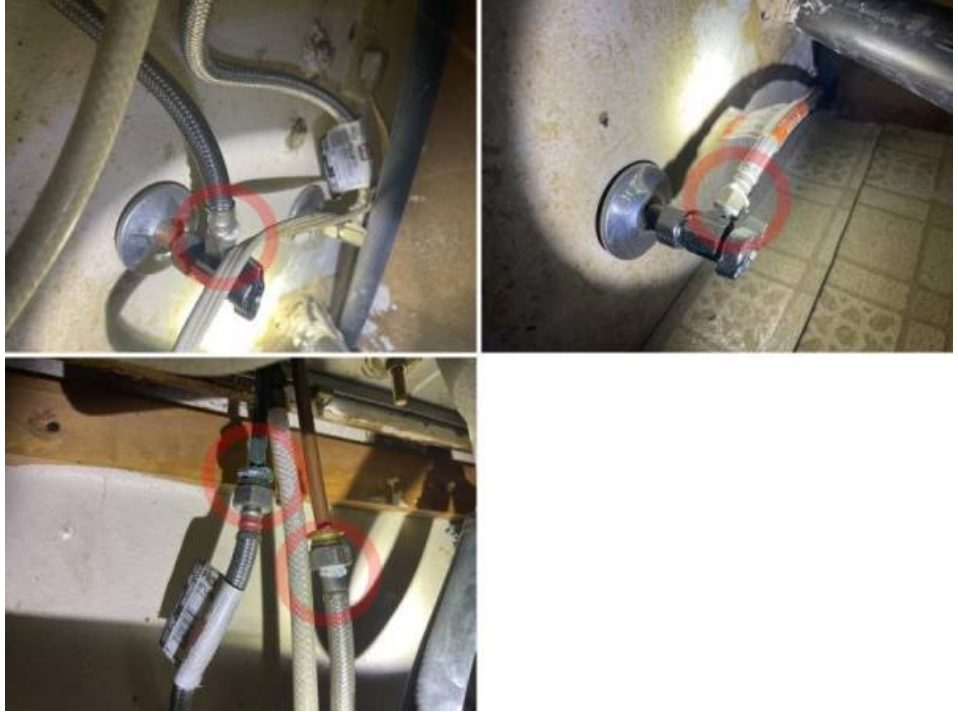
MAINTENANCE: Shutoff valve or connector is corroded. Corroded components will eventually fail; we recommend replacing corroded components when observed.

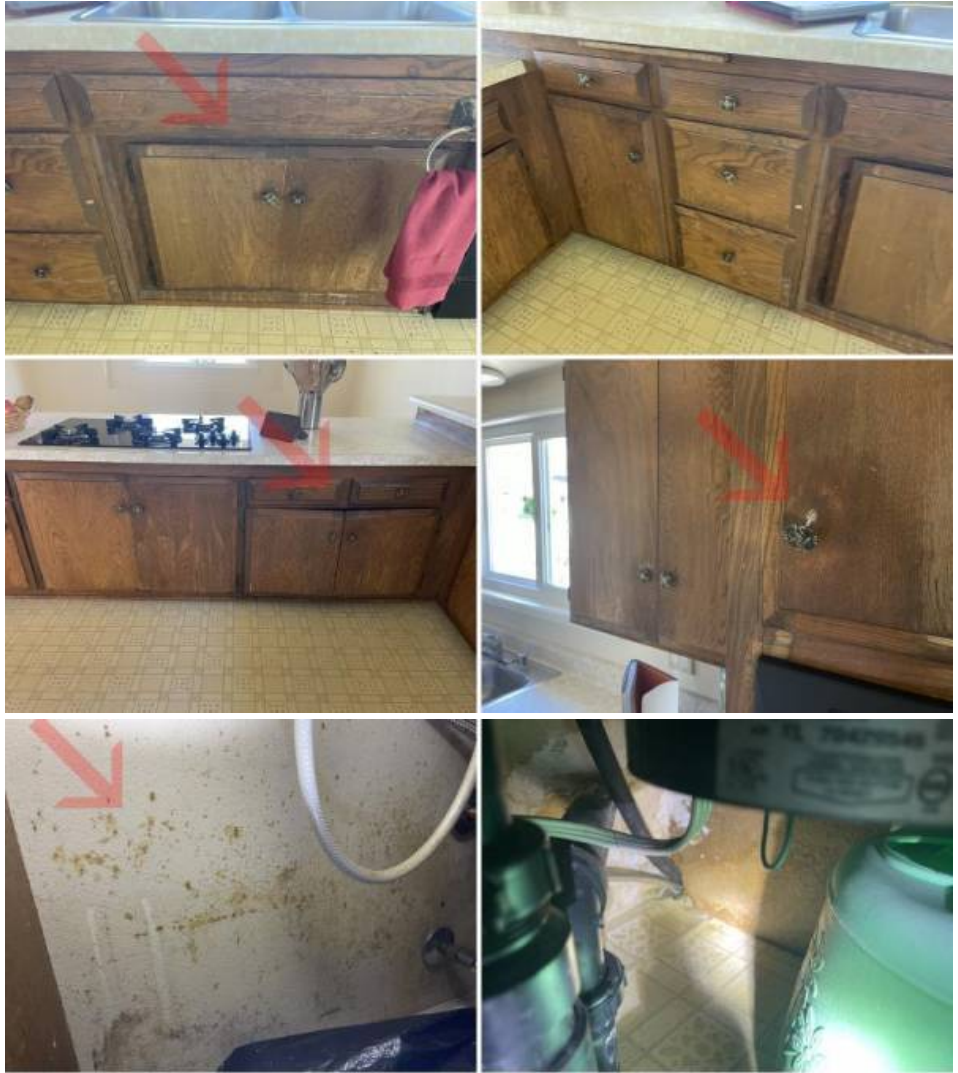
MAINTENANCE: Moderate to heavy wear. Some hinges or doors may be damaged, or do not latch securely, or drawer guides/slides are worn or in disrepair.

DEFERRED: Possible surface mold on inside wall. This is common in closet and cabinets of low air flow a dust. Further inspection may be desired by a licensed mold inspector.

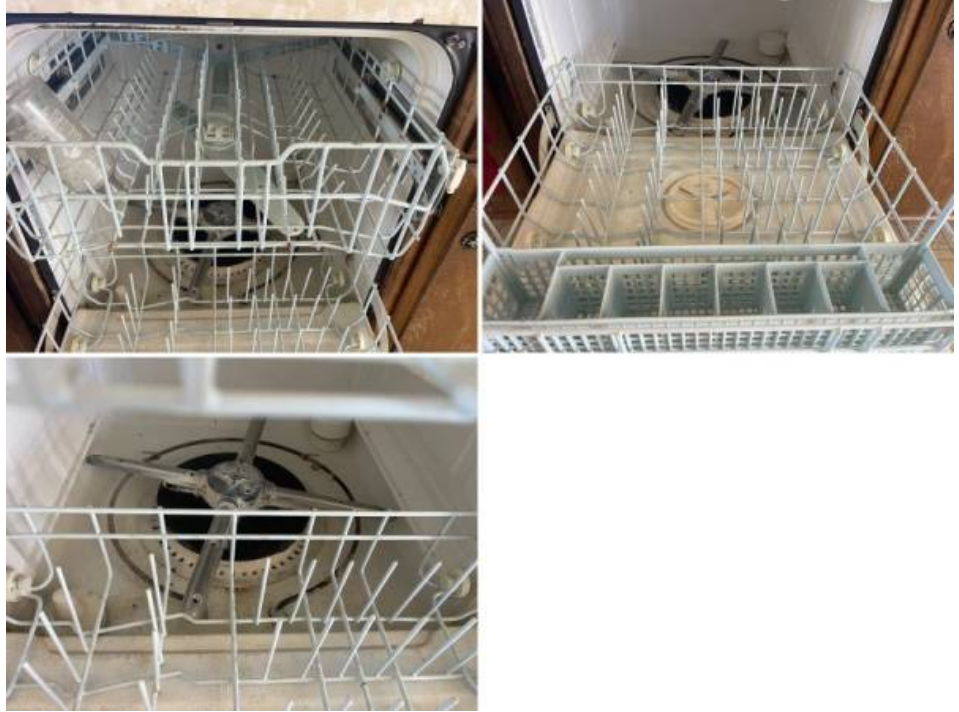
DEFECTIVE: Did not respond to user controls.
MONITOR: Older model appliance may be near the end of its useful life.

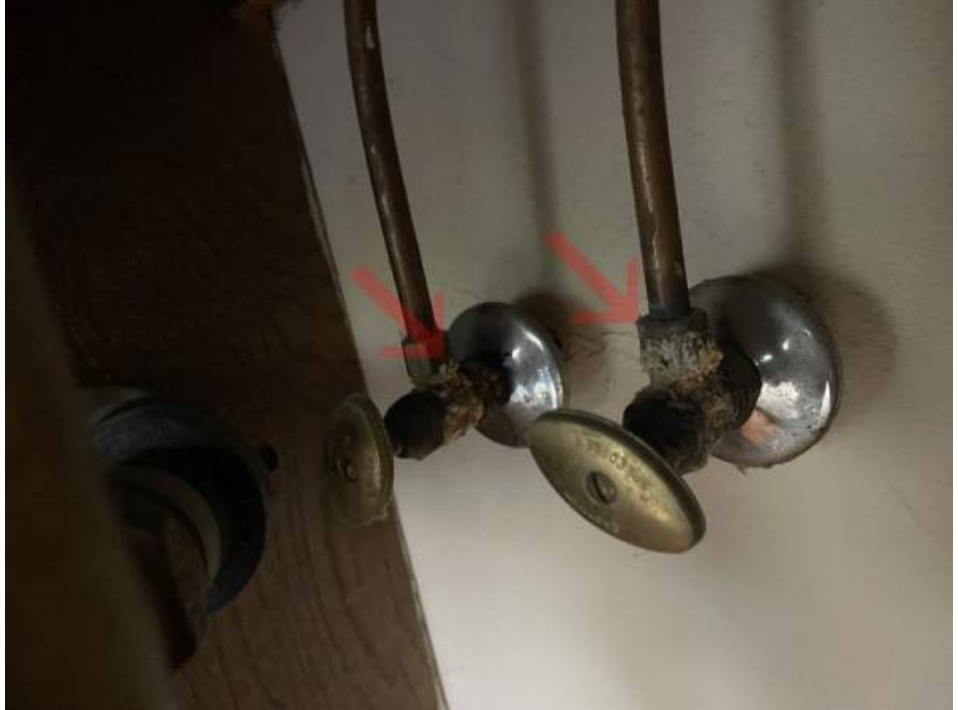
MAINTENANCE: Shutoff valve or connector is corroded. Corroded components will eventually fail; we recommend replacing corroded components when observed.

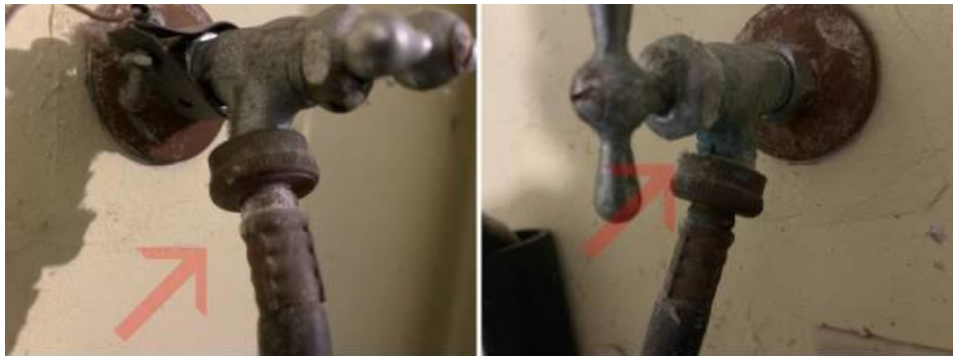
DEFERRED: Laundry machines and appliances are not inspected or operated.
MAINTENANCE: Hot and cold valves or lines have light corrosion. Recommend switching out corroded parts before a leak occurs.

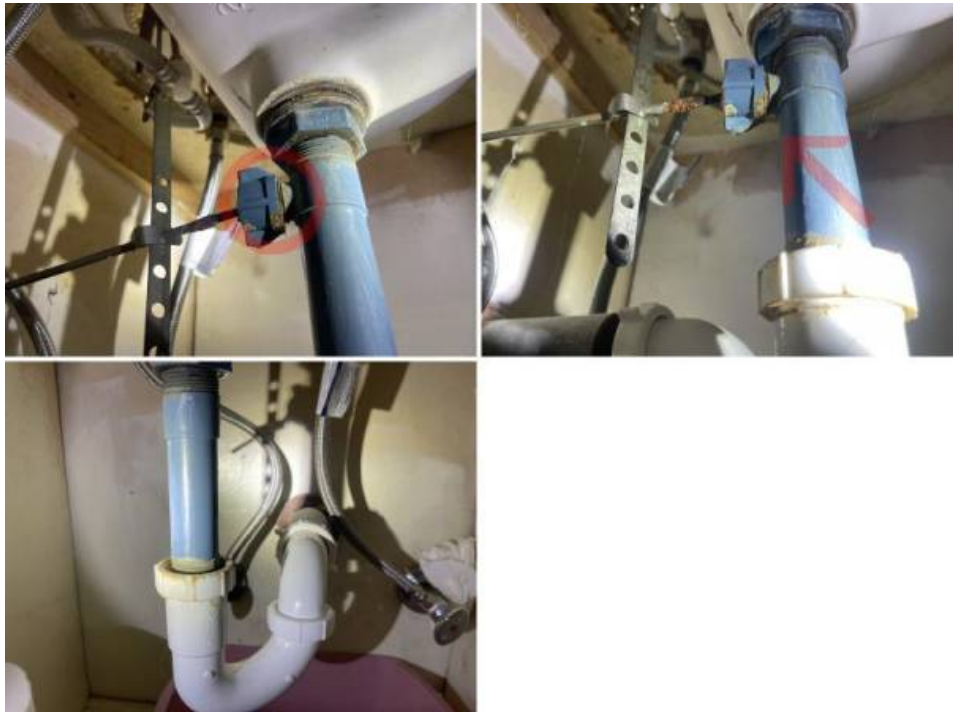
<i>Description</i>	1/2 Bath.
<i>Location</i>	Family room.
<i>Ventilation</i>	SERVICEABLE. Window.
<i>Ground Fault Circuit Interrupters (GFCI)</i>	1/2 bath. SAFETY: One or more receptacles are not GFCI protected. We recommend installing and maintaining GFCI protection at all bathroom receptacles.
<i>Sink</i>	SERVICEABLE.
<i>Faucet</i>	1/2 bath. Hot handle. MAINTENANCE: Faucet valve is difficult to turn. This can often be repaired by changing worn components such as washers, seats and/or stems. In some instances it may be necessary to replace the fixture.
<i>Plumbing below sink</i>	1/2 bath. Leaking at stopper. MAINTENANCE: Active leak viewed in the drain or water supply line. We recommend further evaluation and repairs as needed by a licensed plumber at this time.

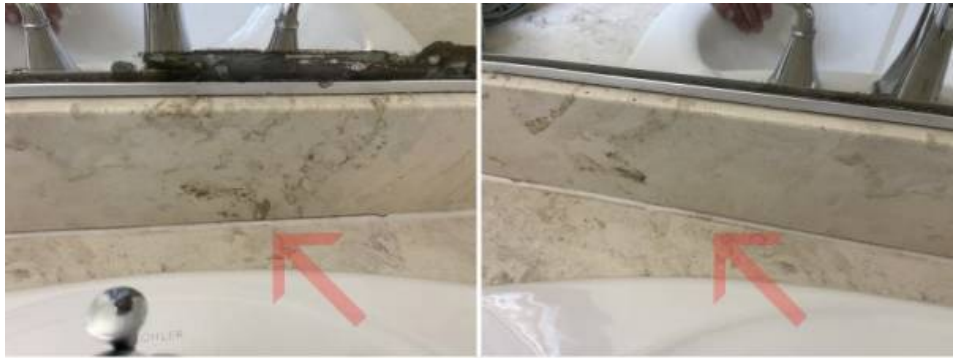
<i>Counter tops</i>	1/2 bath. Marble. MAINTENANCE: Caulking is deteriorated. We recommend re-caulking backsplash as
---------------------	---

needed at this time to prevent water intrusion and subsequent damage.

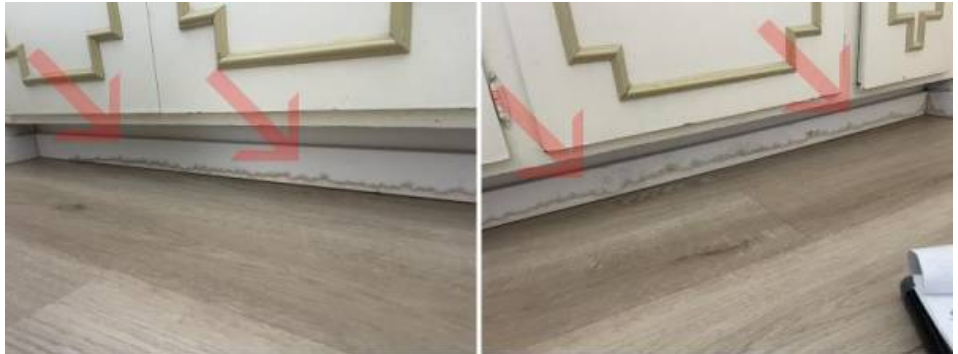
Moisture stain at base of cabinet. Recommend asking seller if there was a leak or something happen.

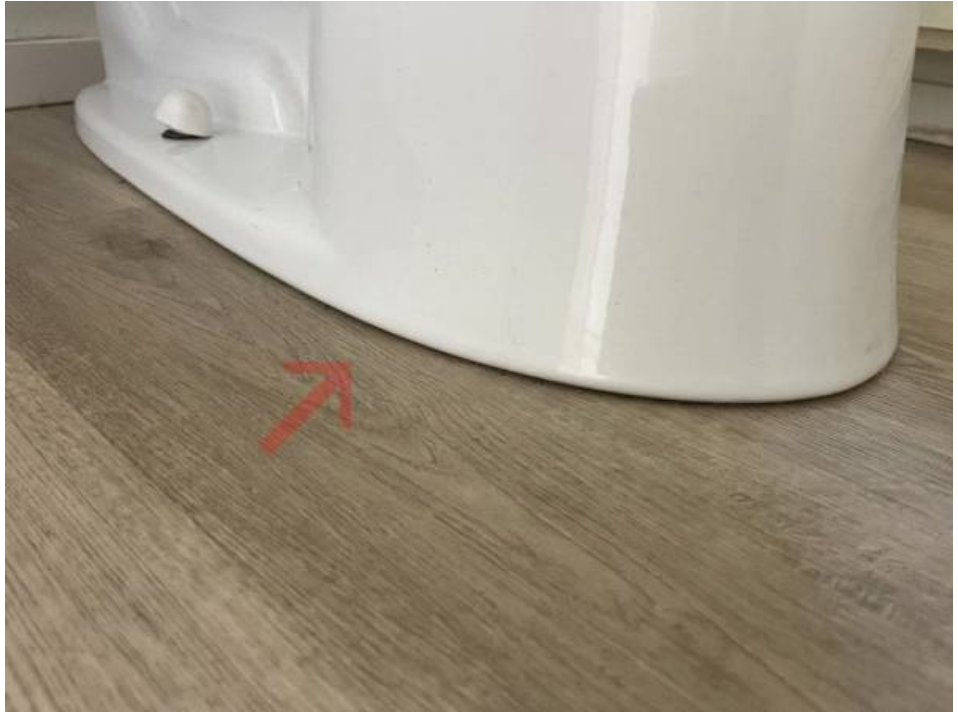
MAINTENANCE: We recommended caulking at the base of the bowl to prevent sewer gases from escaping into the bathroom if the primary wax seal fails.

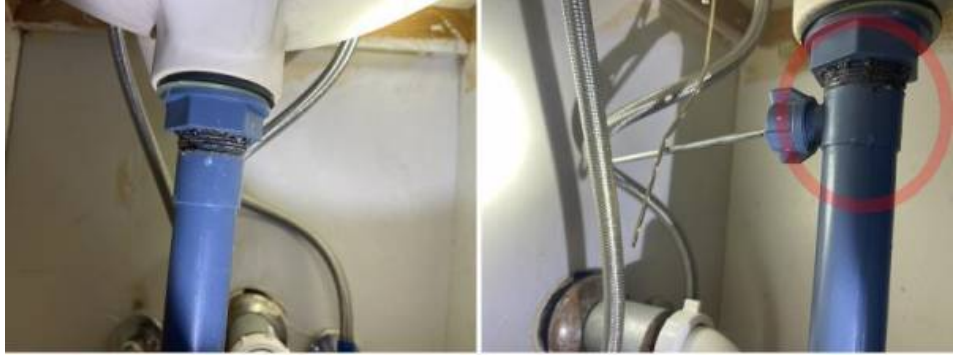
Main bath.
Leaking at connection to sink.
MAINTENANCE: Active leak viewed in the drain or water supply line. We recommend further evaluation and repairs as needed by a licensed plumber at this time.

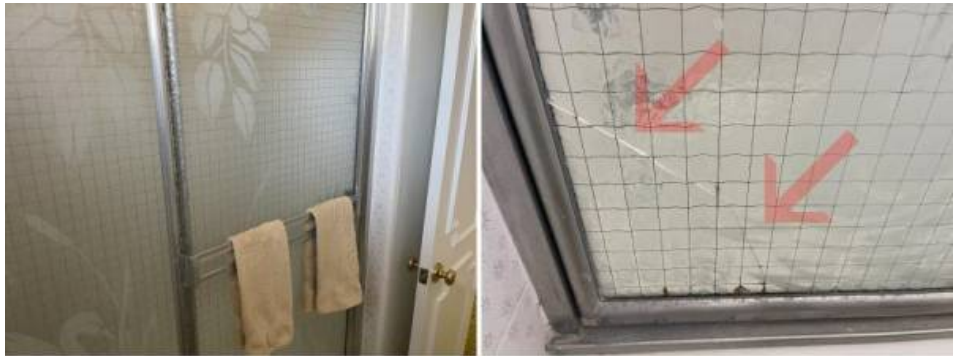
Main bath.
SAFETY: Wire glass is not an approved type of safety glass by today's standards. We recommend replacing with safety glass (may require replacing the entire enclosure). Glass is cracked.

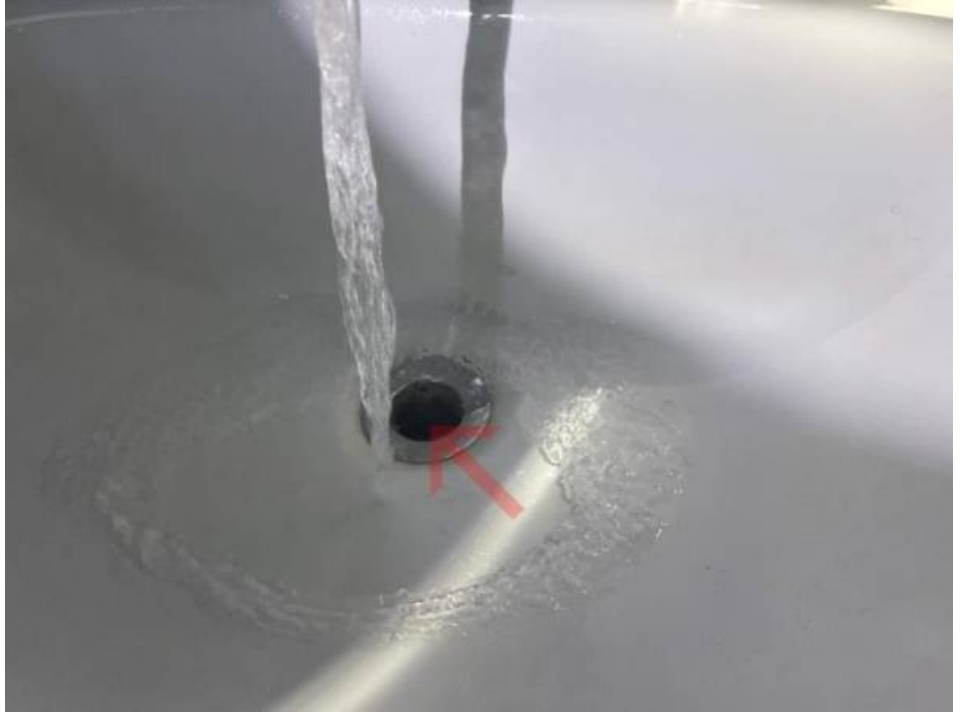
Primary bath.
SERVICEABLE.
MAINTENANCE: Pop-up stopper needs adjustment or repair.

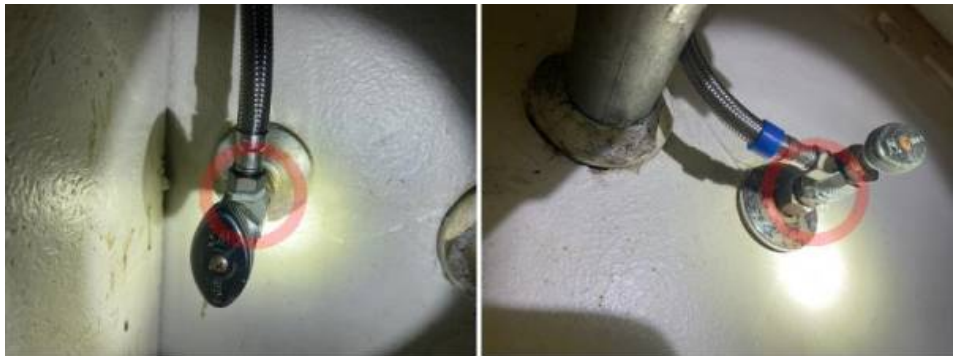
Primary bath.
MAINTENANCE: Shutoff valve or connector is corroded. Corroded components will eventually fail; we recommend replacing corroded components when observed.

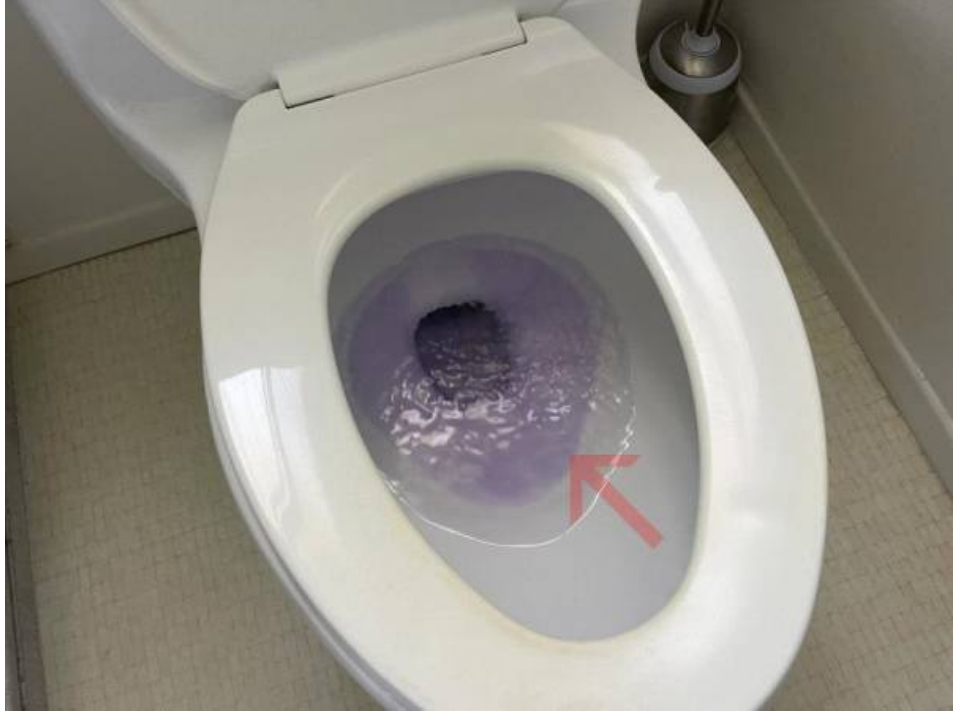
SERVICEABLE.
Purple stain in bowl.
.8.

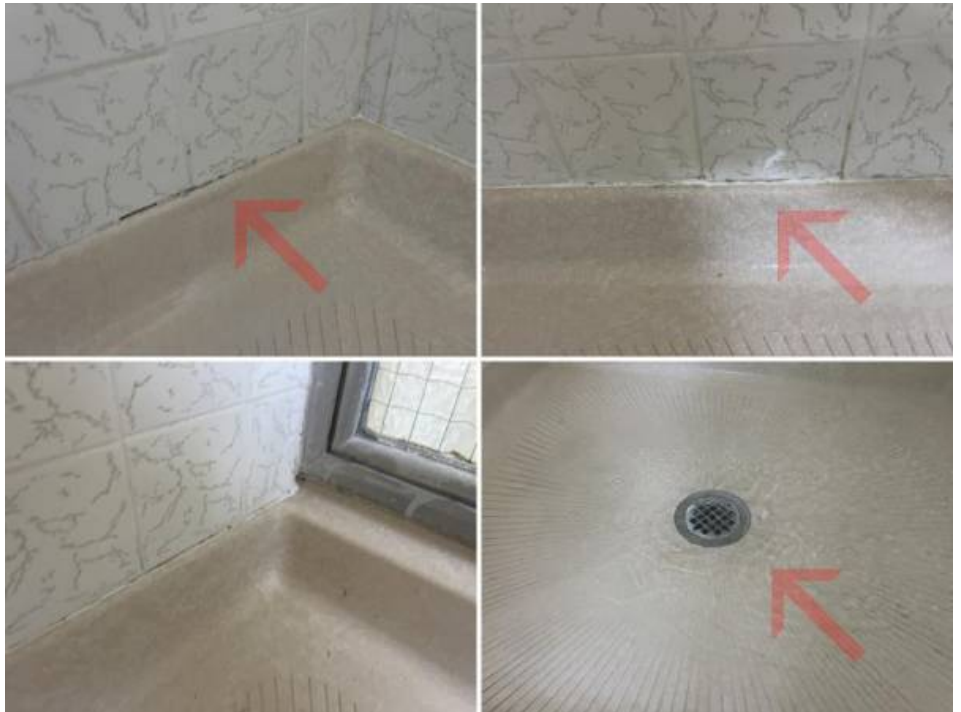
MAINTENANCE: Drains poorly. We recommend further evaluation by a licensed plumber.

MAINTENANCE: Caulking is deteriorated or missing at the shower dam, wall or floor. We recommend caulking as needed at this time to prevent water intrusion and subsequent damage.

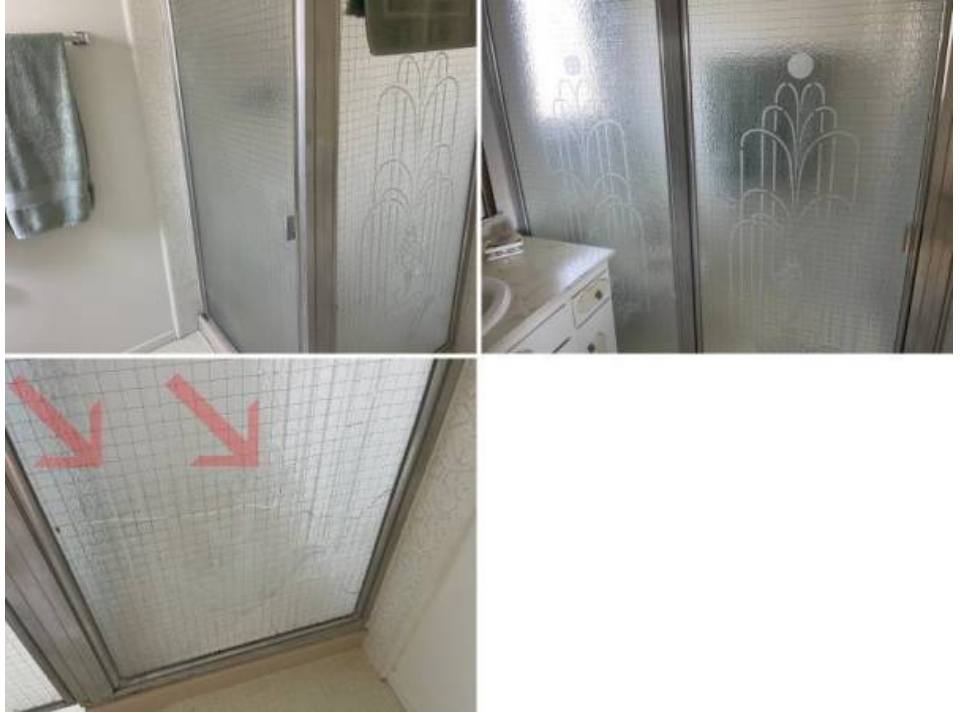
SAFETY: Wire glass is not an approved type of safety glass by today's standards. We recommend replacing with safety glass (may require replacing the entire enclosure). Glass is cracked.
