Inspection reference: 5716 Sunmist Dr., RPV, CA 90275

Confidential Inspection Report
5716 Sunmist Dr.
Rancho Palos Verdes CA 90275

July 5, 2026

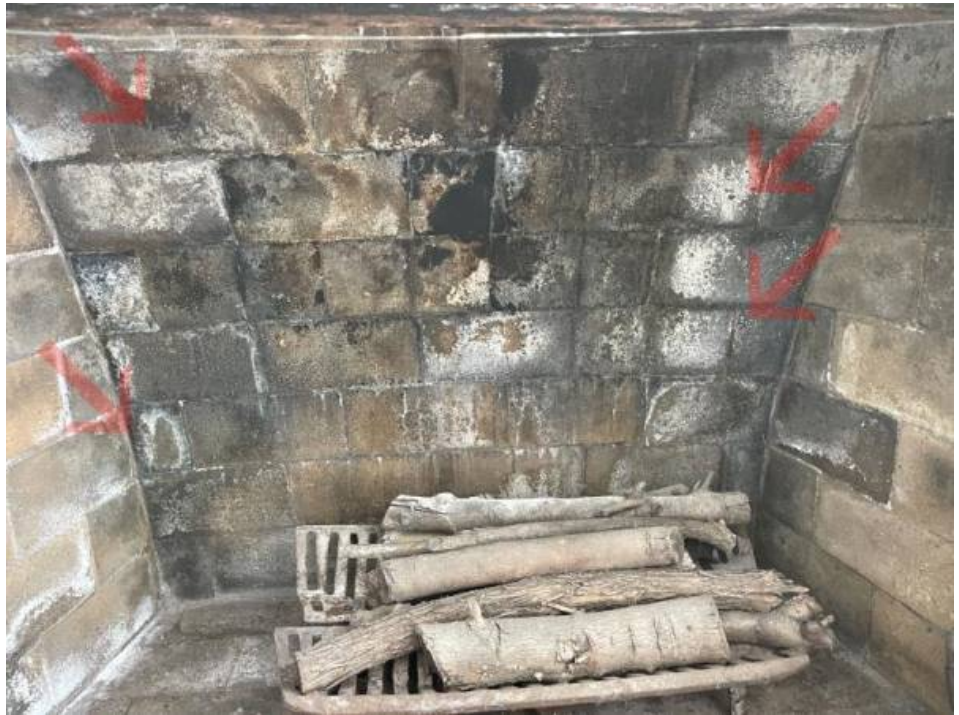
Possibly from exterior moisture issue wicking up.

DEFECTIVE: Efflorescence in firebox. This is an indication of moisture intrusion, which can cause deterioration of the masonry.

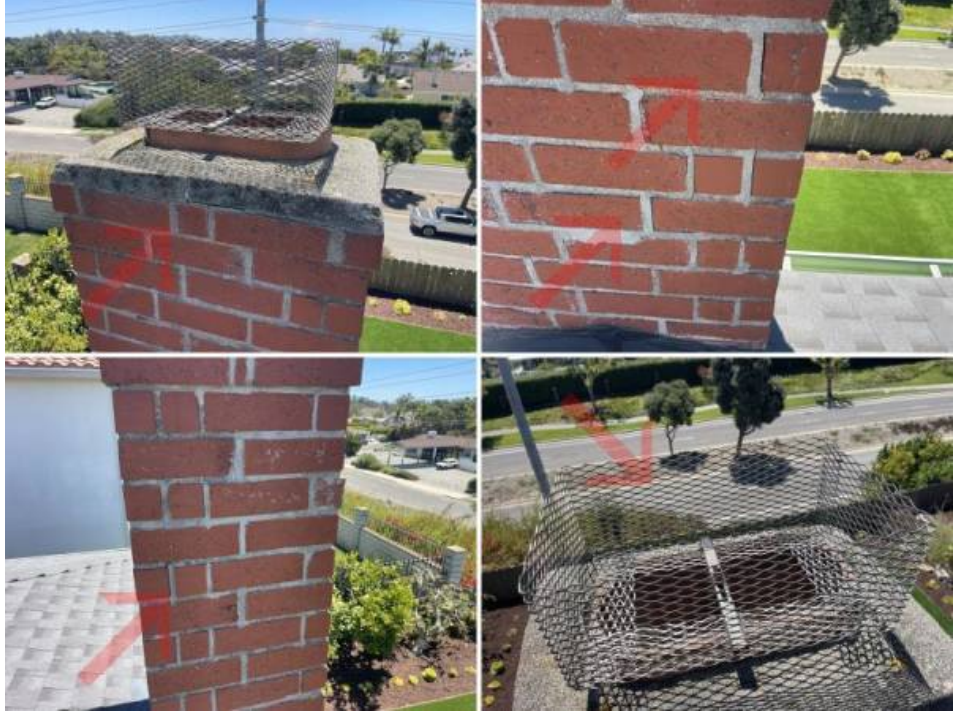
DEFECTIVE: Mortar is moderately loose and deteriorated. We recommend further evaluation by a qualified fireplace professional prior to use.

DEFECTIVE: Small cracks observed. We recommend further evaluation by a qualified fireplace professional prior to use.

MAINTENANCE: Crown is cracked or otherwise deteriorated. The crown protects the masonry from the effects of weather and needs maintenance/repair at this time. We recommend further evaluation and repair as needed by a qualified fireplace professional.

Rain cap missing.

MAINTENANCE: No rain cap. Rain caps are not required on masonry chimneys; however, they protect the chimney and firebox from deterioration and we recommend installing them on all chimneys.
