October 18, 2024

F.N. 1-24-0635

Subject: Structural Inspection of Single-Family Residence
7050 Via Del Mar, Rancho Palos Verdes, CA 90275

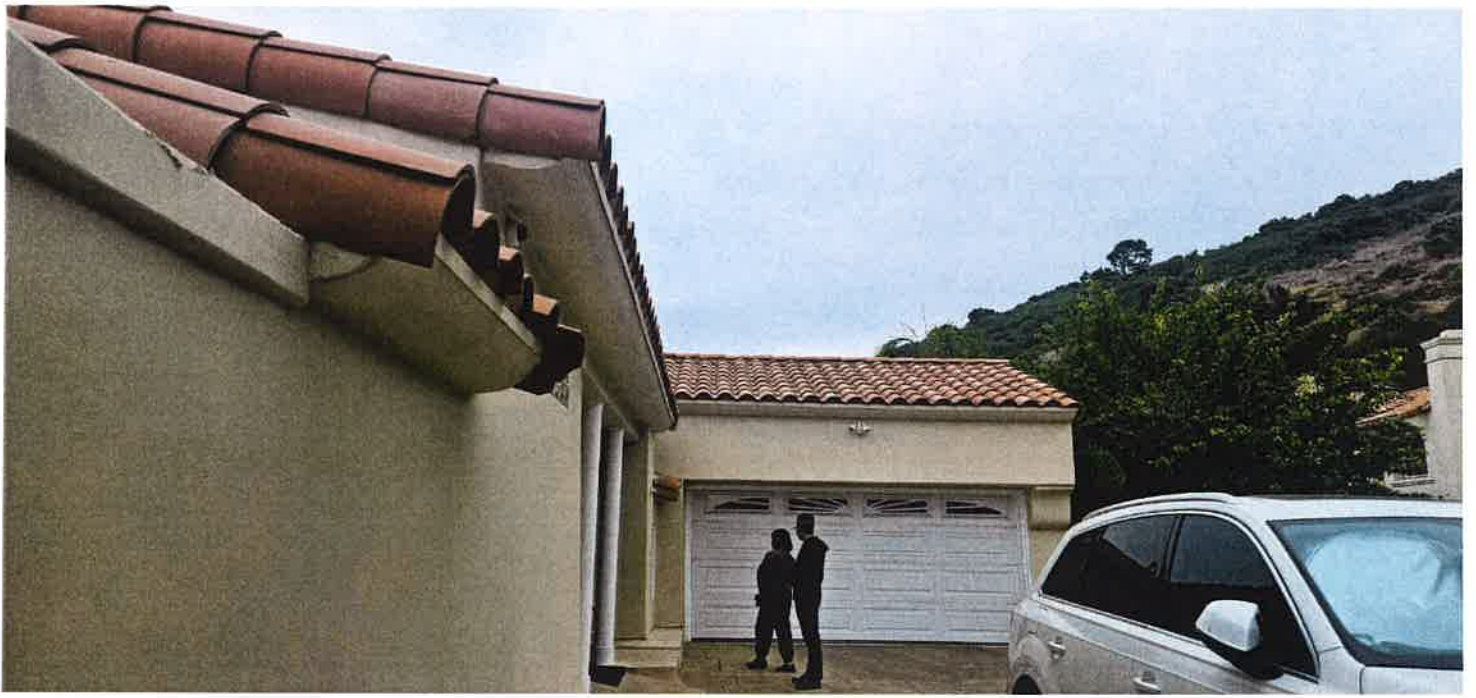
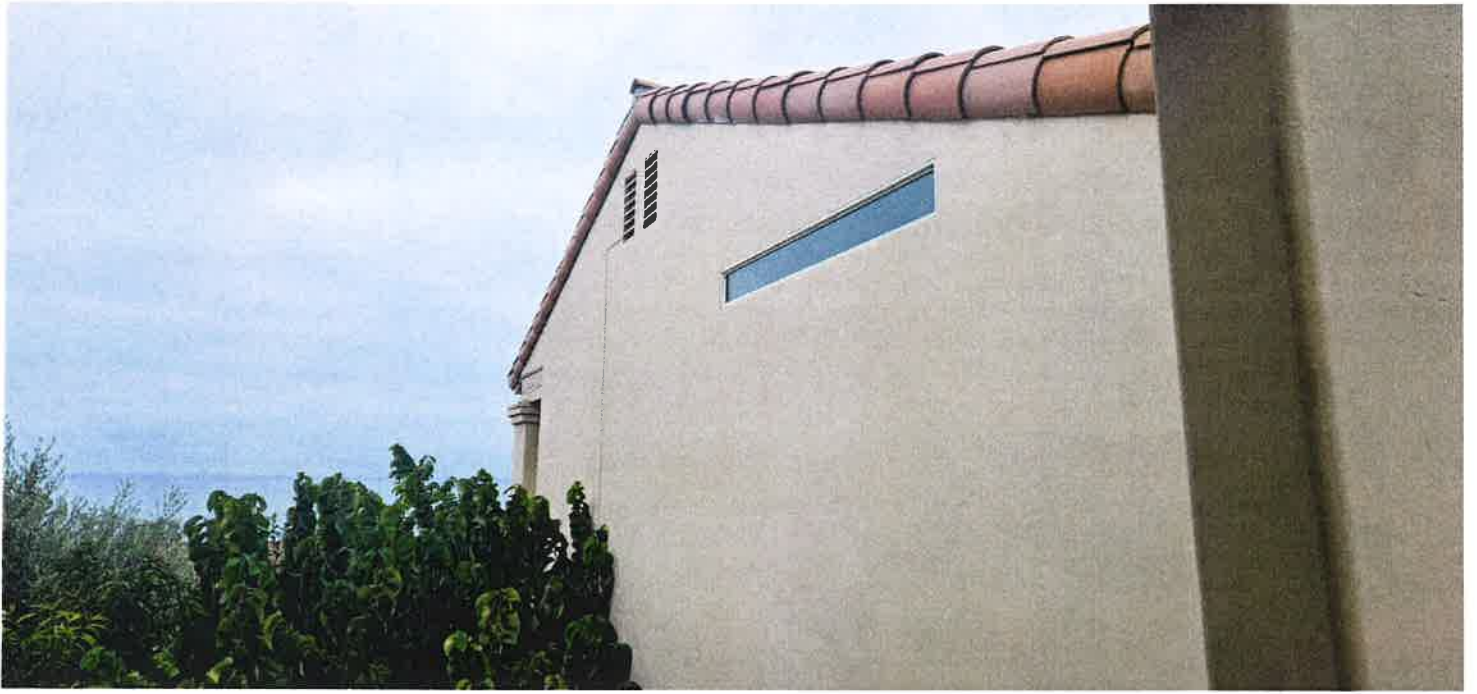
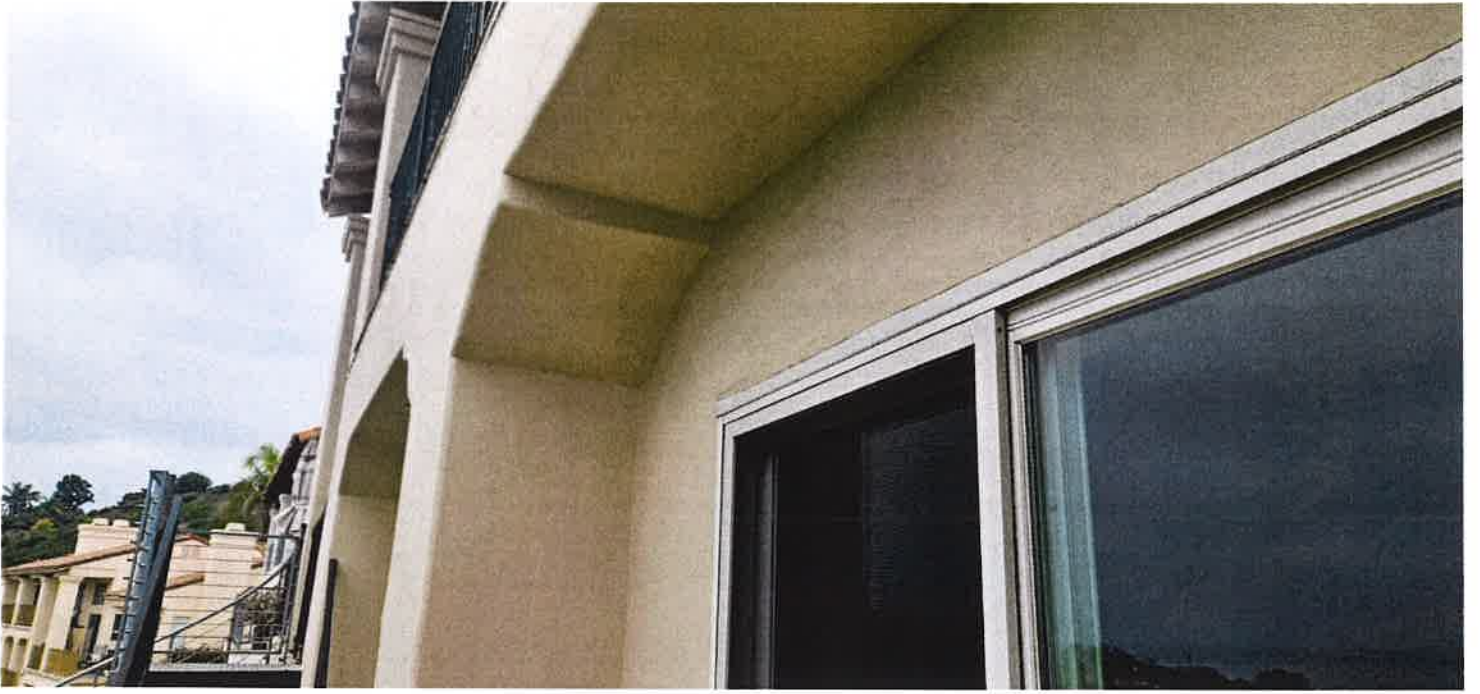
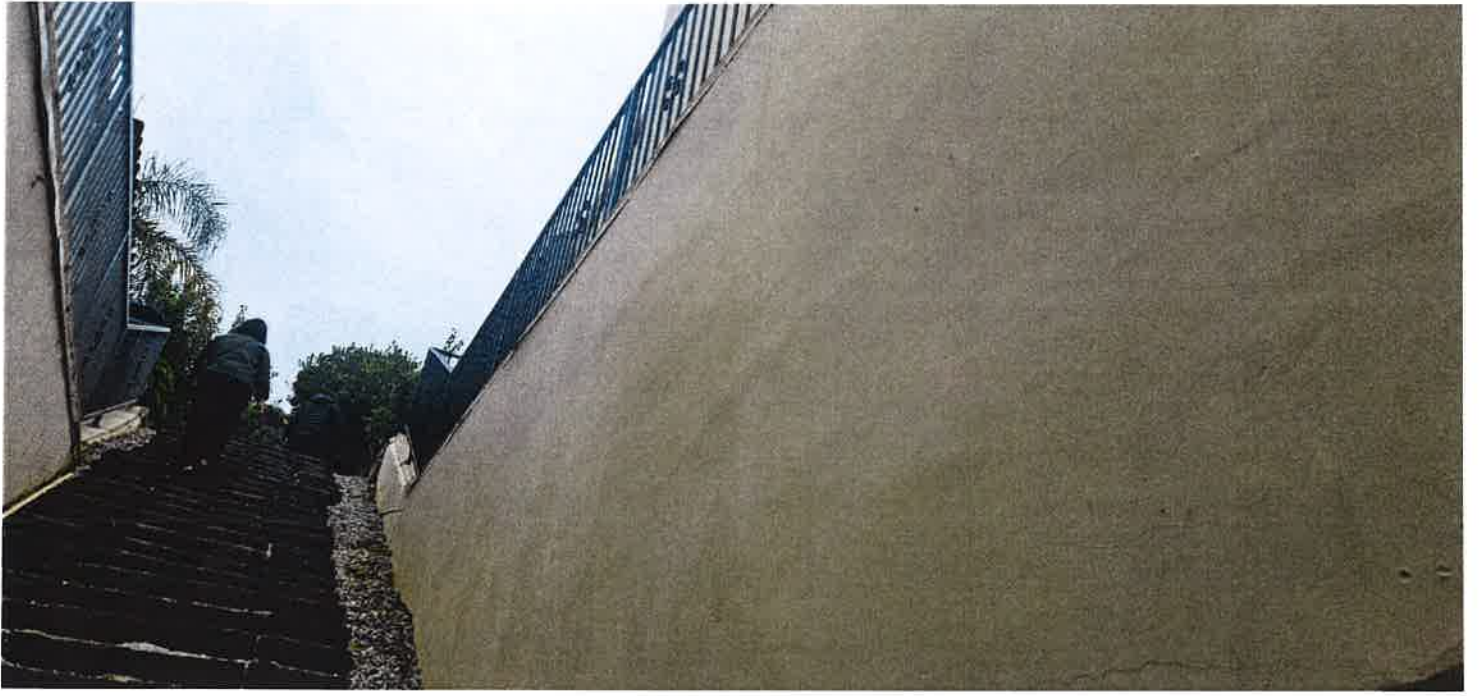
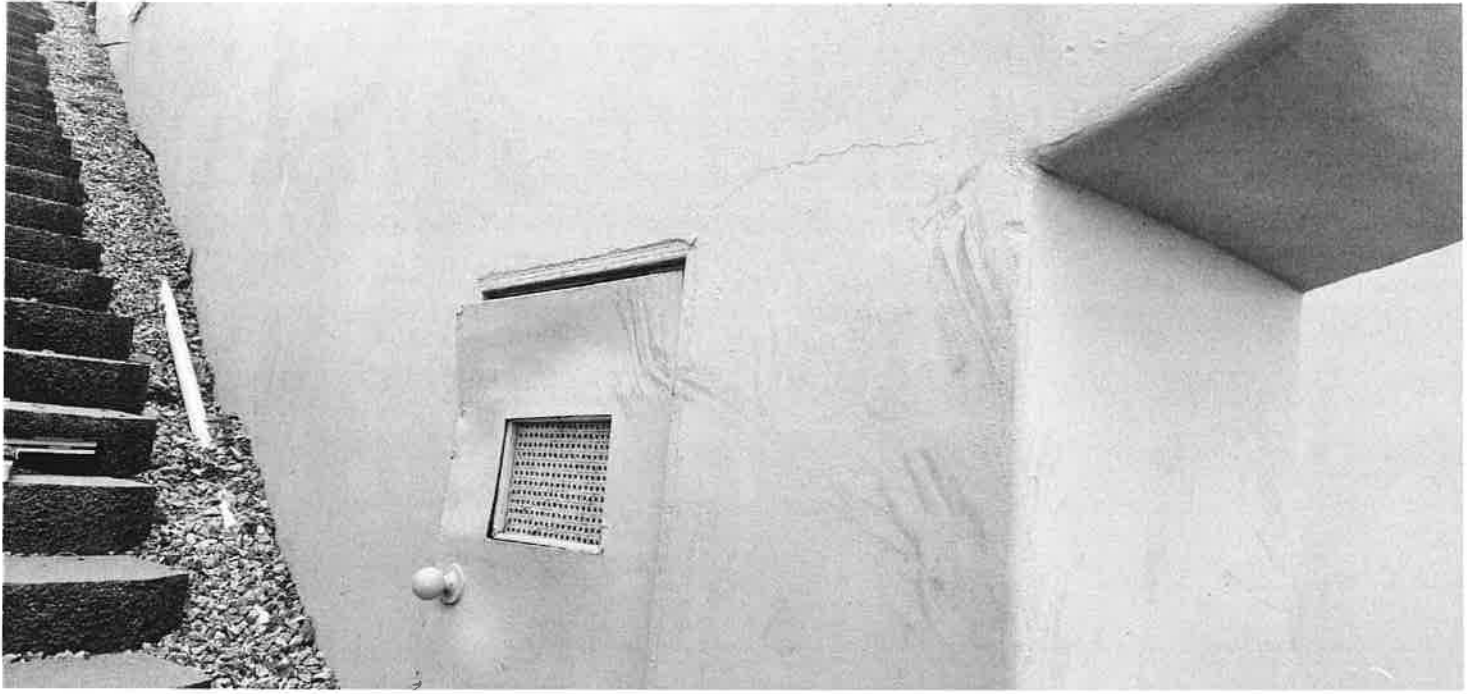
No noticeable evidence of cracks was detected on the exterior stucco wall surfaces of the residence as represented in Photographs 1 – 5, 8 & 9.

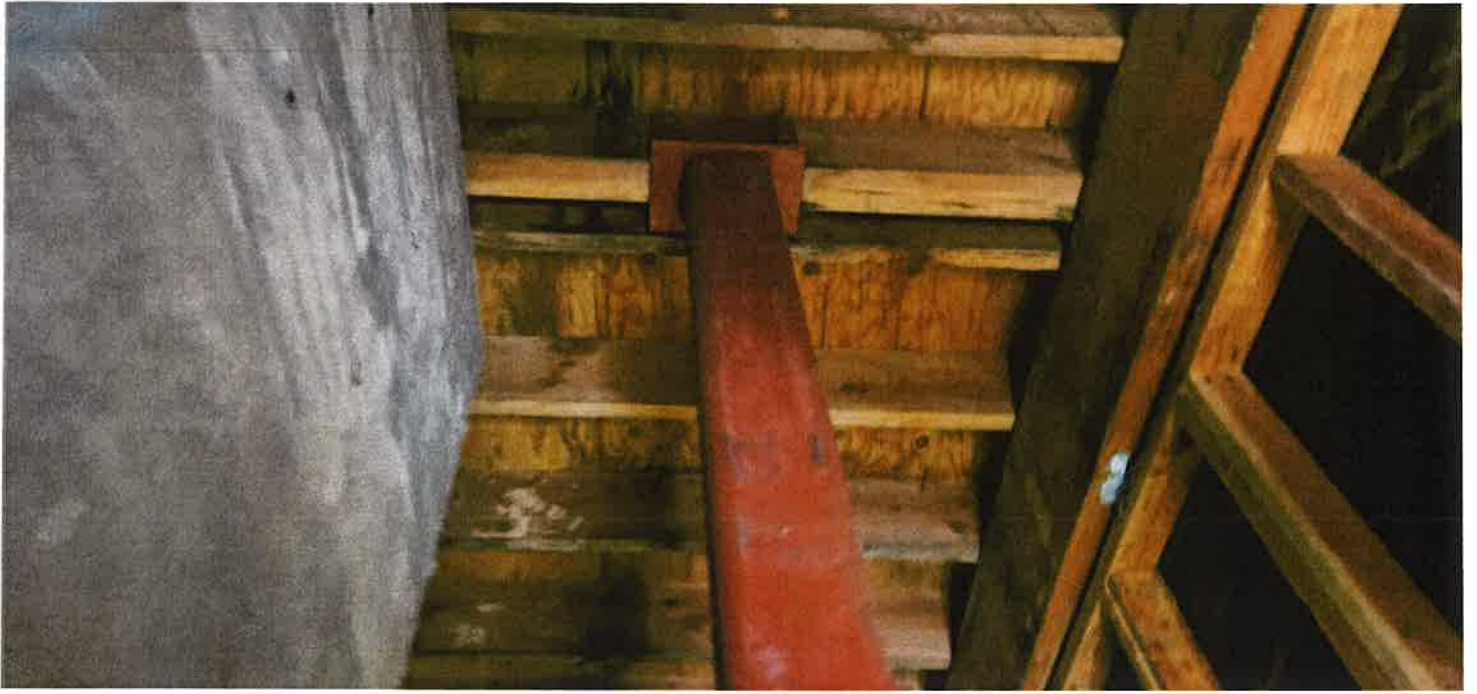
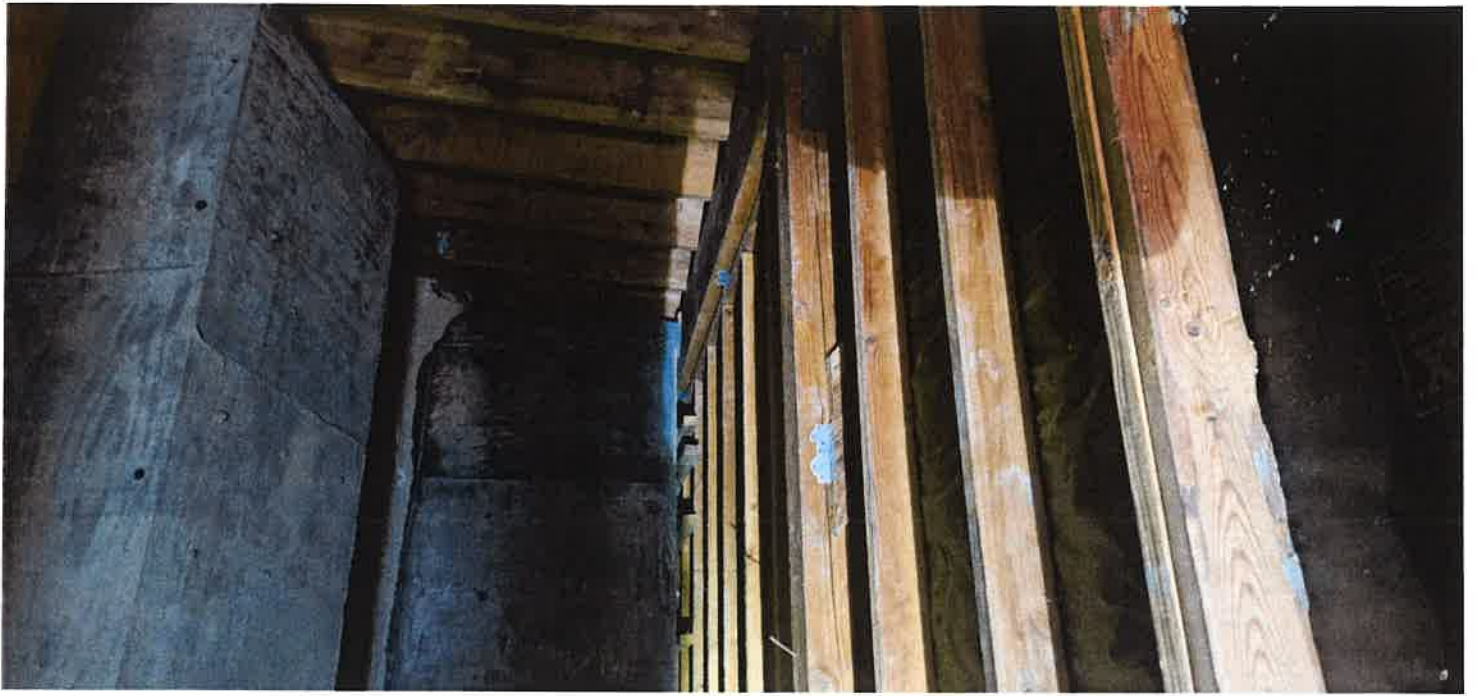
There is an underfloor access door at the northwest corner of the residence as shown in Photograph 5. No noticeable evidence of cracks in the exposed concrete foundations or separations in the floor and wall framing was detected as depicted in Photographs 6 & 7.

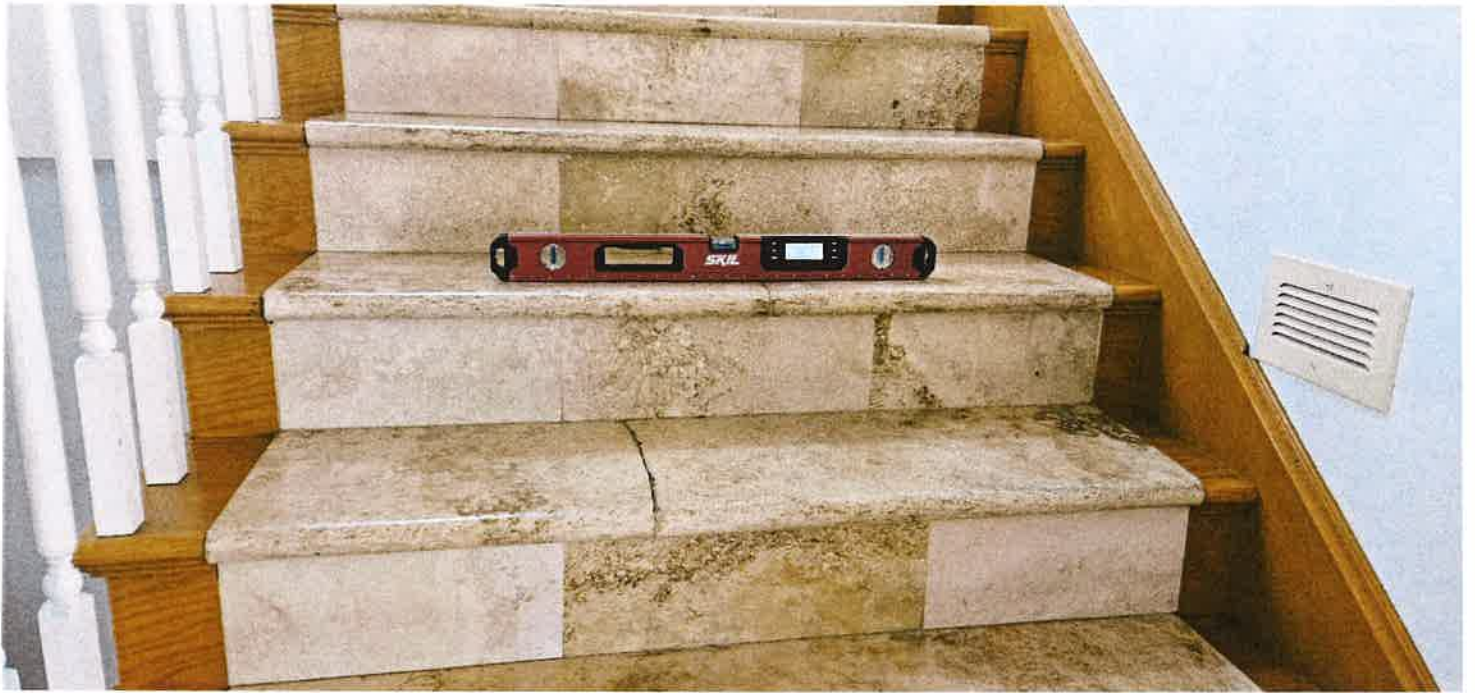
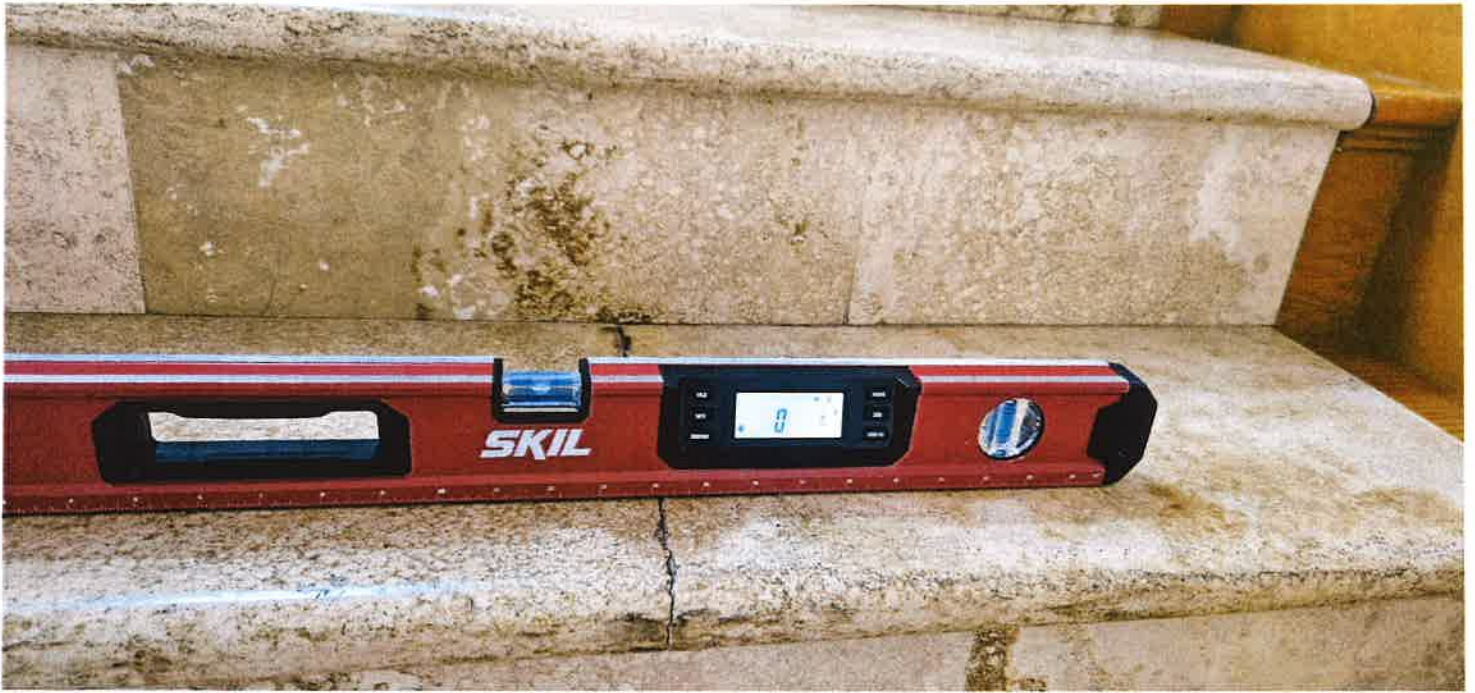
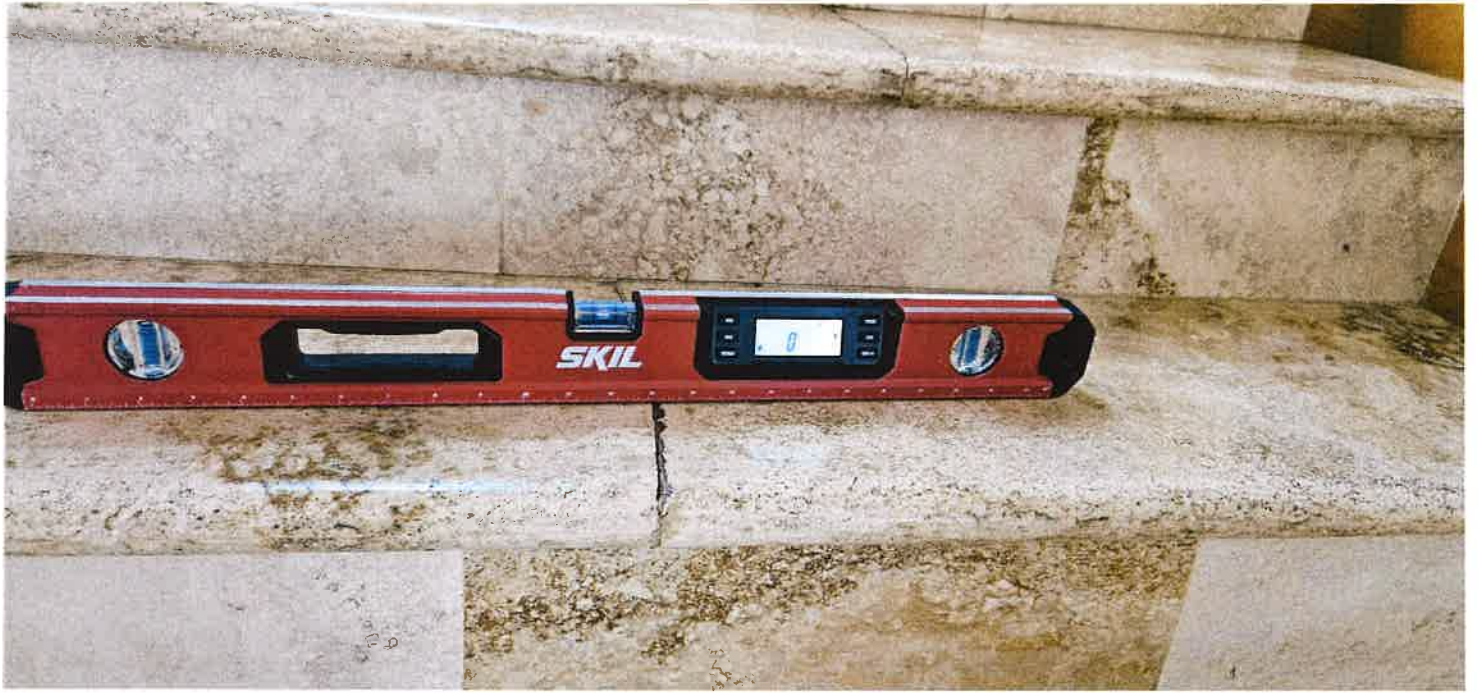
Using a digital hand-level, we placed it horizontally on the interior steps where cracks in the marble flooring was reported by the tenant which provided relatively level readings as shown in Photographs 10 – 12.

The cracks in the rigid marble floor tiles in the stairway, the dining room and kitchen are attributed to normal flexure of the supporting wood flooring from normal foot traffic loading and possibly due to a non-uniform mortar base. No noticeable tilting or unlevelness of the interior floor surfaces at these locations were detected. *Any cracks wider than 1/16 inch in width should be filled with a suitable material designed for marble floor tile repairs.*

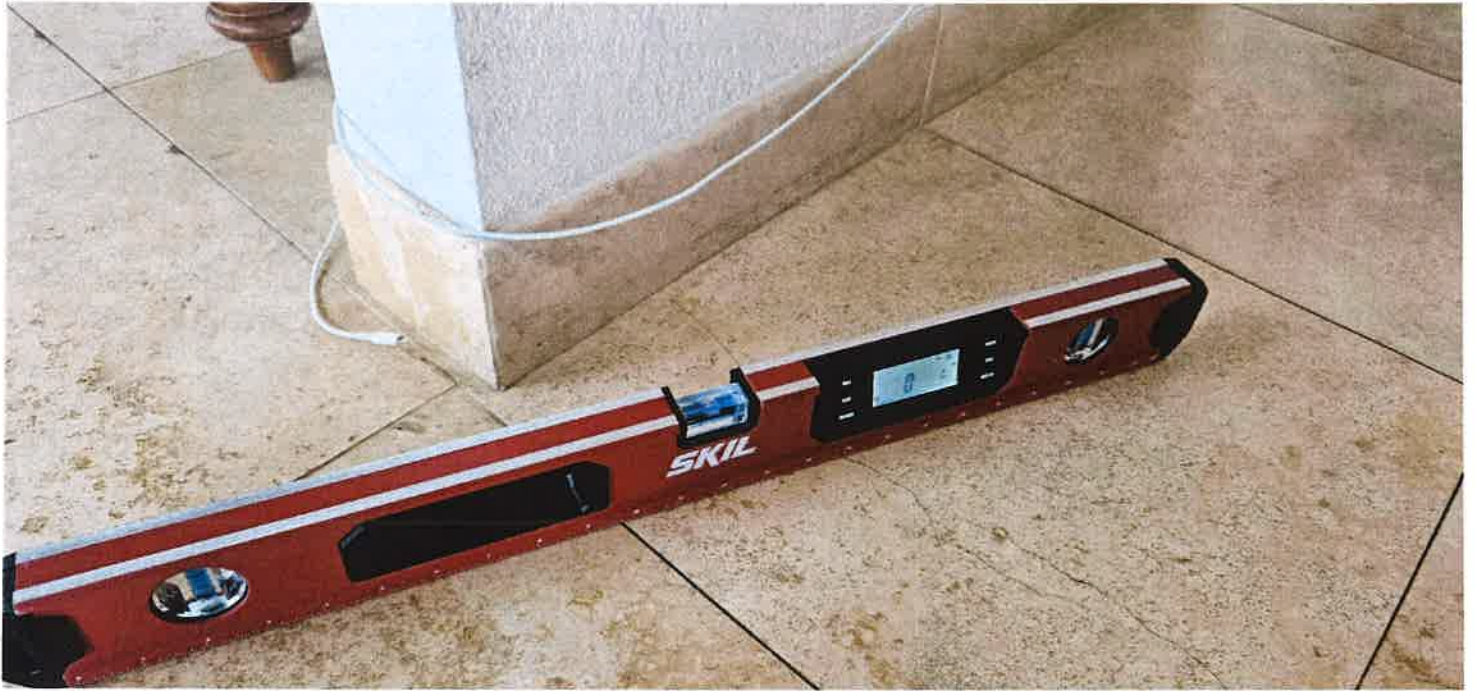
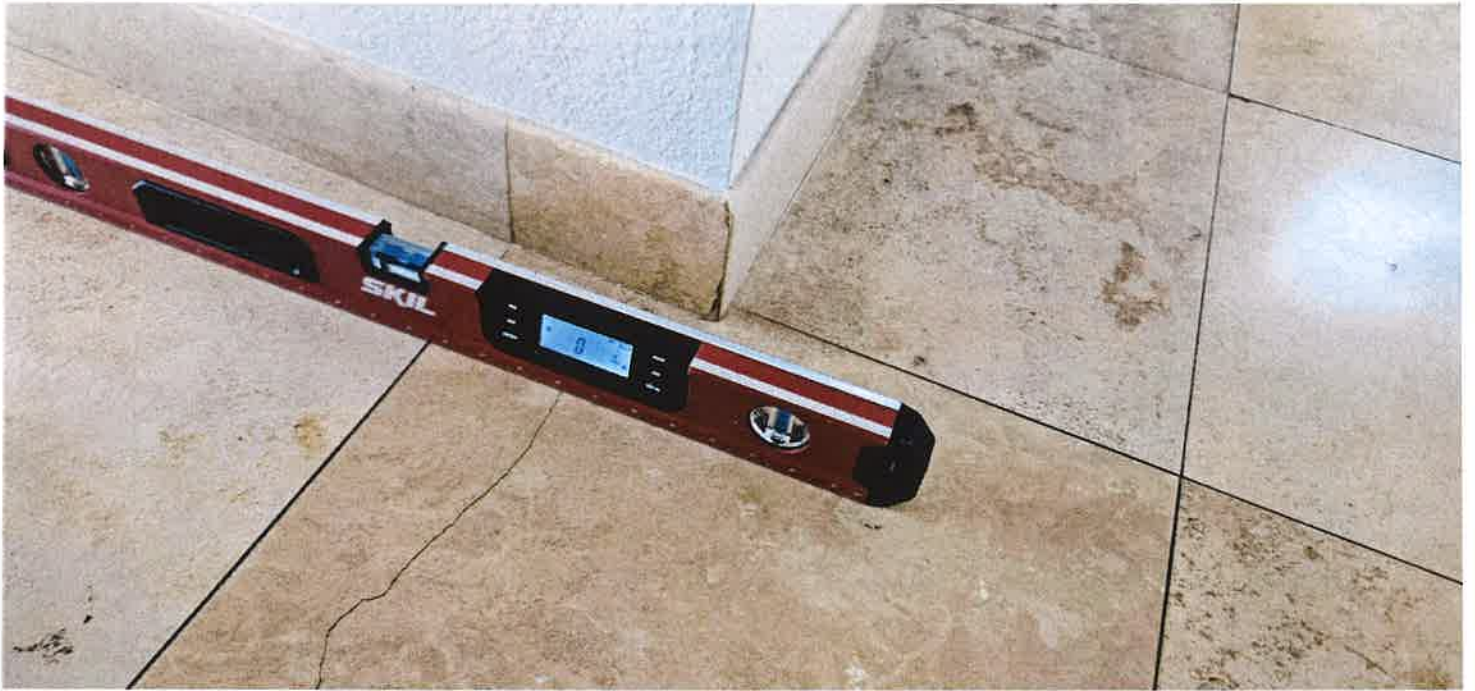
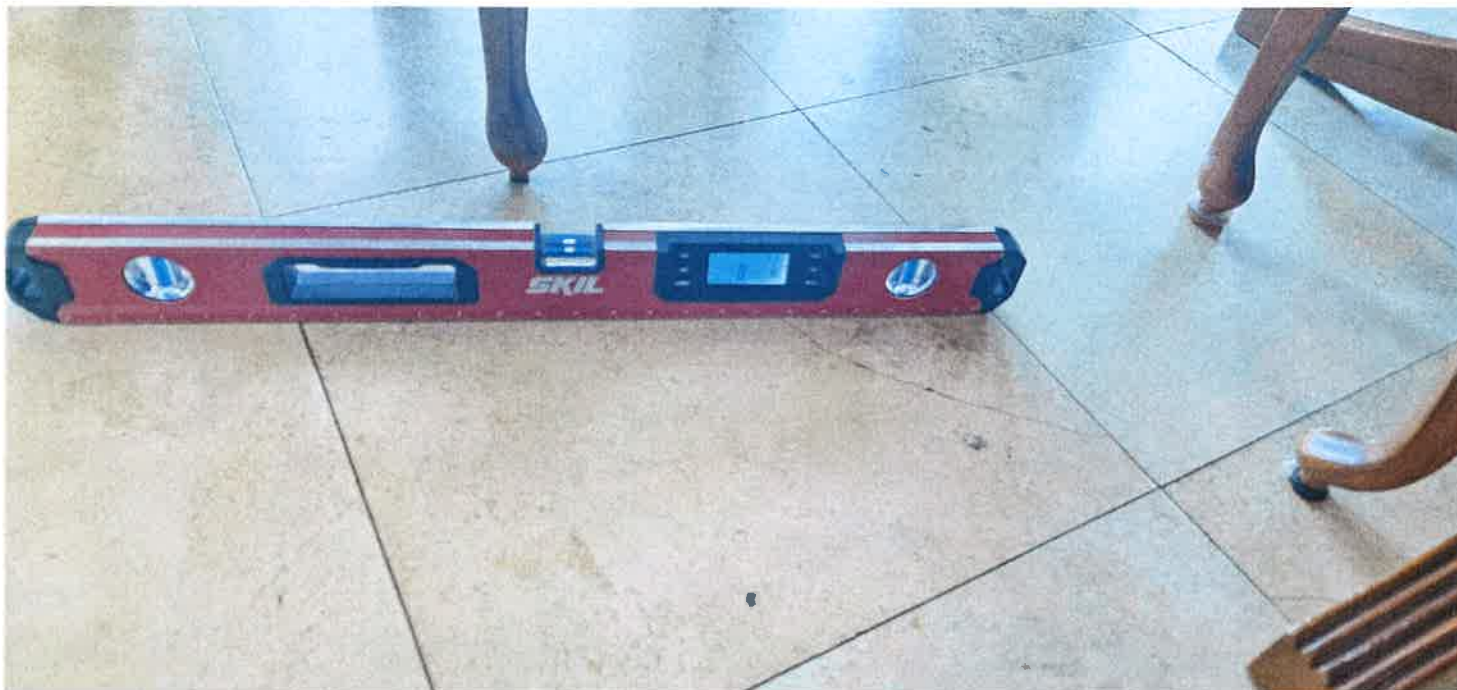
Similarly, we were shown cracks by the tenant in the dining room and kitchen areas as depicted in Photographs 13 – 15 which also provided relatively level floor readings from our digital hand-level.

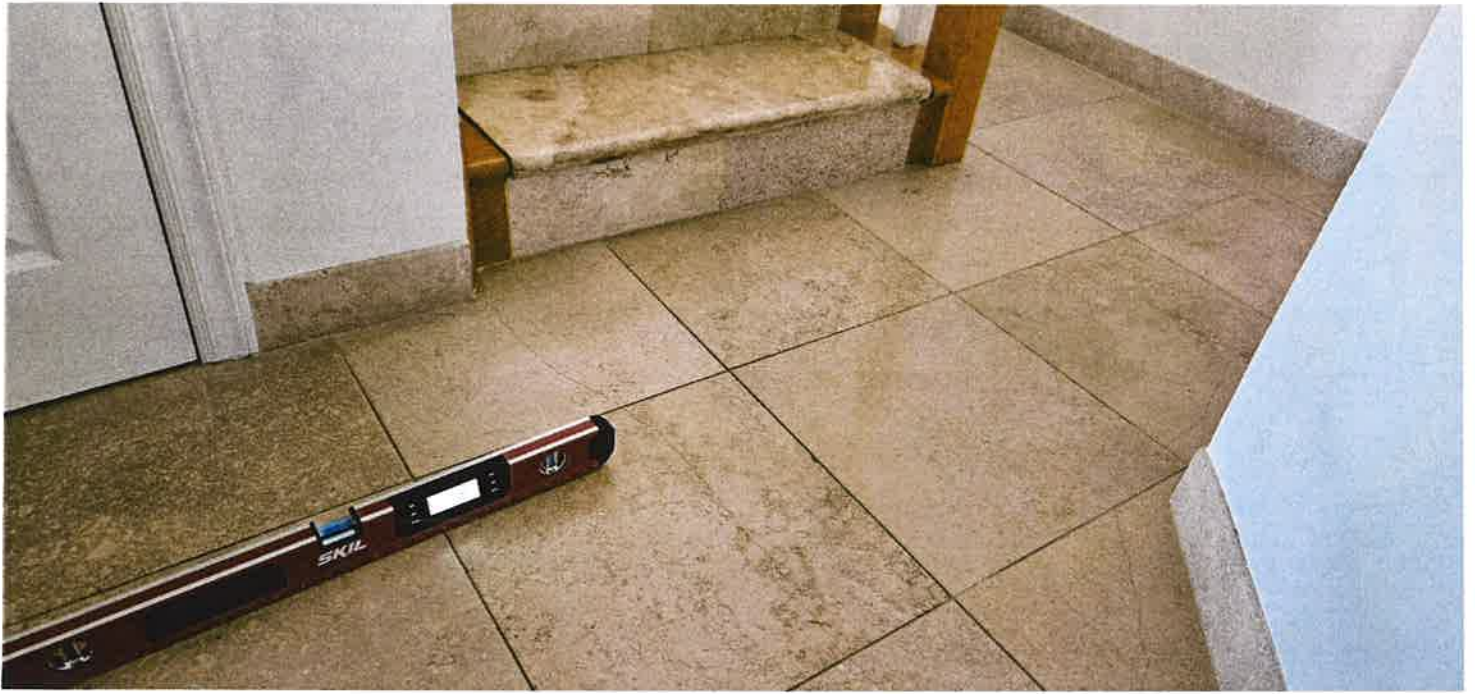
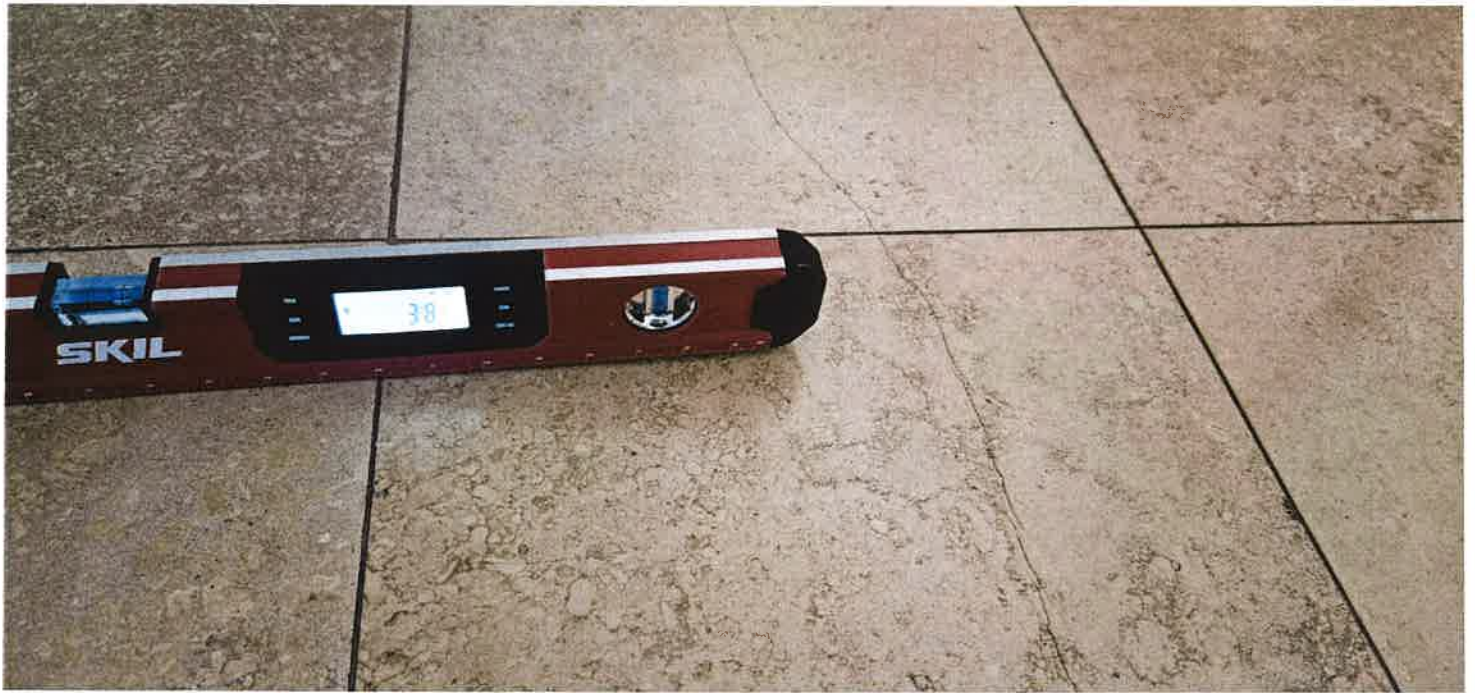
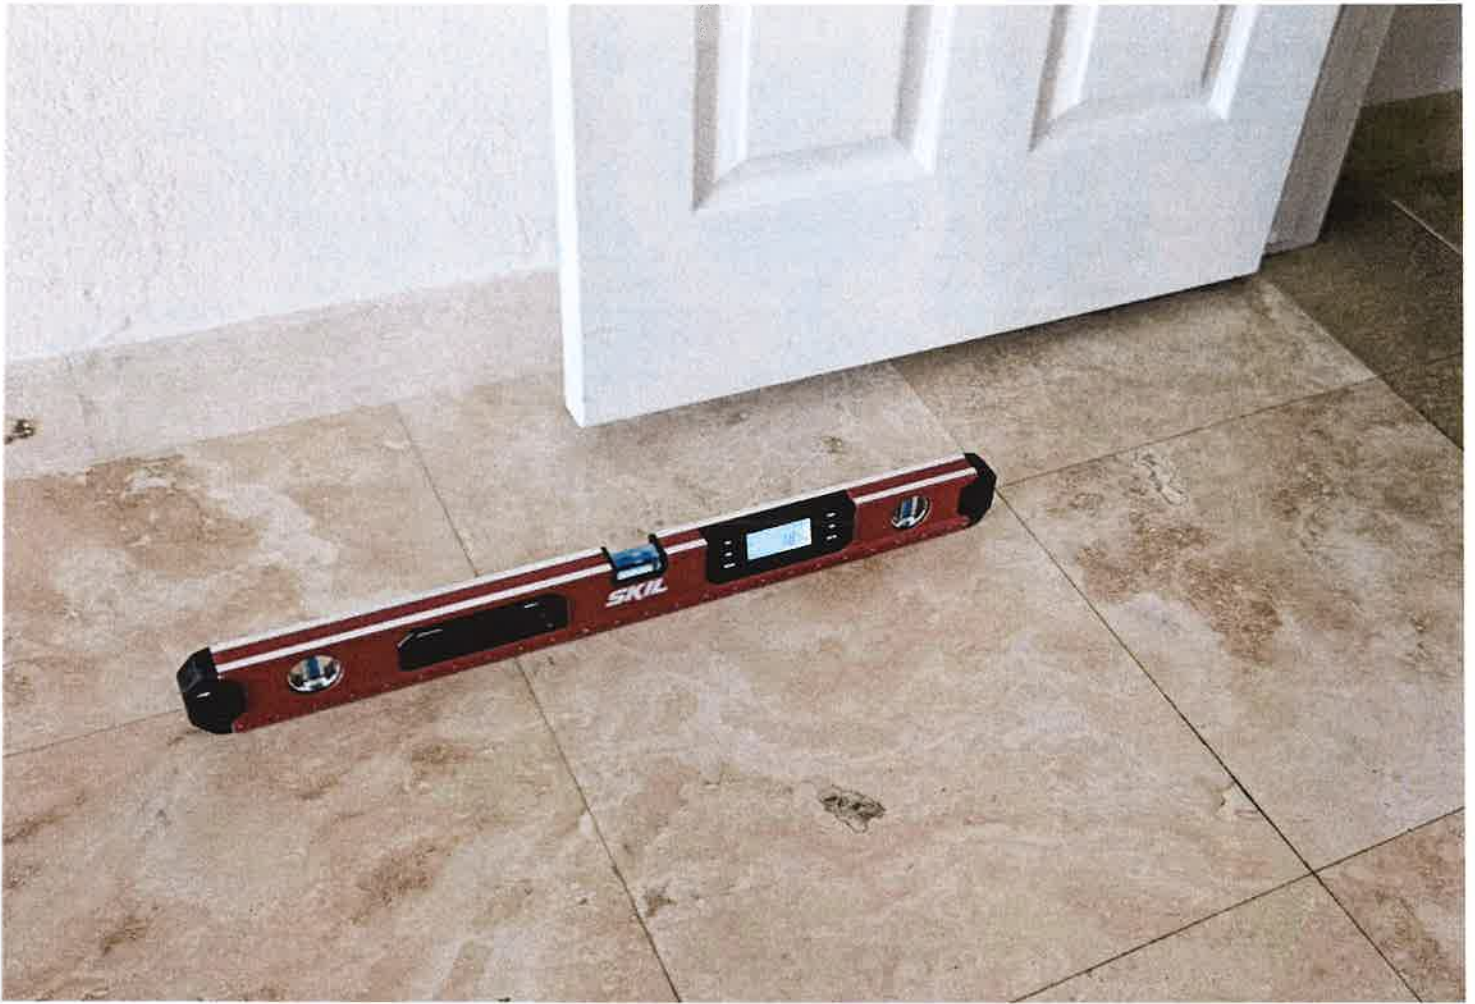
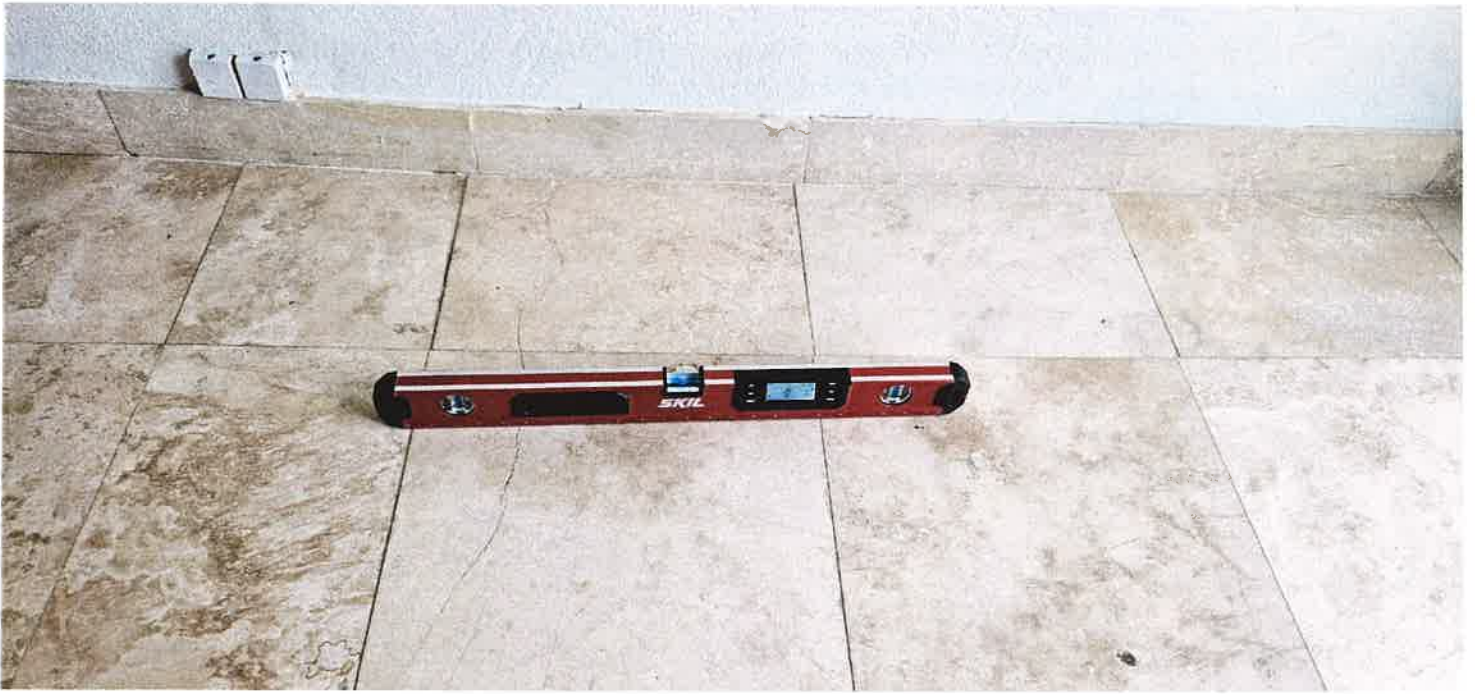
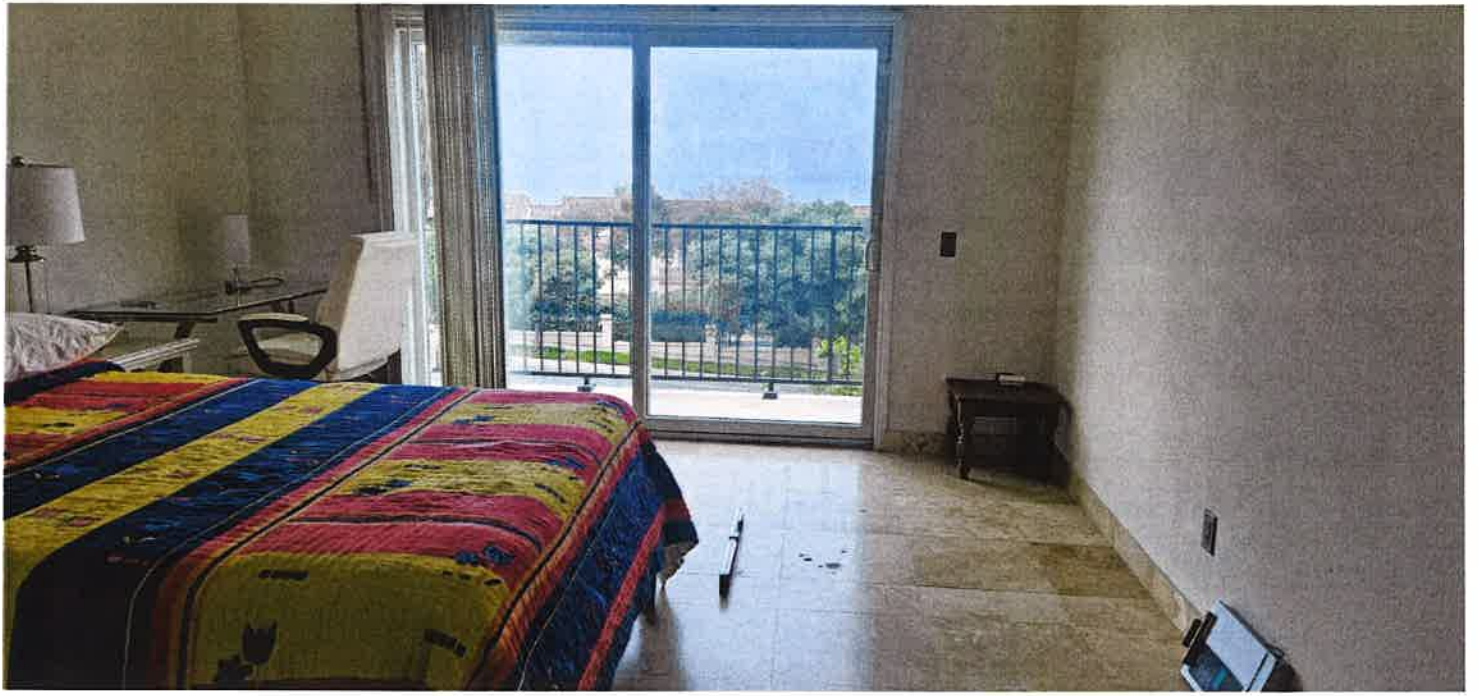
Using our digital hand-level, we noted that the interior floor marble tiled surface exhibited a downward from the base of the stairway towards the westerly direction into the bedrooms as shown in Photographs 16 – 20 where the west end section of the bedroom provided relatively level readings separated by a noticeable crack in the interior marble tiled floor that continues in the north to south directions between the three bedrooms as shown in Photographs 21 – 23.

We noted that there are crack lines in the interior marble flooring that continue between the three lower-level bedrooms which parallel the rear exterior wall. Our testing provided relatively level floor readings at these west sections of the bedrooms which were found to be supported by massive concrete foundations as exposed in the west underfloor crawlspace. It is unclear as to the type of soil that the existing foundations are supported by throughout the residence. The cracks in the marble flooring may be attributed to stiffer vertical support at the west building sections as compared to other adjacent flooring which may be supported

At the present time, it is our opinion that the cause of the cracking in the interior marble flooring at the lower level three bedrooms can be attributed to normal flexural movement between various floor framing supported by foundations with varying rigidities.

It is our recommendation that an interior floor manometer survey be conducted at all residence floor levels and in the attached garage to serve as a Datum Base for future comparative surveys. A second survey can be conducted should wall cracks develop measuring 1/8 inch and wider. Our office and a geotechnical engineer should be consulted to interpret and compare the surveys to determine if any foundation improvements may be necessary.
