October 18, 2024

F.N. 1-24-0635

Subject: Structural Inspection of Single-Family Residence
7050 Via Del Mar, Rancho Palos Verdes, CA 90275

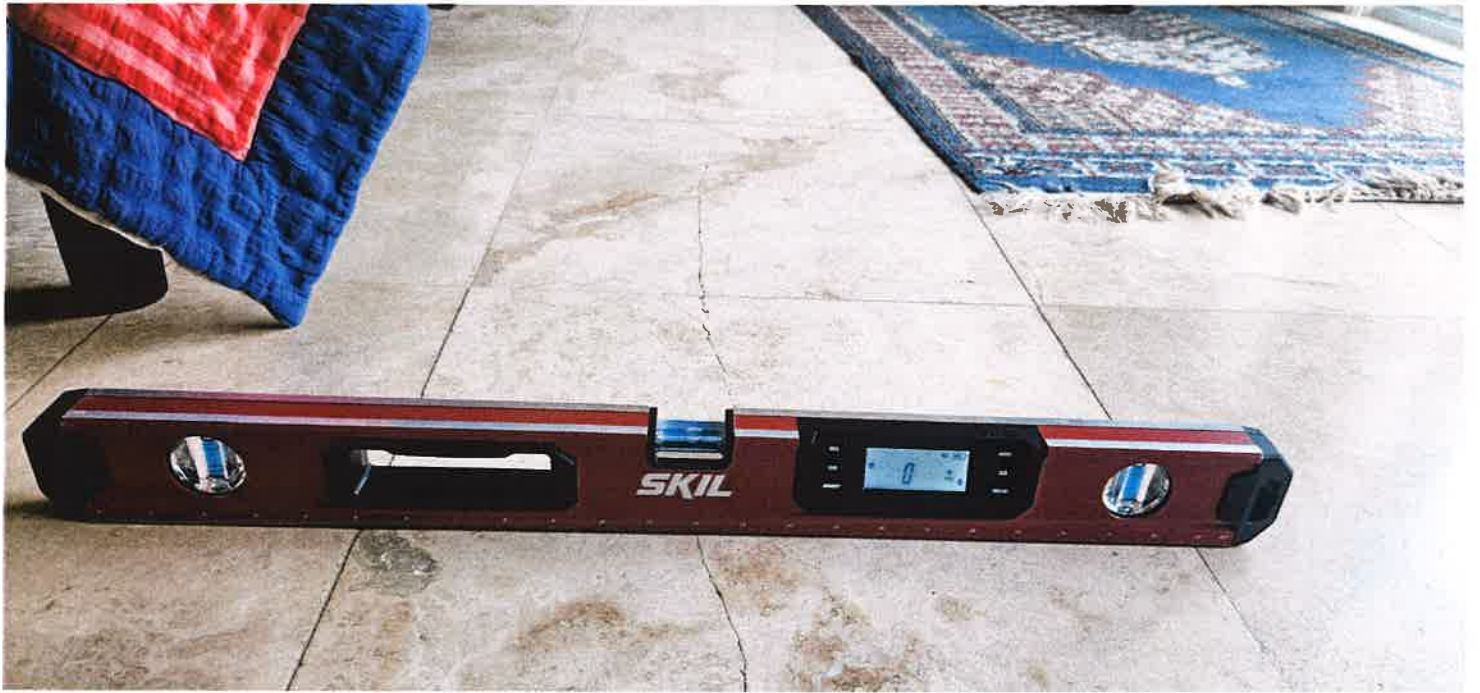
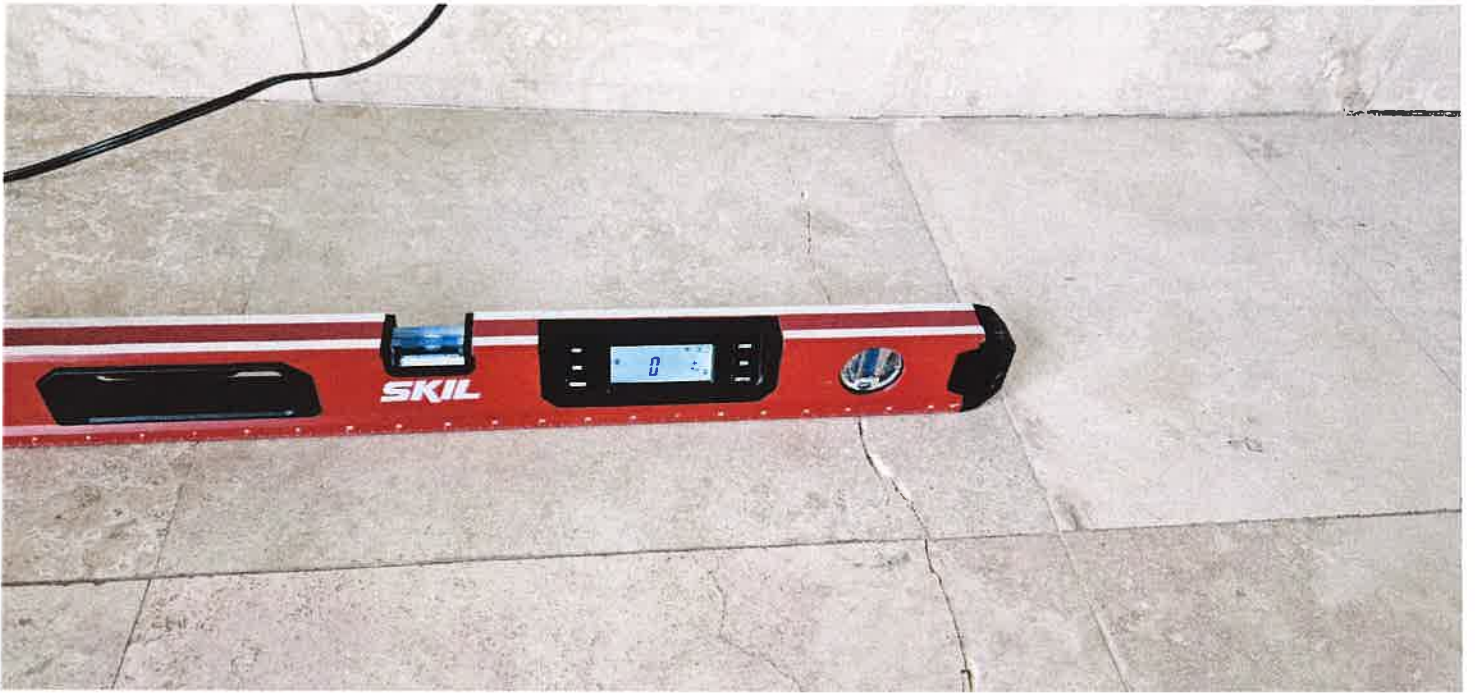
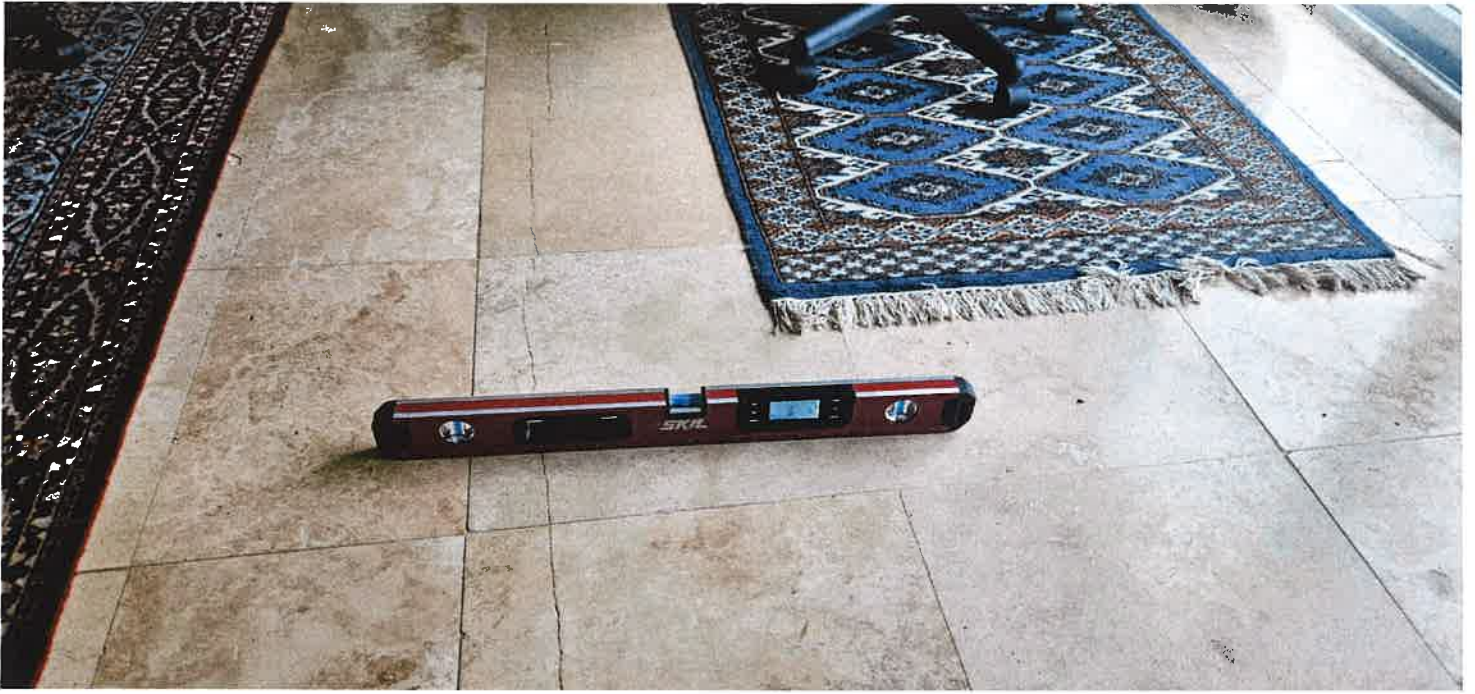
Using our digital hand-level, we noted that the interior floor marble tiled surface exhibited a downward from the base of the stairway towards the westerly direction into the bedrooms as shown in Photographs 16 – 20 where the west end section of the bedroom provided relatively level readings separated by a noticeable crack in the interior marble tiled floor that continues in the north to south directions between the three bedrooms as shown in Photographs 21 – 23.

We noted that there are crack lines in the interior marble flooring that continue between the three lower-level bedrooms which parallel the rear exterior wall. Our testing provided relatively level floor readings at these west sections of the bedrooms which were found to be supported by massive concrete foundations as exposed in the west underfloor crawlspace. It is unclear as to the type of soil that the existing foundations are supported by throughout the residence. The cracks in the marble flooring may be attributed to stiffer vertical support at the west building sections as compared to other adjacent flooring which may be supported

At the present time, it is our opinion that the cause of the cracking in the interior marble flooring at the lower level three bedrooms can be attributed to normal flexural movement between various floor framing supported by foundations with varying rigidities.

It is our recommendation that an interior floor manometer survey be conducted at all residence floor levels and in the attached garage to serve as a Datum Base for future comparative surveys. A second survey can be conducted should wall cracks develop measuring 1/8 inch and wider. Our office and a geotechnical engineer should be consulted to interpret and compare the surveys to determine if any foundation improvements may be necessary.

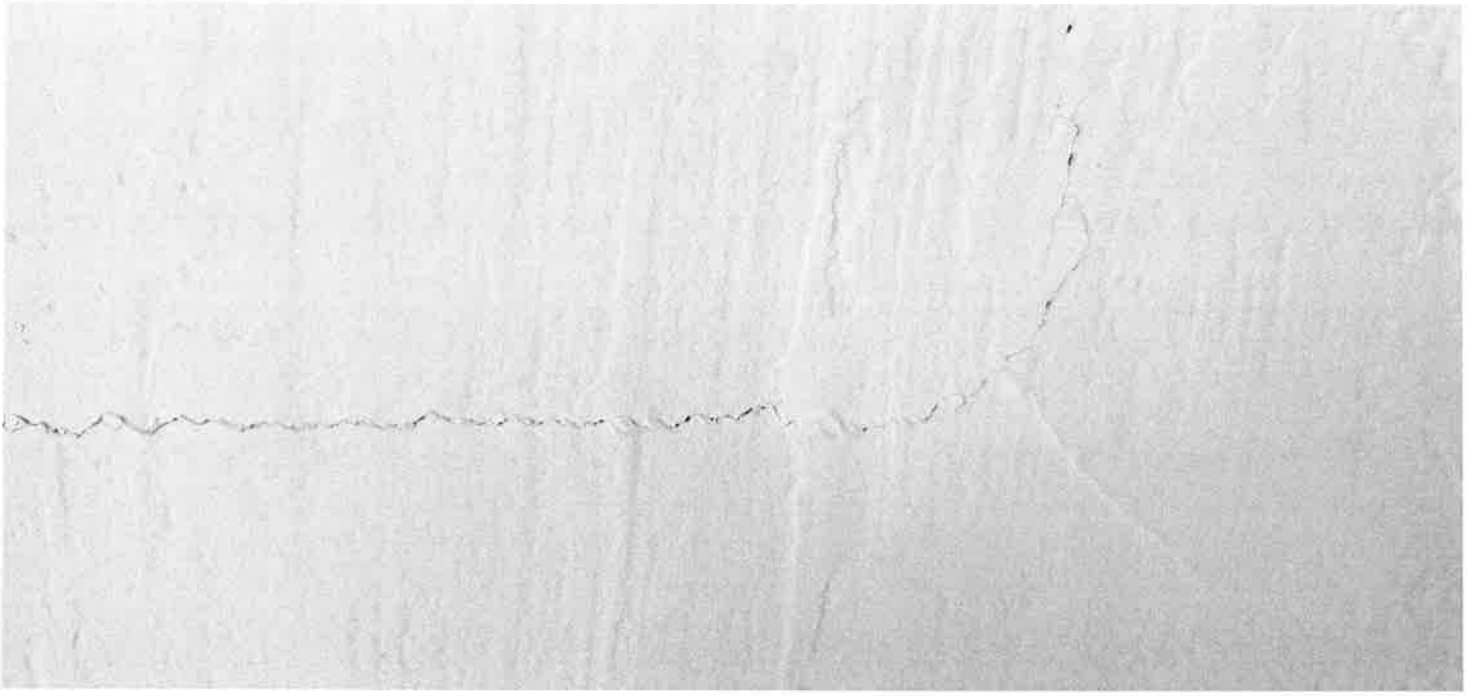
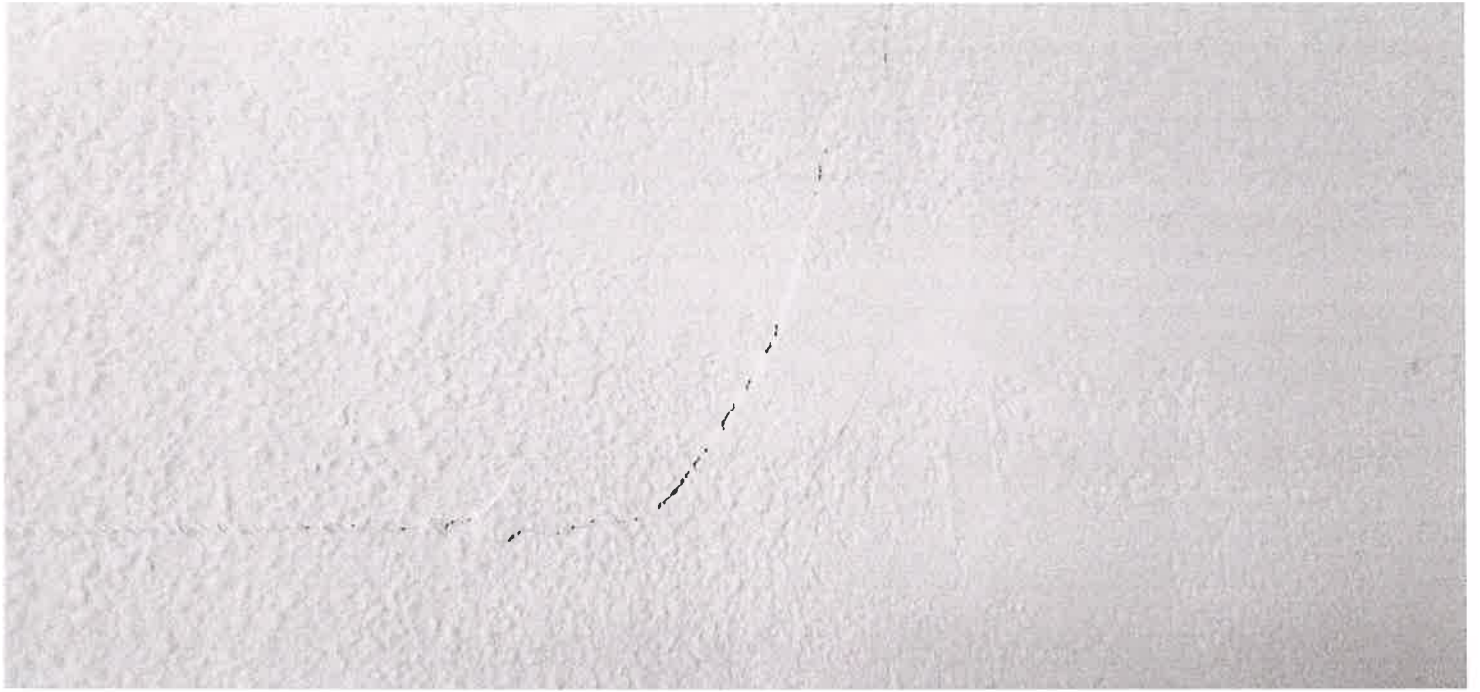
In one of the bedrooms, we detected evidence past repair to an interior wall crack which exhibit slight evidence of re-cracking as depicted in Photographs 24 & 25.
