## RESIDENTIAL REPORT

3660 Walnut Blvd 43  
Brentwood, CA 94513

03/25/2026

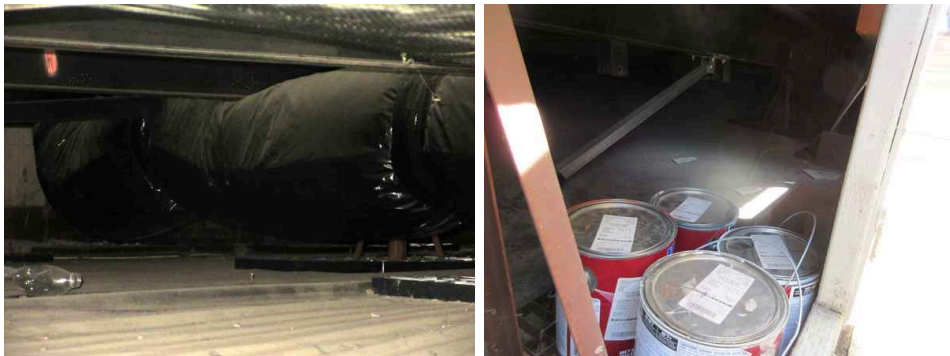
**PORTIONS OF THE CRAWLSPACE NOT VISABLE**

Several portions of the crawlspace were inaccessible for inspection due to lack of proper clearance to crawl, stored items, ducting, under carriage metal framing and jacks stands and were not inspected. No opinion is given regarding inaccessible areas.

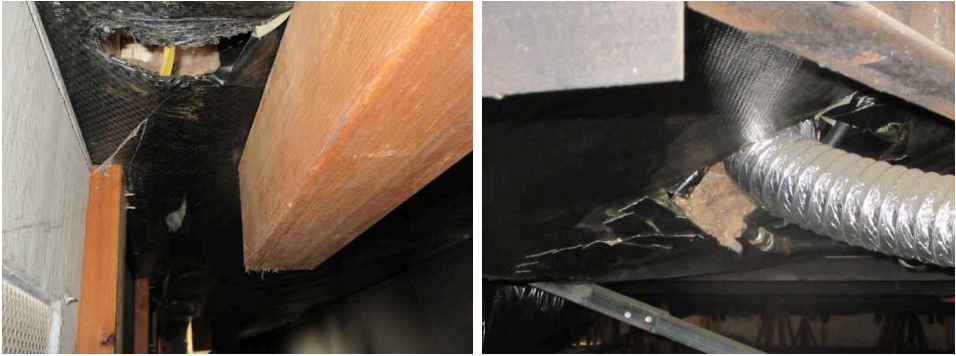
## 2.2.1 Crawlspace

**DAMAGED UNDERCARRIAGE INSULATION COVERING**

The underbelly fabric covering at the undercarriage is damaged. This protective layer shields the insulation and mechanical systems from weather exposure and pest intrusion. Damaged covering can allow moisture infiltration, accelerate insulation deterioration, and create entry points for rodents and insects. The affected areas should be patched.

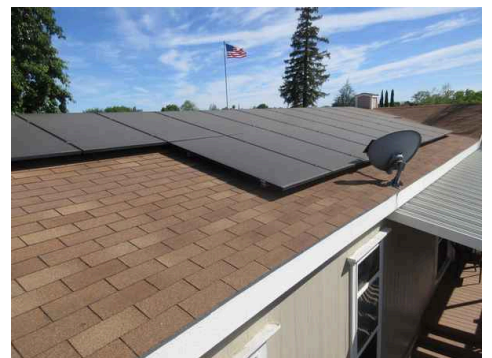
### SOLAR PANELS LIMIT TO ACCESS ROOF

Solar panels on the roof restricted the inspection of the roofing below.

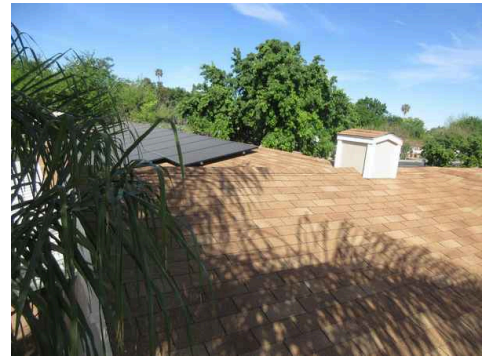
3.1.1 Coverings

### TREES NEAR ROOF

The tree limbs and vegetation that are in contact with roof and/or hanging near roof should be trimmed to reduce roof covering deterioration and/or avoid/reduce moisture intrusion.

The Inspector recommends having tree limbs trimmed by a Qualified Tree Professional/Contractor as necessary.

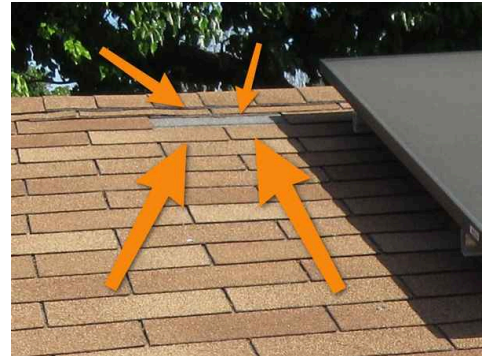
### 3.1.2 Coverings

#### MINOR REPAIRS NEEDED TO ROOF

Minor repairs to the roofing are needed. Damaged or missing roofing material should be repaired. All roof penetrations should be examined by a qualified roofer and sealed as necessary.

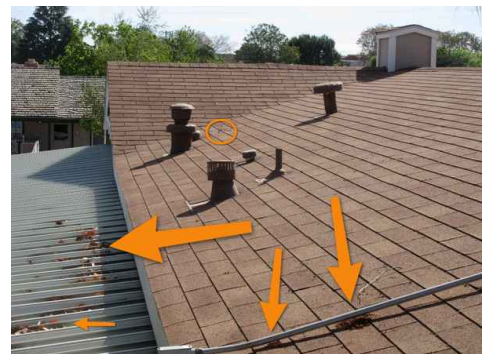
### 3.1.3 Coverings

#### DEBRIS ON ROOF

Debris should be removed from the roofing to reduce risk of leaks and early roof wear.

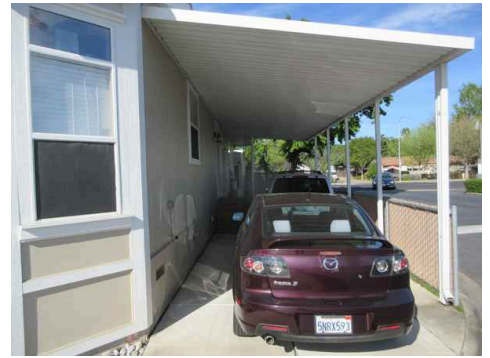
### WALKWAYS INACCESSIBLE FOR INSPECTION

The majority of the walkways were inaccessible for inspection due to leaves covering these areas. We recommend the leaves be removed and the area be further inspected.

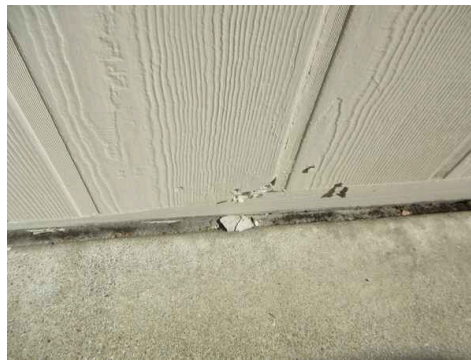
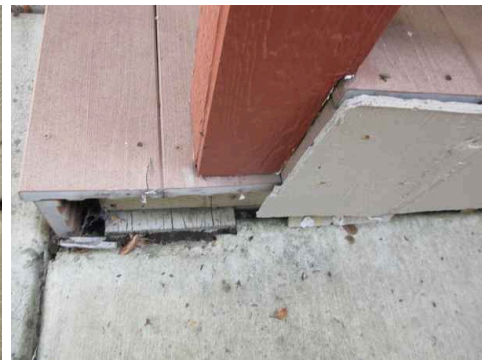
### 4.2.1 Siding, Flashing & Trim

#### **CEMENT BOARD SIDING DAMAGED**

Damaged or cracked siding was noted at exterior walls. Repair as needed to prevent water entry.

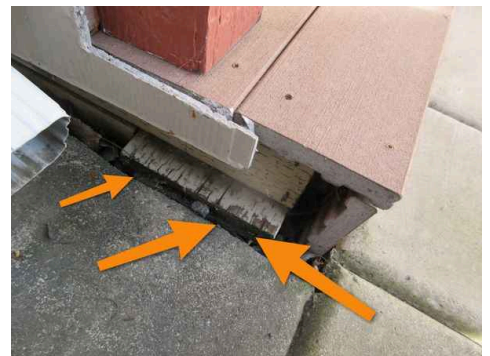
### 4.4.1 Decks, Balconies, Porches & Steps

#### **BASE OF FRONT PORCH MINIMAL DAMAGE**

The base of the front porch step framing has minimal damage and is in earth to wood contact. Ideally the steps should be placed on concrete

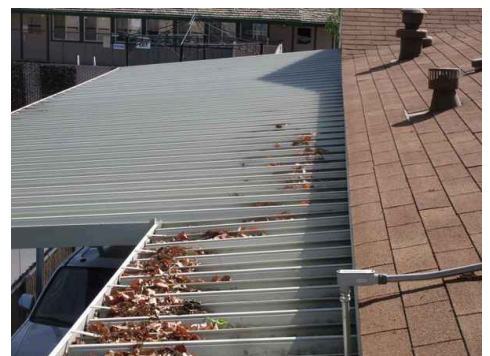
### 4.4.2 Decks, Balconies, Porches & Steps

#### **DEBRIS ON CARPORT COVER**

Debris was observed accumulating on the carport cover during inspection. Accumulated debris can trap moisture, promote deterioration of the cover material, and potentially damage the structure if weight becomes excessive. The carport cover should be cleared of all debris and a regular maintenance schedule established to prevent future buildup.

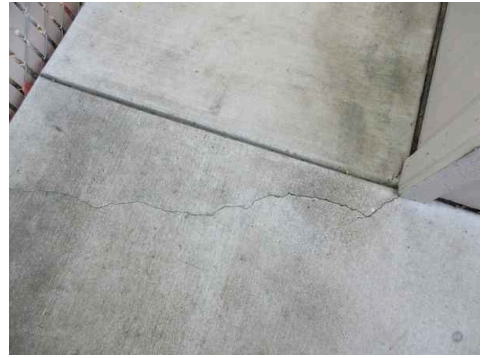
#### 4.7.1 Walkways, Patios & Driveways

### TYPICAL SIZE CRACKS WALKWAYS

Typical size cracks note in the walkway and patio. Cracks more than 1/8 inch high can present a trip hazard.

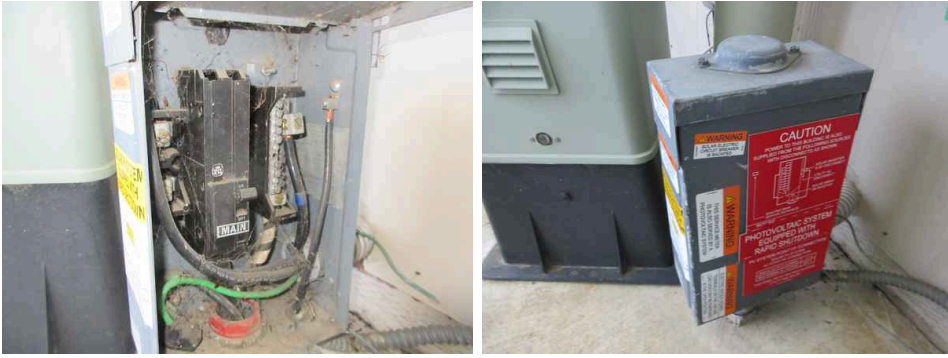
**DEAD FRONT COVER MISSING**

The inner dead front cover of the main panel is missing and should be added as a safety measure.

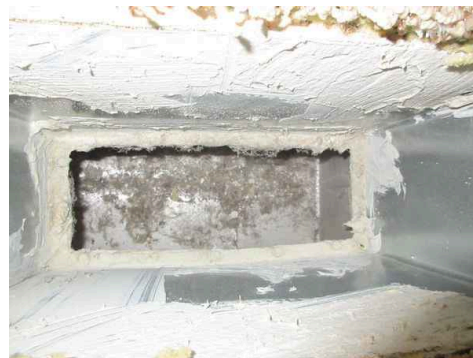
#### DUCT CLEANING IS RECOMMENDED

Duct cleaning is recommend.

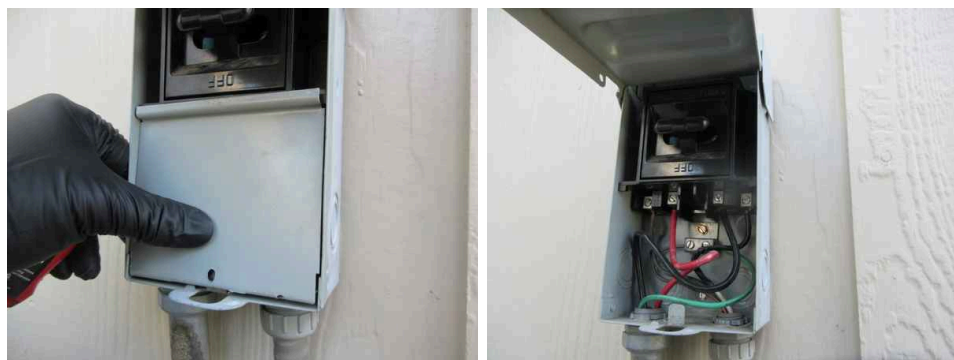
#### MISSING INNER COVER ON A/C DISCONNECT

The inner cover on the air conditioning disconnect is not attached as it is the improper cover. This exposes electrical components during inspection and creates a potential shock hazard for anyone contacting the exposed parts. The disconnect cover should be replaced by a qualified HVAC or electrical professional to ensure proper safety and protection of the electrical components.

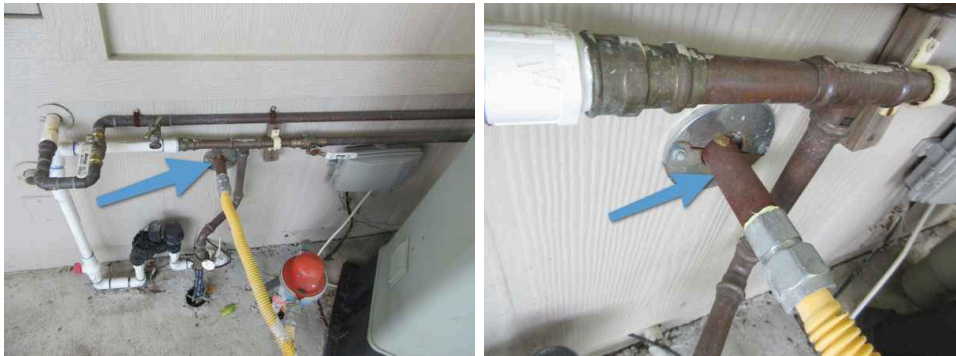
#### **SURFACE RUST ON GAS PIPE**

Surface rust was observed on the exterior gas pipe during inspection. Rust on gas pipes can compromise structural integrity and potentially lead to gas leaks if corrosion progresses. The affected pipe should be evaluated by a qualified professional who can determine if treatment, coating, or replacement is necessary.

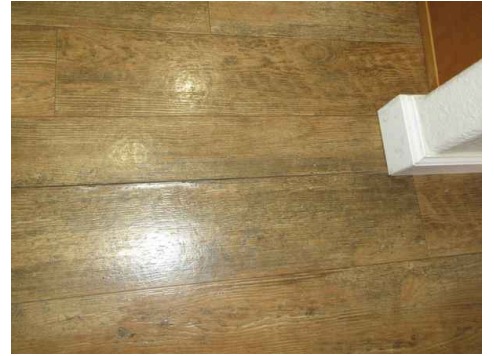
## KITCHEN

Seams in the vinyl flooring are not in ideal condition. Improvement is discretionary. Beware of a possible trip hazard.
