# WOOD DESTROYING PESTS AND ORGANISMS INSPECTION REPORT

| Building No.<br>182 | Street<br>Luzon St | City<br>Morro Bay | Zip<br>93442-3018 | Date of Inspection<br>06/30/2026 | Number of Pages<br>1 of 5 |

**Report #: 113880**

## \*\*\*Complete Inspection Report\*\*\*

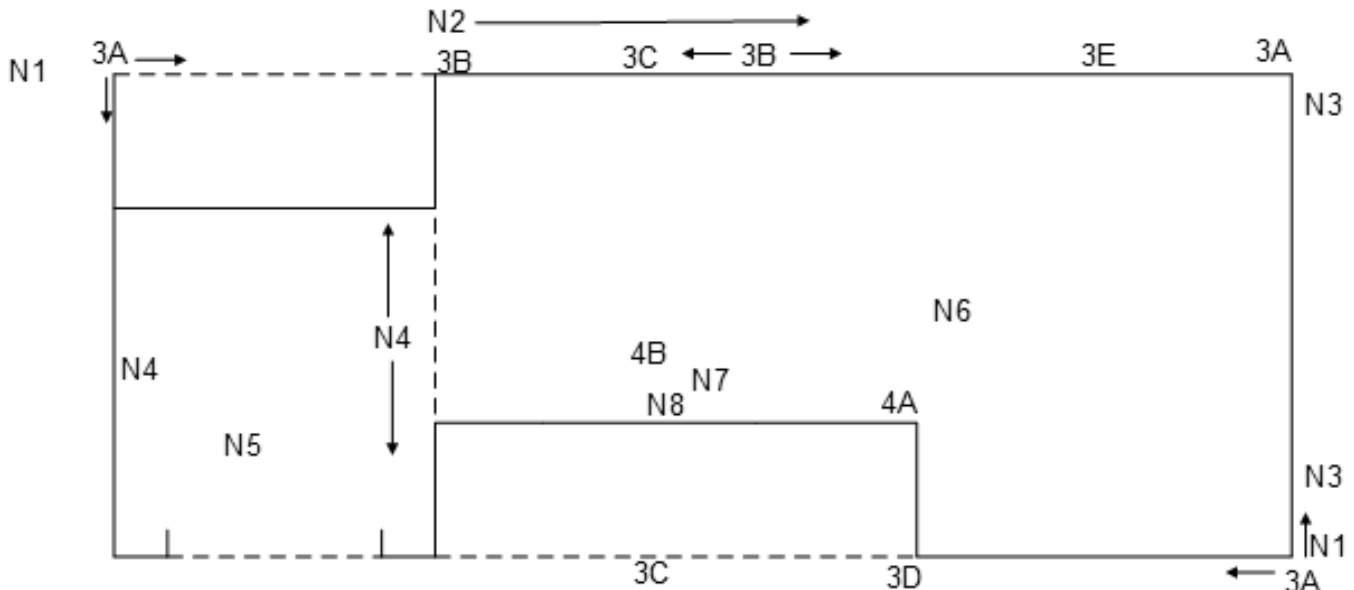
Diagram not to scale-Finding locations approximate

| Finding: | 3A | Fungus damage was found at the fascia of the eave area. |
| Finding: | 3B | Fungus damage was found at the wood members of the eave area. |
| Finding: | 3C | Fungus damage was found at the rafter end of the eave area. |
| Finding: | 3D | Fungus damage was found at the roof sheathing of the eave area. |
| Finding: | 3E | Fungus damage was found at the sub structure access frame. |

| Finding: | 4A | The toilet was found to be loosely bolted to the floor. This creates a potential source of leakage. |
| Finding: | 4B | An excessive moisture condition exists due to leakage at the substructure drain line. |

| Recommendation: | | Replace the fungus damaged portions of fascia as needed. |
| Recommendation: | | Replace the fungus damaged portions of the wood members as needed. |
| Recommendation: | | Replace the fungus damaged portions of the rafter end as needed. |
| Recommendation: | | Replace the fungus damaged portions of roof sheathing as needed. |
| Recommendation: | | Remove and replace the damaged portions of the substructure access frame as needed to eliminate the fungus infection and damage. |

| Recommendation: | | Reset the toilet using a new wax seal and bolts. Additional costs may apply if the toilet flange is found to be damaged or if existing supply line/valve cannot be reused. |
| Recommendation: | | Make the necessary corrections to eliminate the leakage at the substructure drain line. |
