## RESIDENTIAL REPORT

5433 Beckford St  
Ventura, CA 93003

Mei-Hua Peterson Trust  
07/31/2025

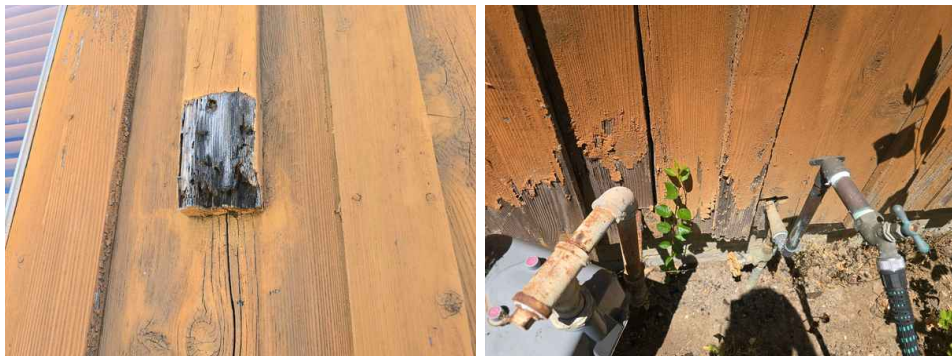
**WOOD DAMAGE NOTED**

Wood damage noted on the trim/siding should be evaluated/repared by a qualified pest control company.

Contact a qualified pest control specialist.

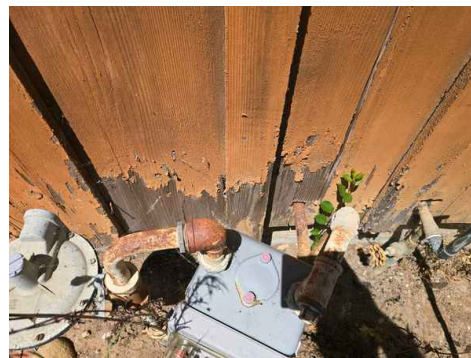
### 2.2.2 Siding, Flashing & Trim:

#### **NEEDS PAINT OR STAIN**

The exterior trim needs re-staining or re-painting to protect it from damage.

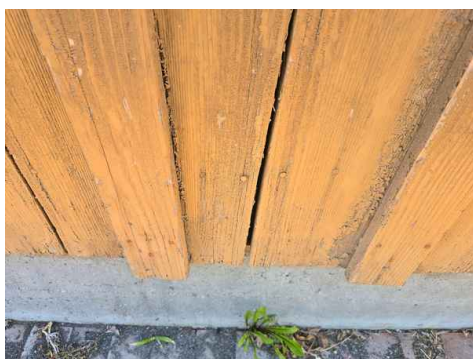
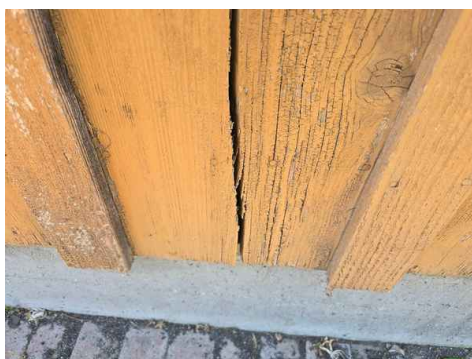
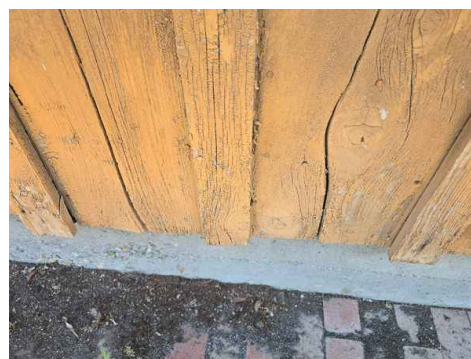
### 2.2.3 Siding, Flashing & Trim:

#### **GAPS/HOLES/CRACKS NOTED AT SIDING**

The gaps/hole(s) at the siding should be repaired to prevent damage from moisture penetration and vermin.

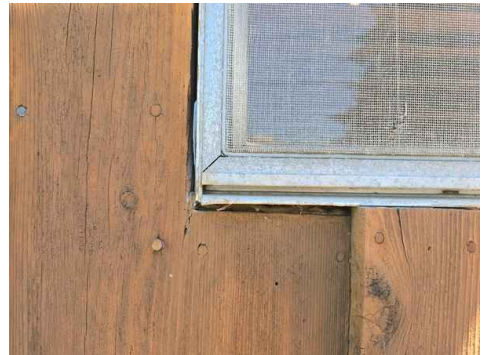
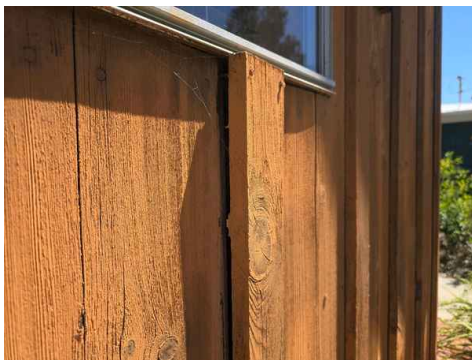
## 2.2.4 Siding, Flashing &amp; Trim:

**CAULKING NEEDED**

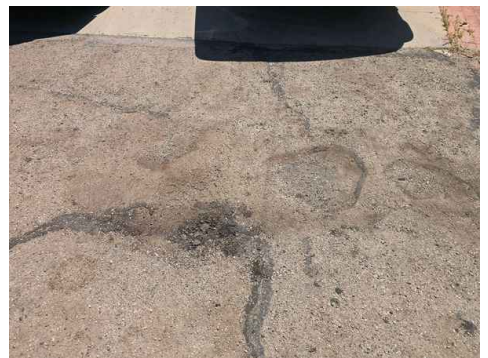
## 2.6.1 Driveways &amp; Walkways:

**DRIVEWAY CRACKING - REPAIR**

Cracks due to settling or lift was observed. We recommend repairing or replacing these areas as needed to prevent further deterioration.

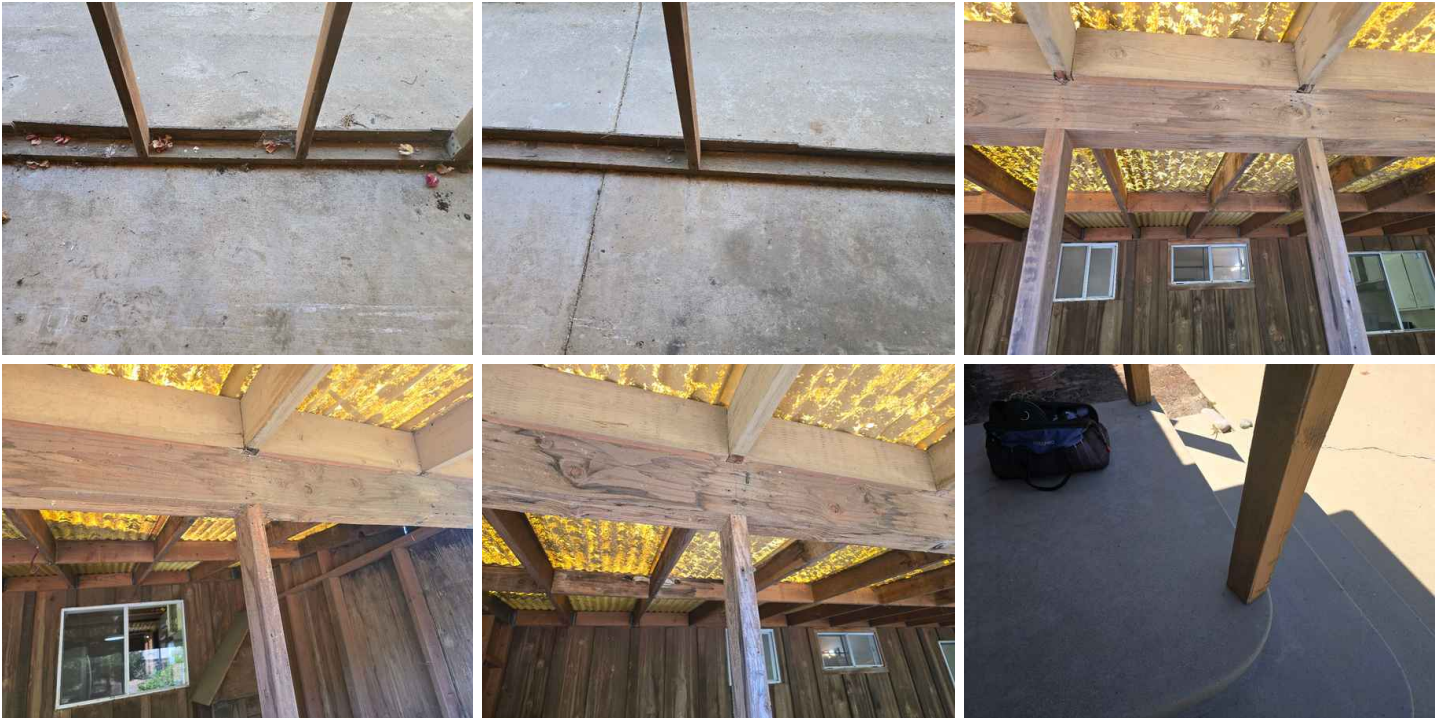
2.8.2 Patio Cover(s):  
**LOOSE/DAMAGED POSTS**  
VARIOUS EXTERIOR

The patio posts are damaged and should be repaired or replaced as needed.

Recommendation  
Contact a qualified professional.

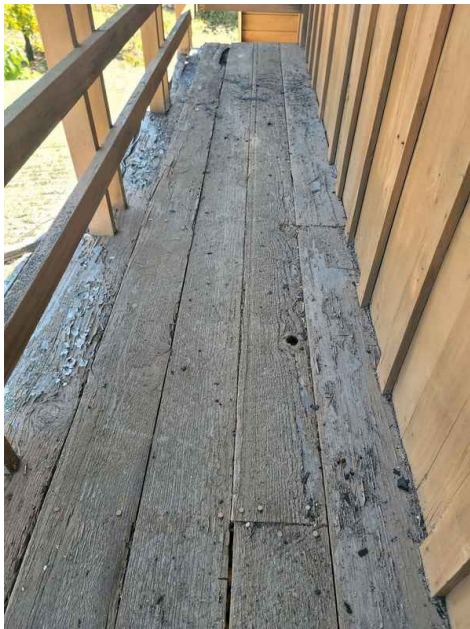
**WOOD DAMAGE NOTED**

One or more boards are showing wood damage. Recommend a qualified pest control company or contractor evaluate and repair as needed.

Contact a qualified deck contractor.

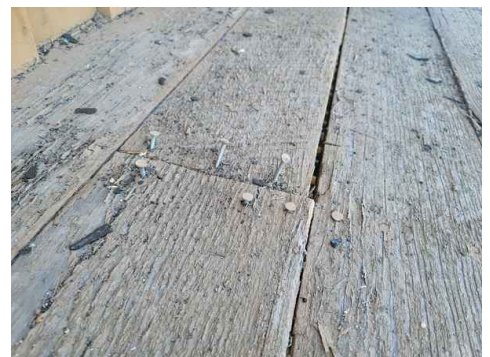
## 2.9.2 Decks &amp; Balconies:

**BALCONY - NAILS EXPOSED**

One or more nails were observed to be exposed. We recommend the nails be properly sealed to prevent leakage.

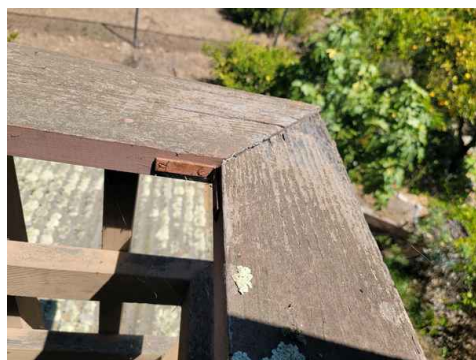
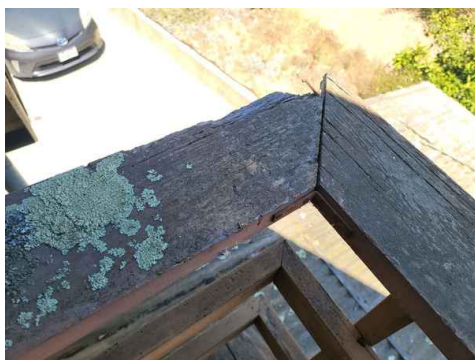
## 2.10.1 Stairs, Guardrails &amp; Handrails:

**WOOD DAMAGE**

The wood damaged railing should be evaluated and repaired by a qualified pest control company for safety.

Contact a qualified pest control specialist.

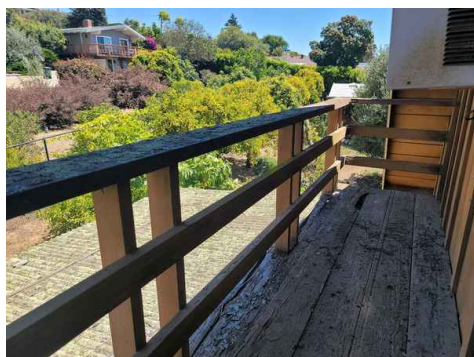
2.10.2 Stairs, Guardrails & Handrails:

### **RAILING IS CLIMBABLE**

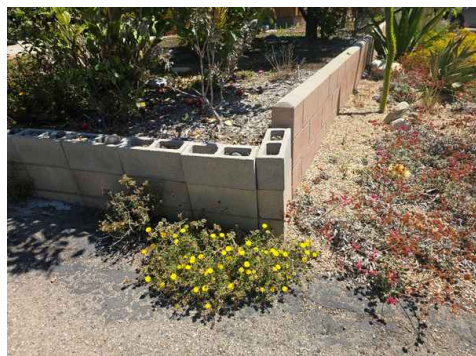
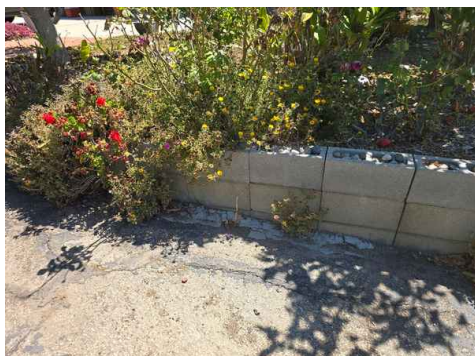
2.12.1 Fencing & Walls:

### **LEANING/DAMAGED/LOOSE BLOCK WALL NOTED**

The leaning/loose/damaged sections of the block wall should be repaired as needed.

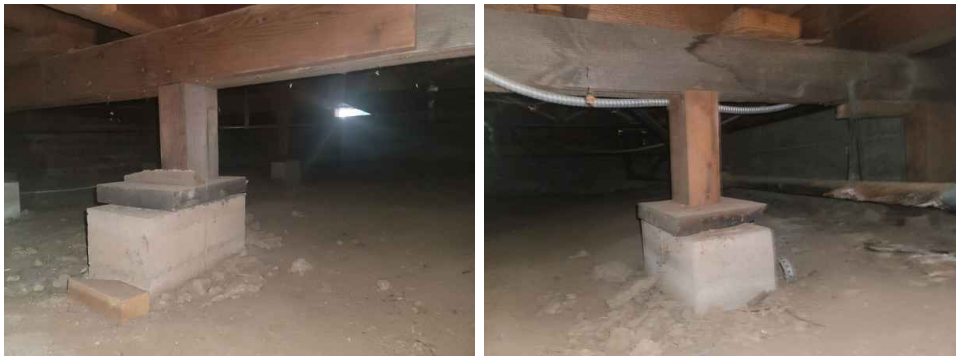
We recommend upgrading the foundation by adding straps to the posts and beams or by installing additional footings with straps that will add better stability in case of earthquakes.

Recommendation  
Contact a qualified professional.

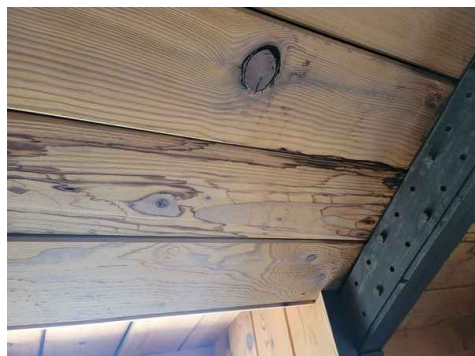
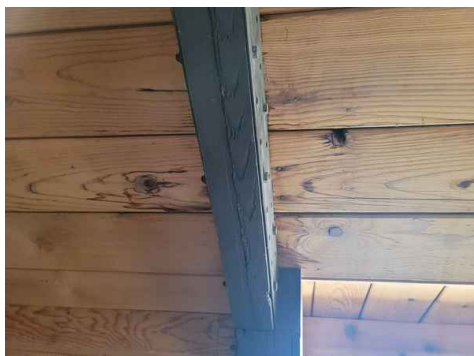
## 3.7.1 Roof and Ceiling Structure:

**OLD STAINS CURRENTLY DRY**

The stains appear to be from previous leakage. Although not wet at this time, we recommend checking with the seller as to what repairs were made or have a qualified roofing contractor evaluate further.

Recommend monitoring.

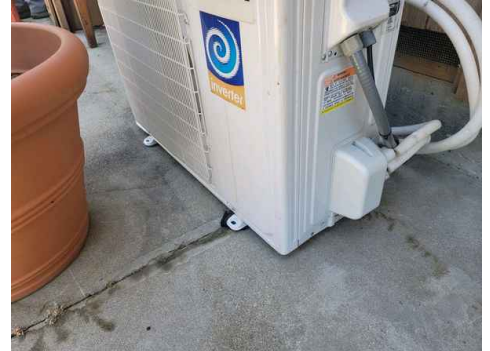
#### MISSING PAD(S)

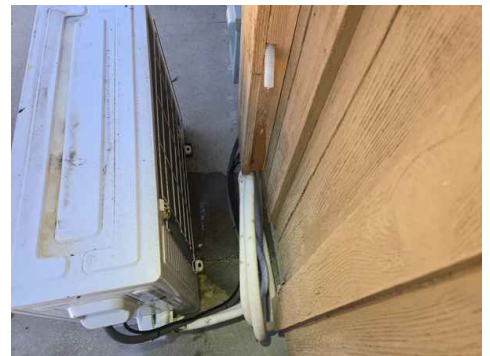
The condensate drain line is incorrectly routed to an unacceptable location. We recommend having a qualified contractor evaluate and determine a better solution. Excessive ponding was noted.

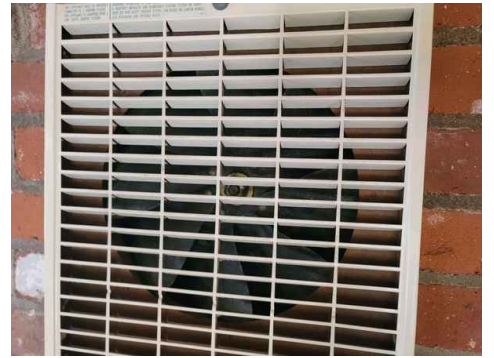
The heating unit fan is not operational and should be repaired or replaced as needed.

Contact a qualified professional.

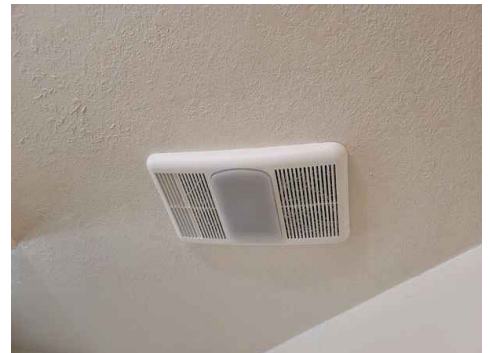
The electric heat in the bathroom is not operational and should be repaired or replaced as needed.

Contact a qualified professional.

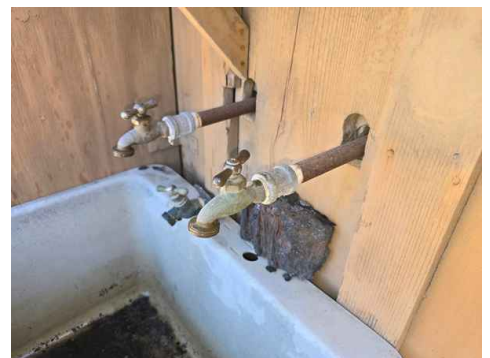
**CORRODED CONNECTION NOTED**

The corroded plumbing piping and/or connections should be repaired or replaced as needed to prevent damage from leakage and to prevent water flow reduction.

Contact a qualified plumbing contractor.

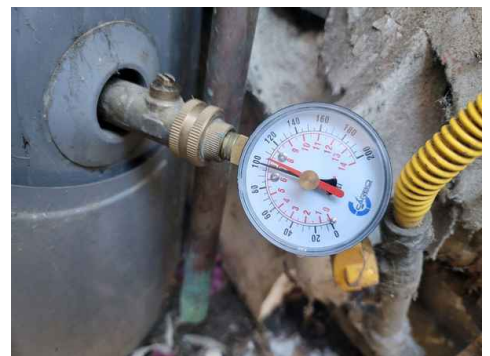
### 11.3.1 Water Pressure:

100 psi

Contact a qualified plumbing contractor.

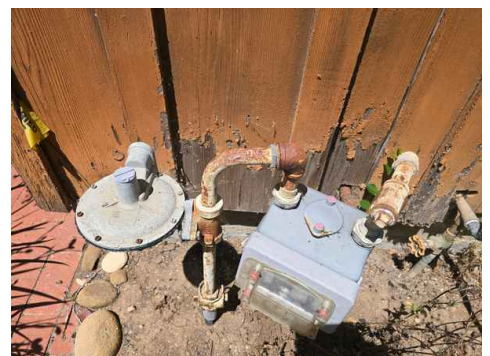
### 11.4.1 Fuel Supply & Distribution

**CORROSION - METER PIPES MINOR**

Contact a qualified professional.

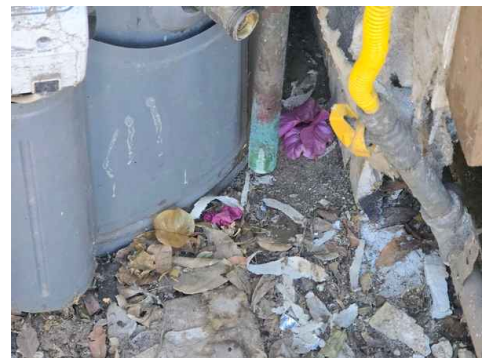
12.4.1 Water Heater TPR Valve:

### **TERMINATE TPR VALVE PIPE TO EXTERIOR**

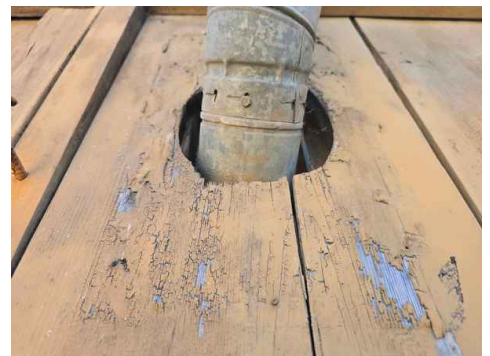
12.5.1 Water Heater Venting:

### **INADEQUATE CLEARANCE OR MISSING VENT COLLAR**

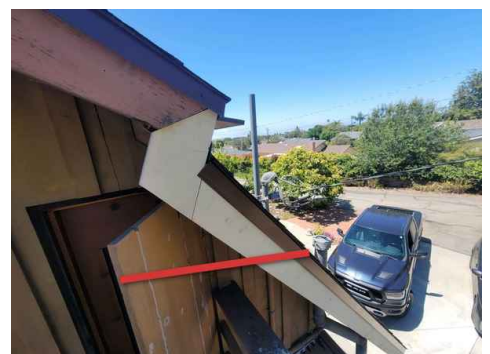
12.5.2 Water Heater Venting:

### **INADEQUATE CLEARANCE TO OPENABLE WINDOW**

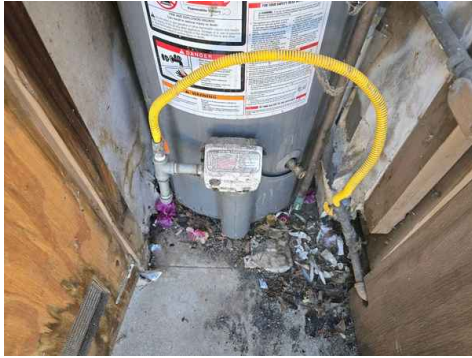
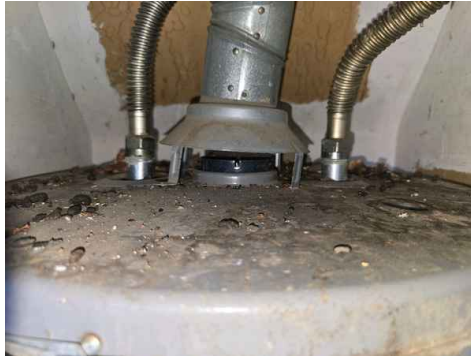
## 12.6.1 Water Heater Miscellaneous:

**MISSING BONDING**

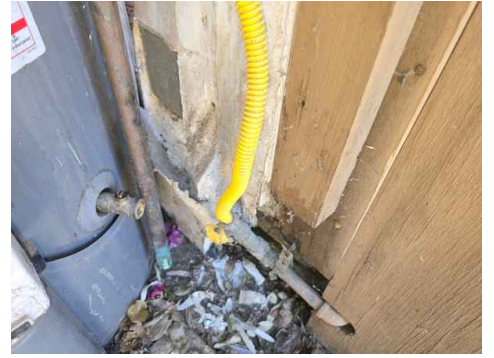
## 12.6.4 Water Heater Miscellaneous:

**MOISTURE STAINS NOTED**

Contact a qualified professional.

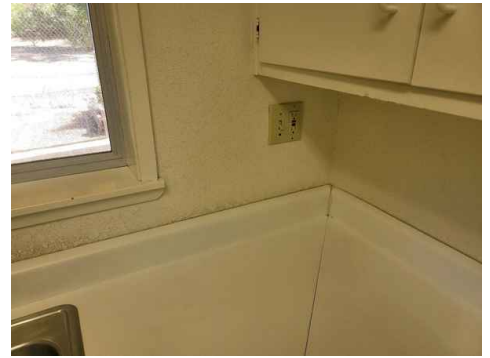
GFCI appears to be defective and should be replaced for safety.  
[Here is a link](#) to read about how GFCI receptacles keep you safe.  
For more information or to order GFCI receptacles go here: [GFCIs](#)  
Recommendation  
Contact a qualified electrical contractor.

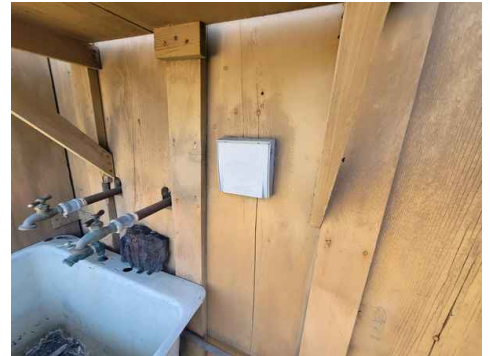
### 13.6.3 GFCI & AFCI:

#### **THE OPEN-GROUNDED GFCI SHOULD BE CORRECTED**

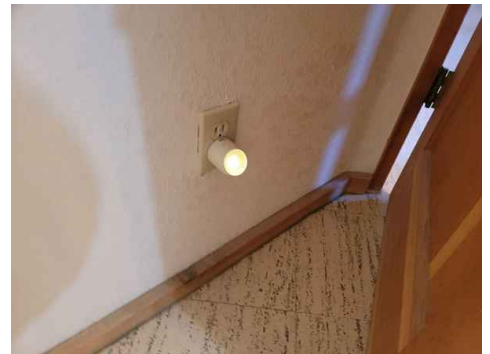
### 13.7.1 Receptacles:

#### **LOOSE RECEPTACLE(S) NOTED**

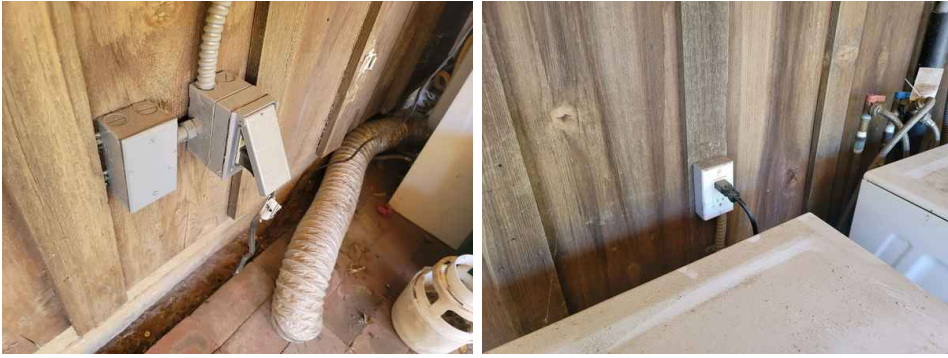
### 13.7.2 Receptacles:

#### **INSTALL WEATHERPROOF COVER(S)**

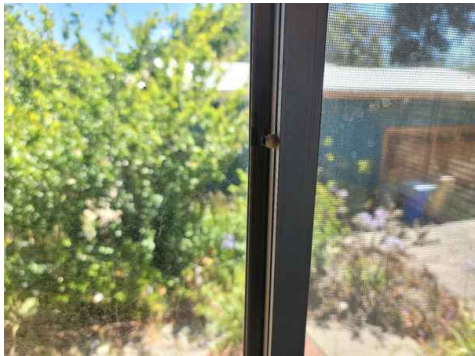
## 15.5.2 Windows:

**BROKEN WINDOW LATCH(ES)**

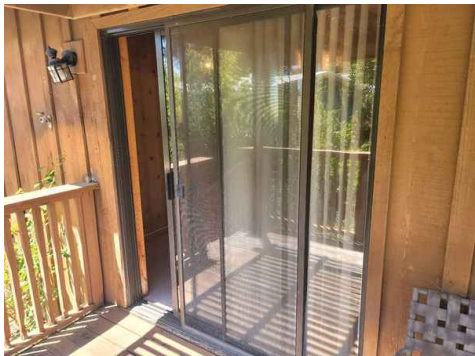
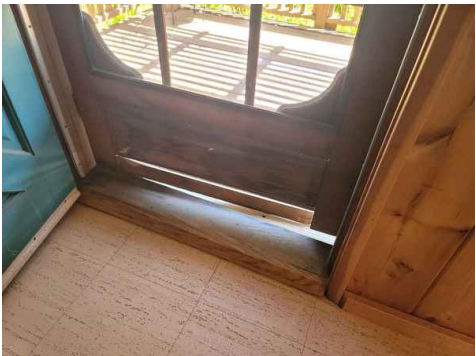
15.6.2 Window and Door Screens:

**SCREEN DOOR NEEDS REPAIR**

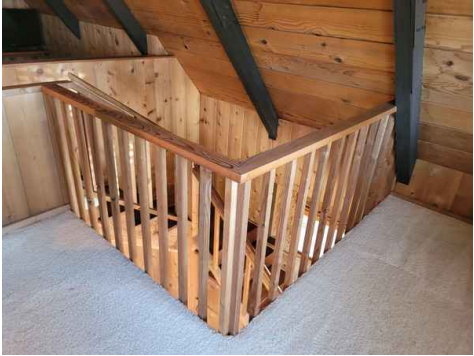
15.10.1 Steps, Stairways & Railings:

**BALUSTER SPACING NEEDS UPGRADING**

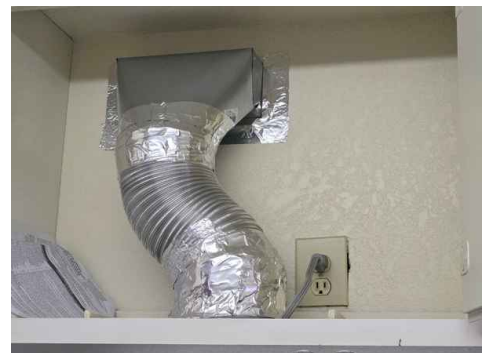
16.4.1 Exhaust Systems:

### **"RIBBED" VENT DUCT NOTED**
