# 805 Home Inspections

## Property Inspection Report

2648 State Street, Unit 25, Santa Barbara, CA 93105  
Inspection prepared for: Daniel Bartal  
Real Estate Agent: Ingrid Vangelos - EXP Realty

Date of Inspection: 6/29/2026

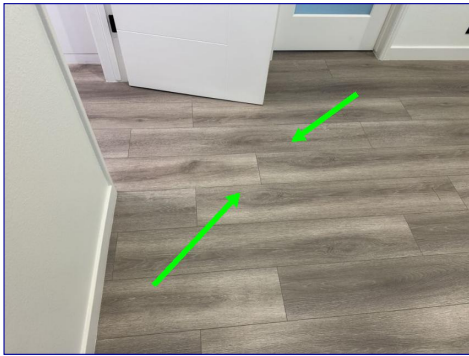
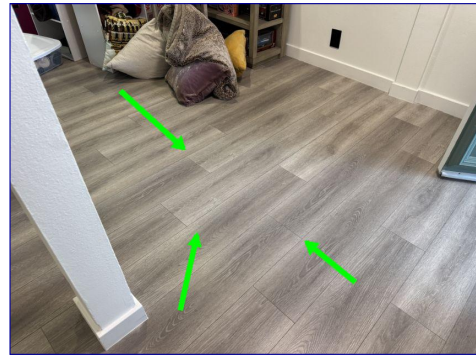
Interior Areas Flooring Condition

- **The home had laminate type wood flooring with lifted areas in the Primary bedroom and the living room. The flooring made popping noises when stepped on and may have been installed too tight to the walls. See photos. Suggest repairs as needed by a flooring company.**

| Interior Areas | | |
|---|---|---|
| Page 6 Item: 7 | Flooring Condition | <ul style="list-style-type: none"> <li>• The home had laminate type wood flooring with lifted areas in the Primary bedroom and the living room. The flooring made popping noises when stepped on and may have been installed too tight to the walls. See photos. Suggest repairs as needed by a flooring company.</li> </ul> |

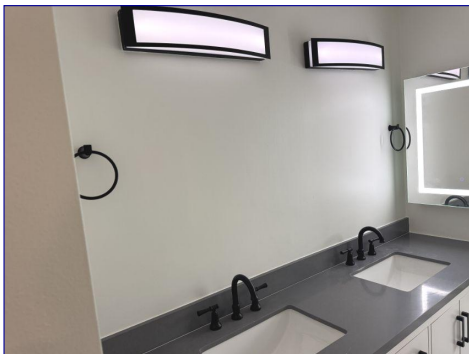
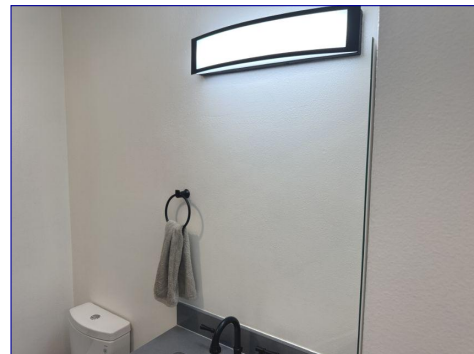
Bathroom Bathroom Mirrors

- The bathrooms were missing the installed bathroom mirrors at the backs of the sinks. See photos. Suggest repairs as needed.

| Interior Areas | | |
|---|---|---|
| Page 8 Item: 4 | Bathroom Mirrors | <ul style="list-style-type: none"> <li>• The bathrooms were missing the installed bathroom mirrors at the backs of the sinks. See photos. Suggest repairs as needed.</li> </ul> |

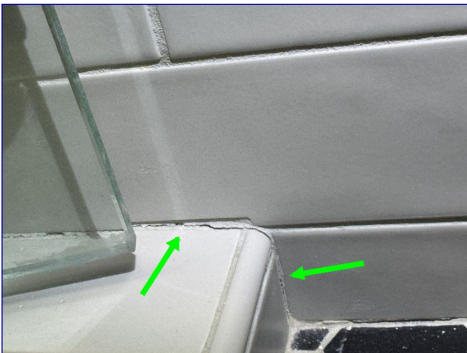
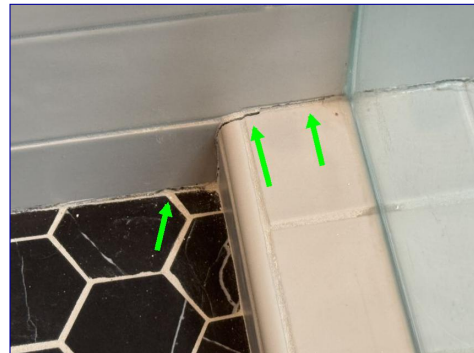
- **Shower floor pan and wall tile gaps:** The Primary bathroom tiled shower had open gaps along the floor pan and the walls of the shower. The open gaps in the grouted seams will allow moisture to enter the walls of the shower. See photos. Suggest repairs as needed.

**Shower floor pan and wall tile gaps:** The Primary bathroom tiled shower had open gaps along the floor pan and the walls of the shower. The open gaps in the grouted seams will allow moisture to enter the walls of the shower. See photos. Suggest repairs as needed.

| Interior Areas | | |
|---|---|---|
| Page 9 Item: 8 | Bathtub / Shower Condition | <ul style="list-style-type: none"> <li>• <b>Shower floor pan and wall tile gaps:</b> The Primary bathroom tiled shower had open gaps along the floor pan and the walls of the shower. The open gaps in the grouted seams will allow moisture to enter the walls of the shower. See photos. Suggest repairs as needed.</li> </ul> |

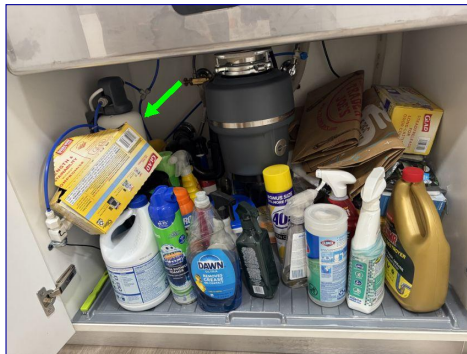
The home had a drinking water filtering system installed under the kitchen sink. See photo. Suggest consulting seller for proper care and maintenance for the filter system.

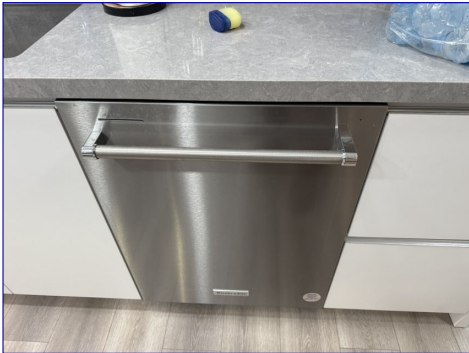
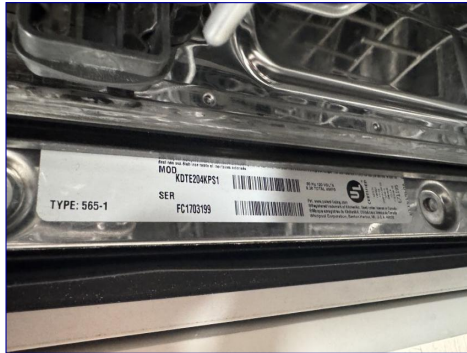
- The dishwasher was turned on and tested by running for a short wash cycle and tested with an infrared thermometer, which shows the heated water inside the dishwasher. The photo serves to show the dishwasher was found to be functional when tested at the time of the inspection. The inspection of the appliance was not intended to cover the cleanliness of the appliance, only the functionality of it. The home inspector provides no warranty nor has an obligation to replace or repair items damaged or found to be nonfunctional at a later date. The information provided is what was observed at the time of the inspection and does not reflect future conditions. It is recommended that you purchase your own home warranty for all appliances.

Kitchen dishwasher manufacturer information.

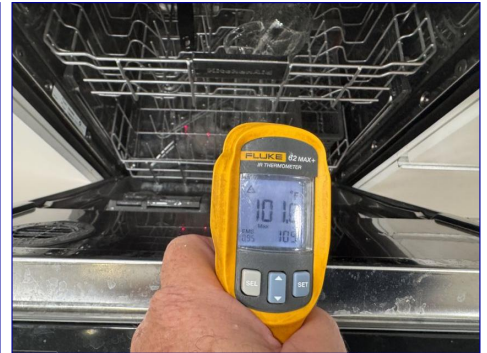
The dishwasher was turned on and tested by running for a short wash cycle and tested with an infrared thermometer, which shows the heated water inside the dishwasher. The photo serves to show the dishwasher was found to be functional when tested at the time of the inspection.

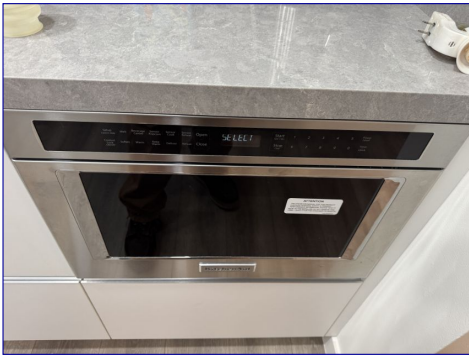
- The microwave was found to be functional at the time of the inspection by placing a small cup of water inside and heating it for 40 seconds. The inspection of the appliance was not intended to cover the cleanliness of the appliance, only the functionality of it. See photo. The home inspector provides no warranty nor has an obligation to replace or repair items damaged or found to be nonfunctional at a later date. The information provided is what was observed at the time of the inspection and does not reflect future conditions. It is recommended that you purchase your own home warranty for all appliances.

Microwave manufacturer information.

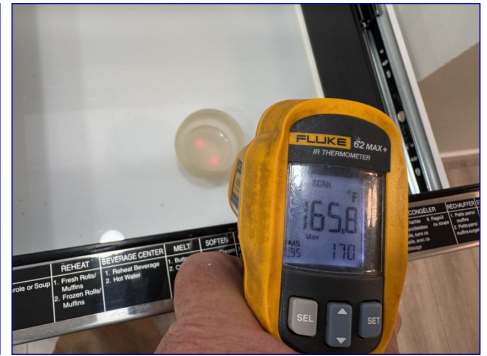
The microwave was found to be functional at the time of the inspection by placing a small cup of water inside and heating it for 40 seconds. See photo.

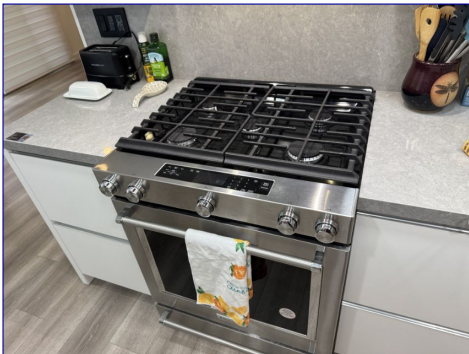
- The kitchen gas oven was tested using installed controls and it functioned normally at the time of the inspection and verified with an infrared thermometer. The inspection of the appliance was not intended to cover the cleanliness of the appliance, only the functionality of it. See photos. The home inspector provides no warranty nor has an obligation to replace or repair items damaged or found to be nonfunctional at a later date. The information provided is what was observed at the time of the inspection and does not reflect future conditions. It is recommended that you purchase your own home warranty for all appliances.

Oven manufacturer information.

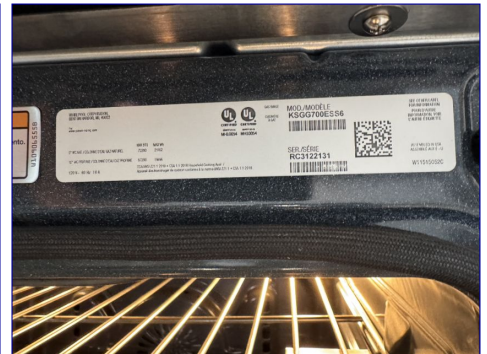
The kitchen gas oven was tested using the installed controls and it functioned normally at the time of the inspection. Verified with an infrared thermometer. See photo.

Oven manufacturer information.

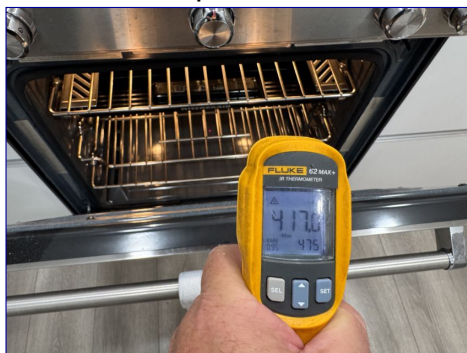
The kitchen gas oven was tested using the installed controls and it functioned normally at the time of the inspection. Verified with an infrared thermometer. See photo.

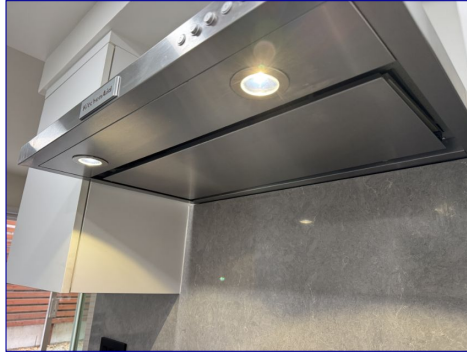
The kitchen exhaust system over the oven was found to be functional at time of inspection.

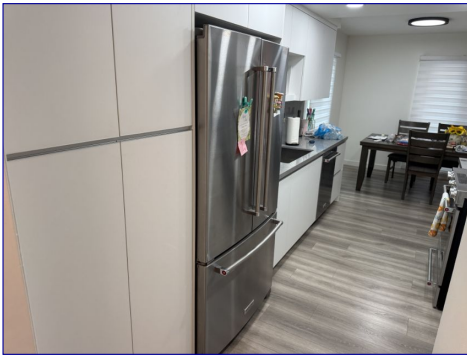
- The refrigerator was tested with an infrared thermal meter showing a normal temperature and found to be functional at time of inspection. The inspection of the appliance was not intended to cover the cleanliness of the appliance, only the functionality of it. See photos. The home inspector provides no warranty nor has an obligation to replace or repair items damaged or found to be nonfunctional at a later date. The information provided is what was observed at the time of the inspection and does not reflect future conditions. It is recommended that you purchase your own home warranty for all appliances.

- **Seller:** The refrigerator had a water dispensing and ice making system installed, but were turned off at the time of the inspection. Suggest commenting on the functionality of the refrigerator's water and ice maker and dispensing systems.

Refrigerator name and model information.

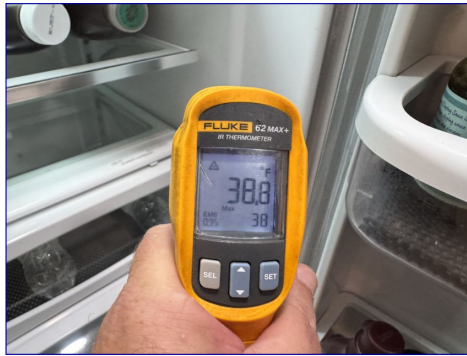
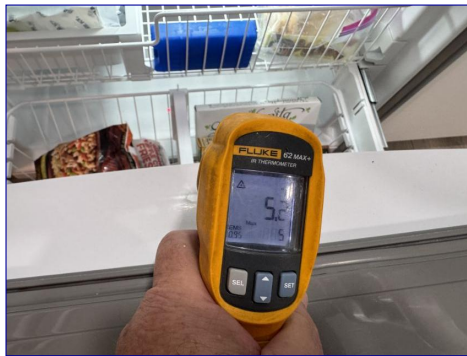
The refrigerator was tested with an infrared thermal meter showing a normal temperature and found to be functional at time of inspection. See photo.

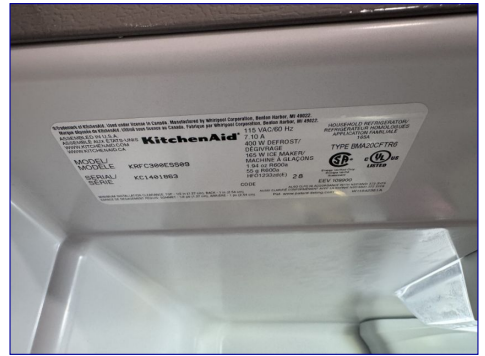
Refrigerator name and model information.

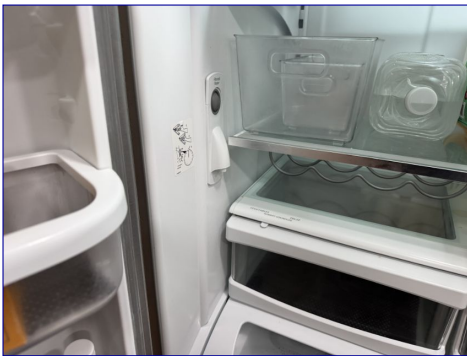
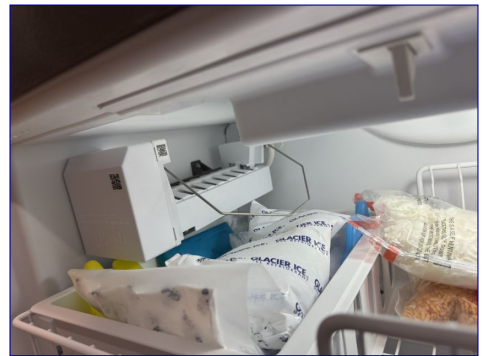
**Seller: The refrigerator had a water dispensing and ice making system installed, but were turned off at the time of the inspection. Suggest commenting on the functionality of the refrigerator's water and ice maker and dispensing systems.**

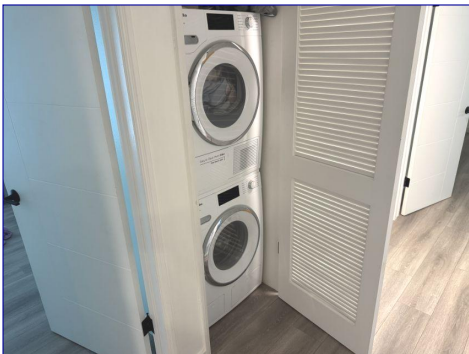
- The laundry washing machine and clothes dryer were tested using the control boards and were functional at the time of the inspection. The home inspector provides no warranty nor has an obligation to replace or repair items damaged or found to be nonfunctional at a later date. The information provided is what was observed at the time of the inspection and does not reflect future conditions. It is recommended that you purchase your own home warranty for all appliances.

• **Missing catch pan:** The indoor clothes washer had no catch pan installed to prevent water damaged to the home in the event of a leak. Suggest installing a catch pan with a drain to the exterior of the home.

Clothes washer and dryer info.

| Interior Areas | | |
|---|---|---|
| Page 15 Item: 5 | Washer & Dryer | <ul style="list-style-type: none"> <li>• <b>Missing catch pan:</b> The indoor clothes washer had no catch pan installed to prevent water damaged to the home in the event of a leak. Suggest installing a catch pan with a drain to the exterior of the home.</li> </ul> |

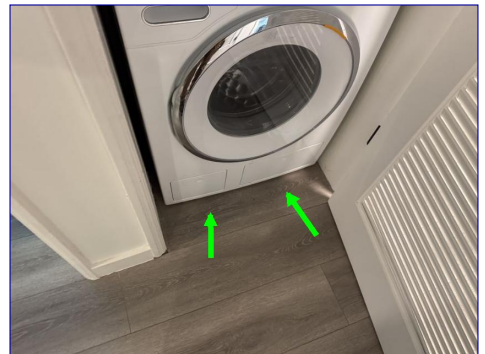
**Missing catch pan:** The indoor clothes washer had no catch pan installed to prevent water damaged to the home in the event of a leak. Suggest installing a catch pan with a drain to the exterior of the home.

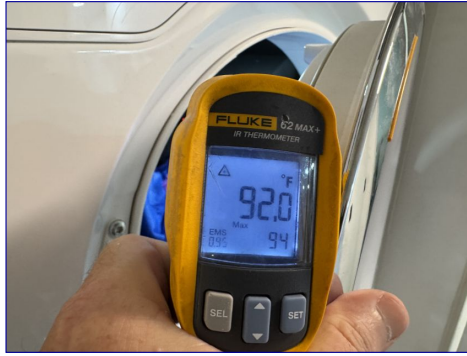
The laundry dryer was operated using the normal controls and found to be function with an infrared thermal meter at the time of the inspection. See photo.

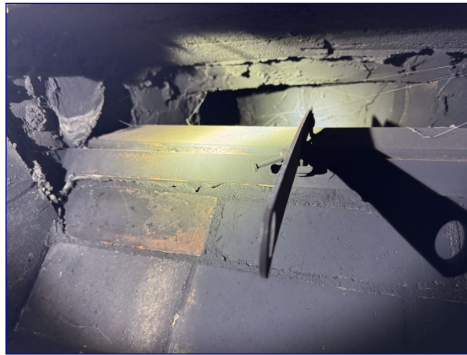
Fireplace Fireplace Lintel, Damper, Firebox

- The damper and firebox all appeared to be functional at the time of the inspection.

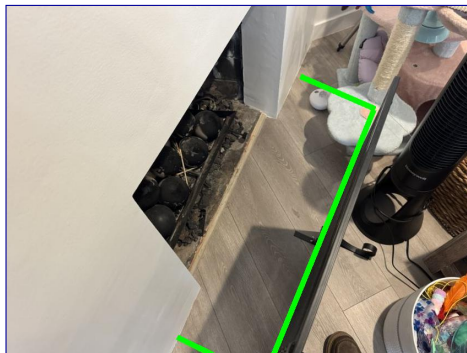
**Gas log with no hearth:** The fireplace was missing an installed non-flammable hearth at the front of the firebox, but it did have a functional gas log setup installed, so a protective hearth was not required only suggested. See photo.

| Interior Areas | | |
|---|---|---|
| Page 17 Item: 3 | Fireplace Hearth Condition | <ul style="list-style-type: none"> <li>• <b>Gas log with no hearth:</b> The fireplace was missing an installed non-flammable hearth at the front of the firebox, but it did have a functional gas log setup installed, so a protective hearth was not required only suggested. See photo.</li> </ul> |

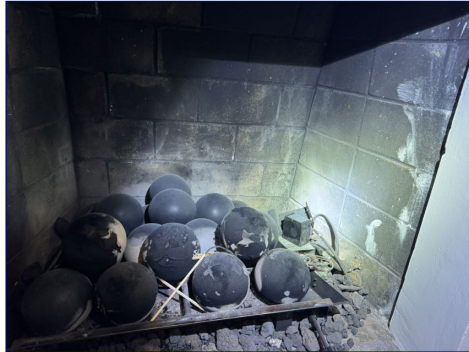
**Remote operated fire logs:** The fireplace had a gas log system installed that operates with a remote. The system would not light at the time of the inspection. Suggest repairs as needed.

| Page 18 Item: 4 | Fireplace Gas Valve | <ul style="list-style-type: none"> <li>• <b>Remote operated fire logs:</b> The fireplace had a gas log system installed that operates with a remote. The system would not light at the time of the inspection. Suggest repairs as needed.</li> </ul> |

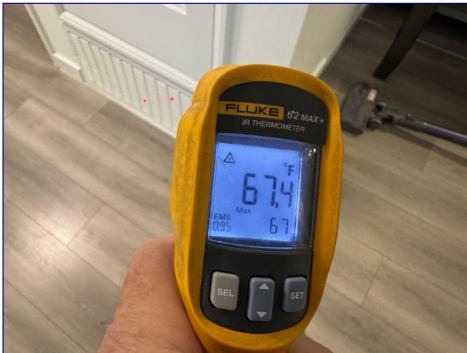
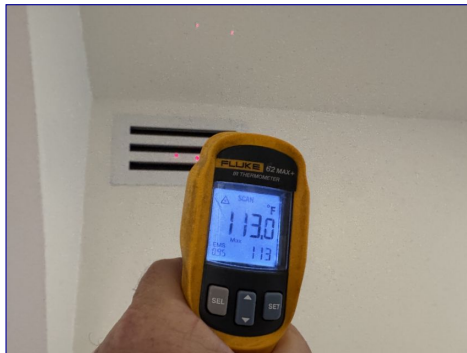
Central Heating / Cooling Systems Forced Air System Condition

- The furnace was operated using the wall thermostat. The furnace was run for ten minutes and the air was tested with an infrared thermal meter before and after running the system, showing a temperature change of more than ten degrees at the registers. The test shows the gas furnace was functional at time of inspection. See photos. The home inspector provides no warranty nor has an obligation to replace or repair items damaged or found to be nonfunctional at a later date. The information provided is what was observed at the time of the inspection and does not reflect future conditions. It is recommended that you purchase your own home warranty for all appliances.

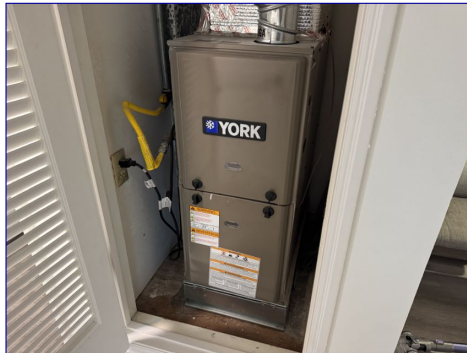
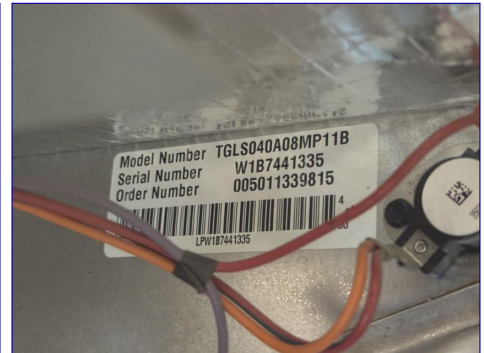
Furnace manufacturer information.

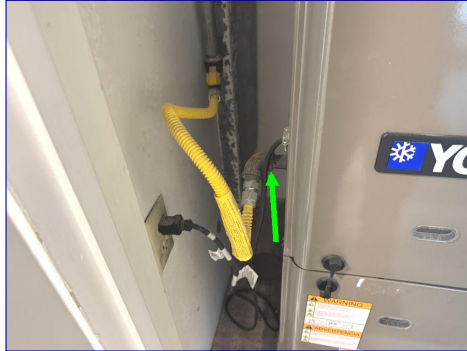
**Missing sediment trap:** There should be an installed sediment trap at the CSST flex line connection, between the gas shutoff valve and the furnace. See photo. Suggest repairs by a qualified HVAC company.

| Page 20 Item: 4 | Furnace Gas Flex Line & Valve Condition | <ul style="list-style-type: none"> <li>• <b>Missing sediment trap:</b> There should be an installed sediment trap at the <b>CSST</b> flex line connection, between the gas shutoff valve and the furnace. See photo. Suggest repairs by a qualified HVAC company.</li> </ul> |

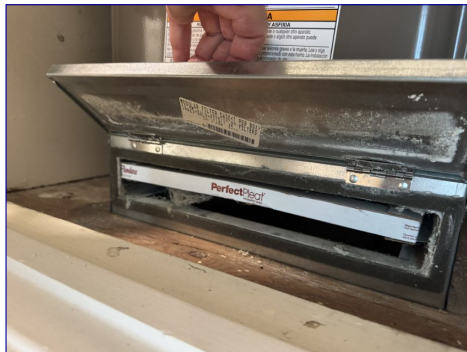
The furnace air filter was located inside the lower area of the furnace. The front furnace panel has to be opened to gain access.

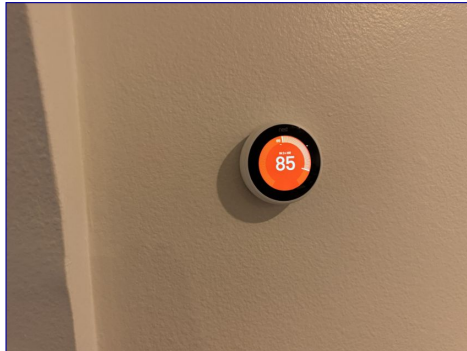
The furnace wall thermostat was located on the wall of the living room.

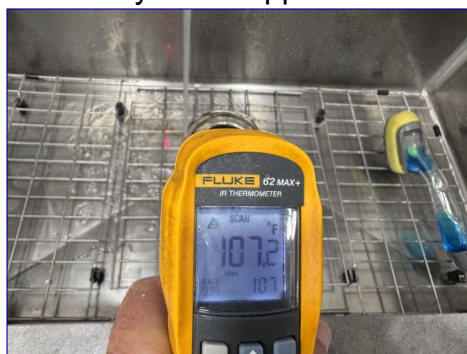
The functionality of the water heater was tested using an infrared thermal tester on the running hot water at the kitchen sink to confirm the water heater was functional at the time of the inspection. See photo.

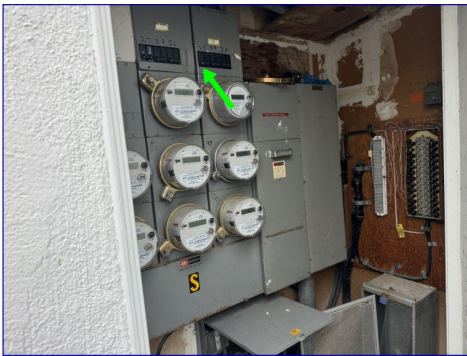
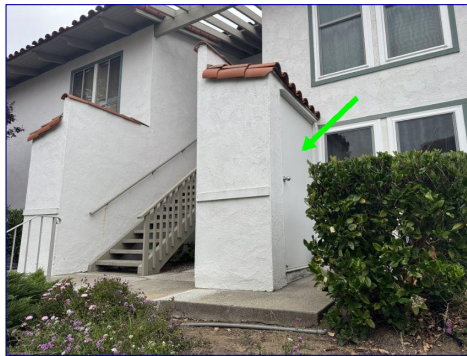
The installed breakers in the main electrical panel were all functional at the time of the inspection.

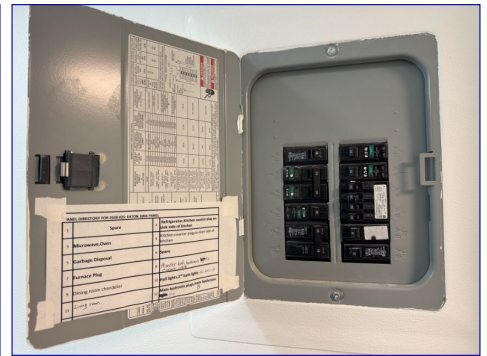
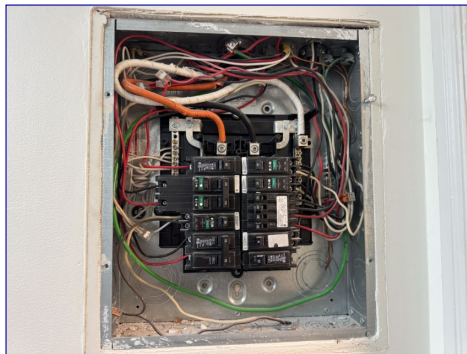
The sub electrical panel appeared to be functional at the time of the inspection.

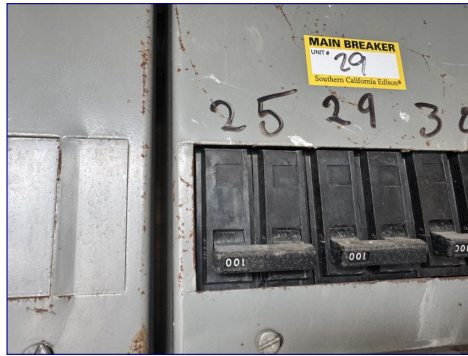
The home had a 100 AMP electrical service installed.

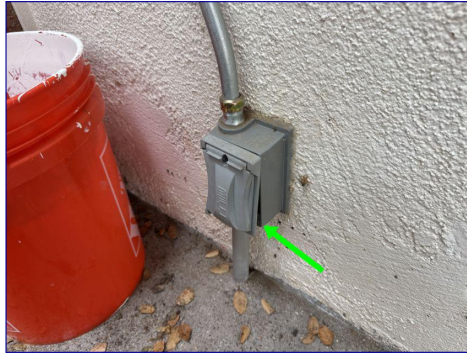
The exterior back patio electrical outlet on the wall had a loose cover plate with an open gap. See photo. Suggest repairs as needed.

| Page 26 Item: 5 | Exterior Electrical Receptacles and GFCI | <ul style="list-style-type: none"> <li>• <b>The exterior back patio electrical outlet on the wall had a loose cover plate with an open gap. See photo. Suggest repairs as needed.</b></li> </ul> |

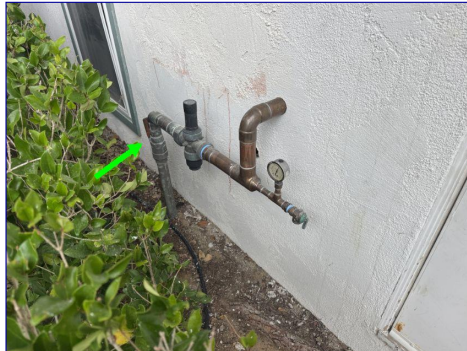
The potable water shutoff valve for the home was controlled by the HOA. Suggest you contact the HOA for questioned as needed.

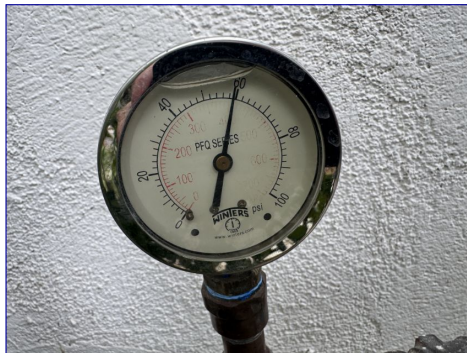
- The home's water pressure was tested and found to be 60 PSI at time of inspection. Recommend is 40 to 80 PSI to avoid unnecessary stress on the pipes and faucets to prevent leaks.

The home's water pressure was found to be 60 PSI when tested at the time of the inspection.

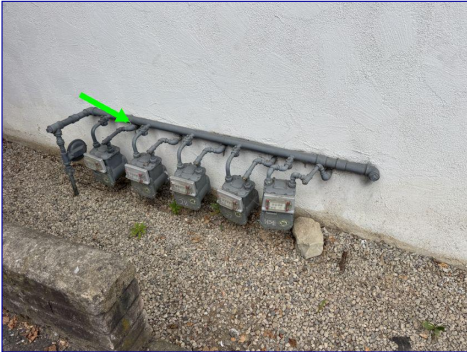
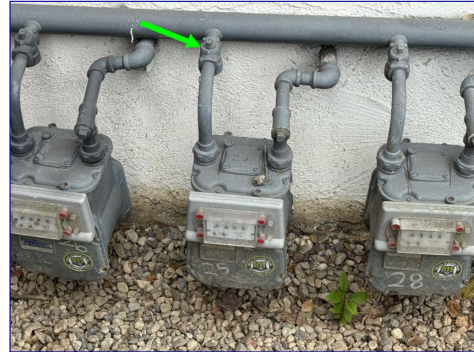
The natural gas utility meter and shutoff valve.
