**ELITE GROUP**  
INSPECTION PROFESSIONALS

PROPERTY LOCATION: 134 North 4th Street Unit E Alhambra, CA 91801

# INSPECTIONREPORT

Order ID: 403018, Pre Listing Inspection

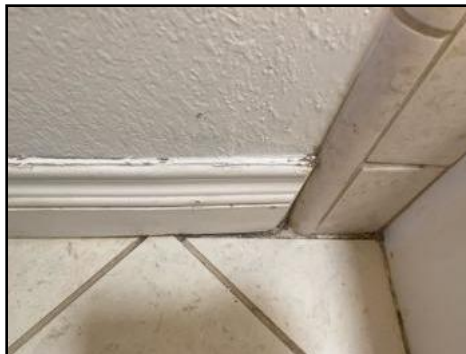
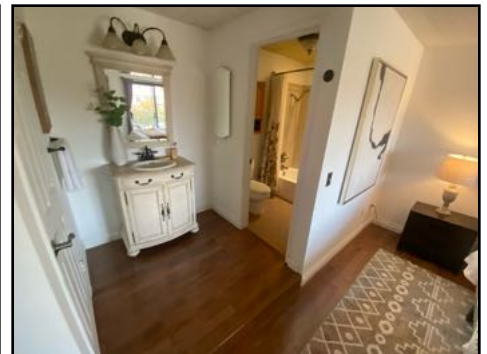
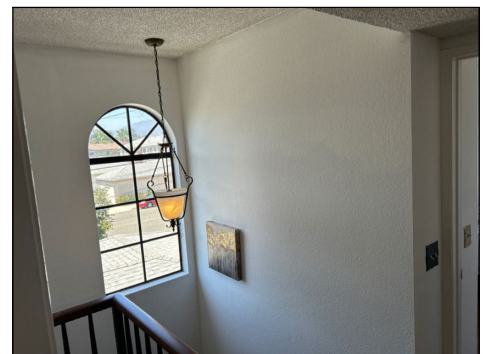
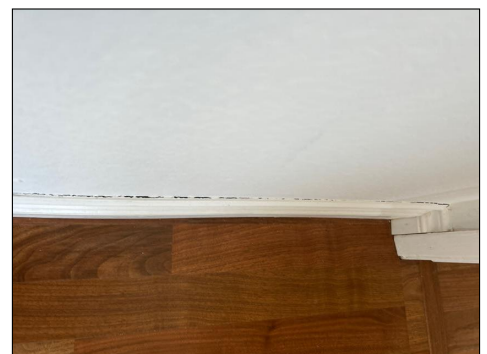
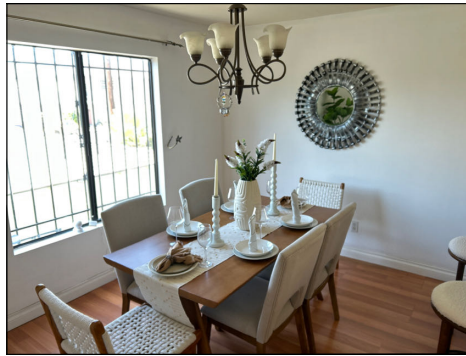
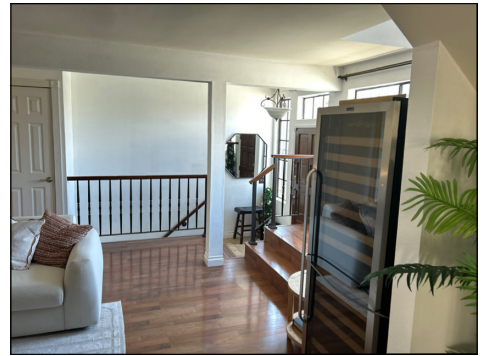
## 1. Wall Conditions

**Loose/worn/stained baseboards in areas - recommend service**

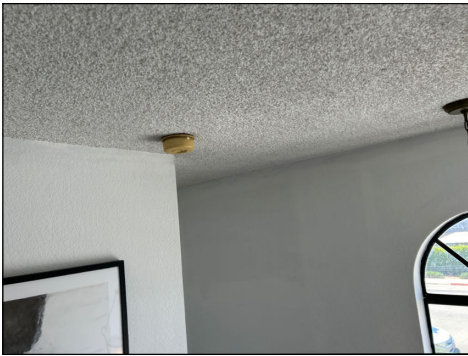
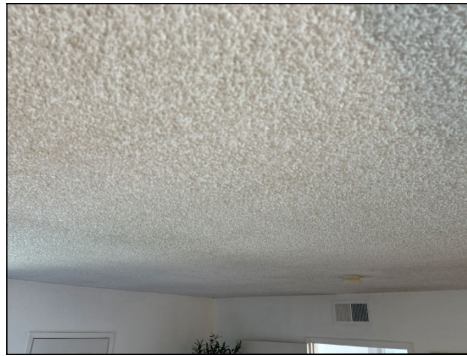
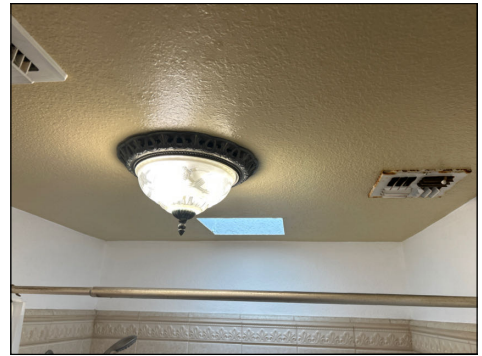
**Spotty areas or signs of moisture accumulation on ceiling in areas - recommend improving ventilation in the bathroom**

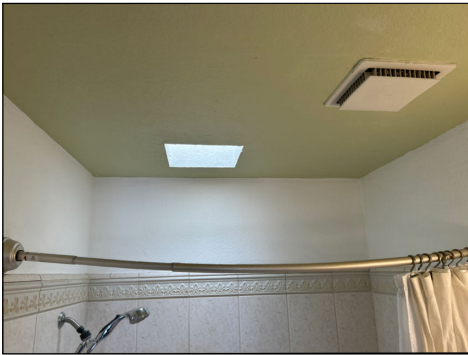
**Spotty areas or signs of moisture accumulation on ceiling in areas - recommend improving ventilation in the bathroom**

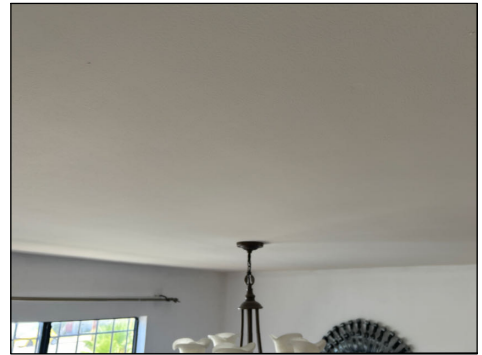
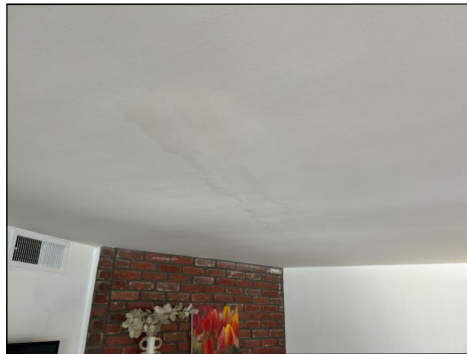
**Stained area at living room - area tested dry at time of inspection - evidence of past moisture issues/leaking - consult seller**

| INTERIOR | | |
|---|---|---|
| Page 13 Item: 2 | Ceiling Conditions | <ul style="list-style-type: none"> <li>• Stained area at living room - area tested dry at time of inspection - evidence of past moisture issues/leaking - consult seller</li> <li>• Peeling/blistered paint at skylights (bathrooms) - evidence of past moisture accumulation - cannot determine if leaking - recommend service</li> </ul> |

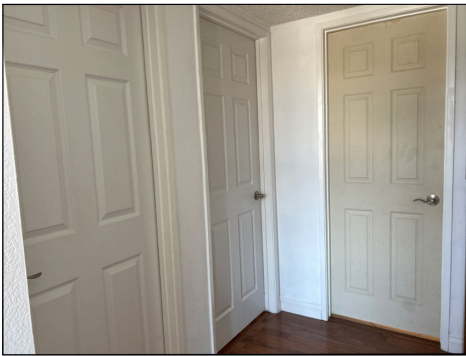
**Drags on floor slightly- recommend service**

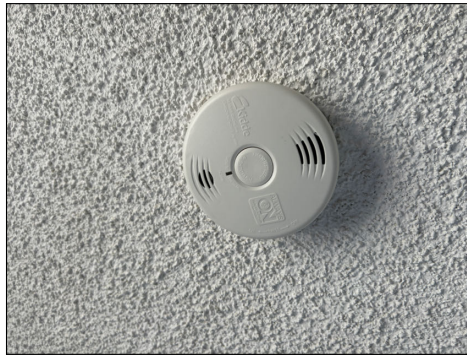
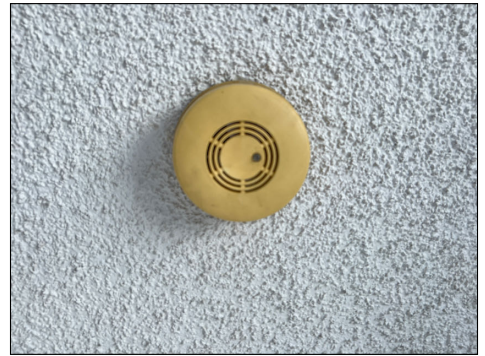
**Did not operate - needs to be serviced or replaced**

| INTERIOR | | |
|---|---|---|
| Page 20 Item: 16 | Smoke Detectors | <ul style="list-style-type: none"> <li>• Did not operate - needs to be serviced or replaced</li> <li>• Worn/older model suggest replacement with modern devices</li> <li>• Recommend upgrading all smoke detectors to the new 10-year battery life units</li> </ul> |

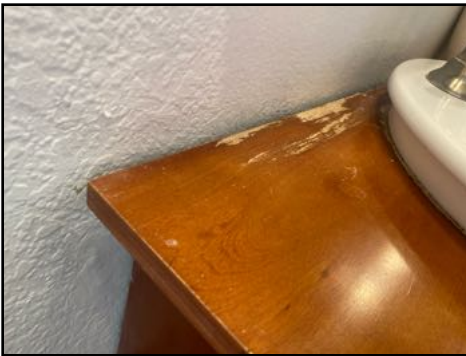
**Counter top and cabinet loose at wall - not secured properly - needs to be serviced at downstairs half, upstairs hall bathrooms**

| INTERIOR | | |
|---|---|---|
| Page 22 Item: 2 | Counters | <ul style="list-style-type: none"> <li>• Counter top and cabinet loose at wall - not secured properly - needs to be serviced at downstairs half, upstairs hall bathrooms</li> <li>• Counter does not have a back or side wall splash prevention materials - potential moisture damage may occur in these areas</li> </ul> |

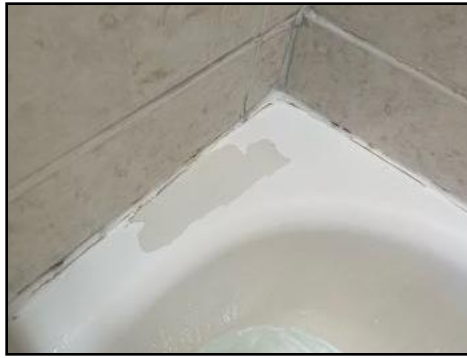
Materials are peeling/chipped at tub - minor

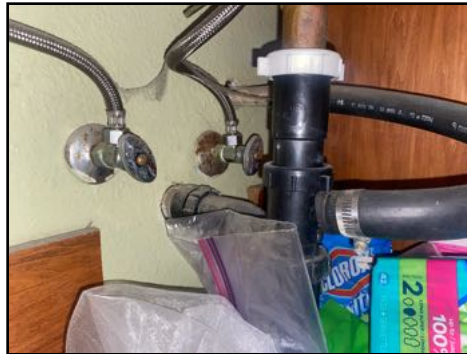
**Heavy silicone used under sink at drain/connections - evidence of past leaking - recommend evaluation at upstairs master bathroom**

| INTERIOR | | |
|---|---|---|
| Page 25 Item: 12 | Plumbing | <ul style="list-style-type: none"> <li>• Heavy silicone used under sink at drain/connections - evidence of past leaking - recommend evaluation at upstairs master bathroom</li> </ul> |

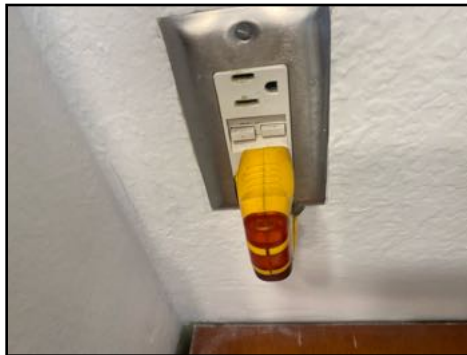
**None installed recommend upgrade for increased safety at master bathroom**

| INTERIOR | | |
|---|---|---|
| Page 26 Item: 14 | GFCIs | <ul style="list-style-type: none"> <li>• None installed recommend upgrade for increased safety at upstairs master bathroom</li> </ul> |

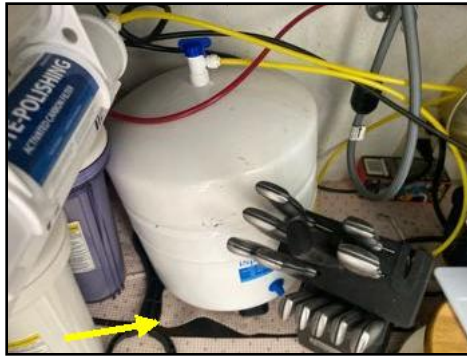
**Moisture damaged under sink at base - visible wet - evidence of moisture issues/leaking - needs to be serviced/evaluated**

| INTERIOR | | |
|---|---|---|
| Page 28 Item: 2 | Cabinets | <ul style="list-style-type: none"> <li>• Moisture damaged under sink at base - visible wet/moisture present - evidence of moisture issues/leaking (possibly filtration/drinking water) - needs to be serviced/evaluated as hidden damage may exist</li> </ul> |

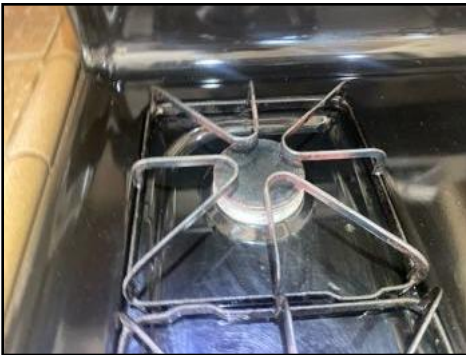
**Back left burner did not self light - needs to be serviced**

| Page 30 Item: 7 | Ranges | • Back left burner did not self light - needs to be serviced |

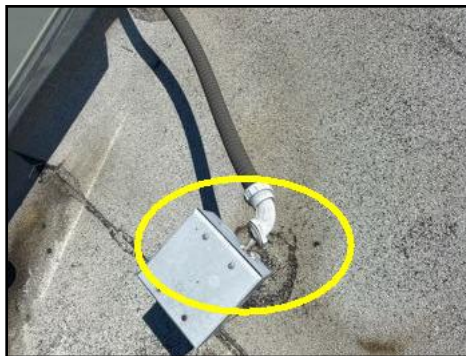
**Loose/detached conduit - exposed wiring (on roof) - needs to be serviced**

| Page 36 Item: 6 | Electrical | • Loose/detached conduit - exposed wiring (on roof) - needs to be serviced |

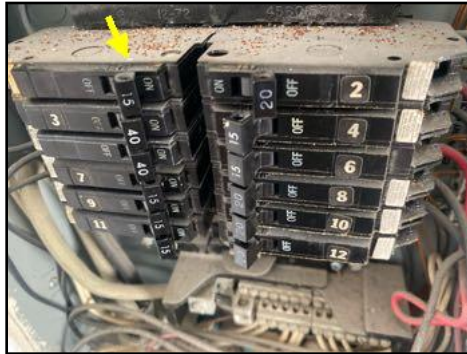
**20amp Breaker in off position -  
cause could not be determined -  
recommend evaluation**

| Page 43 Item: 4 | Breakers | • 20amp Breaker in off position - cause could not be determined - recommend evaluation |

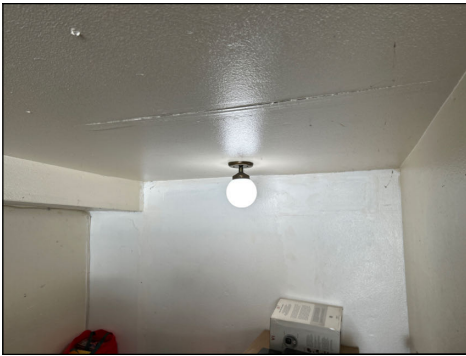
**Outlet cover missing - needs to be serviced**

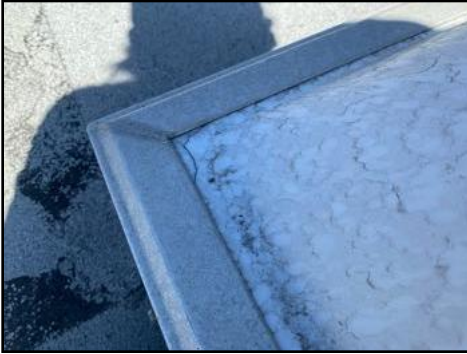
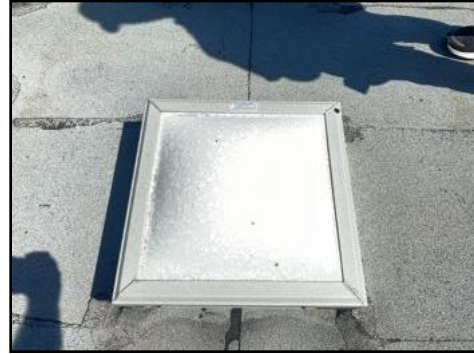
**Cracked lens - small - over master bathroom -  
recommend service/sealing/patching**

| Page 58 Item: 6 | Sky Lights | • Cracked lens - small - over master bathroom - recommend service/sealing/patching |

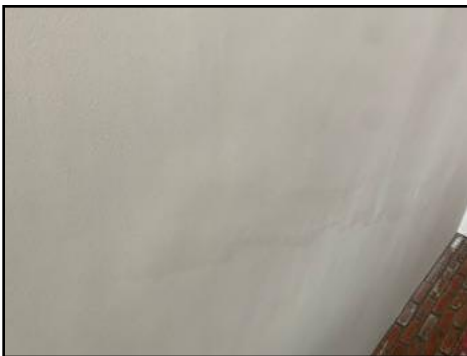
**Stained area at living room - area tested dry at time of inspection - evidence of past moisture issues/leaking - consult seller**
