## Inspection Services

### *Inspection Report*

Address: 1754 Brahma St Paso Robles, CA 93446

07/13/2026

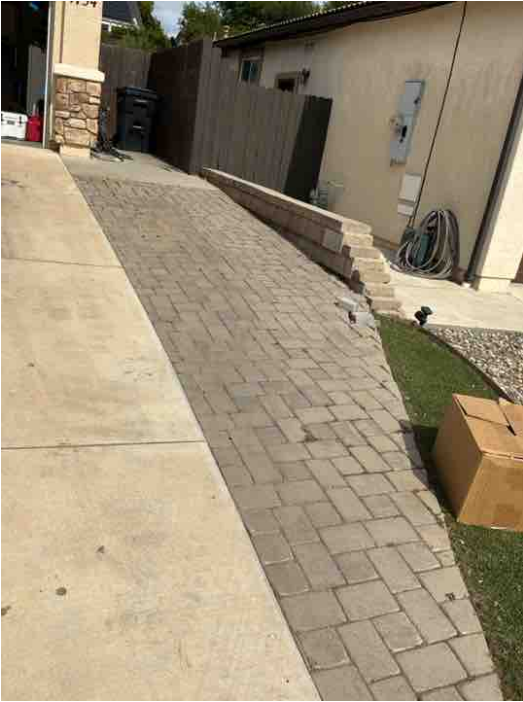
### 13: Brick Paver

**14:** Typical & common cracks found in areas of the driveway.

**SU** **15:** Areas of the driveway are uneven with potential trip hazards. Upgrades recommended.

**FI** **UPG** **16:** Some settling and/or sinking of the pavers noted at of the areas of the paver driveway. Sink holes or settling in the paver driveway may be related to poor compaction, heavy vehicle traffic and/or an excessive water condition under the pavers which can or has caused some settling. The settling of the pavers can also cause ponding of water and trip hazards. Upgrades recommended.

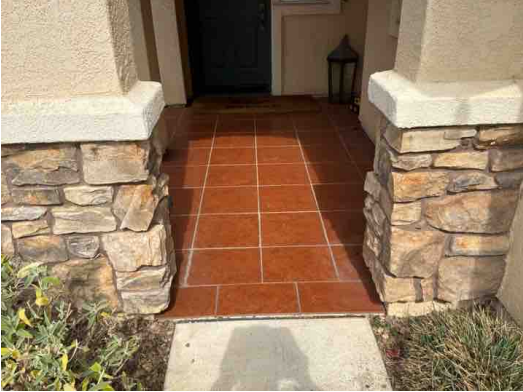
**DS 18:** Tiled Concrete Walkways

*Some tiles when used at exterior walkways can be slippery when wet. Use caution.*

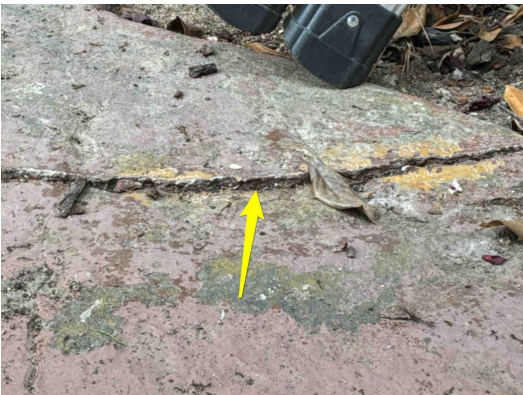
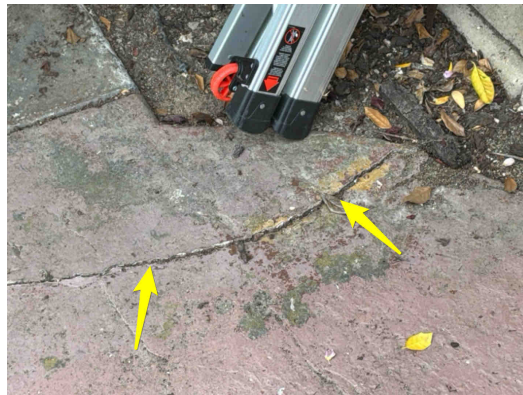
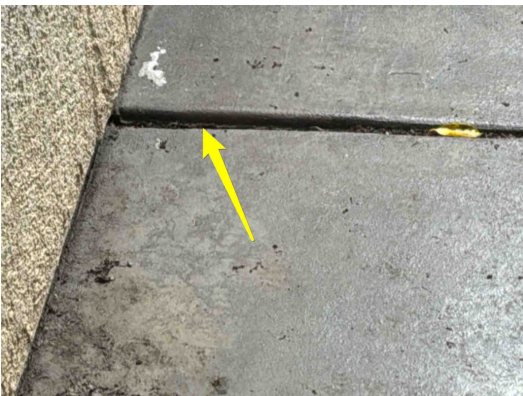
**E&C UPG 21:** Some moderate cracks with some trip hazards found at areas North Side Yard concrete sidewalk due to the adjacent trees. Upgrades or repairs recommended.

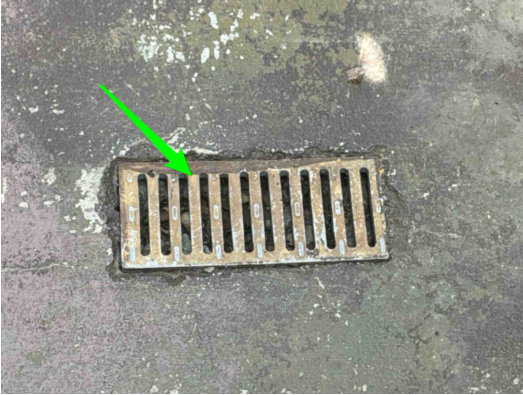
**MR 22:** Surface drains and boxes noted in areas of the walkways. Drains are not tested. The condition of the underground piping and terminations are unknown. Recommend having drains and terminations cleaned, tested and inspected by a qualified landscape contractor to determine the proper flow. Keep drains clean and free of debris regularly.

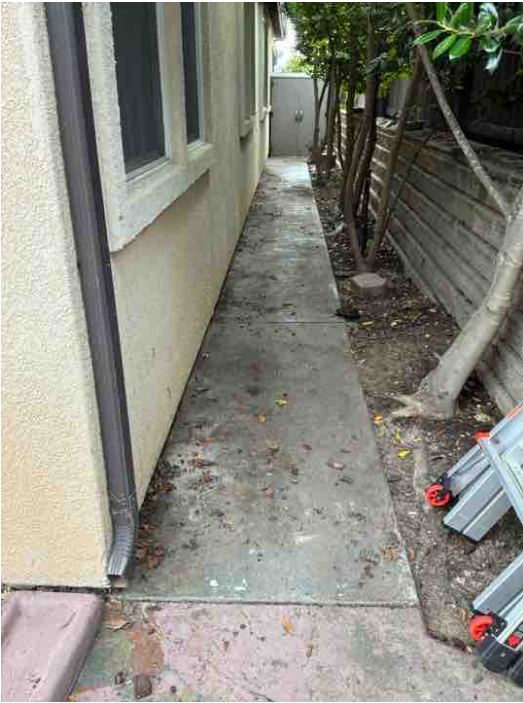
**UPG DS 24:** Areas of the NORTH SIDE YARD walkway exhibited poor drainage and improper slope toward the building due to the root intrusion from the adjacent trees. Walkways should slope away from the structure to help prevent water intrusion and moisture-related conditions.

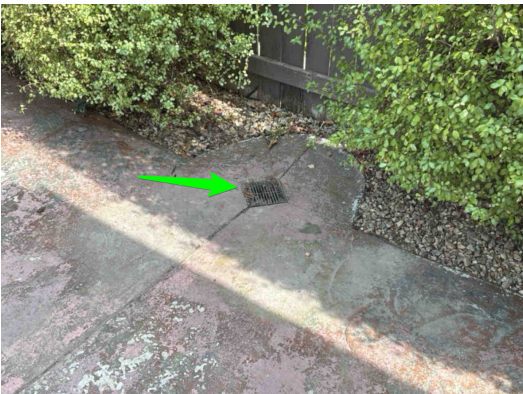
**MR UPG DS 28: Disclosure:** Some surface drains noted in areas of the patio. Drains not tested. Drain may be undersized for certain rain condition conditions. The condition of the underground piping and terminations are unknown. Recommend having drains and terminations cleaned, tested and inspected by a qualified landscape contractor to determine the proper flow. Keep drains clean and free of debris regularly. A second overflow drain is recommended.

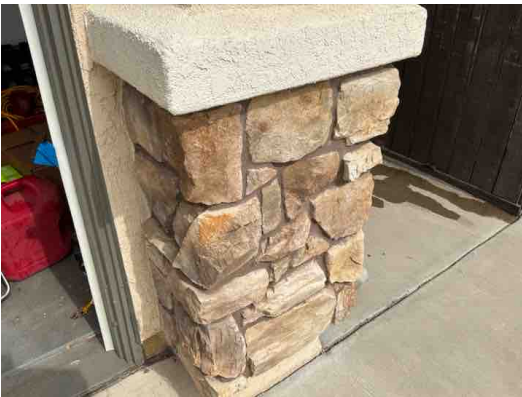
**31:** Rock Veneer

**Disclosure:** Conditions behind the rock veneer unknown. Referred to the Termite report for additional comments or recommendations.

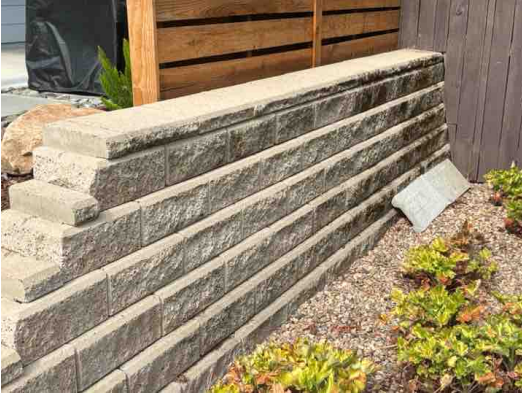
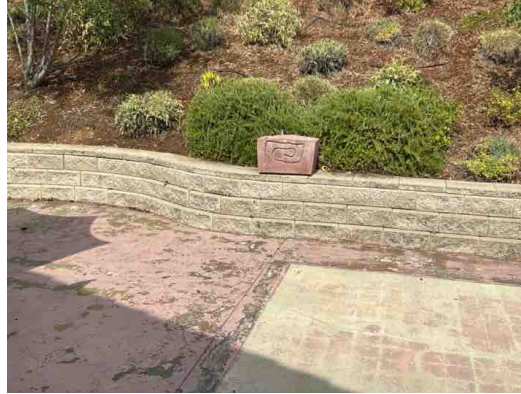
**42: Type:** Stacked interlocking masonry block system

**43:** The retaining walls appear serviceable.

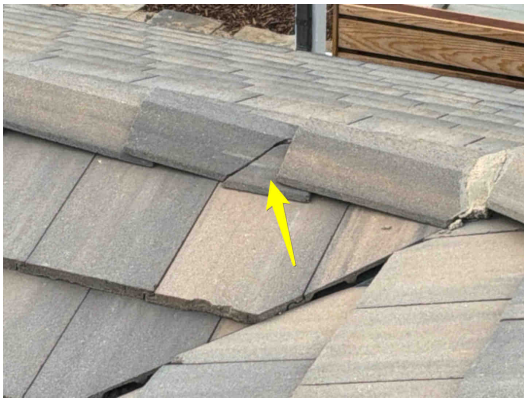
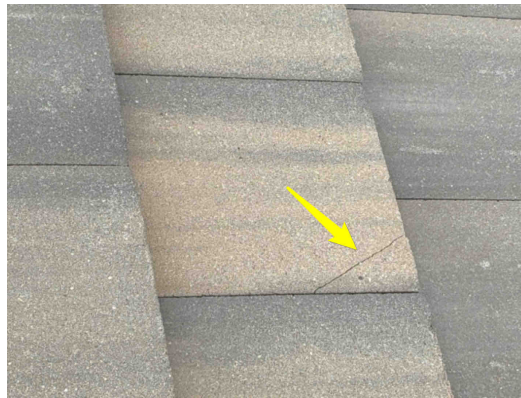
Example

**E&C 49:** A few cracked or chipped roof tiles needing repair or replacement. Contact a licensed roofing contractor for further evaluation of the roof and to determine location(s) and quantity of the roof tiles needing repair or replacement.

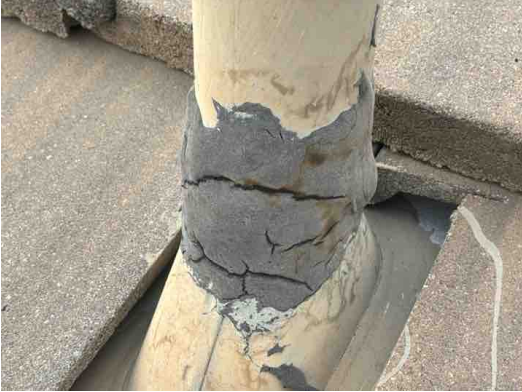
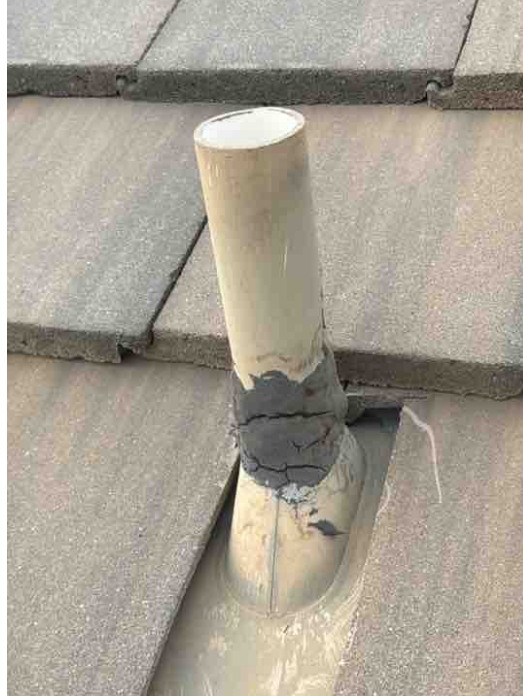
**MR 52:** Deteriorated sealant at some roof flashings, around the roof penetrations. Maintenance recommended to help prevent water intrusion into areas of the attic. Have roofer evaluate the roof flashings and correct as needed.

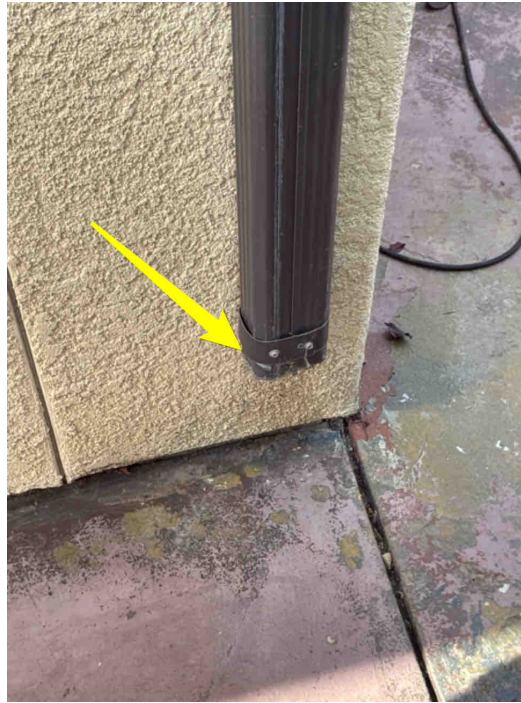
**UPG 56:** Improper termination of some rain gutter downspouts. Rain gutter downspout should be terminated in such a way that it directs the water away from the building. Missing the lower angled portion of the rain gutter downspout diverting the water away from the building.

Example. On the southeast corner

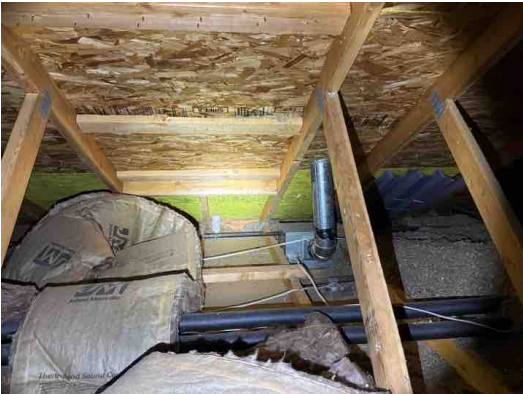
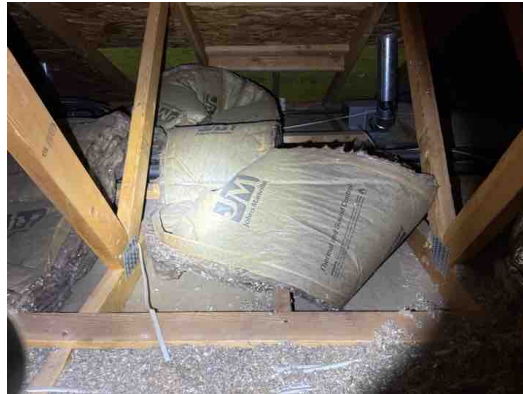
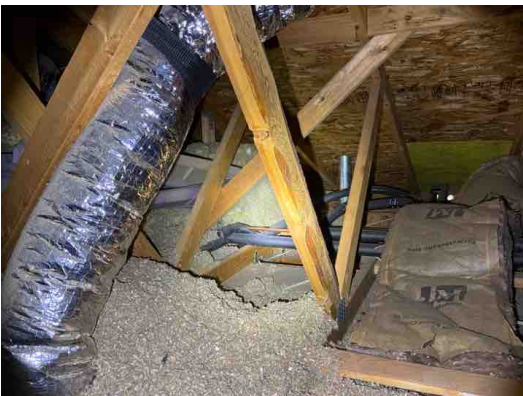
**E&C 63:** Areas of poor and inadequate coverage of the insulation in areas of the attic. Installation missing in areas ABOVE THE PRIMARY BEDROOM BATHROOM. Corrections recommended.

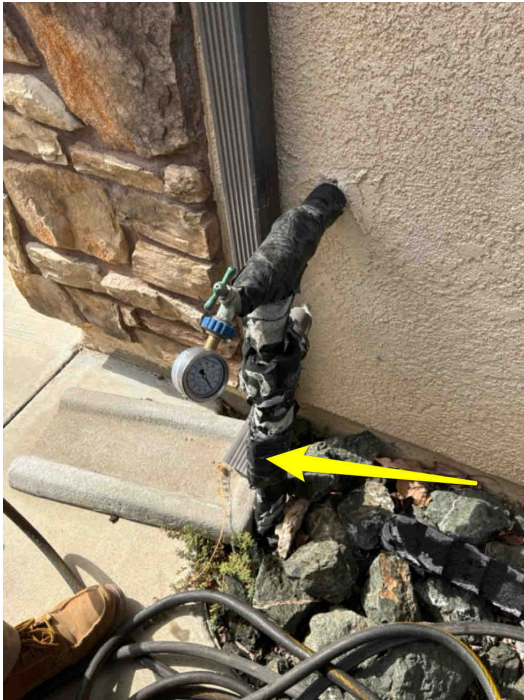
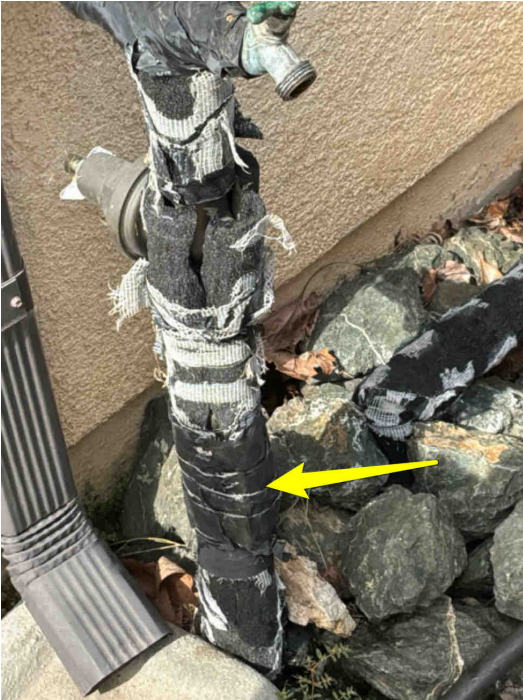
*The main water shut off valve is not accessible and has been covered with duct tape. Proper upgrades are recommended for easy emergency access.*

Shut off valve location

Shut off valve covered with duct tape

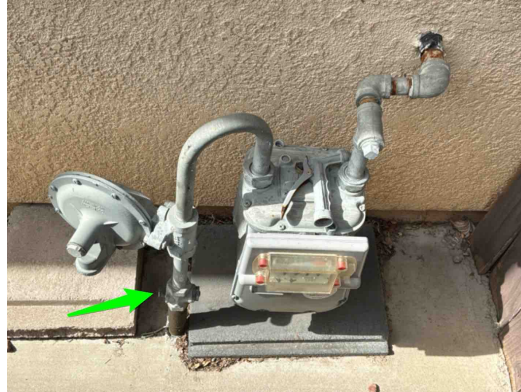
Main gas shut off valve

**77: Gas shut-off appears serviceable.**

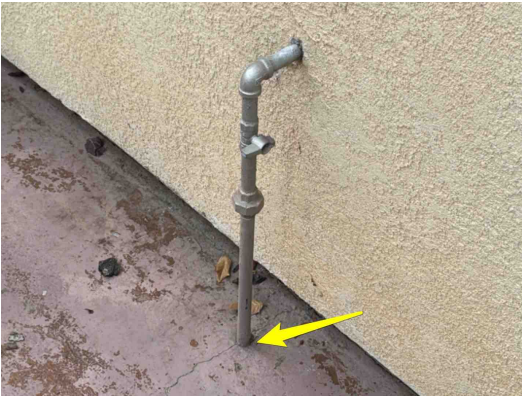
**UPG 78: Disclosure:** Gas pipe not protected / sleeved through concrete at meter. No visible deterioration or damage found at this time. Continue to monitor.

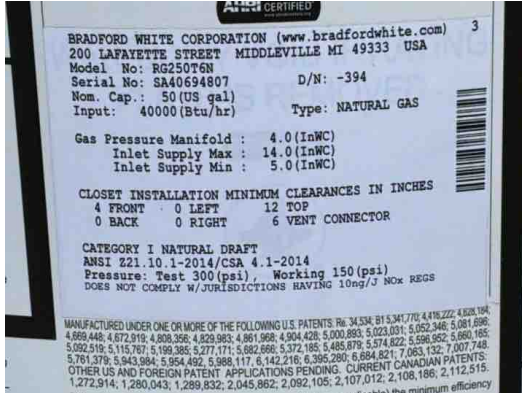
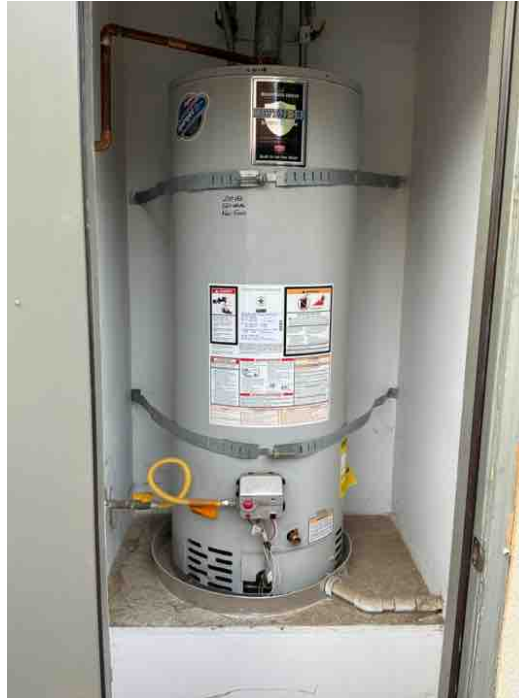
**Date:** 2018: *The average lifespan of this type of water heater is approximately 10 years. This water heater is approximately 8 years old. Water heaters can fail without warning and should be monitored and inspected regularly for leaks, corrosion, and other signs of deterioration.*

81: Water Heater Operated when tested.

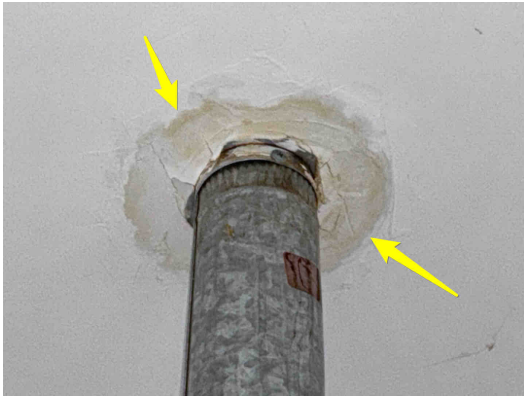
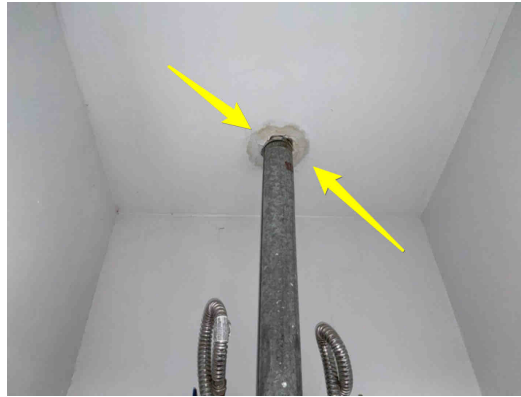
**FI 86:** Some moisture stains noted at the drywall ceiling around the water heater vent pipe. This is indicative of a past or current roof leak. Unable to determine at this time if the roof leak is old or current. Recommend additional review and from a licensed roofer. Ask seller for additional disclosures as to any previous leak repairs performed around the water heater vent pipe.

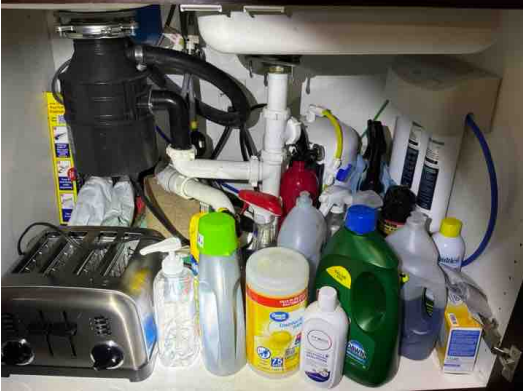
**DS 96: Disclosure:** *Restricted view below kitchen sink (areas not fully visible). Do a secondary check carefully once kitchen cabinets are empty.*

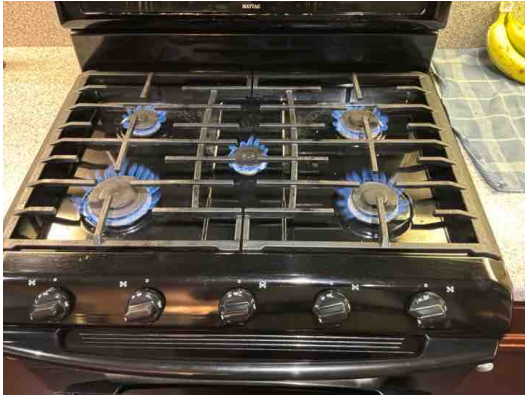
**106:** The cooktop is Natural Gas and operated when tested

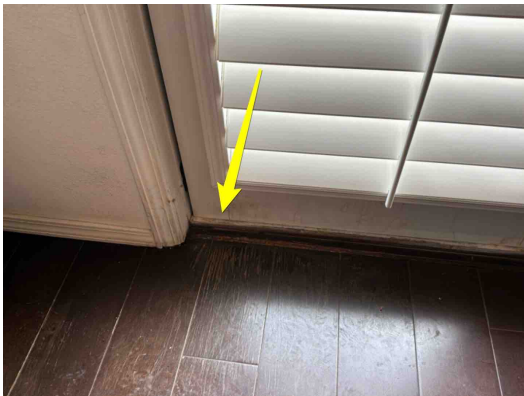
**E&C** **UPG** **130:** The FAMILY ROOM Exterior door rubs & sticks at the bottom at the threshold. Maintenance or repairs recommended.

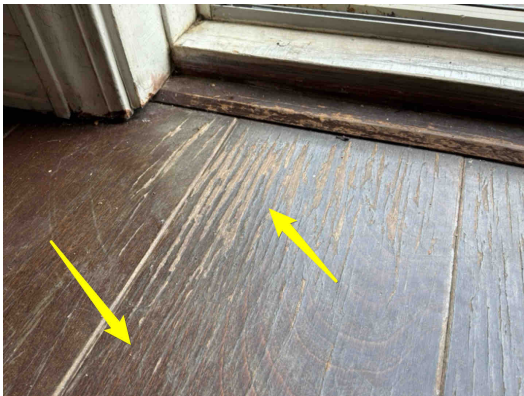
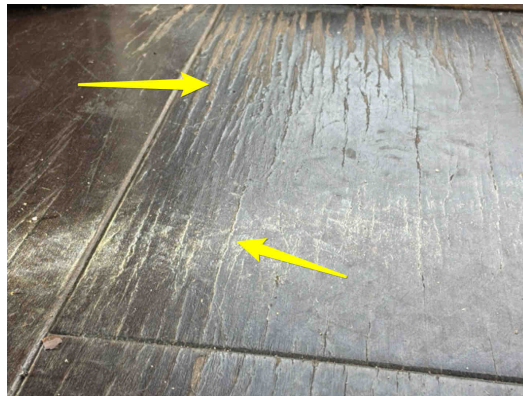
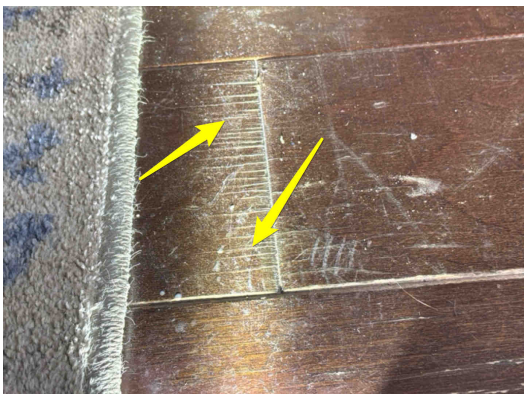
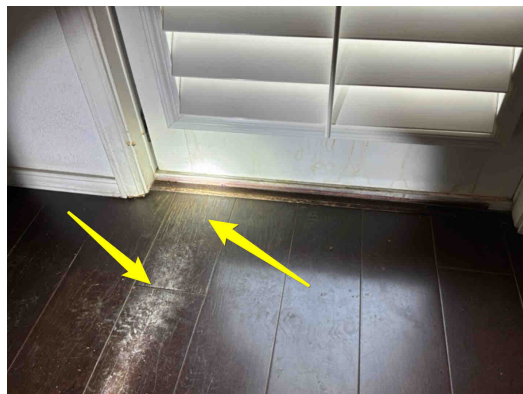
Example location

**FI 142:** Some visible moisture staining and damage of the wood flooring noted ON THE INSIDE OF THE FAMILY ROOM EXTERIOR DOOR. Evidence of a past intrusion or moisture condition.

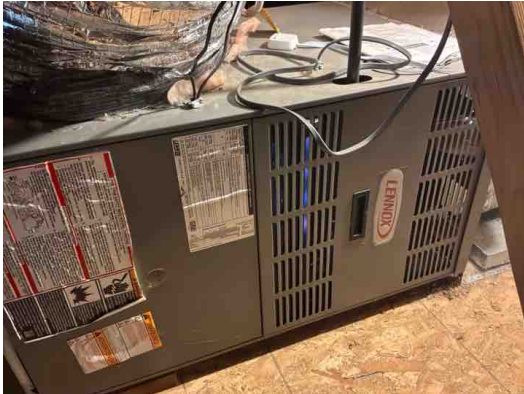
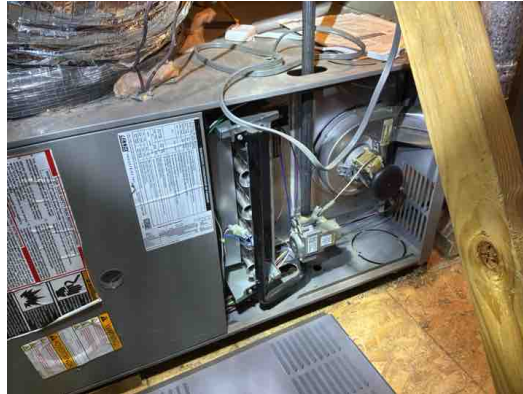
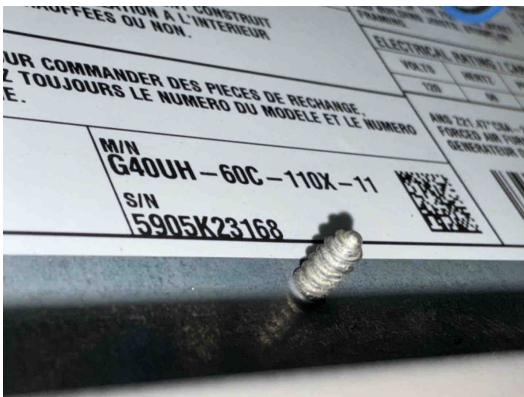
**DATE:** 2005 The average life of this type of furnace is +/- 30-35 years. This furnace is approximately 21 years old .

150: **HEATING SYSTEM CONDITION:** The heating system operated when tested.

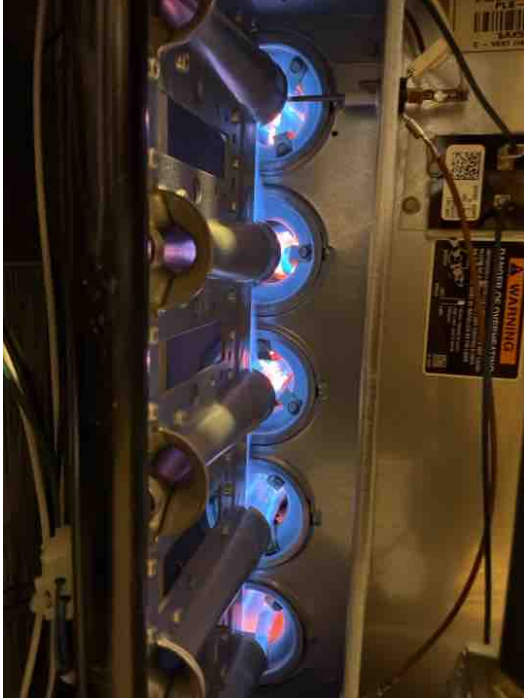
**E&C 152:** Damaged or Deteriorated "NOx" SCREENS found inside the furnace burn chamber. Simple removal or replacement is recommended. Recommend further review recommendations by a qualified and licensed HVAC professional familiar with the minimum installation requirements.

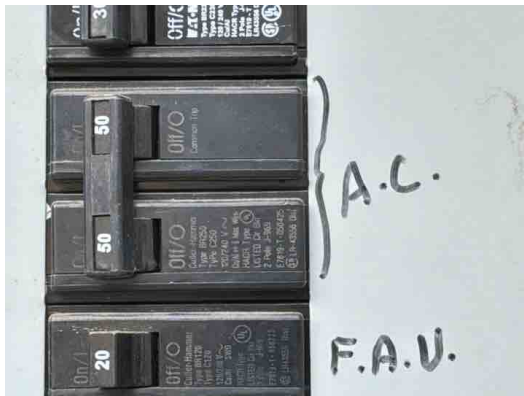
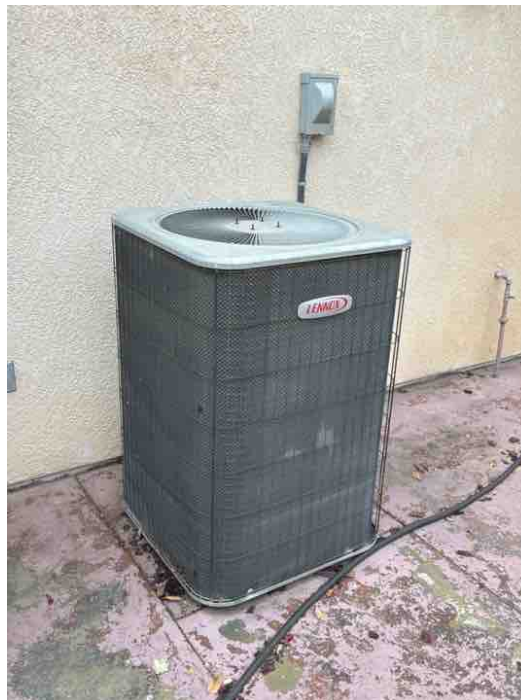
**Refrigerant Type:** R-22. The phasing out of R-22 began in 2010, when manufacturers were no longer able to produce new equipment designed with it. In 2020 and the ban expanded to only allow the use of recycled or previously stockpiled Freon to service existing air conditioner

**Date:** 2006 The average life of this type of air conditioner condenser is +/- 20-25 years. This air conditioner condenser is approximately 20 years old .

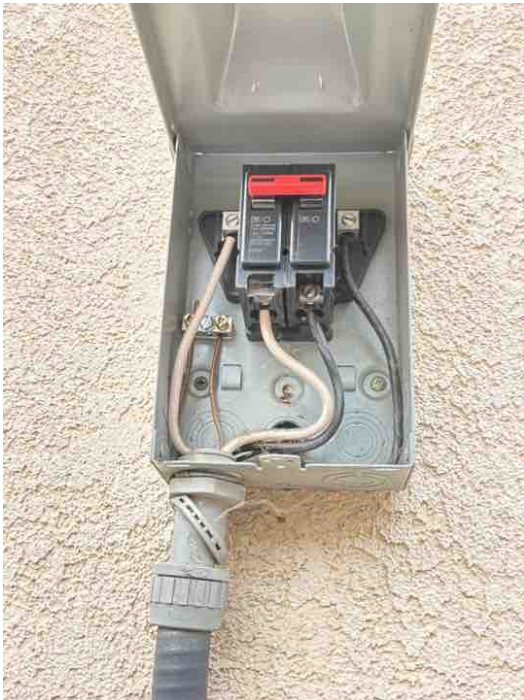
**160:** Electrical Disconnect Provided at or near the Equipment per standards.

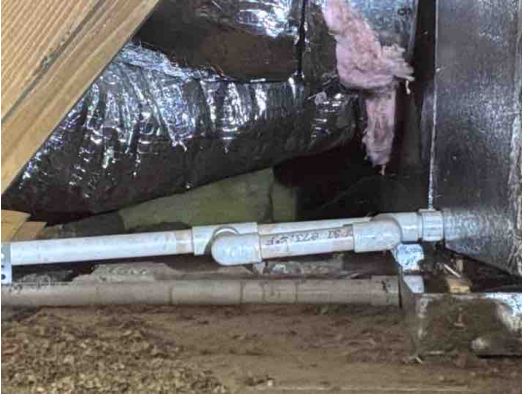
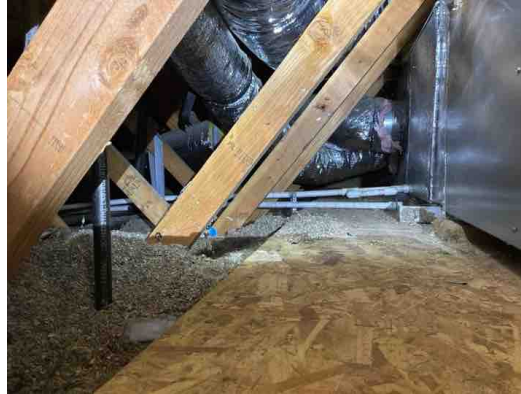
**E&C 162:** Improper connection of the Air conditioner secondary condensate drip piping into the primary drain piping at coil in ATTIC.

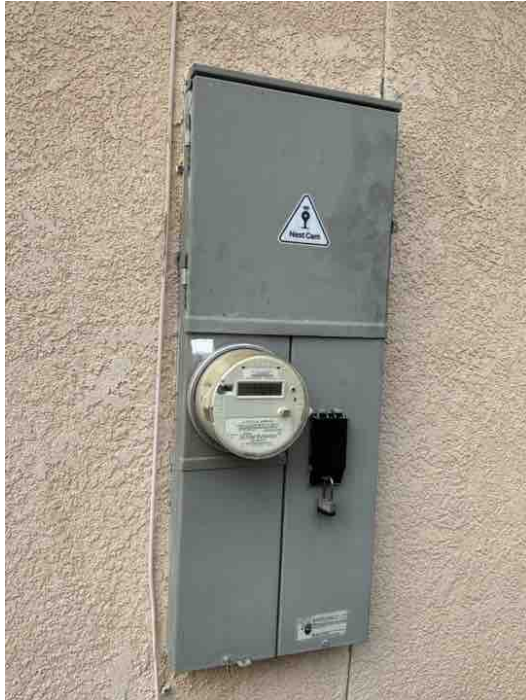
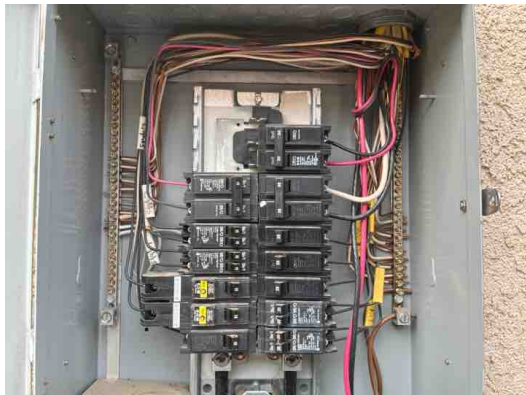
**164: MAIN ELECTRICAL PANEL CONDITION:** \*No visible wiring defects in the MAIN ELECTRICAL PANEL.

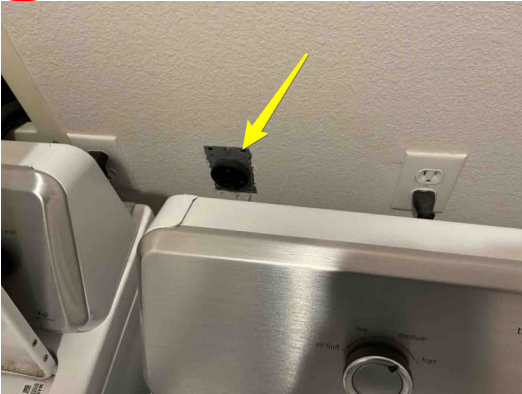
**SC 172:** Missing electrical cover plate: AT THE LAUNDRY ROOM 240 VOLT OUTLET

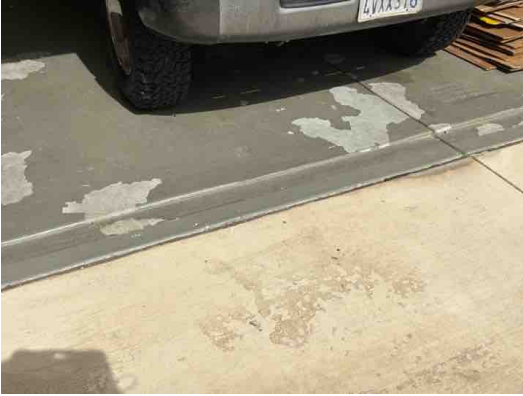
**MR 179: Disclosure:** Some deterioration noted areas of the garage painted floor. Maintenance recommended.

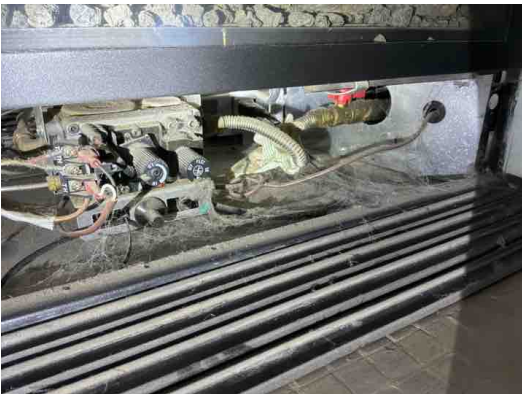
**MR** 195: Recommend cleaning the controller compartment under the FAMILY ROOM gas fireplace. Needed maintenance recommended.

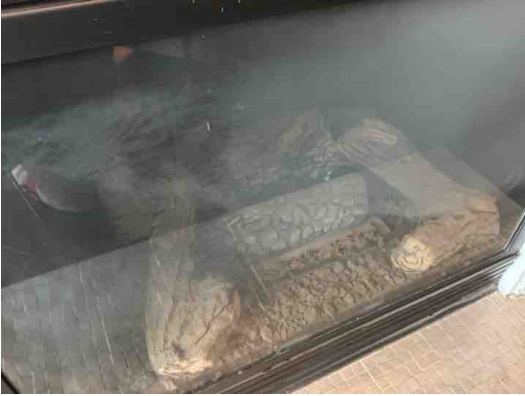
**MR 196:** Recommend cleaning the glass at the gas fireplace as part of typical maintenance.
