# *Accurate Inspection Team LLC*

## Property Inspection Report

2837 Estado St, Pasadena, CA 91107  
Inspection prepared for: Cher Works & Steve works  
Real Estate Agent: Pete Whan - Pete Whan & Associates

Date of Inspection: 7/20/2026 Time: 2:00 pm  
Age of Home: 1938 Size: 1,344 sqft  
Weather: Sunny & Hot

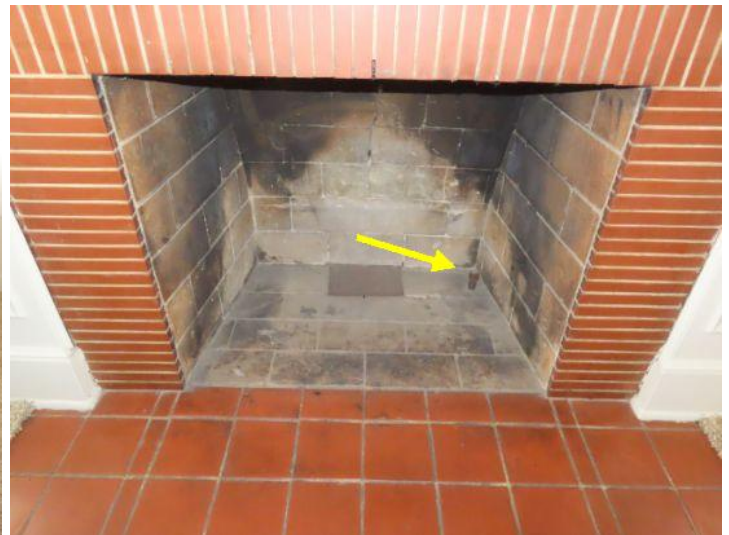
Observations: limited inspection only, gas line is capped, recommend cleaning, damper door missing

gas line is capped

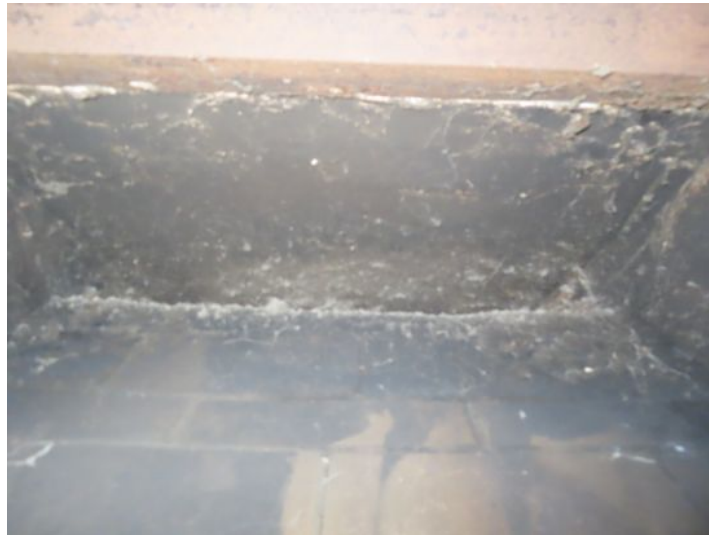
damper door missing

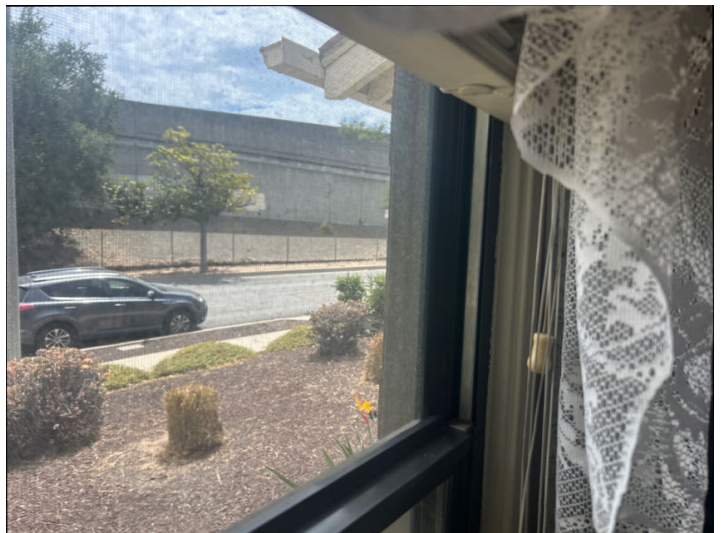
Observations: could not access some windows due to height, window coverings or personal items, functional, worn hardware, dirty tracks, recommend cleaning tracks, **windows throughout the structure are in need of servicing, broken balance spring at the window**

broken balance spring at the window

| Interior | | |
|---|---|---|
| Page 5 Item: 13 | Interior Windows | windows throughout the structure are in need of servicing, broken balance spring at the window |

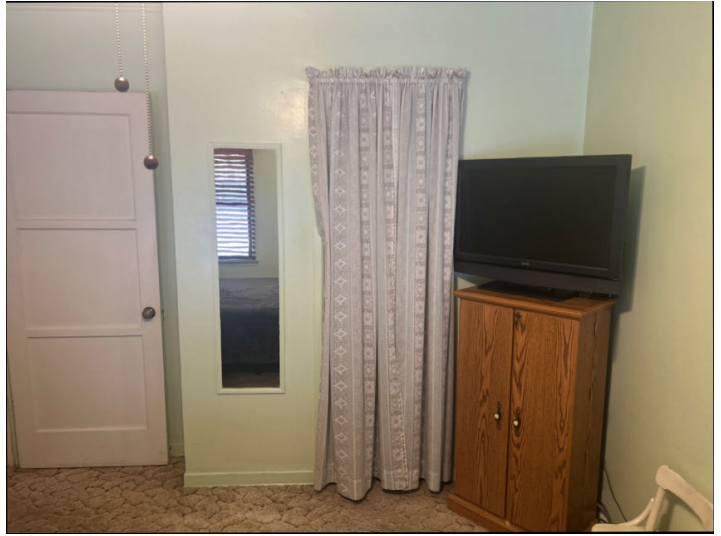
Observations: functional, worn hardware, closet door is missing, closet door did not latch

closet door is missing

| Interior | | |
|---|---|---|
| Page 7 Item: 5 | Bedroom Closets | closet door is missing, closet door did not latch |

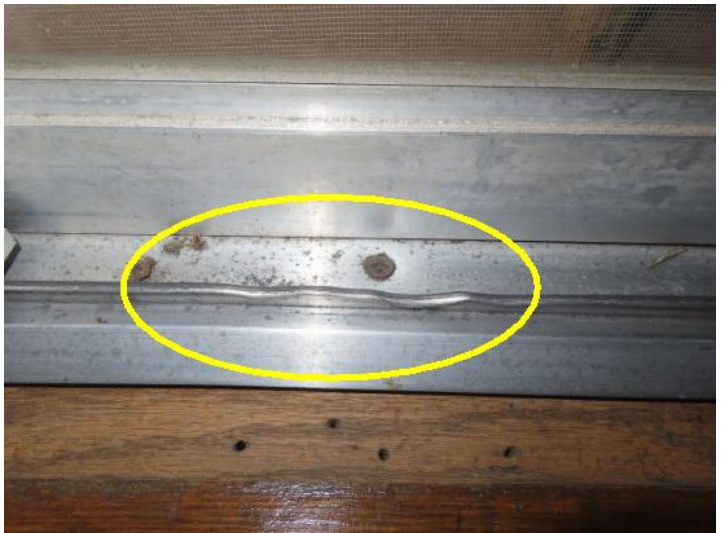
Observations: functional, worn hardware, dirty tracks, worn track, sliding door bounces

worn track, sliding door bounces

| Interior | | |
|---|---|---|
| Page 7 Item: 9 | Bedroom Sliding Doors | worn track, sliding door bounces |

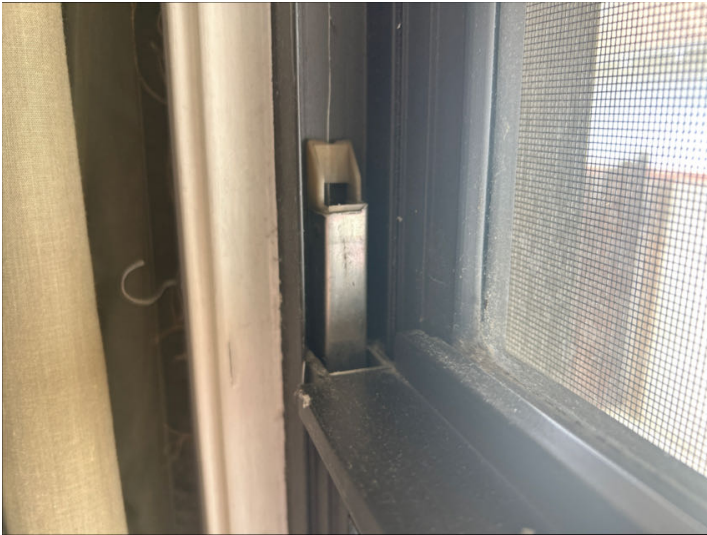
Observations: functional, worn hardware, dirty tracks, recommend cleaning tracks, **broken balance spring at the window**

broken balance spring at the window

| Interior | | |
|---|---|---|
| Page 8 Item: 13 | Bedroom Windows | broken balance spring at the window |

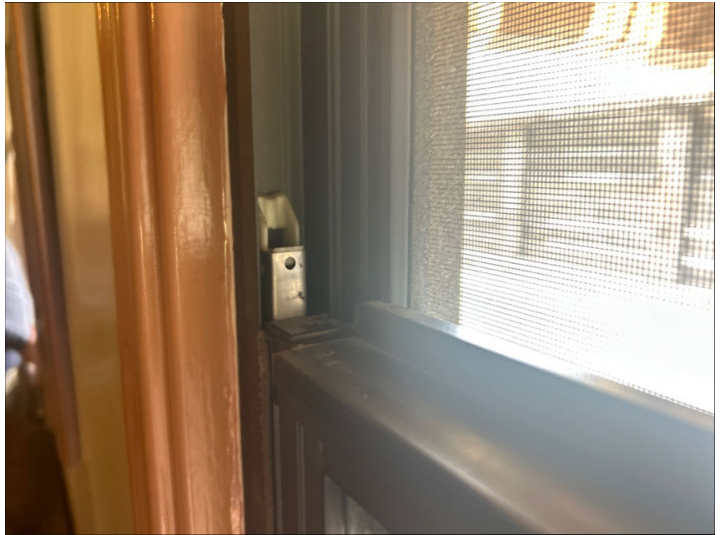
broken balance spring at the window

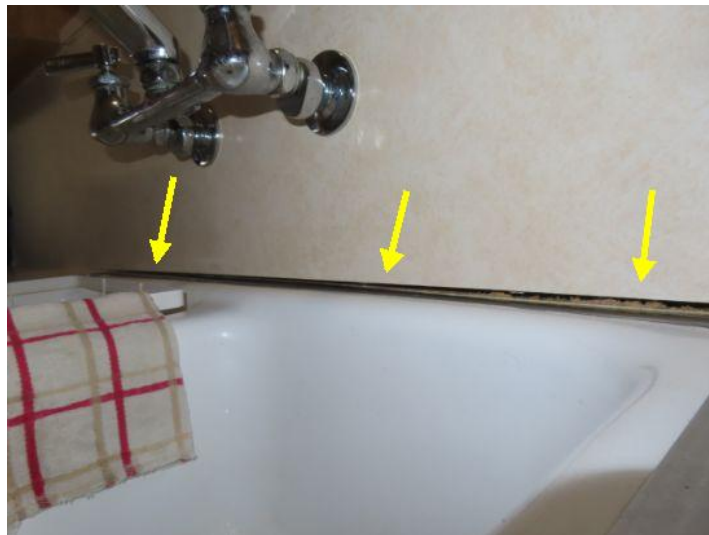
Observations: some not visible due to personal items, normal wear, **gapped at the sink area, recommend caulking**

gapped at the sink area, recommend caulking

| Interior | | |
|---|---|---|
| Page 12 Item: 3 | Kitchen Counters | gapped at the sink area, recommend caulking |

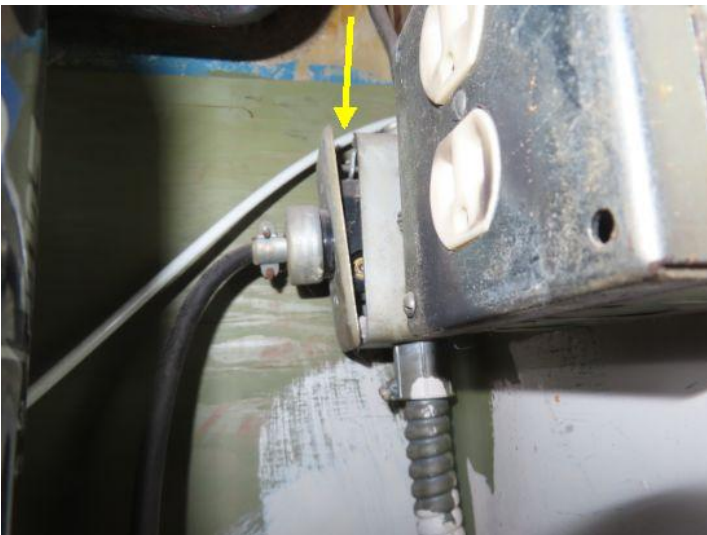
Observations: some outlets not accessible, worn switches & outlets, under cabinet light did not operate, **loose outlet under the sink, exposed romex wires inside the cabinets, 2 prong outlets present**

loose outlet under the sink

| Interior | | |
|---|---|---|
| Page 13 Item: 7 | Kitchen Electrical | loose outlet under the sink, exposed romex wires inside the cabinets, 2 prong outlets present |

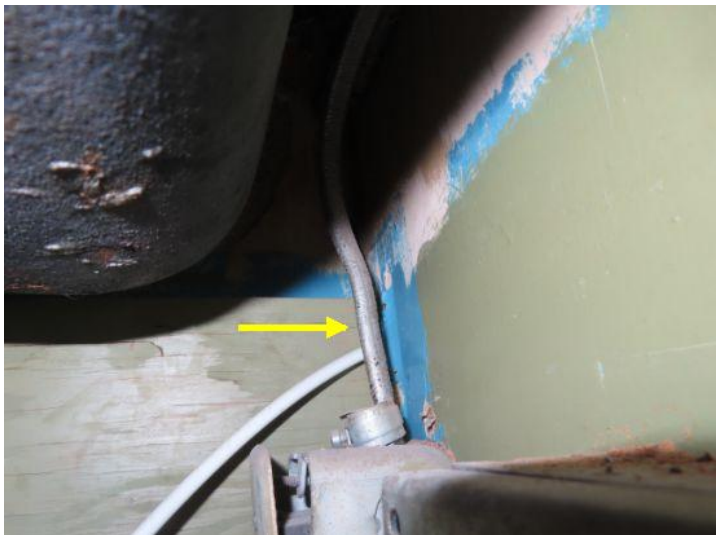
exposed romex wires inside the cabinets

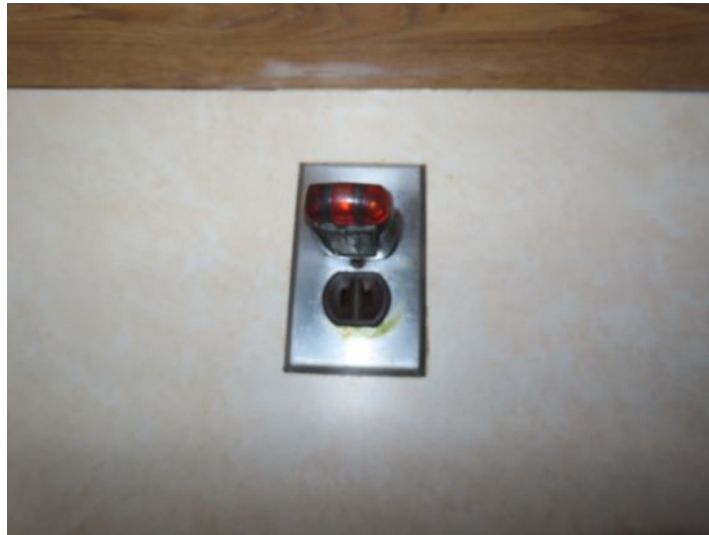
Observations: none visible, **recommend all outlets by the sink area are GFCI protected**

recommend all outlets by the sink area are GFCI protected

| Interior | | |
|---|---|---|
| Page 13 Item: 8 | Kitchen GFCI | recommend all outlets by the sink area are GFCI protected |

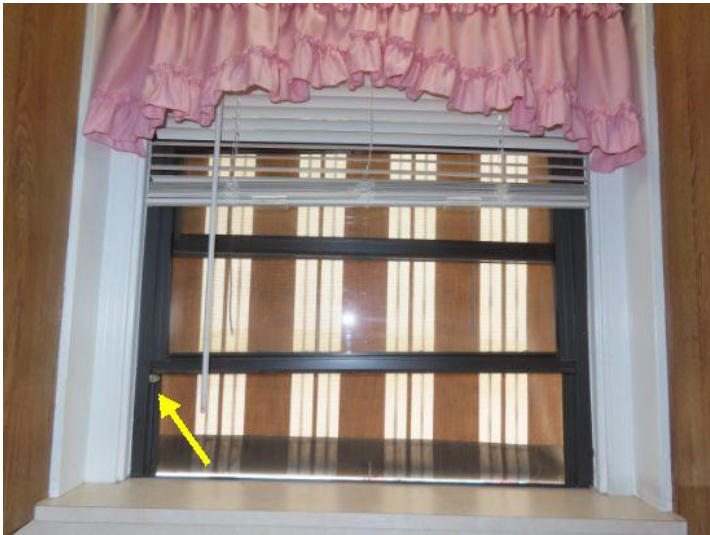
Observations: functional, worn hardware, loose balance spring at the window

loose balance spring at the window

| Interior | | |
|---|---|---|
| Page 15 Item: 22 | Kitchen Windows | loose balance spring at the window |

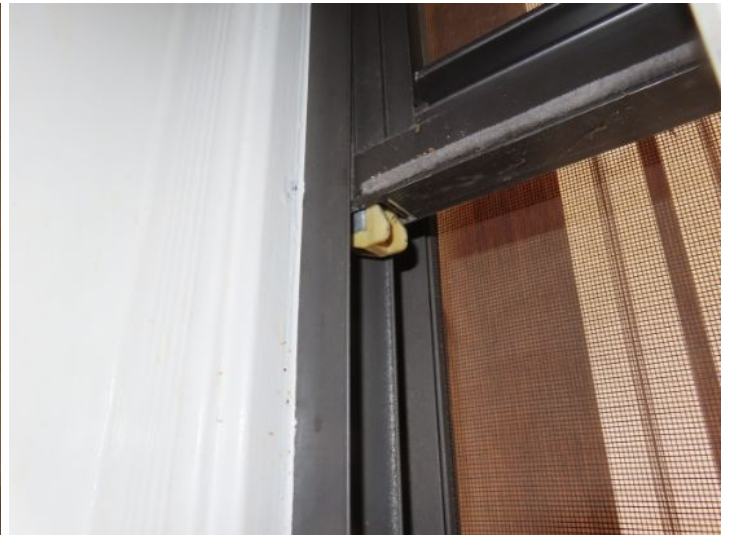
loose balance spring at the window

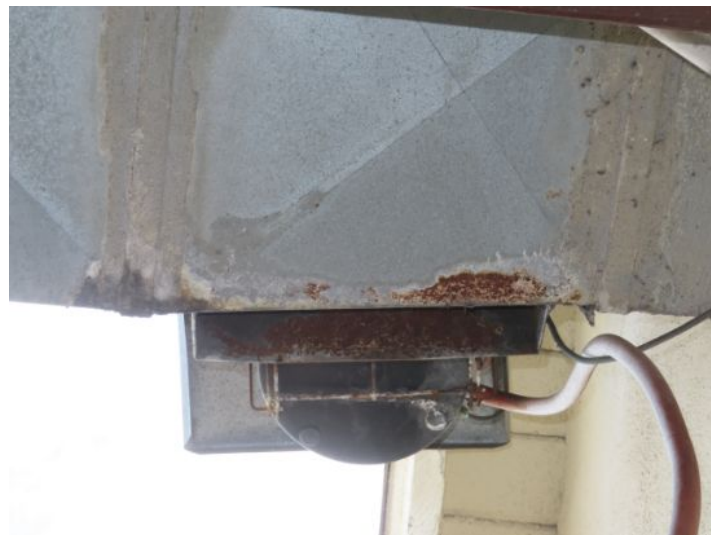
Observations: rusted

rusted

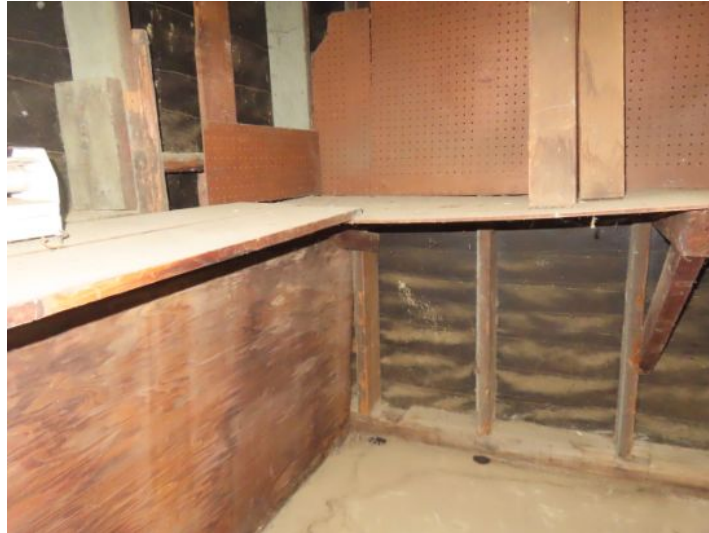
Observations: worn, some not visible due to personal items, counter appears weak, not for heavy objects

counter appears weak, not for heavy objects

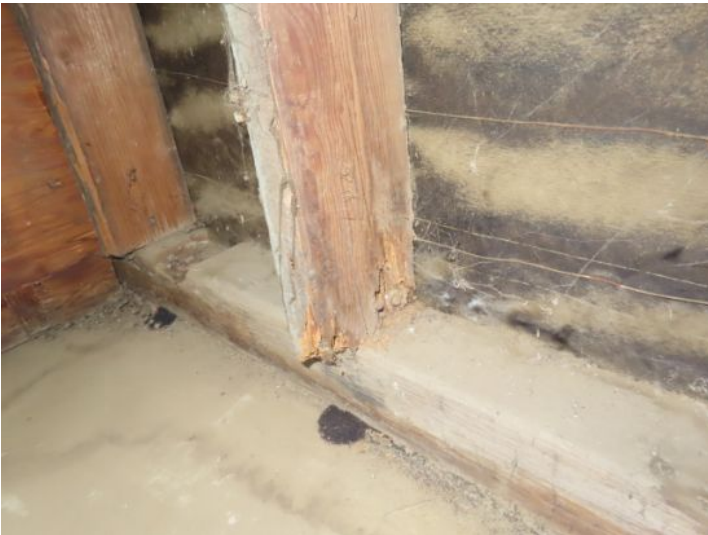
Observations: personal items prevent complete inspection, stains present, evidence of past leaking, **deteriorated wood, consult termite report**

deteriorated wood, consult termite report

| Interior | | |
|---|---|---|
| Page 28 Item: 14 | Garage Walls & Firewall | deteriorated wood, consult termite report |

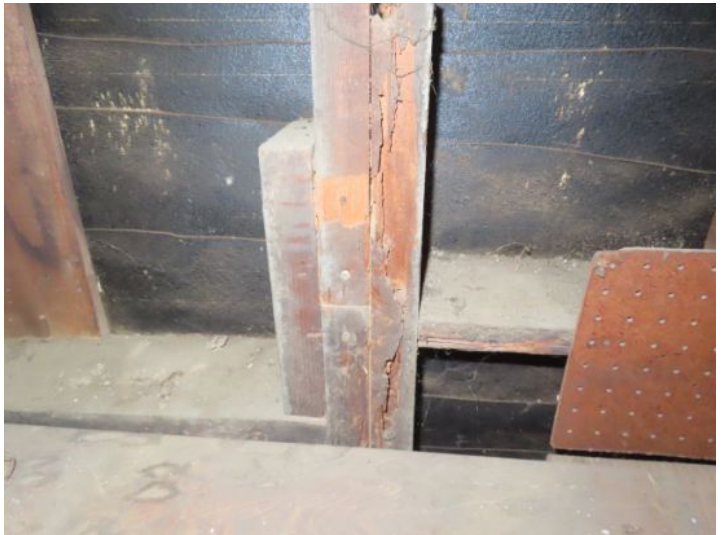
deteriorated wood, consult termite report

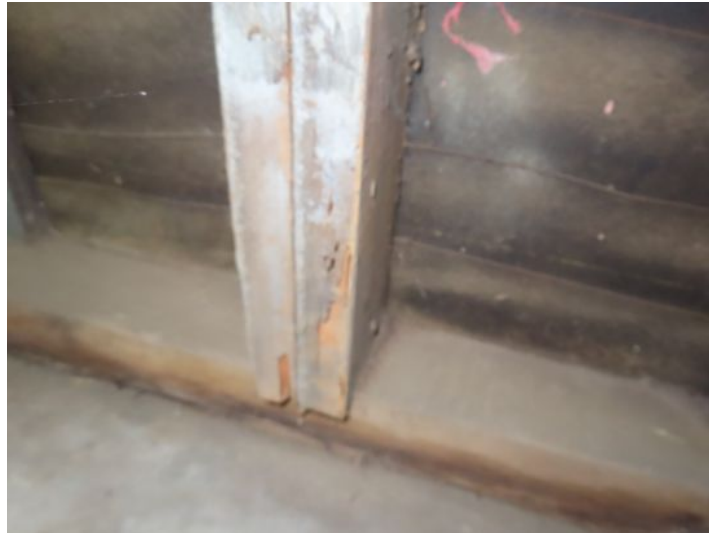
deteriorated wood, consult termite report

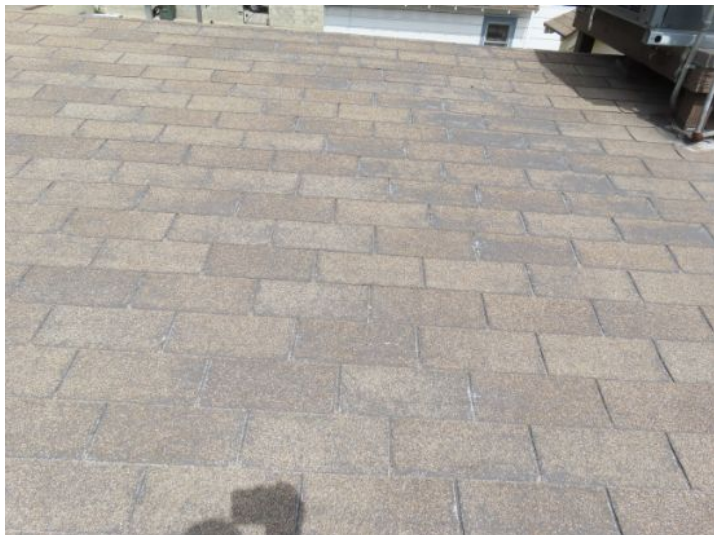
Observations: **deteriorated roofing material, missing shingles, patched areas, recommend a licensed roofing contractor to evaluate**

deteriorated roofing material

| Roof Area | | |
|---|---|---|
| Page 33 Item: 1 | Roof Condition | deteriorated roofing material, missing shingles, patched areas, recommend a licensed roofing contractor to evaluate |

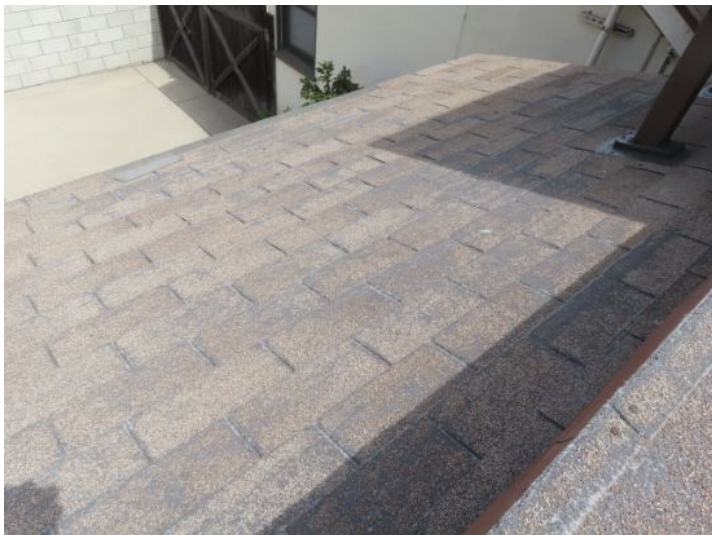
deteriorated roofing material

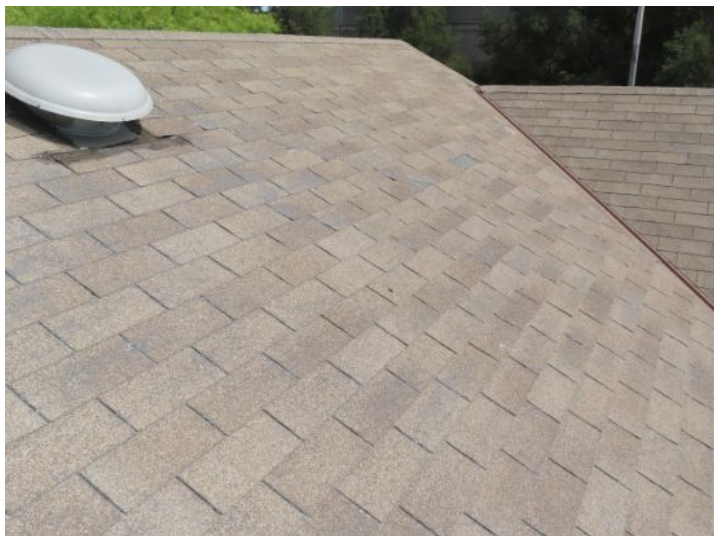
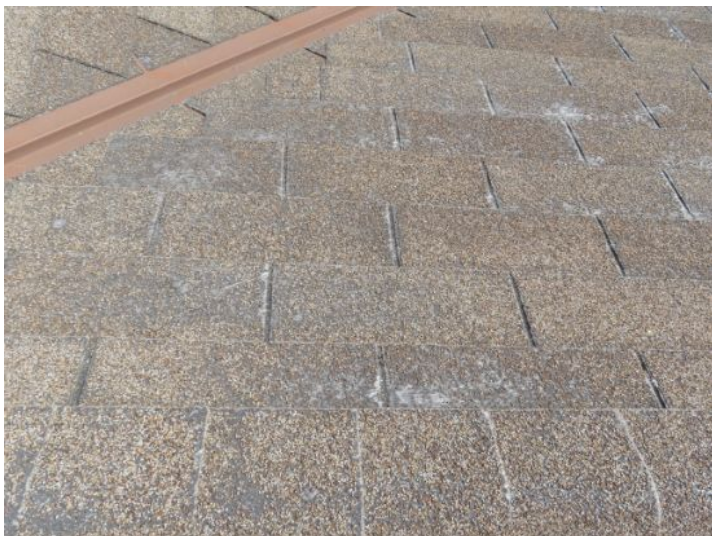
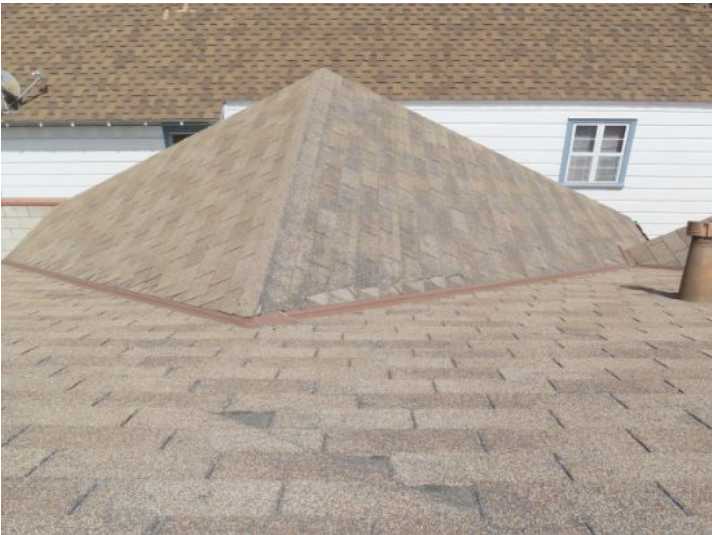
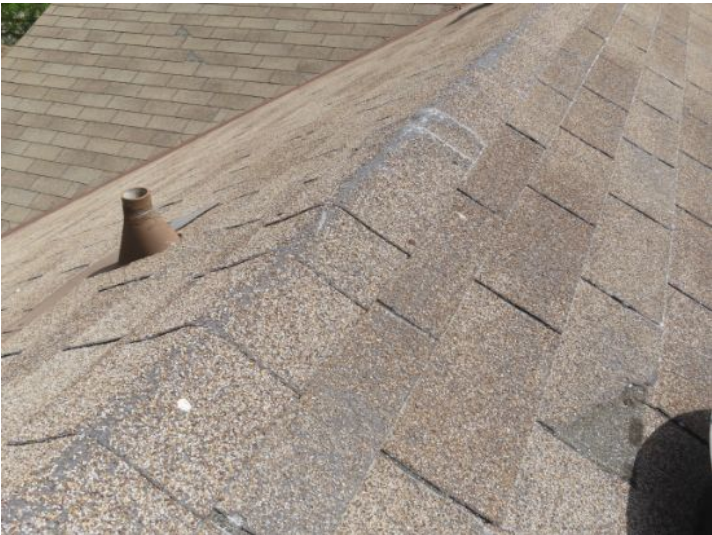
deteriorated roofing material

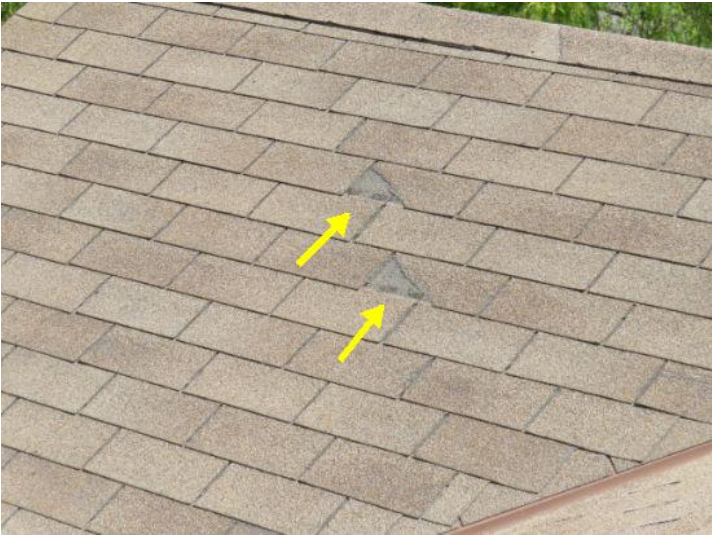
missing shingles

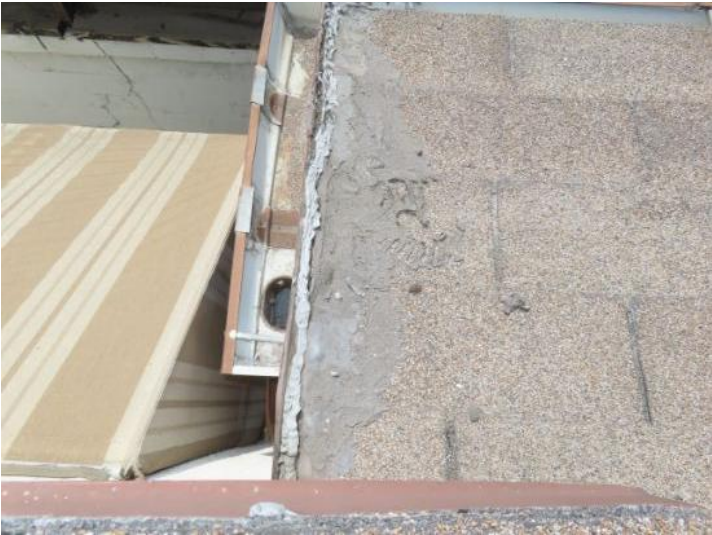
patched areas

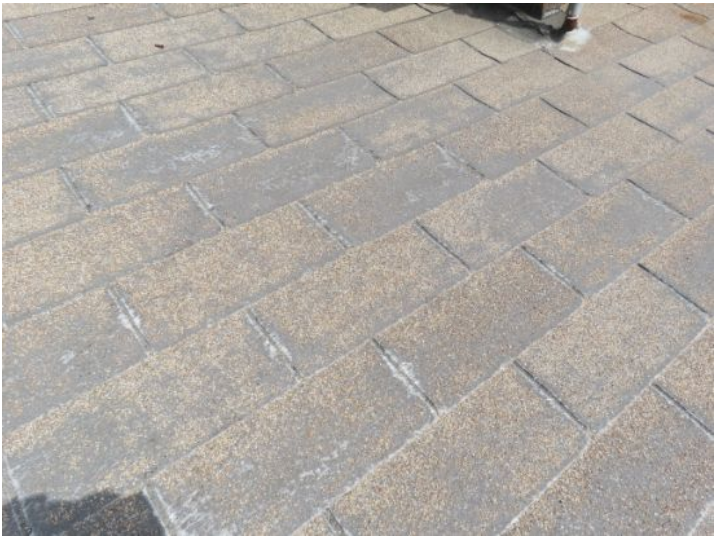
deteriorated roofing material

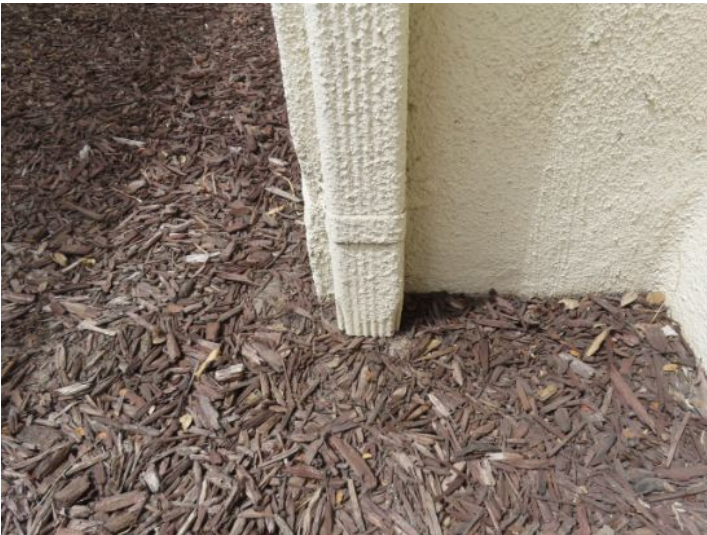
Observations: functional, in areas, recommend rain gutters on all pitched areas, **gutters do not divert water away from structure**

gutters do not divert water away from structure

| Roof Area | | |
|---|---|---|
| Page 35 Item: 4 | Rain Gutters | gutters do not divert water away from structure |

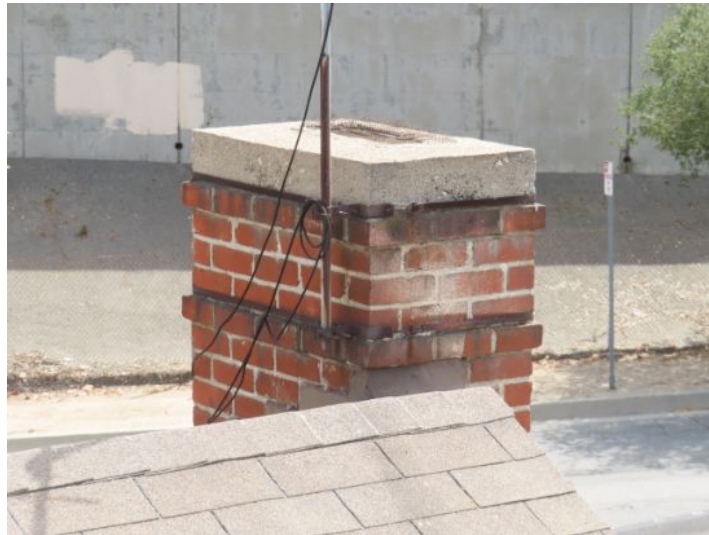
Observations: present, recommend rain cap for the chimney

present, recommend rain cap for the chimney

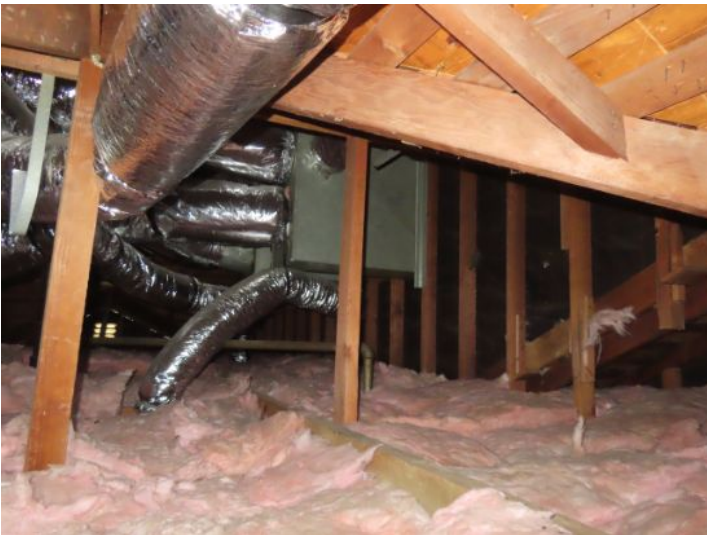
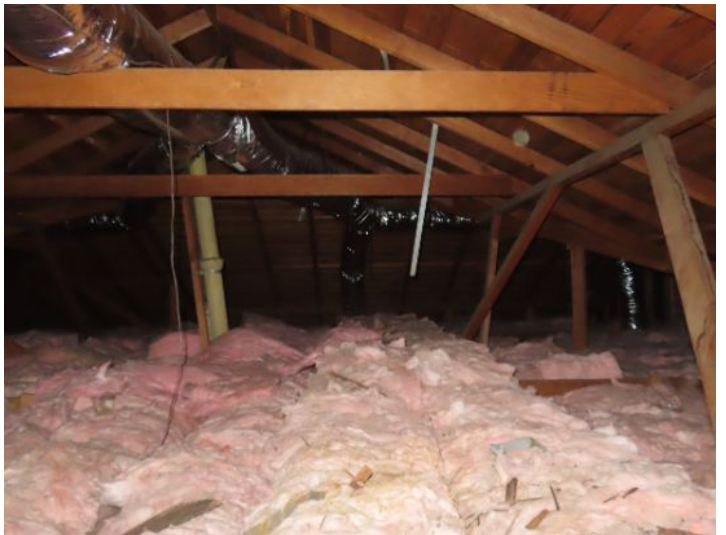
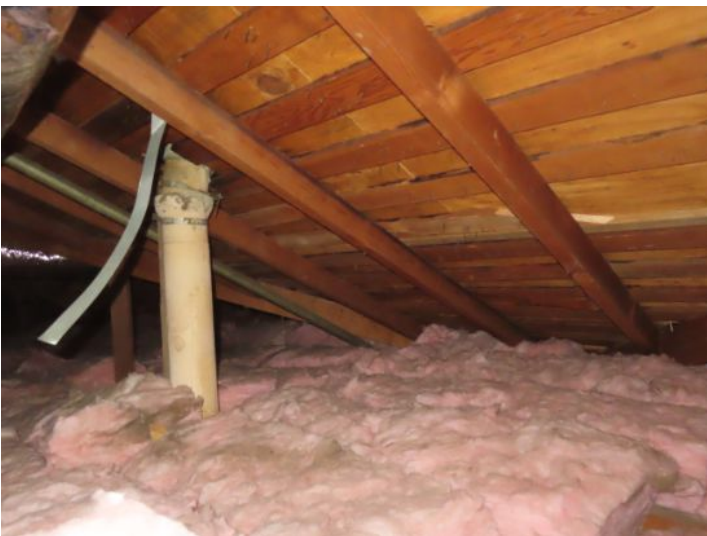
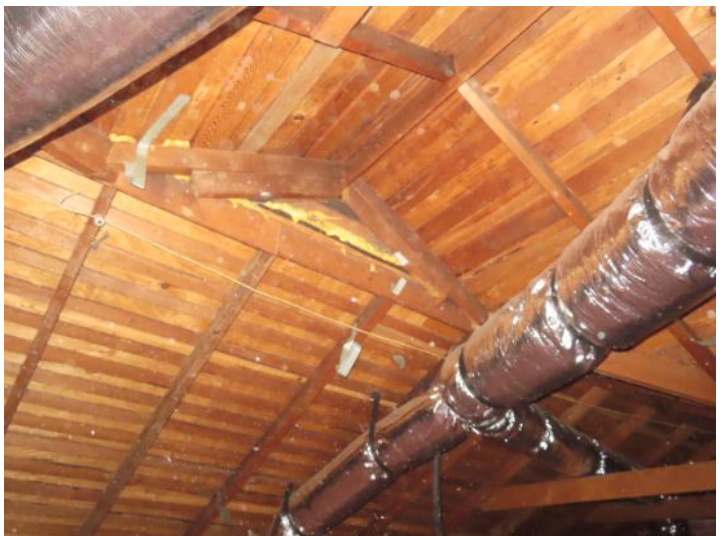
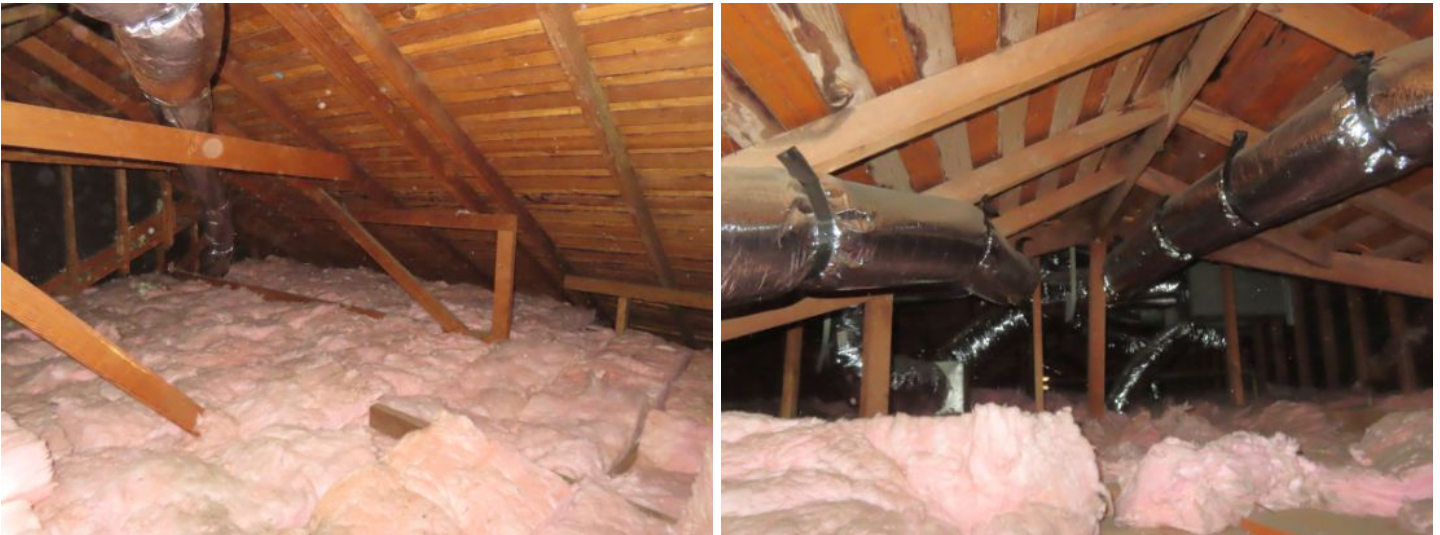
Observations: good, could not access all areas, stains in areas, evidence of past leaking

stains in areas, evidence of past leaking

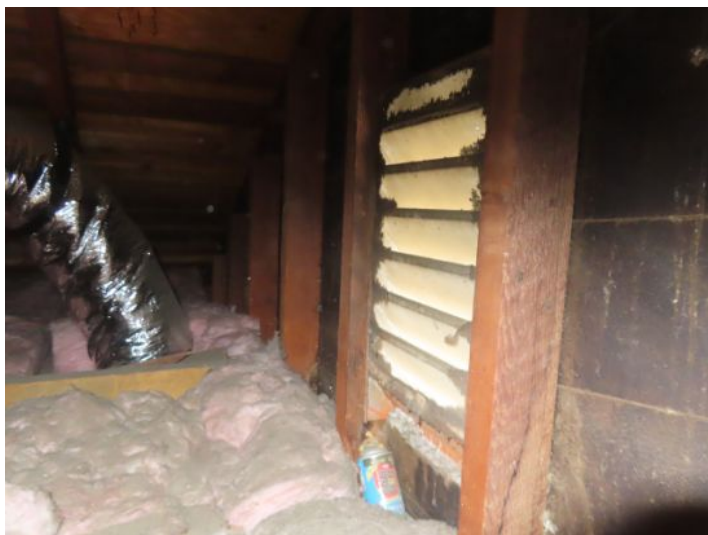
Observations: could not access some attic vents due to the location, **missing screens at the attic vents**

missing screens at the attic vents

| Roof Area | | |
|---|---|---|
| Page 40 Item: 10 | Attic Vent Screens | missing screens at the attic vents |

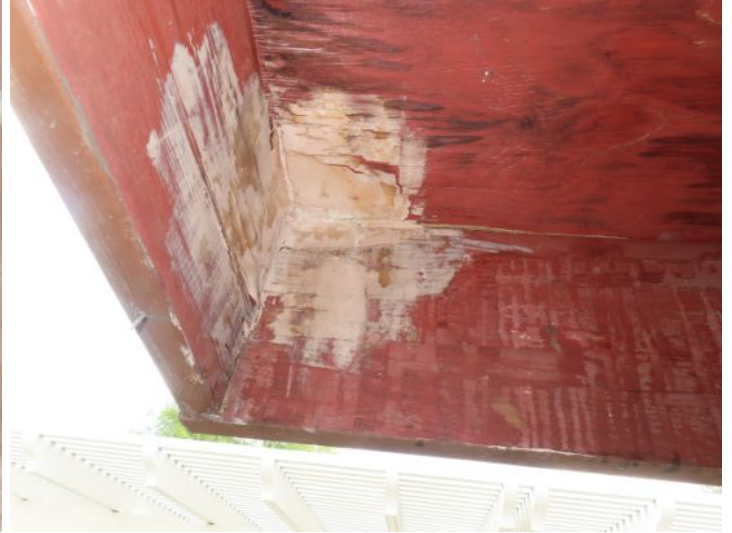
Observations: weathered, bird nest present, **evidence of leaking at the eaves**

evidence of leaking at the eaves

| Roof Area | | |
|---|---|---|
| Page 42 Item: 2 | Exterior Eaves & Facia | evidence of leaking at the eaves |

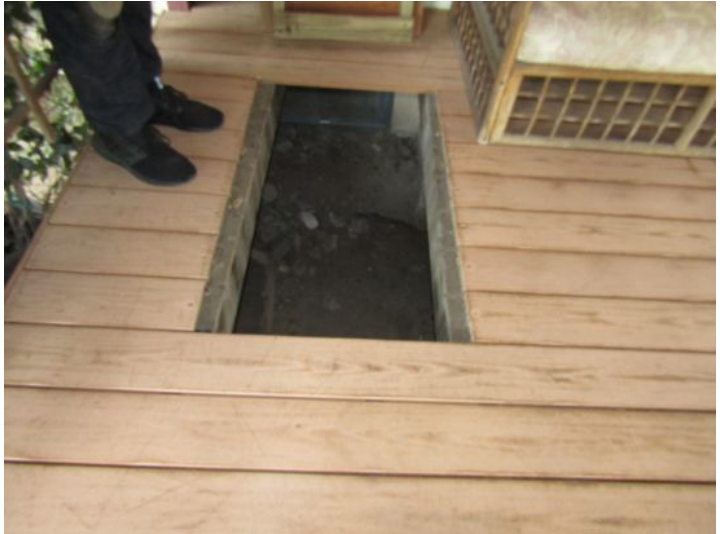
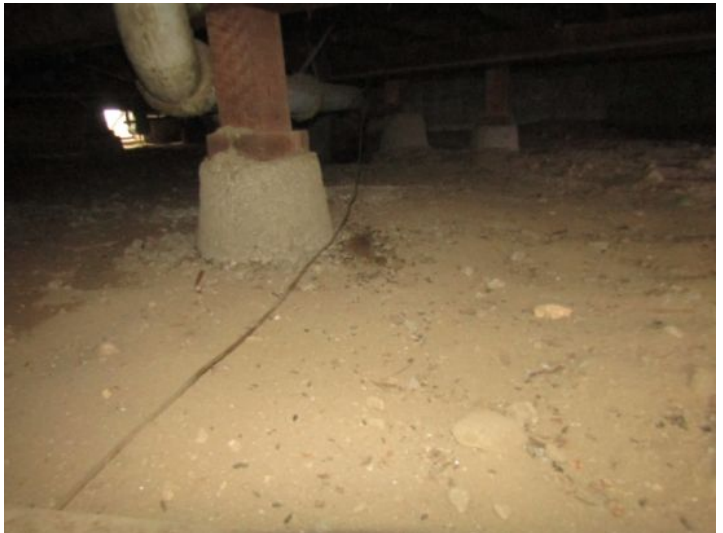
rodent trap present

rodents droppings present

| Roof Area | | |
|---|---|---|
| Page 43 Item: 3 | Access | rodents droppings present |

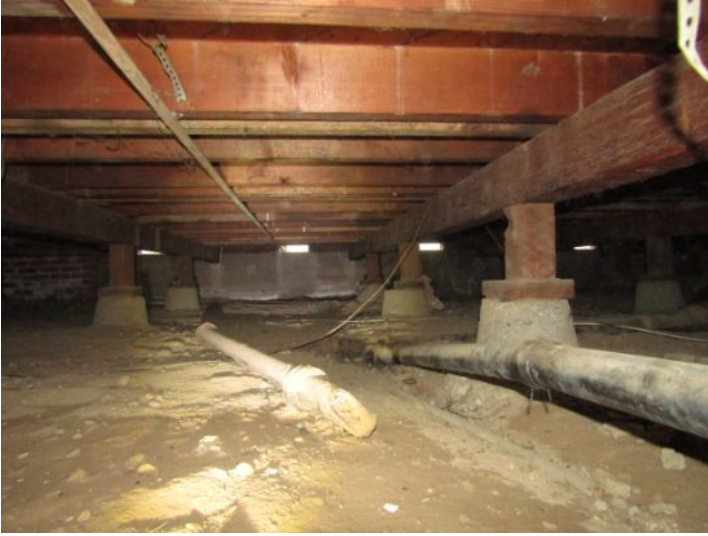
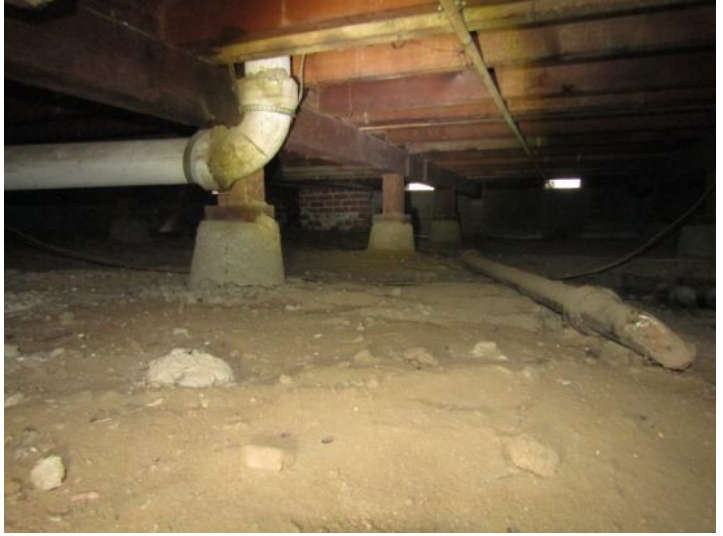
Observations: recommend T-Straps at the post and girders, off center post

off center post

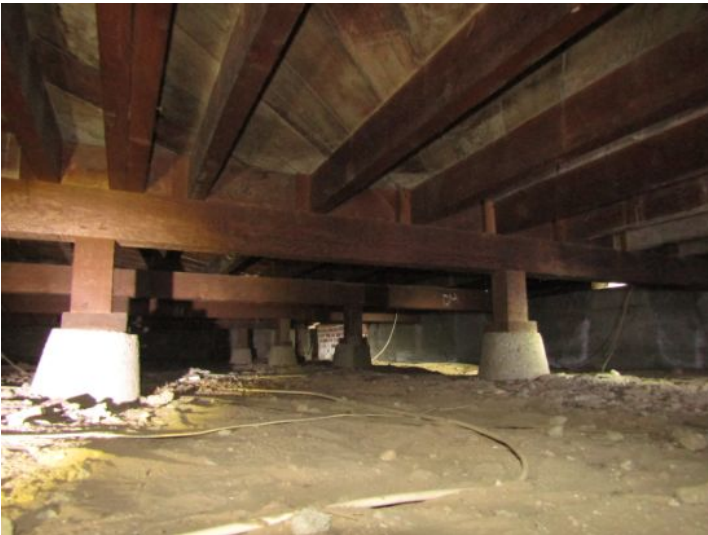
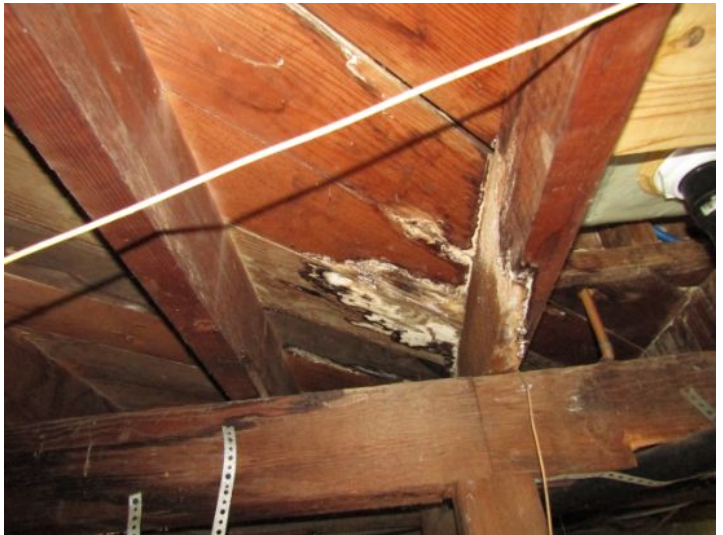
Observations: good, stained in areas, **deteriorated wood in areas, consult termite report on all wood area**

deteriorated wood in areas

| Roof Area | | |
|---|---|---|
| Page 44 Item: 7 | Sub Flooring & Joist | deteriorated wood in areas, consult termite report on all wood area |

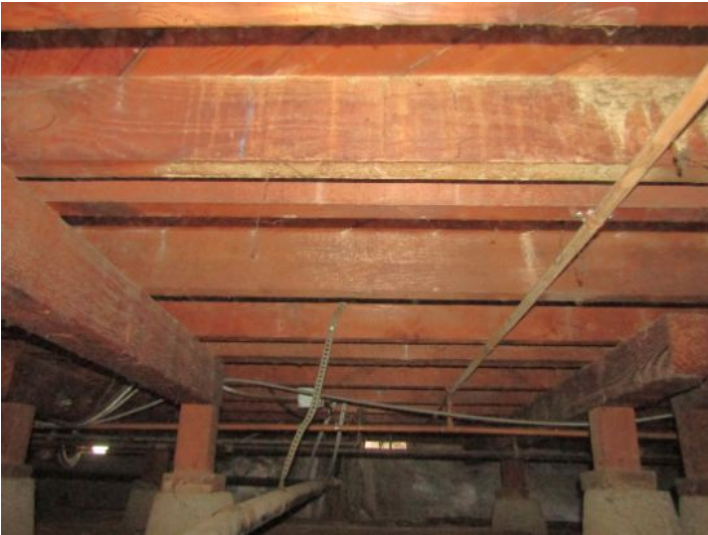
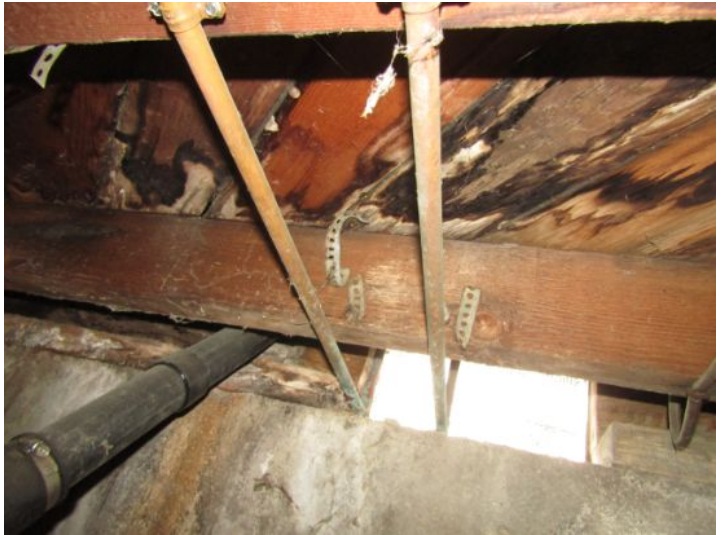
deteriorated wood in areas

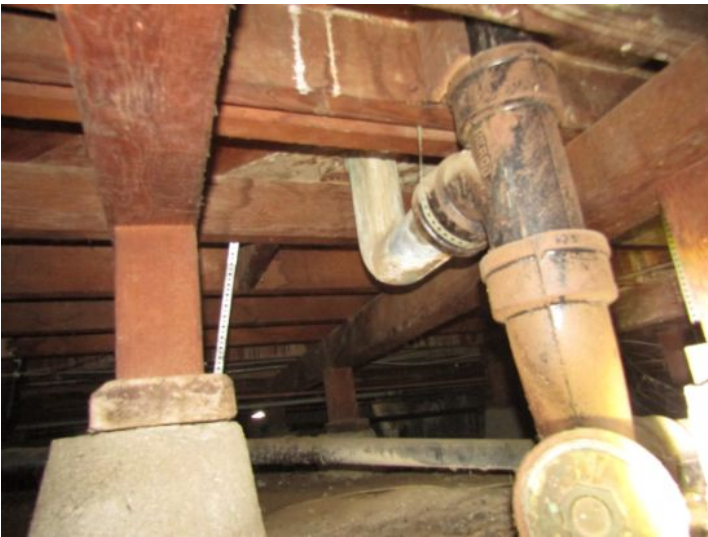
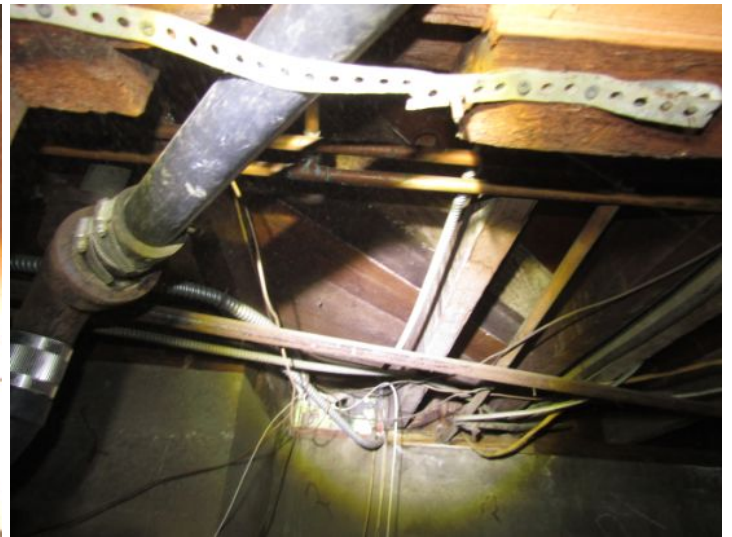
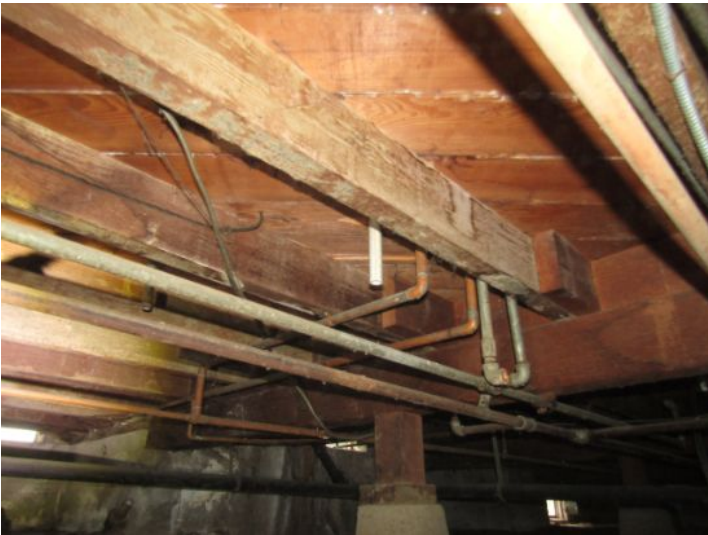
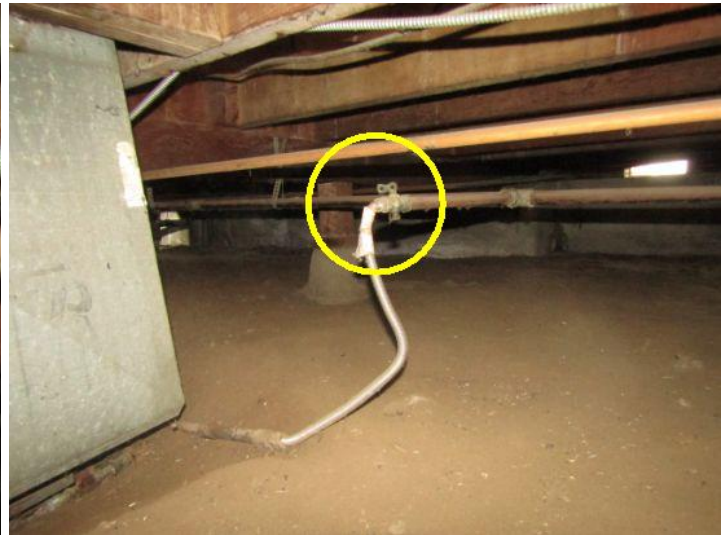
Observations: functional, recommend capping old floor heater gas line, corrosion present, old pipes present

recommend capping old floor heater gas line

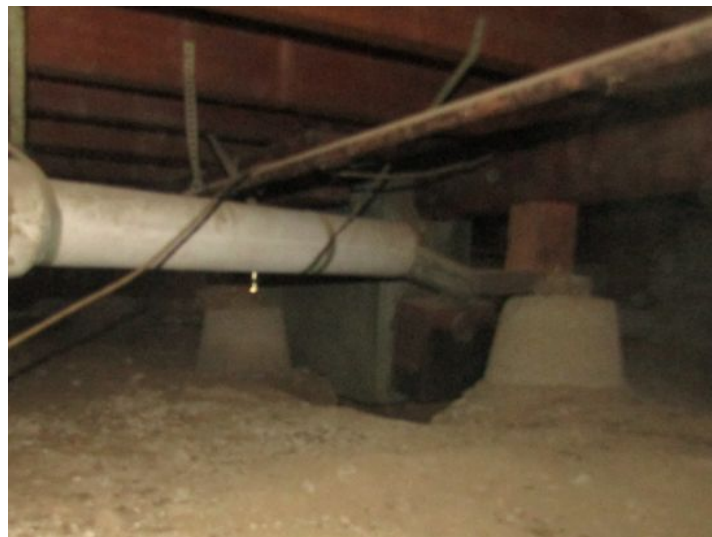
Observations: none, old floor heater present

old floor heater present

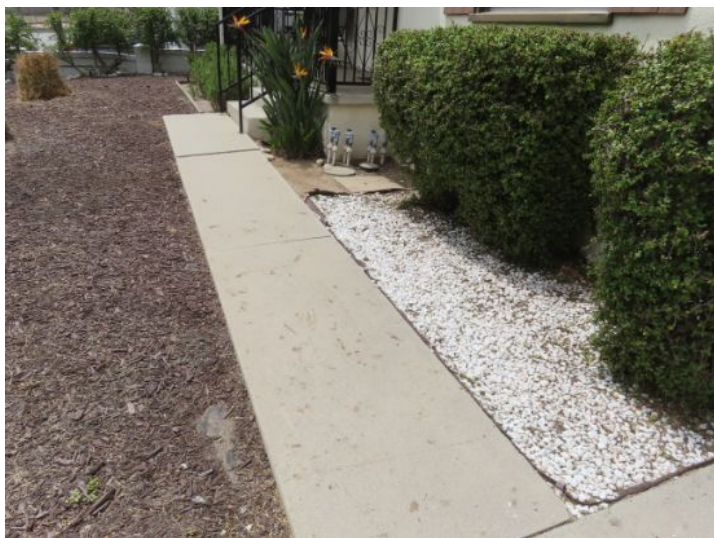
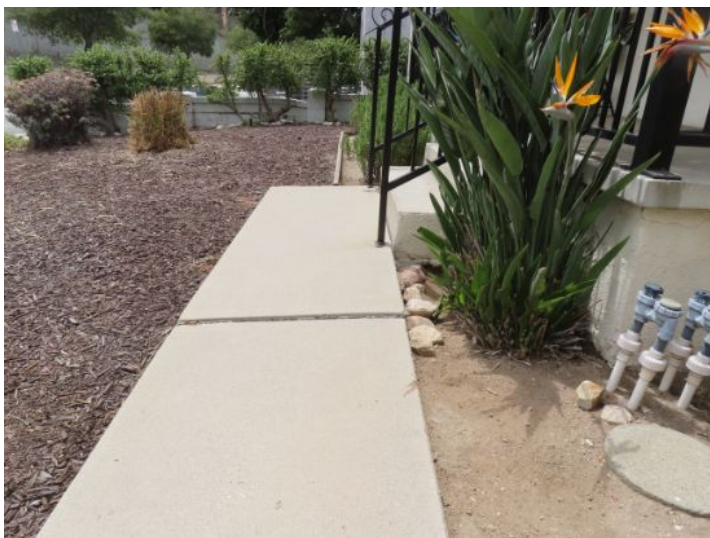
Observations: stained, lifting

lifting

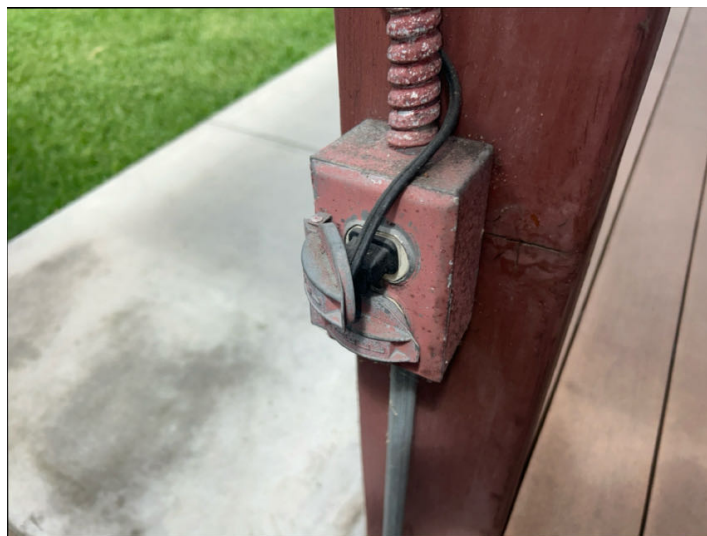
Observations: **recommend -GFCI on all exterior outlets**

recommend -GFCI on all exterior outlets

| Roof Area | | |
|---|---|---|
| Page 52 Item: 8 | Exterior GFCI Outlets | recommend -GFCI on all exterior outlets |

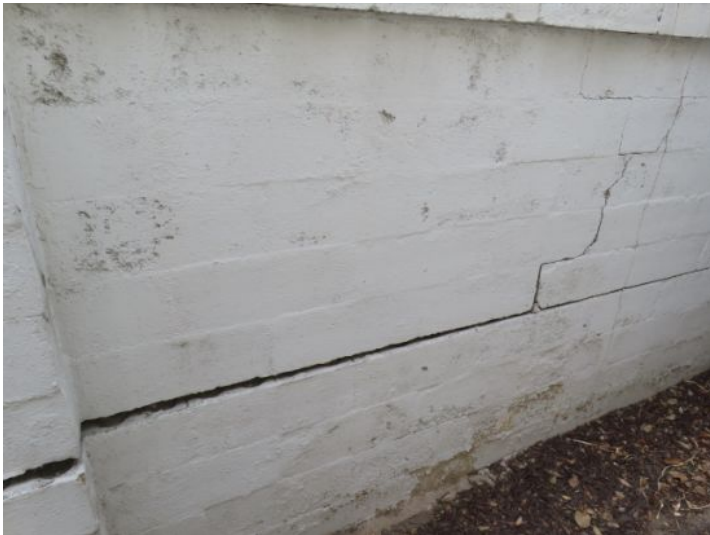
Observations: limited inspection, weathered, separating cracks, foliage prevented complete inspection, leaning

separating cracks

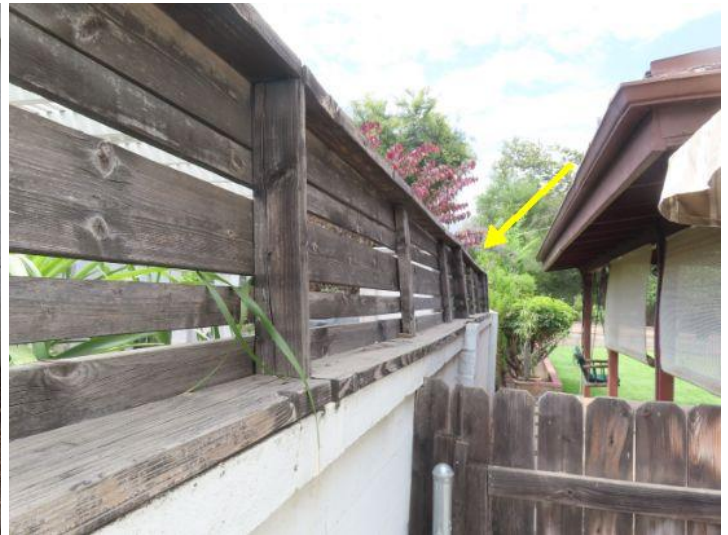
leaning

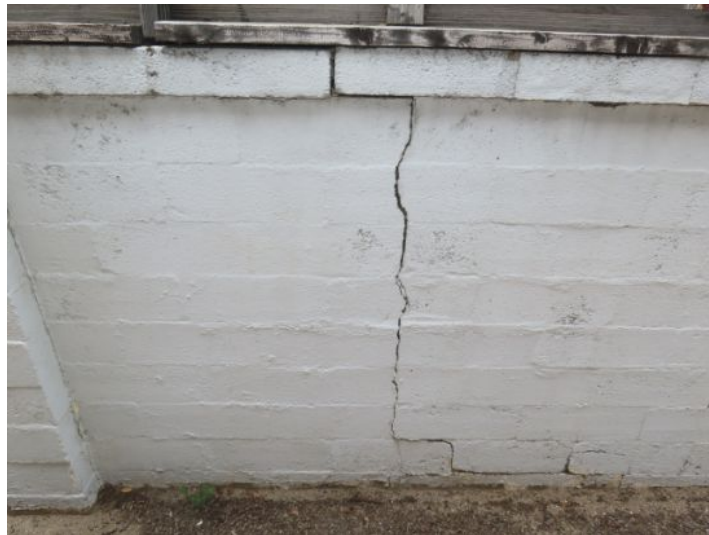
separating cracks
