# *Accurate Inspection Team LLC*

## Property Inspection Report

2837 Estado St, Pasadena, CA 91107  
Inspection prepared for: Cher Works & Steve works  
Real Estate Agent: Pete Whan - Pete Whan & Associates

Date of Inspection: 7/20/2026 Time: 2:00 pm  
Age of Home: 1938 Size: 1,344 sqft  
Weather: Sunny & Hot

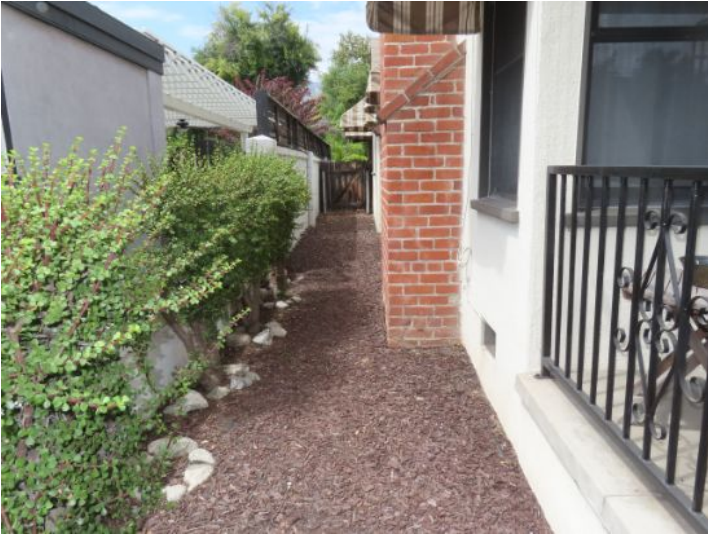
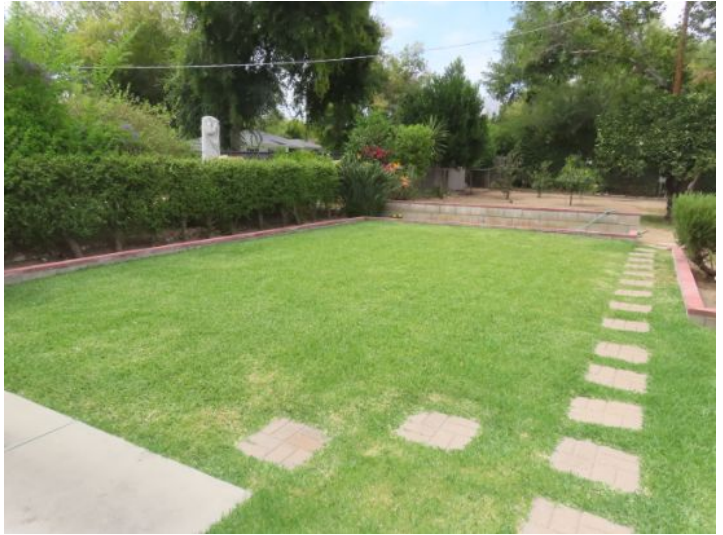
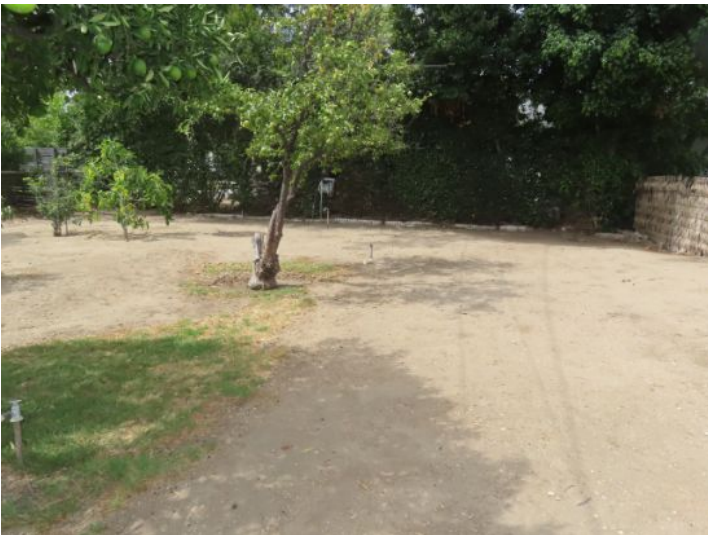
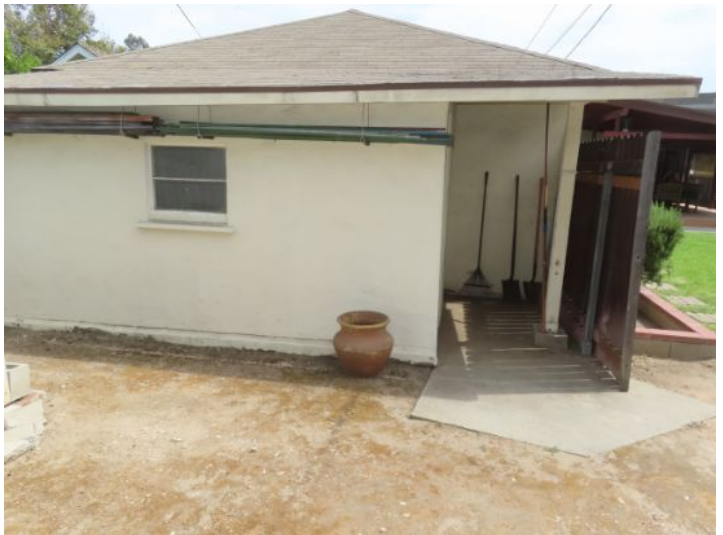
Observations: no drains visible, **grade slopes toward structure in areas, recommend diverting water away from the structure**

grade slopes toward structure in areas,  
recommend diverting water away from the  
structure

| Roof Area | | |
|---|---|---|
| Page 54 Item: 11 | Exterior Grading | grade slopes toward structure in areas, recommend diverting water away from the structure |

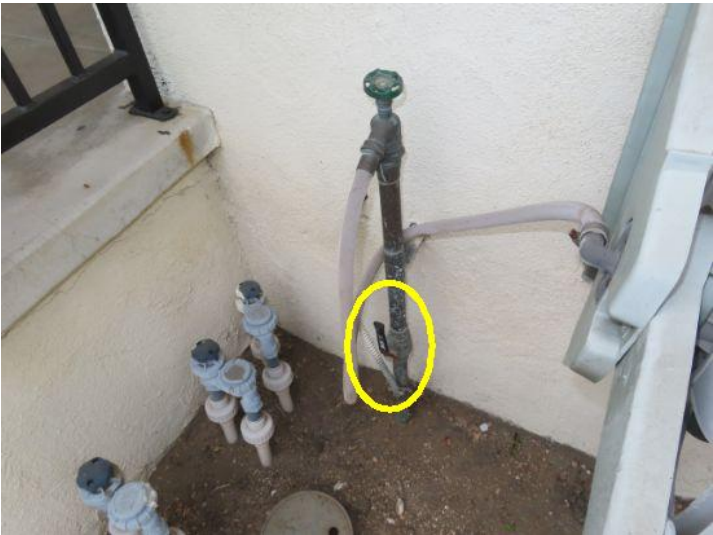
main water shut off

Observations: functional, worn valve, rusted handle
