**EXECUTIVE INSPECTIONS***An Independent & Certified, Residential & Commercial, Property Inspection Company*

8840 DUVAL LANEHEMET, CALIFORNIAInspection Date 07/14/2026Inspection Time 10:30 AM\*\*\* Special  
Instructions: \_\_\_\_\_Owner ROBIN FOURNIERAddress 8840 DUVAL LANECity HEMETTelephone ( 858 ) - 869 - 5110Inspector REGGIE IIPaid By ROBIN FOURNIER**Payment Method:** Zelle: Paid In Full ☒Credit Card Trans or Check # ☐ \_\_\_\_\_To Be Paid On Delivery or Mailed: ☐**Buyer Agent:**N/A

# EXECUTIVE INSPECTIONS REPORT

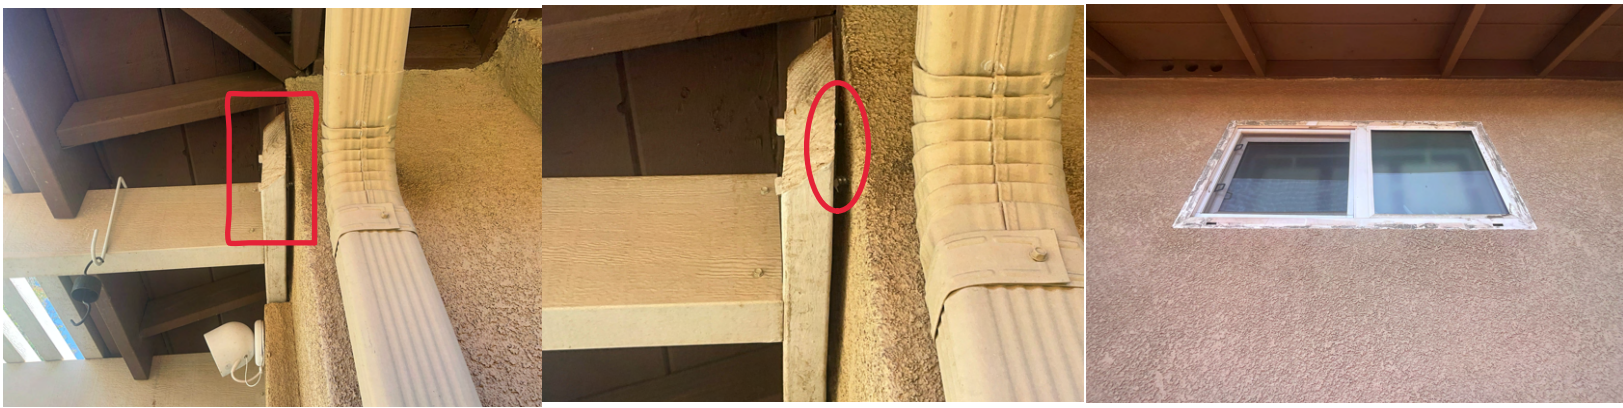
SERVICE ADVISED: RECOMMEND TIGHTENING PATIO COVER ANCHOR BOLTS AT CONNECTION TO HOUSE SHOWING THREADS ..... & ..... TOUCH UP SERVICE AT SOME WINDOW TRIM SHOWING SIGNS OF WEAR ( COSMETIC )

SERVICE ADVISED: RECOMMEND TIGHTENING  
PATIO COVER ANCHOR BOLTS AT CONNECTION TO  
HOUSE SHOWING THREADS.

RECOMMEND TOUCH UP SERVICE AT SOME WINDOW TRIM SHOWING  
SIGNS OF WEAR ( COSMETIC ).

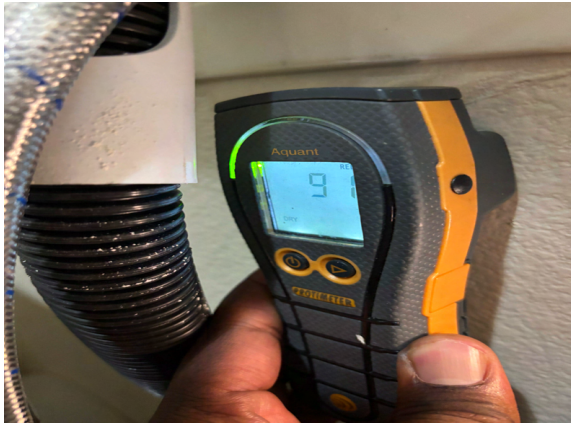
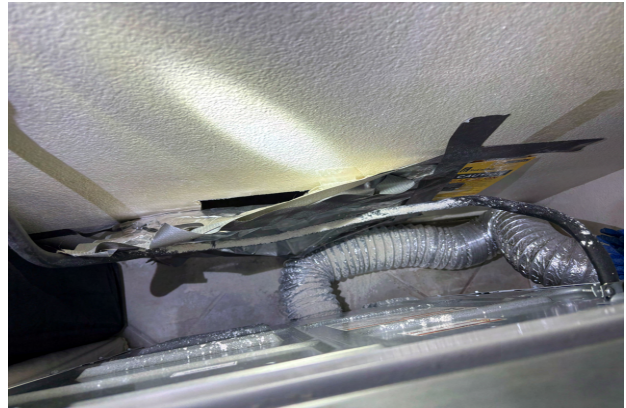
SERVICE ADVISED: RECOMMEND DRYWALL TOUCH UPS FOR EVIDENCE OF WEAR AT PAST LEAKAGE NEAR LAUNDRY WATER SERVICE ( DRY ) AND DRYWALL PATCH FOR WALL OPENING NEAR DRYER

☒ 110 VOLT ☒ 220 VOLT SERVICE ADVISED: RECOMMEND DRYWALL TOUCH UPS FOR EVIDENCE OF WEAR AT PAST LEAKAGE ( DRY )

SERVICE ADVISED: RECOMMEND DRYWALL PATCH FOR WALL OPENING NEAR DRYER

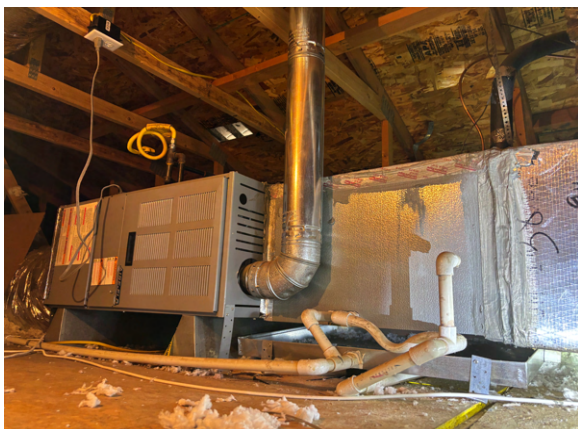
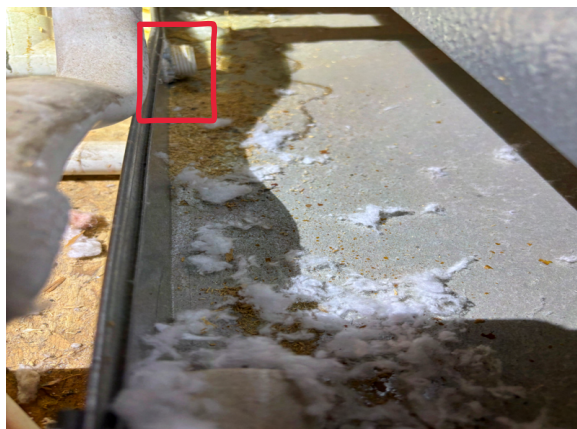
RECOMMEND CLEANING FOR EXCESS DEBRIS AT ATTIC CONDENSATE OVERFLOW PAN ( CAN CLOG PVC DRAIN LINE )

RECOMMEND CLEANING FOR EXCESS DEBRIS AT ATTIC CONDENSATE OVERFLOW PAN ( CAN CLOG PVC DRAIN LINE ).

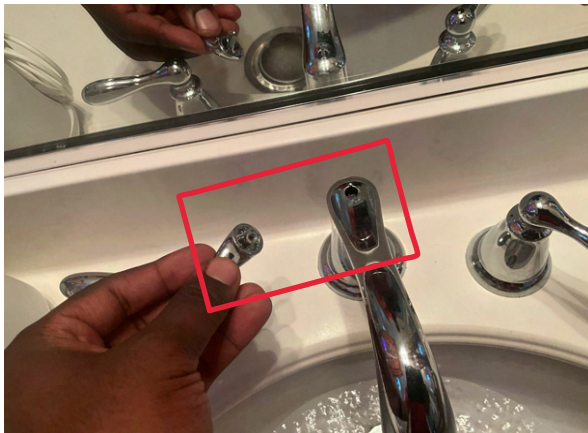
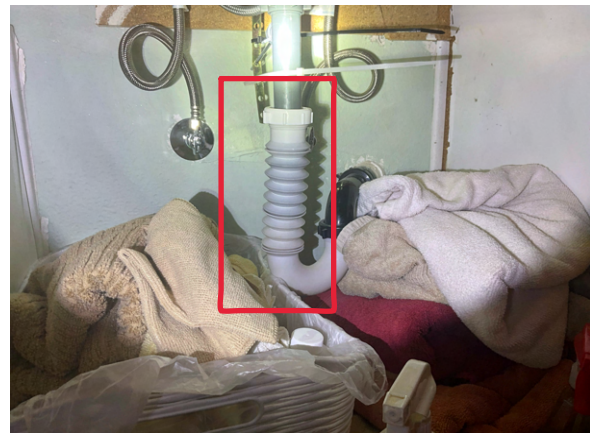
PLUMBER ADVISED: DUE TO LOOSE SINK STOPPER HANDLE AND SLOW DRAINAGE AT LEFT SINK CORRUGATED DRAIN PIPE ( MASTER BATHROOM )

| EXECUTIVE INSPECTIONS REPORT | | | | | | | | | |
|---|---|---|---|---|--|--|--|--|--|
| MASTER BATHROOM | | PLUMBER ADVISED: DUE TO LOOSE SINK STOPPER HANDLE, SLOW DRAINAGE AT LEFT SINK CORRUGATED DRAIN PIPE ( KNOWN TO CLOG ) AND TUB SHOWER DIVERTER NOT FULLY SEPARATING FLOW. | | | | | | | |

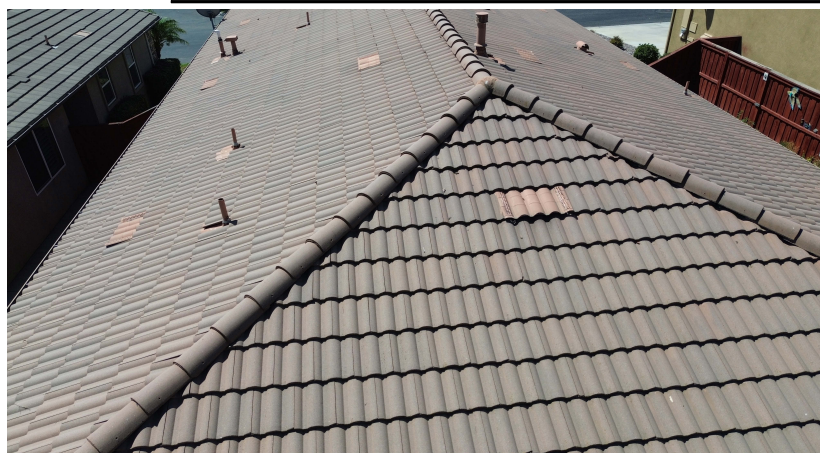
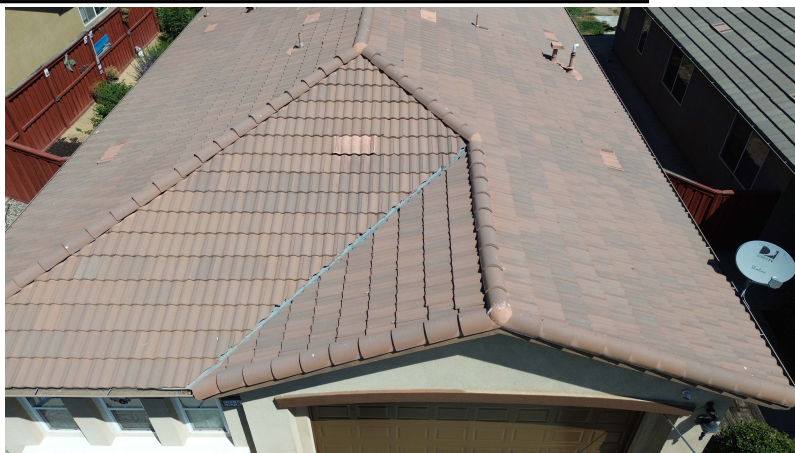
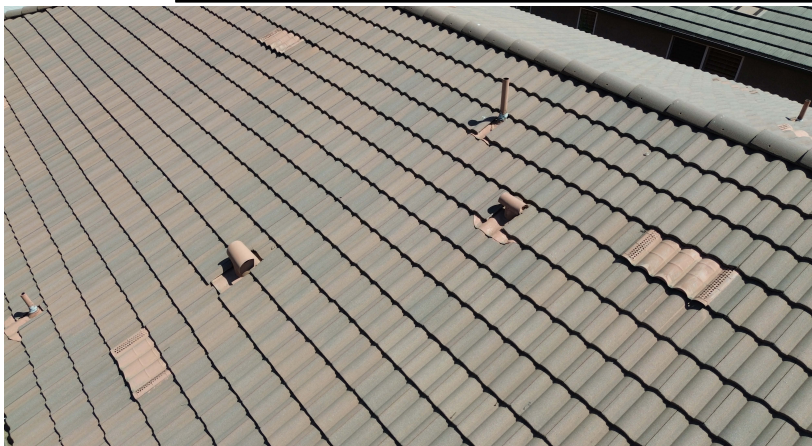
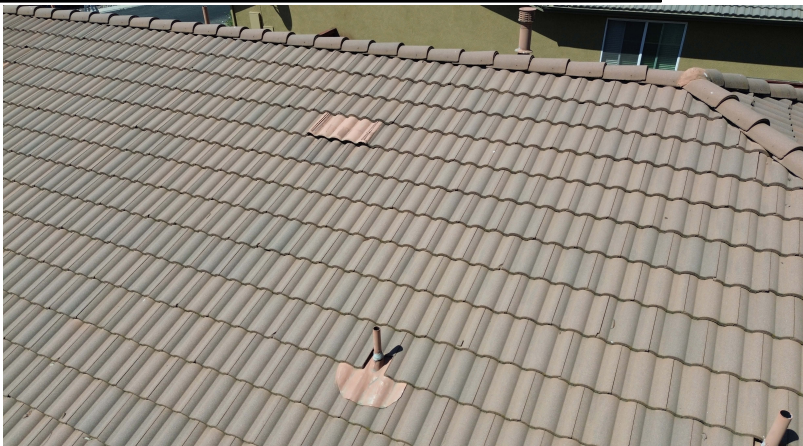
ROOF PHOTOS FOR YOUR RECORDS

ROOF PHOTOS CONTINUED
